ORNL/TM-2001/7

Montezuma Creek Stability Evaluation at Site of Former Monticello Tailings Pile

Final Report

Date Published: January 2001

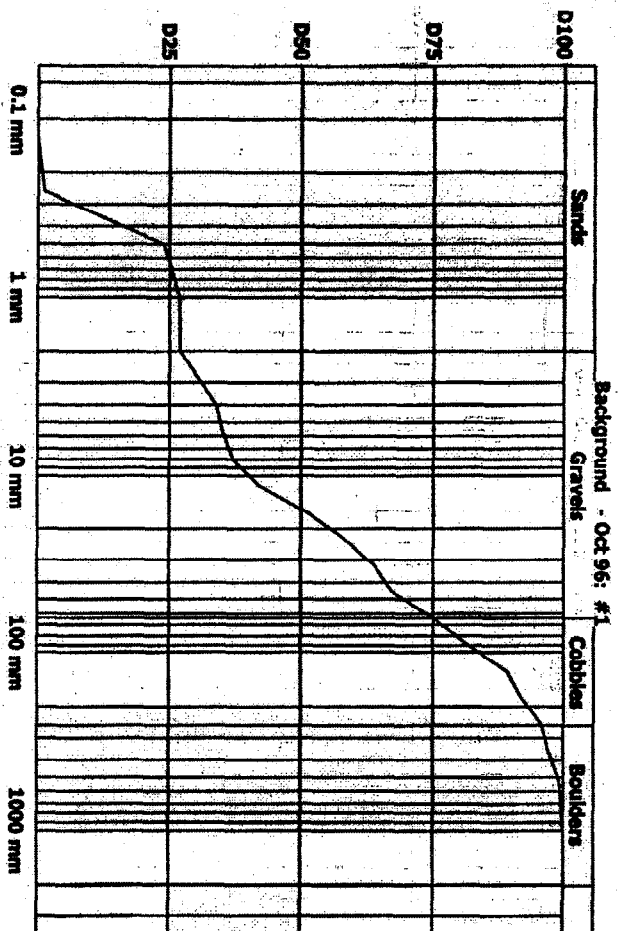
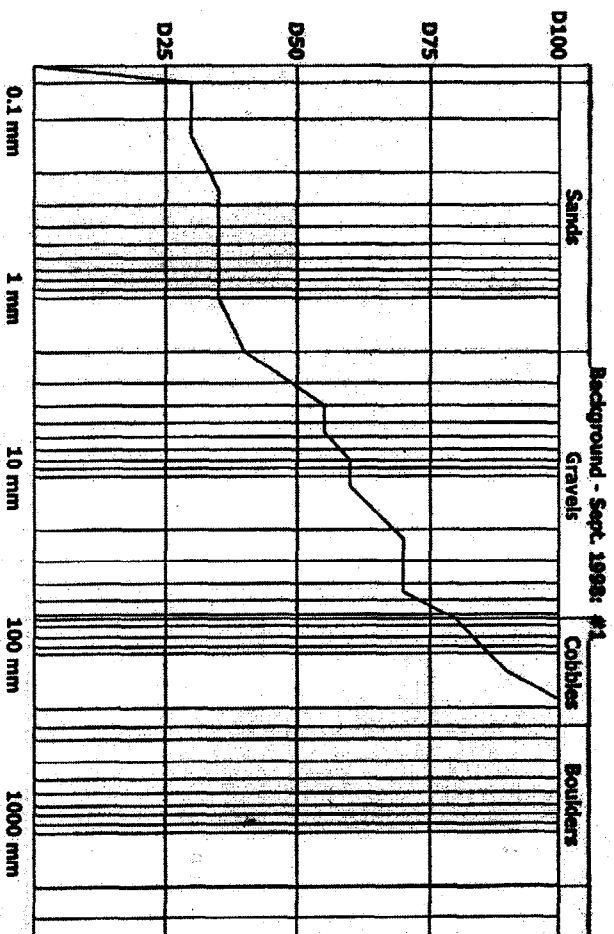
Fig. 3.2. Pebble count data from background site.

6. **D/25, D/50, D/75**—These data are taken from the pebble count. The D/50 is the median particle moved by the stream and is used in the classification table in Fig. 1.1. Streams with a D/50 of sand or gravel are much more productive biologically than those with a silt and clay substrate because the latter prevent light penetration and air exchange. Data from the background site (Fig. 3.2) indicate that gravel is the natural D/50 for Montezuma Creek.

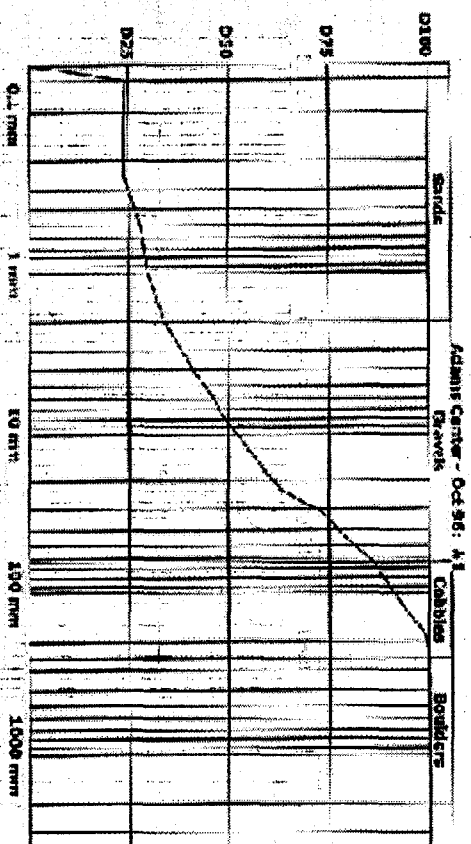
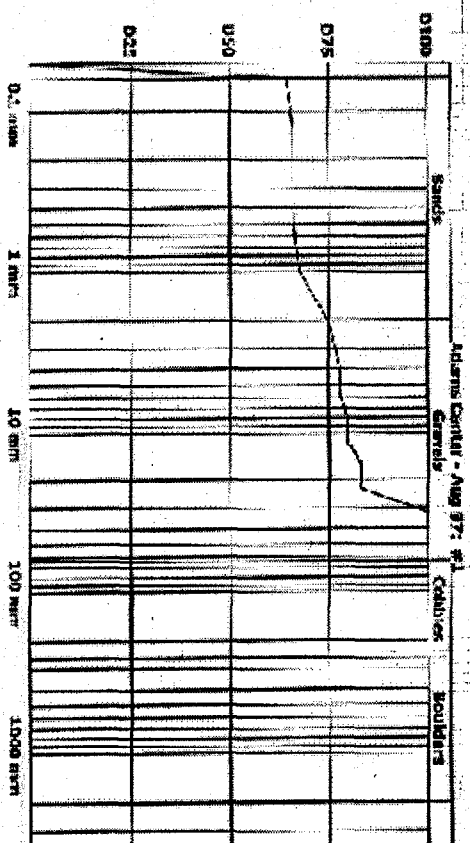
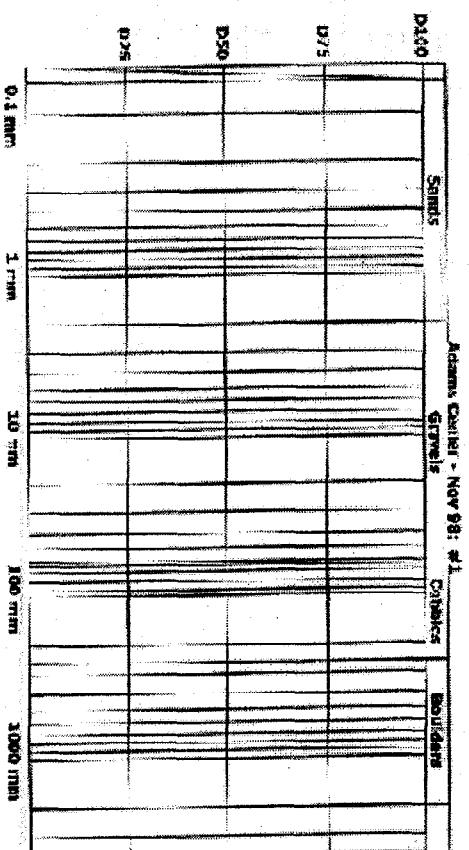
Fig. 3.3. Pebble count data at the Adams cross section.

The pebble count also yields a determination of how the stream bottom varies year-by-year. An increasing accumulation of silt and clay indicates increased bank erosion and/or an altered flow regime. In 1996, the D/50 for the Adams center location was a gravel just as at the background location. However, in 1997 and 1998, the D/50 at the Adams center location became a silt/clay (Fig. 3.3). This change indicates that the gravels have become covered with fine sediment, an indication of a significant increase in sediment supply. In addition, although a silt/clay substrate was identified in both 1997 and 1998, field notes indicate that additional fine sediment had accumulated in 1998 such that the total depth of fine sediment was approximately 8 in.

The D/75 is used to estimate the largest particle moved at the bankfull stage. Again, the results show deterioration in stream competence during the remediation period. For example, the D/75 at the Adams cross section, MZ-2, and D. S. Owl Barn all changed from gravel or sand to silt-clay during the course of these surveys. These data demonstrate that sediment supply was increased and flow competence decreased during 1997 and 1998 when remediation was at its peak. The Adams and MZ-2 sites have not recovered, but there may be a significant contribution of fine sediment from the land use at the Adams site.

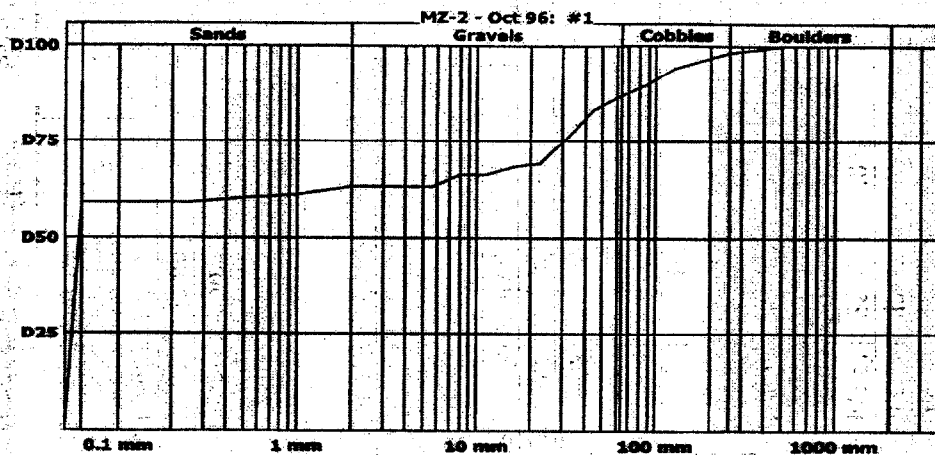
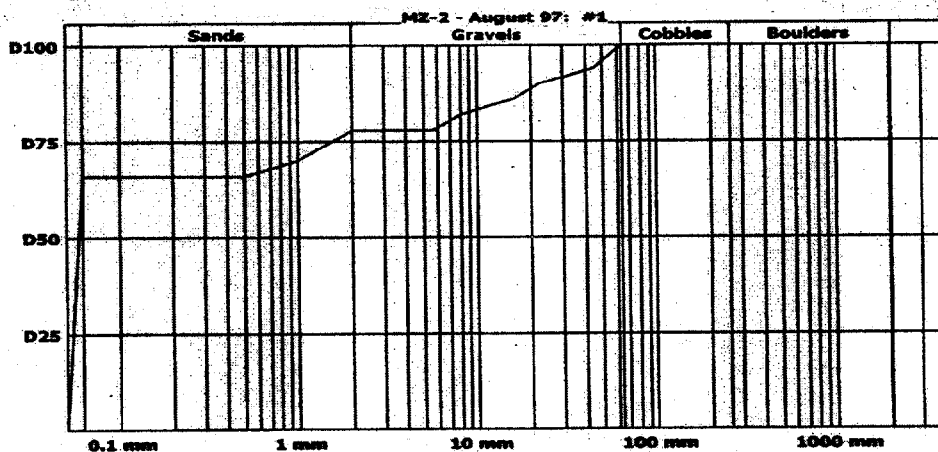
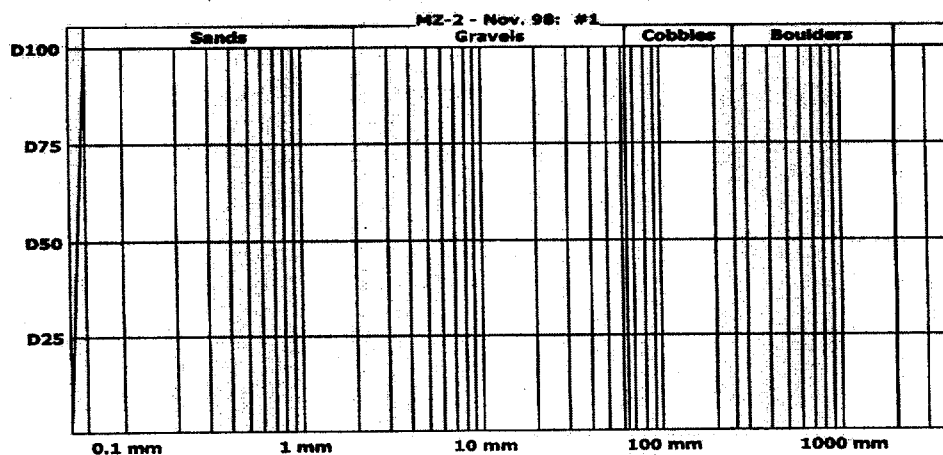
Fig. 3.4. Pebble count data at the MZ-2 cross section.

The MZ-2 site had a silt-clay substrate during each survey (Fig. 3.4). Figure 3.4 shows data through 1998, but the 1999 and 2000 surveys indicated no change from 1998. Through 1998, the D. S. Owl Barn location showed the same effects as the Adams site in that the D/50 went successively from sand or gravel to silt-clay (Fig. 3.5). In 1999 and 2000, however, the pebble count for the D. S. Owl Barn site again has a D/50 of gravel with the graph's appearance much like the August 1997 data in Fig. 3.5. The confluence location, as at the background site, shows little change during the survey period (Fig. 3.6). The data for July 2000 at the confluence site are virtually identical to the 1998 data shown in Fig. 3.6.

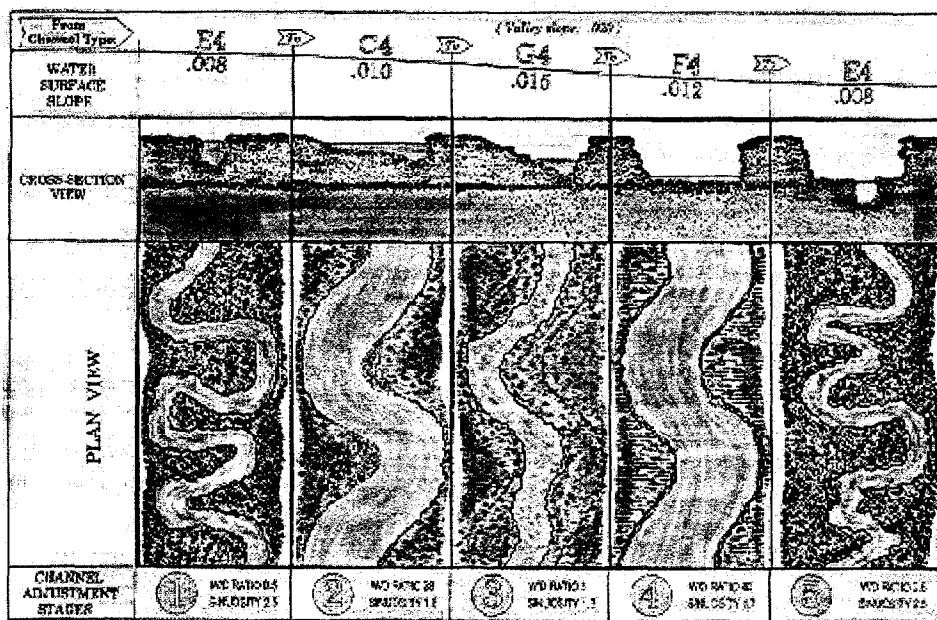
8. Type—The data in Table 3.2 are collectively used to determine the geomorphic stream type using the scheme from Fig. 1.1. The data demonstrate that the background location is a B4, as compared to the confluence location, which is an E4 or E5. The B and E stream types are typical, natural stream types for the terrain through which Montezuma Creek flows. The background location is less entrenched and less sinuous with a somewhat higher slope, hence the B stream type. The confluence location is in a flat plain where more sinuosity and lower slope result in an E stream. The Adams, MZ-2, and D. S. Owl Barn locations all would be expected to be E streams based on the data from the confluence and the background locations. Instead, C and F classifications were usually found. As demonstrated by Rosgen (1994), when an E stream deteriorates, it initially may grade as a C before becoming an F (Fig. 3.7). An F-stream is a highly entrenched stream with unstable banks on both sides.

Fig. 3.7. Successive changes undergone by an impacted E stream (Rosgen 1994).
