Metals and Ceramics Division

**Correlation of Process Data and Electrochemical Noise to Assess Kraft Digester
Corrosion: Spring Grove Experiment**

‡Glatfelter Company, Spring Grove, PA

Date Published: April 2003

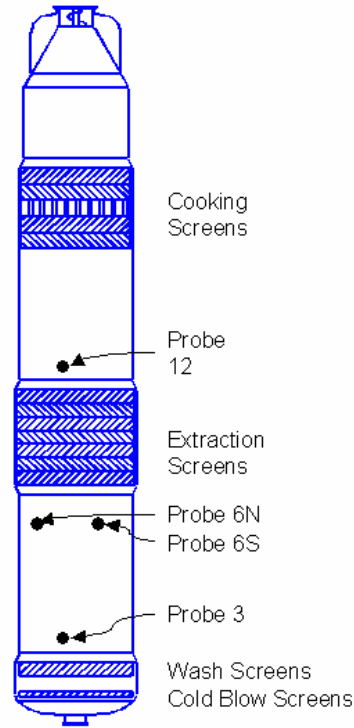
A schematic diagram of the Spring Grove digester appears in Fig. 1. The vessel is approximately 150 ft. tall and 12 ft. in diameter, and the relative positions of the ECN probes for this experiment are indicated on the schematic drawing. The number associated with each probe was determined from the ring section number of the shell it represents and, in the case of the two probes at a single elevation, the further notation “N” and “S” describes the relative side of the vessel. The “N” designation indicates the probe on the northeast side of the vessel with approximately the same longitude as the service manway. The “S” designation indicates the probe in the southwest portion of the vessel almost directly across the vessel from the probe at the “6N” location. The probes at ring 3 and ring 12 have the same vessel longitude, which is only very slightly different from the longitudinal position of the probe at ring 6N. More information on the probes is given in a subsequent section.

Fig. 1. Schematic of the Spring Grove digester and probe locations.

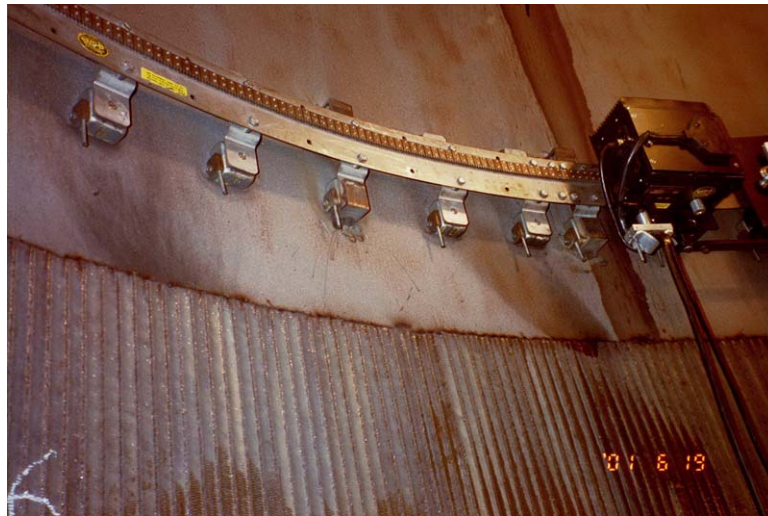
Following the visual inspection, the automated welding equipment was installed and the overlay activity on rings 5 and 6 commenced. The overlay material was type 309LSi stainless steel, applied automatically in overlapping vertical beads about 3/4 in. wide and 3/16 in. thick. Figure 13 shows the top edge of the weld overlay and the track for the automated welding equipment. The overlay applied in June 2001 covered the entire diameter from just below the

Fig. 13. Automated welding equipment and the top edge of the weld overlay area inside the digester. June 2001 overlay application.

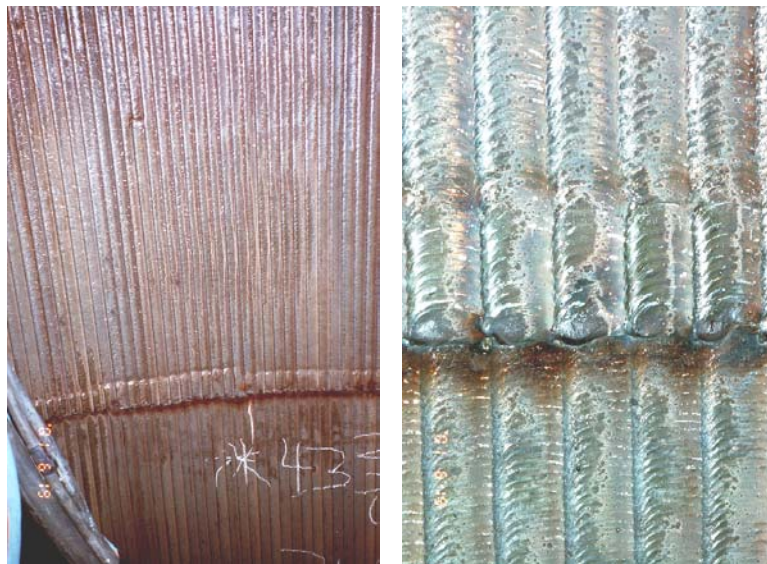
extraction screens to an elevation approximately 20 feet lower in the vessel. Figure 14 shows the region where the upper and lower overlay applications in June 2001 overlapped, and Fig. 15 presents one of the (few) minor repairs required after the overlay was completed but before the vessel was restarted.

Fig. 14. View of region where upper and lower overlay zones overlap. June 2001 overlay application.

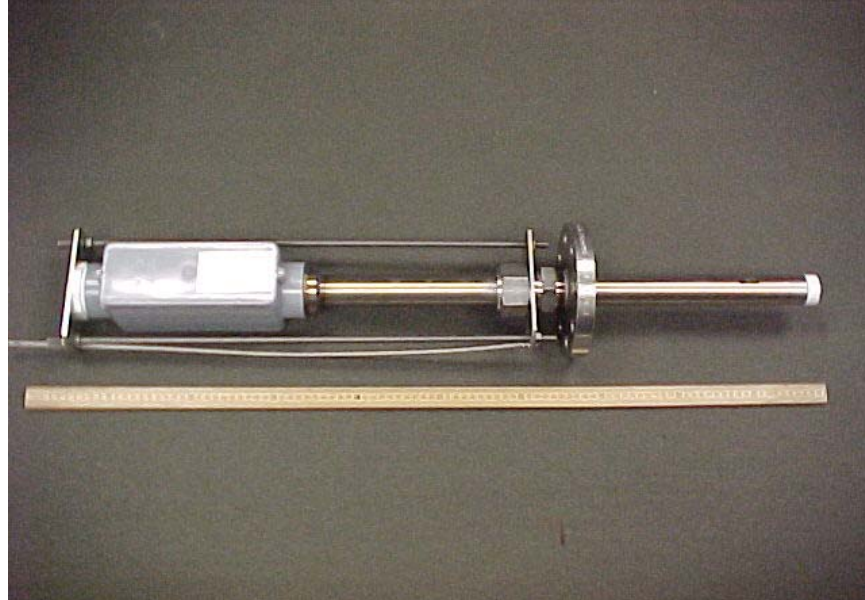
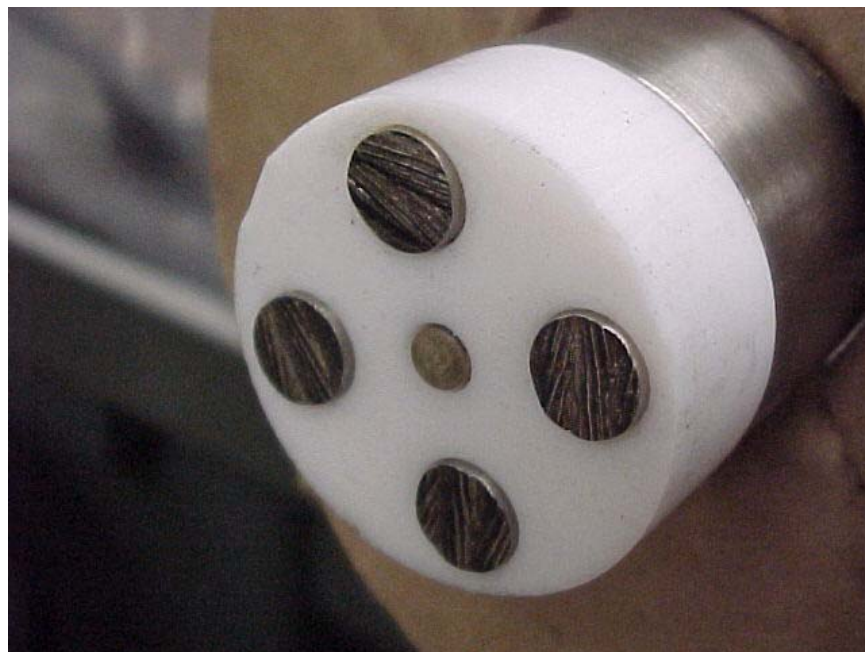
The probe bodies used in this experiment (see Fig. 16) were fabricated of 316L stainless steel with electrodes embedded in a teflon header. [No composition certification for the 316L probe bodies is available, but by specification limits 316L has 16-18 Cr, 10-14 Ni, 2-3 Mo, <2 Mn, <1 Si, and <0.03 C.] The probe was designed with an adjustable body length so that the surface of the working end could be placed precisely flush with the vessel ID at each probe location. The working end of the probe included two pairs of electrodes representing two materials – mild steel (type 1020) similar to the vessel construction material and 309LSi overlay similar to the overlay used on ring sections 5 and 6. The working end of the probe included a centrally located piece of silver to function as the reference electrode. To monitor temperature for each electrode, a thermocouple was located inside the probe about 3 in. behind the teflon header. [The probe design called for the thermocouple to be exposed is a sheath on the working face of the teflon header, but fabrication problems led the manufacturer to move the thermocouple. Additional detail appears in section 3.3.3.]

Fig. 16. Adjustable length dual probe used in the Spring Grove experiment. At top, the overall probe is shown. At bottom, a close-up of the teflon header with electrodes is shown. In the probe shown here, all four electrodes are overlay material (two each of types 309LSi and 312 stainless steel, which was the new probe installed at Spring Grove) but for the probes discussed in this report, two electrodes were 309LSi and two were type 1020 mild steel.

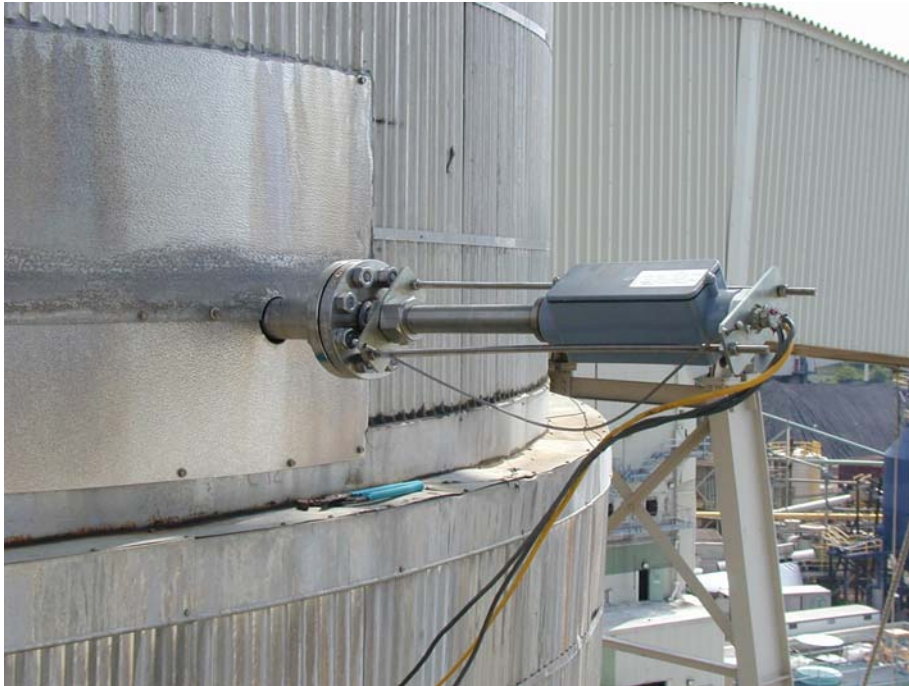
Figure 17 shows an installed probe as it appears from outside the vessel. The box at the end of the probe contains the terminal strip for making electrical connections to the electrodes. The wires from each probe run to a central collection point near the digester control room, where the data processing equipment and computer were located.

Fig. 17. View of installed probe (with insulation pulled away). This particular probe is the ring 6N location. The box at the end of the probe contains electrical connections to the electrodes.

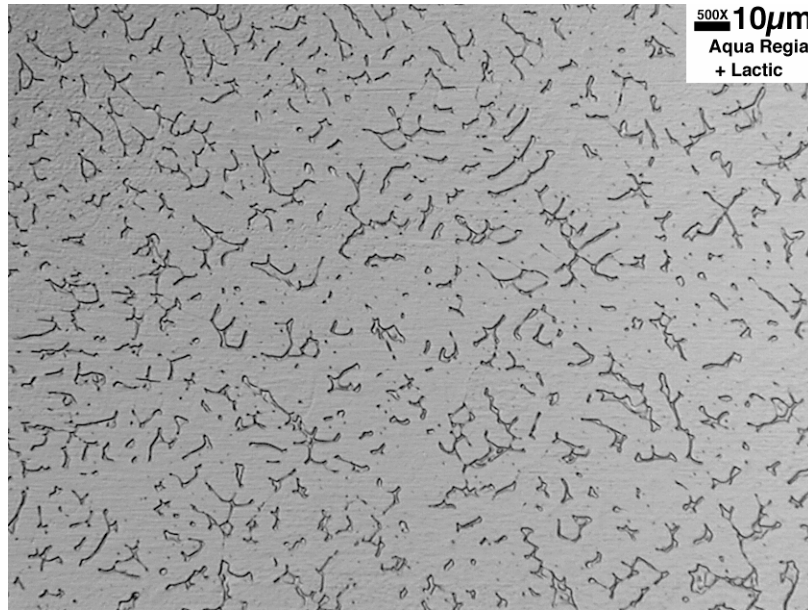
Fig. 19. Cross section of laboratory prepared 309LSi overlay showing residual ferrite in an austenite matrix. The ferrite content and morphology was relatively uniform throughout this specimen.

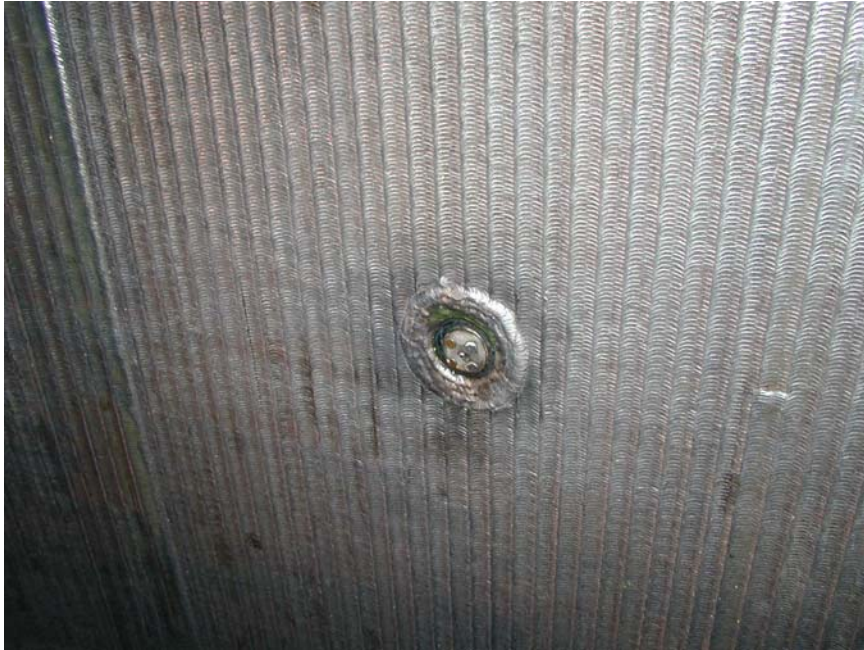
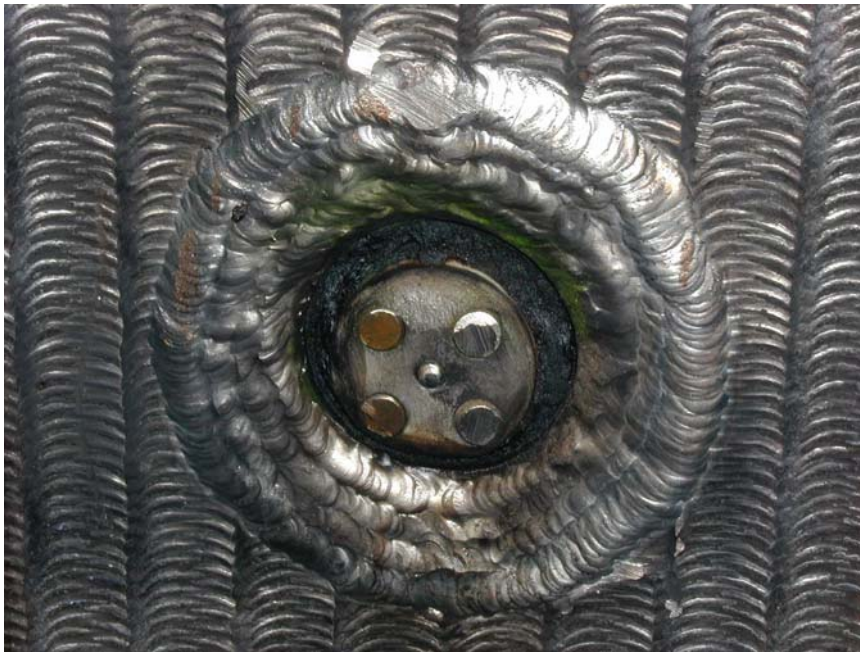
Due to the application of the new overlay on rings 3 and 4 at the beginning of the maintenance outage, a photographic record of the condition of the steel surfaces at/around the position of the ring 3 probe immediately after the year-long test period was not collected. Figure 21 shows the region around the ring 3 probe with the new overlay already in place.

Fig. 21. Digester shell near/around the ring 3 probe following the application of additional 309LSi overlay. Photo from the June 2002 inspection; overlay applied just prior to inspection.

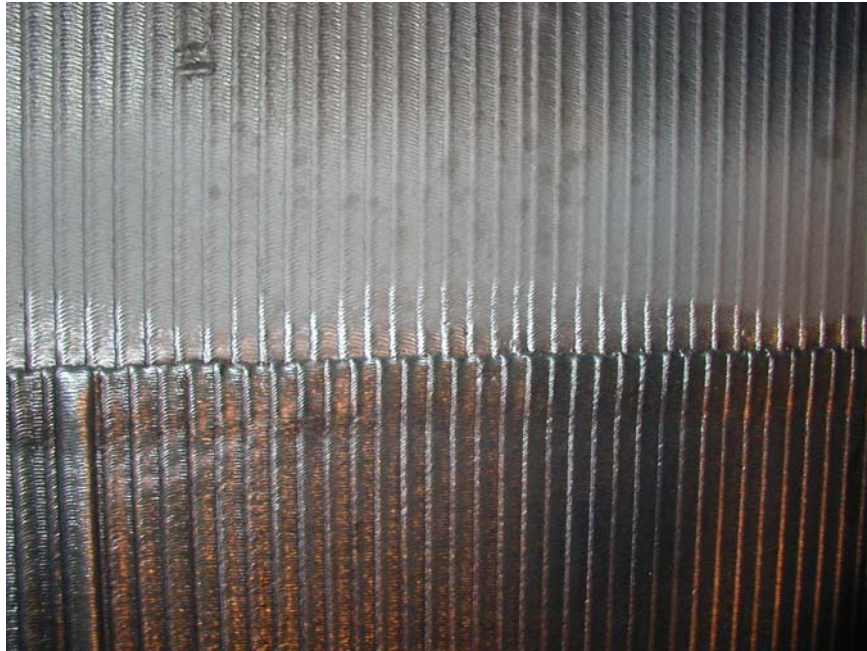
Figure 22 shows the intersection of the year-old overlay with the new overlay material. In this lighting, the older overlay has a slightly dull cast compared to the fresh “heat tint” appearance of the new overlay. However, thickness measurements and visual inspection suggest that the overlay in service for one year is essentially unchanged from its as-deposited condition. In particular, the solidification ripples and surface profile of the year-old overlay and the new material are essentially identical.

Fig. 22. Intersection of the 309LSi overlay applied on rings 5 and 6 in June 2001 (top portion) with the overlay applied in June 2002 to rings 3 and 4.

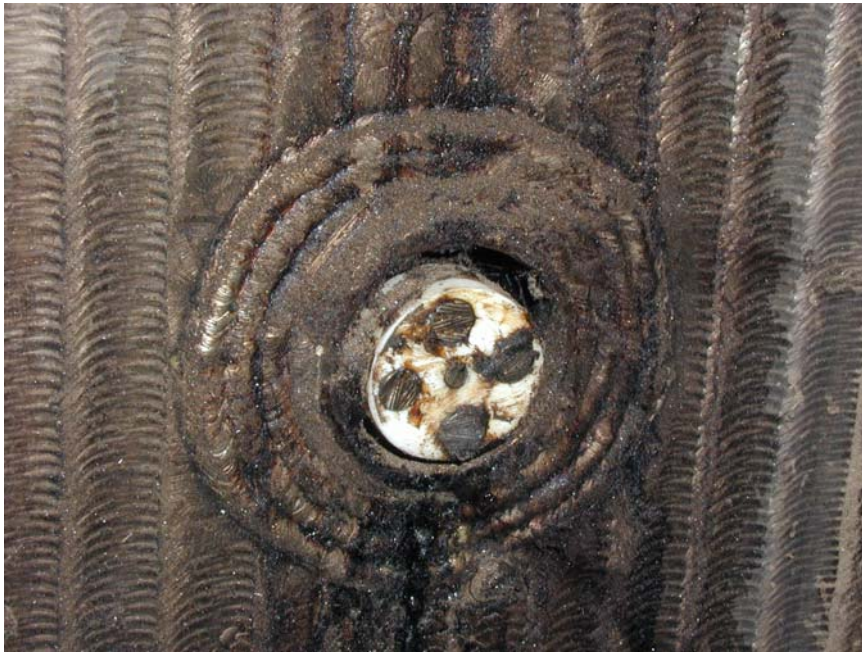
Figures 23 and 24 show the ring 6N and ring 6S probe ports, respectively. The overlay at this elevation is in generally excellent condition, although in limited areas the sharp detail of the solidification ripples seems slightly lost due to minor erosion/wash. There was no obvious difference in performance of the overlay on the opposite side of the vessel at this elevation.

Fig. 24. ECN probe in the ring 6S port. Photo from June 2002.

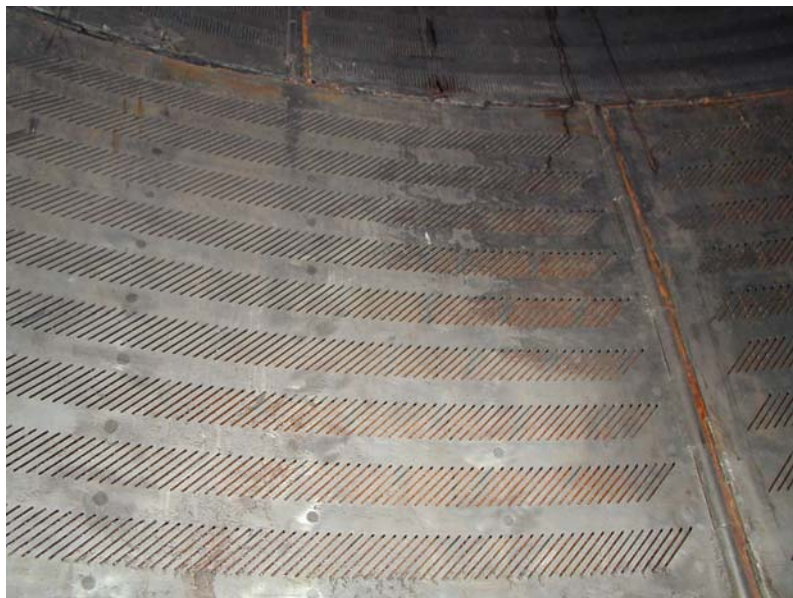
Figure 26 shows a new extraction screen design installed during the 2001 outage. The intent is that the angled screen slots improve the wiping action of the chip mass to minimize clogging of the screens.

Fig. 26. New extraction screen design (slots at an angle).

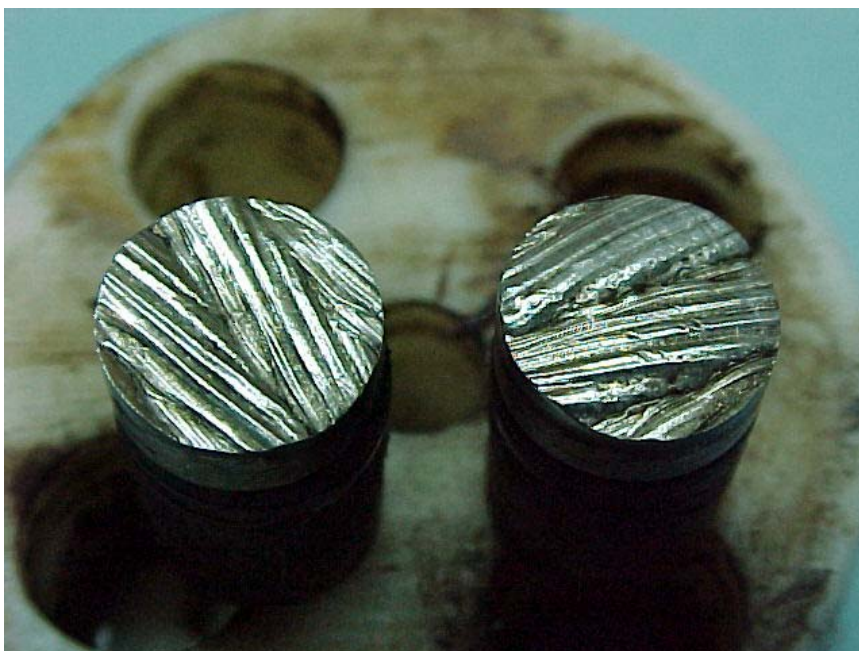
Figure 31 shows the working end of the ring 6N probe following the year-long exposure, which included the inhibited acid cleaning received by the vessel internals and light water rinsing. The 309LSi electrodes appear largely unaffected by the exposure, but it is clear that the mild steel electrodes have some corrosion product accumulation and have been significantly attacked. In addition, the teflon header appears to have fared quite well during the exposure. The absence of attack on the 309LSi specimens is confirmed by the close-up view in Fig. 32 – the surfaces of the electrode exposed to the process remain bright and shiny with the weld solidification ripples retaining much detail. The mild steel electrodes were severely attacked, but as shown in Fig. 33

Fig. 32. Close-up of 309LSi electrode specimens from ring 6N probe.

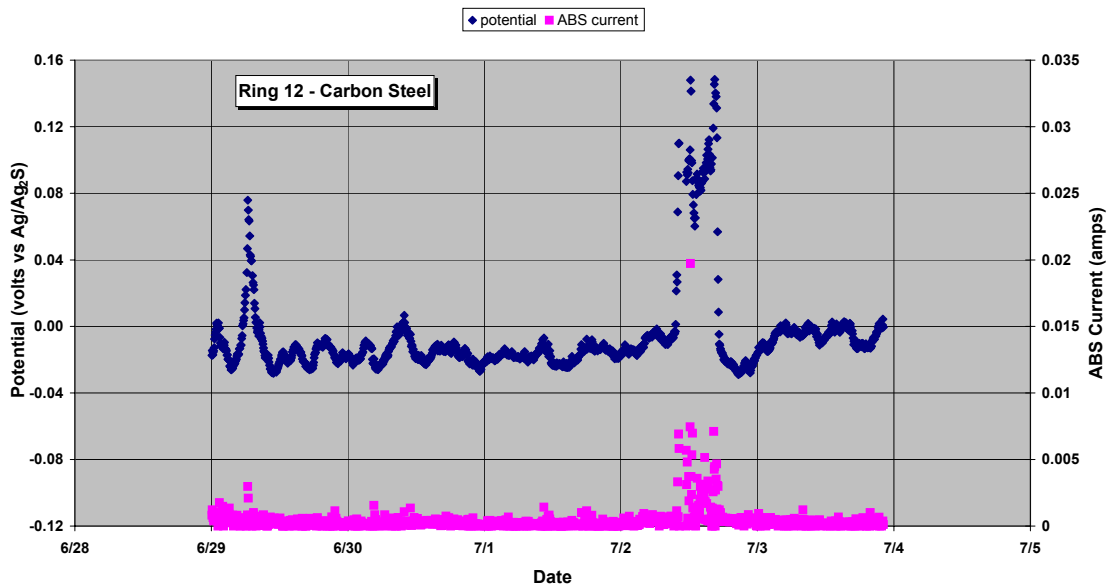
Figure 35 is representative of the ECN behavior of the steel at ring 12 early in the experiment. Note that the potential is relatively constant with only two significant deviations. On 6/29, the potential increases to a maximum of about 100 mv greater than the nominal value but has almost no current activity above the baseline level associated with this event. On 7/2, there is even a larger (magnitude and duration) potential increase for which there is a coincident modest current change. Although the absolute value of current is plotted here, it is significant to note that the steel at ring 12 showed no current bias – that is, neither electrode preferentially became anodic to the other and the current fluctuated randomly about the value of zero and continued to do so until very late in the exposure.

Fig. 35. Representative ECN data for the carbon steel electrodes at ring 12.

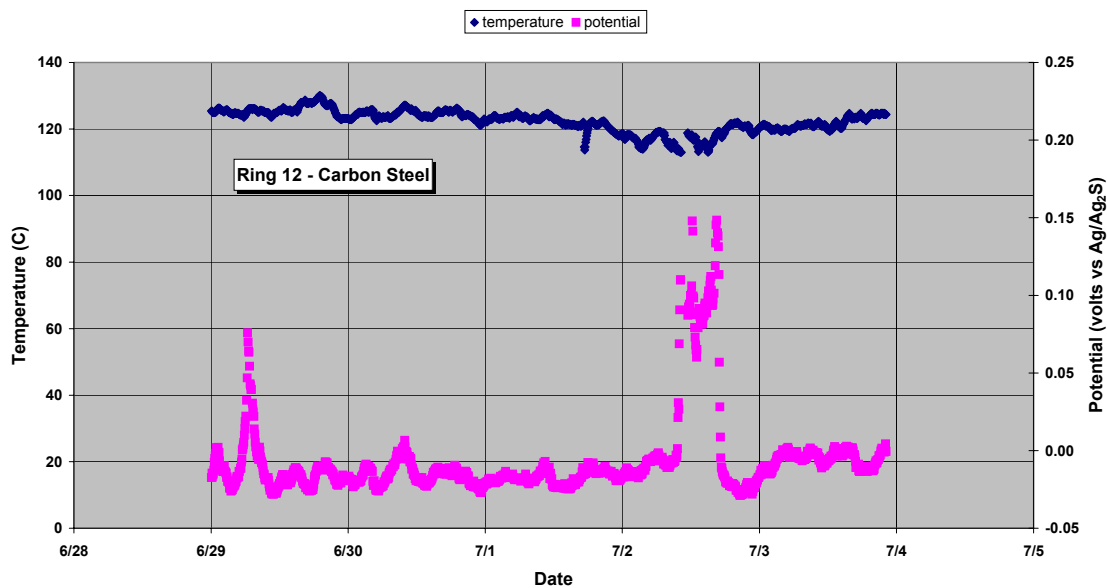
In Figure 36, the probe potential and temperature are plotted together to show that neither potential excursion is associated with a substantial temperature change. Further, the average electrode temperature on ring 12 varied only about 1.5°C during the two potential excursions, with the lower average temperature producing the most significant current response. While there are limited exceptions at all probe positions, it was found to be a general trend that the temperature at each probe location is sufficiently constant to have little apparent effect on ECN activity. The potential excursions depicted in Fig. 35 were not correlated to any specific

Fig. 36. Temperature and potential plotted together for the same period shown in Fig. 35.

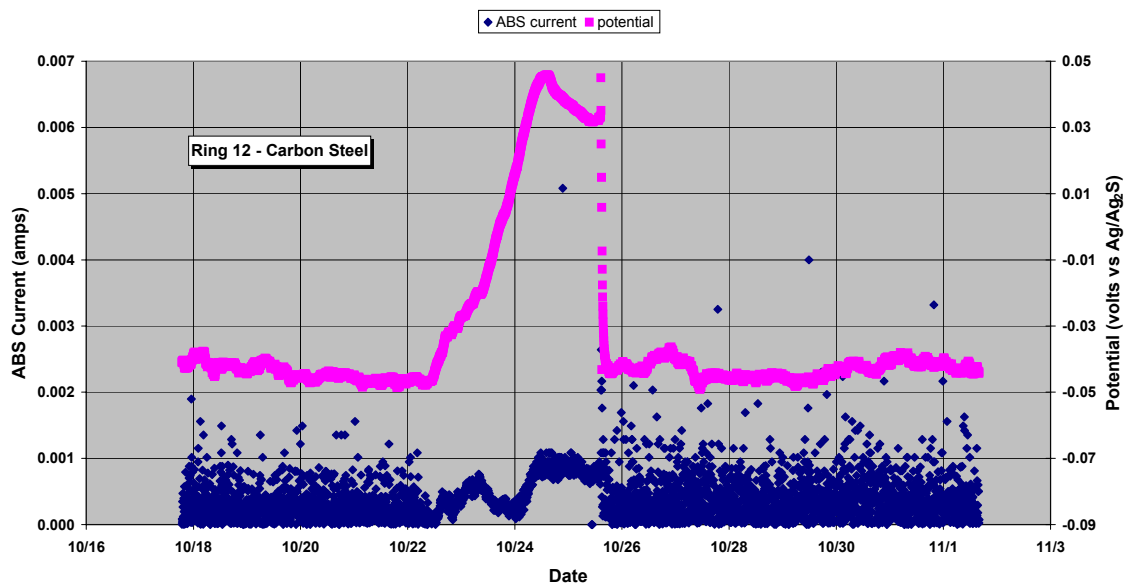
Figure 37 represents ECN data from ring 12 somewhat later in the exposure. With the exception of transients associated with shutdown and start-up of the vessel, this potential excursion is perhaps the largest for ring 12 in terms of combined magnitude and duration. Figure 37 shows that the potential is essentially constant at near -45 mv (vs. Ag/Ag₂S) before and after the steady excursion to a potential near 100 mv above average. During the excursion, the average current per unit time is about double that of the average during the remainder of the period shown, but is nevertheless an insignificant corrosion event. No significant process variable change was identified to coincide with this event, although it is perhaps significant that the stainless steel electrodes at ring 12 also indicated a similar kind of activity change occurring at the same time as that for the steel electrodes. This result perhaps indicates a change in redox activity within the vessel corresponding to a chemistry change that is not monitored in the vessel. Similar to a previous example, Fig. 38 shows that the probe temperature is not likely to be a significant factor in the ECN behavior associated with this excursion.

Fig. 37. ECN excursion for the steel electrodes at ring 12.

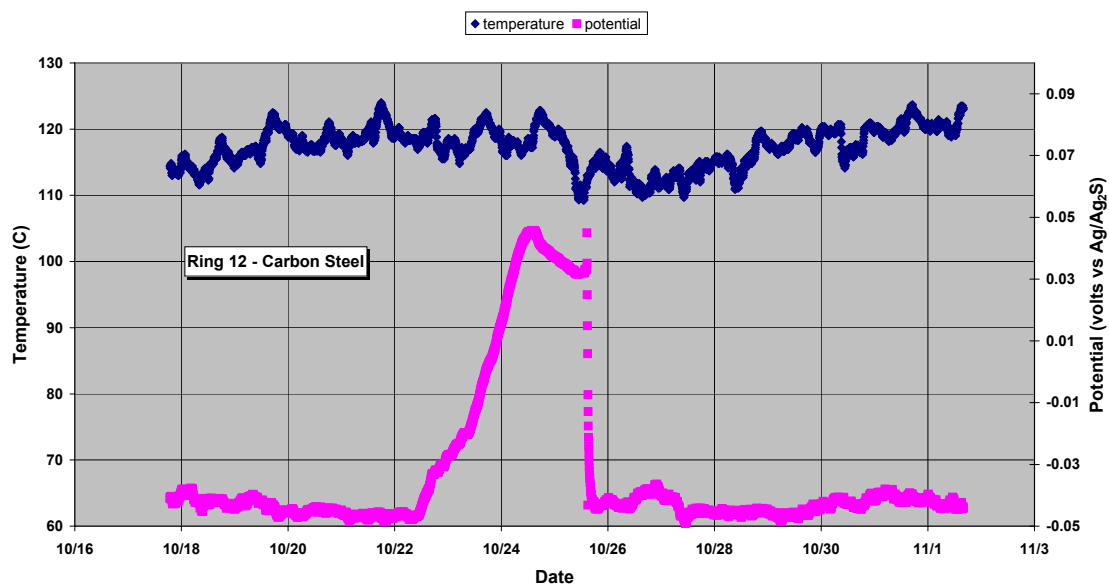
Fig. 38. Temperature and potential plotted together for the same period shown in Fig. 37.

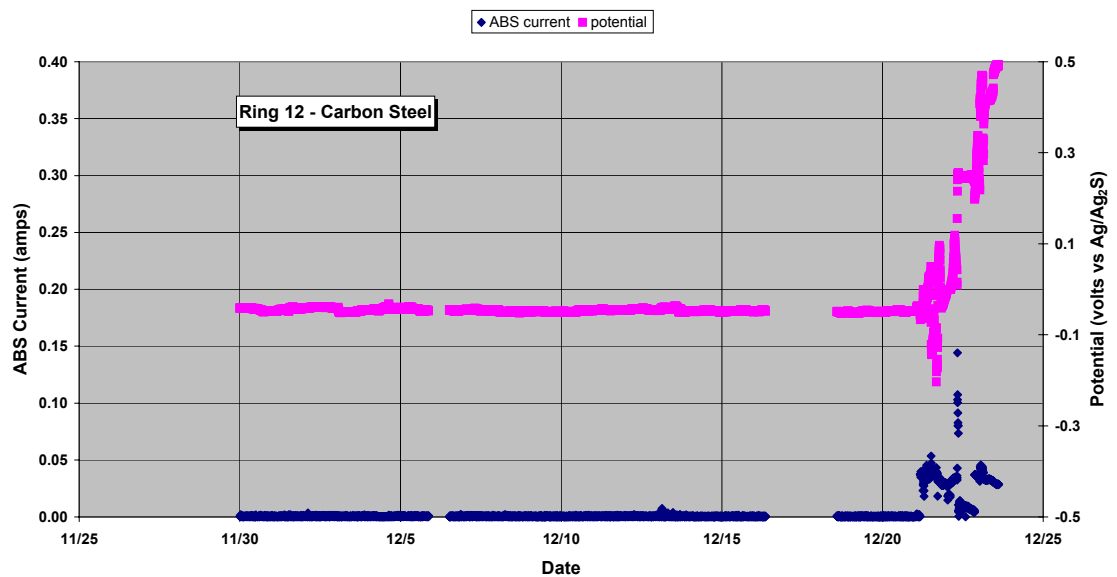
By about four months after start-up, the steel potential at ring 12 became remarkably constant. Figure 39 shows that the steel electrodes at ring 12 had a potential of -50 mv (vs. Ag/Ag₂S) for weeks at a stretch, with essentially zero corrosion current during this time. The excursion beginning on December 21 is associated with a planned shutdown of the vessel. Note that there is a significant potential excursion and current activity associated with the shutdown event. Again, Fig. 40 shows that the nominal temperature variations for the ring 12 probe continue with no effect on potential (and, by inference, current) at least until the shutdown in late December.

Fig. 39. ECN data for the steel electrodes at ring 12 leading up to the planned outage on December 21.

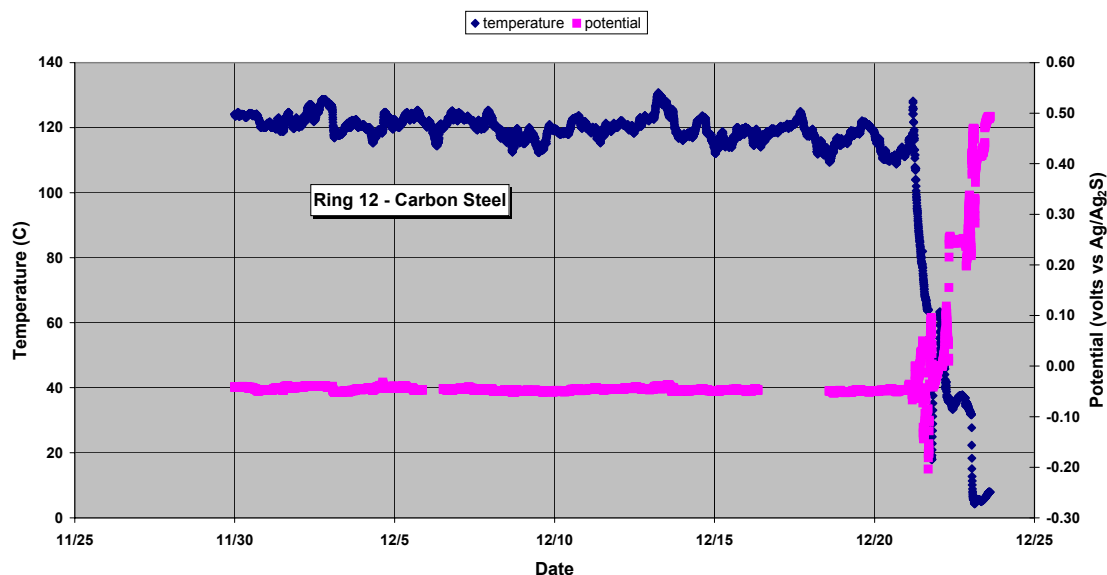
Fig. 40. Temperature and potential plotted together for the same period shown in Fig. 39.

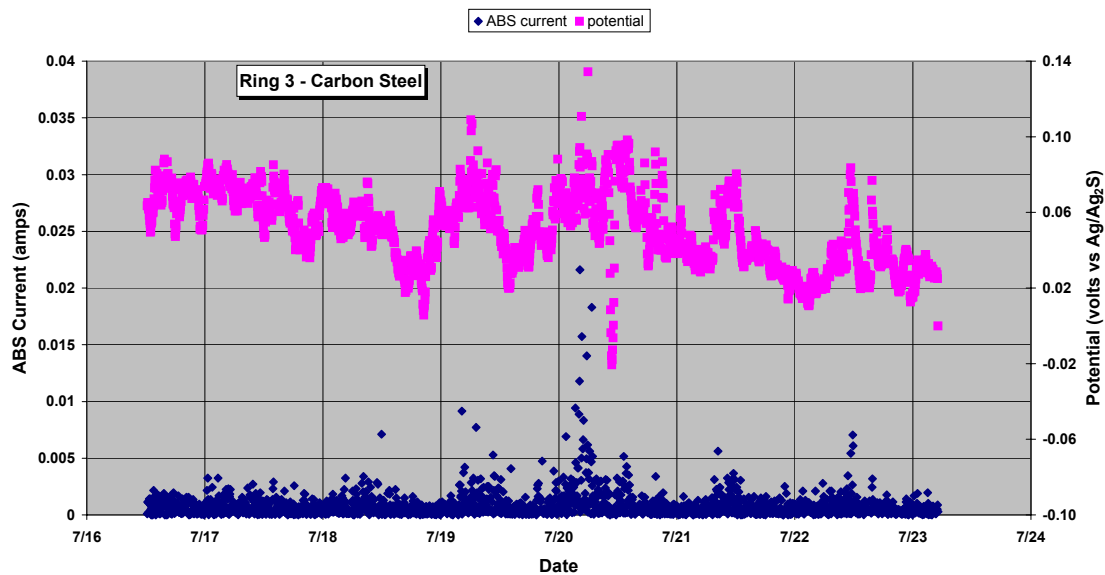
Figure 41 is representative of the ECN behavior of the steel electrodes at ring 3 through the first six months of the exposure. The potential varies about ± 40 mv around a numerical average of +51 mv (vs. Ag/Ag₂S) for the period shown. With the exception of a momentary current spike to above 0.02 amps corresponding to the highest potential spike (to +135 mv), none of the potential variations seem to have significant impact on the current noise. Similar to previous examples, Fig. 42 shows that routine potential variations of ± 40 mv or more are often associated with a temperature that is constant within $\pm 5^\circ\text{C}$.

Fig 41. Representative ECN data for the steel electrodes in the ring 3 probe early in the exposure.

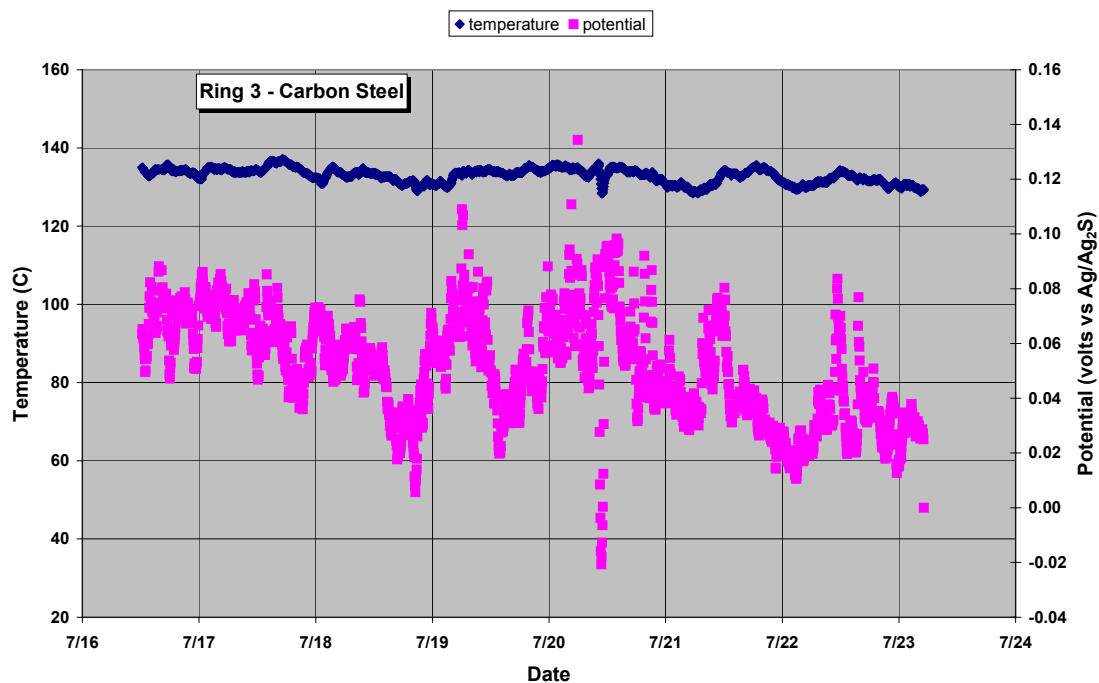
Fig 42. Temperature and potential for ring 3 steel electrodes for the same period as shown in Fig. 41.

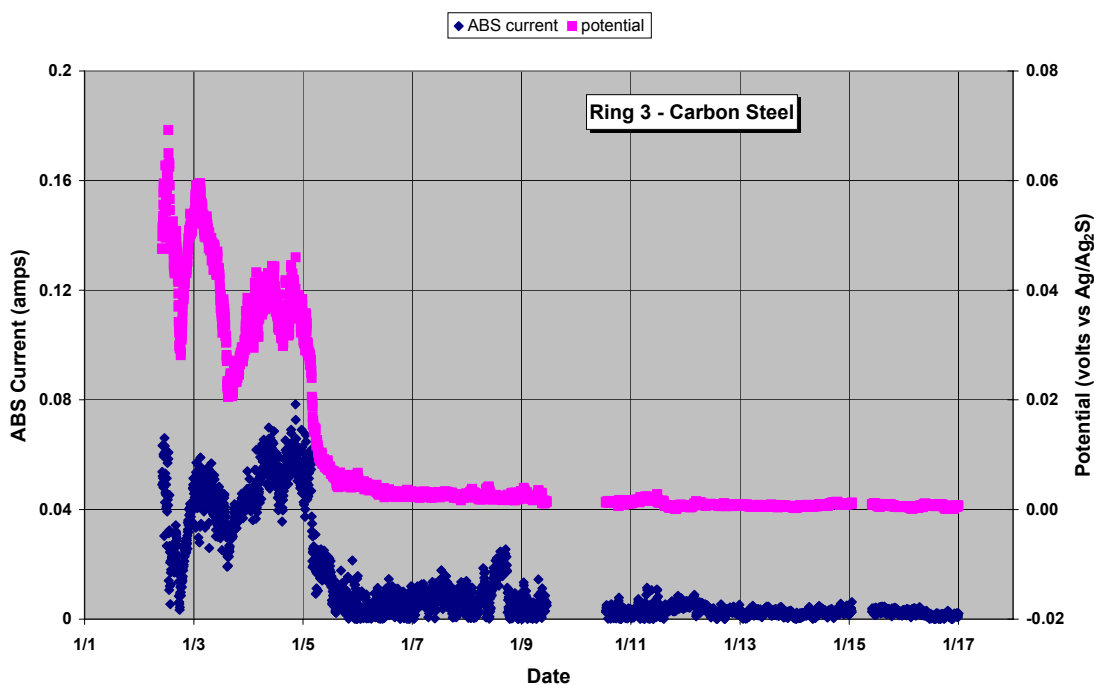
Six months into the exposure, the potential of the steel electrodes at ring 3 continued to vary irregularly, but the extremes of the variation, in particular the maximum potential, slowly decreased. Generally, the current noise remained uniform and modest, but increased significantly in magnitude after the start-up in January. On January 5 (see Fig. 43), the steel probes experienced a significant and sustained negative shift in potential (from an average near +40 mv to about zero mv) and a corresponding decrease in current magnitude. No changes in recorded process variables coincide with the sudden potential/current change indicated here. Again, Fig. 44 shows that the change in potential early in January does not appear related to probe temperature.

Fig. 43. Representative ECN data for the steel electrodes in the ring 3 probe following the January restart.

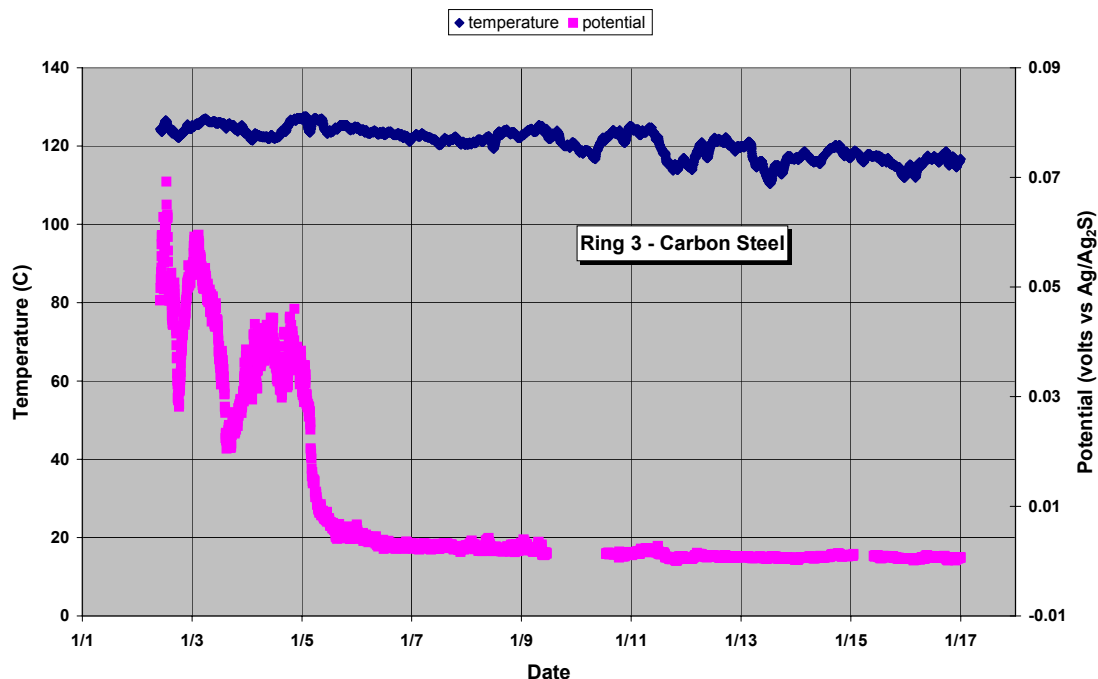
Fig. 44. Temperature and potential for ring 3 steel electrodes for the same period as shown in Fig. 43.

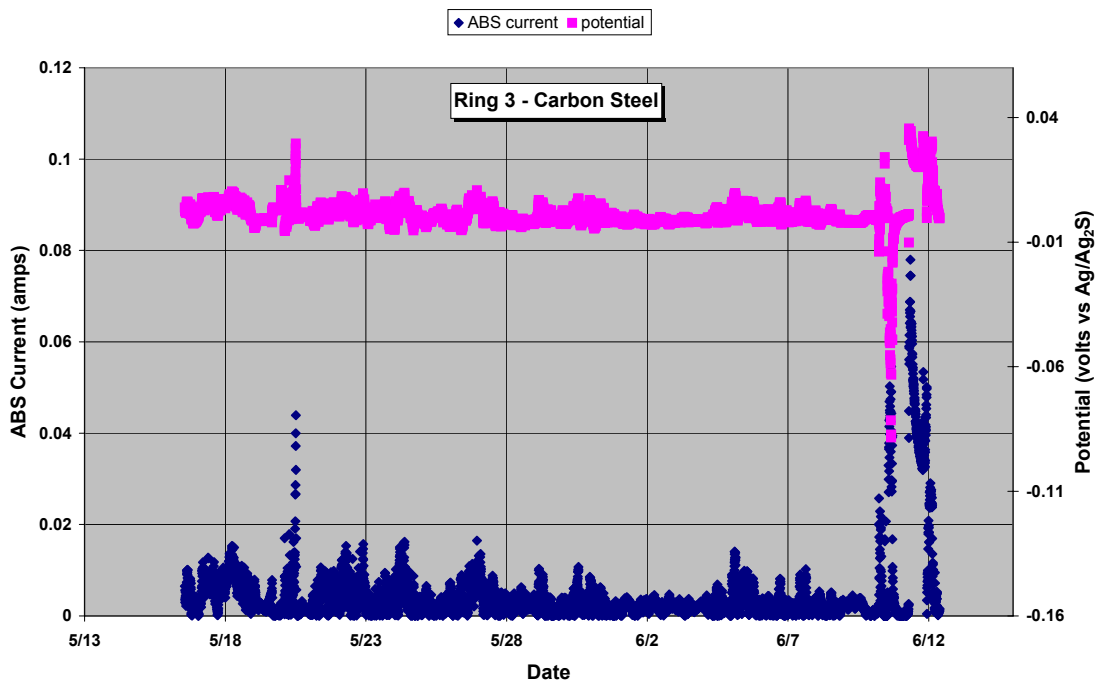
The ECN behavior established on the steel probes at ring 3 in January continued essentially uninterrupted until the digester shutdown in June. Figures 45 and 46 are representative of this behavior, and they reveal modest current demand and few variations in potential greater than about ± 5 mv. The modest upset in potential and current noise and particularly probe 3 temperature on May 19-20 is associated with a significant process upset (chip feed problems) in which many process variables changed significantly (but briefly) and all the probes responded with similar potential/current excursions.

Fig. 45. Representative ECN data for the steel electrodes in the ring 3 probe late in the exposure period.

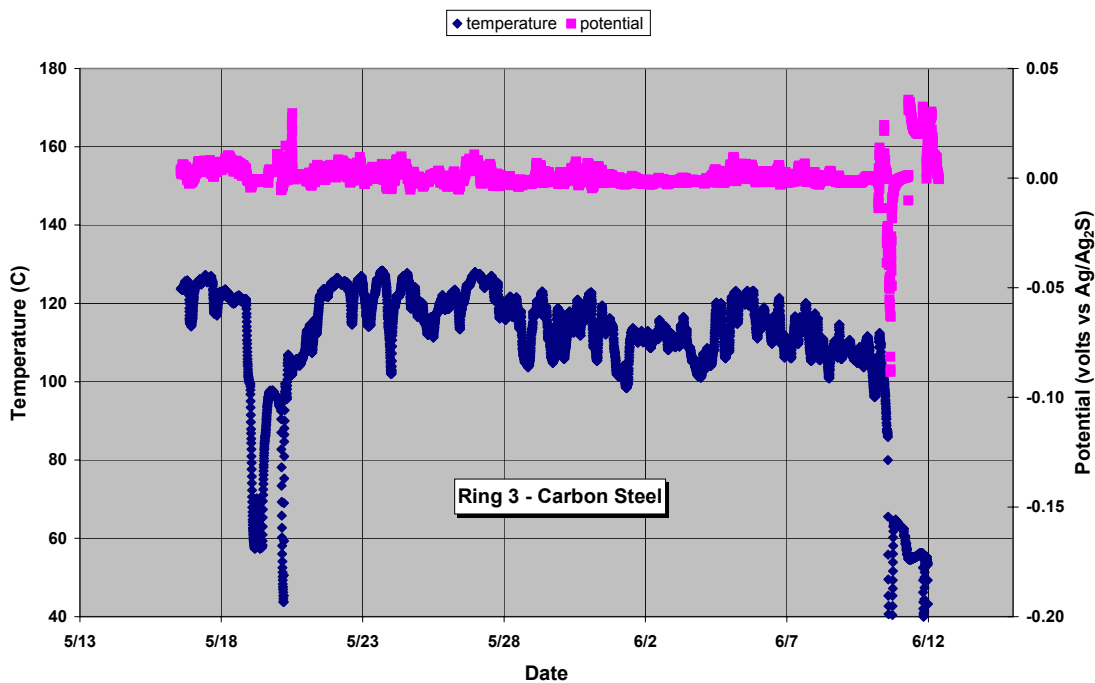
Fig. 46. Temperature and potential for ring 3 steel electrodes for the same period as shown in Fig. 45.

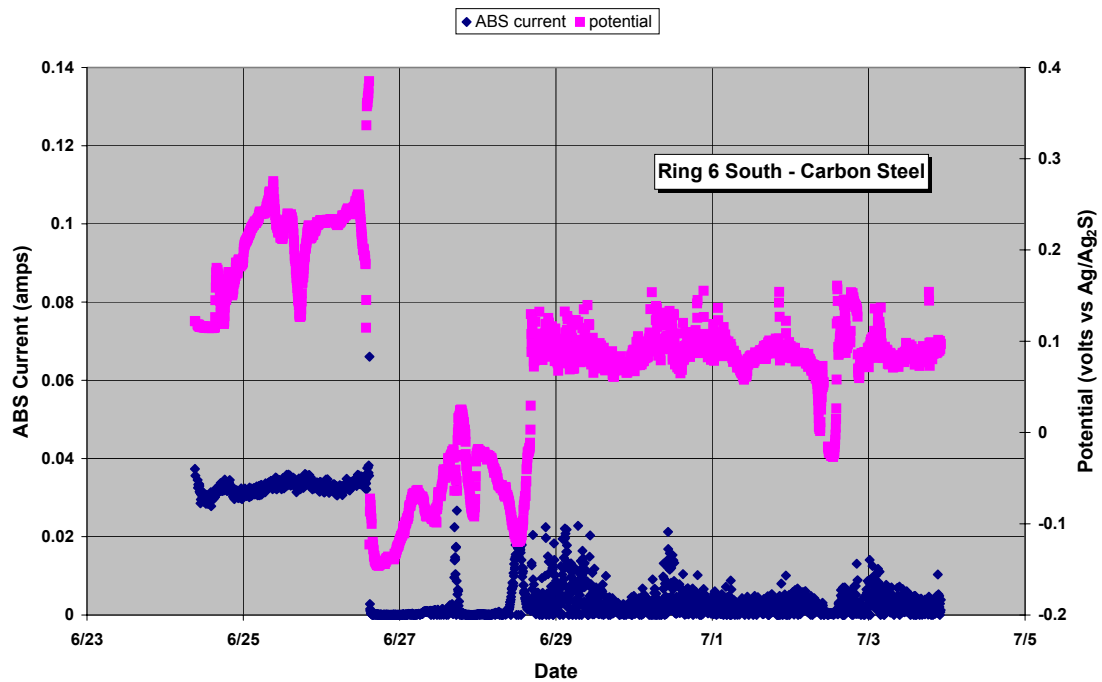
Compared to the potential of the steel electrodes at rings 3 and 12, the potential of the steel at ring 6S is significantly higher over the course of the exposure. Figure 47 shows ring 6S data near the start-up on June 24, and there are three distinct regions in the period shown. In the initial period ending on June 26, the absolute value current sum indicates an average corrosion current of at least 8.9 amps/day and correspondingly high average potential of +205 mv (vs. Ag/Ag₂S). Shortly after start-up, from about June 26 – 28, the average potential drops to -74 mv and the corrosion current drops to an average of 0.6 amps/day. Beginning late on June 28, the steel at ring 6S assumes a more typical ECN behavior observed for the remainder of the period (and the year). The average potential of +87 mv is between the previous extremes as is the average corrosion current of 1.8 amps/day. While temperature data was not available until June 26, it is clear from Fig. 48 that temperature and potential excursions don't follow a particular pattern.

Fig. 47. Representative ECN data for the steel electrodes in the ring 6S probe early in the exposure.

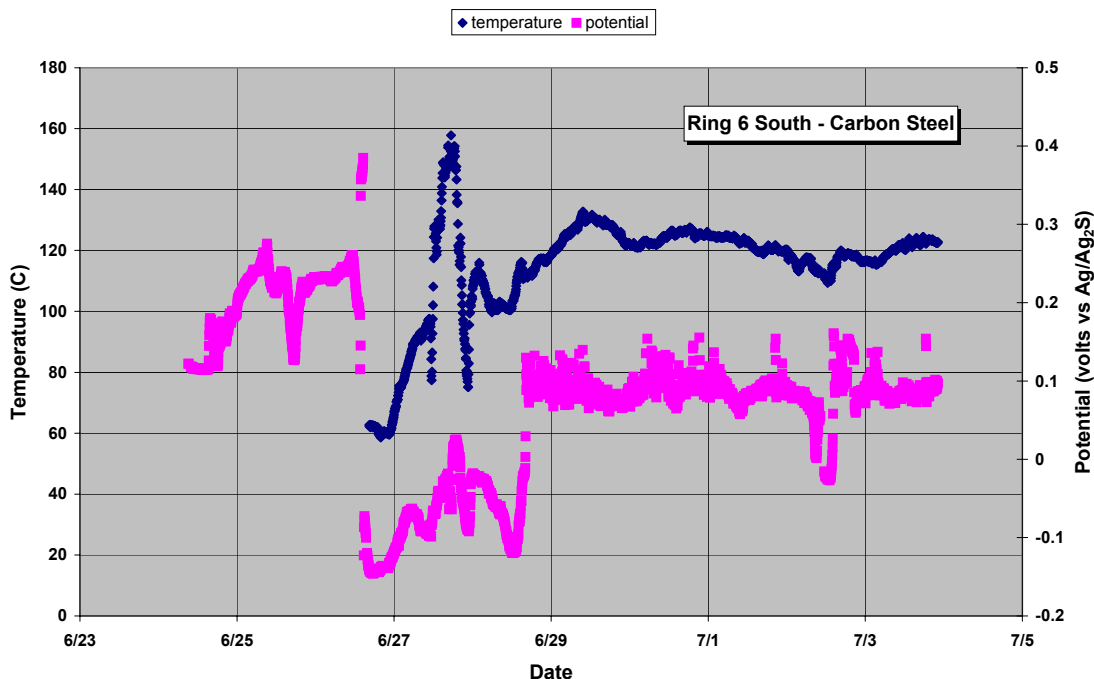
Fig. 48. Temperature and potential for the steel electrodes in the ring 6S probe for the same period as shown in Fig. 47.

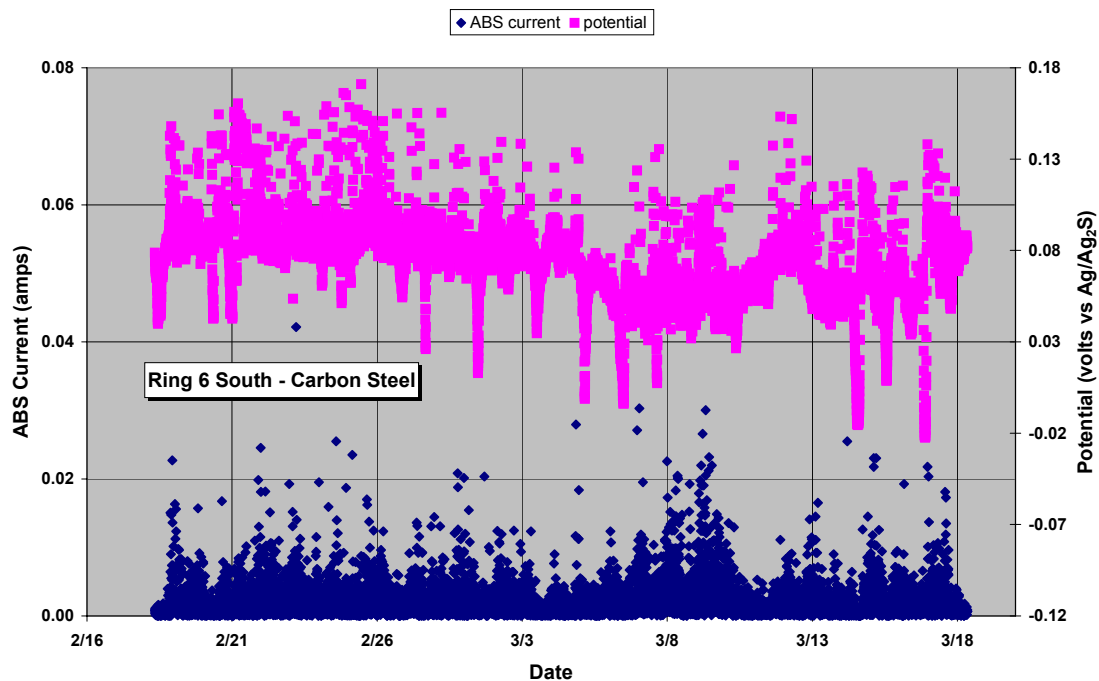
Figure 49 is representative of the nominal ECN behavior of the steel at ring 6S after the initial start-up. The average potential maintains significant short-term variation with an average near +80-85 mv (vs. Ag/Ag₂S), but the current sum is lower in this month-long period than any similar period in 2002. In fact, beginning with the period shown in Fig. 49, the current flowing between the steel electrodes at ring 6S approximately doubles in each of the following three months, with no corresponding change in the operational data or average potential. In addition, the ring 6S steel electrodes began to display some current bias (current noise not centered on zero) about nine months into the exposure period. Again, Fig. 50 shows that the potential variations are not directly correlated with the probe temperature. Although not represented graphically, the shutdown in June 2002 exhibited behavior similar to the start-up data shown in Fig. 47.

Fig. 49. Representative ECN data for the steel electrodes in the ring 6S probe after the initial start-up.

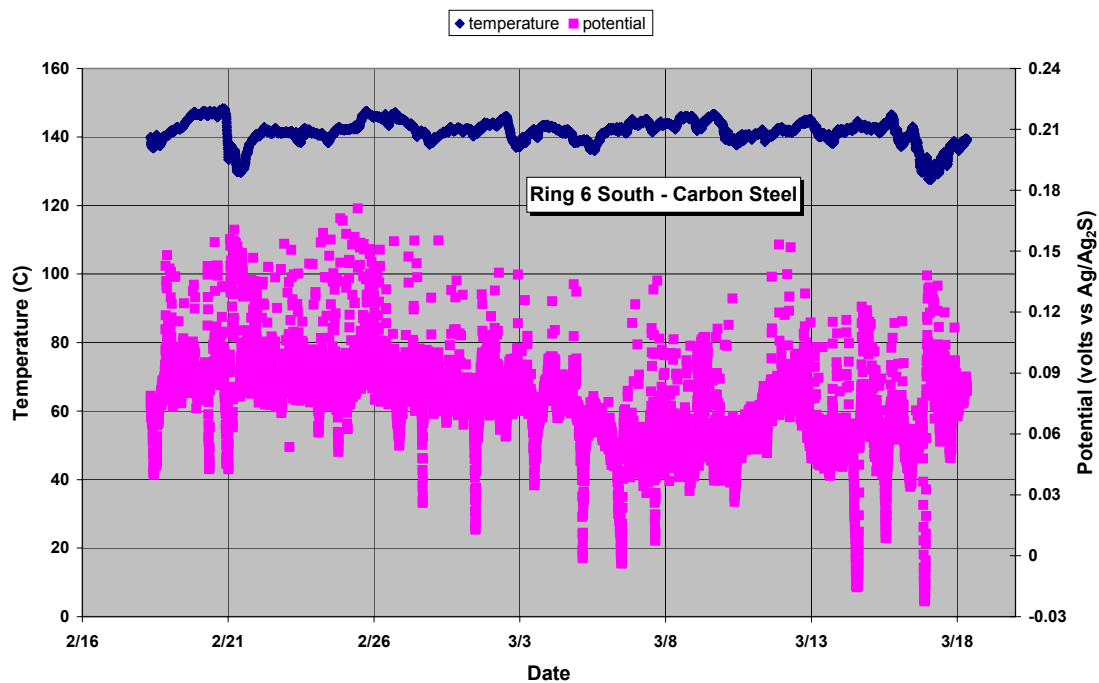
Fig. 50. Temperature and potential for the steel electrodes in the ring 6S probe for the same period as shown in Fig. 49.
