Metals and Ceramics Division

**Correlation of Process Data and Electrochemical Noise to Assess Kraft Digester
Corrosion: Spring Grove Experiment**

‡Glatfelter Company, Spring Grove, PA

Date Published: April 2003

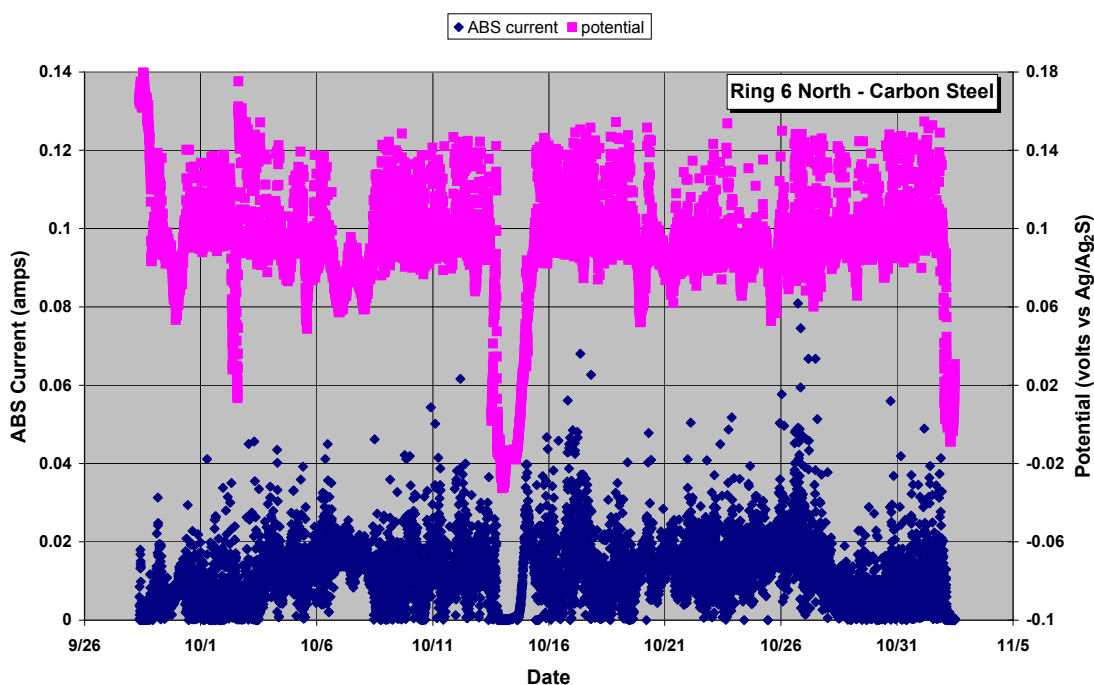
The probe at ring 6N was located at the same elevation as that for ring 6S, but 180° away on the opposite side of the vessel. Figure 51 shows that the potential of the steel electrodes at ring 6N is similarly variable but somewhat higher on average than at ring 6S, and the current sum for the period shown is about seven times larger for the steel at 6N than at 6S. There was another month-long period (not shown in Fig. 51) in which the current sum associated with ring 6N activity is a factor of approximately seven larger than for ring 6S, but the average difference over the entire exposure period was closer to a factor of 2.5.

It is interesting that there are two prolonged (>24 h) potential excursions to lower than nominal values shown in Fig. 51. The most severe – on October 13-14 – is associated with a current decrease to near zero. As evident in Fig. 52, this large potential decrease is associated

Fig. 51. Representative ECN data for the steel electrodes in the ring 6N probe.
