Correlation of Process Data and Electrochemical Noise to Assess Kraft Digester Corrosion: Kamloops Experiment

ORNL/TM-2002/33

**Correlation of Process Data and Electrochemical Noise to Assess Kraft Digester Corrosion:
Kamloops Experiment**

Date Published: April 2002

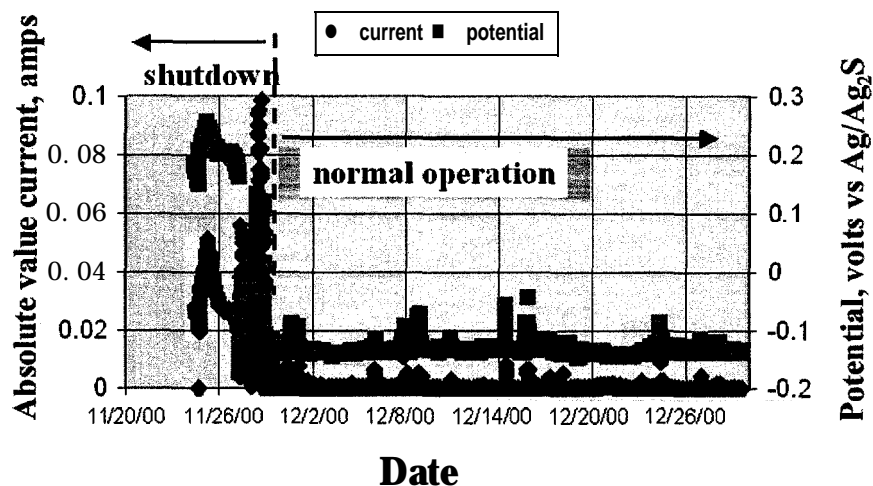
Because Probe #5 was the least active among all the probes in terms of corrosion noise, examination of data from this probe is instructive for understanding general characteristics. For example, Fig. 29 shows that the nominal potential of the steel at the position of Probe #5 – for the month of December – was approximately -140 mV vs. Ag/Ag₂S, which corresponds roughly to a value of -1020 mV vs. SCE [8]. During the final few days of November shown on Fig. 29, there is a large transient associated with shutdown and start-up activity – this transient is included here for contrast with the more nominal behavior but will be discussed in a separate paragraph. The potential was relatively stable at about -140 mV vs. Ag/Ag₂S over the duration of the experiment, and exhibited only about ten brief (minutes to a few hours in duration) potential spikes to more positive potential over the entire month of December. For the specific interval shown in Fig. 29, the potential typically spiked to the range of -50 to -100 mV vs. Ag/Ag₂S, although very occasionally a potential spike to almost 0 mV vs. Ag/Ag₂S was observed during other time periods.

Figure 29 also shows that there was a corresponding current response (shown here in absolute value; see discussion in section above) associated with each potential excursion. Generally speaking, the current noise associated with probe #5 for the month of December was very modest at approximately a milliamp or less. The largest current spikes for Probe #5 in December were to approximately 10 milliamps.

Fig. 29. Representative ECN data for Probe #5.

The December corrosion activity indicated for Probe #5 is exclusively general corrosion. Figure 30 is a polarization curve for mild steel in liquor removed from the wash zone (near the position of Probe #5) in the Kamloops digester. It indicates that at the observed nominal potential for Probe #5, the system is expected to be corroding modestly and in a general fashion at the open circuit potential. All of the potential spikes observed for Probe #5 fall in/around the active “nose” of the polarization curve, and none achieve a sufficient potential to fall in the traditional passive range as indicated by the polarization behavior. Similarly, since pitting is associated with potentials even more positive than the passive range, the ECN data in Fig. 29 also predicts no pitting activity. As will be discussed in a subsequent section, the post-test analysis of the surfaces of Probe #5 confirmed only extremely modest general corrosion and no pits. Further, the upper portion of the anodic polarization curve shown in Fig. 30 -the portion above about -800 mV vs. SCE – has a shape that is controlled largely by the scan rate and the liquor composition and is usually associated with redox reactions involving sulfur species in pulp-making liquors. In the range of potentials experienced by Probe #5, the polarization curve indicates the current contribution from these redox reactions should be very small.

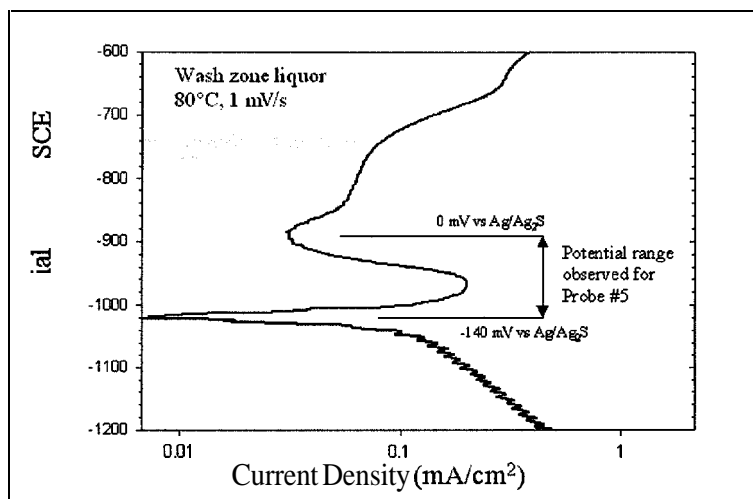
Fig. 30. Polarization curve for mild steel in wash zone liquor removed from the Kamloops digester.

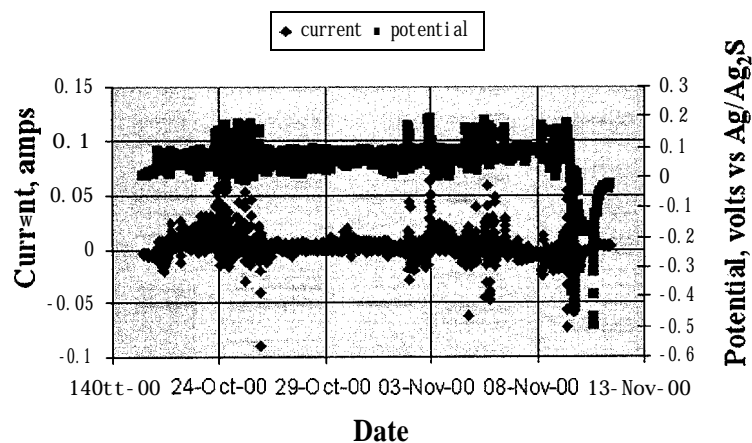
In contrast to Probe #5, the current and potential activity of Probe #3 were much more variable over the period of investigation. Figure 31 shows a representative snapshot of ECN data for Probe #3. [Like the data in Fig. 29, a large current/potential excursion is included for contrast with more nominal behavior. This will be discussed in relation to shutdown and start-up transients in a subsequent paragraph.] In the case of Probe #3, the potential shifts rapidly and almost constantly between about 0 mV and 80 mV vs. Ag/Ag₂S over the period of the experiment, with periodic spikes to about 180 mV vs. Ag/Ag₂S. The current activity shows largely white noise around very low -but not precisely zero – current, and large bursts of current activity associated with the potential spikes.

Fig. 31. Representative ECN data for Probe #3.

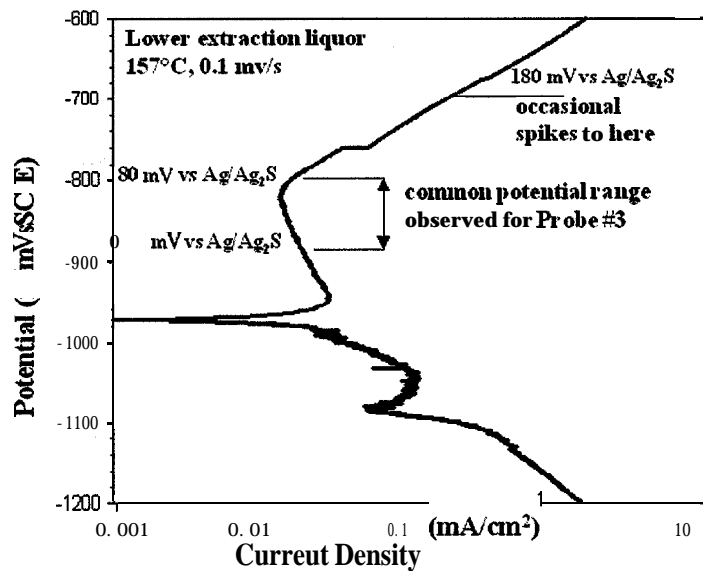
A polarization curve for mild steel in lower extraction zone liquor (removed from the digester at a location near Probe #3) is shown in Fig. 32. It shows that the nominal potential range of Probe #3 (0-80 mV vs. Ag/Ag₂S) falls within the passive range of behavior for steel. The potential spikes to about 180 mV vs. Ag/Ag₂S (shown in Fig. 31) routinely generate large current responses, but current at this potential has a large component resulting from redox reactions involving sulfur in addition to perhaps some mildly transpassive behavior.

Fig. 32. Polarization curve for mild steel in lower extraction liquor removed from the Kamloops digester.

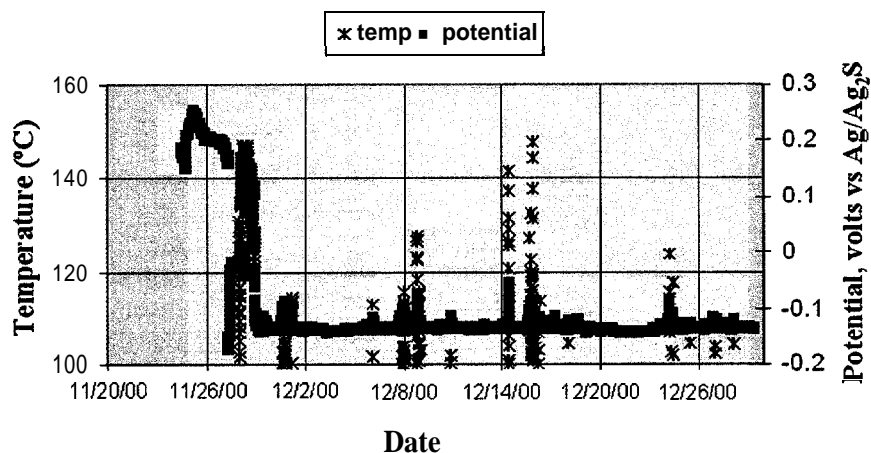
A representative temperature profile for Probe #5 is shown in Fig. 33 – along with the corresponding potential data – and is plotted such that only the largest temperature spikes appear on the graph (temperatures over 100°C). Again, focusing on the December data for the present (and omitting the transient at the end of November), plotting in this fashion makes it obvious that the potential/current noise activity is associated directly with the swings in temperature at this position in the digester. The trend for Probe #5 is that a ΔT of at least 40-50°C is required to generate a potential spike of 10 mV, with larger ΔT associated with larger potential spikes.

Fig. 33. Temperature and potential data for Probe #5.

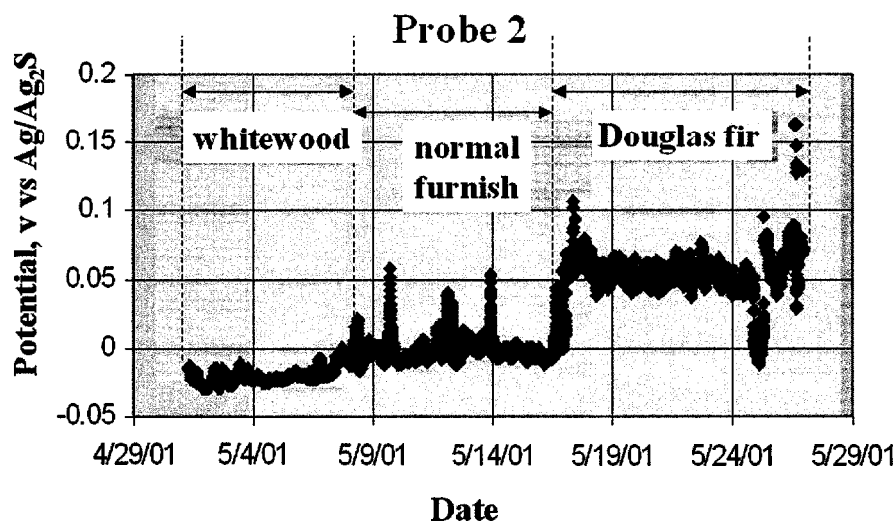
Analysis of the ECN data at Kamloops over the year-long experiment indicated that, among parameters for which data was collected, furnish composition was the most significant operational variable influencing corrosion activity. Figure 37 is representative of the potential data associated with Probe #2 for all three furnish compositions. Note that the potential is fairly constant while pulping whitewood, slightly higher and somewhat more noisy (more spikes) while pulping the normal furnish, and increases about 60 mV in step-function fashion when the furnish

Fig. 37. Representative ECN potential data for Probe #2 showing variation as a function of furnish composition.

composition changes to Douglas fir. The potential for each corrosion probe changes in a qualitatively similar fashion to that depicted in Fig. 37 for Probe #2, but this one was selected for graphical representation because the white noise in the potential data was so slight that the change in potential as a function of furnish composition is easy to display graphically.

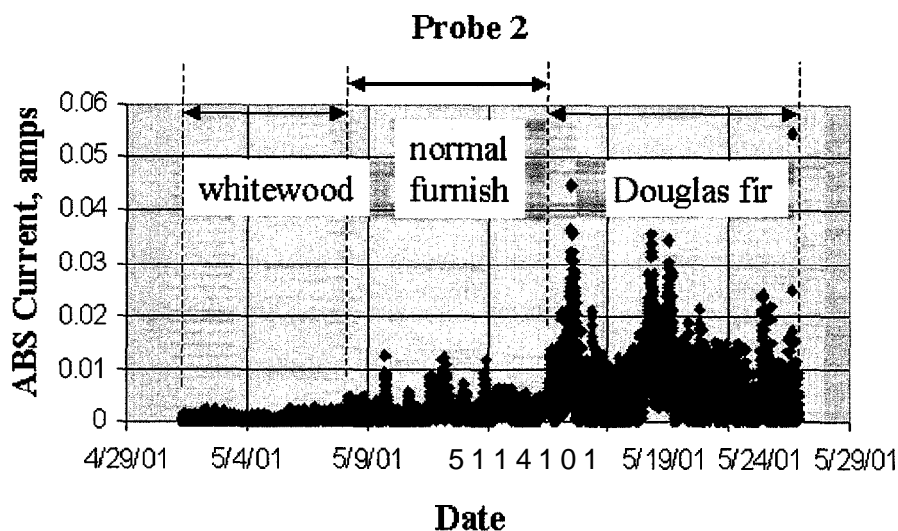
The corresponding current data for Probe #2 appear in Fig. 38. Consistent with the potential data, it shows that current activity is very low during whitewood pulping, only modestly higher pulping the normal furnish, but significantly higher during the Douglas fir run. Probe #2 revealed changes in current and potential associated with furnish changes at times corresponding precisely to those indicated in the operator's log for the digester (no time delay between furnish change and response at Probe #2). Although there is more general scatter in the data for the other probes further down the digester, it is nevertheless clear that all probes indicate generally similar responses to furnish composition within a very brief time of changes introduced into the vessel.

Fig. 38. Representative ECN current data for Probe #2 as a function of furnish composition.

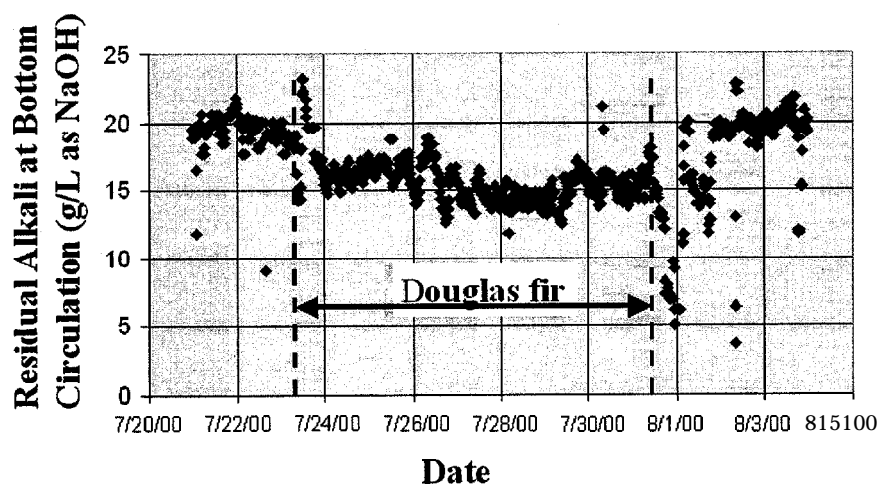
A few operational variables, such as production rate, dilution factor, inner counter-wash rate, alkali charge, and residual alkali were found to exhibit slight variations from the normal values coincident with changes in furnish composition and corrosion activity. While each of these may contribute a small portion to the entire observed effect of Douglas fir pulping, each of these parameters are changed slightly – but intentionally – to facilitate Douglas fir pulping. As a result, these are not independent parameters in the strictest sense. As an example, Fig. 39 shows a slight change in residual alkali content (measured at the bottom circulation loop) as a function of a brief change from normal furnish to Douglas fir. While it could be argued, in a general sense, that decreased alkalinity (weak liquor) could contribute to marginal passivation of the steel and thus increase corrosion activity, the change observed in Fig. 39 is a process adjustment made to account for Douglas fir content in the furnish. Further, brief excursions to reduced alkali content at this and other locations in the vessel do not seem to correlate with increased corrosion

activity unless there is a coincident change to a more aggressive furnish. As a result, the aggressive furnish is considered to be the independent variable and the parameter of greatest significance for vessel corrosion.

Fig. 39. Residual alkali measured on the bottom circulation loop decreases coincident with a Douglas fir pulping campaign.

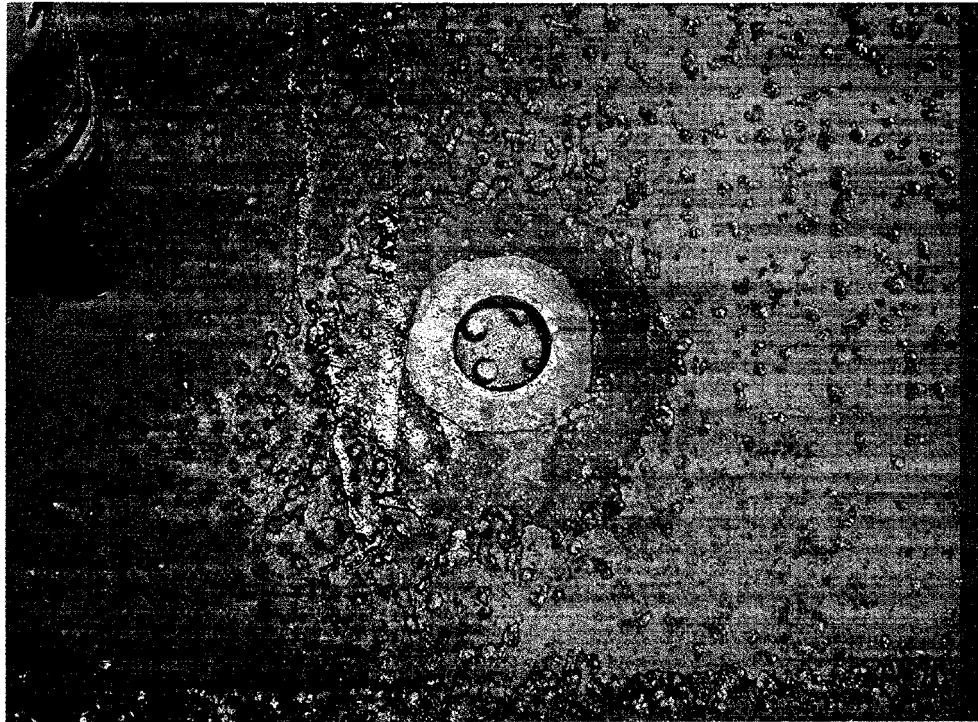
Probe #3 is shown in a general view in Fig. 46 and in a closer view in Fig. 47. A general pitting pattern on the shell around the port is evident and was insignificantly changed in depth/extent from the previous year's inspection. In particular, compare Figure 11 (June 2000) with Fig. 46 (June 2001). Some minor pit agglomeration may have occurred, particularly adjacent to the port boss (absence of flash rust and similar lighting in the recent photo obscures the comparison), but otherwise there was so little change over the past year that individual pits/patterns can be identified in both photographs. Like the other probes, the teflon header was displaced from the steel electrodes into the port cavity, but it was not apparent that the teflon had been degraded in any fashion.

Fig. 46. Post-test view of Probe #3 and the surrounding digester shell.

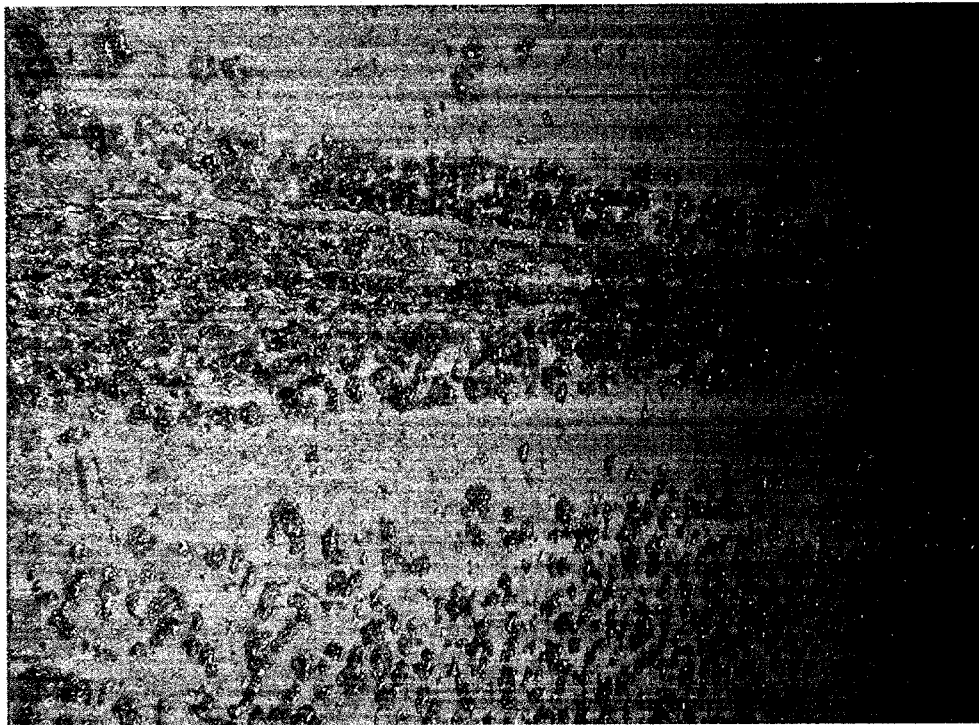
In the area between the EX screens and the MC screens (RS 10-12), the weld areas seemed to have a somewhat greater density of pitting than the general shell areas, but all of the pits were on the order of 1.5-1.7 mm (60-70) mils deep. The pits in this area, like other “ocean and island” pitting patterns, were characterized by smooth, flat bottoms and sharp edges at which the pit periphery meets the shell wall. Figure 48 is a photograph of the area around RS 11, showing corrosion at/along the weld as well as on the shell in general. Pits here are 1.5-1.7 mm (60-70 mils) deep and relatively uniform. Figure 49 shows a large “ocean” region (large recessed area from agglomerated pitting) that appears to have a relationship to surface grinding associated with a weld bracket. Both areas were observed in the prior inspection and were not detectably changed in general appearance or depth of pitting.

Fig. 48. Representative view of RS11 and the adjacent shell.

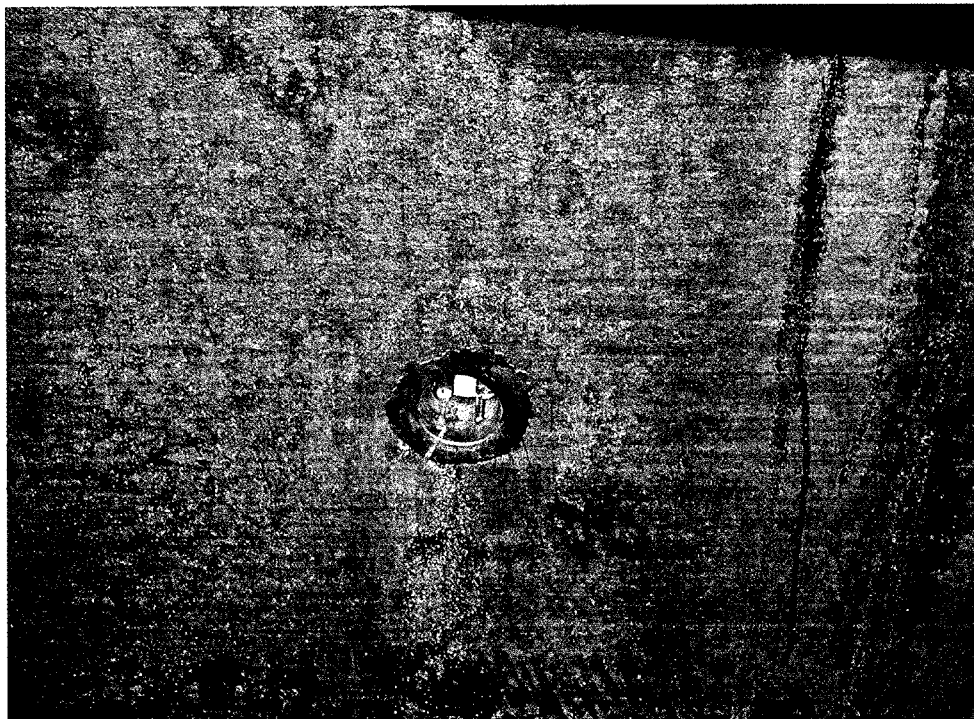
Figure 52 shows a general view of Probe #5 (below the wash screens) and Fig. 53 shows a close-up photograph of the same region. Like Probe #4, the teflon header is significantly displaced but physically unchanged. The shell around the probe was relatively smooth, and exhibited only shallow surface relief and pit precursors. Comparison of Fig. 18 (June 2000) and Fig. 53 (June 2001) suggest little or no change in the vicinity of Probe #5.

Fig. 52. Post-test view of Probe #5.

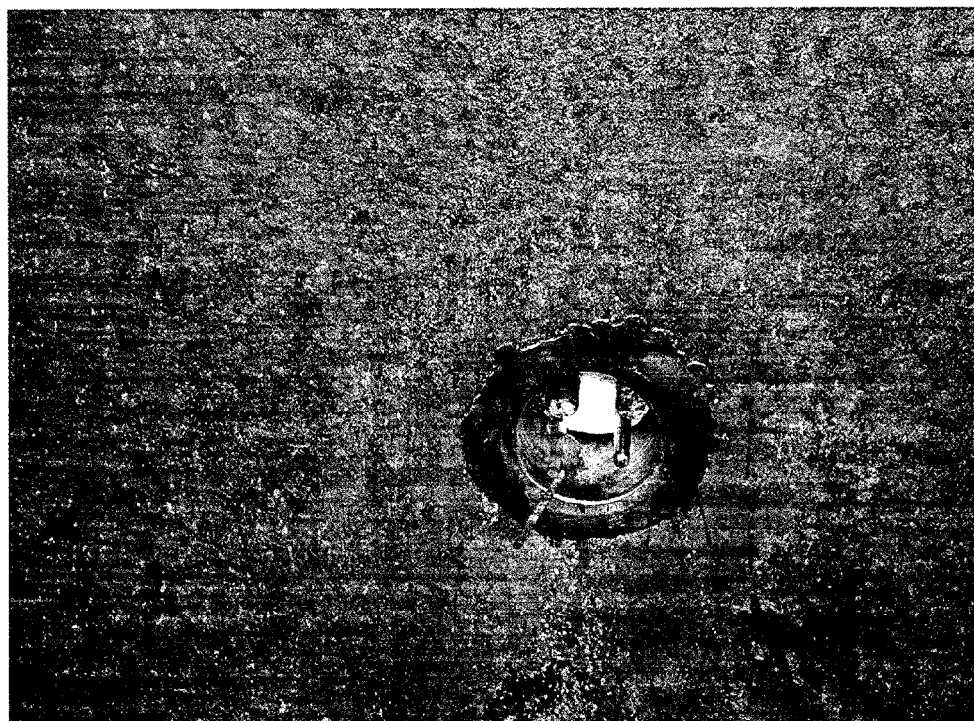
Fig. 53. Closer view of Probe #5.

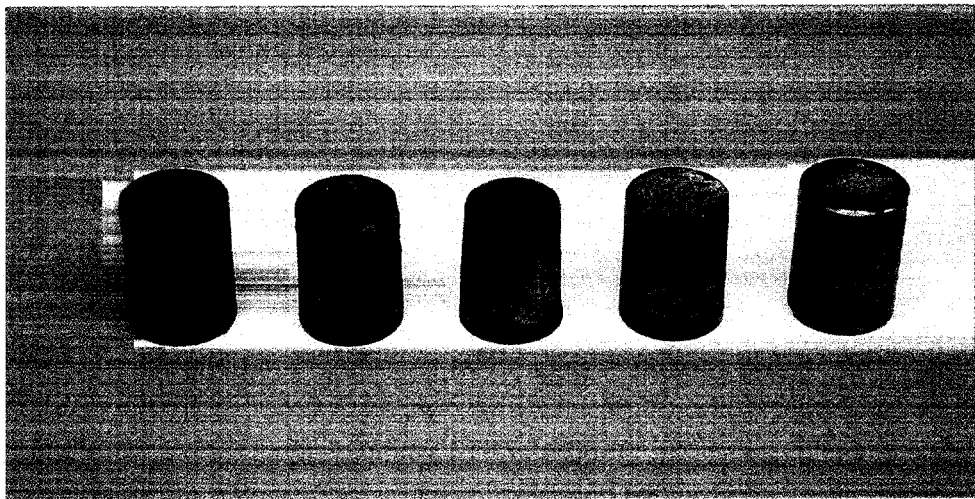
The electrodes from each probe were examined in the as-corroded condition following the test and found to have relatively uniform corrosion product accumulation and coloration patterns common to general corrosion. No pits or signs of crevice corrosion (for example, on the electrode surfaces nominally against the teflon shroud) were apparent on any of the electrodes. Figure 54 is representative of the post-test appearance (prior to any cleaning) of the electrode specimens.

Fig. 54. Post-test appearance of an electrode from each probe in the digester. Probes #1-5 are represented left-to-right, respectively, in the photograph.

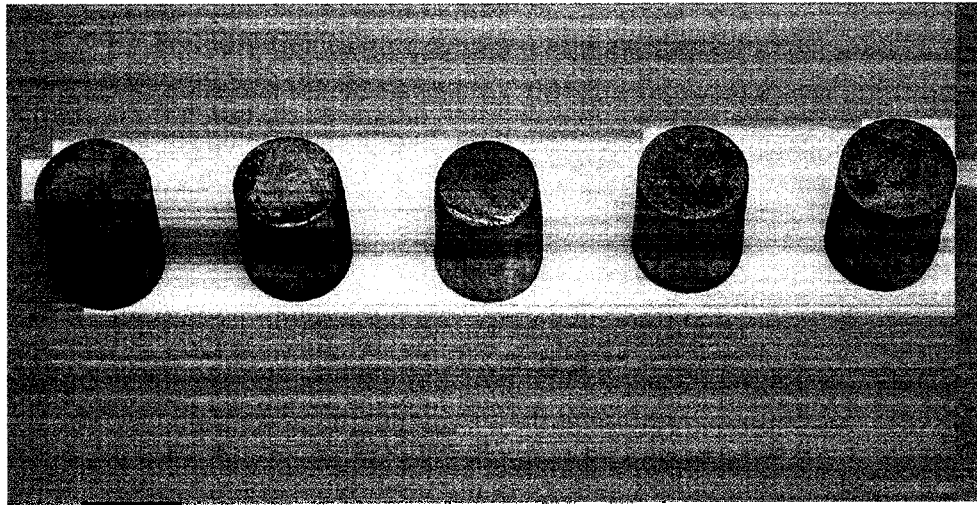
After the initial examination, the electrode specimens were cleaned in inhibited hydrochloric acid per the standard practice of ASTM G-1 (Procedure C.3.5) to remove the corrosion products without incurring further corrosion on the specimens. Figure 55 is representative of the post-cleaning appearance of the specimens, and it reveals that the specimens also appear very similar following cleaning. The cleaning procedure also did not reveal any signs of significant localized corrosion on any of the electrodes, simply a slightly mottled appearance common to general corrosion processes. The exposed circular faces of Probe #3 appeared almost polished, indicating a rather high general corrosion rate, as did some portion of the cylindrical sides that became exposed as the specimens corroded during the test.

Fig. 55. Post-cleaning appearance of an electrode from each probe in the digester. Probes #1-5 are represented left-to-right, respectively, in the photograph.

In the cleaned condition, the post-test dimensions of the electrodes were recorded for comparison with initial dimensions. Table 9 gives a summary of the results. Due to the post-test appearance indicating no surface roughening and ECN data revealing no significant corrosion on Probe #5, the dimensions of electrodes from Probe #5 were considered to be representative of the precise initial dimensions of the electrodes. Probes #1 and #5 have dimensions essentially

unaffected by exposure for one year in the digester. However, Probes #2, #3, and #4 each suffered a readily detectable change in dimensions over the course of the experiment. Using a total exposure time of approximately one year and the fact that corrosion on the diameter happens from two directions while corrosion on the specimen length happens in only one, the average annual corrosion rate for each probe position, shown in Table 9, was calculated.
