THORIUM NITRATE STOCKPILE DRUM CHARACTERIZATION REPORT

**THORIUM NITRATE STOCKPILE
DRUM CHARACTERIZATION REPORT**

Prepared for
U.S. Defense Logistics Agency
Defense National Stockpile Center
Fort Belvoir, Virginia

Prepared by
OAK RIDGE NATIONAL LABORATORY
Oak Ridge, Tennessee 37831
managed by
UT-BATTELLE, LLC
for the
U.S. DEPARTMENT OF ENERGY
under contract DE-AC05-00OR22725

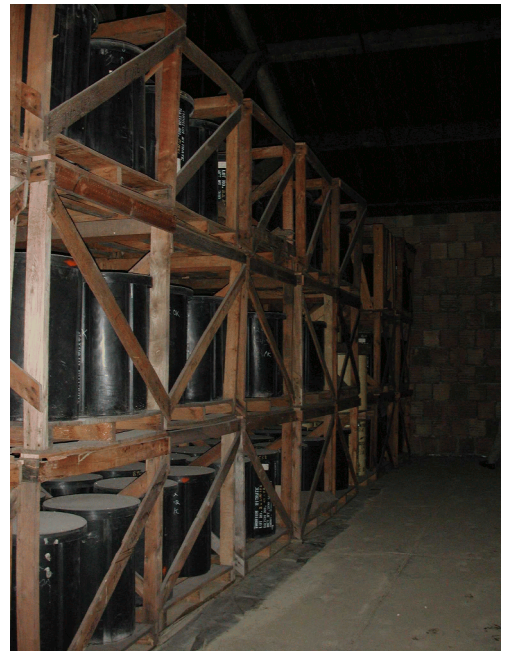
Fig. 5. Stack of MD-4 drums.

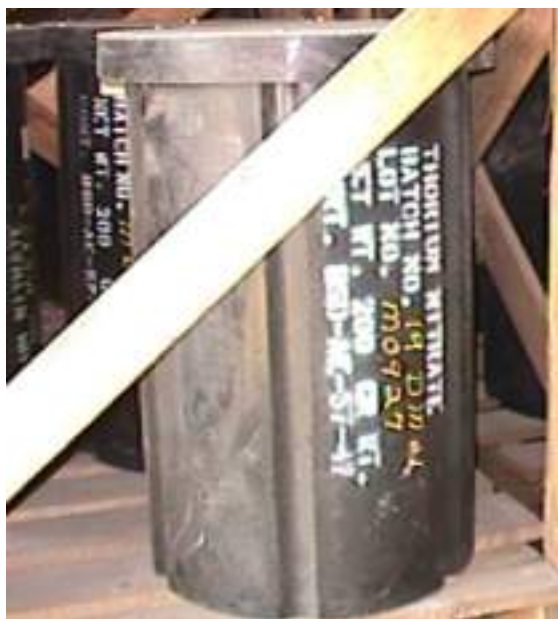
Fig. 6. Closeup view of MD-4 drum.

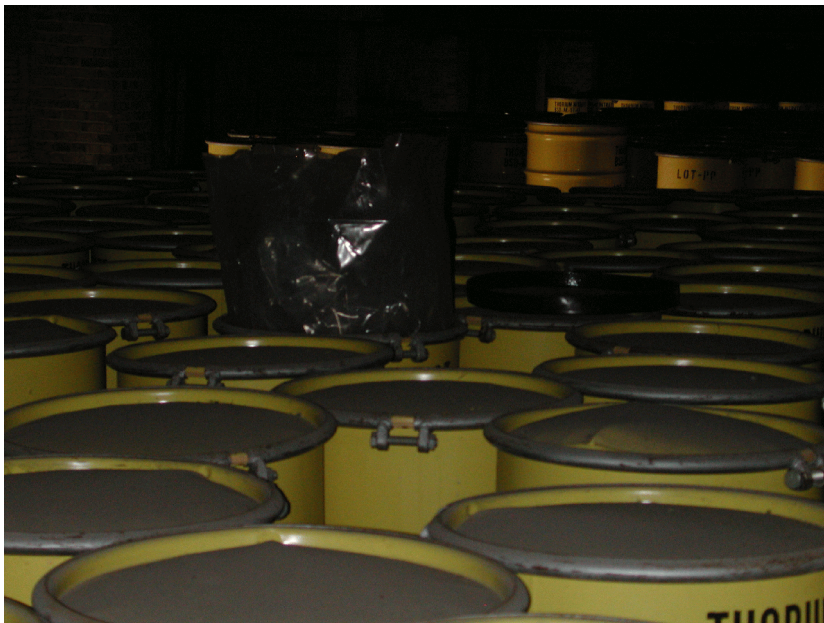
Fig. 28. MD-1 drum that lost its lid.

During the retrieval of drums in Building 913 for the 2002 sampling campaign, a drum in lot 21 was discovered that had lost its lid, apparently from overpressurization of the drum (see Figs. 10 and 28). The drum was in the middle of a stack of drums, which prevented a detailed inspection from being performed at that time. This drum and another nearby drum that was significantly bulging were retrieved and inspected in detail during the April 2003 headspace gas sampling campaign which is discussed in further detail in Sect. 4.2.

The tightness of the drum ring is also likely to vary from drum to drum. The drum ring on the drum that lost its lid may have not had the drum ring properly tightened. Thus far, only one drum has been found without its lid, but there may be drums beneath the top tier of drums with inadequately tightened drum rings. When the top tier of drums are removed from the stack, the potential exists for drums in the lower tier to lose their lids, so care must be exercised when removing pallets from the stacks.

During the 2002 ThN sampling campaign, a drum in lot 21 in Building 913 was discovered to have lost its lid (see Fig. 28), apparently due to overpressurization. At that time, the drum was not accessible. In addition, several of the MD-1 drums that had been opened for sampling had shown evidence of internal gas pressure, and several MD-1 drums have bulged lids which would indicate that the drum either is pressurized or has been pressurized at some time and has self vented. A drum with a bulged lid can be seen in Fig. 28 near the drum that lost its lid.

Final sampling records indicated that only 20 of the 60 drums opened did not have either head space pressure, pressure from internal packaging (i.e. bags) or both. In addition to the quantitative data developed during the drum opening process, one drum was observed to have blown its lid (Fig. 28). Several other drums were observed to have permanently deformed lids. All these effects are presumably from gas pressure.

During the sampling of the ThN, it was determined that pressure in the headspace of the MD-1 drums was a significant industrial safety issue. One drum at Curtis Bay Depot had apparently lost its lid to overpressurization and several others had bulged and deformed lids due to pressure that was either in the drum or at one time was in the drum and had since self vented. No drums of other configurations were found to contain headspace pressure. A headspace gas sampling campaign was conducted, and it was determined that carbon dioxide was the primary constituent contributing to the gas pressure. Carbon dioxide is believed to have resulted when nitric acid seeped from the interstitial pores of the ThN matrix, penetrated the internal packaging, and came in contact with slaked lime which was placed in the drums to neutralize any leaking acid. It is believed that the slaked lime contained some calcium carbonate which released carbon dioxide when it reacted with the nitric acid. As a result, when retrieving drums of domestic origin ThN stored in metal drums should be handled with special attention to minimize the risk of another drum losing its lid.

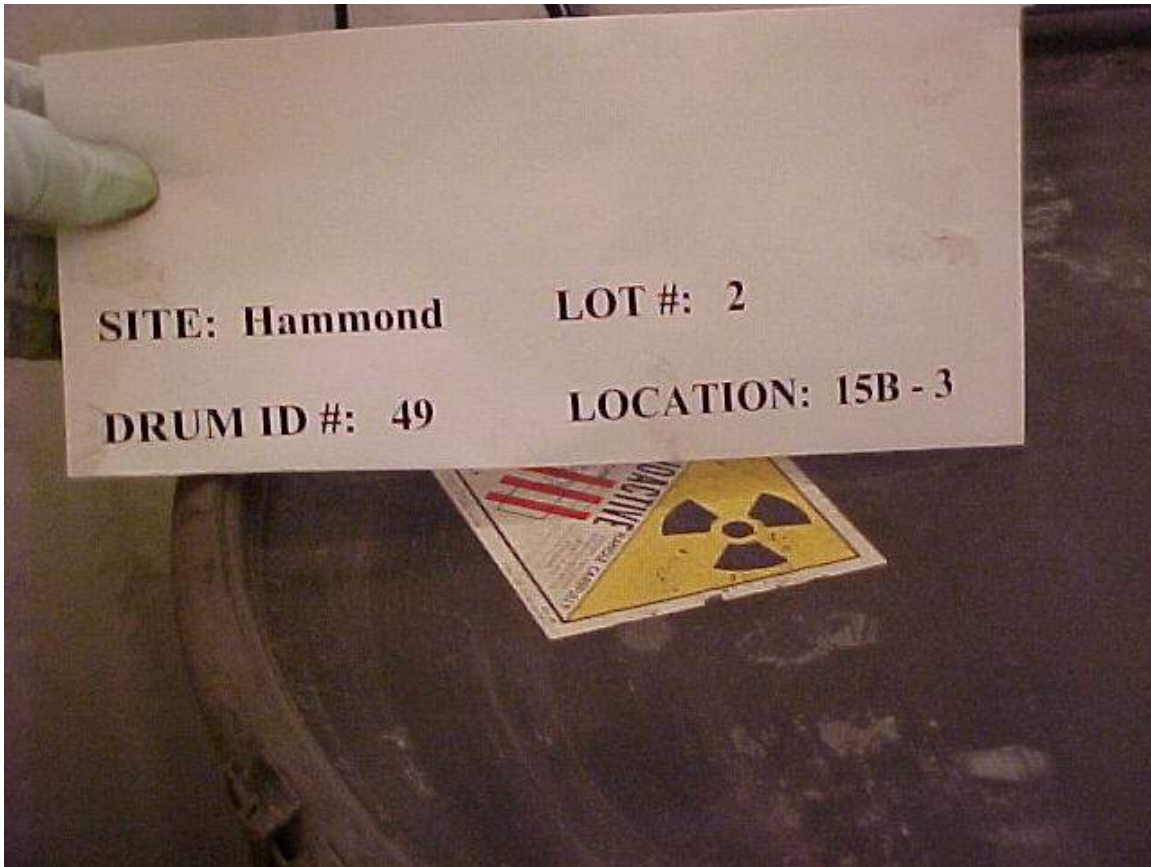
Lot No.	<u>2</u>	Inspection/Sample	<u>Visual Inspection</u>
Drum ID No.	<u>49</u>	Date	<u>6-6-2002</u>
Location	<u>15B-3</u>	Photo No.	<u>2 of 8</u>
Site	<u>Hammond</u>		
Container	<u>85-gallon steel drum</u>	Container Condition	<u>Good – drum ring also in good condition</u>

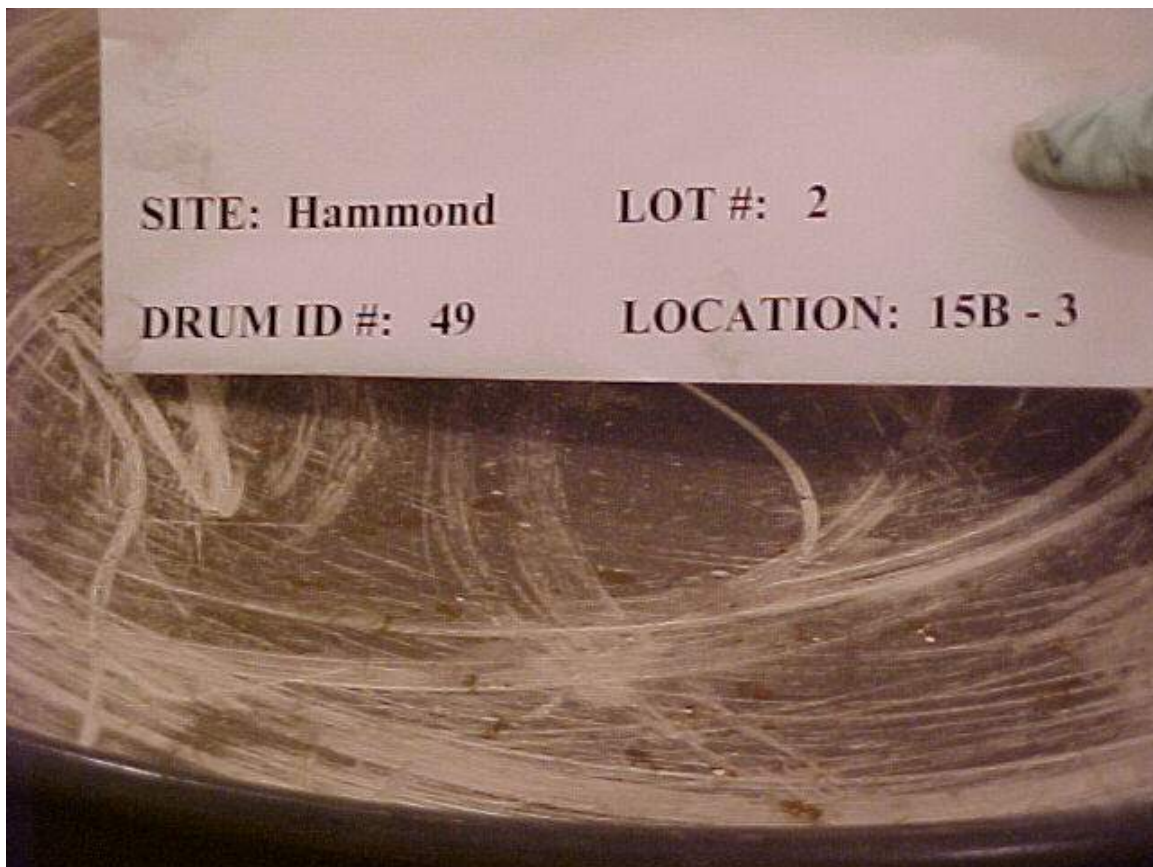
Lot No. 2
Drum ID No. 49
Location 15B-3
Site Hammond

55 gal drum lid – Good Condition
Ring is in good condition with 3/8 x 3 1/2 bolt/nut
Ring and lid are tight
55-gal drum is packaged in an 85-gal drum with vermiculite
No gasses present

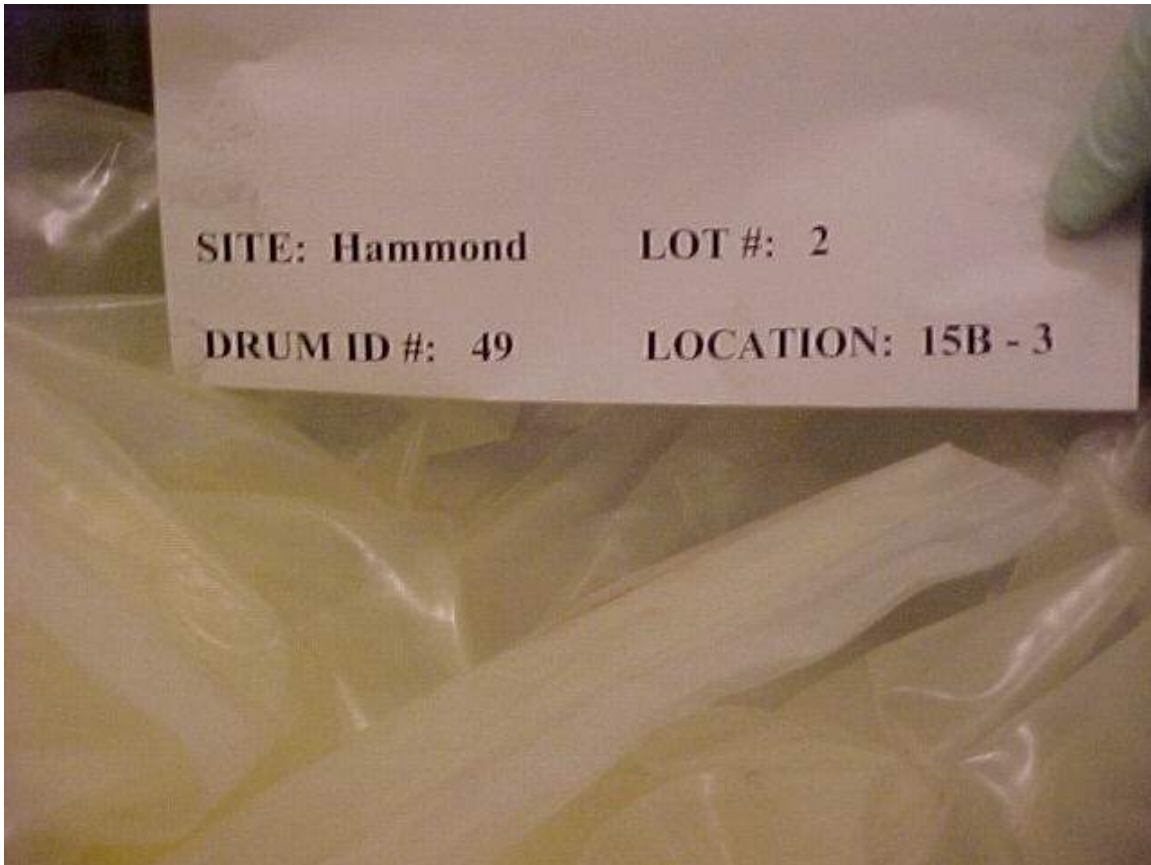
Inspection/Sample Visual Inspection
Date 6-6-2002
Photo No. 4 of 8

1st Poly liner/bag
Sealed - Poly liner/bag - Good Condition
No gasses present

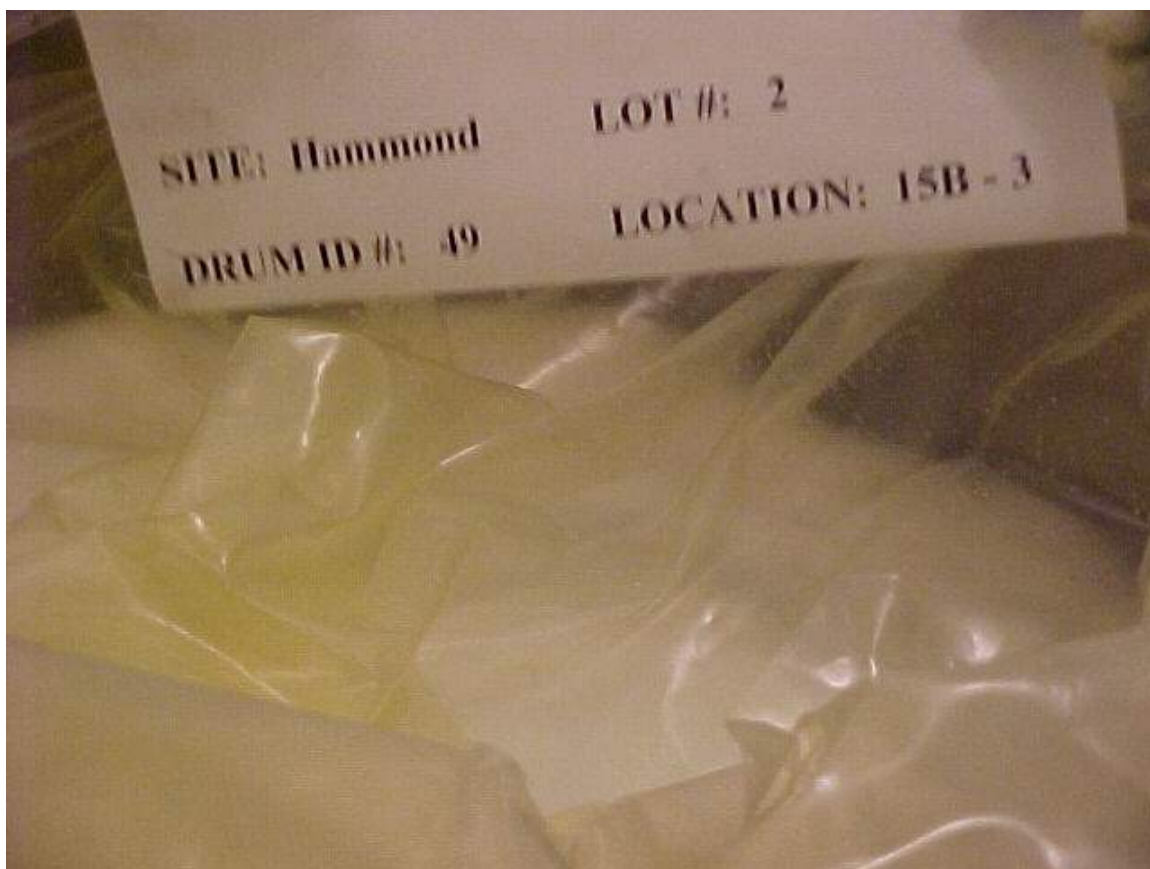
Inspection/Sample Visual Inspection
Date 6-6-2002
Photo No. 5 of 8

2nd Poly liner/bag – Good Condition
No moisture present
No measurement of gasses present

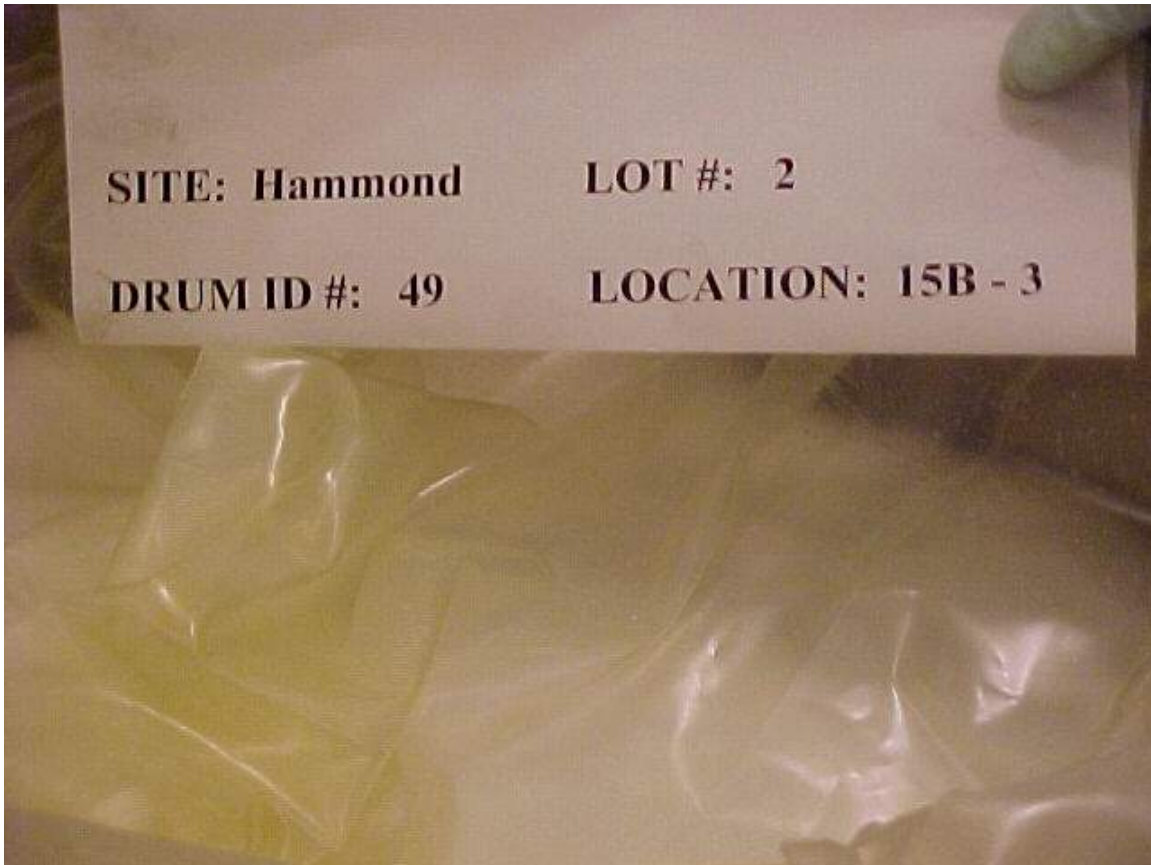
Inspection/Sample Visual Inspection
Date 6-6-2002
Photo No. 6 of 8

Another photo of the 2nd poly liner/bag
No holes or tears in liner/bag
No gasses present

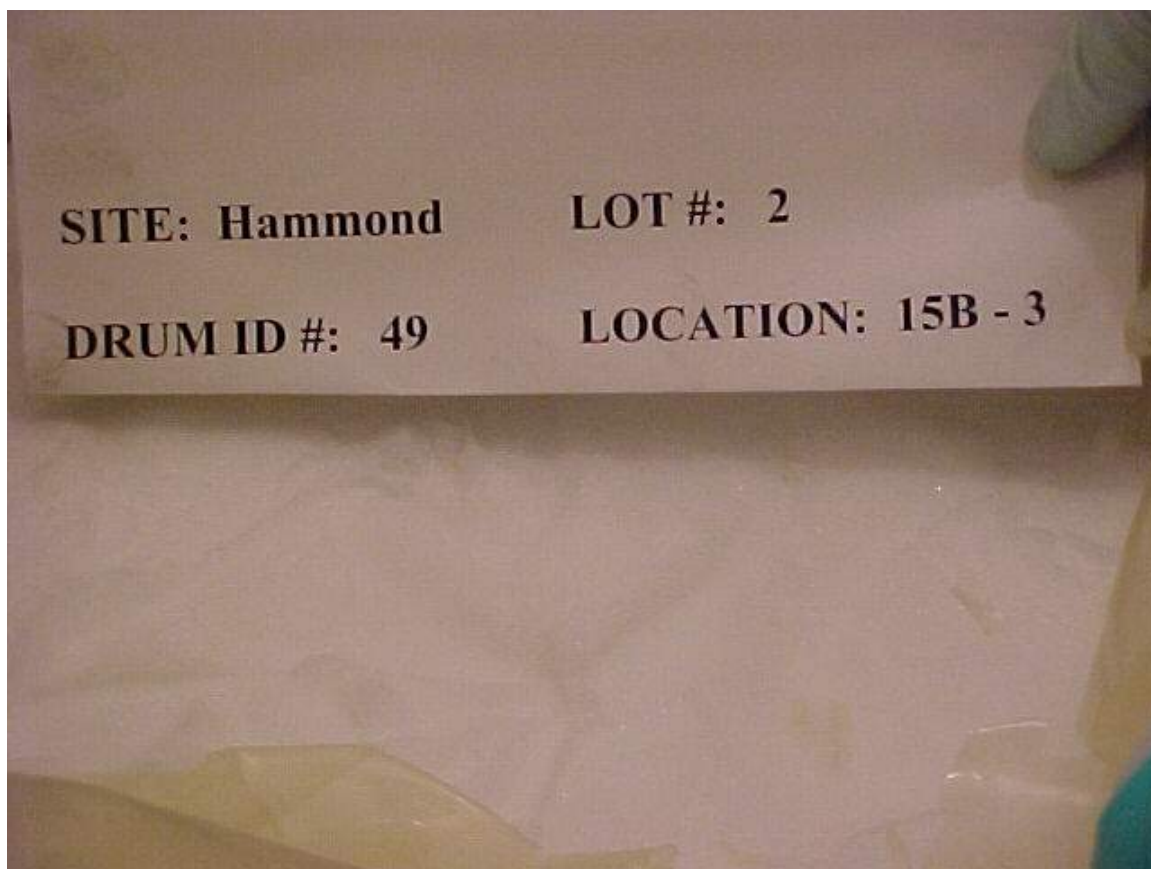
Inspection/Sample Visual Inspection
Date 6-6-2002
Photo No. 7 of 8

Monolith - White in color
Solid and very dry
No measurement of gasses present

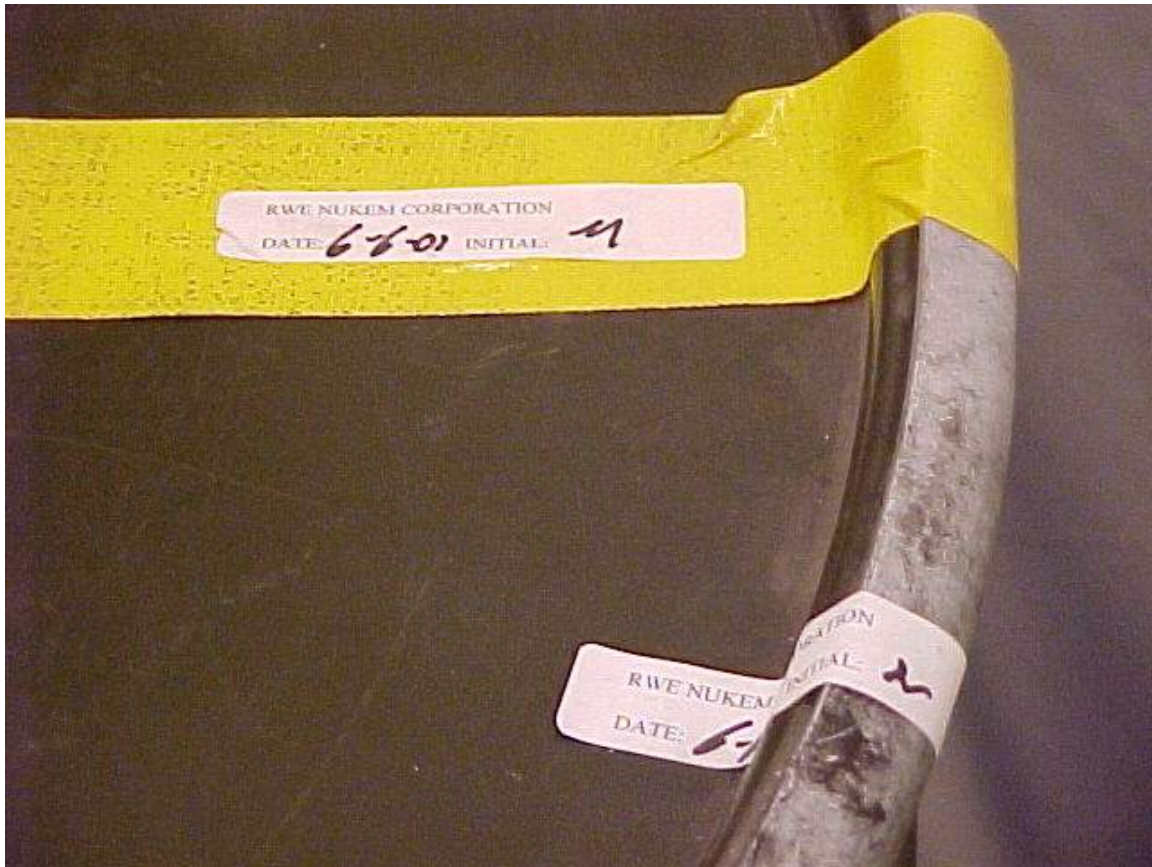
Inspection/Sample Visual Inspection
Date 6-6-2002
Photo No. 8 of 8

85-gal container – Good Condition
Sealed/dated - Completed

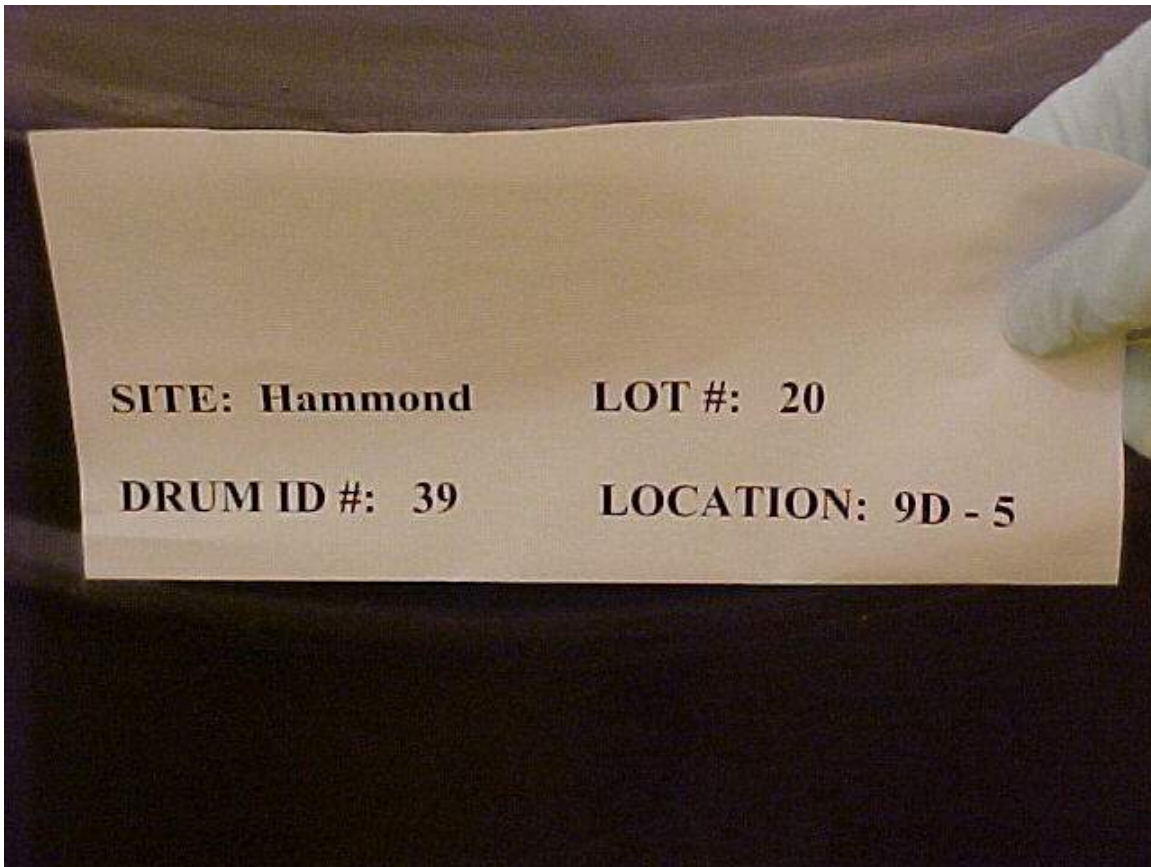
Inspection/Sample Visual Inspection
Date 6-6-2002
Photo No. 2 of 7

85 gal drum lid – Good Condition
Ring is also in good condition

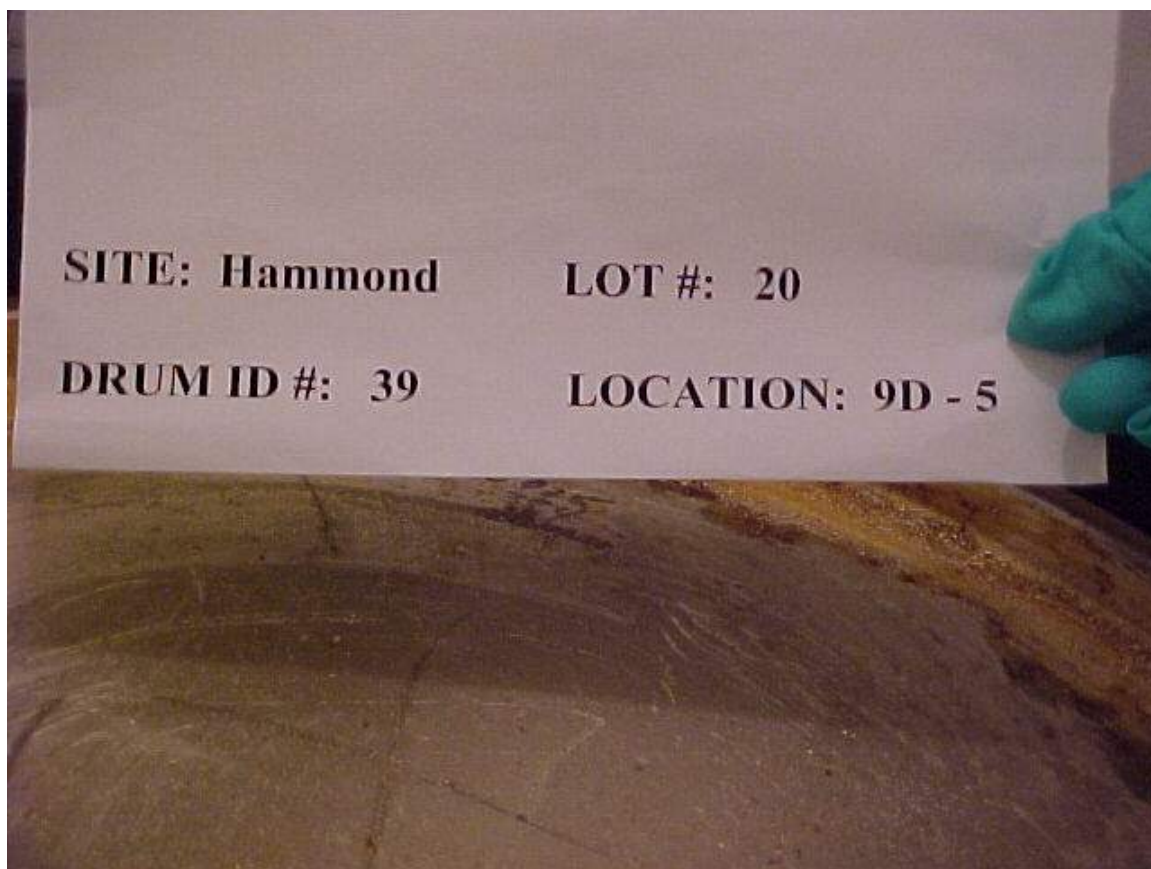
Lot No.	<u>20</u>	Inspection/Sample	<u>Visual Inspection</u>
Drum ID No.	<u>39</u>	Date	<u>6-6-2002</u>
Location	<u>9D-5</u>	Photo No.	<u>3 of 7</u>
Site	<u>Hammond</u>

55 gal lid – Good Condition

Observing the ring we noticed that the ring was extremely loose

55 gal drum is package in a 85 gal overpack with vermiculite

No measurement of gasses present

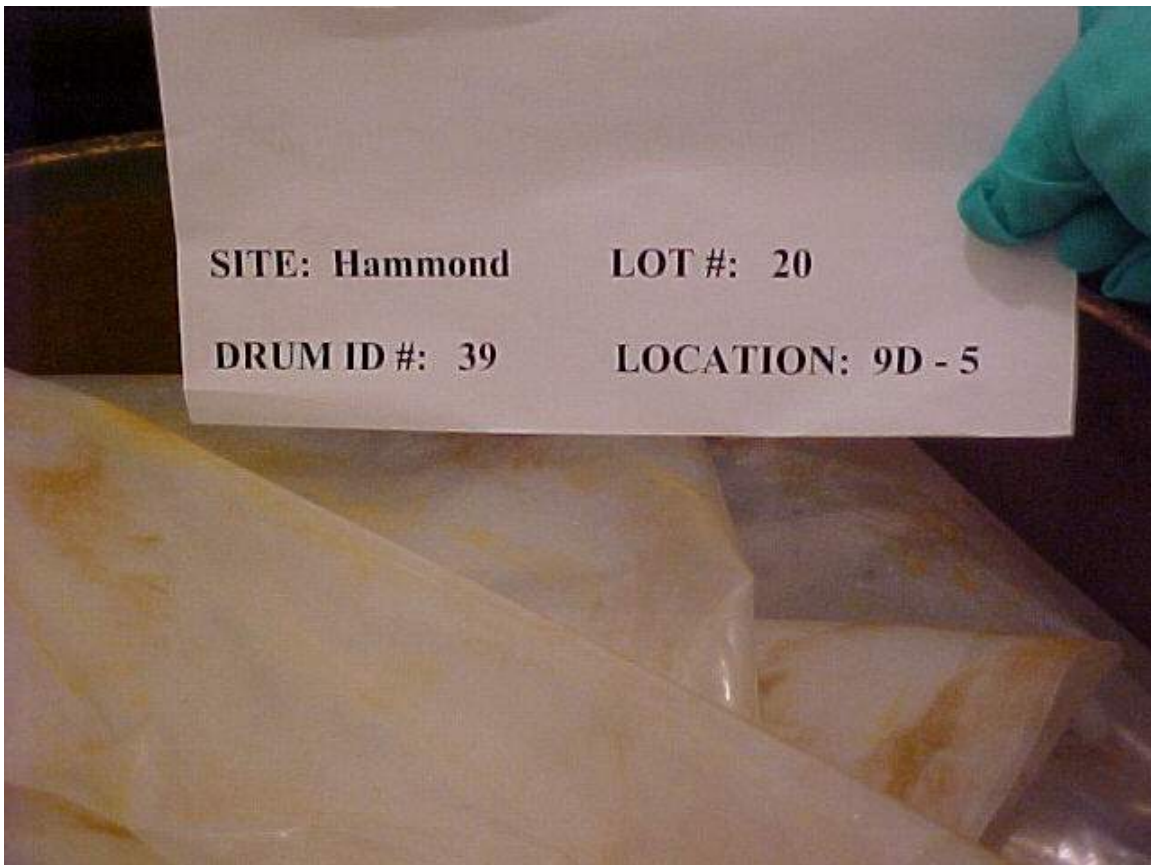
Inspection/Sample Visual Inspection
Date 6-6-2002
Photo No. 4 of 7

1st poly liner/bag – Good Condition
Liner is sealed and in good condition
No measurement of gasses present
Notice of rusty powder on top of liner
A sample was taken of the rusty powder for analysis

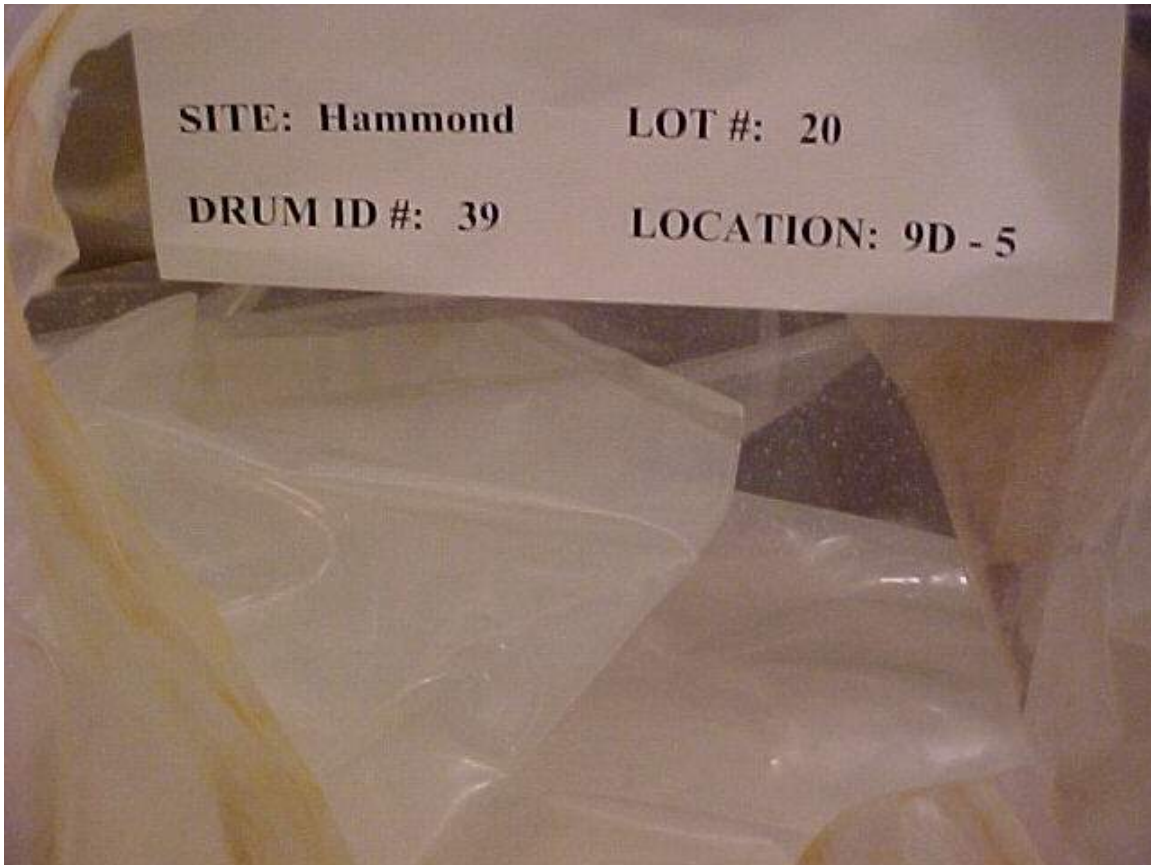
Inspection/Sample Visual Inspection
Date 6-6-2002
Photo No. 5 of 7

2nd poly liner/bag – good condition
Small amounts of crystal/moisture inside liner/bag
No gasses present

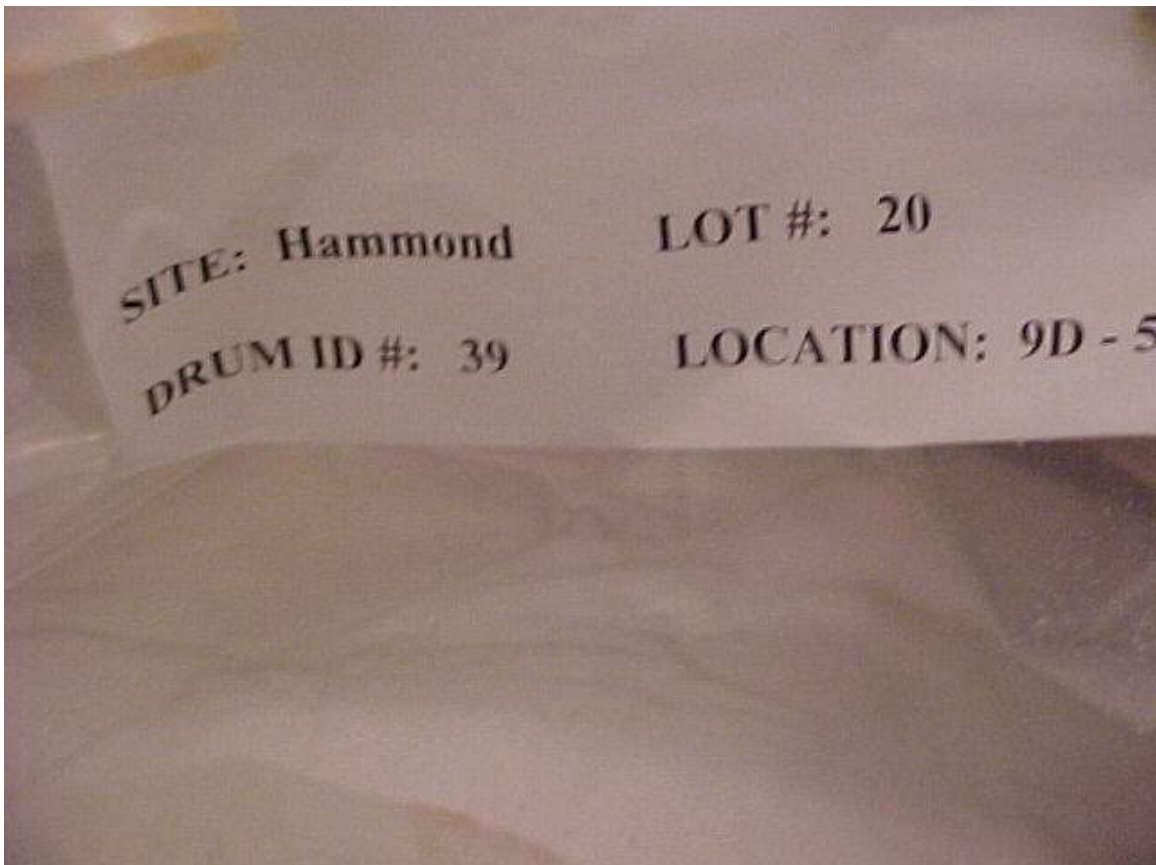
Inspection/Sample Visual Inspection
Date 6-6-2002
Photo No. 6 of 7

Monolith – white in color
Solid – dry
Moisture/crystal on inside of liner/bag
pH sample was taken – red/high – 0 results
No gasses present

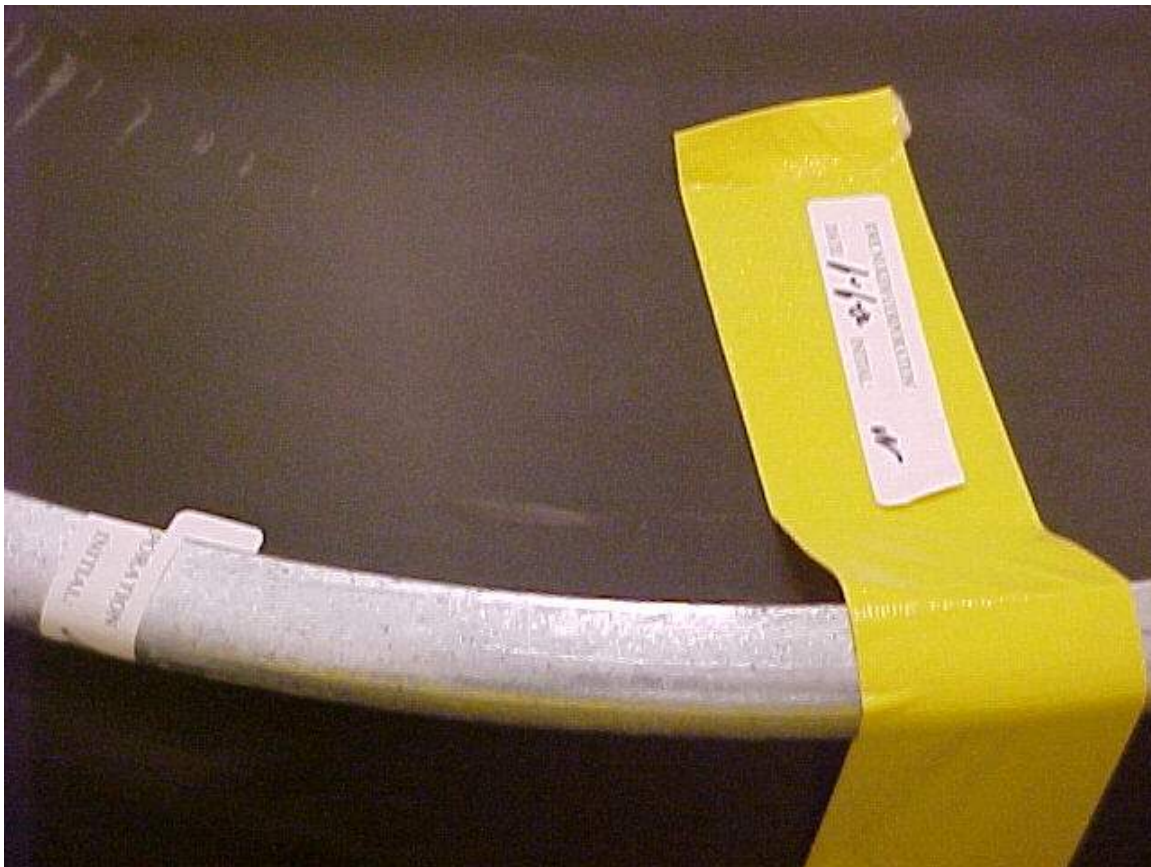
Inspection/Sample Visual Inspection
Date 6-6-2002
Photo No. 7 of 7

85 gal drum – Good Condition
Sealed/dated - Completed

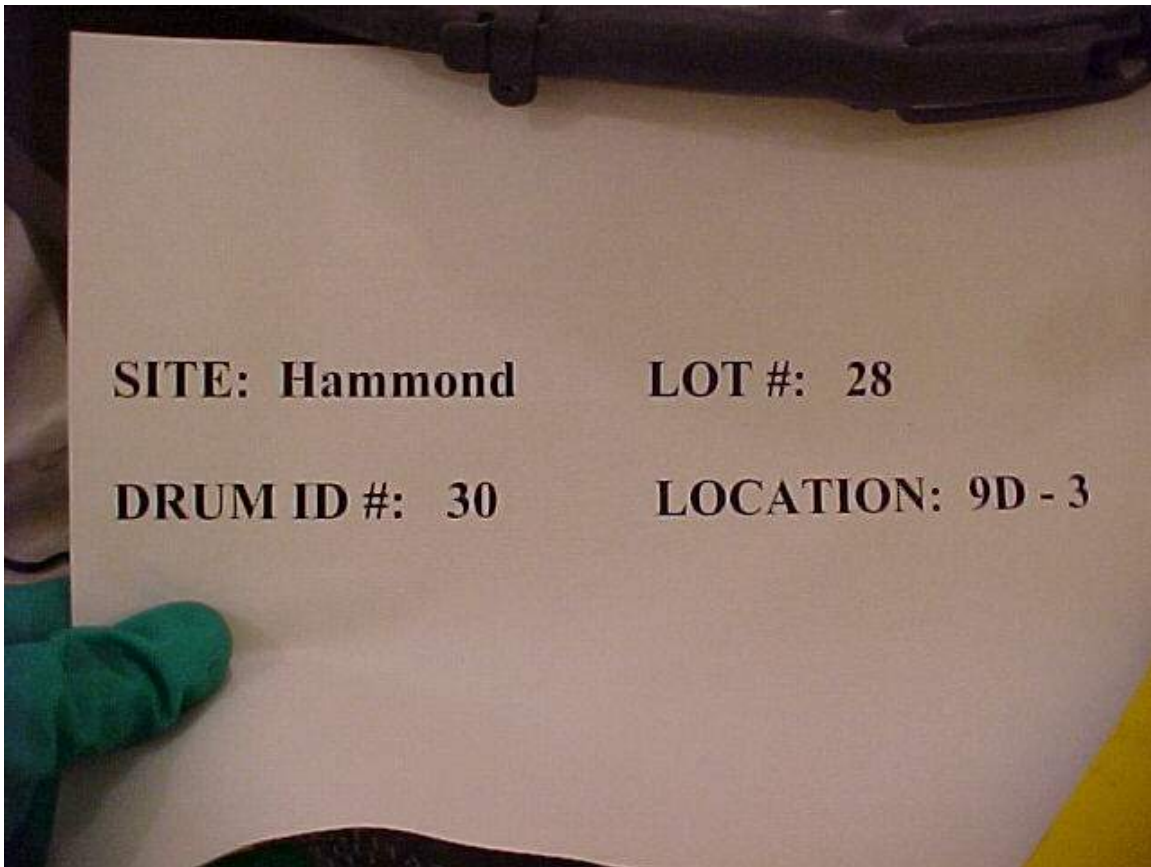
Inspection/Sample Visual Inspection
Date 6-5-2002
Photo No. 2 of 7

85-gal lid – Good Condition
Ring around lid is also in good condition

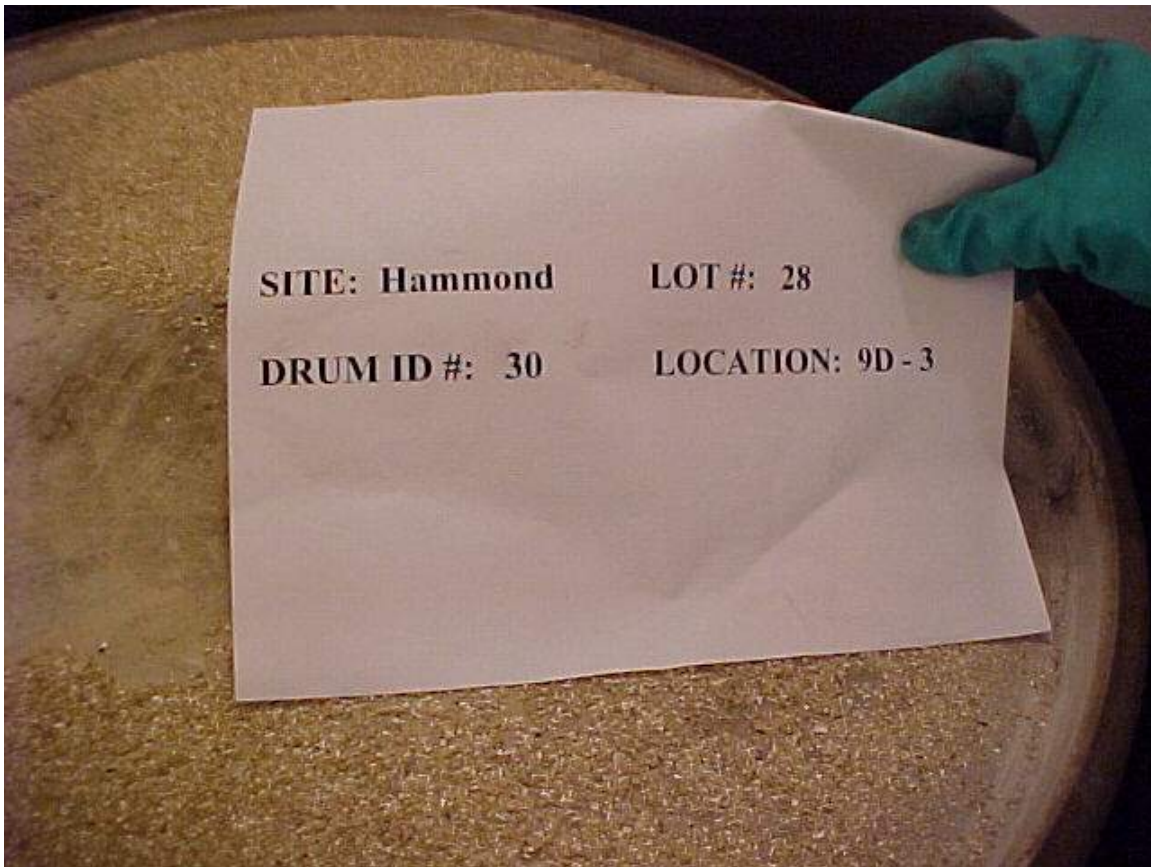
Inspection/Sample Visual Inspection
Date 6-5-2002
Photo No. 3 of 7

55-gal lid – Good Condition

Lid was cleaned off with a vacuum

No measurement of gasses present

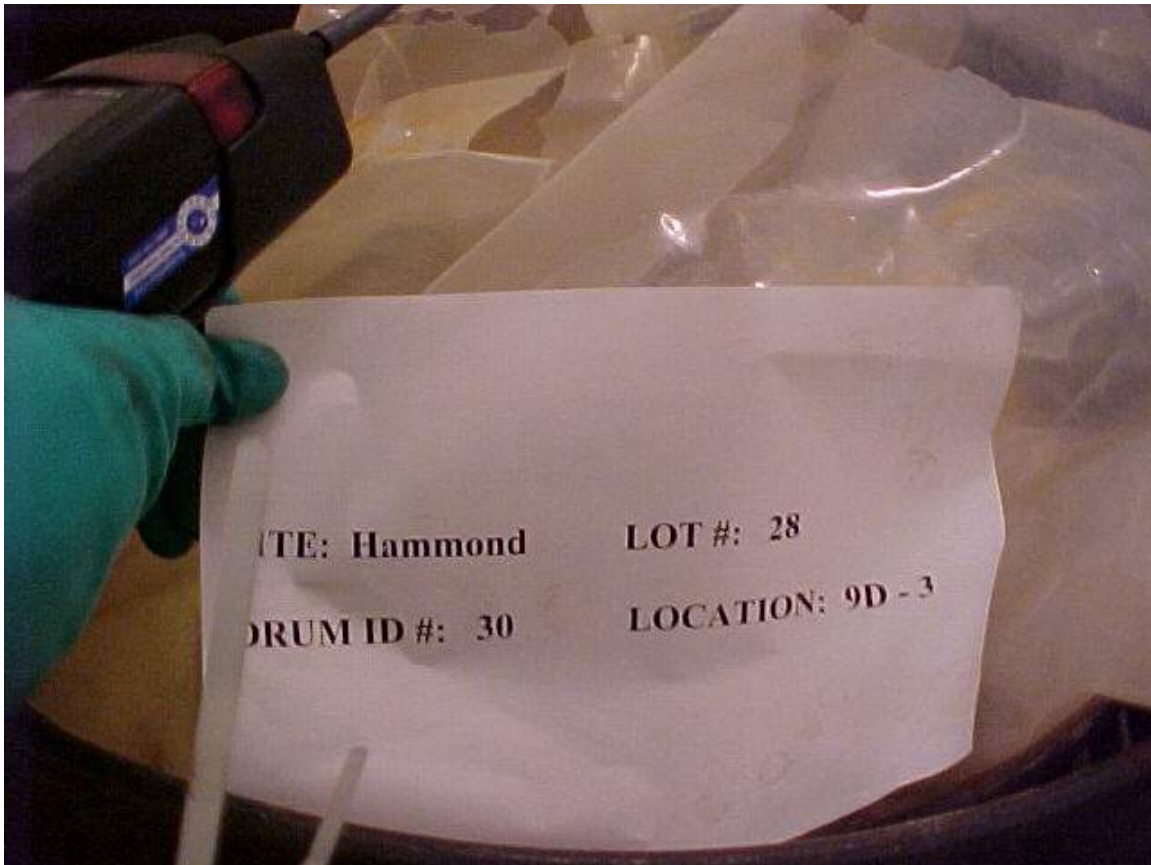
Inspection/Sample Visual Inspection
Date 6-5-2002
Photo No. 4 of 7

1st poly liner/bag - Bad Condition
There are holes all in the liner/bag
No gasses are present

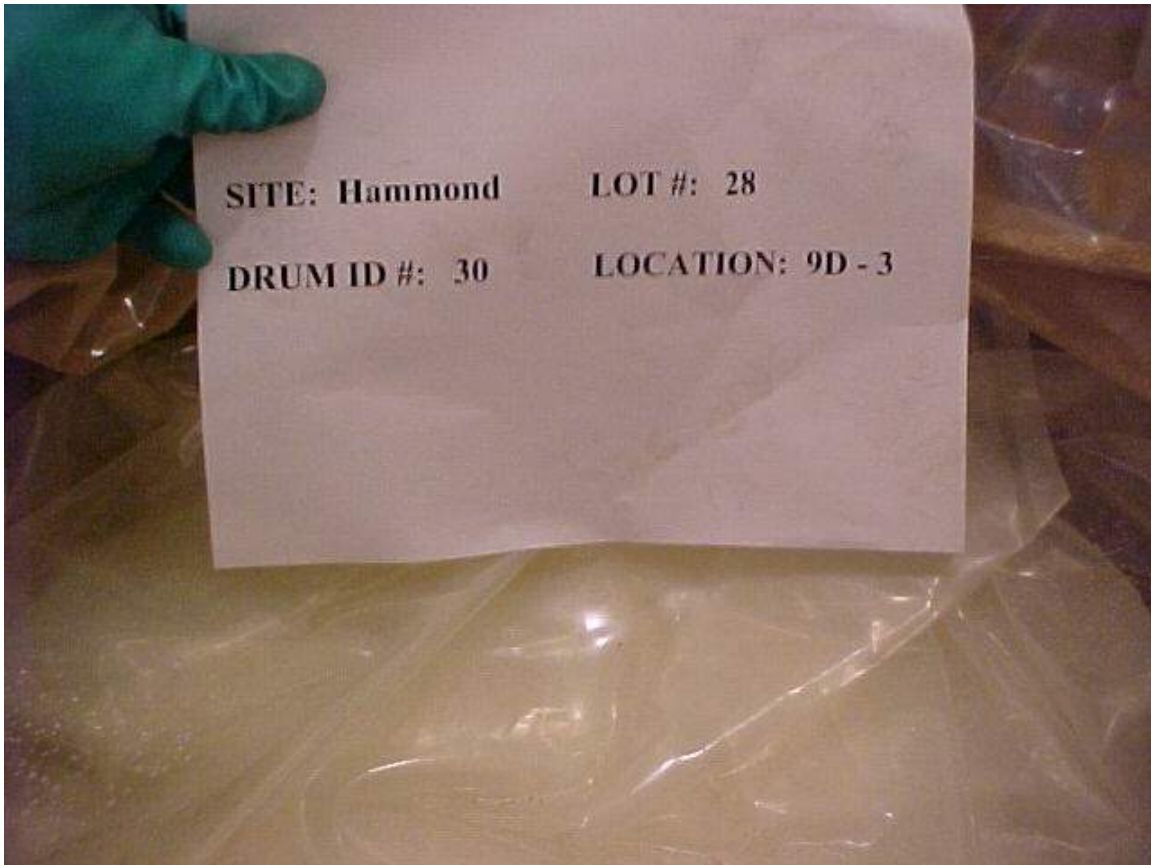
Inspection/Sample Visual Inspection
Date 6-5-2002
Photo No. 5 of 7

2nd poly liner/bag – Good Condition
Moisture is present
No measurement of gasses found

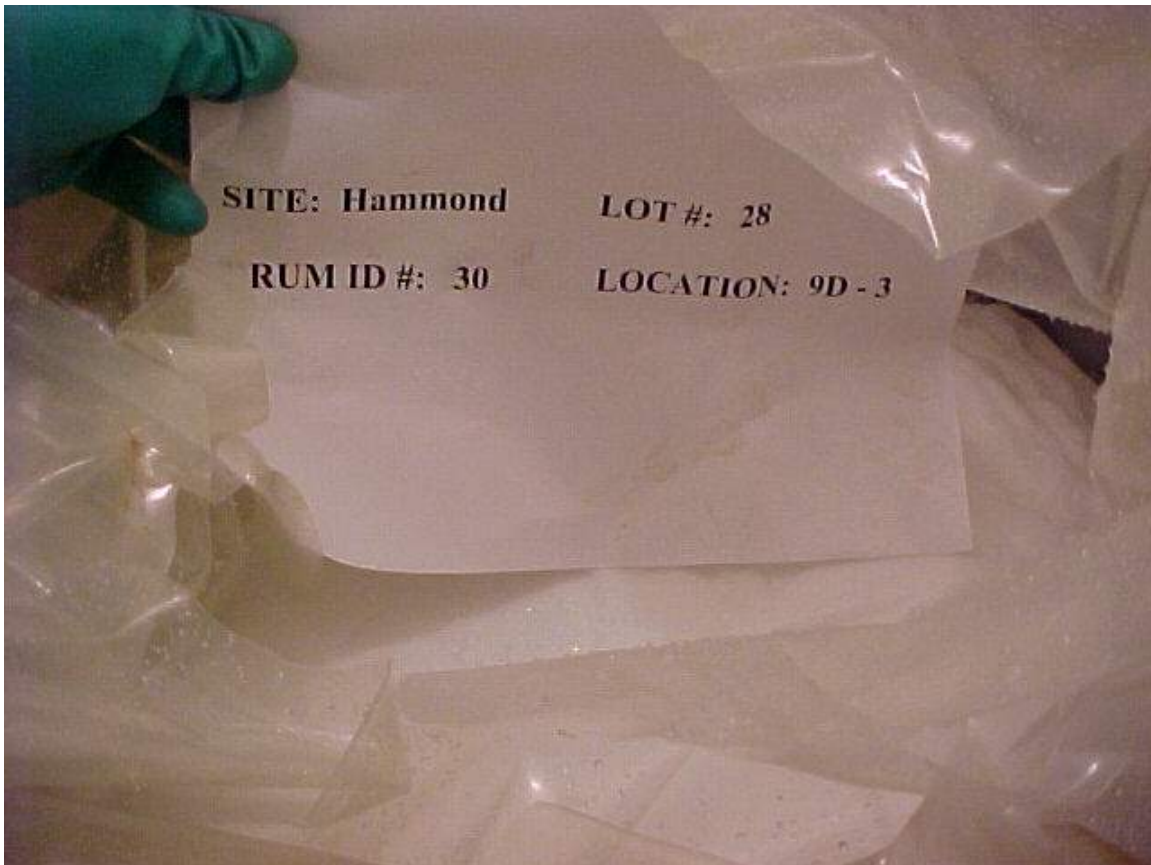
Inspection/Sample Visual Inspection
Date 6-5-2002
Photo No. 6 of 7

NOx – 7.0ppm

Continuous monitoring for gasses until gasses dissipated to 0.0ppm

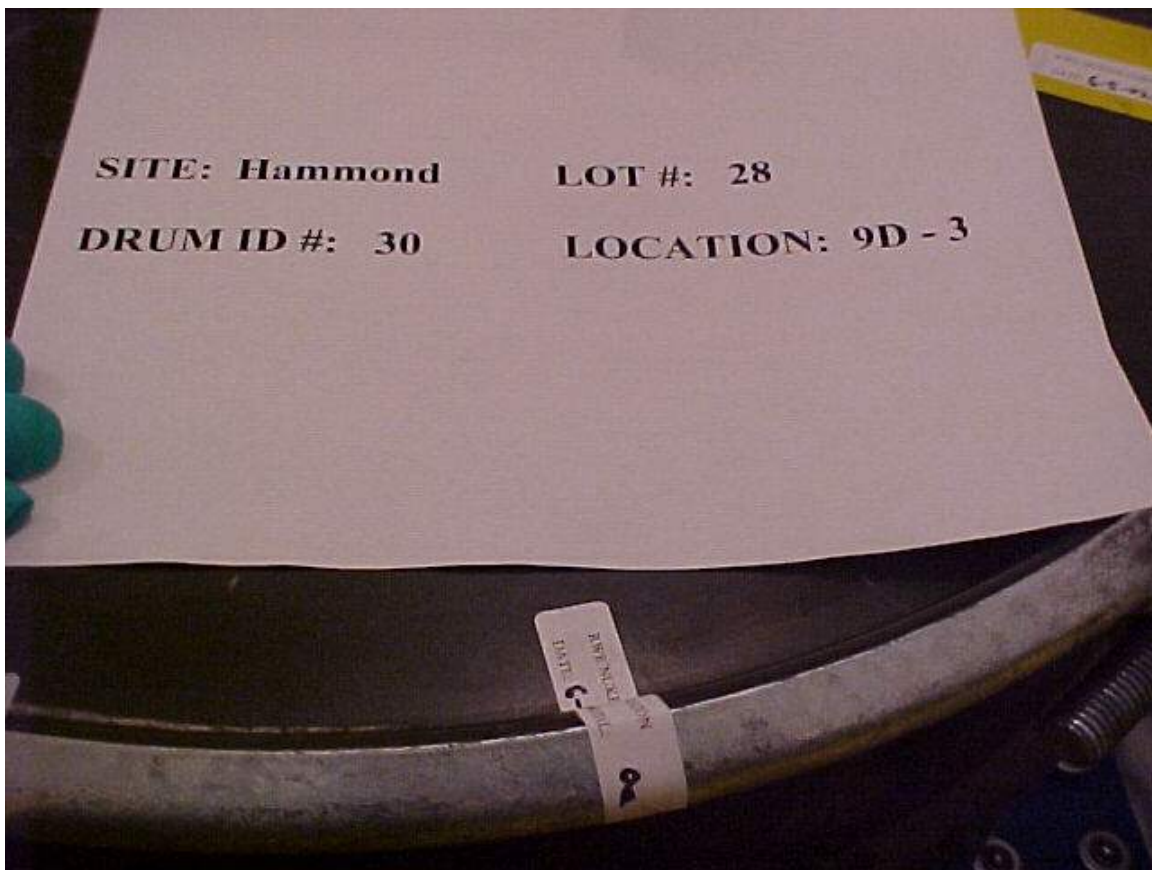
Inspection/Sample Visual Inspection
Date 6-5-2002
Photo No. 6 of 7

85-gal container – Good Condition
Sealed/dated – Completed

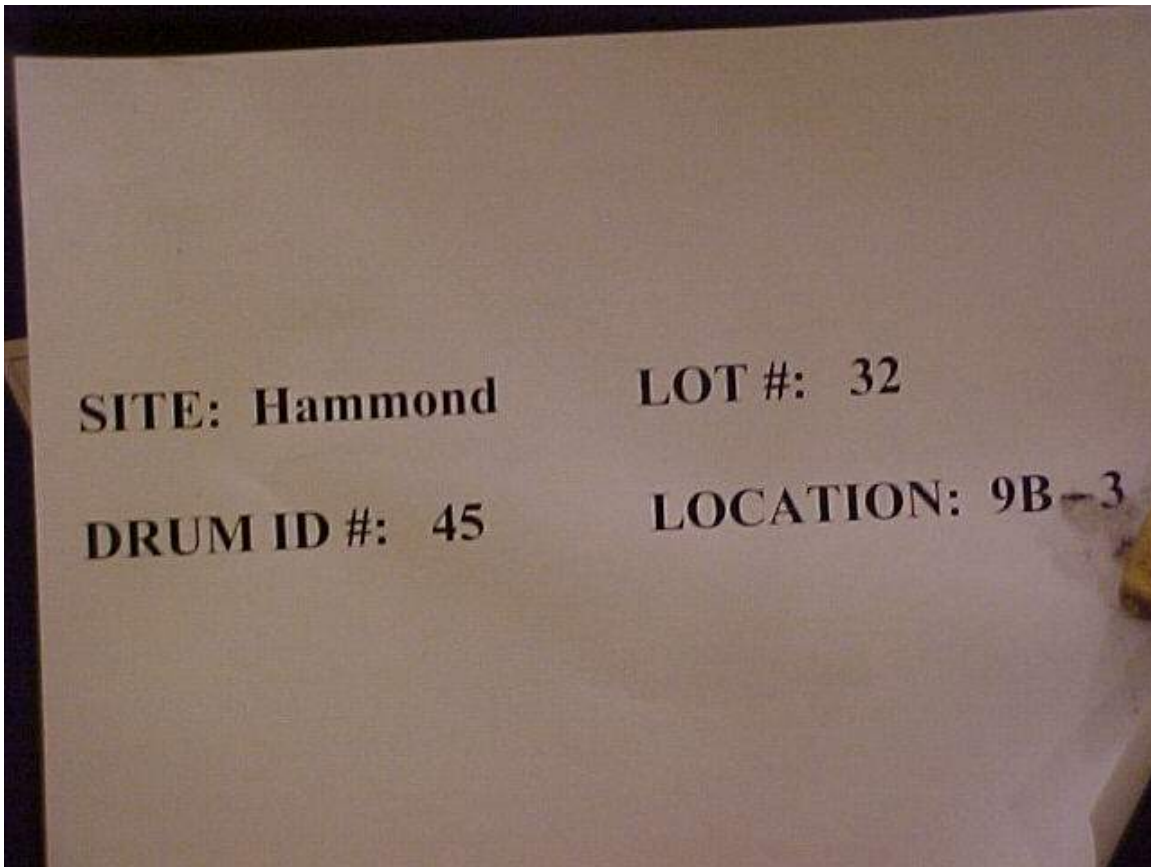
Inspection/Sample Visual Inspection
Date 6-5-2002
Photo No. 2 of 7

85 gal lid – Good Condition
Ring is tight and in good condition
