THORIUM NITRATE STOCKPILE DRUM CHARACTERIZATION REPORT

**THORIUM NITRATE STOCKPILE
DRUM CHARACTERIZATION REPORT**

Prepared for
U.S. Defense Logistics Agency
Defense National Stockpile Center
Fort Belvoir, Virginia

Prepared by
OAK RIDGE NATIONAL LABORATORY
Oak Ridge, Tennessee 37831
managed by
UT-BATTELLE, LLC
for the
U.S. DEPARTMENT OF ENERGY
under contract DE-AC05-00OR22725

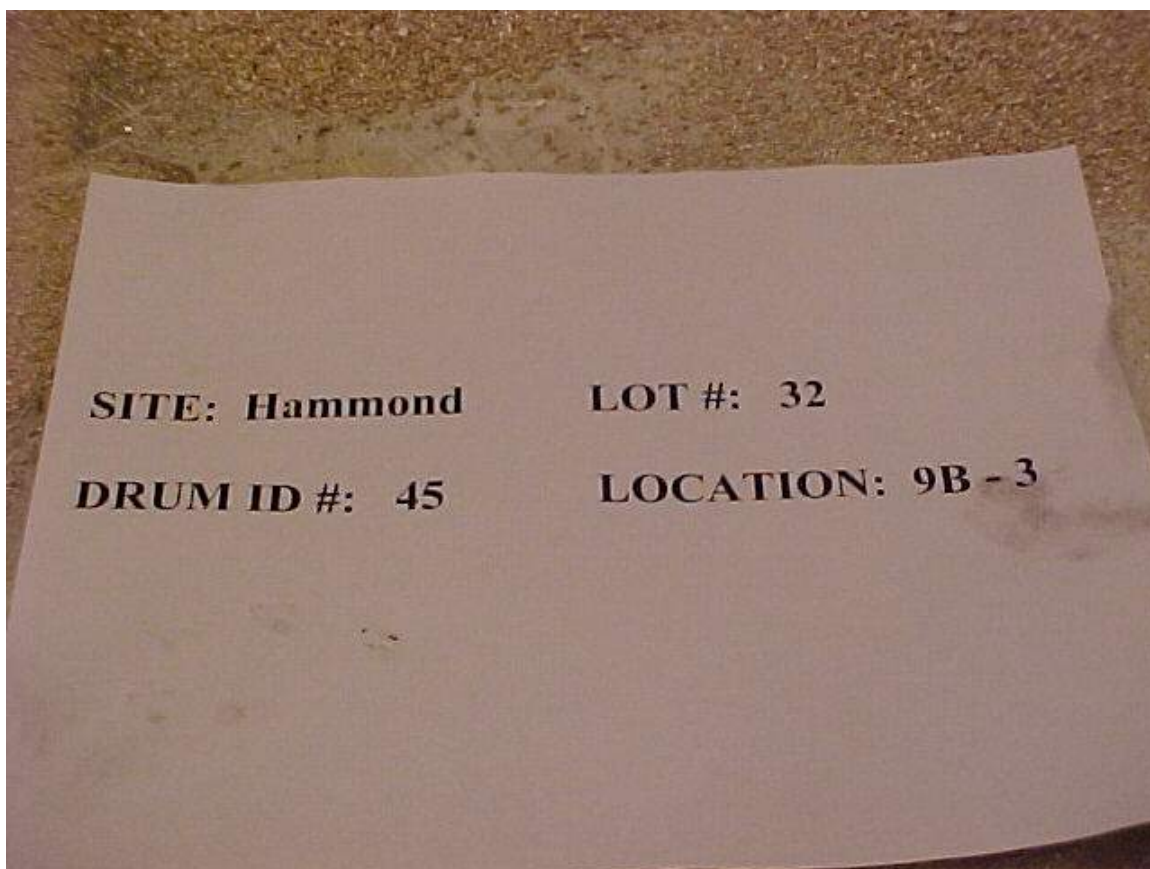
Inspection/Sample Visual Inspection
Date 6-5-2002
Photo No. 3 of 7

55 gal lid – Good Condition
Lid is cover with vermiculite
Lid was vacuum and cleaned
Ring has a 3/8 x 3 1/2 bolt/nut
Ring is tightly on the drum
55 gal drum is pack inside a 85 gal overpack
No gasses present

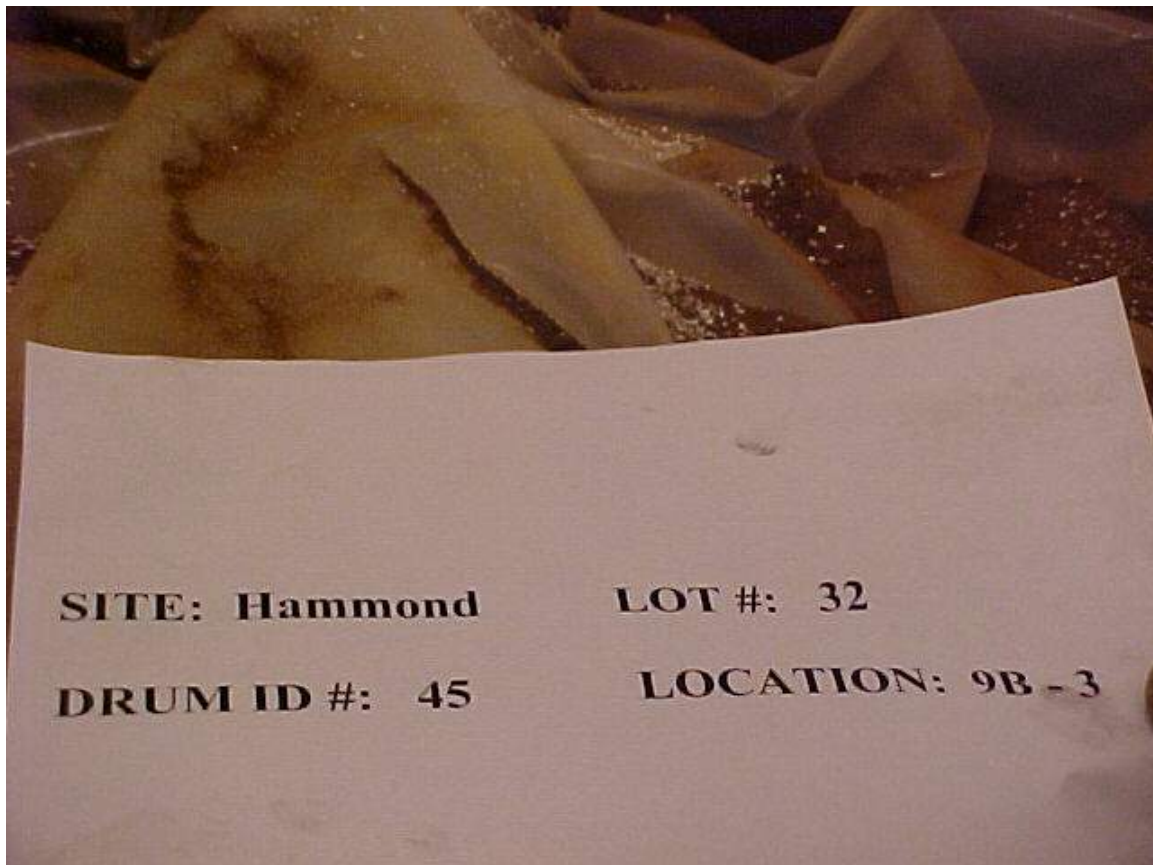
Inspection/Sample Visual Inspection
Date 6-5-2002
Photo No. 4 of 7

1st poly liner/bag – Good Condition
Poly liner/bag was sealed and in good condition
Vermiculite and rusty/power covered liner/bag
The debris was vacuumed from the liner/bag
No gasses were present

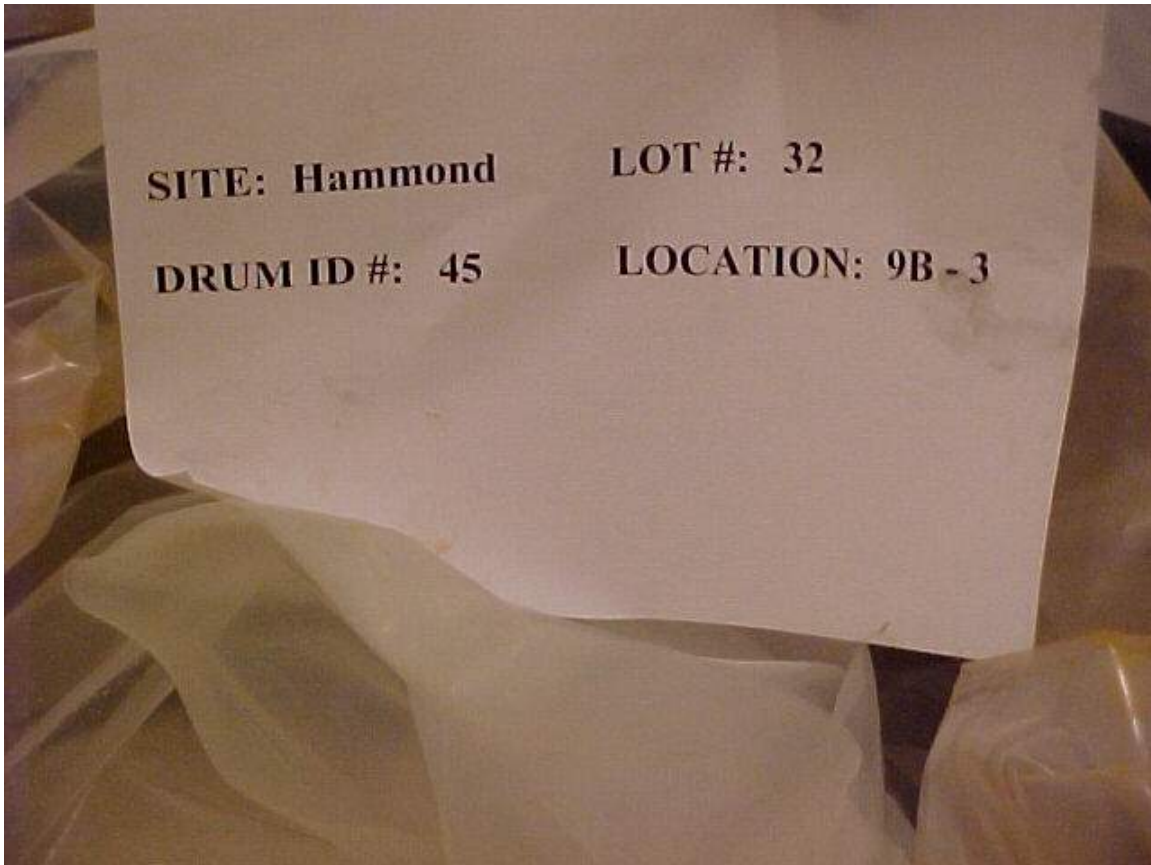
Inspection/Sample Visual Inspection
Date 6-5-2002
Photo No. 5 of 7

2nd poly liner/bag – Good Condition
No moisture present
No measurements of gasses present

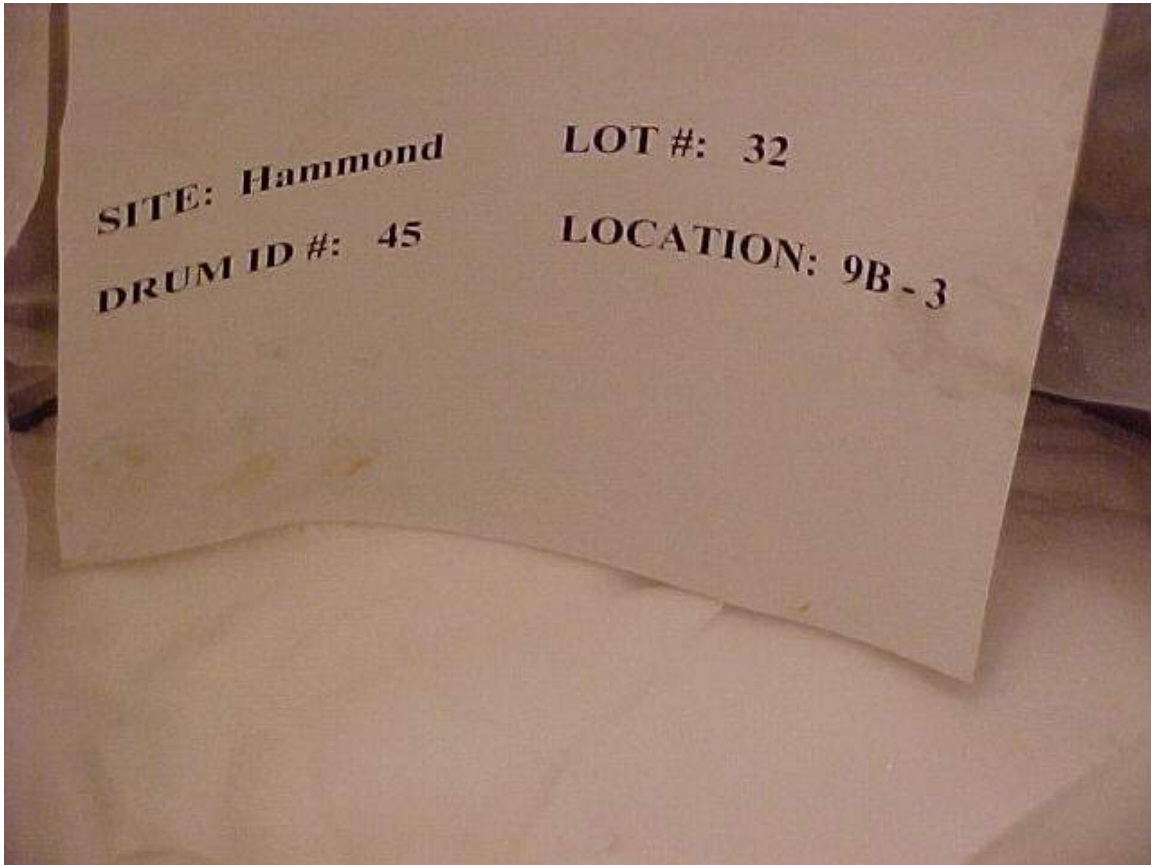
Inspection/Sample Visual Inspection
Date 6-5-2002
Photo No. 6 of 7

Monolith – white in color
Solid - Very dry
No moisture present
No measurement of gasses present

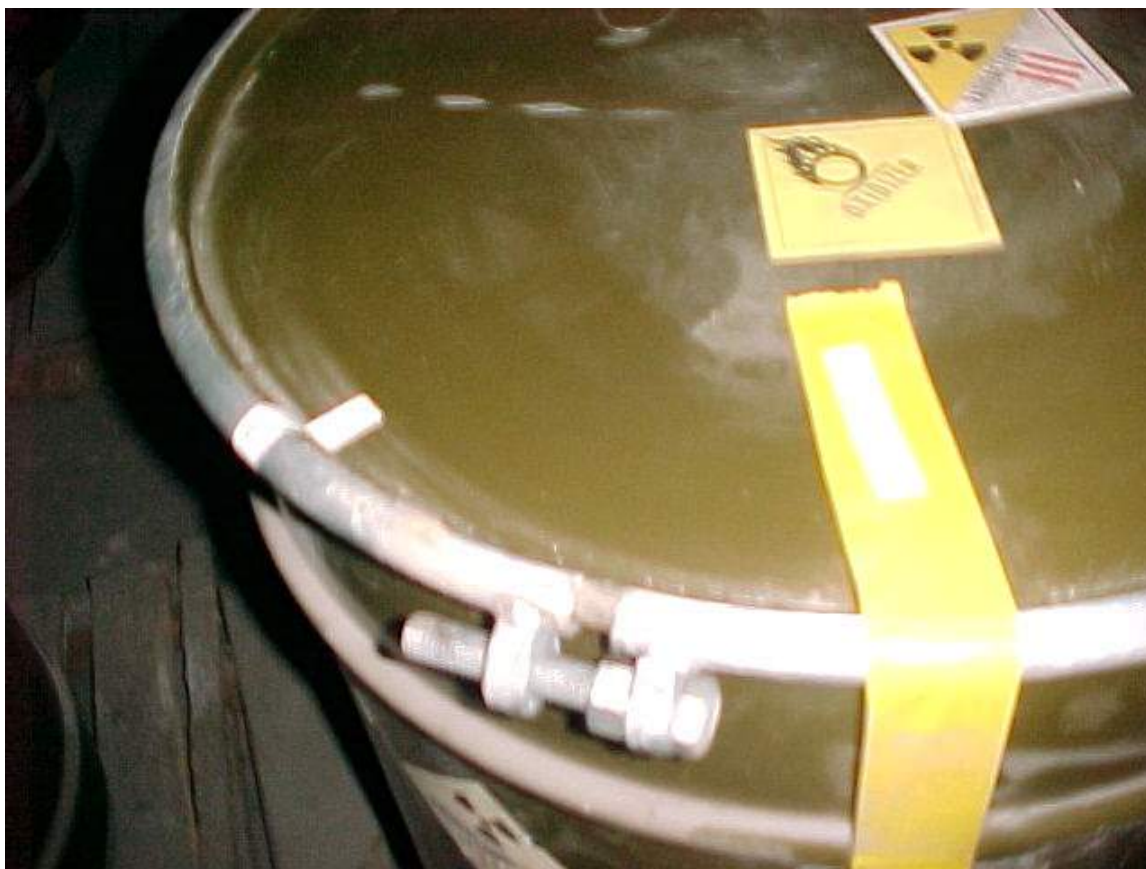
Inspection/Sample Visual Inspection
Date 6-5-2002
Photo No. 7 of 7

85-gal container – Good Condition
Sealed/dated – Completed
Picture did not properly focus (somewhat blurry image)

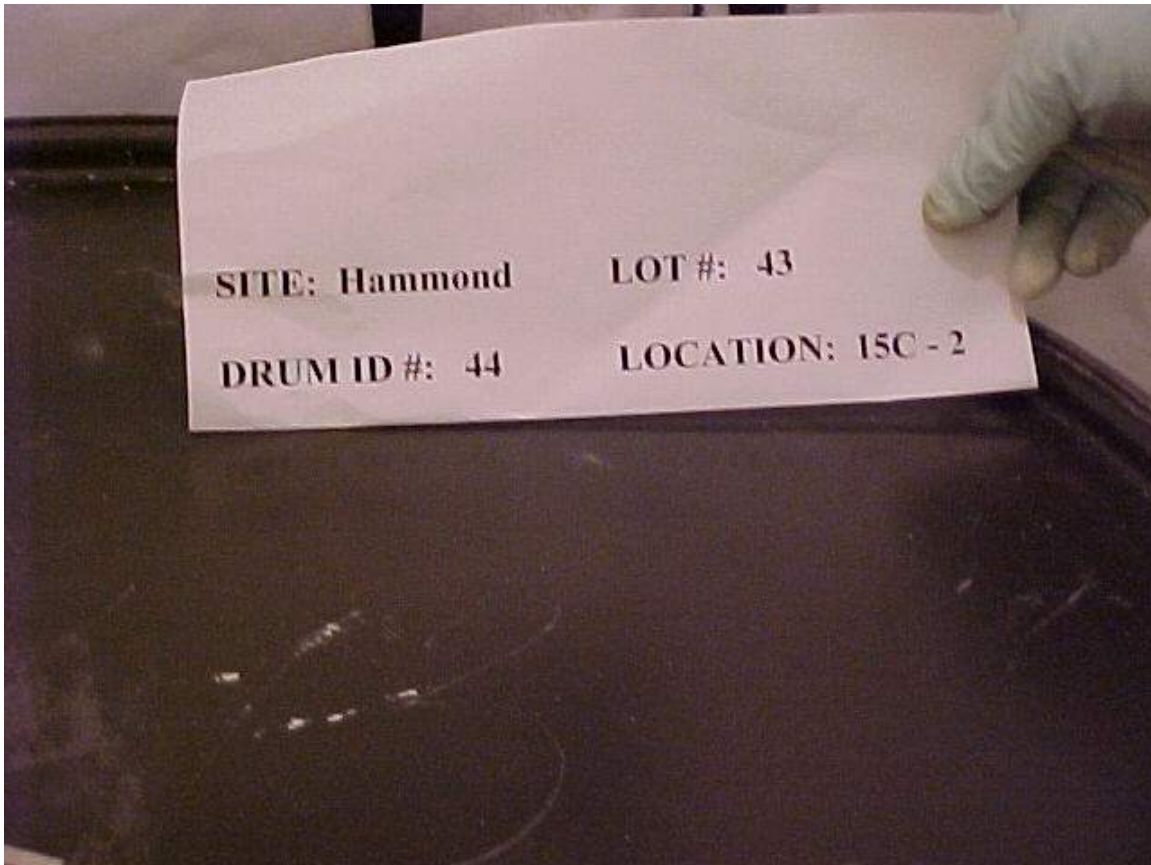
Inspection/Sample Visual Inspection
Date 6-6-2002
Photo No. 2 of 7

55 gal drum lid – Good Condition
Ring is also in good condition
No measurement of gasses present

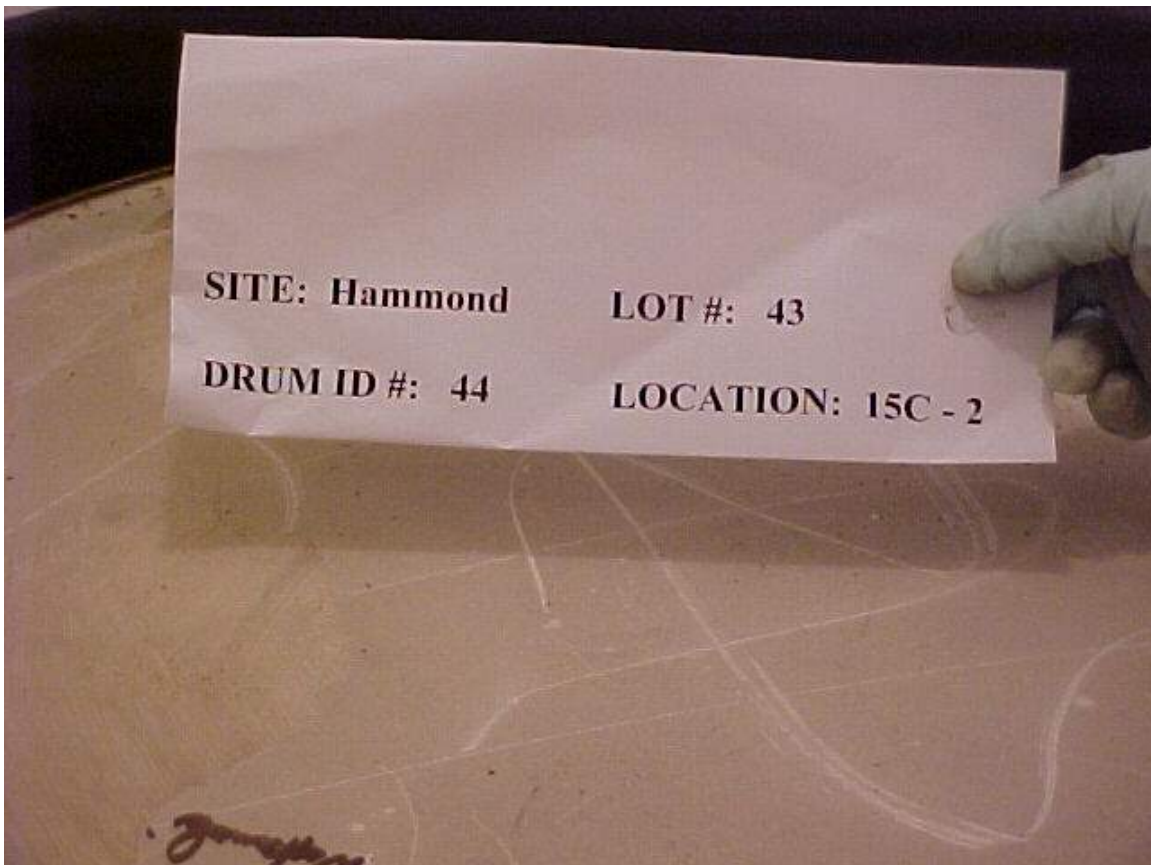
Inspection/Sample Visual Inspection
Date 6-6-2002
Photo No. 3 of 7

55 gal inter lid – Good Condition
Ring has a 3/8 x 3 1/2 bolt/nut holding it on
Ring and lid are on tight
55-gal drum is packaged with vermiculite about 2/3 of 55-gal height
No gasses present

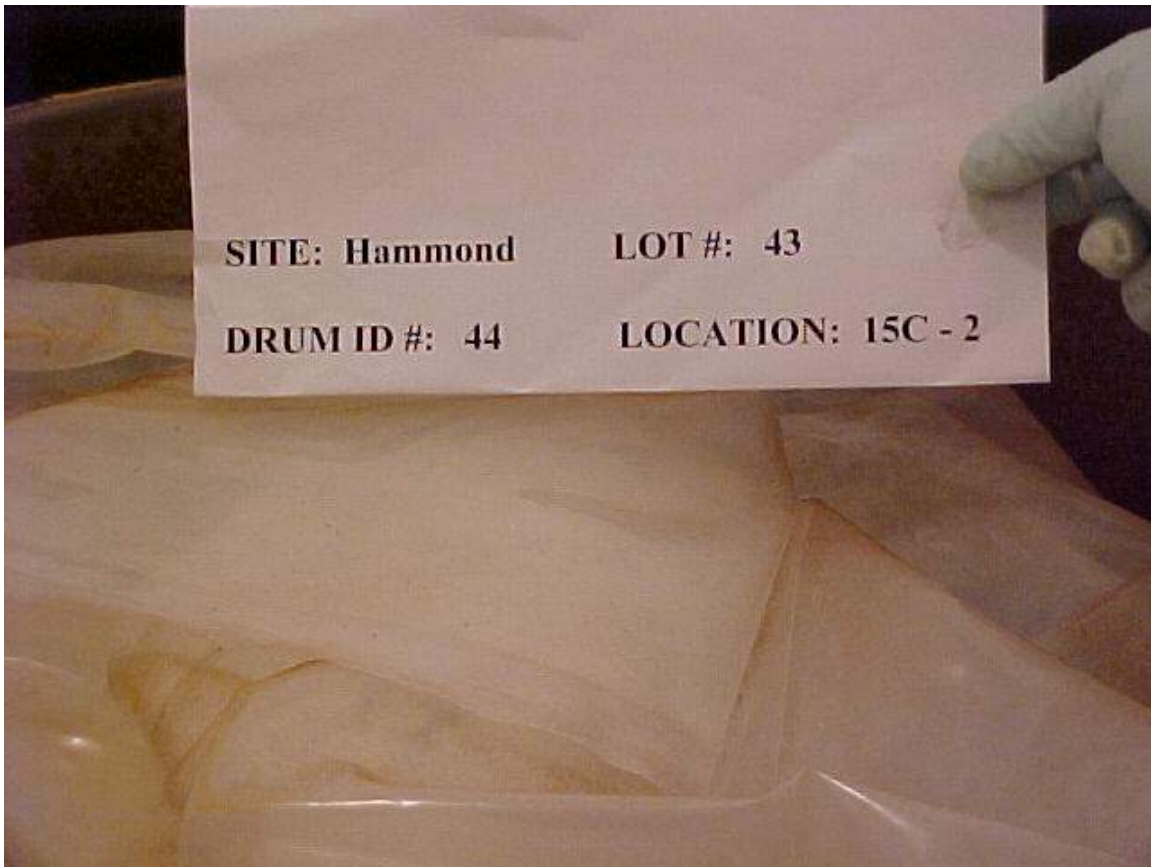
Inspection/Sample Visual Inspection
Date 6-6-2002
Photo No. 4 of 7

1st poly liner/bag - Fair Condition
No gas measurements present

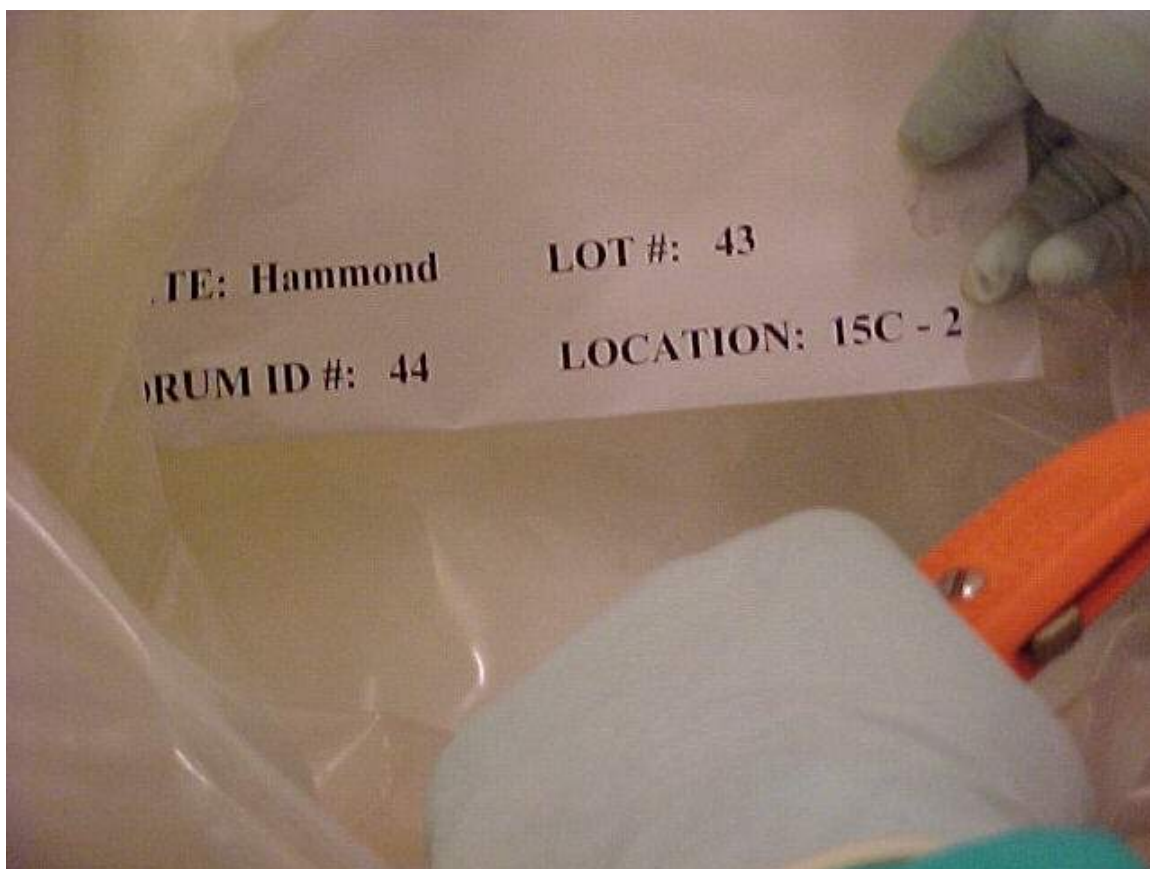
Inspection/Sample Visual Inspection
Date 6-6-2002
Photo No. 5 of 7

2nd poly liner/bag - Good Condition
No moisture present
No gasses present

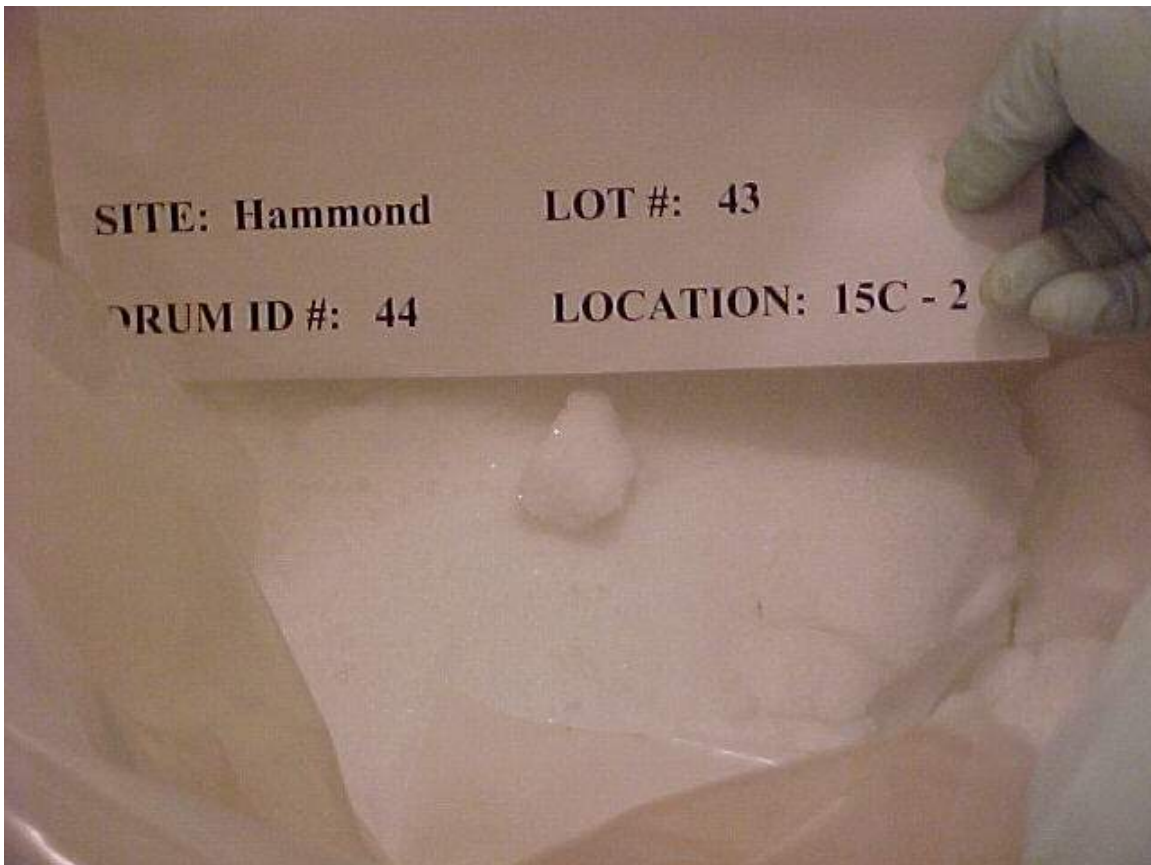
Inspection/Sample Visual Inspection
Date 6-6-2002
Photo No. 6 of 7

Monolith – white in color
Broken/cracked in several places
Very dry
No moisture present
No gasses present

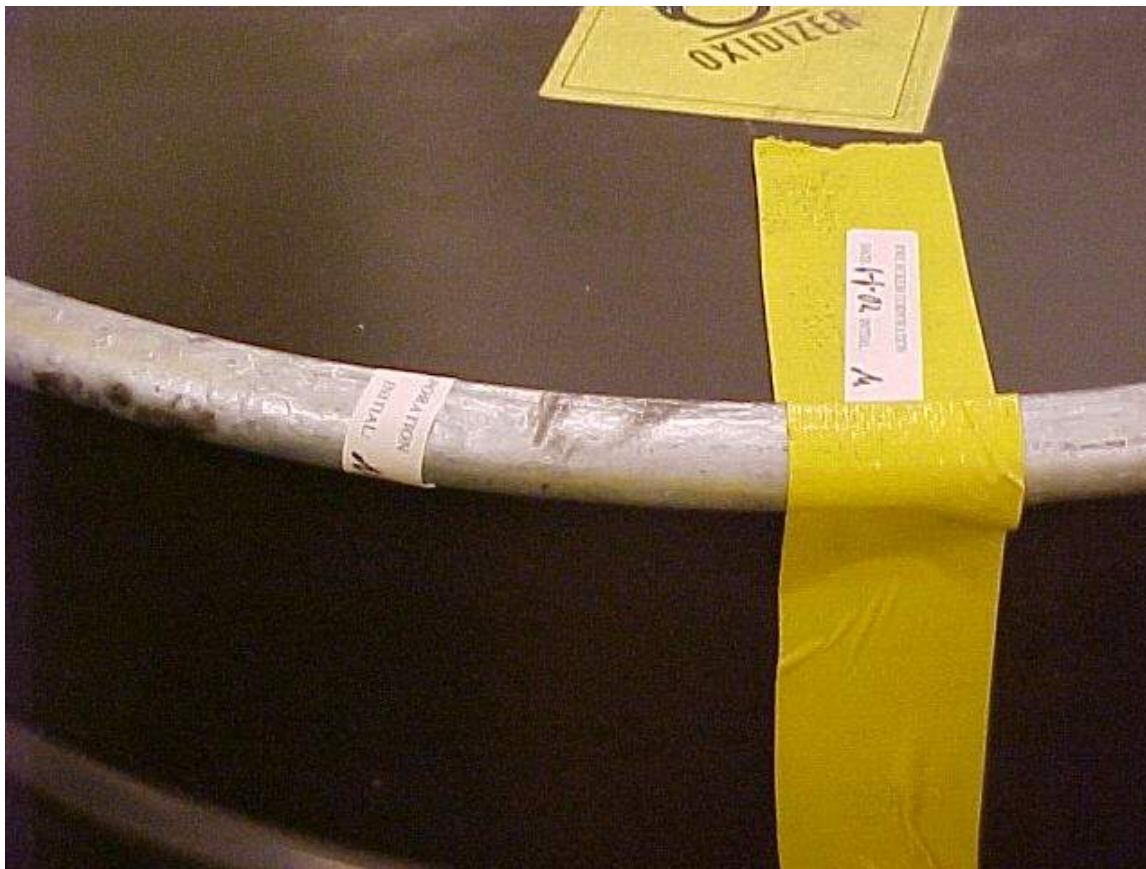
Inspection/Sample Visual Inspection
Date 6-6-2002
Photo No. 7 of 7

85-gal container – Good Condition
Sealed/dated - Completed

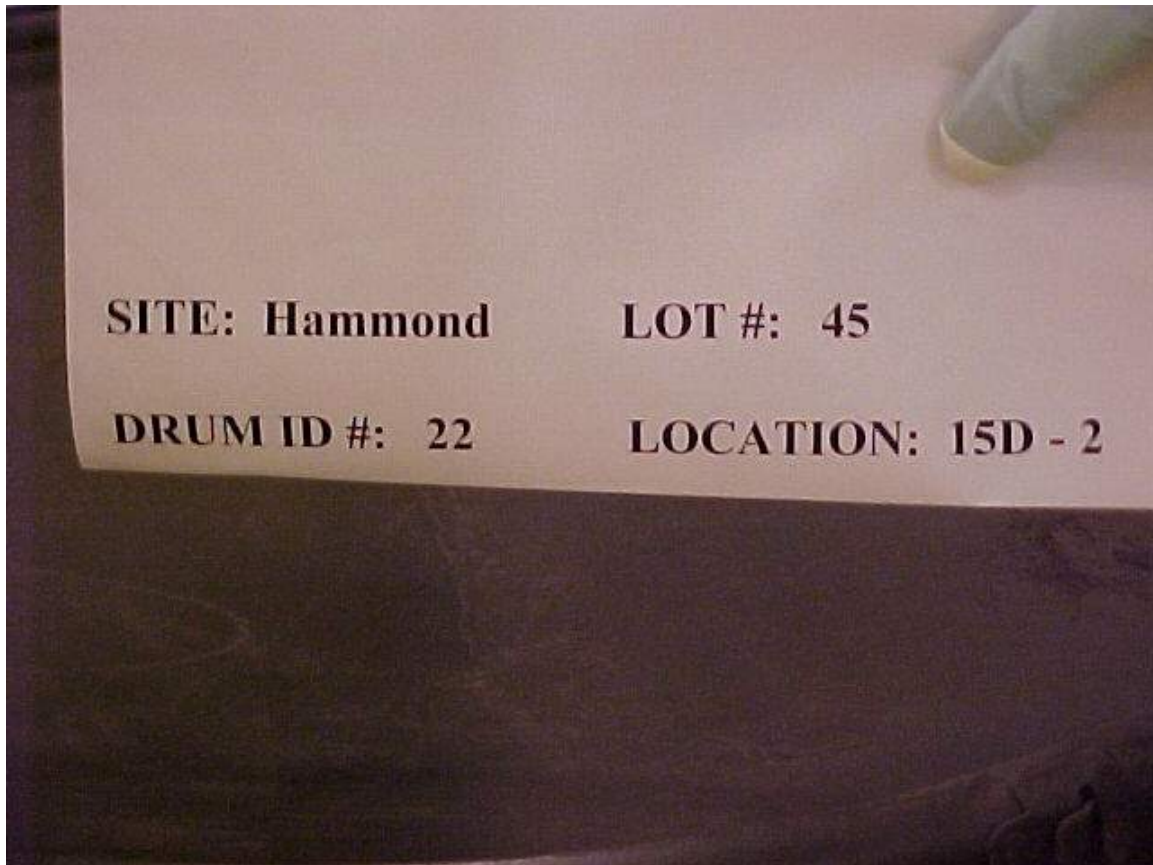
Ring in good condition

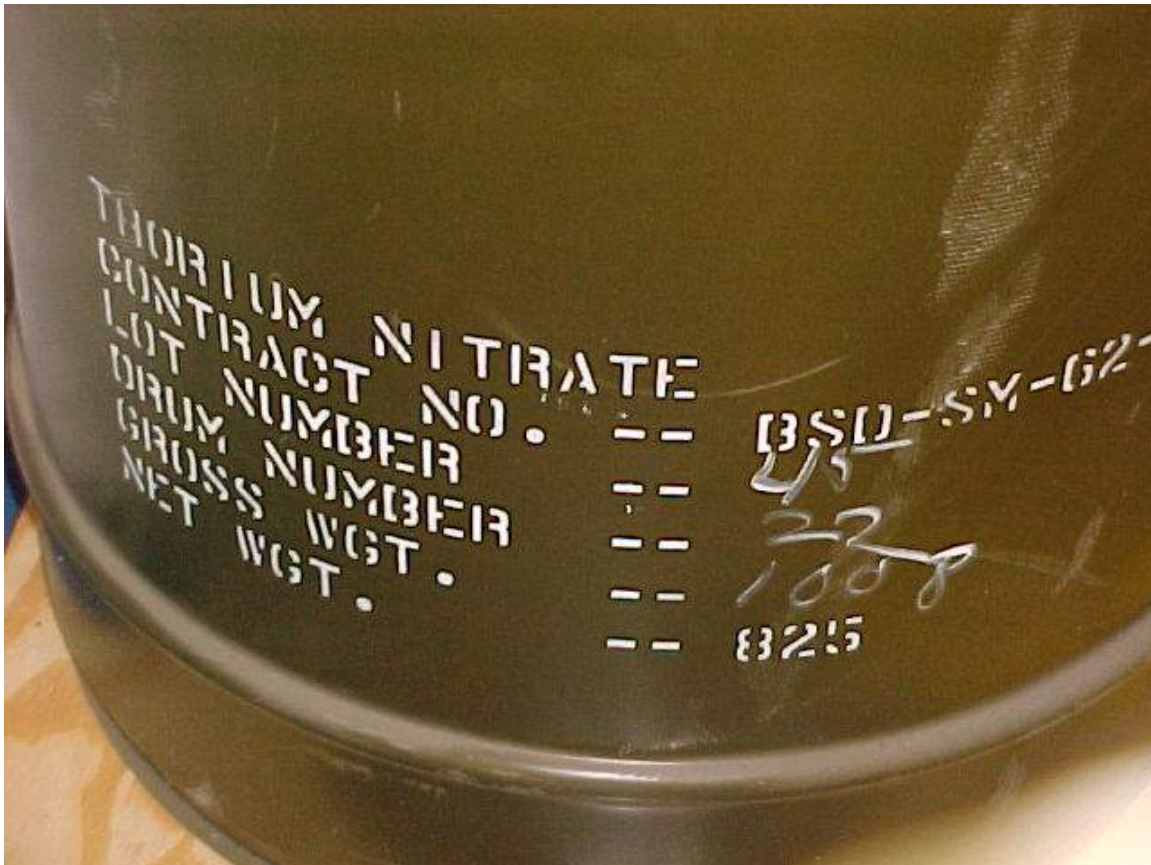
Inspection/Sample Visual Inspection
Date 6-6-2002
Photo No. 2 of 8

Lot No. 45
Drum ID No. 22
Location 15D-2
Site Hammond
85 gal container – Good Condition
Dose – surface – 30mR
1m - 3mR

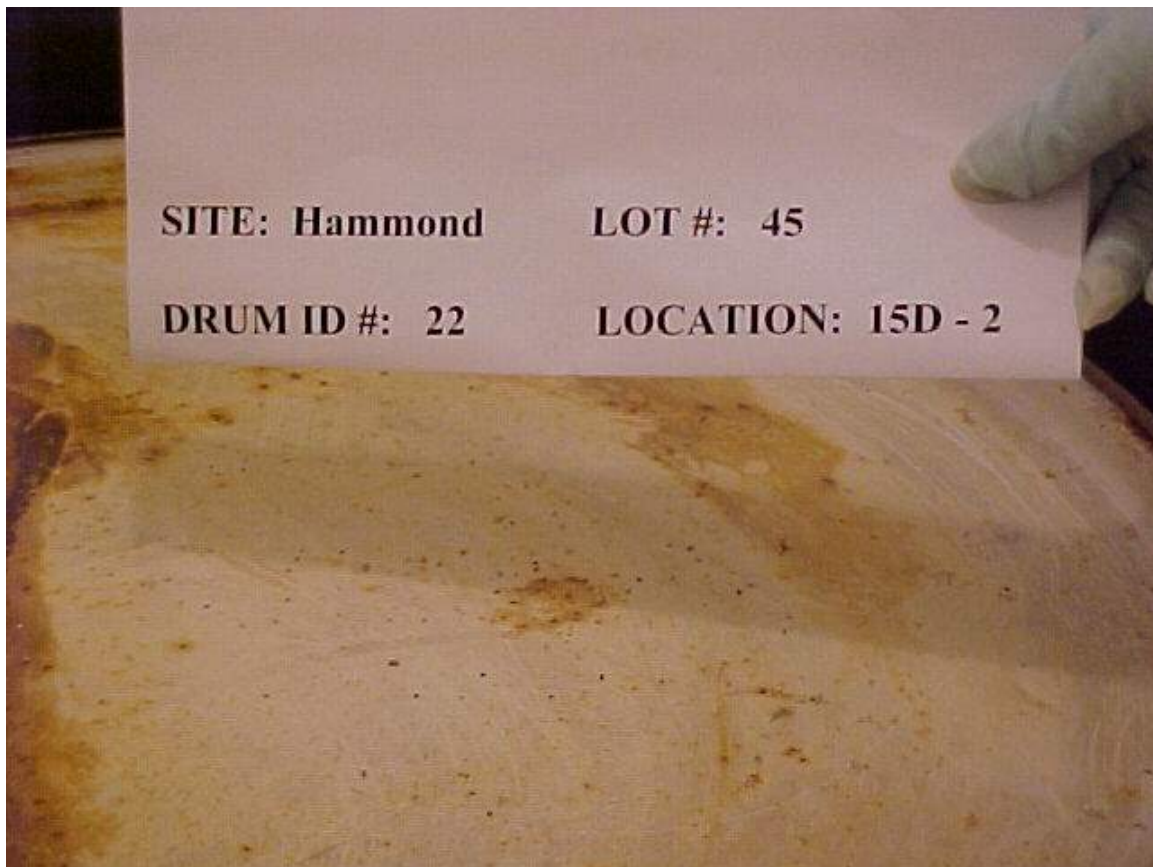
Inspection/Sample Visual Inspection
Date 6-6-2002
Photo No. 3 of 8

55 gal drum lid – Good Condition
Ring in good condition
Rings are secured by 3/8 x 3-1/2 bolt/nut
Ring and lid on tight
55-gal drum is packaged with vermiculite
No measurement of gasses present

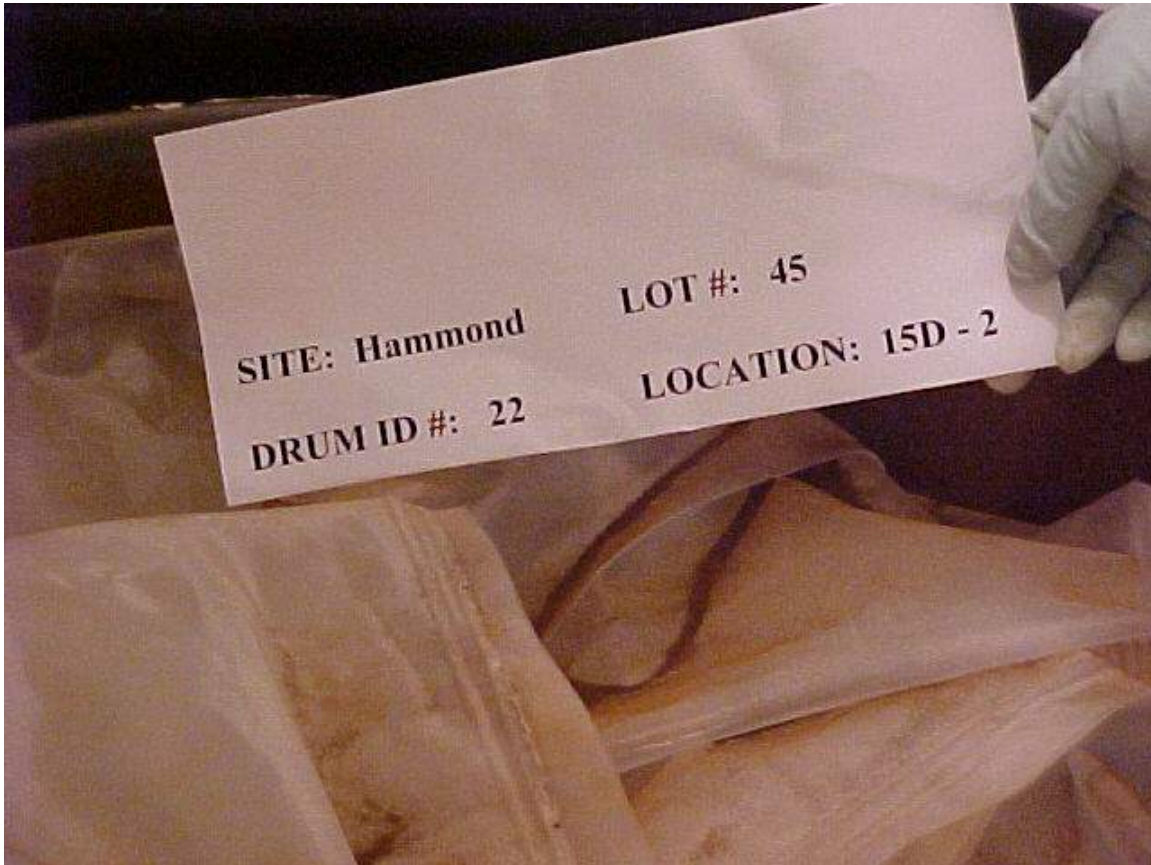
Inspection/Sample Visual Inspection
Date 6-6-2002
Photo No. 4 of 8

1st poly liner/bag – bad Condition
Although the liner/bag seal was in tack
The liner/bag had several holes in it
No gasses present

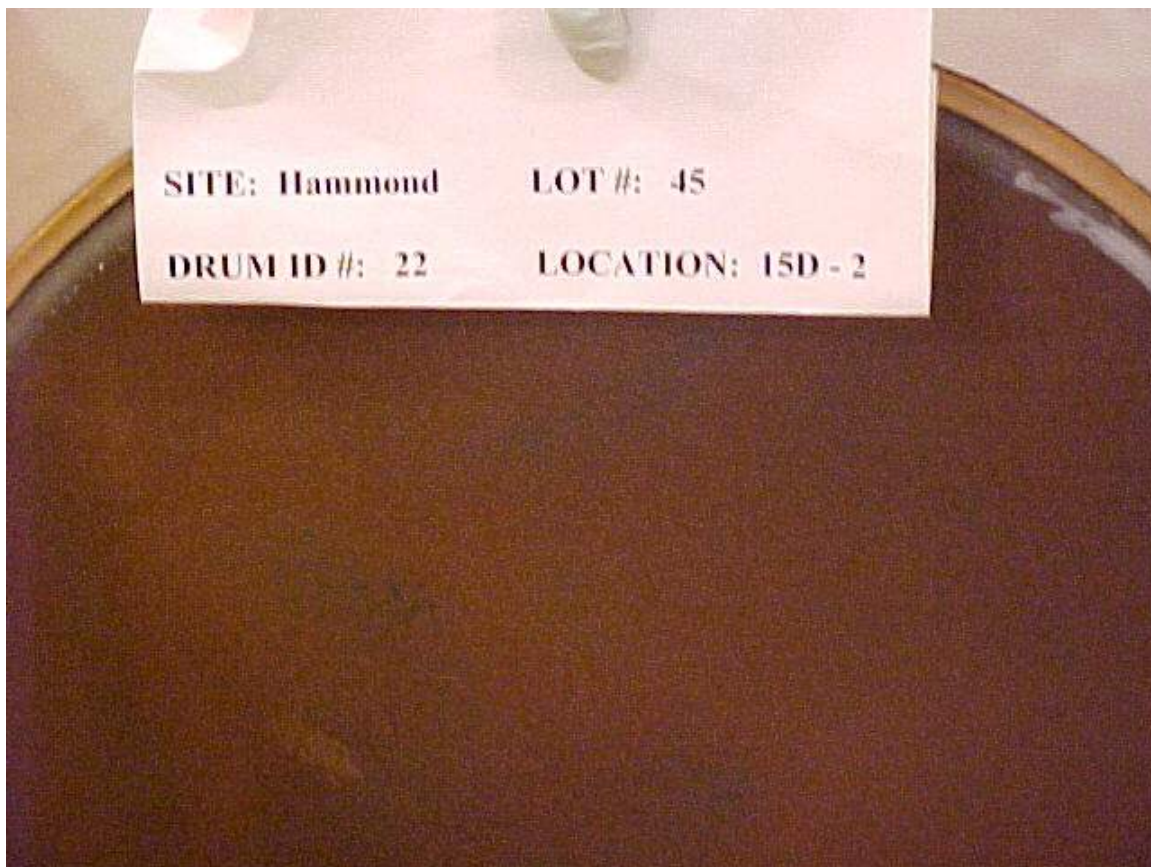
Lot No.	<u>45</u>	Inspection/Sample	<u>Visual Inspection</u>
Drum ID No.	<u>22</u>	Date	<u>6-6-2002</u>
Location	<u>15D-2</u>	Photo No.	<u>5 of 8</u>
Site	<u>Hammond</u>

This is a picture of the inside lid of the 55-gal container
It shows rust/powder on it

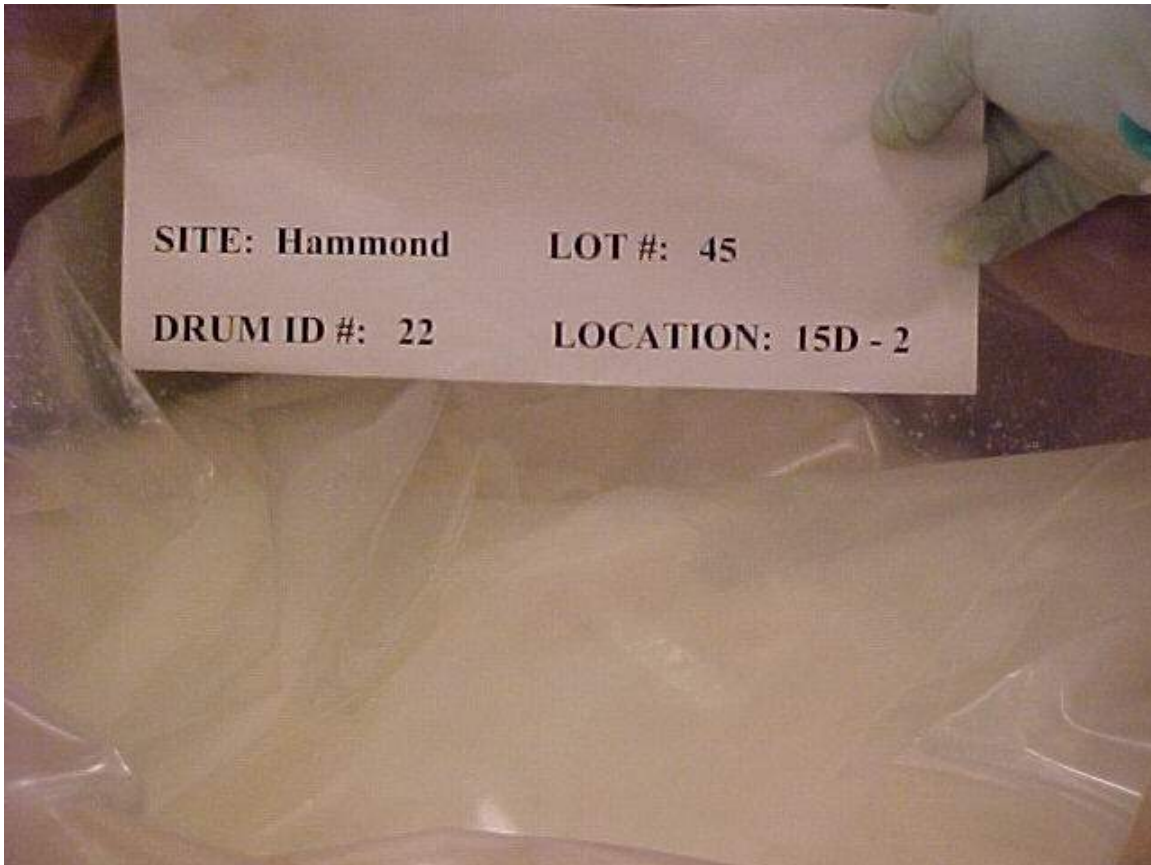
Inspection/Sample Visual Inspection
Date 6-6-2002
Photo No. 6 of 8

2nd poly liner/bag – Good Condition
Moisture was in side the liner/bag
No measurement of gasses present

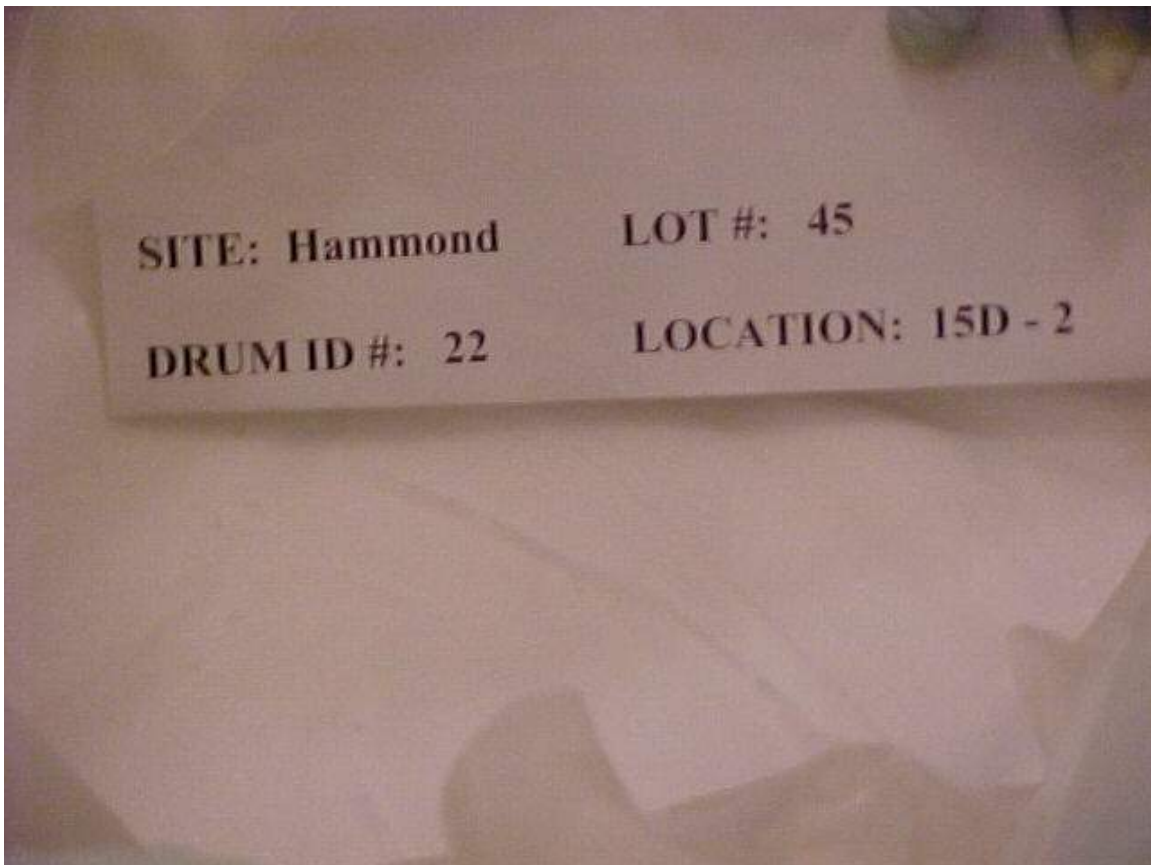
Inspection/Sample Visual Inspection
Date 6-6-2002
Photo No. 7 of 8

Monolith - white in color
Solid - very dry
No gas measurements present
Crystal/moisture on inside liner/bag
pH was taken - red indicator - 0 - results/high

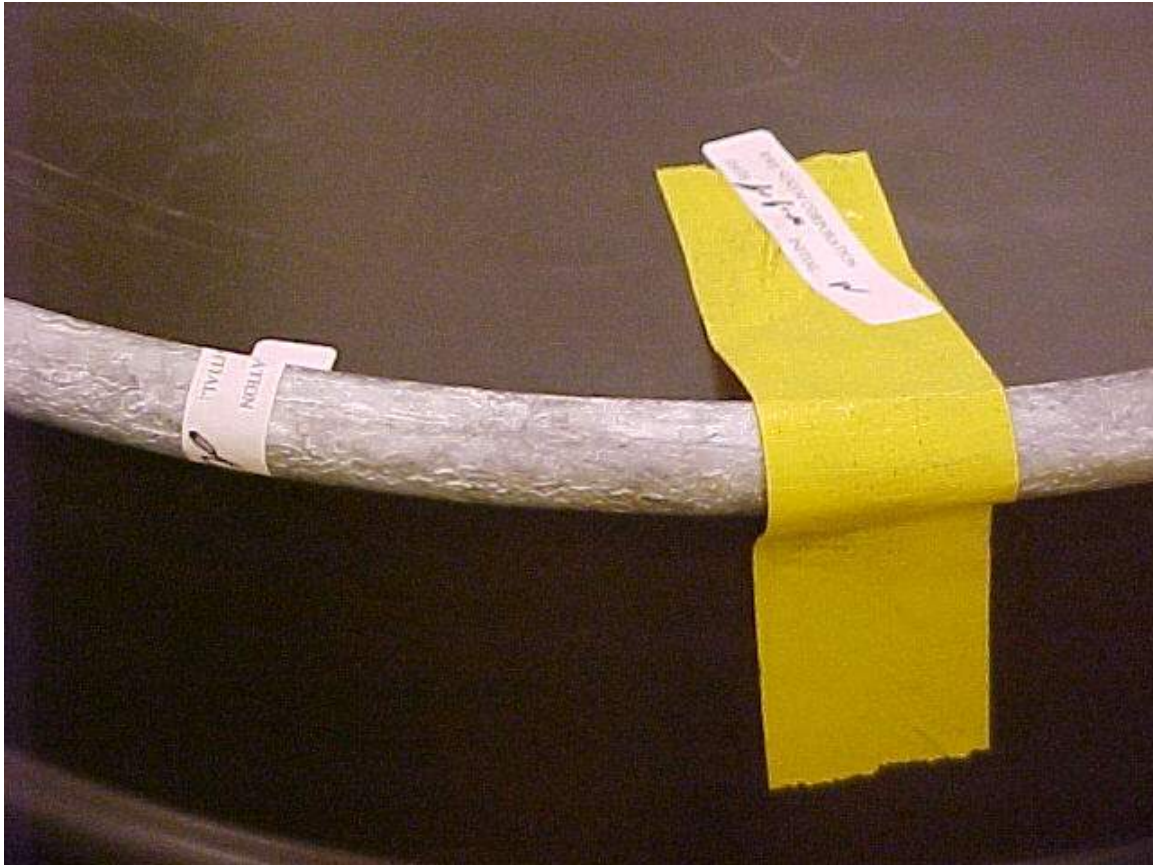
Inspection/Sample Visual Inspection
Date 6-6-2002
Photo No. 8 of 8

85-gal container – Good Condition
Sealed/dated – Completed

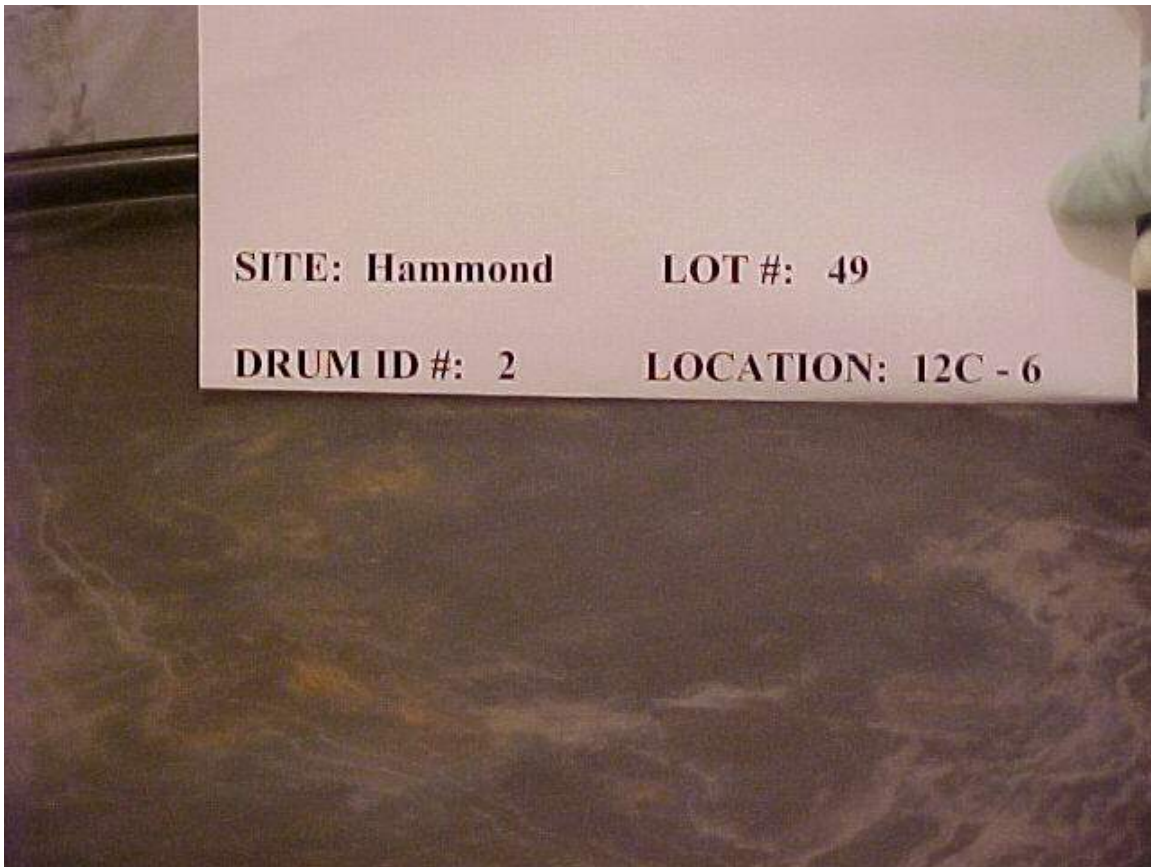
Inspection/Sample Visual Inspection
Date 6-6-2002
Photo No. 2 of 7

85 gal lid – Good Condition
Ring is also in good condition

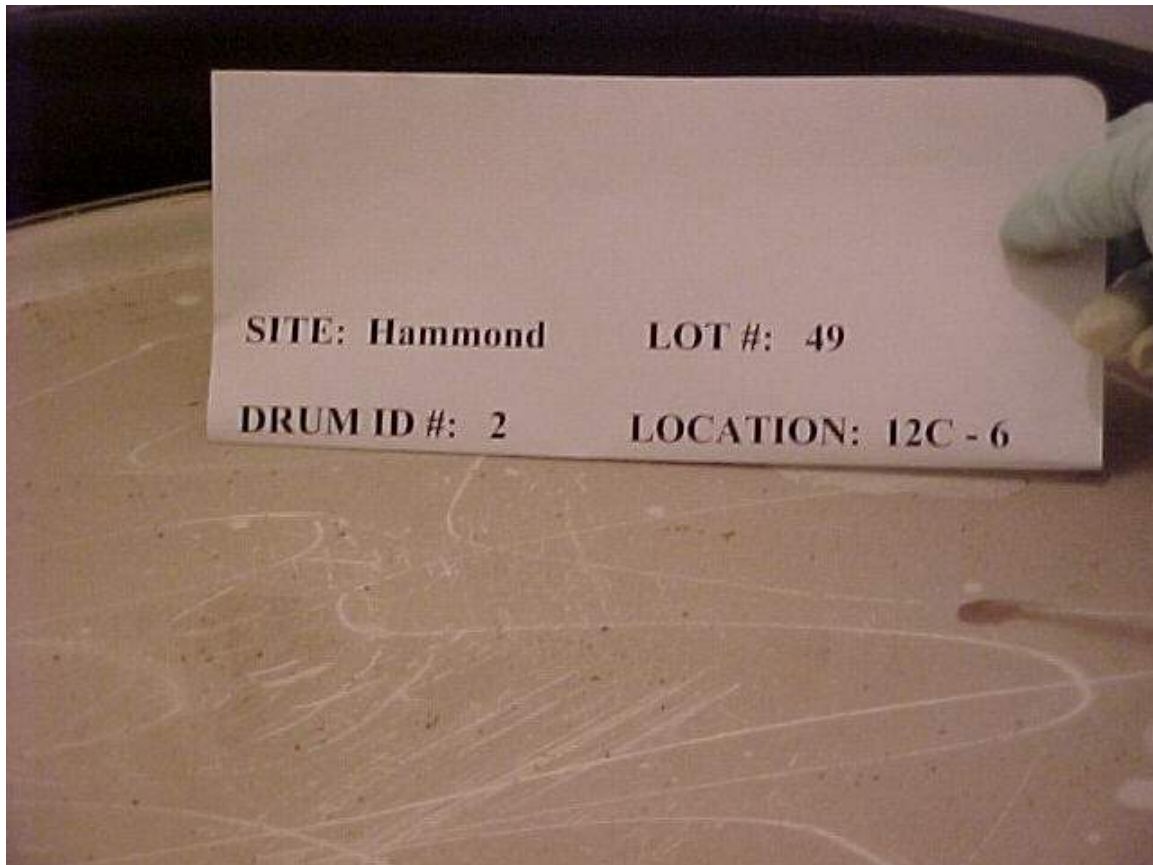
Inspection/Sample Visual Inspection
Date 6-6-2002
Photo No. 3 of 7

55 gal lid – Good Condition

Ring is also in good condition

55 gal drums are packaged with vermiculite inside a 85-gal overpack

No gasses present

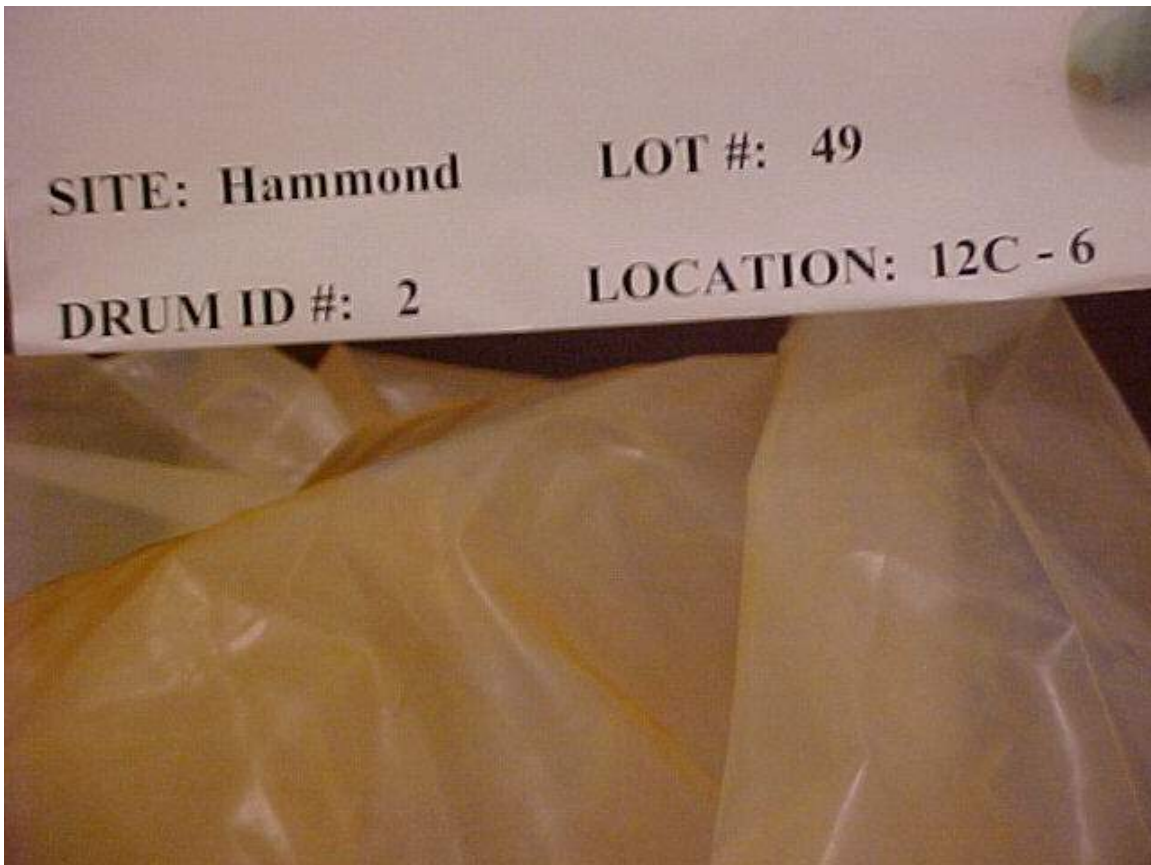
Inspection/Sample Visual Inspection
Date 6-6-2002
Photo No. 4 of 7

1st poly liner/bag – Good Condition
No gas measurement present
Small amounts of rust apparent on top of inside drum
Lid and poly liner/bag – good condition
Took sample of rust/powder
