THORIUM NITRATE STOCKPILE DRUM CHARACTERIZATION REPORT

**THORIUM NITRATE STOCKPILE
DRUM CHARACTERIZATION REPORT**

Prepared for
U.S. Defense Logistics Agency
Defense National Stockpile Center
Fort Belvoir, Virginia

Prepared by
OAK RIDGE NATIONAL LABORATORY
Oak Ridge, Tennessee 37831
managed by
UT-BATTELLE, LLC
for the
U.S. DEPARTMENT OF ENERGY
under contract DE-AC05-00OR22725

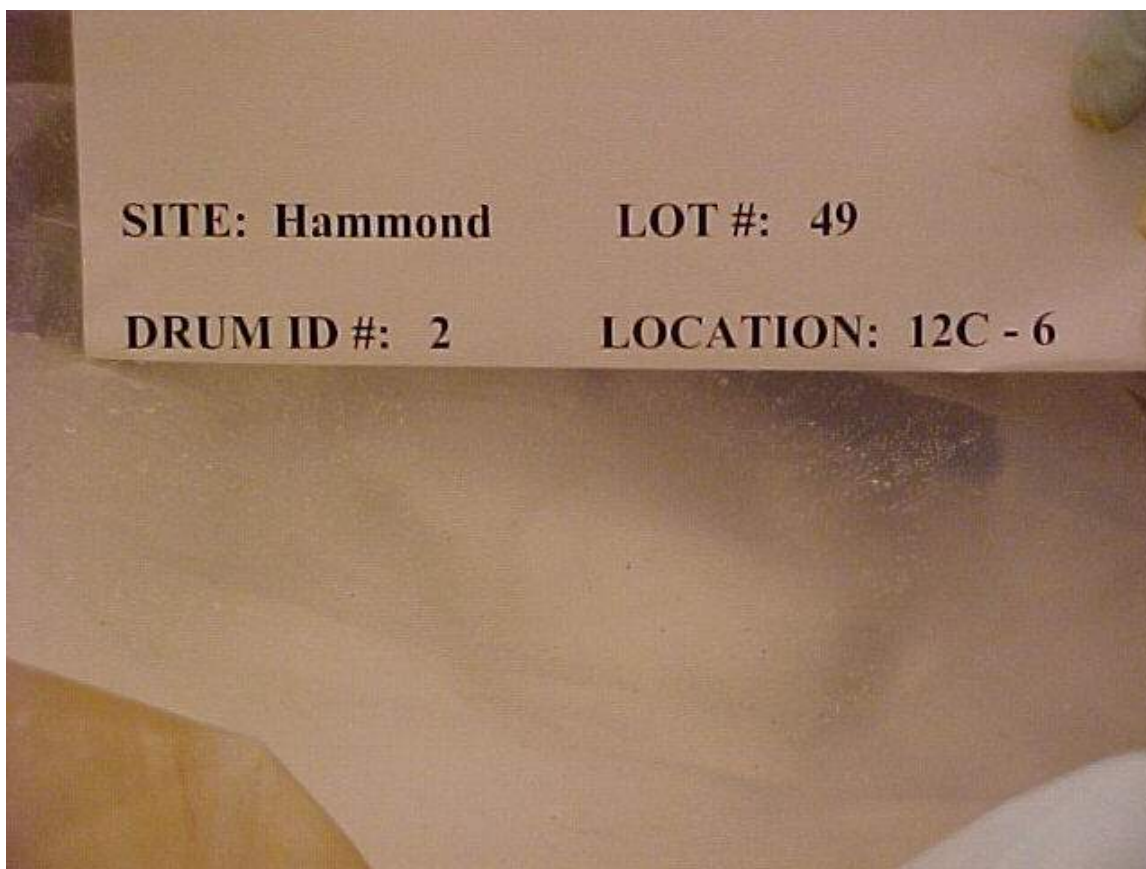
Inspection/Sample Visual Inspection
Date 6-6-2002
Photo No. 5 of 7

2nd poly liner/bag – Good Condition
Little moisture inside bag
No gasses present

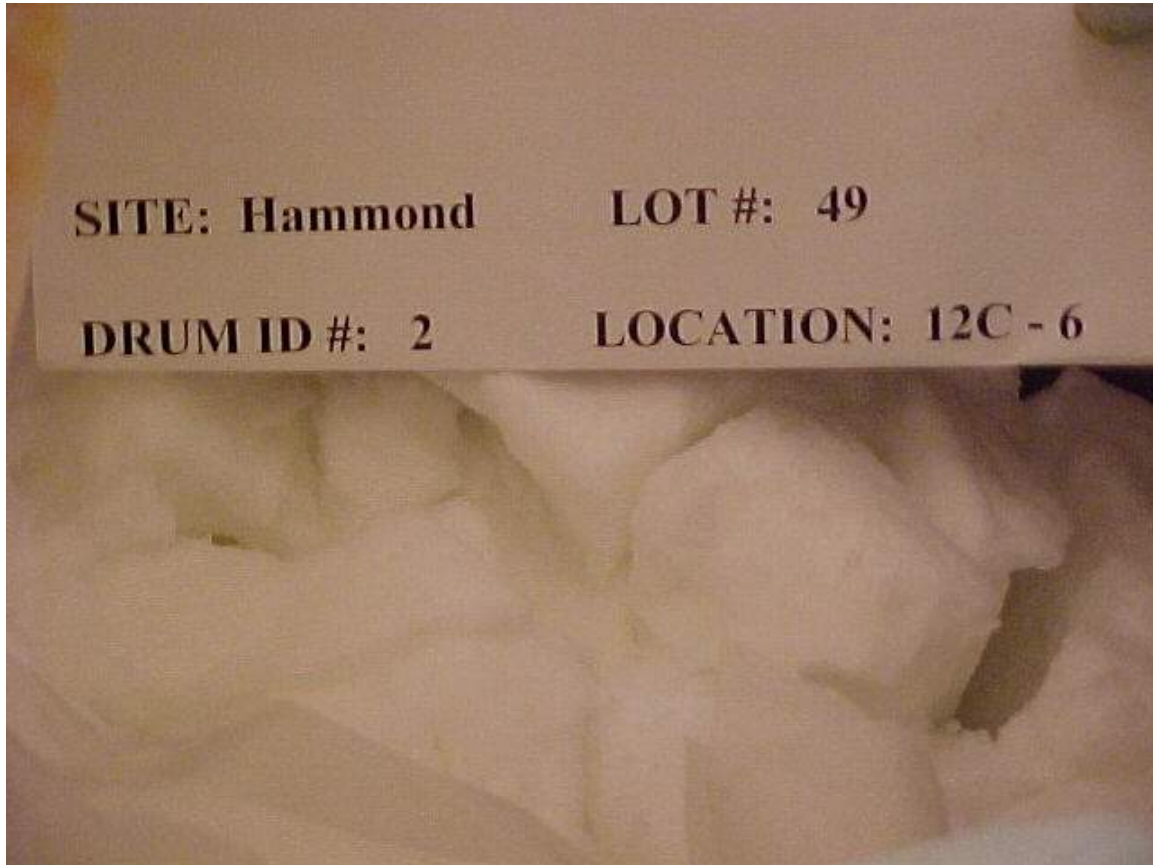
Inspection/Sample Visual Inspection
Date 6-6-2002
Photo No. 6 of 7

Monolith – white in color
Broken/cracked in several places
No gasses present
Very dry

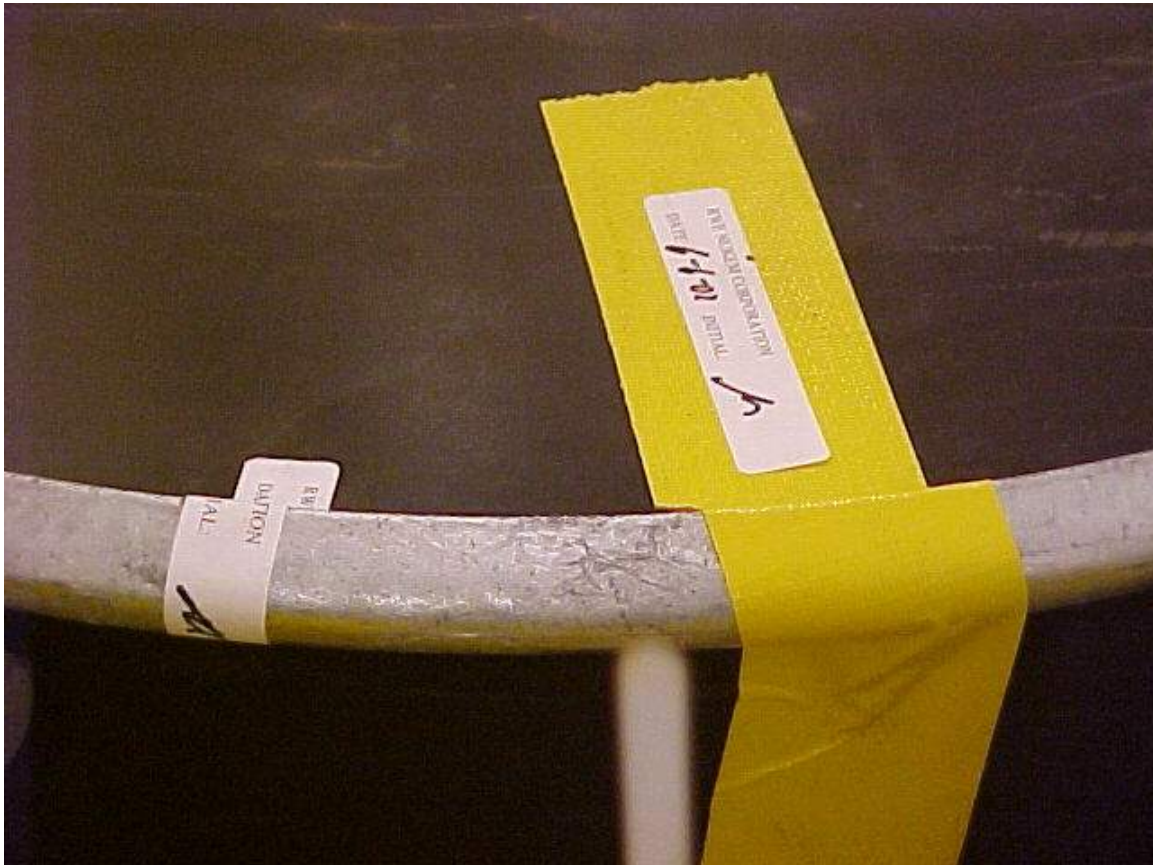
Inspection/Sample Visual Inspection
Date 6-6-2002
Photo No. 7 of 7

85-gal container – Good Condition
Sealed/dated - Completed

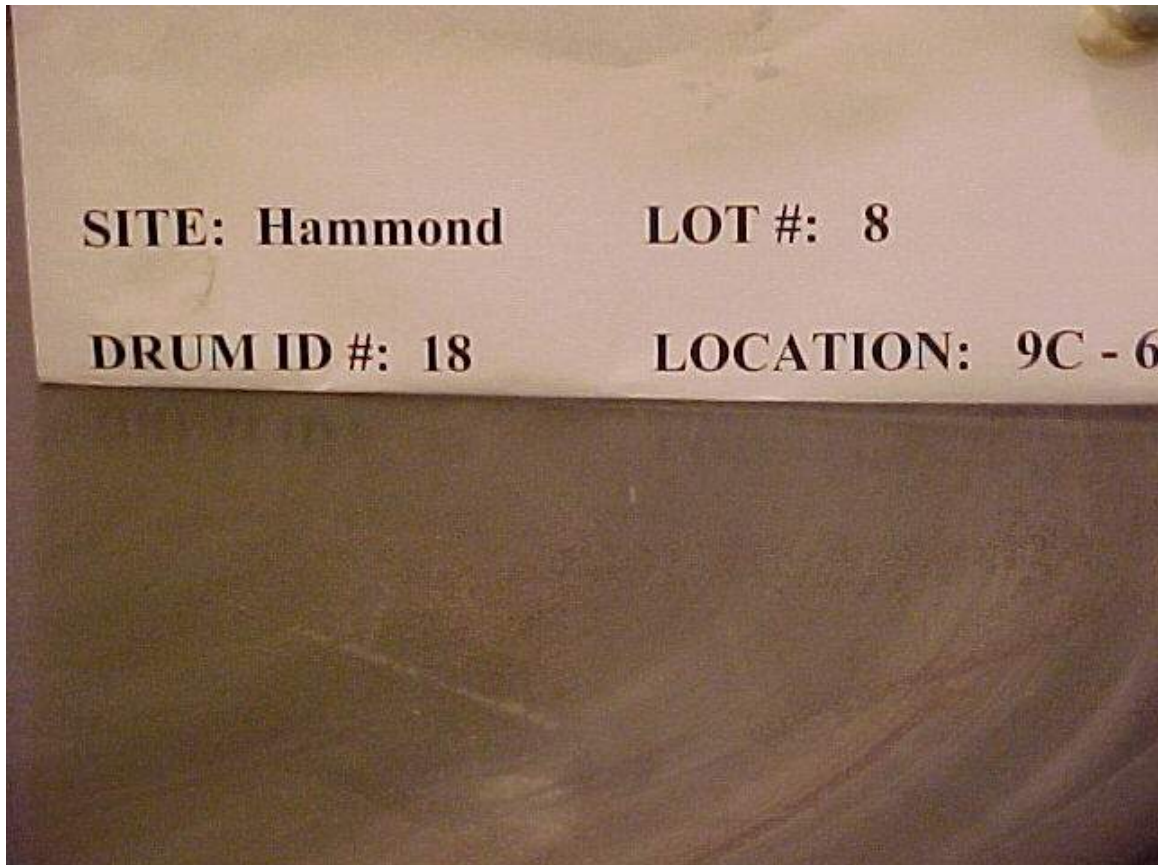
Lot No.	<u>8</u>	Inspection/Sample	<u>Visual Inspection & Sampling</u>
Drum ID No.	<u>18</u>	Date	<u>6-7-2002</u>
Location	9C-6	Photo No.	<u>2 of 14</u>
Site	<u>Hammond</u>

85 gal drum – Good Condition

Ring – Good Condition

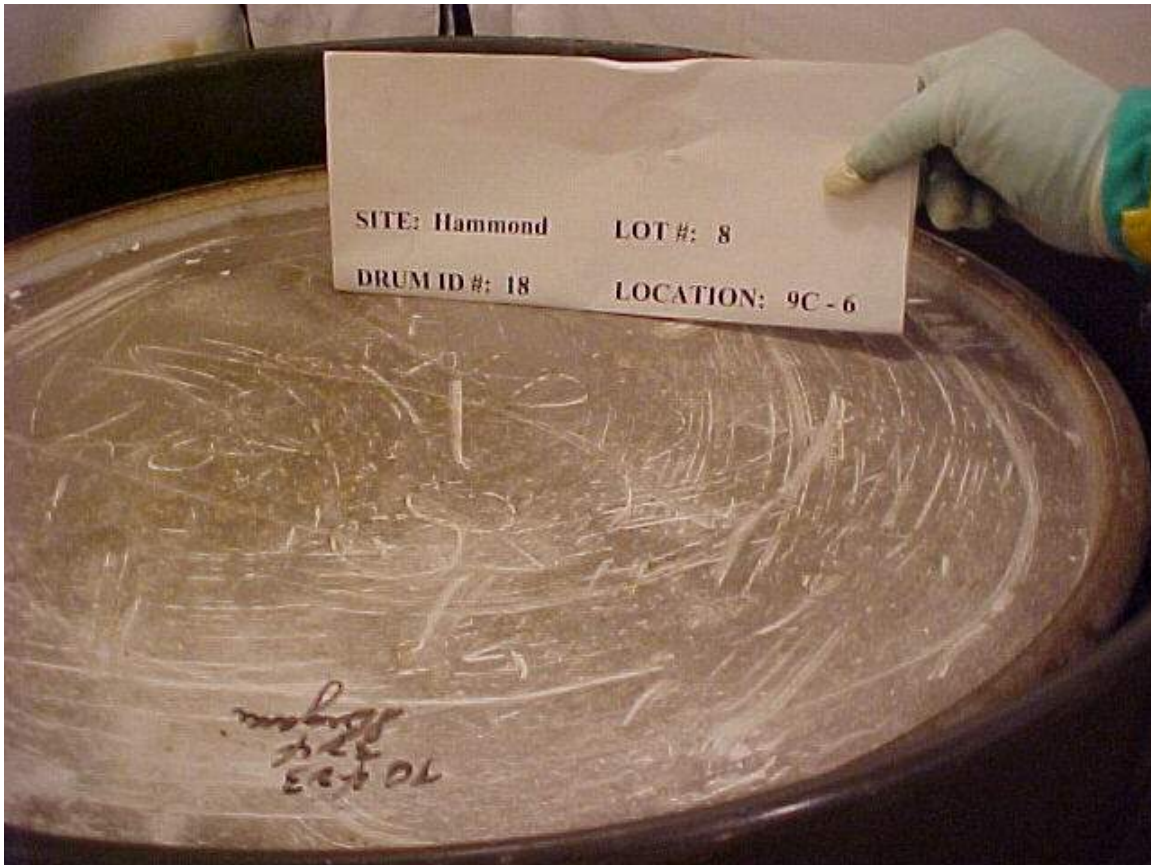
Lot No.	<u>8</u>	Inspection/Sample	<u>Visual Inspection & Sampling</u>
Drum ID No.	<u>18</u>	Date	<u>6-7-2002</u>
Location	<u>9C-6</u>	Photo No.	<u>3 of 14</u>
Site	<u>Hammond</u>

55 gal drum lid– Good Condition

Ring 3/8 x 31/2 bolt – Good Condition/tight

55 gal container is package in a 85 overpack with vermiculite

No Gasses present

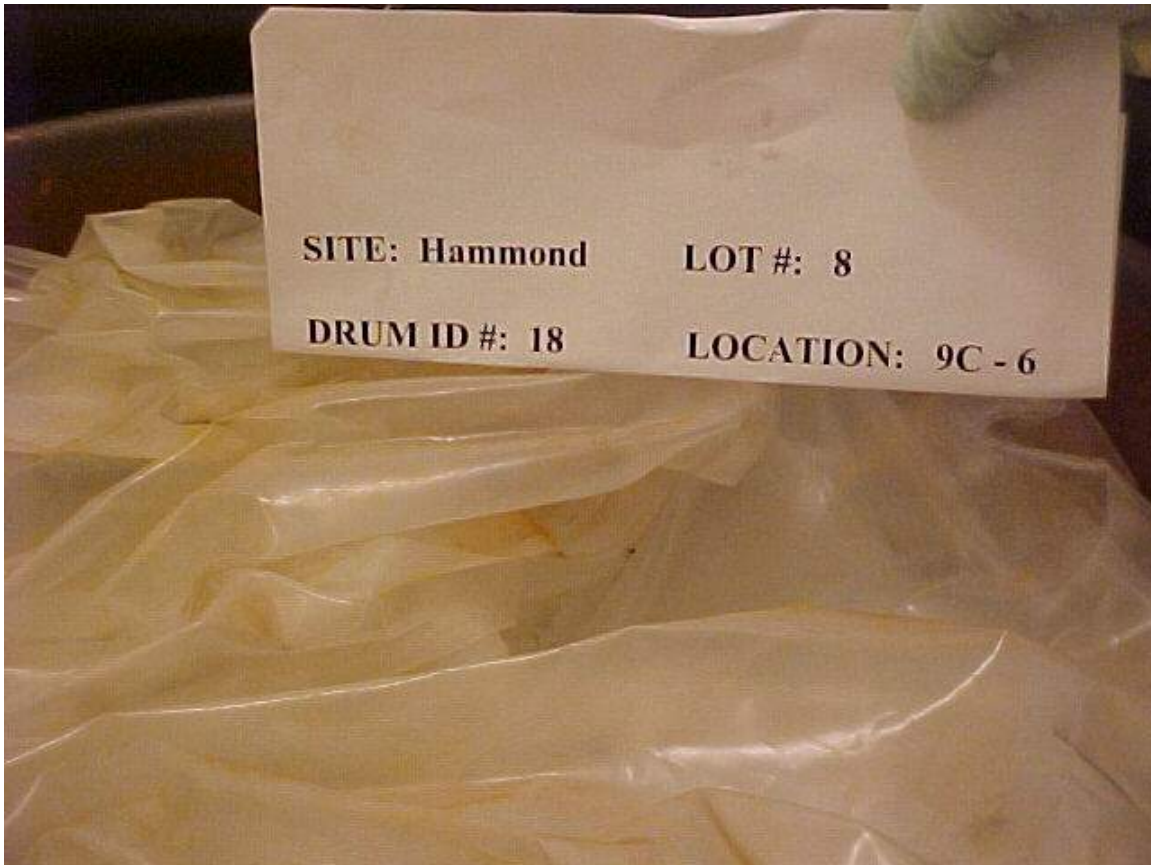
Lot No.	<u>8</u>	Inspection/Sample	<u>Visual Inspection & Sampling</u>
Drum ID No.	<u>18</u>	Date	<u>6-7-2002</u>
Location	9C-6	Photo No.	<u>4 of 14</u>
Site	<u>Hammond</u>

1st Poly liner/bag - Good Condition
Seal in good condition
No holes in liner/bag
No Gasses present

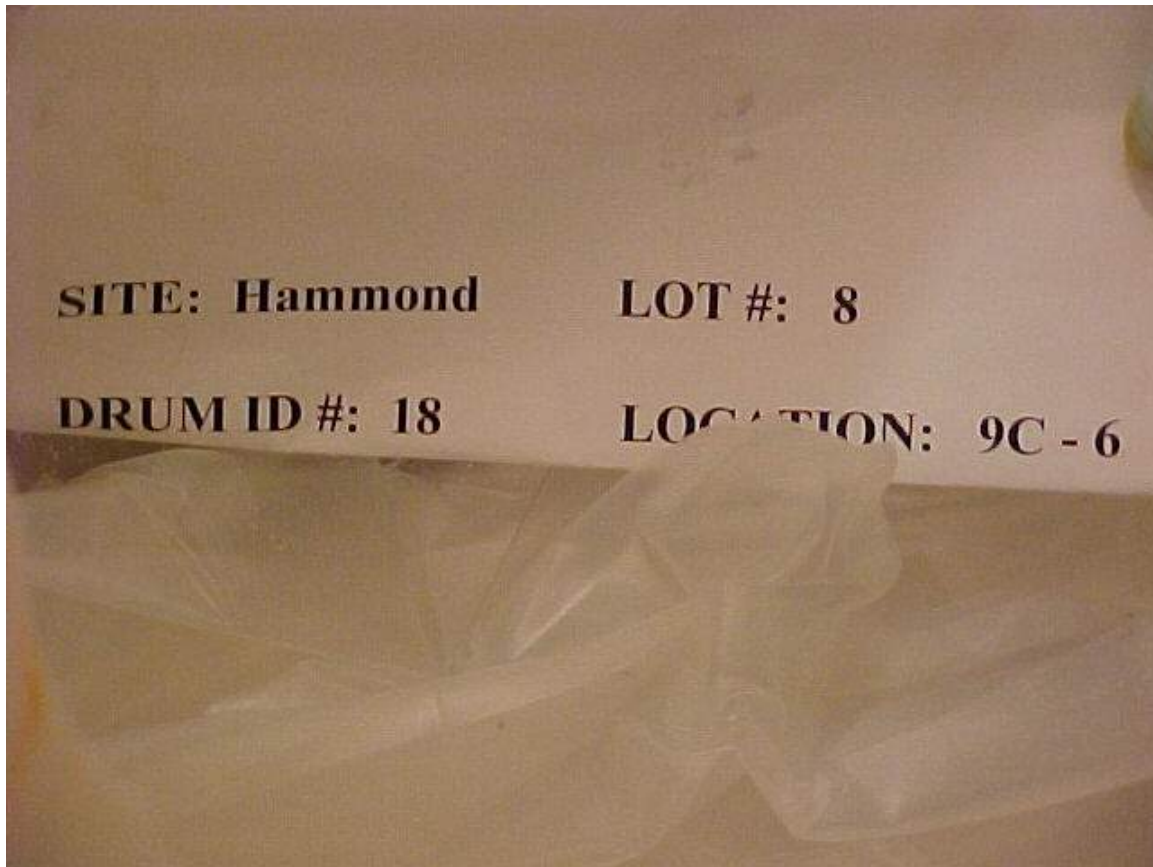
Inspection/Sample Visual Inspection & Sampling
Date 6-7-2002
Photo No. 5 of 14

2nd Poly liner/bag - Good Condition
Seal in good condition
No holes in liner/bag
No Moisture
No Gasses present

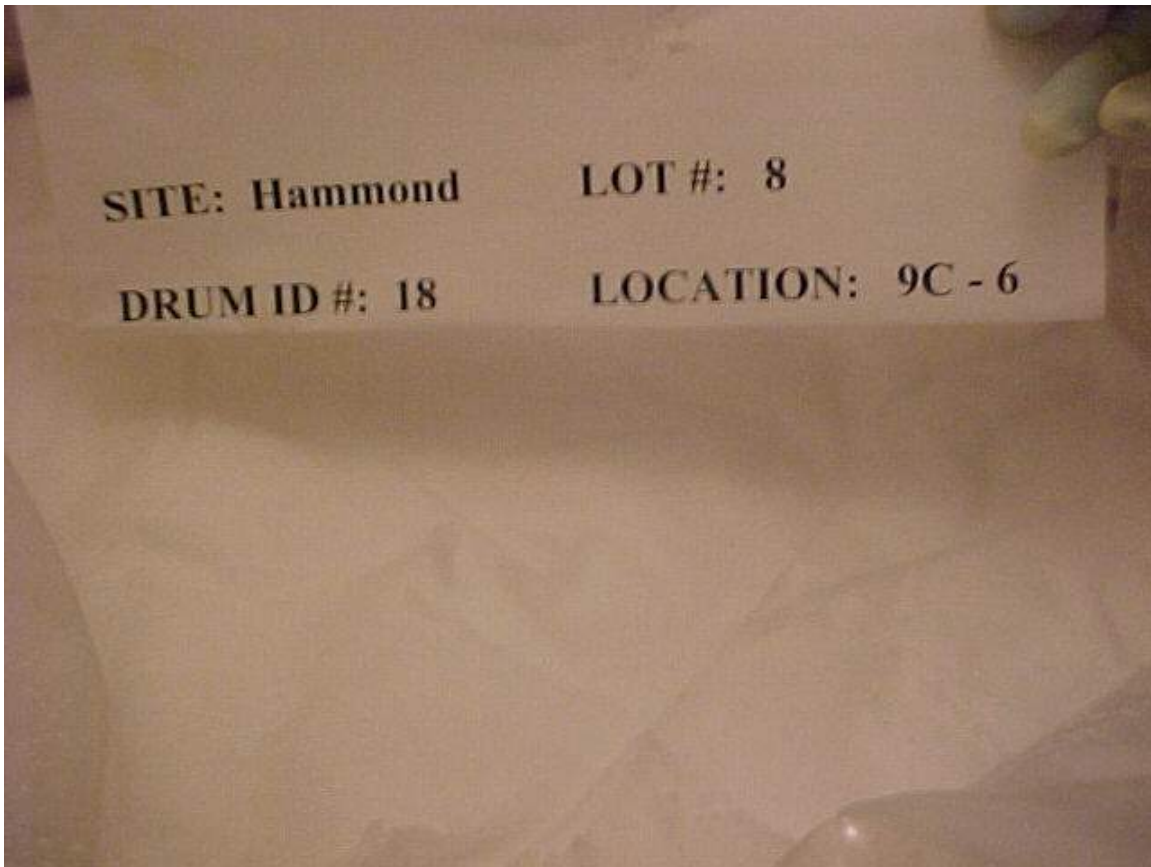
Lot No.	<u>8</u>	Inspection/Sample	<u>Visual Inspection & Sampling</u>
Drum ID No.	<u>18</u>	Date	<u>6-7-2002</u>
Location	9C-6	Photo No.	<u>6 of 14</u>
Site	<u>Hammond</u>

Monolith – White in Color
Solid – very dry
No Gasses present

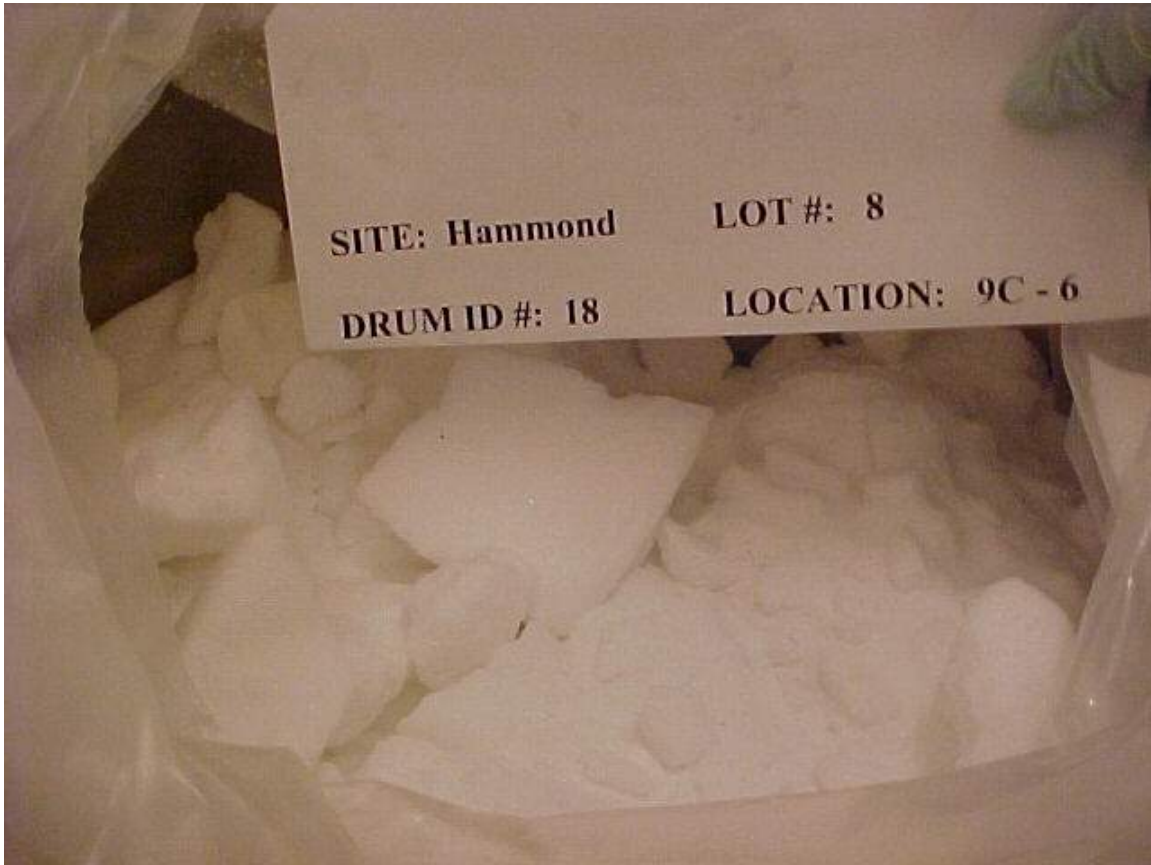
Lot No.	<u>8</u>	Inspection/Sample	<u>Visual Inspection & Sampling</u>
Drum ID No.	<u>18</u>	Date	<u>6-7-2002</u>
Location	9C-6	Photo No.	<u>8 of 14</u>
Site	<u>Hammond</u>

Coring was too brittle and fine...had to use chisel and hammer
to break up into large pieces to fit 2-liter container
No Gases present

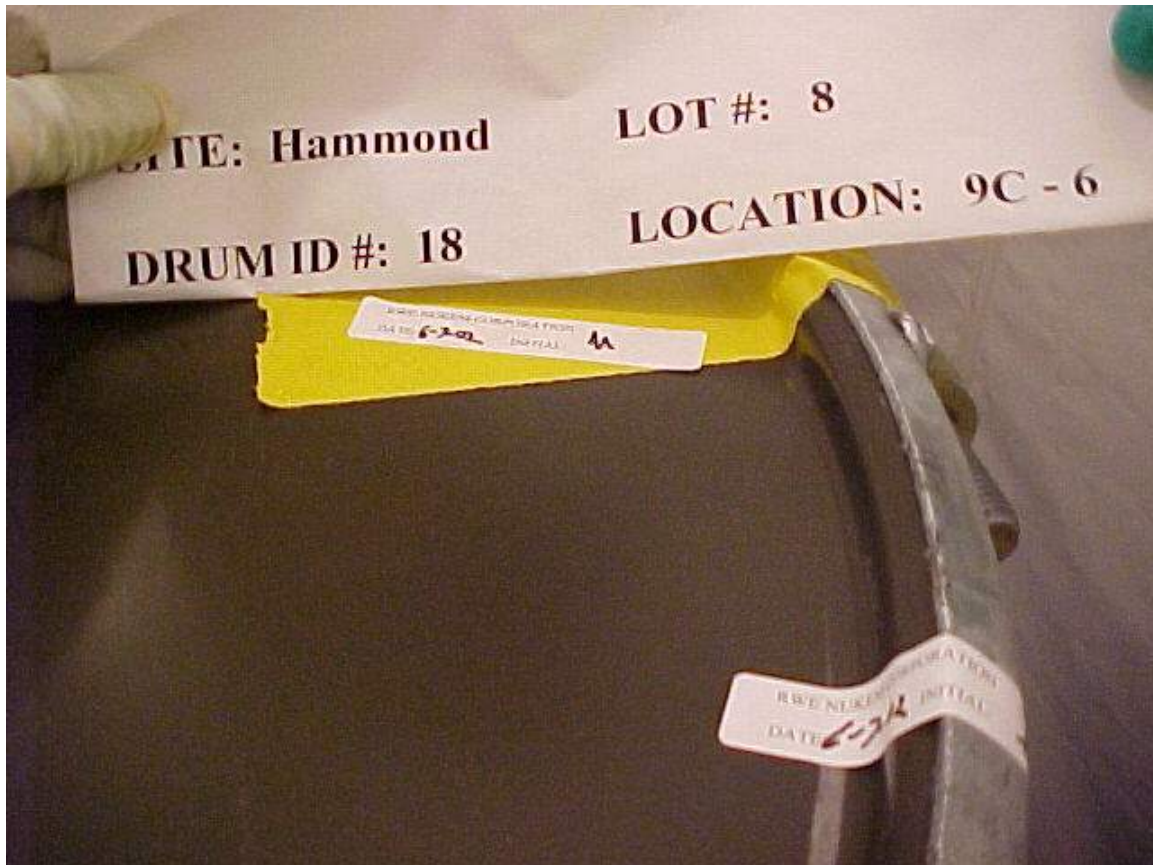
Lot No.	<u>8</u>	Inspection/Sample	<u>Visual Inspection & Sampling</u>
Drum ID No.	<u>18</u>	Date	<u>6-7-2002</u>
Location	<u>9C-6</u>	Photo No.	<u>14 of 14</u>
Site	<u>Hammond</u>

85 gal container – Good Condition
Sealed/Dated – completed

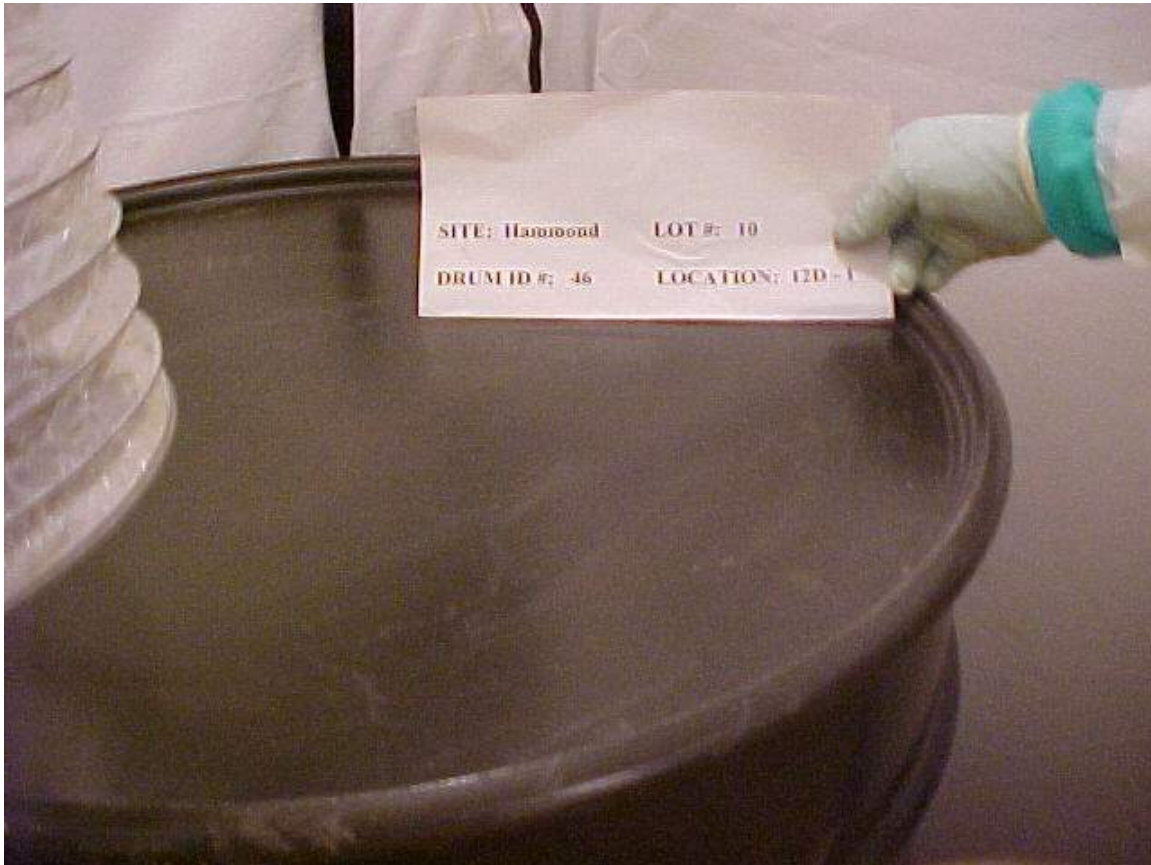
Lot No.	<u>10</u>	Inspection/Sample	<u>Visual Inspection & Sampling</u>
Drum ID No.	<u>46</u>	Date	<u>6-10-2002</u>
Location	12D-1	Photo No.	<u>2 of 11</u>
Site	<u>Hammond</u>

Lid of 85-gal drum - Good Condition

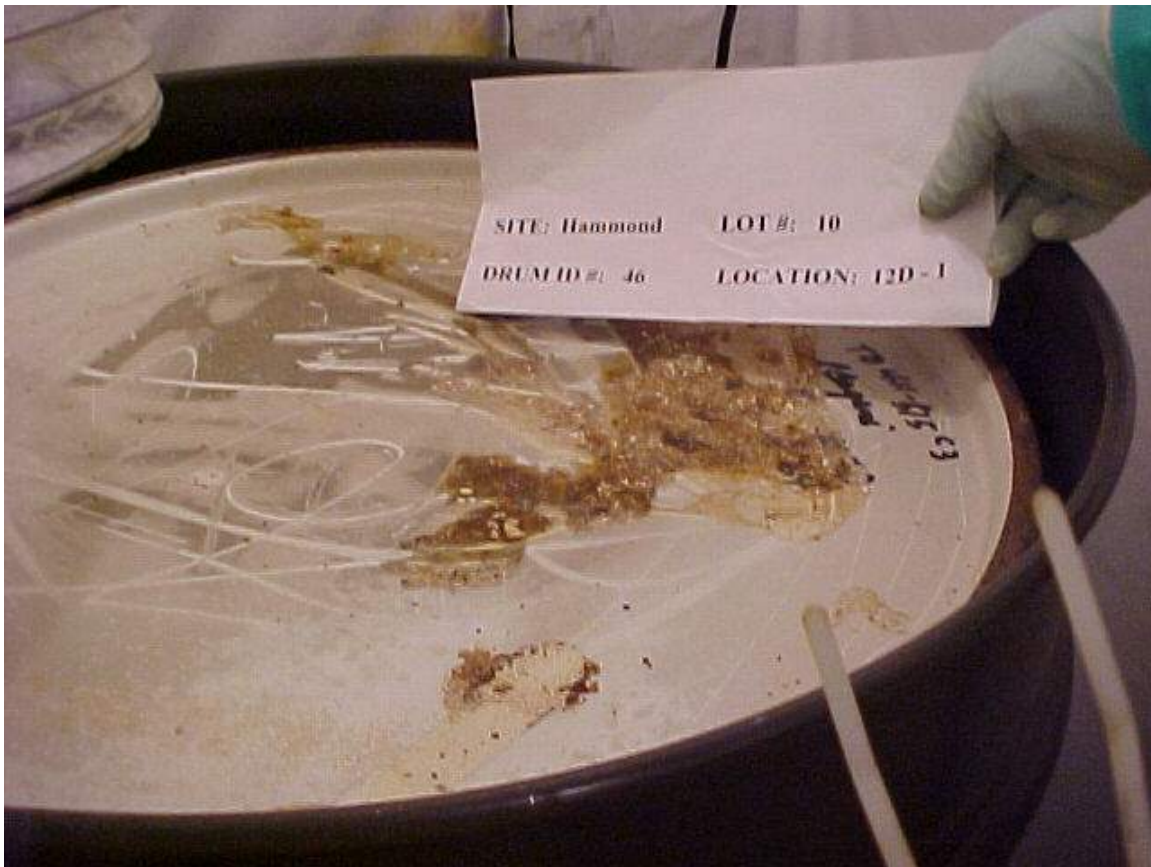
Visual Inspection & Sampling
6-10-2002
3 of 11

55gal drum-good condition
no gases present
ring - good condition

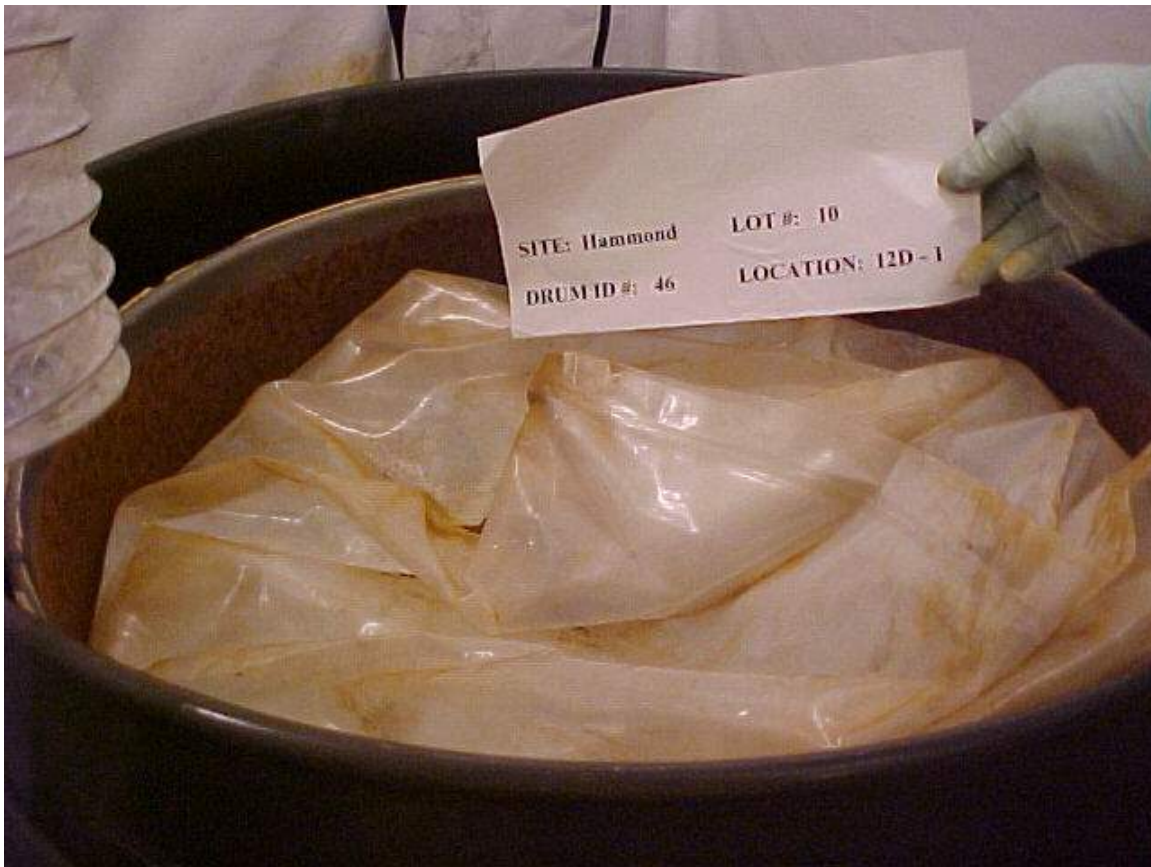
Lot No.	<u>10</u>	Inspection/Sample	<u>Visual Inspection & Sampling</u>
Drum ID No.	<u>46</u>	Date	<u>6-10-2002</u>
Location	12D-1	Photo No.	<u>4 of 11</u>
Site	<u>Hammond</u>

1st poly-liner/bag- Good Condition
No gasses present

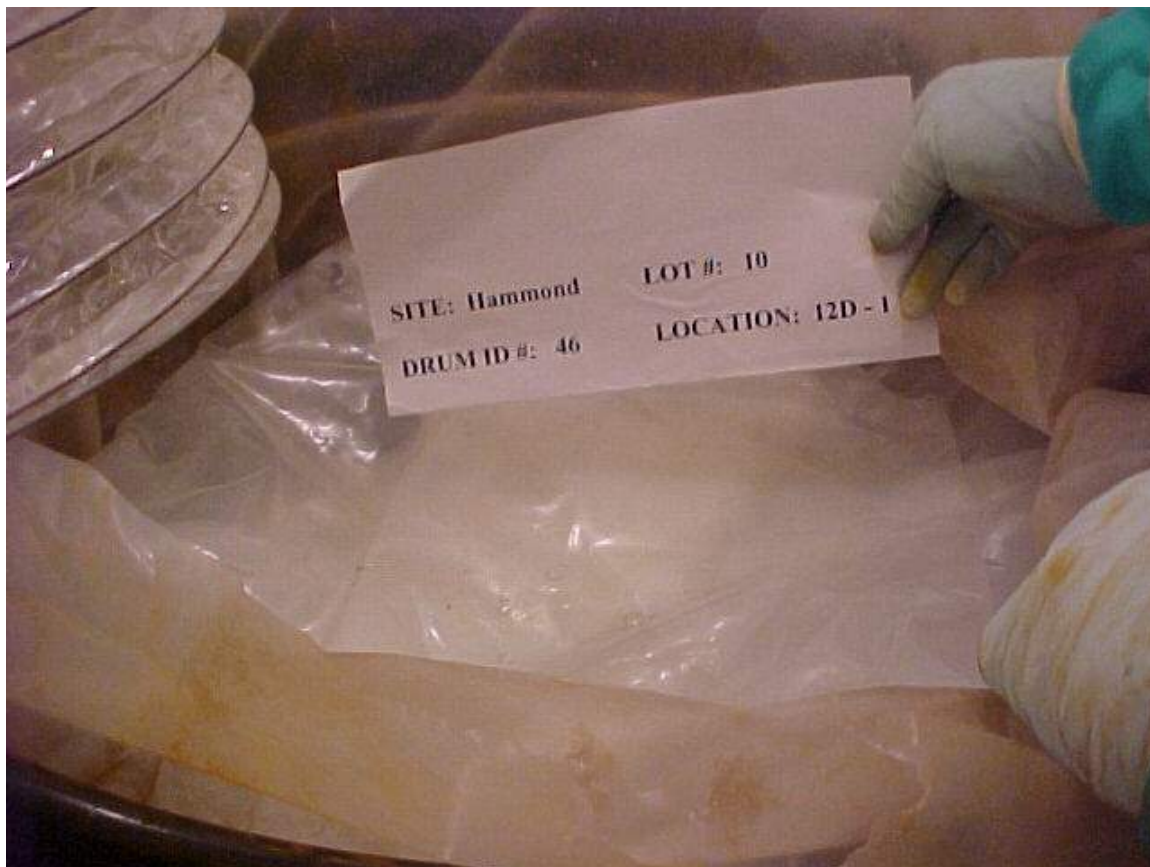
Lot No.	<u>10</u>	Inspection/Sample	<u>Visual Inspection & Sampling</u>
Drum ID No.	<u>46</u>	Date	<u>6-10-2002</u>
Location	<u>12D-1</u>	Photo No.	<u>5 of 11</u>
Site	<u>Hammond</u>

2nd Poly-liner/bag- Good Condition
No gasses present

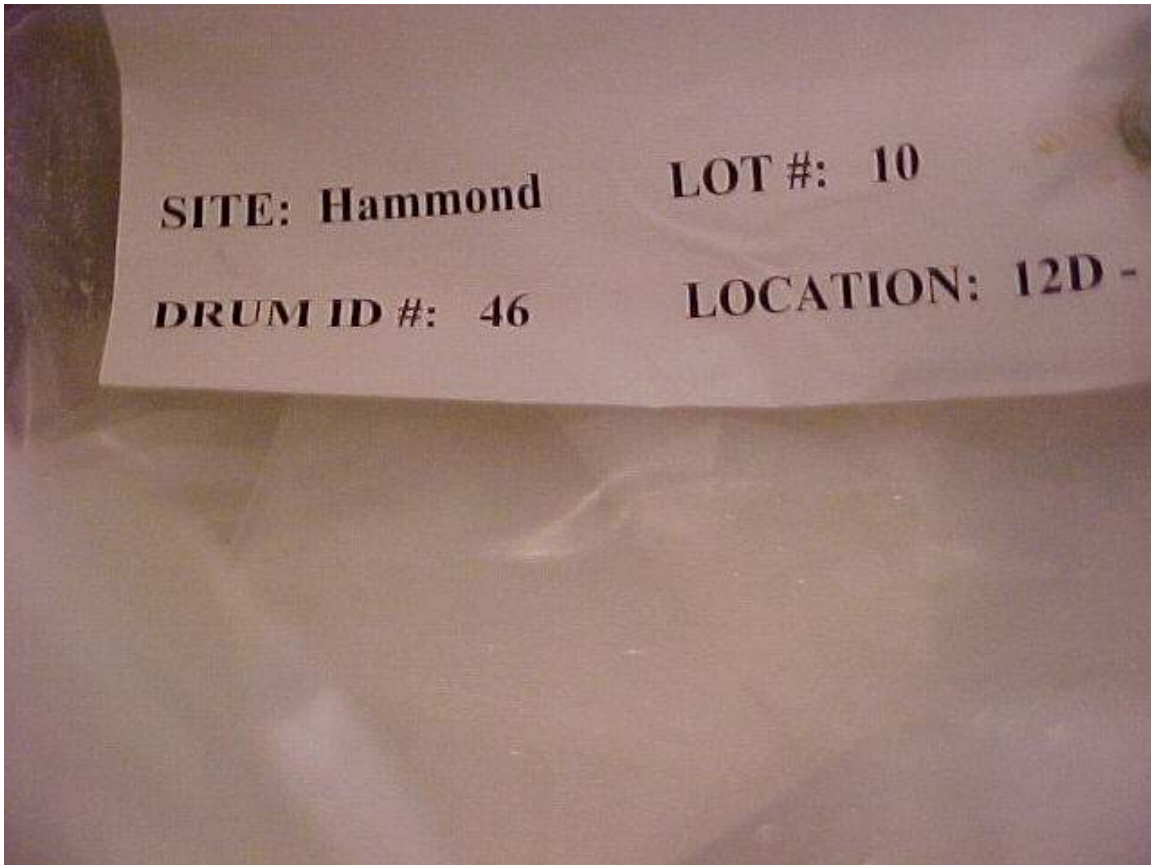
Lot No.	<u>10</u>	Inspection/Sample	<u>Visual Inspection & Sampling</u>
Drum ID No.	<u>46</u>	Date	<u>6-10-2002</u>
Location	12D-1	Photo No.	<u>6 of 11</u>
Site	<u>Hammond</u>

3rd Poly-liner/bag- Good Condition
No gasses present
You can see water crystals/wet damp inside of liner

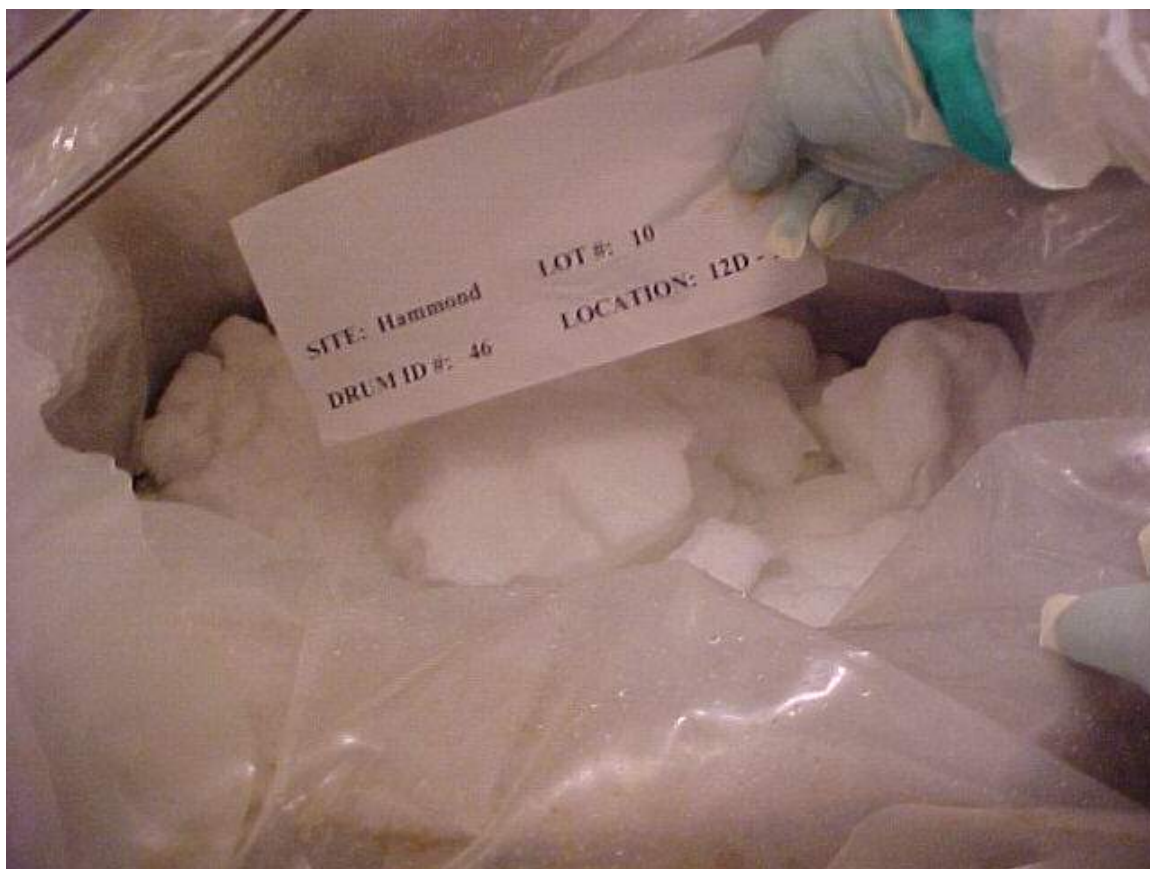
Lot No.	<u>10</u>	Inspection/Sample	<u>Visual Inspection & Sampling</u>
Drum ID No.	<u>46</u>	Date	<u>6-10-2002</u>
Location	12D-1	Photo No.	<u>7 of 11</u>
Site	<u>Hammond</u>

Monolith-white in color
Chunks/ broken
Damp/wet inside
Took pH reading color Red-0 scale
No gasses present

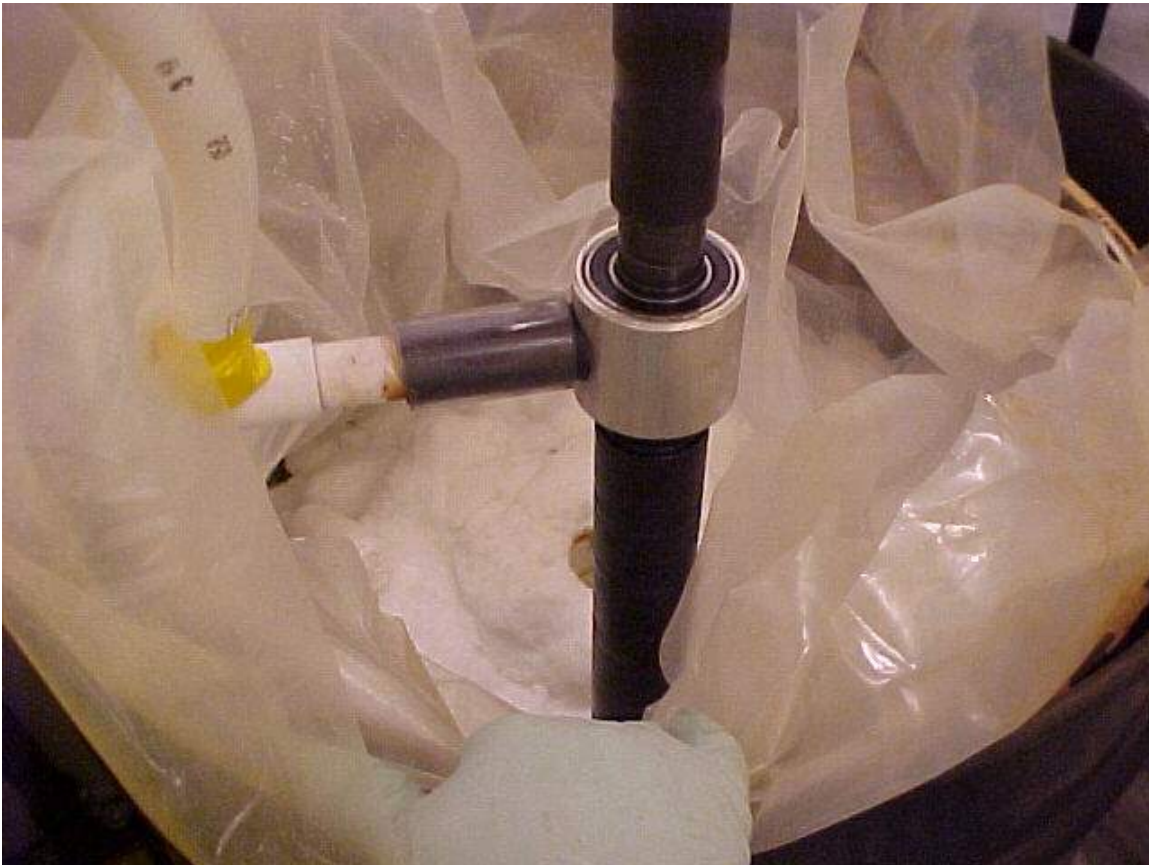
Lot No.	<u>10</u>	Inspection/Sample	<u>Visual Inspection & Sampling</u>
Drum ID No.	<u>46</u>	Date	<u>6-10-2002</u>
Location	<u>12D-1</u>	Photo No.	<u>9 of 11</u>
Site	<u>Hammond</u>

Drilling for core samples did not work had to use chisel to get sample

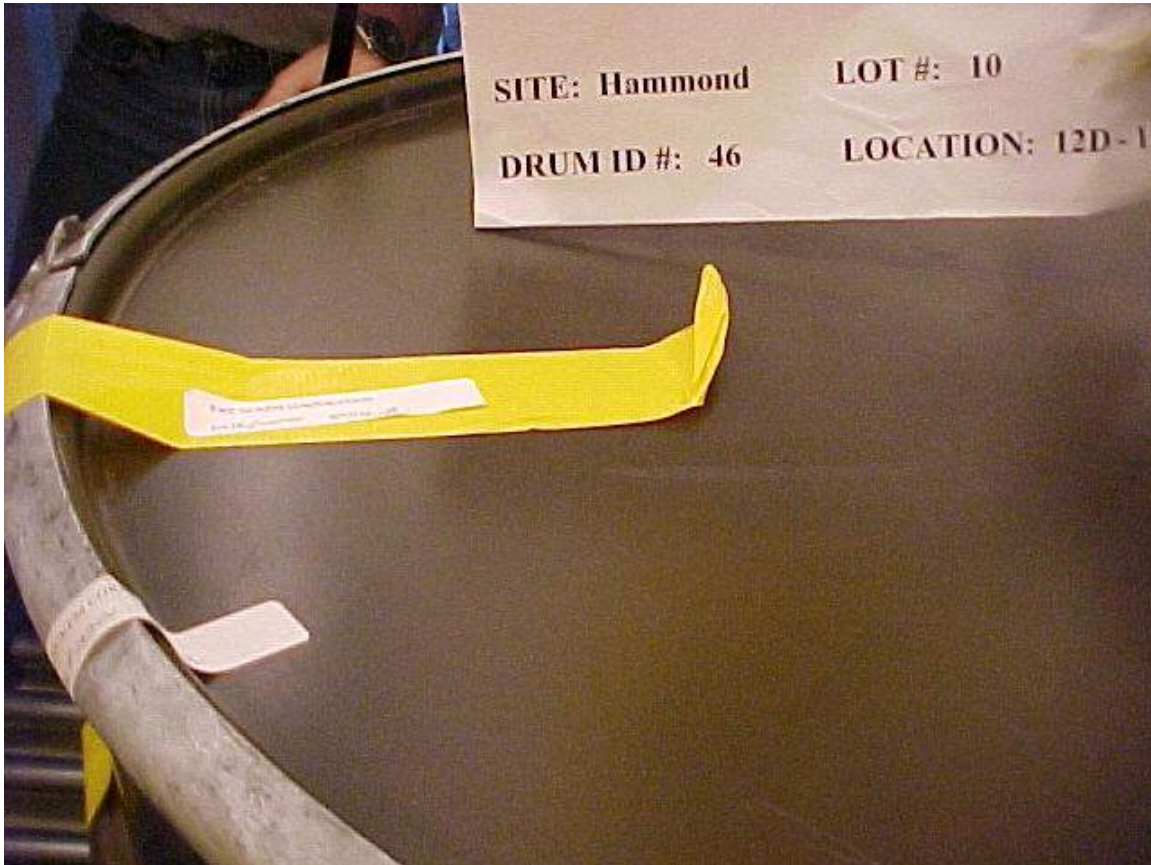
Lot No.	<u>10</u>	Inspection/Sample	<u>Visual Inspection & Sampling</u>
Drum ID No.	46	Date	<u>6-10-2002</u>
Location	12D-1	Photo No.	<u>11 of 11</u>
Site	<u>Hammond</u>

85 gal drum lid and ring secured
Drum sealed/dated/completed

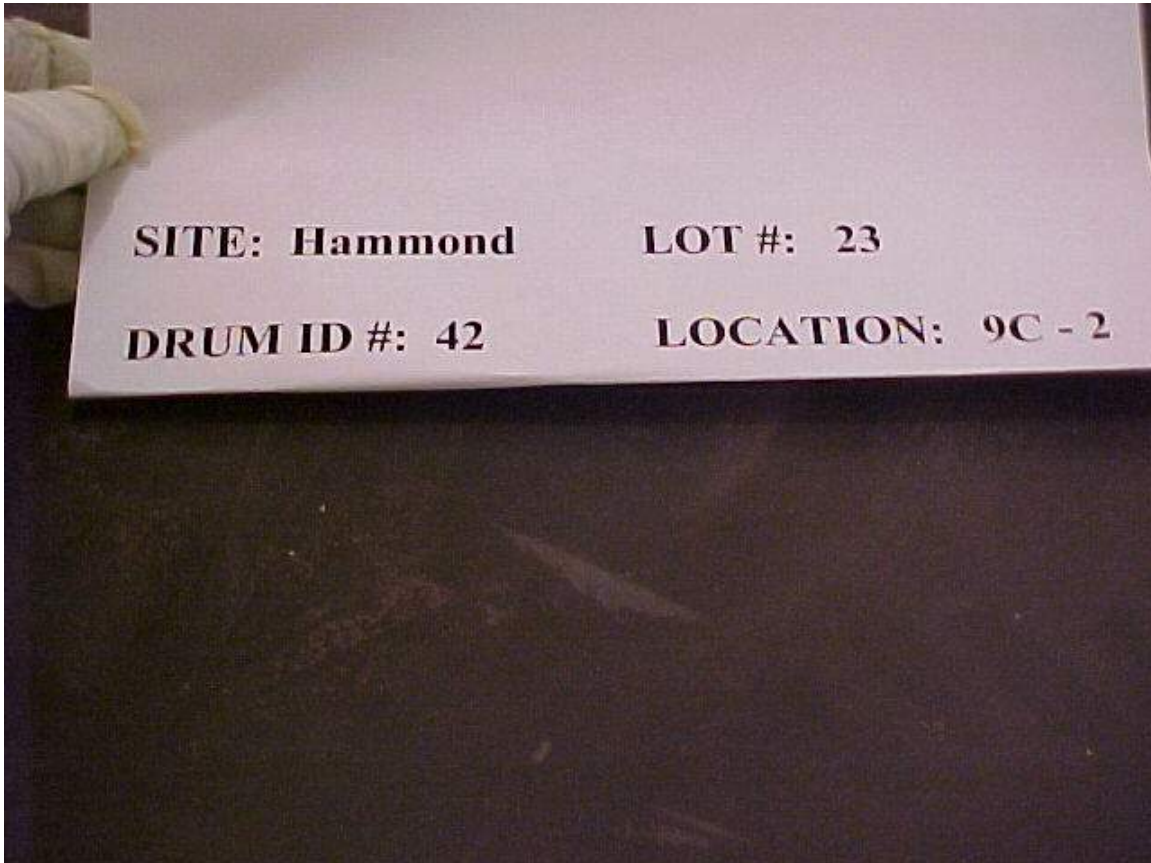
Lot No.	<u>23</u>	Inspection/Sample	<u>Visual Inspection & Sampling</u>
Drum ID No.	<u>42</u>	Date	<u>6-07-2002</u>
Location	<u>9C-2</u>	Photo No.	<u>2 of 17</u>
Site	<u>Hammond</u>

85 gal drum lid – Good Condition
Ring is also in good condition

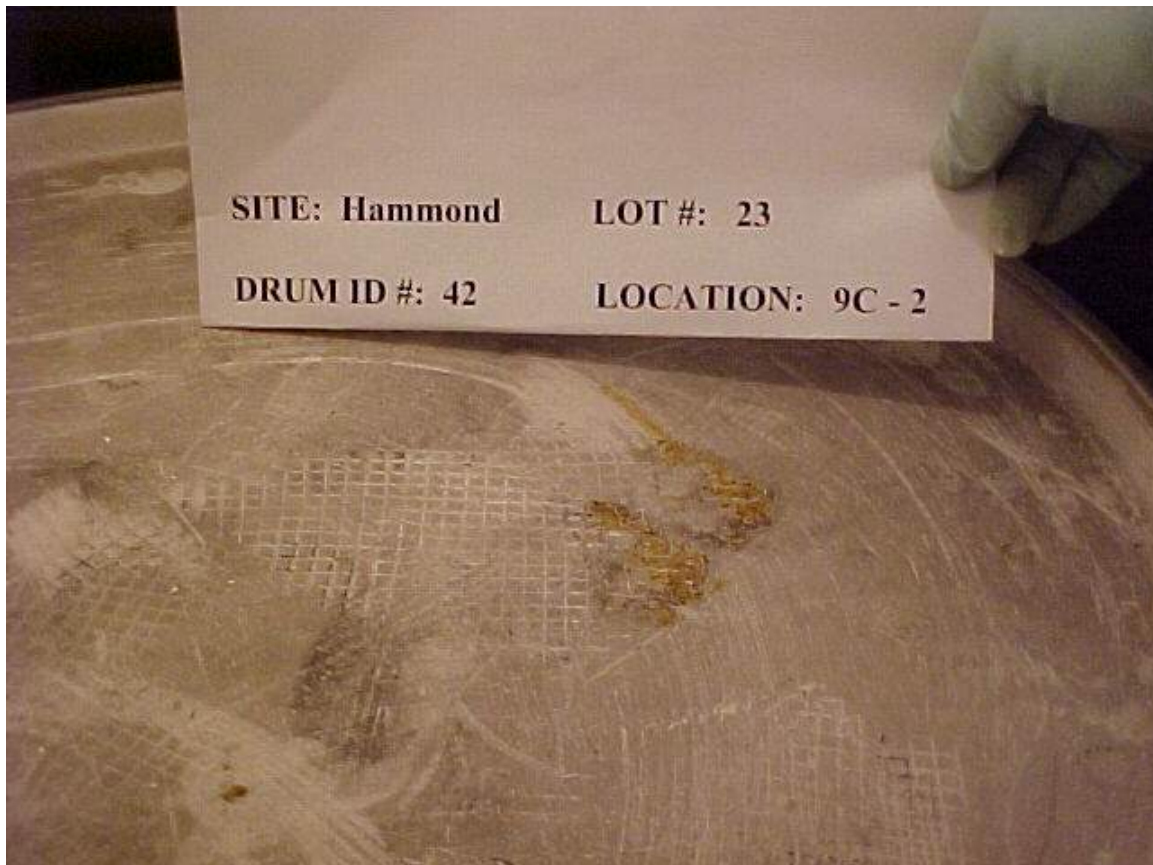
Lot No.	<u>23</u>	Inspection/Sample	<u>Visual Inspection & Sampling</u>
Drum ID No.	<u>42</u>	Date	<u>6-07-2002</u>
Location	<u>9C-2</u>	Photo No.	<u>3 of 17</u>
Site	<u>Hammond</u>

55 gal lid – Good Condition

Ring 3/8 x 3 1/2 bolt/nut is in good condition/tight

55 gal drum is in a 85 gal overpack with vermiculite

No gasses present

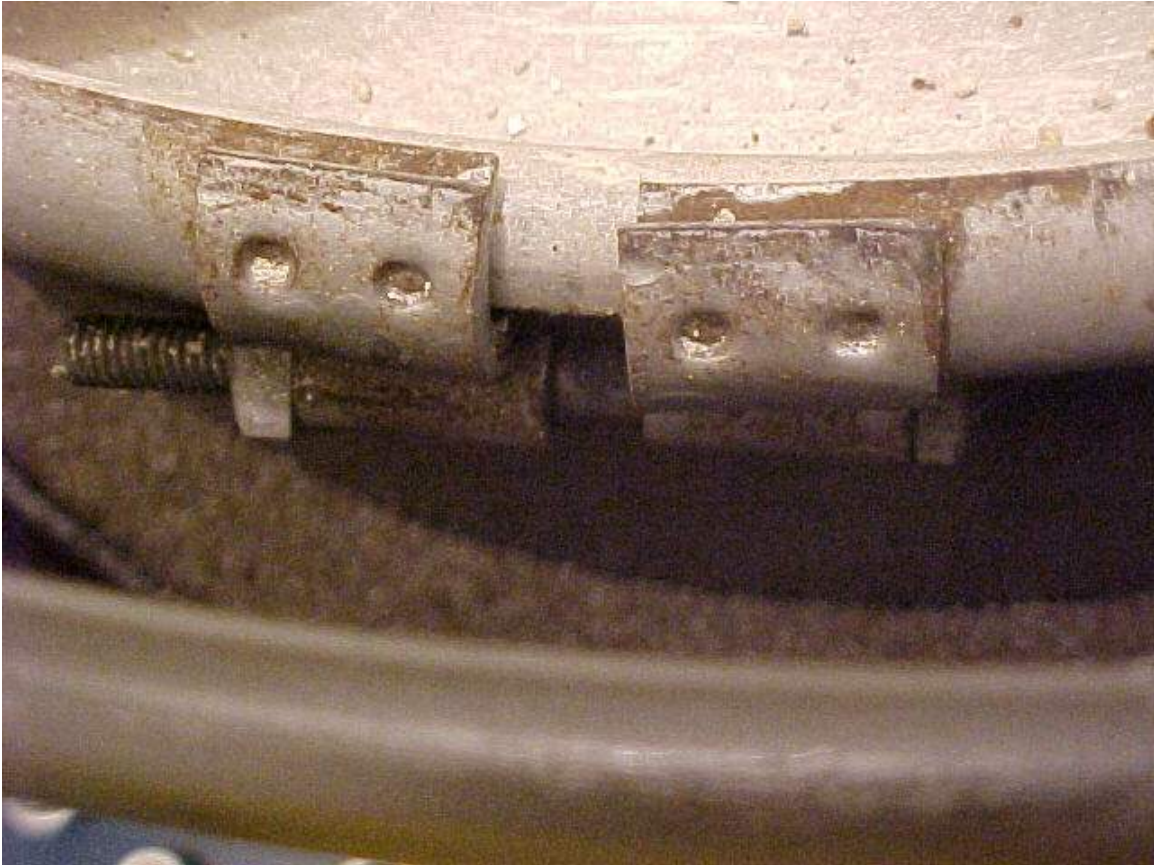
Lot No.	<u>23</u>	Inspection/Sample	<u>Visual Inspection & Sampling</u>
Drum ID No.	<u>42</u>	Date	<u>6-07-2002</u>
Location	<u>9C-2</u>	Photo No.	<u>4 of 17</u>
Site	<u>Hammond</u>

This shows the integrity of the lid on the 55-gal container – Good Condition
Notice the 3/8 x 3 1/2 bolt and nut combination – difficult to reach bolt/nut combination
