THORIUM NITRATE STOCKPILE DRUM CHARACTERIZATION REPORT

**THORIUM NITRATE STOCKPILE
DRUM CHARACTERIZATION REPORT**

Prepared for
U.S. Defense Logistics Agency
Defense National Stockpile Center
Fort Belvoir, Virginia

Prepared by
OAK RIDGE NATIONAL LABORATORY
Oak Ridge, Tennessee 37831
managed by
UT-BATTELLE, LLC
for the
U.S. DEPARTMENT OF ENERGY
under contract DE-AC05-00OR22725

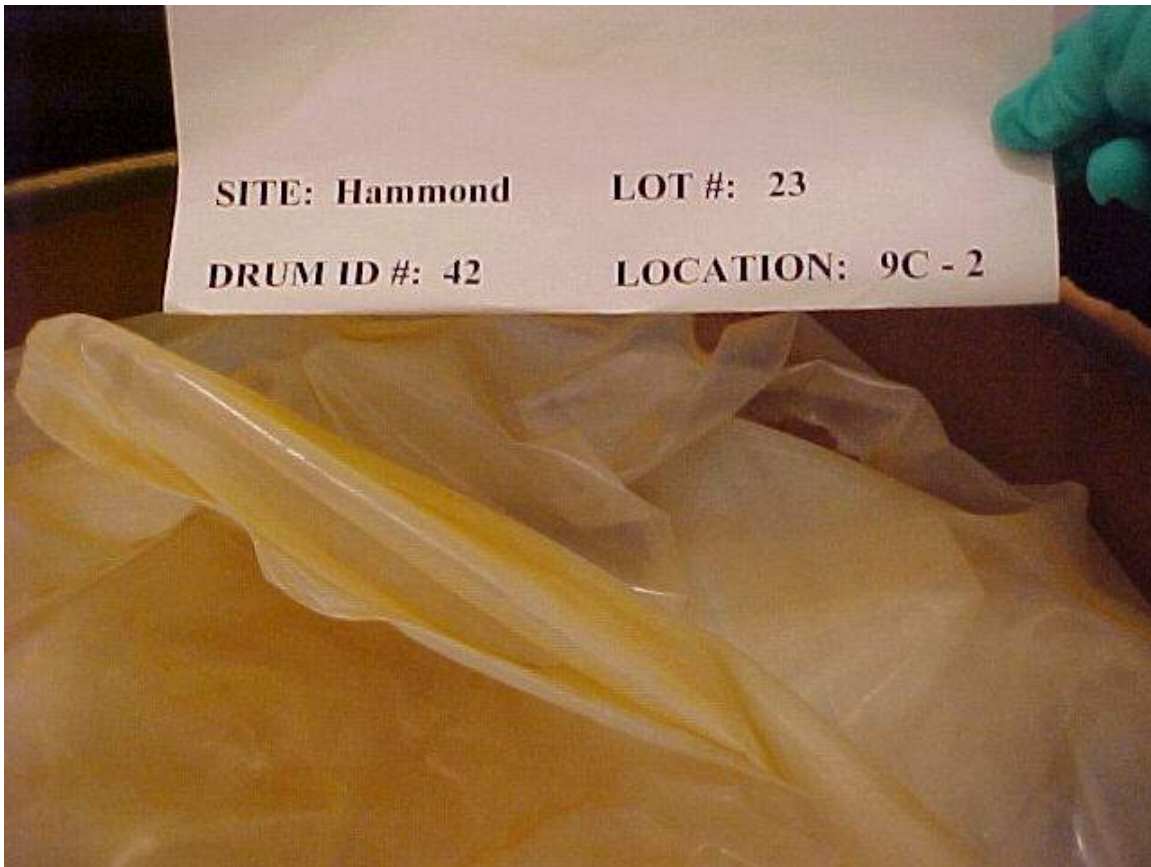
Inspection/Sample Visual Inspection & Sampling
Date 6-07-2002
Photo No. 5 of 17

1st Poly liner/bag – Good Condition
Liner is sealed and in good condition
No measurement of gasses present

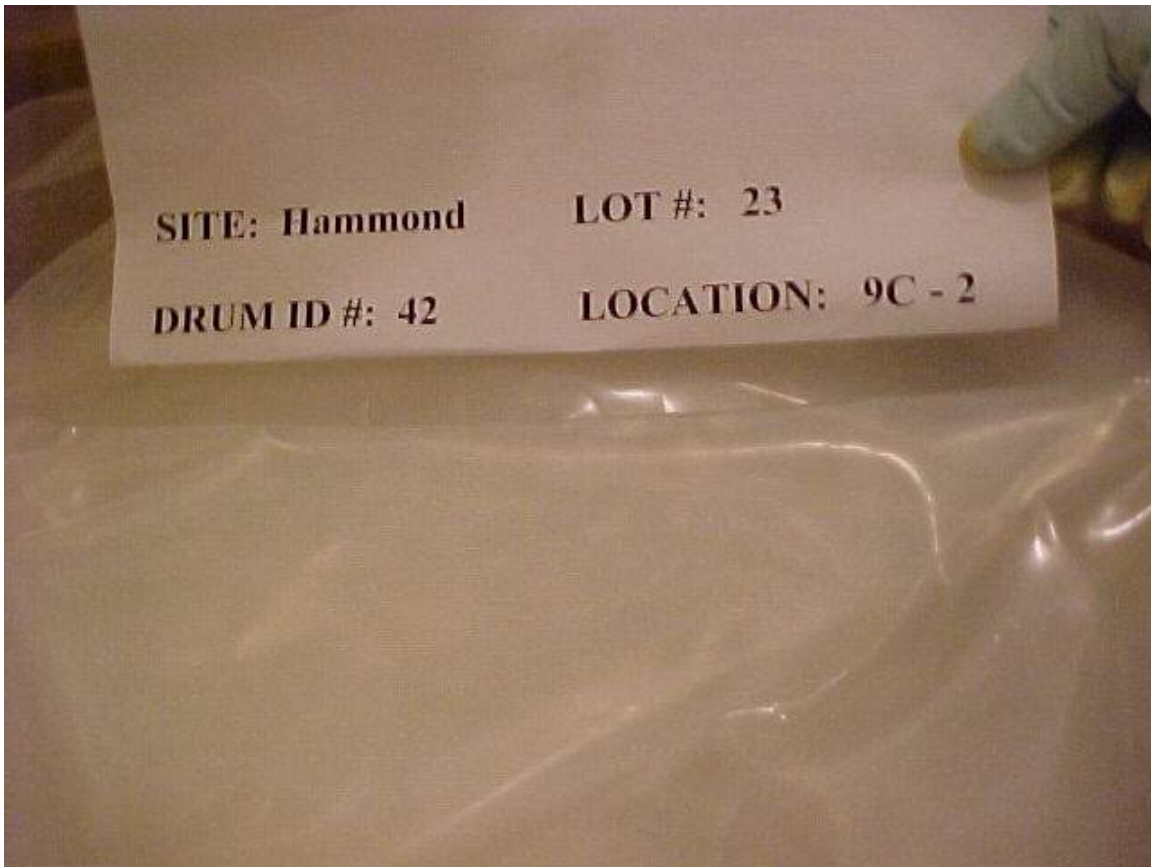
Lot No.	<u>23</u>	Inspection/Sample	<u>Visual Inspection & Sampling</u>
Drum ID No.	<u>42</u>	Date	<u>6-07-2002</u>
Location	<u>9C-2</u>	Photo No.	<u>6 of 17</u>
Site	<u>Hammond</u>

2nd Poly liner/bag – Good Condition
No moisture
No gasses present

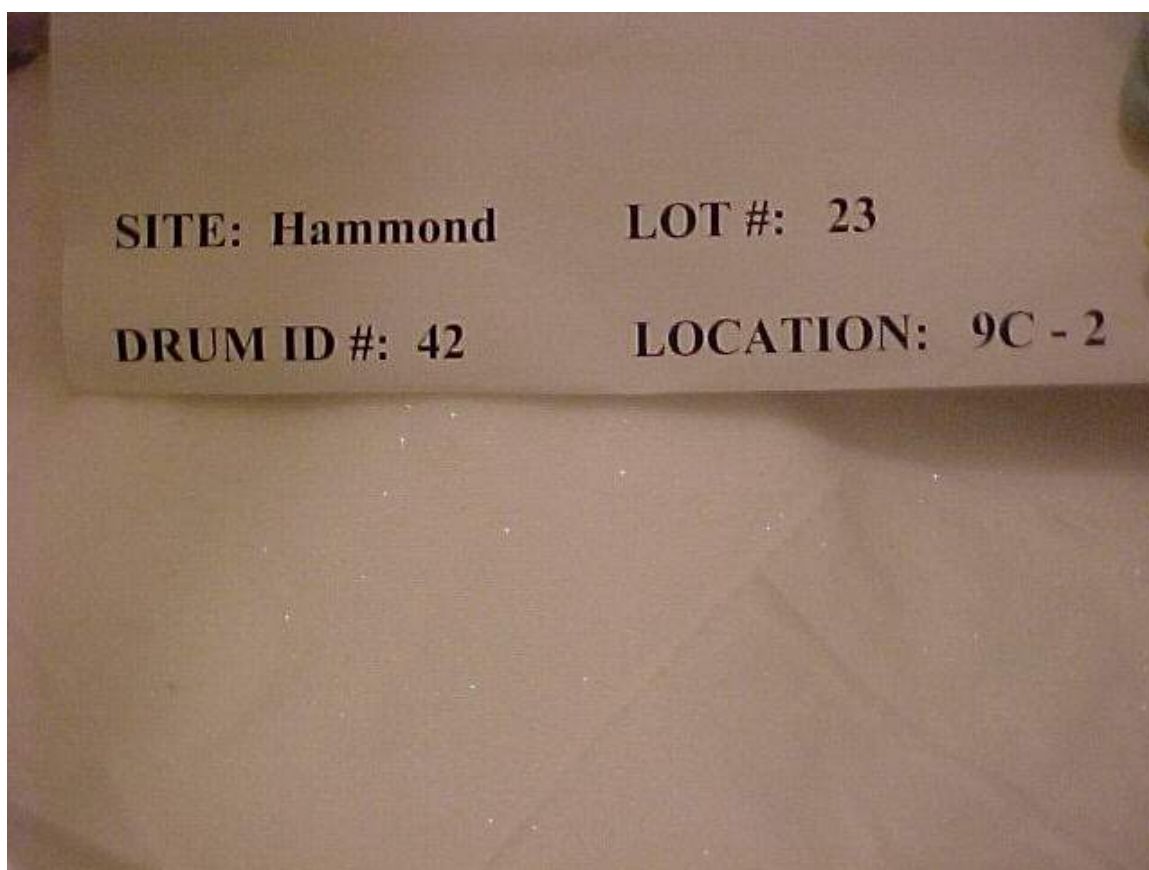
Inspection/Sample Visual Inspection & Sampling
Date 6-07-2002
Photo No. 7 of 17

Monolith - White in color
Solid - dry
No gasses present

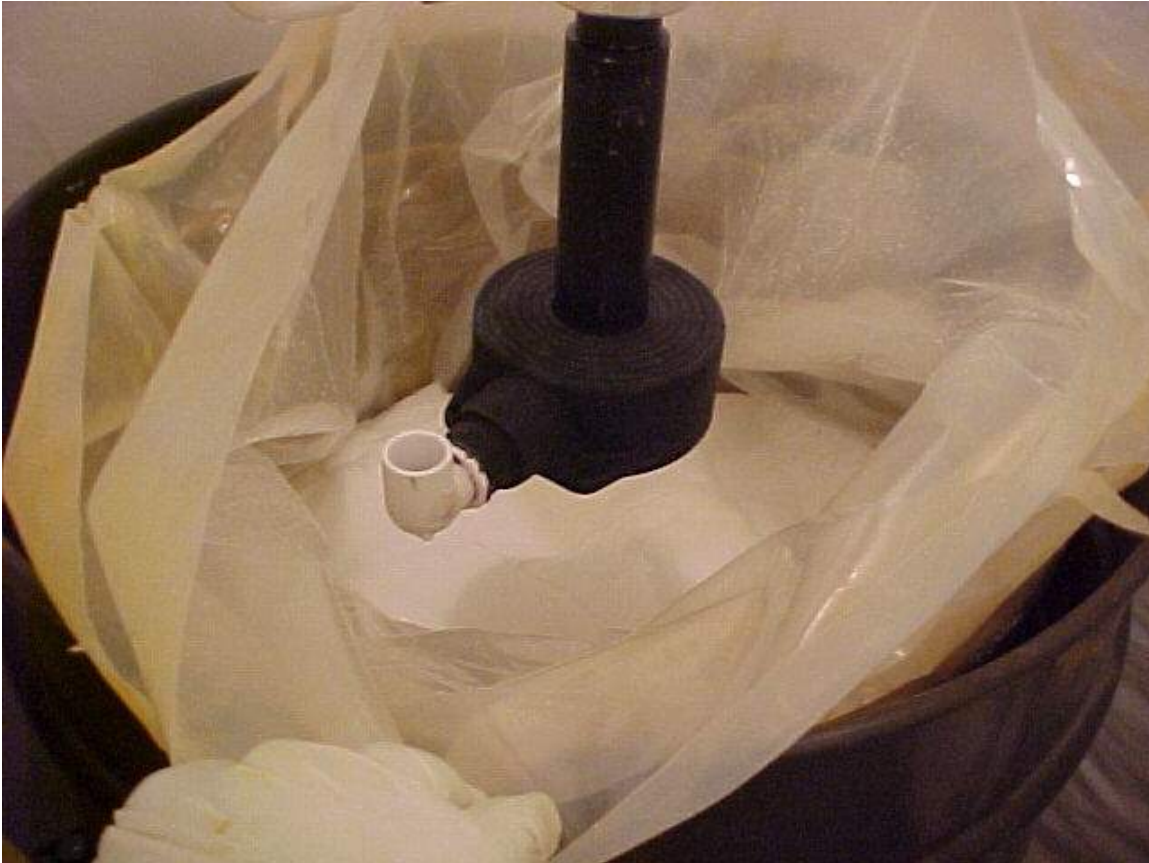
Lot No.	<u>23</u>	Inspection/Sample	<u>Visual Inspection & Sampling</u>
Drum ID No.	<u>42</u>	Date	<u>6-07-2002</u>
Location	<u>9C-2</u>	Photo No.	<u>8 of 17</u>
Site	<u>Hammond</u>

This shows the drill bit with the vaccum adapter in place
No gasses present

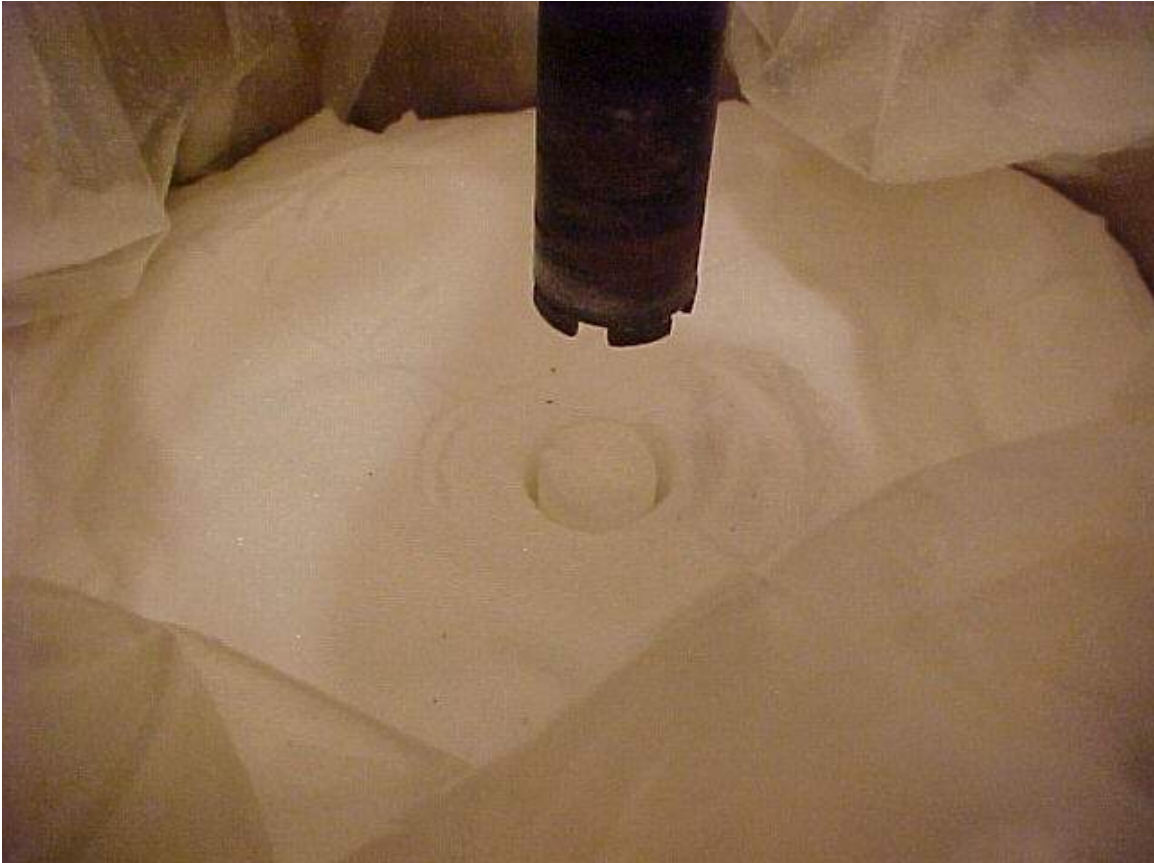
Lot No.	<u>23</u>	Inspection/Sample	<u>Visual Inspection & Sampling</u>
Drum ID No.	<u>42</u>	Date	<u>6-07-2002</u>
Location	<u>9C-2</u>	Photo No.	<u>9 of 17</u>
Site	<u>Hammond</u>

Here is the 1st core sample taken
No gasses present

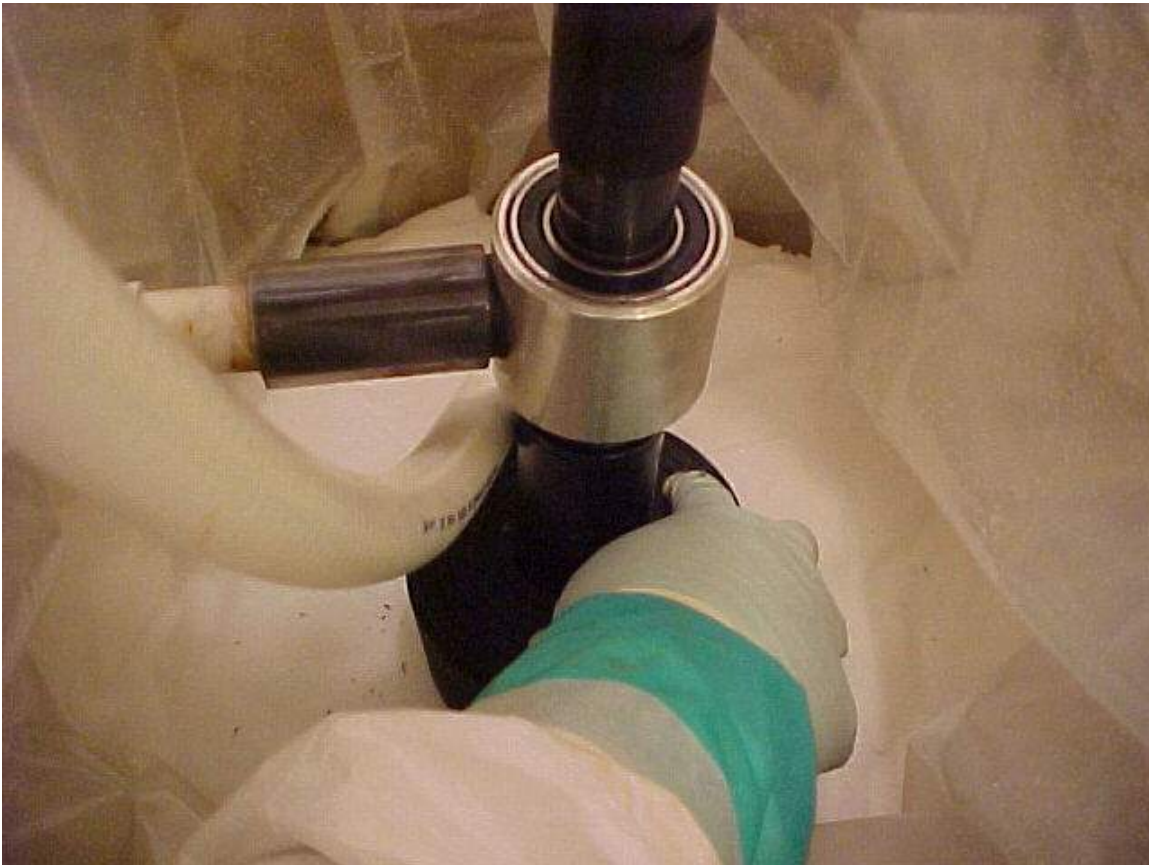
Lot No.	<u>23</u>	Inspection/Sample	<u>Visual Inspection & Sampling</u>
Drum ID No.	<u>42</u>	Date	<u>6-07-2002</u>
Location	<u>9C-2</u>	Photo No.	<u>10 of 17</u>
Site	<u>Hammond</u>

This picture shows how the vacuum system works
We are drilling for the 2nd core sample
No gasses are present

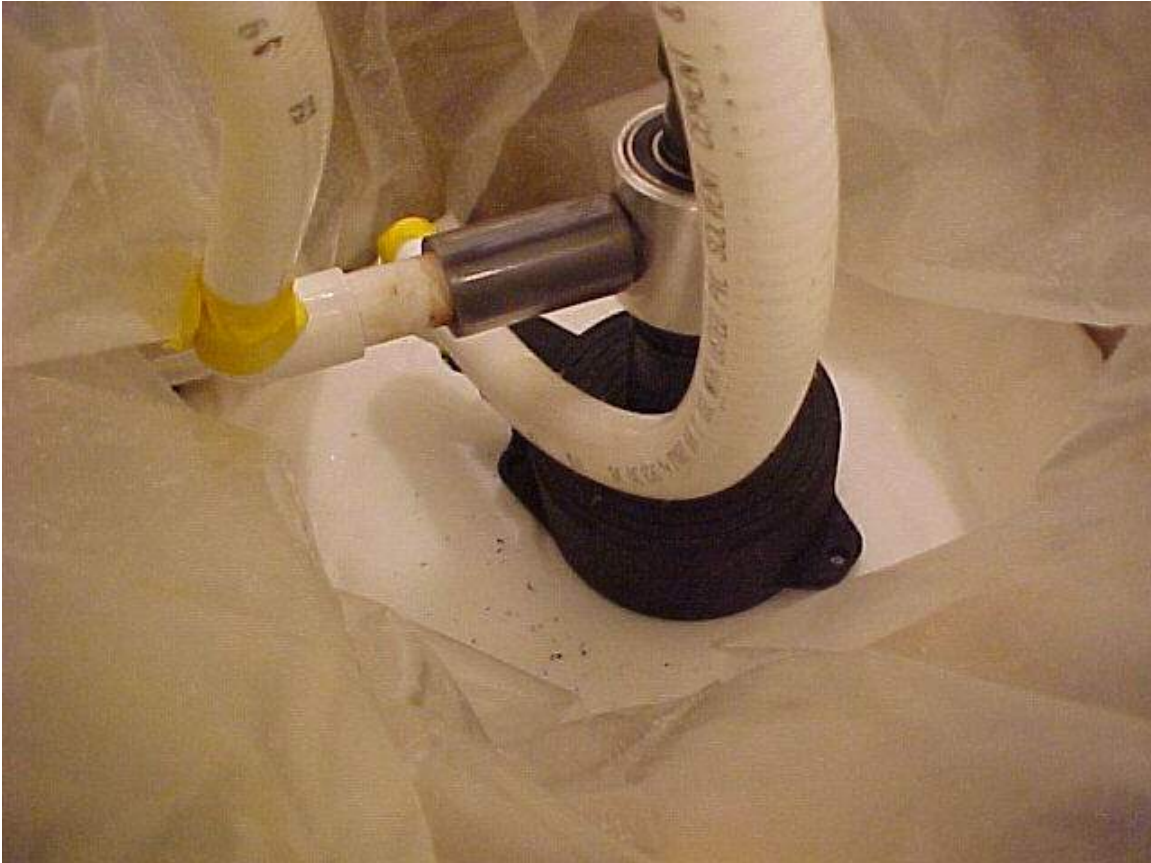
Lot No.	<u>23</u>	Inspection/Sample	<u>Visual Inspection & Sampling</u>
Drum ID No.	<u>42</u>	Date	<u>6-07-2002</u>
Location	<u>9C-2</u>	Photo No.	<u>11 of 17</u>
Site	<u>Hammond</u>

Another picture of the drill and vacuum system operating
No gasses present

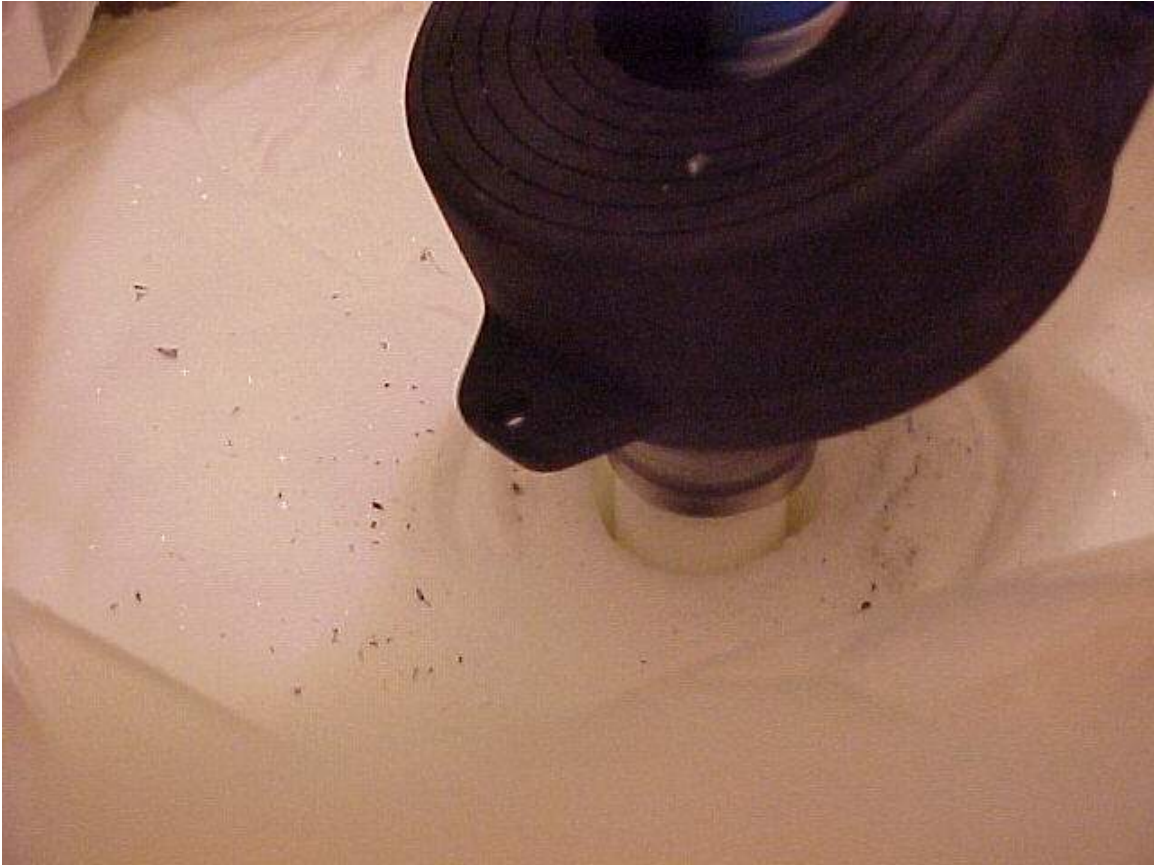
Lot No.	<u>23</u>	Inspection/Sample	<u>Visual Inspection & Sampling</u>
Drum ID No.	<u>42</u>	Date	<u>6-07-2002</u>
Location	<u>9C-2</u>	Photo No.	<u>12 of 17</u>
Site	<u>Hammond</u>

Lifting the drill and vacuum cover shows a piece of the core sample
No gasses present

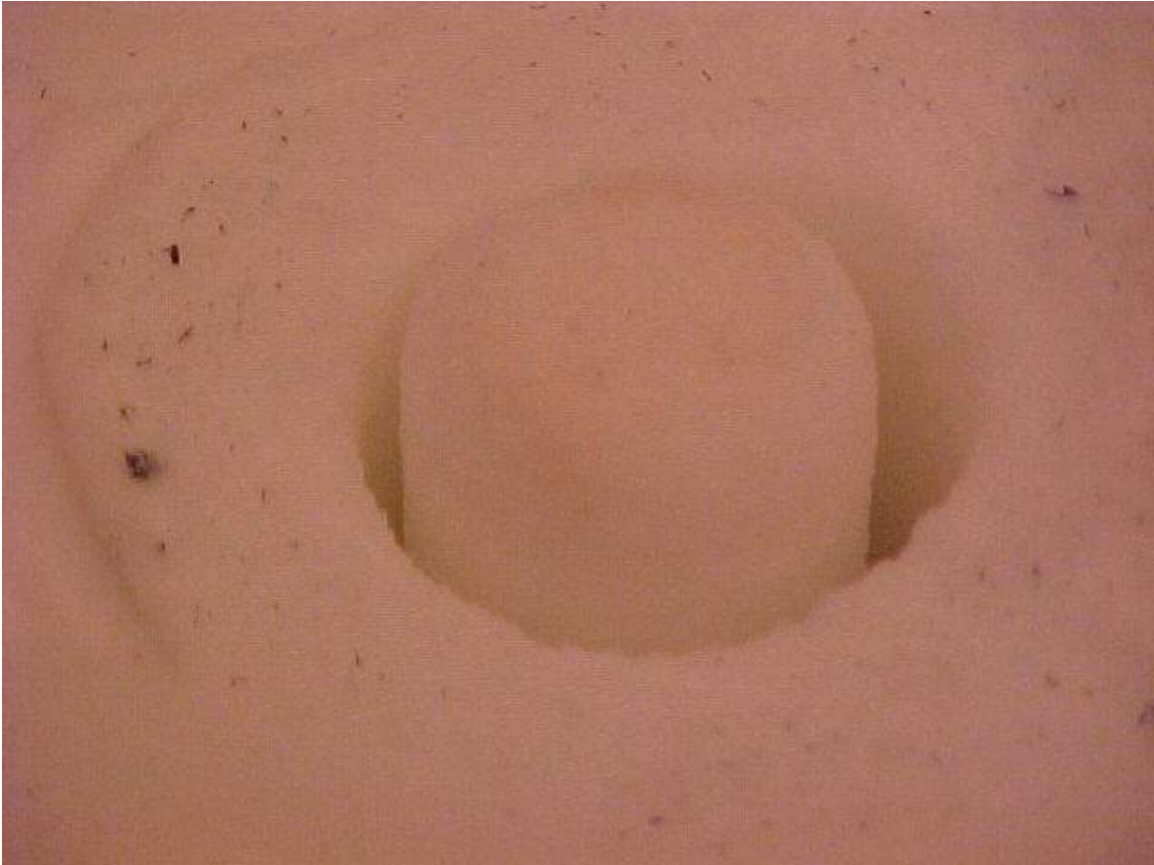
Lot No.	<u>23</u>	Inspection/Sample	<u>Visual Inspection & Sampling</u>
Drum ID No.	<u>42</u>	Date	<u>6-07-2002</u>
Location	<u>9C-2</u>	Photo No.	<u>13 of 17</u>
Site	<u>Hammond</u>

A closes-up picture of the 2nd core sample still in the core block
No gasses present

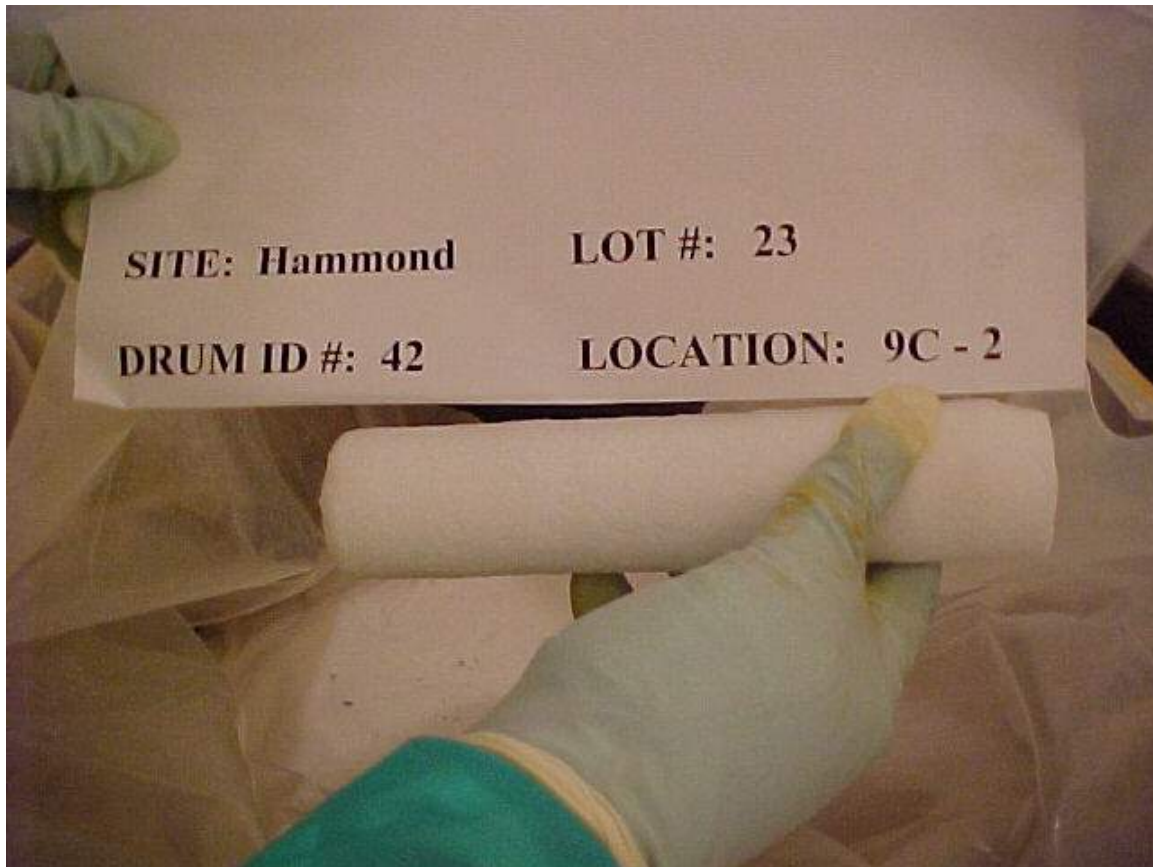
Lot No.	<u>23</u>	Inspection/Sample	<u>Visual Inspection & Sampling</u>
Drum ID No.	<u>42</u>	Date	<u>6-07-2002</u>
Location	<u>9C-2</u>	Photo No.	<u>14 of 17</u>
Site	<u>Hammond</u>

Here is a picture of the 1st core sample
Notice that the paper is 8 ½ x 11 landscape
This shows the core sample is about 8'' long and in good condition
This core sample weight is 572gm
There are no gasses present

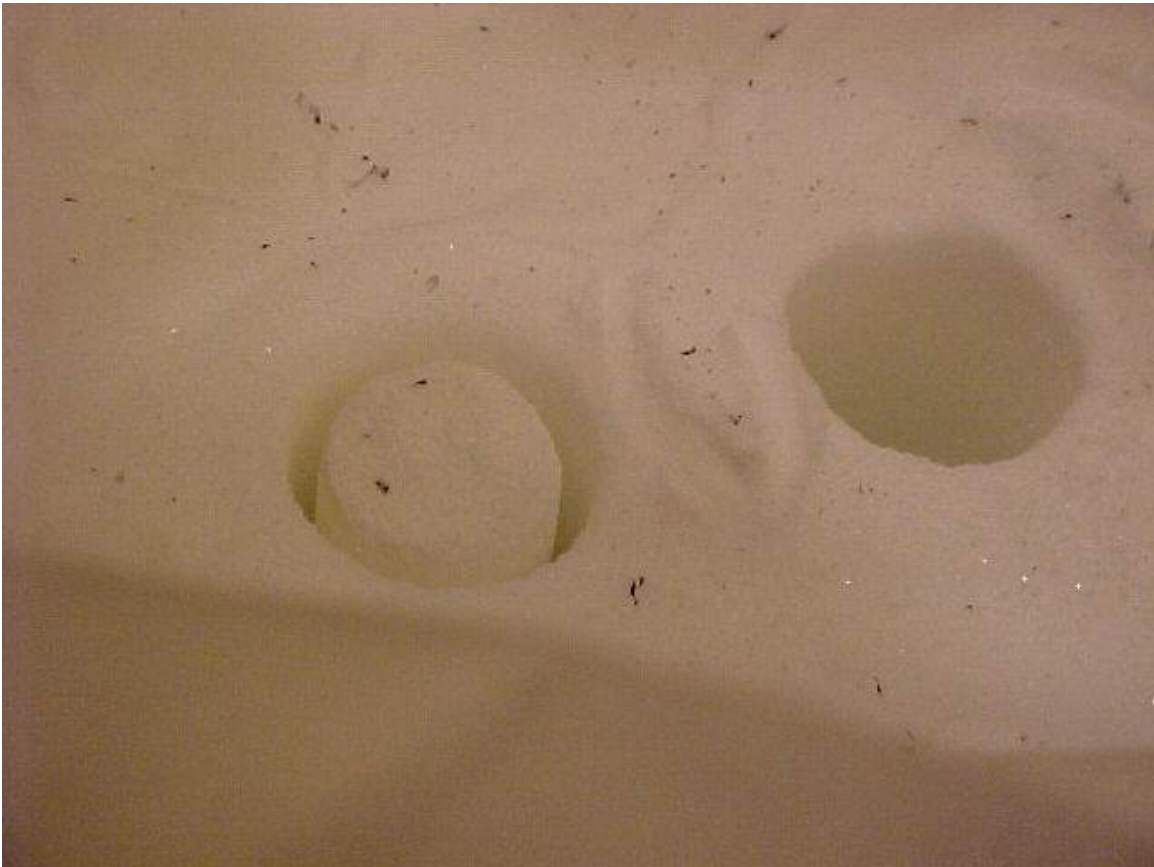
Lot No.	<u>23</u>	Inspection/Sample	<u>Visual Inspection & Sampling</u>
Drum ID No.	<u>42</u>	Date	<u>6-07-2002</u>
Location	<u>9C-2</u>	Photo No.	<u>15 of 17</u>
Site	<u>Hammond</u>

Both core holes drilled with one core sample already taken out
This picture shows a clean cut with the drill
No gasses present

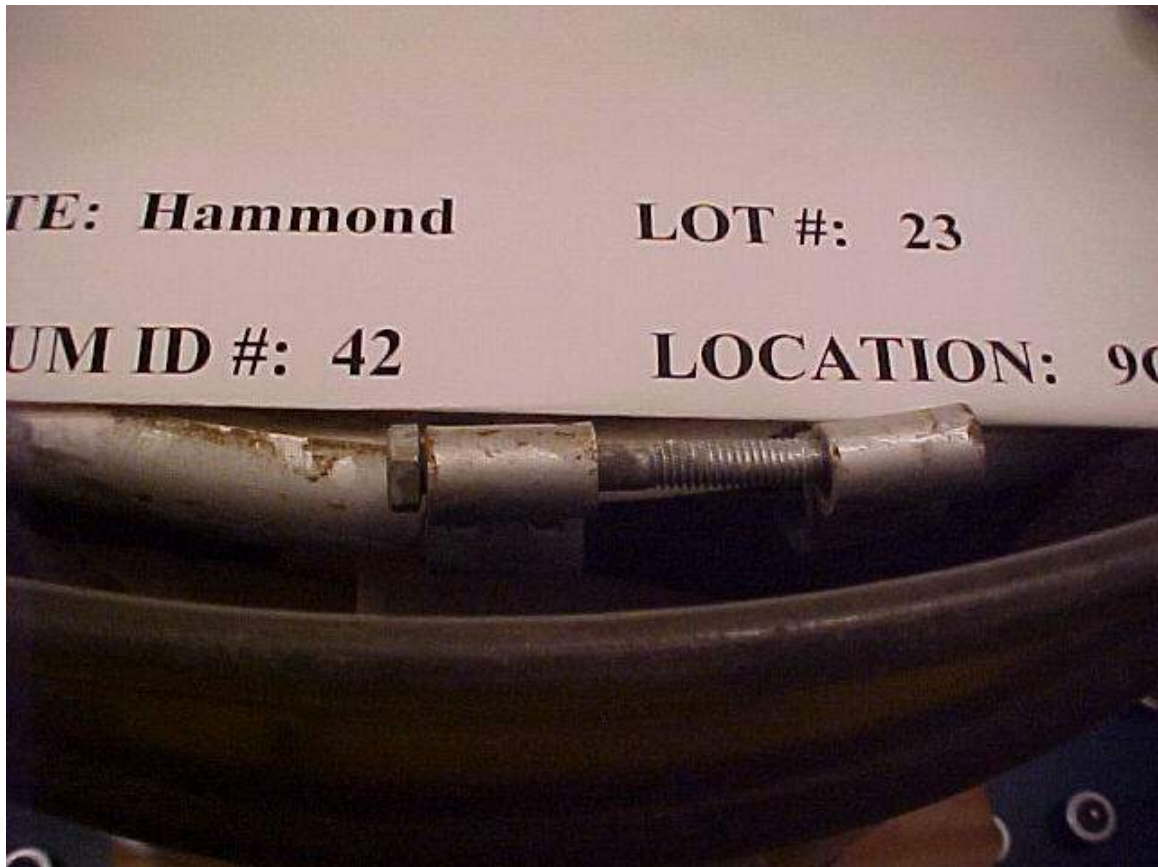
Lot No.	<u>23</u>	Inspection/Sample	<u>Visual Inspection & Sampling</u>
Drum ID No.	<u>42</u>	Date	<u>6-07-2002</u>
Location	<u>9C-2</u>	Photo No.	<u>16 of 17</u>
Site	<u>Hammond</u>

55-gal drum ring placement – Good Condition
Ring is installed upside down for easy access
No gasses present

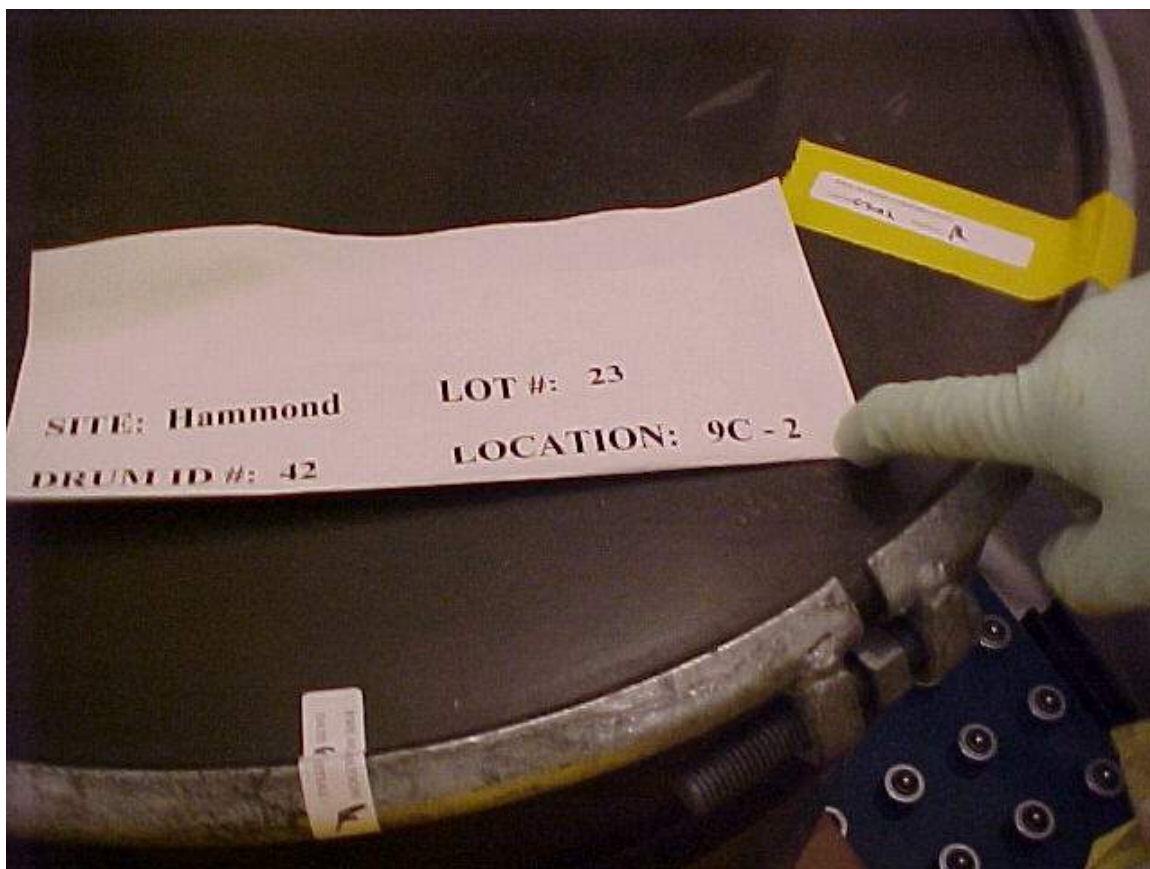
Lot No.	<u>23</u>	Inspection/Sample	<u>Visual Inspection & Sampling</u>
Drum ID No.	<u>42</u>	Date	<u>6-07-2002</u>
Location	<u>9C-2</u>	Photo No.	<u>17 of 17</u>
Site	<u>Hammond</u>

85-gal container – Good Condition
Sealed/dated - Completed

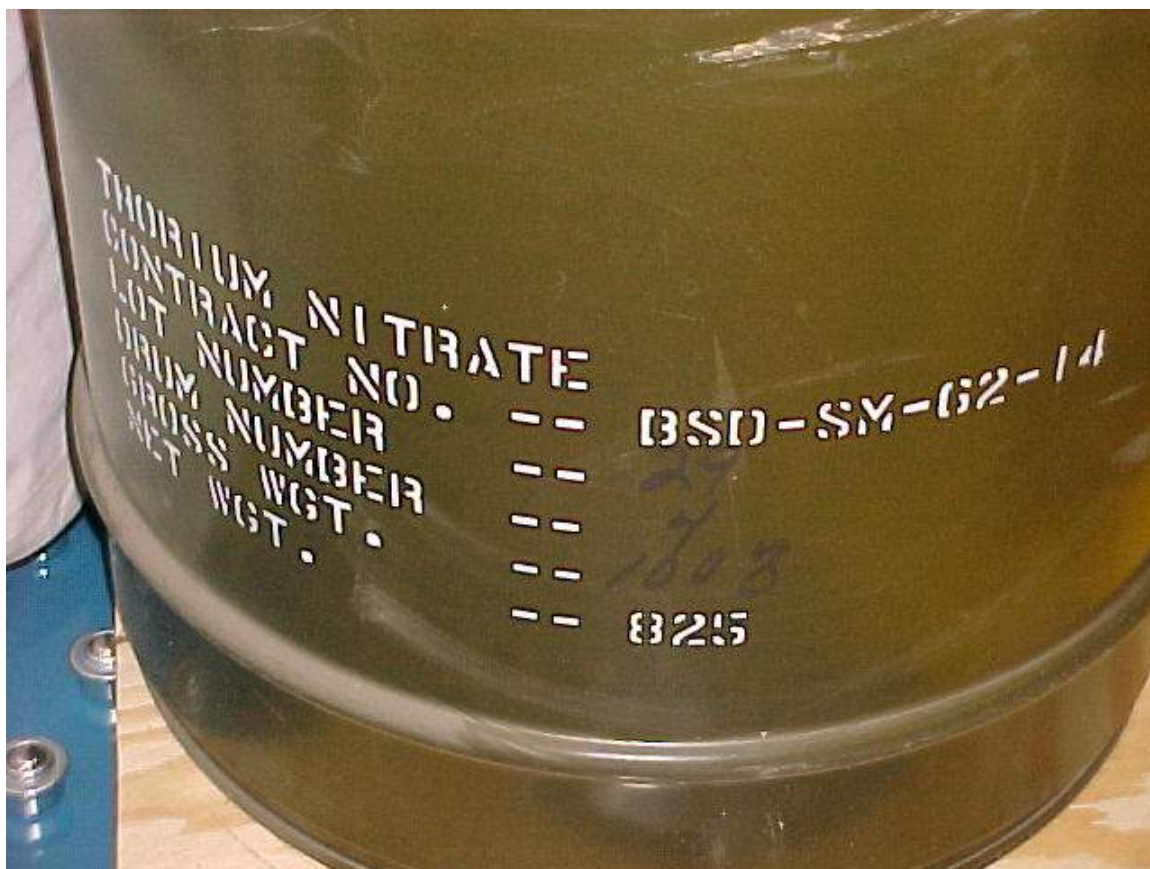
Lot No.	<u>29</u>	Inspection/Sample	<u>Visual Inspection & Sampling</u>
Drum ID No.	<u>4</u>	Date	<u>6-07-2002</u>
Location	<u>9B-4</u>	Photo No.	<u>1 of 12</u>
Site	<u>Hammond</u>		
Container	<u>85-gallon steel drum</u>	Container Condition	<u>Good</u>
Dose Rate	Surface <u>30 mR/hr</u> 1 meter <u>3 mR/hr</u>

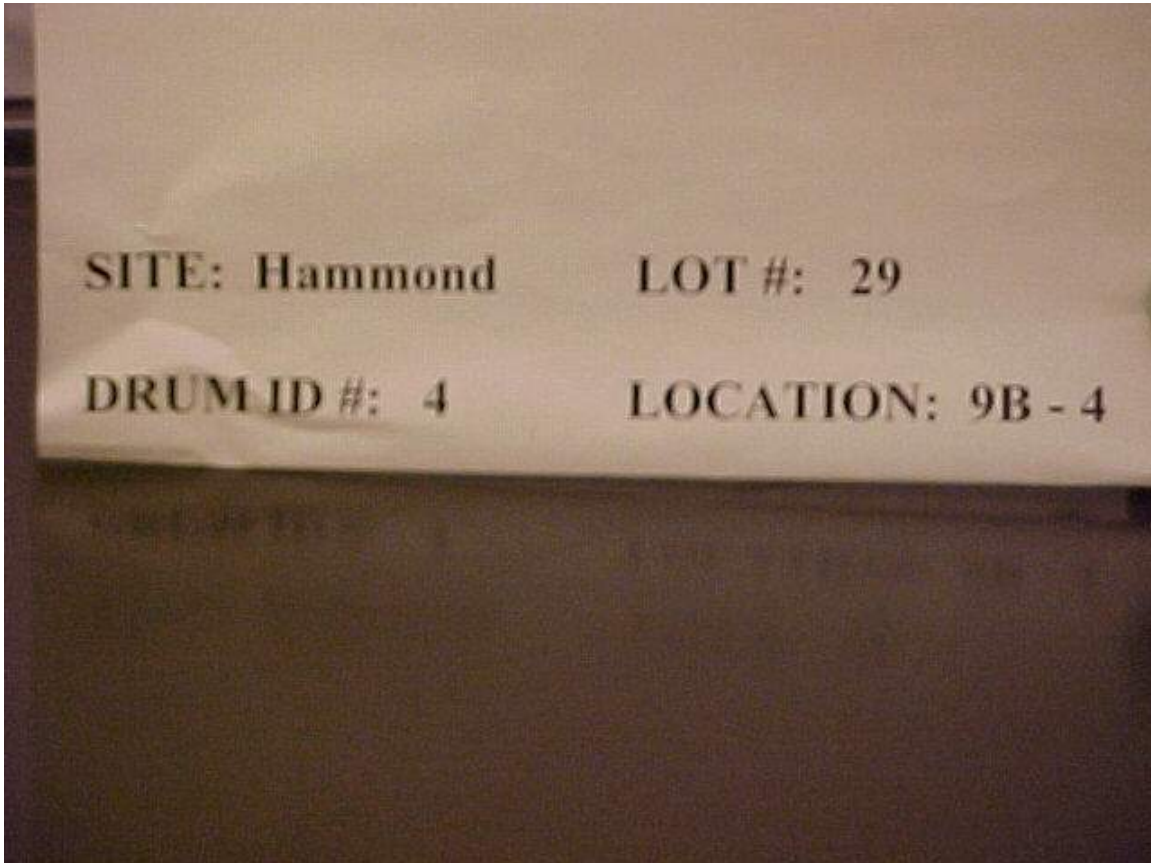
Lot No.	<u>29</u>	Inspection/Sample	<u>Visual Inspection & Sampling</u>
Drum ID No.	<u>4</u>	Date	<u>6-07-2002</u>
Location	<u>9B-4</u>	Photo No.	<u>2 of 12</u>
Site	<u>Hammond</u>

85 gal drum lid – Good Condition
Ring is also in good condition

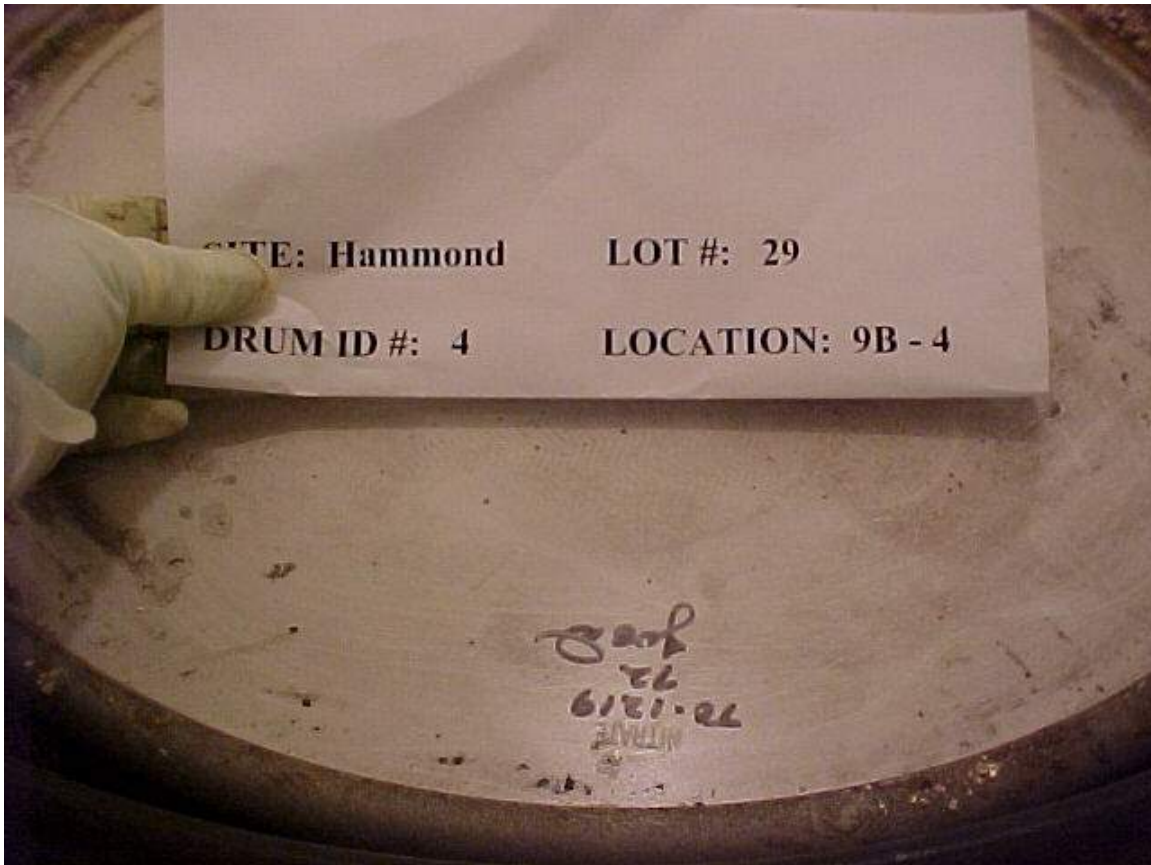
Lot No.	<u>29</u>	Inspection/Sample	<u>Visual Inspection & Sampling</u>
Drum ID No.	<u>4</u>	Date	<u>6-07-2002</u>
Location	<u>9B-4</u>	Photo No.	<u>3 of 12</u>
Site	<u>Hammond</u>

55 gal containers lid – Good Condition
Ring is bolted with a 3/8 x 3-1/2 bolt
55 gal drum is placed in a 85 overpack with vermiculite
No gasses present

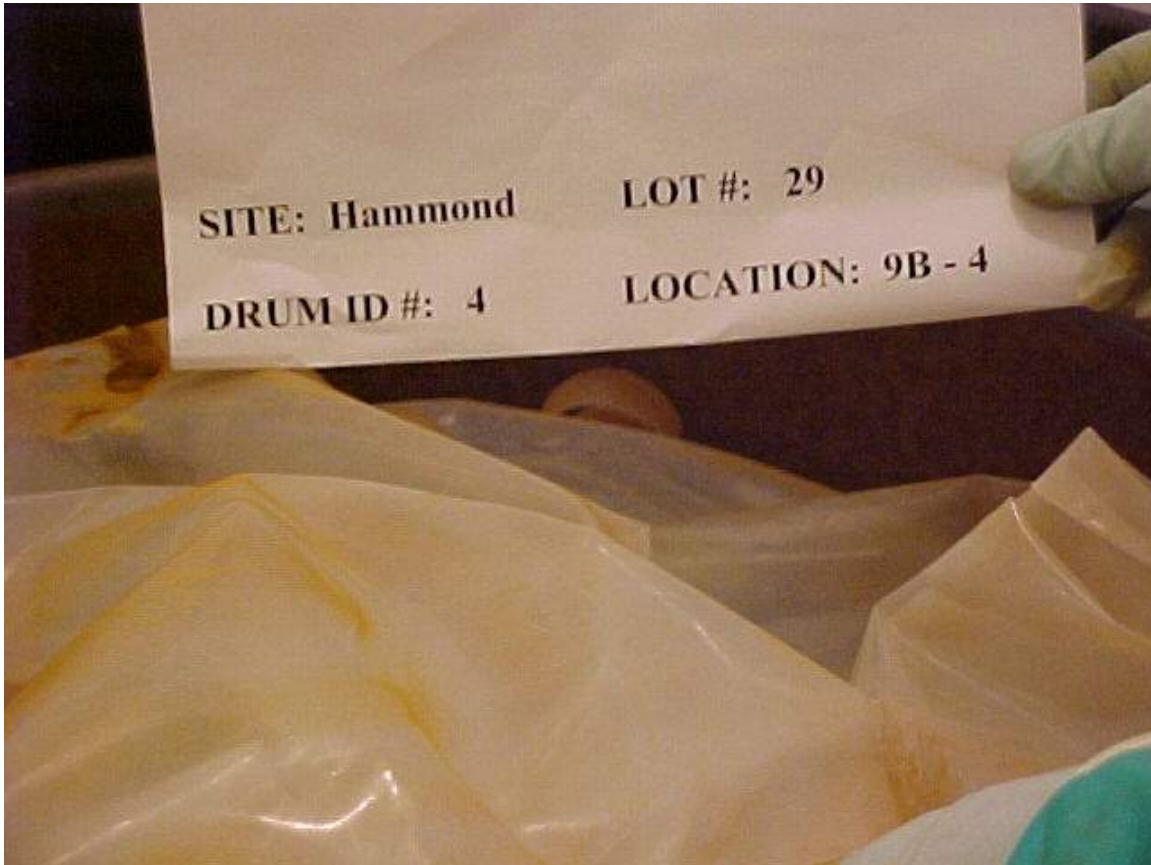
Lot No.	<u>29</u>	Inspection/Sample	<u>Visual Inspection & Sampling</u>
Drum ID No.	<u>4</u>	Date	<u>6-07-2002</u>
Location	<u>9B-4</u>	Photo No.	<u>4 of 12</u>
Site	<u>Hammond</u>

1st poly liner/bag – Good Condition
Seal is in good condition
No gassed present

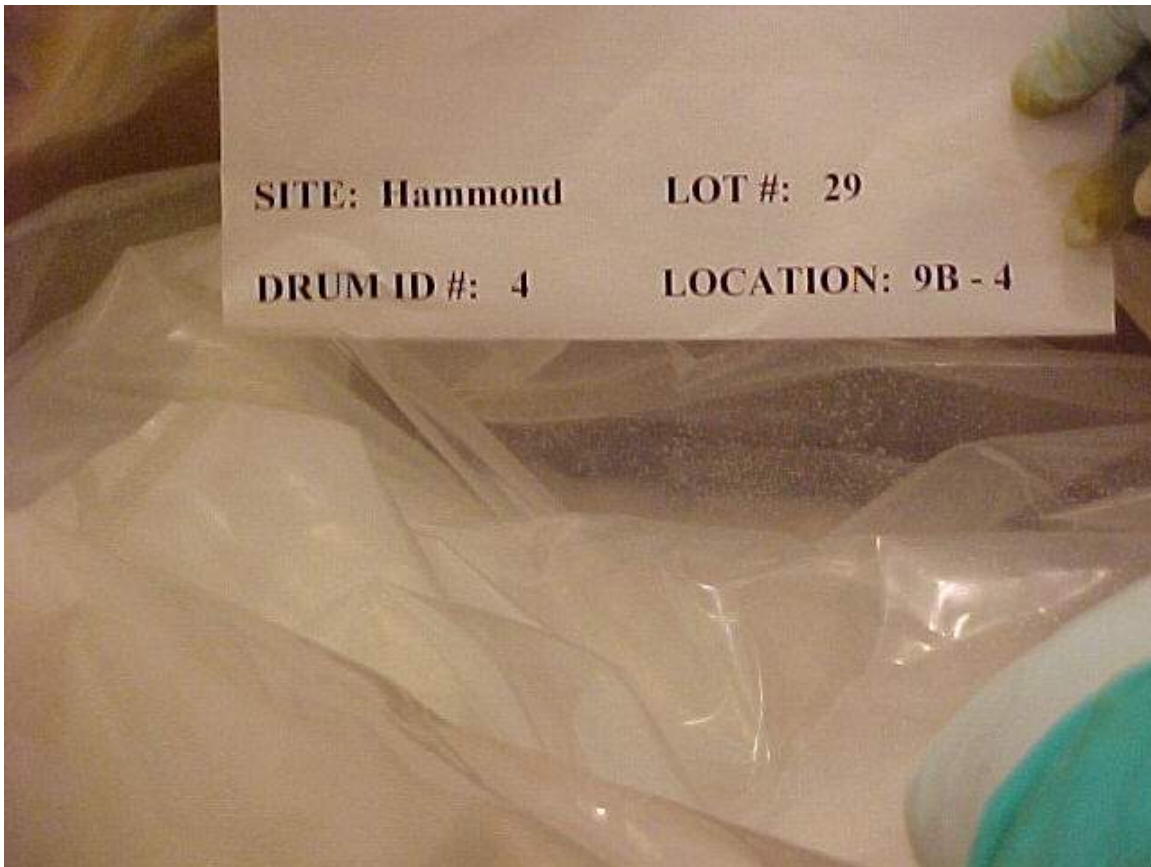
Lot No.	<u>29</u>	Inspection/Sample	<u>Visual Inspection & Sampling</u>
Drum ID No.	<u>4</u>	Date	<u>6-07-2002</u>
Location	<u>9B-4</u>	Photo No.	<u>5 of 12</u>
Site	<u>Hammond</u>

2nd poly liner/bag – Good Condition
Moisture crystals present inside bag
No gasses present

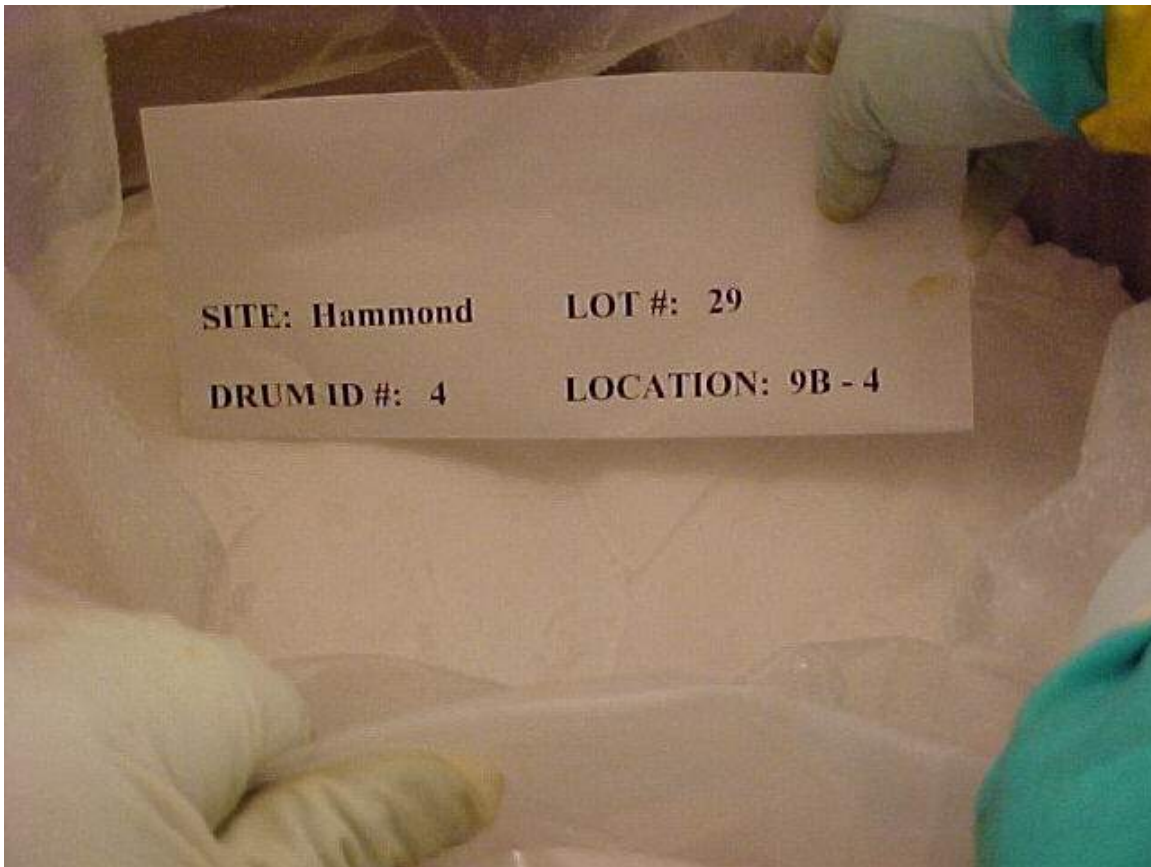
Lot No.	<u>29</u>	Inspection/Sample	<u>Visual Inspection & Sampling</u>
Drum ID No.	<u>4</u>	Date	<u>6-07-2002</u>
Location	<u>9B-4</u>	Photo No.	<u>6 of 12</u>
Site	<u>Hammond</u>

Monolith – white in color
Solid – very dry
No gasses present while monitoring

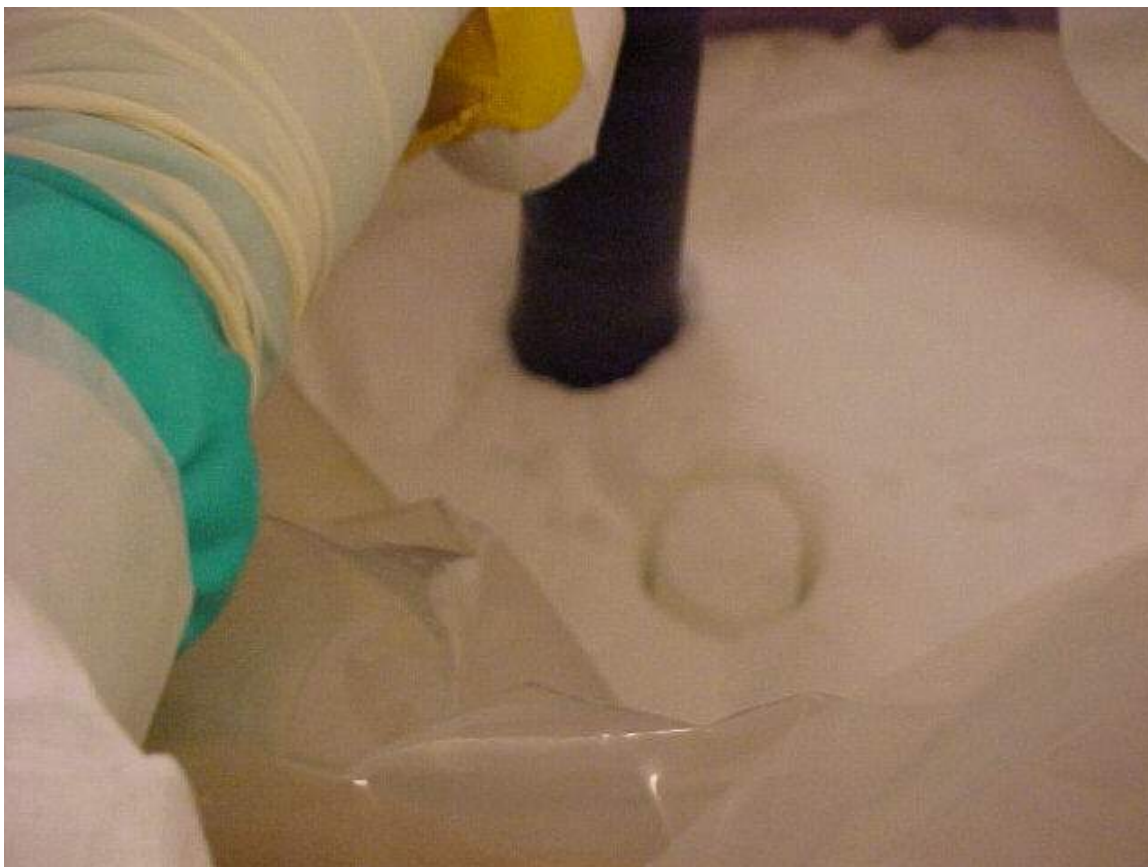
Lot No.	<u>29</u>	Inspection/Sample	<u>Visual Inspection & Sampling</u>
Drum ID No.	<u>4</u>	Date	<u>6-07-2002</u>
Location	<u>9B-4</u>	Photo No.	<u>7 of 12</u>
Site	<u>Hammond</u>

This shows (1) one core already drilled and another core sample is being drilled
No gasses are present

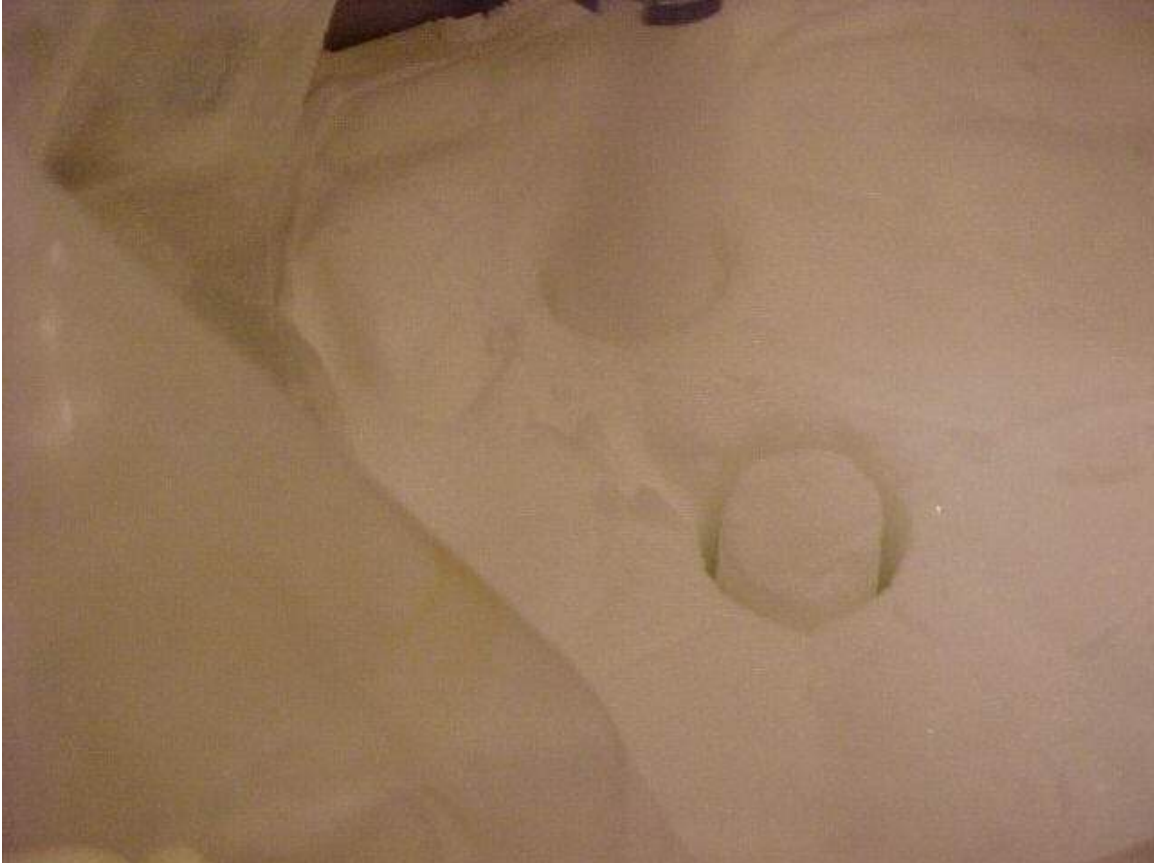
Lot No.	<u>29</u>	Inspection/Sample	<u>Visual Inspection & Sampling</u>
Drum ID No.	<u>4</u>	Date	<u>6-07-2002</u>
Location	<u>9B-4</u>	Photo No.	<u>8 of 12</u>
Site	<u>Hammond</u>

The drill bit is lifted from the core sample
Some particles fall over core
Both core samples are in view
No gasses present
