THORIUM NITRATE STOCKPILE DRUM CHARACTERIZATION REPORT

**THORIUM NITRATE STOCKPILE
DRUM CHARACTERIZATION REPORT**

Prepared for
U.S. Defense Logistics Agency
Defense National Stockpile Center
Fort Belvoir, Virginia

Prepared by
OAK RIDGE NATIONAL LABORATORY
Oak Ridge, Tennessee 37831
managed by
UT-BATTELLE, LLC
for the
U.S. DEPARTMENT OF ENERGY
under contract DE-AC05-00OR22725

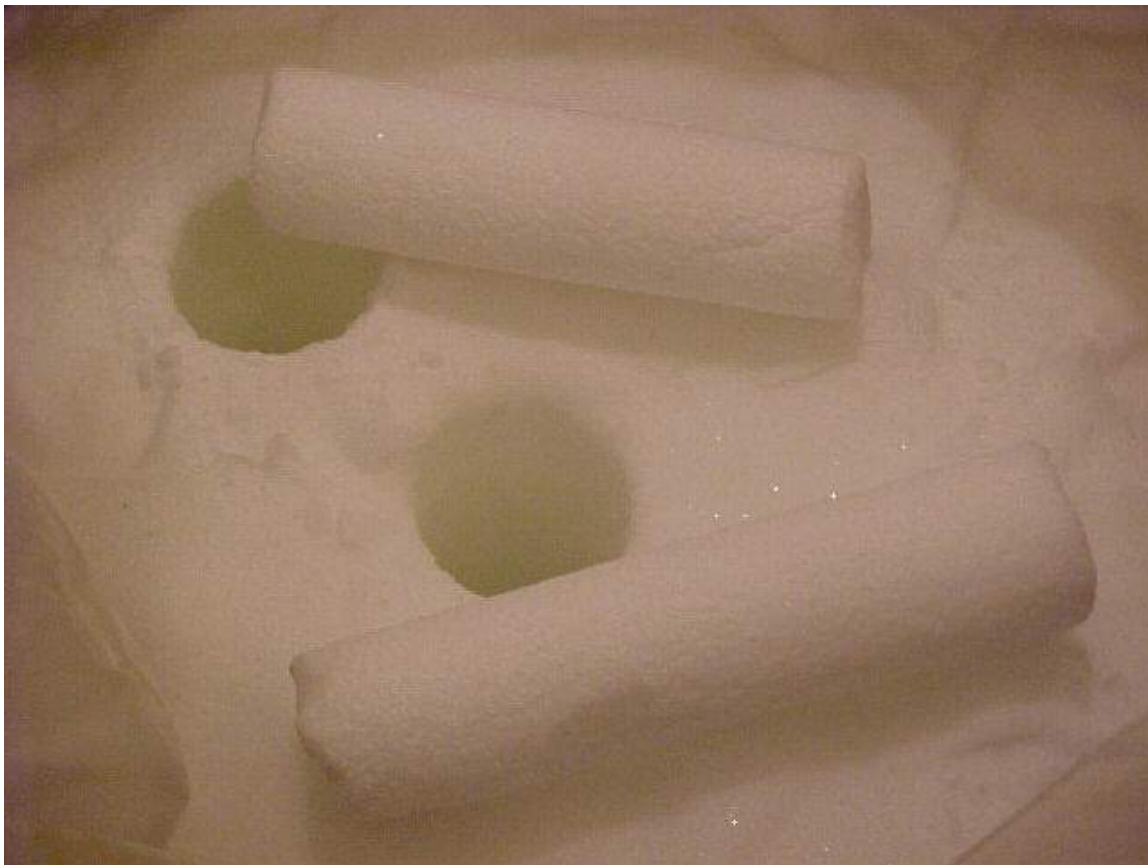
Lot No.	<u>29</u>	Inspection/Sample	<u>Visual Inspection & Sampling</u>
Drum ID No.	<u>4</u>	Date	<u>6-07-2002</u>
Location	<u>9B-4</u>	Photo No.	<u>9 of 12</u>
Site	<u>Hammond</u>

Both core samples lying on top of core block – both are in good condition
No gasses present

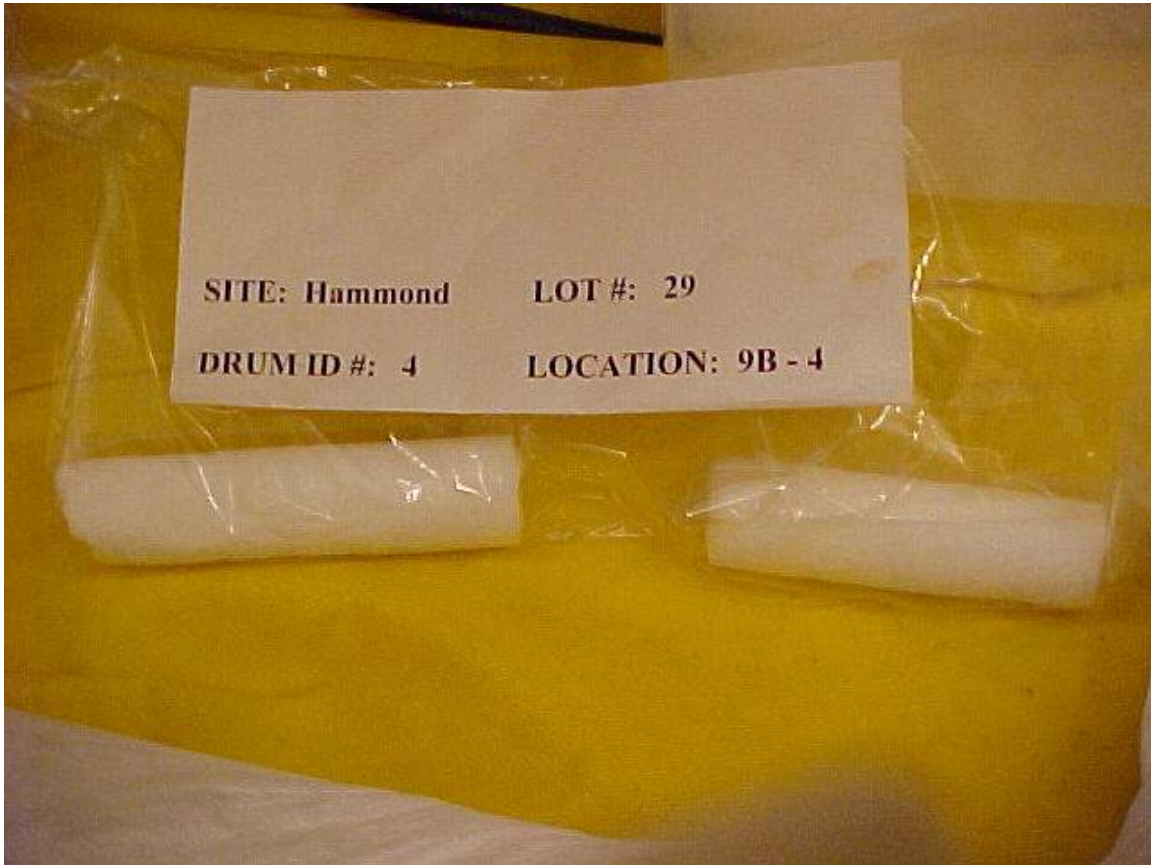
Lot No.	<u>29</u>	Inspection/Sample	<u>Visual Inspection & Sampling</u>
Drum ID No.	<u>4</u>	Date	<u>6-07-2002</u>
Location	<u>9B-4</u>	Photo No.	<u>10 of 12</u>
Site	<u>Hammond</u>

Here both core samples are sealed in individual plastic bags

Weight of the core on the left – 629 gm

Weight of the core on the right – 518 gm

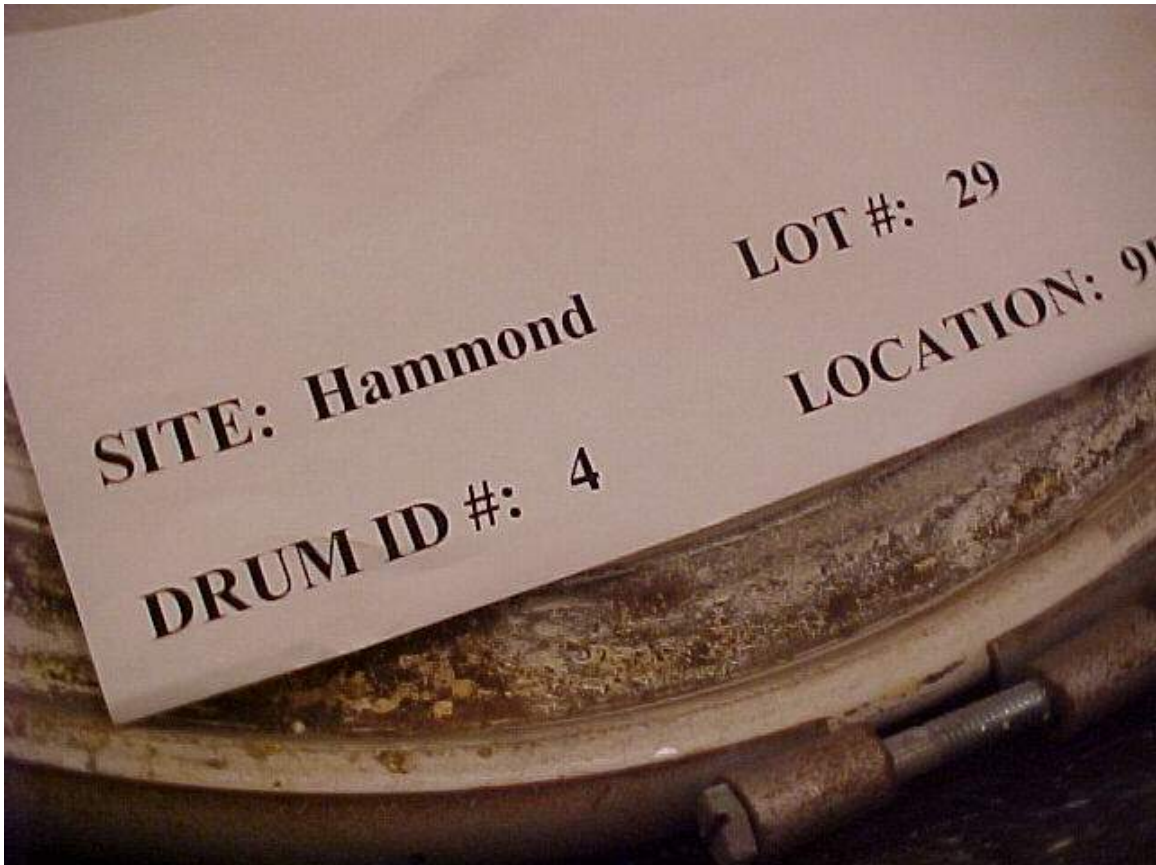
Lot No.	<u>29</u>	Inspection/Sample	<u>Visual Inspection & Sampling</u>
Drum ID No.	<u>4</u>	Date	<u>6-07-2002</u>
Location	<u>9B-4</u>	Photo No.	<u>11 of 12</u>
Site	<u>Hammond</u>

55 gal drum lid secured and in good condition
Ring on upside down to tighten bolts
No gasses are present

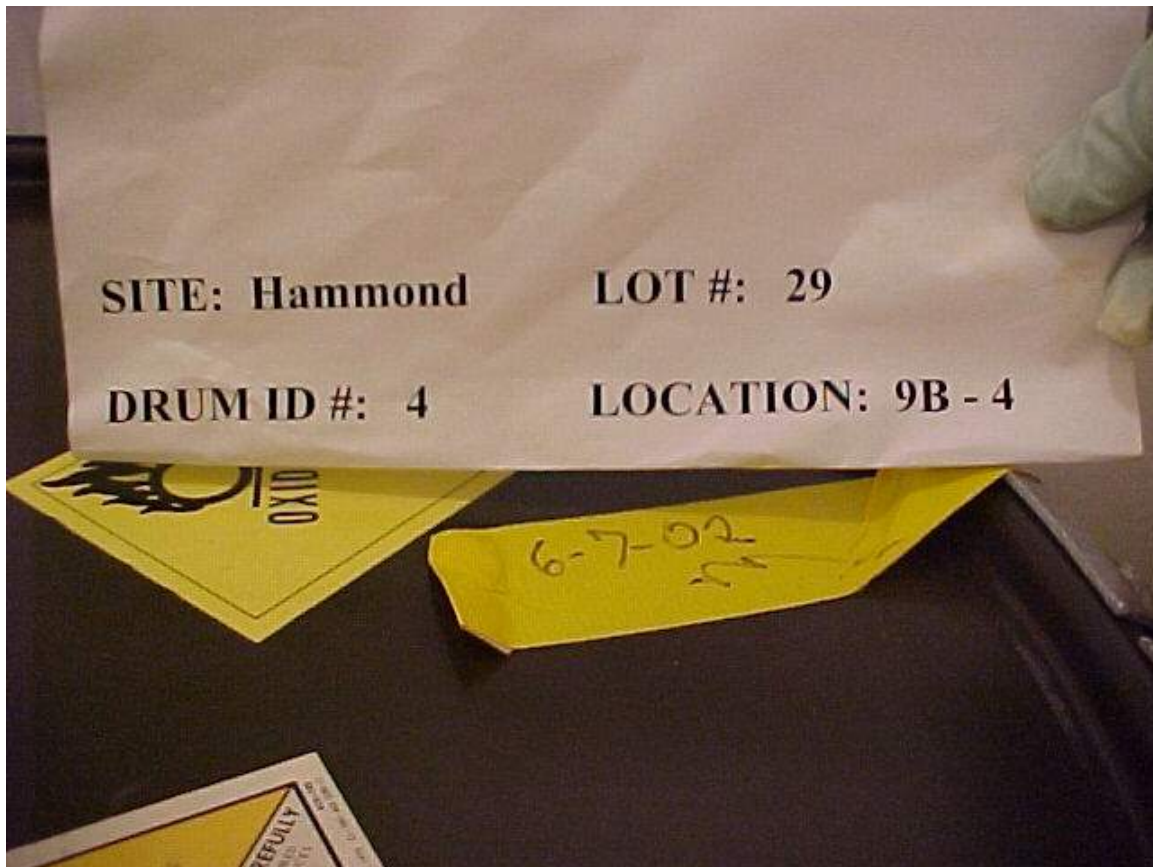
Lot No.	<u>29</u>	Inspection/Sample	<u>Visual Inspection & Sampling</u>
Drum ID No.	<u>4</u>	Date	<u>6-07-2002</u>
Location	<u>9B-4</u>	Photo No.	<u>12 of 12</u>
Site	<u>Hammond</u>

85-gal container – Good Condition
Sealed/Dated – Completed

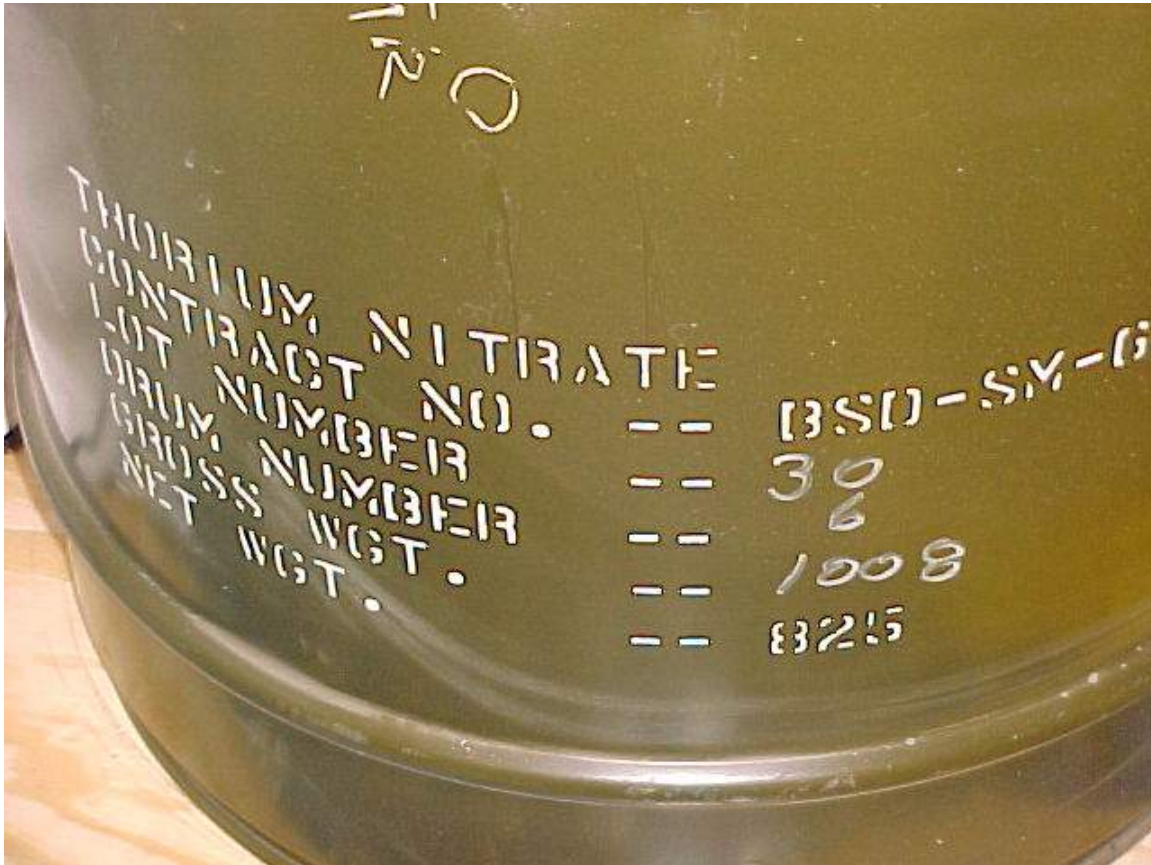
Lot No.	<u>30</u>	Inspection/Sample	<u>Visual Inspection & Sampling</u>
Drum ID No.	<u>6</u>	Date	<u>6-07-2002</u>
Location	<u>9D-1</u>	Photo No.	<u>1 of 16</u>
Site	<u>Hammond</u>		
Container	<u>85-gallon steel drum</u>	Container Condition	<u>Good</u>
Dose Rate	Surface <u>32 mR/hr</u> 1 meter <u>3 mR/hr</u>

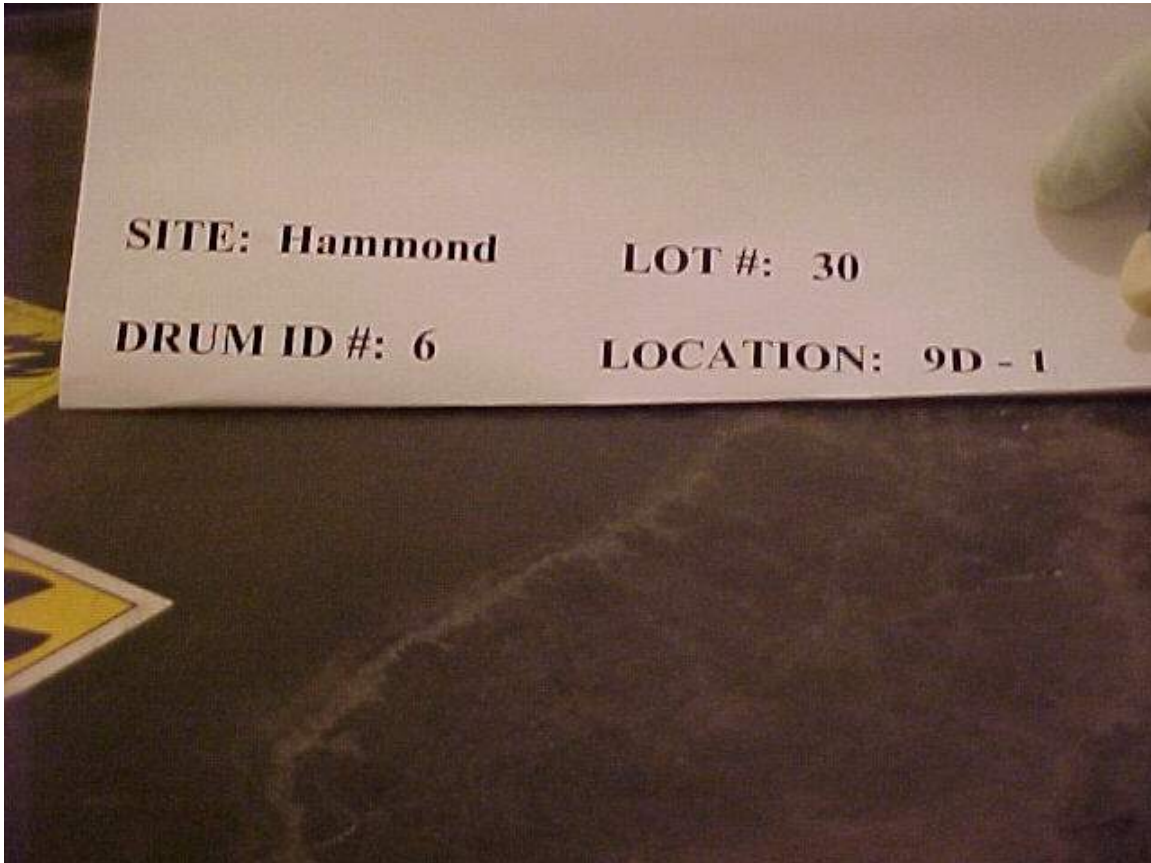
Lot No.	<u>30</u>	Inspection/Sample	<u>Visual Inspection & Sampling</u>
Drum ID No.	<u>6</u>	Date	<u>6-07-2002</u>
Location	<u>9D-1</u>	Photo No.	<u>2 of 16</u>
Site	<u>Hammond</u>

85 gal drum lid – Good Condition
Ring on drum lid is in good condition

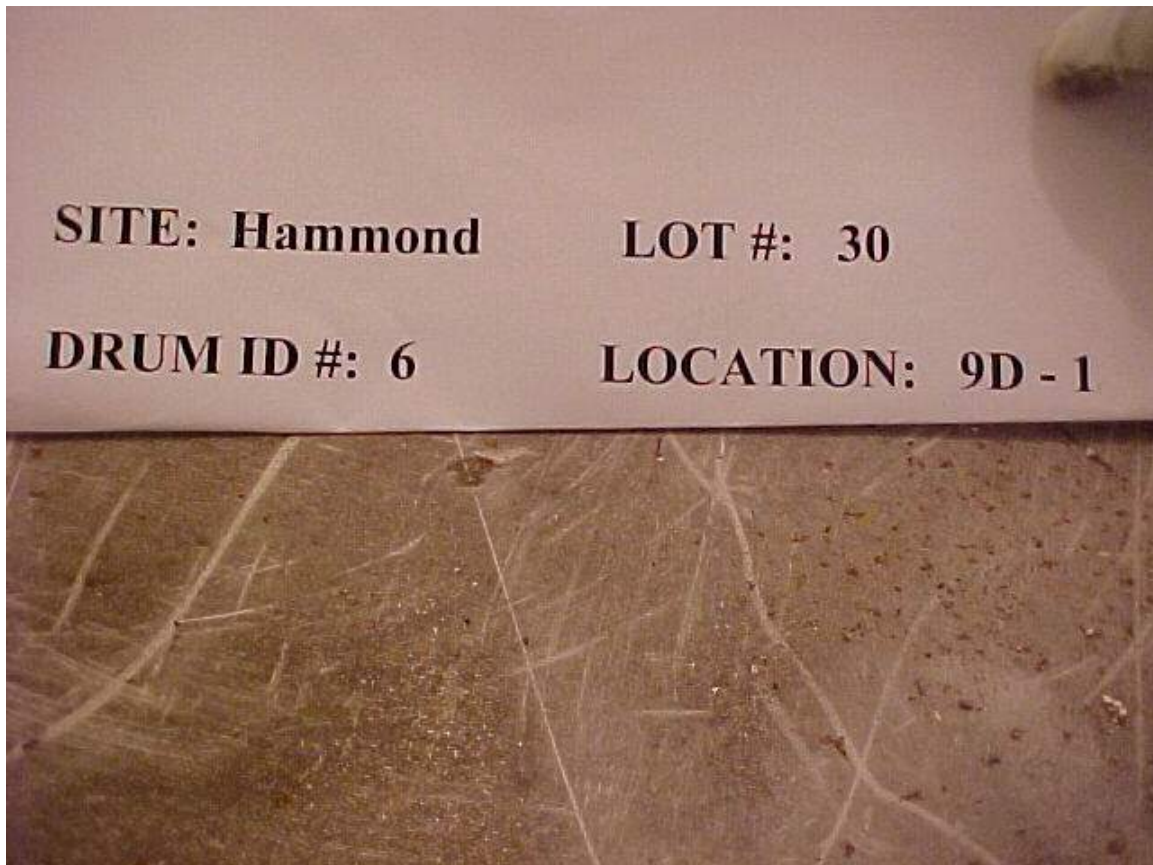
Lot No.	<u>30</u>	Inspection/Sample	<u>Visual Inspection & Sampling</u>
Drum ID No.	<u>6</u>	Date	<u>6-07-2002</u>
Location	<u>9D-1</u>	Photo No.	<u>3 of 16</u>
Site	<u>Hammond</u>

55-gal container – Good Condition
Ring on 55 gal drum is also in good condition
Ring has a 3/8 x 3 1/2 bolt – rusty and tight
55 gal drum is package in a 85 gal overpack with vermiculite

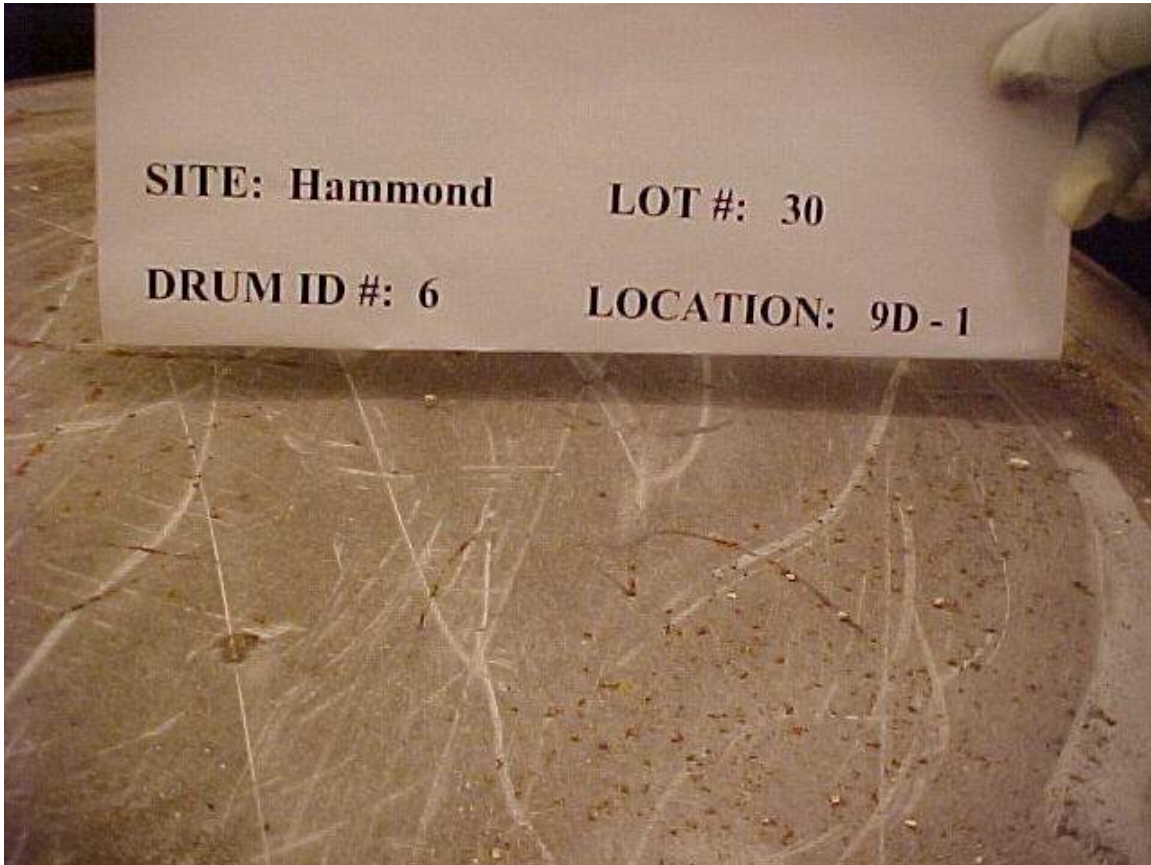
Lot No.	<u>30</u>	Inspection/Sample	<u>Visual Inspection & Sampling</u>
Drum ID No.	<u>6</u>	Date	<u>6-07-2002</u>
Location	<u>9D-1</u>	Photo No.	<u>4 of 16</u>
Site	<u>Hammond</u>

Another picture of the 55 gal drum lid

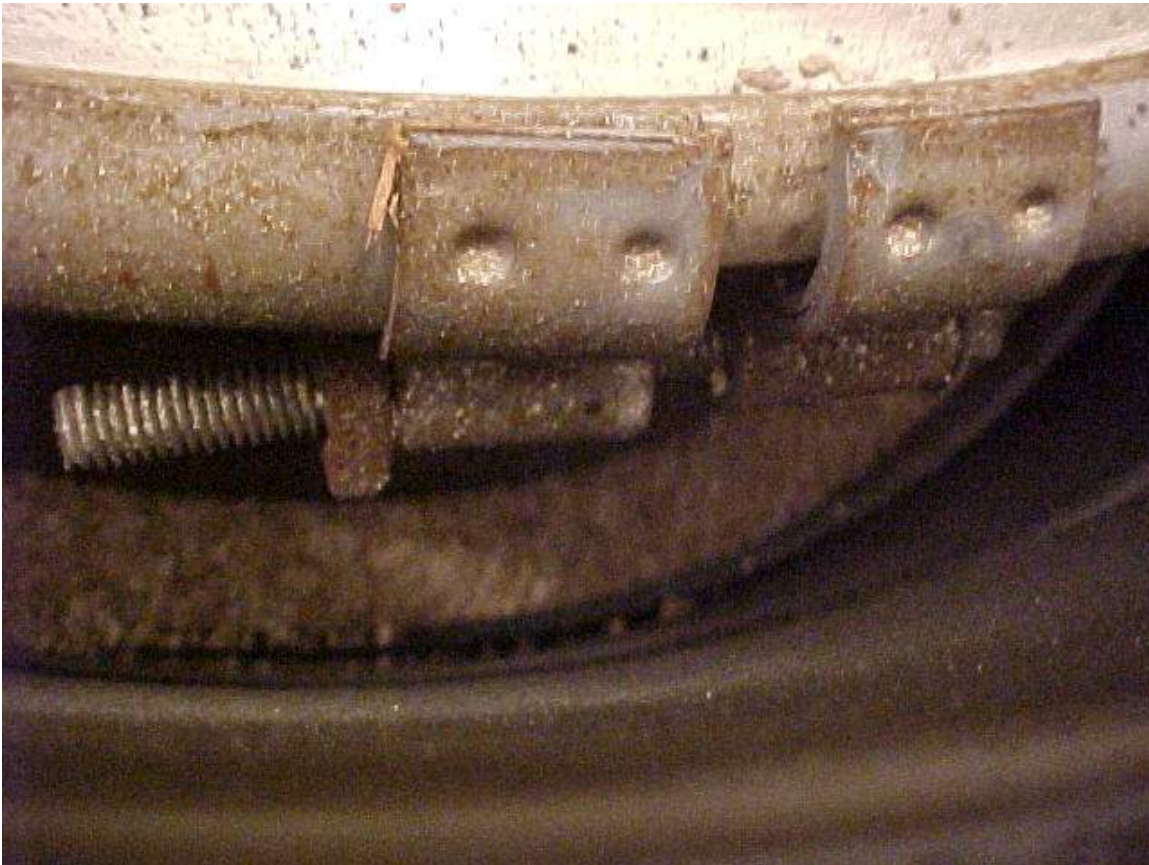
Lot No.	<u>30</u>	Inspection/Sample	<u>Visual Inspection & Sampling</u>
Drum ID No.	<u>6</u>	Date	<u>6-07-2002</u>
Location	<u>9D-1</u>	Photo No.	<u>5 of 16</u>
Site	<u>Hammond</u>

This shows the difficulty at getting to some of the 3/8 bolts
Underneath and bent
No gasses present

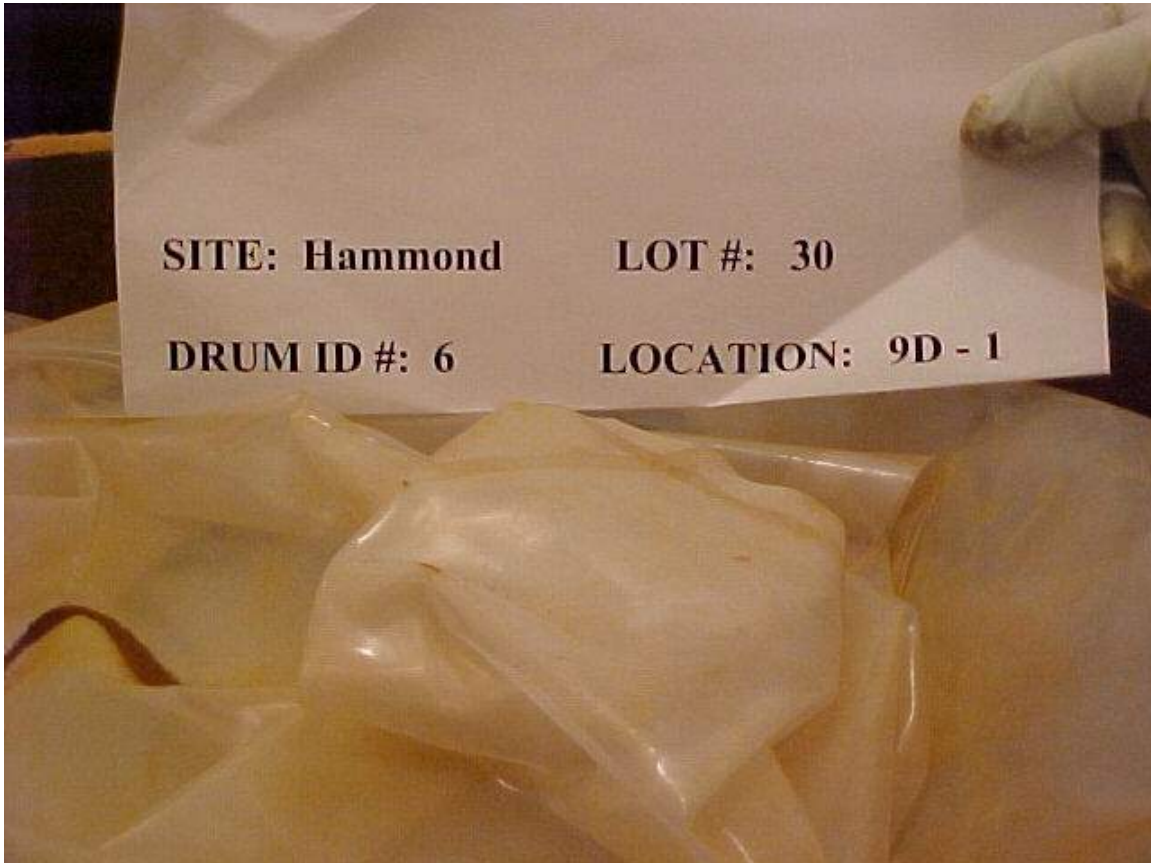
Lot No.	<u>30</u>	Inspection/Sample	<u>Visual Inspection & Sampling</u>
Drum ID No.	<u>6</u>	Date	<u>6-07-2002</u>
Location	<u>9D-1</u>	Photo No.	<u>6 of 16</u>
Site	<u>Hammond</u>

1st Poly liner/bag – Good Condition
No gasses present

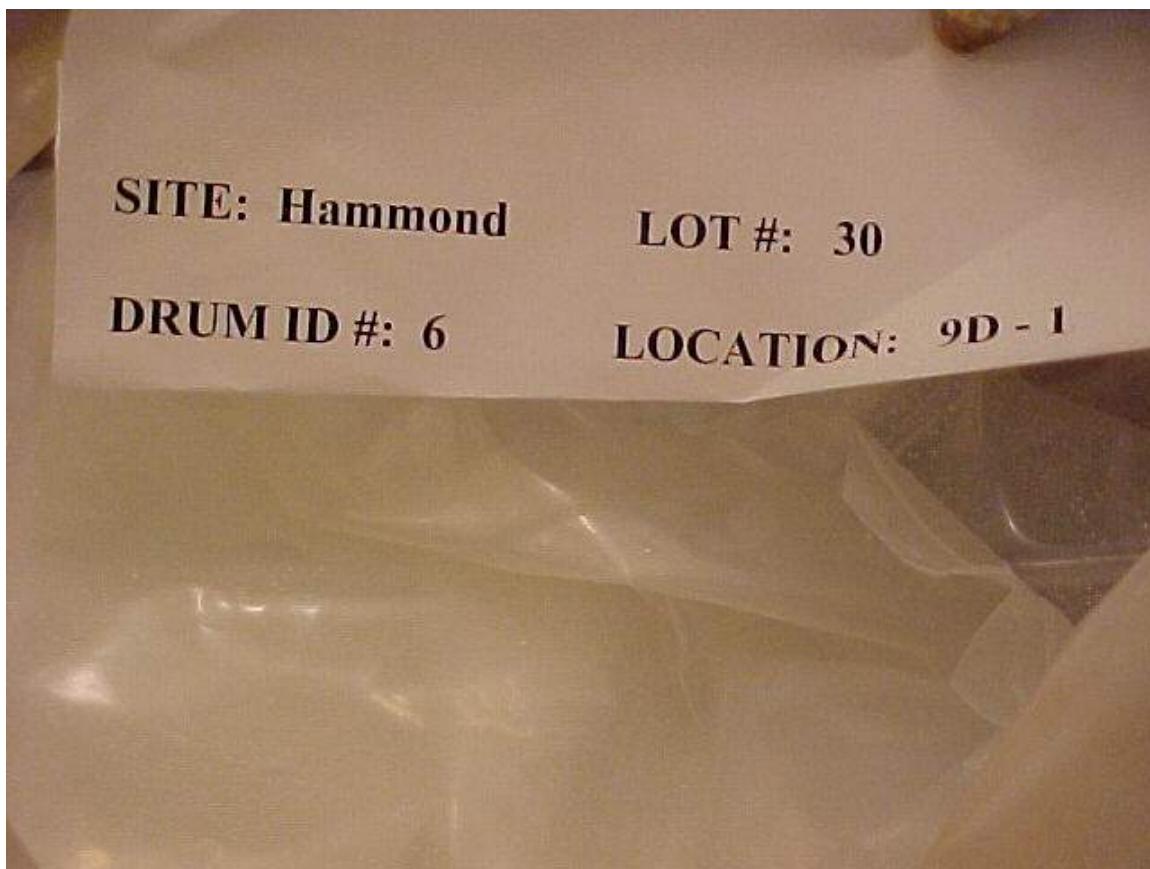
Lot No.	<u>30</u>	Inspection/Sample	<u>Visual Inspection & Sampling</u>
Drum ID No.	<u>6</u>	Date	<u>6-07-2002</u>
Location	<u>9D-1</u>	Photo No.	<u>7 of 16</u>
Site	<u>Hammond</u>

2nd poly liner/bag – Good Condition
No moisture
No gasses present

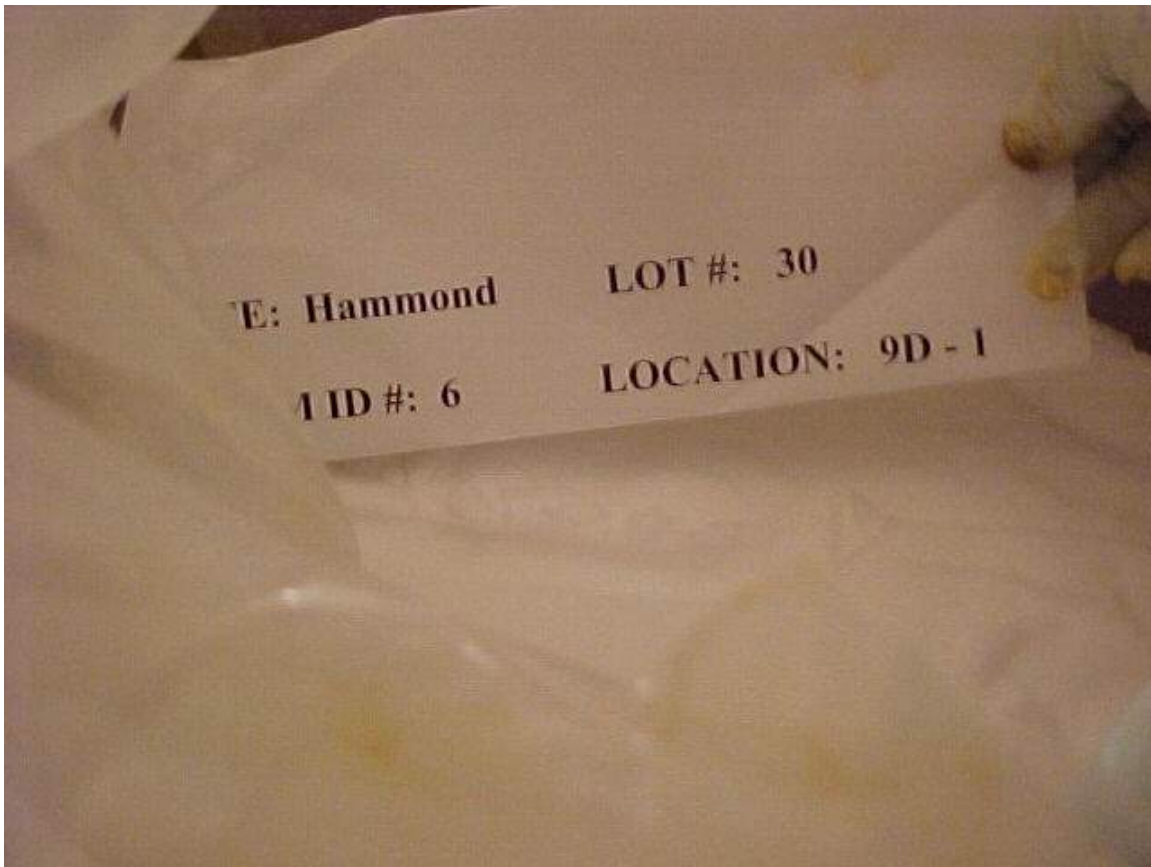
Lot No.	<u>30</u>	Inspection/Sample	<u>Visual Inspection & Sampling</u>
Drum ID No.	<u>6</u>	Date	<u>6-07-2002</u>
Location	<u>9D-1</u>	Photo No.	<u>8 of 16</u>
Site	<u>Hammond</u>

Solid - very dry

No gasses present

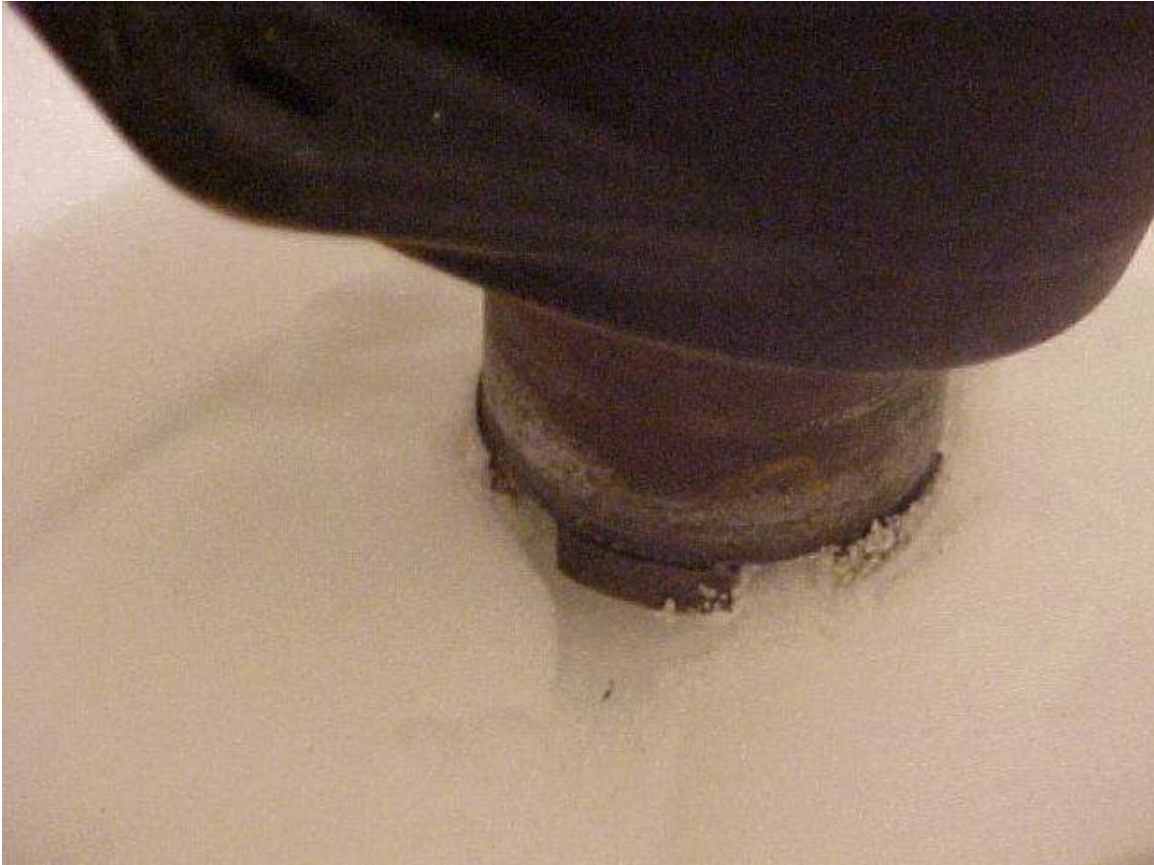
Lot No.	<u>30</u>	Inspection/Sample	<u>Visual Inspection & Sampling</u>
Drum ID No.	<u>6</u>	Date	<u>6-07-2002</u>
Location	<u>9D-1</u>	Photo No.	<u>9 of 16</u>
Site	<u>Hammond</u>

Close-up of drill right before drilling of a core sample
No gasses present

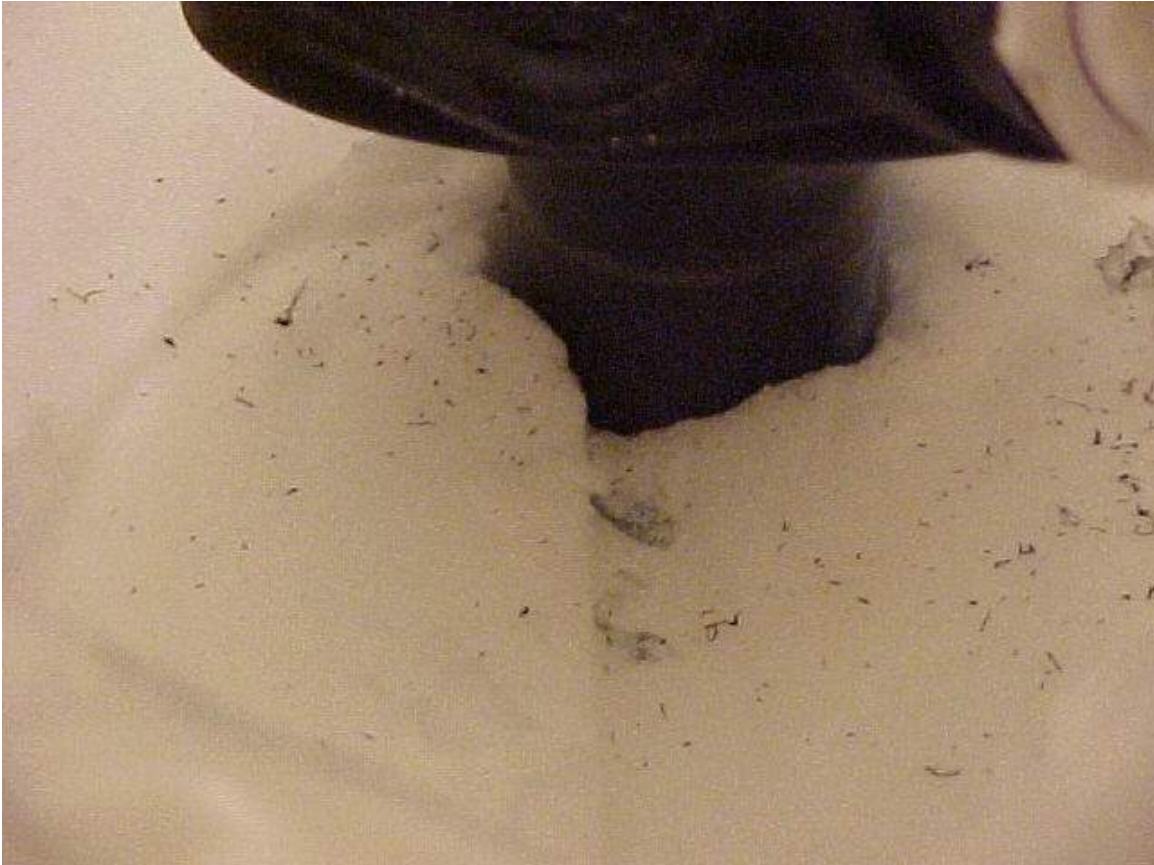
Lot No.	<u>30</u>	Inspection/Sample	<u>Visual Inspection & Sampling</u>
Drum ID No.	<u>6</u>	Date	<u>6-07-2002</u>
Location	<u>9D-1</u>	Photo No.	<u>10 of 16</u>
Site	<u>Hammond</u>

Close-up of drill, drilling through monolith block
No gasses present

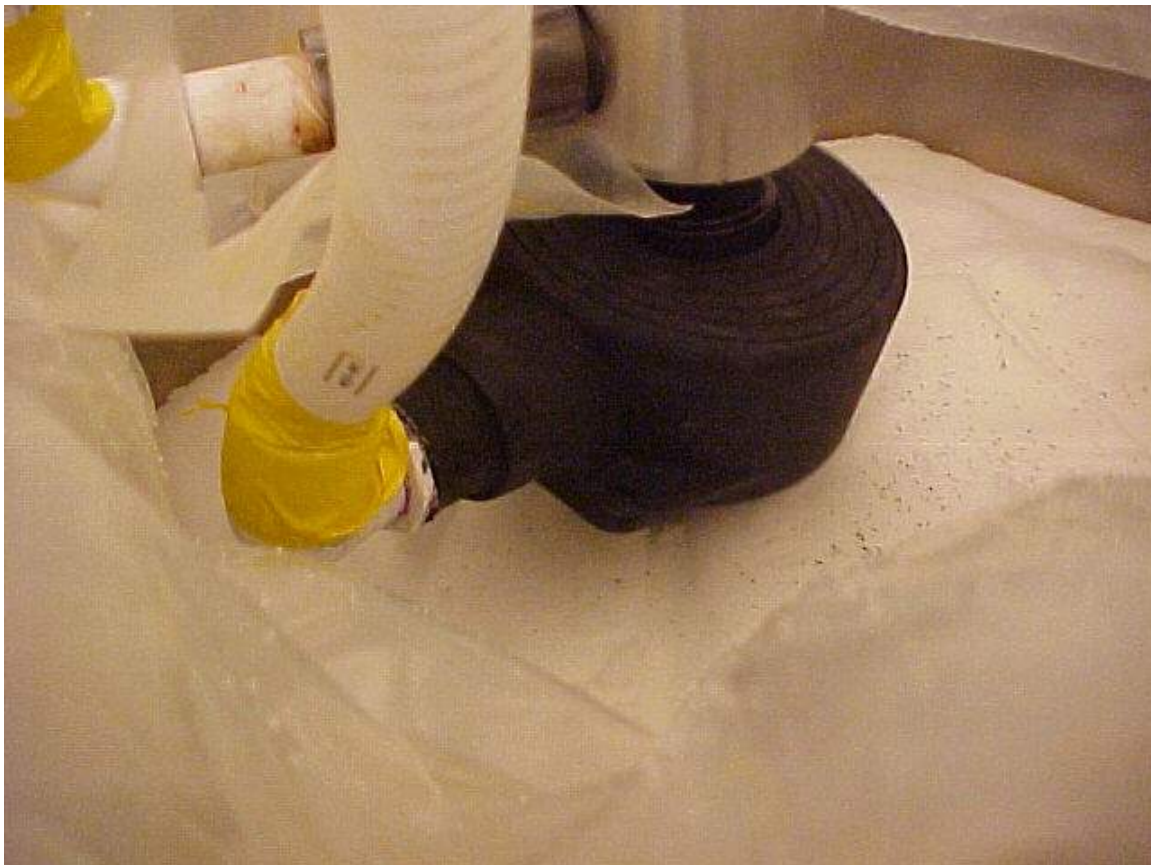
Lot No.	<u>30</u>	Inspection/Sample	<u>Visual Inspection & Sampling</u>
Drum ID No.	<u>6</u>	Date	<u>6-07-2002</u>
Location	<u>9D-1</u>	Photo No.	<u>11 of 16</u>
Site	<u>Hammond</u>

A look at the vacuum system for the drill
No gasses present

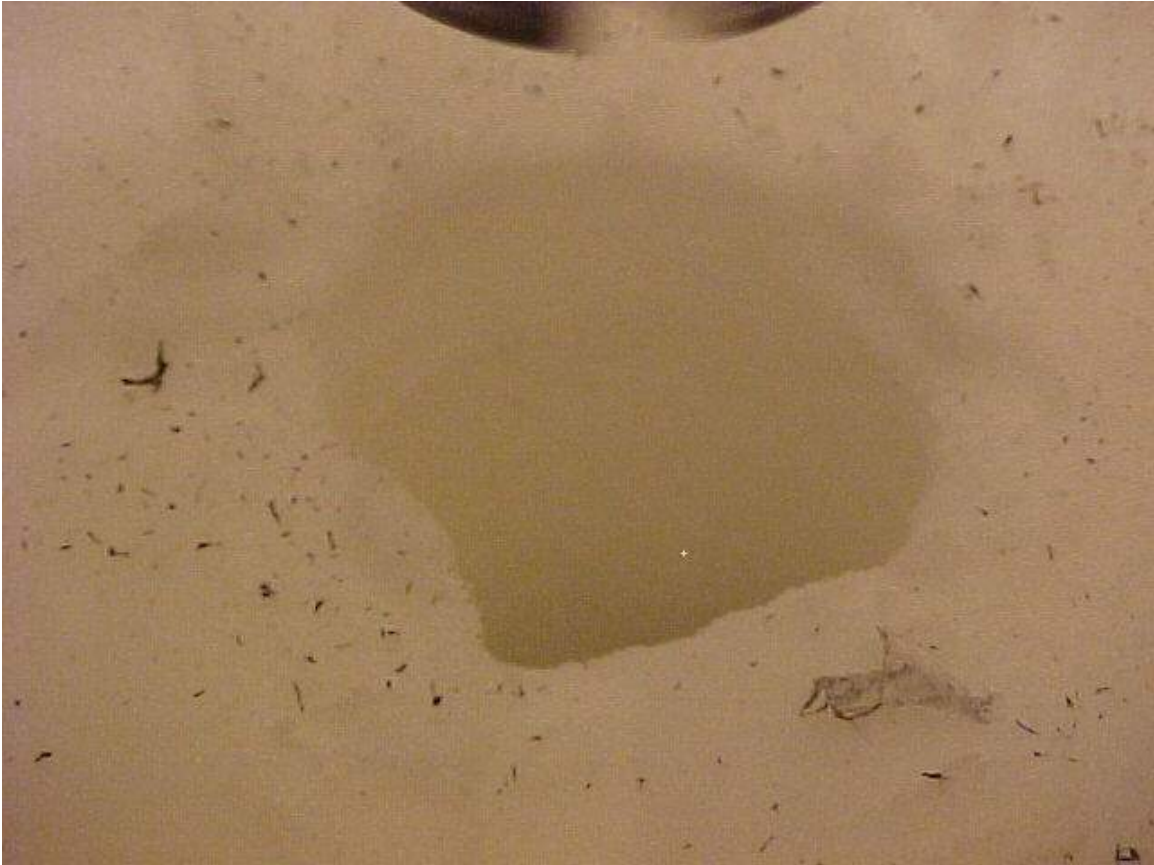
Lot No.	<u>30</u>	Inspection/Sample	<u>Visual Inspection & Sampling</u>
Drum ID No.	<u>6</u>	Date	<u>6-07-2002</u>
Location	<u>9D-1</u>	Photo No.	<u>12 of 16</u>
Site	<u>Hammond</u>

A hole were the drill left after core sample was taken out
The black dots are the plastic housing on the vacuum cover

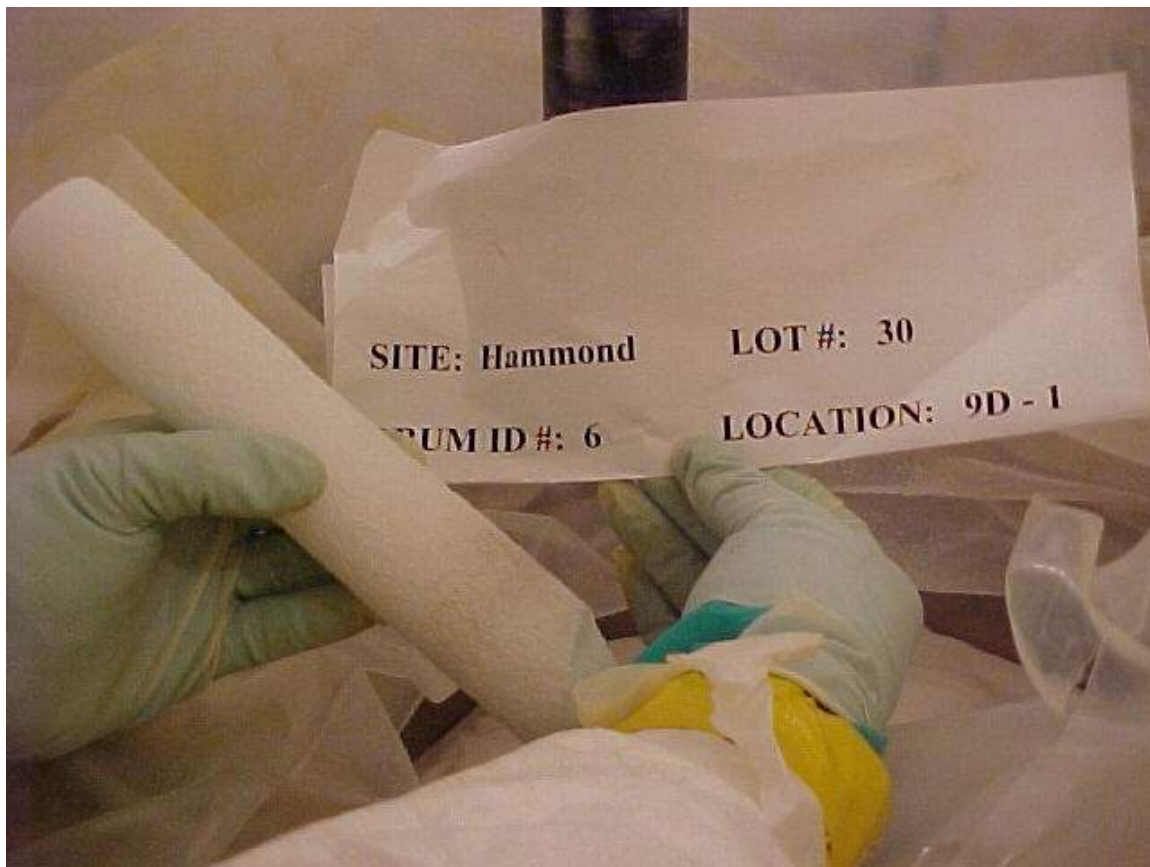
Lot No.	<u>30</u>	Inspection/Sample	<u>Visual Inspection & Sampling</u>
Drum ID No.	<u>6</u>	Date	<u>6-07-2002</u>
Location	<u>9D-1</u>	Photo No.	<u>13 of 16</u>
Site	<u>Hammond</u>

Here is a picture of the core that was taken
No gasses present

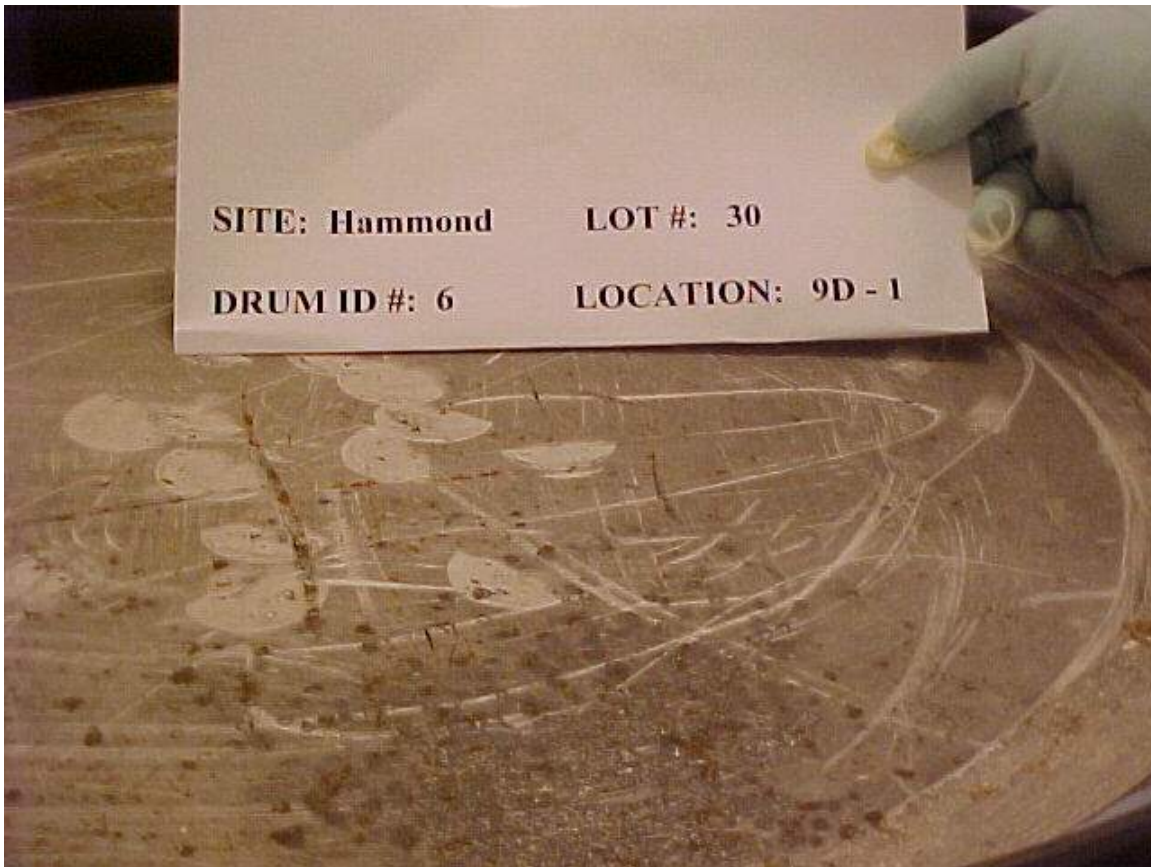
Lot No.	<u>30</u>	Inspection/Sample	<u>Visual Inspection & Sampling</u>
Drum ID No.	<u>6</u>	Date	<u>6-07-2002</u>
Location	<u>9D-1</u>	Photo No.	<u>14 of 16</u>
Site	<u>Hammond</u>

55 gal container lid– Good Condition
Ring is tight and secure
No gasses present

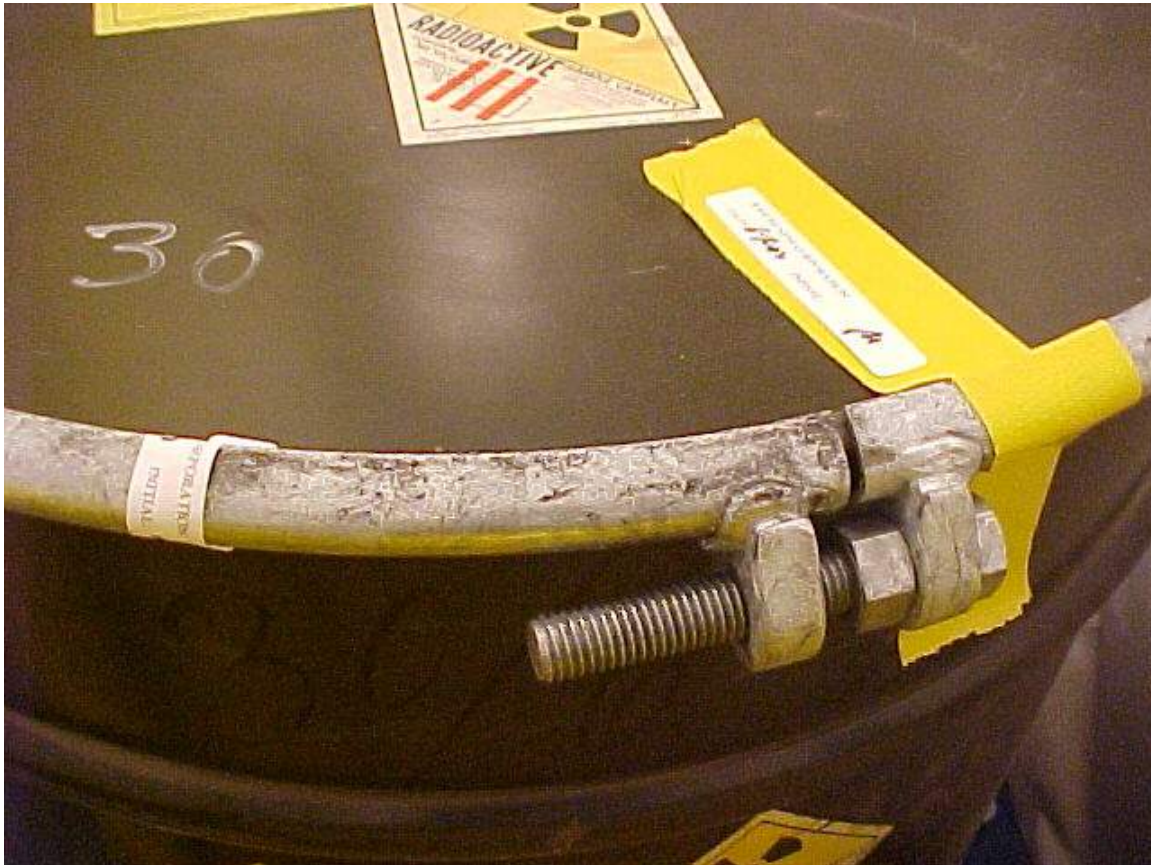
Lot No.	<u>30</u>	Inspection/Sample	<u>Visual Inspection & Sampling</u>
Drum ID No.	<u>6</u>	Date	<u>6-07-2002</u>
Location	<u>9D-1</u>	Photo No.	<u>16 of 16</u>
Site	<u>Hammond</u>

85-gal container – Good Condition

Sealed/dated - Completed

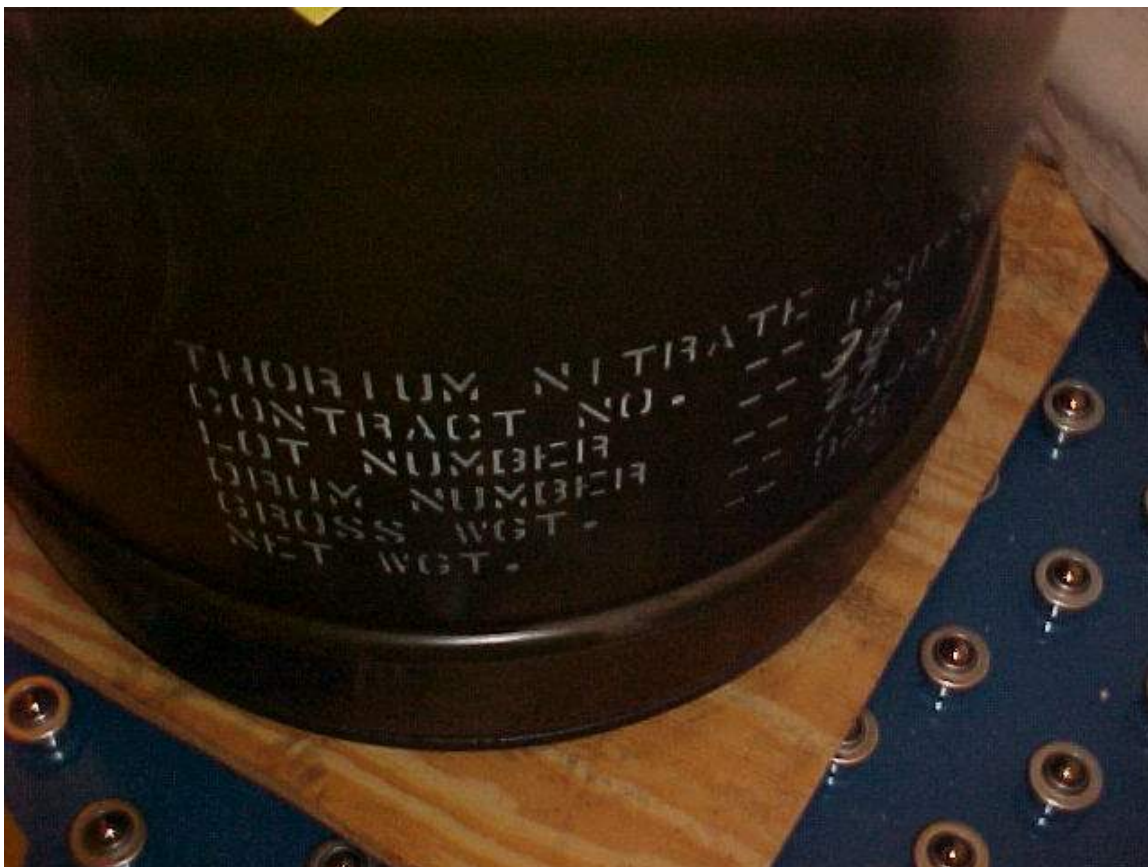
Lot No.	<u>38</u>	Inspection/Sample	<u>Visual Inspection & Sampling</u>
Drum ID No.	<u>25</u>	Date	<u>6-10-2002</u>
Location	<u>15C-5</u>	Photo No.	<u>1 of 10</u>
Site	<u>Hammond</u>		
Container	<u>85-gallon steel drum</u>	Container Condition	<u>Good</u>
Dose Rate	Surface <u>32 mR/hr</u> 1 meter <u>3 mR/hr</u>

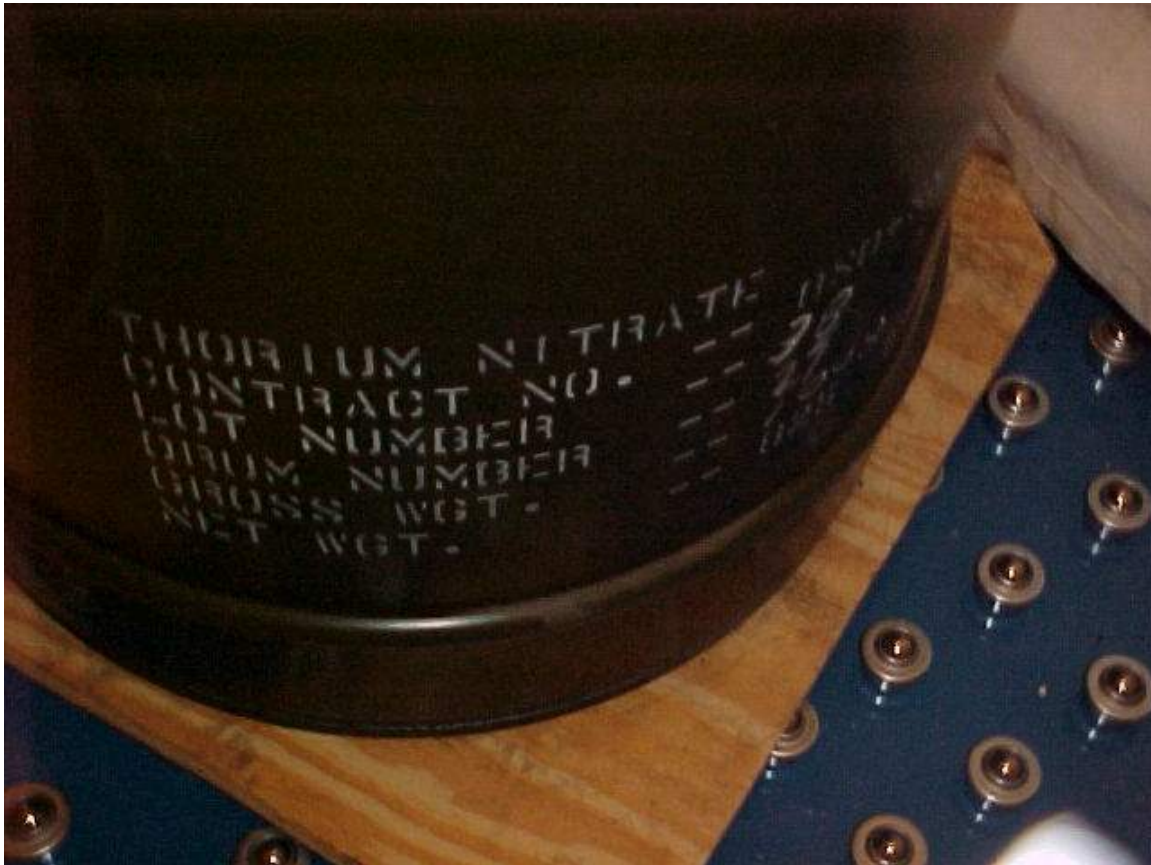
Lot No.	<u>38</u>	Inspection/Sample	<u>Visual Inspection & Sampling</u>
Drum ID No.	<u>25</u>	Date	<u>6-10-2002</u>
Location	<u>15C-5</u>	Photo No.	<u>2 of 10</u>
Site	<u>Hammond</u>

85-gal drum – Good Condition

Another picture of outer 85-gal drum in case prior picture was too dark
