THORIUM NITRATE STOCKPILE DRUM CHARACTERIZATION REPORT

**THORIUM NITRATE STOCKPILE
DRUM CHARACTERIZATION REPORT**

Prepared for
U.S. Defense Logistics Agency
Defense National Stockpile Center
Fort Belvoir, Virginia

Prepared by
OAK RIDGE NATIONAL LABORATORY
Oak Ridge, Tennessee 37831
managed by
UT-BATTELLE, LLC
for the
U.S. DEPARTMENT OF ENERGY
under contract DE-AC05-00OR22725

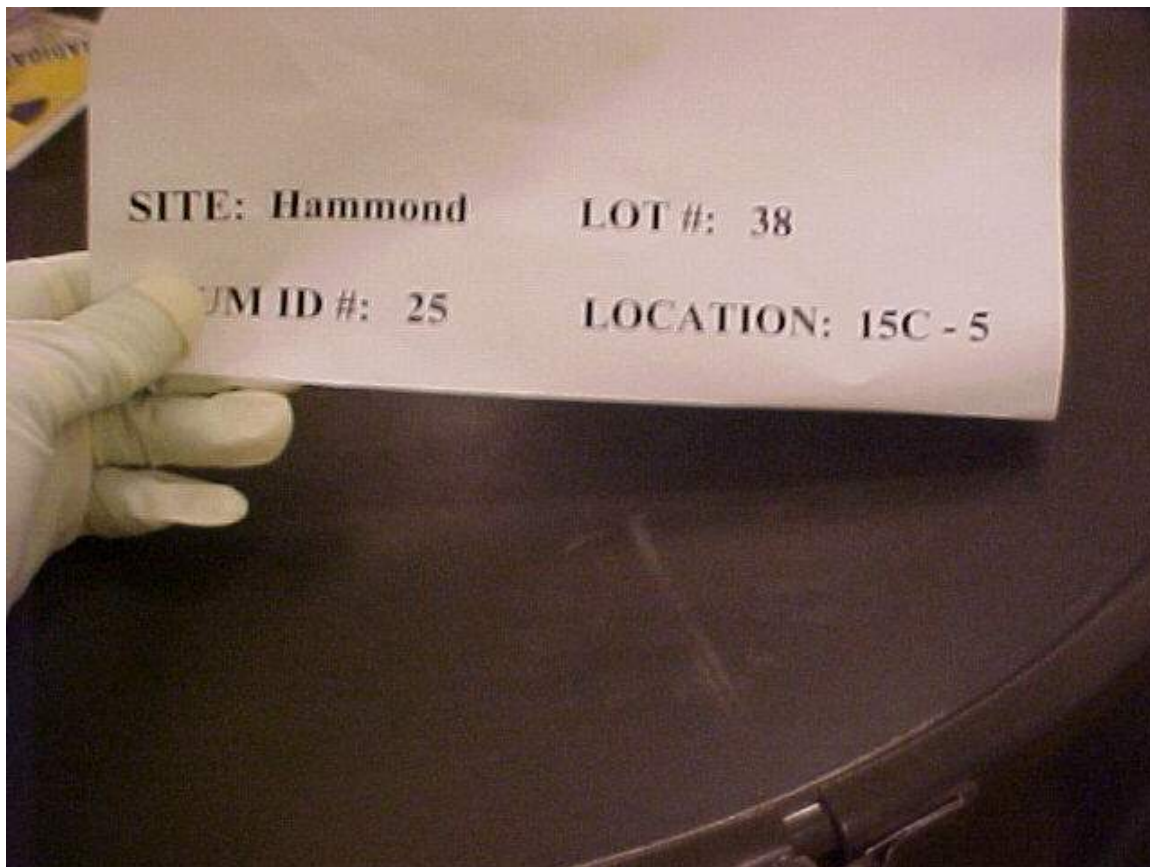
Lot No.	<u>38</u>	Inspection/Sample	<u>Visual Inspection & Sampling</u>
Drum ID No.	<u>25</u>	Date	<u>6-10-2002</u>
Location	<u>15C-5</u>	Photo No.	<u>3 of 10</u>
Site	<u>Hammond</u>

Lid and ring of 85-gal drum – Good Condition

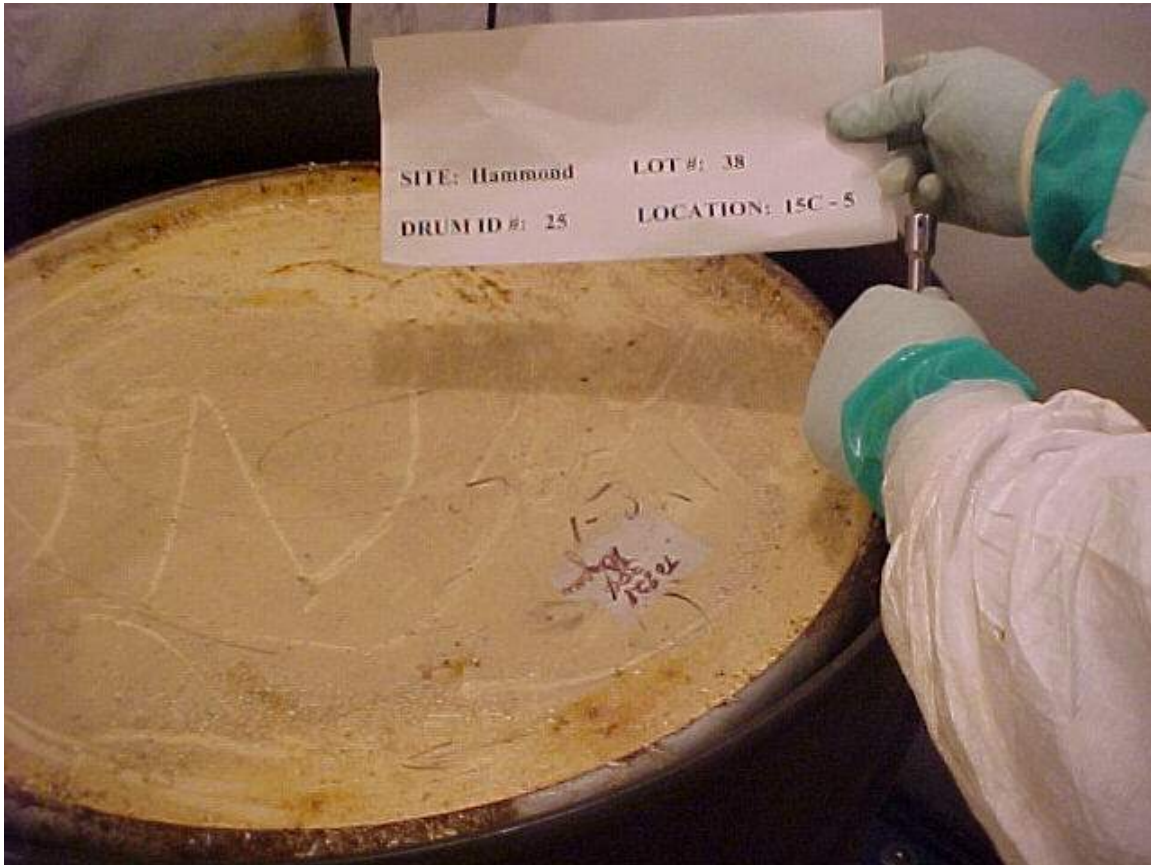
Lot No.	<u>38</u>	Inspection/Sample	<u>Visual Inspection & Sampling</u>
Drum ID No.	<u>25</u>	Date	<u>6-10-2002</u>
Location	<u>15C-5</u>	Photo No.	<u>4 of 10</u>
Site	<u>Hammond</u>

55gal drum-good condition

No gases present

Ring-good condition

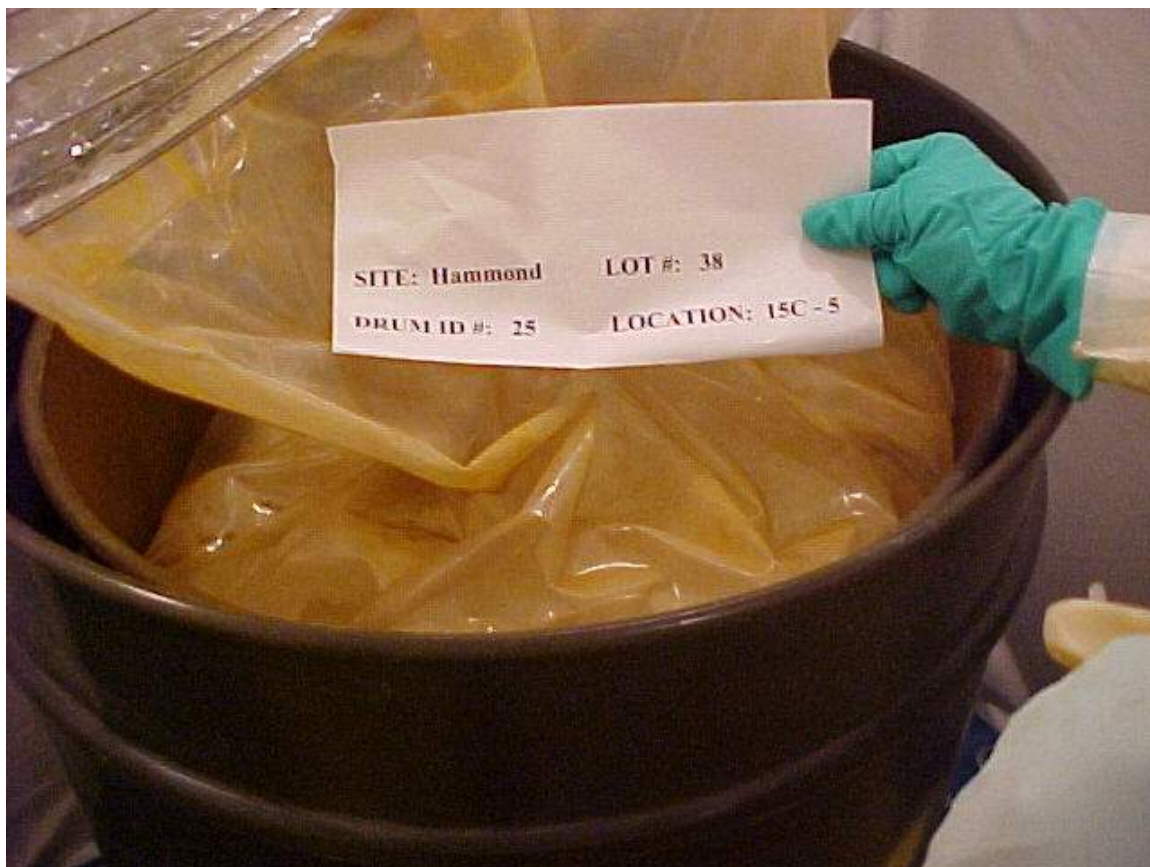
Lot No.	<u>38</u>	Inspection/Sample	<u>Visual Inspection & Sampling</u>
Drum ID No.	<u>25</u>	Date	<u>6-10-2002</u>
Location	<u>15C-5</u>	Photo No.	<u>5 of 10</u>
Site	<u>Hammond</u>

1st poly-liner/bag- Good Condition
No gasses present

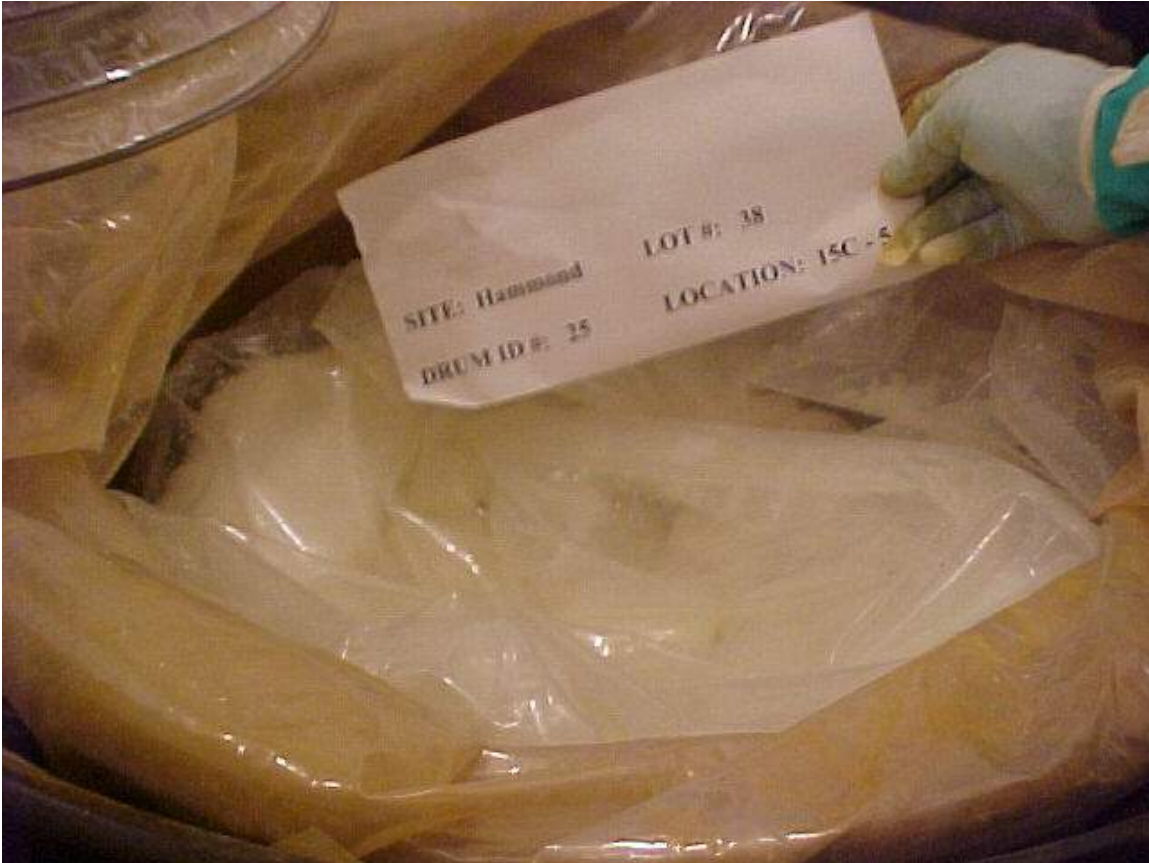
Lot No.	<u>38</u>	Inspection/Sample	<u>Visual Inspection & Sampling</u>
Drum ID No.	<u>25</u>	Date	<u>6-10-2002</u>
Location	<u>15C-5</u>	Photo No.	<u>6 of 10</u>
Site	<u>Hammond</u>

2nd Poly-liner/bag- Good Condition
No gasses present

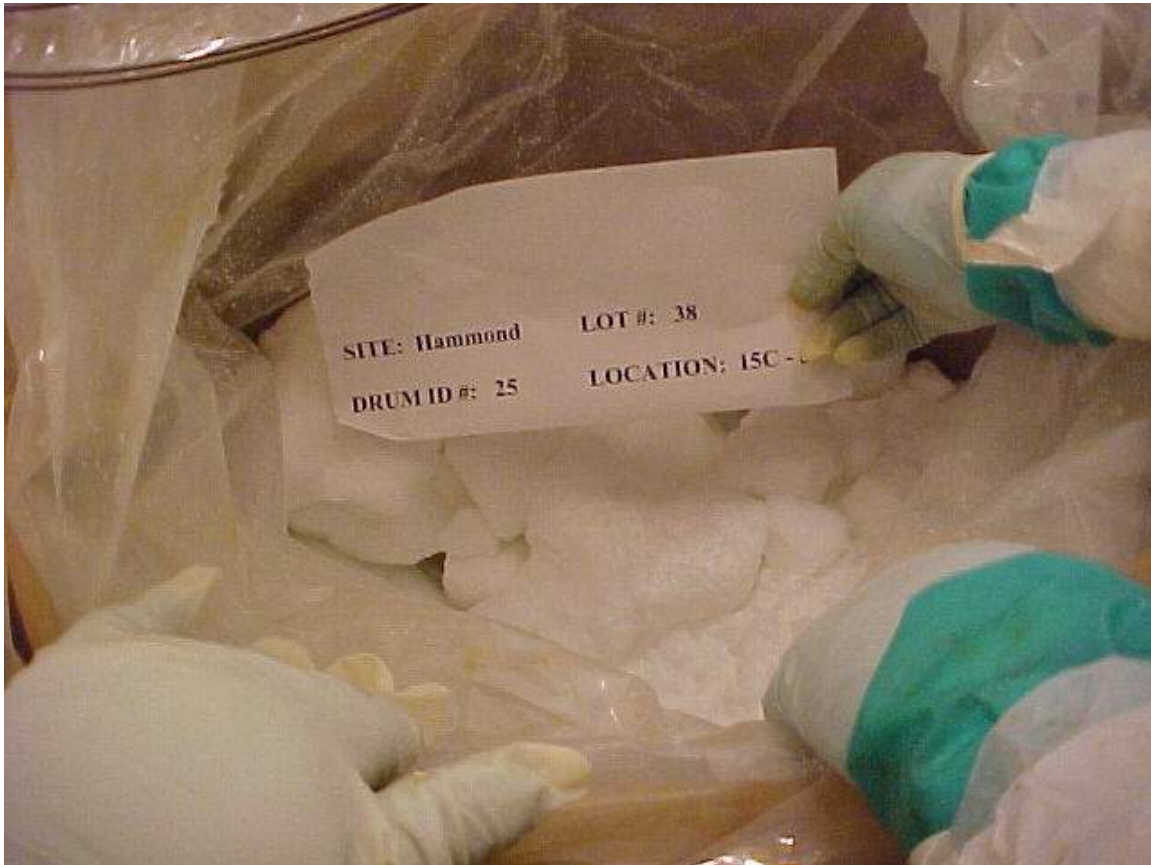
Lot No.	<u>38</u>	Inspection/Sample	<u>Visual Inspection & Sampling</u>
Drum ID No.	<u>25</u>	Date	<u>6-10-2002</u>
Location	<u>15C-5</u>	Photo No.	<u>7 of 10</u>
Site	<u>Hammond</u>

Monolith-white in color
Chunks / broken
Damp/wet inside
Took pH reading color Red-0 scale
No gasses present

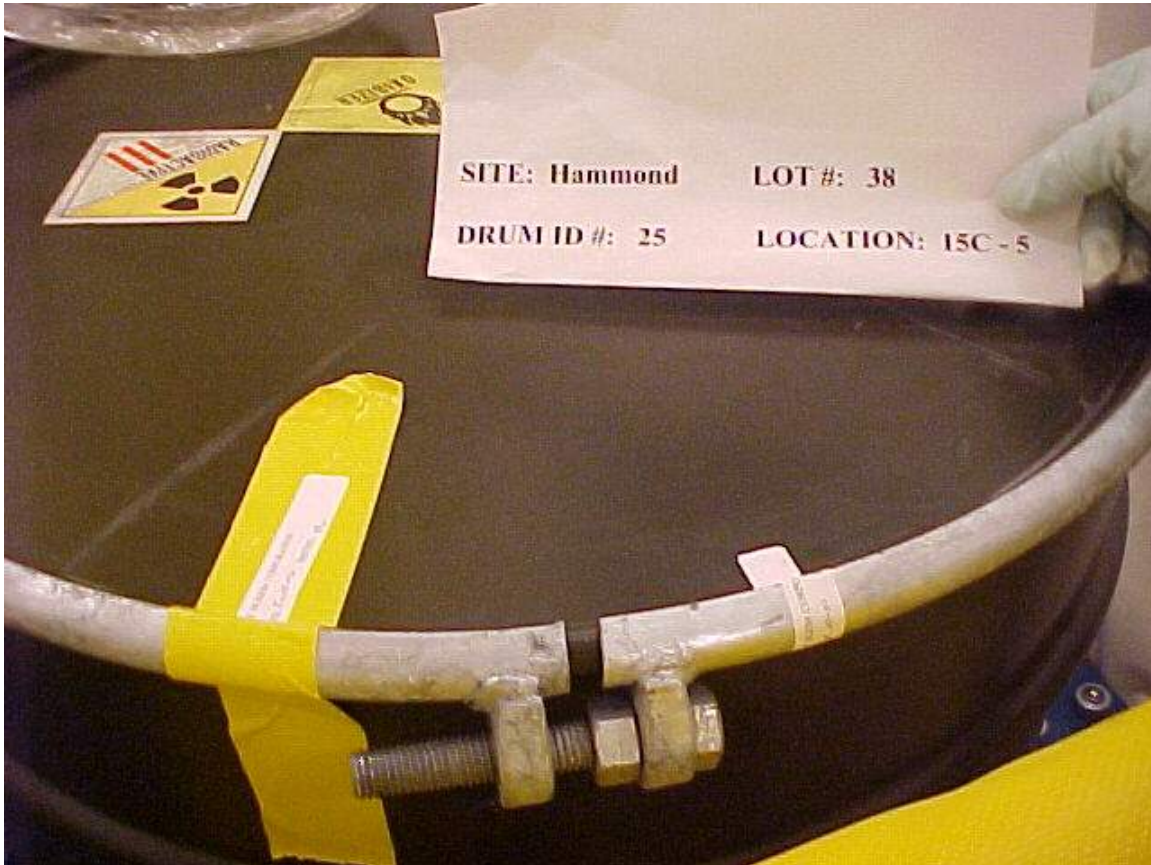
Lot No.	<u>38</u>	Inspection/Sample	<u>Visual Inspection & Sampling</u>
Drum ID No.	<u>25</u>	Date	<u>6-10-2002</u>
Location	<u>15C-5</u>	Photo No.	<u>10 of 10</u>
Site	<u>Hammond</u>

85 gal drum lid and ring secured
Drum sealed/dated/completed

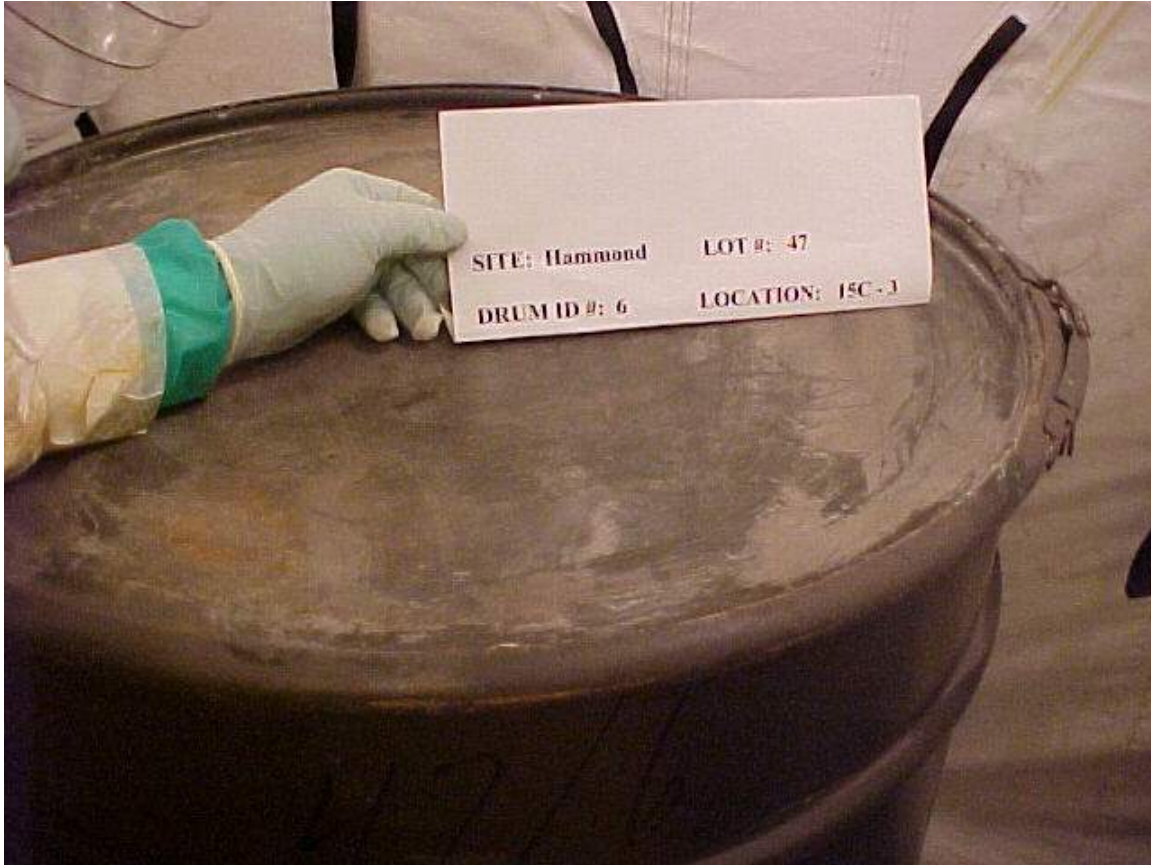
Lot No.	<u>47</u>	Inspection/Sample	<u>Visual Inspection & Sampling</u>
Drum ID No.	<u>6</u>	Date	<u>6-10-2002</u>
Location	<u>12D-1</u>	Photo No.	<u>2 of 11</u>
Site	<u>Hammond</u>

Lid of 85 gal drum - Good Condition

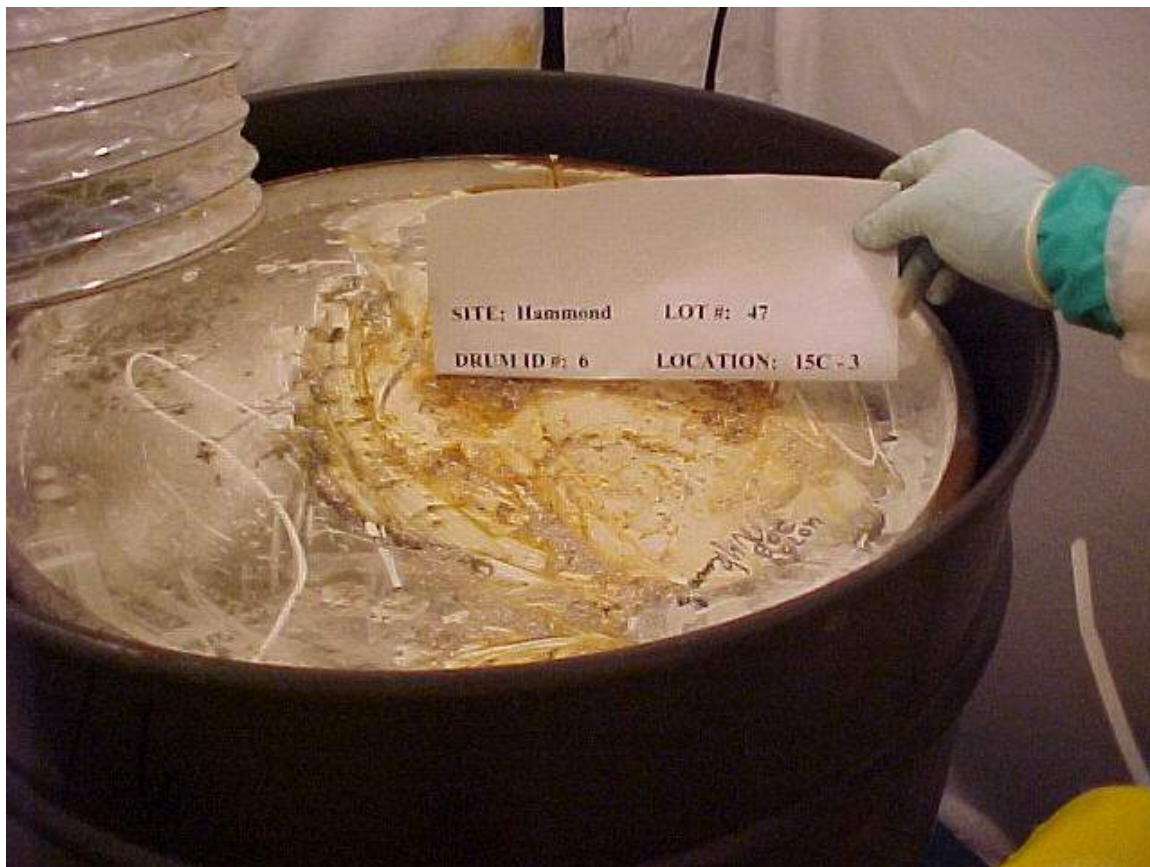
Lot No.	<u>47</u>	Inspection/Sample	<u>Visual Inspection & Sampling</u>
Drum ID No.	<u>6</u>	Date	<u>6-10-2002</u>
Location	<u>12D-1</u>	Photo No.	<u>3 of 11</u>
Site	<u>Hammond</u>

55-gal drum-good condition

No gases present

Ring-good condition

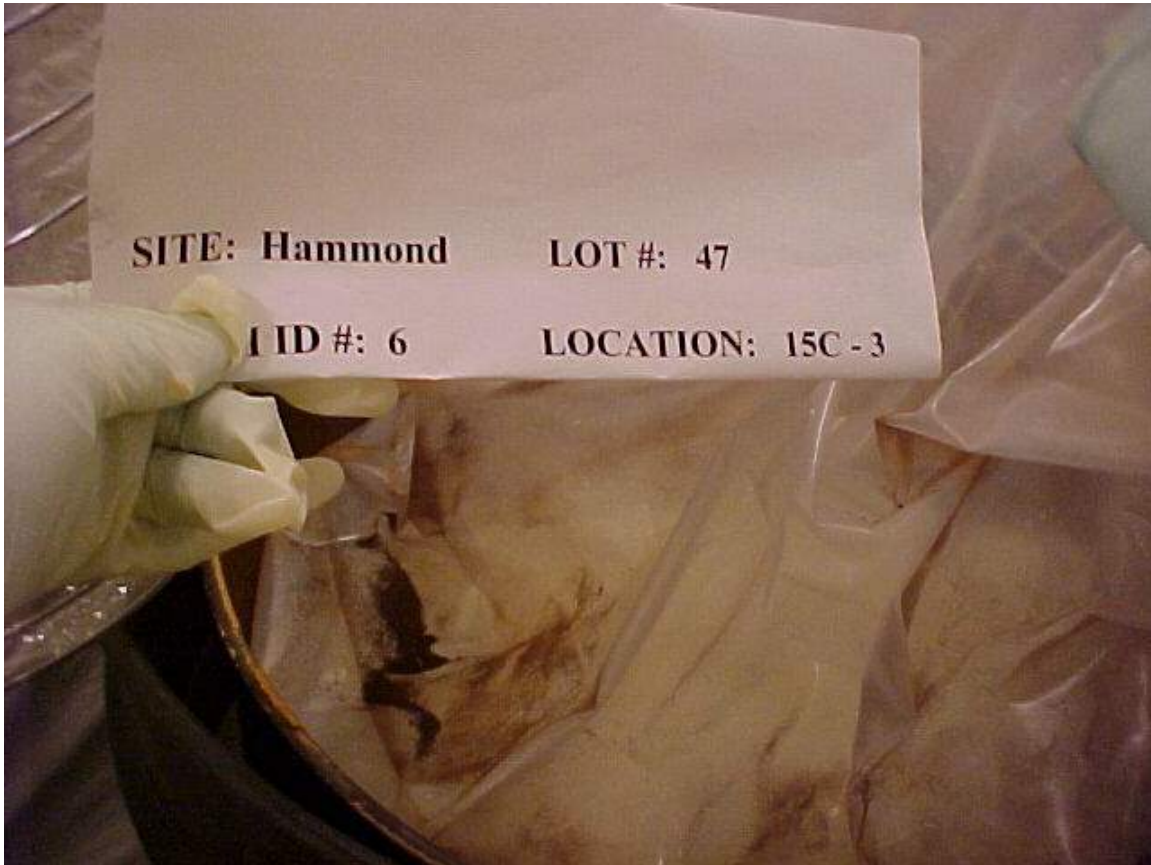
Lot No.	<u>47</u>	Inspection/Sample	<u>Visual Inspection & Sampling</u>
Drum ID No.	<u>6</u>	Date	<u>6-10-2002</u>
Location	<u>12D-1</u>	Photo No.	<u>4 of 11</u>
Site	<u>Hammond</u>

1st poly-liner/bag- Good Condition
No gasses present

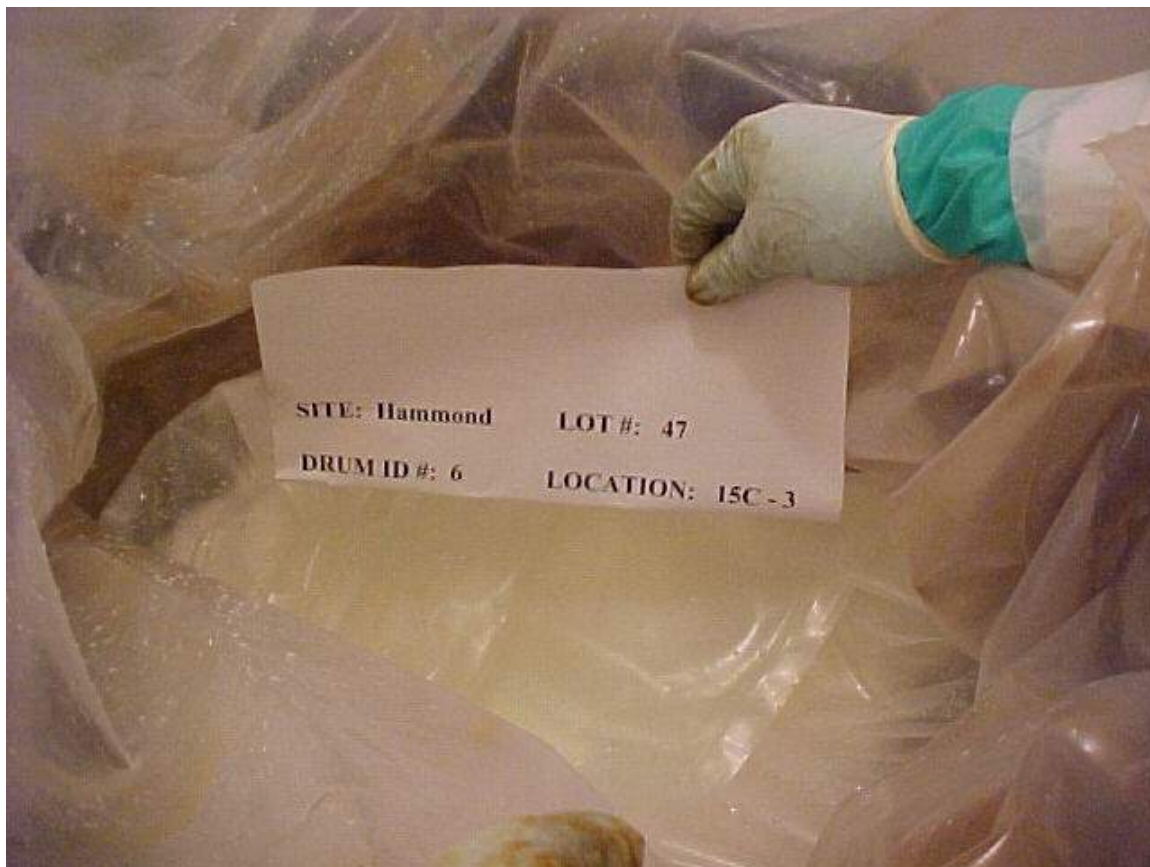
Lot No.	<u>47</u>	Inspection/Sample	<u>Visual Inspection & Sampling</u>
Drum ID No.	<u>6</u>	Date	<u>6-10-2002</u>
Location	<u>12D-1</u>	Photo No.	<u>5 of 11</u>
Site	<u>Hammond</u>

2nd Poly-liner/bag- Good Condition

No gasses present

Wet crystals formed in the bag/ chunky pieces visible

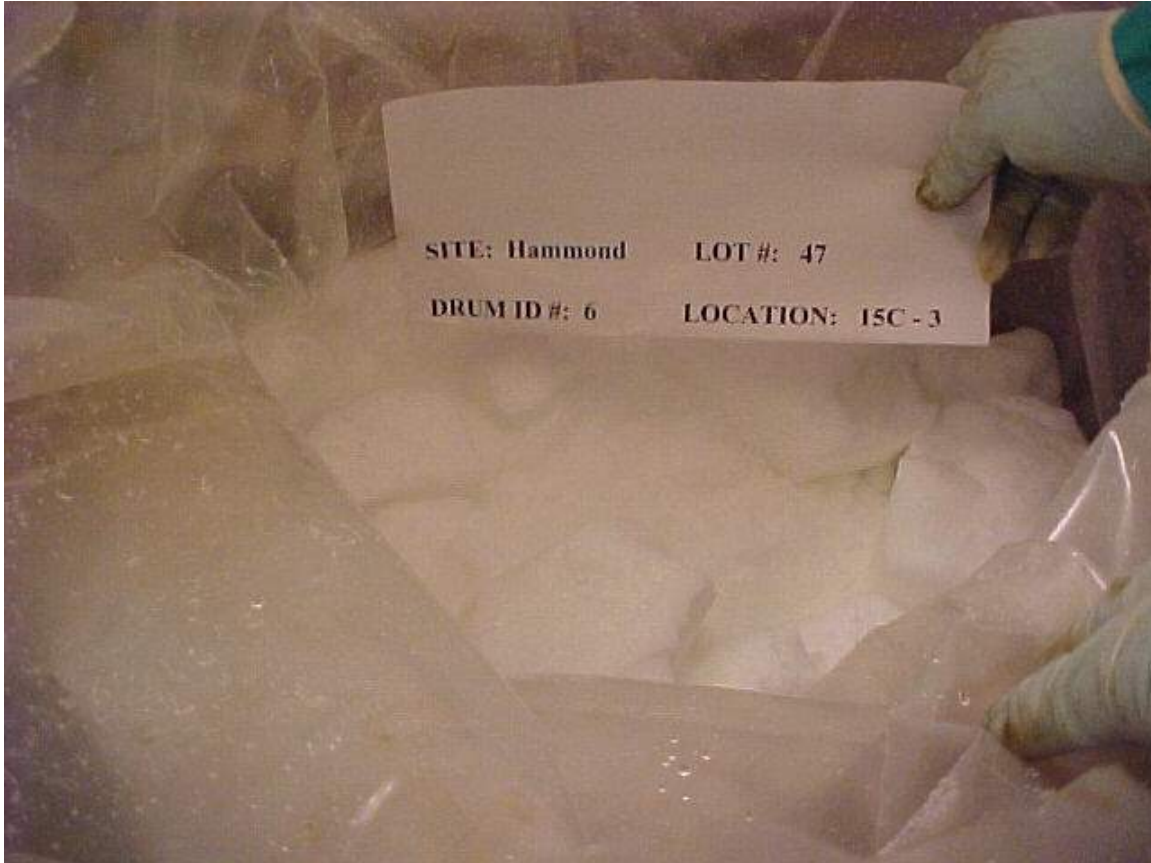
Lot No.	<u>47</u>	Inspection/Sample	<u>Visual Inspection & Sampling</u>
Drum ID No.	<u>6</u>	Date	<u>6-10-2002</u>
Location	<u>12D-1</u>	Photo No.	<u>6 of 11</u>
Site	<u>Hammond</u>

Monolith-white in color
Chunks/ broken
Damp/wet inside
Took pH reading color Red-0 scale
No gasses present

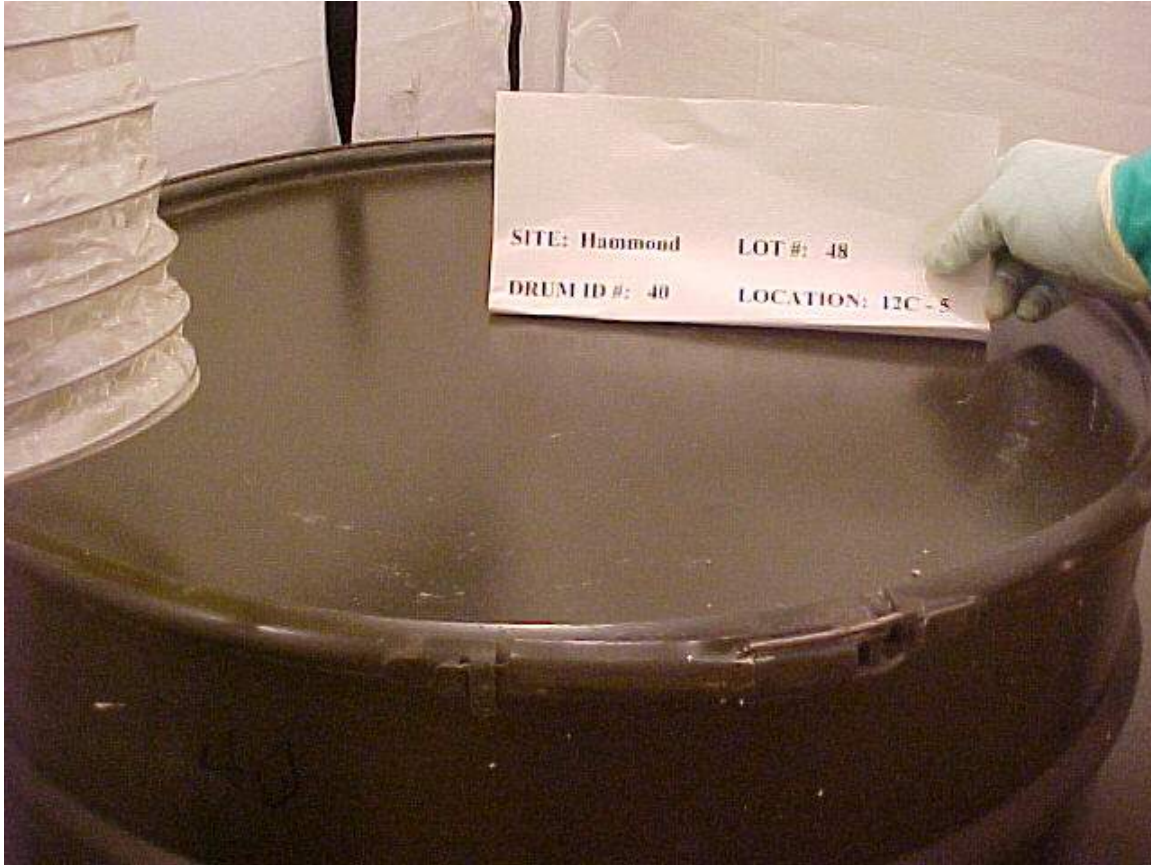
Lot No.	<u>48</u>	Inspection/Sample	<u>Visual Inspection & Sampling</u>
Drum ID No.	<u>40</u>	Date	<u>6-10-2002</u>
Location	<u>12C-5</u>	Photo No.	<u>2 of 14</u>
Site	<u>Hammond</u>

Lid of 85 gal drum - Good Condition

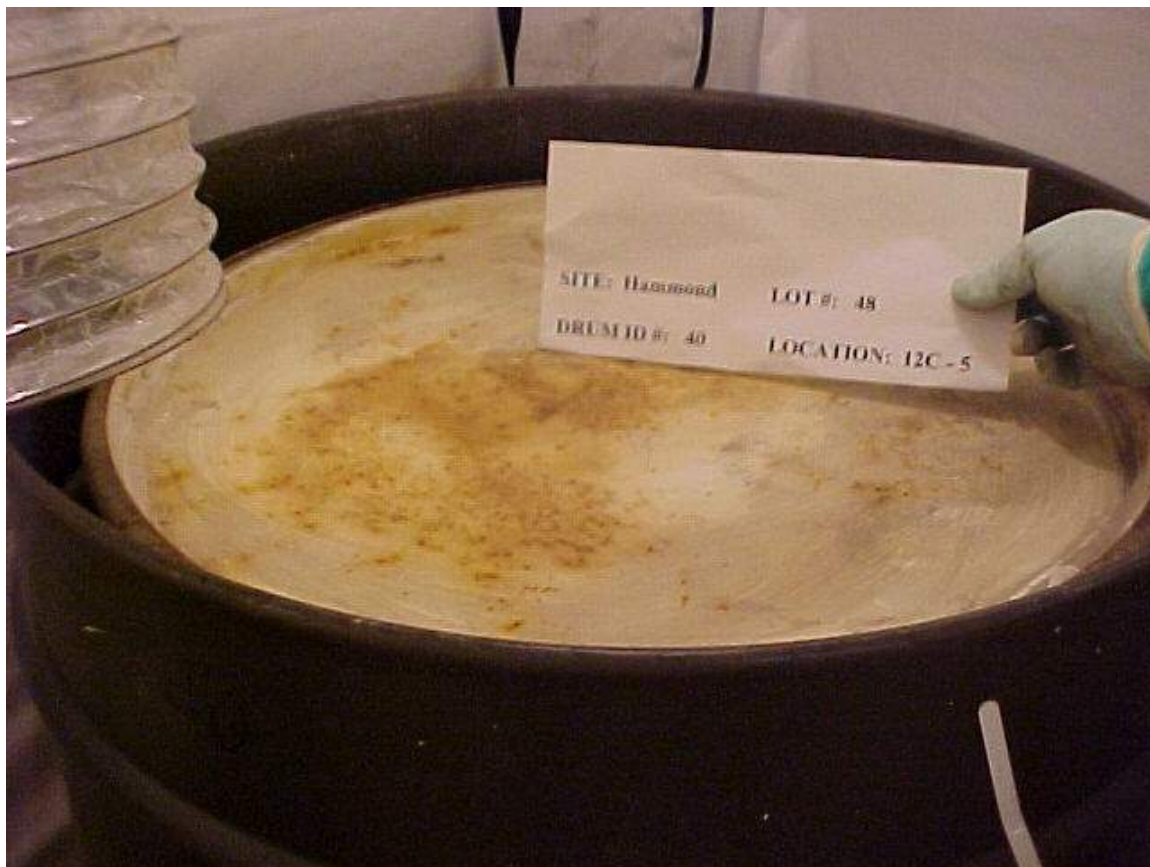
Lot No.	<u>48</u>	Inspection/Sample	<u>Visual Inspection & Sampling</u>
Drum ID No.	<u>40</u>	Date	<u>6-10-2002</u>
Location	<u>12C-5</u>	Photo No.	<u>3 of 14</u>
Site	<u>Hammond</u>

55-gal drum-good condition
no gases present
ring-good condition

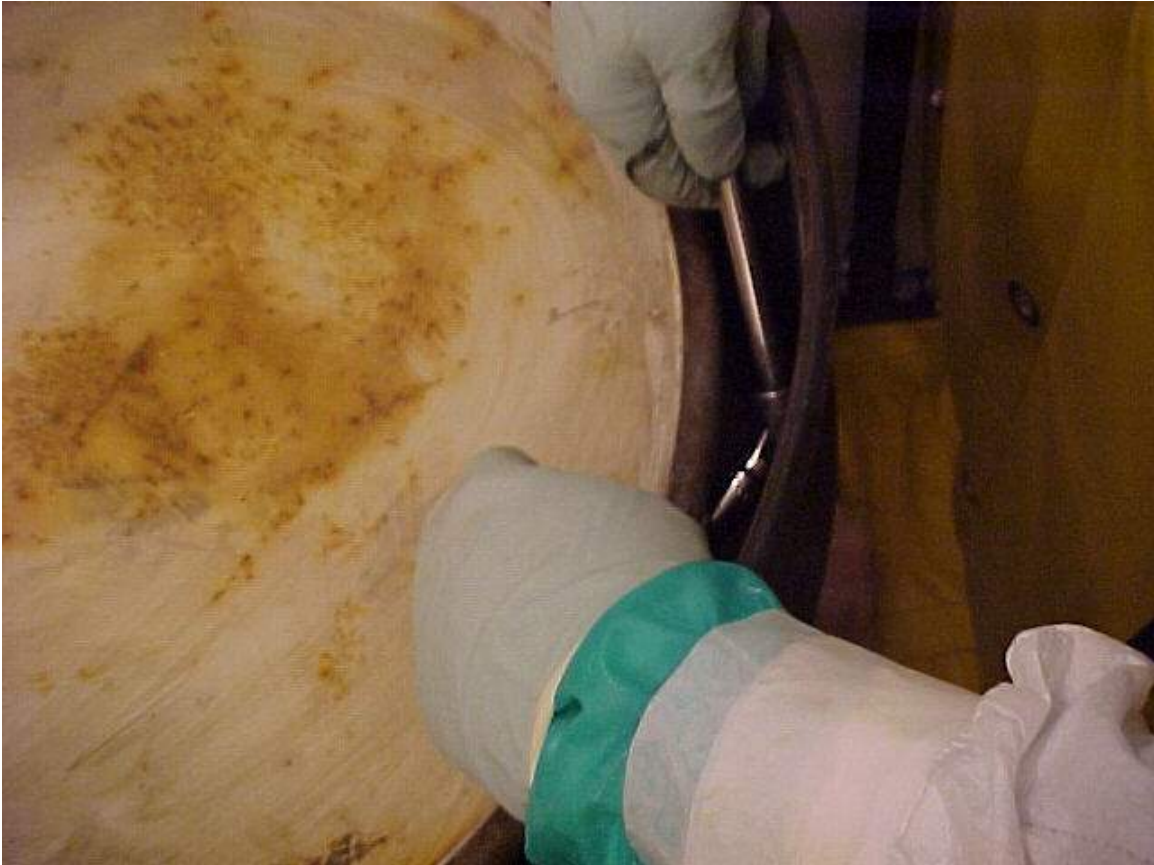
Lot No.	<u>48</u>	Inspection/Sample	<u>Visual Inspection & Sampling</u>
Drum ID No.	<u>40</u>	Date	<u>6-10-2002</u>
Location	<u>12C-5</u>	Photo No.	<u>4 of 14</u>
Site	<u>Hammond</u>

This picture shows the position/ difficulty of removing bolt from ring

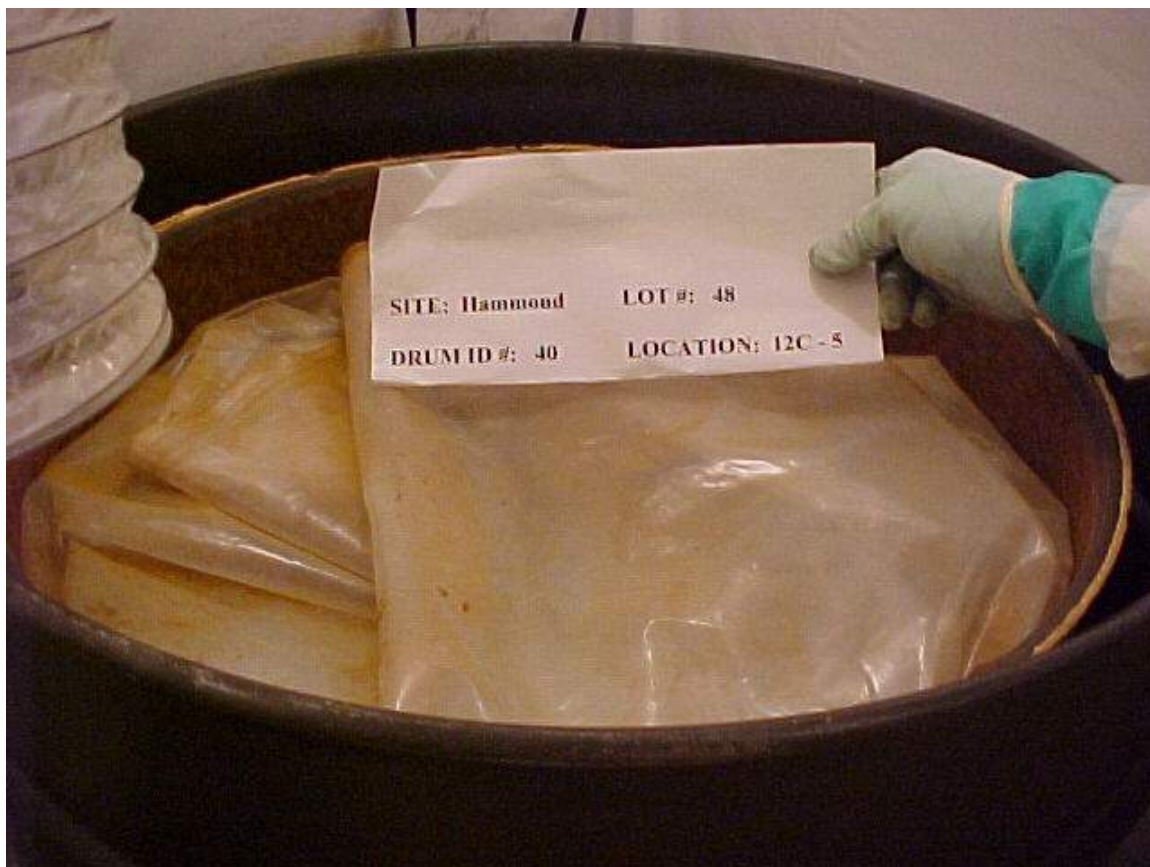
Lot No.	<u>48</u>	Inspection/Sample	<u>Visual Inspection & Sampling</u>
Drum ID No.	<u>40</u>	Date	<u>6-10-2002</u>
Location	<u>12C-5</u>	Photo No.	<u>5 of 14</u>
Site	<u>Hammond</u>

1st poly-liner/bag- Good Condition
No gasses present

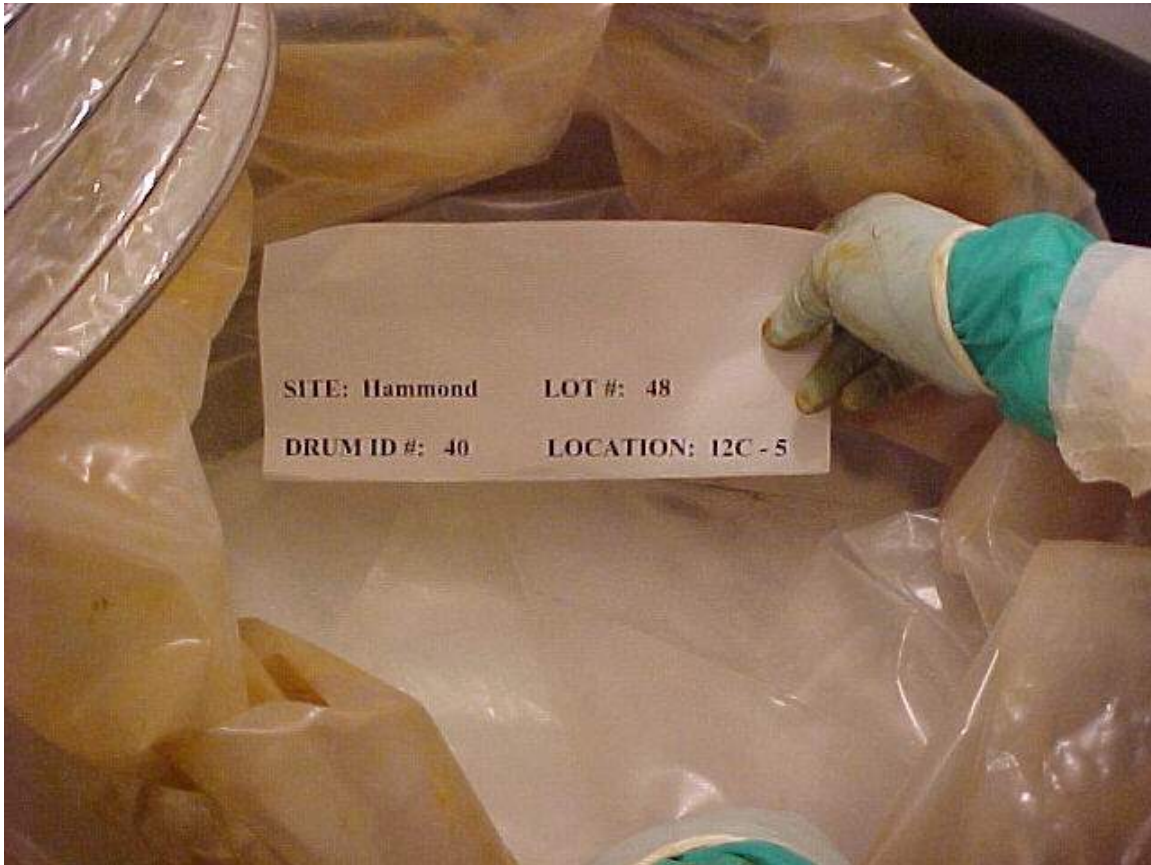
Lot No.	<u>48</u>	Inspection/Sample	<u>Visual Inspection & Sampling</u>
Drum ID No.	<u>40</u>	Date	<u>6-10-2002</u>
Location	<u>12C-5</u>	Photo No.	<u>6 of 14</u>
Site	<u>Hammond</u>

2nd Poly-liner/bag- Good Condition
No gasses present

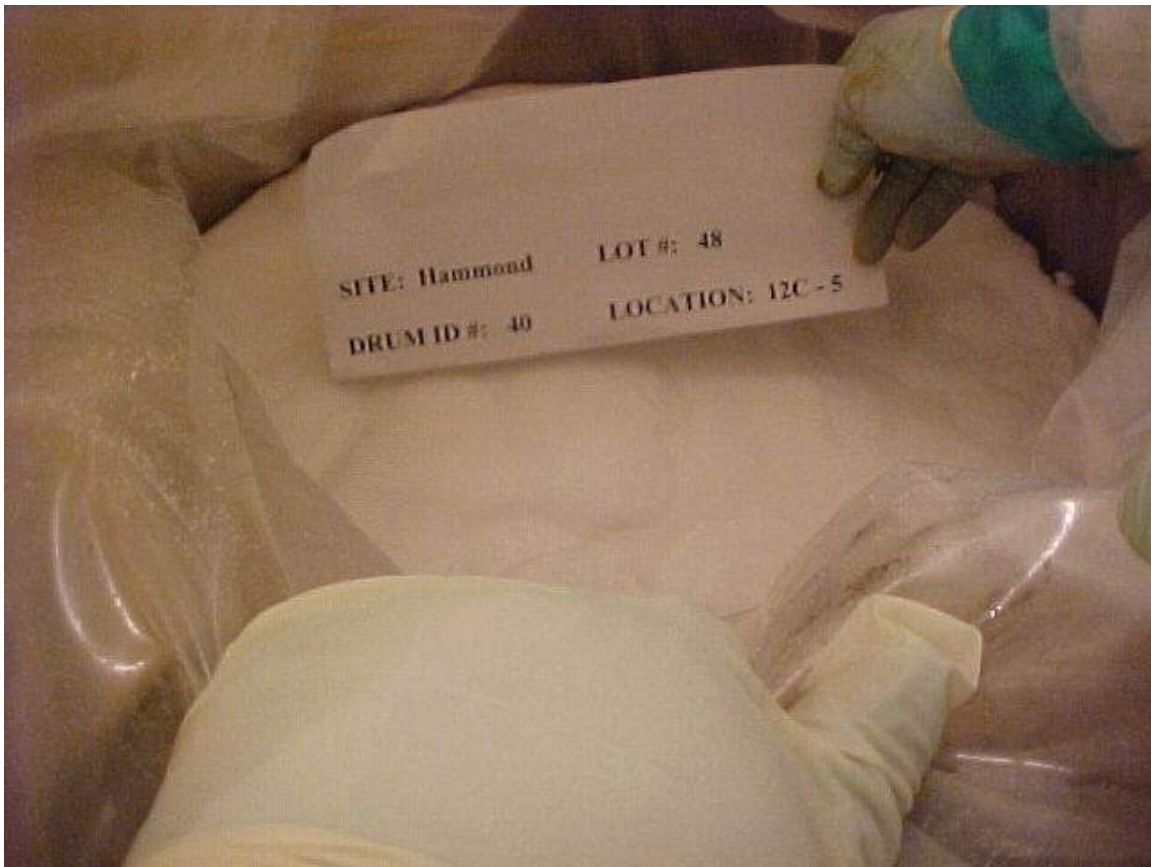
Visual Inspection & Sampling
6-10-2002
7 of 14

Monolith-white in color
Solid
No gasses present
Light moisture

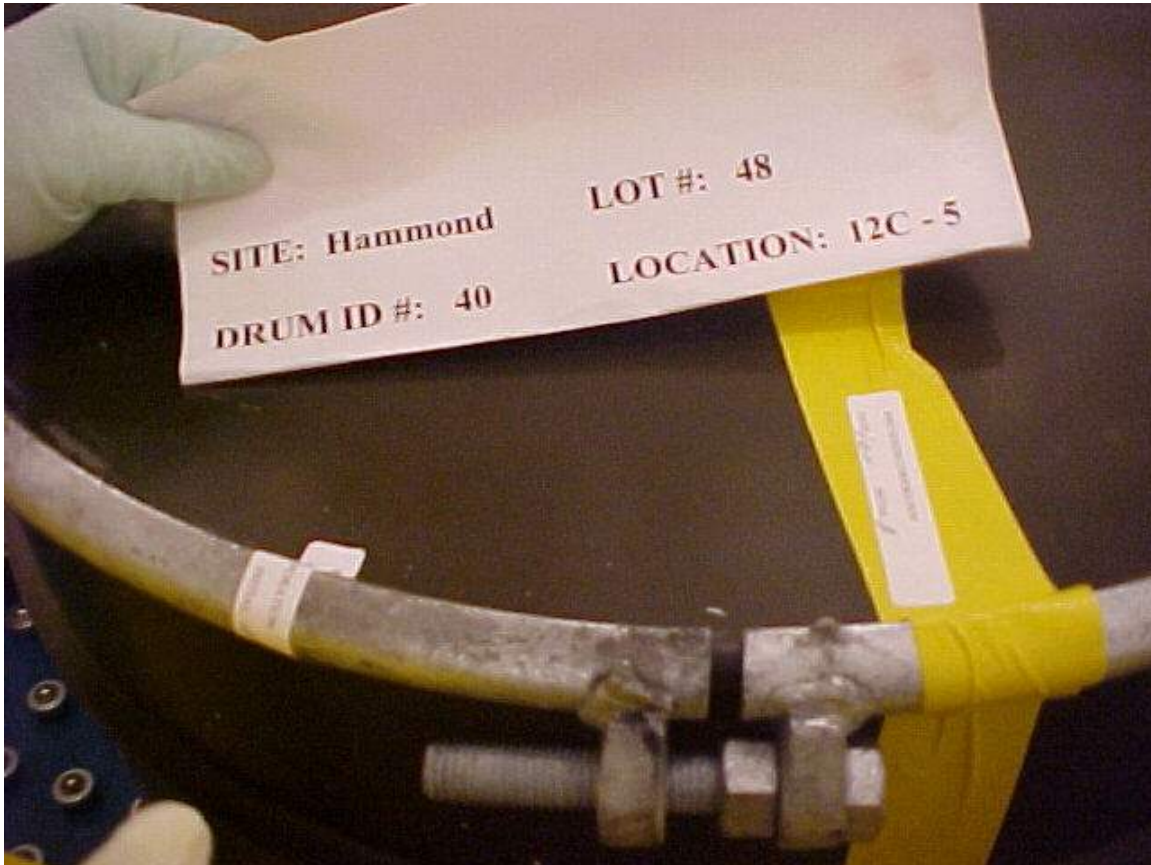
Lot No.	<u>48</u>	Inspection/Sample	<u>Visual Inspection & Sampling</u>
Drum ID No.	<u>40</u>	Date	<u>6-10-2002</u>
Location	<u>12C-5</u>	Photo No.	<u>14 of 14</u>
Site	<u>Hammond</u>

85 gal drum lid and ring secured
Drum sealed/dated/completed

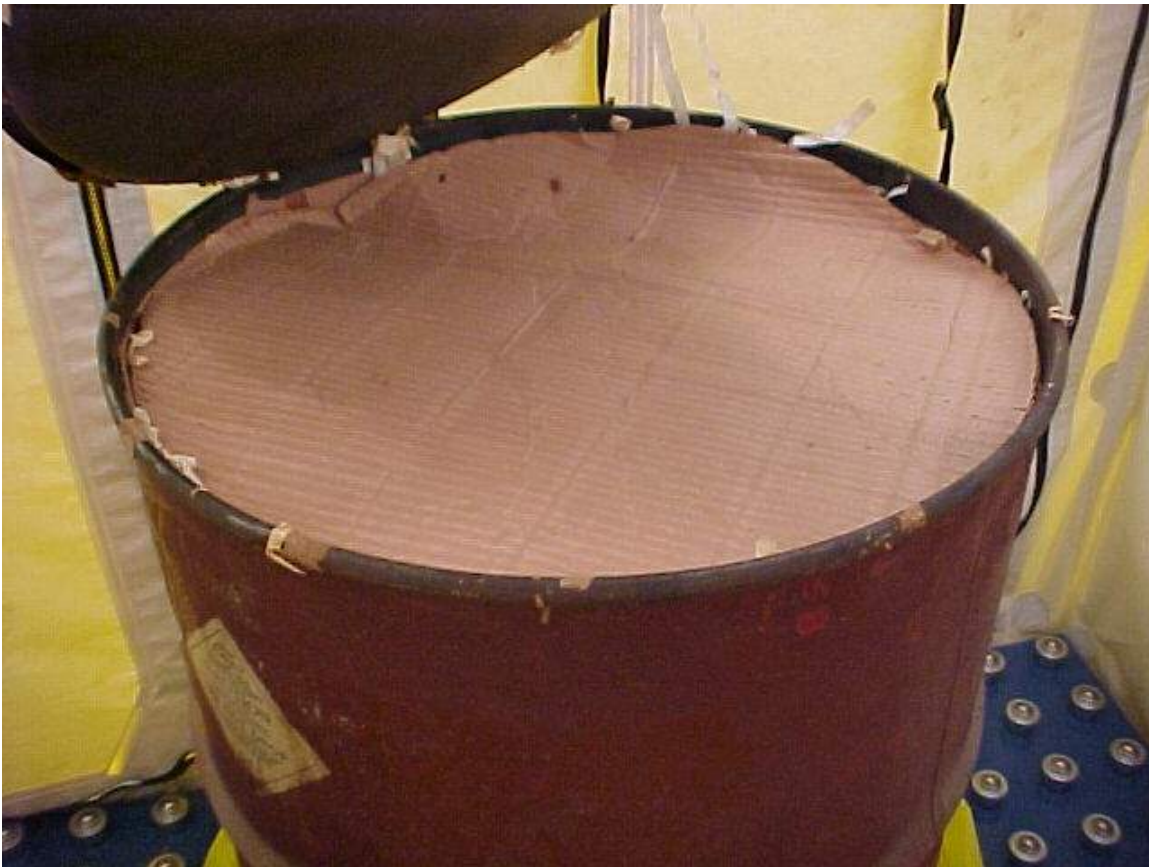
Photo No. 2 of 9

Round cardboard lid covering the shredded paper – good condition
No gasses present

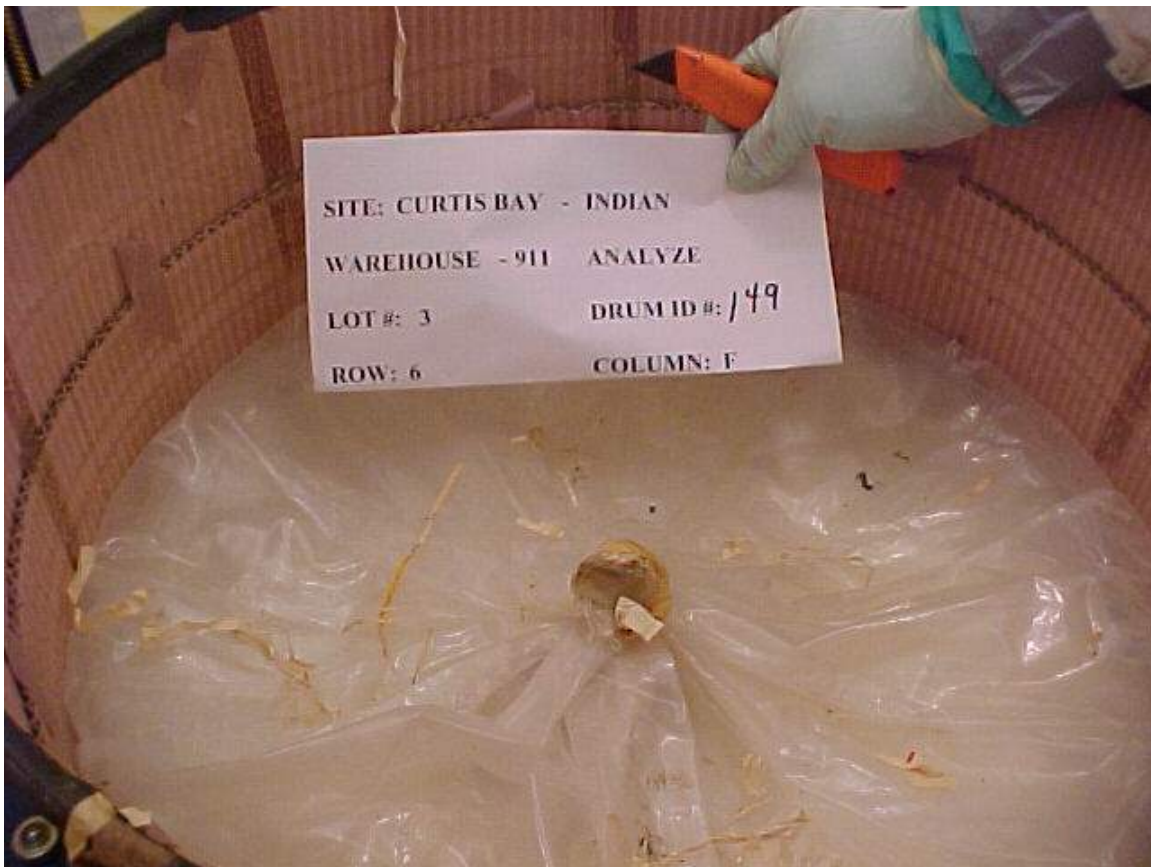
Photo No. 4 of 9

1st poly liner/bag – good condition
No gasses present

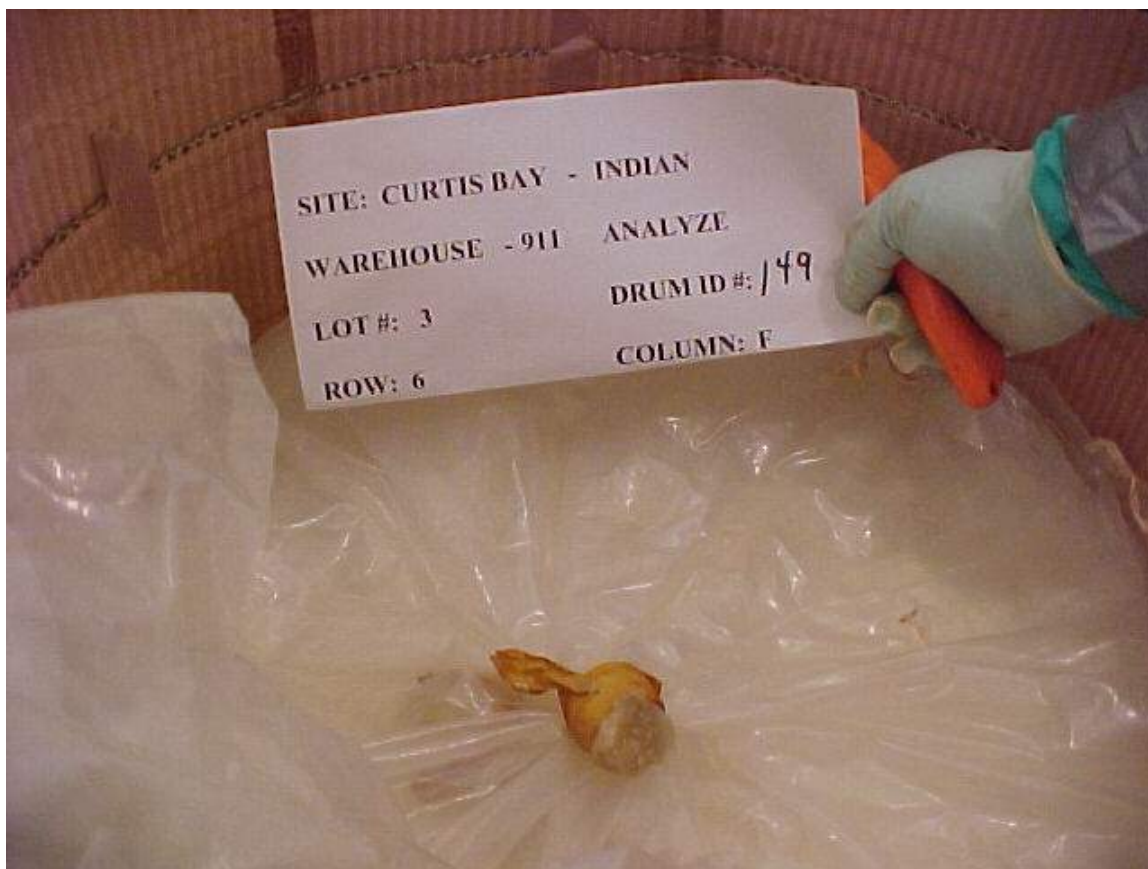
2nd poly liner/bag – good condition
No gasses present

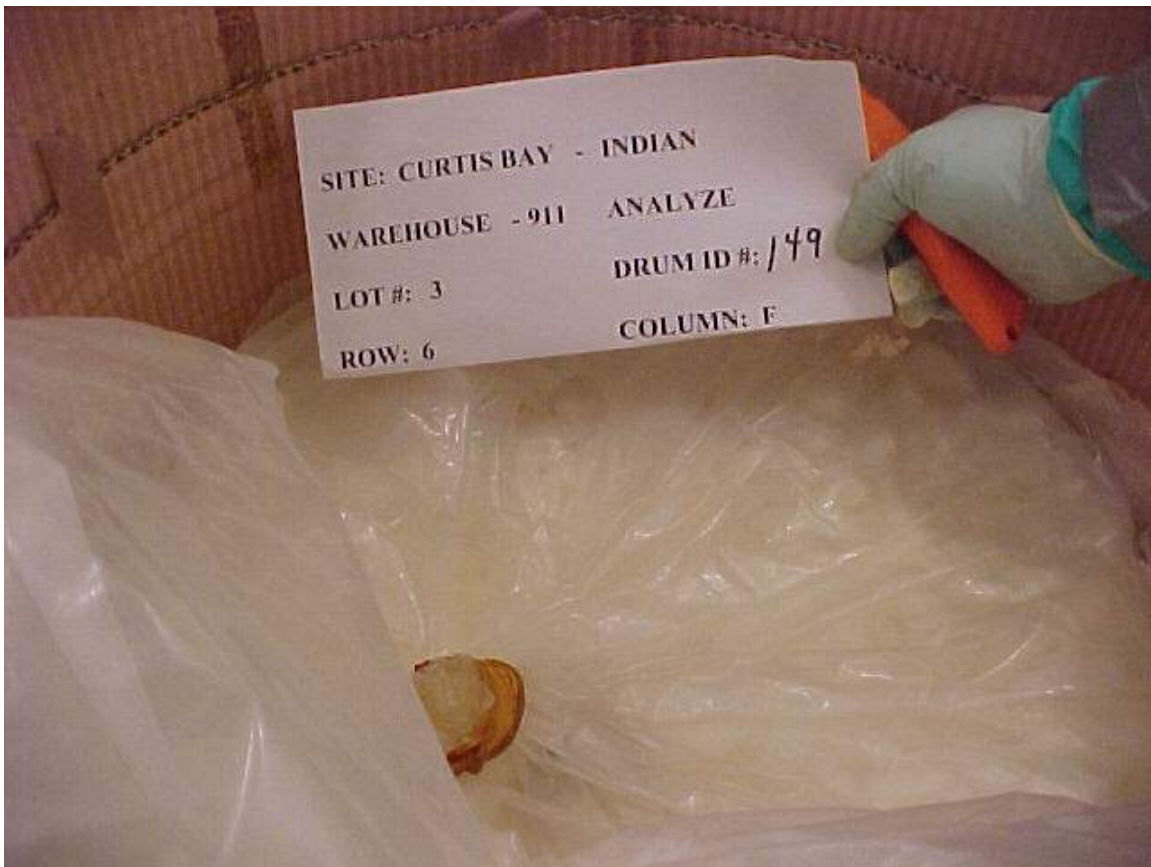
Photo No. 6 of 9

3rd poly liner/bag – good condition
No gasses present
