THORIUM NITRATE STOCKPILE DRUM CHARACTERIZATION REPORT

**THORIUM NITRATE STOCKPILE
DRUM CHARACTERIZATION REPORT**

Prepared for
U.S. Defense Logistics Agency
Defense National Stockpile Center
Fort Belvoir, Virginia

Prepared by
OAK RIDGE NATIONAL LABORATORY
Oak Ridge, Tennessee 37831
managed by
UT-BATTELLE, LLC
for the
U.S. DEPARTMENT OF ENERGY
under contract DE-AC05-00OR22725

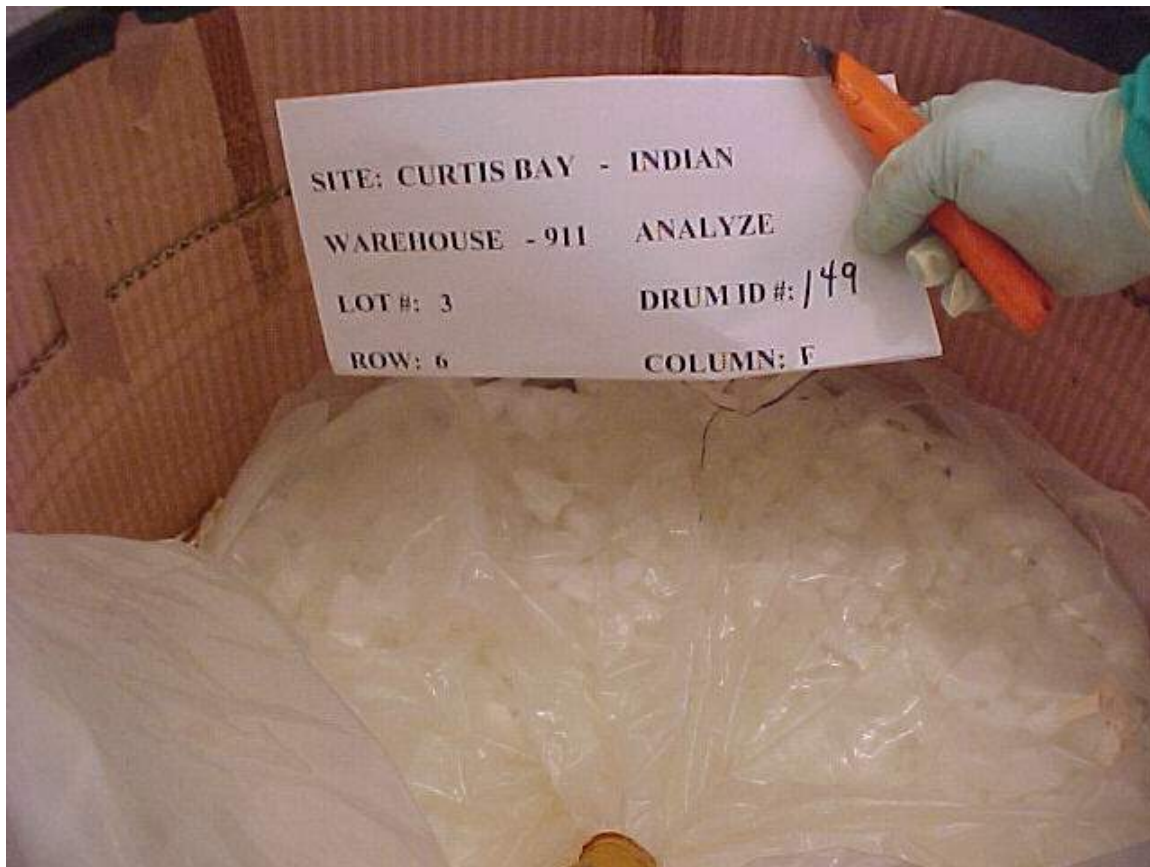
10:30**Other Information**Photo No. 7 of 94th poly liner/bag – good condition

No gasses present

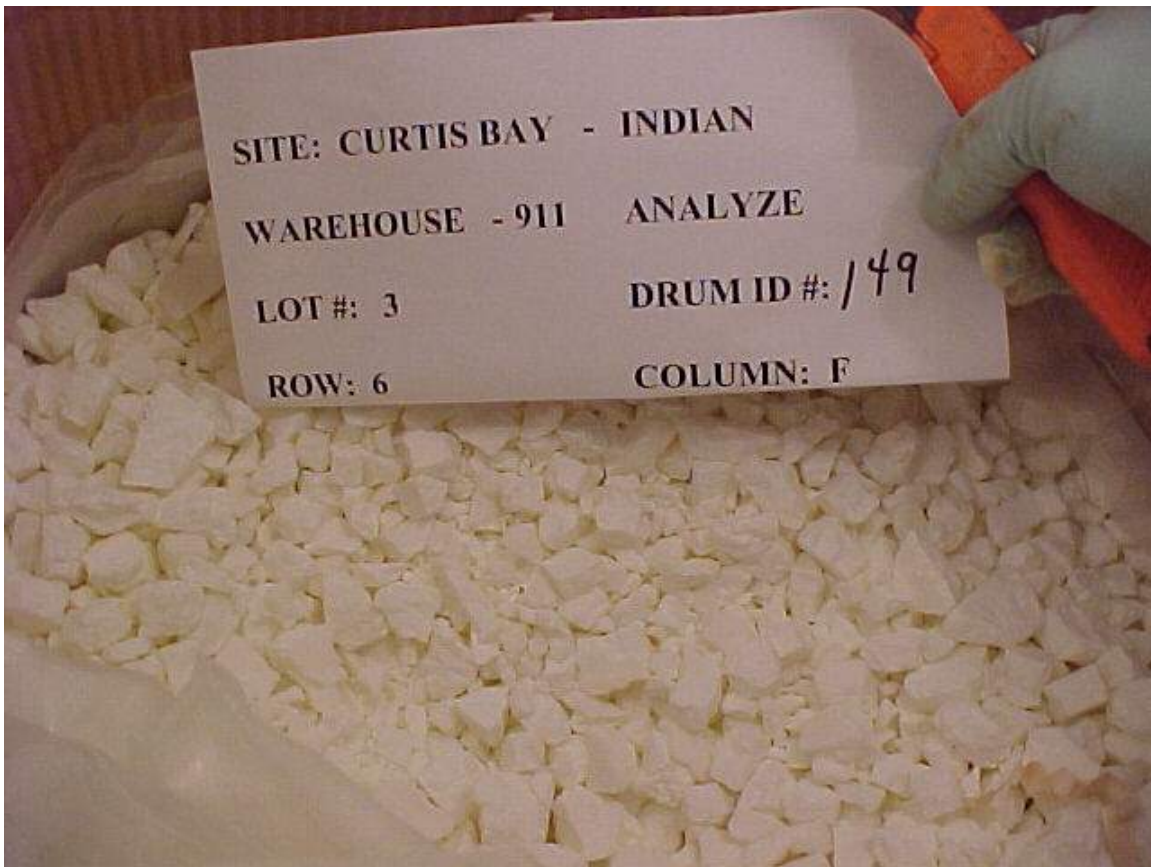
Photo No. 8 of 9

Thorium Nitrate looks like white gravel – solid – dry
No gasses present

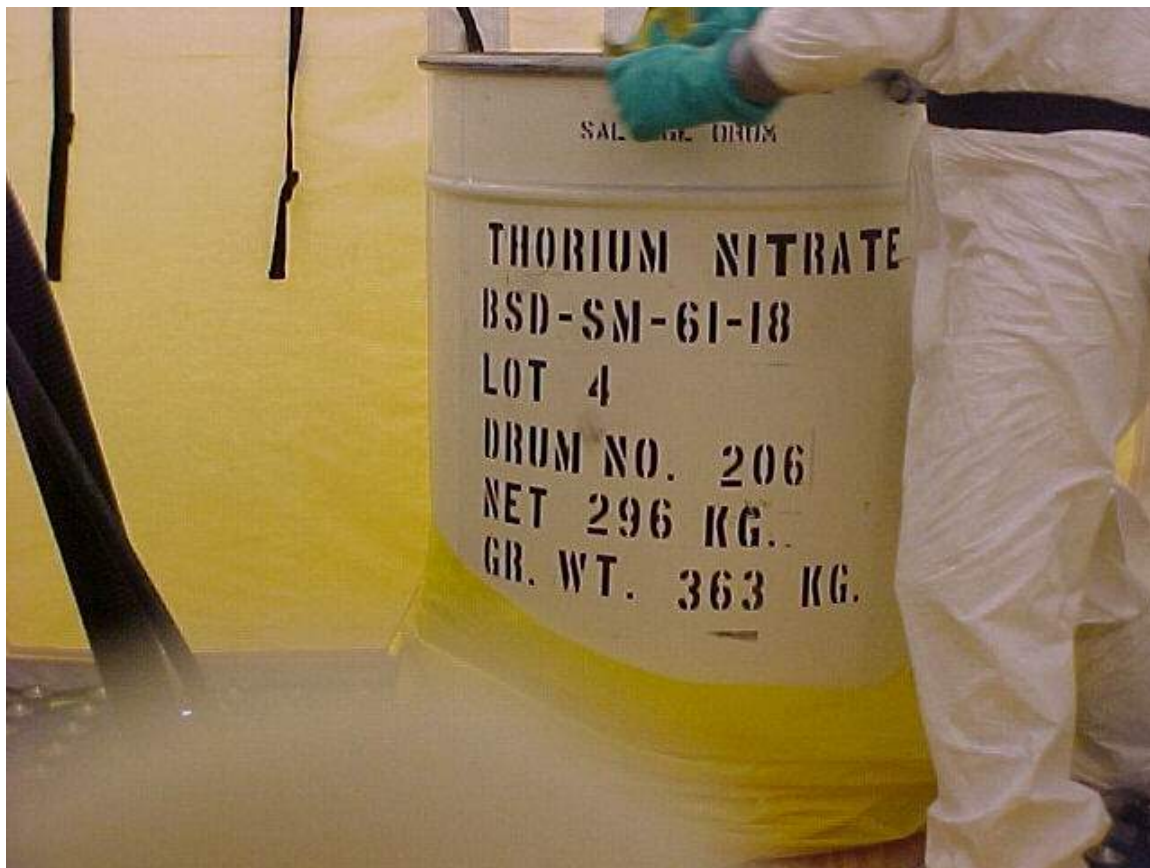
General InformationSite Curtis BayThN Origin IndianLot No. 4Drum ID No. 206Inspection/Sample
DispositionVisual Inspection & Sampling
Analyze**Physical Location of Drum**Warehouse 911Row 2
Column E**Inspection/Sample Date & Time**Date 7-3-2002Time 10:15**Other Information**Photo No. 1 of 8Container 85-gallon steel drumContainer
Condition GoodDose Rate Surface 30 mR/hr
 1 meter 4.0 mR/hr

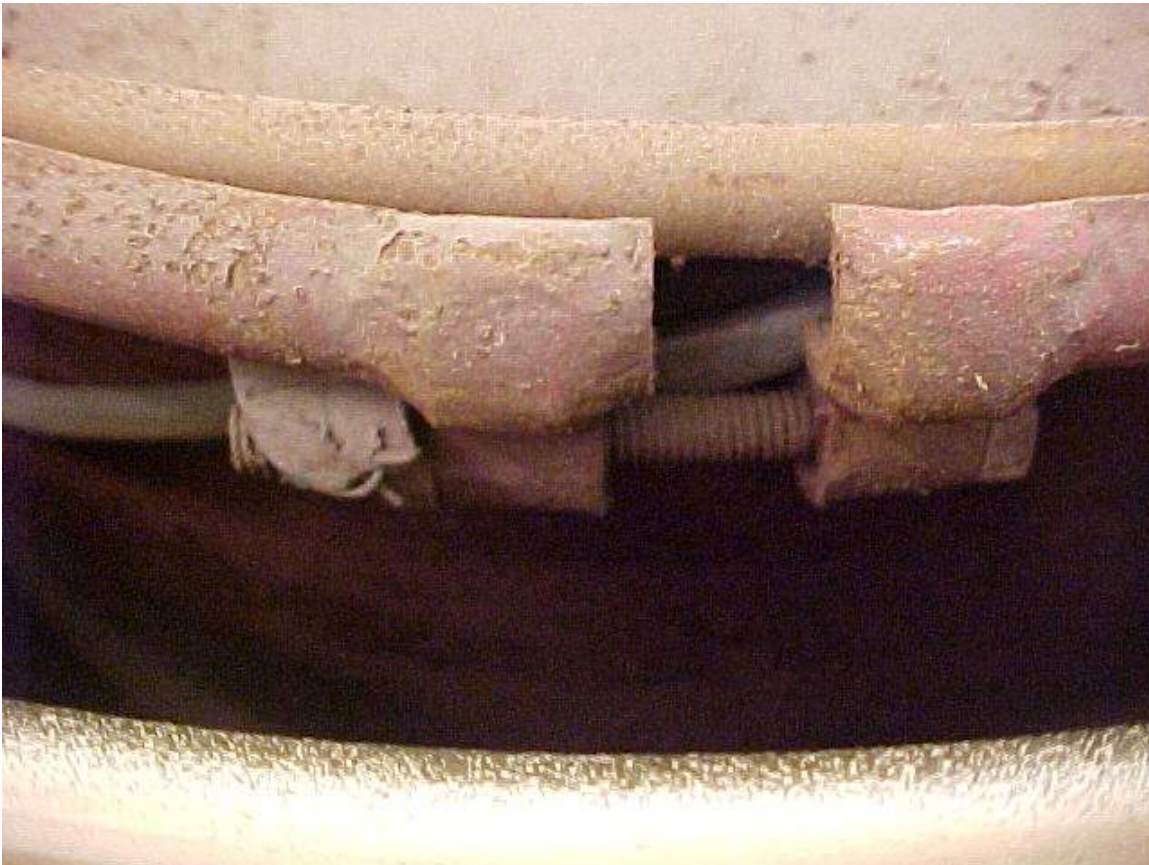
Photo No. 2 of 8

55-gal drum ring of inner 55-gallon drum is rusted & bent and hard to reach with tools to open
No gasses present

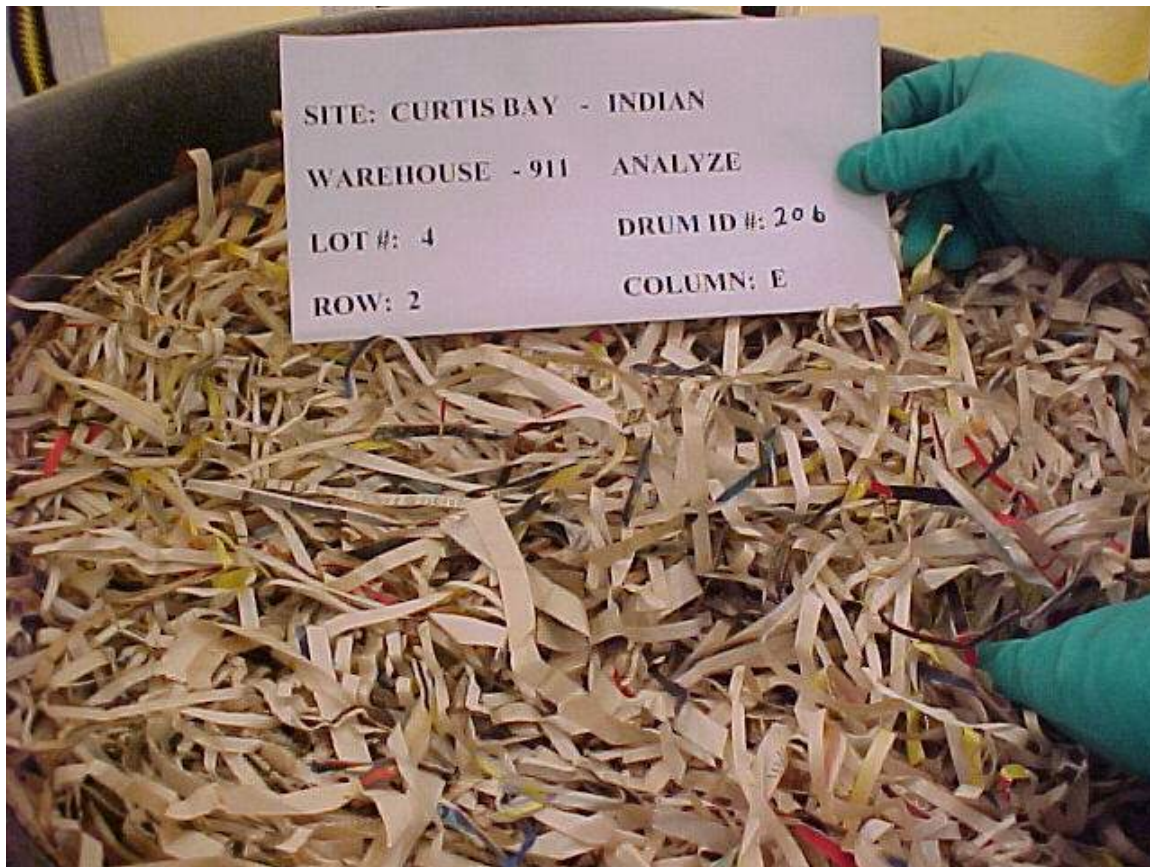
The shredded paper – good condition

No gasses present

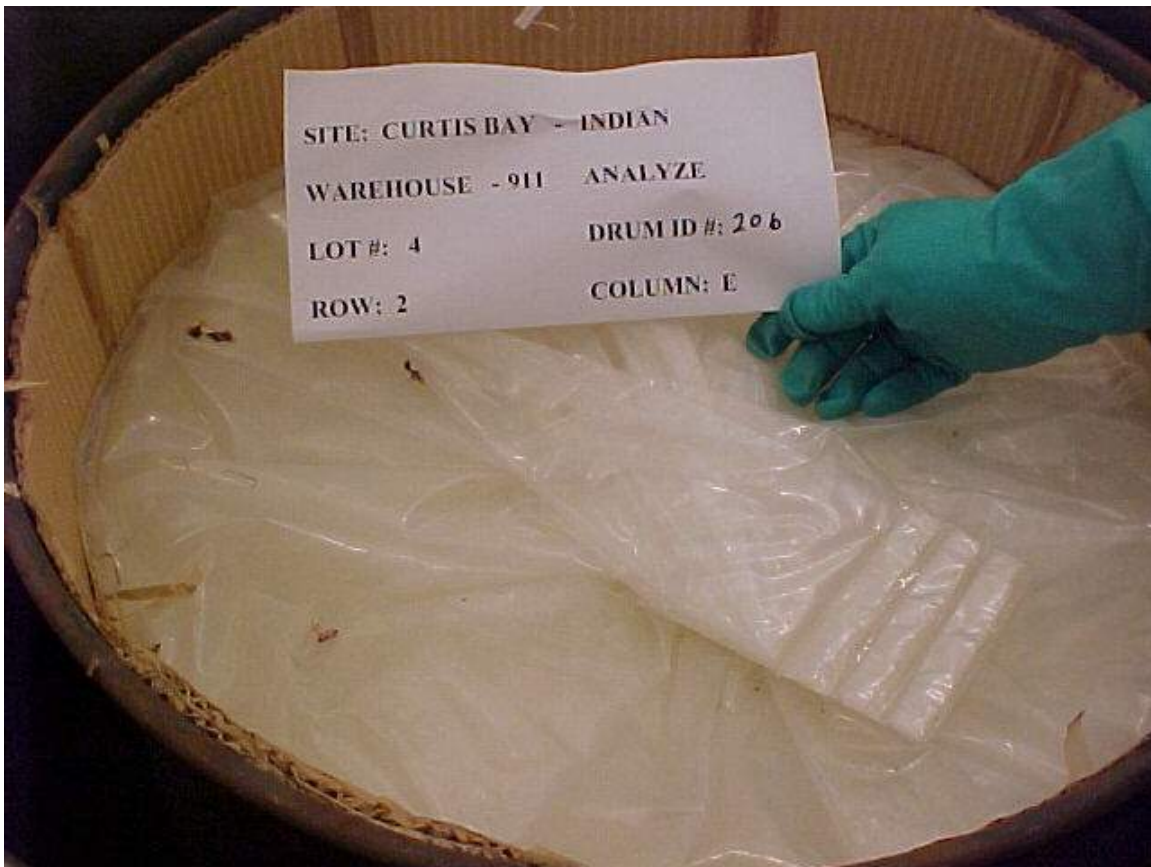
1st polyliner/bag – good condition

No gasses present

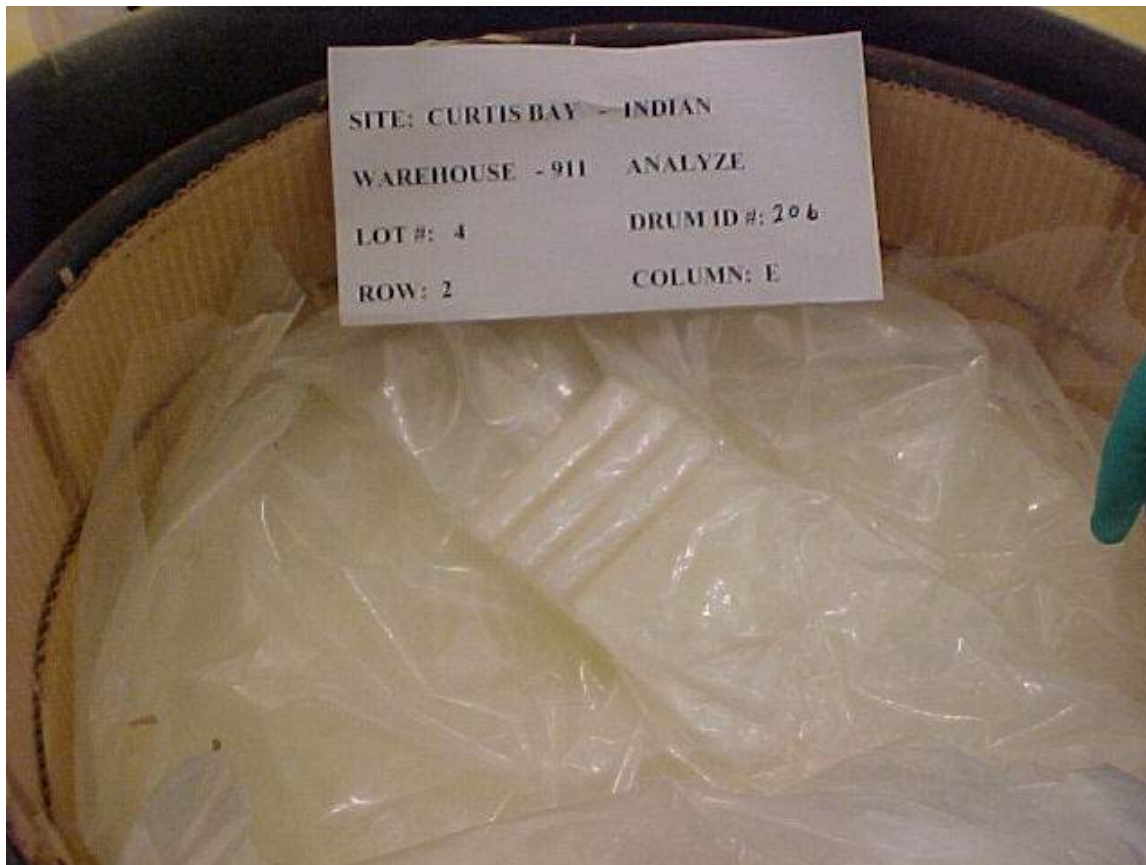
2nd polyliner/bag – good condition
No gasses present

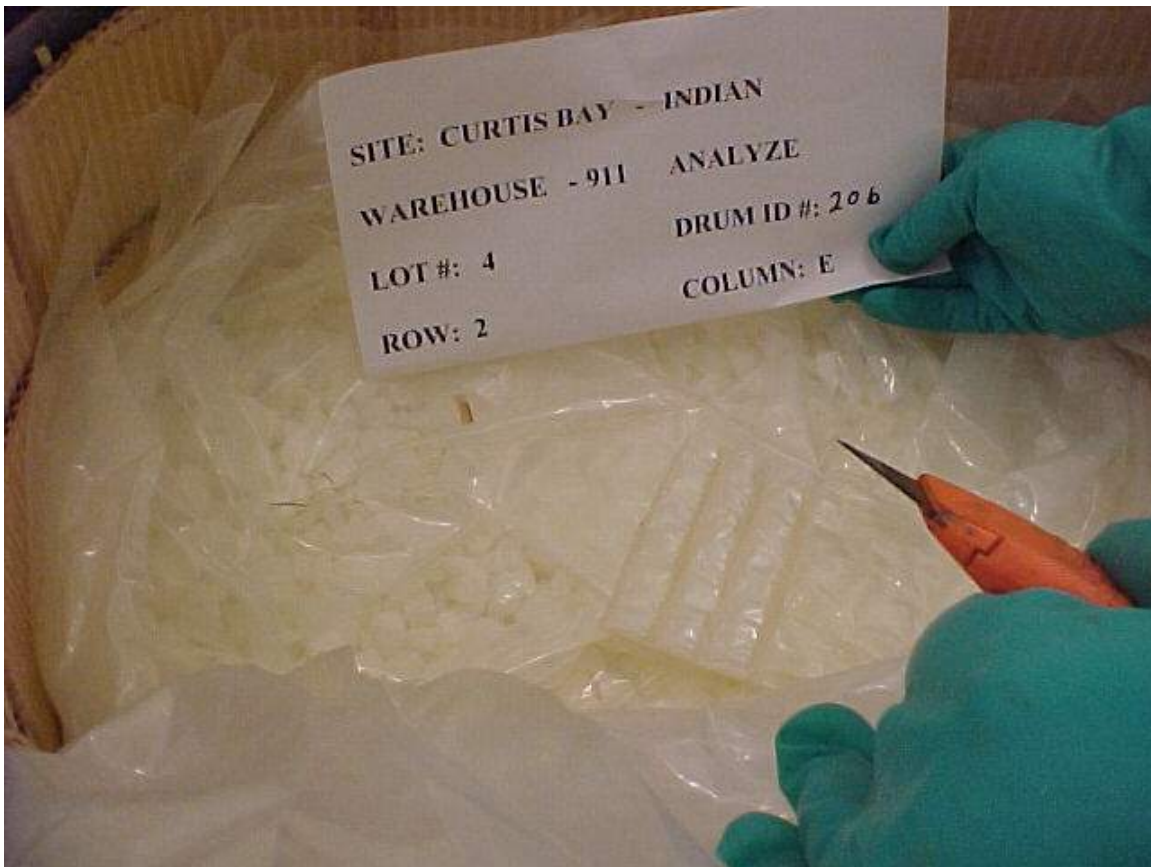
Photo No. 6 of 8

3rd polyliner/bag – good condition
No gasses present

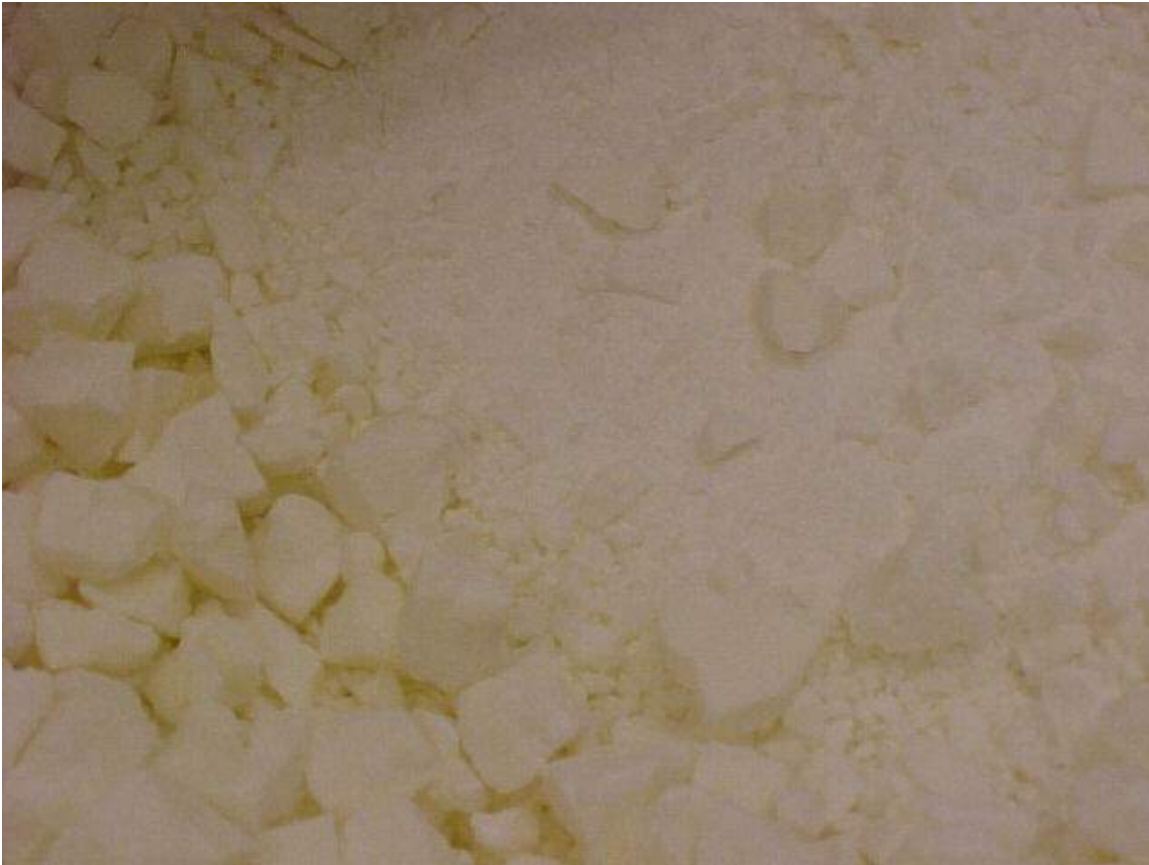
Thorium Nitrate looks like white gravel – solid – dry
No gasses present

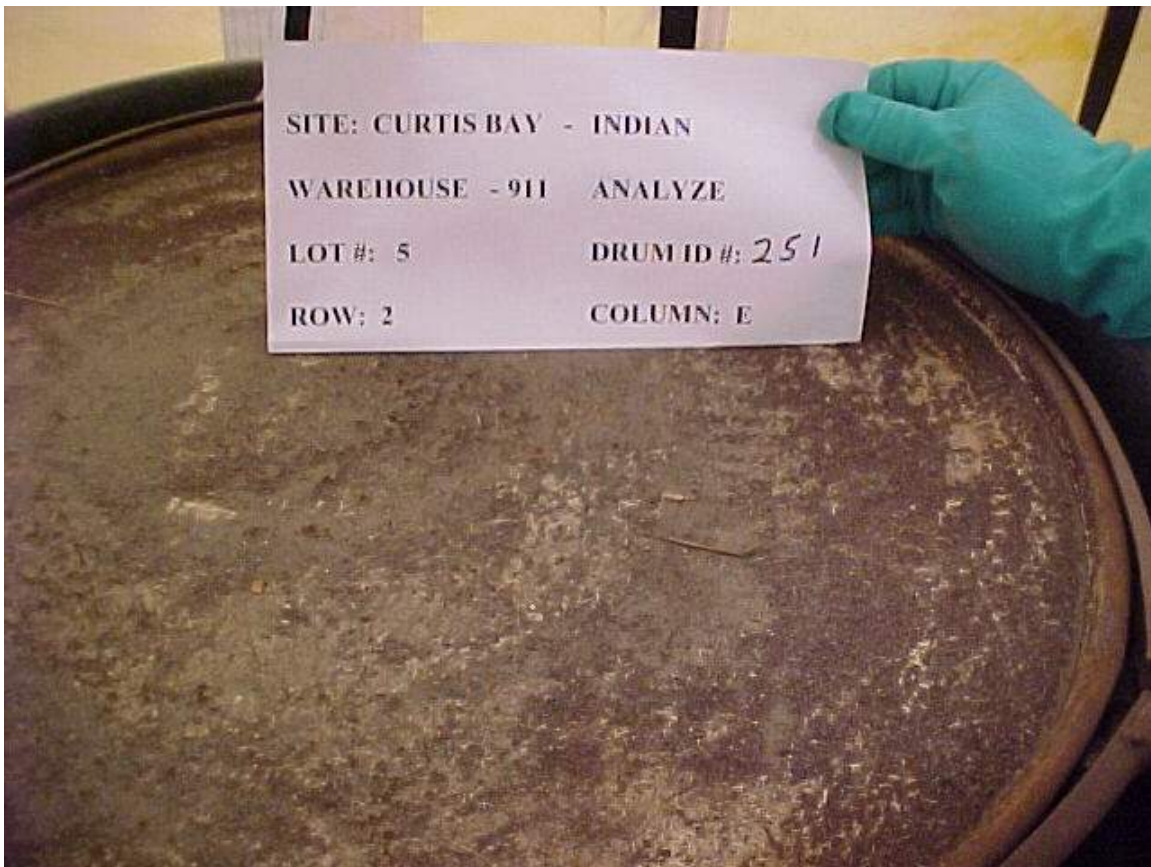
Photo No. 2 of 9

55-gal container and ring – Fair condition
No gasses present

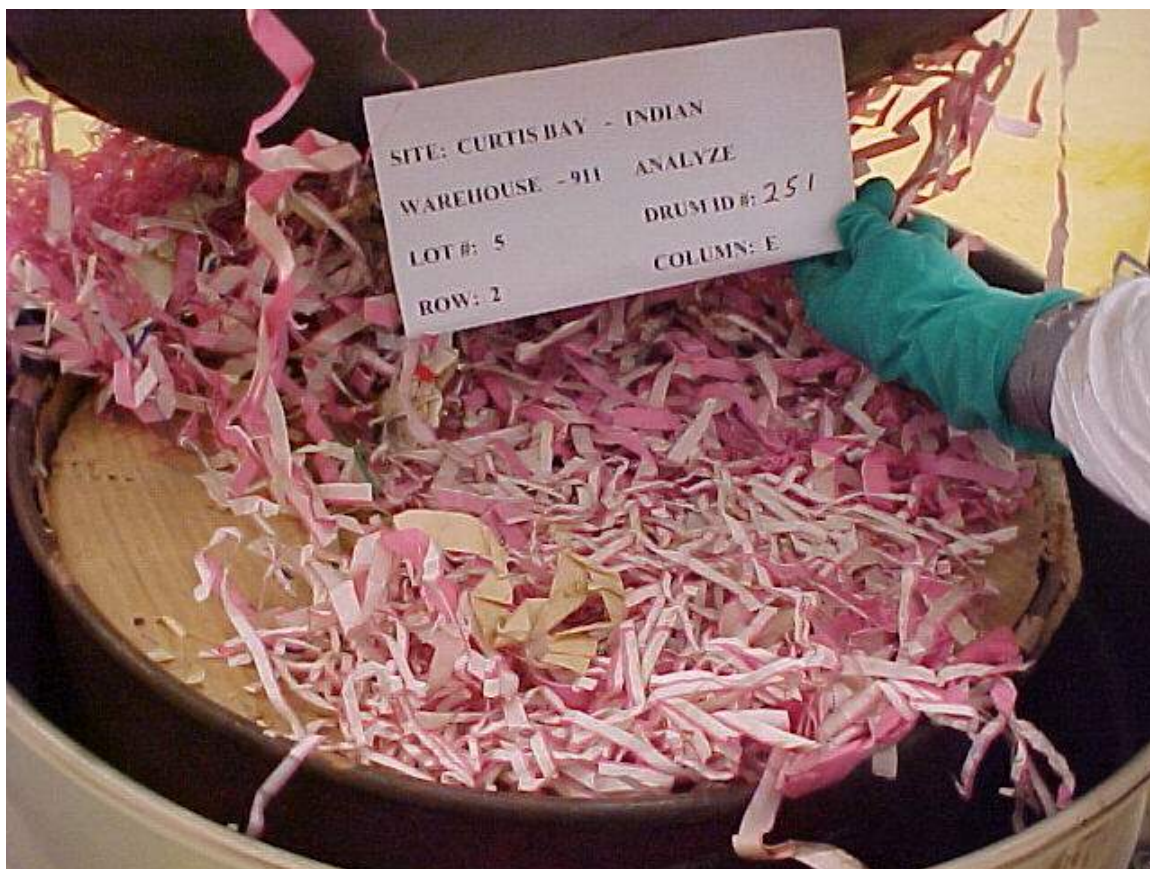
The shredded paper under the 55 gal lid
No gasses present

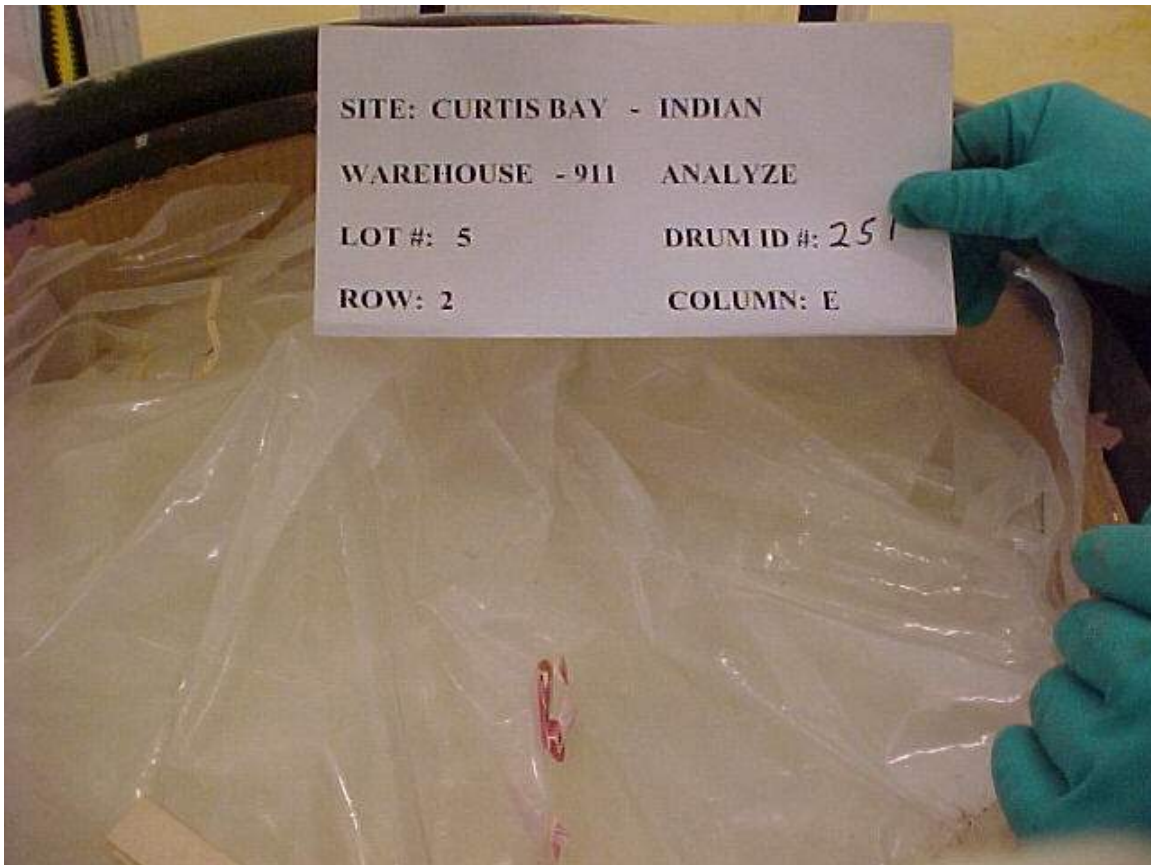
1st poly liner/bag – good condition

No gasses present

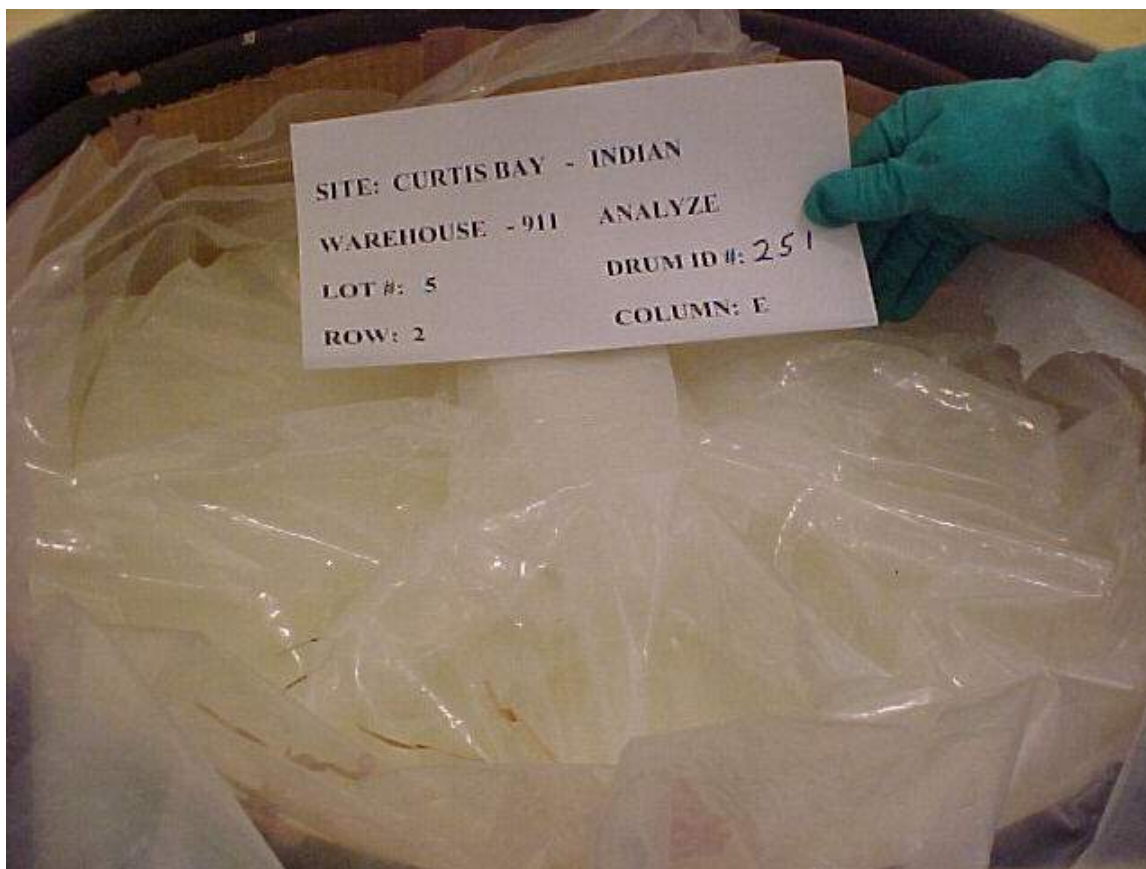
2nd poly liner/bag – good condition
No gasses present

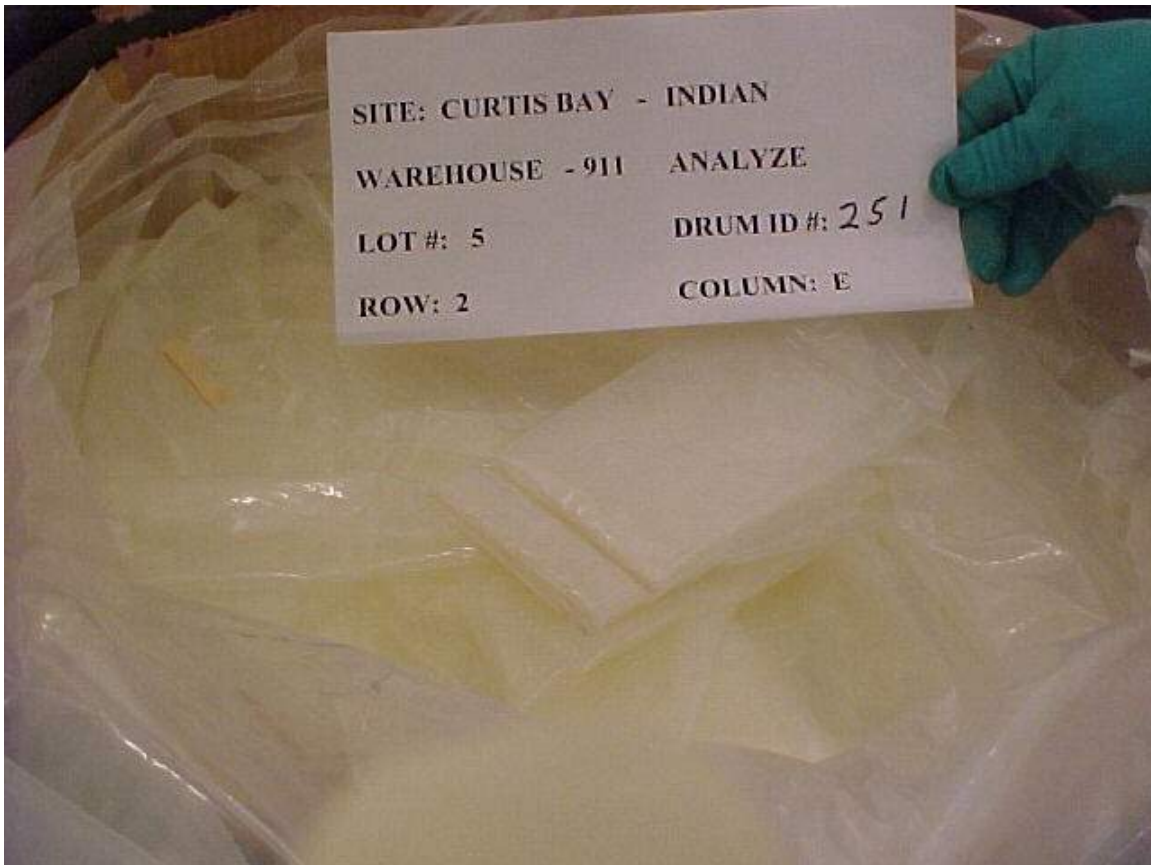
Photo No. 6 of 9

3rd poly liner/bag – good condition
No gasses present

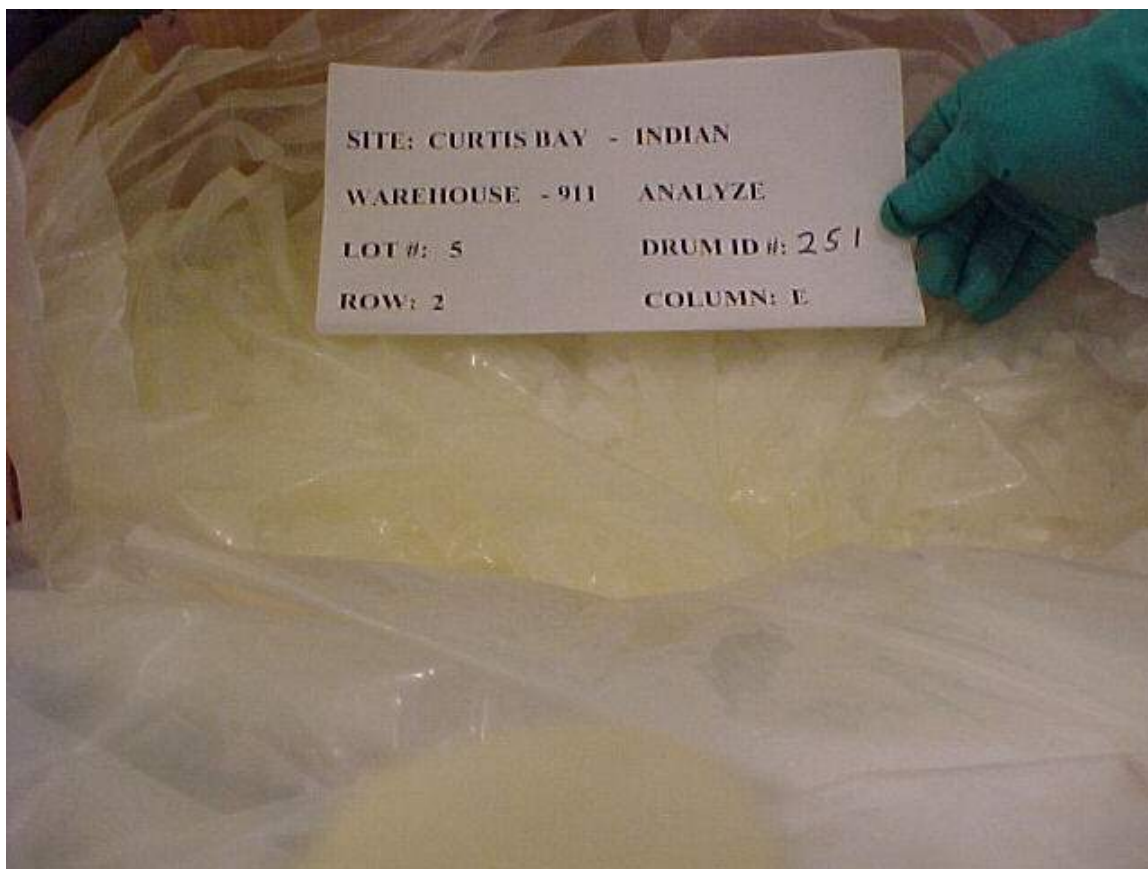
4th poly liner/bag – good condition
No gasses present

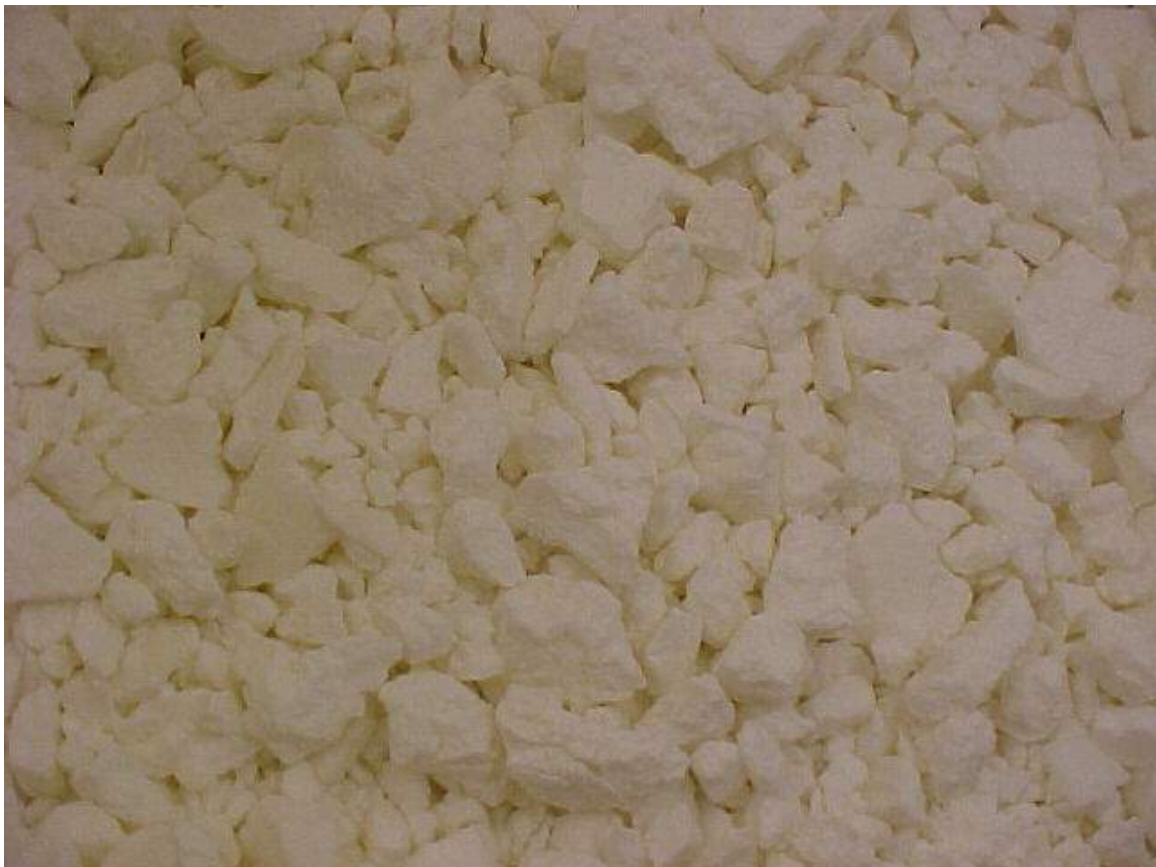
Photo No. 8 of 9

Indian – Thorium Nitrate – white – gravel/rock looking – dry
No gasses present

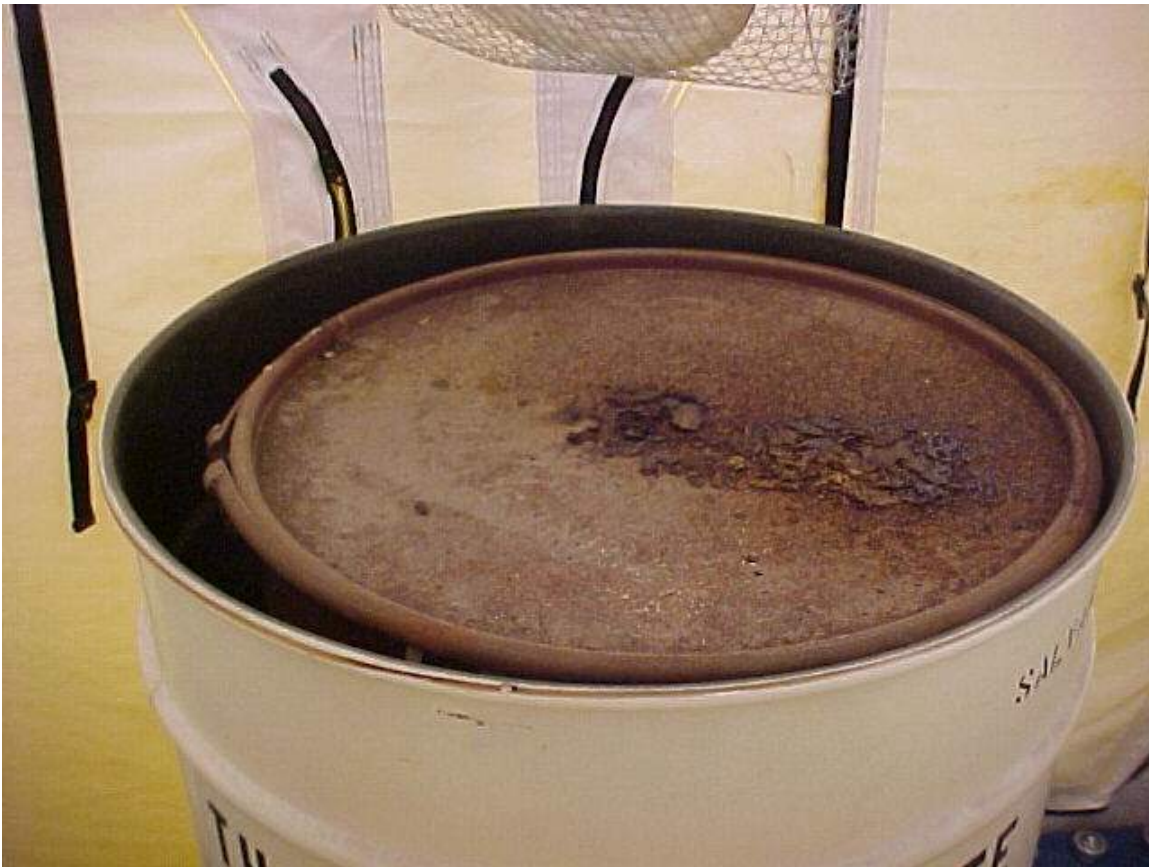
Photo No. 2 of 10

Picture of the 55 gal container – fair condition
No gasses present

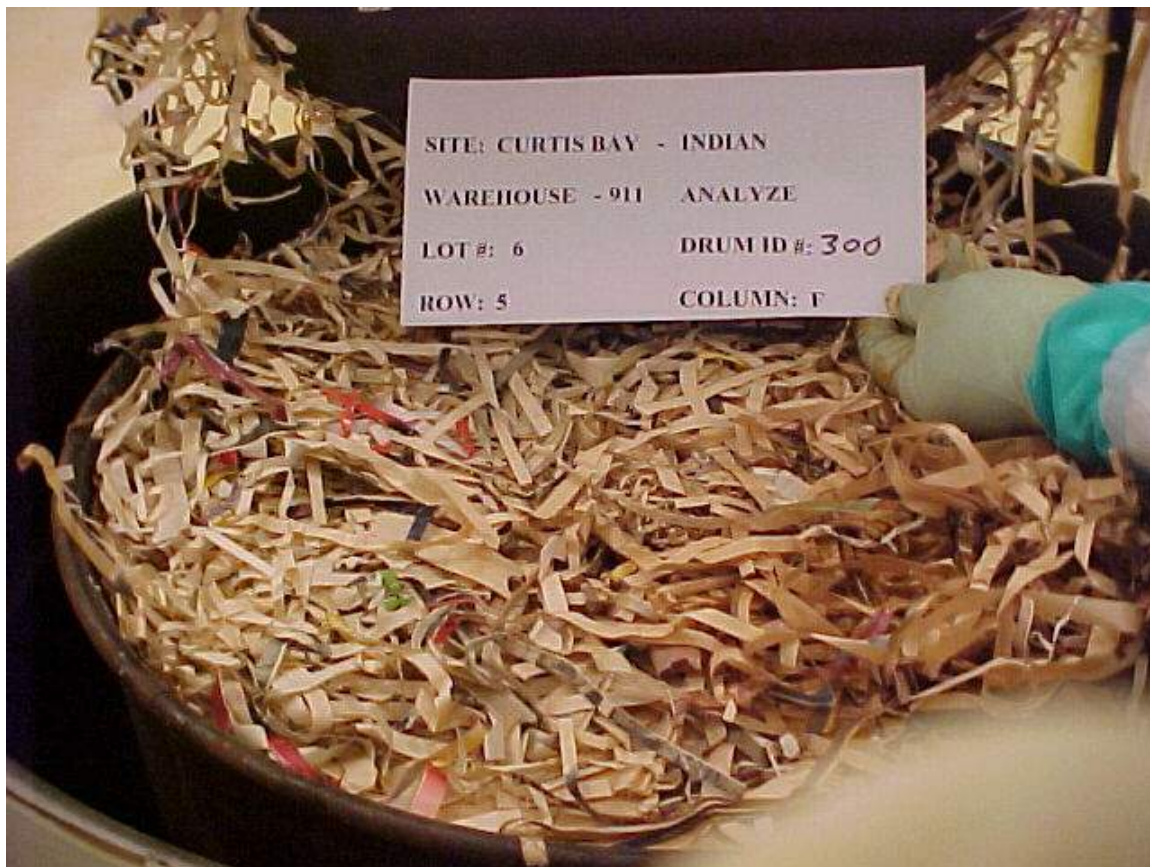
Shredded paper for packaging

No gasses present

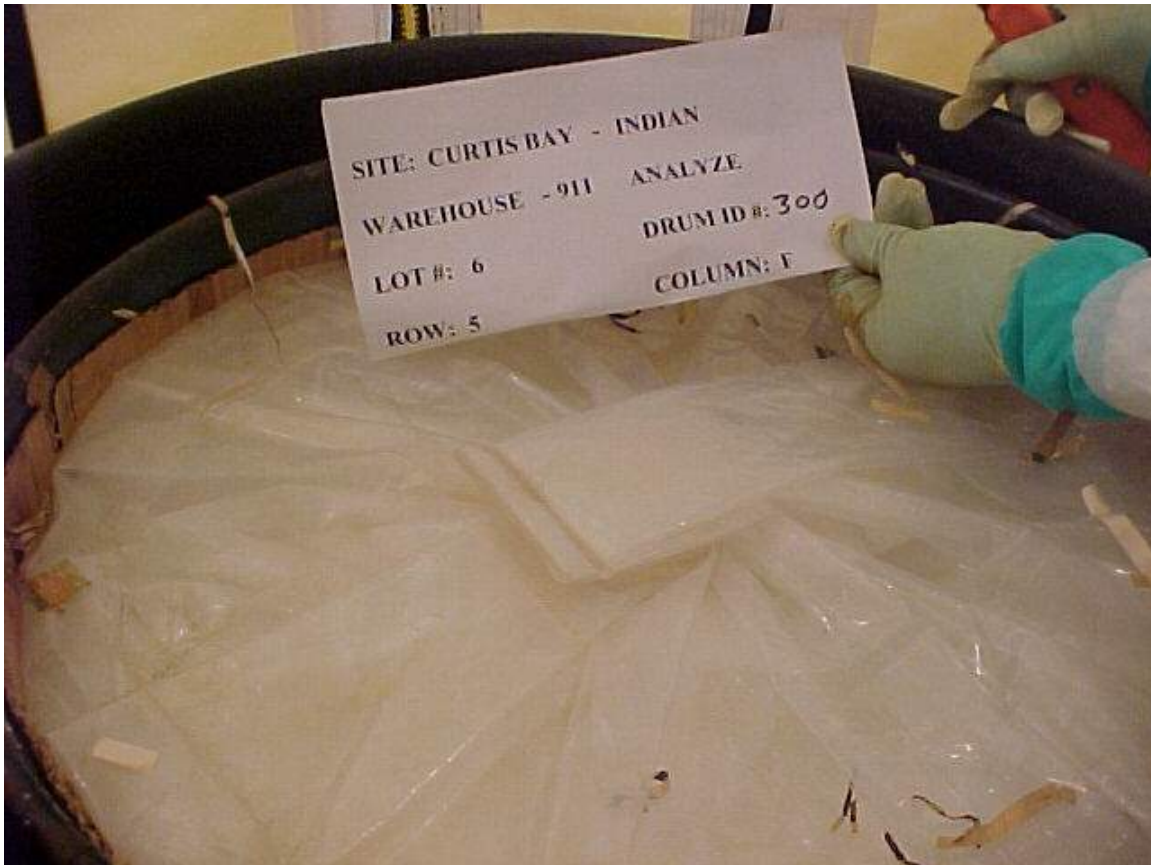
Photo No. 4 of 10

1st poly liner/bag – good condition
No gasses present

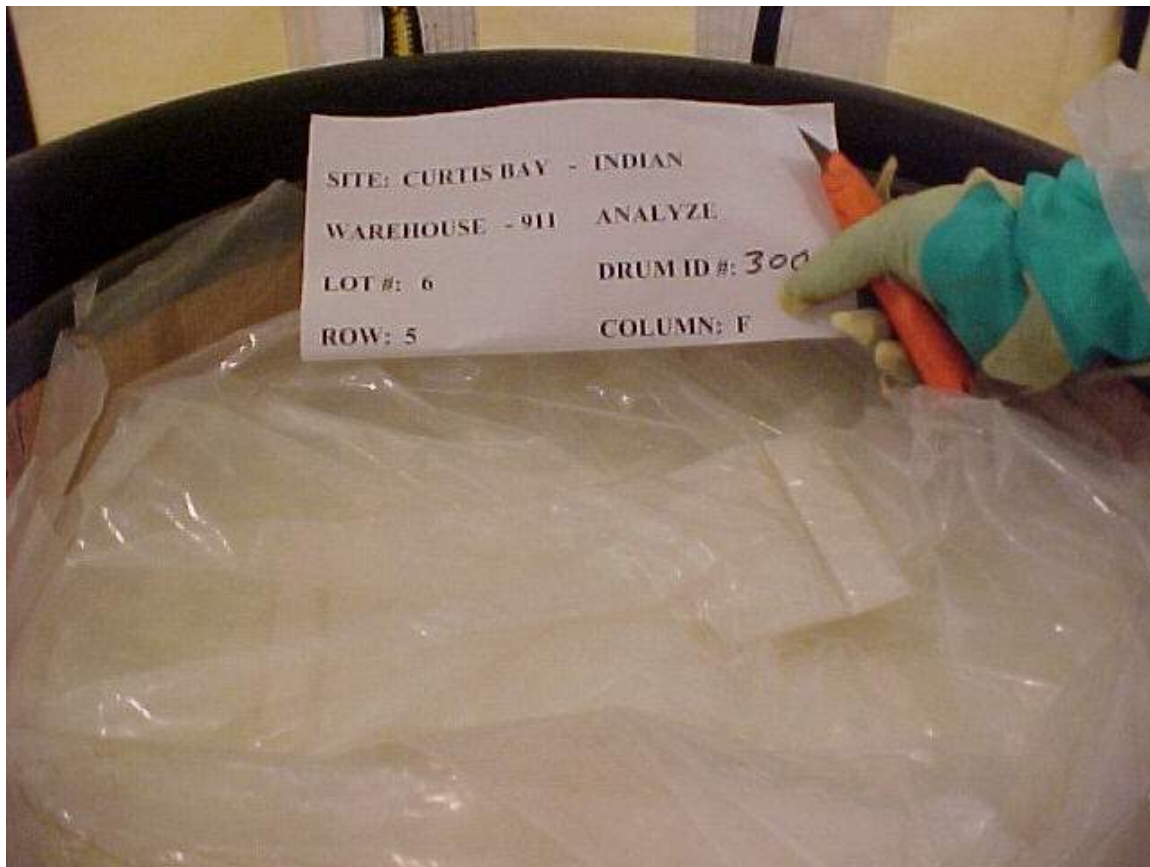
08:45**Other Information**Photo No. 5 of 102nd poly liner/bag – good condition

No gasses present

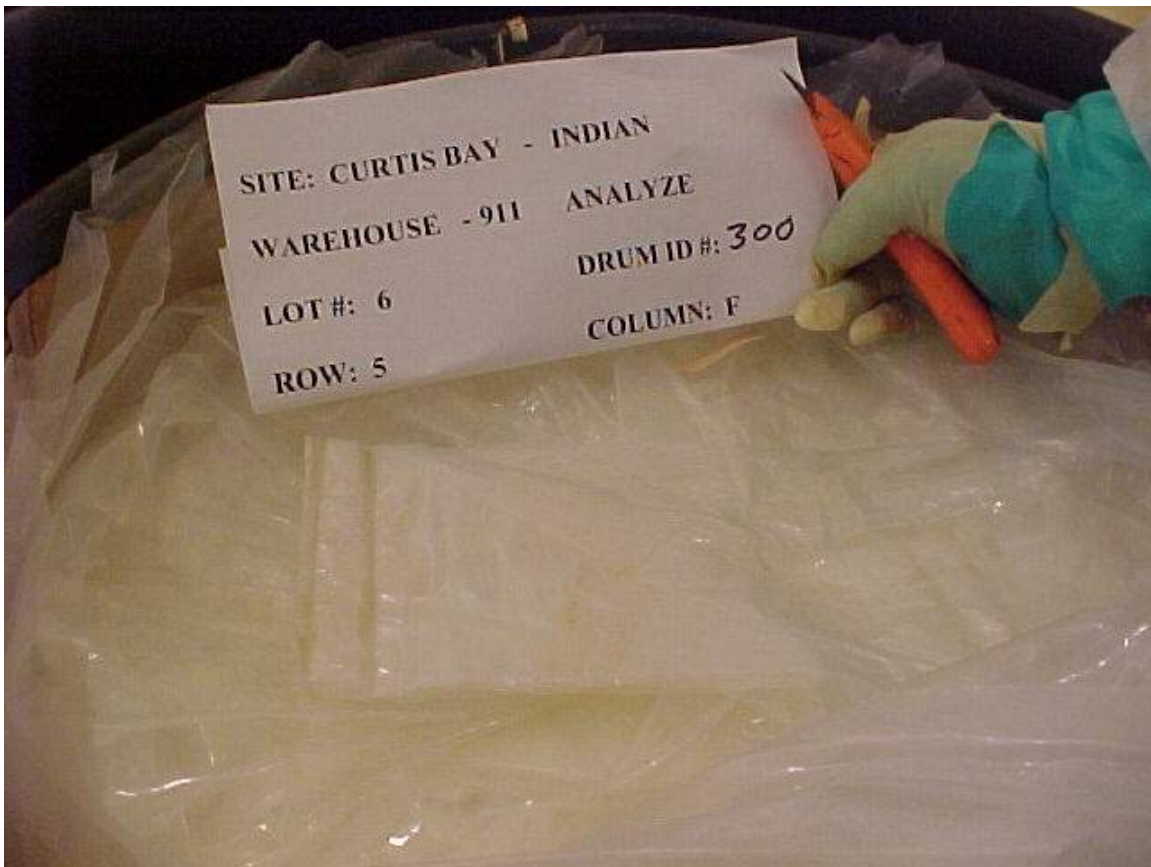
Photo No. 6 of 10

3rd poly liner/bag – good condition
No gasses present

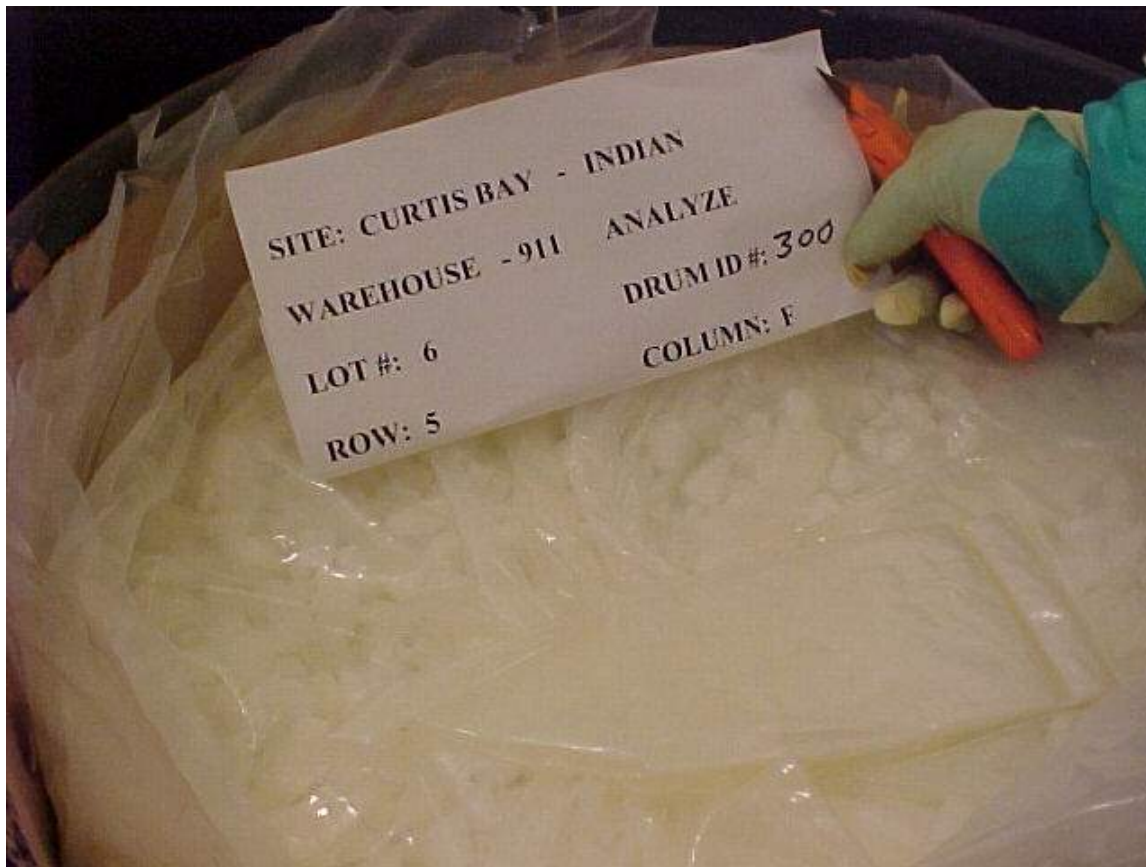
4th poly liner/bag – good condition
No gasses present
