THORIUM NITRATE STOCKPILE DRUM CHARACTERIZATION REPORT

**THORIUM NITRATE STOCKPILE
DRUM CHARACTERIZATION REPORT**

Prepared for
U.S. Defense Logistics Agency
Defense National Stockpile Center
Fort Belvoir, Virginia

Prepared by
OAK RIDGE NATIONAL LABORATORY
Oak Ridge, Tennessee 37831
managed by
UT-BATTELLE, LLC
for the
U.S. DEPARTMENT OF ENERGY
under contract DE-AC05-00OR22725

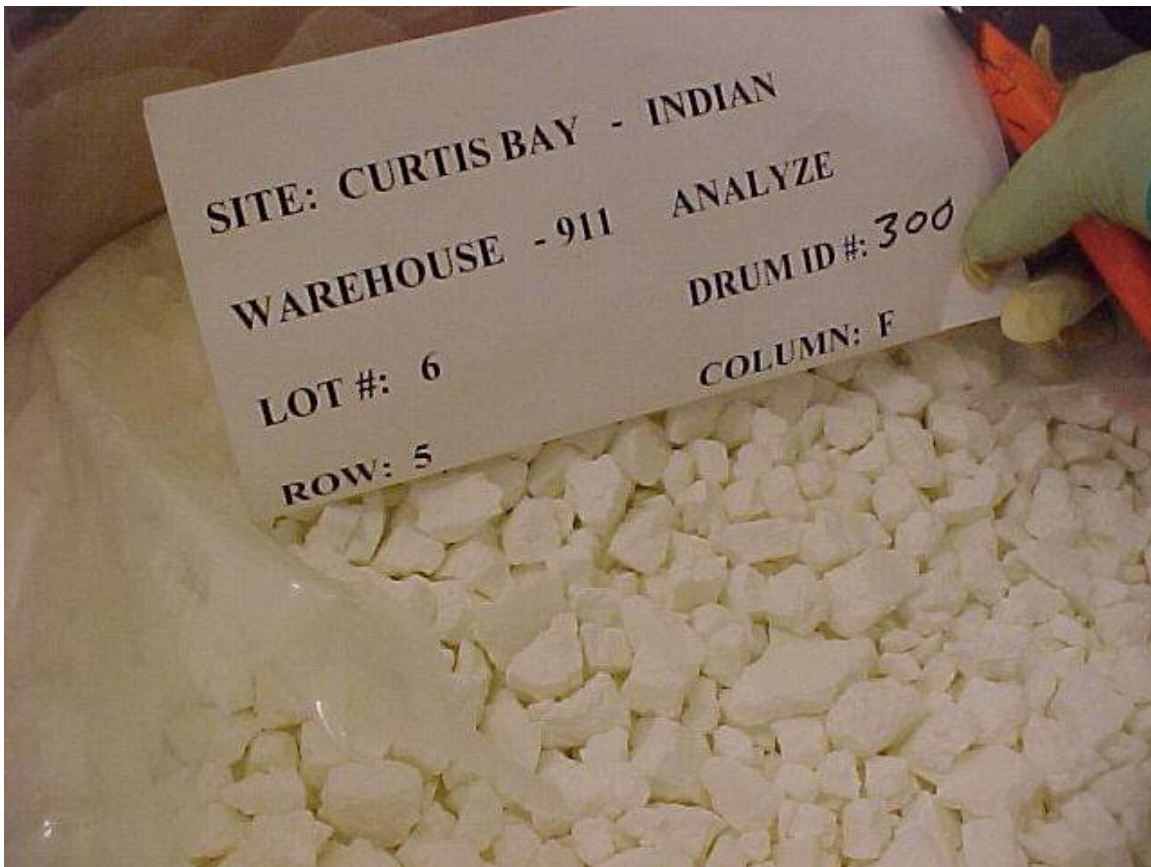
Photo No. 8 of 10

Thorium Nitrate – solid – dry
No gasses present

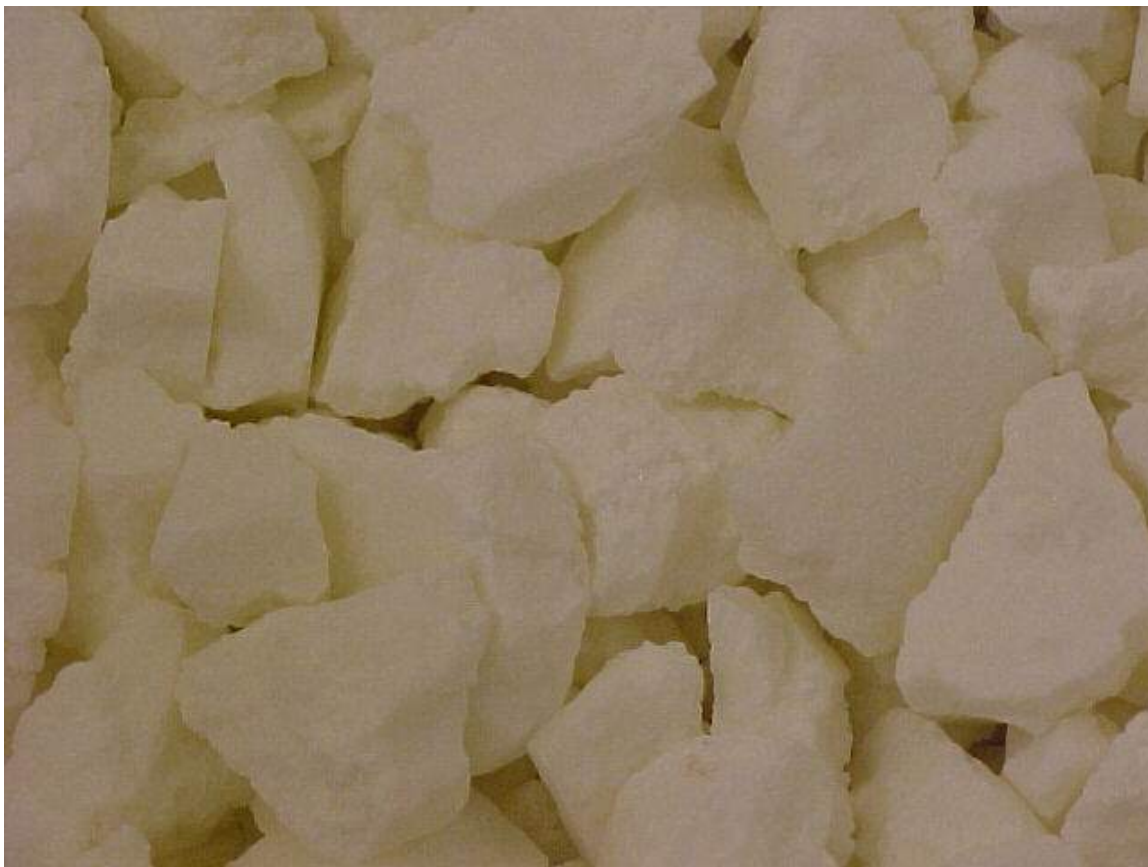
Close-up of Thorium Nitrate particles

No gasses present

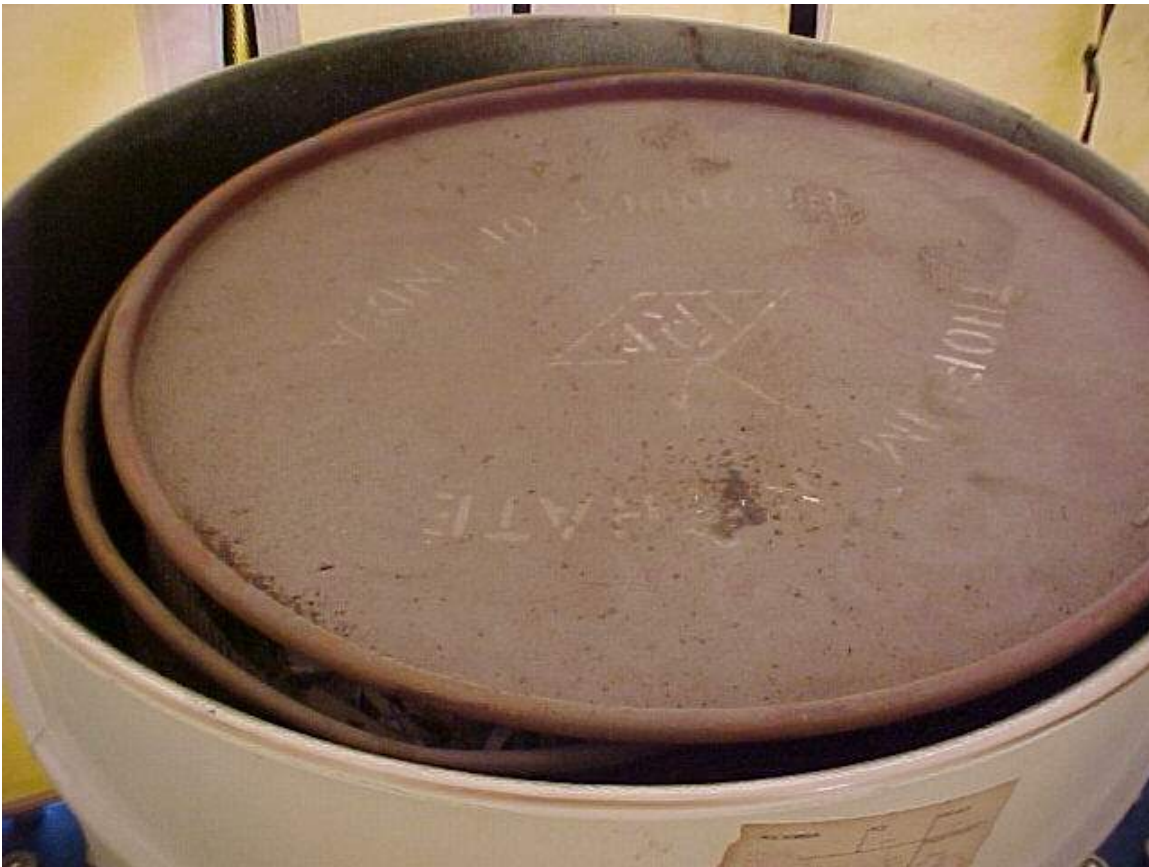
Photo No. 2 of 9

55-gal container – shows the ring already off the drum
No gasses present

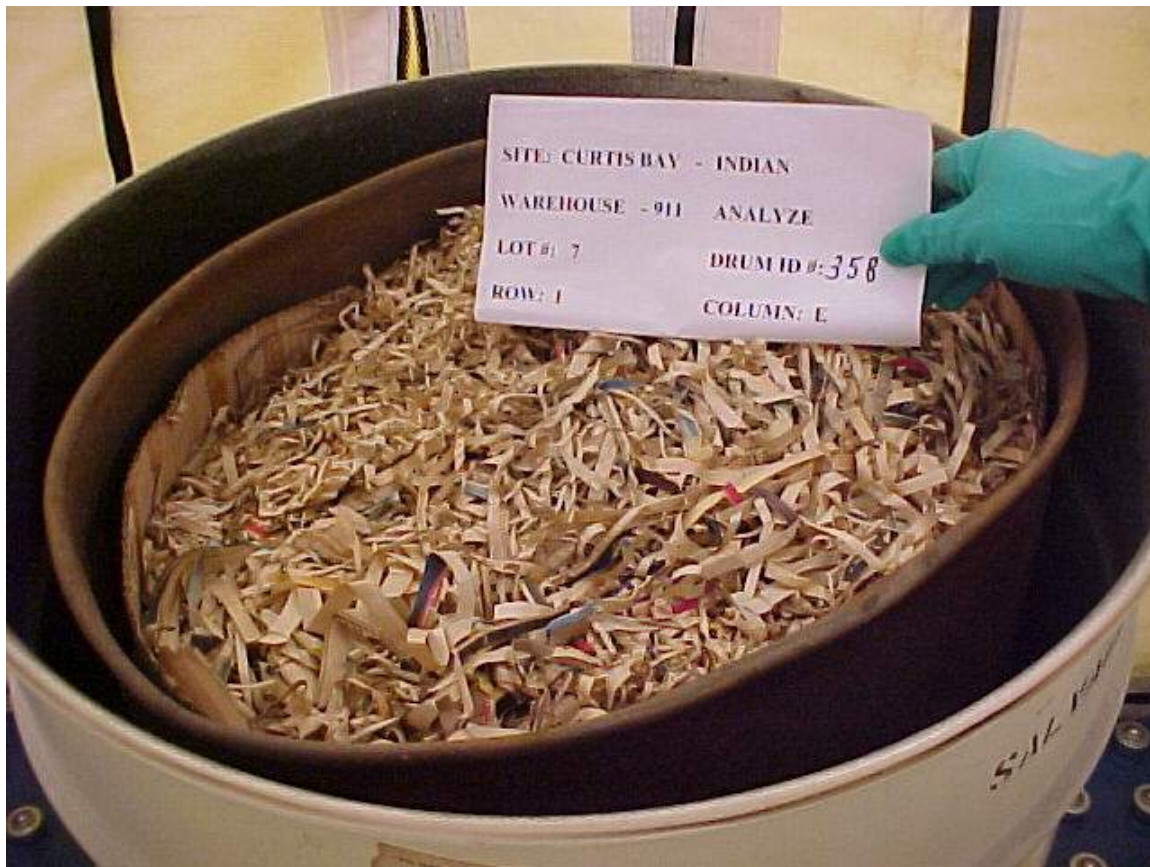
10:00**Other Information**Photo No. 3 of 91st layer – shredded paper

No gasses present

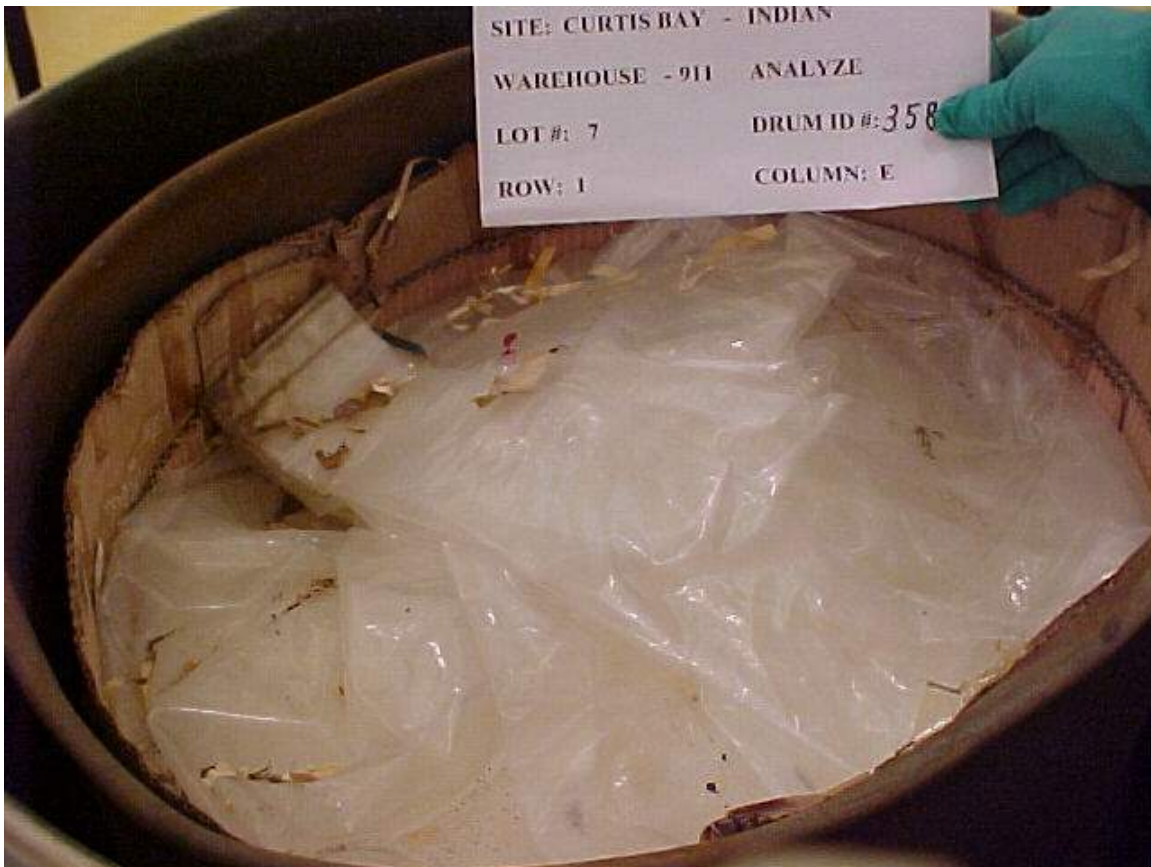
Photo No. 4 of 9

1st poly liner/bag – good condition
No gasses present

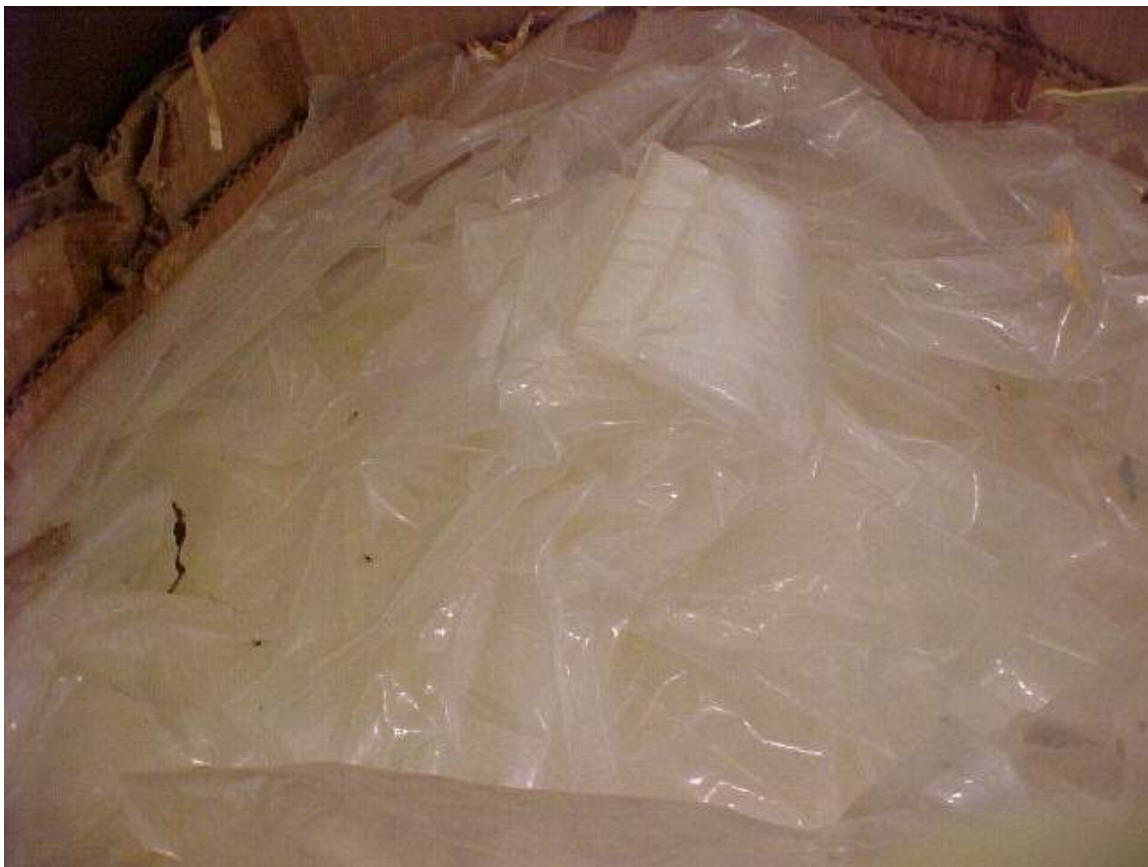
10:00**Other Information**Photo No. 5 of 92nd poly liner/bag – good condition

No gasses present

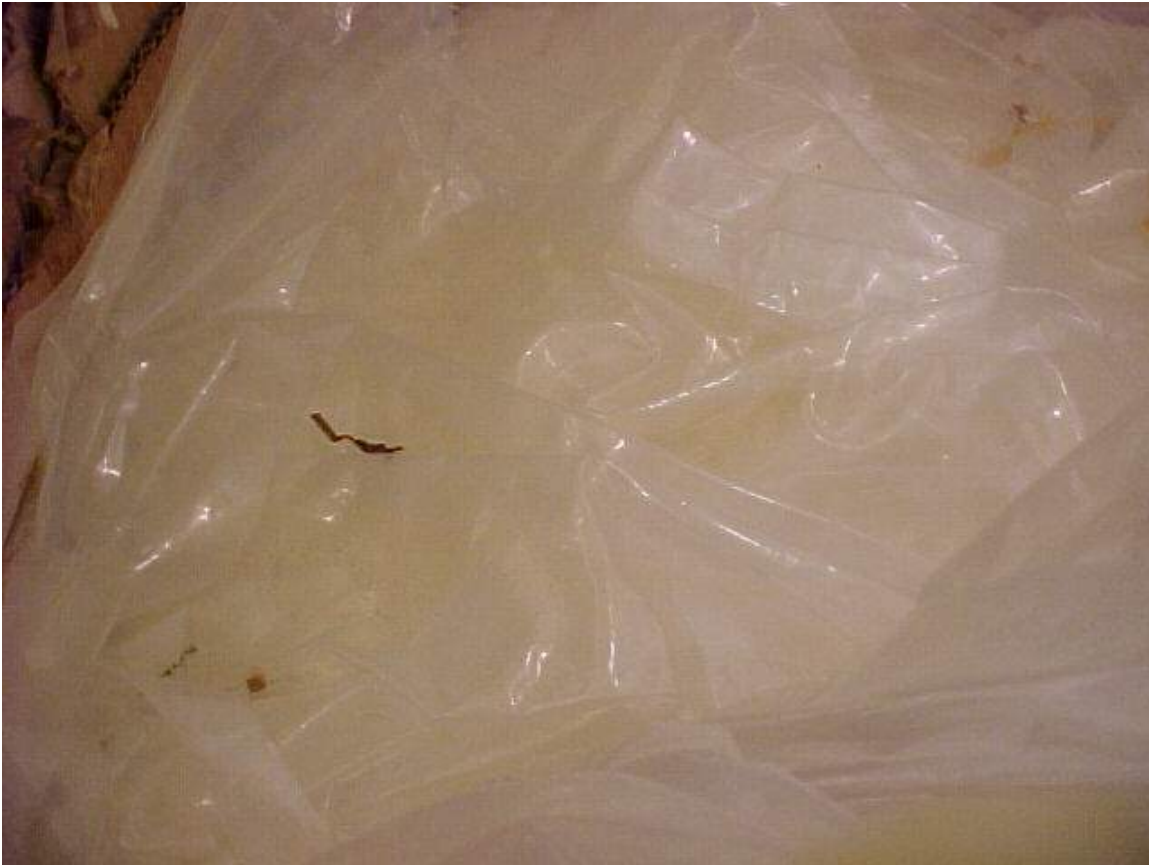
Photo No. 6 of 9

3rd poly liner/bag – good condition
No gasses present

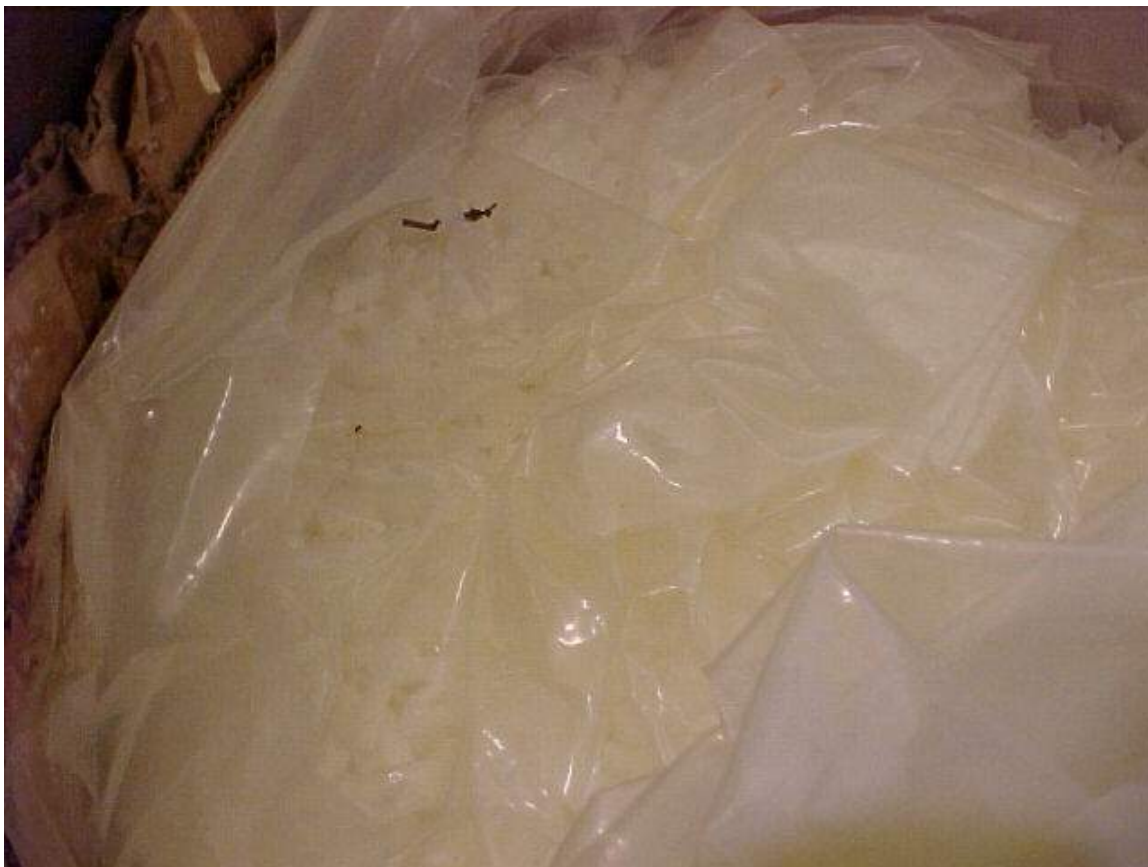
4th poly liner/bag – good condition
No gasses present

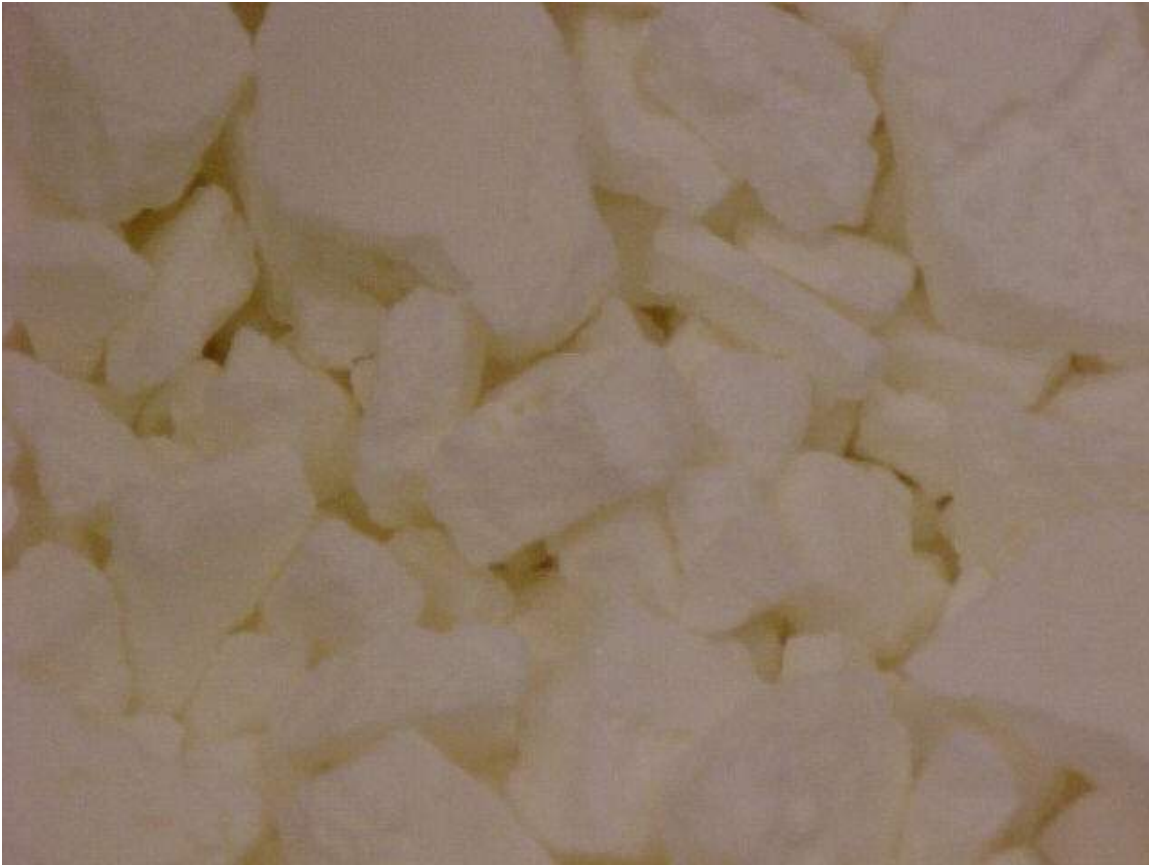
Photo No. 8 of 9

Thorium Nitrate – gravel looking – solid – dry
No gasses present

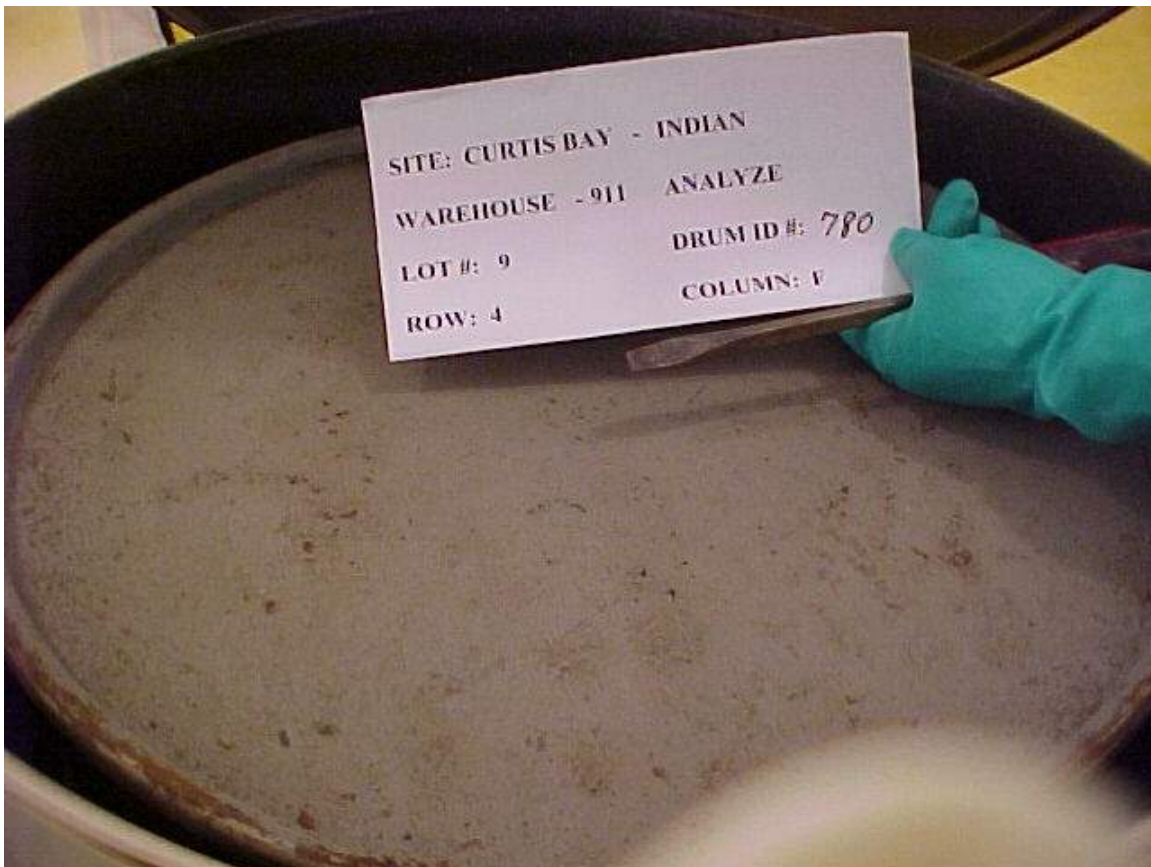
Photo No. 2 of 9

55-gal container – there was no ring on the 55-gal drum
No gasses present

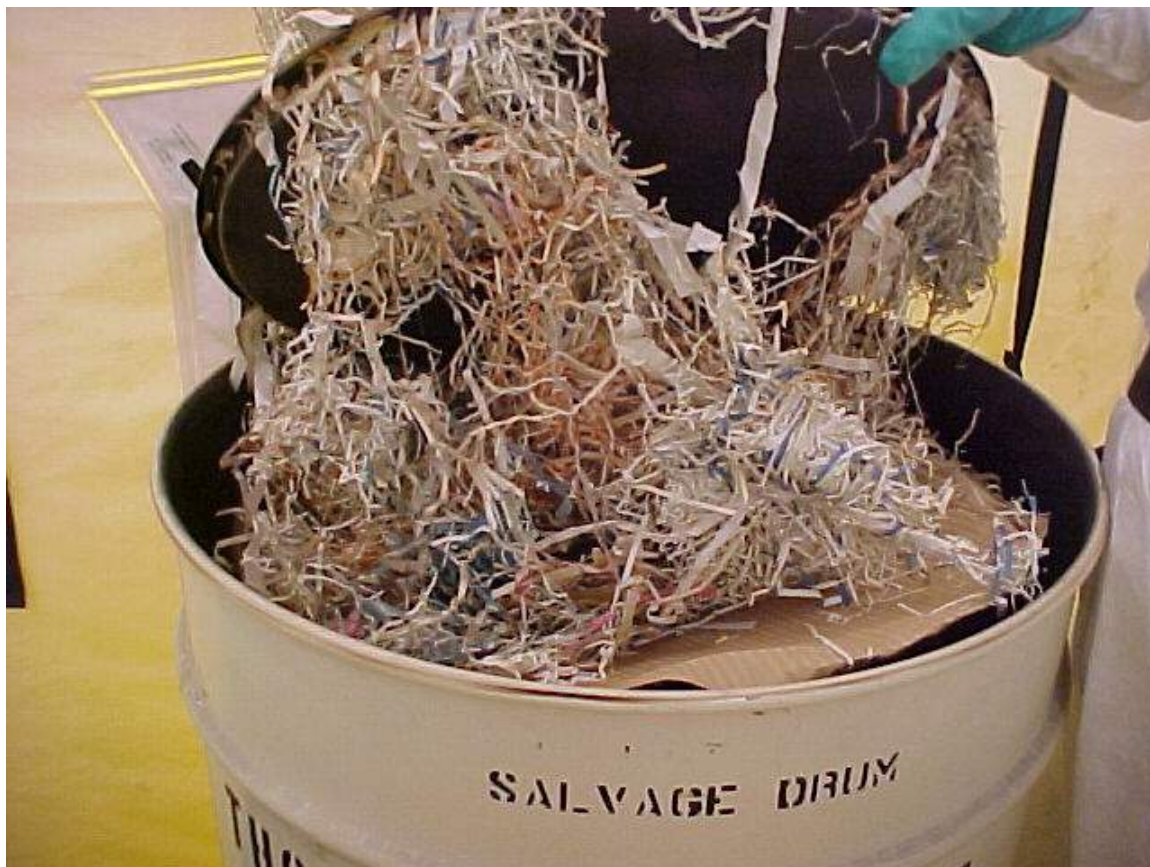
Shredded paper in container

No gasses present

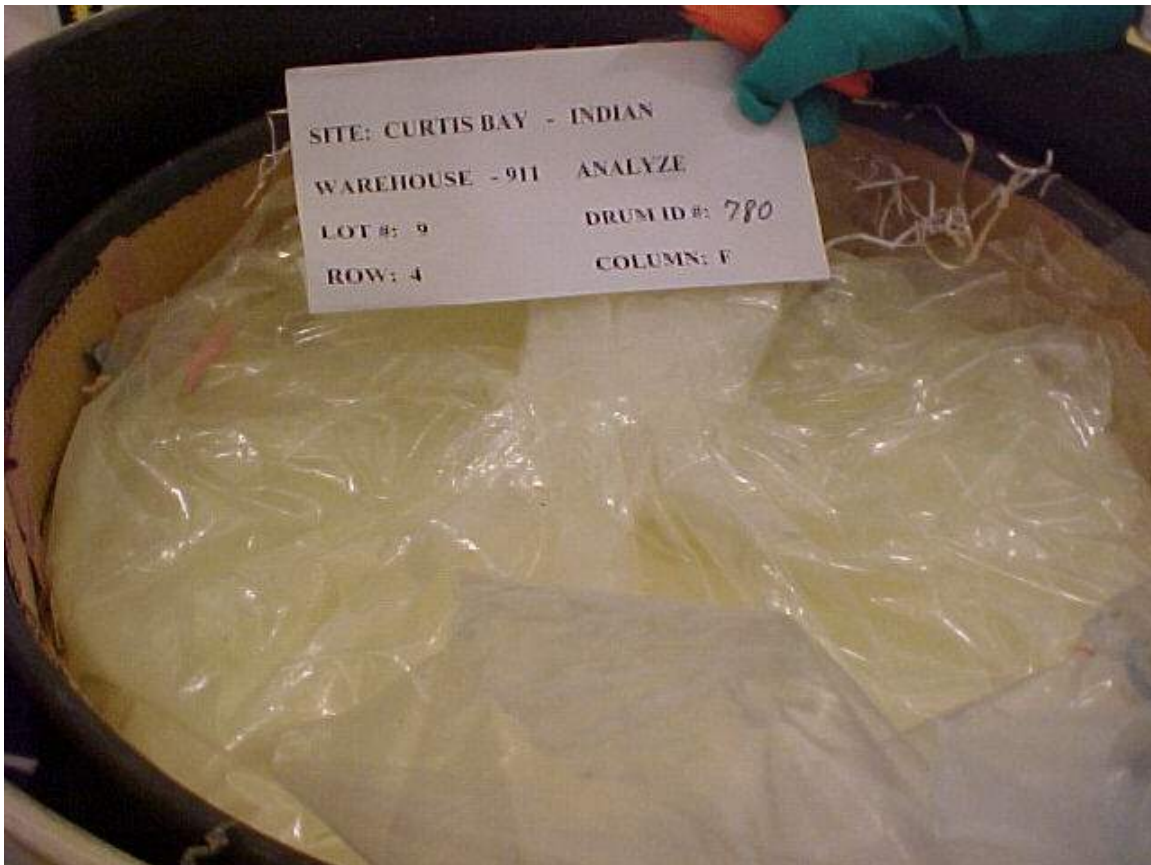
Photo No. 4 of 9

1st poly liner/bag – good condition
No gasses present

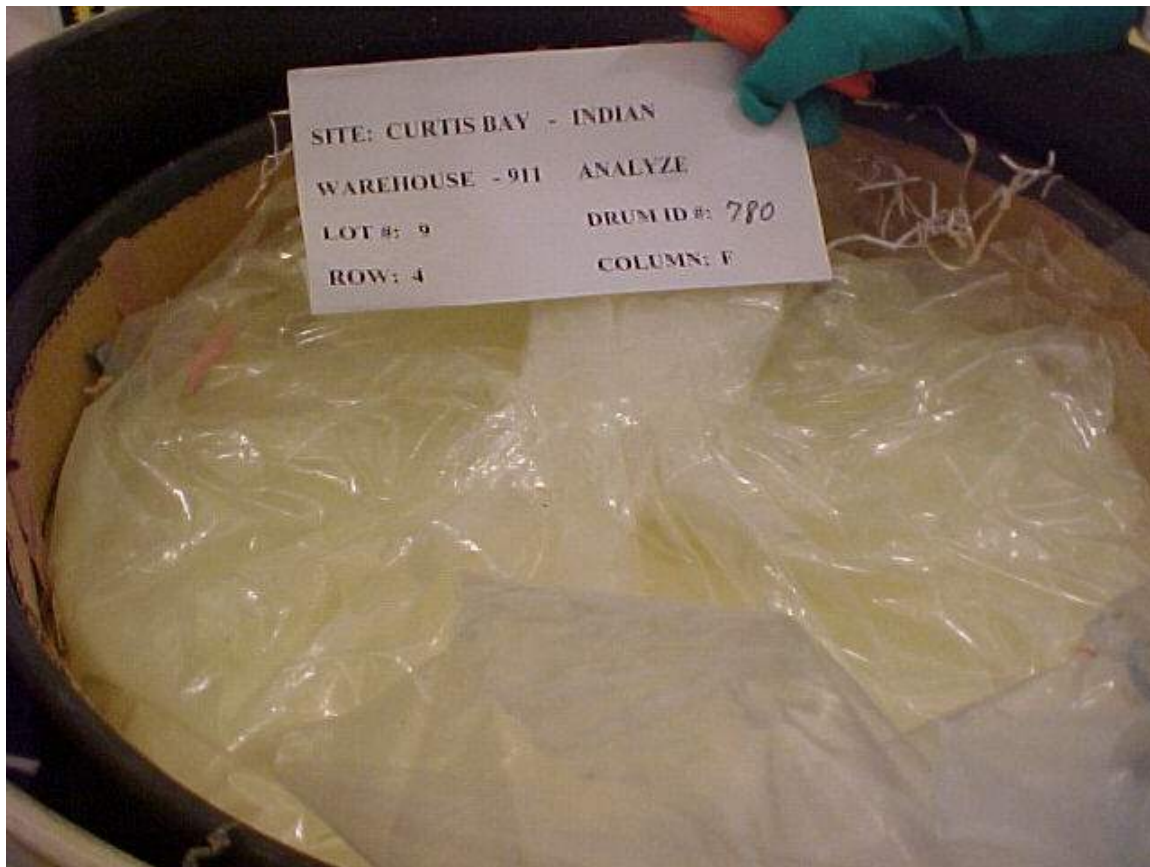
09:15**Other Information**Photo No. 5 of 92nd poly liner/bag – good condition

No gasses present

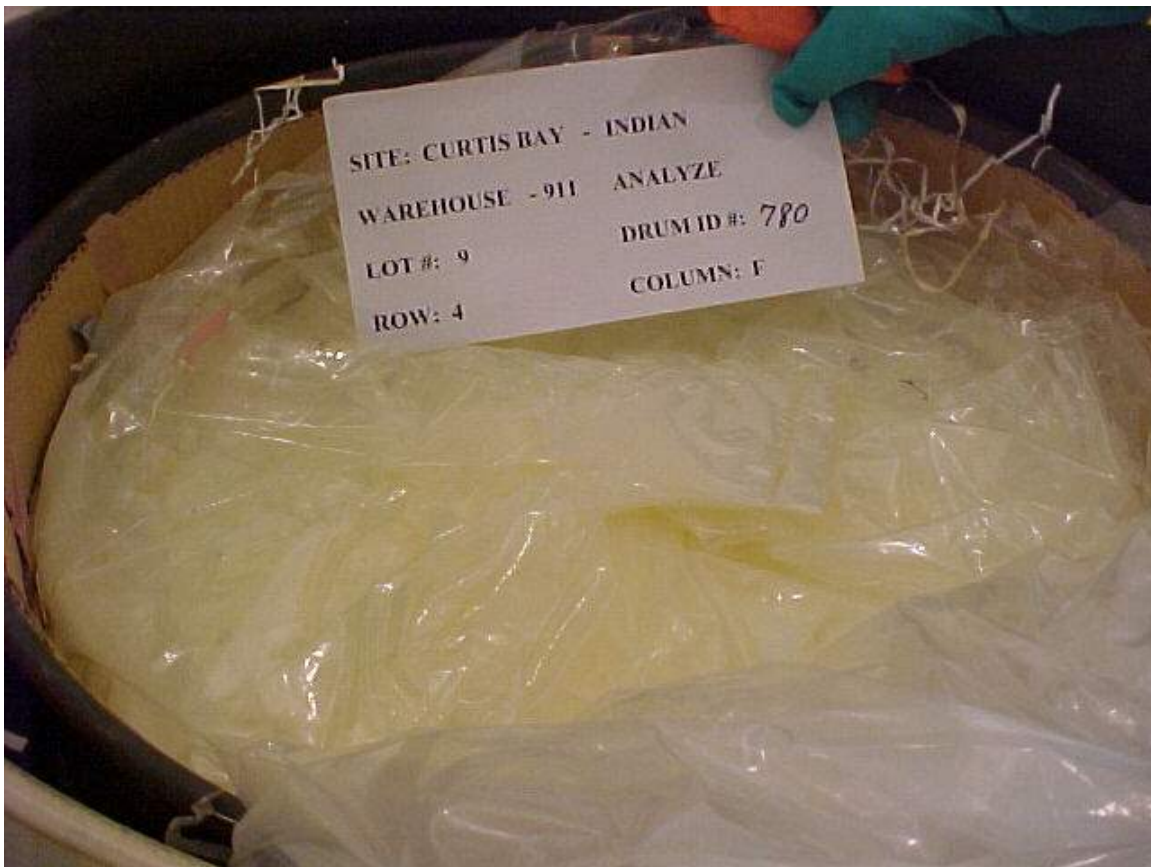
Photo No. 6 of 9

3rd poly liner/bag – good condition
No gasses present

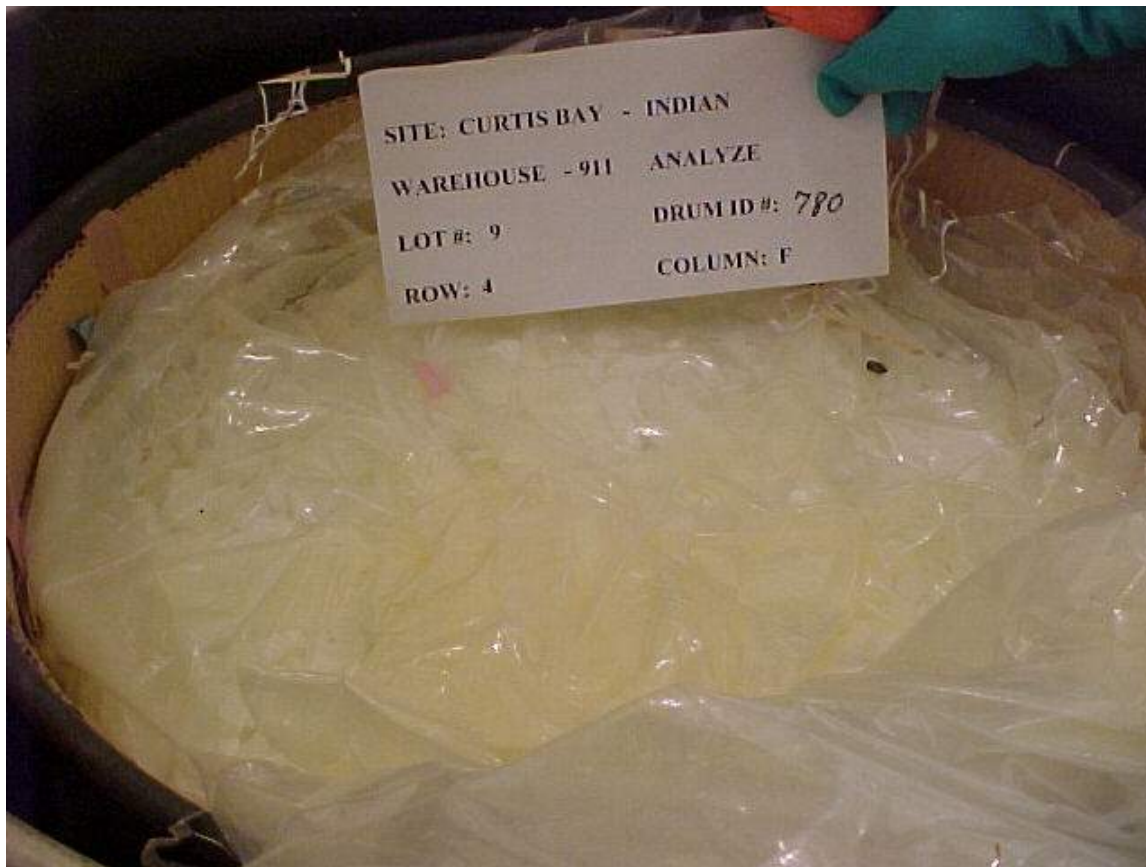
09:15**Other Information**Photo No. 7 of 9

4th poly liner/bag – good condition
No gasses present

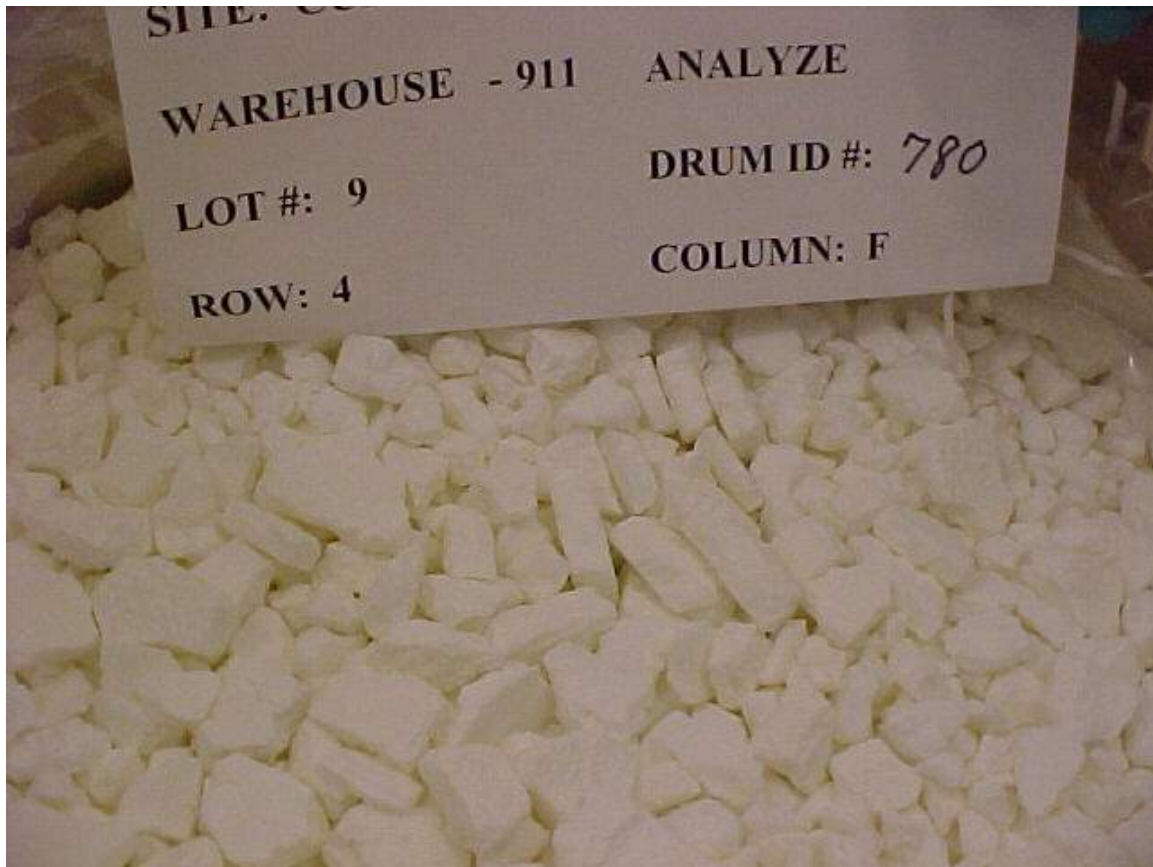
Photo No. 8 of 9

Indian – Thorium Nitrate – gravel looking – solid – dry
No gasses present

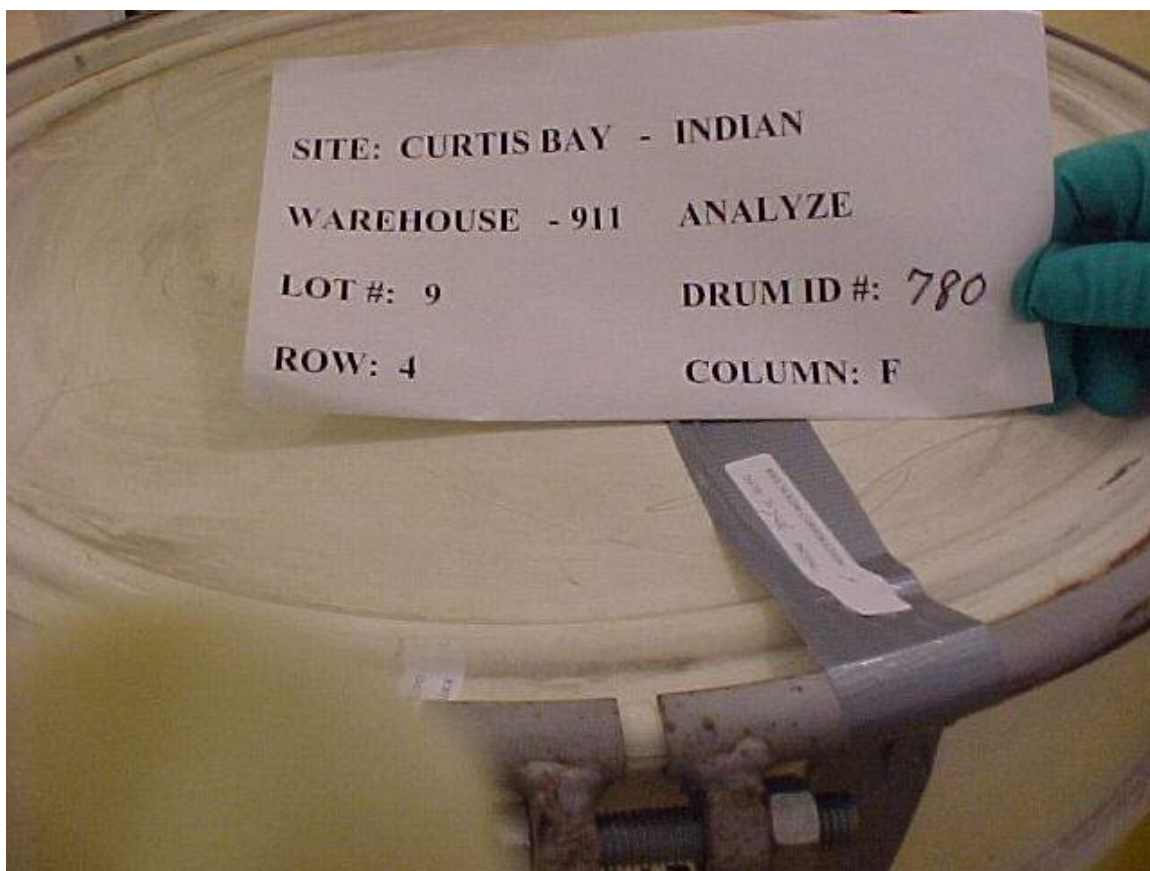
Sealed & dated - complete

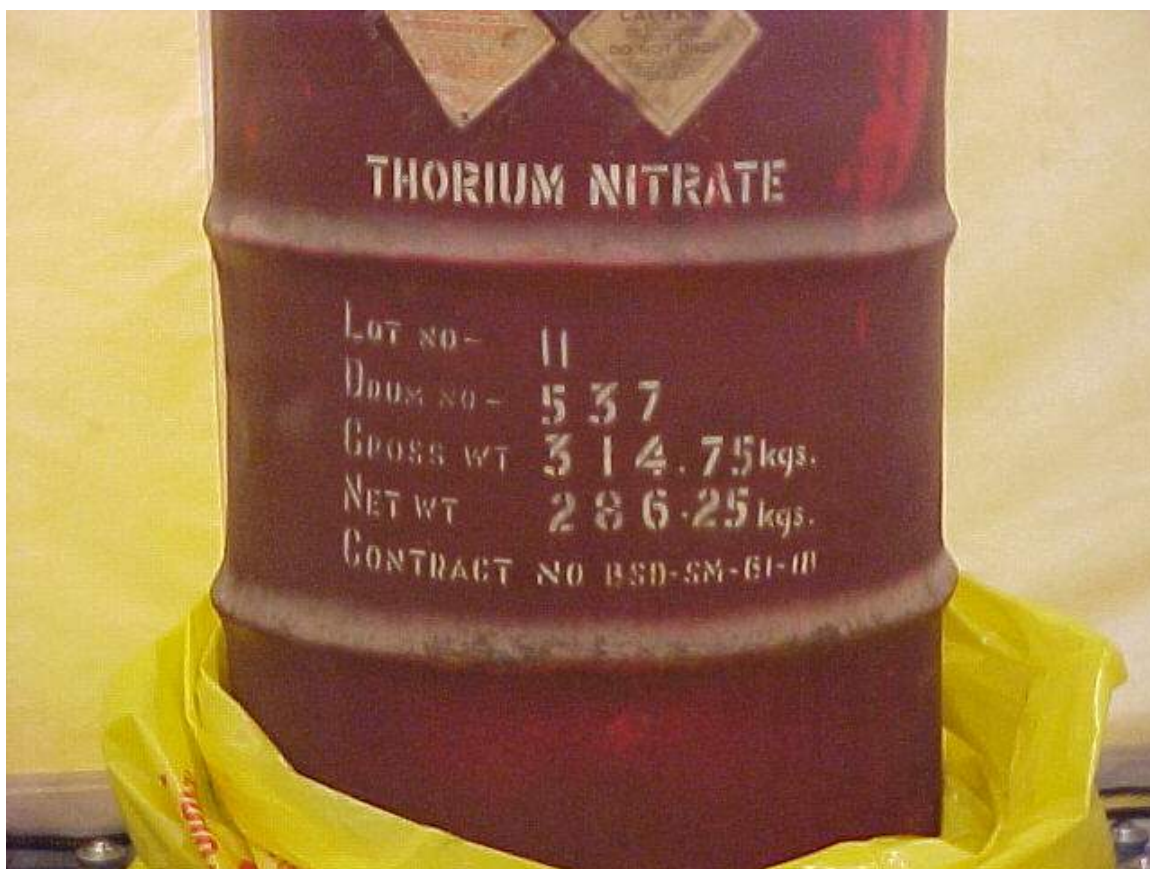
General InformationSite Curtis BayThN Origin IndianLot No. 11Drum ID No. 537Inspection/Sample
DispositionVisual Inspection & Sampling
Analyze**Physical Location of Drum**Warehouse 911Row 8
Column F**Inspection/Sample Date & Time**Date 7-2-2002Time 10:50**Other Information**Photo No. 1 of 8Container 55-gallon steel drumContainer
Condition FairContainer Wall Thickness 0.1565 inDose Rate Surface 44.0 mR/hr
1 meter 4.0 mR/hr

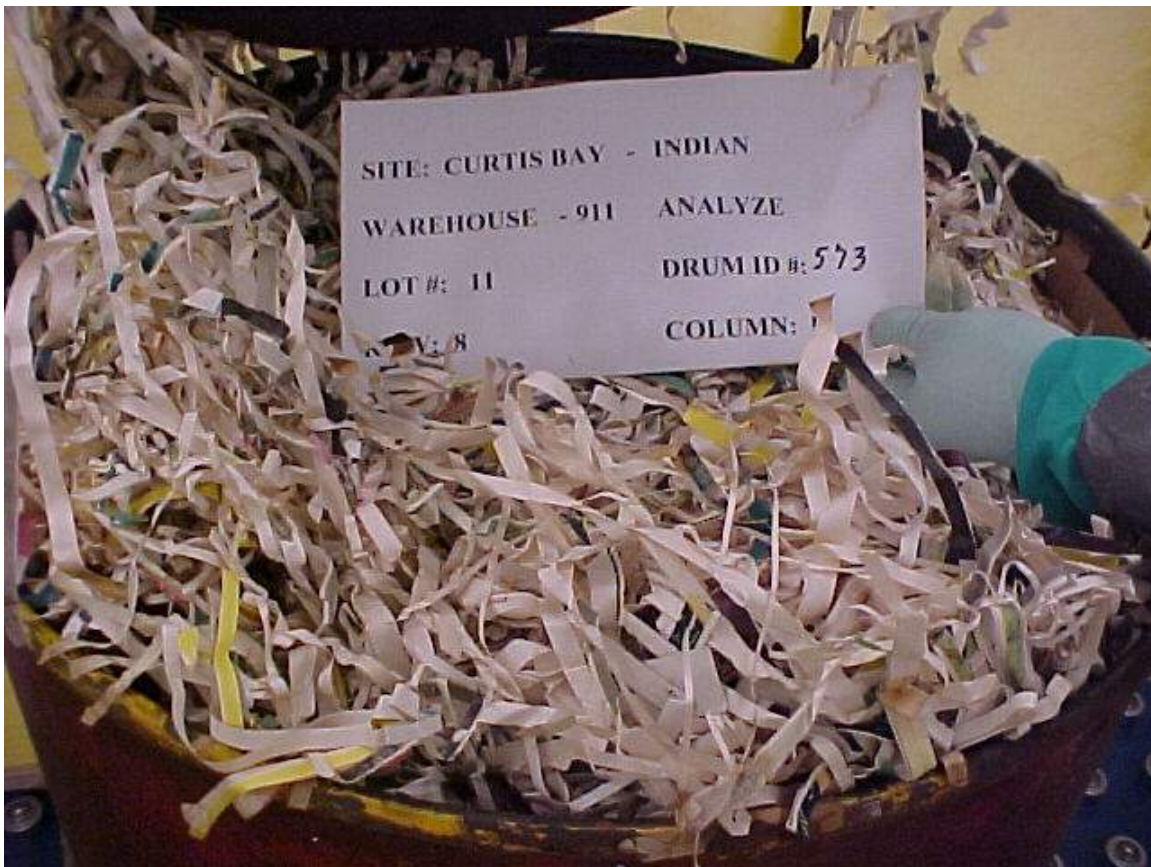
Shredded paper for packaging

No gasses present

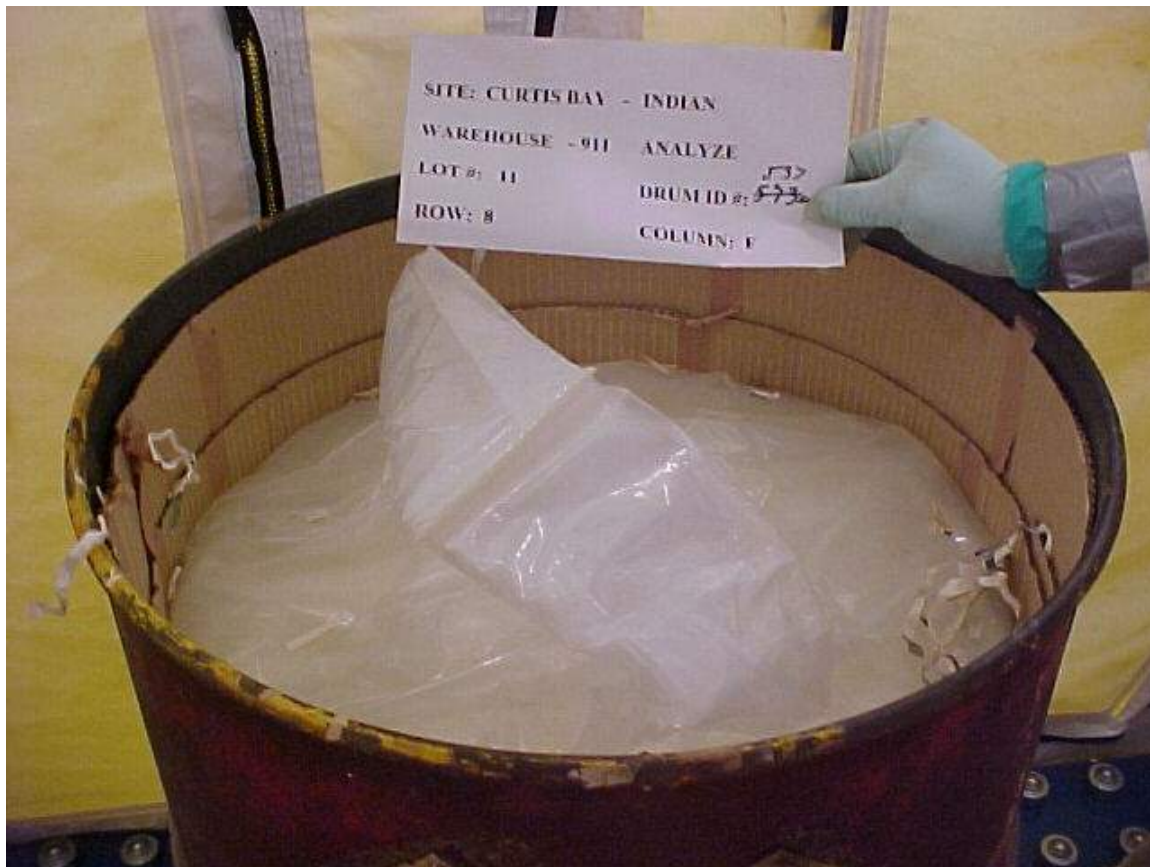
10:50**Other Information**Photo No. 3 of 81st poly liner/bag – good condition

No gasses present

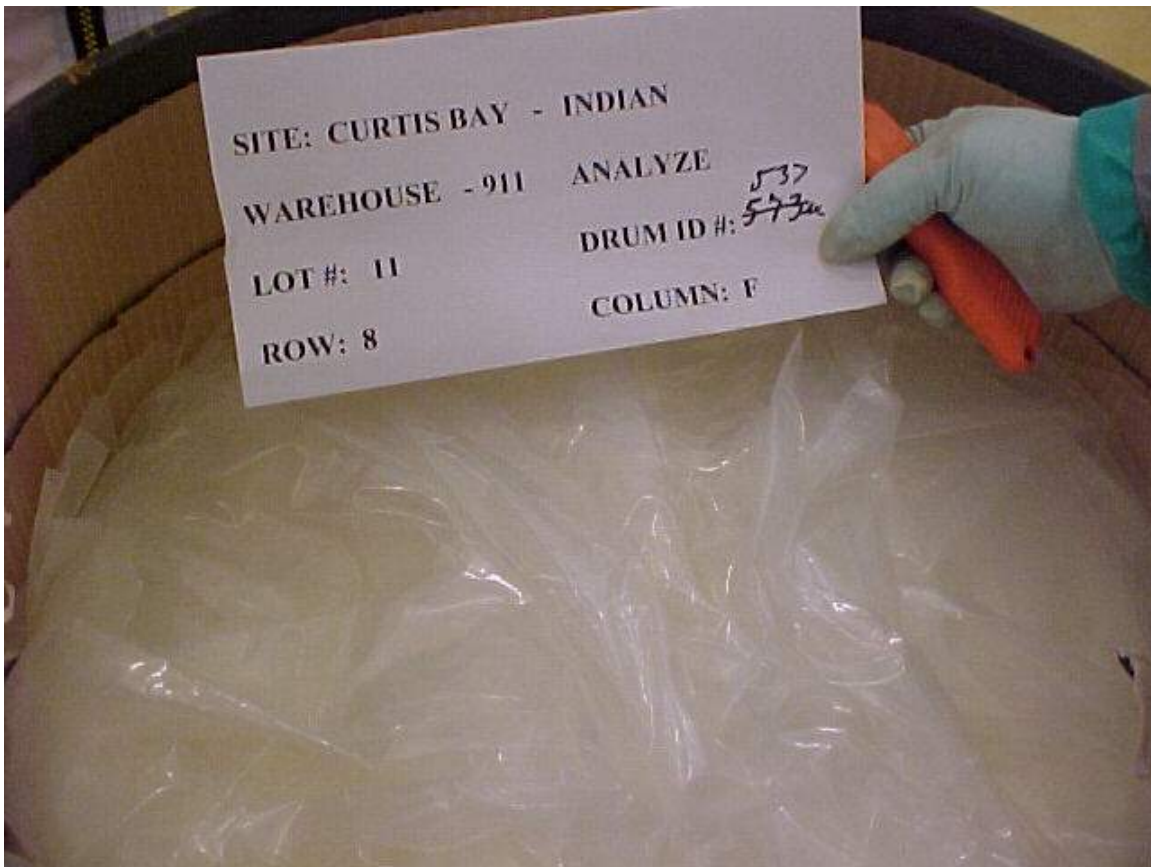
Photo No. 4 of 8

2nd poly liner/bag – good condition
No gasses present

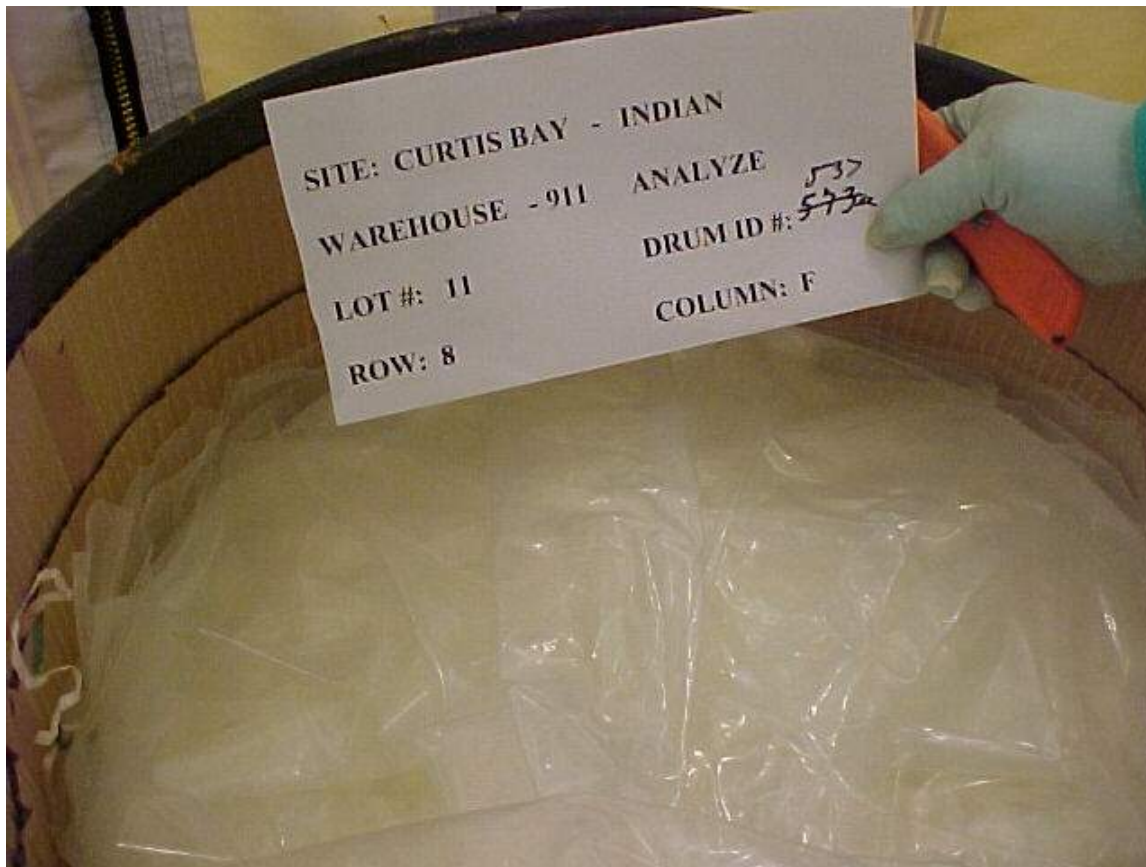
General InformationSite Curtis BayThN Origin IndianLot No. 11Drum ID No. 537Inspection/Sample
DispositionVisual Inspection & Sampling
Analyze**Physical Location of Drum**Warehouse 911Row 8
Column F**Inspection/Sample Date & Time**Date 7-2-2002Time 10:50**Other Information**Photo No. 5 of 83rd poly liner/bag – good condition

No gasses present
