THORIUM NITRATE STOCKPILE DRUM CHARACTERIZATION REPORT

**THORIUM NITRATE STOCKPILE
DRUM CHARACTERIZATION REPORT**

Prepared for
U.S. Defense Logistics Agency
Defense National Stockpile Center
Fort Belvoir, Virginia

Prepared by
OAK RIDGE NATIONAL LABORATORY
Oak Ridge, Tennessee 37831
managed by
UT-BATTELLE, LLC
for the
U.S. DEPARTMENT OF ENERGY
under contract DE-AC05-00OR22725

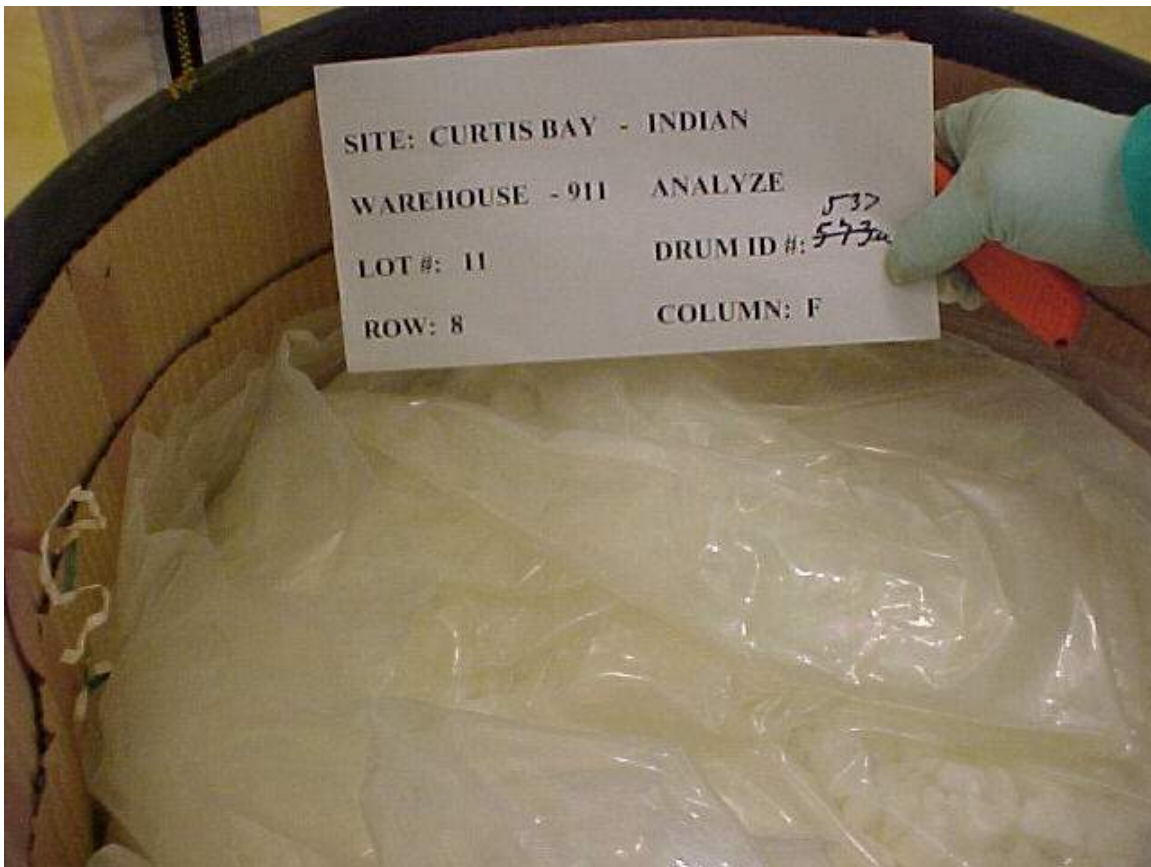
Photo No. 6 of 8

4th poly liner/bag – good condition
No gasses present

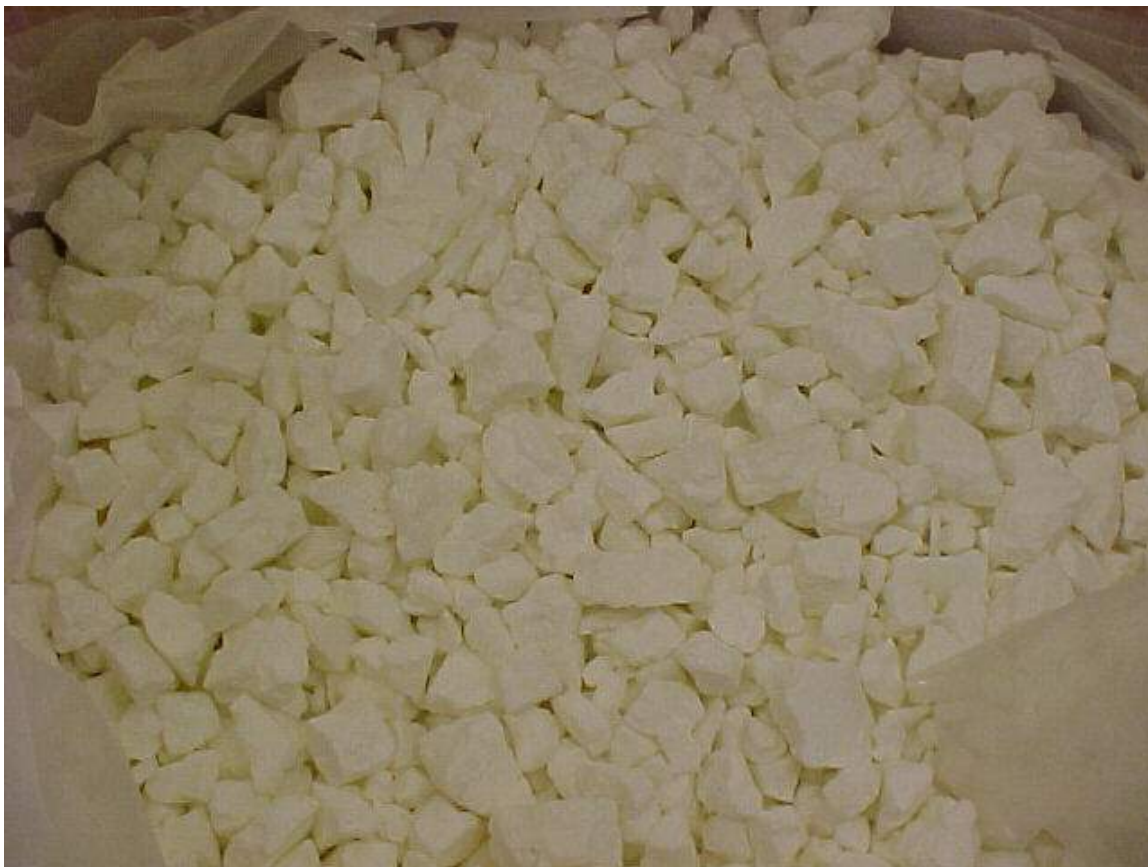
10:50**Other Information**Photo No. 7 of 8

Thorium Nitrate – white gravel looking – solid – dry
No gasses present

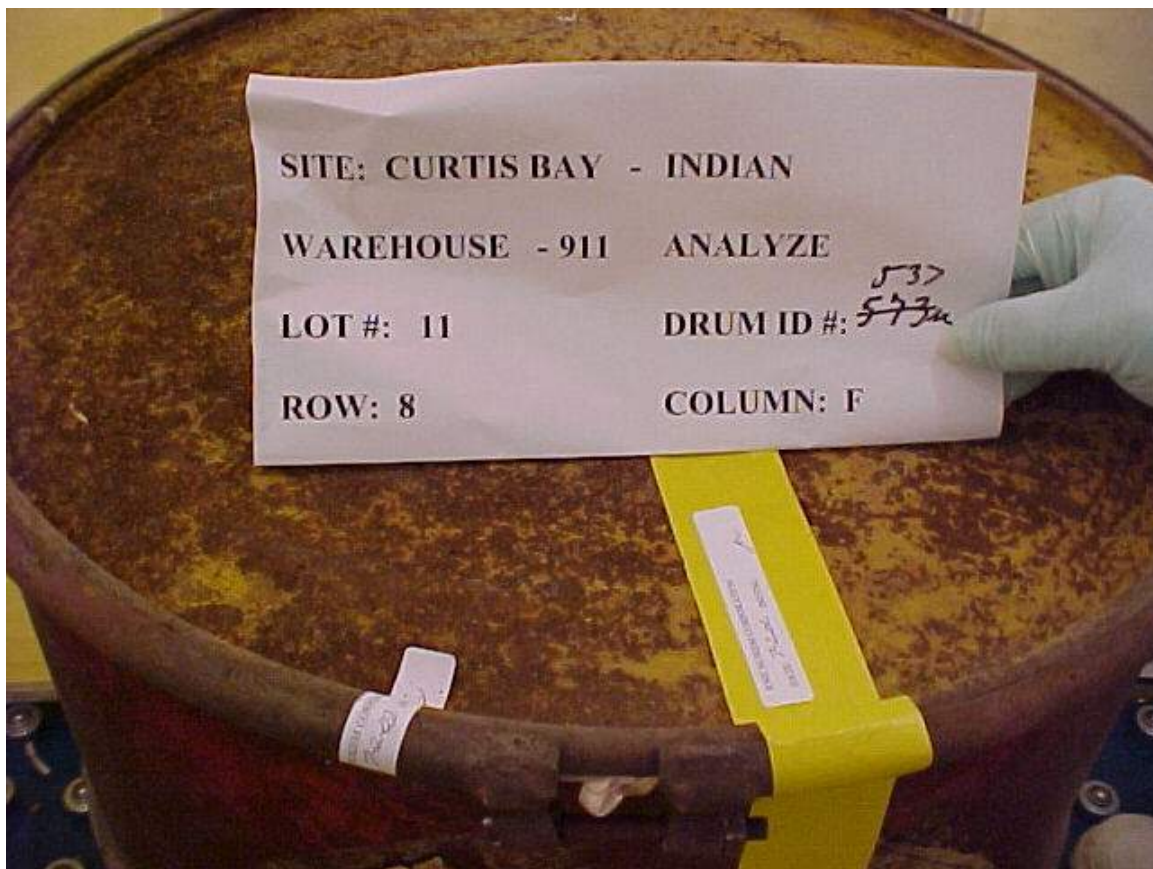
Photo No. 8 of 8

Sealed & dated - complete

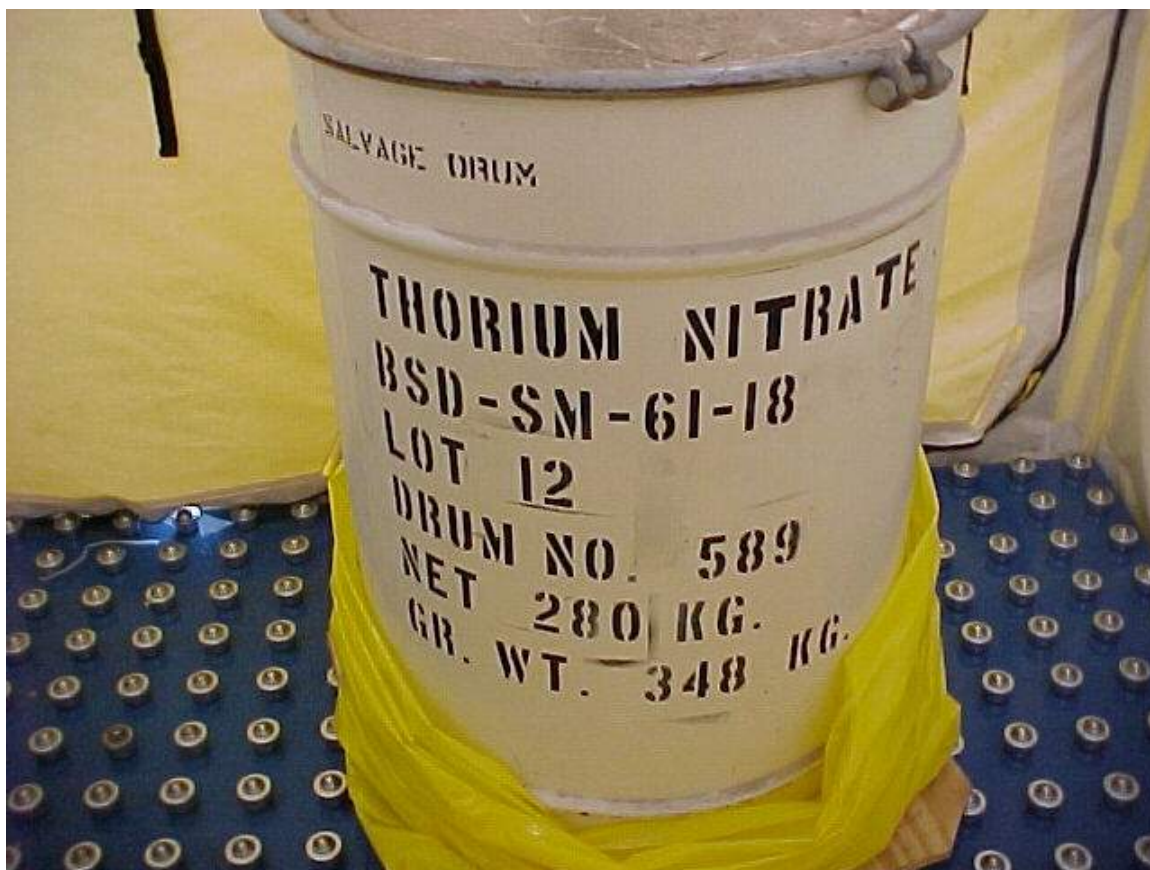
General InformationSite Curtis BayThN Origin IndianLot No. 12Drum ID No. 589Inspection/Sample
DispositionVisual Inspection & Sampling
Analyze**Physical Location of Drum**Warehouse 911Row 9
Column F**Inspection/Sample Date & Time**Date 7-2-2002Time 9:50**Other Information**Photo No. 1 of 9Container 85-gallon steel drumContainer
Condition GoodDose Rate Surface 35.0 mR/hr
 1 meter 4.2 mR/hr

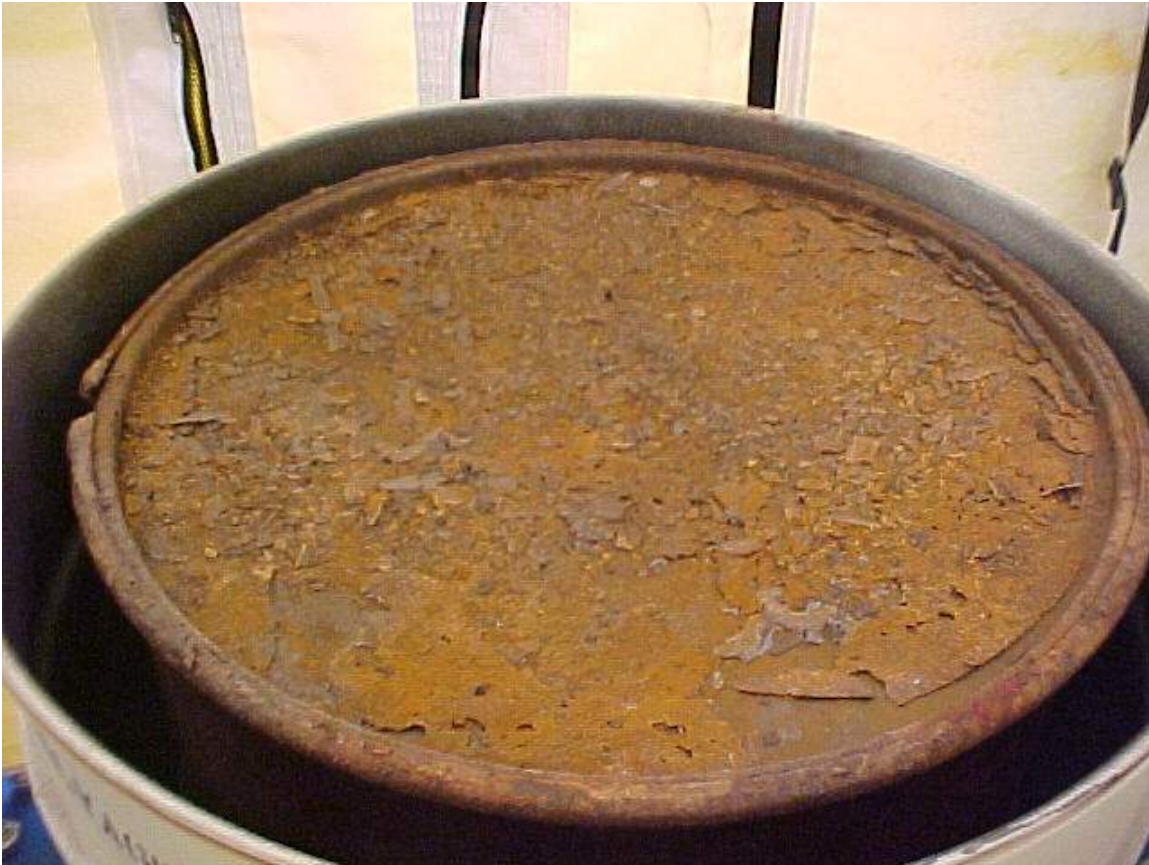
55 gal drum – ring was not on – lid in poor/fair condition

No gasses present

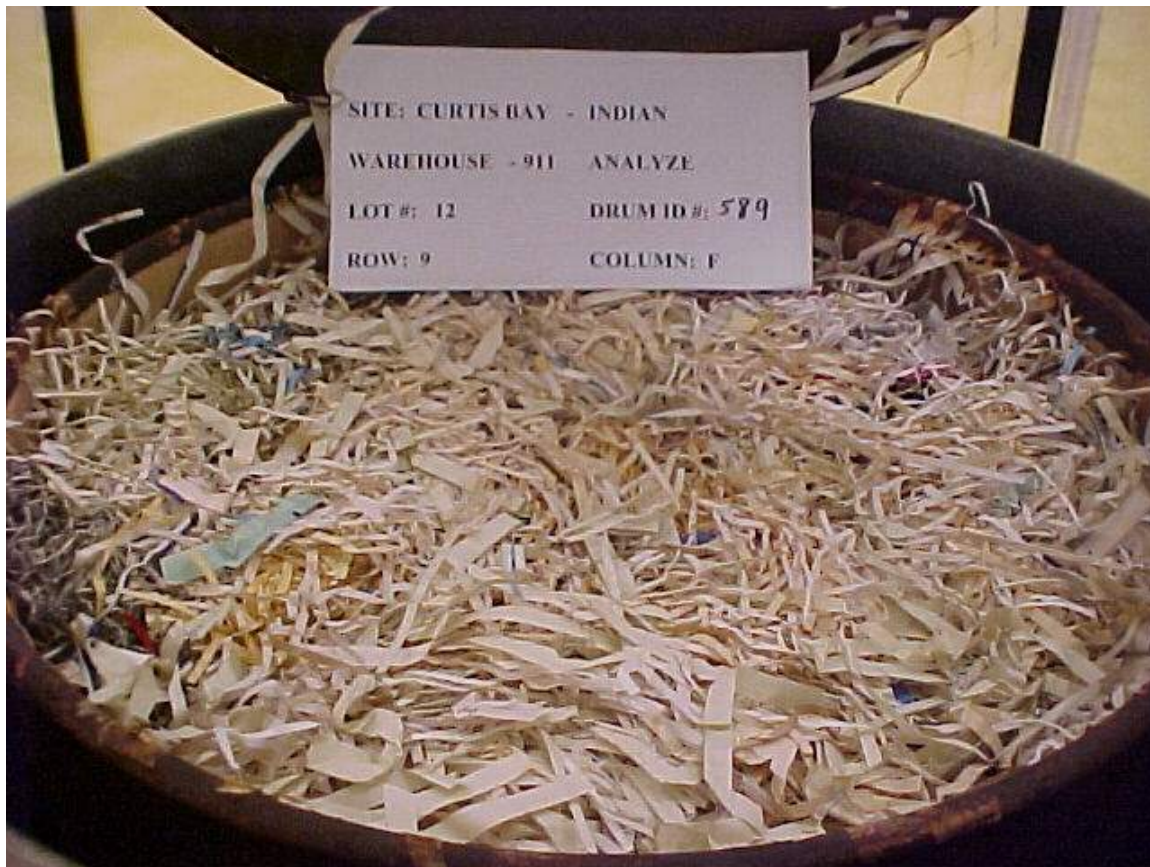
Shredded paper for packaging

No gasses present

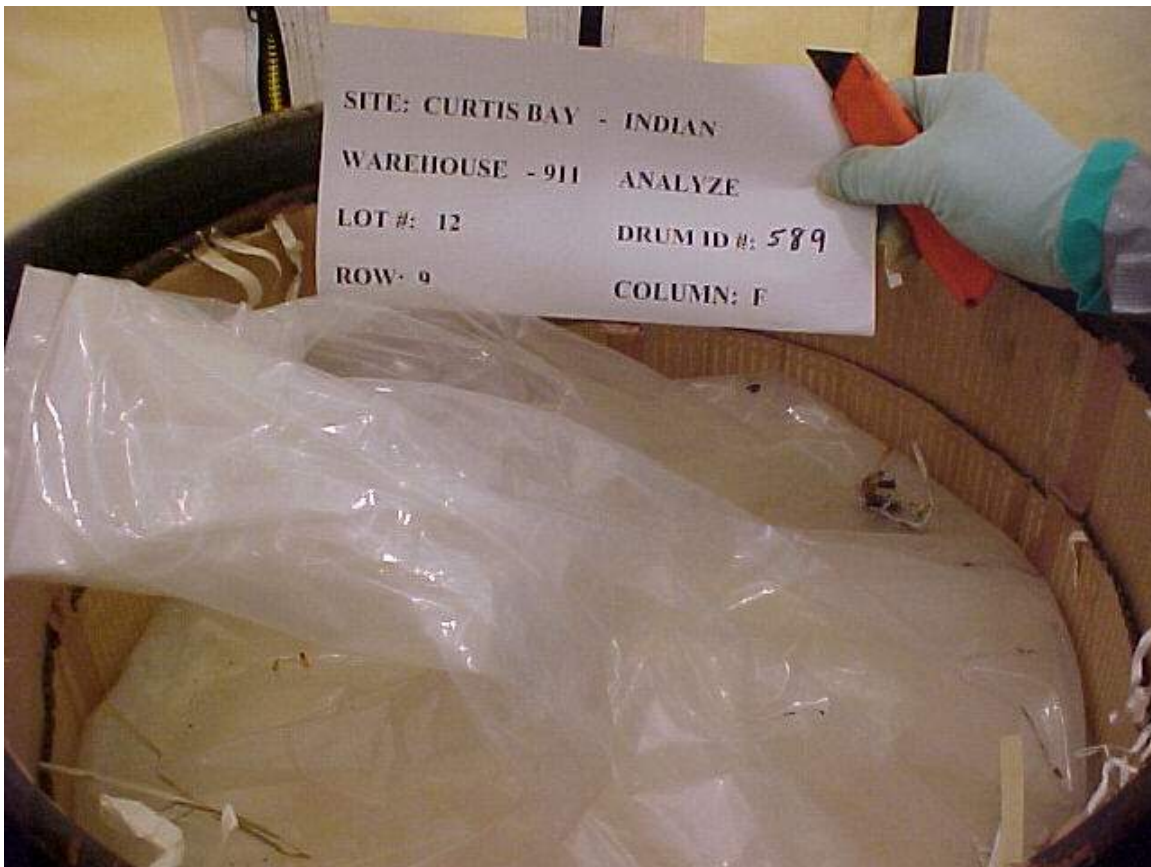
Photo No. 4 of 9

1st poly liner/bag – good condition
No gasses present

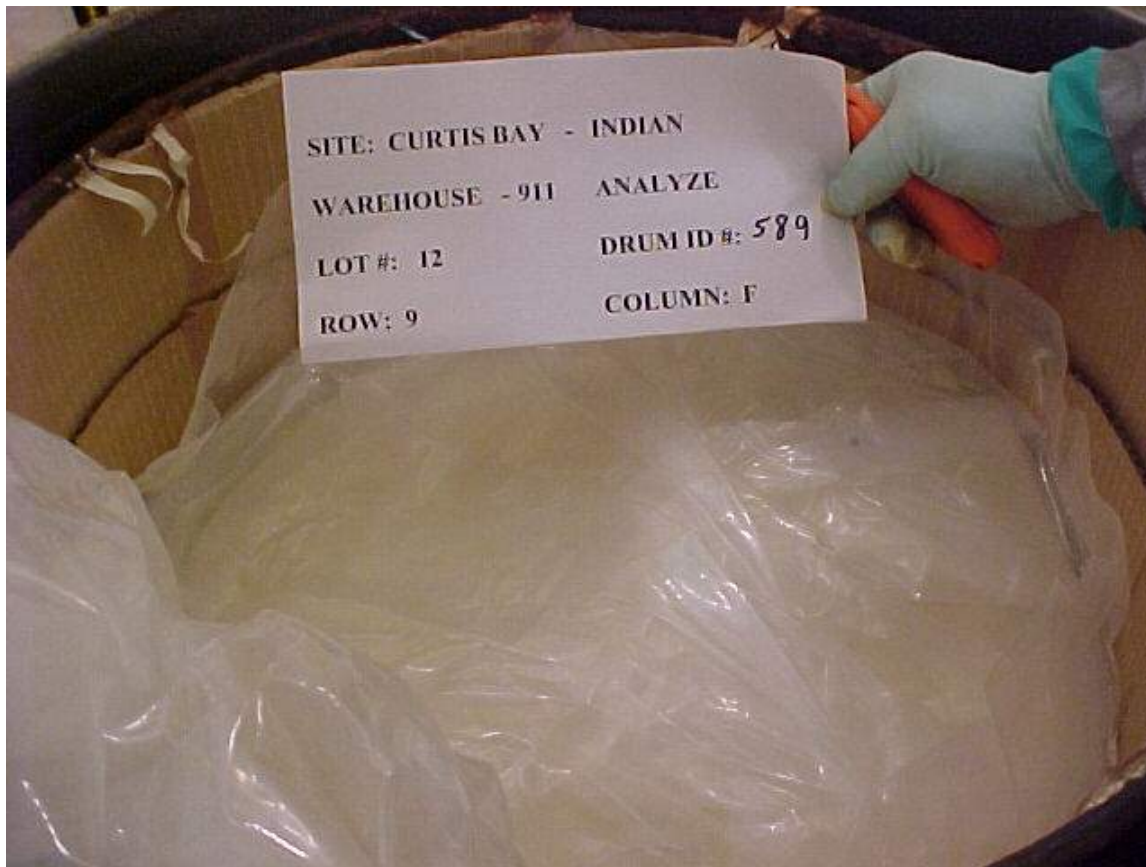
General InformationSite Curtis BayThN Origin IndianLot No. 12Drum ID No. 589Inspection/Sample
DispositionVisual Inspection & Sampling
Analyze**Physical Location of Drum**Warehouse 911Row 9
Column F**Inspection/Sample Date & Time**Date 7-2-2002Time 9:50**Other Information**Photo No. 5 of 92nd poly liner/bag – good condition

No gasses present

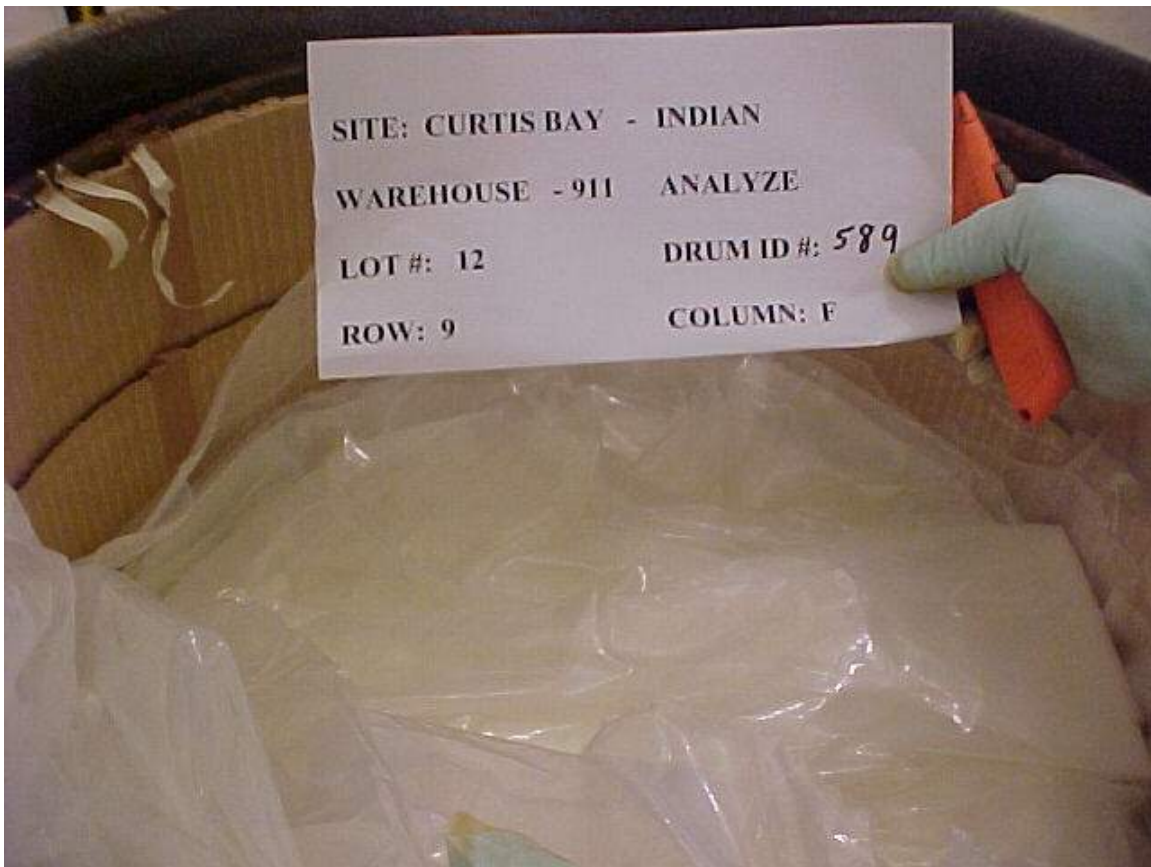
Photo No. 6 of 9

3rd poly liner/bag – good condition
No gasses present

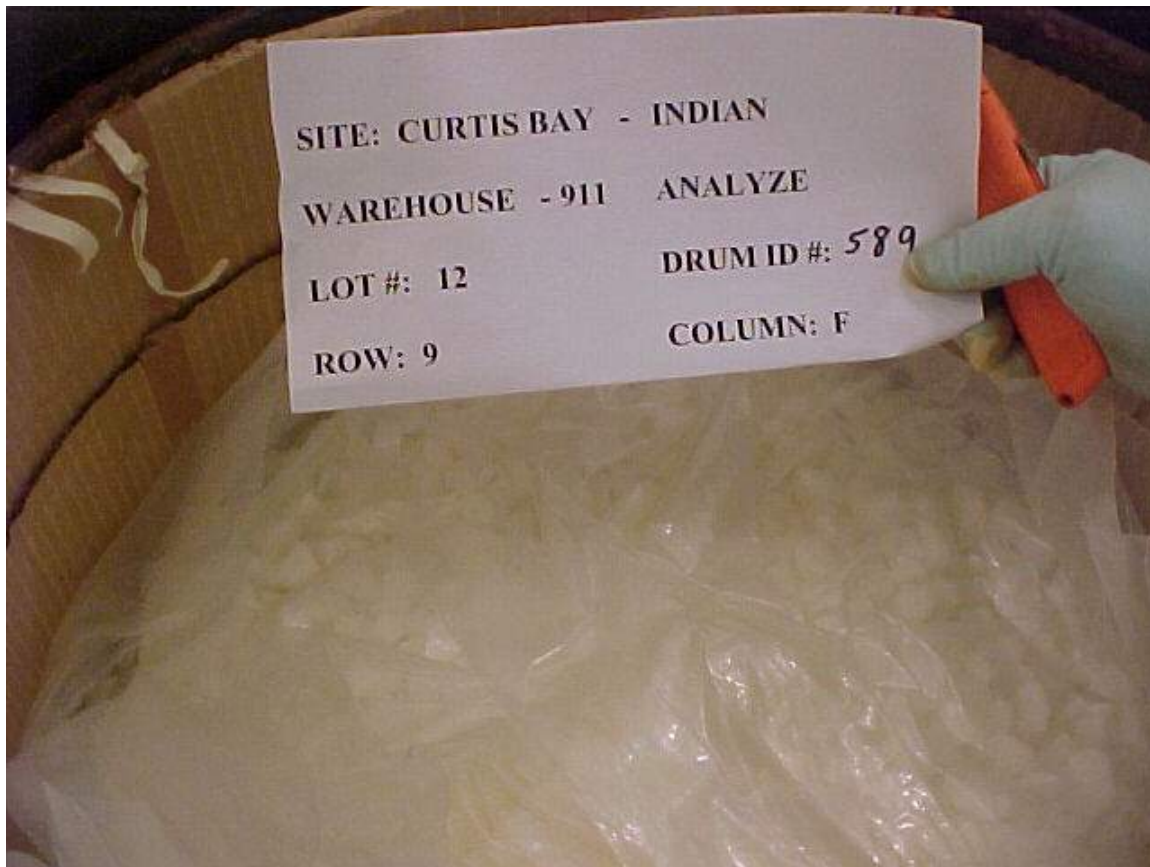
General InformationSite Curtis BayThN Origin IndianLot No. 12Drum ID No. 589Inspection/Sample
DispositionVisual Inspection & Sampling
Analyze**Physical Location of Drum**Warehouse 911Row 9
Column F**Inspection/Sample Date & Time**Date 7-2-2002Time 9:50**Other Information**Photo No. 7 of 94th poly liner/bag – good condition

No gasses present

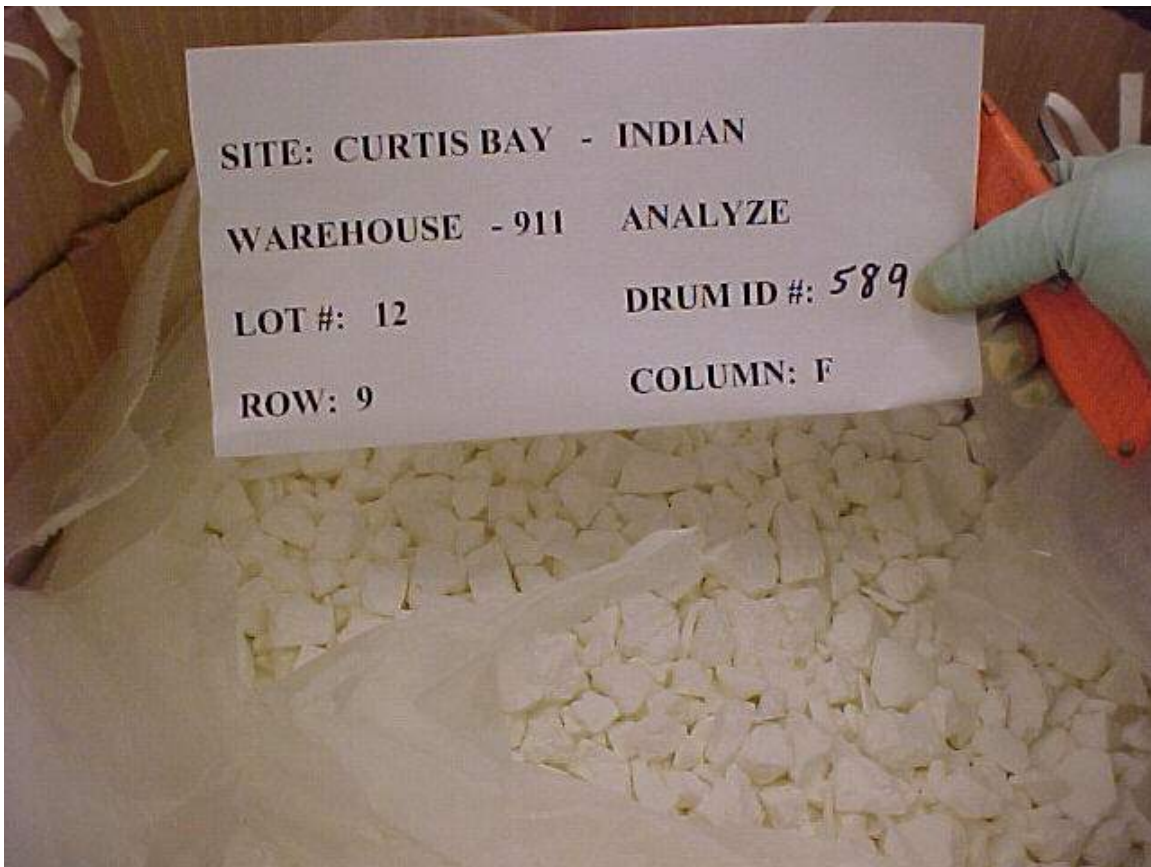
Photo No. 8 of 9

Thorium Nitrate – solid – white – gravel shape - dry
No gasses present

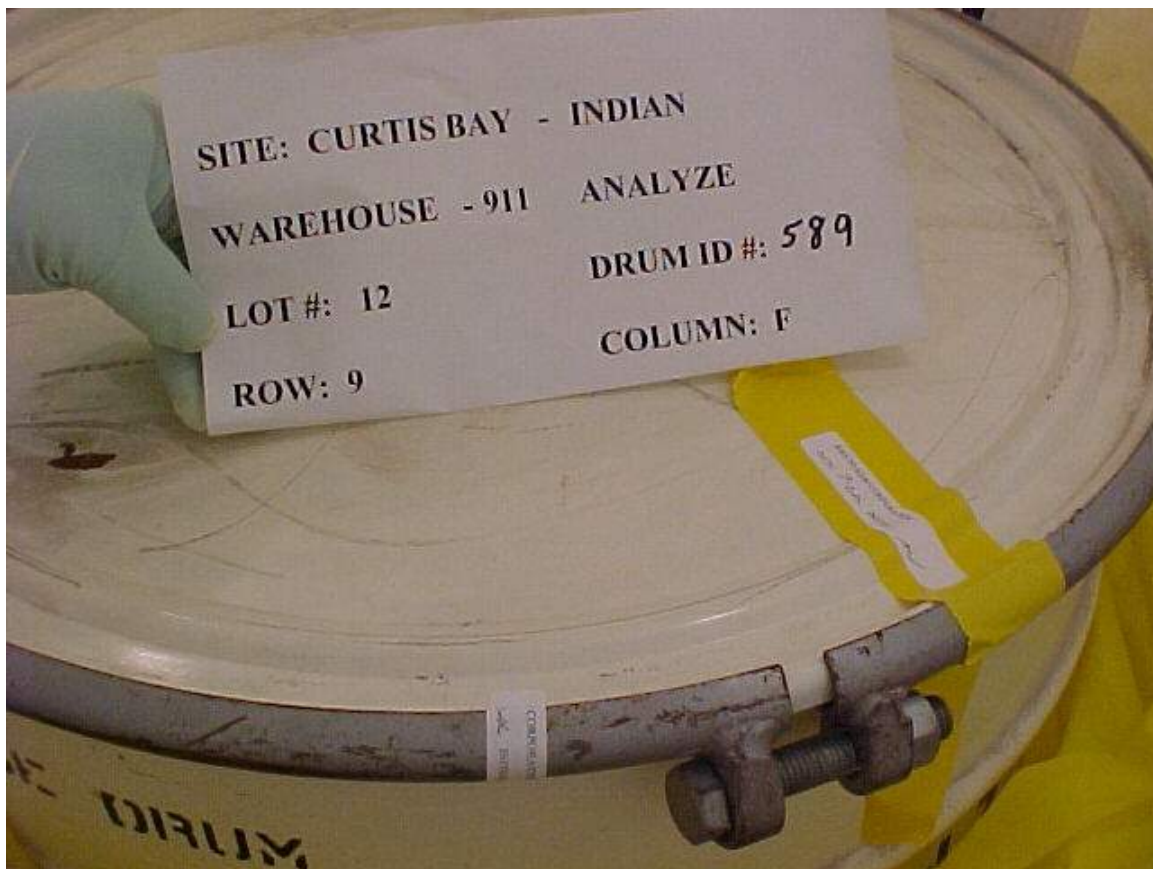
Sealed & dated - completed

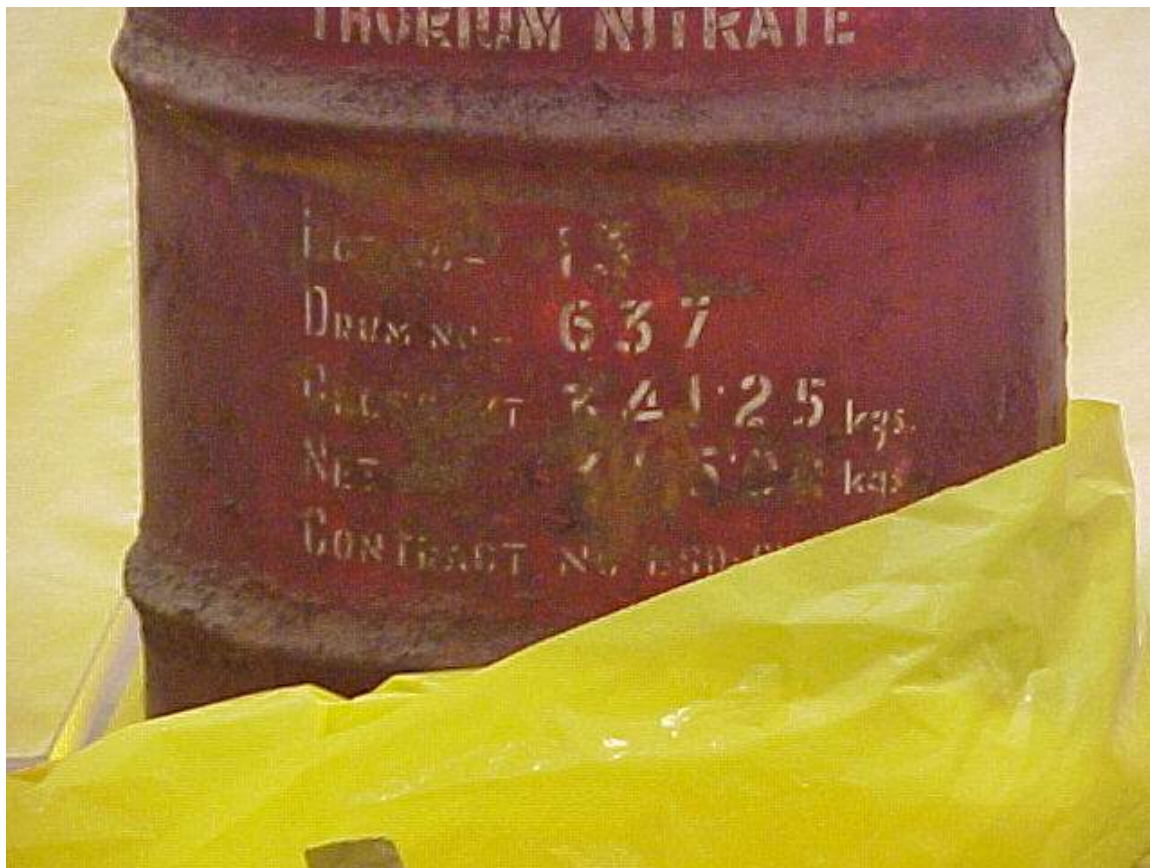
General InformationSite Curtis BayThN Origin IndianLot No. 13Drum ID No. 637Inspection/Sample
DispositionVisual Inspection & Sampling
Analyze**Physical Location of Drum**Warehouse 911Row 2
Column F**Inspection/Sample Date & Time**Date 7-2-2002Time 10:05**Other Information**Photo No. 1 of 8Container 55-gallon steel drumContainer
Condition FairDose Rate Surface 35.0 mR/hr
1 meter 4.2 mR/hr

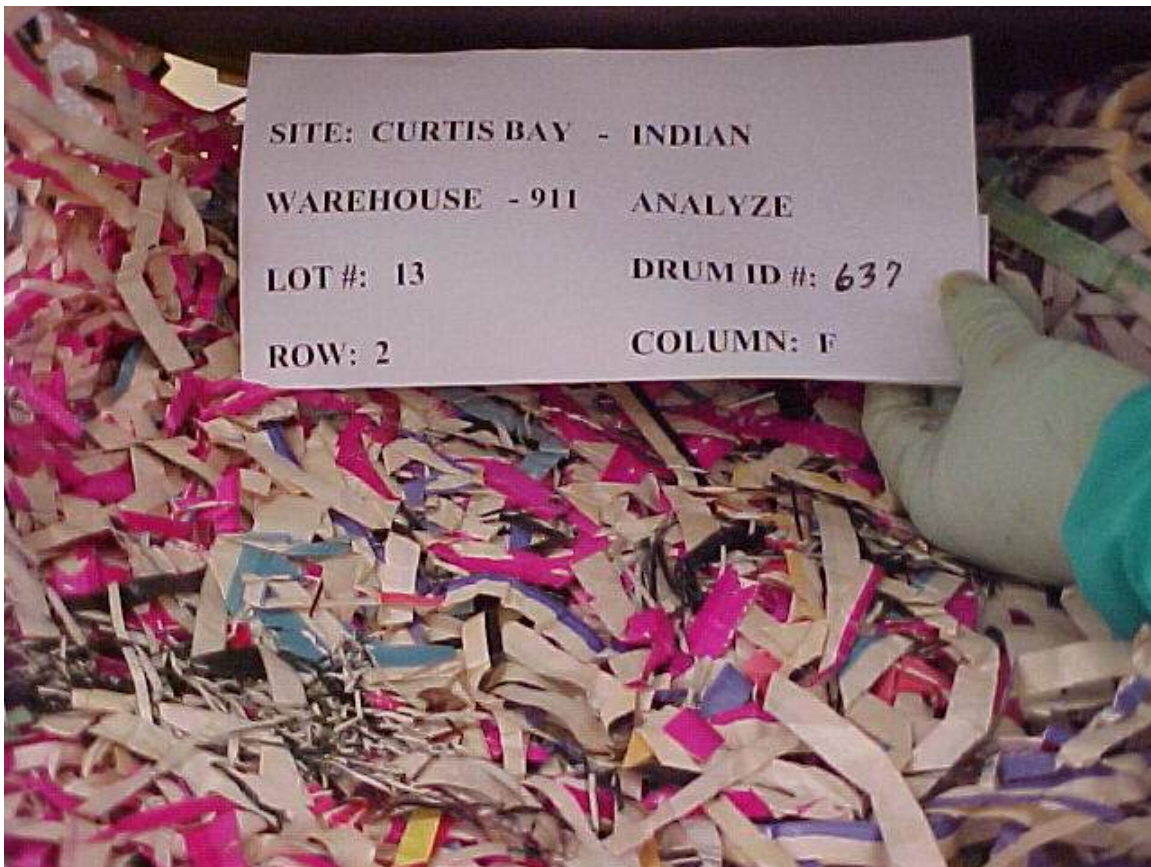
Photo No. 2 of 8

The packaging under the 55-gal drum lid is shredded paper
No gasses present

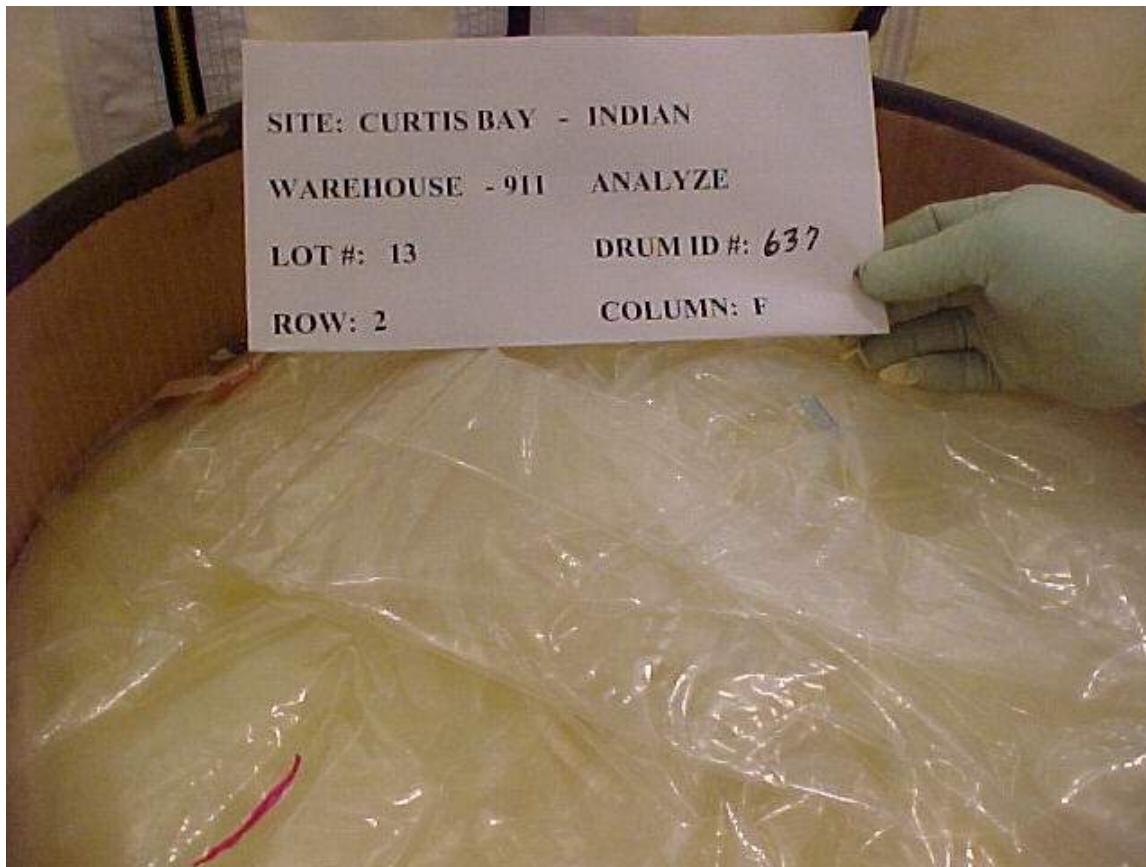
General InformationSite Curtis BayThN Origin IndianLot No. 13Drum ID No. 637Inspection/Sample
DispositionVisual Inspection & Sampling
Analyze**Physical Location of Drum**Warehouse 911Row 2
Column F**Inspection/Sample Date & Time**Date 7-2-2002Time 10:05**Other Information**Photo No. 3 of 81st poly liner/bag – good condition

No gasses present

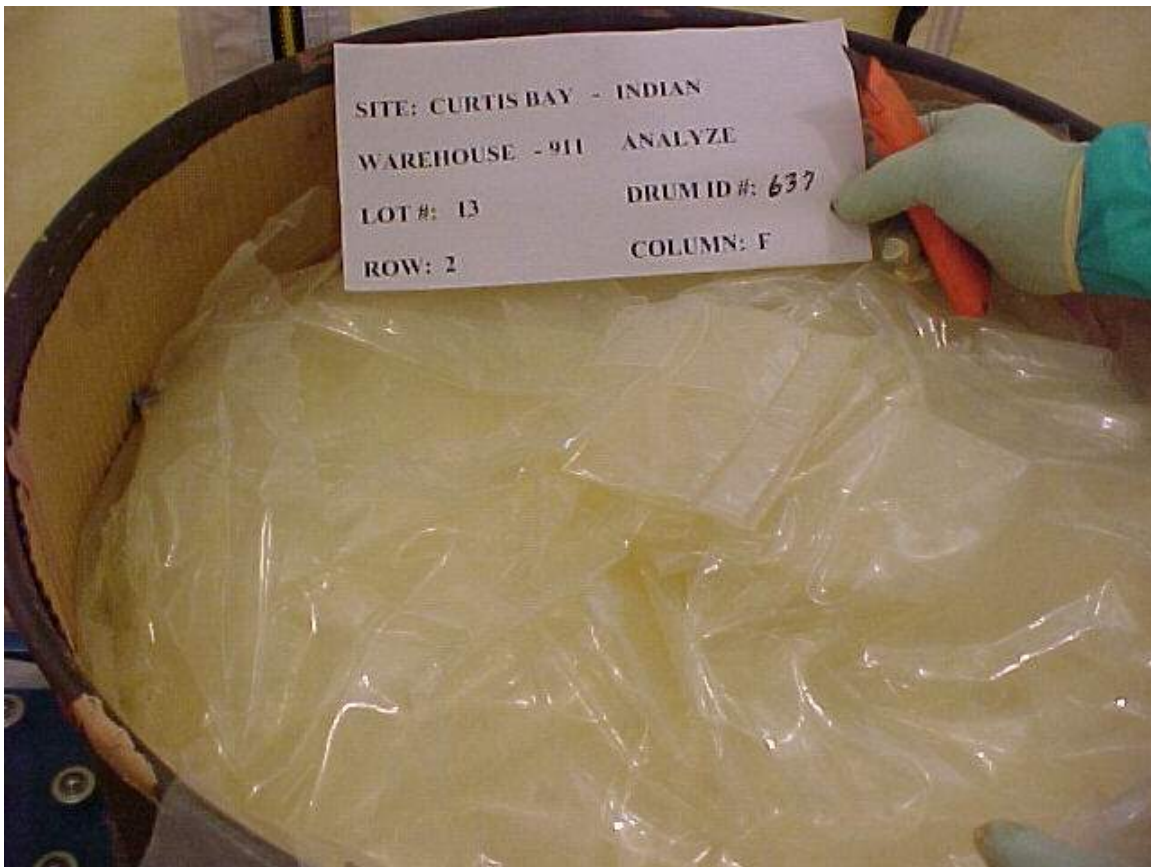
Photo No. 4 of 8

2nd poly liner/bag – good condition
No gasses present

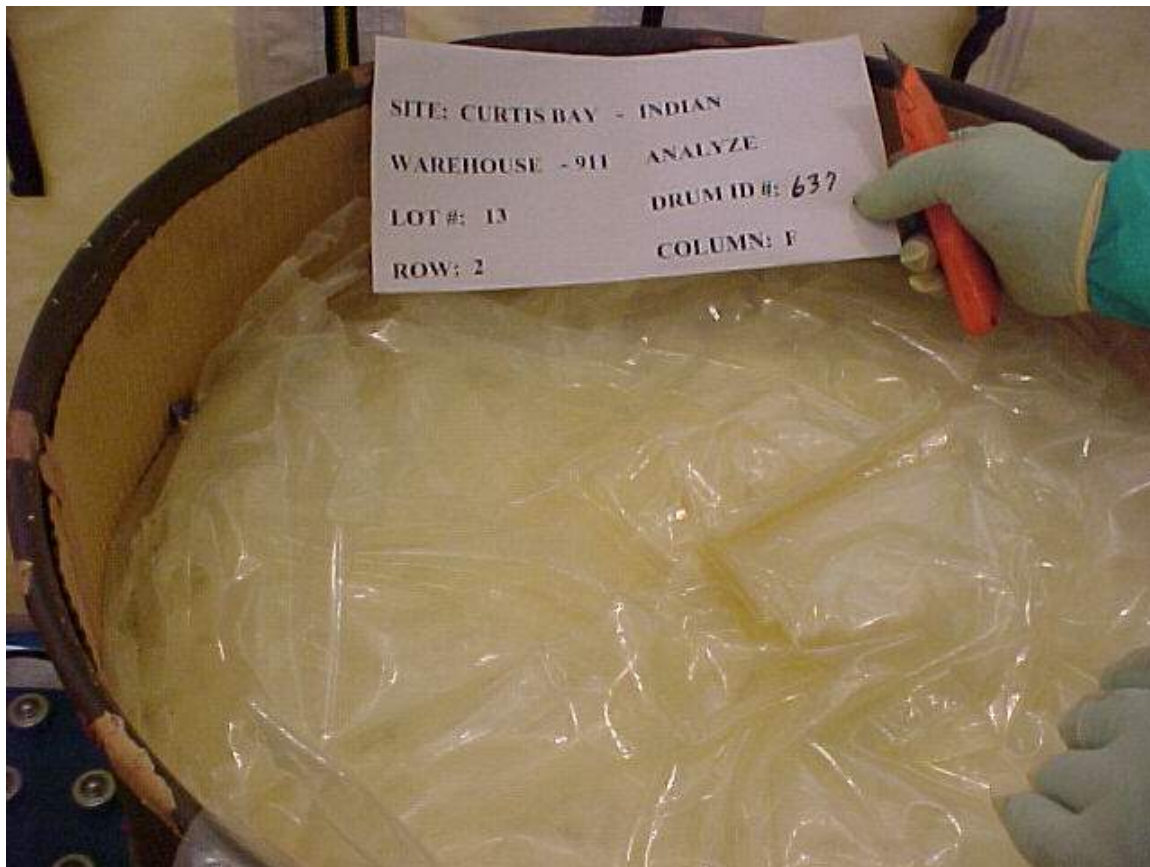
General InformationSite Curtis BayThN Origin IndianLot No. 13Drum ID No. 637Inspection/Sample
DispositionVisual Inspection & Sampling
Analyze**Physical Location of Drum**Warehouse 911Row 2
Column F**Inspection/Sample Date & Time**Date 7-2-2002Time 10:05**Other Information**Photo No. 5 of 83rd poly liner/bag – good condition

No gasses present

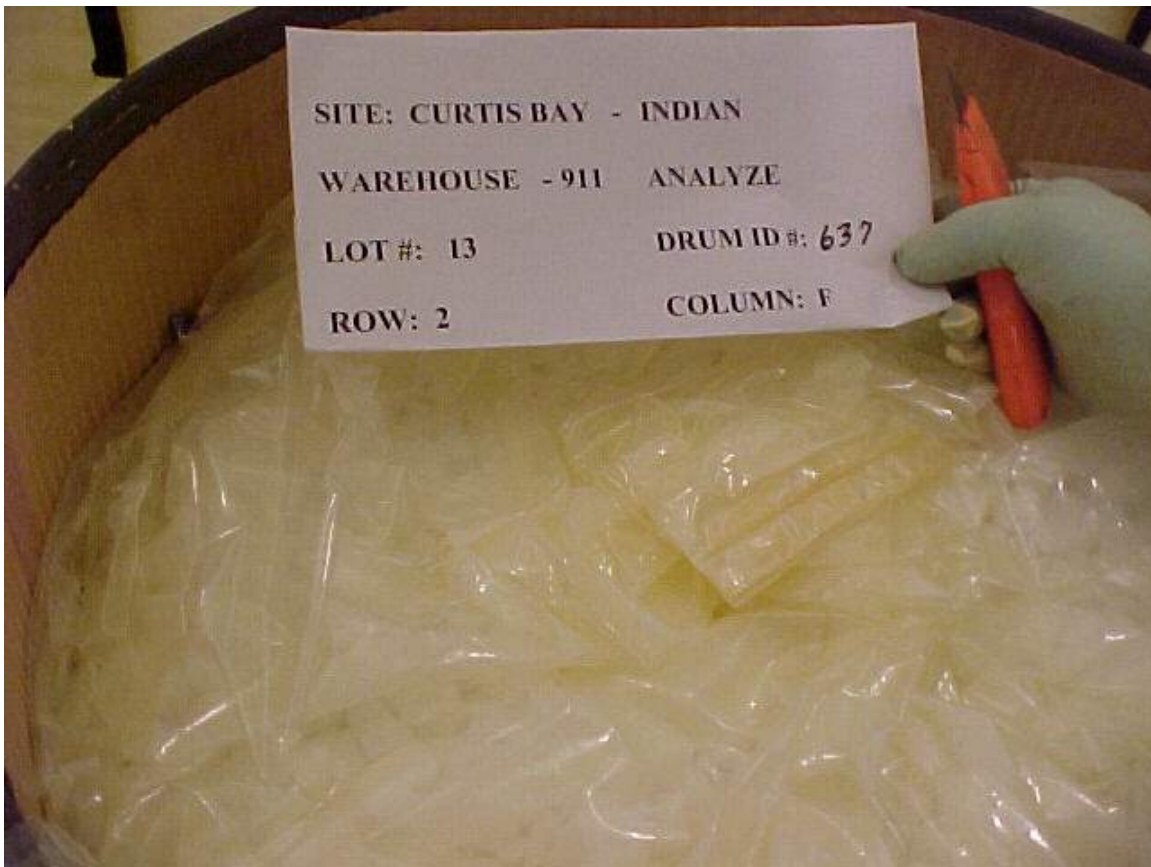
Photo No. 6 of 8

4th poly liner/bag – good condition
No gasses present

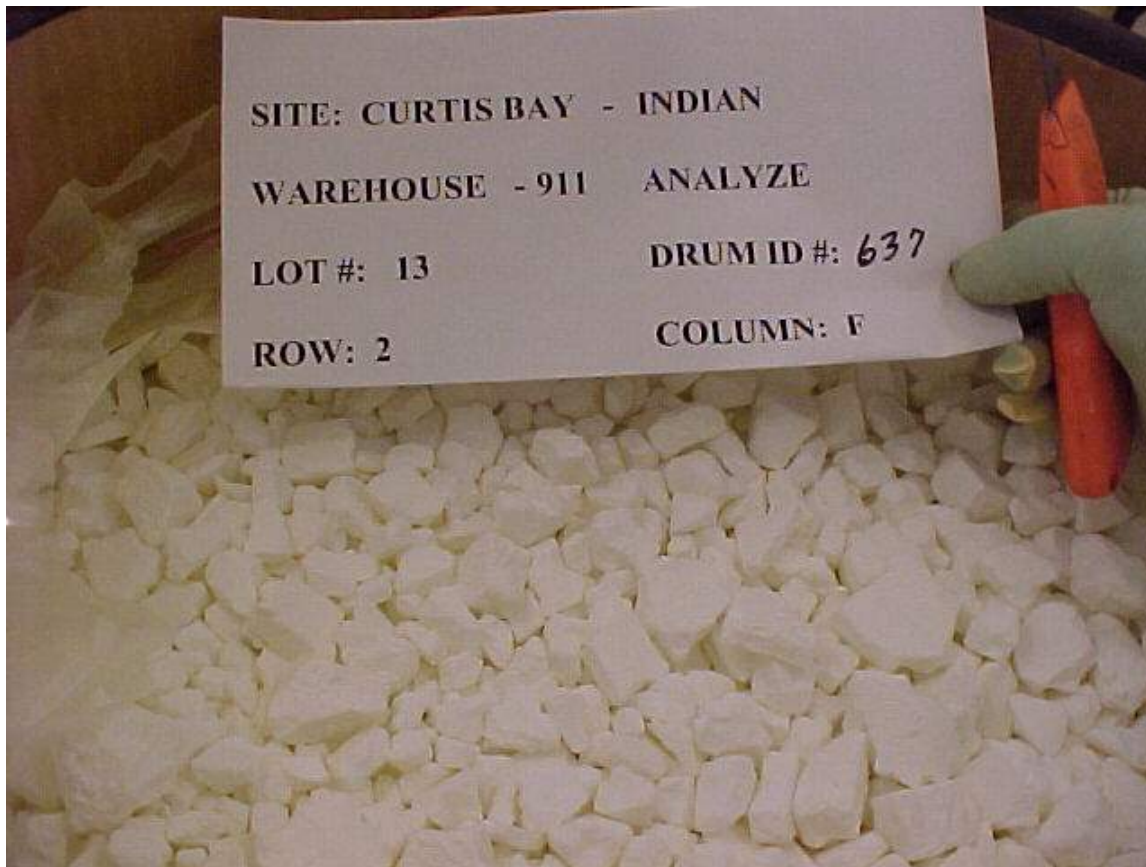
Thorium Nitrate – dry – solid – white – shape of gravel

No gasses present

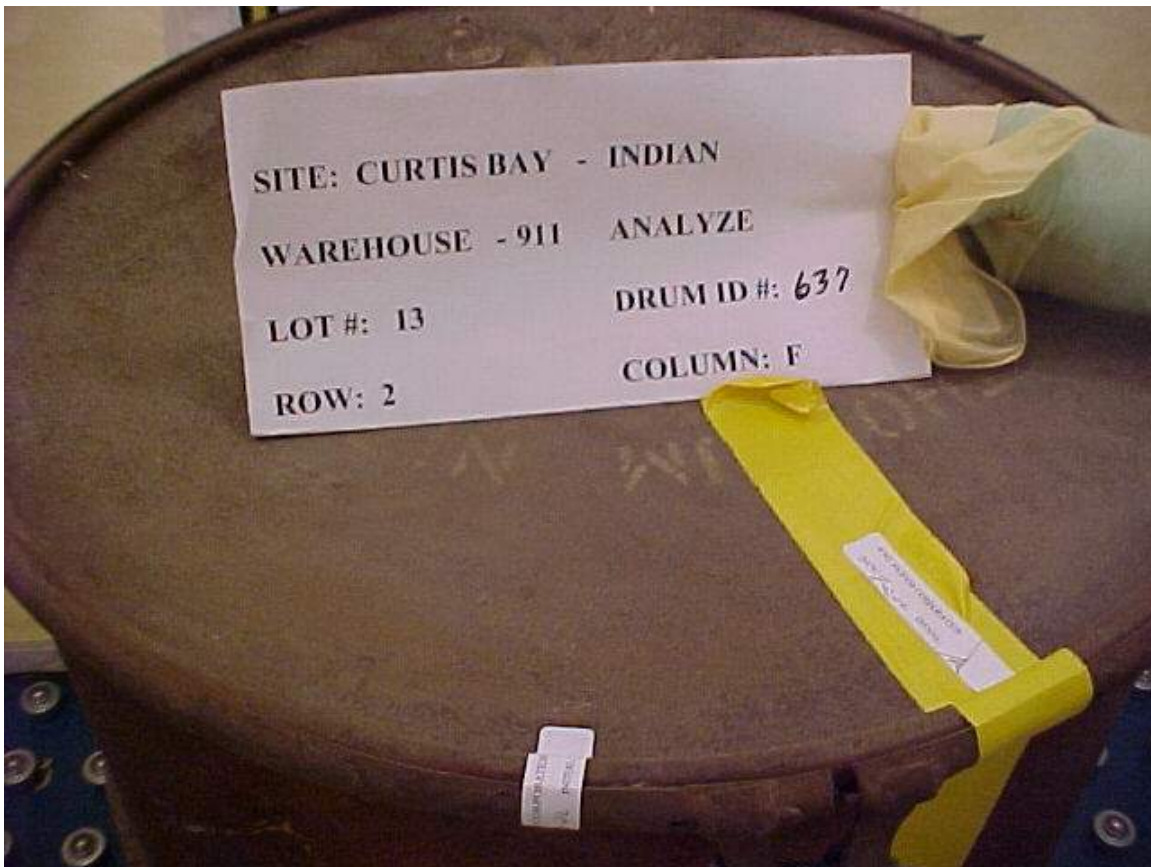
Photo No. 8 of 8

Sealed & dated - completed

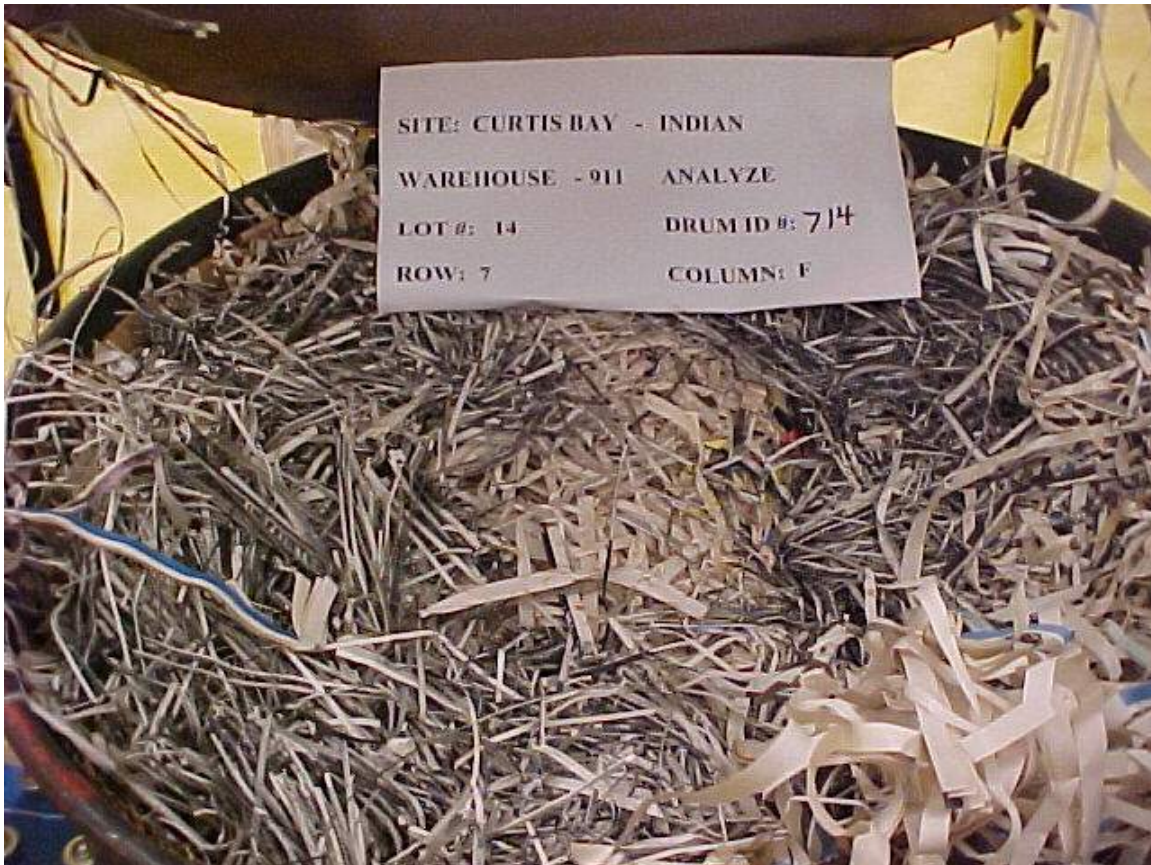
Container	<u>55-gallon steel drum</u>	Container	<u>Fair</u>
		Condition

Packaging under 55-gal drum lid is shredded paper
No gasses present

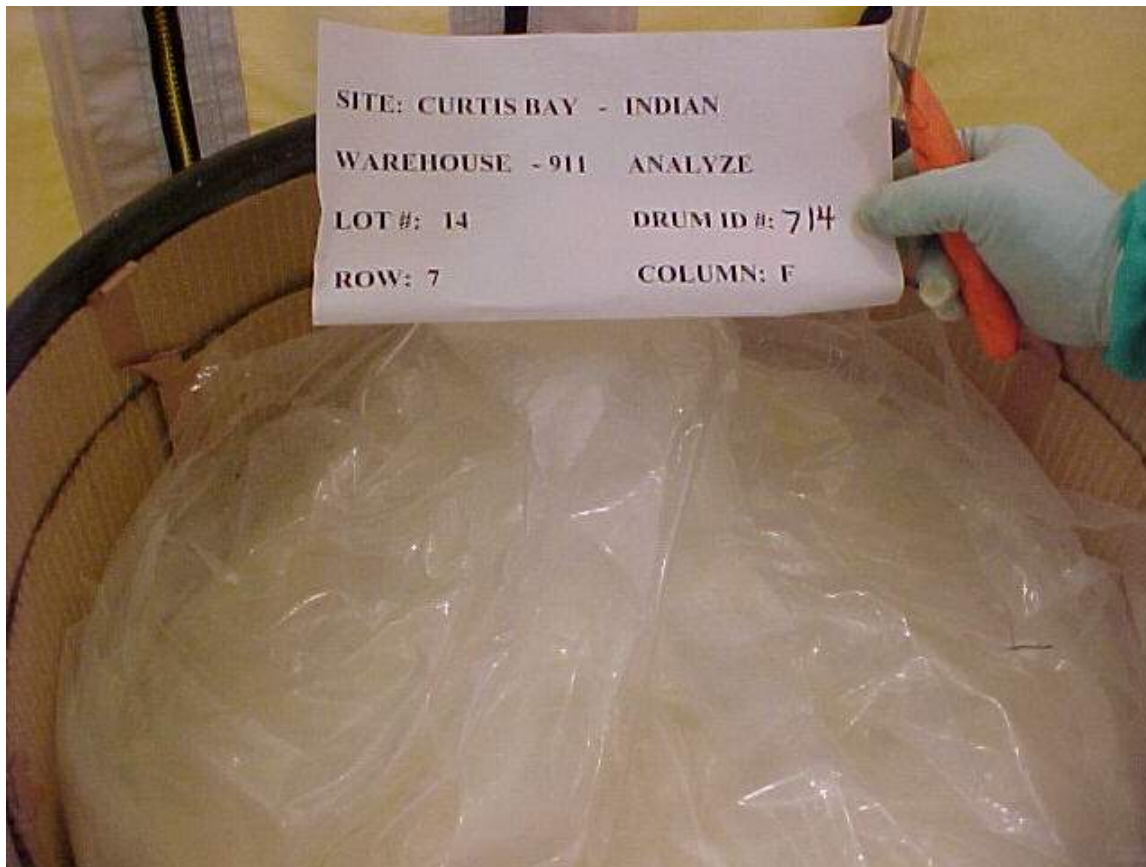
General InformationSite Curtis BayThN Origin IndianLot No. 14Drum ID No. 714Inspection/Sample
DispositionVisual Inspection & Sampling
Analyze**Physical Location of Drum**Warehouse 911Row 7
Column F**Inspection/Sample Date & Time**Date 7-2-2002Time 11:15**Other Information**Photo No. 3 of 71st poly liner/bag – good condition

No gasses present
