THORIUM NITRATE STOCKPILE DRUM CHARACTERIZATION REPORT

**THORIUM NITRATE STOCKPILE
DRUM CHARACTERIZATION REPORT**

Prepared for
U.S. Defense Logistics Agency
Defense National Stockpile Center
Fort Belvoir, Virginia

Prepared by
OAK RIDGE NATIONAL LABORATORY
Oak Ridge, Tennessee 37831
managed by
UT-BATTELLE, LLC
for the
U.S. DEPARTMENT OF ENERGY
under contract DE-AC05-00OR22725

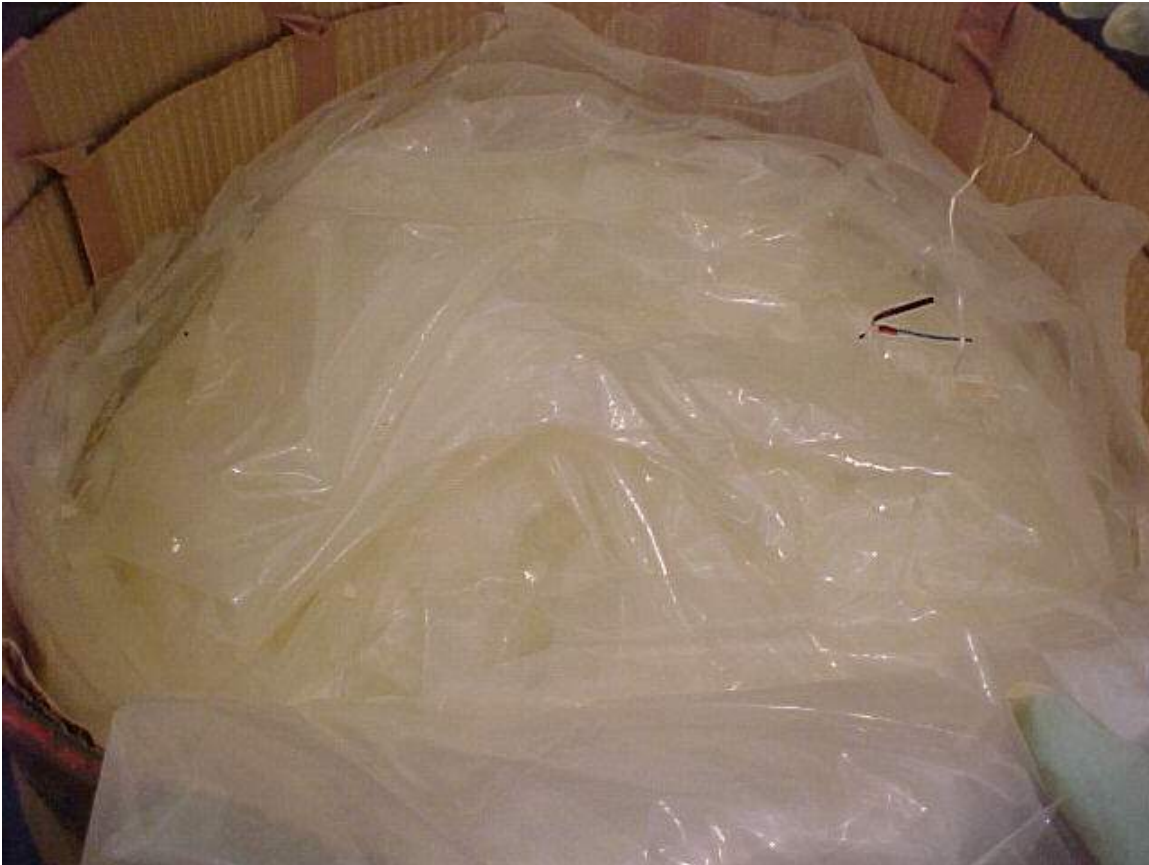
Photo No. 4 of 7

2nd poly liner/bag – good condition
No gasses present

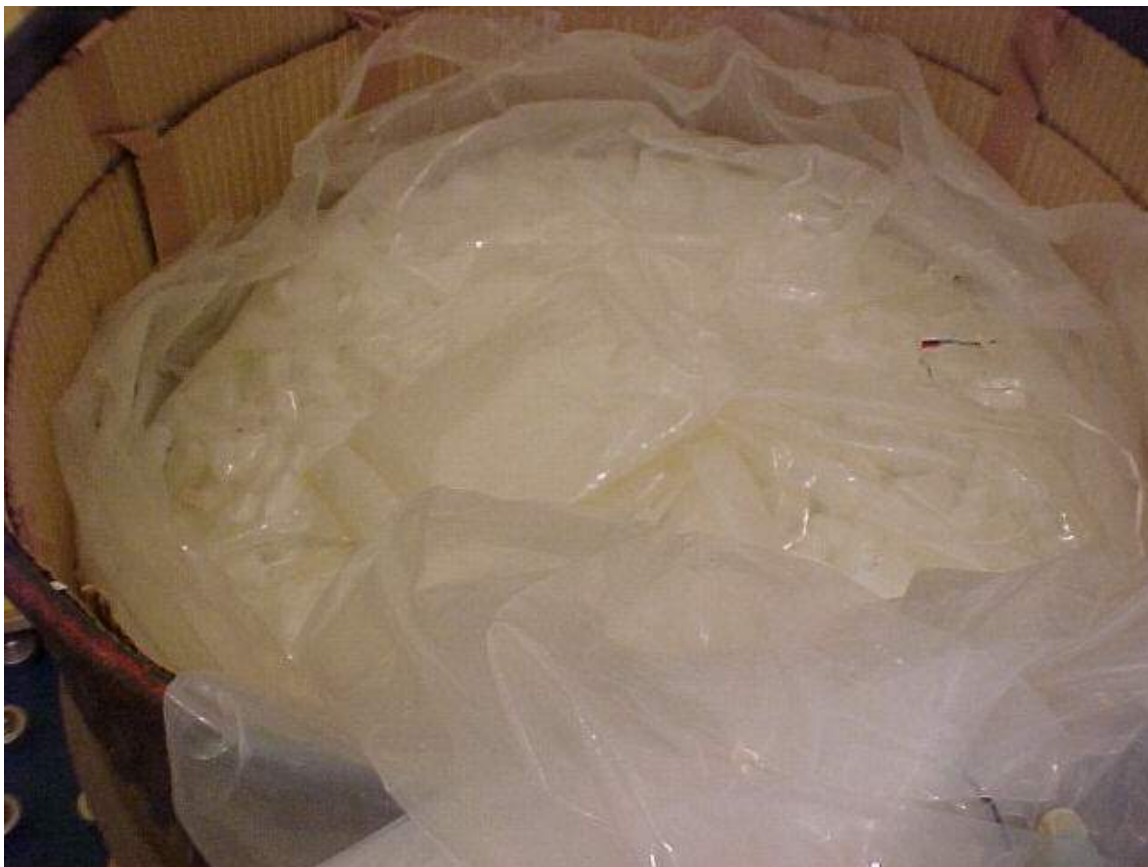
11:15**Other Information**Photo No. 5 of 7

3rd poly liner/bag – good condition
No gasses present

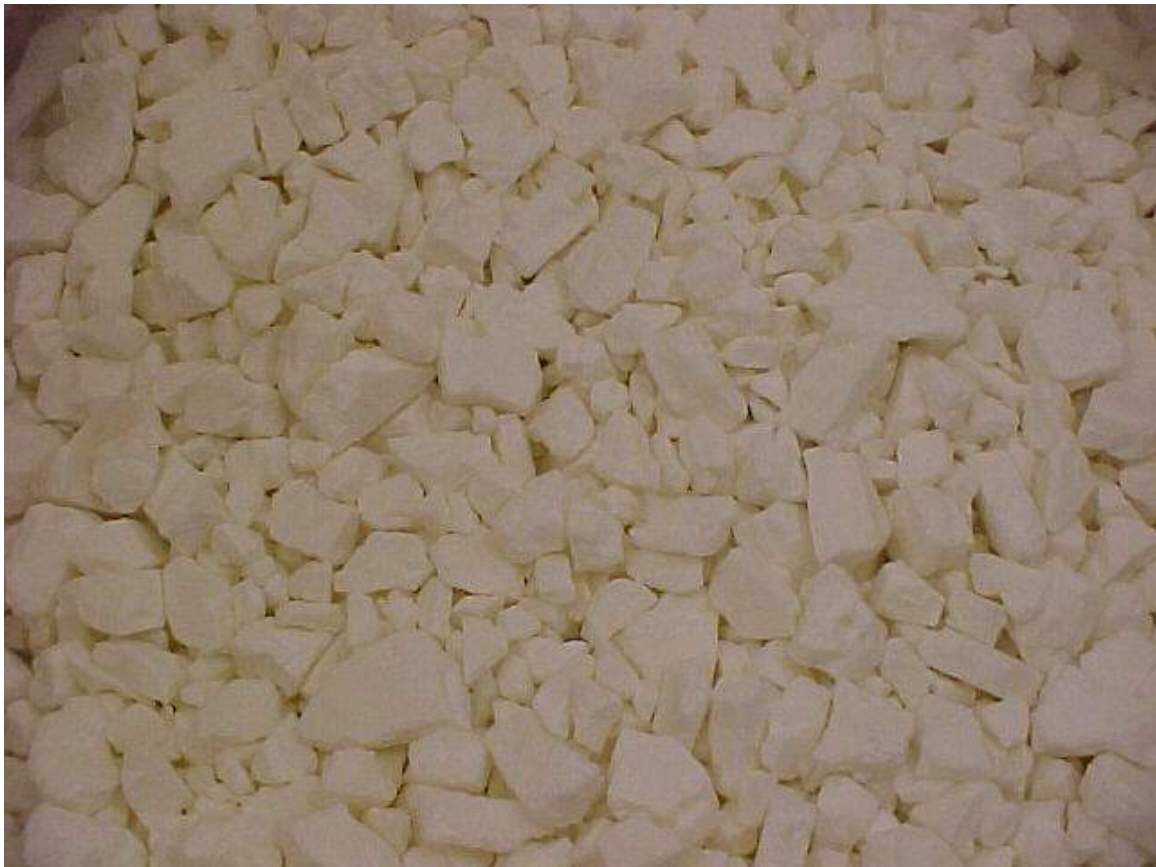
Photo No. 6 of 7

Thorium Nitrate – dry – solid – white – gravel shape
No gasses present

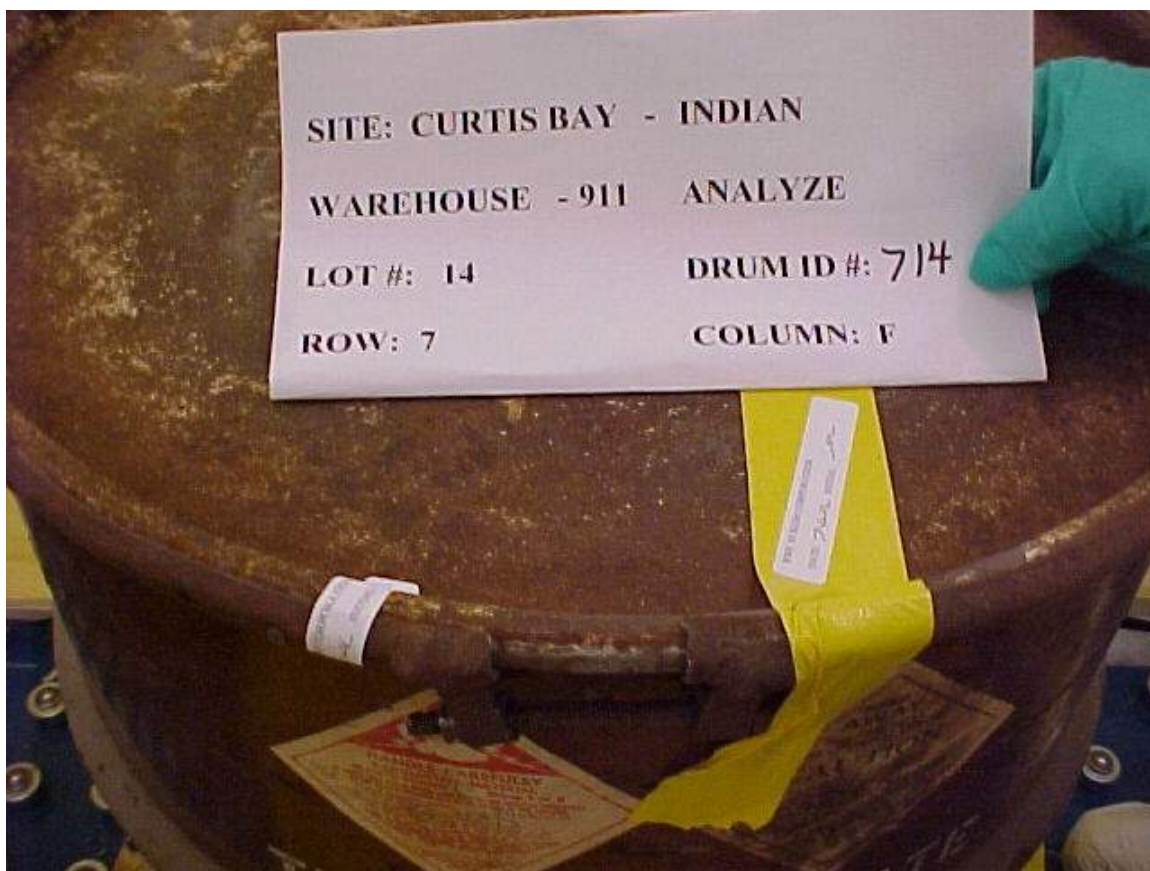
Sealed & dated - complete

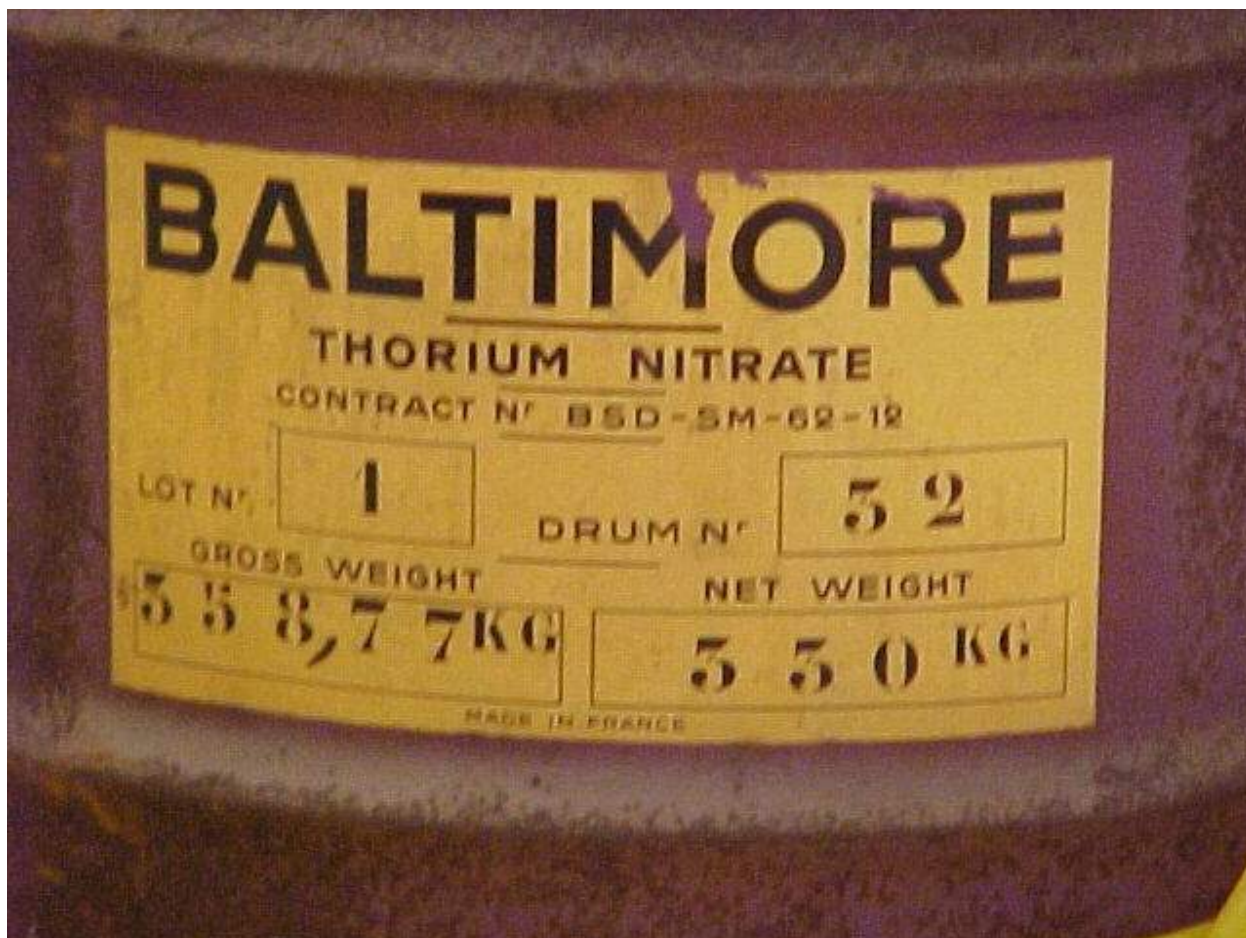
General InformationSite Curtis BayThN Origin FrenchLot No. 1Drum ID No. 52Inspection/Sample
DispositionVisual Inspection & Sampling
Analyze**Physical Location of Drum**Warehouse 912Row 7
Column E**Inspection/Sample Date & Time**Date 7-8-2002Time 13:45**Other Information**Photo No. 1 of 5Container 55-gallon steel drumContainer
Condition FairContainer Wall Thickness 0.1565 inDose Rate Surface 44 mR/hr
1 meter 4.0 mR/hr

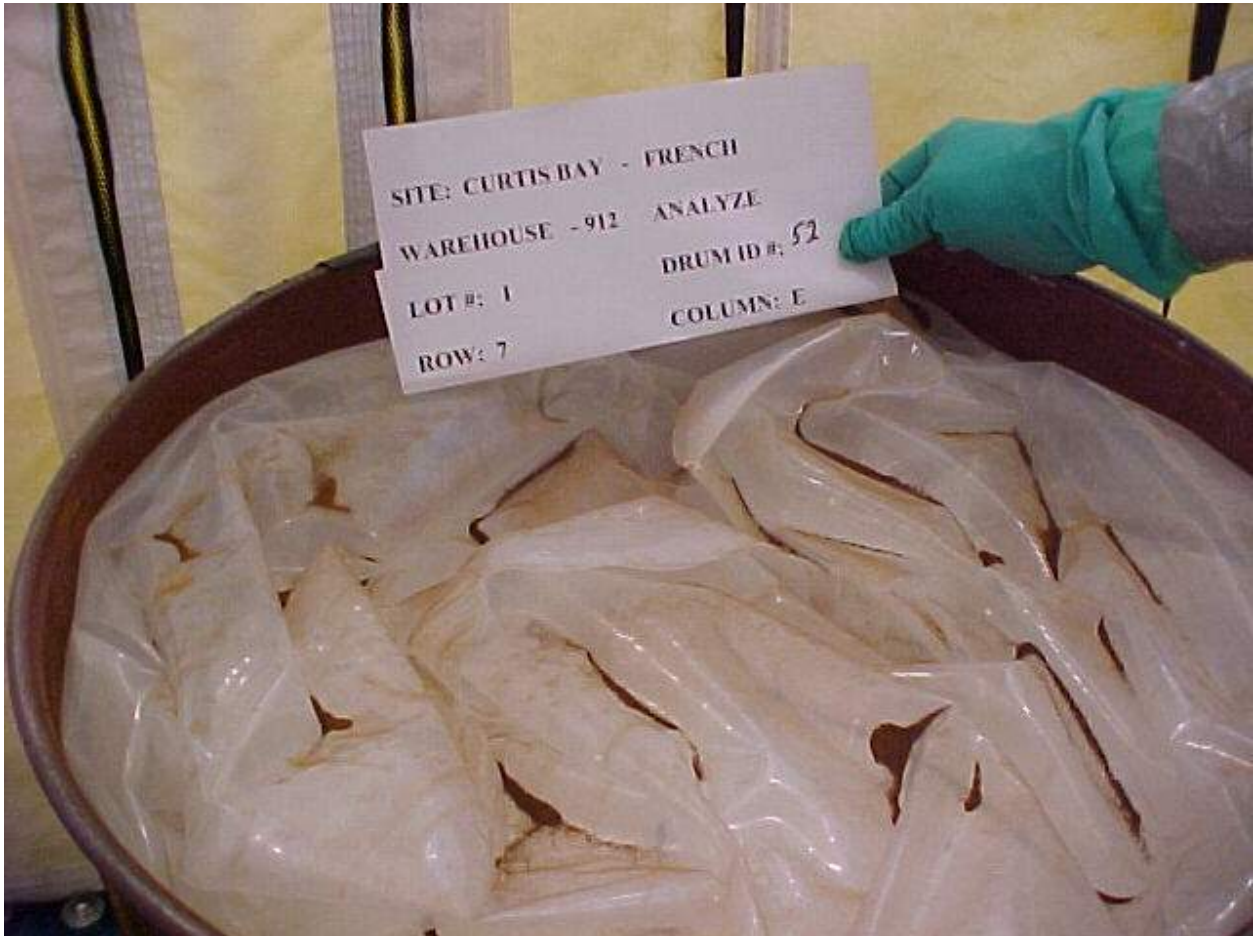
Dose Rate Surface 44 mR/hr
 1 meter 4.0 mR/hr

1st poly liner/bag – good condition
No gasses present

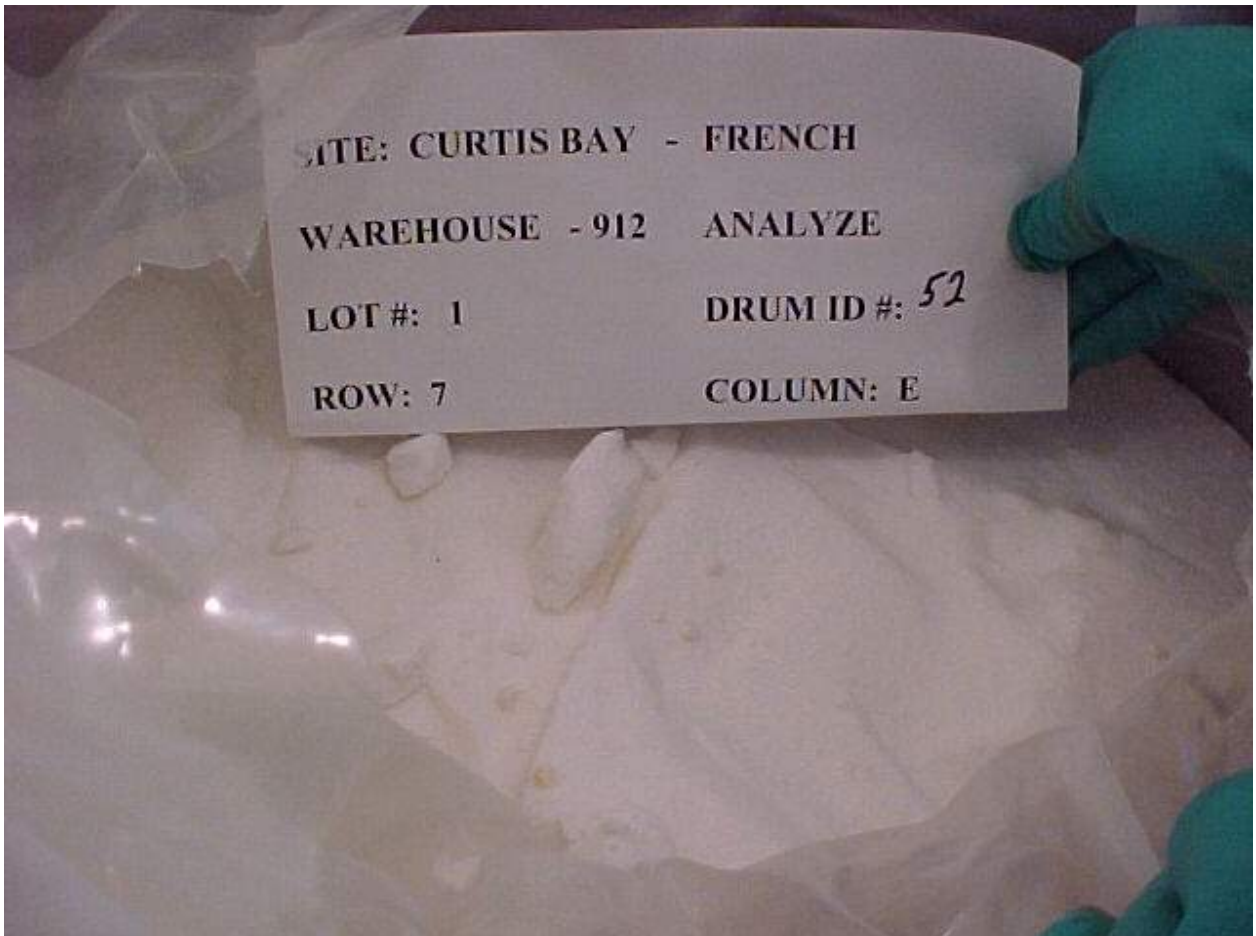
Thorium Nitrate – Powder – white – dry
No gasses present

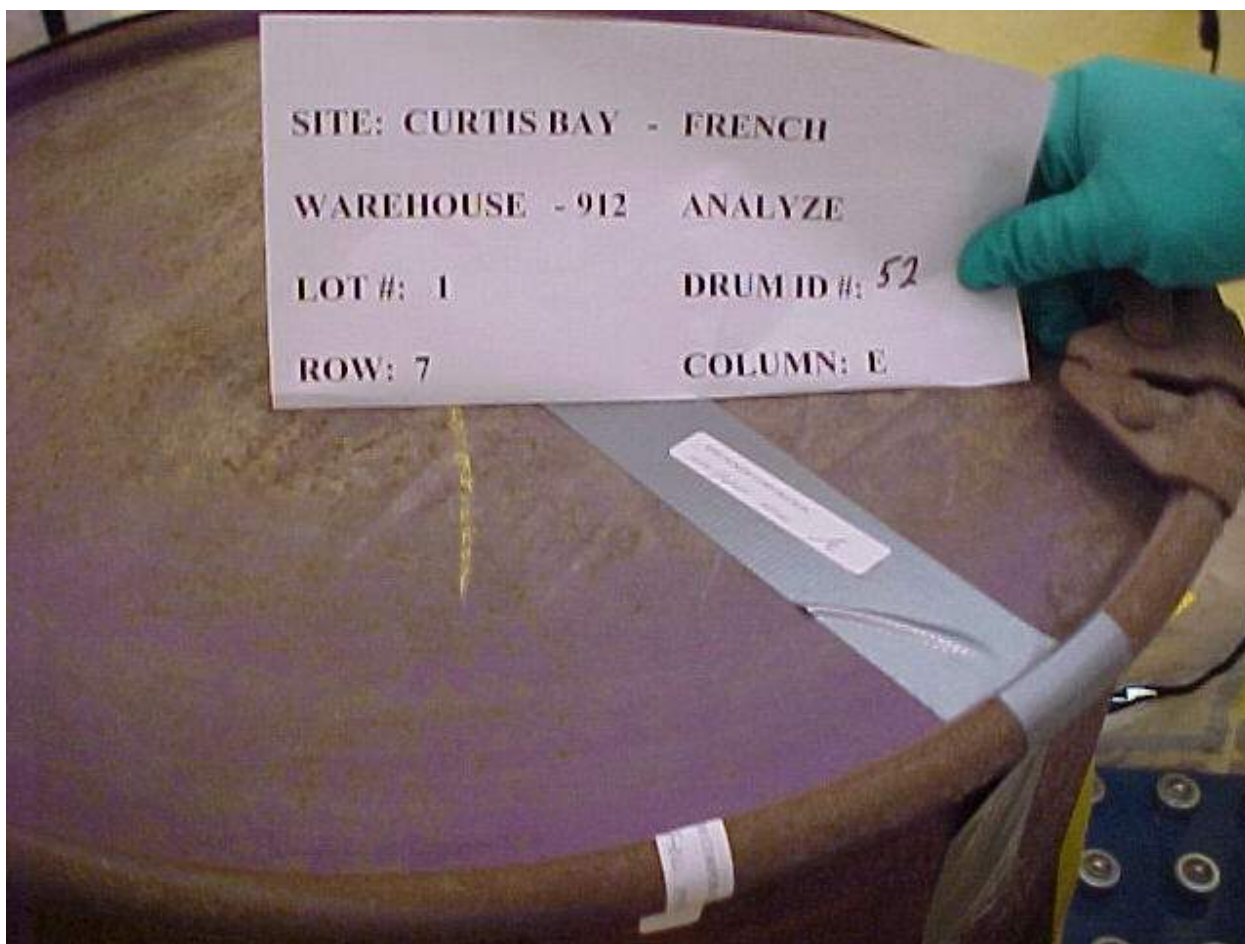
Sealed & dated - Complete

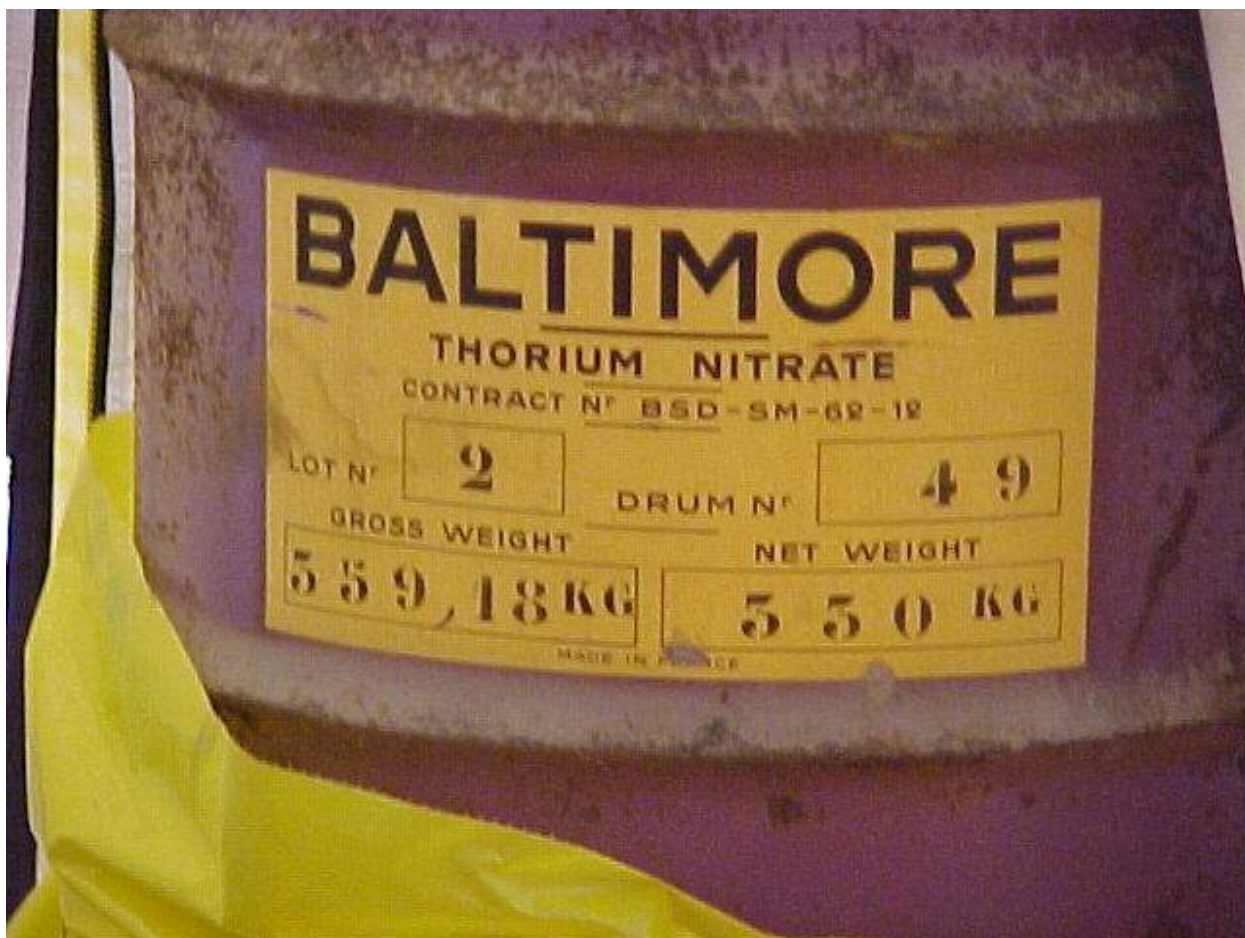
Outer Container Condition/Description (rusty, leaking, good, etc.): fair

General InformationSite Curtis BayThN Origin FrenchLot No. 2Drum ID No. 49Inspection/Sample
DispositionVisual Inspection & Sampling
Analyze**Physical Location of Drum**Warehouse 912Row 9
Column E**Inspection/Sample Date & Time**Date 7-8-2002Time 13:30**Other Information**Photo No. 1 of 5Container 55-gallon steel drumContainer
Condition FairContainer Wall Thickness 0.1565 inDose Rate Surface 42 mR/hr
1 meter 3.8 mR/hr

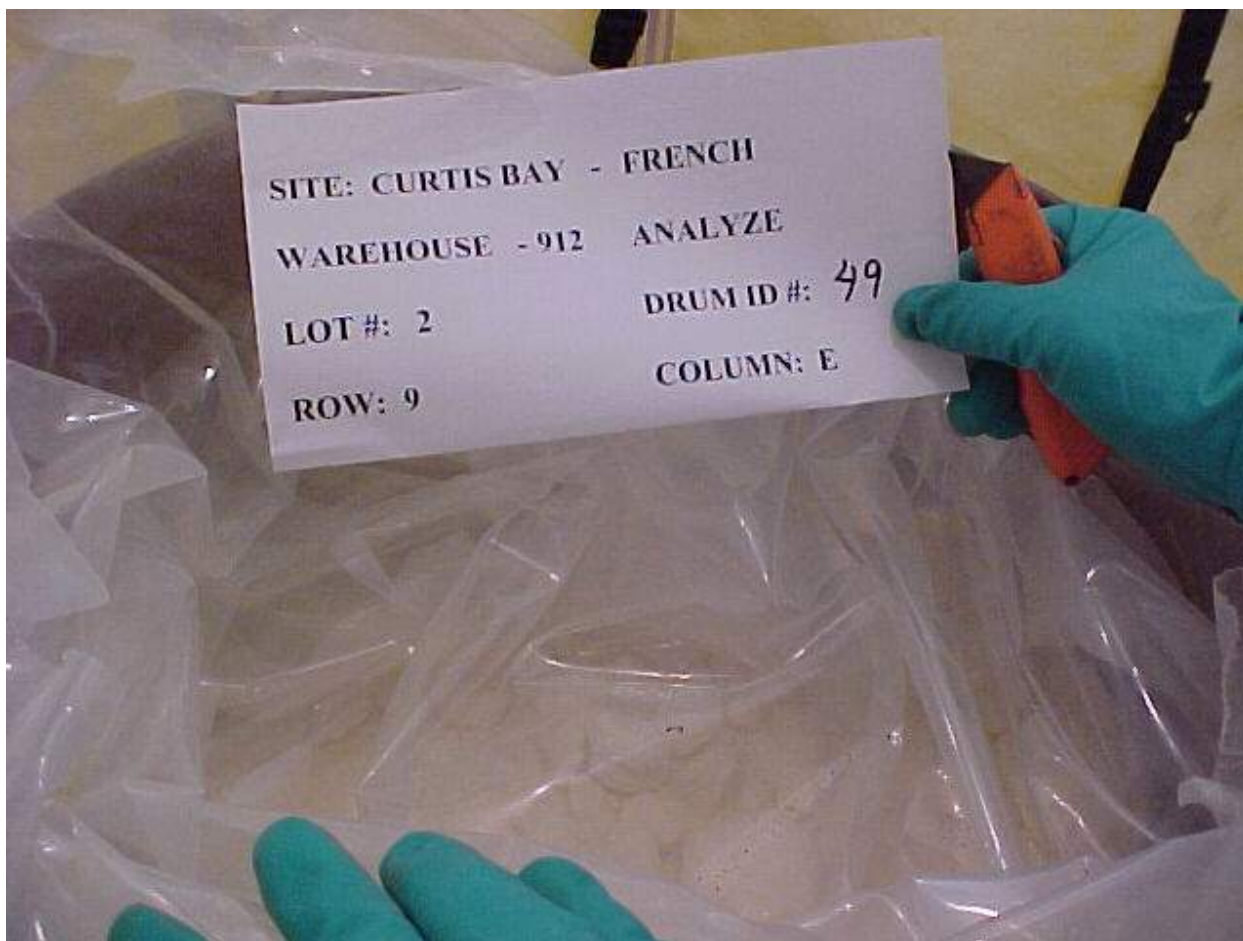
General InformationSite Curtis BayThN Origin FrenchLot No. 2Drum ID No. 49Inspection/Sample
DispositionVisual Inspection & Sampling
Analyze**Physical Location of Drum**Warehouse 912Row 9
Column E**Inspection/Sample Date & Time**Date 7-8-2002Time 13:30**Other Information**Photo No. 3 of 5Dose Rate Surface 42 mR/hr
 1 meter 3.8 mR/hr2nd poly liner/bag – good condition
No gasses present

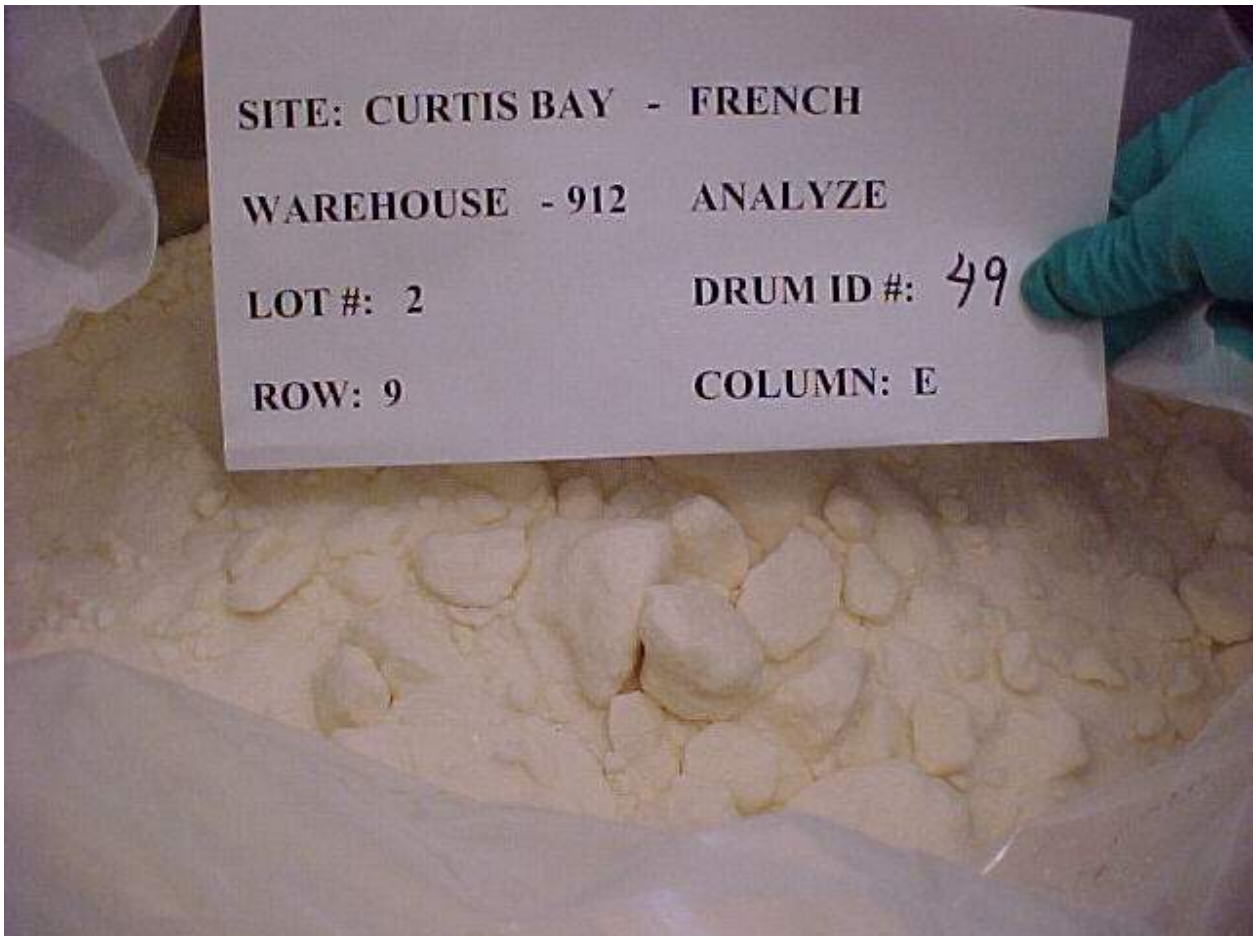
Thorium Nitrate – Some gravel pieces but most is Powder – white – dry
No gasses present

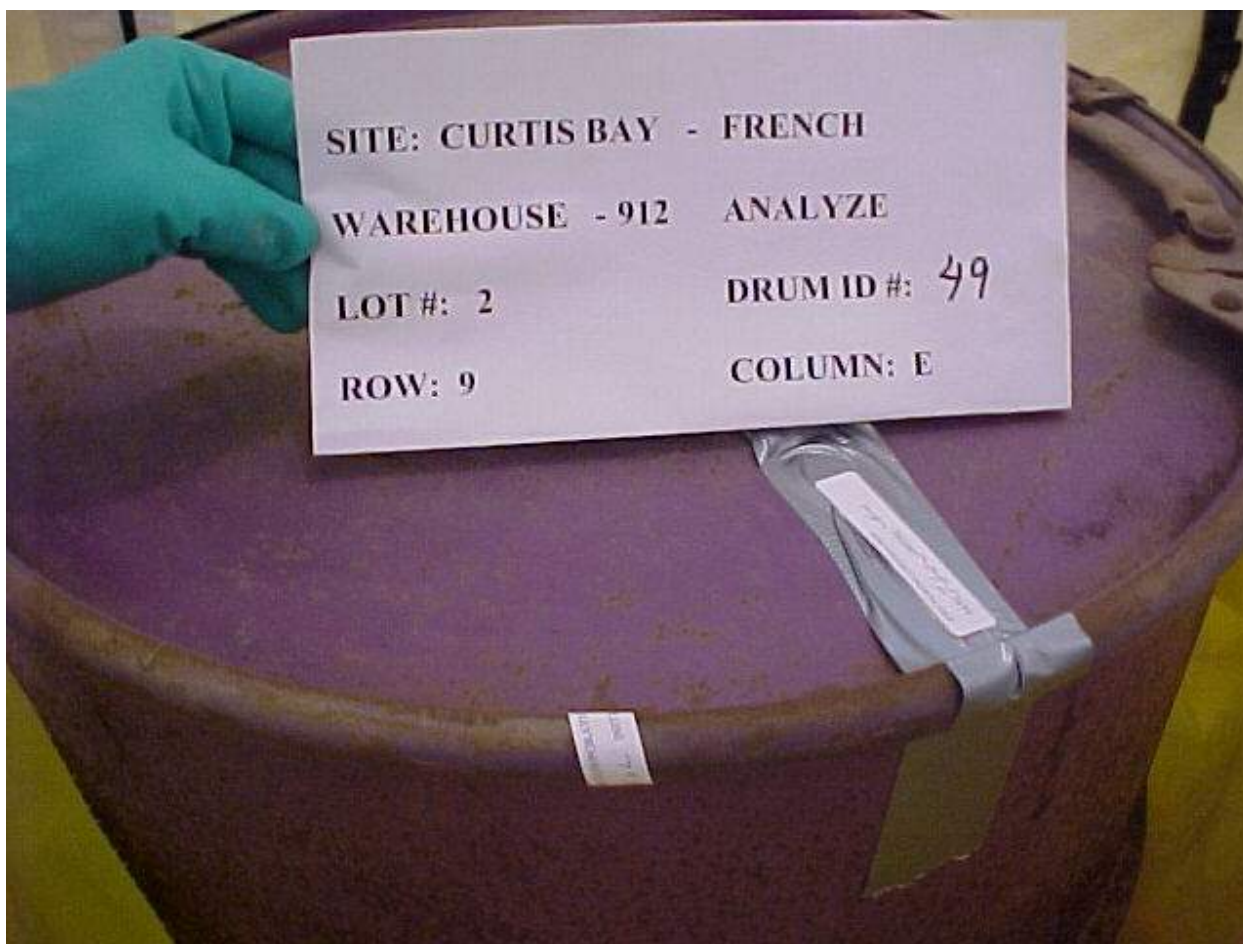
Sealed & dated - Complete

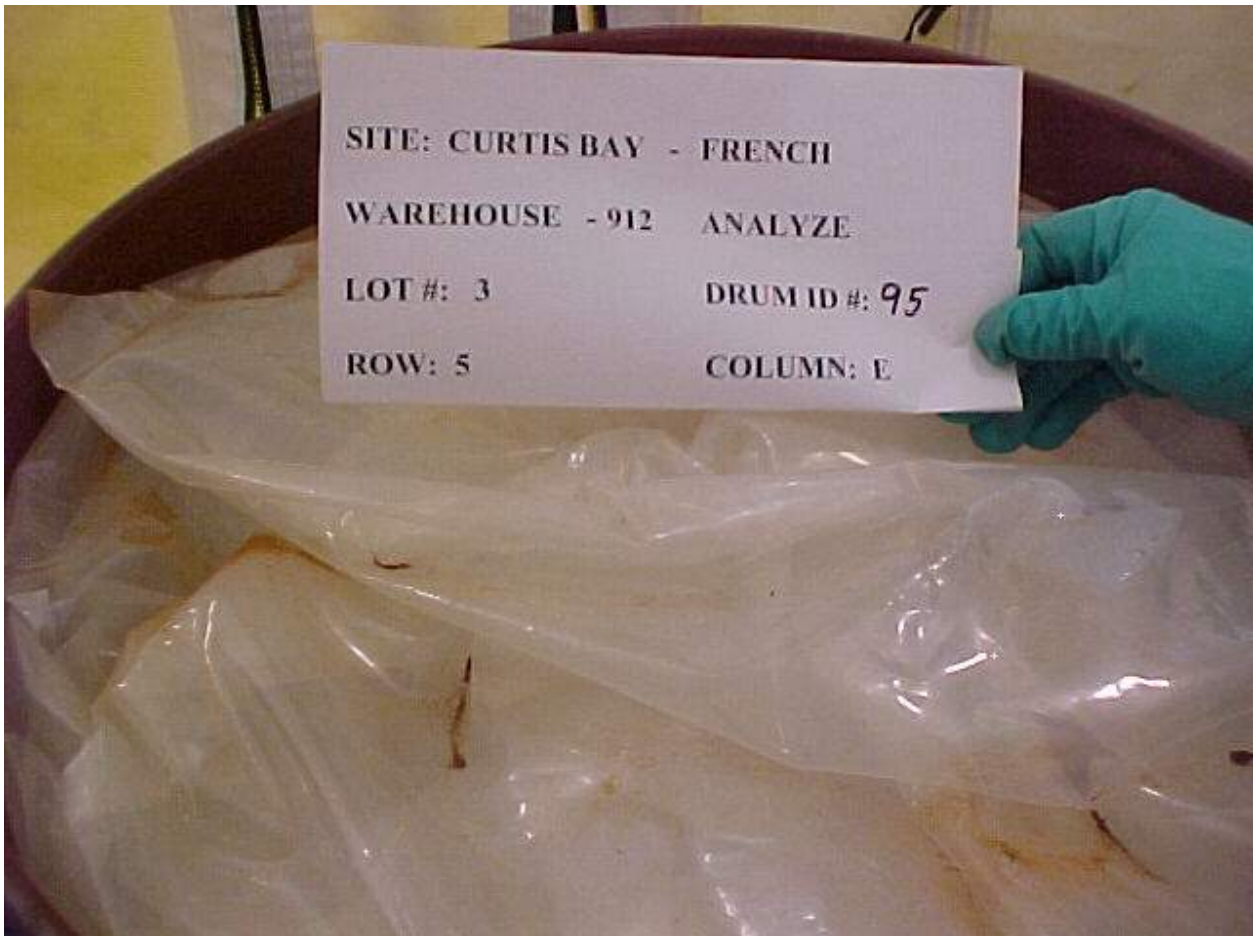
1st poly liner/bag – good condition
No gasses present

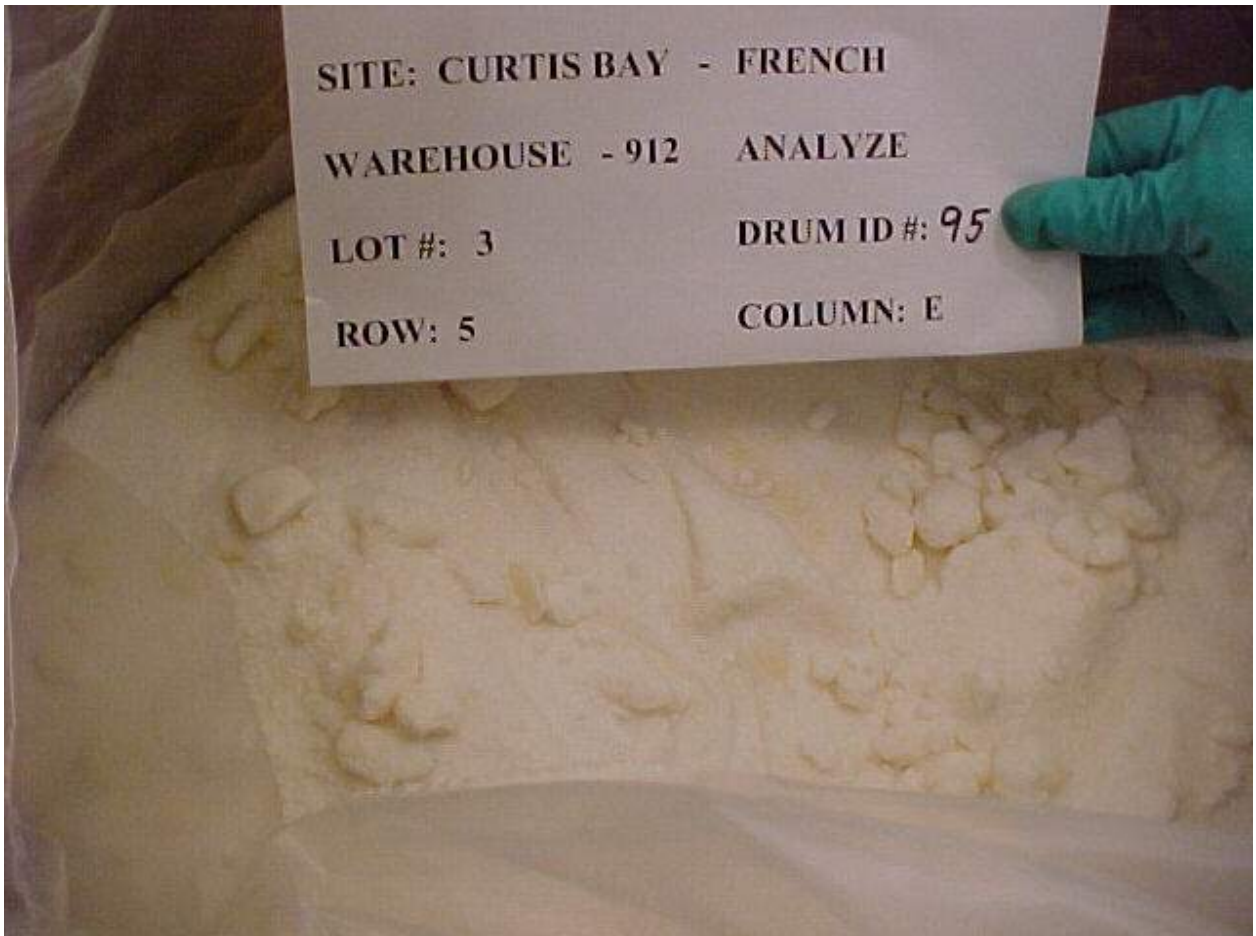
Thorium Nitrate – Powder – white – dry
No gasses present

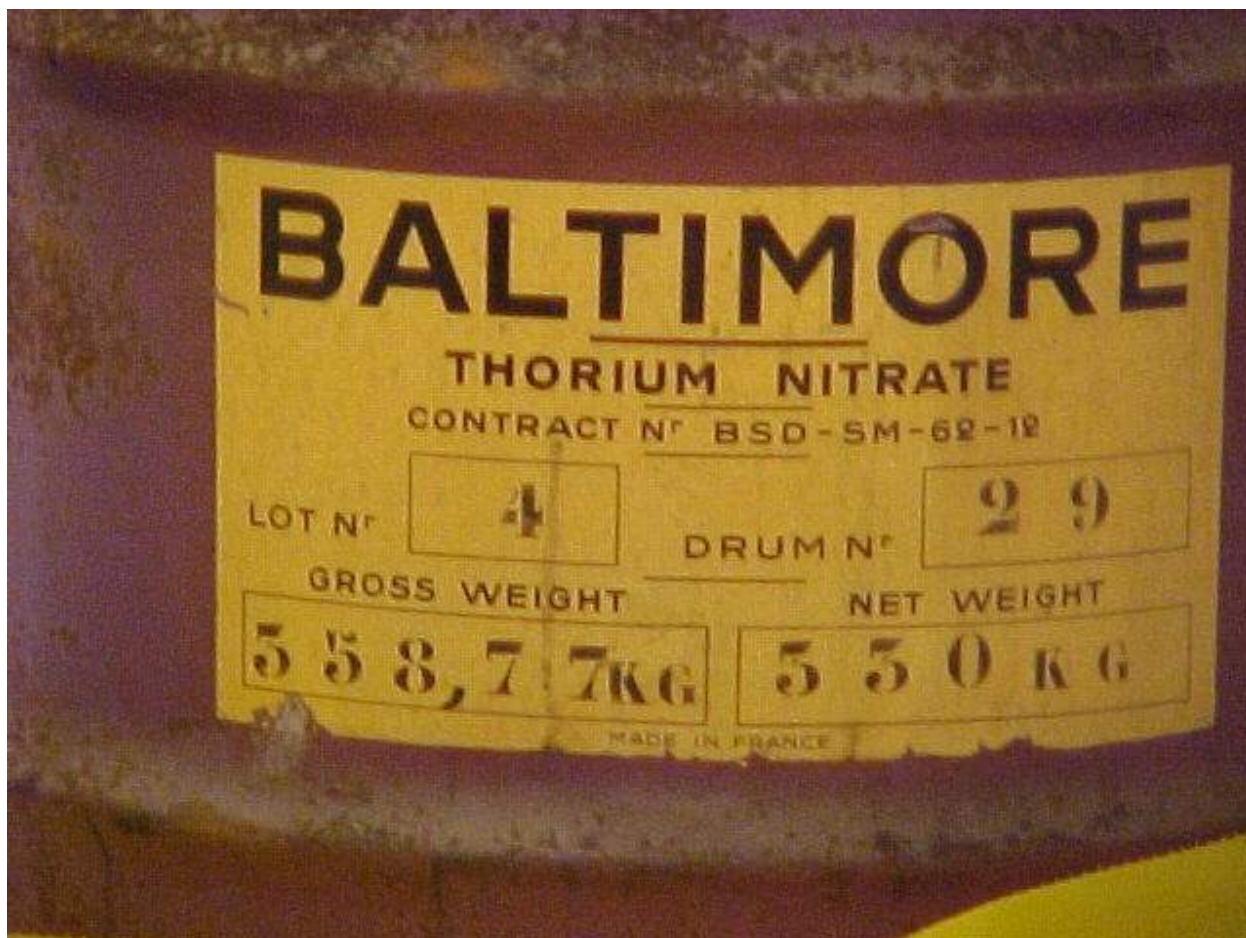
General InformationSite Curtis BayThN Origin FrenchLot No. 4Drum ID No. 29Inspection/Sample
DispositionVisual Inspection & Sampling
Analyze**Physical Location of Drum**Warehouse 912Row 3
Column E**Inspection/Sample Date & Time**Date 7-8-2002Time 14:00**Other Information**Photo No. 1 of 5Container 55-gallon steel drumContainer
Condition FairContainer Wall Thickness 0.1565 inDose Rate Surface 44 mR/hr
1 meter 4.0 mR/hr

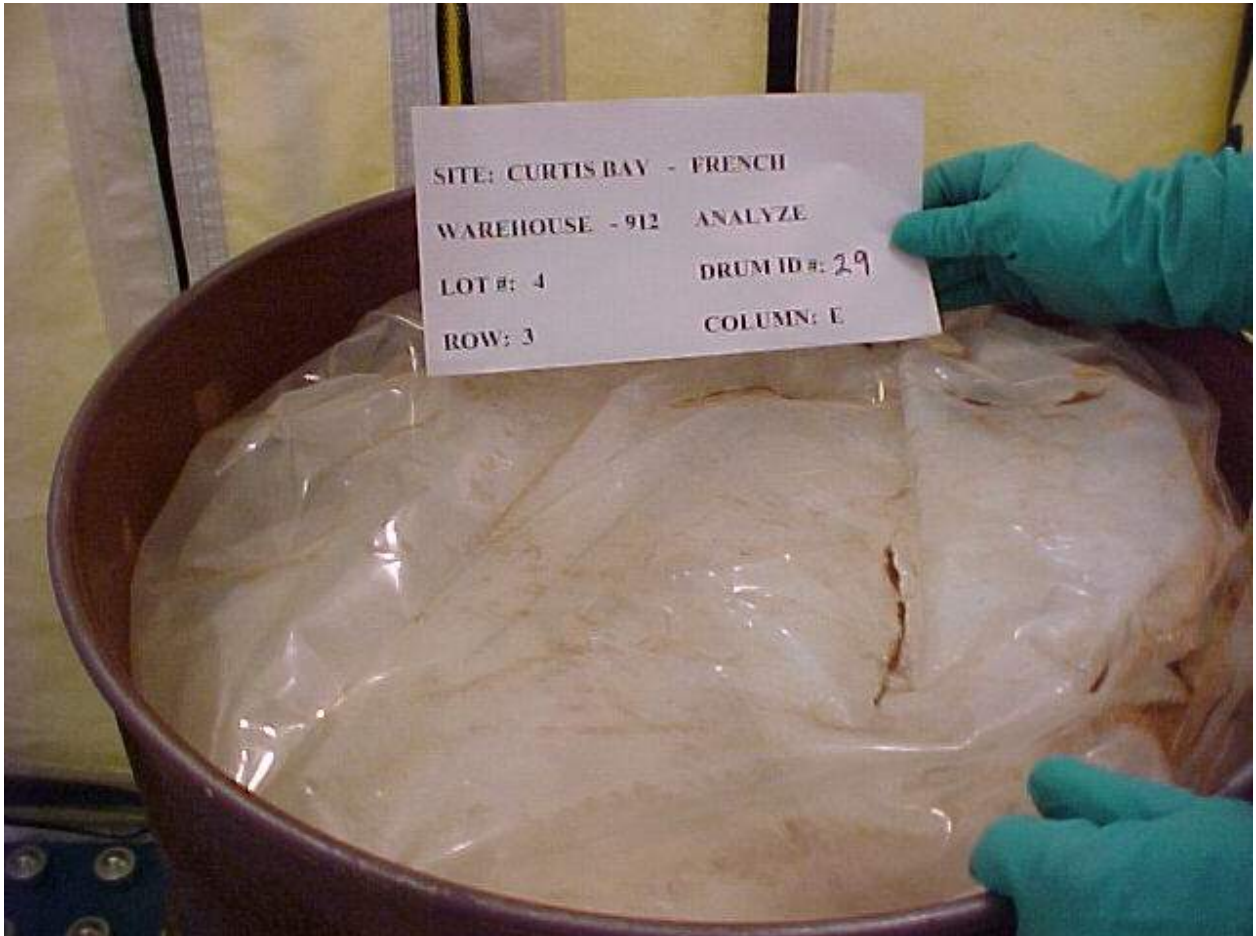
1st polyliner/bag – good condition
No gasses present

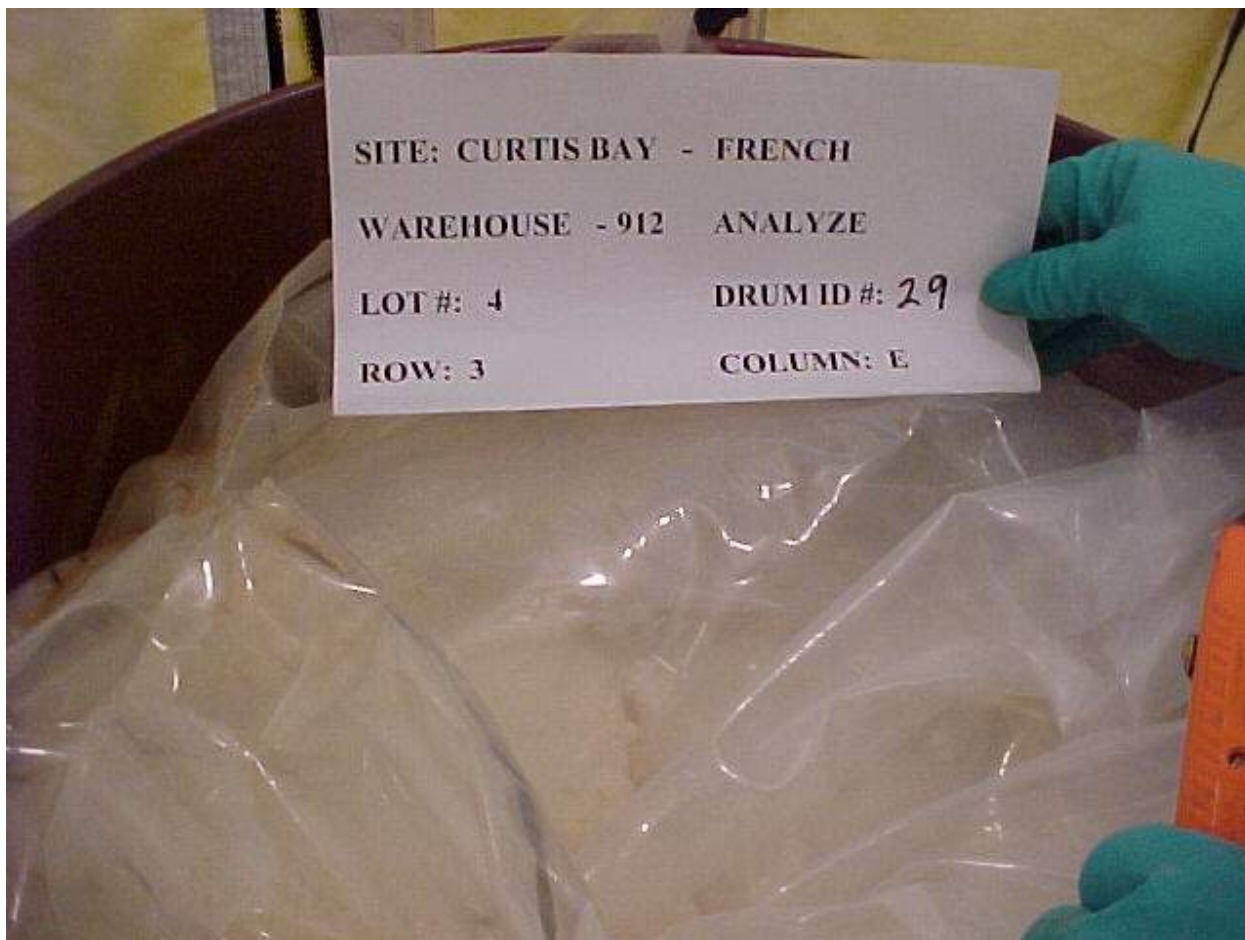
General InformationSite Curtis BayThN Origin FrenchLot No. 4Drum ID No. 29Inspection/Sample
DispositionVisual Inspection & Sampling
Analyze**Physical Location of Drum**Warehouse 912Row 3
Column E**Inspection/Sample Date & Time**Date 7-8-2002Time 14:00**Other Information**Photo No. 3 of 5Dose Rate Surface 44 mR/hr
 1 meter 4.0 mR/hr2nd polyliner/bag – good condition
No gasses present

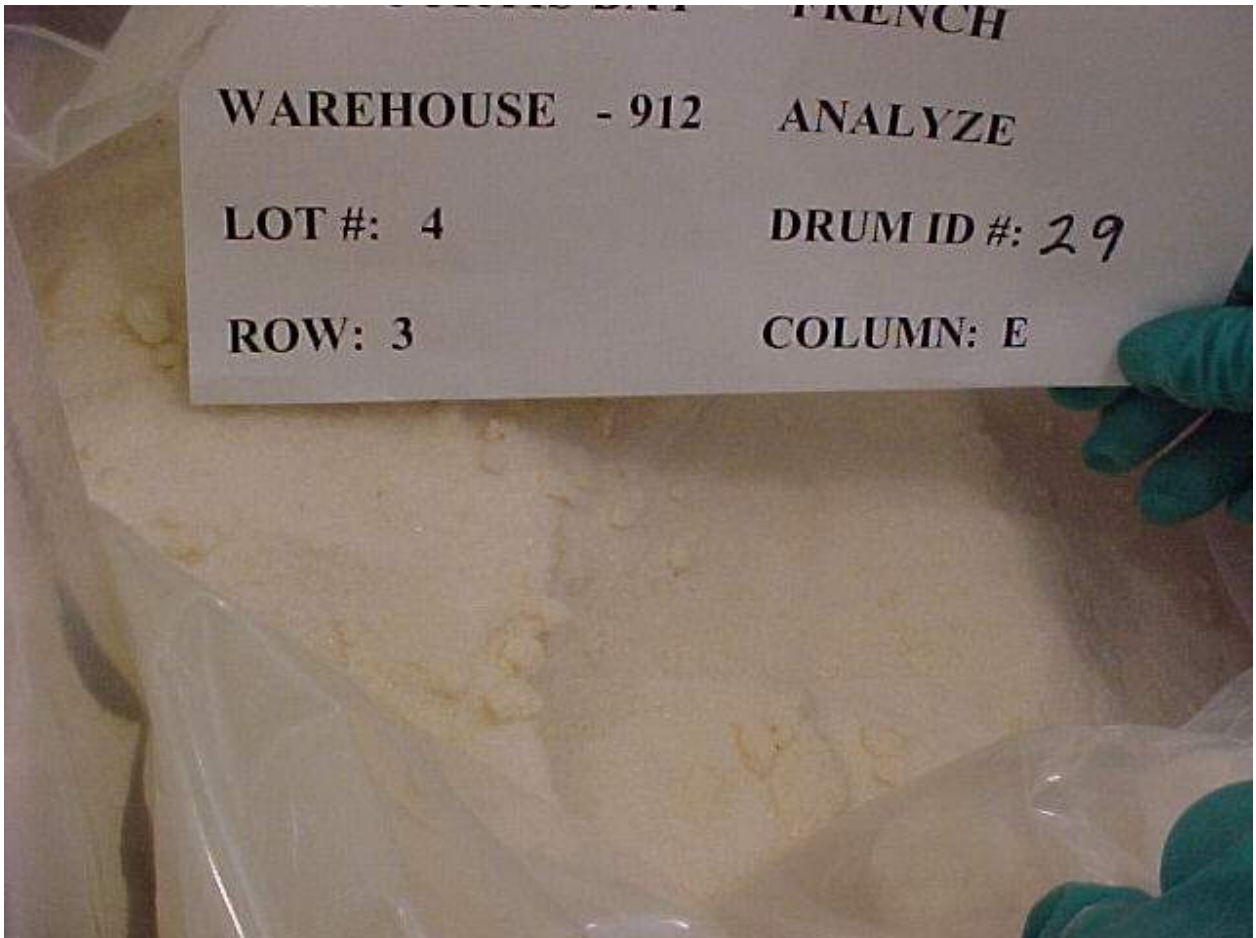
Thorium Nitrate – Powder – white – dry
No gasses present

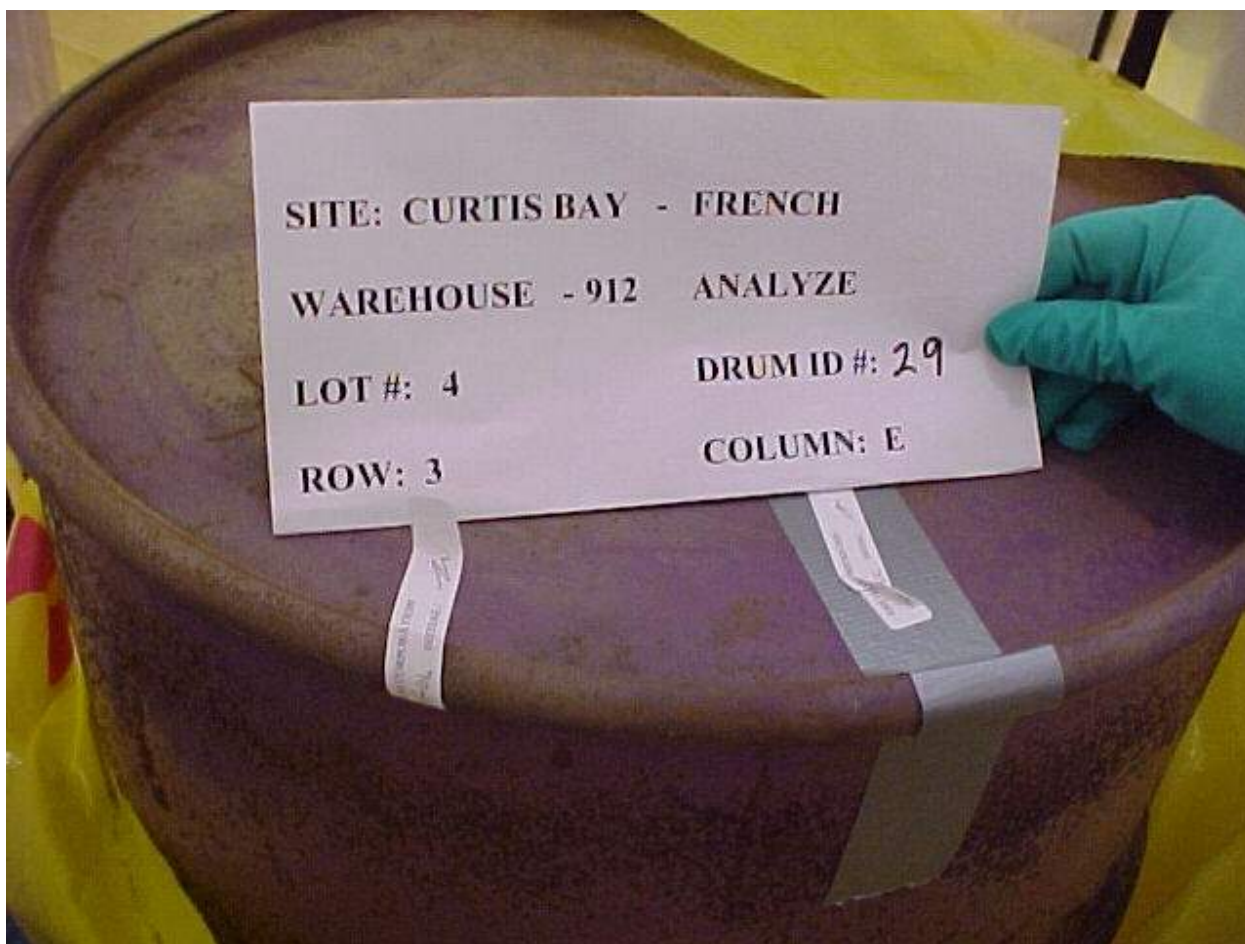
Sealed & dated - Complete
