THORIUM NITRATE STOCKPILE DRUM CHARACTERIZATION REPORT

**THORIUM NITRATE STOCKPILE
DRUM CHARACTERIZATION REPORT**

Prepared for
U.S. Defense Logistics Agency
Defense National Stockpile Center
Fort Belvoir, Virginia

Prepared by
OAK RIDGE NATIONAL LABORATORY
Oak Ridge, Tennessee 37831
managed by
UT-BATTELLE, LLC
for the
U.S. DEPARTMENT OF ENERGY
under contract DE-AC05-00OR22725

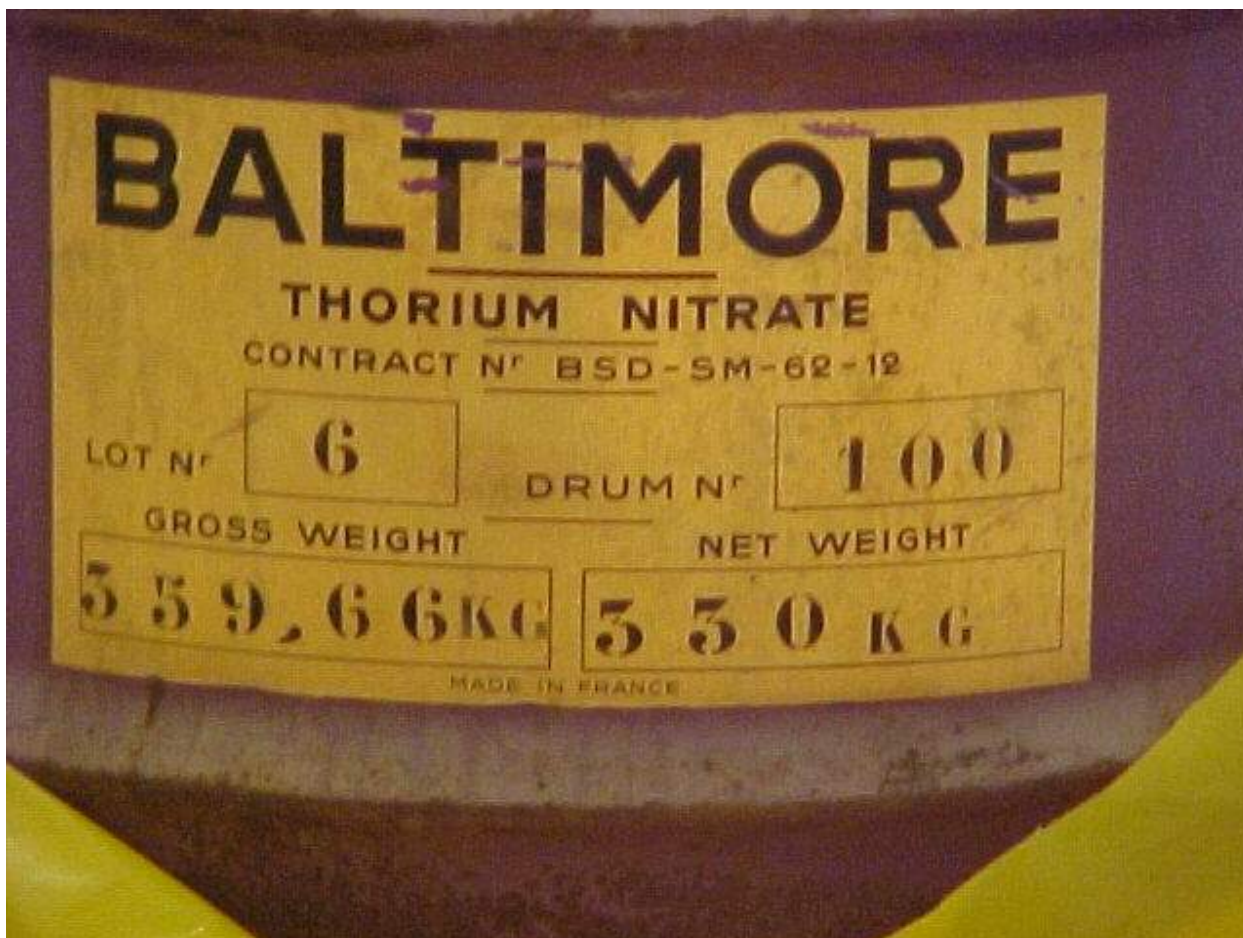
Container	<u>55-gallon steel drum</u>	Container	<u>Fair</u>
		Condition

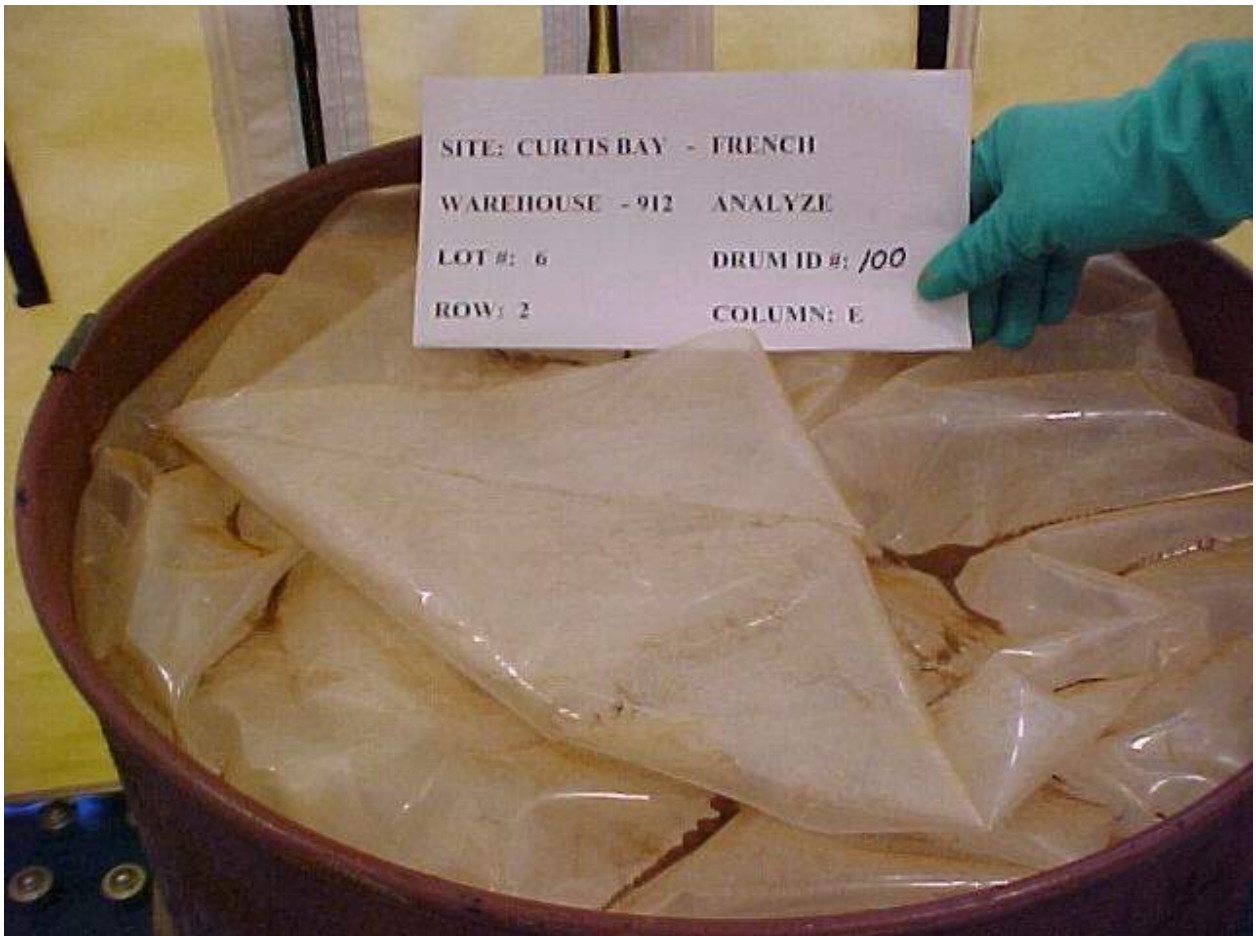
1st poly liner/bag – good condition
No gasses present

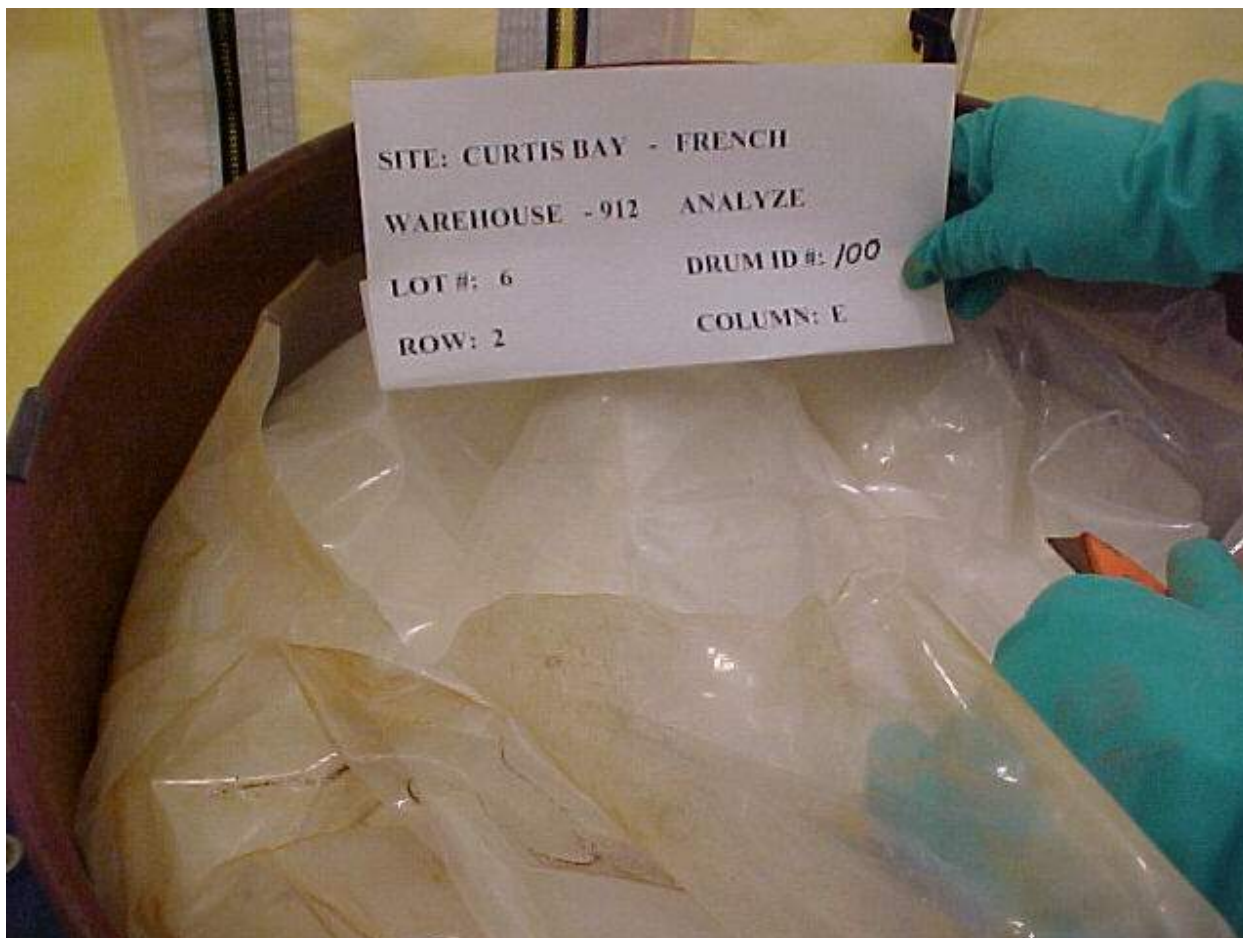
13:45**Other Information**Photo No. 3 of 5Dose Rate Surface 42 mR/hr
 1 meter 4.0 mR/hr

2nd poly liner/bag – good condition
No gasses present

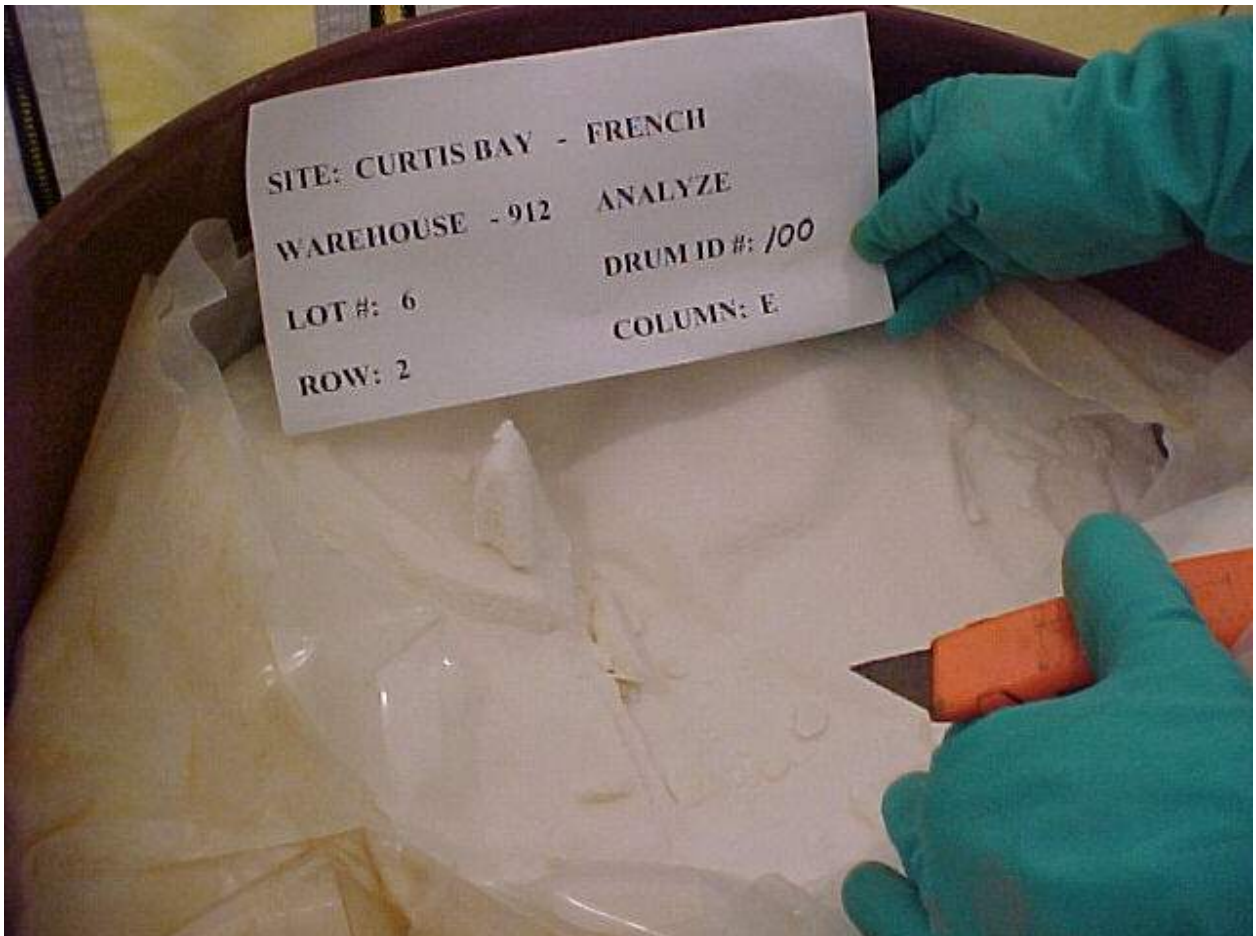
Thorium Nitrate – Powder – white – dry
No gasses present

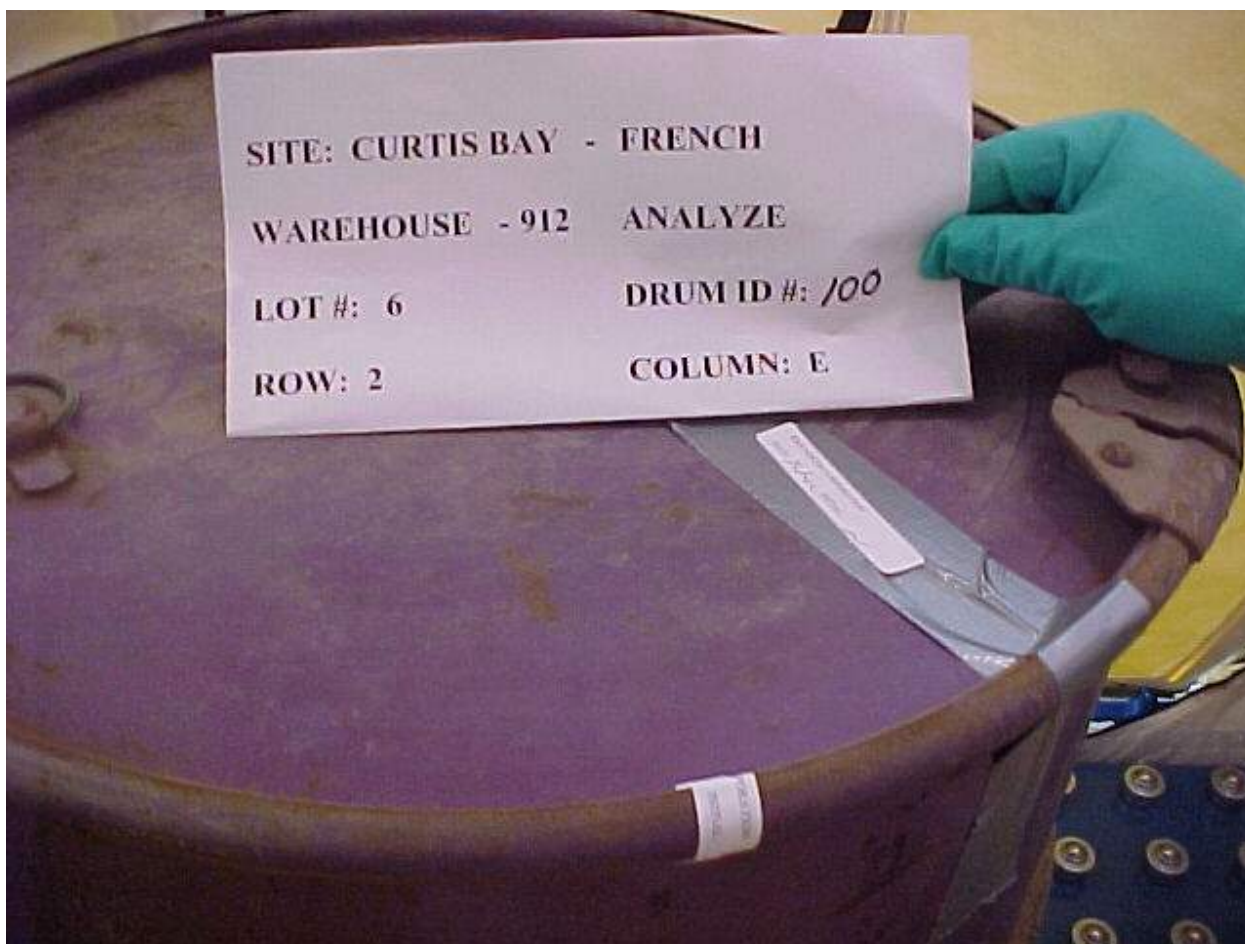
13:45**Other Information**Photo No. 4 of 5Dose Rate Surface 42 mR/hr
 1 meter 4.0 mR/hr

Sealed & dated - Complete

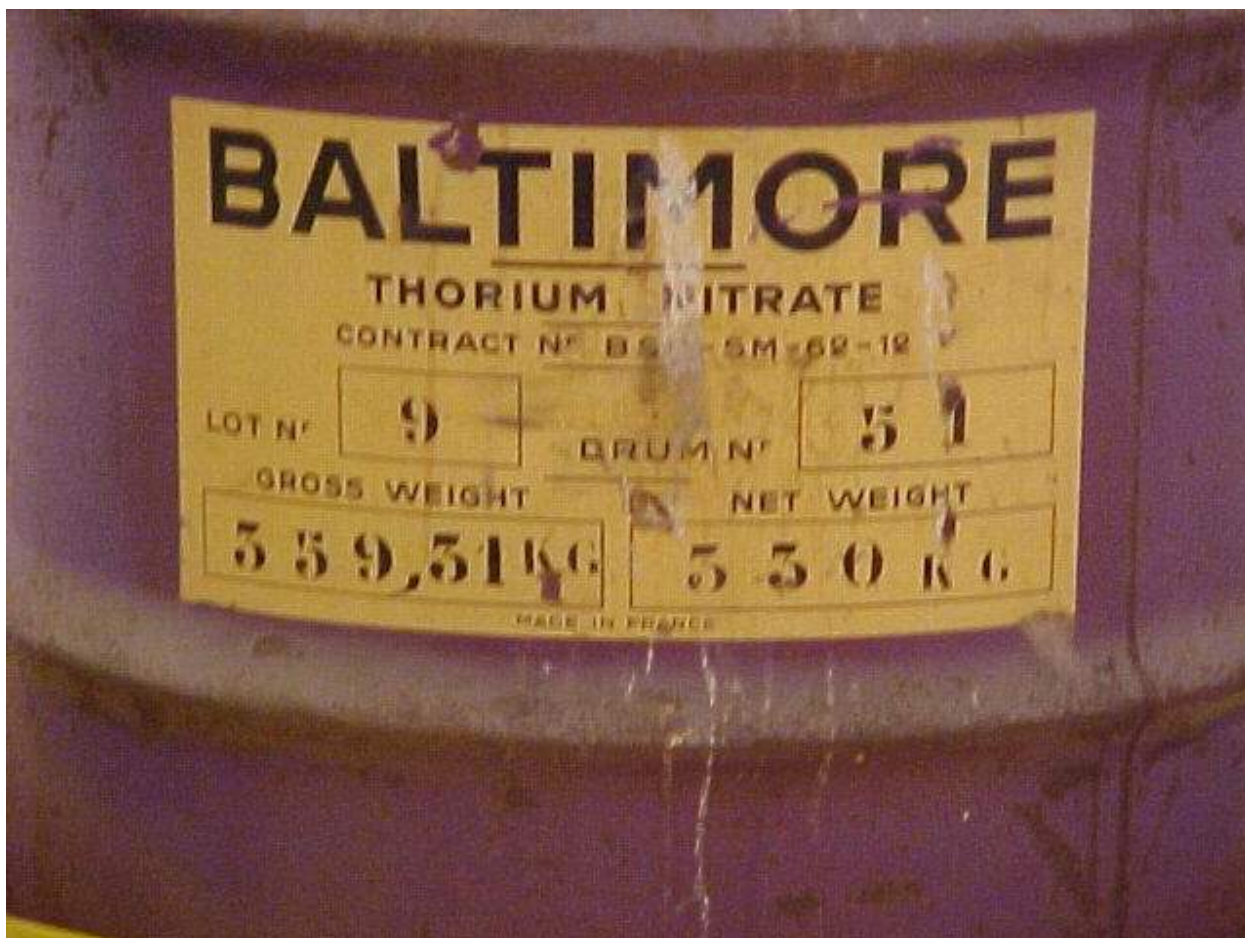
General InformationSite Curtis BayThN Origin FrenchLot No. 9Drum ID No. 51Inspection/Sample
DispositionVisual Inspection & Sampling
Analyze**Physical Location of Drum**Warehouse 912Row 1
Column E**Inspection/Sample Date & Time**Date 7-8-2002Time 12:30**Other Information**Photo No. 1 of 5Container 55-gallon steel drumContainer
Condition FairContainer Wall Thickness 0.1565 inDose Rate Surface 44 mR/hr
1 meter 3.8 mR/hr

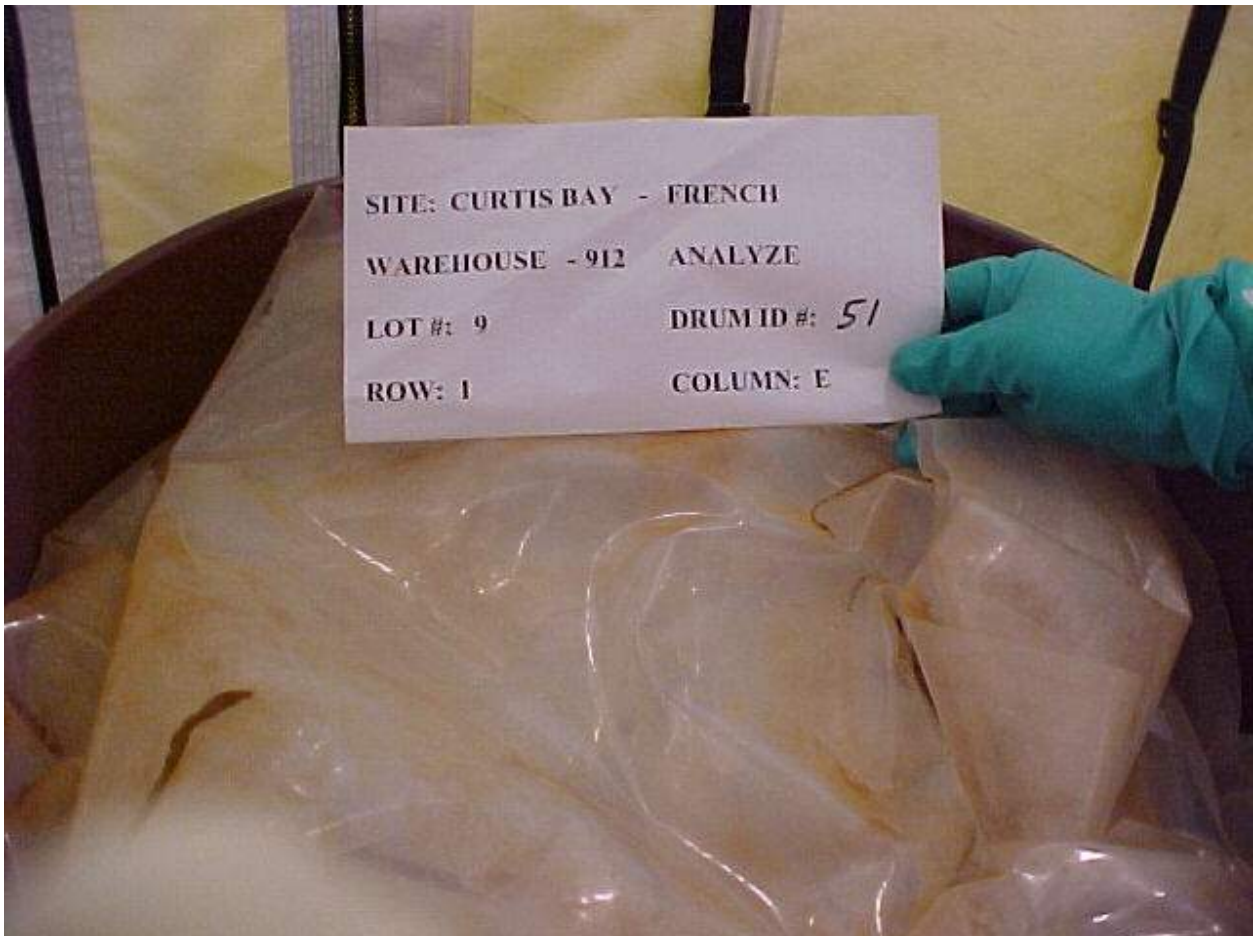
1st poly liner/bag – good condition
No gasses present

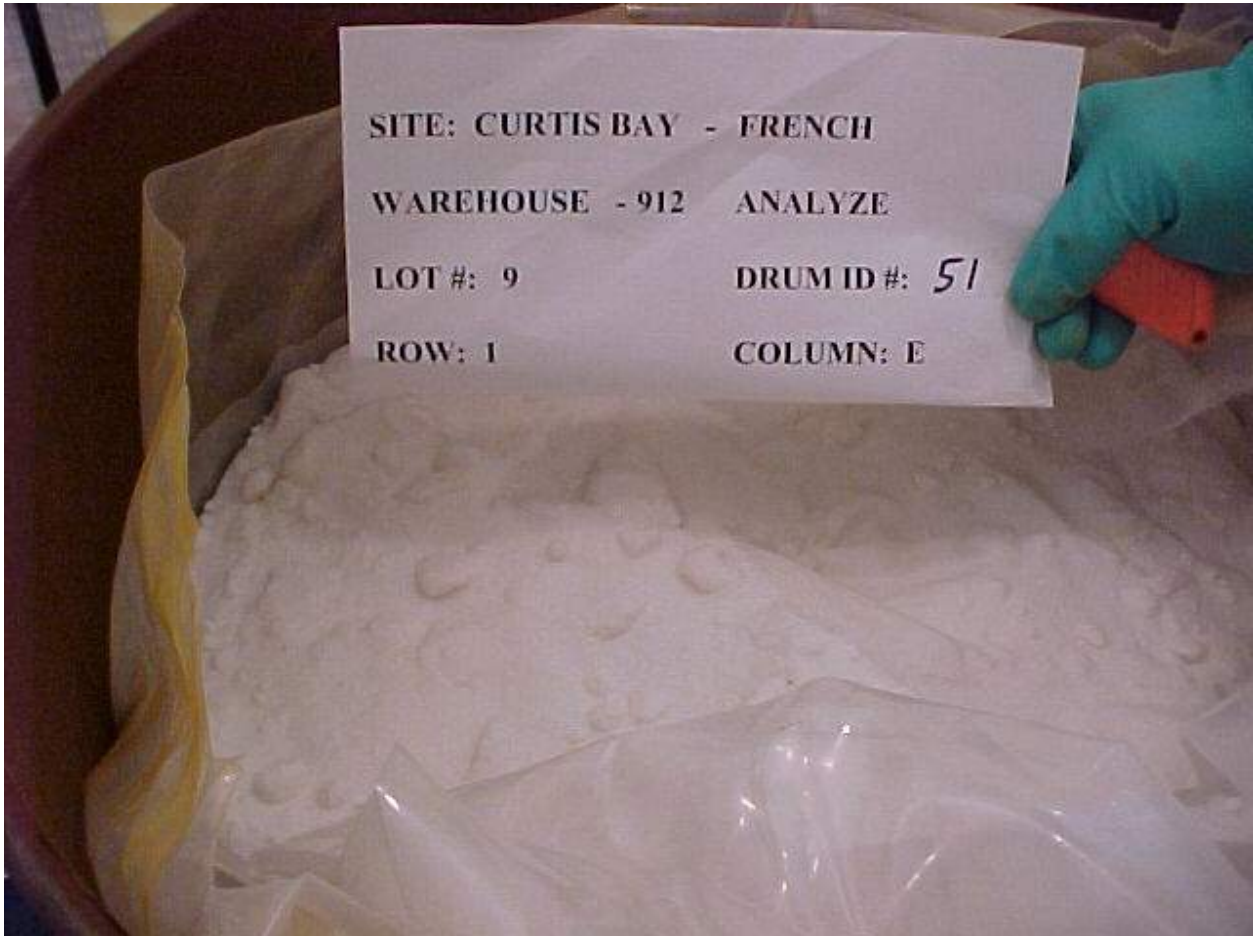
Thorium Nitrate – Powder – white – dry
No gasses present

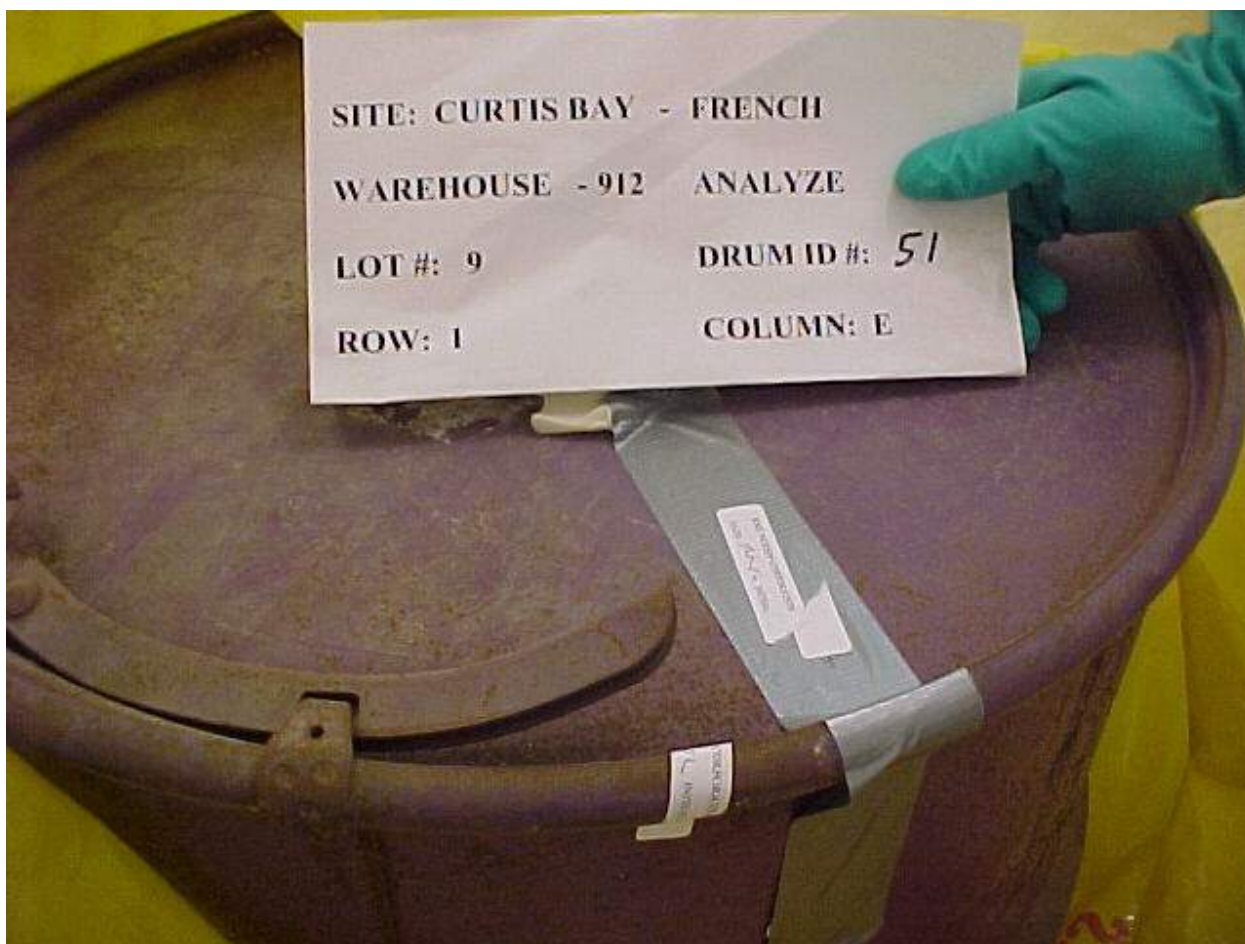
12:30**Other Information**Photo No. 5 of 5Dose Rate Surface 44 mR/hr
 1 meter 3.8 mR/hr

Sealed & dated - Complete

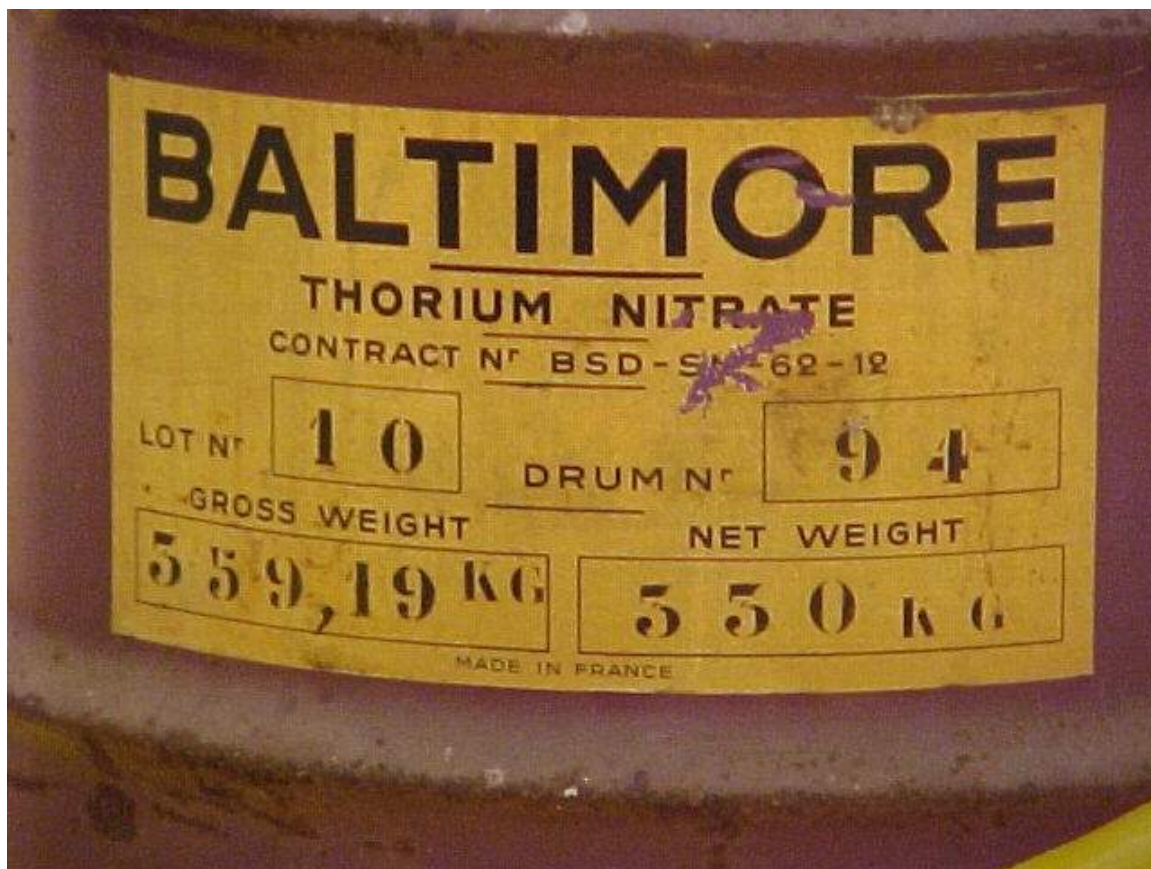
General InformationSite Curtis BayThN Origin FrenchLot No. 10Drum ID No. 94Inspection/Sample
DispositionVisual Inspection & Sampling
Analyze**Physical Location of Drum**Warehouse 911Row 6
Column E**Inspection/Sample Date & Time**Date 7-2-2002Time 11:40**Other Information**Photo No. 1 of 5Container 55-gallon steel drumContainer
Condition FairContainer Wall Thickness 0.1565 inDose Rate Surface 44 mR/hr
1 meter 5.0 mR/hr

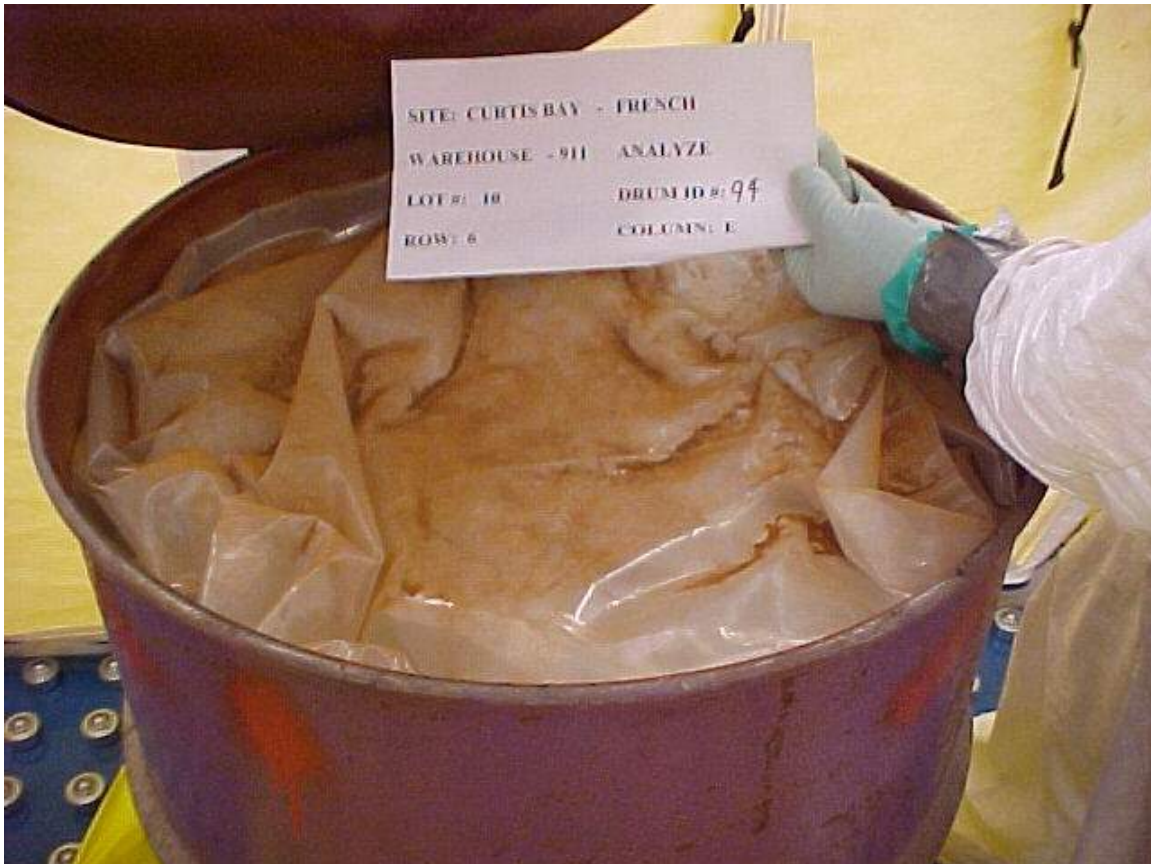
1st poly liner/bag – good condition
No gasses present

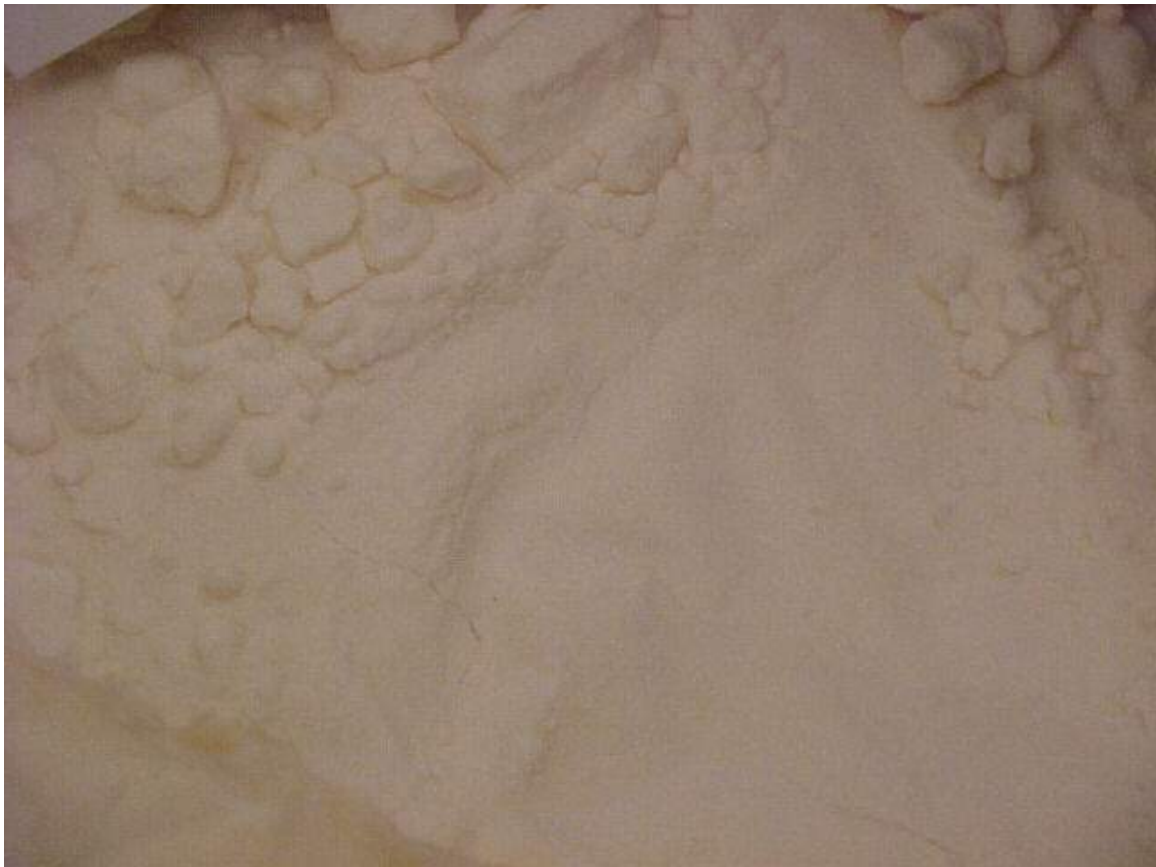
French – Thorium Nitrate – Powder – white – dry
No gasses present

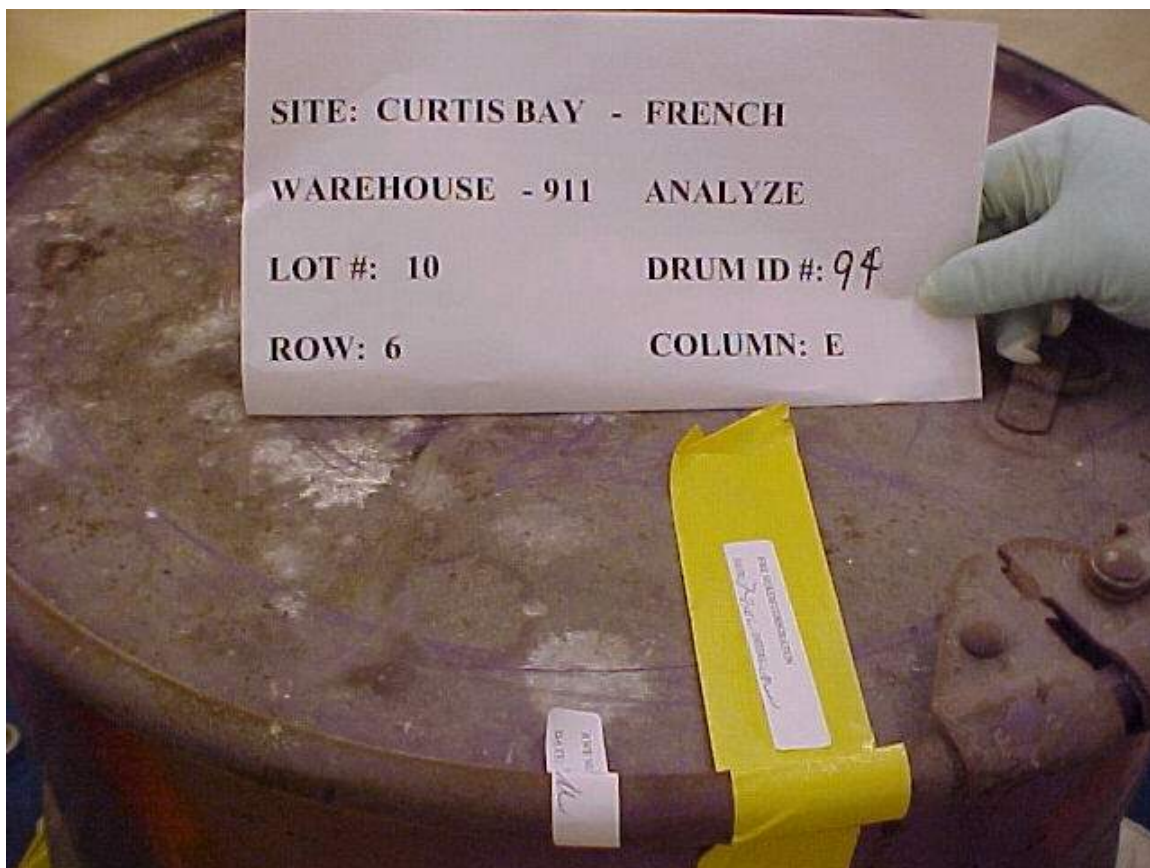
Sealed & dated – Complete

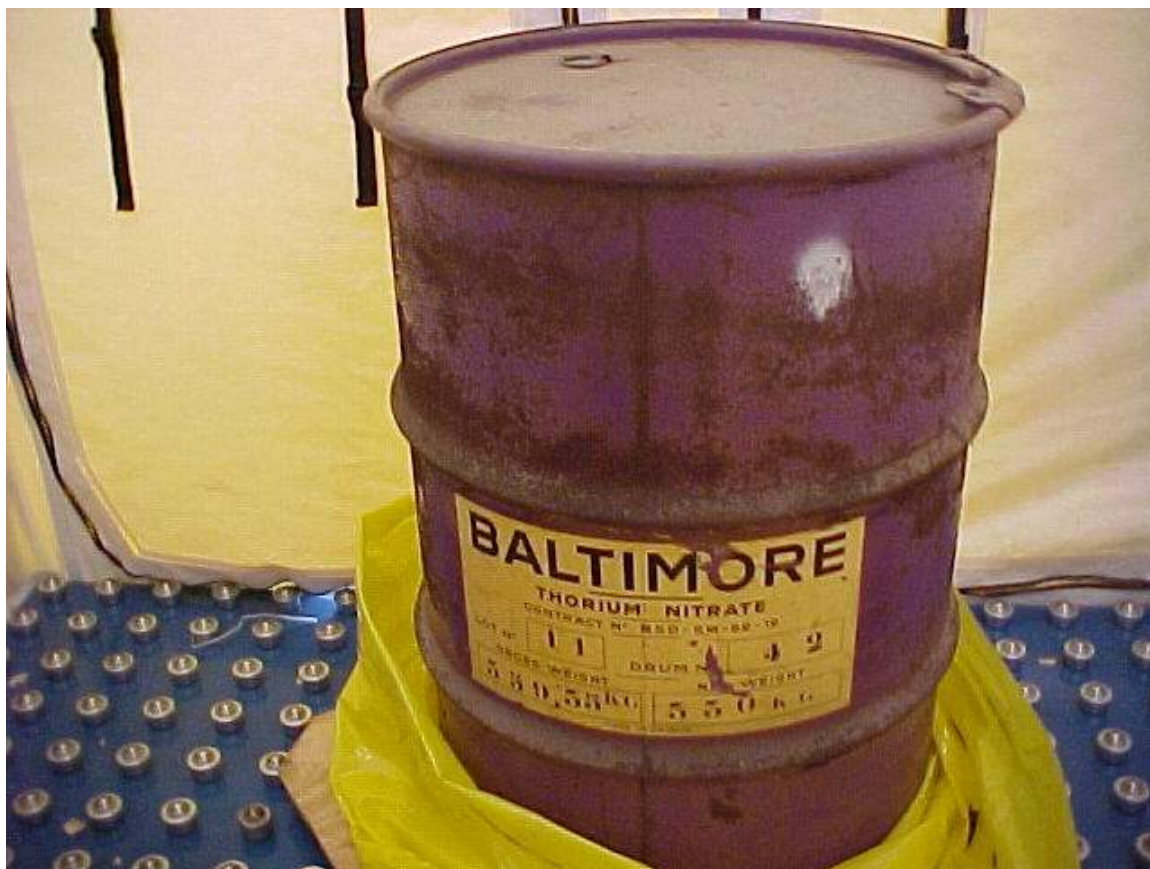
General InformationSite Curtis BayThN Origin FrenchLot No. 11Drum ID No. 42Inspection/Sample
DispositionVisual Inspection & Sampling
Analyze**Physical Location of Drum**Warehouse 911Row 8
Column E**Inspection/Sample Date & Time**Date 7-2-2002Time 09:40**Other Information**Photo No. 1 of 8Container 55-gallon steel drumContainer
Condition FairContainer Wall Thickness 0.1565 inDose Rate Surface 44 mR/hr
1 meter 4.2 mR/hr

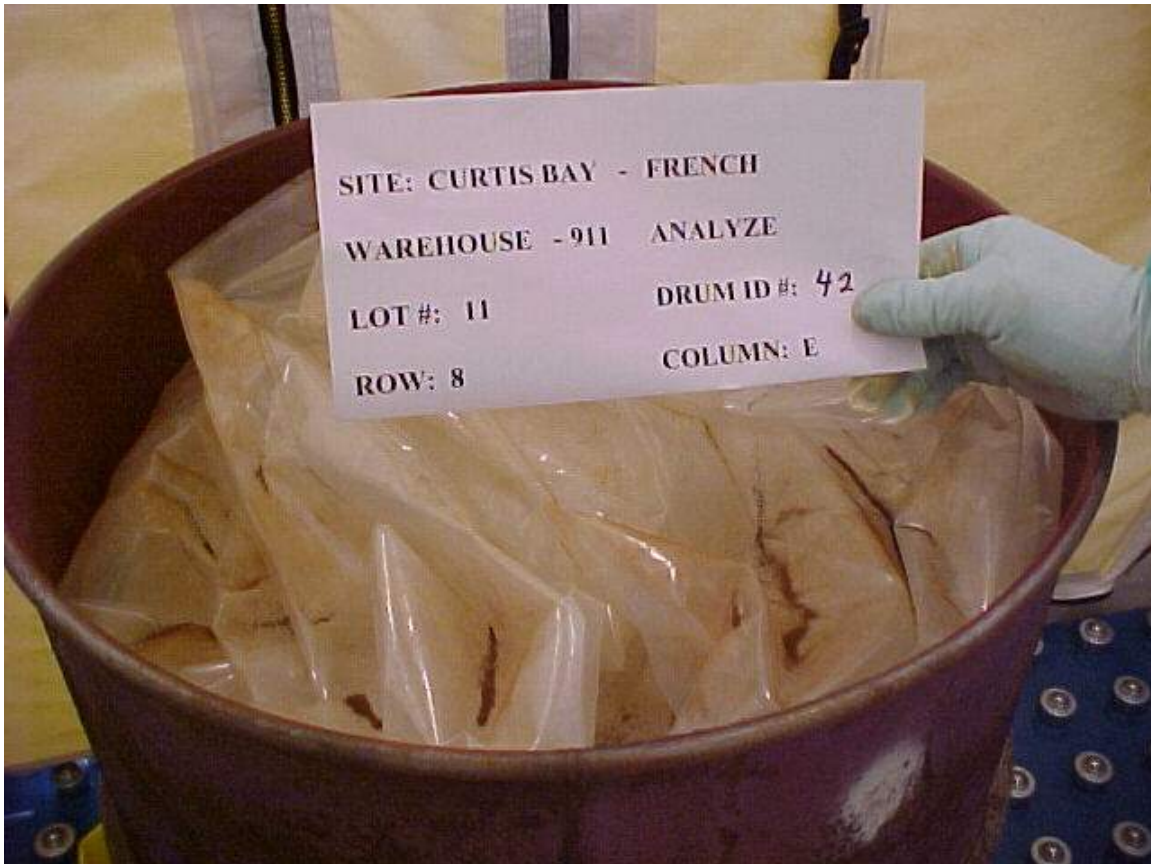
1st poly liner/bag – good condition
No gasses present

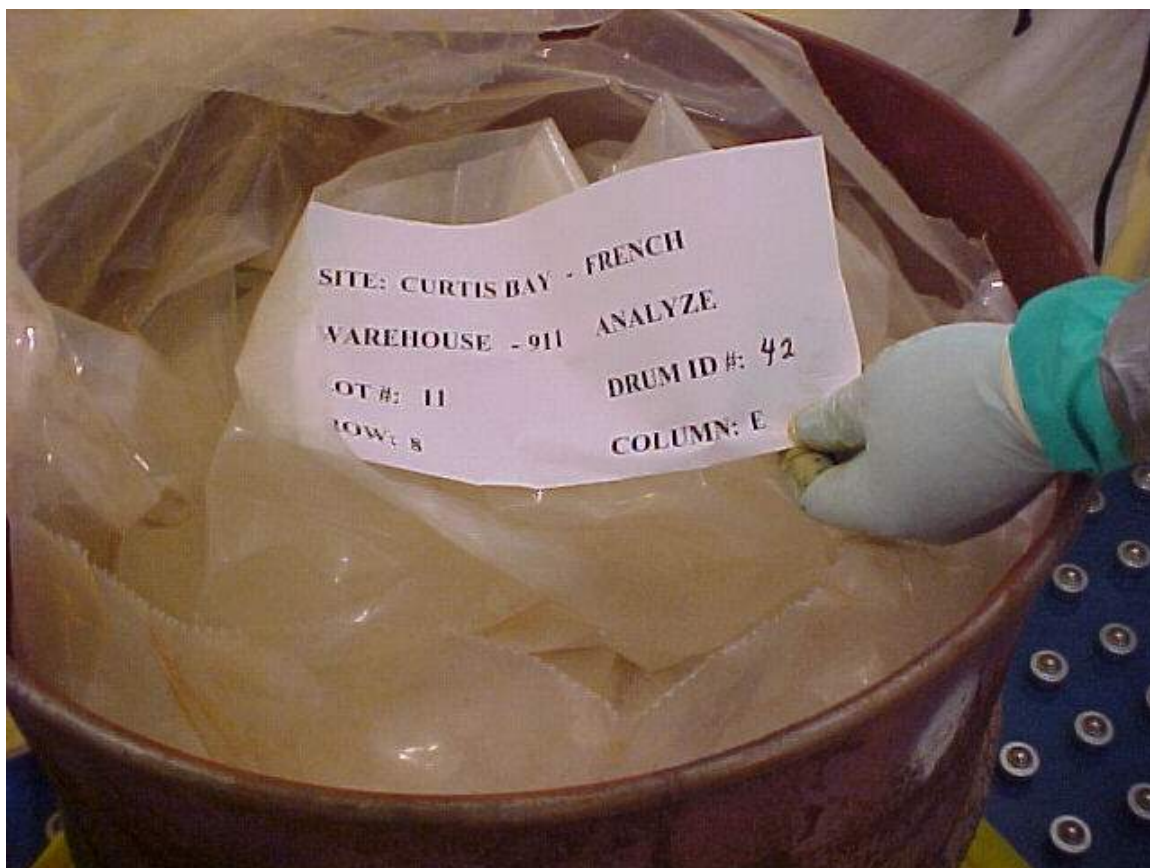
09:40**Other Information**Photo No. 3 of 8Dose Rate Surface 44 mR/hr
 1 meter 5.0 mR/hr2nd poly liner/bag – good condition

No gasses present

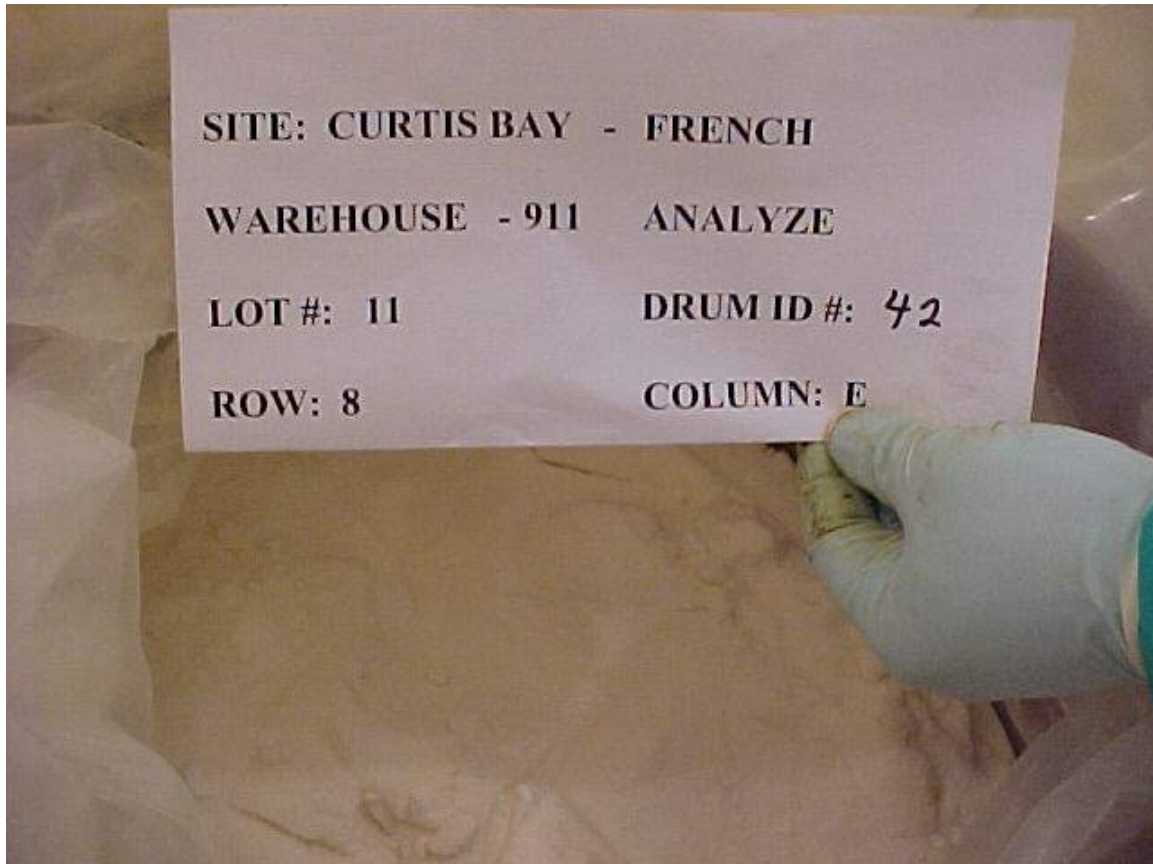
French – Thorium Nitrate – powder – white – dry
No gasses present

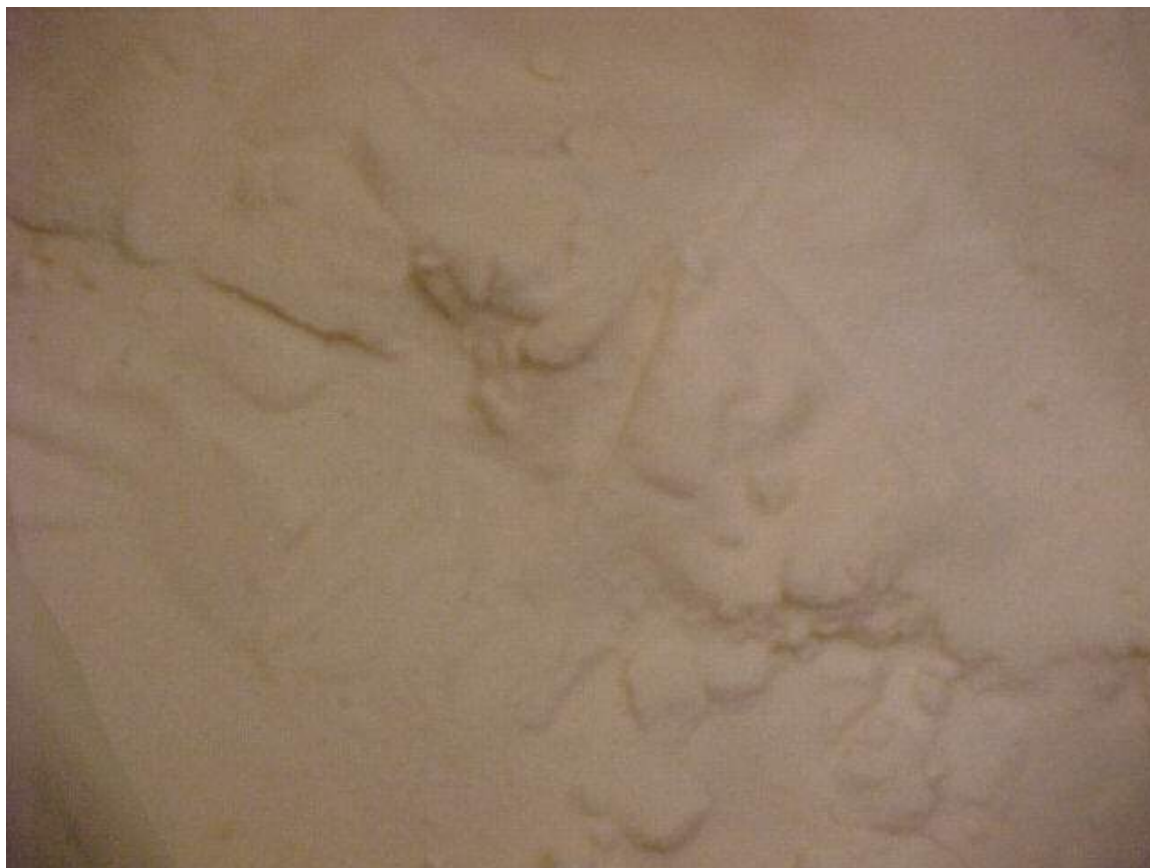
Close-up of the Powder (Thorium Nitrate)

No gasses present

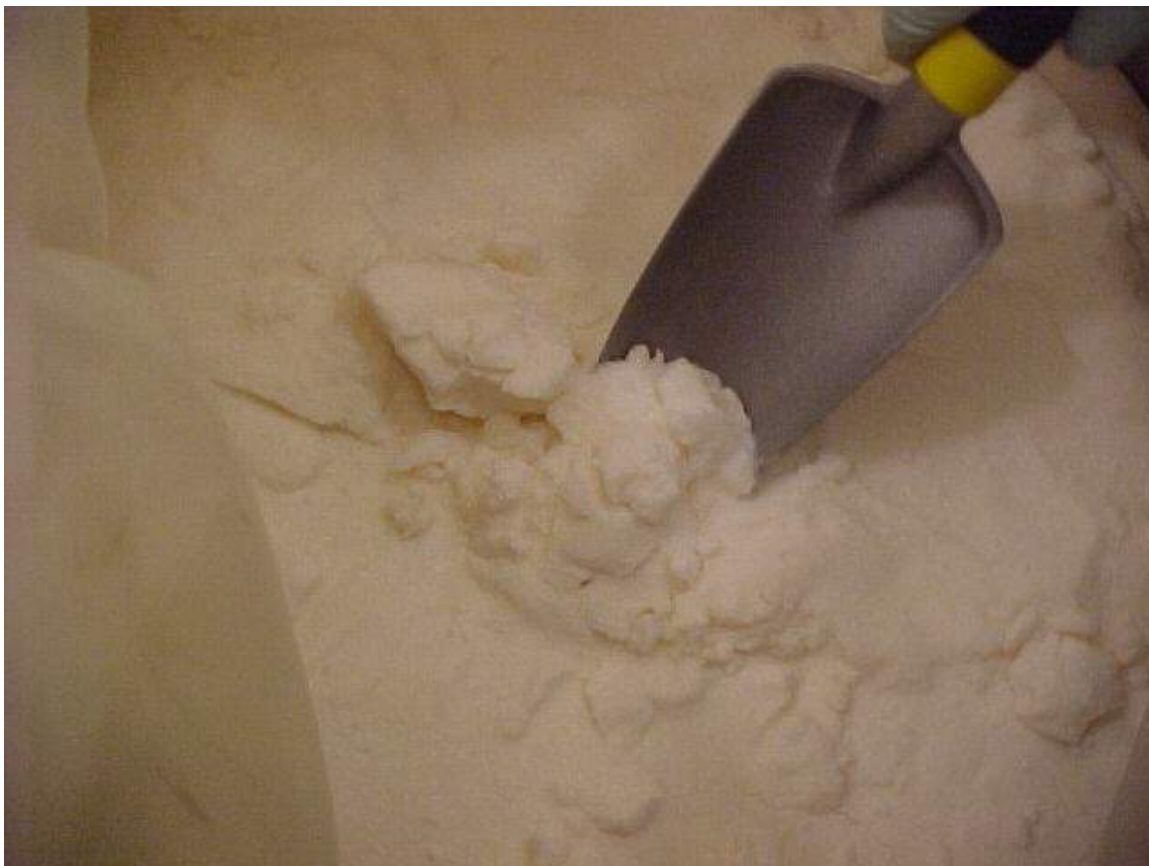
This photo shows the ThN material in the powder form as the scoop is used to collect the sample
No gasses present

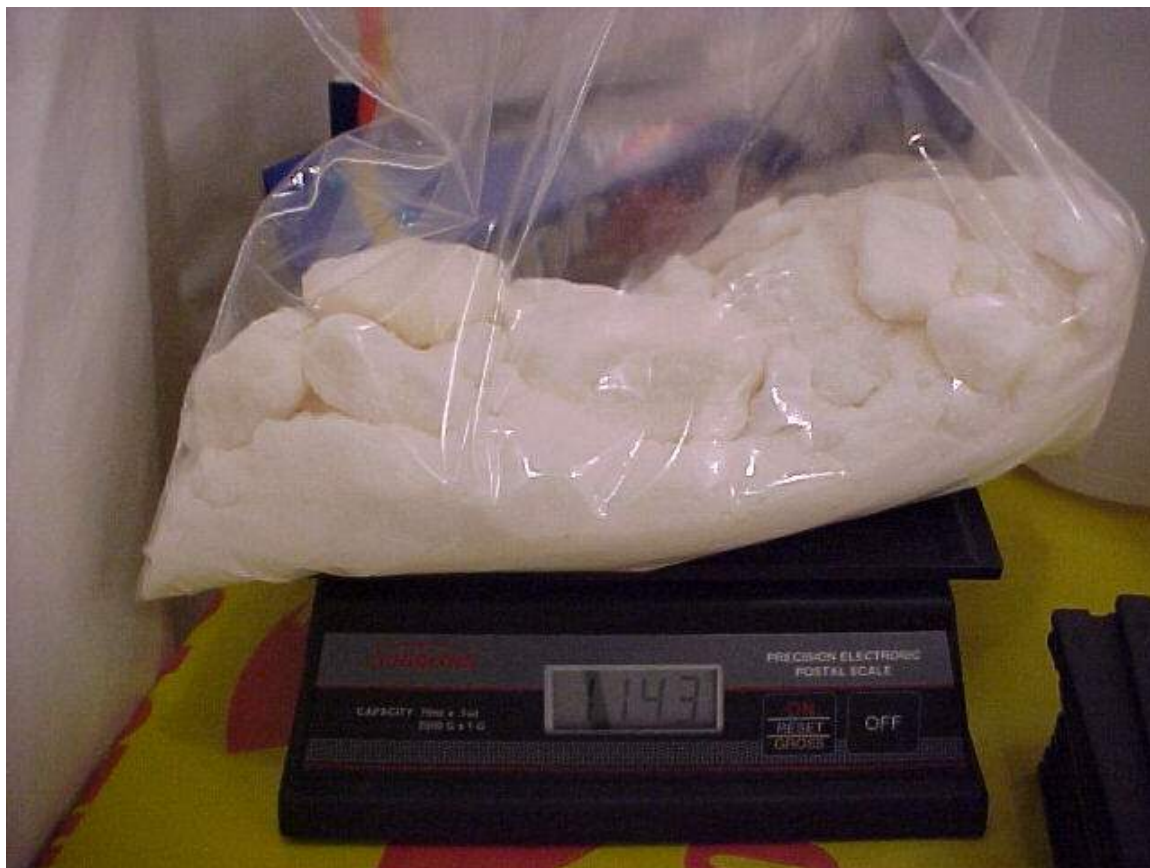
09:40**Other Information**Photo No. 7 of 8Dose Rate Surface 44 mR/hr
 1 meter 5.0 mR/hr

This photo shows the ThN material being weighed for shipment
No gasses present

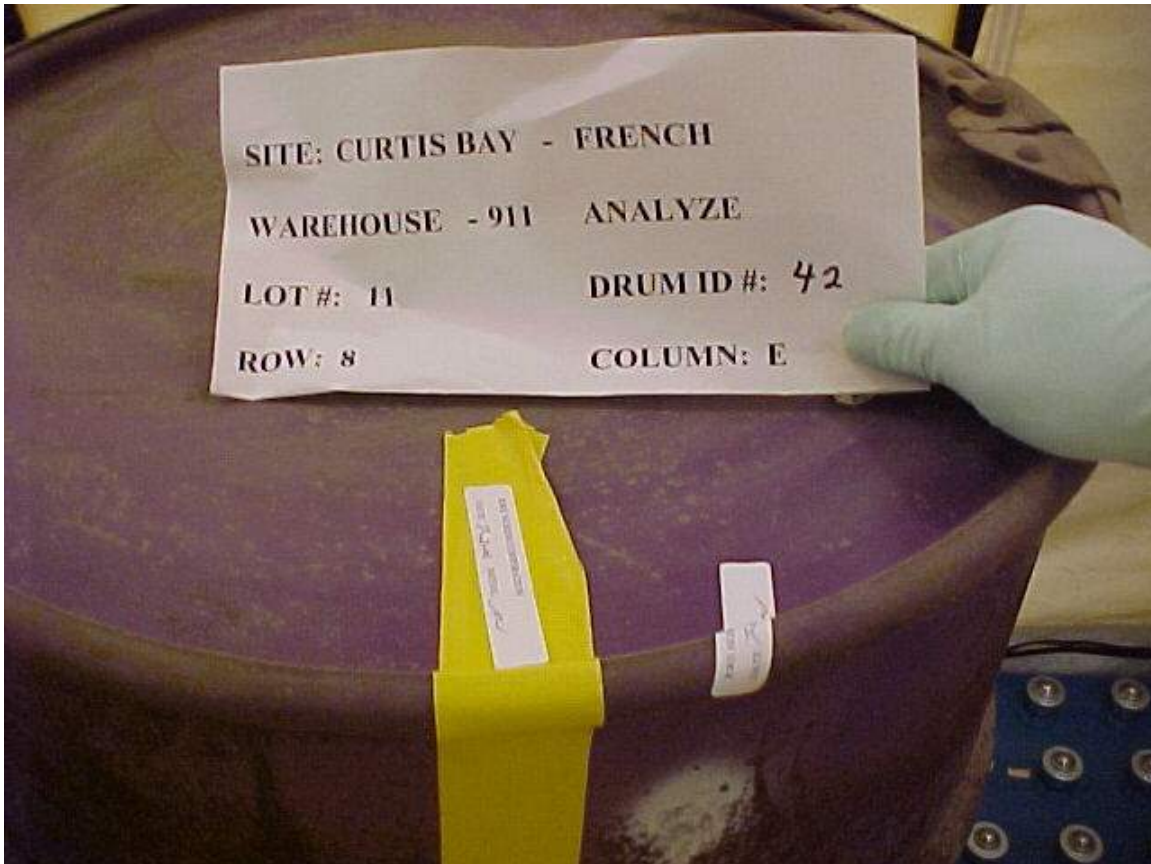
Sealed/Dated - Completed
