THORIUM NITRATE STOCKPILE DRUM CHARACTERIZATION REPORT

**THORIUM NITRATE STOCKPILE
DRUM CHARACTERIZATION REPORT**

Prepared for
U.S. Defense Logistics Agency
Defense National Stockpile Center
Fort Belvoir, Virginia

Prepared by
OAK RIDGE NATIONAL LABORATORY
Oak Ridge, Tennessee 37831
managed by
UT-BATTELLE, LLC
for the
U.S. DEPARTMENT OF ENERGY
under contract DE-AC05-00OR22725

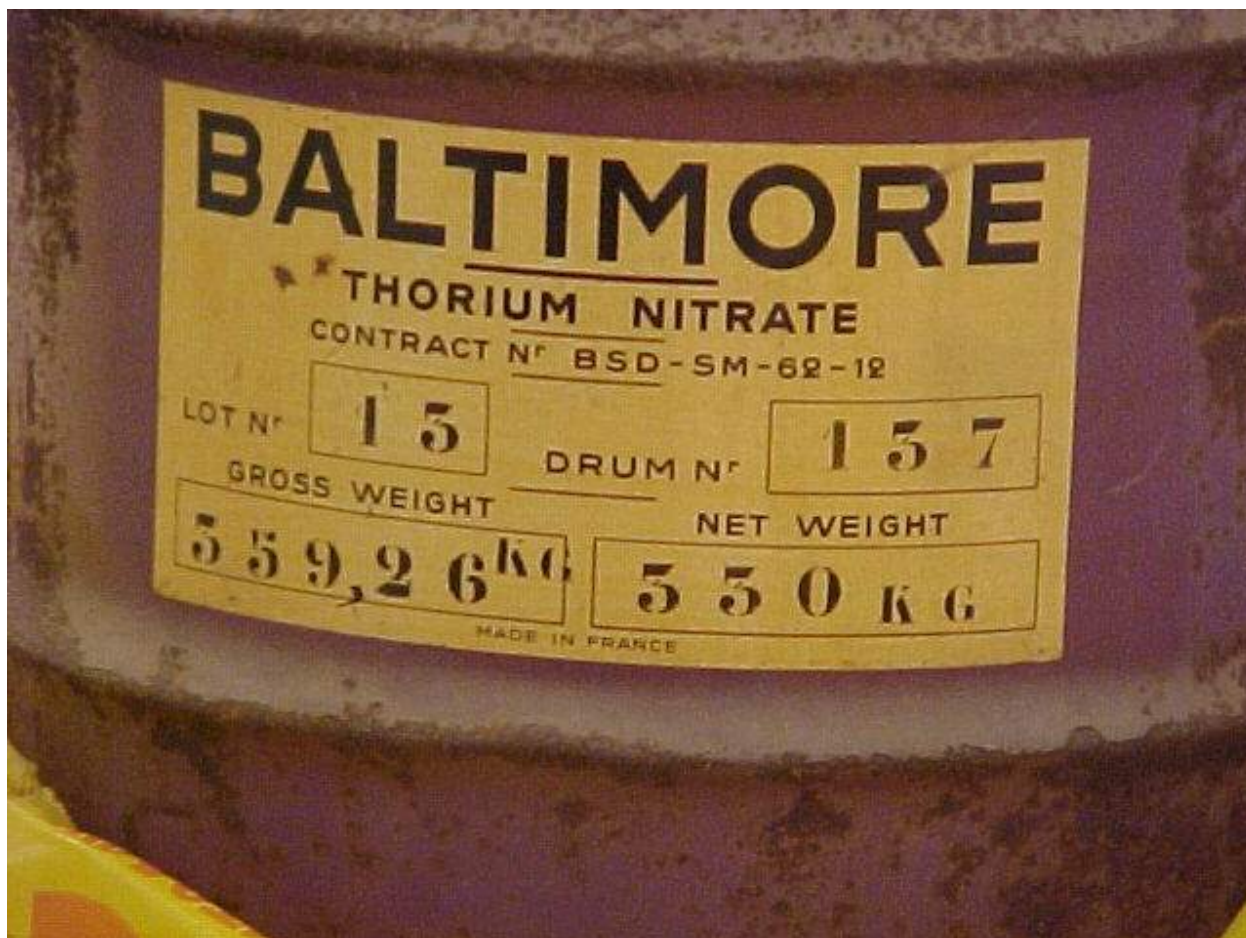
General InformationSite Curtis BayThN Origin FrenchLot No. 13Drum ID No. 137Inspection/Sample
DispositionVisual Inspection & Sampling
Analyze**Physical Location of Drum**Warehouse 912Row 9
Column F**Inspection/Sample Date & Time**Date 7-8-2002Time 12:45**Other Information**Photo No. 1 of 5Container 55-gallon steel drumContainer
Condition FairContainer Wall Thickness 0.1565 inDose Rate Surface 44 mR/hr
1 meter 3.8 mR/hr

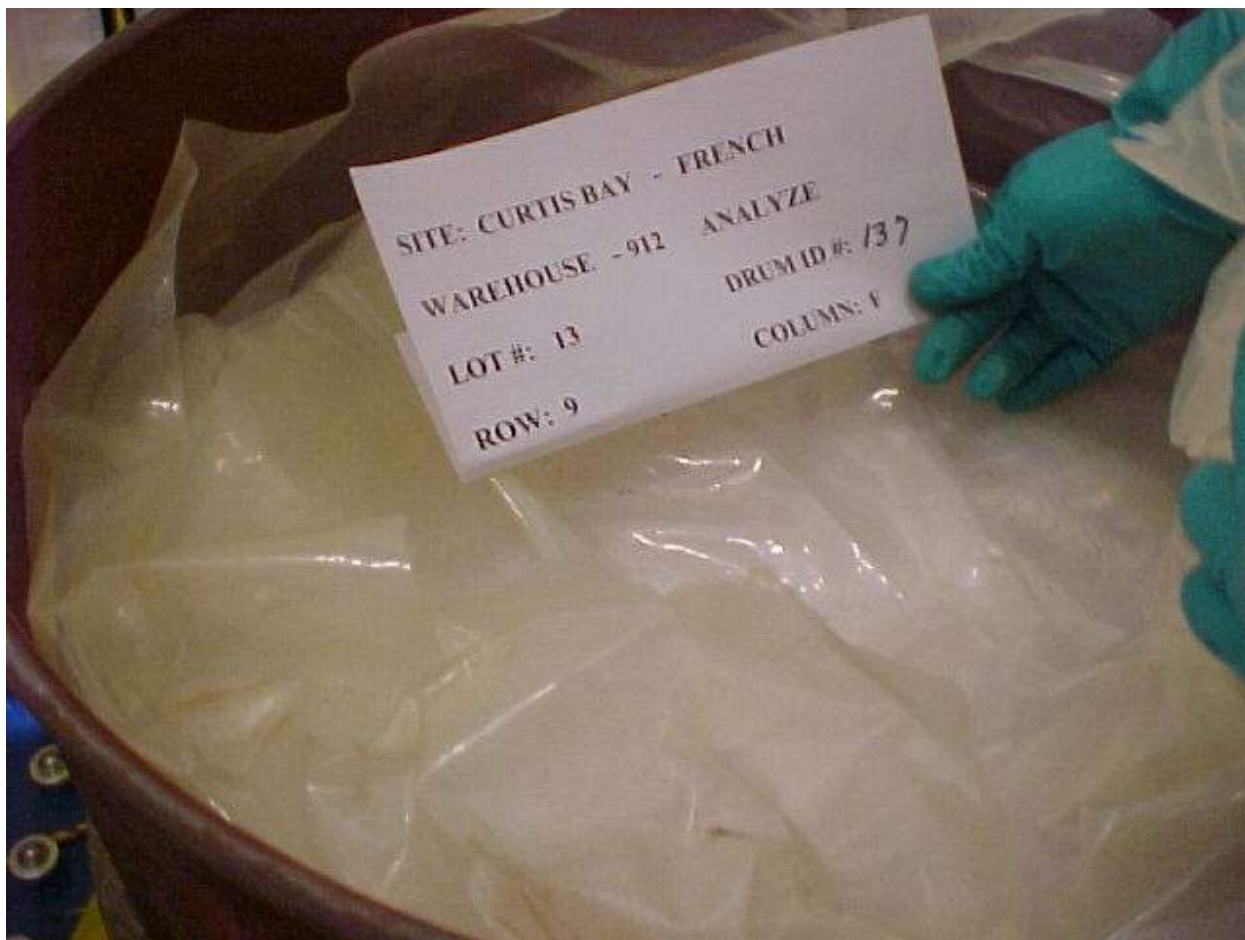
12:45**Other Information**Photo No. 3 of 5Dose Rate Surface 44 mR/hr
 1 meter 3.8 mR/hr2nd poly liner/bag – good condition
No gasses present

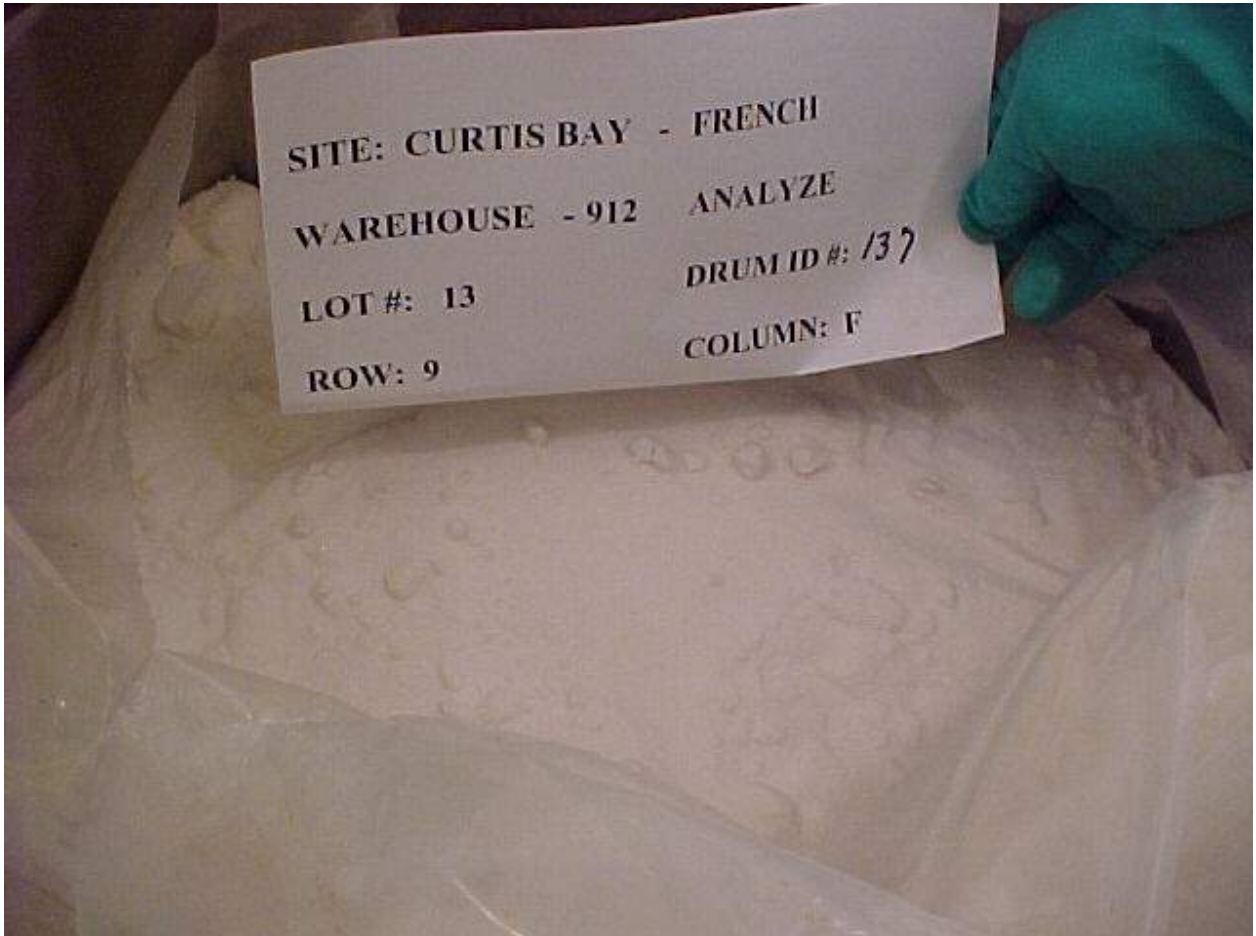
Thorium Nitrate – Powder – white – dry
No gasses present

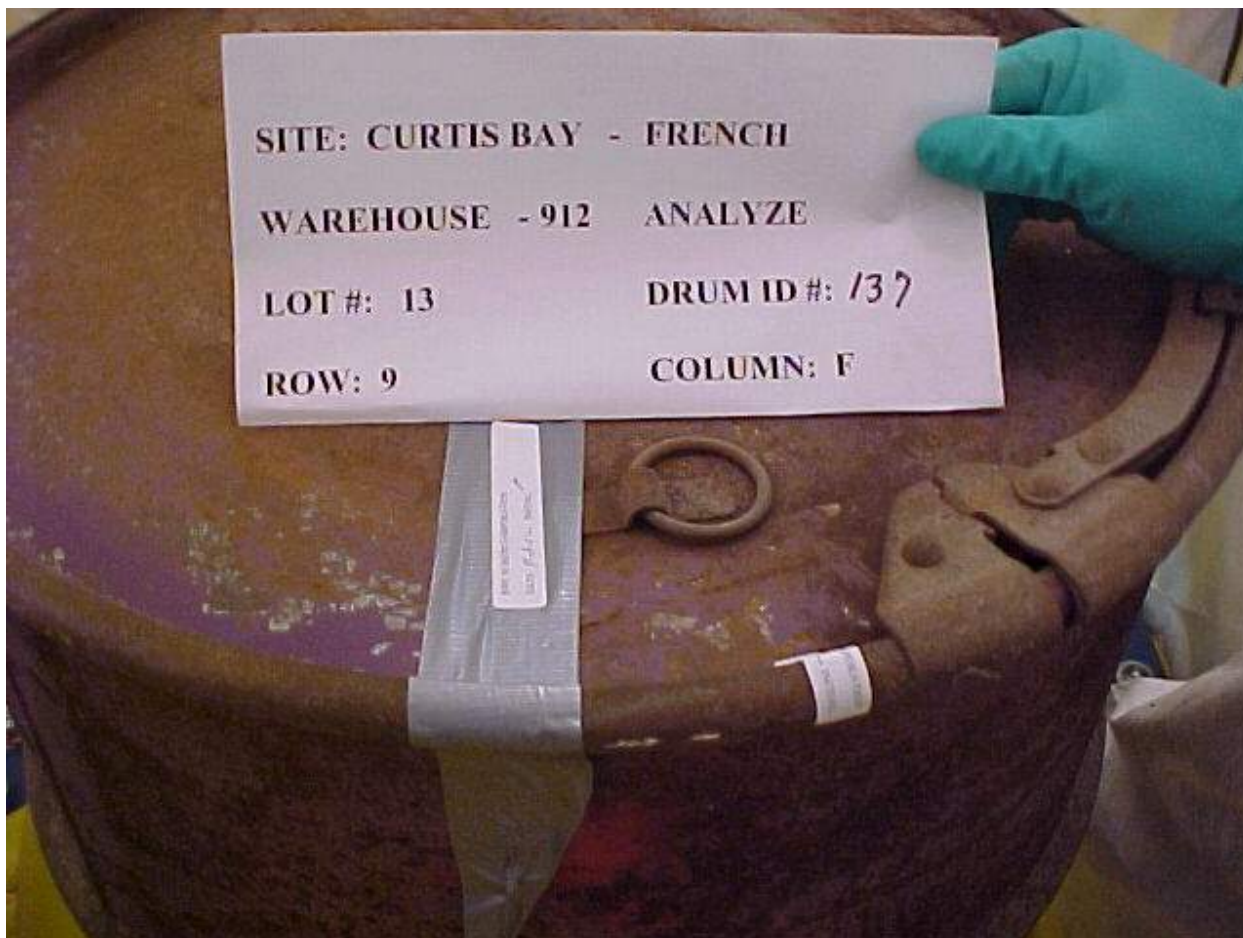
Sealed/Dated – Completed

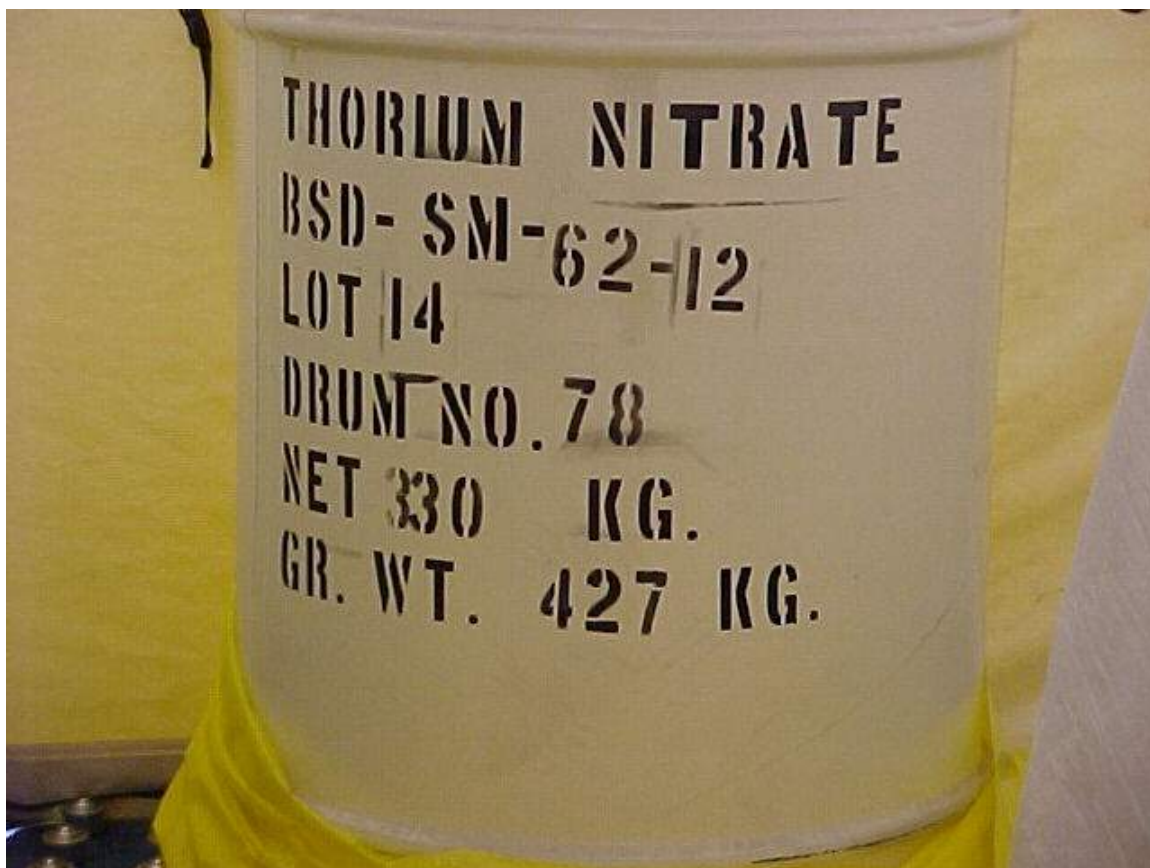
General InformationSite Curtis BayThN Origin FrenchLot No. 14Drum ID No. 78Inspection/Sample
DispositionVisual Inspection & Sampling
Analyze**Physical Location of Drum**Warehouse 911Row 4
Column E**Inspection/Sample Date & Time**Date 7-3-2002Time 09:55**Other Information**Photo No. 1 of 6Container 85-gallon steel drumContainer
Condition GoodDose Rate Surface 38 mR/hr
 1 meter 4.5 mR/hr

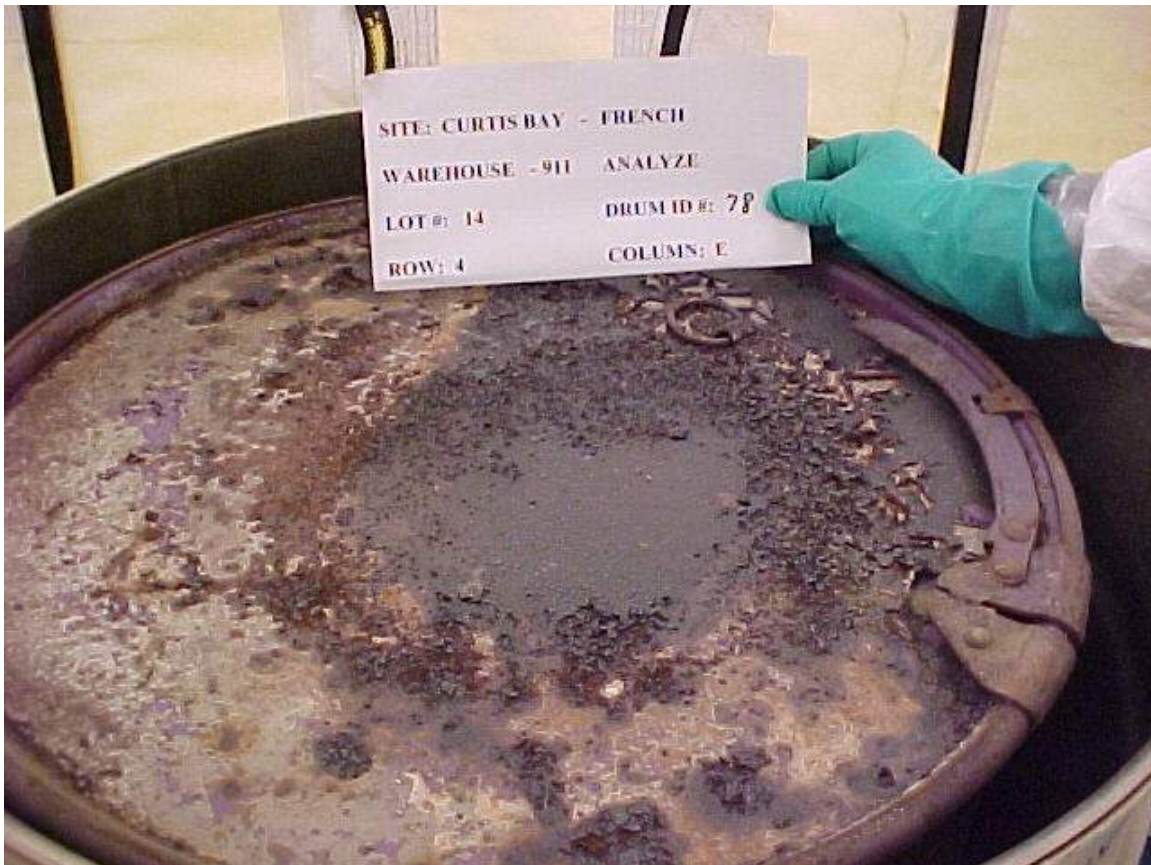
55-gal drum – fair condition

Ring on the container was in very bad condition – the ring was replaced

No gasses present

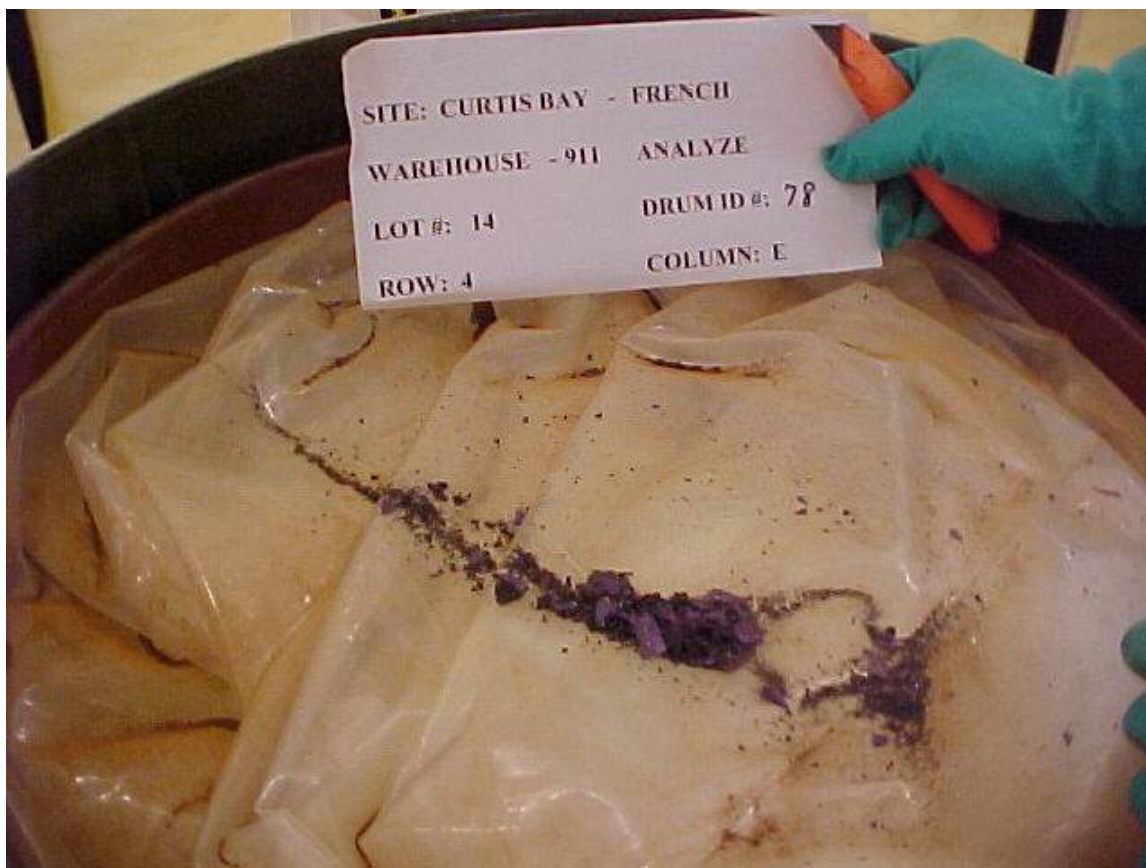
09:55**Other Information**Photo No. 3 of 6Dose Rate Surface 38 mR/hr
 1 meter 4.5 mR/hr1st poly liner/bag – good condition
No gasses present

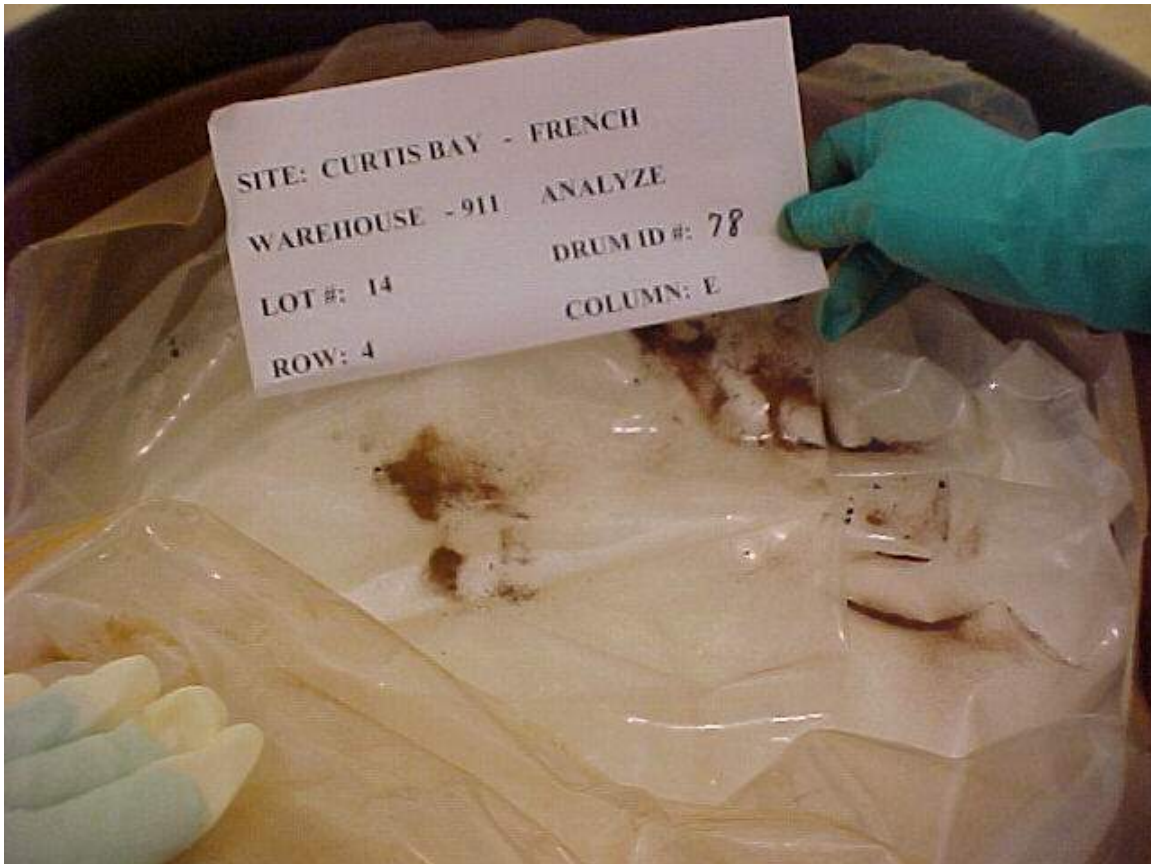
2nd poly liner/bag – good condition
No gasses present

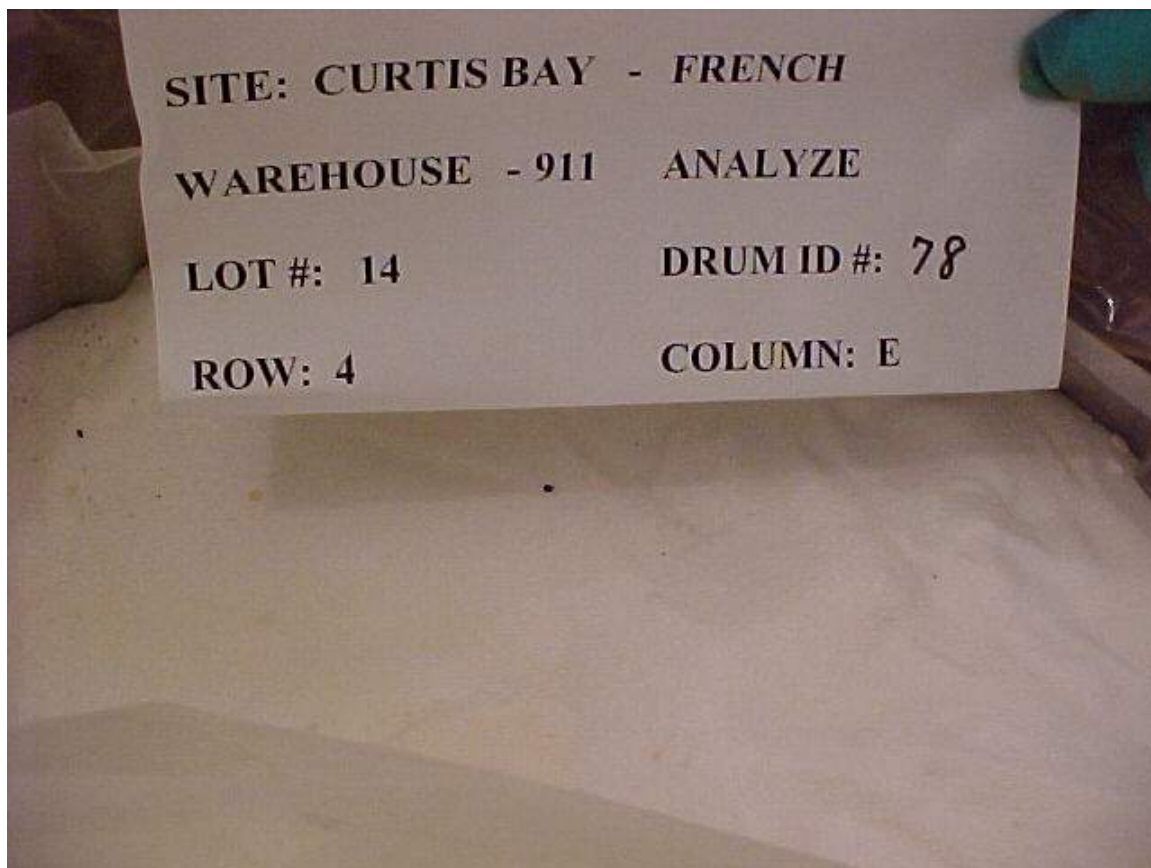
General InformationSite Curtis BayThN Origin FrenchLot No. 14Drum ID No. 78Inspection/Sample
DispositionVisual Inspection & Sampling
Analyze**Physical Location of Drum**Warehouse 911Row 4
Column E**Inspection/Sample Date & Time**Date 7-3-2002Time 09:55**Other Information**Photo No. 5 of 6Dose Rate Surface 38 mR/hr
 1 meter 4.5 mR/hrThorium Nitrate – Powder form – white – dry
No gasses present

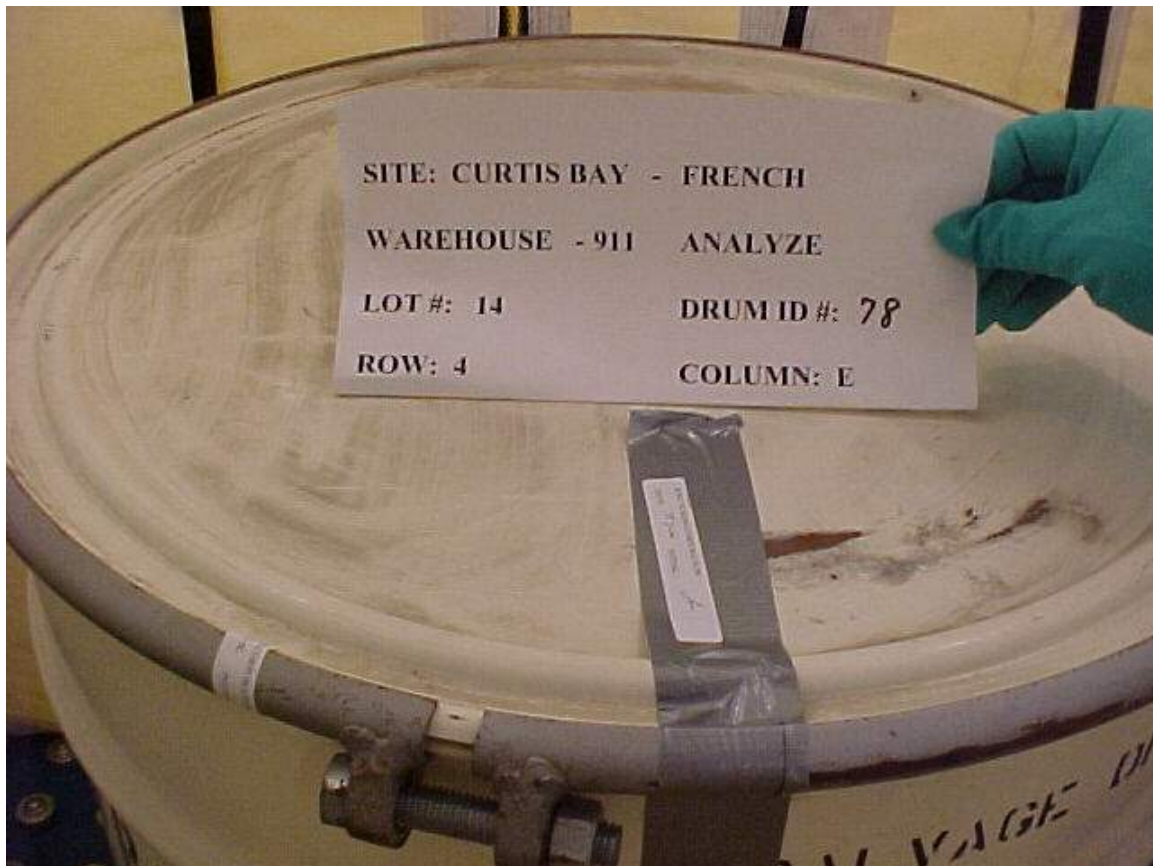
Sealed & dated - Complete

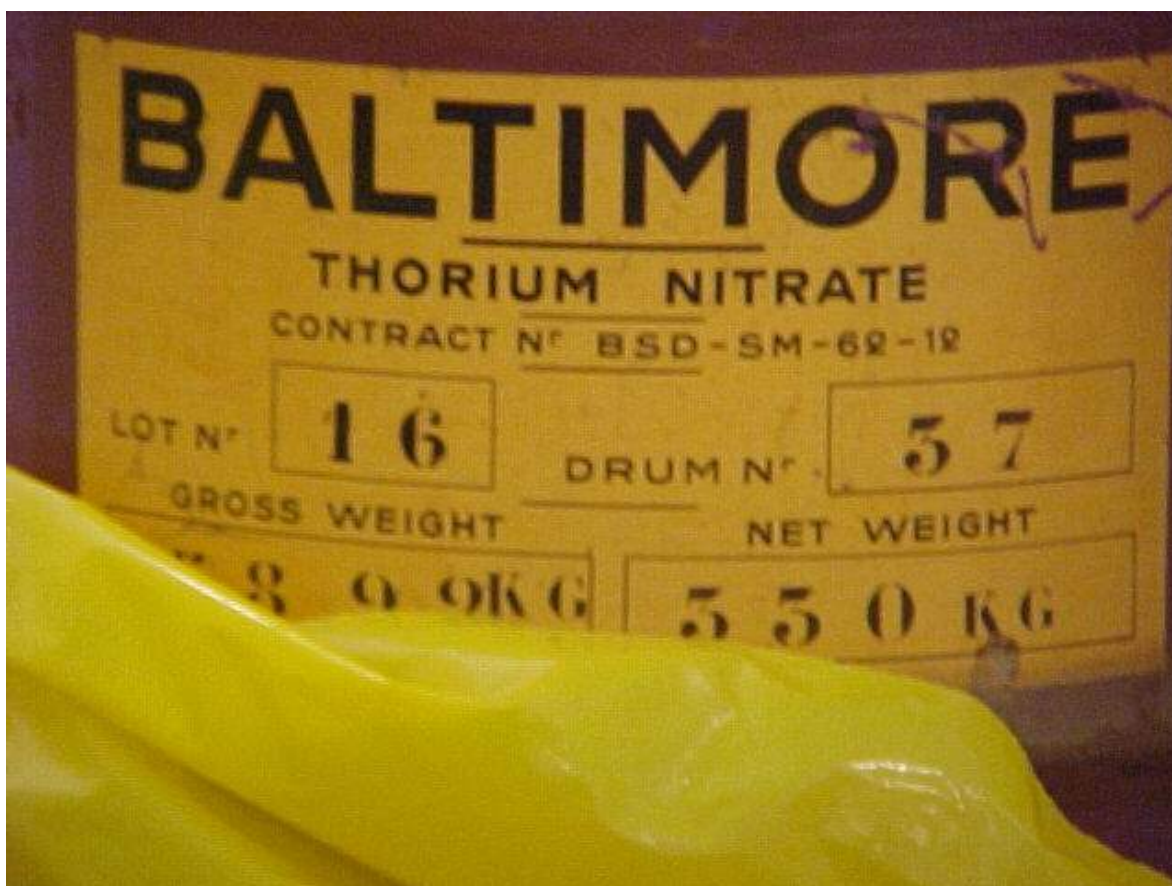
General InformationSite Curtis BayThN Origin FrenchLot No. 16Drum ID No. 57Inspection/Sample
DispositionVisual Inspection & Sampling
Analyze**Physical Location of Drum**Warehouse 912Row 2
Column F**Inspection/Sample Date & Time**Date 7-8-2002Time 14:30**Other Information**Photo No. 1 of 5Container 55-gallon steel drumContainer
Condition FairContainer Wall Thickness 0.1565 inDose Rate Surface 43 mR/hr
1 meter 4.0 mR/hr

No gasses present

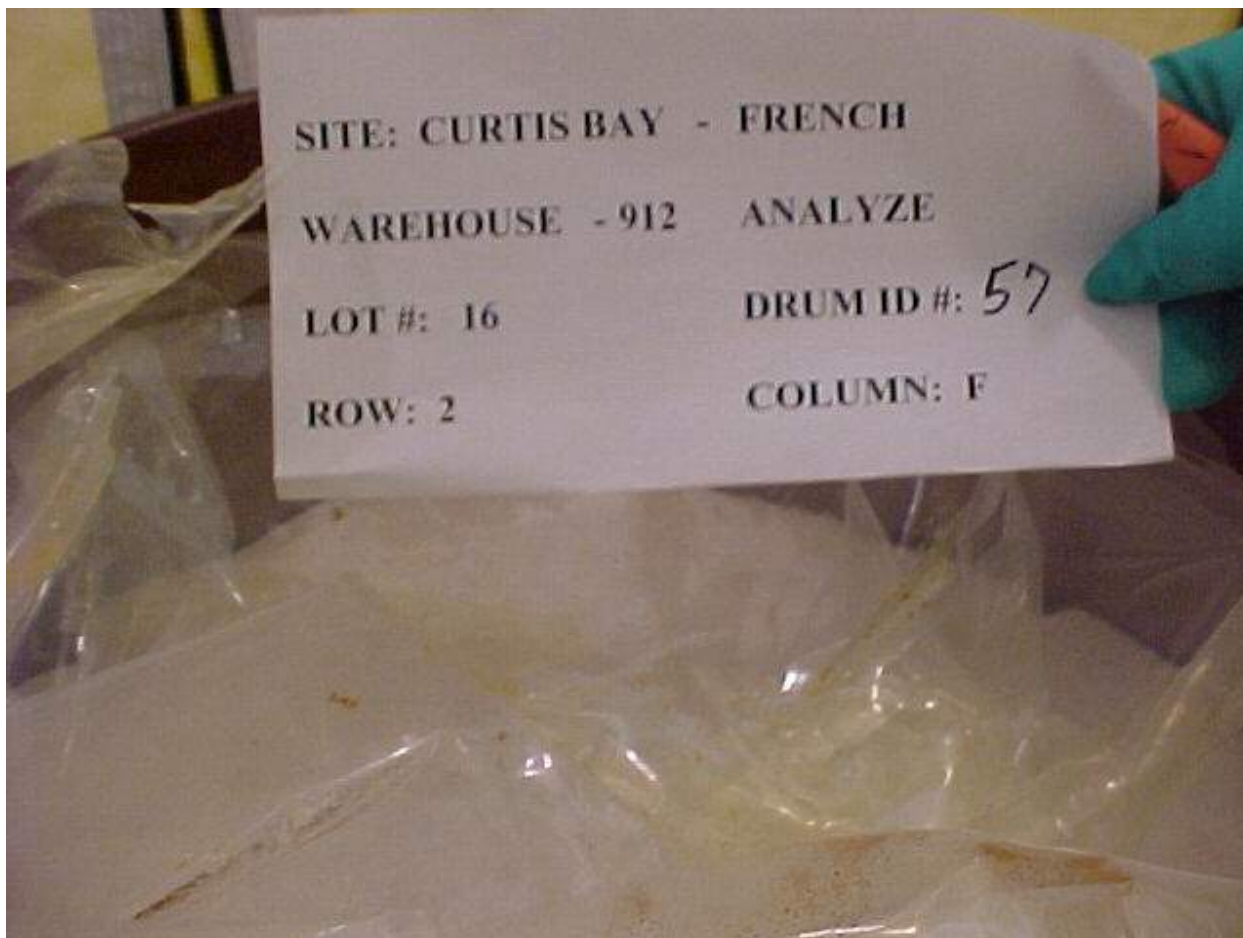
14:30**Other Information**Photo No. 3 of 5Dose Rate Surface 43 mR/hr
 1 meter 4.0 mR/hr2nd poly liner/bag – good condition
No gasses present

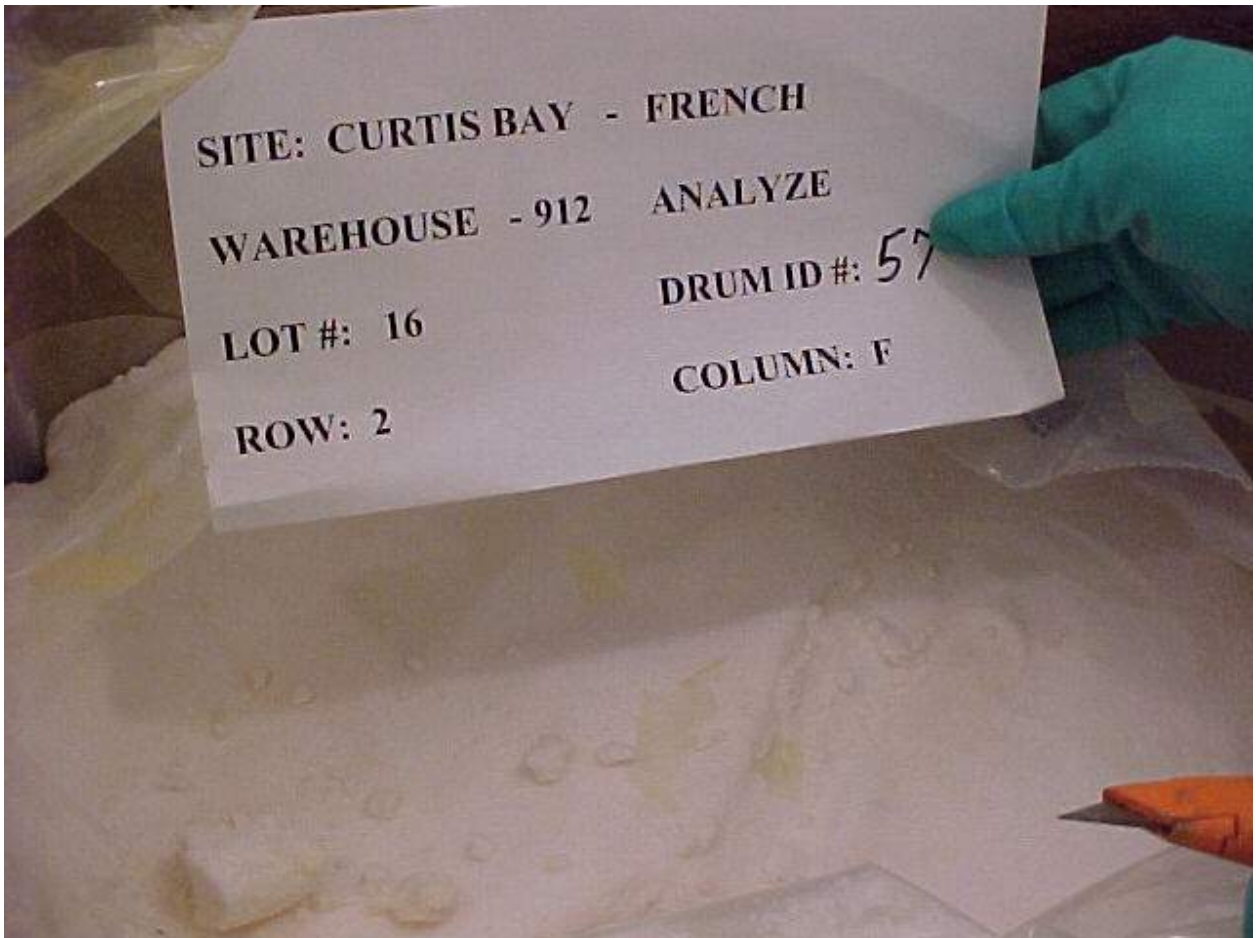
Thorium Nitrate – Powder – white – dry
No gasses present

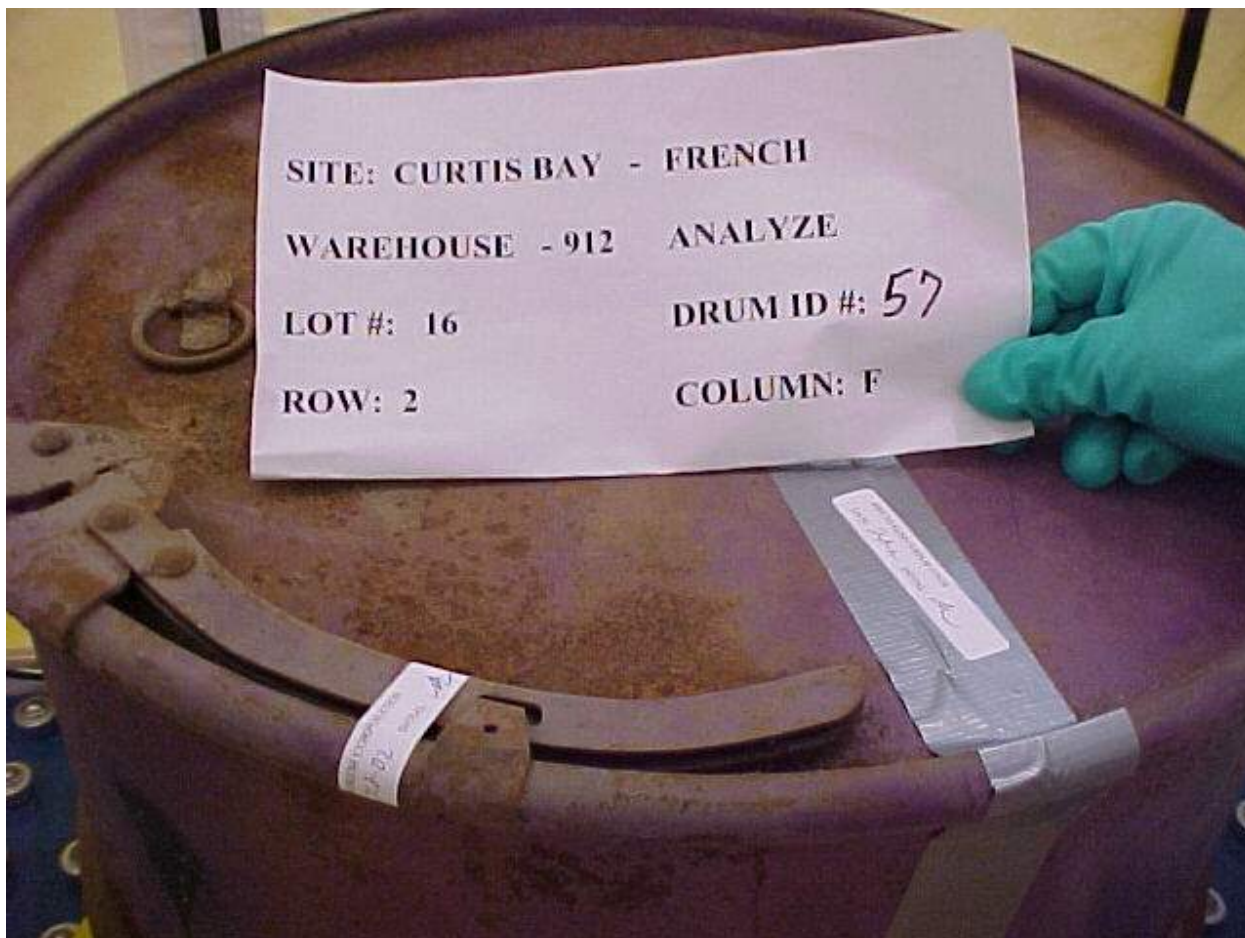
Sealed/Dated – Completed

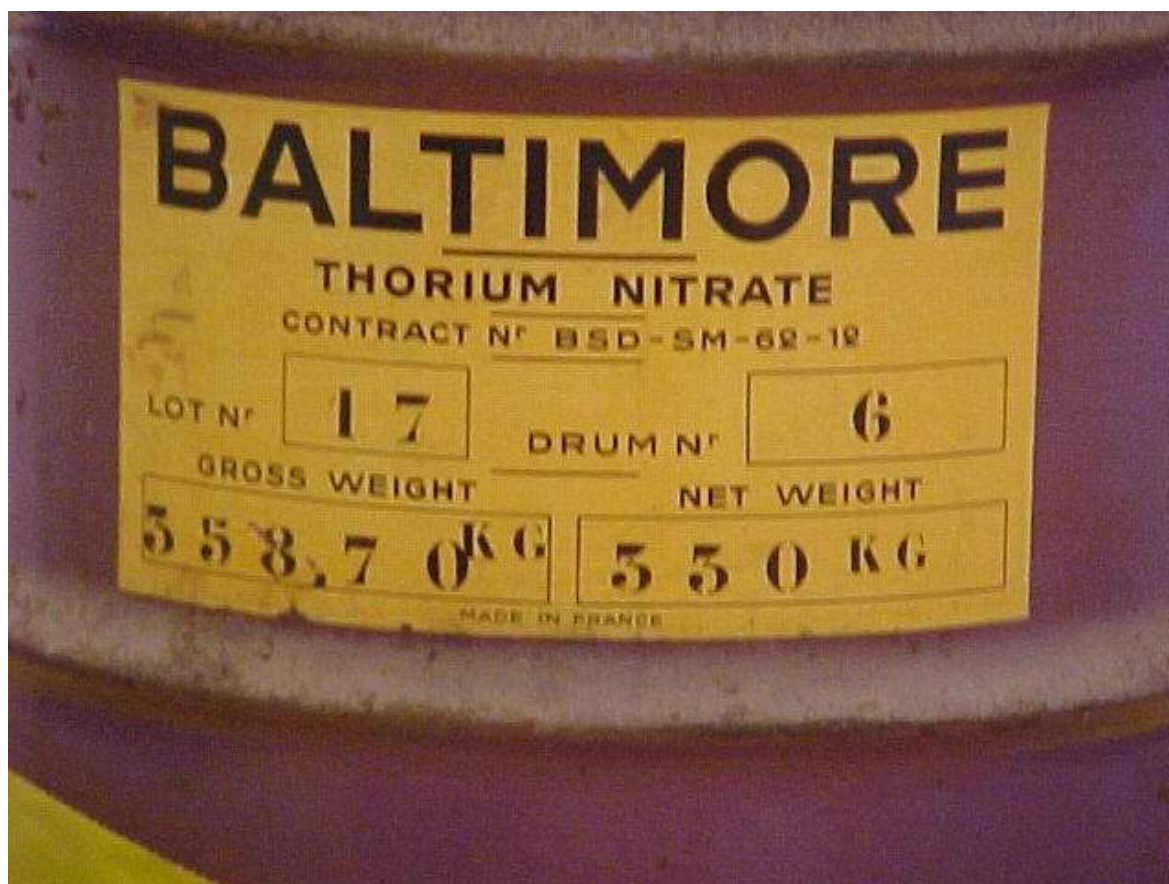
General InformationSite Curtis BayThN Origin FrenchLot No. 17Drum ID No. 6Inspection/Sample
DispositionVisual Inspection & Sampling
Analyze**Physical Location of Drum**Warehouse 912Row 7
Column F**Inspection/Sample Date & Time**Date 7-8-2002Time 13:10**Other Information**Photo No. 1 of 5Container 55-gallon steel drumContainer
Condition FairContainer Wall Thickness 0.1565 inDose Rate Surface 45 mR/hr
1 meter 4.0 mR/hr

No gasses present

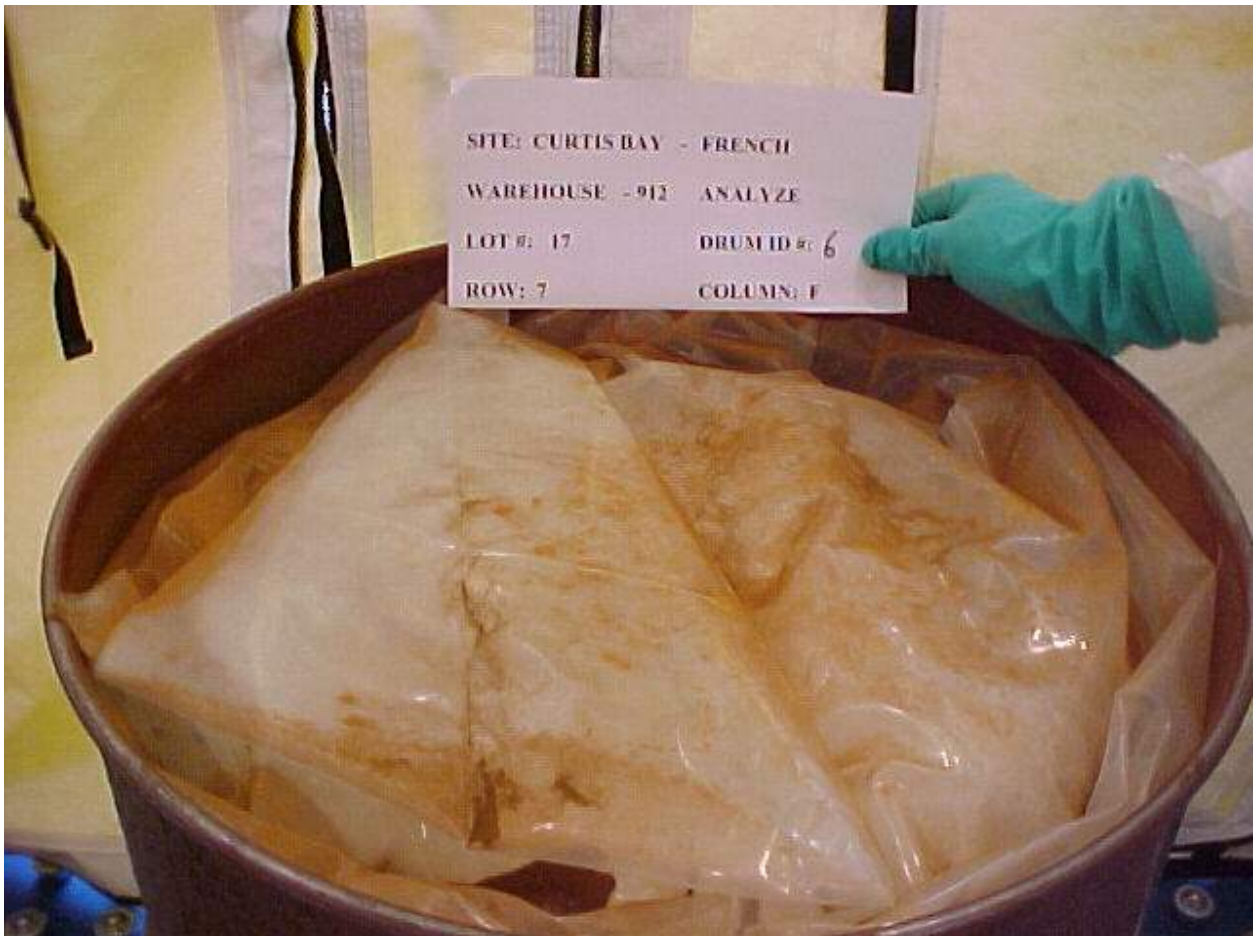
1st poly liner/bag – good condition
No gasses present

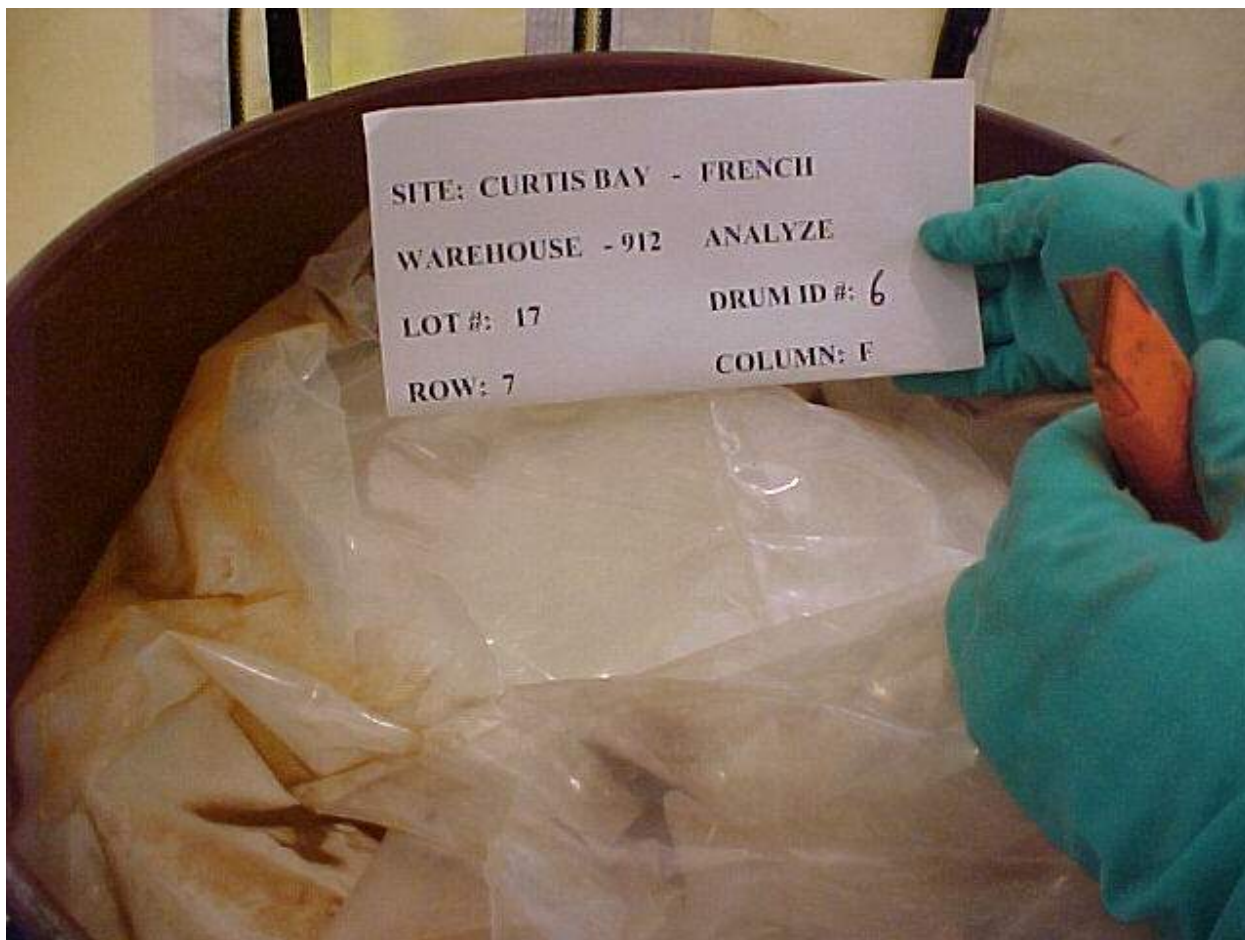
13:10**Other Information**Photo No. 3 of 5Dose Rate Surface 45 mR/hr
 1 meter 4.0 mR/hr2nd poly liner/bag – good condition
No gasses present

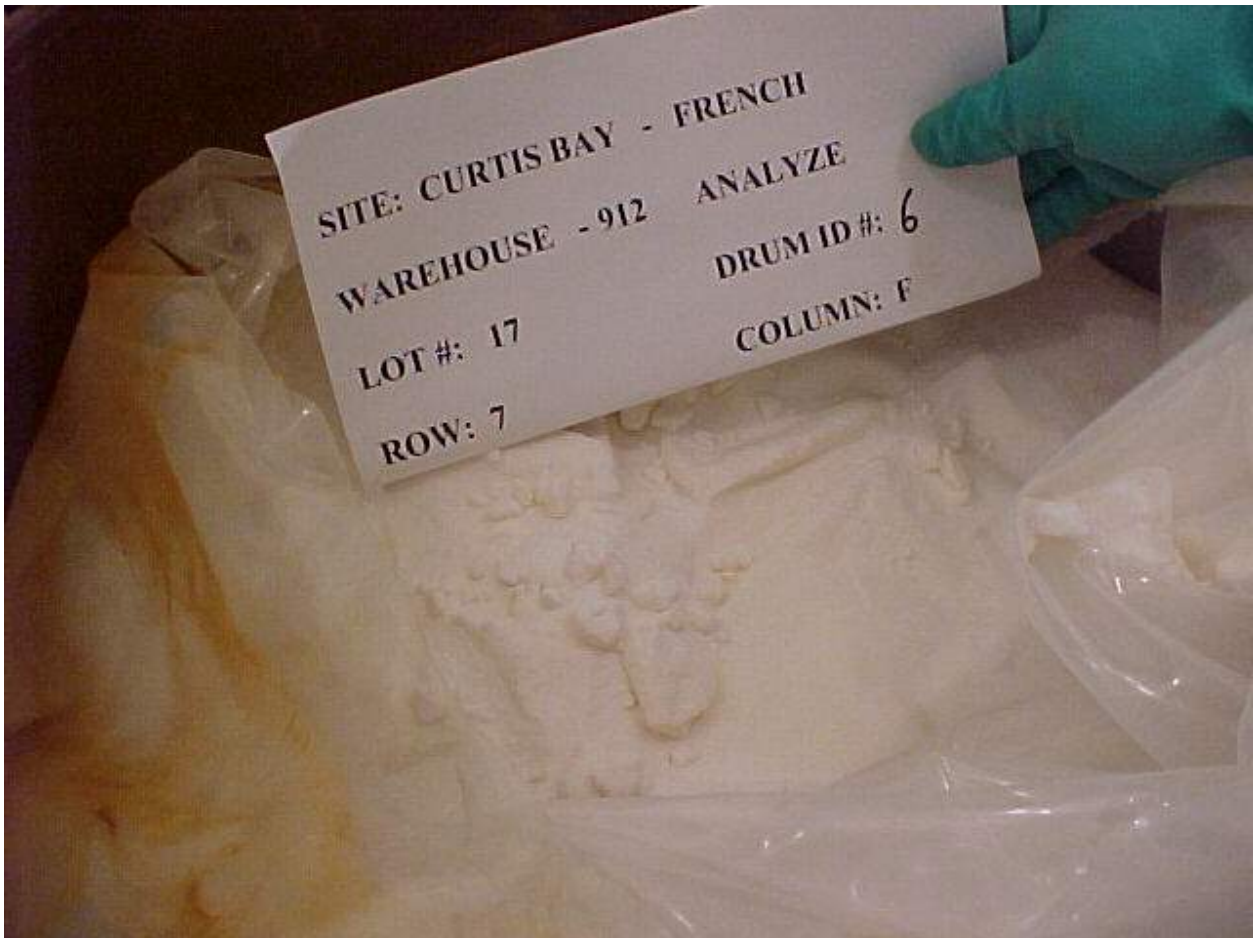
Thorium Nitrate – Powder – white – dry
No gasses present

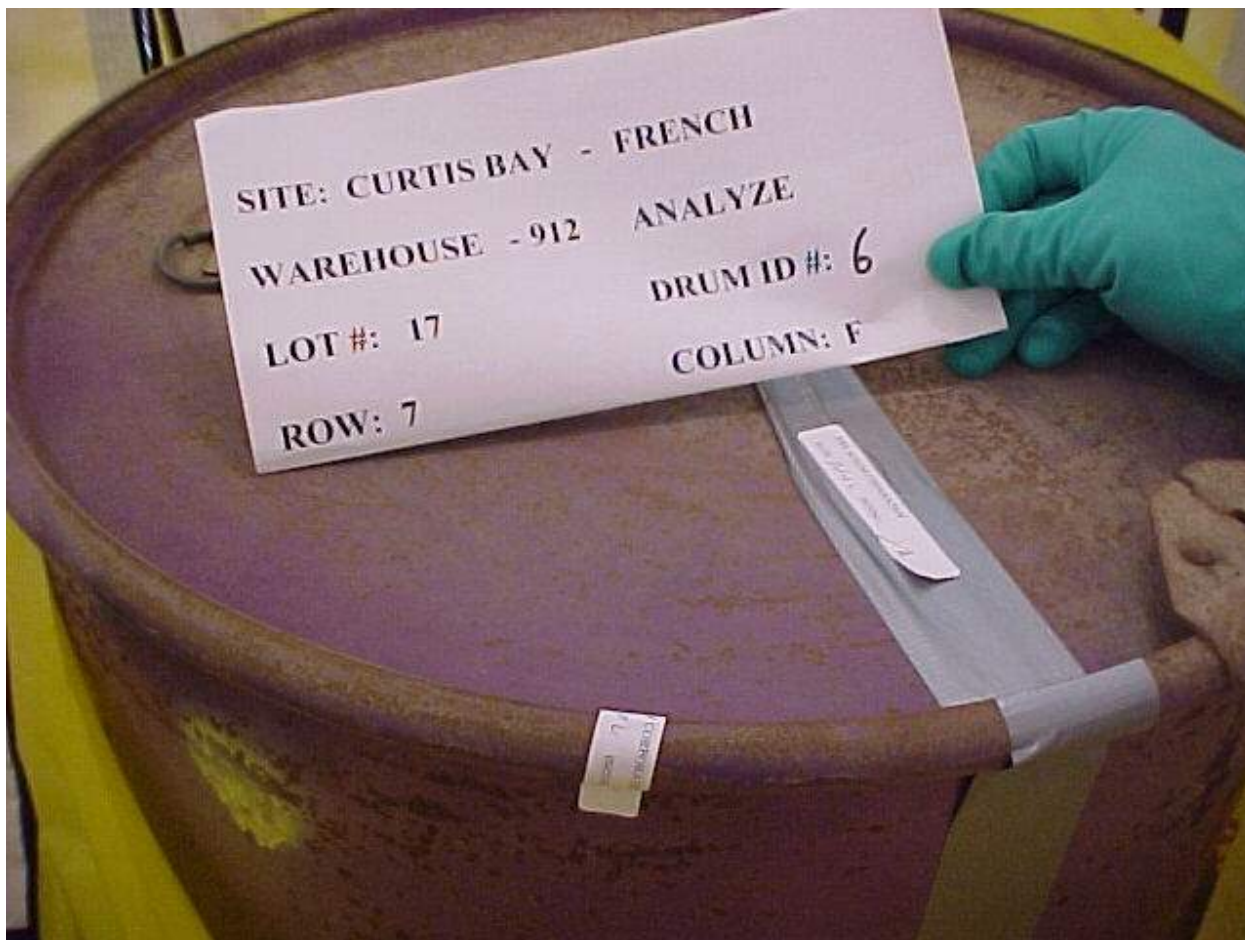
Sealed/Dated – Completed

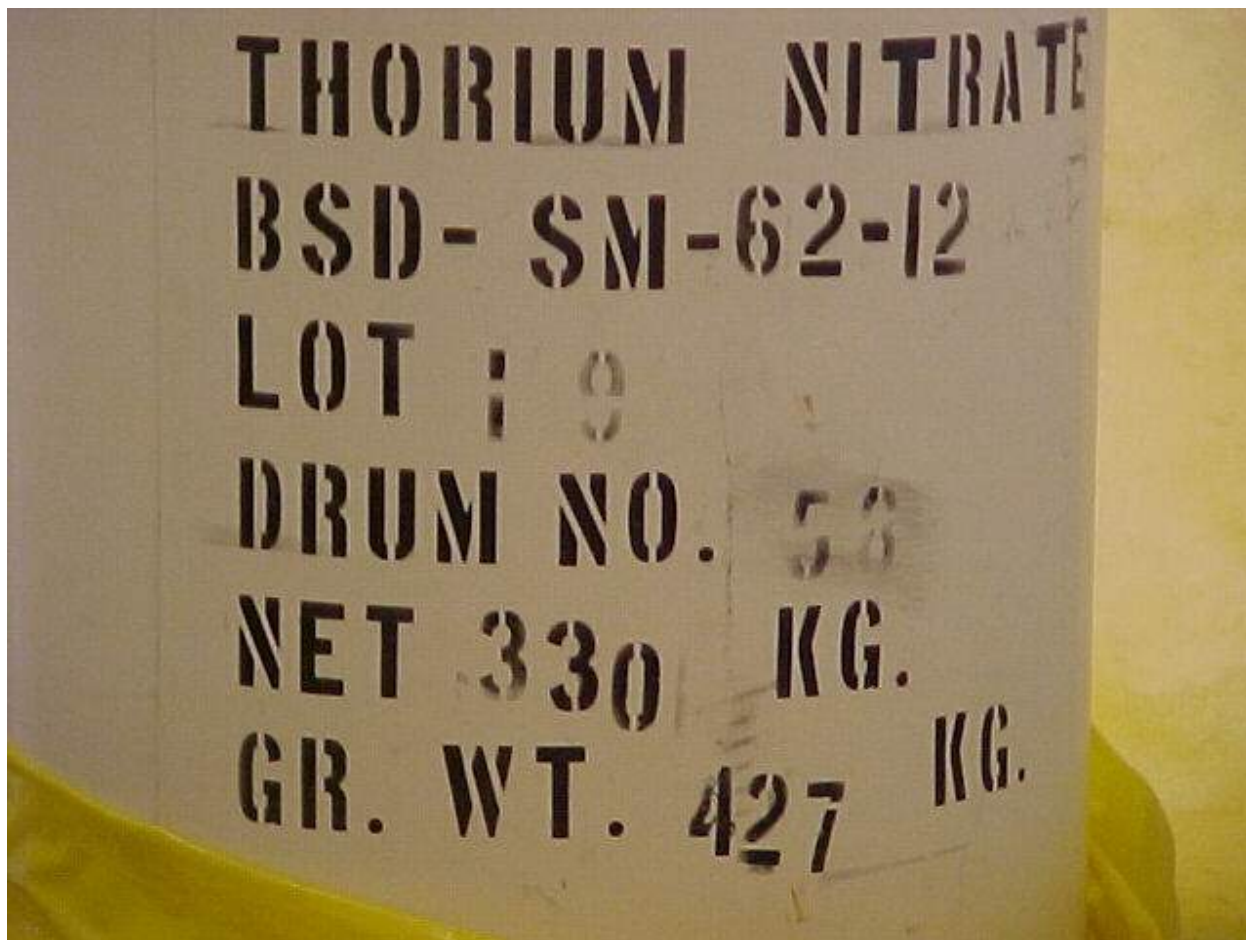
Container	<u>85-gallon steel drum</u>	Container Condition	<u>Good</u>
-----------	-----------------------------	---------------------	-------------
