THORIUM NITRATE STOCKPILE DRUM CHARACTERIZATION REPORT

**THORIUM NITRATE STOCKPILE
DRUM CHARACTERIZATION REPORT**

Prepared for
U.S. Defense Logistics Agency
Defense National Stockpile Center
Fort Belvoir, Virginia

Prepared by
OAK RIDGE NATIONAL LABORATORY
Oak Ridge, Tennessee 37831
managed by
UT-BATTELLE, LLC
for the
U.S. DEPARTMENT OF ENERGY
under contract DE-AC05-00OR22725

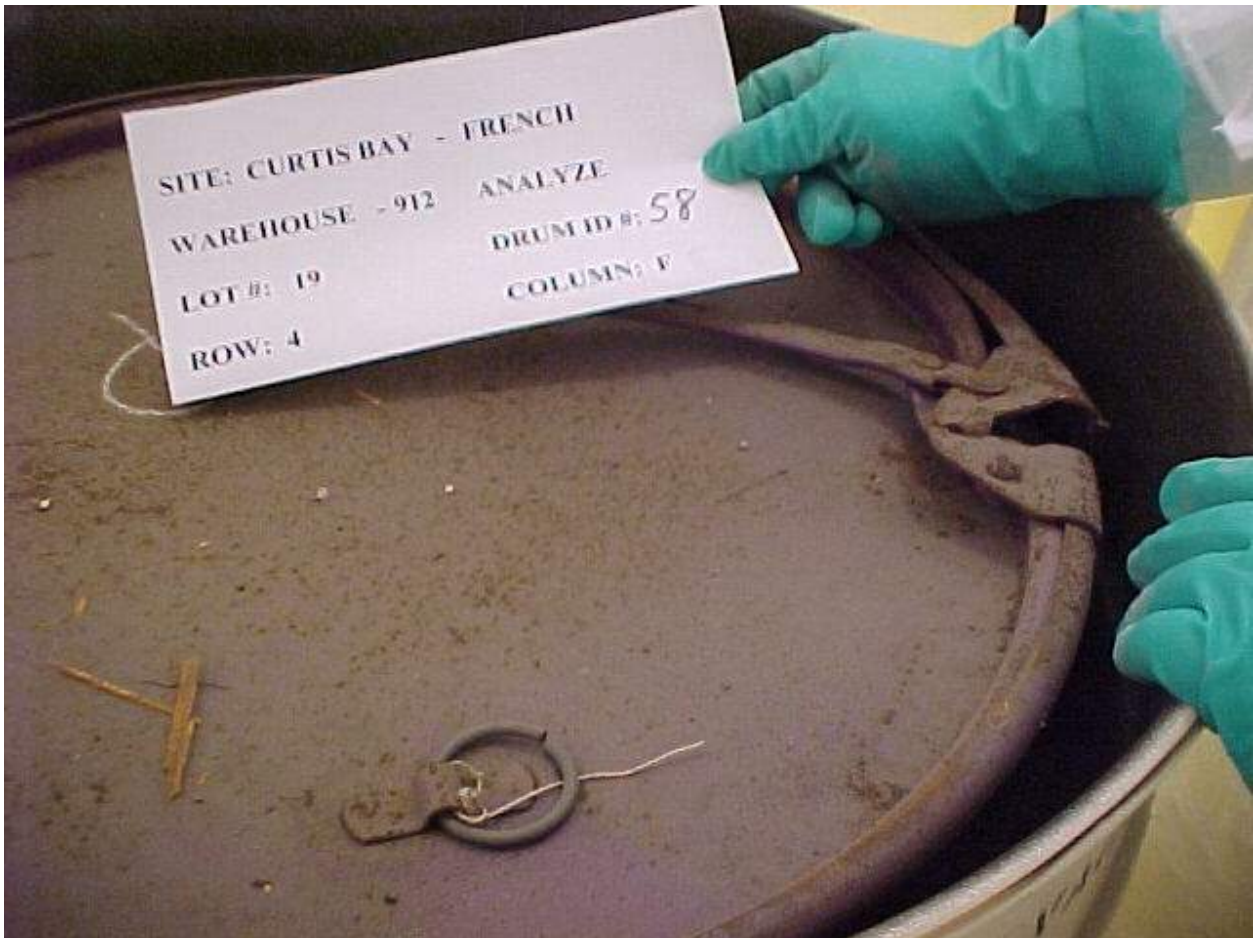
55-gal drum – fair condition

No gasses present

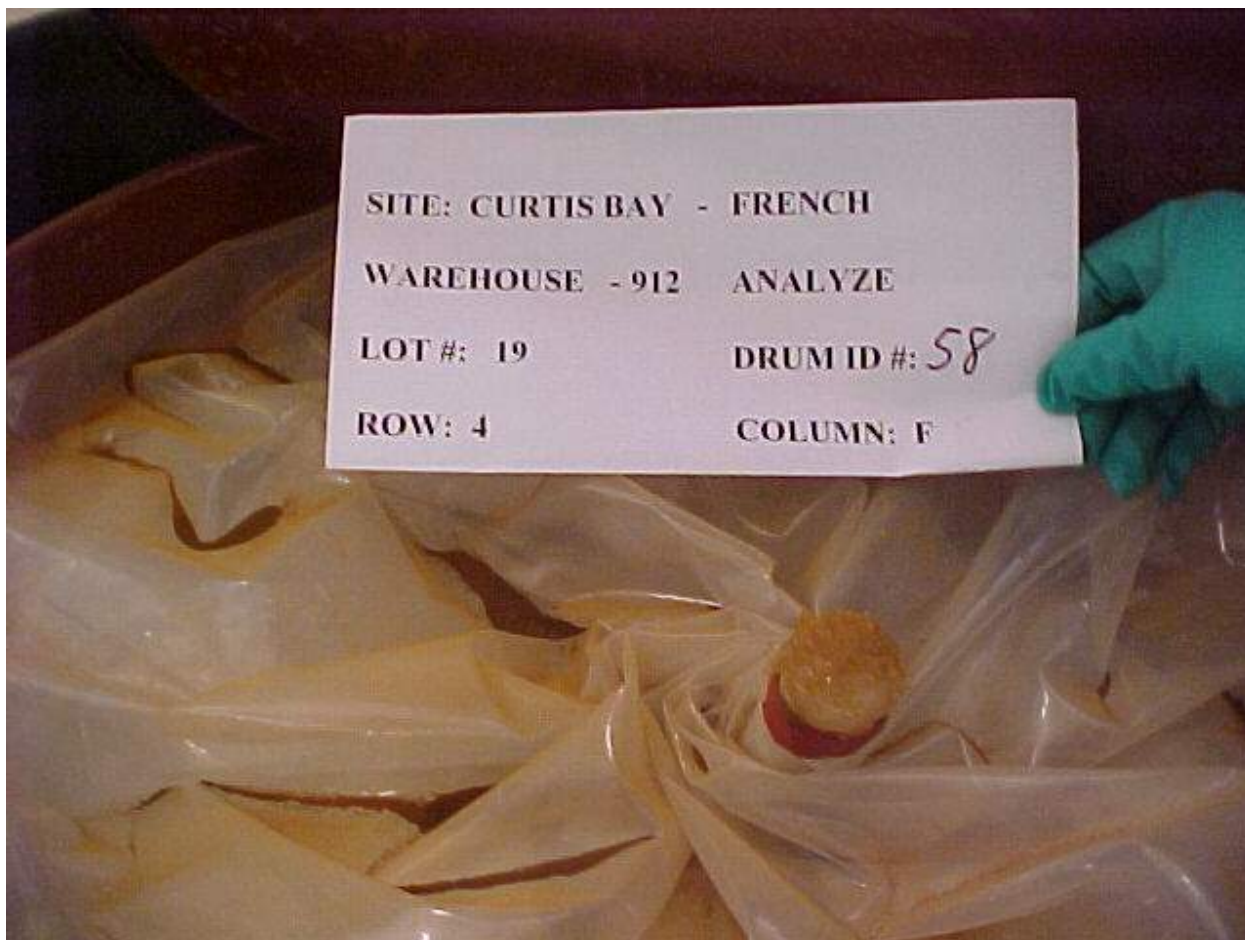
15:00**Other Information**Photo No. 3 of 6Dose Rate Surface 36 mR/hr
 1 meter 3.0 mR/hr1st poly liner/bag – good condition
No gasses present

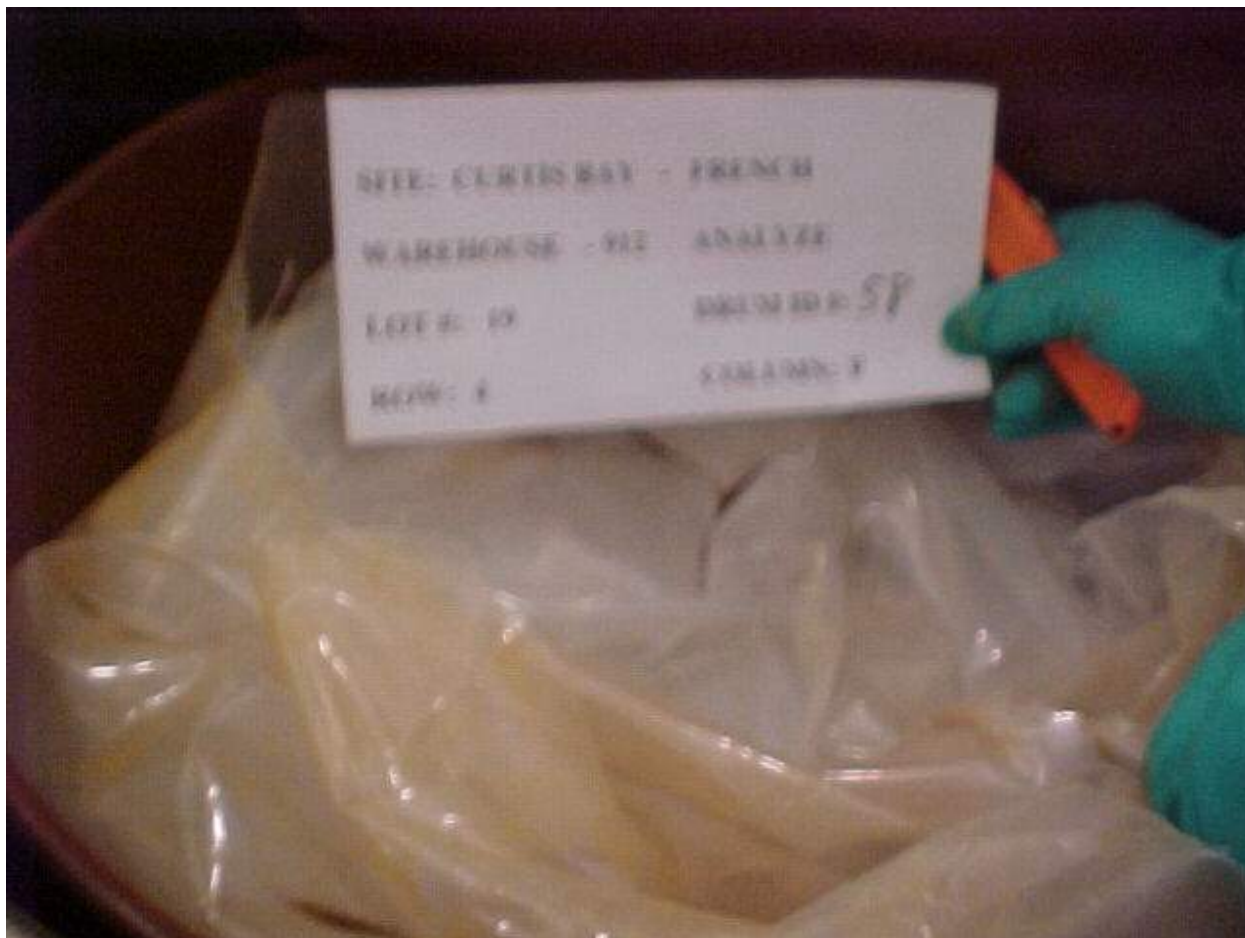
2nd poly liner/bag – good condition
No gasses present

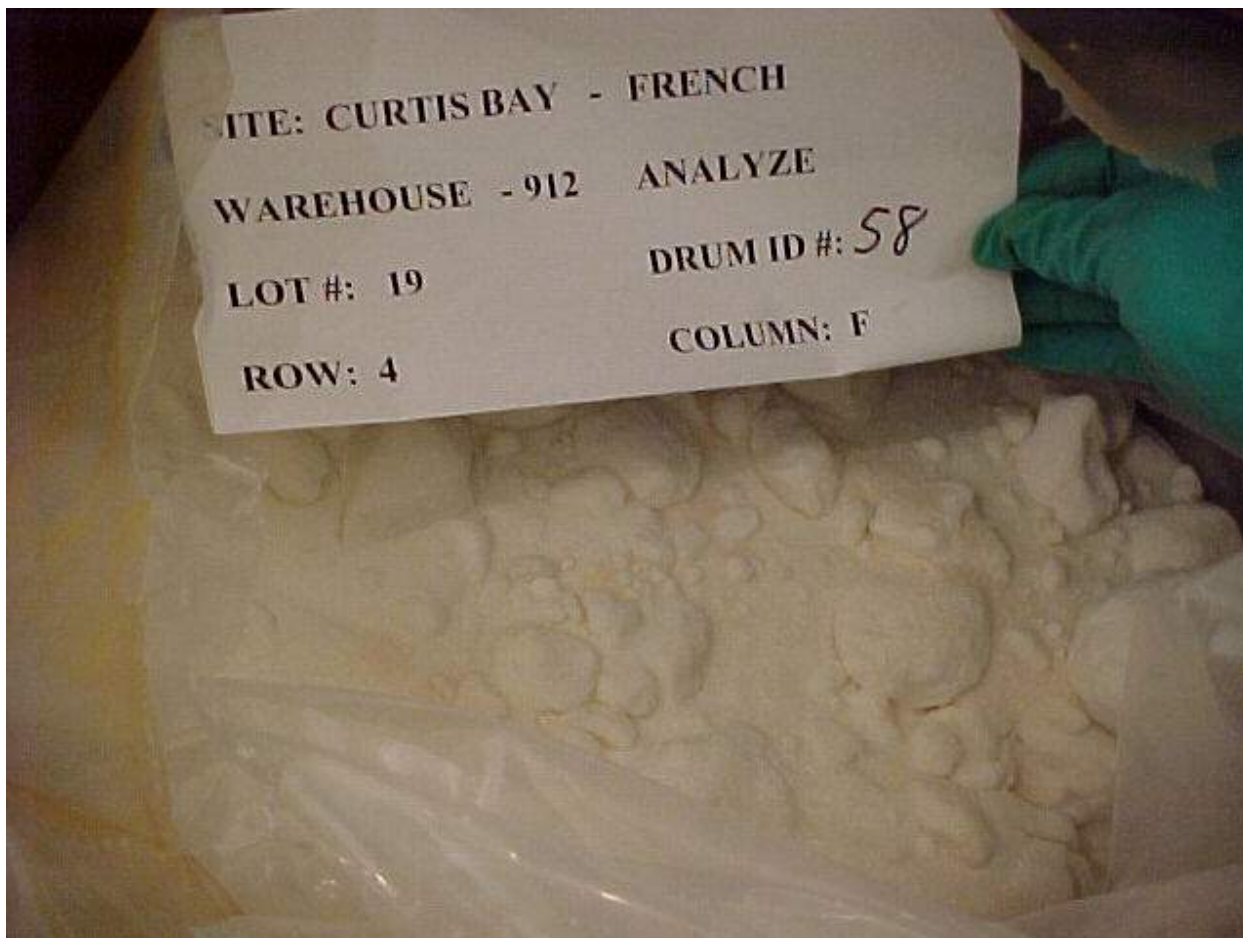
15:00**Other Information**Photo No. 5 of 6Dose Rate Surface 36 mR/hr
 1 meter 3.0 mR/hrThorium Nitrate – Powder – white – dry
No gasses present

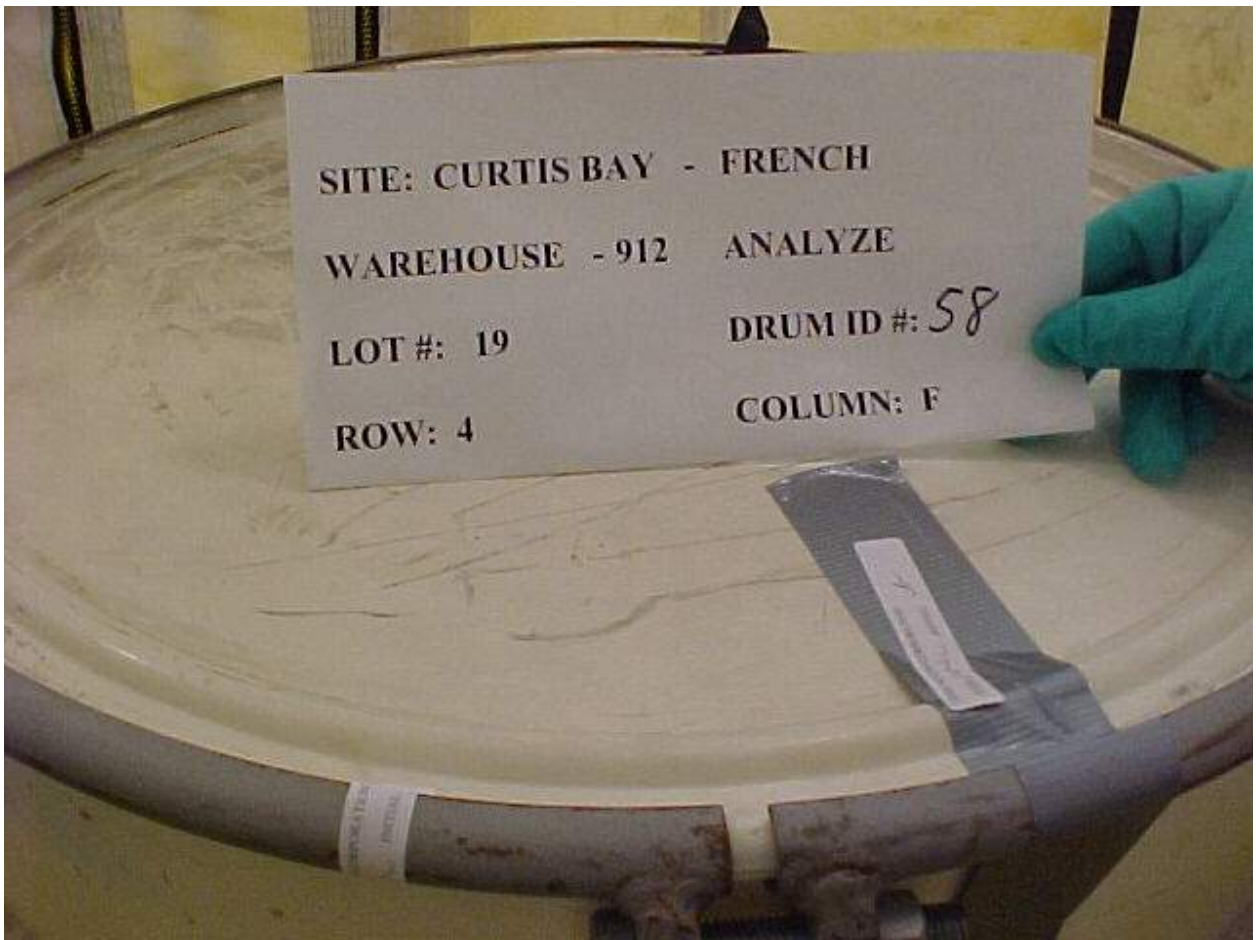
Sealed/Dated – Completed

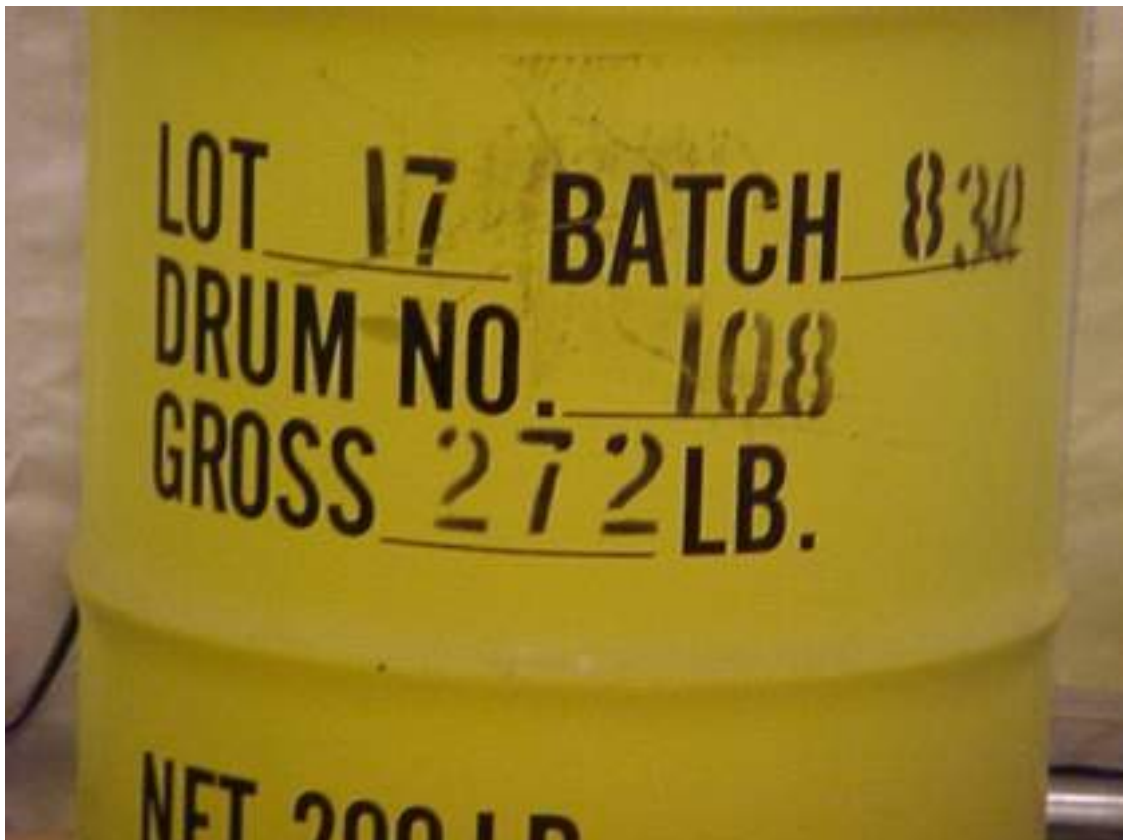
Drum released pressure while loosening/removing bolt from 30-gal drum ring
 Gasses present during initial loosening of drum ring – until evacuated by HEPA blower
 (relatively short timeframe – typically less than a few seconds)

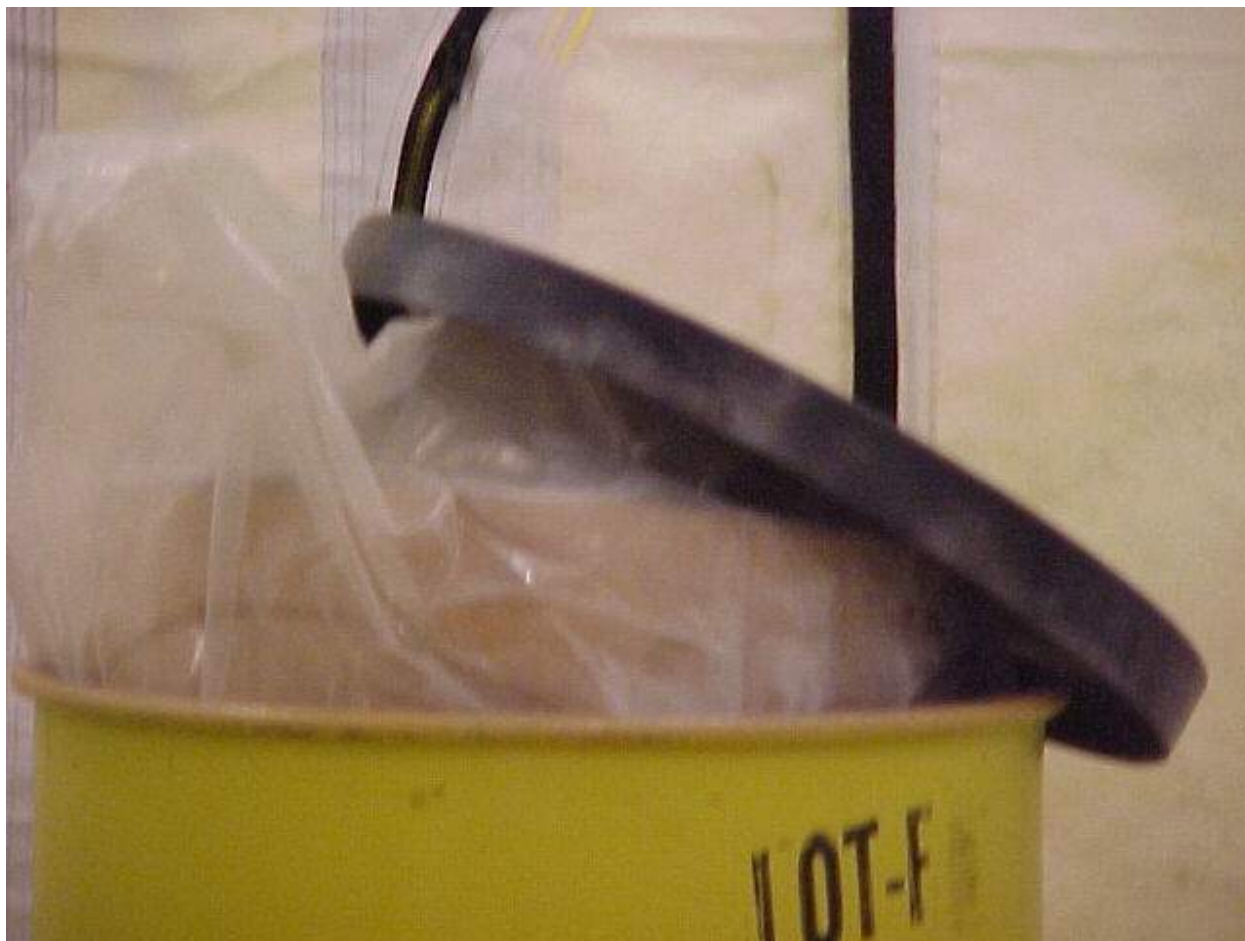
Black plastic lid from rigid poly drum liner – good condition

Raised lid indicates gas pressure buildup inside of inner poly bag(s) – internal pressure is sufficient to push drum lid through center of drum ring after the ring has been loosened

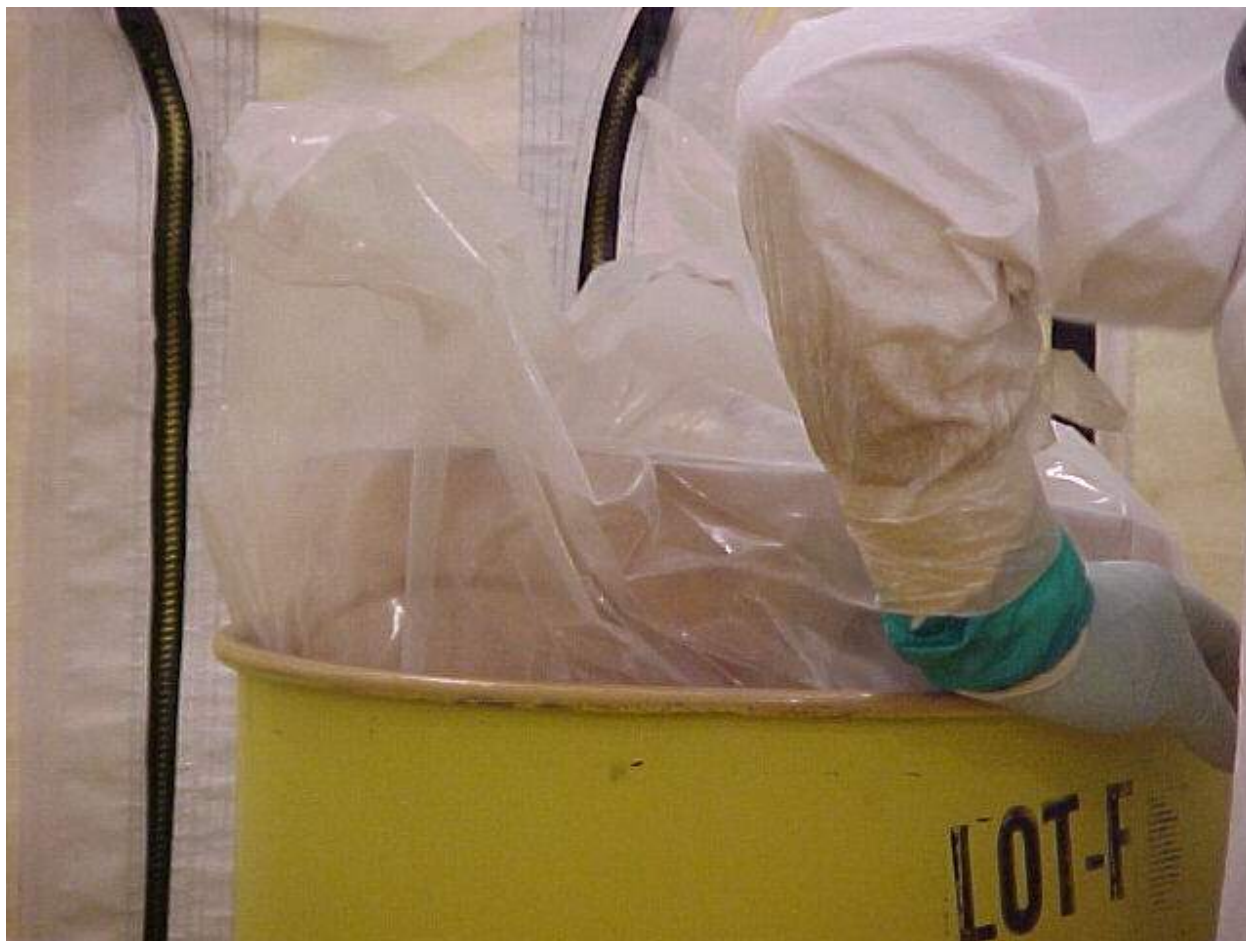
General InformationSite Curtis BayThN Origin DomesticLot No. 17Drum ID No. 108Inspection/Sample
DispositionVisual Inspection & Sampling
Analyze**Physical Location of Drum**Warehouse 912Row 2
Column A**Inspection/Sample Date & Time**Date 7-10-2002Time 11:00**Other Information**Photo No. 3 of 11Dose Rate Surface 24 mR/hr
 1 meter 2.5 mR/hr1st poly liner/bag – good condition

Internal pressure of inner packaging raises the poly liner/bag

No gasses present

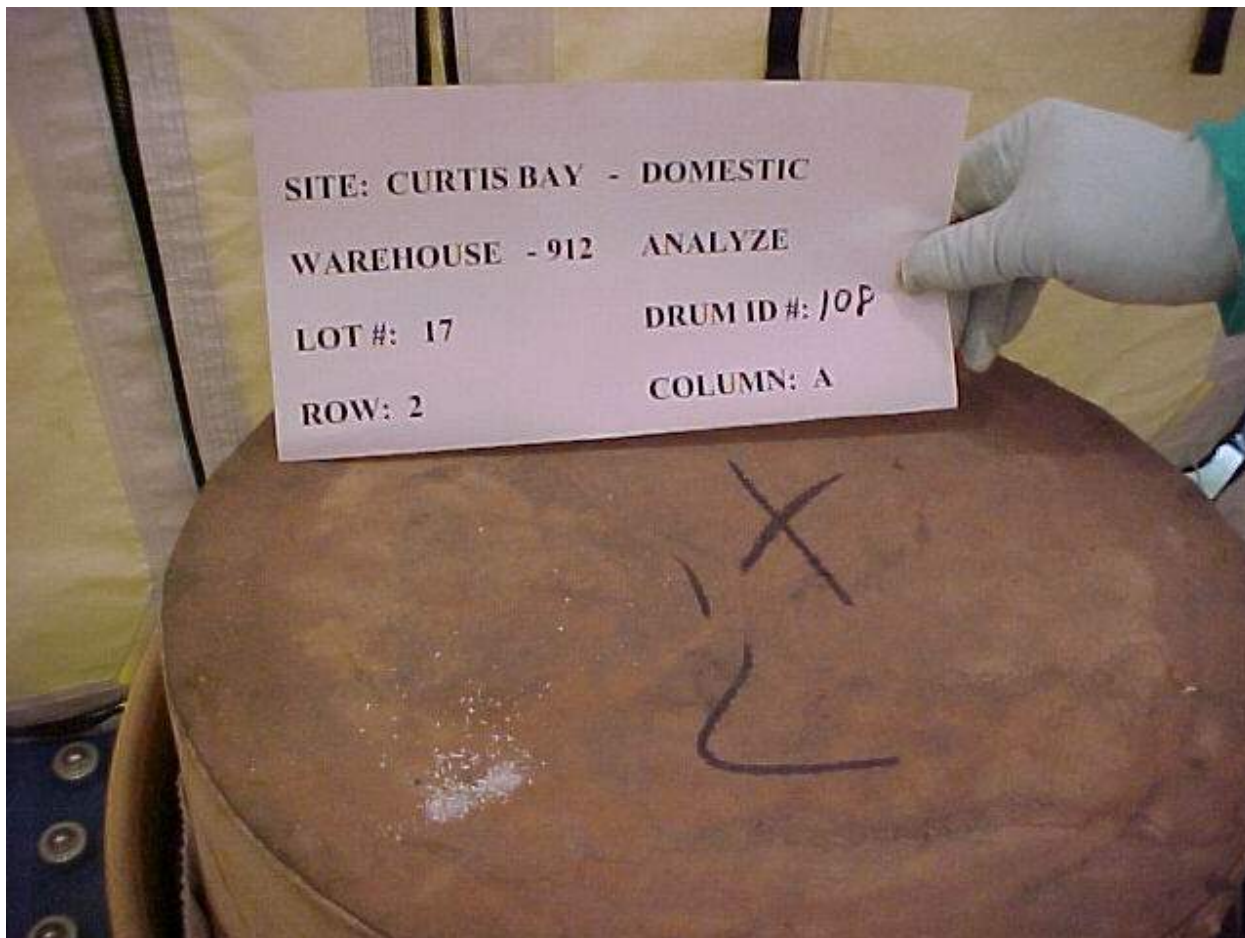
Fiber lid of fiber drum – good condition

Internal pressure causes the tape seal around the fiber drum/lid to separate after the 30-gal drum lid is removed.

No gasses present

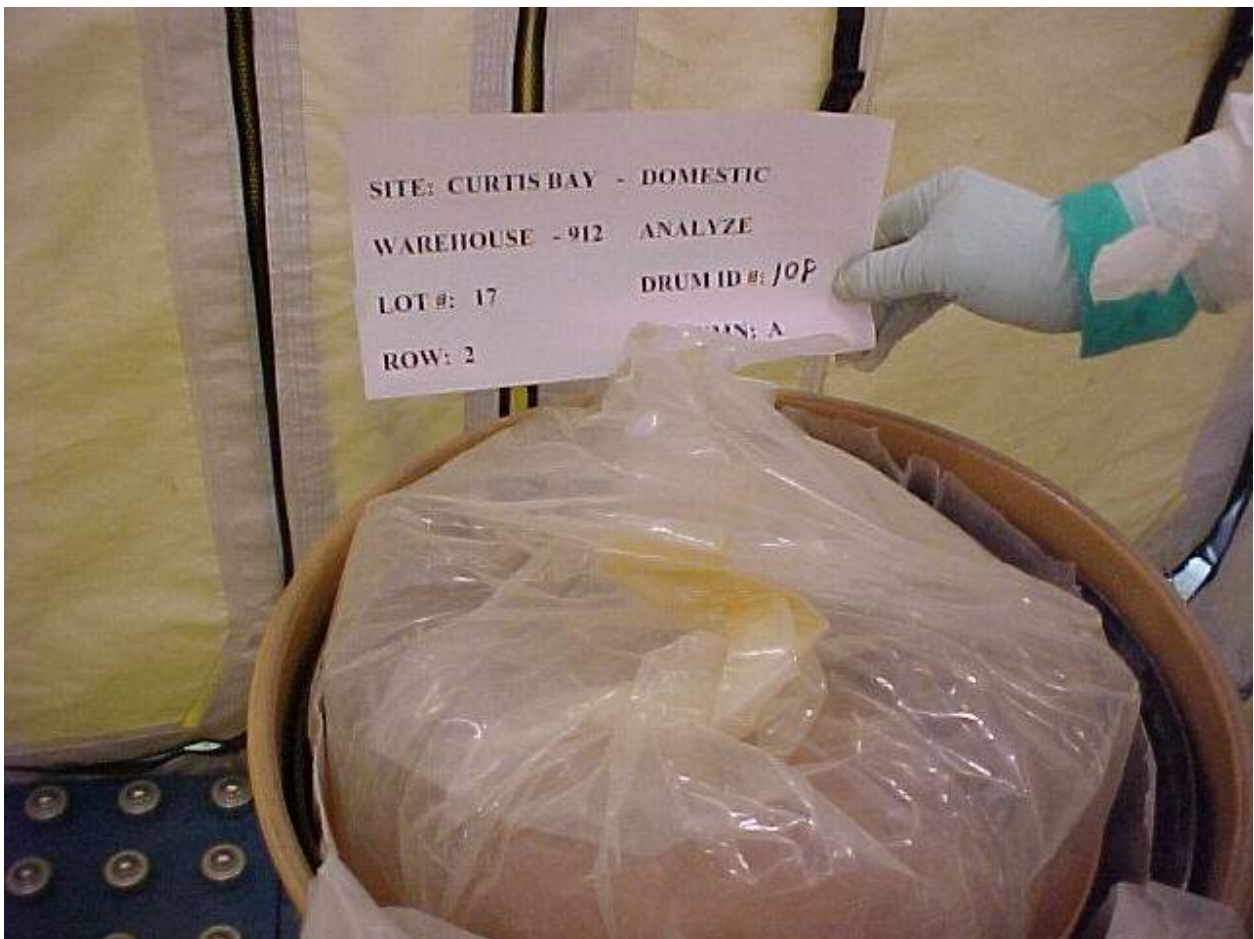
2nd poly liner/bag – good condition

Poly bag's appearance is similar to an inflated balloon due to internal pressure buildup

No gasses present

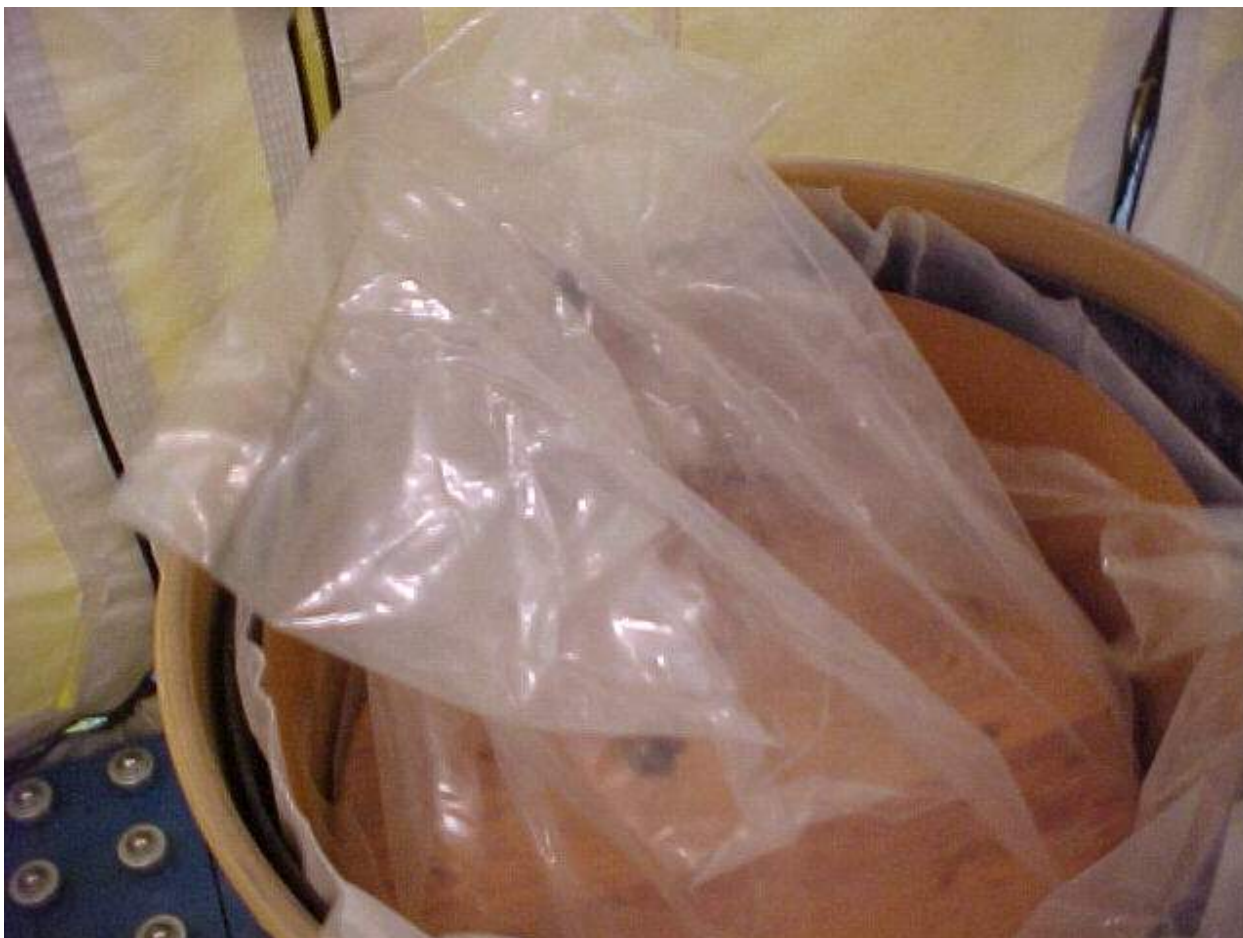
3rd poly liner/bag – good condition
Opened Poly liner/bag – No gasses in breathing zone
Gasses in headspace – LEL – 4.6% LEL - NO - >50.0ppm – NOx – >50.0ppm
Drum vented - All gasses dissipated

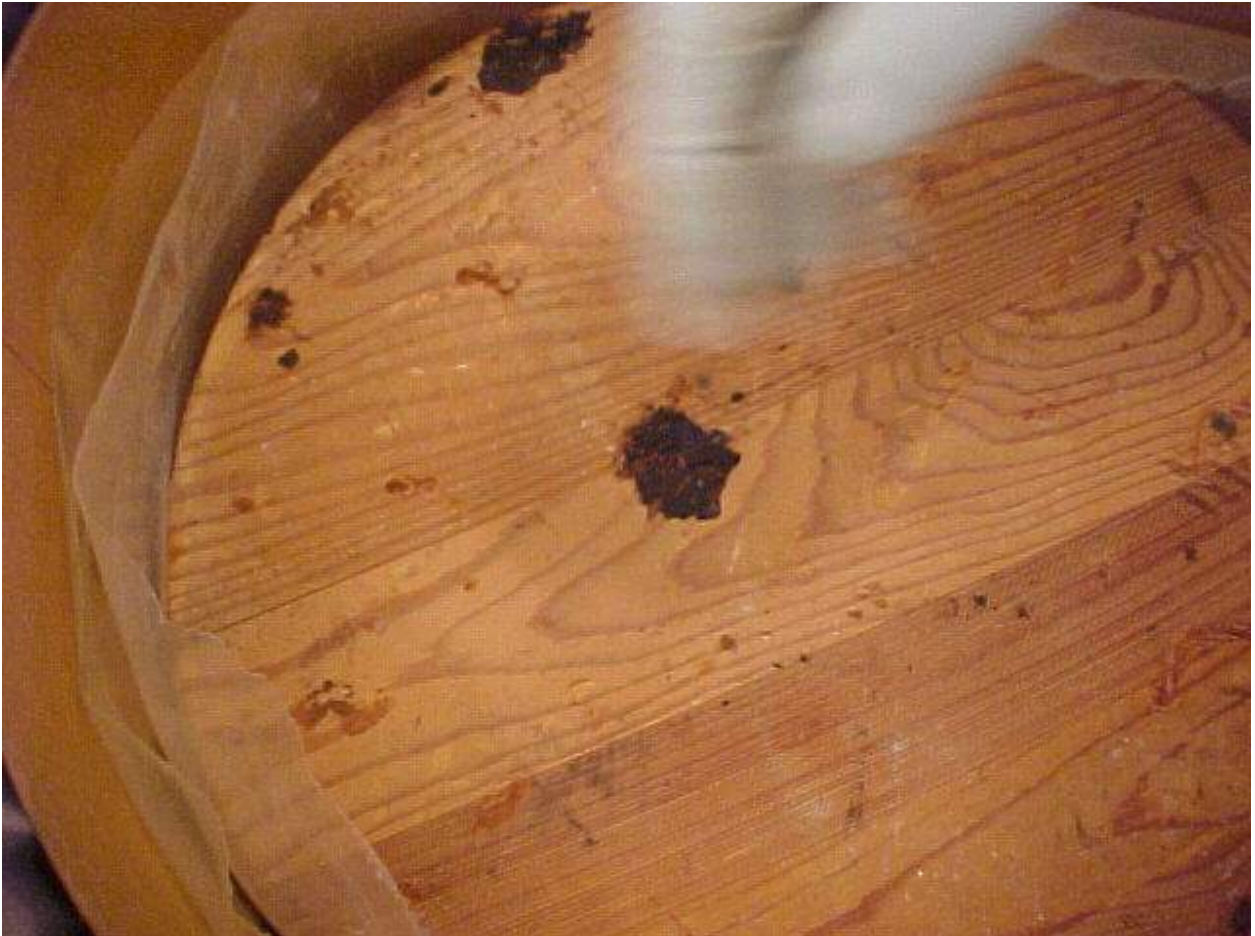
11:00**Other Information**Photo No. 7 of 11Dose Rate Surface 24 mR/hr
 1 meter 2.5 mR/hr

Wooden Lid (on inner fiber/overpack container) – good condition
No gasses present

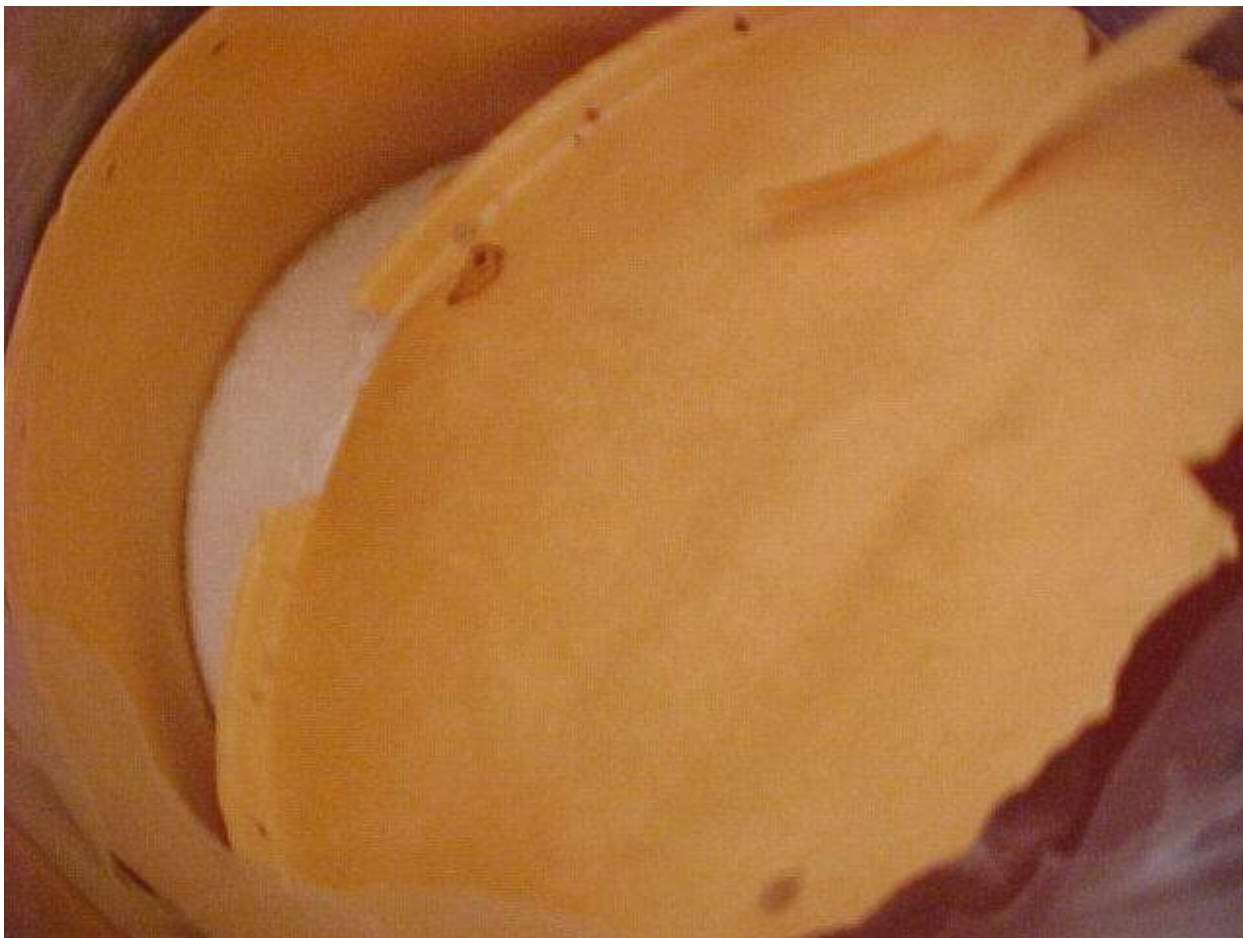
Labpack container “paper” lid (underside of wooden lid) – good condition
No gasses present

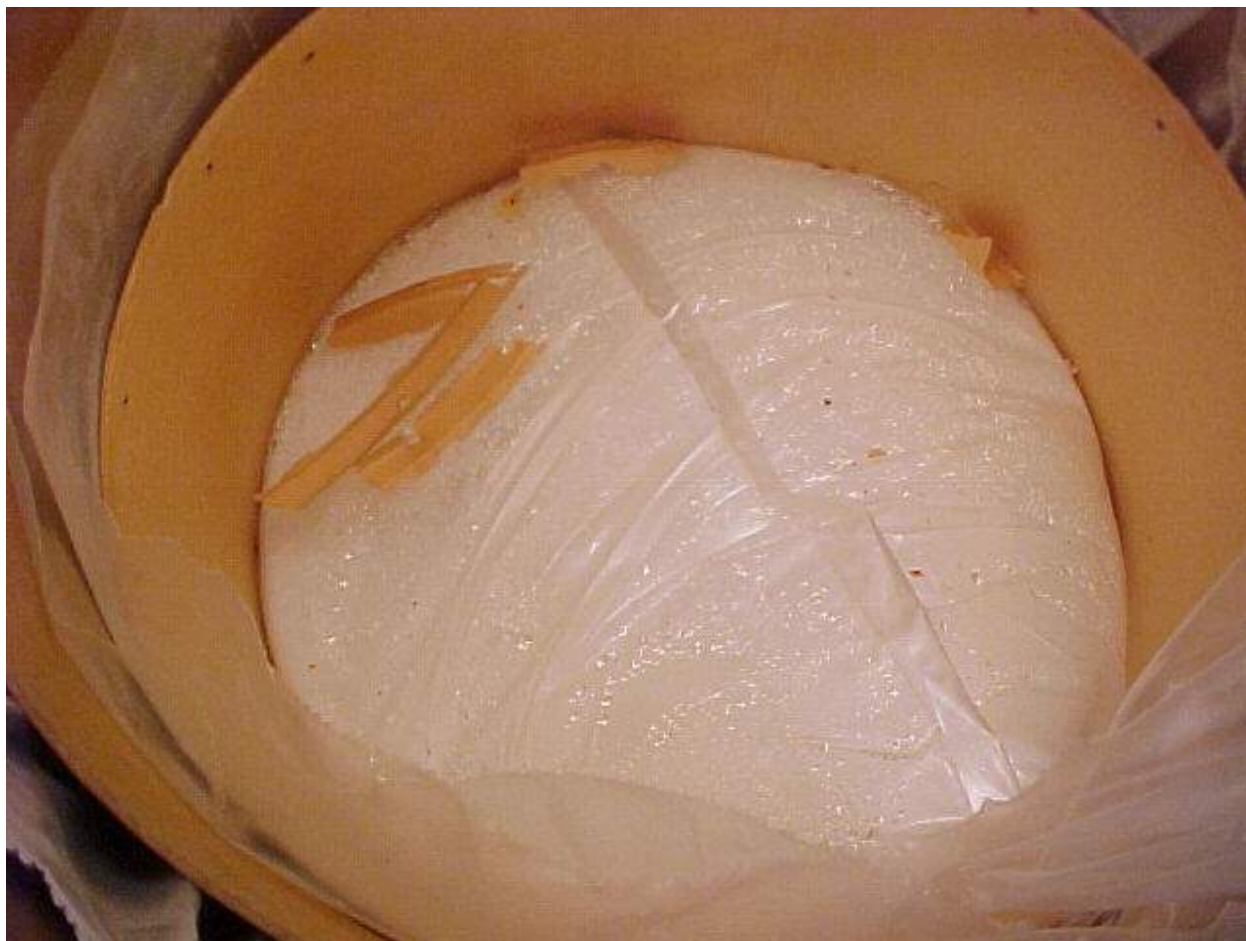
4th poly (thin film) liner/bag – good condition – note how thin film is slightly “puffed” out – indicating a slight pressure inside of the thin film.

No gasses present

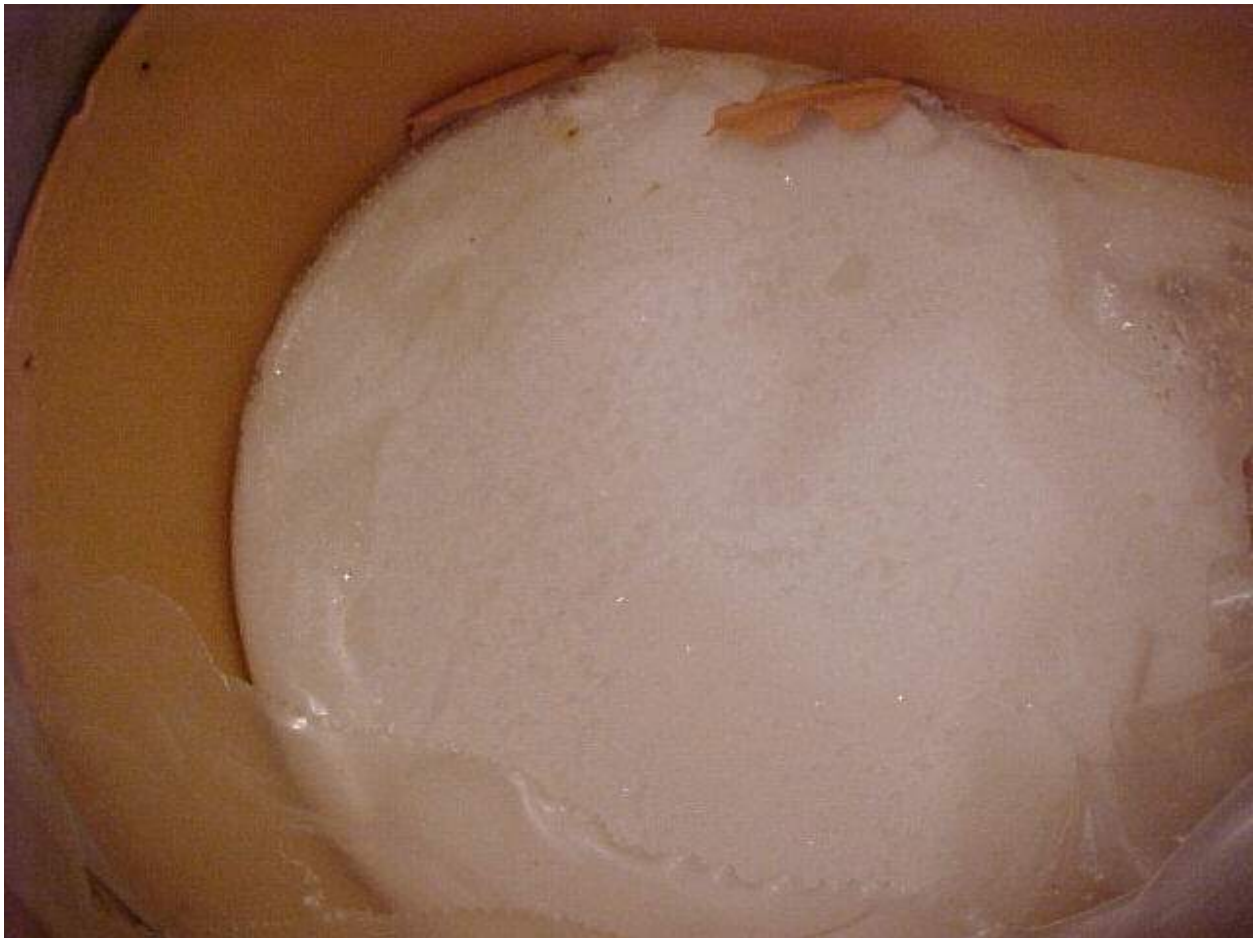
Thorium Nitrate material – monolith – white – solid - dry
No gasses present

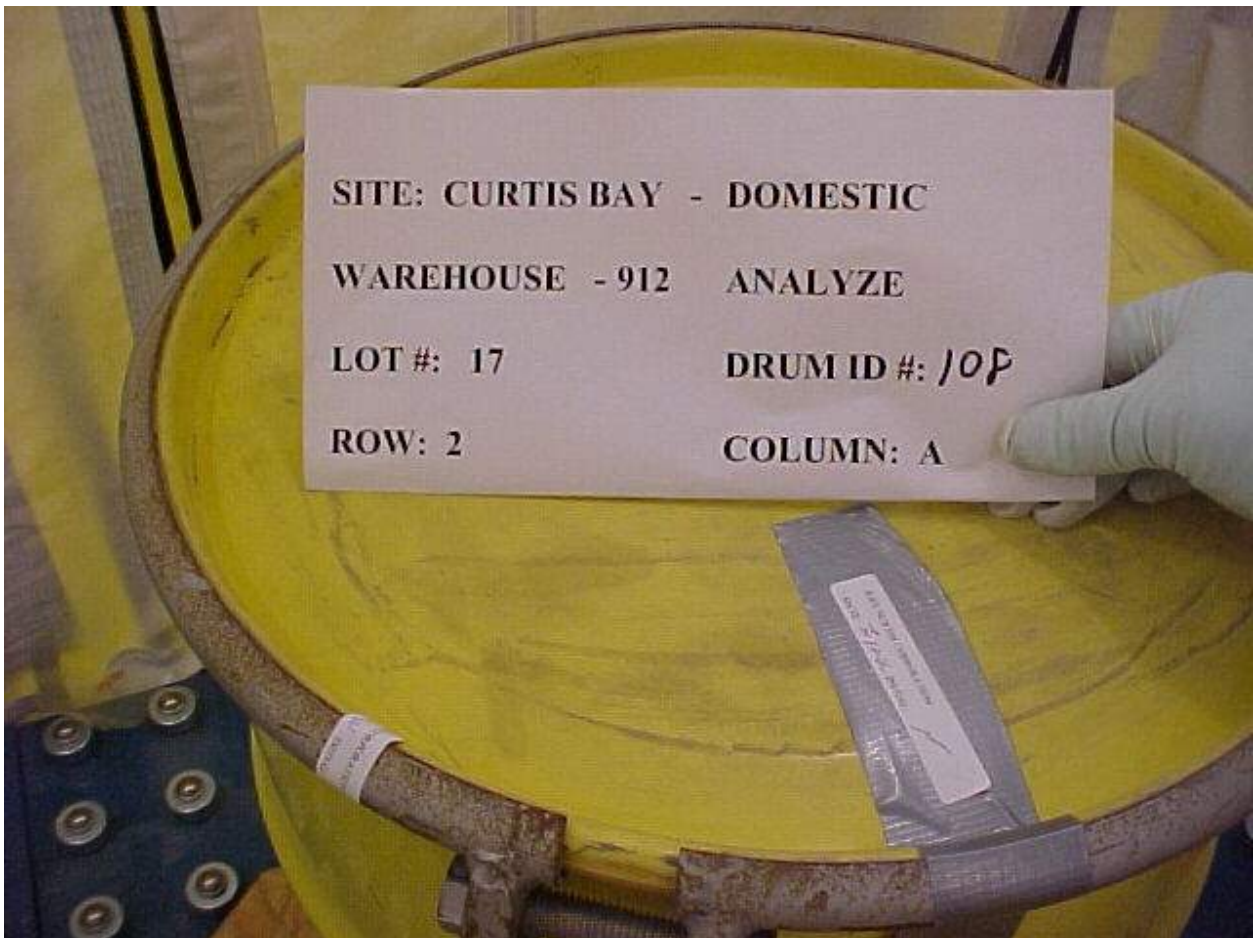
11:00**Other Information**Photo No. 10 of 11Dose Rate Surface 24 mR/hr
 1 meter 2.5 mR/hr

Sealed & Dated - Completed

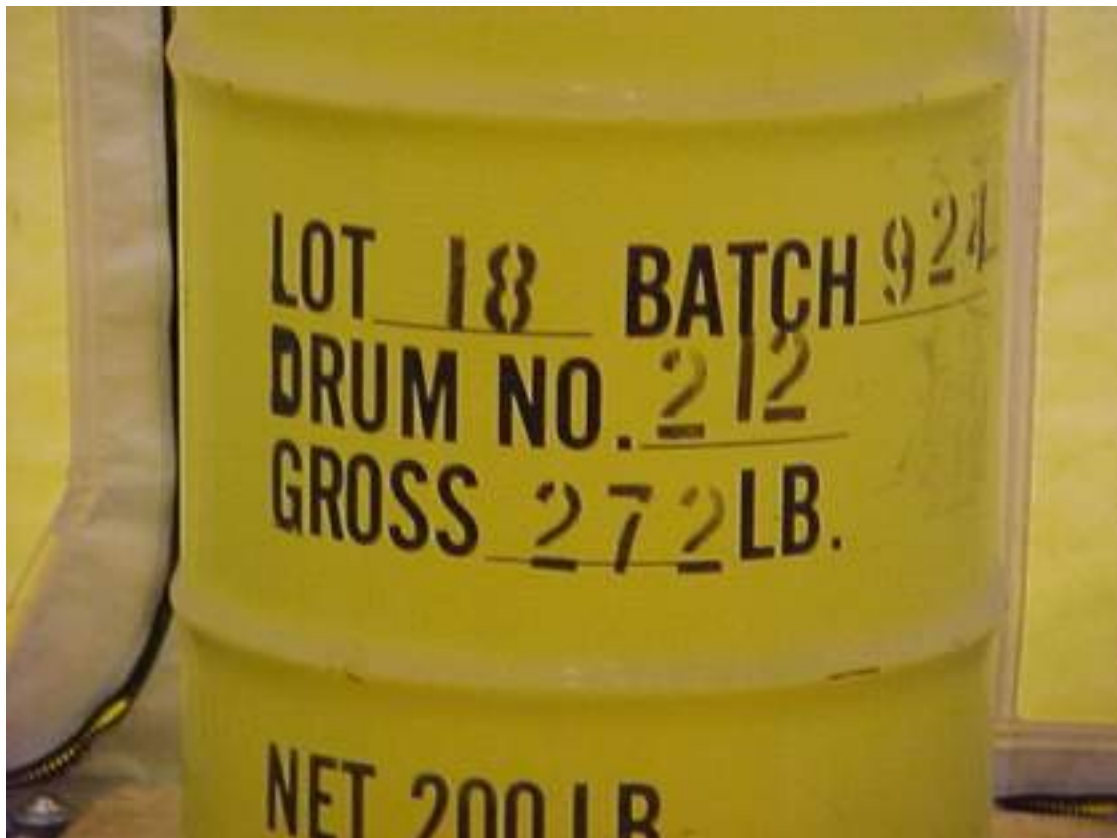
14:10**Other Information**Photo No. 1 of 10Container 30-gallon steel drumContainer
ConditionGoodDose Rate Surface 24 mR/hr
 1 meter 2.6 mR/hr

Drum released pressure while loosening/removing bolt from 30-gal drum ring
 Gasses present during initial loosening of drum ring – until evacuated by HEPA blower
 (relatively short timeframe – typically less than a few seconds)

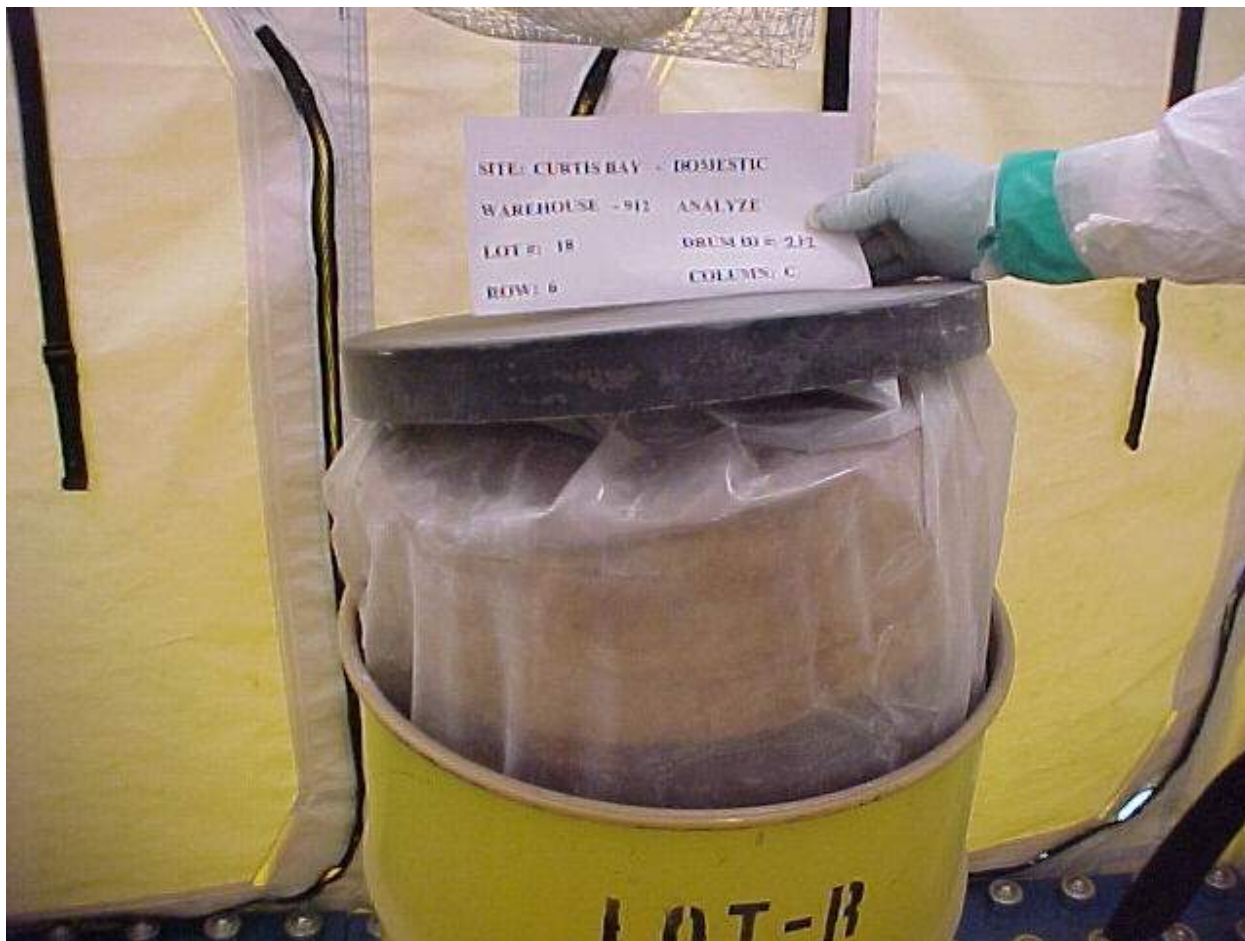
Black plastic lid from rigid poly drum liner – good condition

Raised lid indicates gas pressure buildup inside of inner poly bag(s) – internal pressure is sufficient to push drum lid through center of drum ring after the ring has been loosened

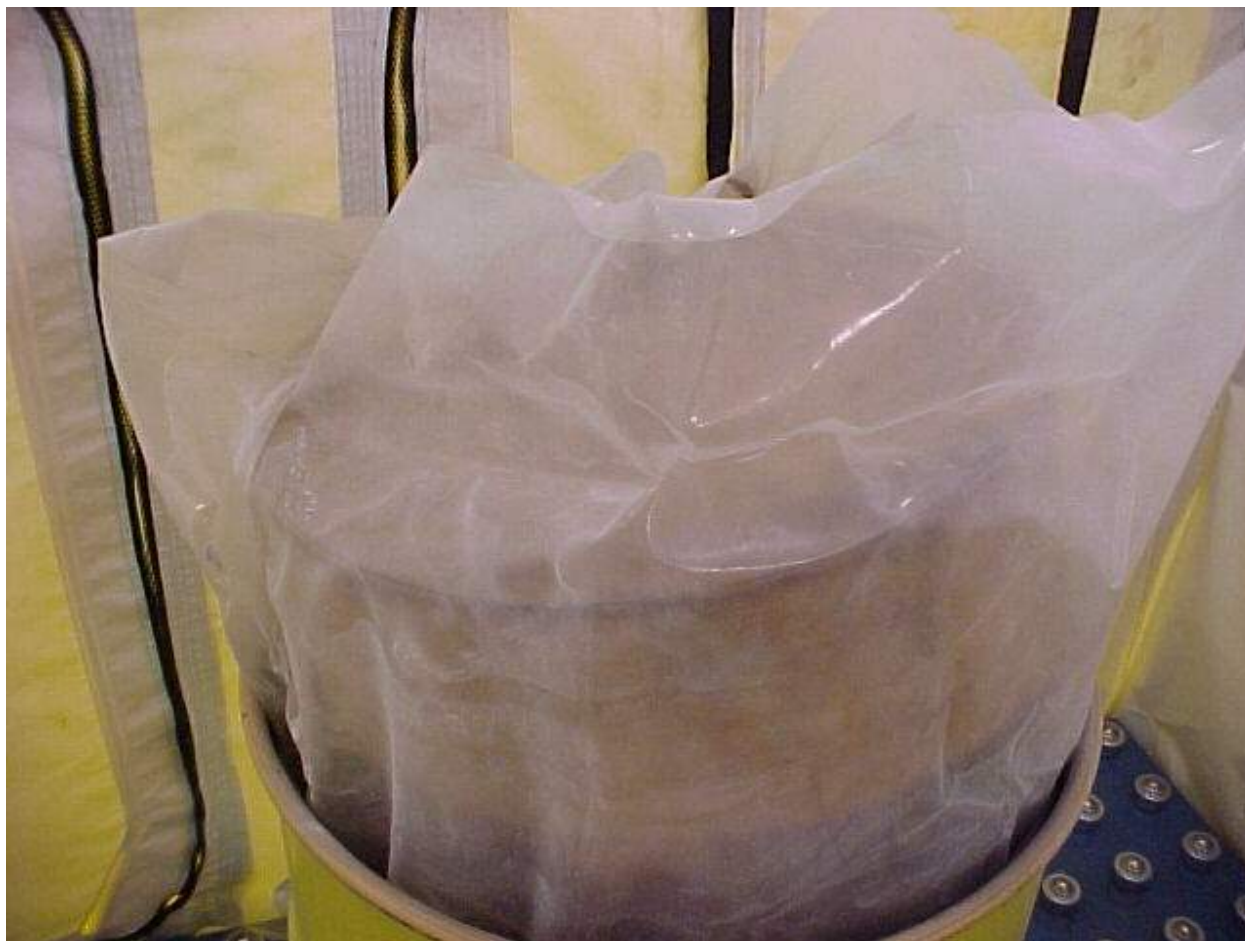
14:10**Other Information**Photo No. 3 of 10Dose Rate Surface 24 mR/hr
 1 meter 2.5 mR/hr1st poly liner/bag – good condition

Internal pressure of inner packaging raises the poly liner/bag

No gasses present
