THORIUM NITRATE STOCKPILE DRUM CHARACTERIZATION REPORT

**THORIUM NITRATE STOCKPILE
DRUM CHARACTERIZATION REPORT**

Prepared for
U.S. Defense Logistics Agency
Defense National Stockpile Center
Fort Belvoir, Virginia

Prepared by
OAK RIDGE NATIONAL LABORATORY
Oak Ridge, Tennessee 37831
managed by
UT-BATTELLE, LLC
for the
U.S. DEPARTMENT OF ENERGY
under contract DE-AC05-00OR22725

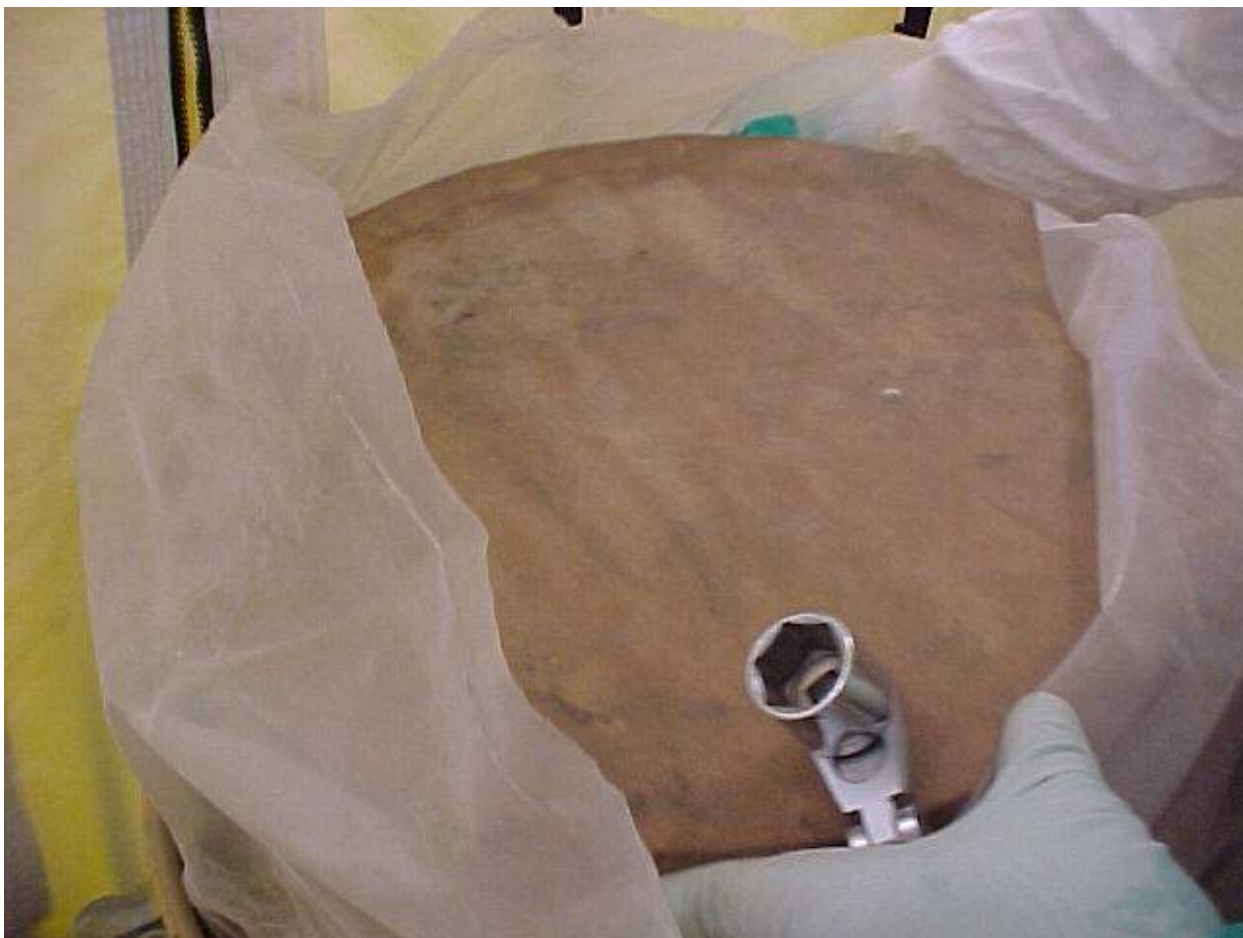
Fiber lid of fiber drum – good condition

Internal pressure causes the tape seal around the fiber drum/lid to separate after the 30-gal drum lid is removed.

No gasses present

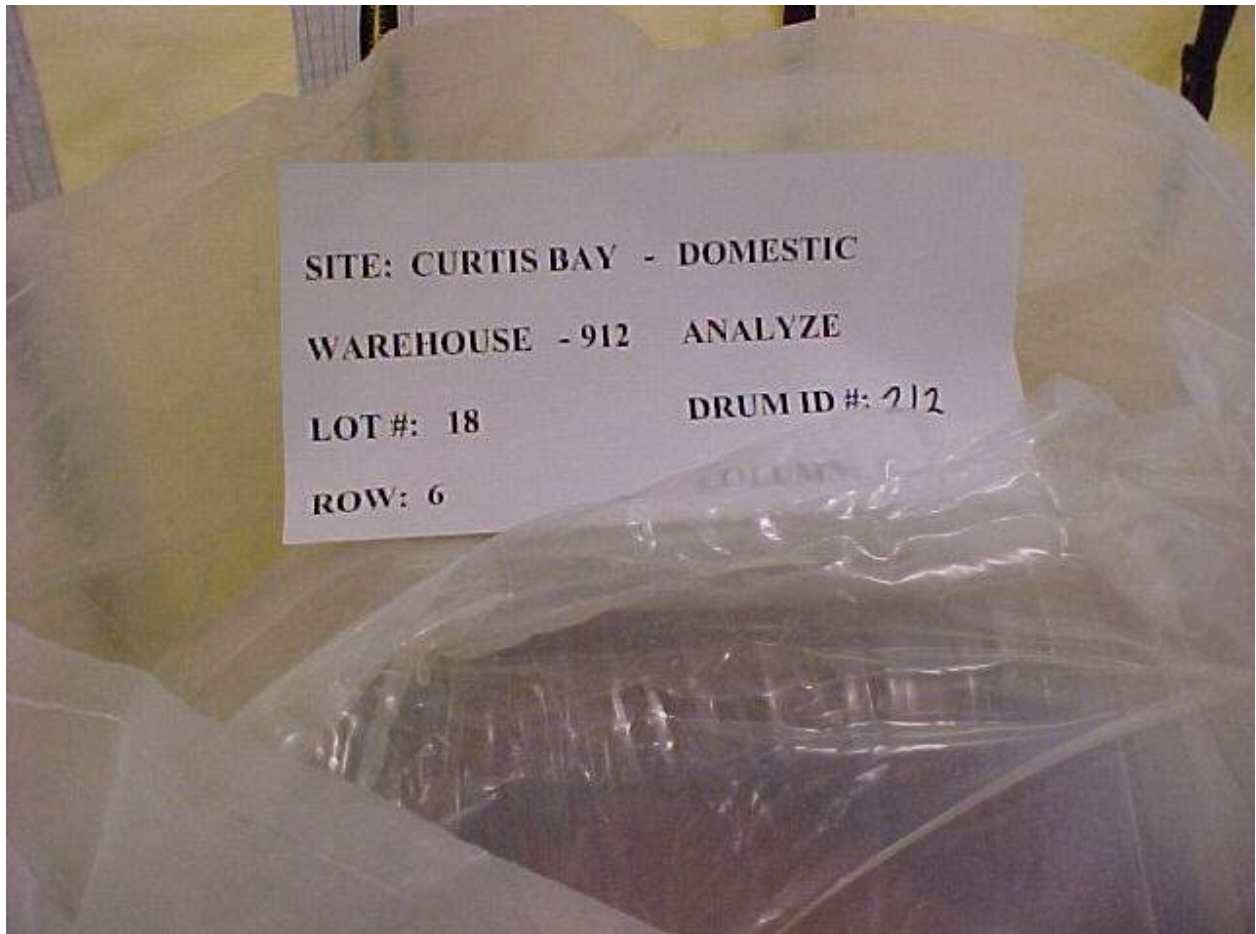
2nd poly liner/bag – good condition – although heat seal has separated due to internal pressure from inner poly bag

Poly bag's appearance is similar to an inflated balloon due to internal pressure buildup

No gasses present

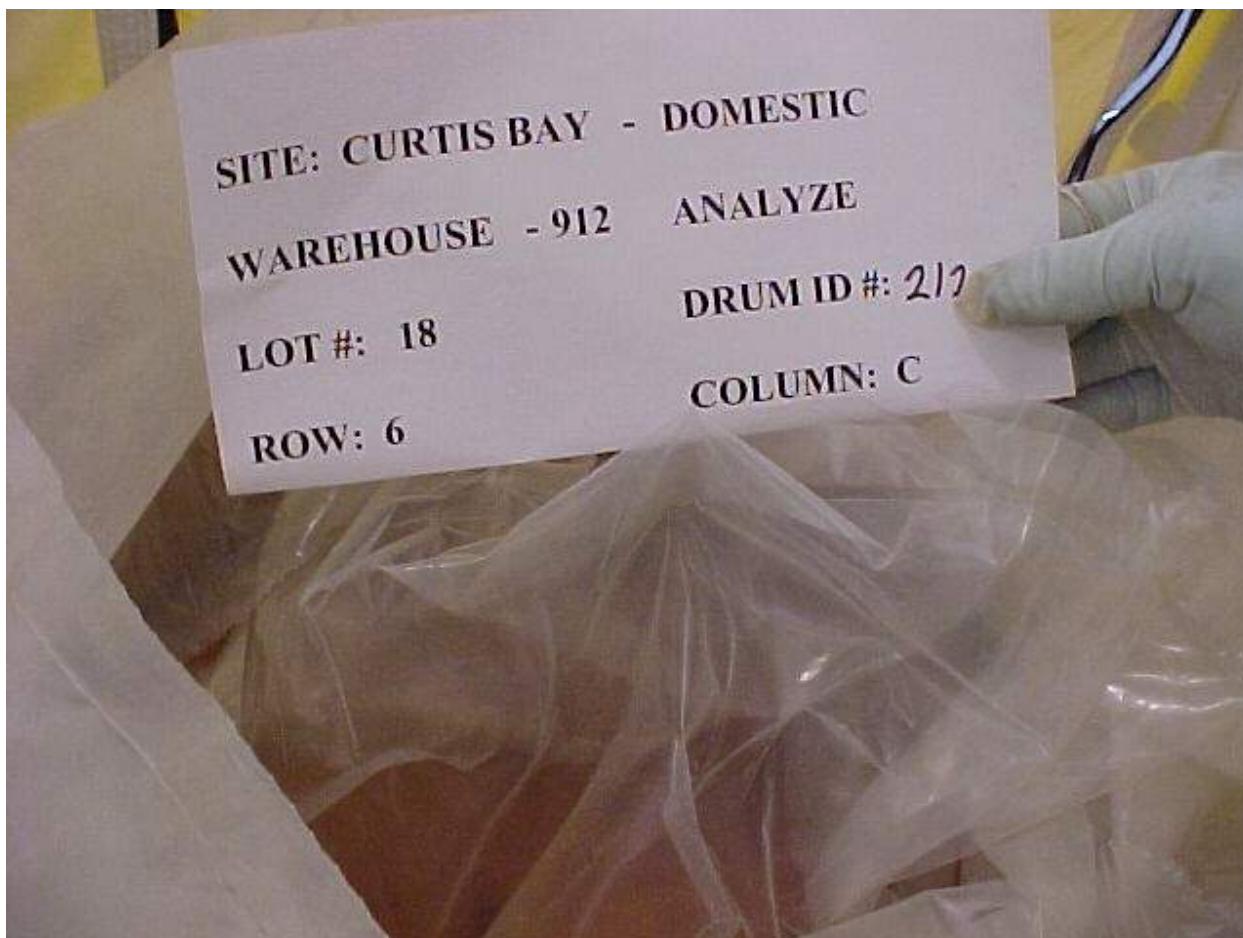
3rd poly liner/bag – good condition
Opened Poly liner/bag – No gasses in breathing zone
Gasses in headspace – LEL – 3.2% LEL - NO - >50.0ppm – NOx – >50.0ppm
Drum vented - All gasses dissipated

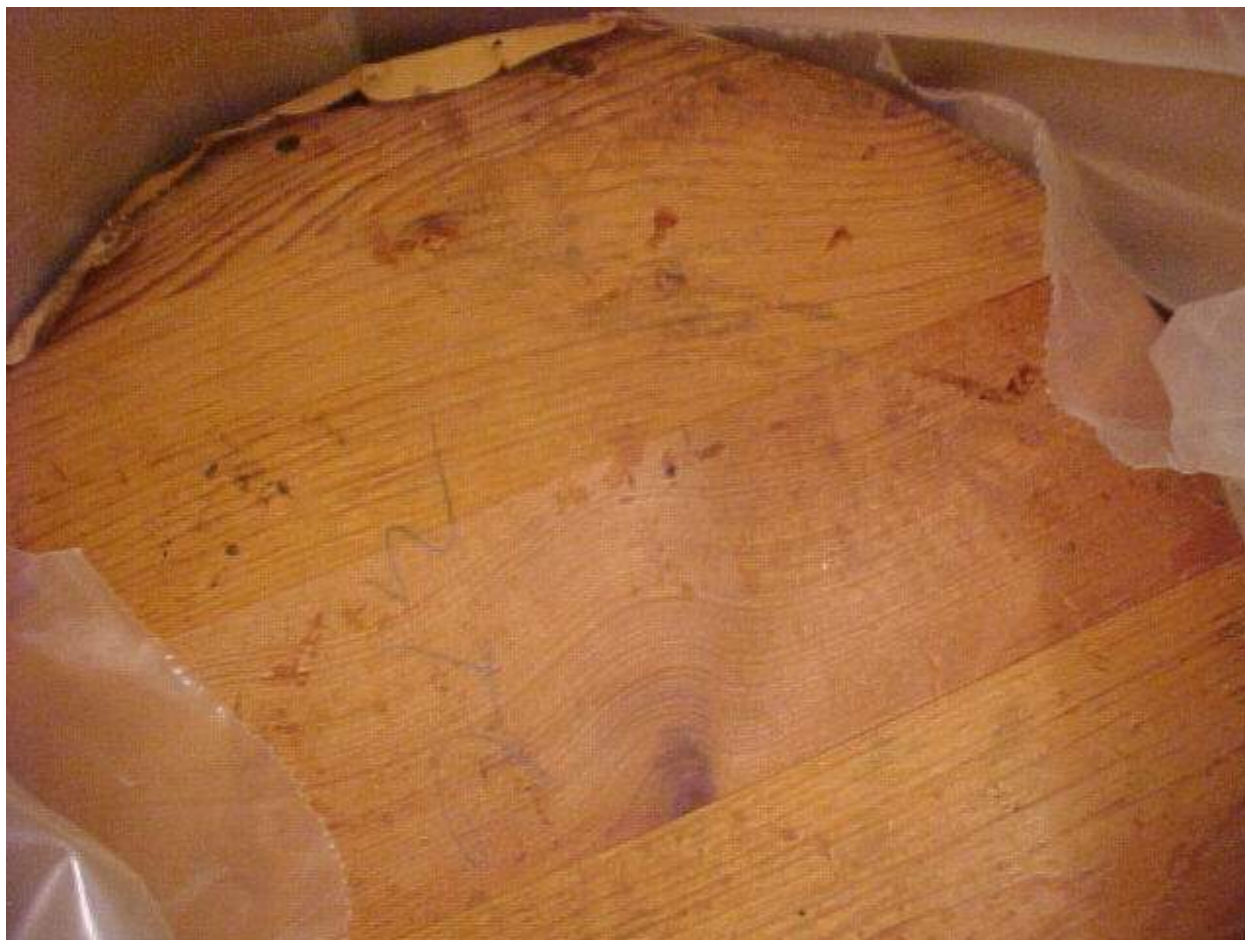
Wooden lid on inner fiber drum (overpack) – good condition

No gasses present

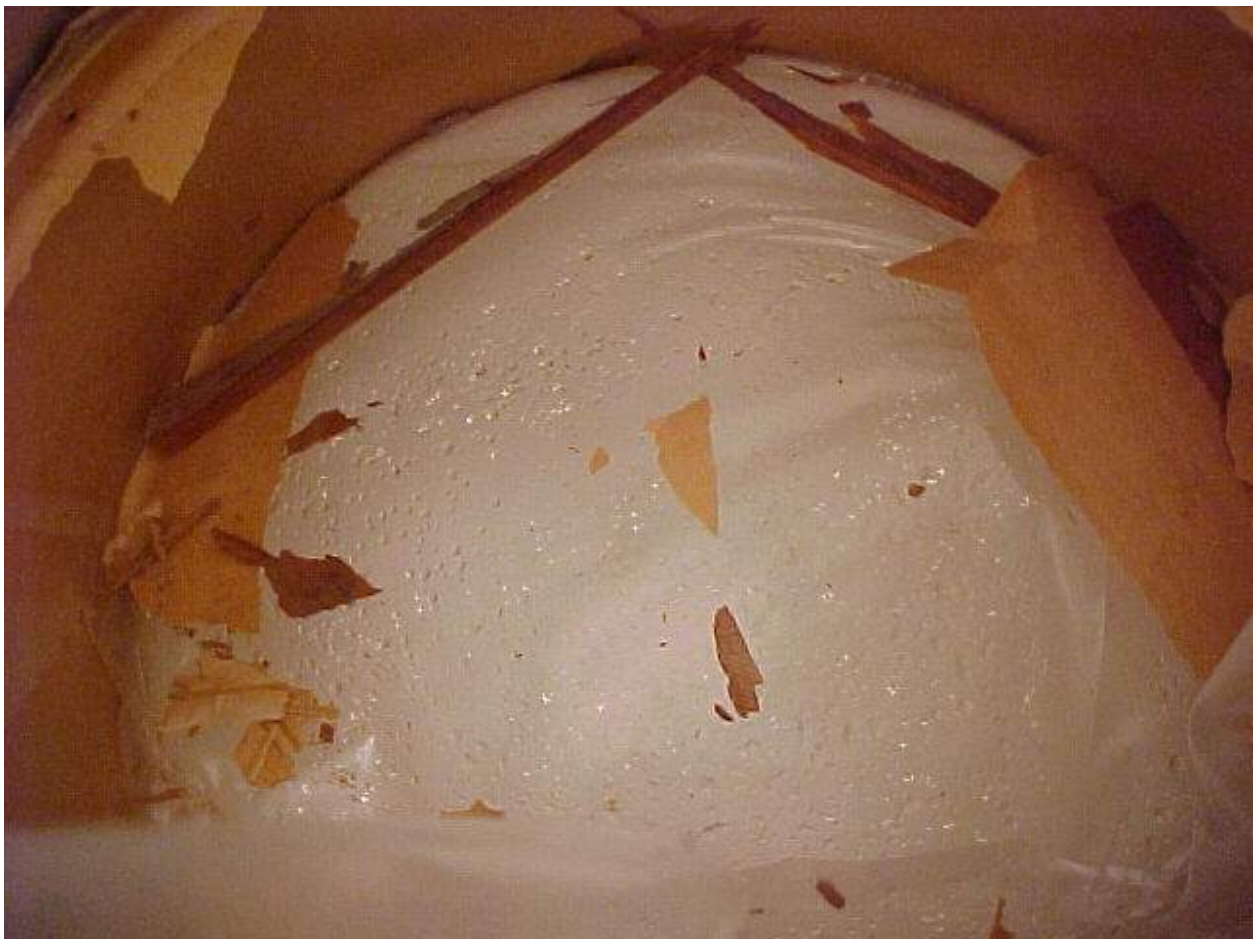
4th poly "thin film" liner/bag - good condition

Slight expansion of thin film shows slight pressurization inside of innermost bag

No gasses present

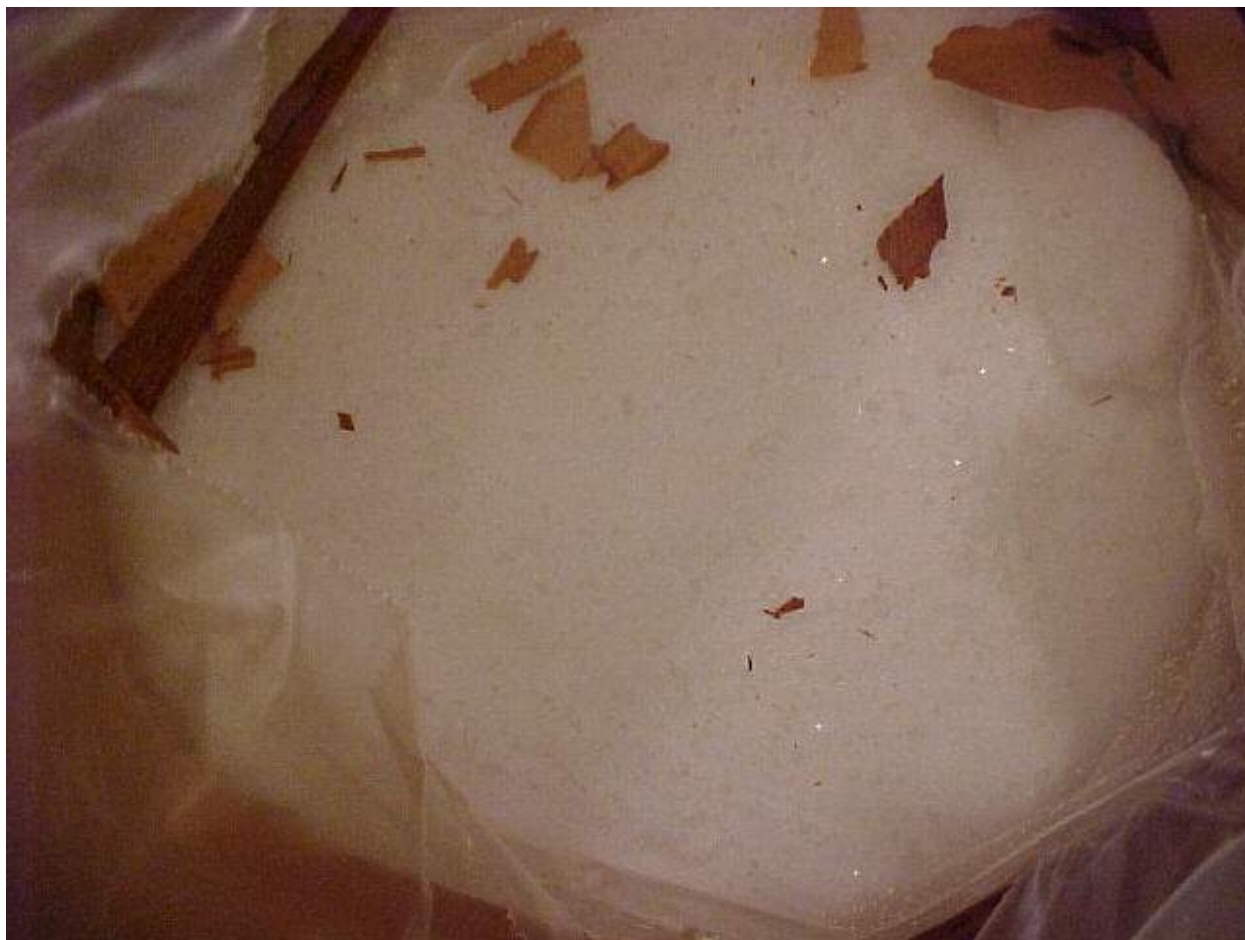
14:10**Other Information**Photo No. 9 of 10Dose Rate Surface 24 mR/hr
 1 meter 2.5 mR/hr

Thorium Nitrate – monolith – white – solid - dry
No gasses present

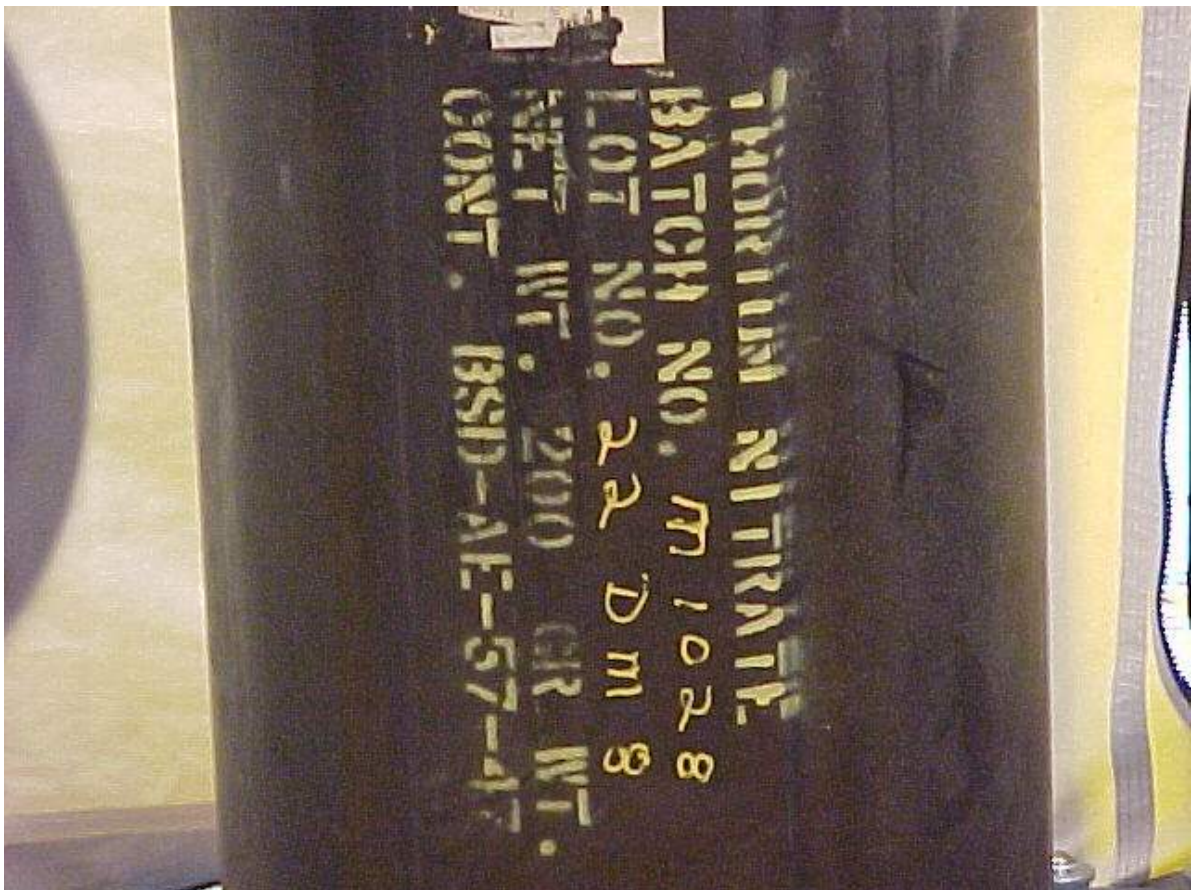
40-gal black poly container with bolt-on lid – good condition

Unable to grasp container with forklift attachment – container did not have sufficient strength to pickup on sides. Other than the outer 30-gal drum and inner black drum liner for the 30-gal drums, these drums have the same type and number of layers as the 30-gal domestic drums. The outer 40-gal drum lid does not have as good of a seal as the 30-gal drum lid that may account for no detection of gas buildup in these 40-gal drums.

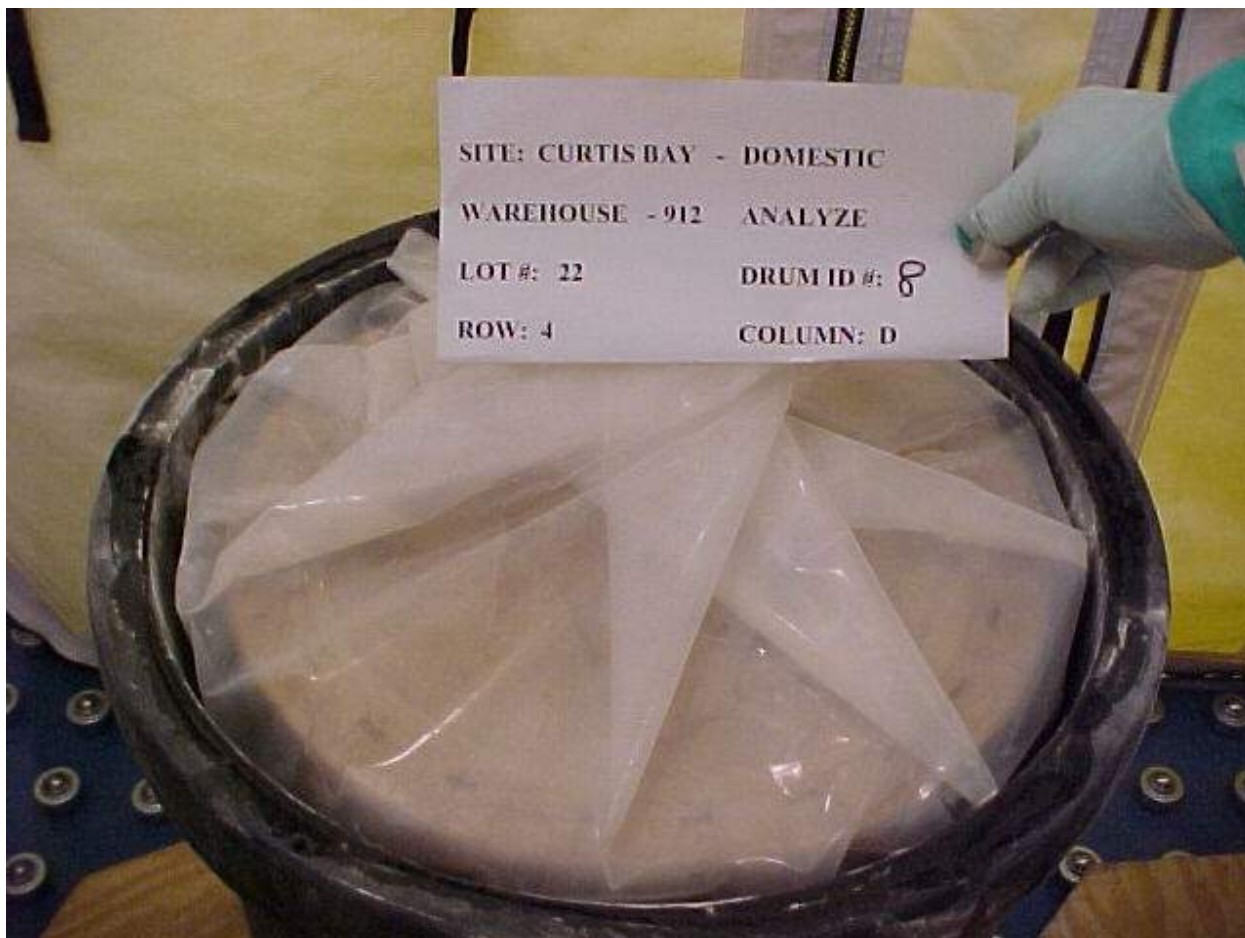
1st poly liner/bag – good condition

No gasses present

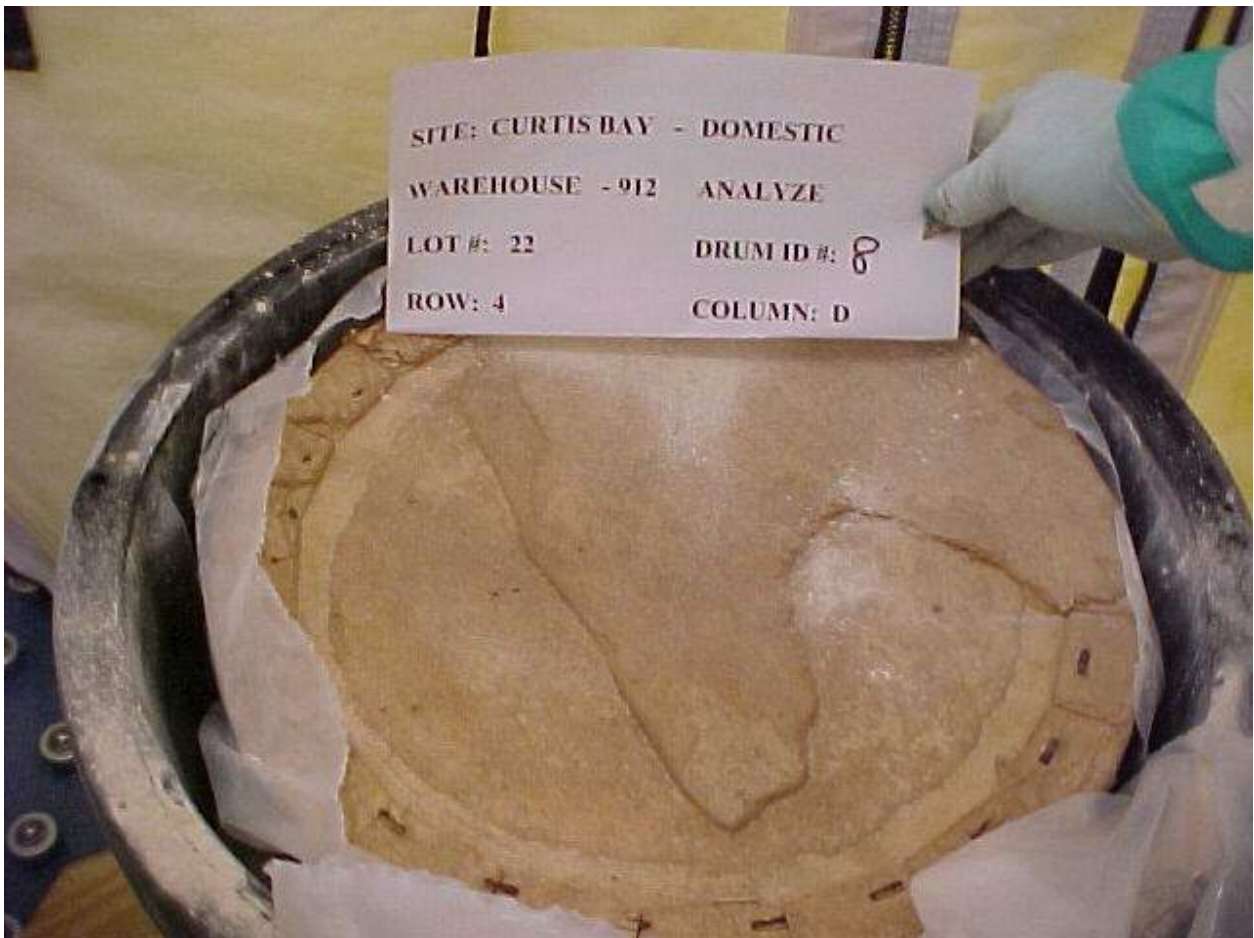
Fiber lid – good condition

No gasses present

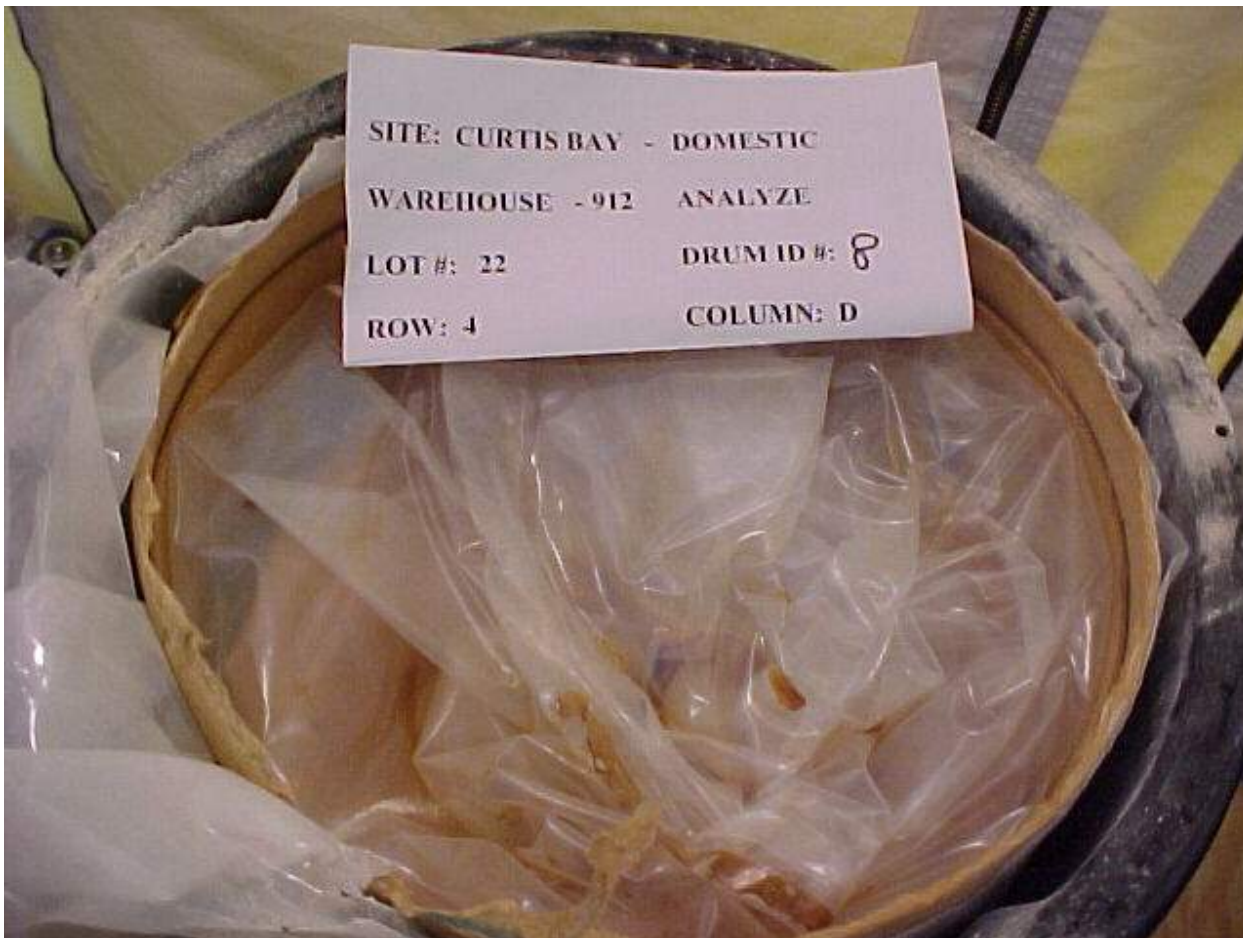
2nd poly liner/bag – good condition

No gasses present

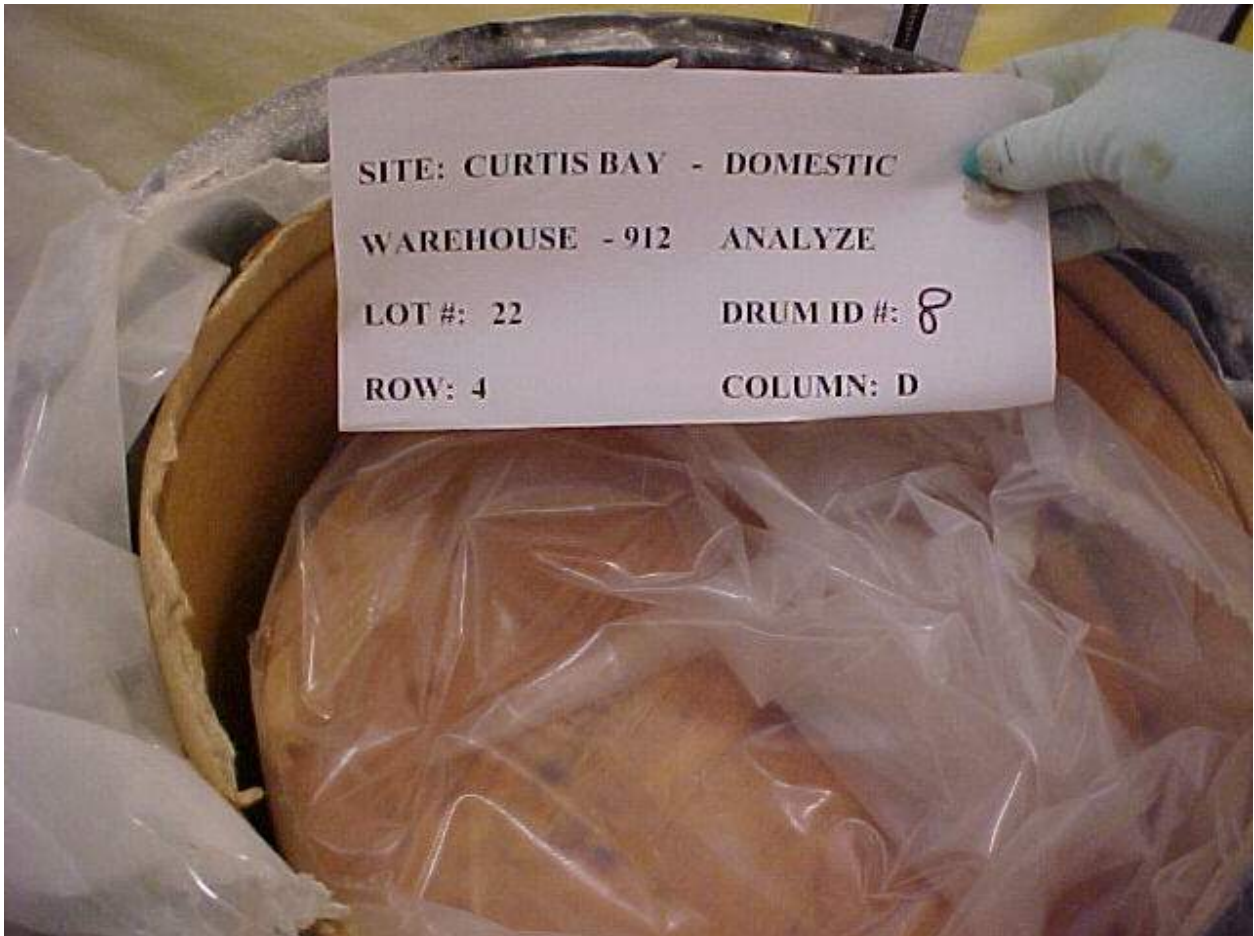
13:30**Other Information**Photo No. 5 of 10Dose Rate Surface 22 mR/hr
 1 meter 2 mR/hr3rd polyliner/bag – good condition

No gasses present

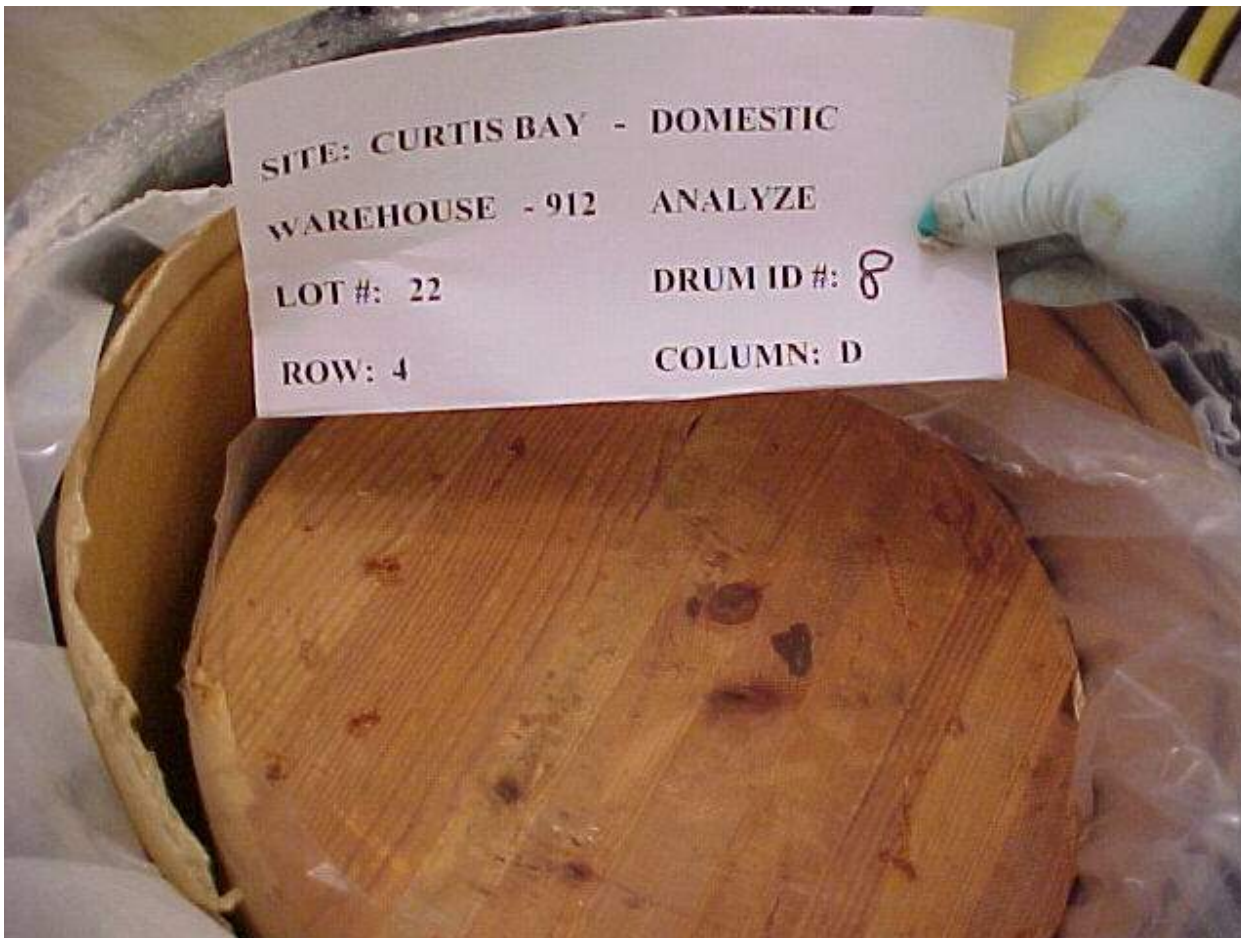
Wooden lid on inner fiber overpack container – good condition
No gasses present

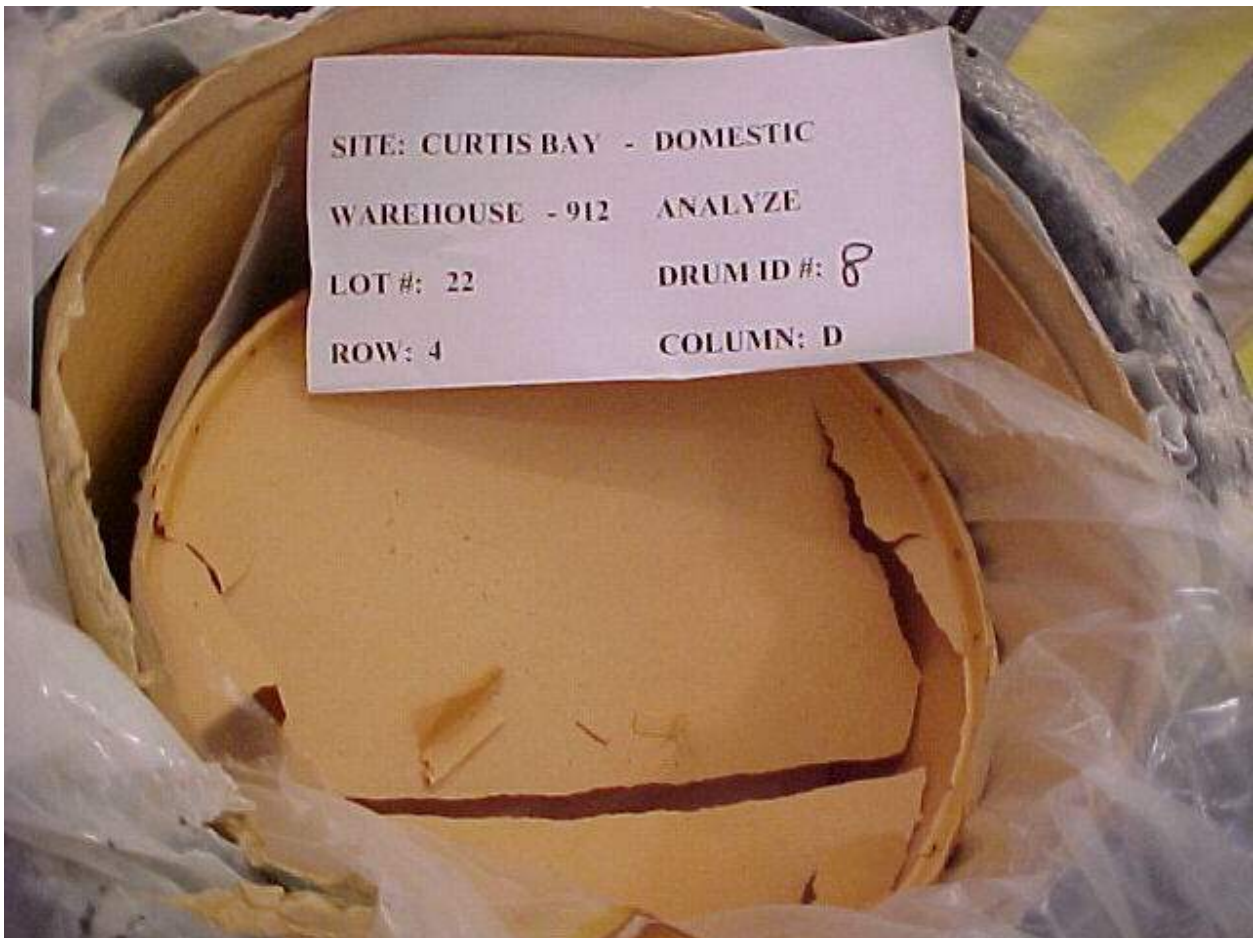
13:30**Other Information**Photo No. 7 of 10Dose Rate Surface 22 mR/hr
 1 meter 2 mR/hr

Labpack (thin paper) container lid is shown
No gasses present

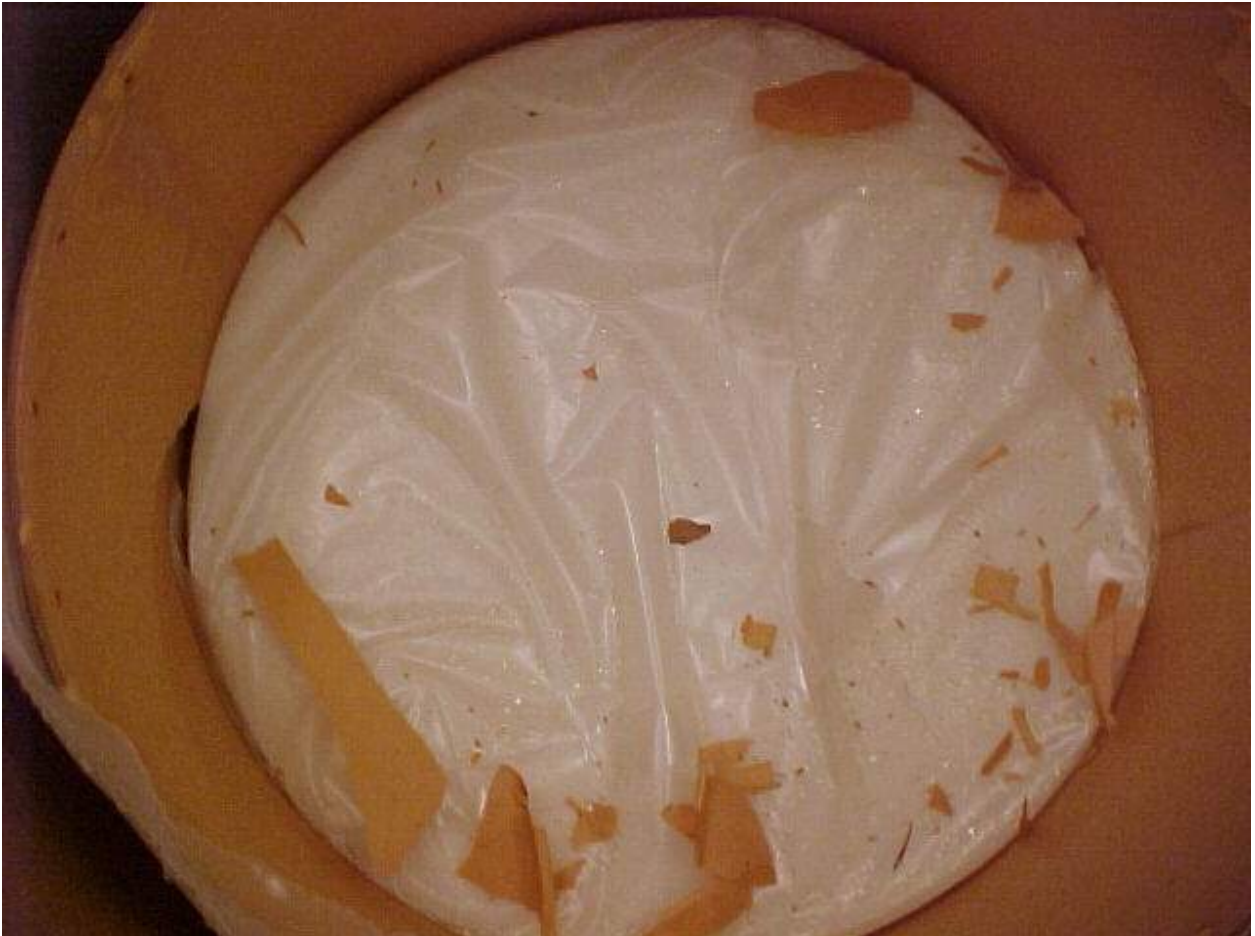
4th poly "thin film" liner/bag - good condition
No gasses present

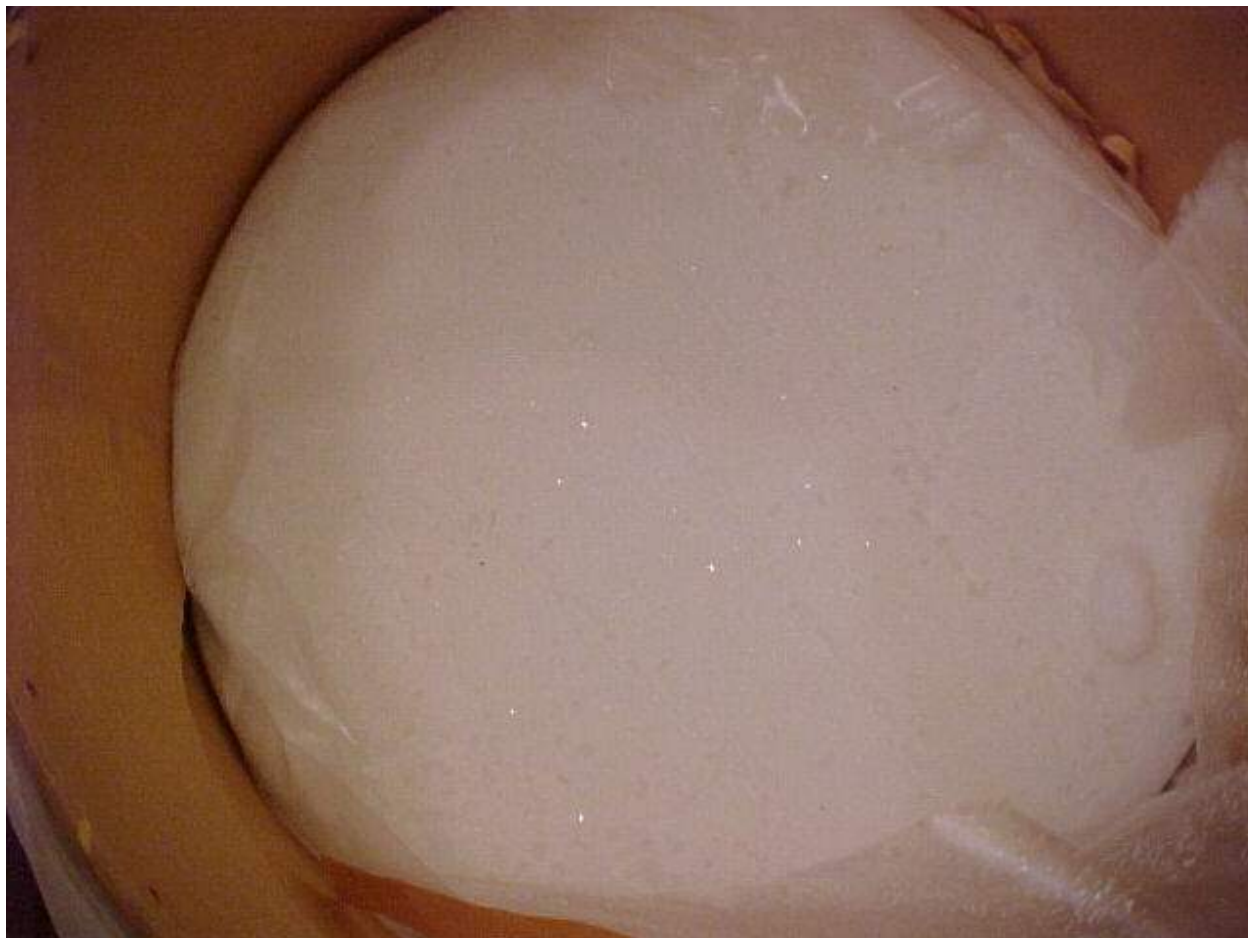
13:30**Other Information**Photo No. 9 of 10Dose Rate Surface 22 mR/hr
 1 meter 2 mR/hr

Thorium Nitrate – monolith – white – solid - dry
No gasses present

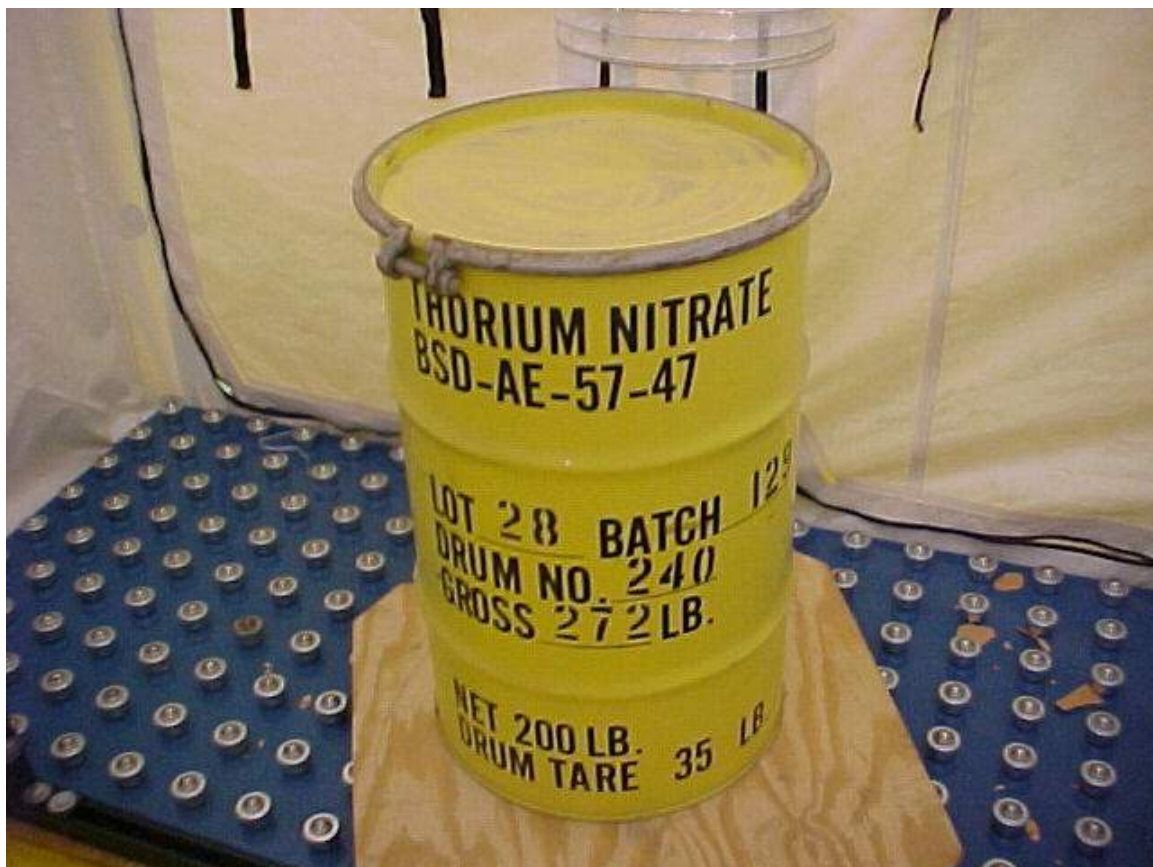
12:30**Other Information**Photo No. 1 of 10Container 30-gallon steel drumContainer
ConditionGoodDose Rate Surface 22 mR/hr1 meter 3.0 mR/hr

Drum released pressure while loosening/removing bolt from 30-gal drum ring
 Gasses present during initial loosening of drum ring – until evacuated by HEPA blower
 (relatively short timeframe – typically less than a few seconds)

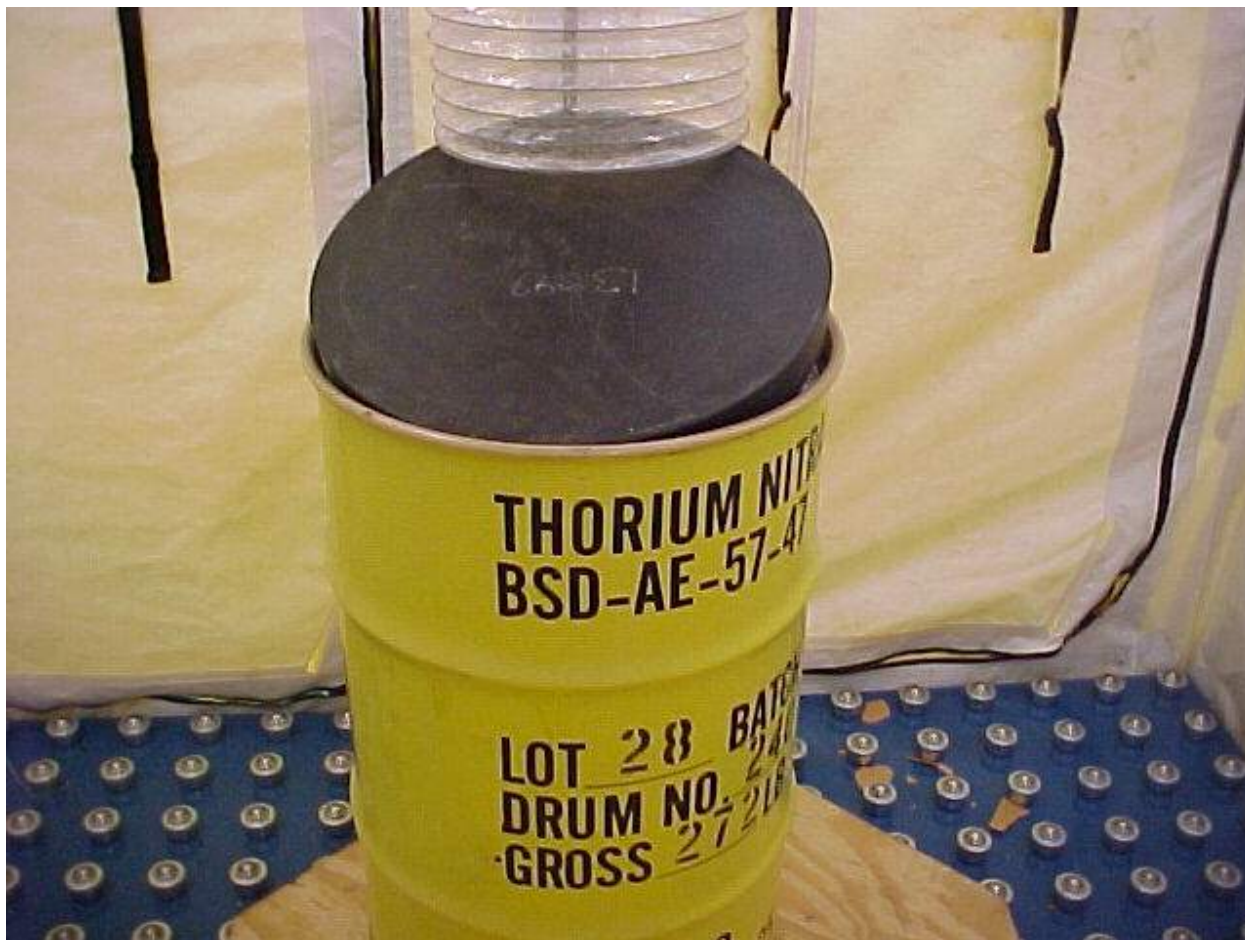
After opening the 30gal drum the plastic lid is shown and in good condition
No gasses present

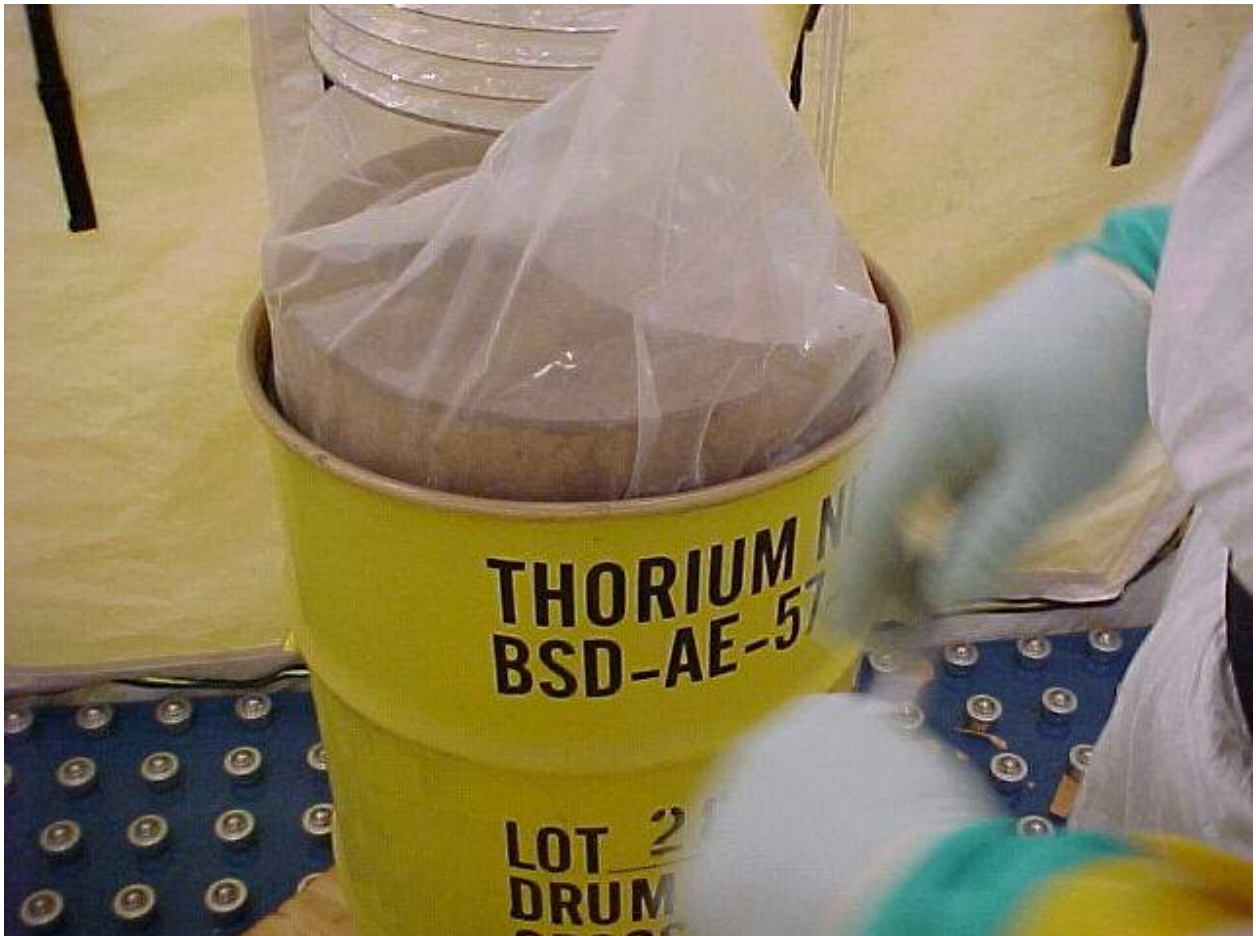
12:30**Other Information**Photo No. 3 of 10Dose Rate Surface 22 mR/hr
 1 meter 3.0 mR/hr1st poly liner/bag – good condition
No gasses present

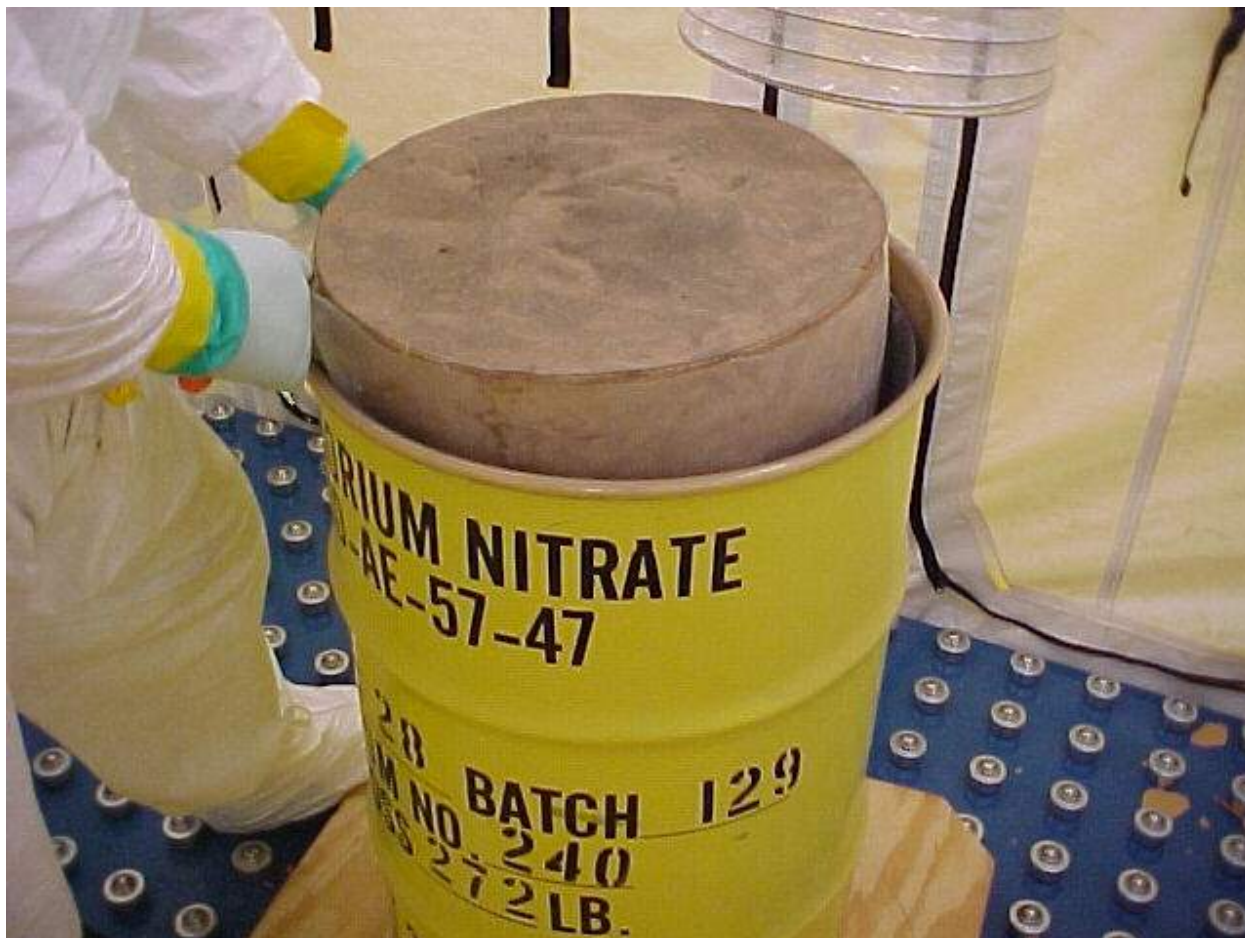
Fiber Lid & Drum – Good Condition

Internal pressure causes the tape seal around the fiber drum/lid to separate after the 30-gal drum lid is removed.

No gasses present
