THORIUM NITRATE STOCKPILE DRUM CHARACTERIZATION REPORT

**THORIUM NITRATE STOCKPILE
DRUM CHARACTERIZATION REPORT**

Prepared for
U.S. Defense Logistics Agency
Defense National Stockpile Center
Fort Belvoir, Virginia

Prepared by
OAK RIDGE NATIONAL LABORATORY
Oak Ridge, Tennessee 37831
managed by
UT-BATTELLE, LLC
for the
U.S. DEPARTMENT OF ENERGY
under contract DE-AC05-00OR22725

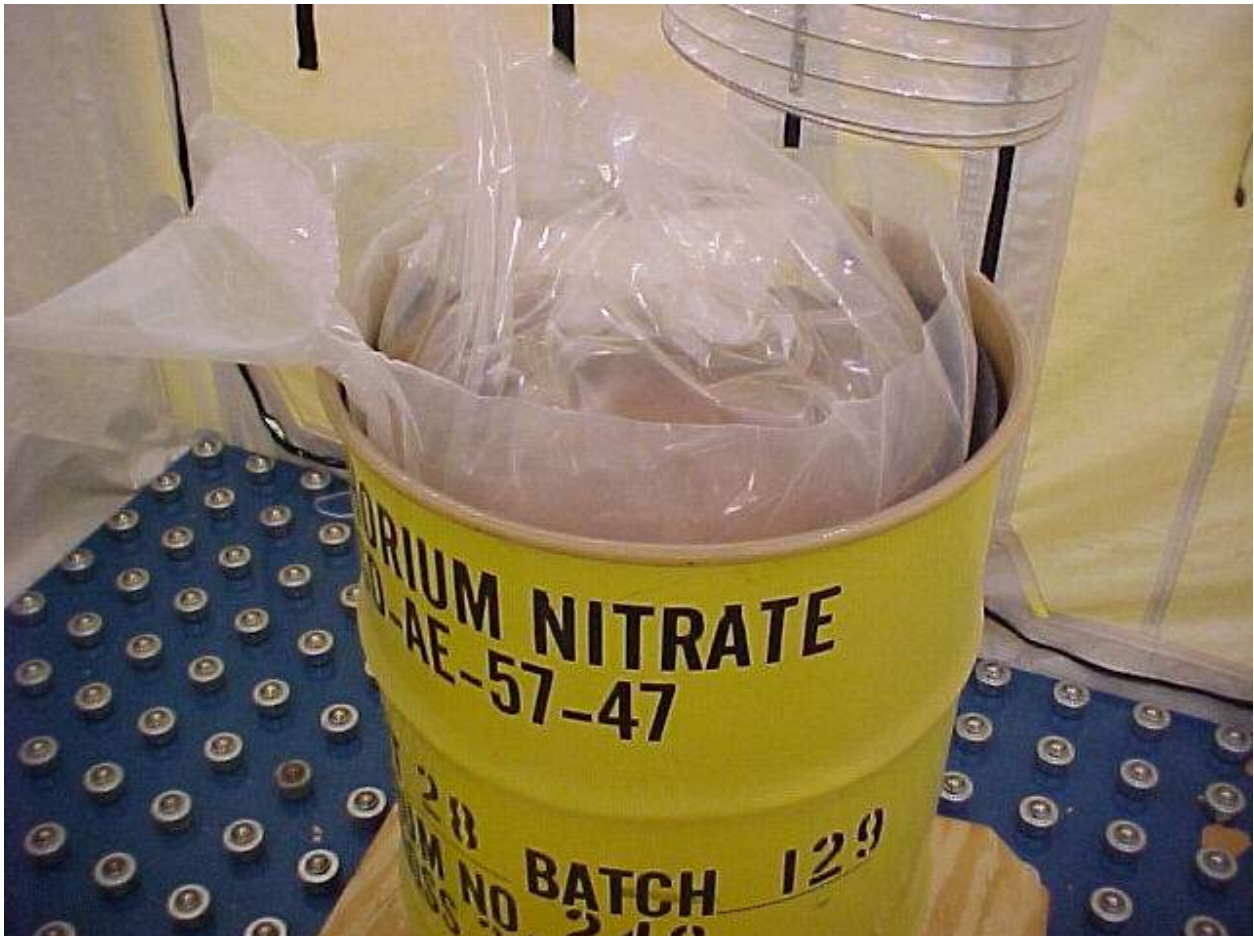
12:30**Other Information**Photo No. 5 of 10Dose Rate Surface 22 mR/hr
 1 meter 3.0 mR/hr

2nd poly liner/bag shows a bubble that is from the pressure buildup inside the 3rd poly bag
 No gasses present

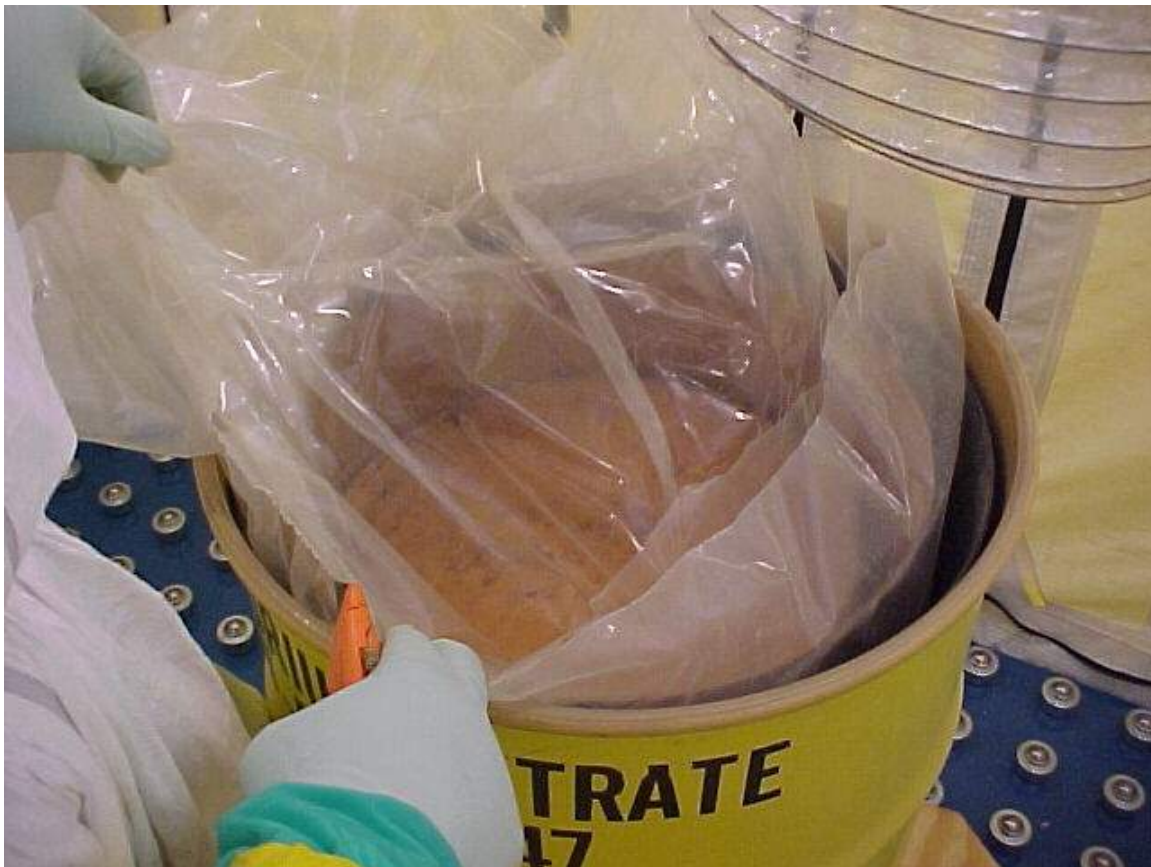
3rd poly liner/bag - good condition – shows internal pressure buildup inside the bag Upon measuring gas buildup inside of bag, instrumentation indicated NO – 7.2 ppm and NOx – 30.1 ppm.
No gasses present (exterior to bag)

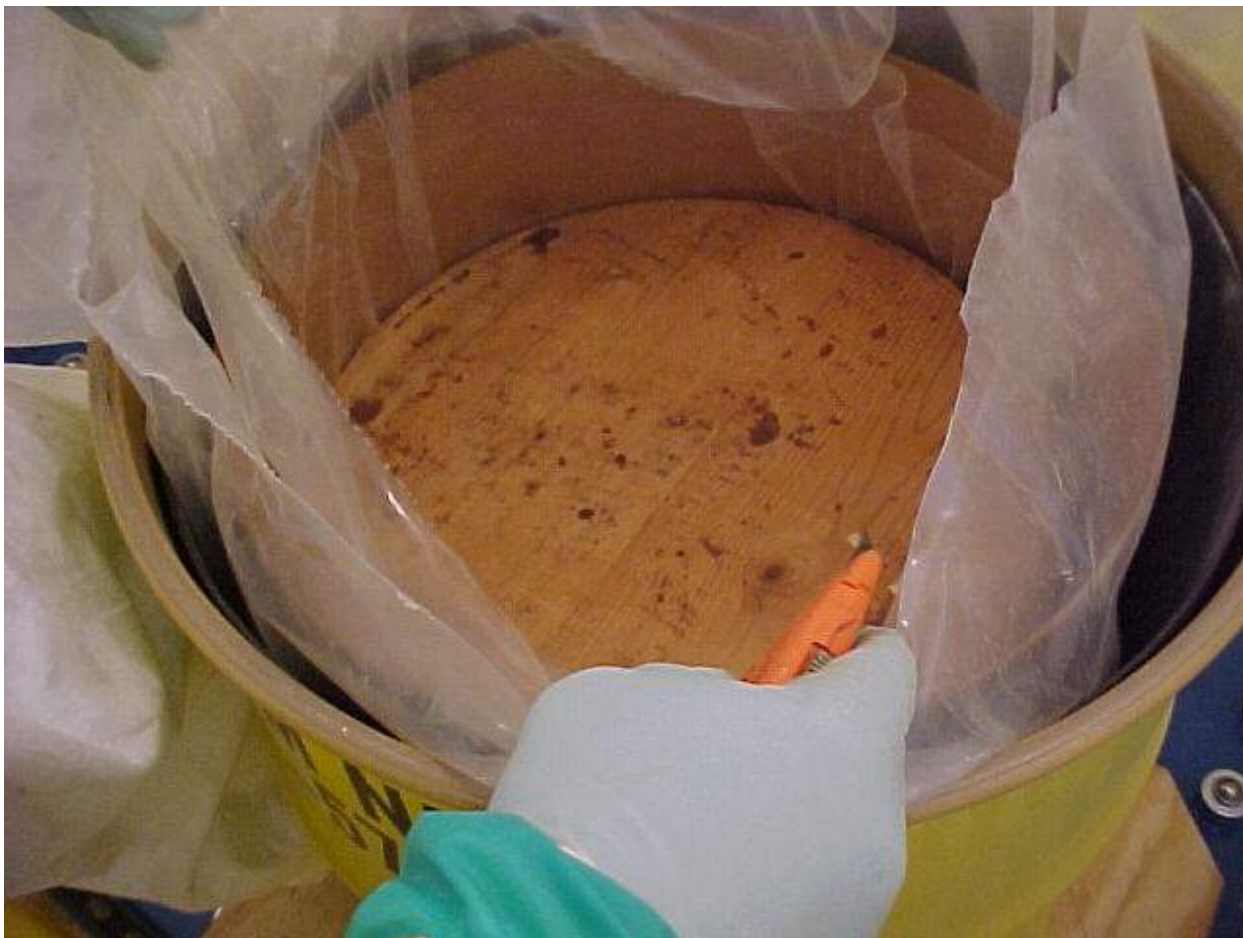
12:30**Other Information**Photo No. 7 of 10Dose Rate Surface 22 mR/hr
 1 meter 3.0 mR/hr

The wooden lid mounted on inner most fiber drum that protects the Thorium Nitrate – good condition
No gasses present

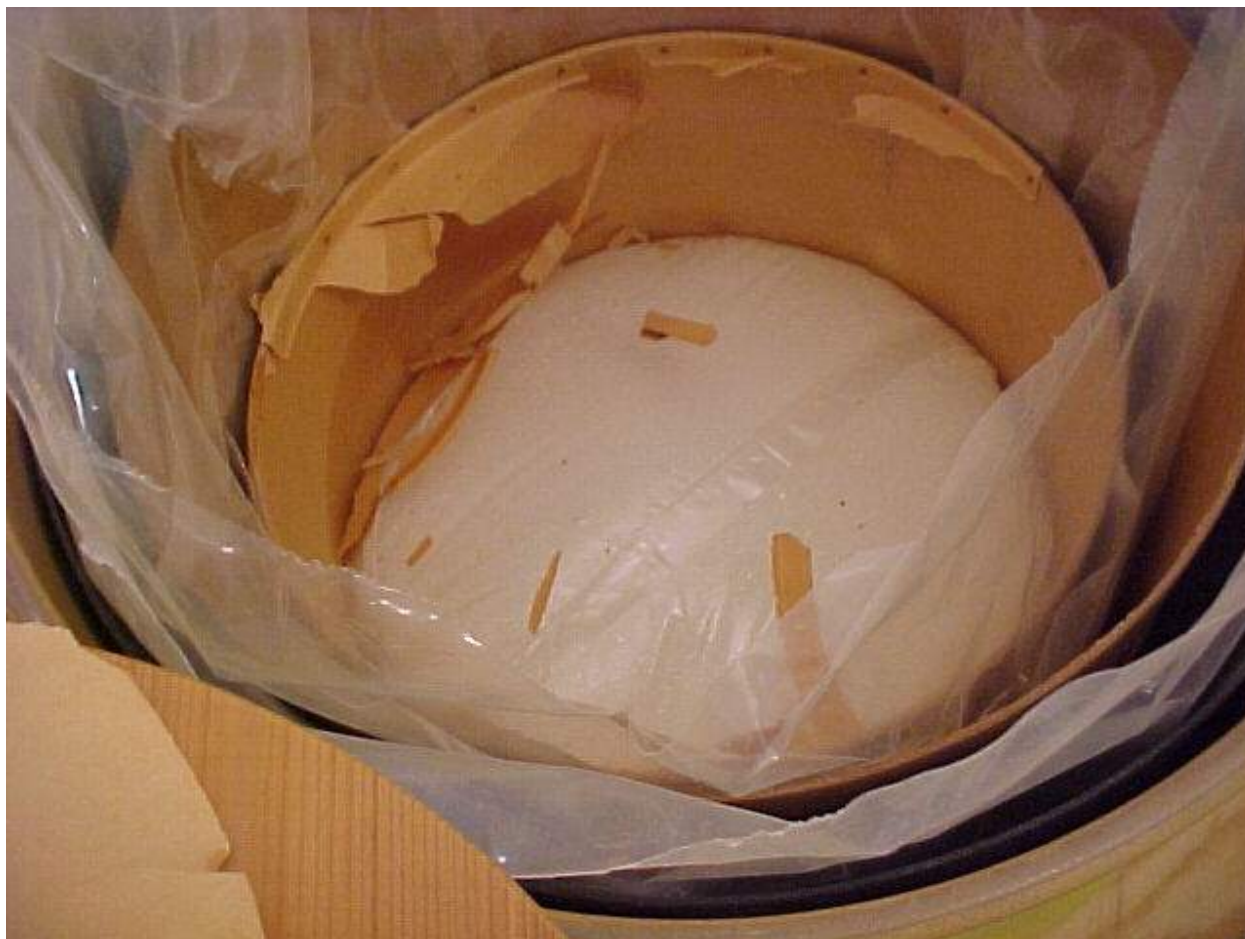
The final poly liner/bag (“thin film” layer) before the Thorium Nitrate – bag shows slight expansion indicating internal pressure inside the bag – apparently gas is being generated by the ThN material then slowly dissipates through all bags then finally builds up inside the 30-gal drum if the drum is tightly sealed.

No gasses present

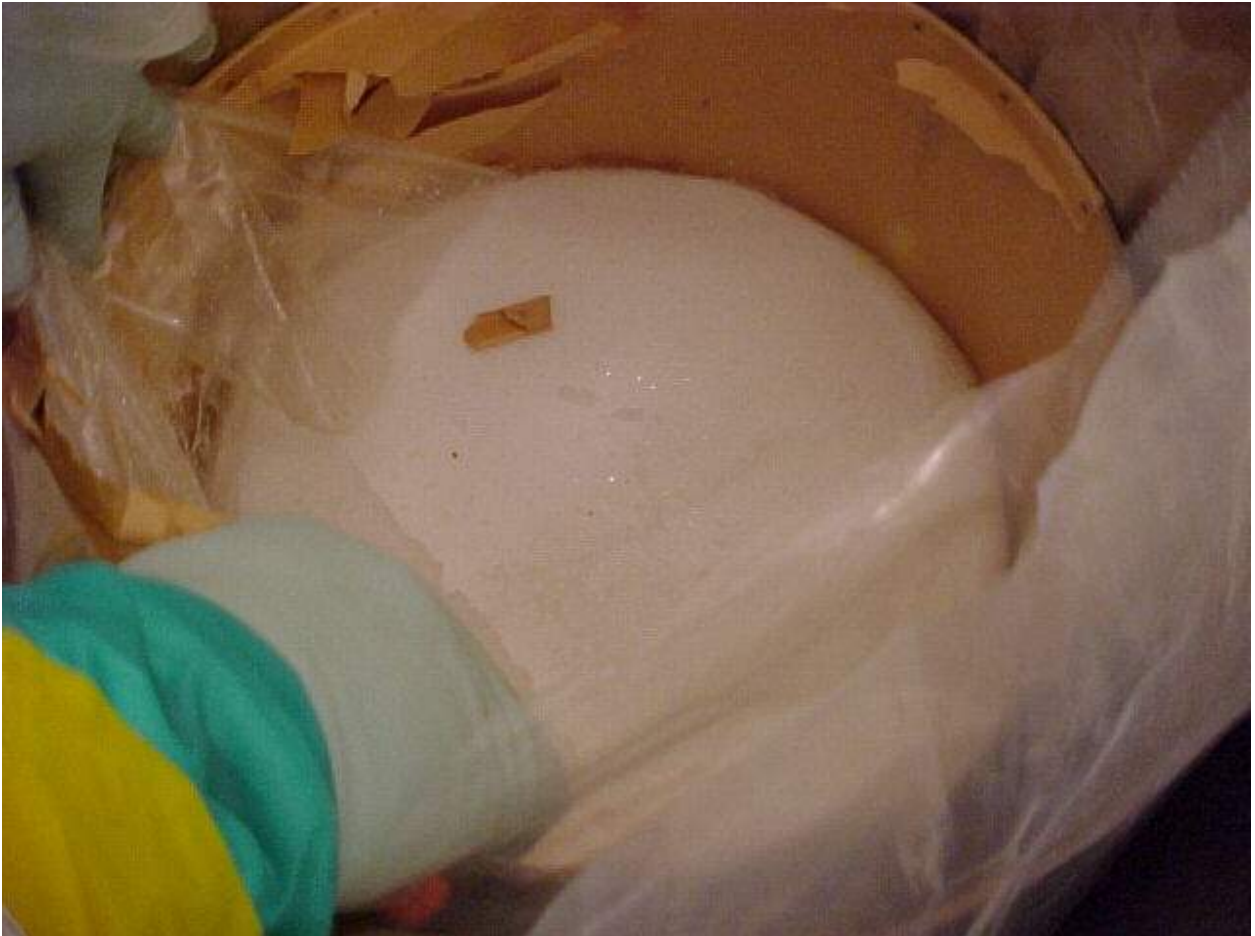
12:30**Other Information**Photo No. 9 of 10Dose Rate Surface 22 mR/hr
 1 meter 3.0 mR/hr

Thorium Nitrate – good condition – monolith – dry – no gasses present following evacuation by HEPA blower.

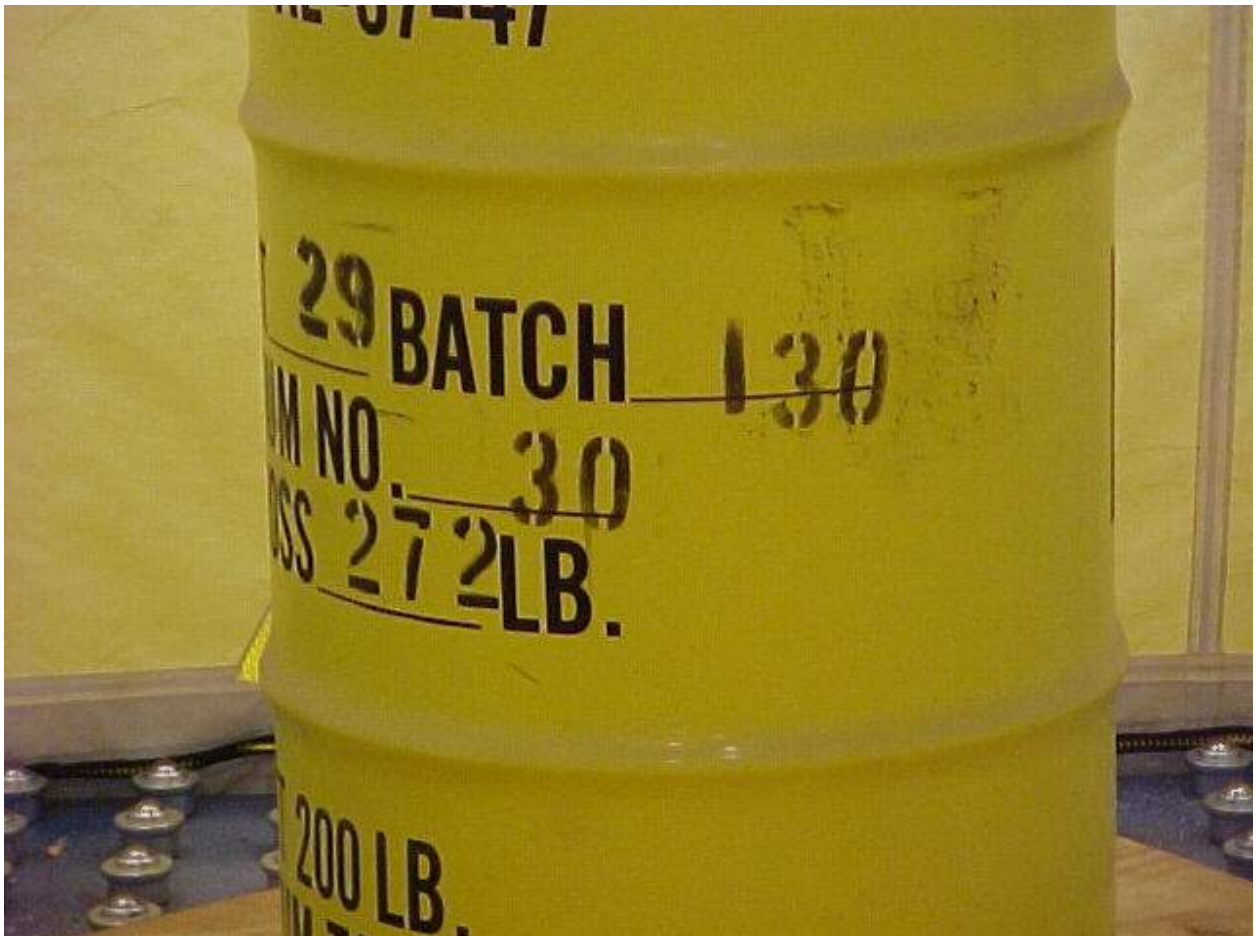
30-gal drum – good condition

Drum released pressure while loosening/removing bolt from 30-gal drum ring

Gasses present during initial loosening of drum ring – until evacuated by HEPA blower
(relatively short timeframe – typically less than a few seconds)

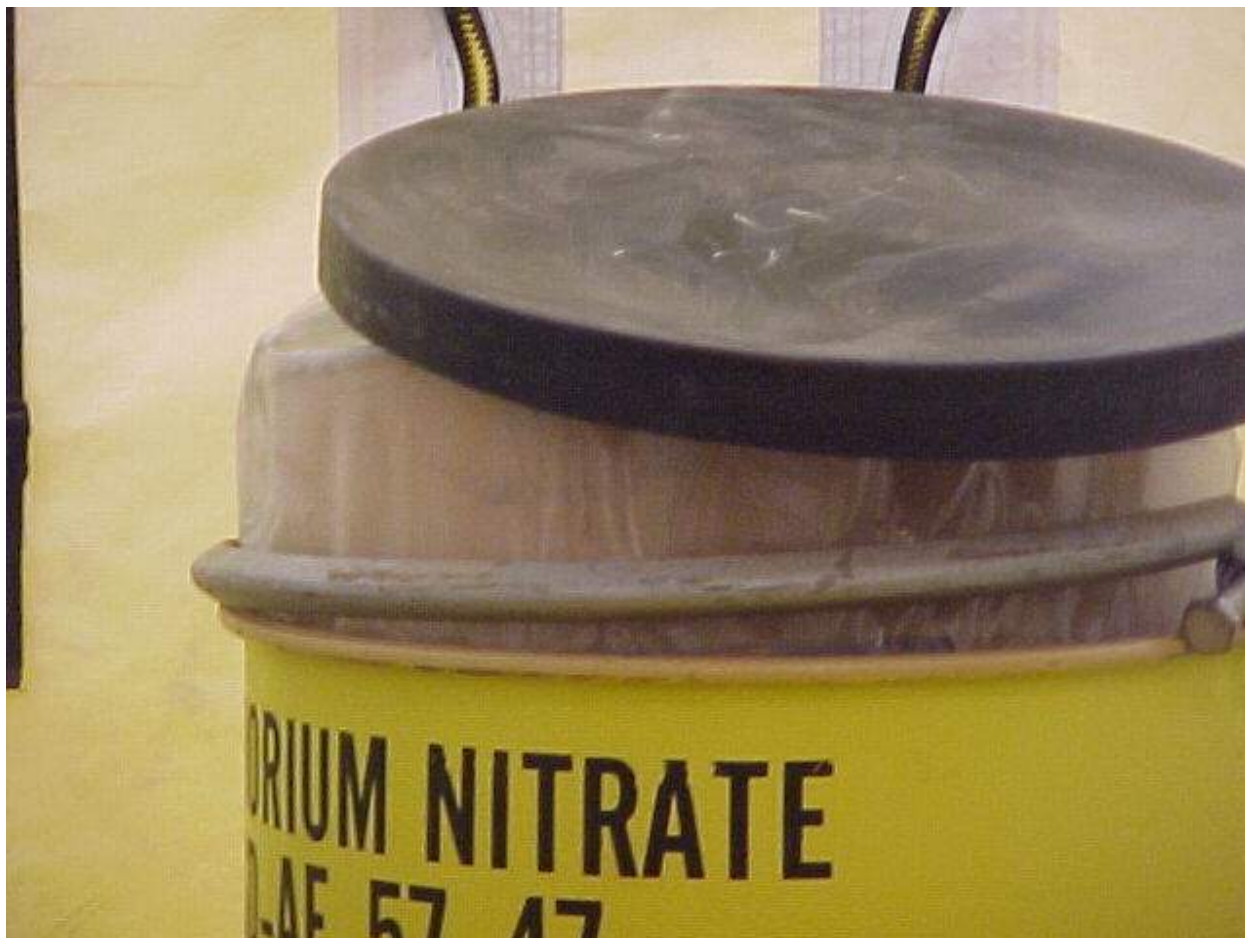
Black plastic lid – good condition

Pressure buildup inside container inflates innermost poly bags resulting in outer packagings being pushed vertically out of the drum (including the black plastic lid shown in this photograph)

No gasses present

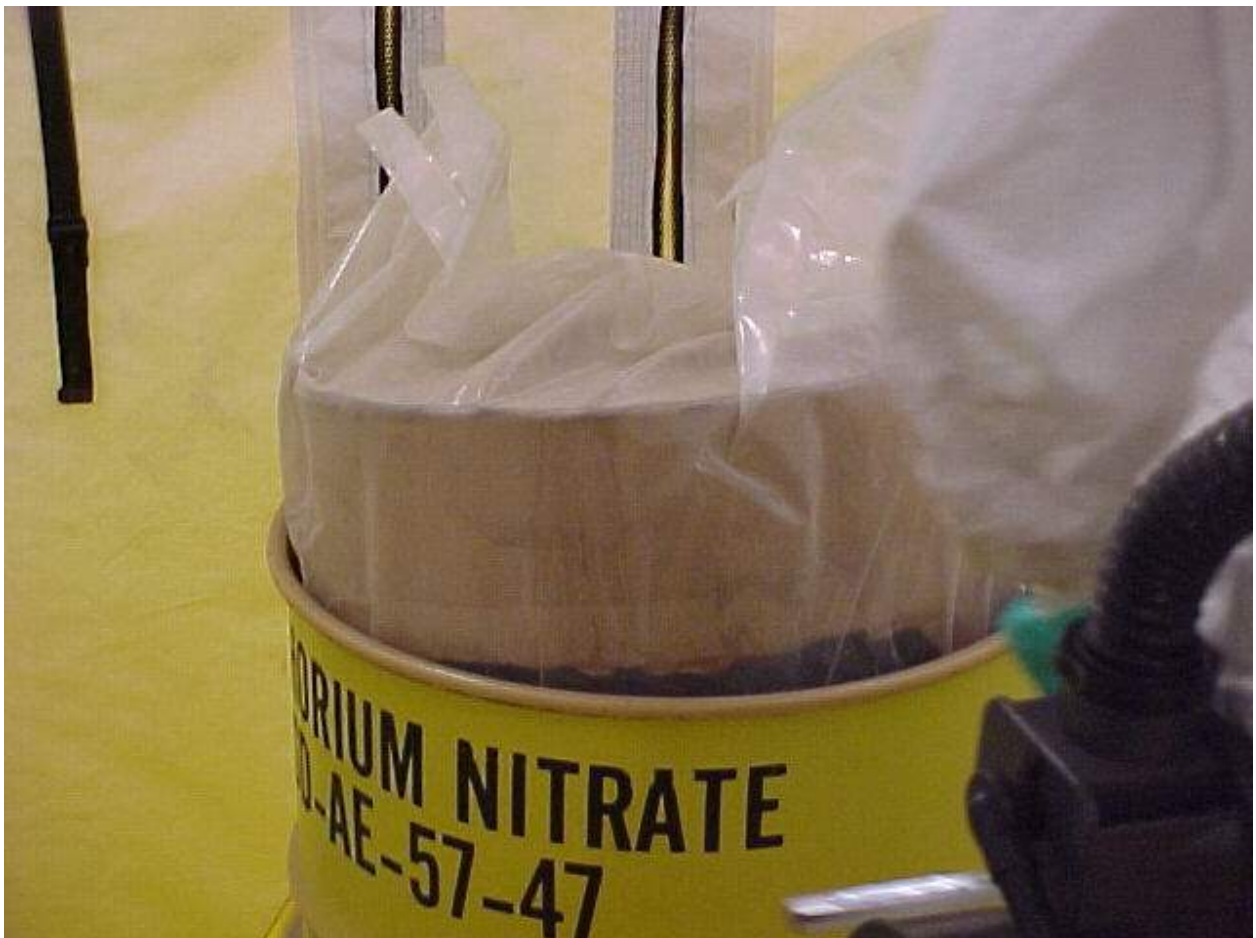
14:45**Other Information**Photo No. 3 of 10Dose Rate Surface 24 mR/hr
 1 meter 2.6 mR/hr1st poly liner/bag – good condition

Gas pressure buildup inside container raises poly liner/bag vertically out of drum.

No gasses present (exterior to bag – please note that HEPA blower is operating directly above drum which would evacuate any gasses slowing dissipating through packagings prior to instrumentation being able to measure these small quantities).

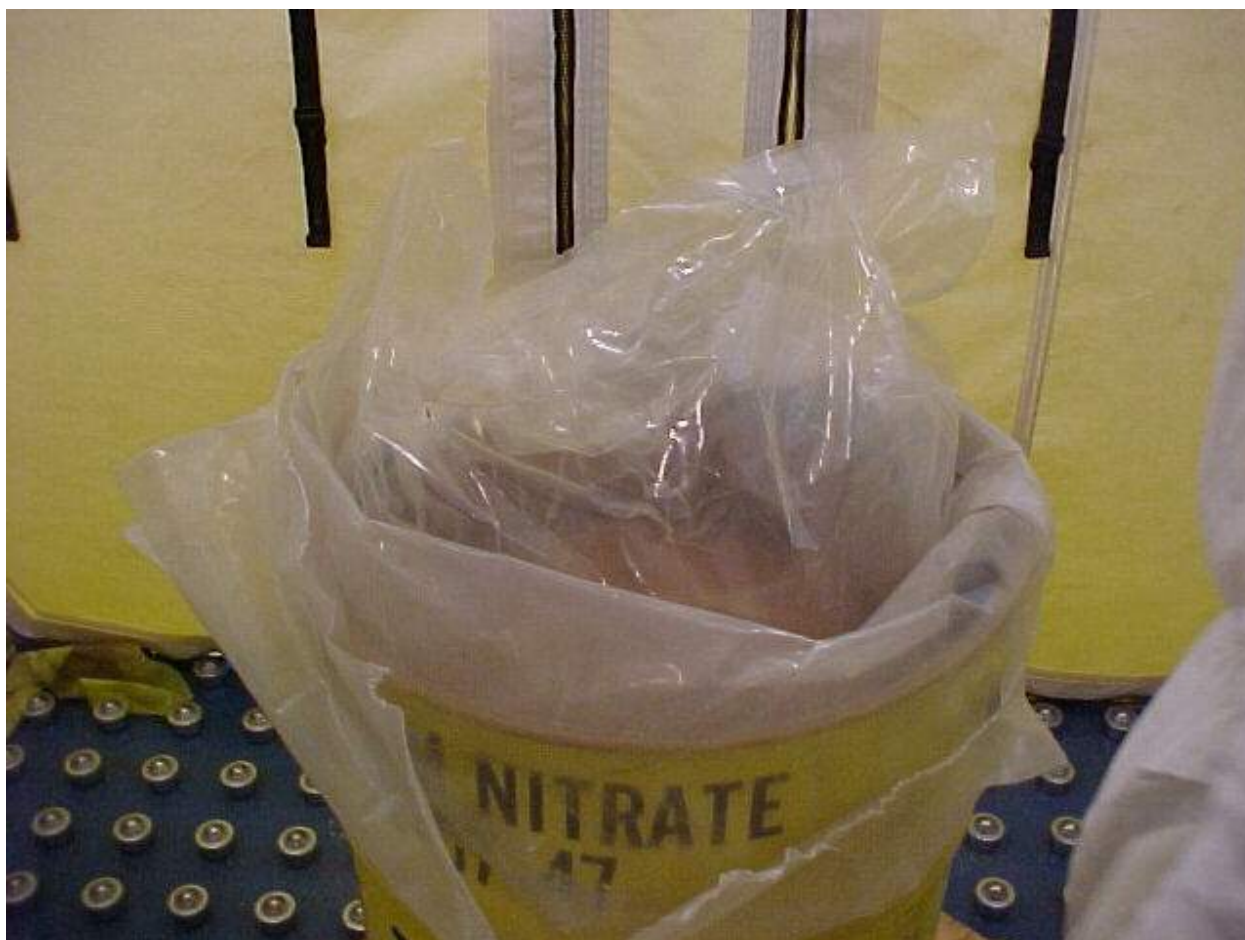
2nd poly liner/bag – good condition
Pressure buildup inside container raises poly liner/bag
No gasses present

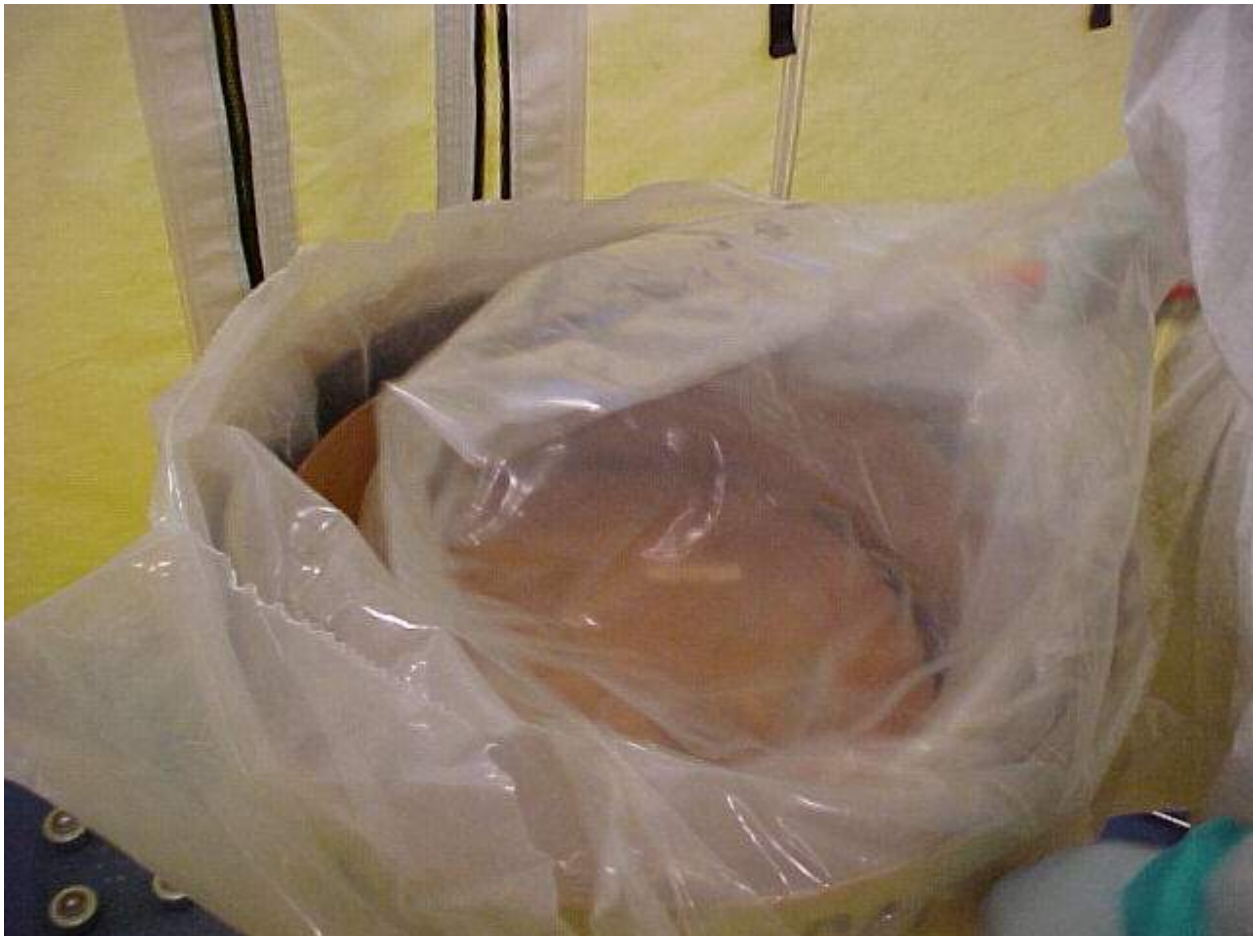
3rd poly liner/bag – good condition
Pressure buildup inside container raises poly liner/bag
Opened Poly liner/bag – No Gasses in breathing zone
Gasses in headspace– LEL – 4.6% - NO - +50.0ppm – NOx – +50.0ppm
Drum vented - All gasses dissipated

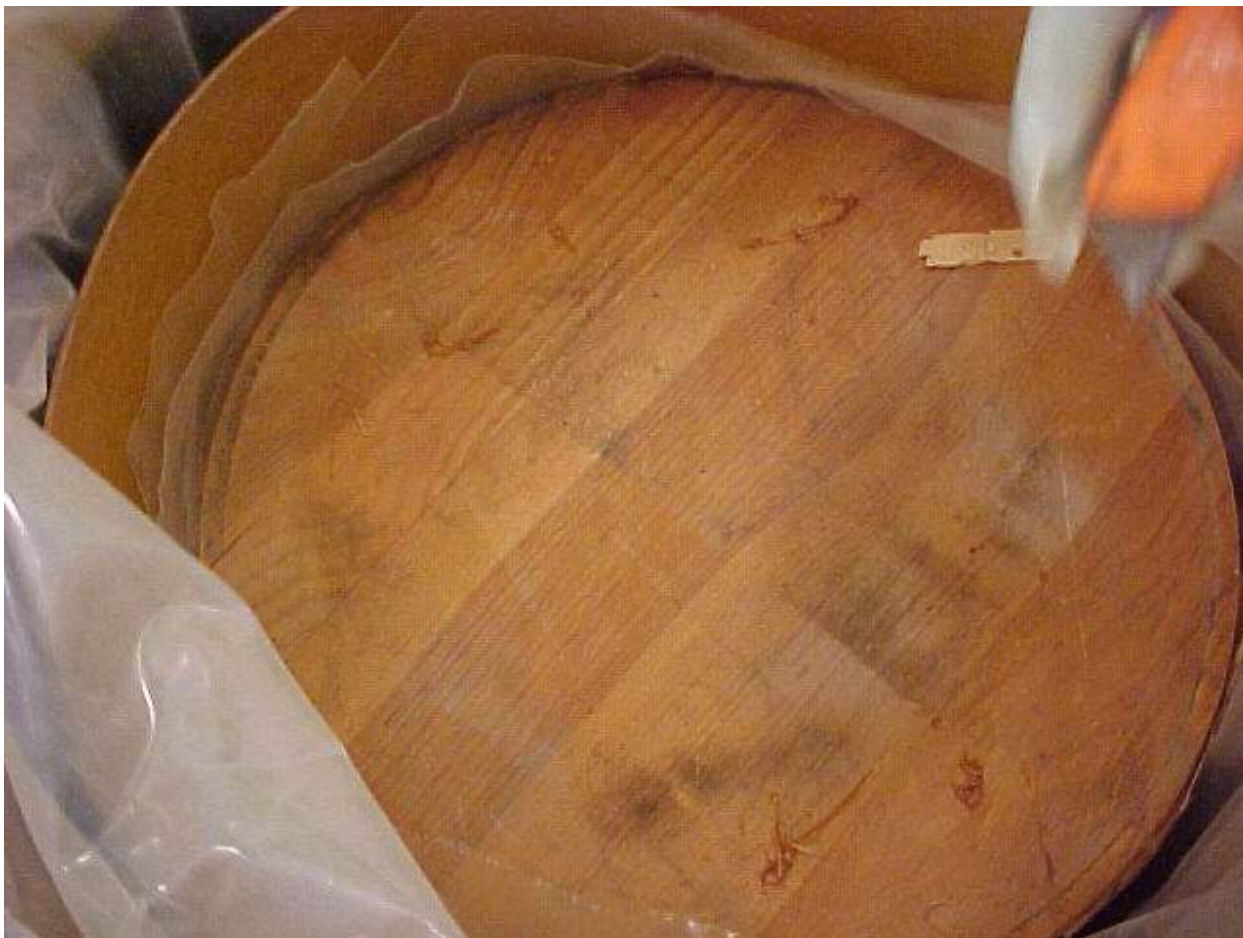
Wooden lid mounted on innermost fiber (overpack) drum – good condition

No gasses present

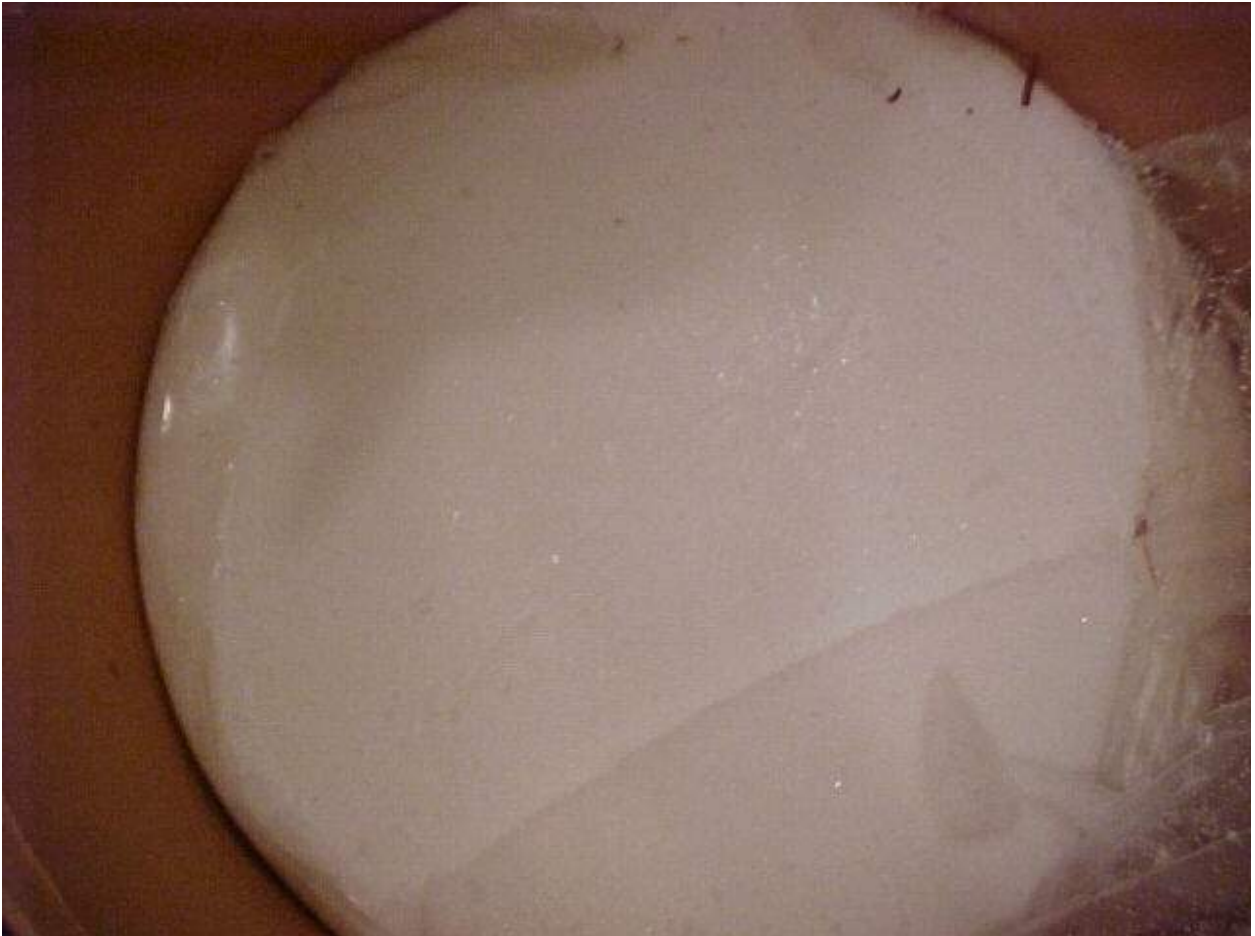
14:45**Other Information**Photo No. 9 of 10Dose Rate Surface 24 mR/hr
 1 meter 2.6 mR/hr

Thorium Nitrate – monolith – white – solid - dry
No gasses present

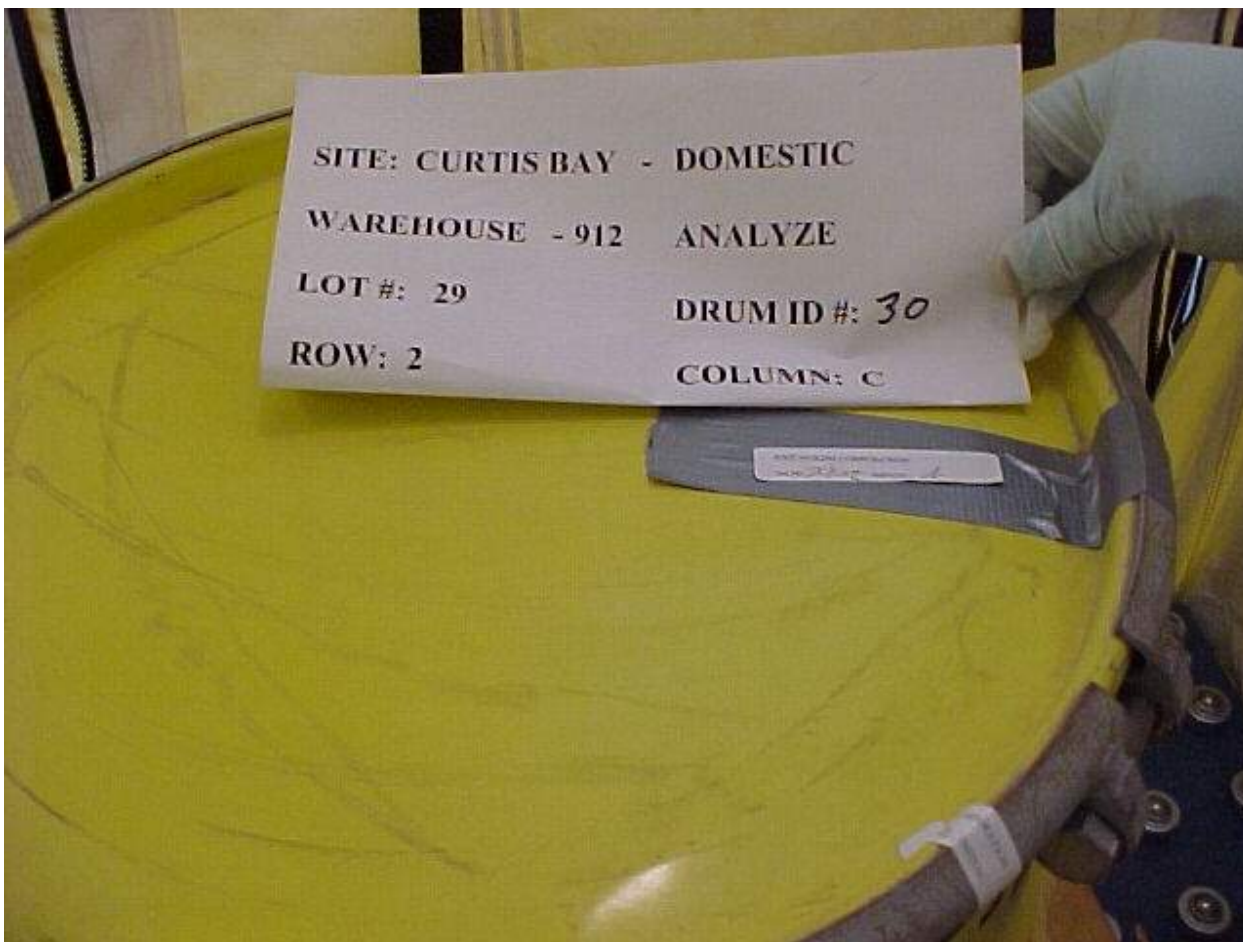
Sealed & dated - Complete

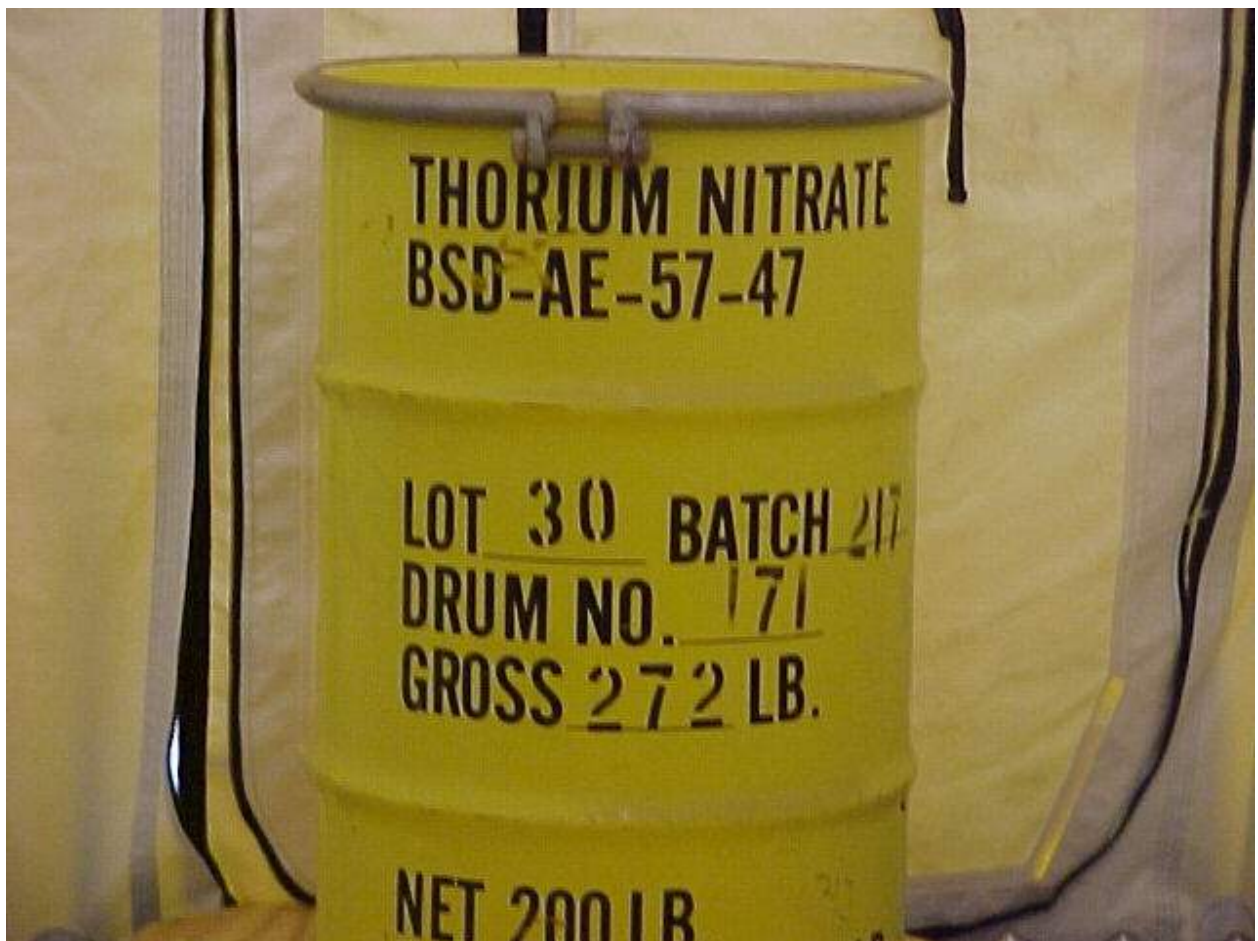
11:40**Other Information**Photo No. 1 of 10Dose Rate Surface 22 mR/hr
 1 meter 3.0 mR/hrContainer 30-gallon steel drumContainer
ConditionGood

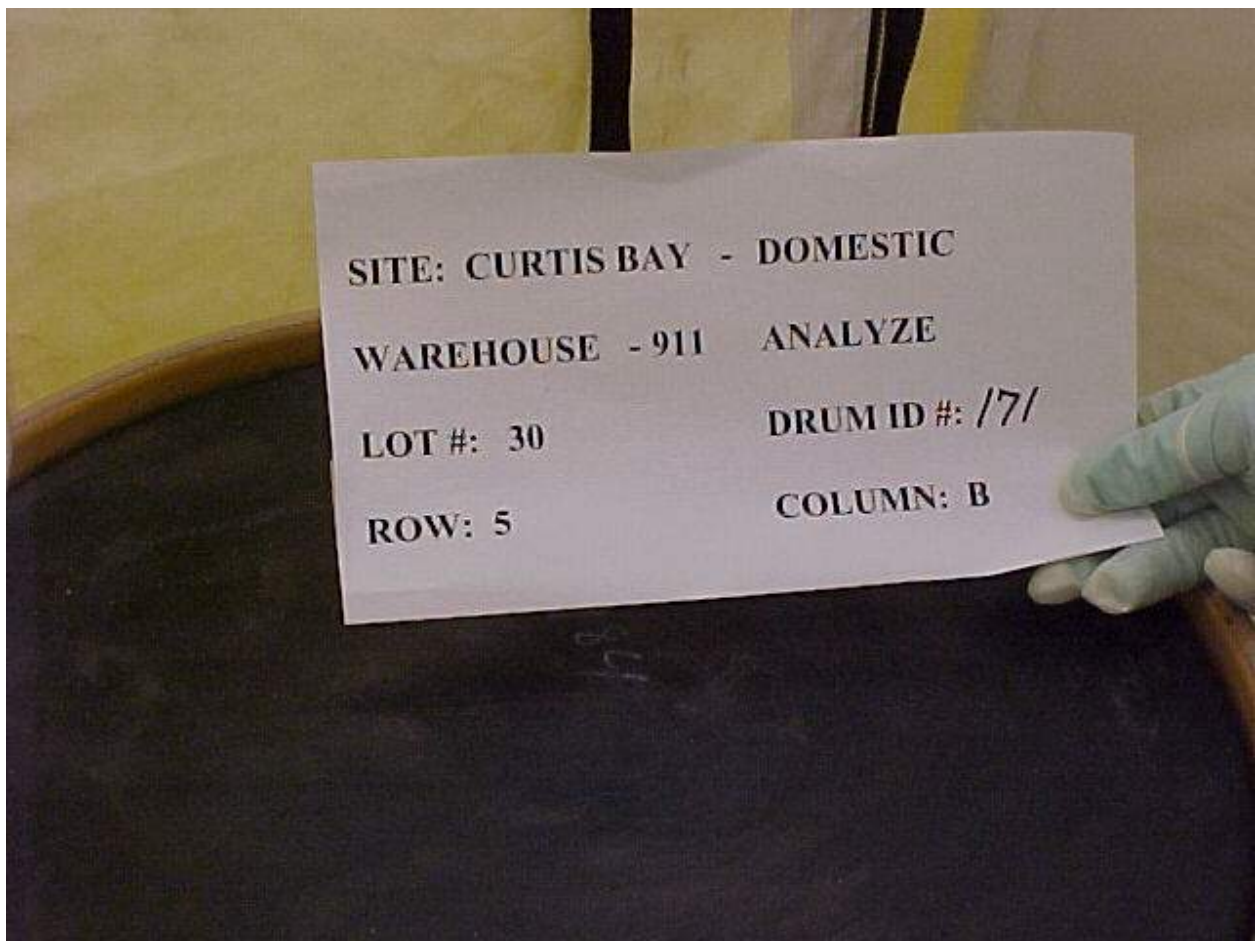
The lid of the black plastic drum liner – since lid is not raised – typically indicates no internal pressure

No gasses present

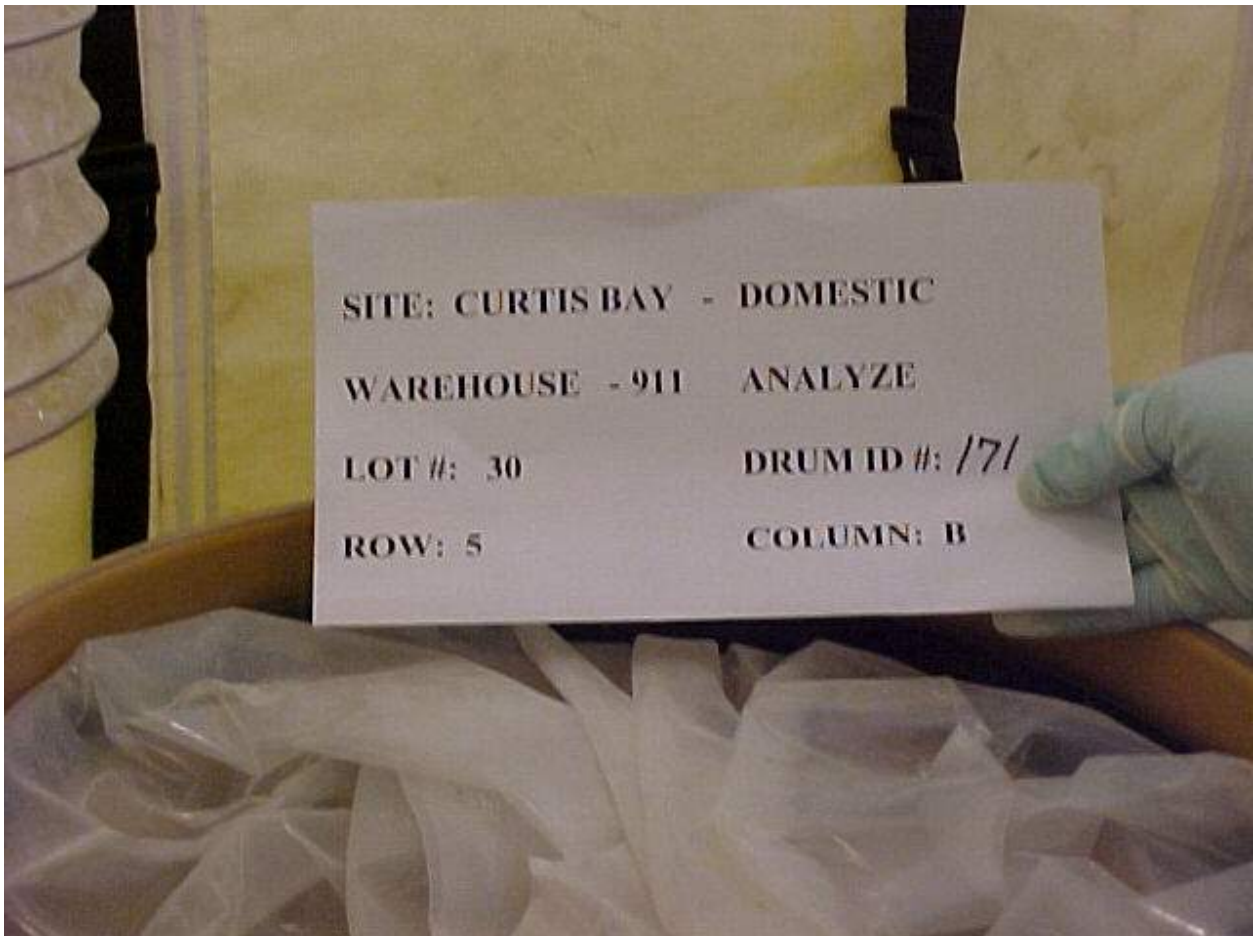
1st poly liner/bag – good condition
No gasses present

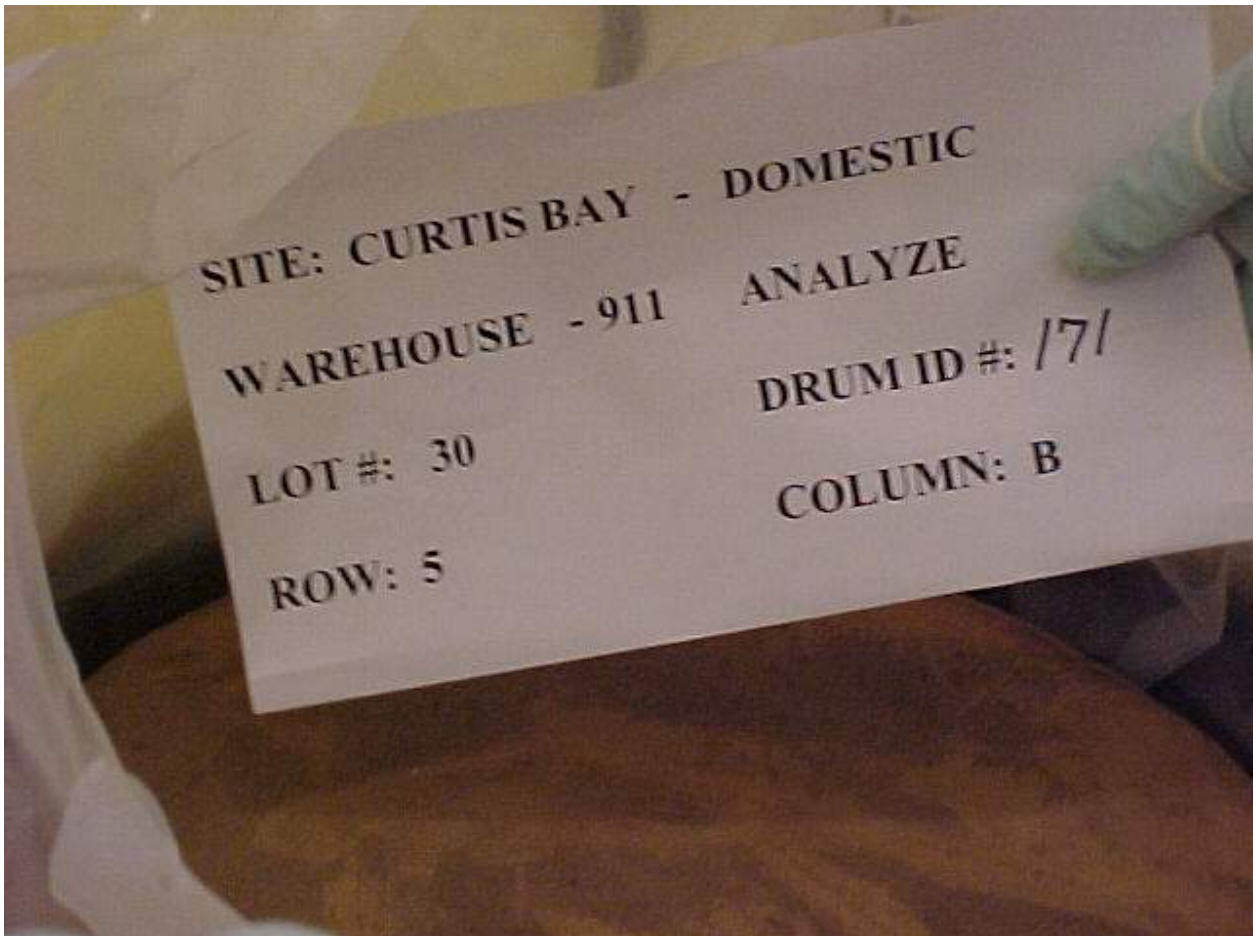
This picture shows the fiber lid on the outermost fiber drum inside of the 30-gal drum
No gasses present

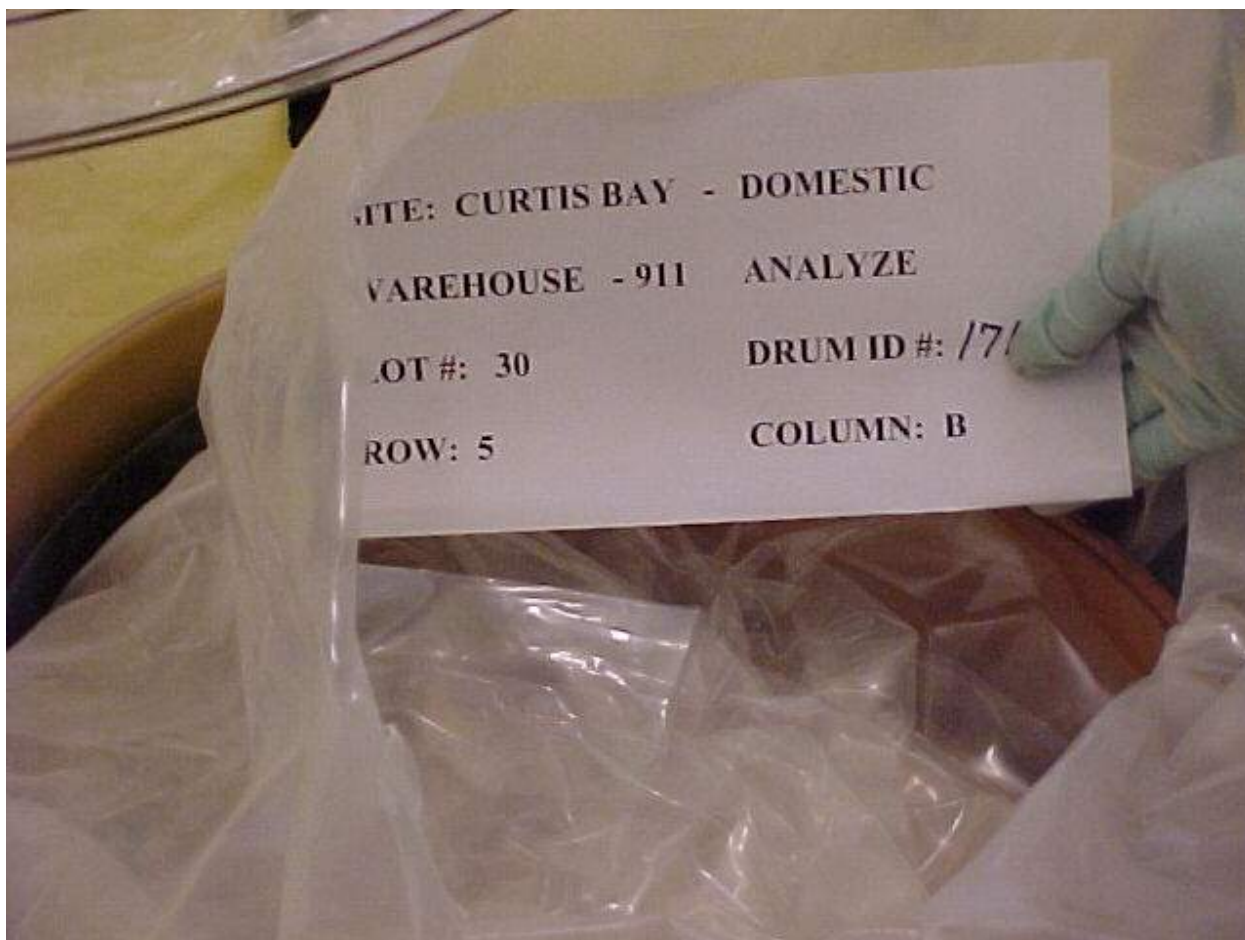
After opening the 2nd poly liner/bag – a picture is taken showing the 3rd poly liner/bag
No gasses present

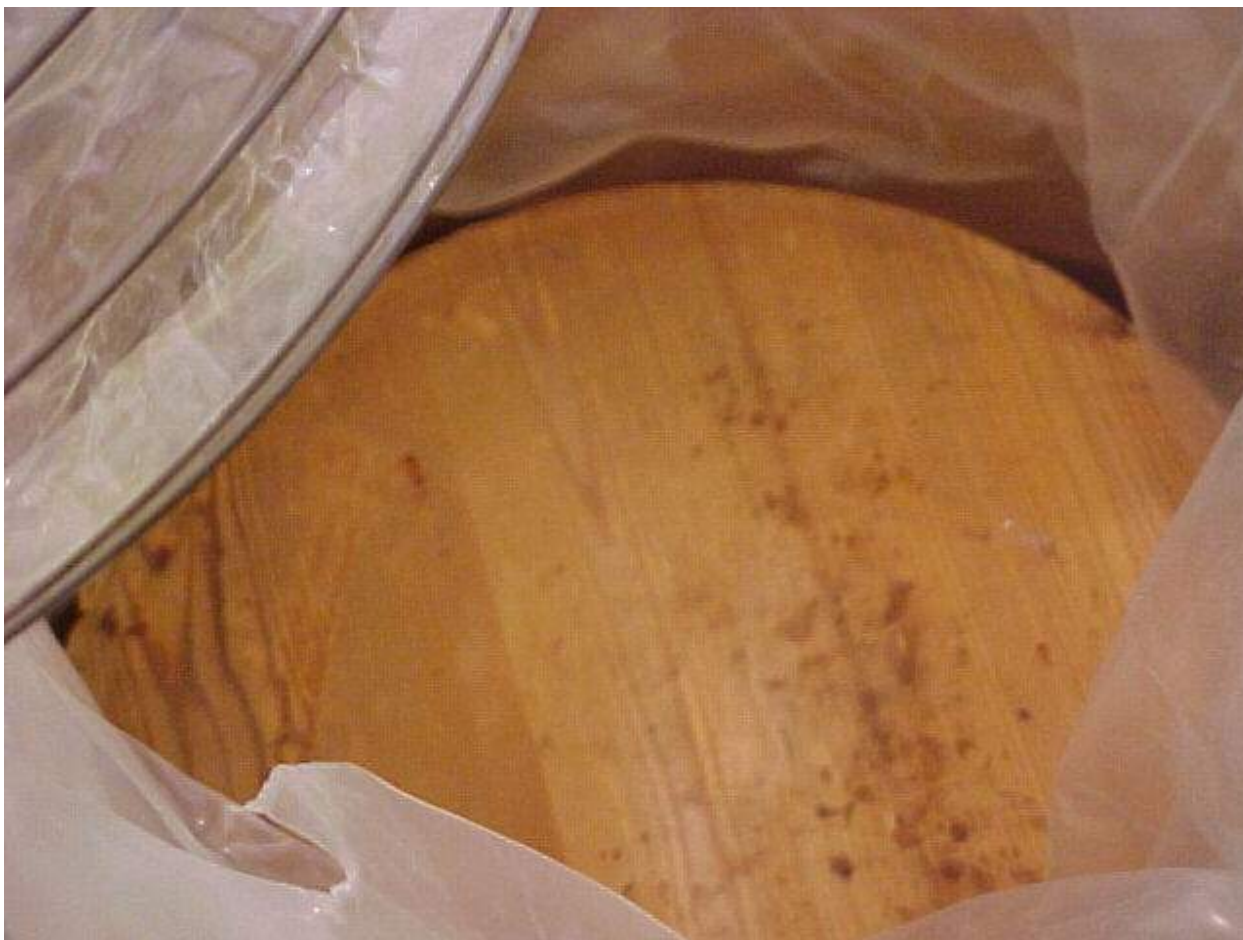
A picture of the wooden lid on in the inner most fiber (overpack) drum – good condition
No gasses present
