THORIUM NITRATE STOCKPILE DRUM CHARACTERIZATION REPORT

**THORIUM NITRATE STOCKPILE
DRUM CHARACTERIZATION REPORT**

Prepared for
U.S. Defense Logistics Agency
Defense National Stockpile Center
Fort Belvoir, Virginia

Prepared by
OAK RIDGE NATIONAL LABORATORY
Oak Ridge, Tennessee 37831
managed by
UT-BATTELLE, LLC
for the
U.S. DEPARTMENT OF ENERGY
under contract DE-AC05-00OR22725

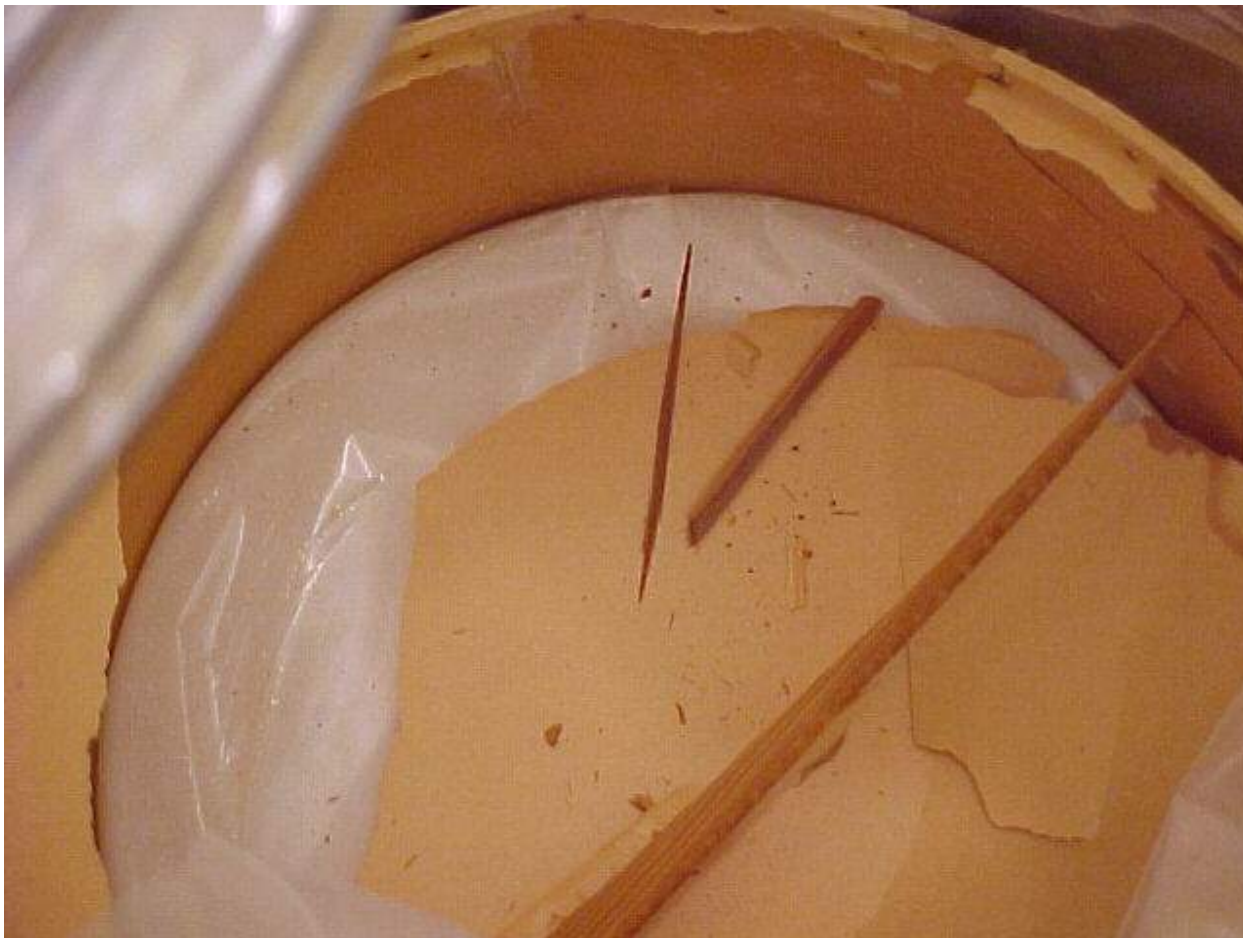
Picture of the labpack “paper thin” lid after removing the wooden lid
No gasses present

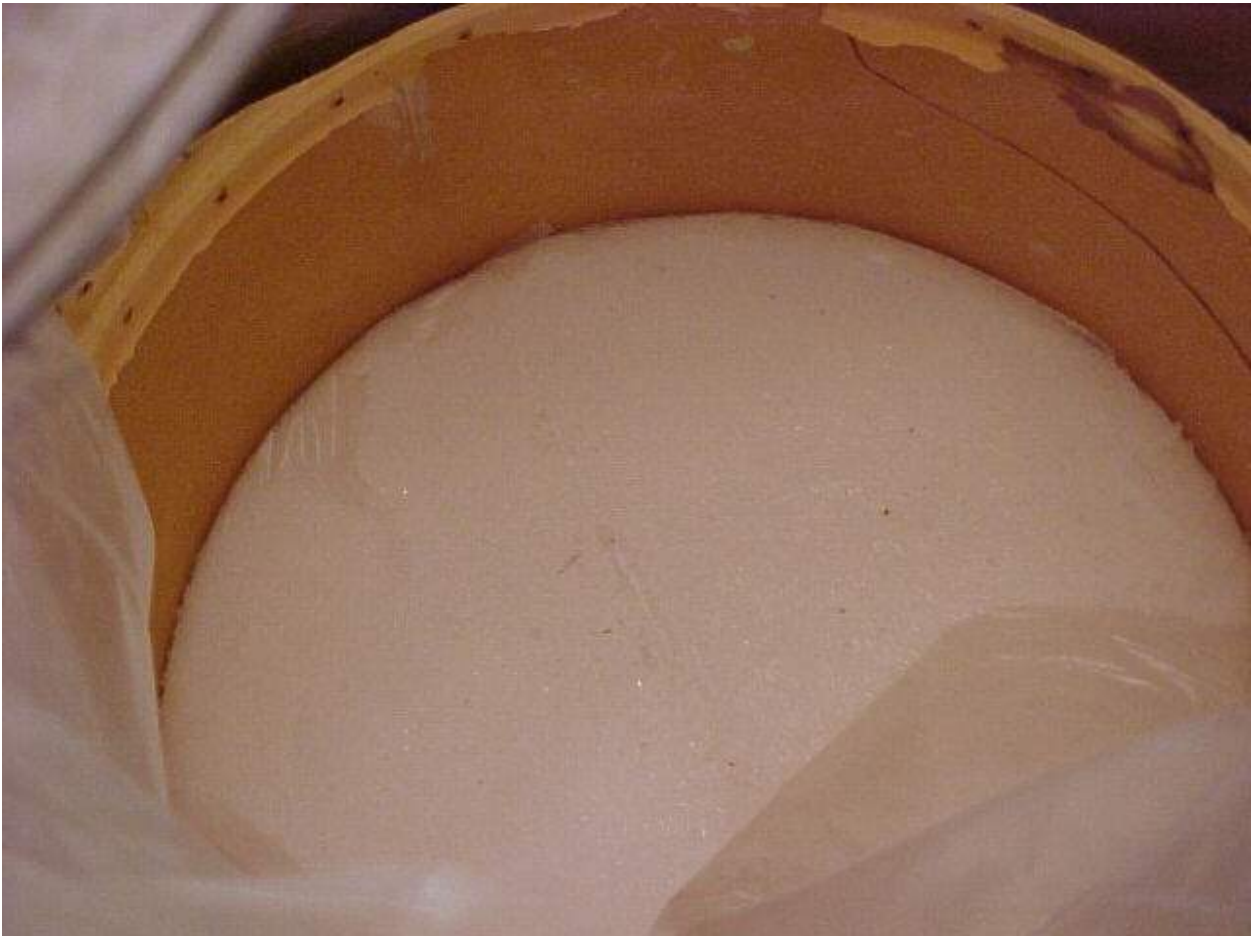
Picture of ThN material – monolith – dry – good condition
No gasses present

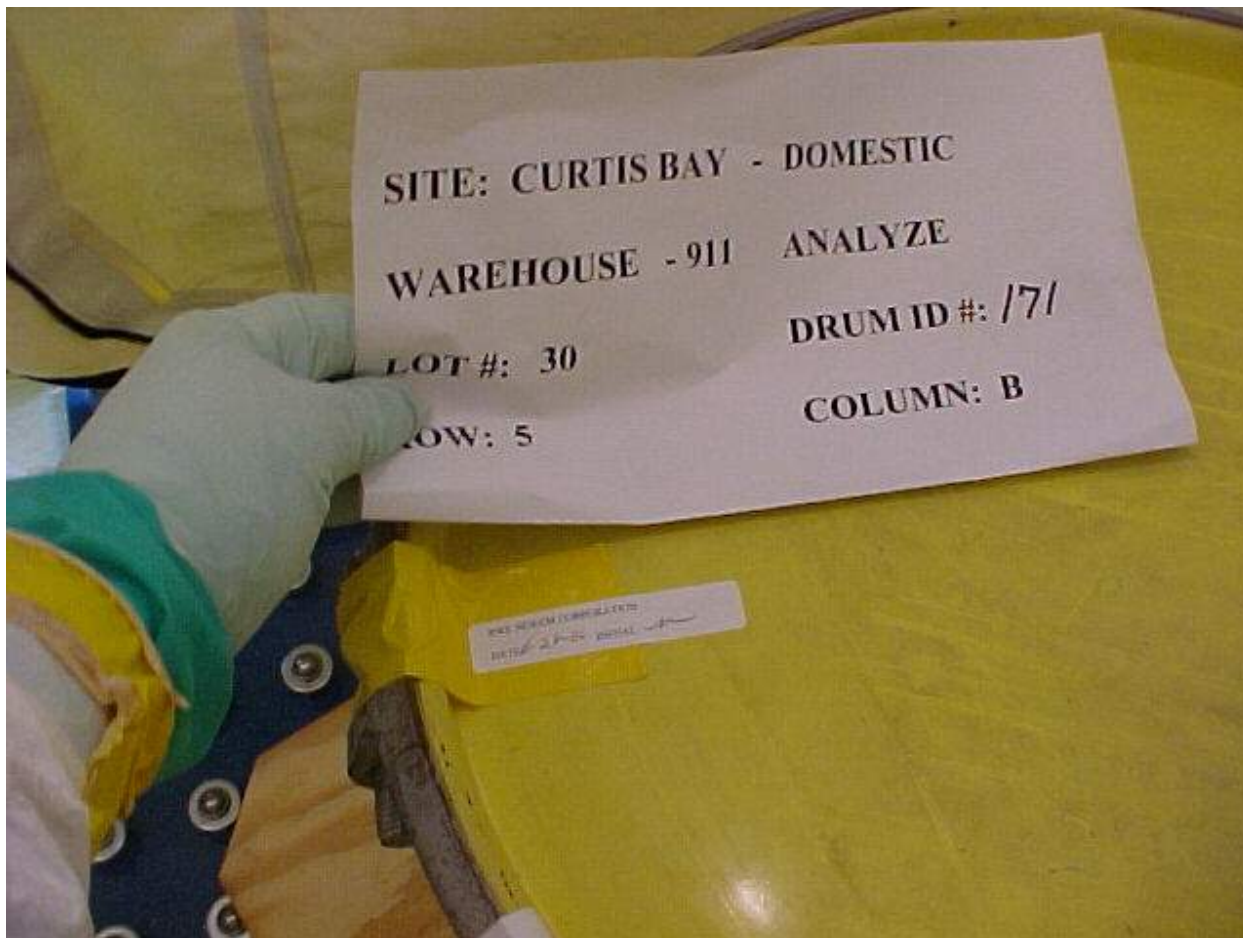
Sealed & dated - Complete

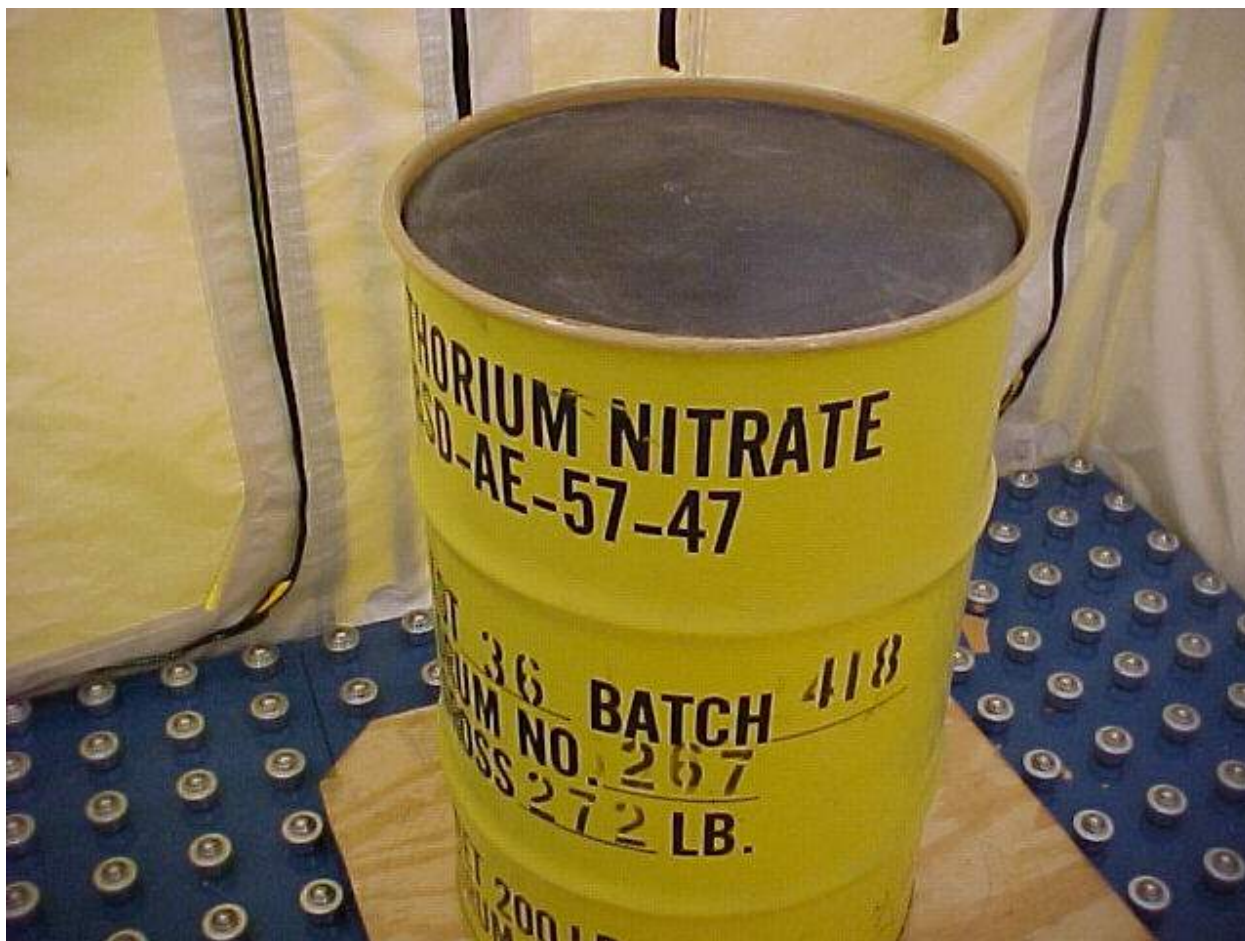
After opening the 30-gal drum, the black plastic lid is shown – good condition
No gasses present

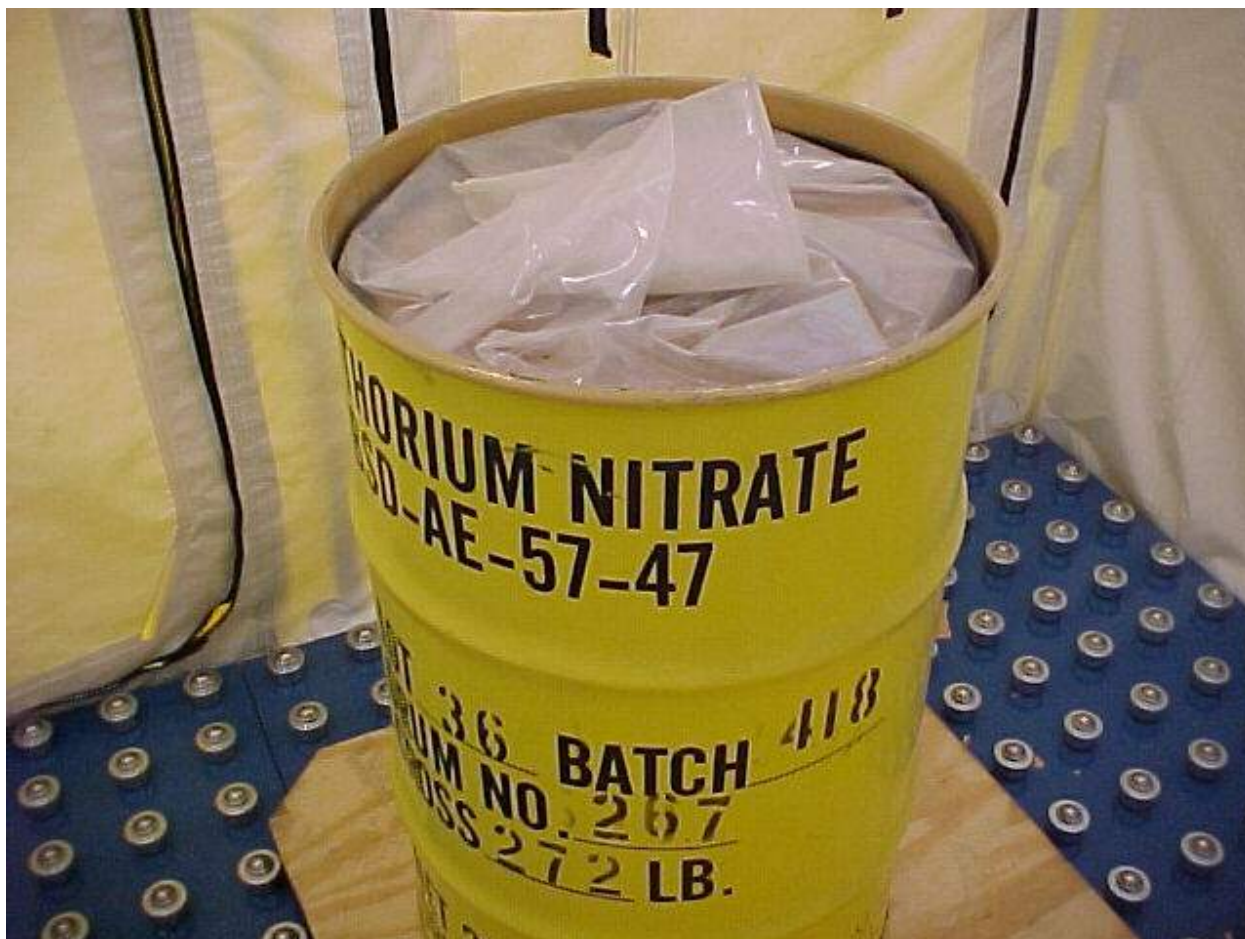
11:40**Other Information**Photo No. 3 of 10Dose Rate Surface 24 mR/hr
 1 meter 3.2 mR/hr1st poly liner/bag – good condition
No gasses present

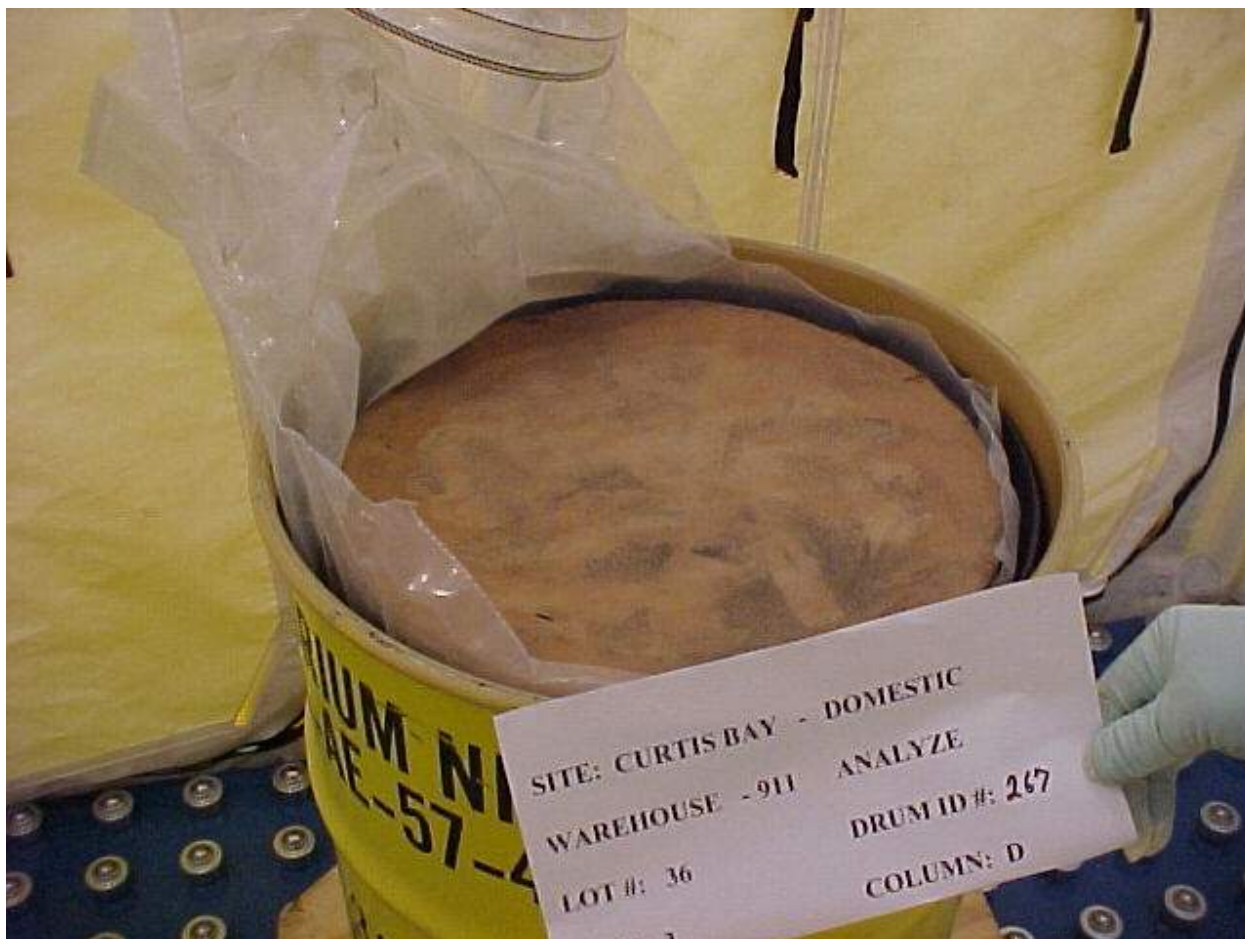
Fiber lid from outermost fiber drum inside of drum – good condition
No gasses present

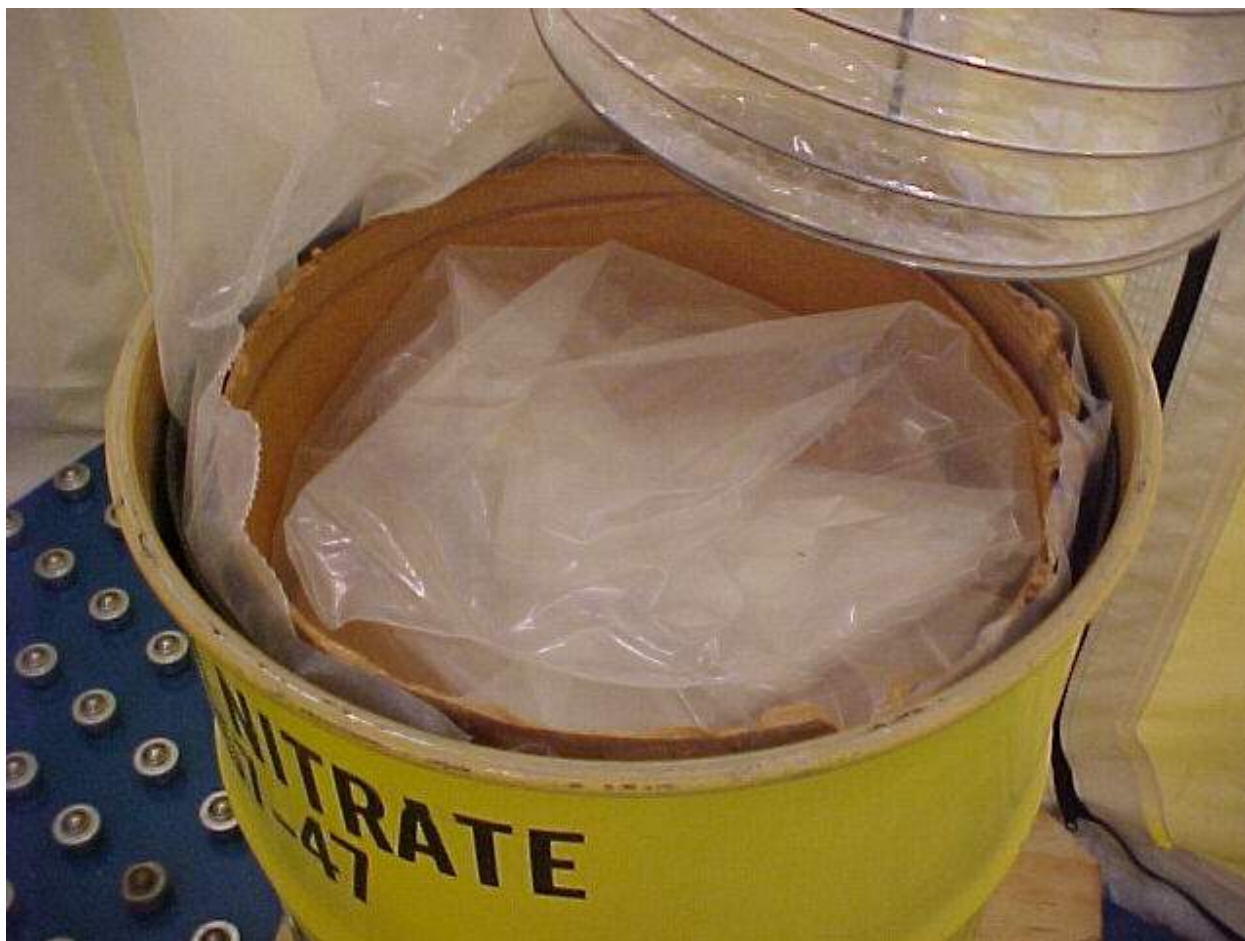
11:40**Other Information**Photo No. 5 of 10Dose Rate Surface 24 mR/hr
 1 meter 3.2 mR/hr2nd poly liner/bag – good condition
No gasses present

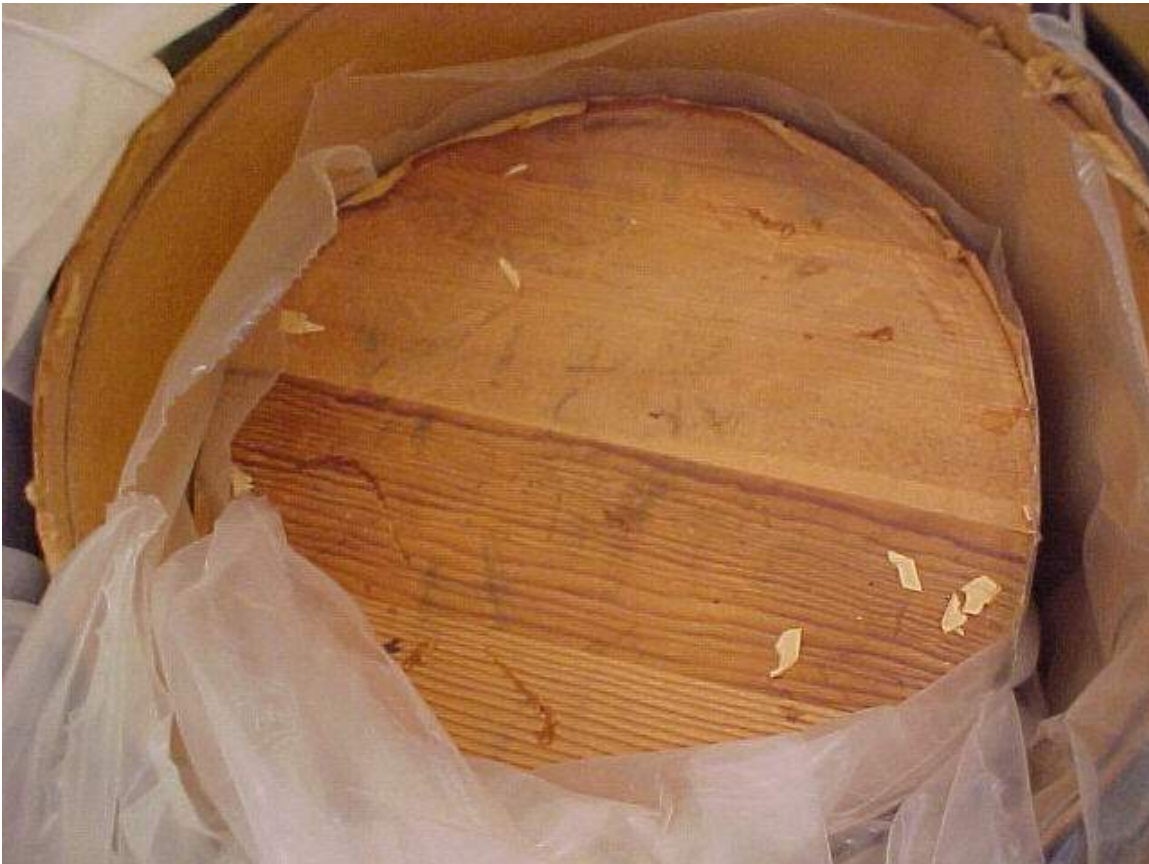
The wooden lid on the innermost fiber (lab-pack) drum – good condition
No gasses present

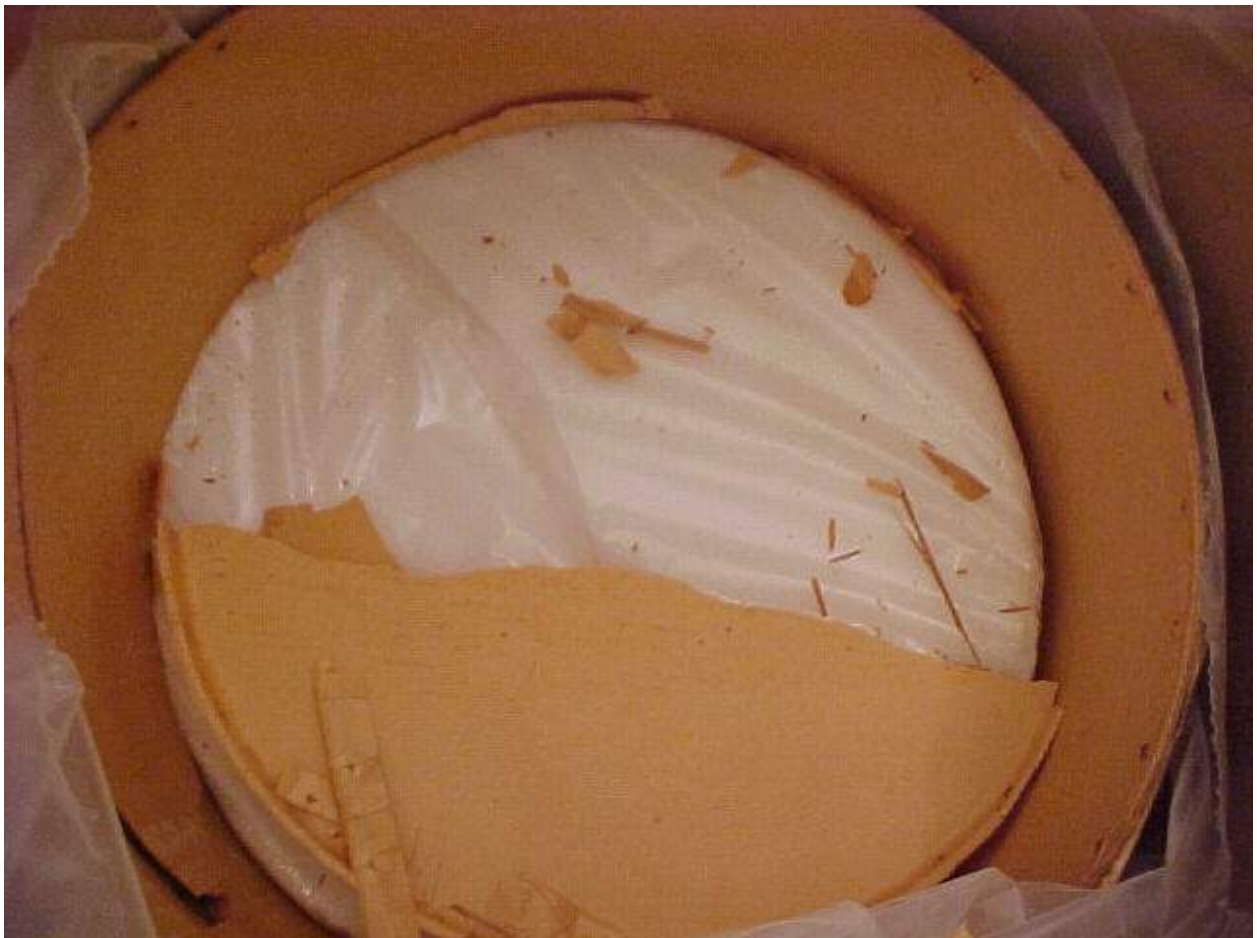
A piece of the lab-pack “paper” lid and the final poly liner protecting the ThN material
No gasses present

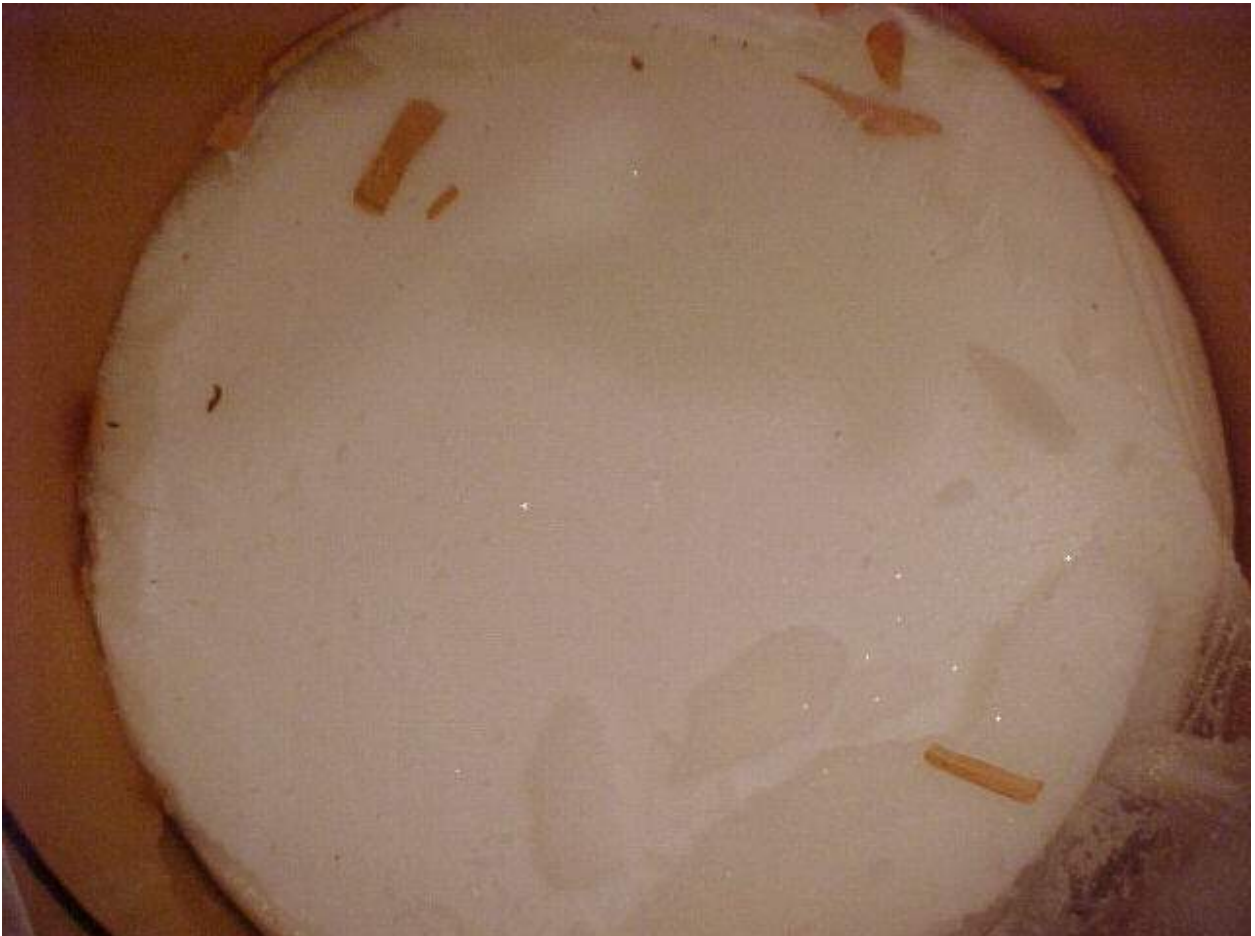
11:40**Other Information**Photo No. 9 of 10Dose Rate Surface 24 mR/hr
 1 meter 3.2 mR/hrThN material – monolith – dry - solid
No gasses present

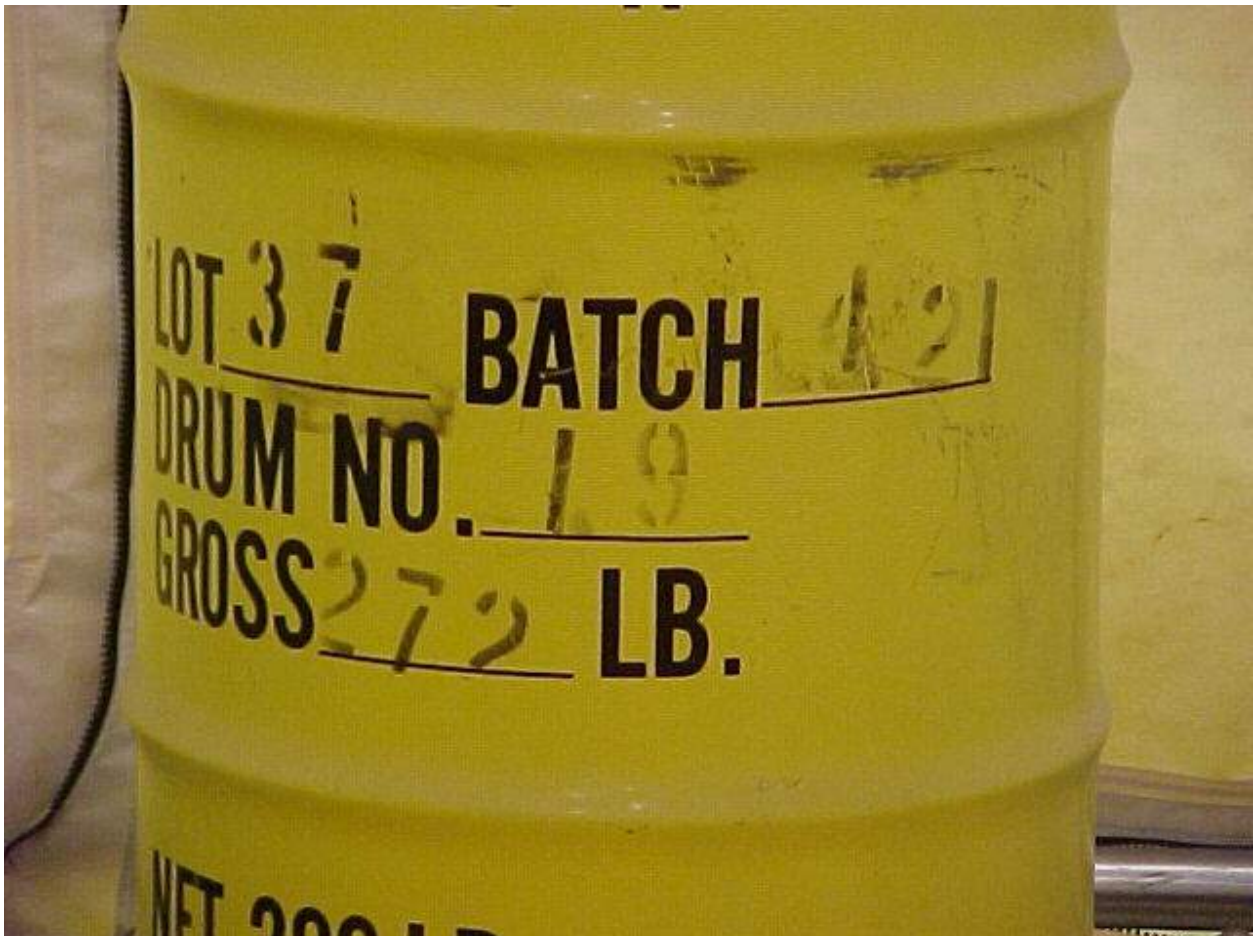
09:30**Other Information**Photo No. 1 of 10Dose Rate Surface 22 mR/hr
 1 meter 2.6 mR/hrContainer 30-gallon steel drumContainer
ConditionHas indentations on lid

Indentations indicate drum is currently pressurized or has relieved through drum gasket seal – drum was not pressurized from tap test and no gas vented while loosening bolt on drum ring; therefore, indentations probably indicate that internal pressure has probably vented through drum gasket seal.

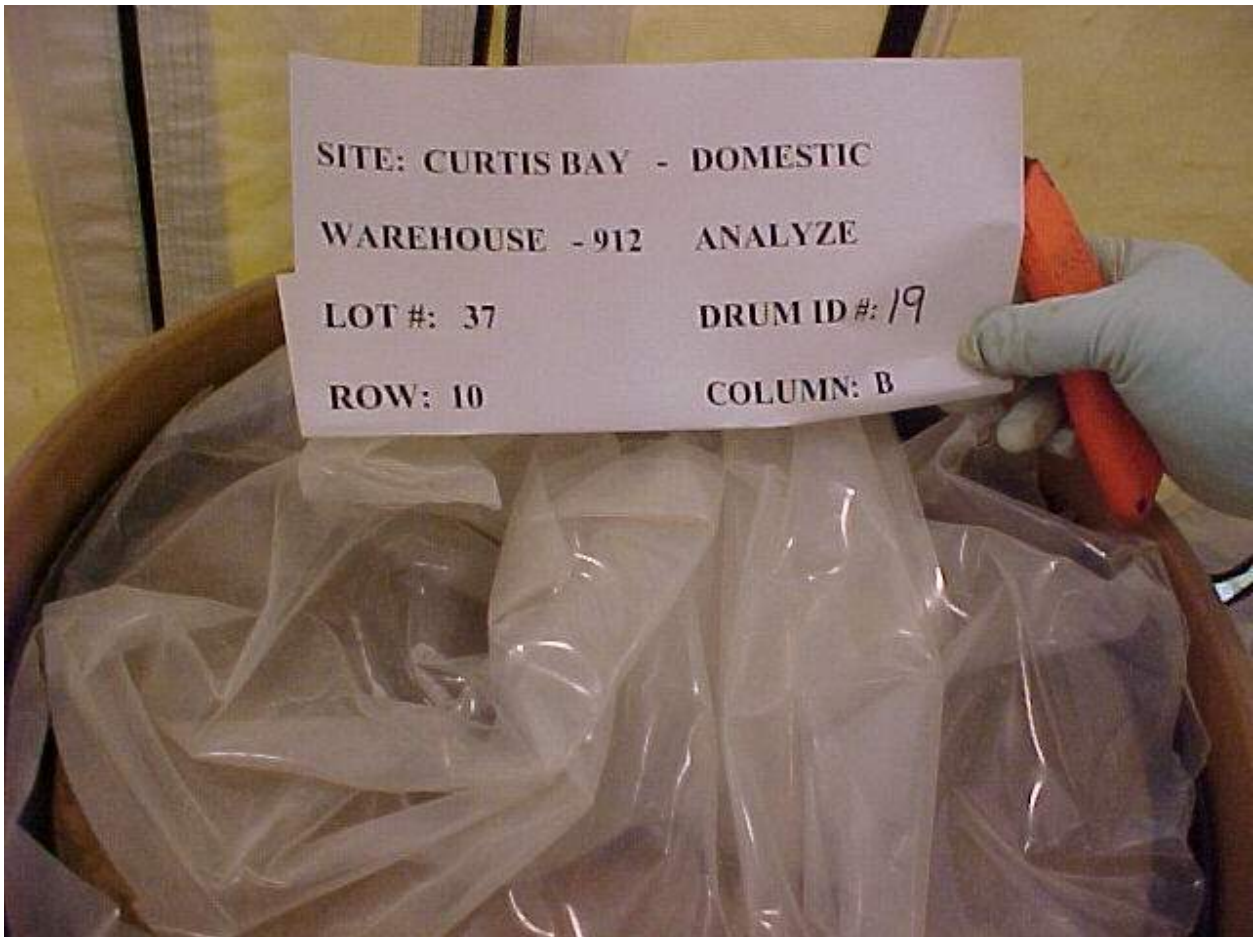
09:30**Other Information**Photo No. 3 of 10Dose Rate Surface 22 mR/hr
 1 meter 2.6 mR/hr1st poly liner/bag – good condition
No gasses present

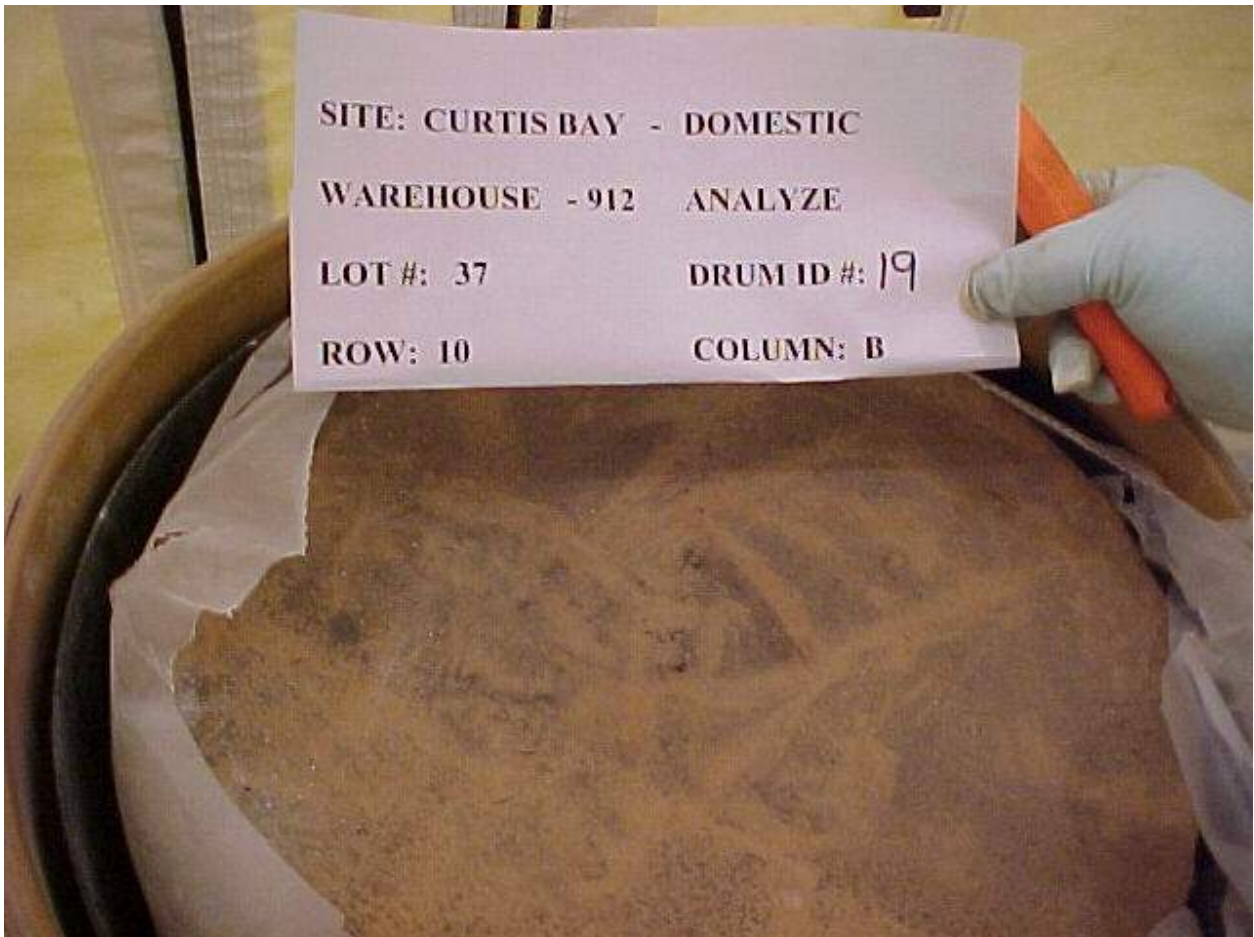
Fiber lid from outermost fiber drum in drum – good condition
No gasses present

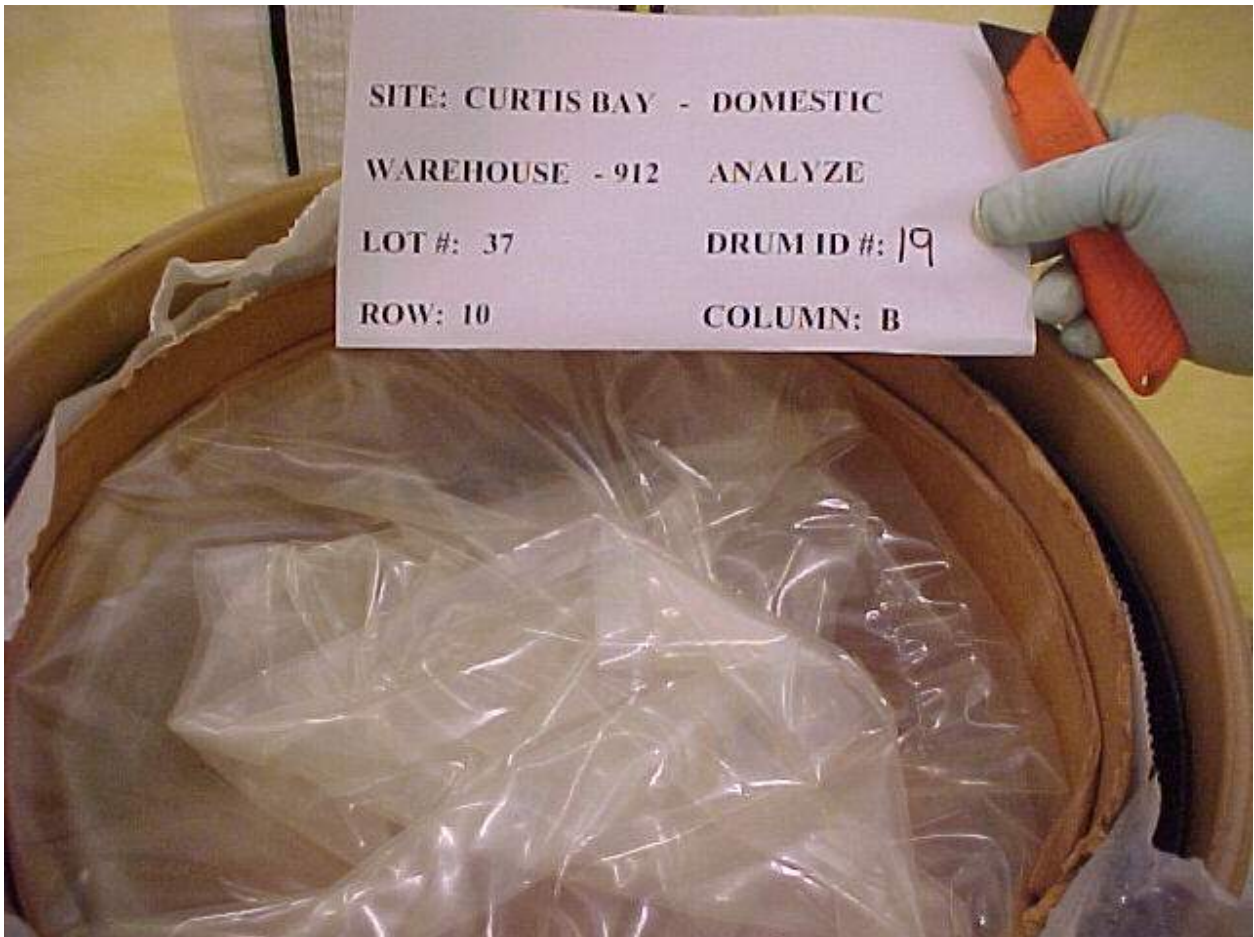
09:30**Other Information**Photo No. 5 of 10Dose Rate Surface 22 mR/hr
 1 meter 2.6 mR/hr2nd poly liner/bag – good condition
No gasses present

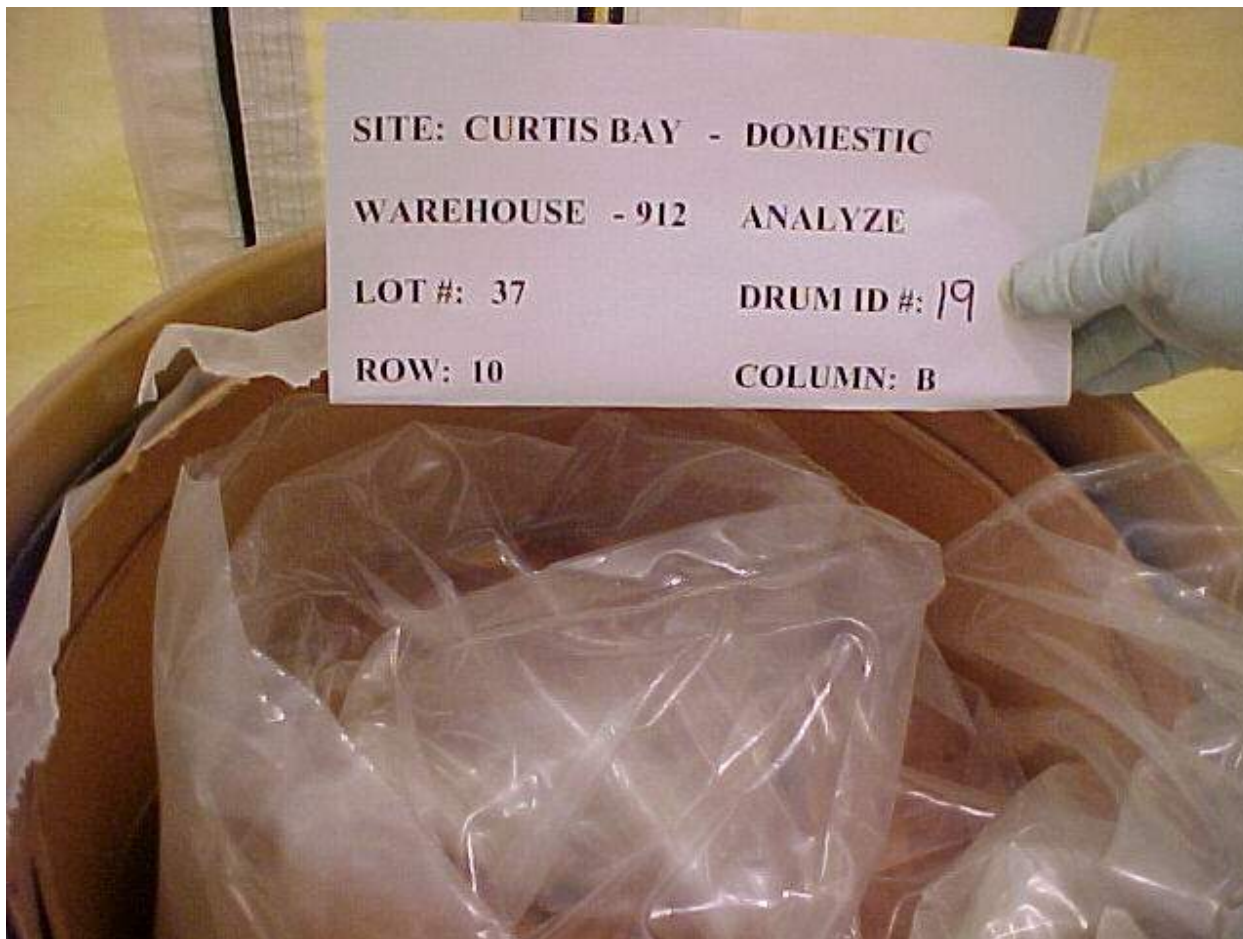
3rd poly liner/bag – good condition
No gasses present

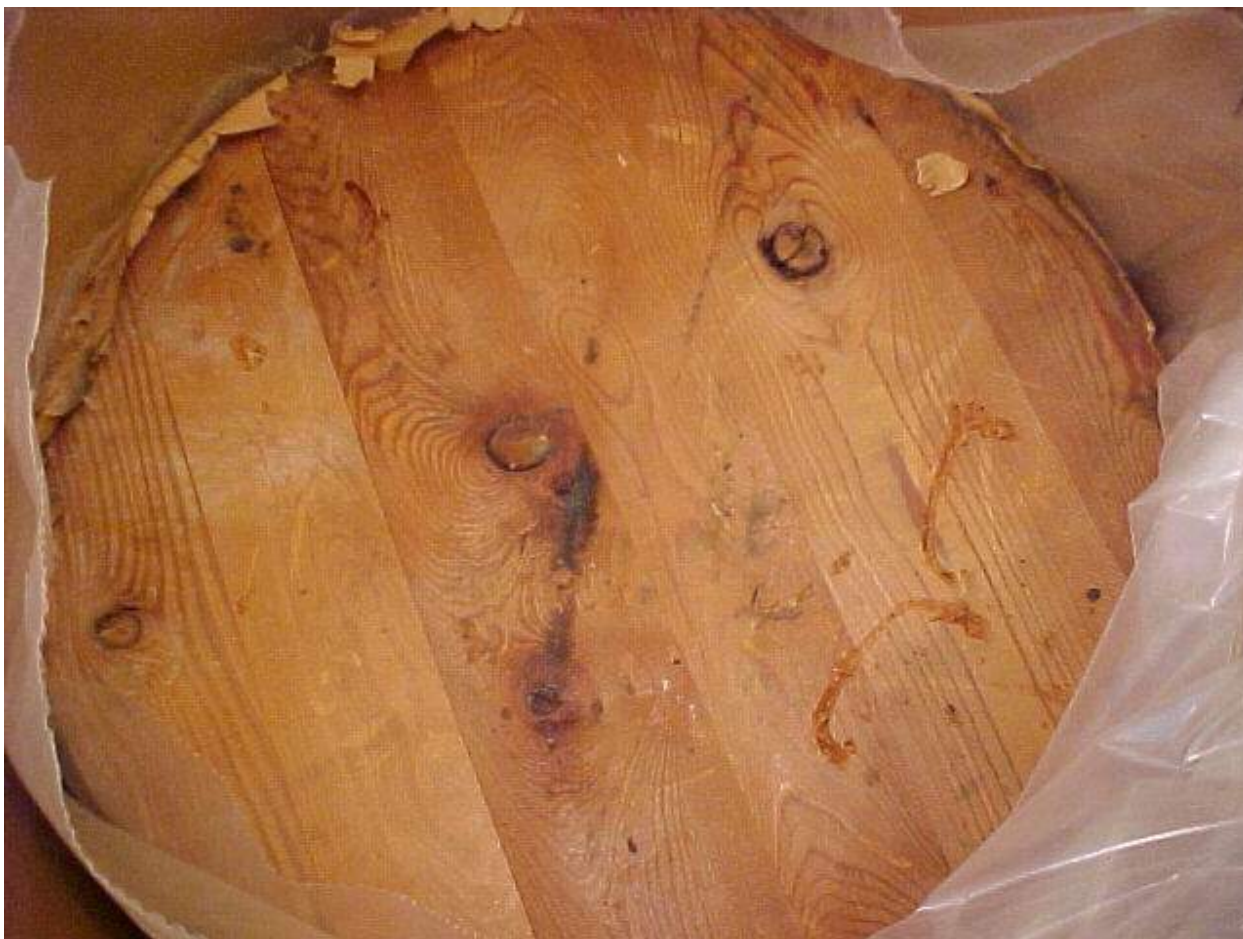
Wooden lid on innermost fiber (lab-pack) drum – good condition
No gasses present

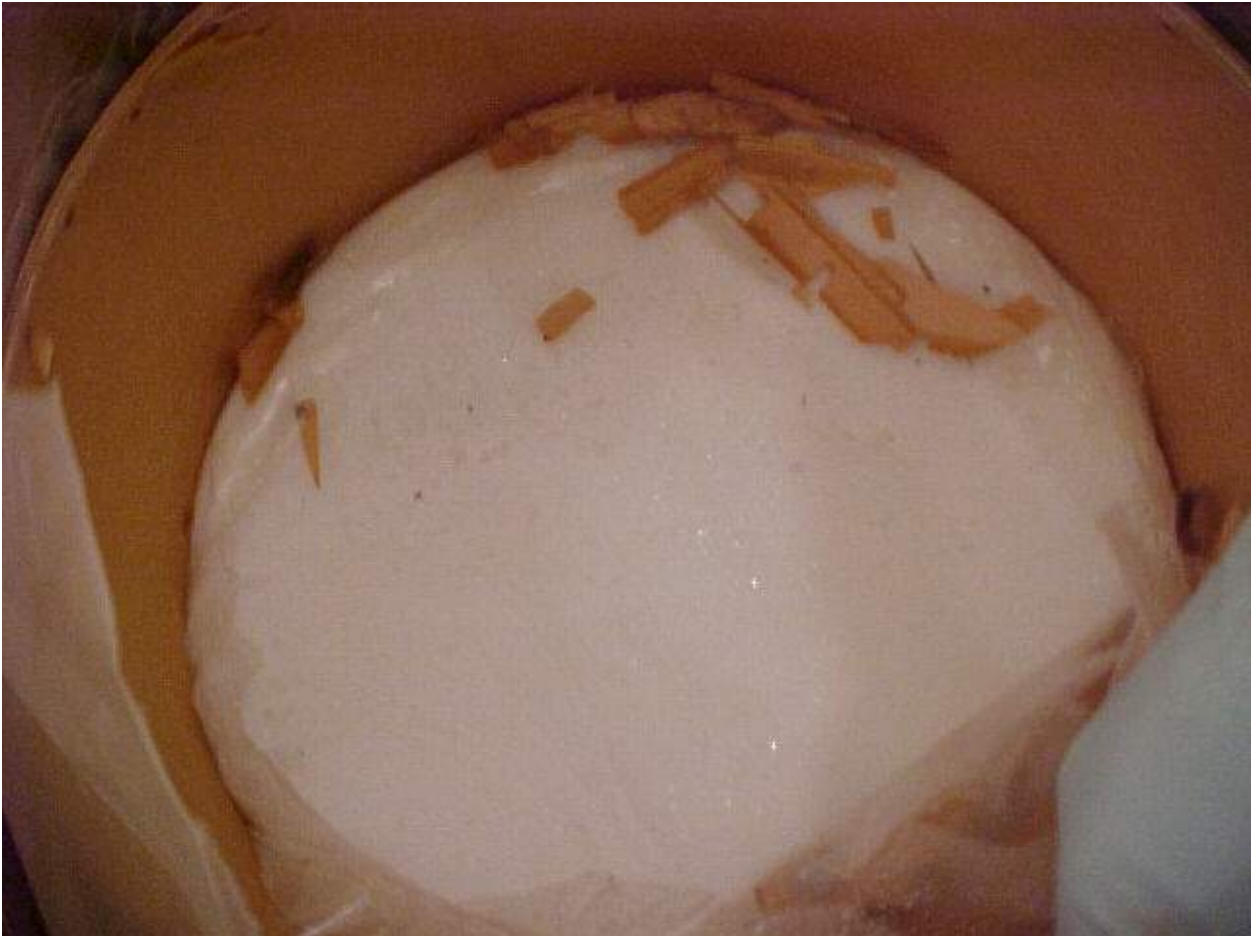
09:30**Other Information**Photo No. 8 of 10Dose Rate Surface 22 mR/hr
 1 meter 2.6 mR/hrThN material – monolith – white – solid - dry
No gasses present

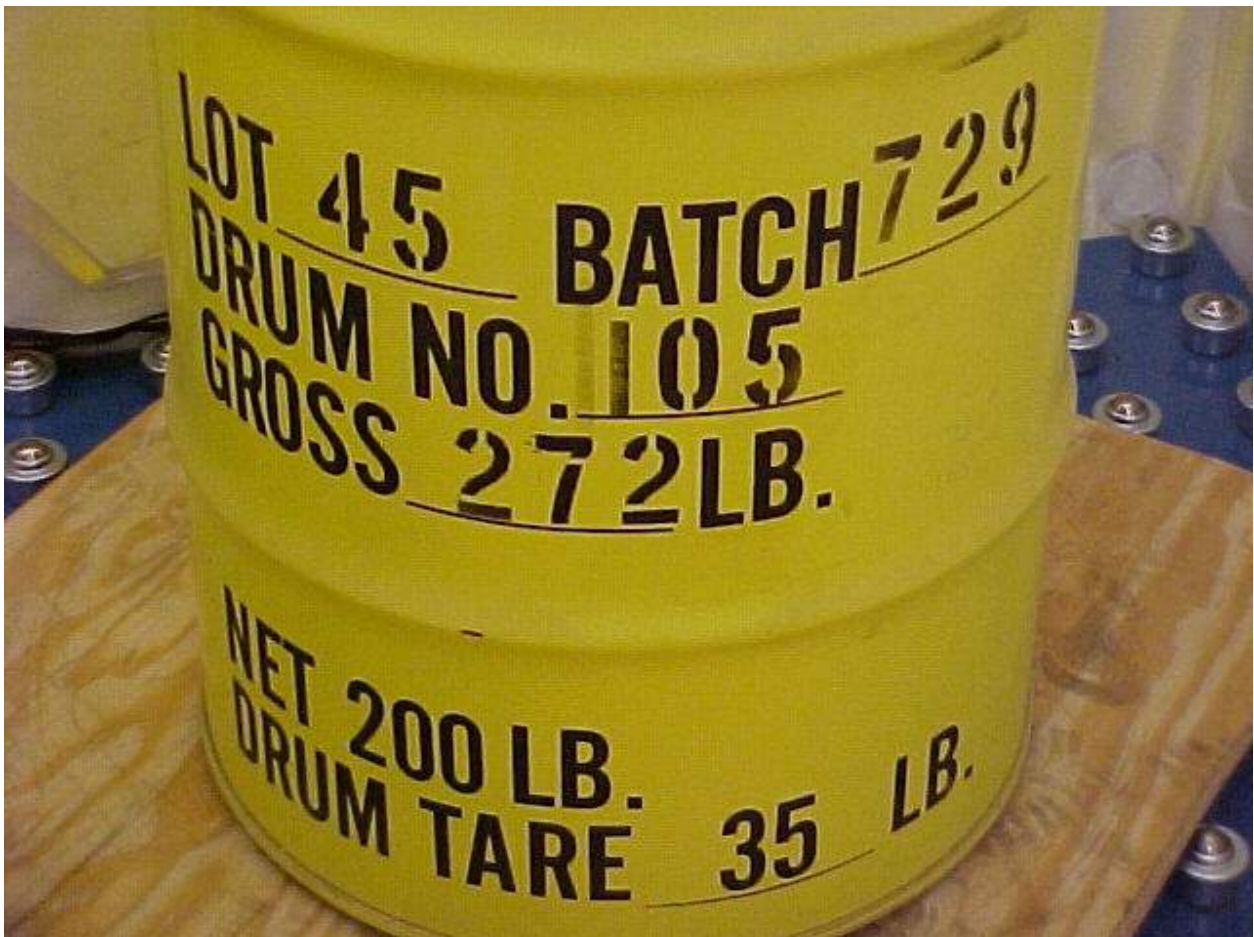
09:30**Other Information**Photo No. 1 of 12Dose Rate Surface 22 mR/hr
 1 meter 2.8 mR/hrContainer 30-gallon steel drumContainer
Conditiongood

Upon loosening bolt on drum ring, gasses slowly dissipated from the drum – continued loosening bolt on bolt ring until drum lid pushed through center of bolt ring.

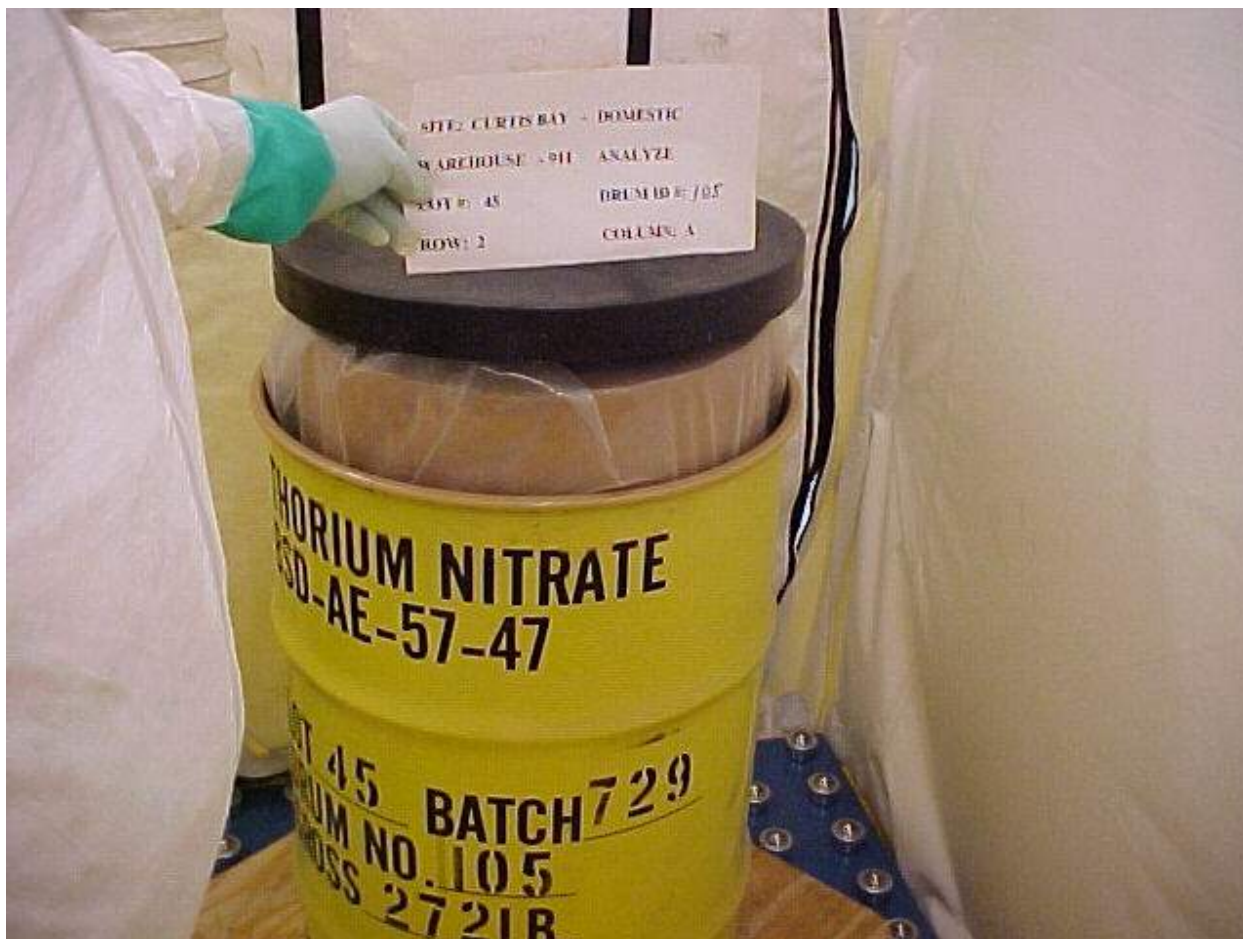
Raised bag indicates internal pressure inside of drum packaging
No gasses present
