THORIUM NITRATE STOCKPILE DRUM CHARACTERIZATION REPORT

**THORIUM NITRATE STOCKPILE
DRUM CHARACTERIZATION REPORT**

Prepared for
U.S. Defense Logistics Agency
Defense National Stockpile Center
Fort Belvoir, Virginia

Prepared by
OAK RIDGE NATIONAL LABORATORY
Oak Ridge, Tennessee 37831
managed by
UT-BATTELLE, LLC
for the
U.S. DEPARTMENT OF ENERGY
under contract DE-AC05-00OR22725

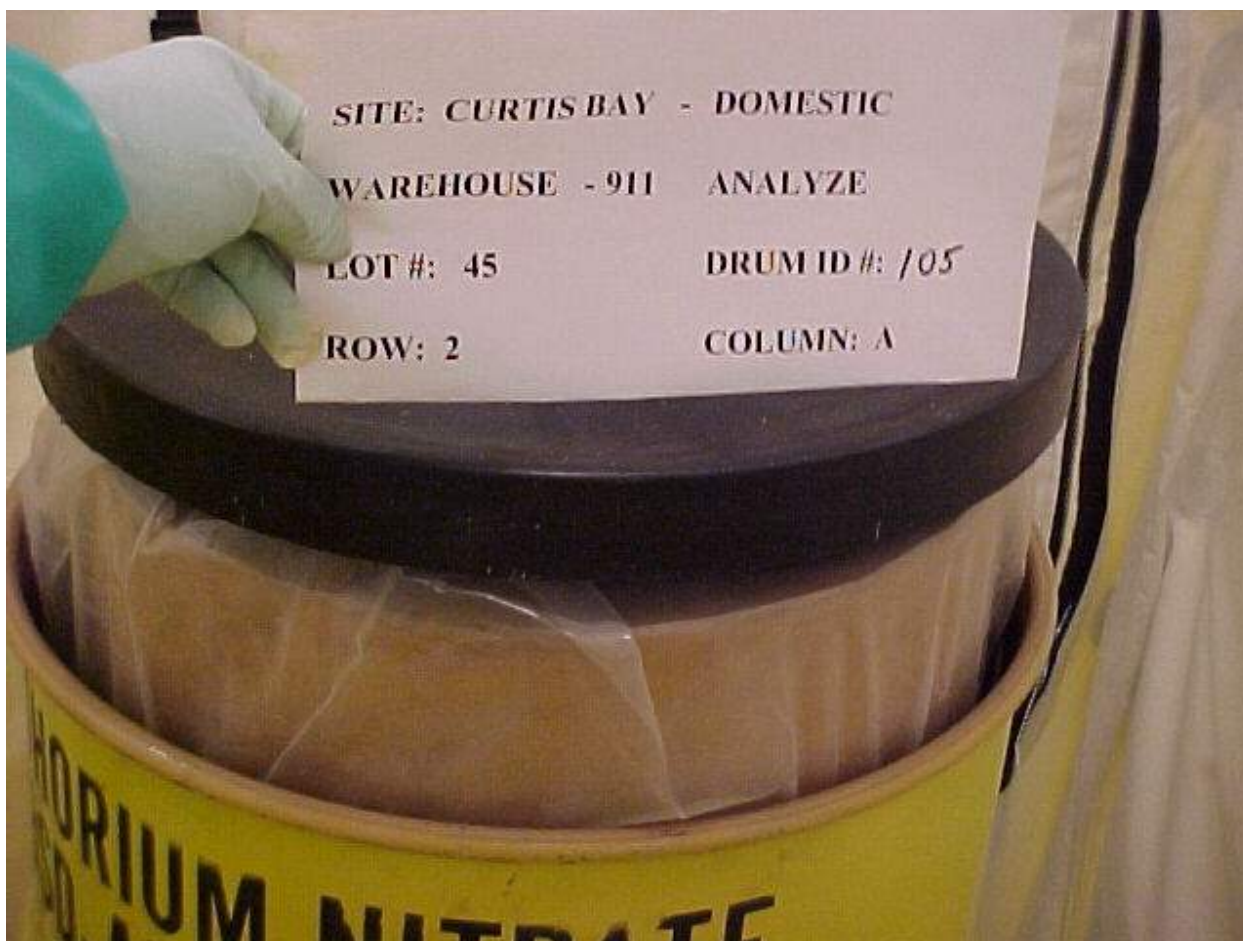
Another view of the internal pressure on this drum
No gasses present

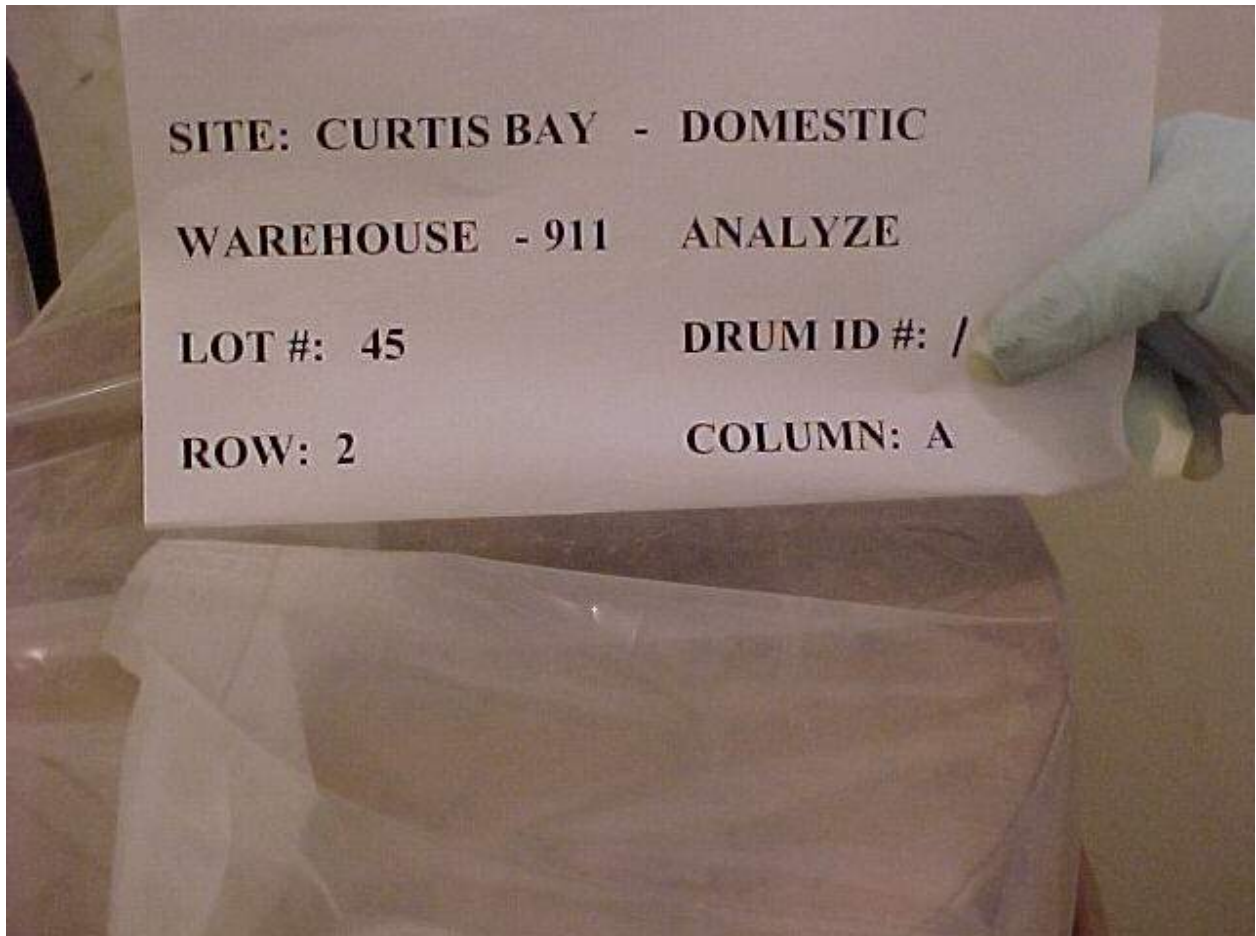
1st poly liner/bag – good condition
No gasses present

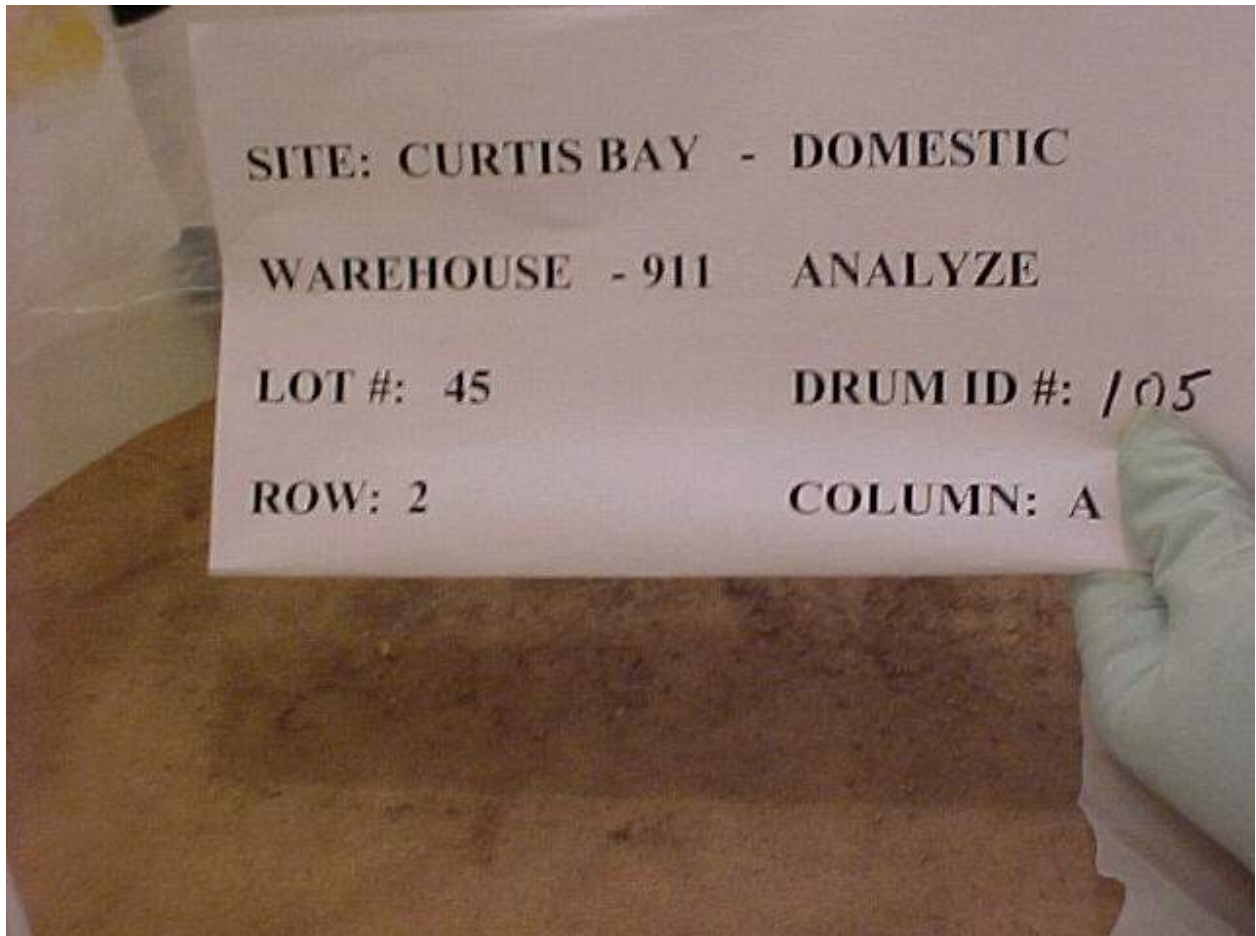
Outermost fiber drum lid (inside of 30-gal drum) – good condition
No gasses present

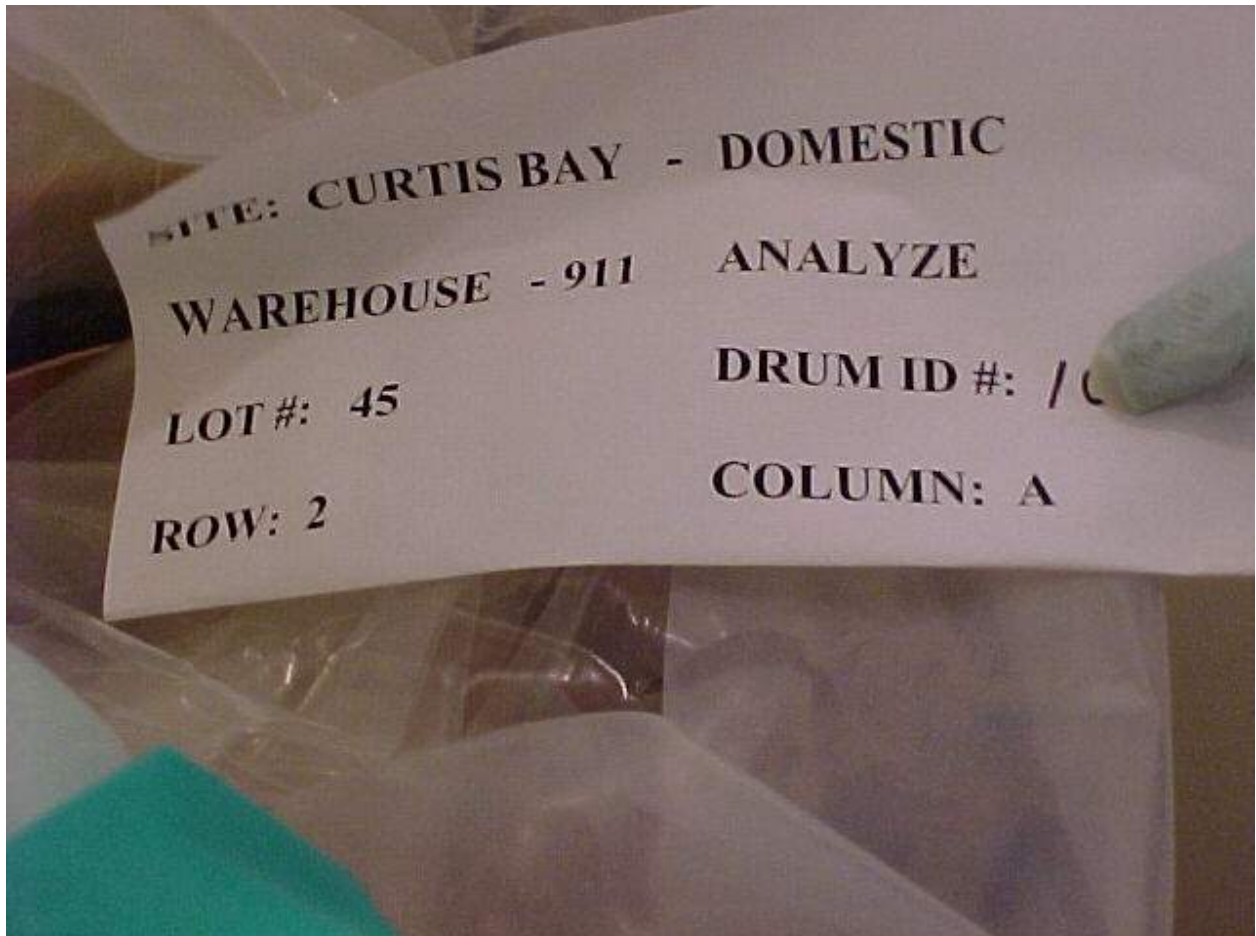
2nd poly liner/bag – good condition
No gasses present exterior to bag

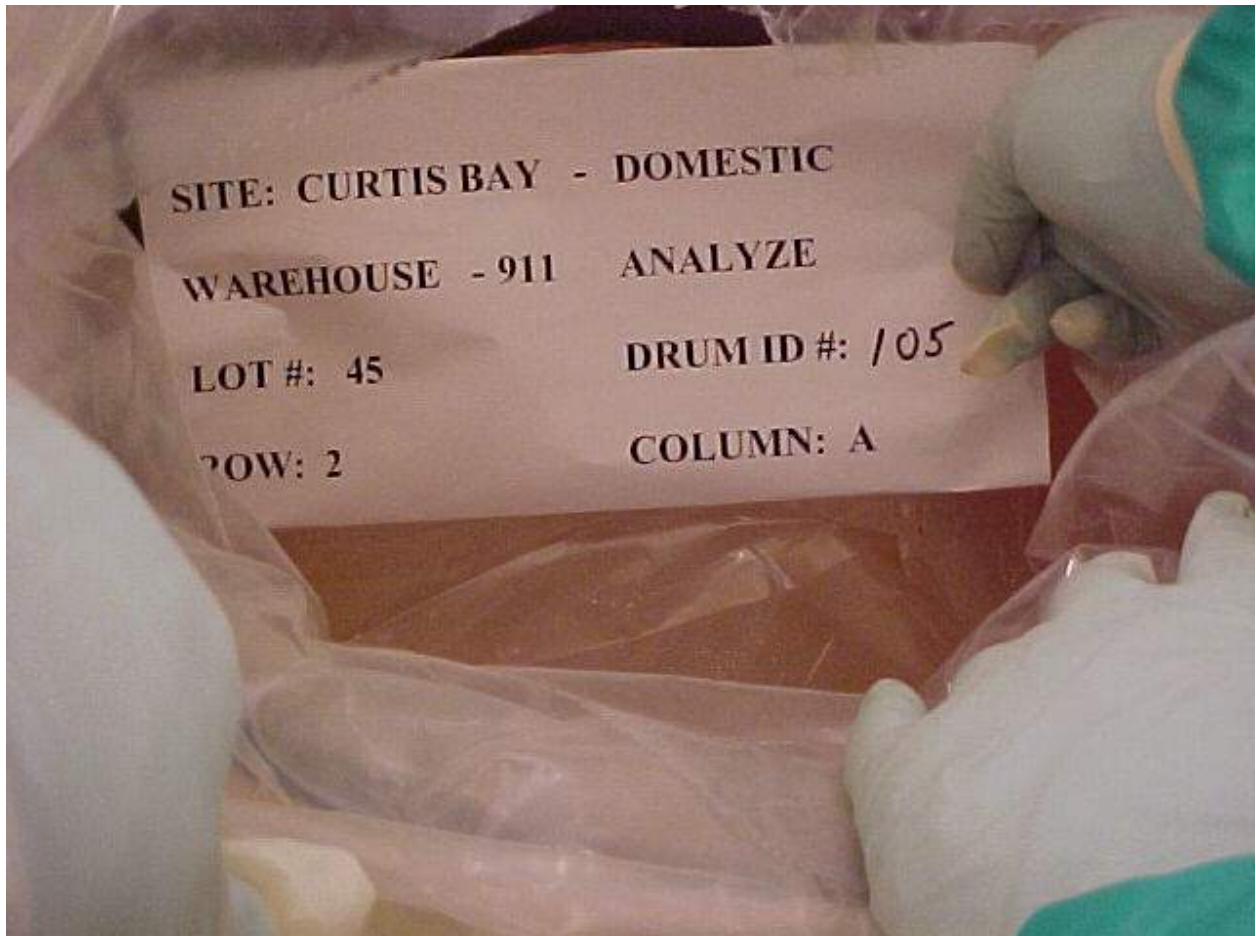
3rd poly liner/bag – good condition (holds majority of inner pressure)

No gasses present exterior to bag – did not measure internal gas pressure

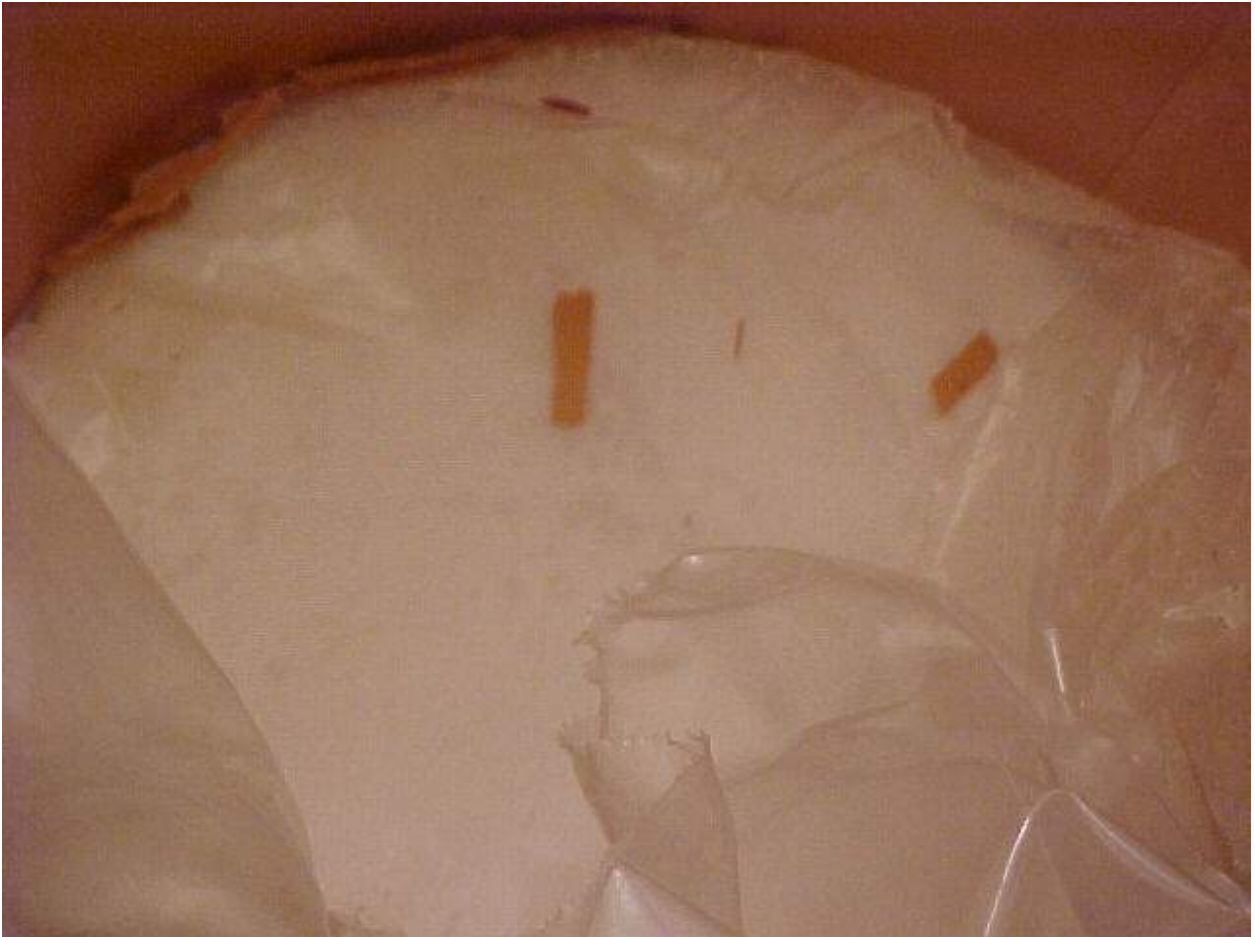
Final poly liner/bag – good condition (“thin film” plastic – thickness similar to “Saran” wrap or similar grocery product)
No gasses present

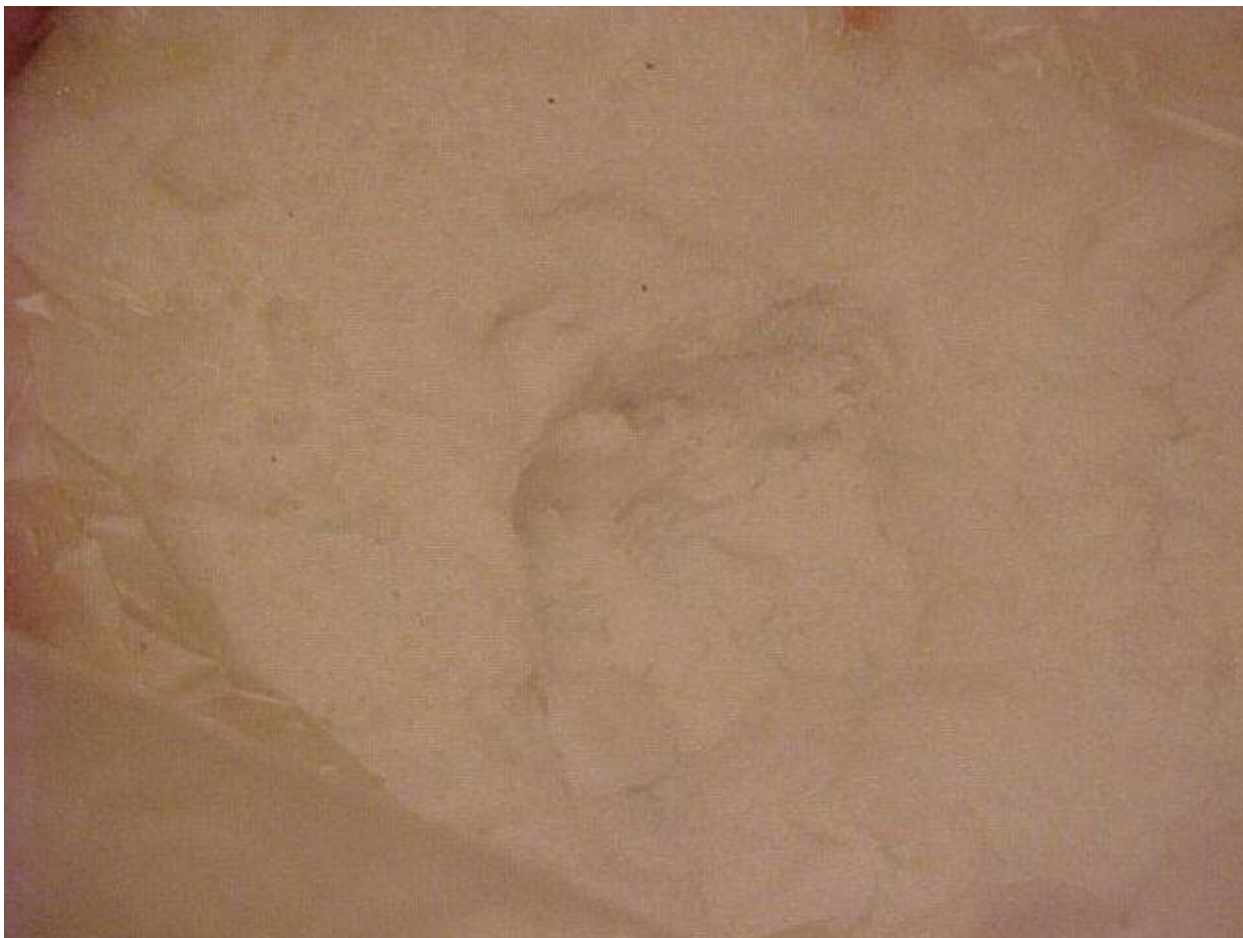
Using the “manual” coring tool to breakup – essentially utilized as a hammer – the tool would not make a good core since material would break apart due to force of impact hammer on sampling tool

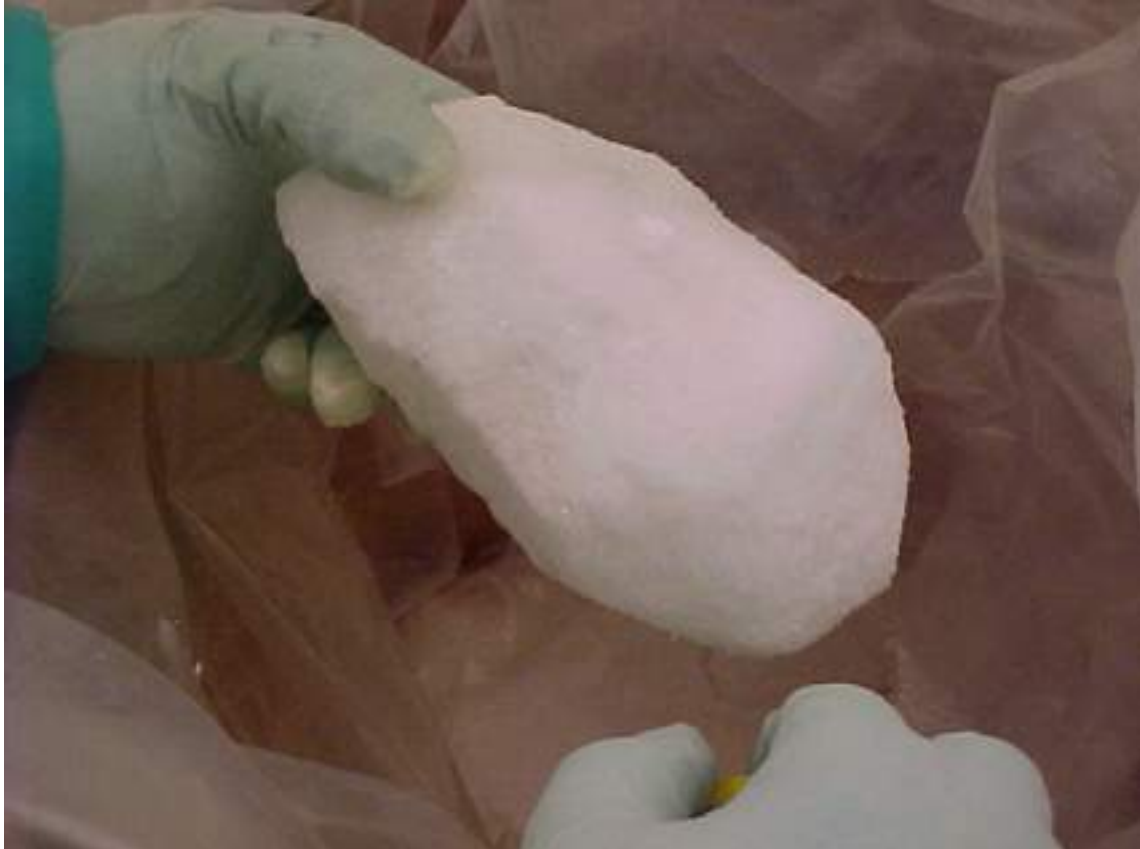
Here is a picture of a representative sample – since the coring machine could not be utilized per UT Battelle instructions, each sample had to be shaped to fit into the 2-liter sample bottle lid. Typically two samples would be shaped (carved utilizing chisels), placed in a plastic zip lock bag then placed into the 2-liter sample bottle. Samples from two drums would then be overpacked into a “Rubbermaid” container and packaged for off-site shipment to the analytical laboratory. No gasses present

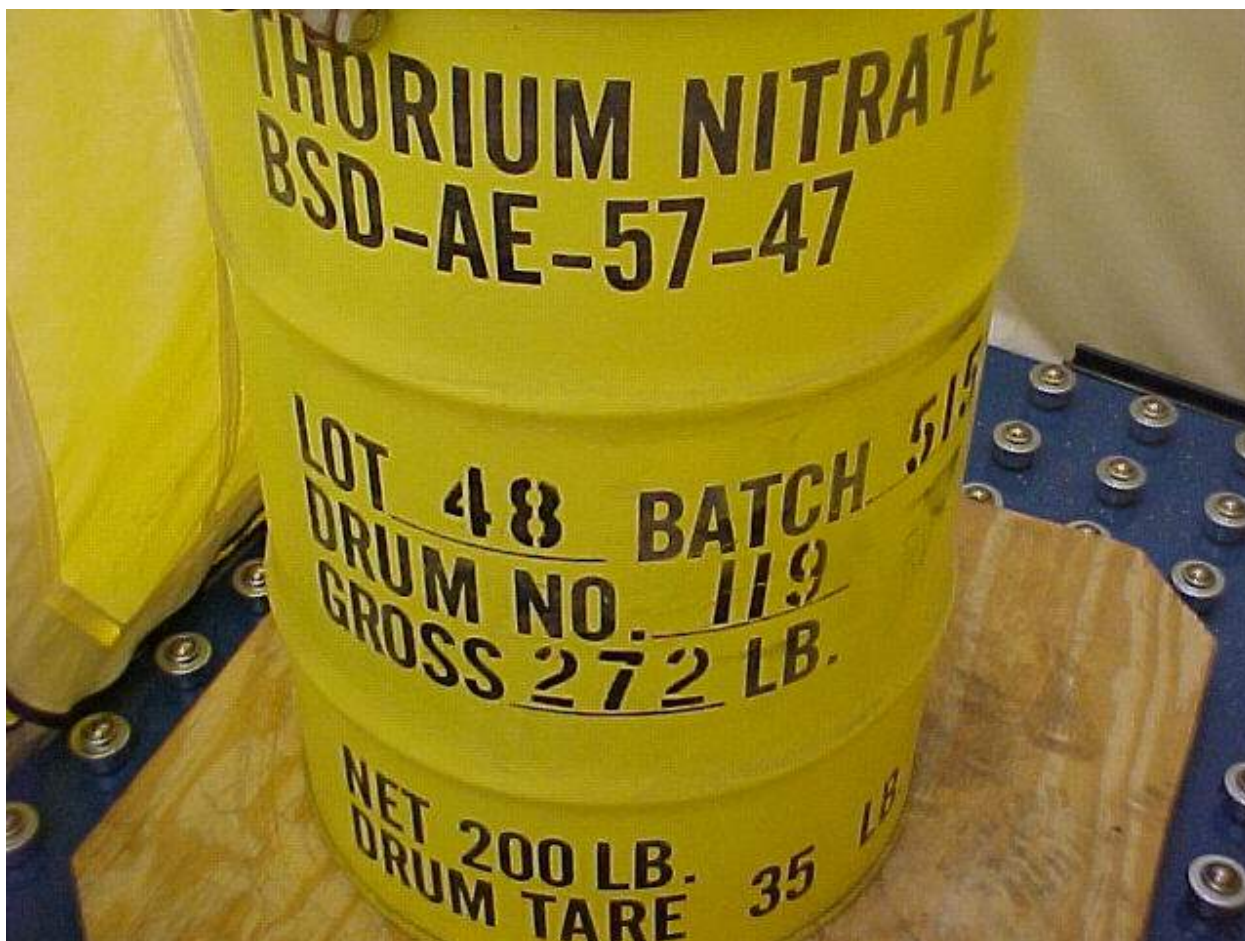
General InformationSite Curtis BayThN Origin DomesticLot No. 48Drum ID No. 119Inspection/Sample
DispositionVisual Inspection & Sampling
Analyze**Physical Location of Drum**Warehouse 911Row 8
Column A**Inspection/Sample Date & Time**Date 6-27-2002Time 14:45**Other Information**Photo No. 1 of 10Dose Rate Surface 20 mR/hr
 1 meter 2.8 mR/hrContainer 30-gallon steel drumContainer good
Condition

Upon loosening bolt on drum ring, gasses slowly dissipated from the drum – continued loosening bolt on bolt ring until drum lid pushed through center of bolt ring.

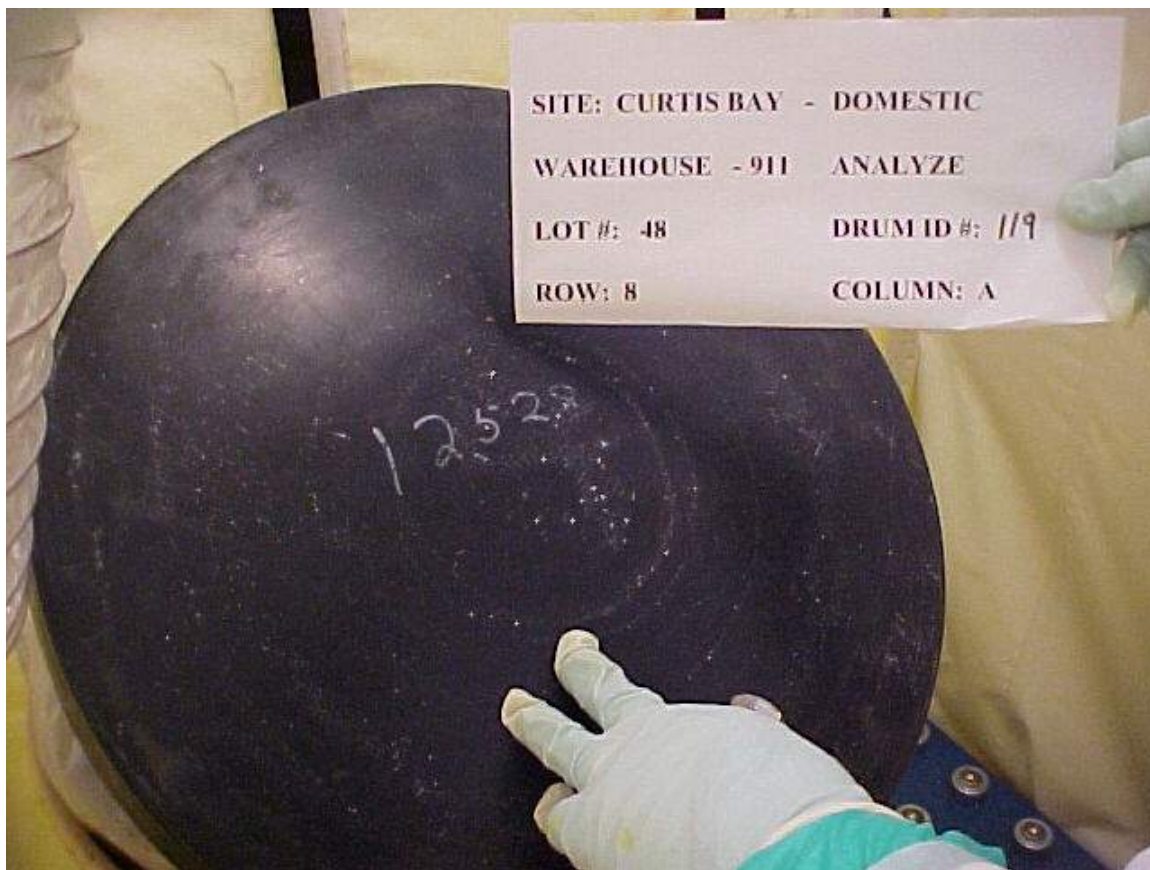
The black plastic lid of the inner drum liner – good condition – being pushed upward indicates the packaging inside of the drum is pressurized.
 No gasses present

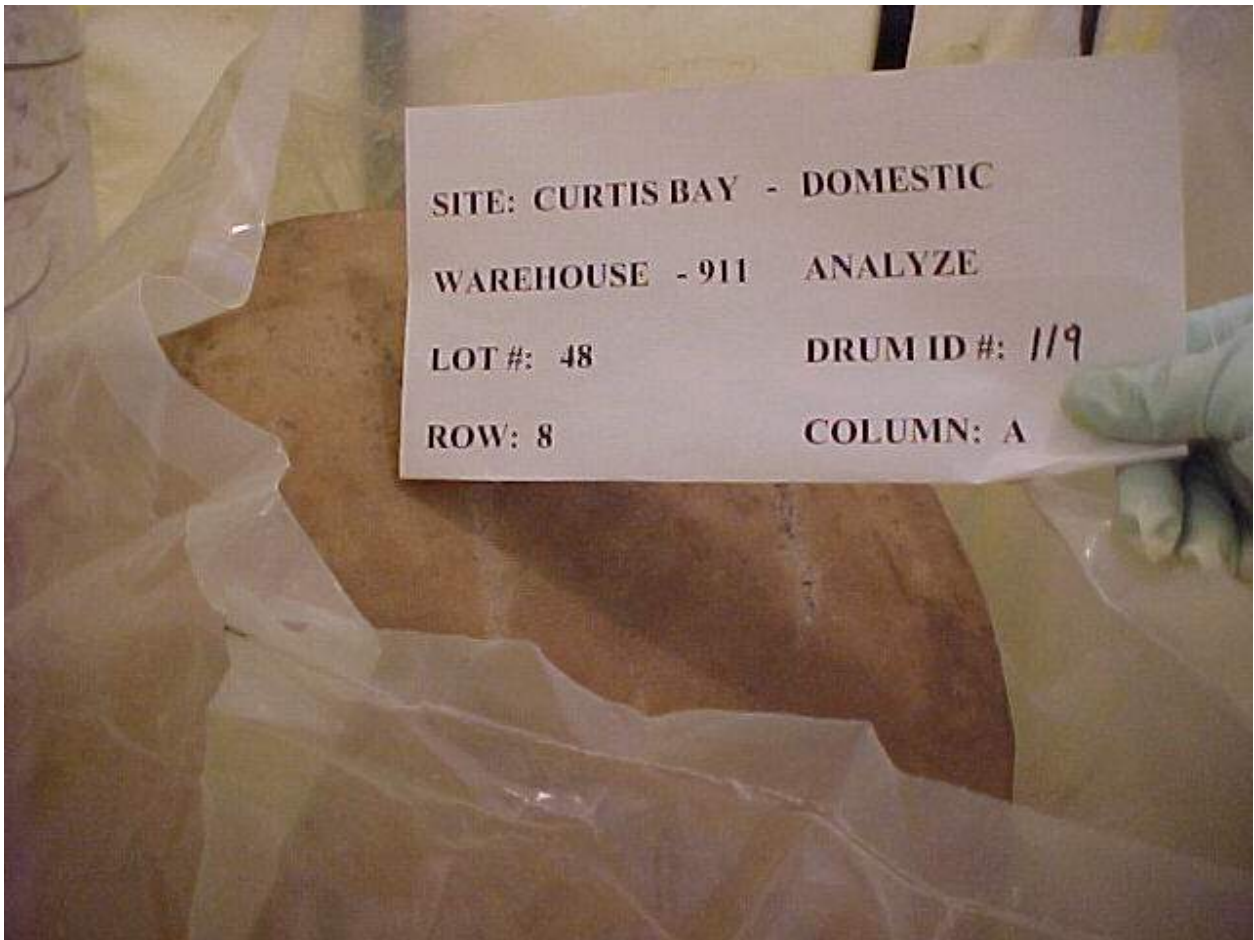
The fiber lid of the outermost fiber drum inside of the 30-gal drum – good condition – internal pressure caused tape seal of fiber drum lid to split raising the lid in a vertical extension.
No gasses present (external to bag)

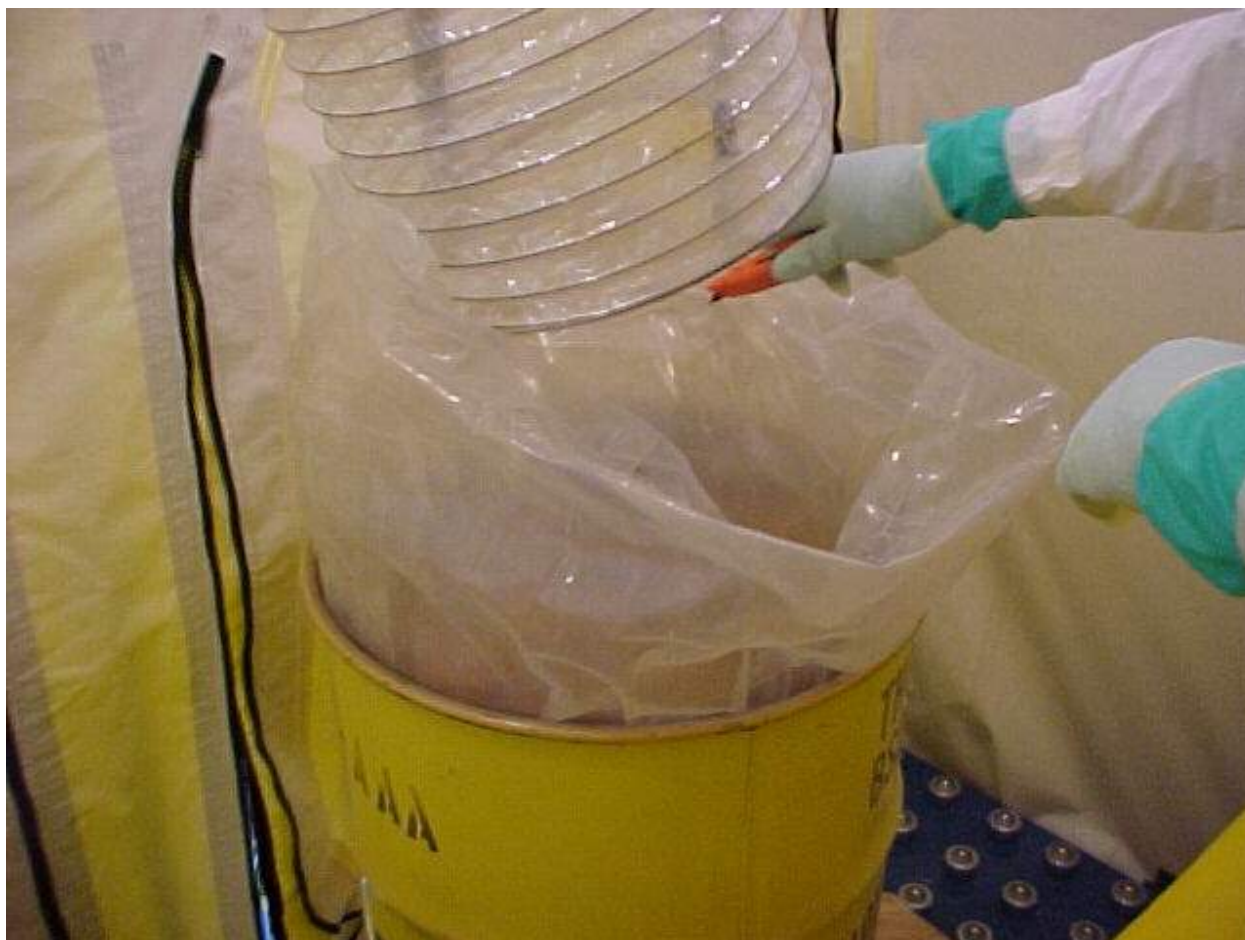
This picture show the venting of any gasses that might be present (after cutting through the 2nd & 3rd poly liners/bags inside of the drum – 3rd bag contained majority of internal pressure – 3rd bag appeared to be similar to an inflated balloon, but did not “pop” upon cutting with utility knife). Did not measure the gases from this drum.

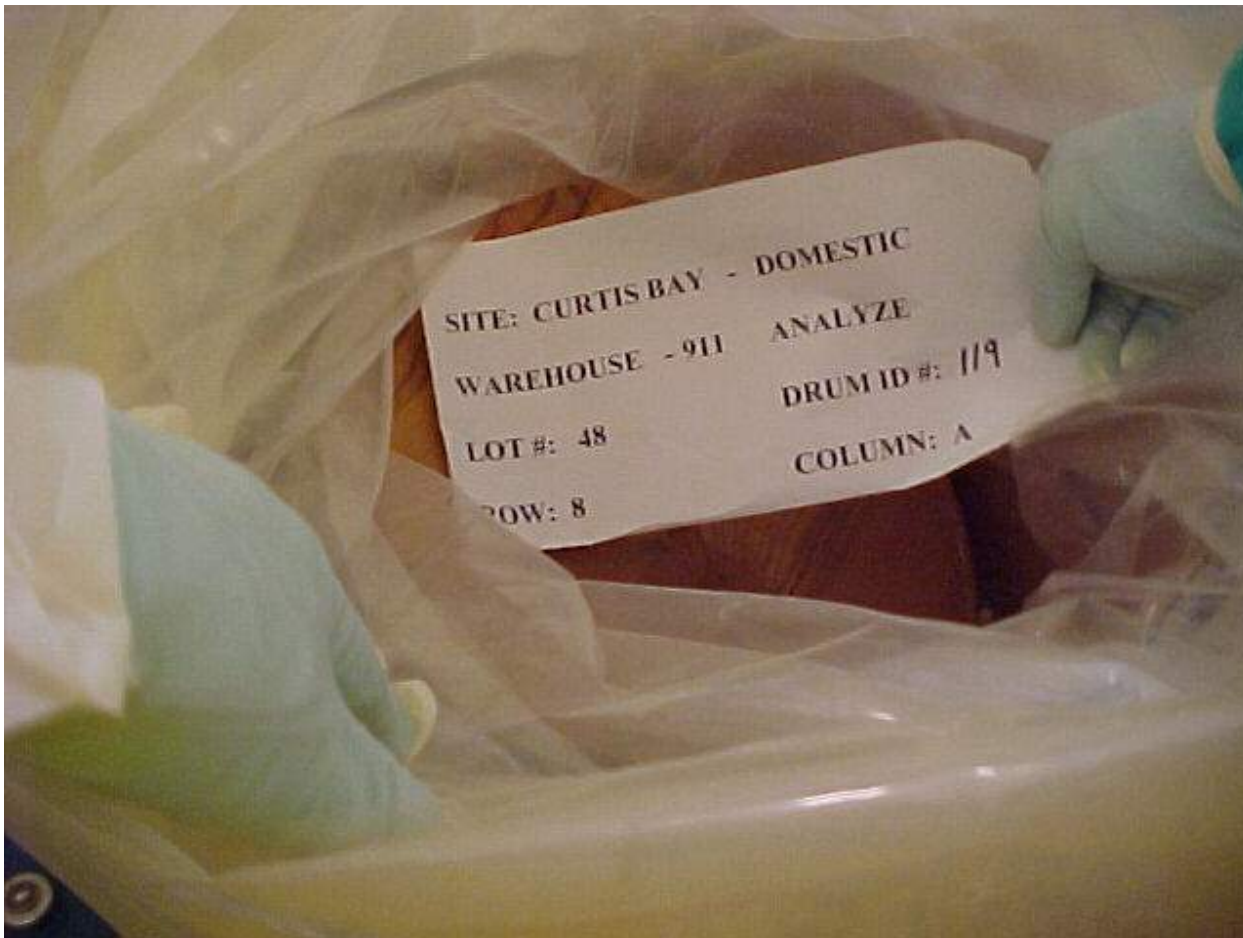
Picture of wooden lid mounted on innermost fiber (lab-pack) drum – good condition
No gasses present (external to lid)

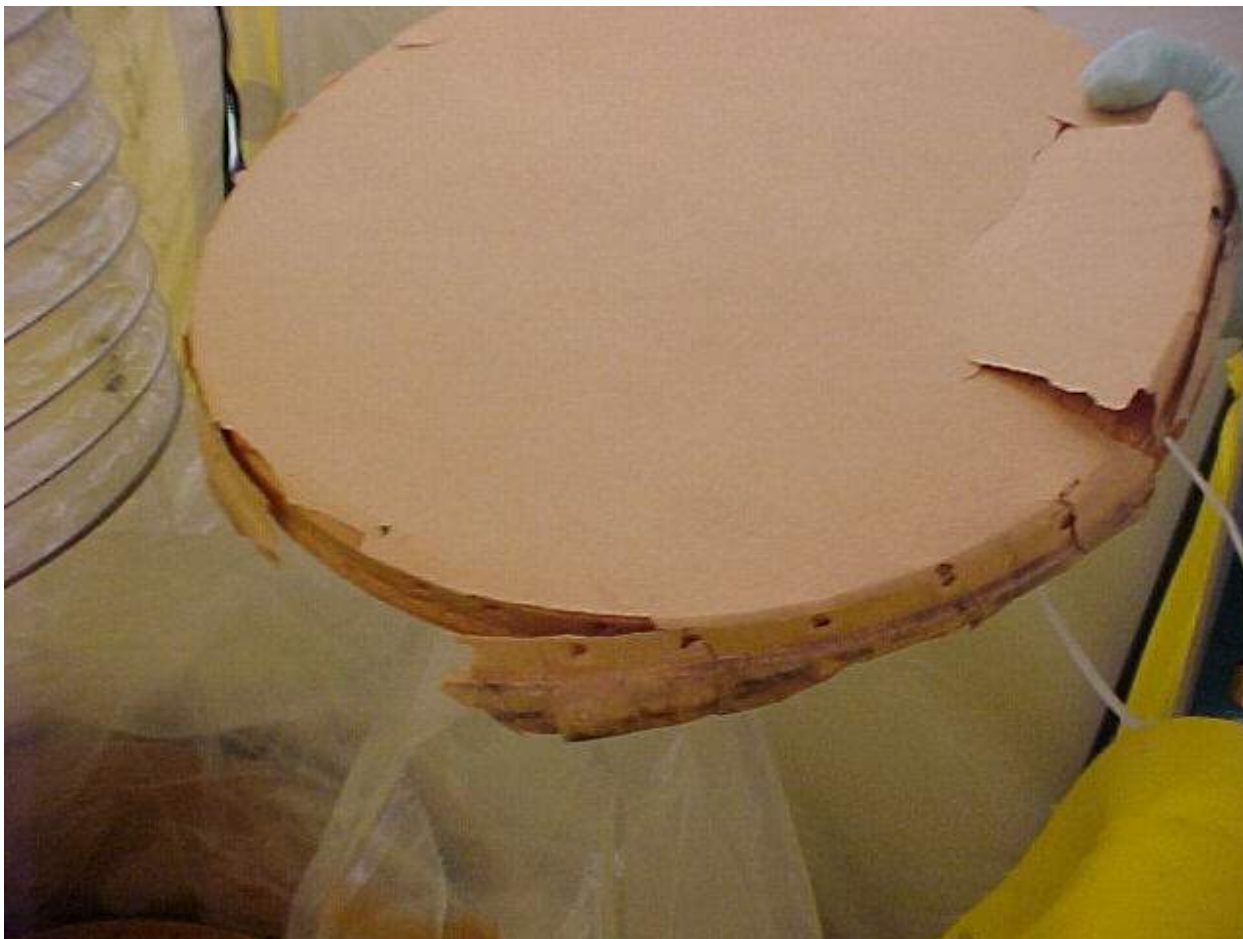
This photograph shows the lab-pack lid (thin film paper attached to the underside of the wooden lid)

No gasses present

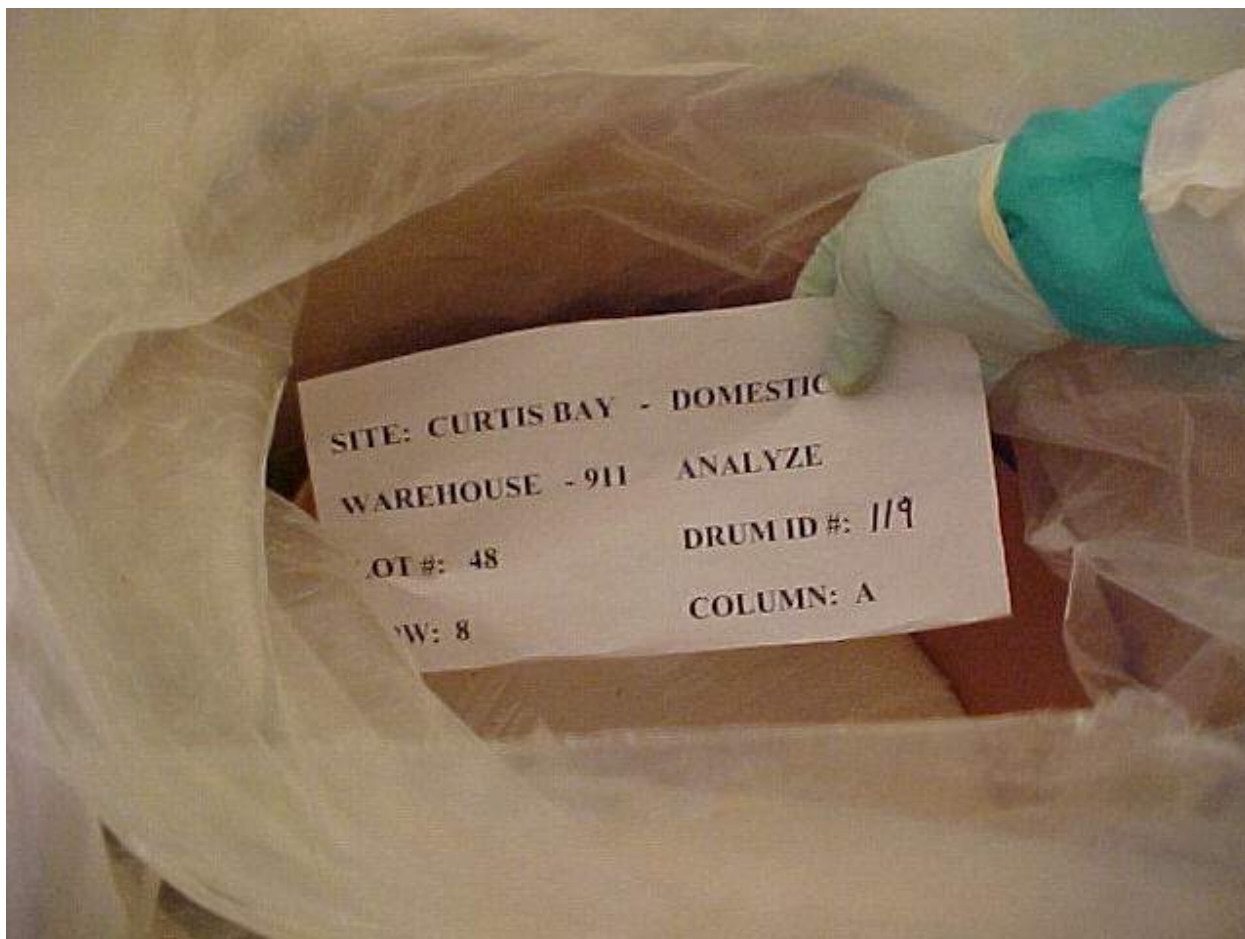
Last plastic "thin film" liner before coring
No gasses present

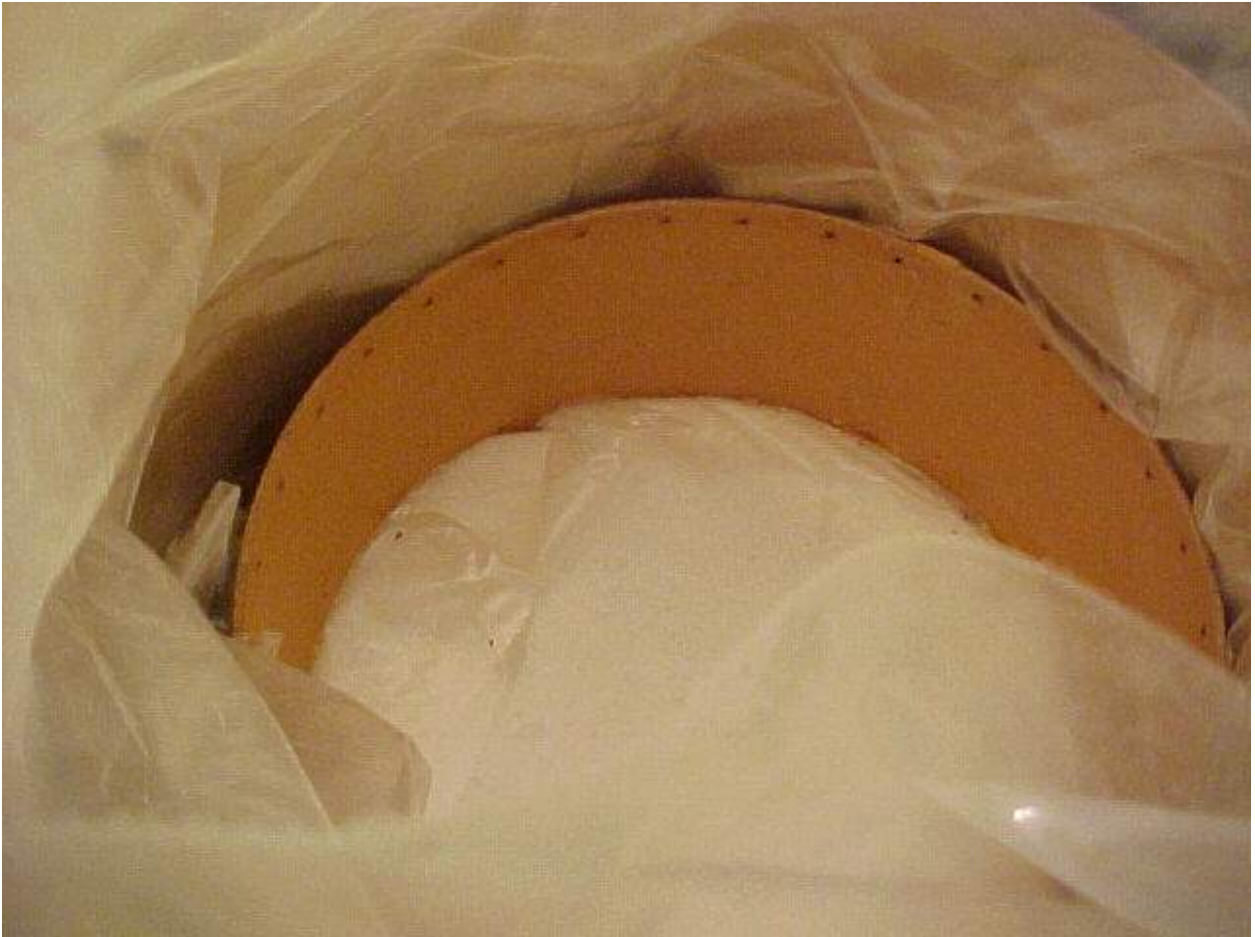
Another picture of the 4th and last plastic “thin film” liner before coring – ThN material is a monolith, solid, white and dry
No gasses present

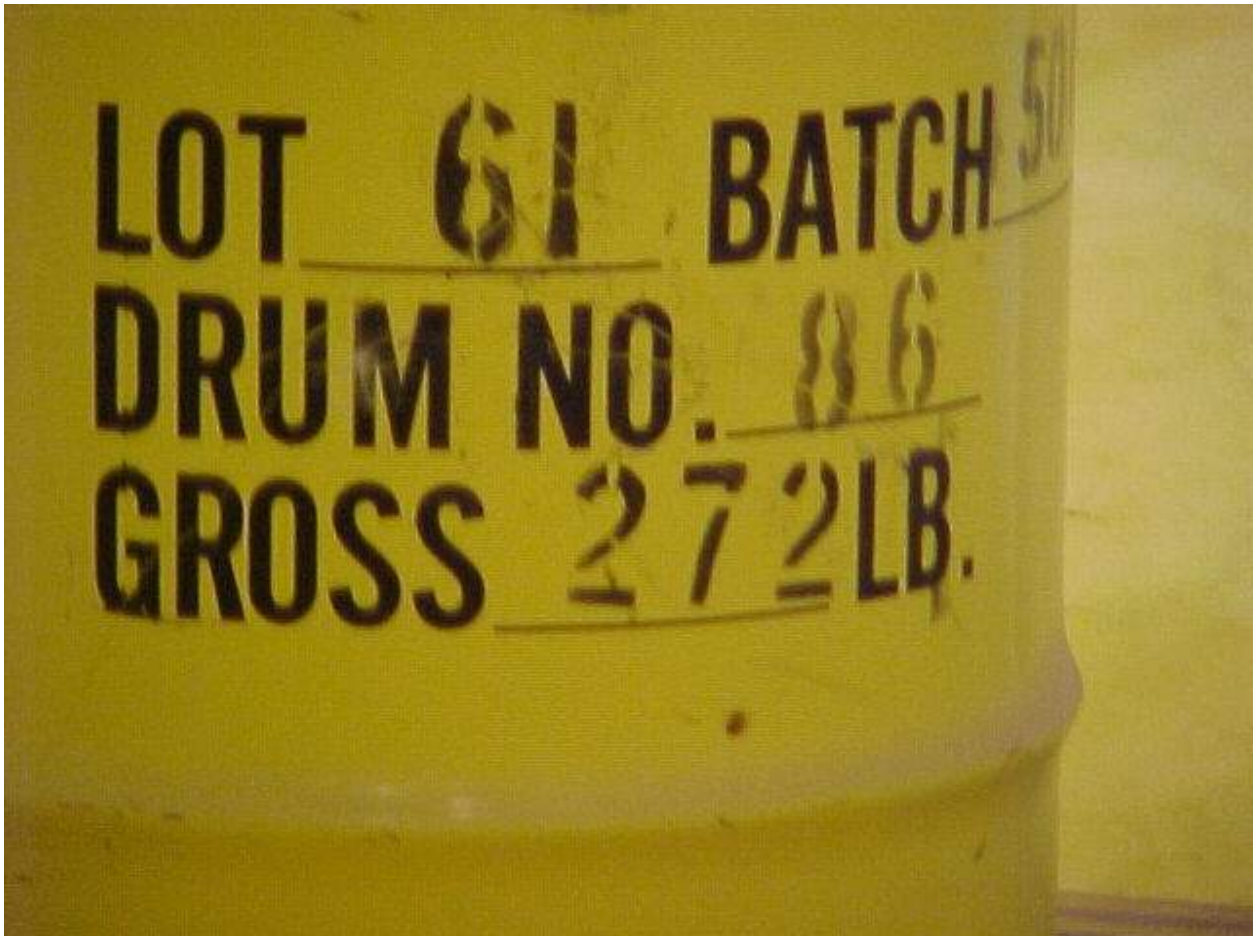
30-gal drum – good condition

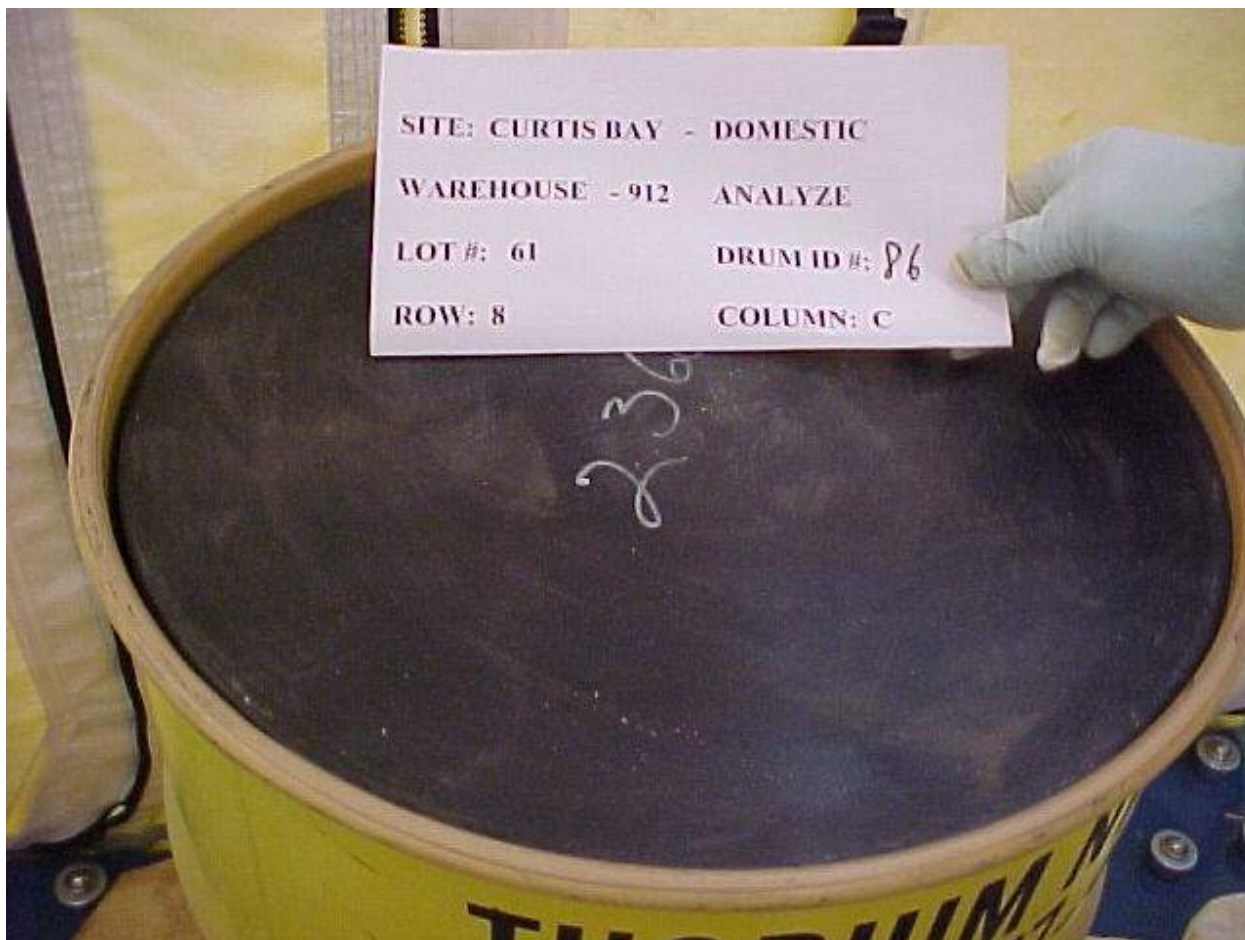
Black plastic lid of plastic drum liner – good condition
No gasses present (breathing zone)

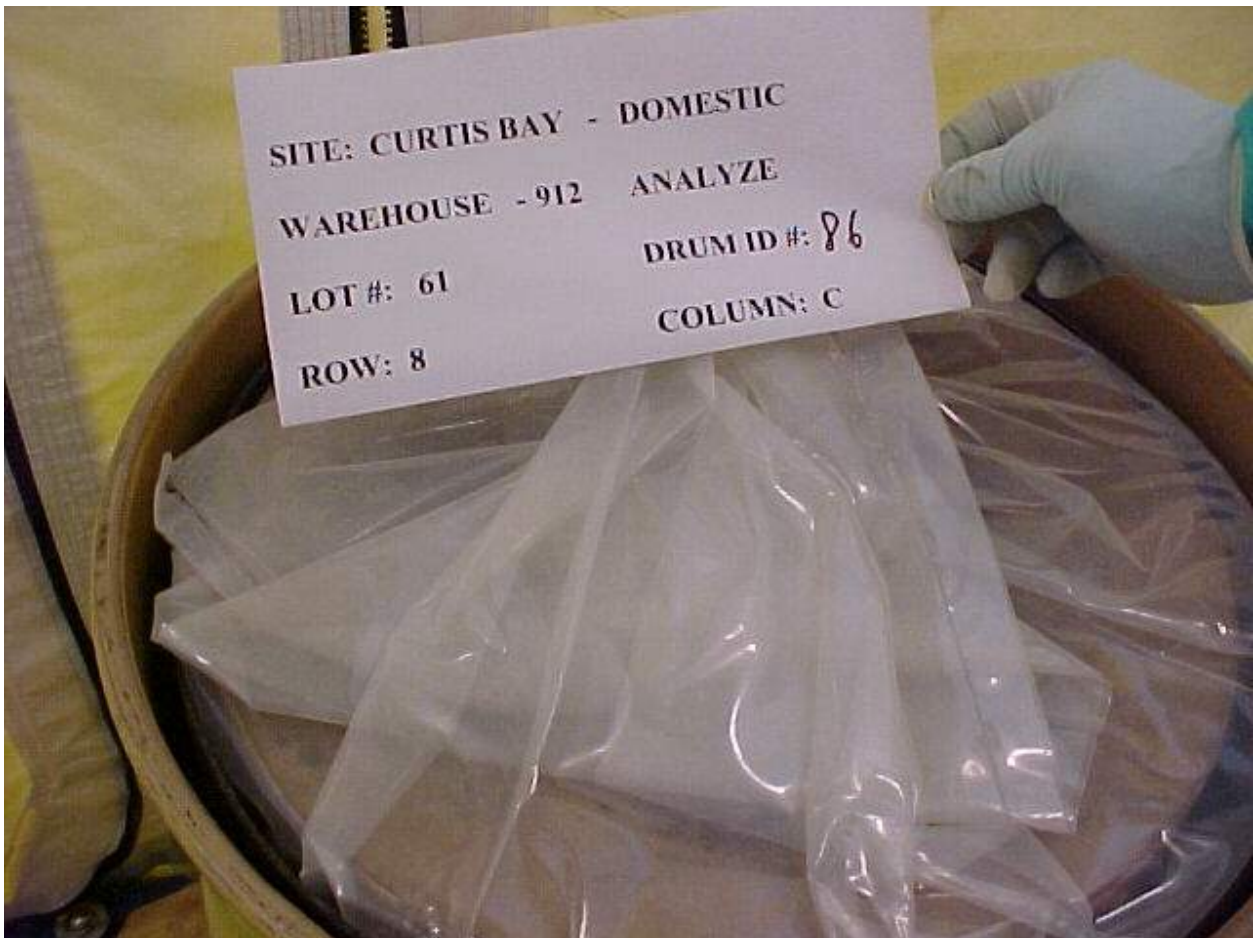
1st poly liner/bag – good condition
No gasses present (breathing zone)
