THORIUM NITRATE STOCKPILE DRUM CHARACTERIZATION REPORT

**THORIUM NITRATE STOCKPILE
DRUM CHARACTERIZATION REPORT**

Prepared for
U.S. Defense Logistics Agency
Defense National Stockpile Center
Fort Belvoir, Virginia

Prepared by
OAK RIDGE NATIONAL LABORATORY
Oak Ridge, Tennessee 37831
managed by
UT-BATTELLE, LLC
for the
U.S. DEPARTMENT OF ENERGY
under contract DE-AC05-00OR22725

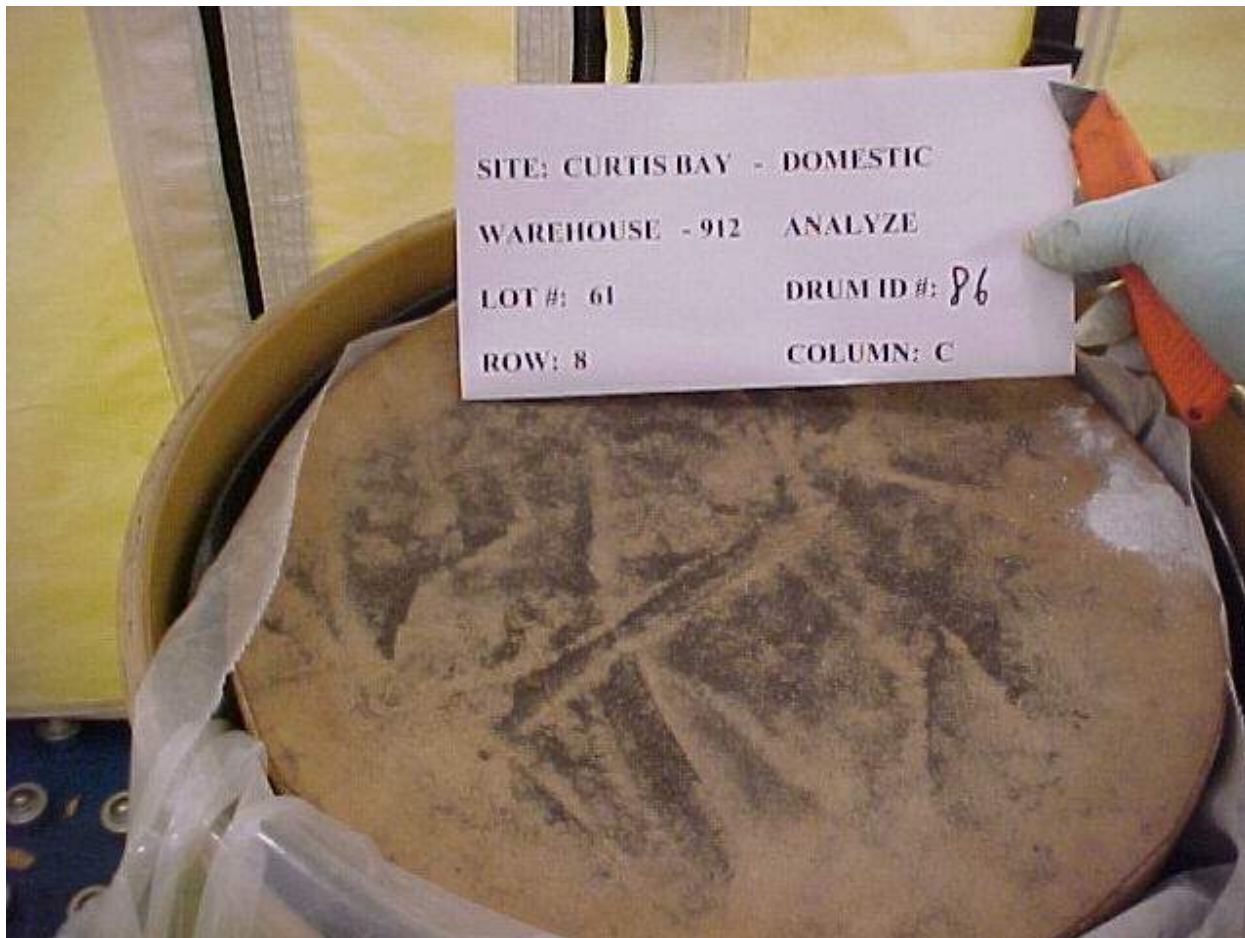
Fiber lid from outermost fiber drum inside of 30-gal drum – good condition
No gasses present (breathing zone)

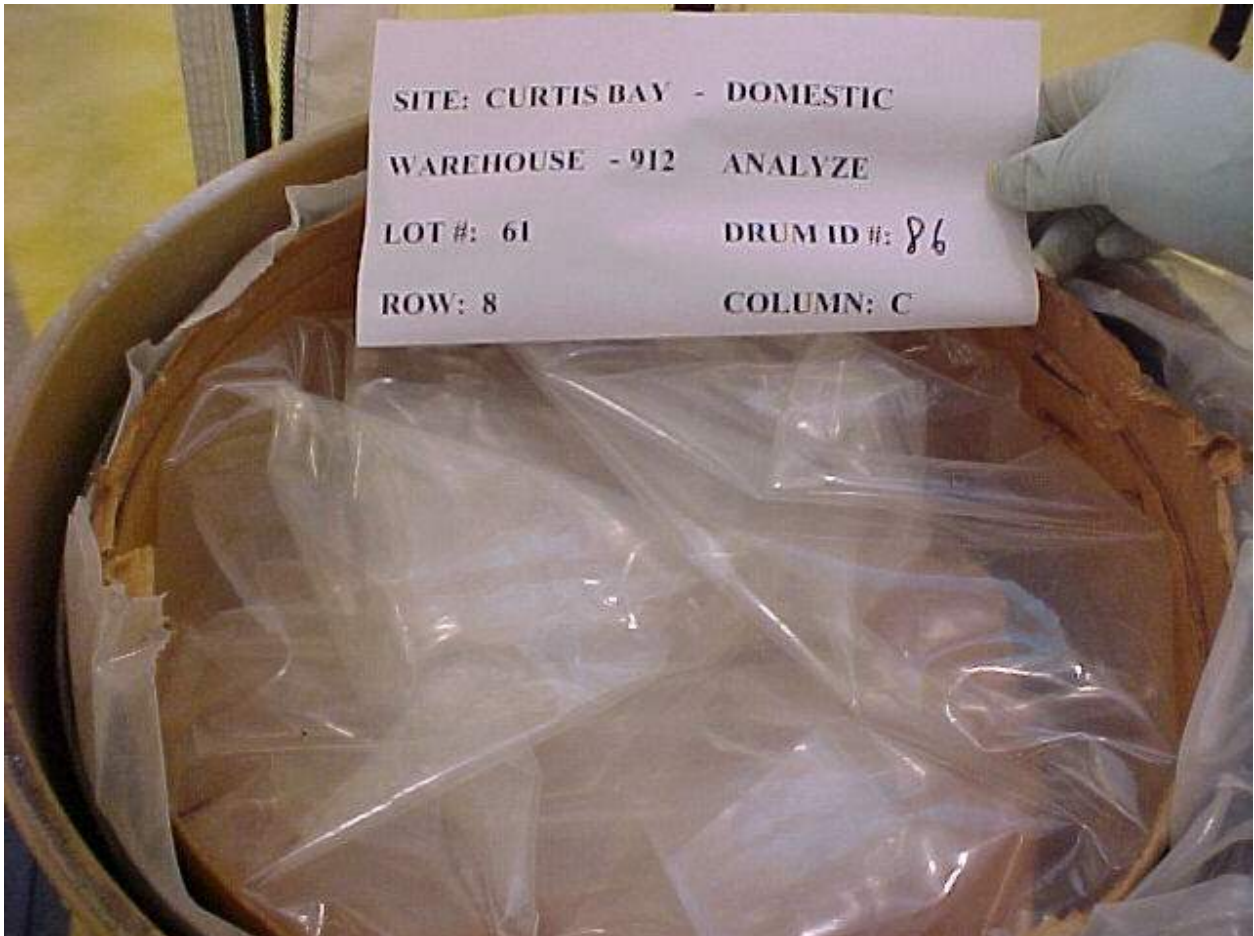
2nd poly liner/bag – good condition
No gasses present (breathing zone)

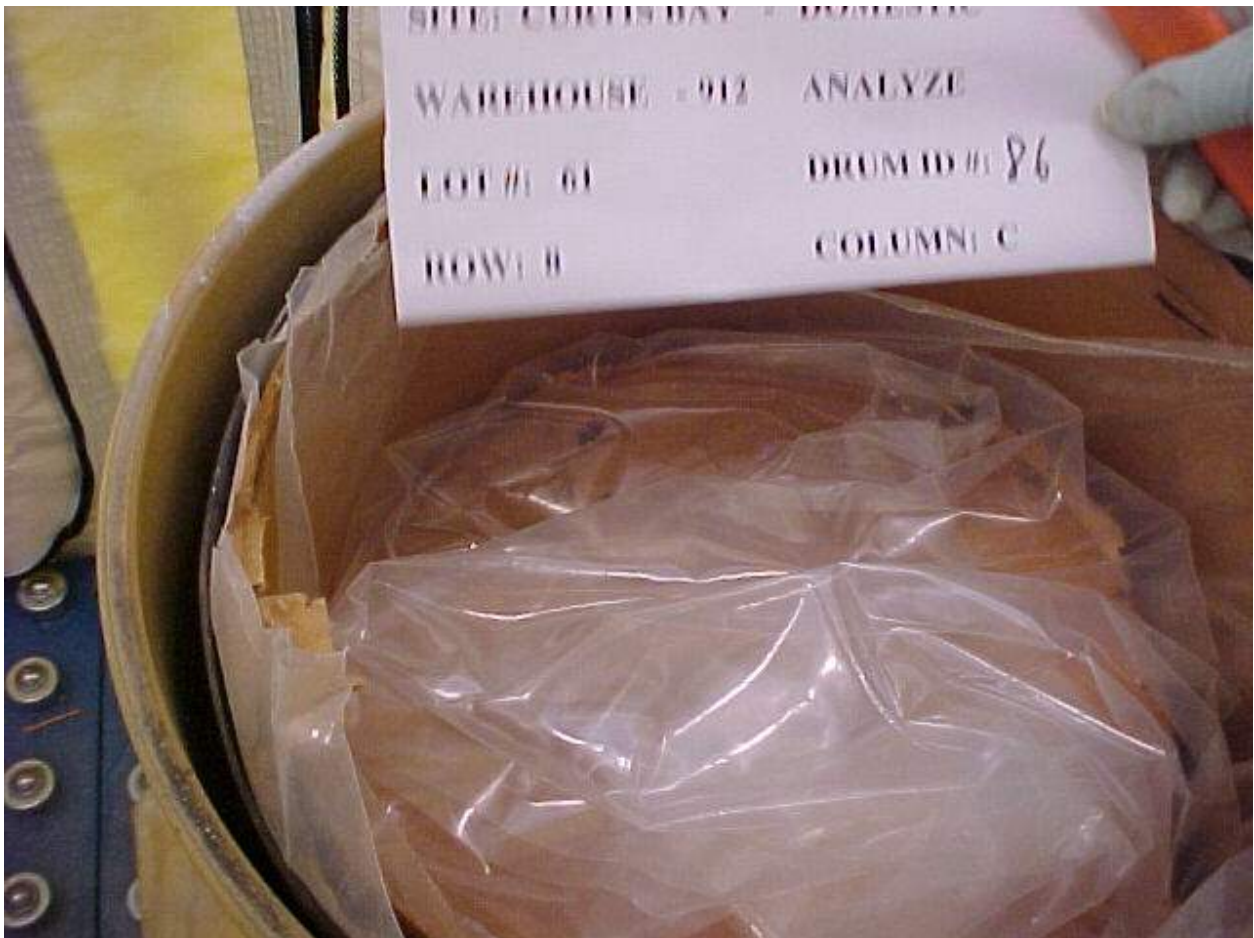
3rd poly liner/bag – good condition
No gasses present (breathing zone)

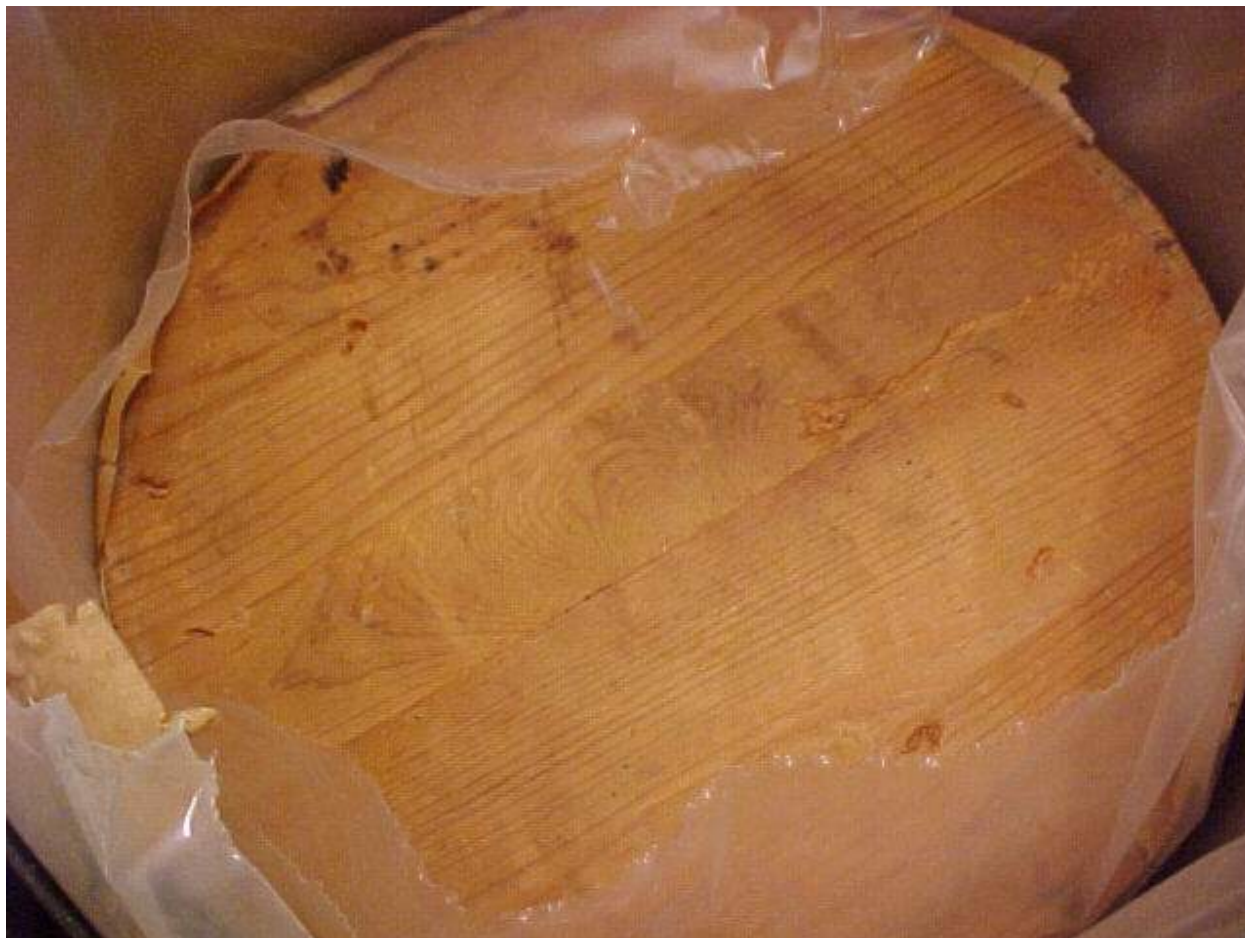
Wooden lid on the innermost fiber drum (lab-pack) – good condition

No gasses present (breathing zone)

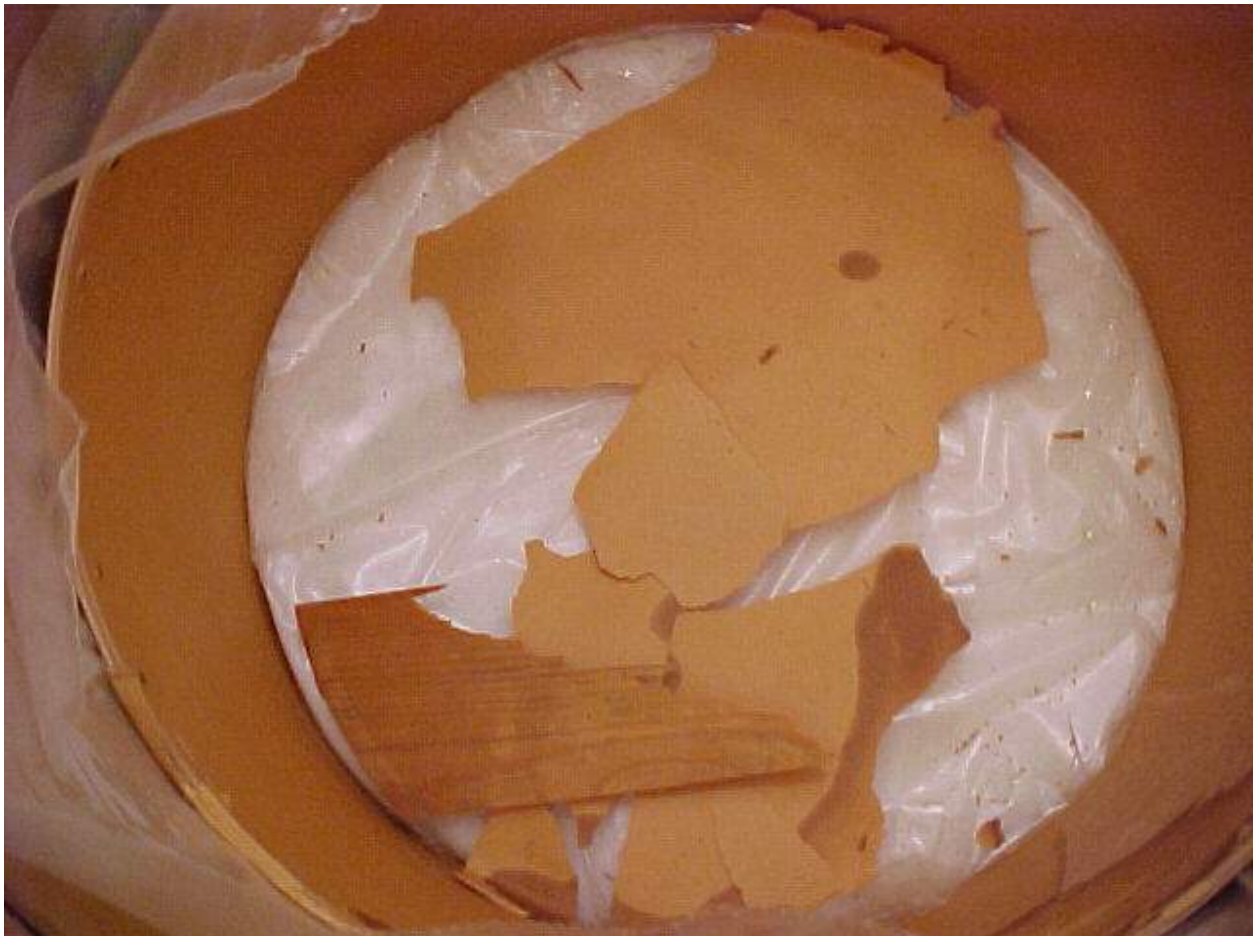
Part of paper that is positioned underneath the wooden lid on the lab-pack drum
No gasses present (breathing zone)

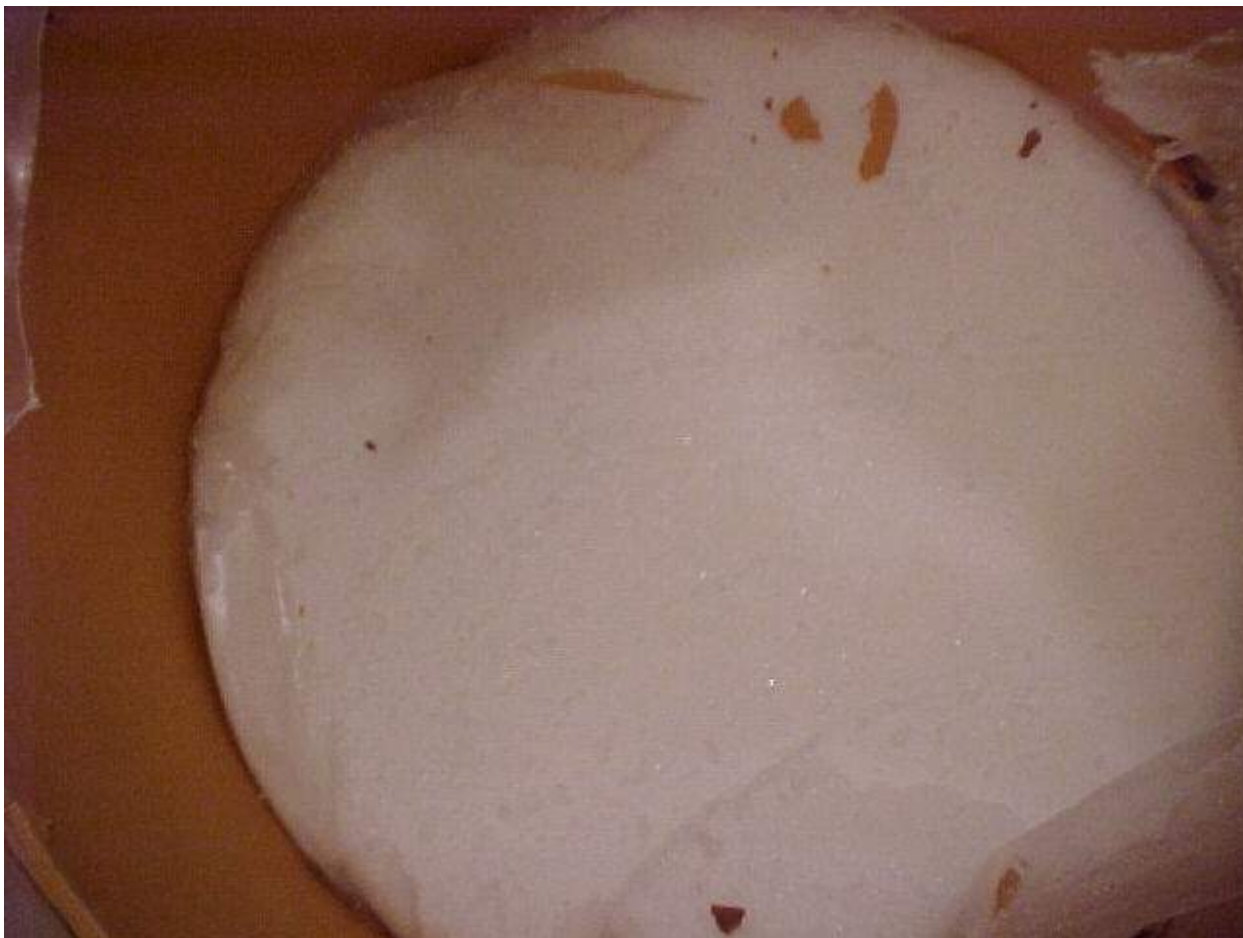
ThN material – solid – monolith – white - dry

No gasses present (breathing zone)

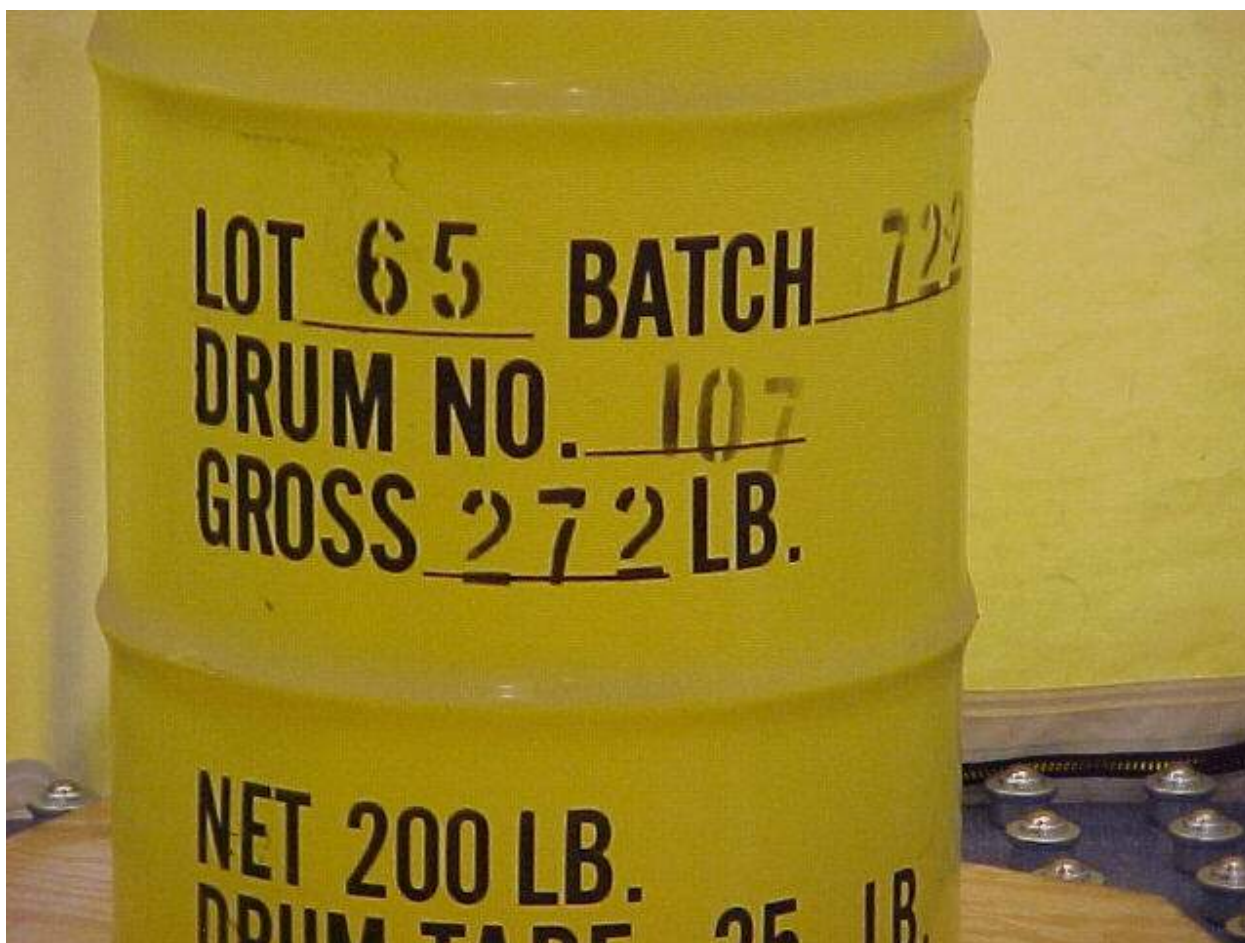
Container	<u>30-gallon steel drum</u>	Container	<u>Has indentations on lid</u>
		Condition

Indentations indicate drum is currently pressurized or has relieved through drum gasket seal – drum was not pressurized from tap test and no gas vented while loosening bolt on drum ring; therefore, indentations probably indicate that internal pressure has probably vented through drum gasket seal.

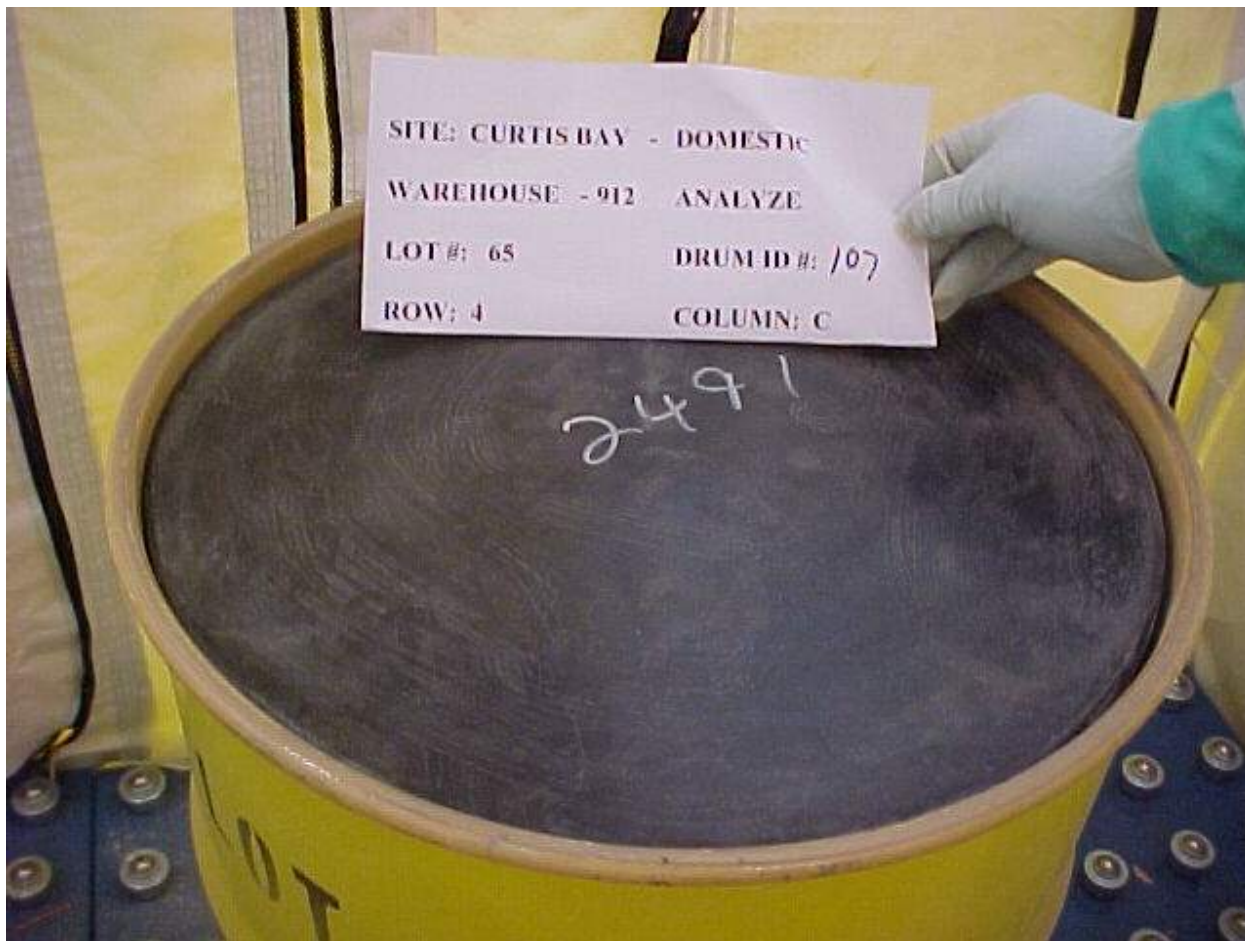
Black plastic lid from inner drum liner – good condition (lid is not sealed to drum liner – merely sits on top of the drum liner)

No gasses present (in breathing zone)

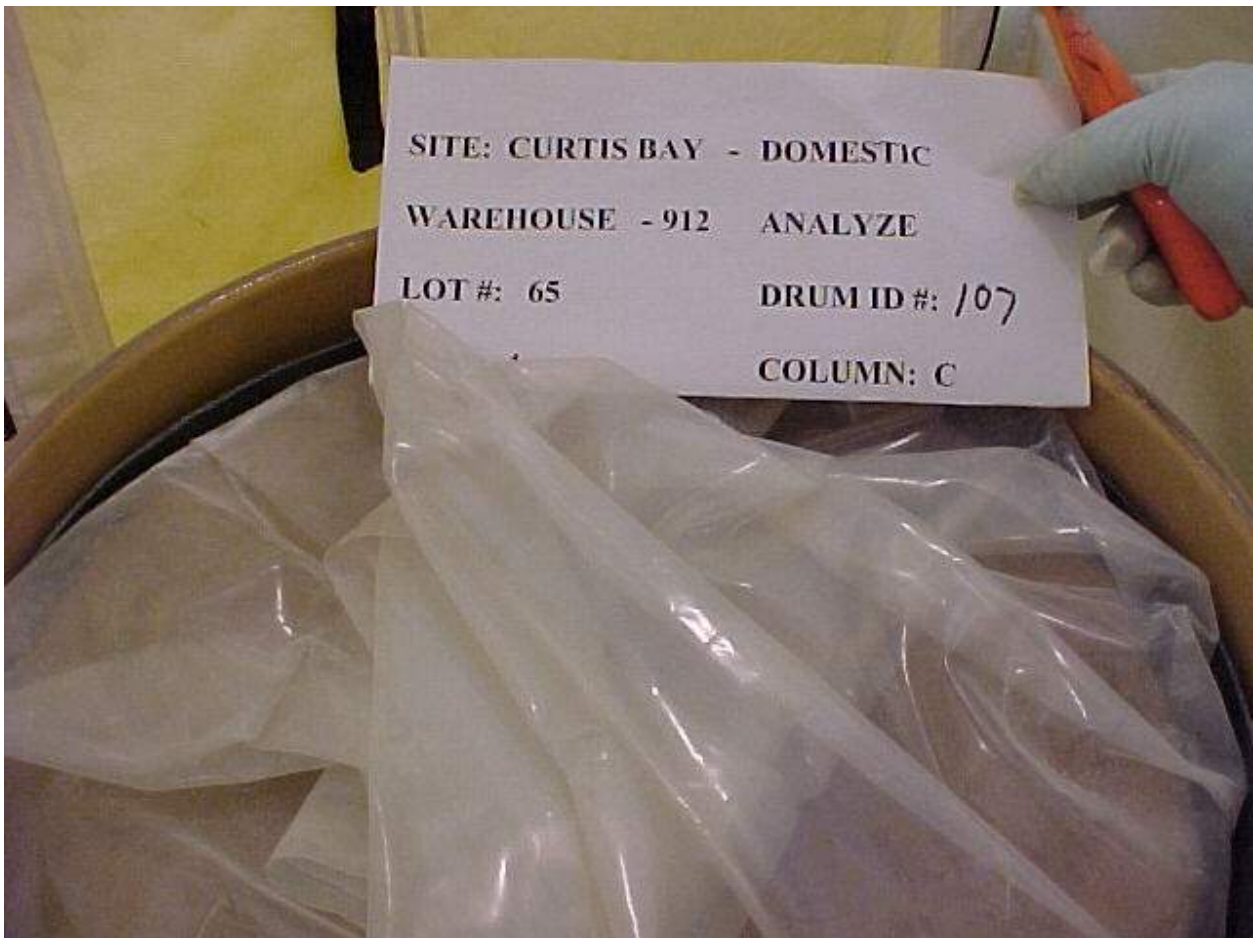
1st poly liner/bag – good condition
No gasses present (in breathing zone)

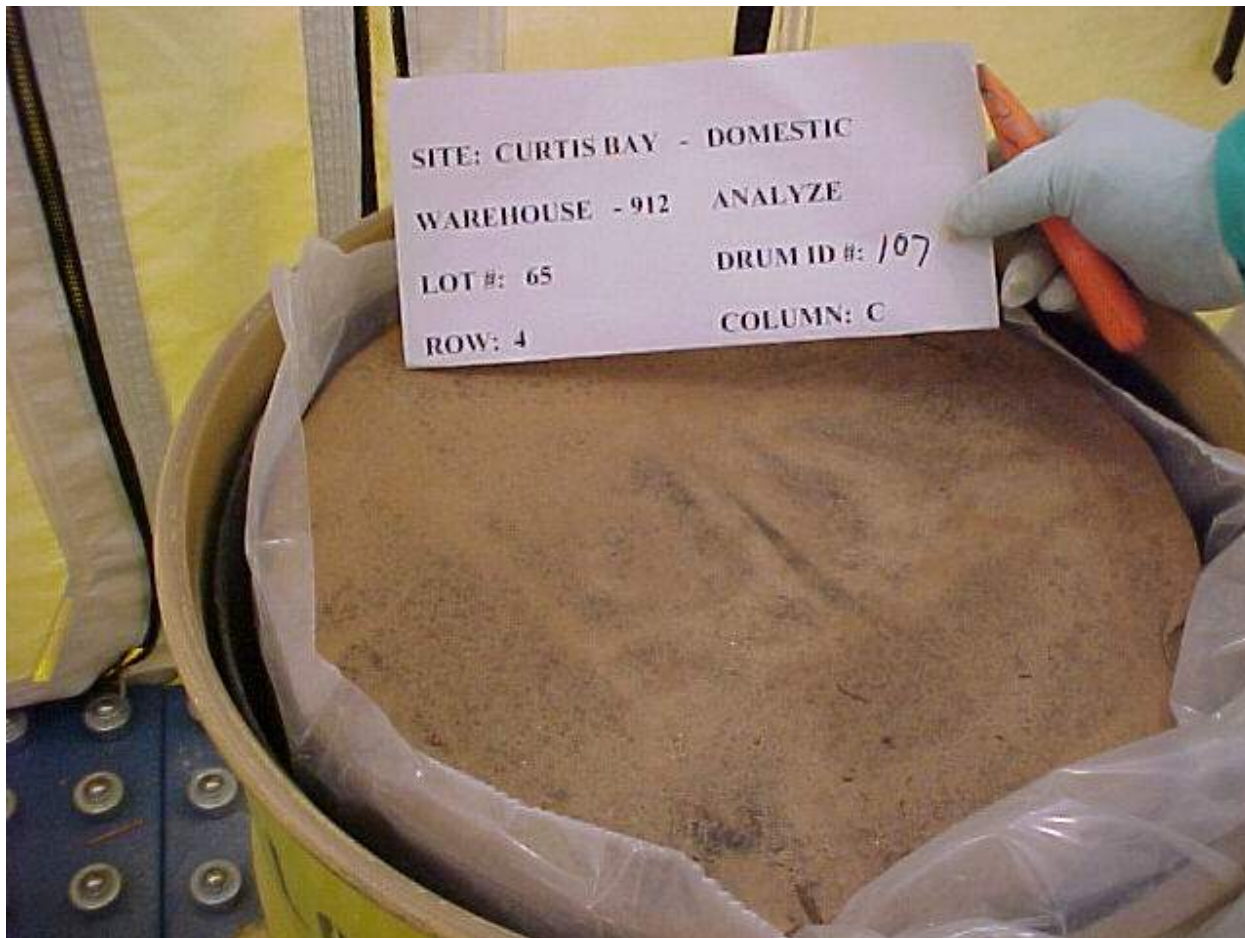
Fiber drum lid from outermost fiber drum inside of 30-gal drum – good condition
No gasses present (in breathing zone)

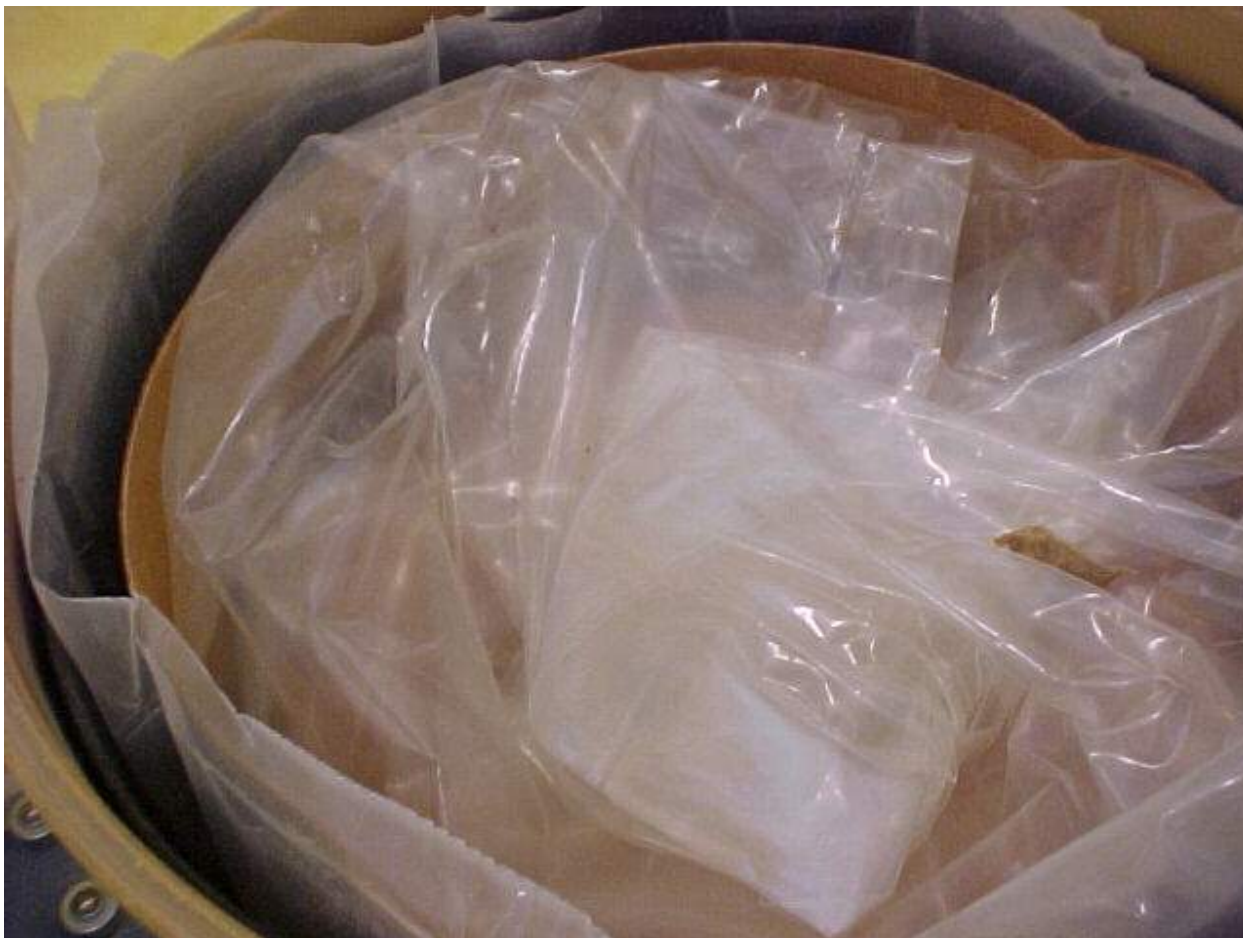
2nd poly liner/bag – good condition
No gasses present (in breathing zone)

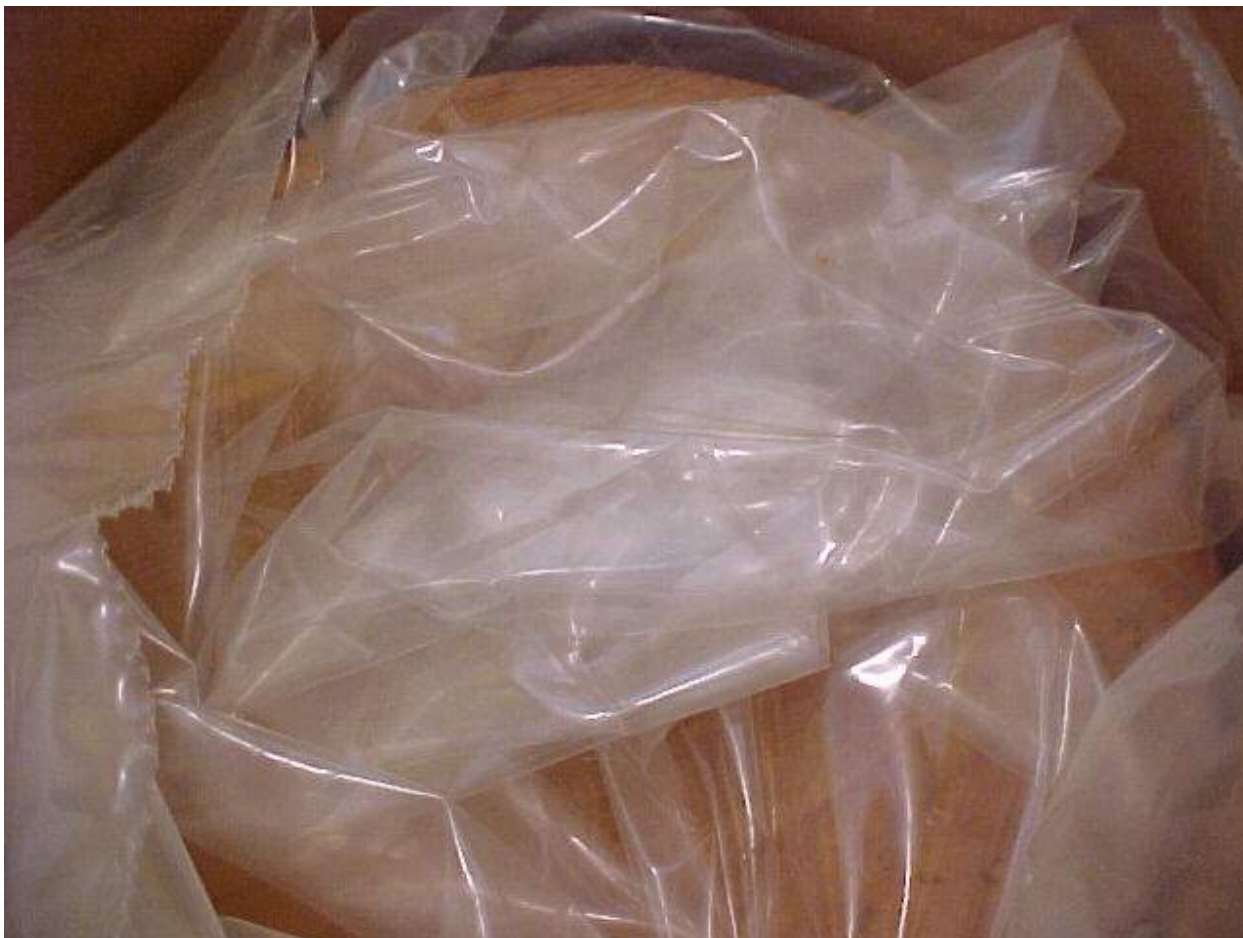
3rd poly liner/bag – good condition
No gasses present (in breathing zone)

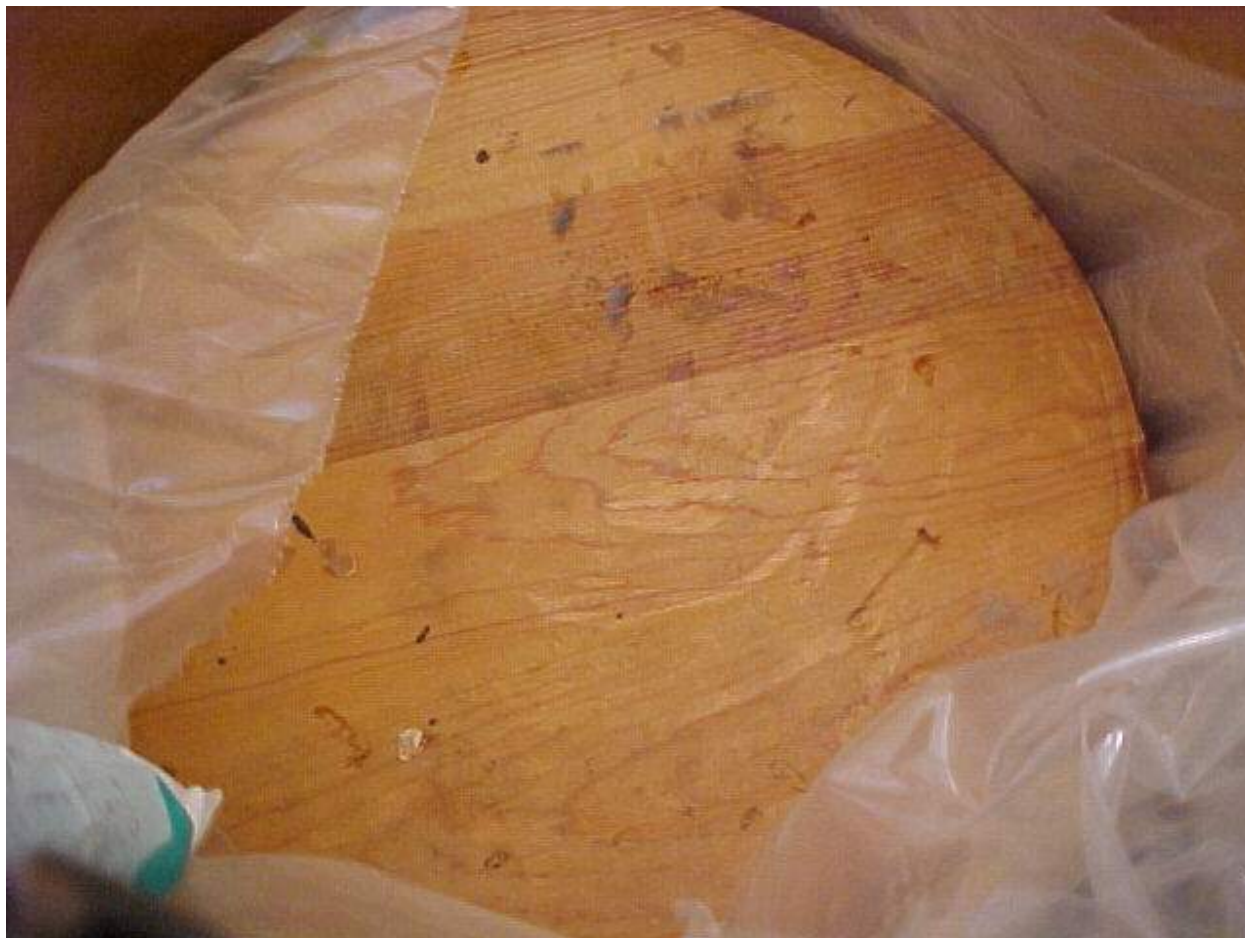
Wooden lid mounted on innermost fiber drum/lab-pack – good condition
No gasses present (in breathing zone)

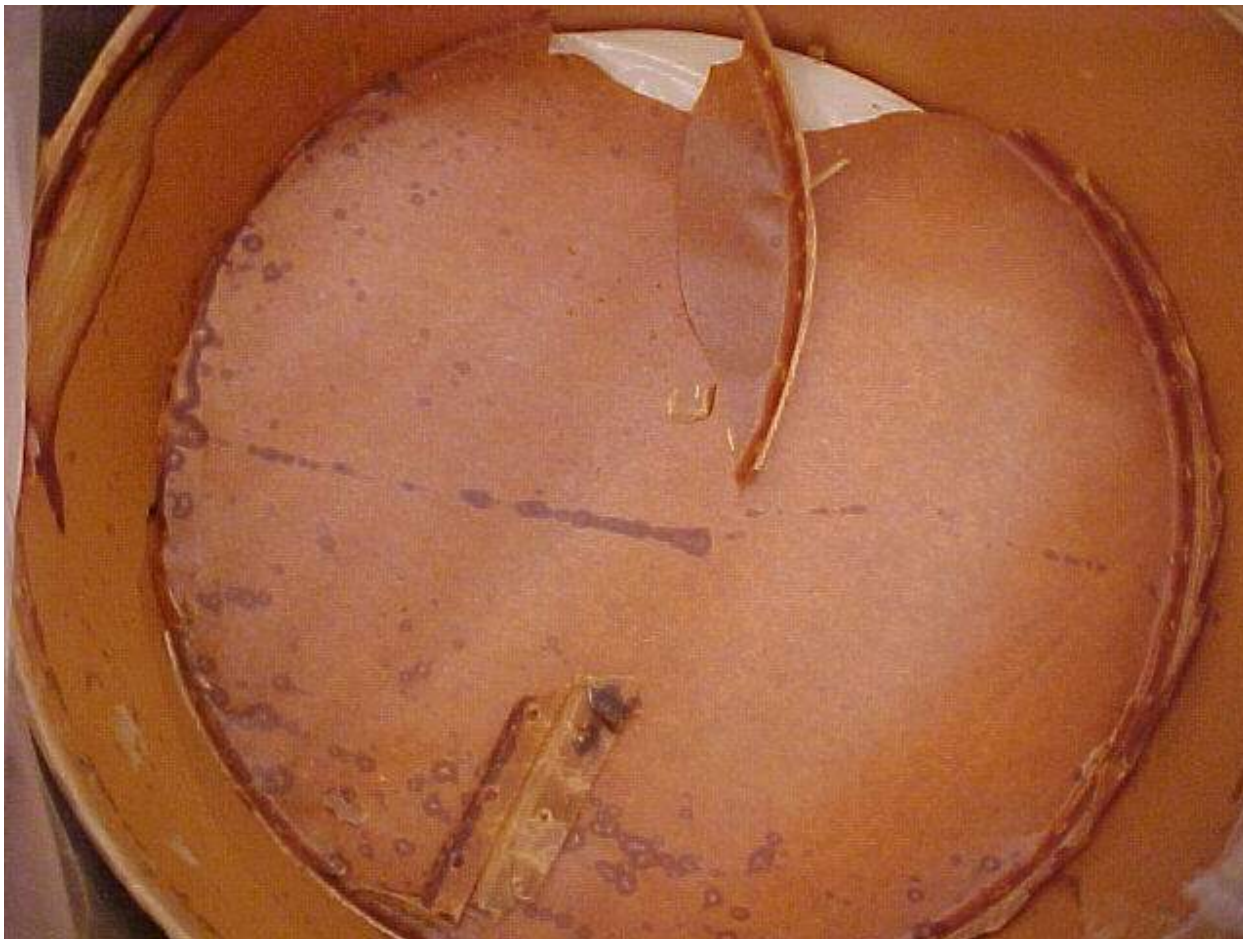
Lab-pack container lid – may be integral part of wooden lid that is mounted on the fiber (lab-pack) drum – thin film paper

No gasses present (in breathing zone)

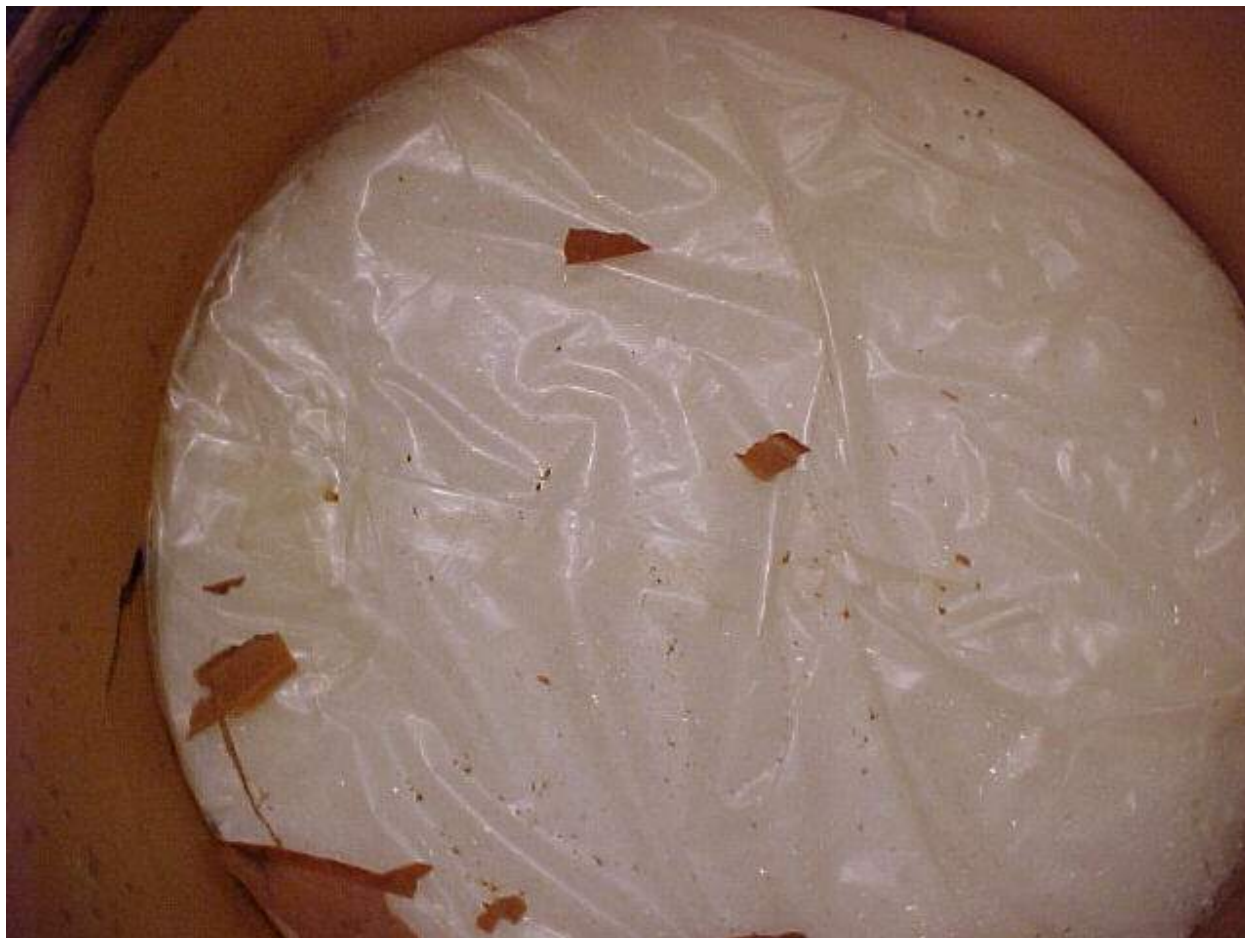
4th poly liner/bag – thin film plastic
No gasses present (in breathing zone)

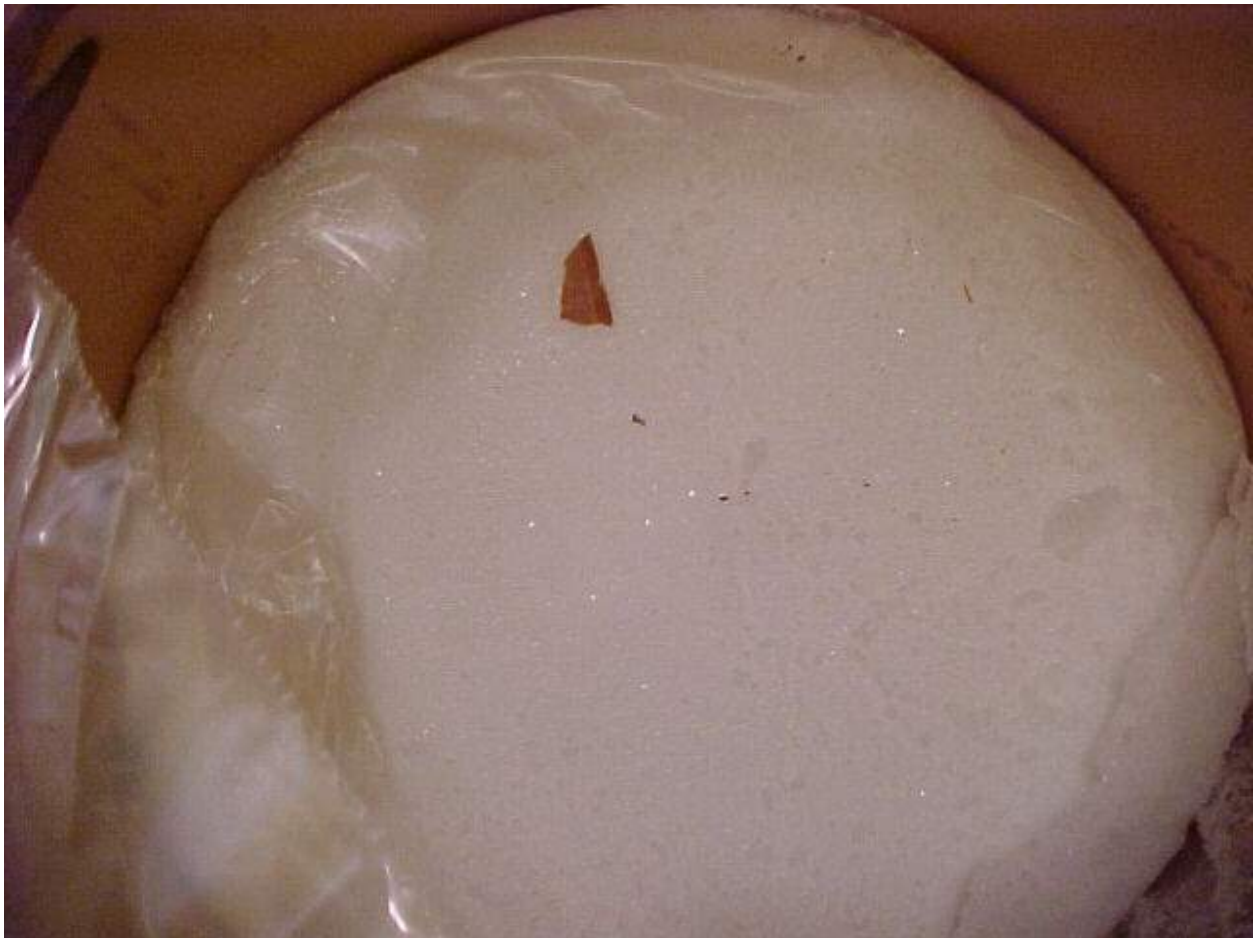
ThN material – solid – white – monolith - dry
No gasses present (in breathing zone)

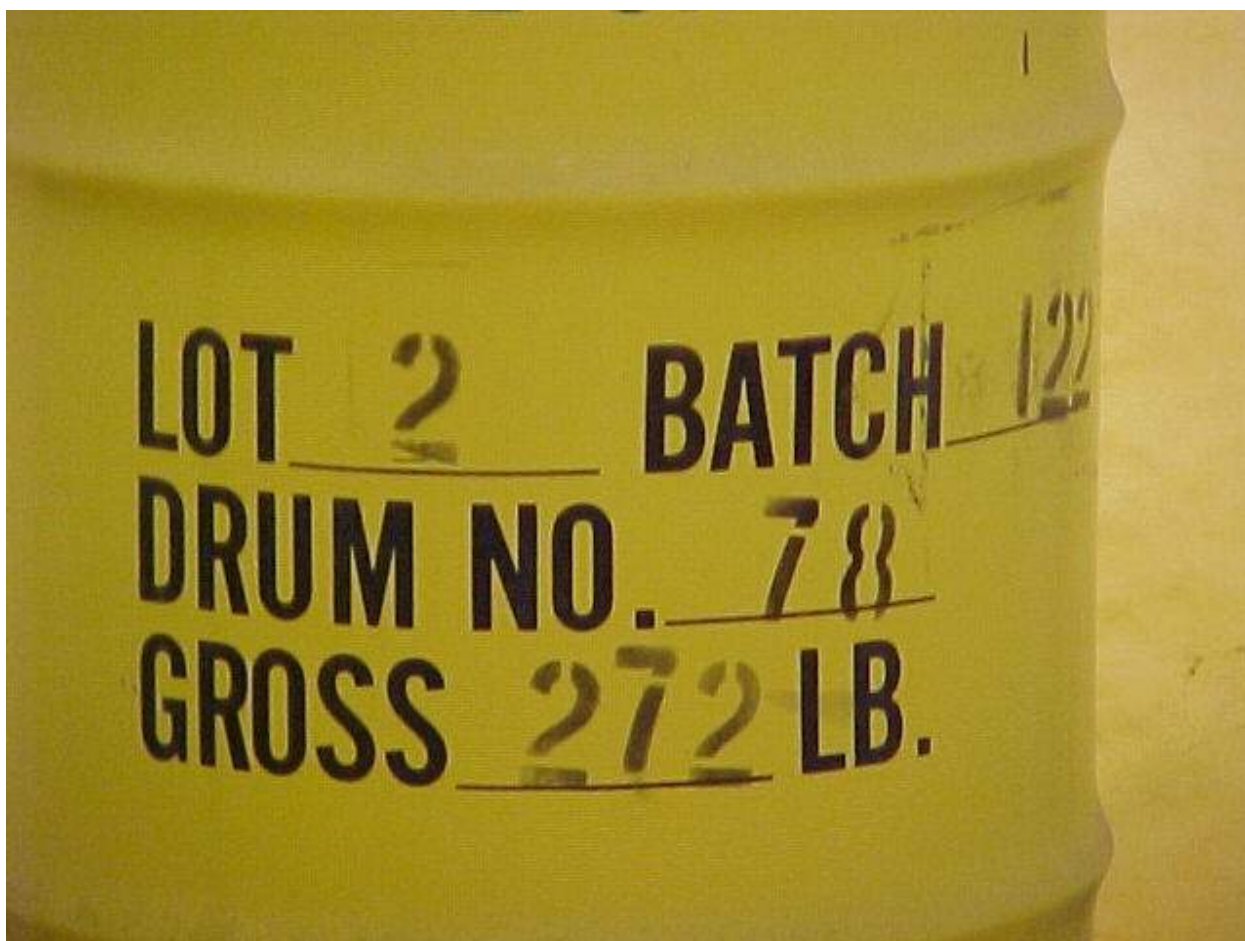
Container	<u>30-gallon steel drum</u>	Container	<u>good</u>
		Condition

Drum released pressure as bolt on drum ring was loosened – prior to complete removal of the drum ring, the drum lid pushed through the center of the ring springing off the drum 1' to 2' vertically. Utilized remote extension on air ratchet to loosen bolt to provide safe distance between operator and drum lid.

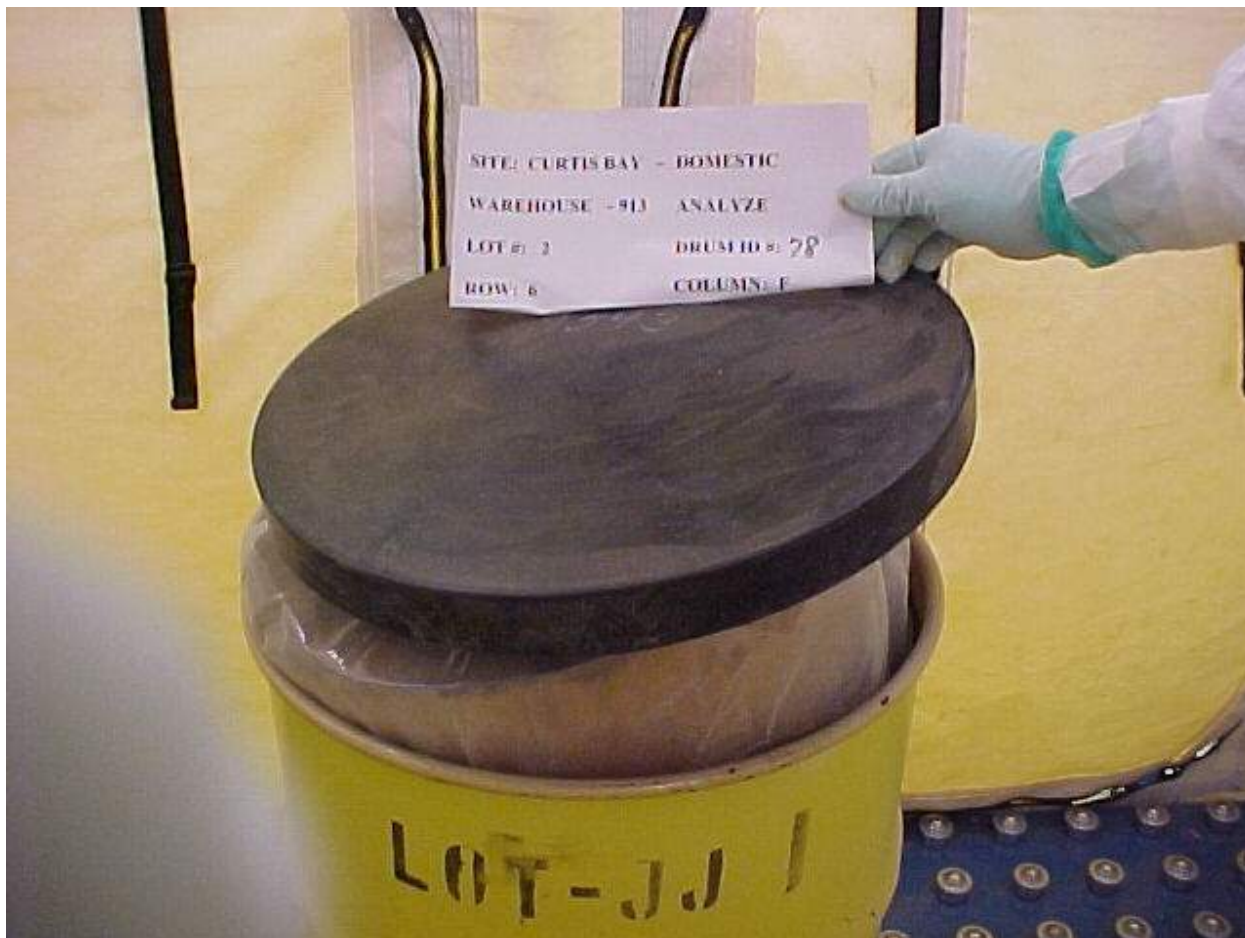
Black plastic lid – good condition Fiber lid – good condition

Pressure buildup inside of container raises poly liner/bag and lids vertically when drum lid is removed. No gasses present in the breathing zone.

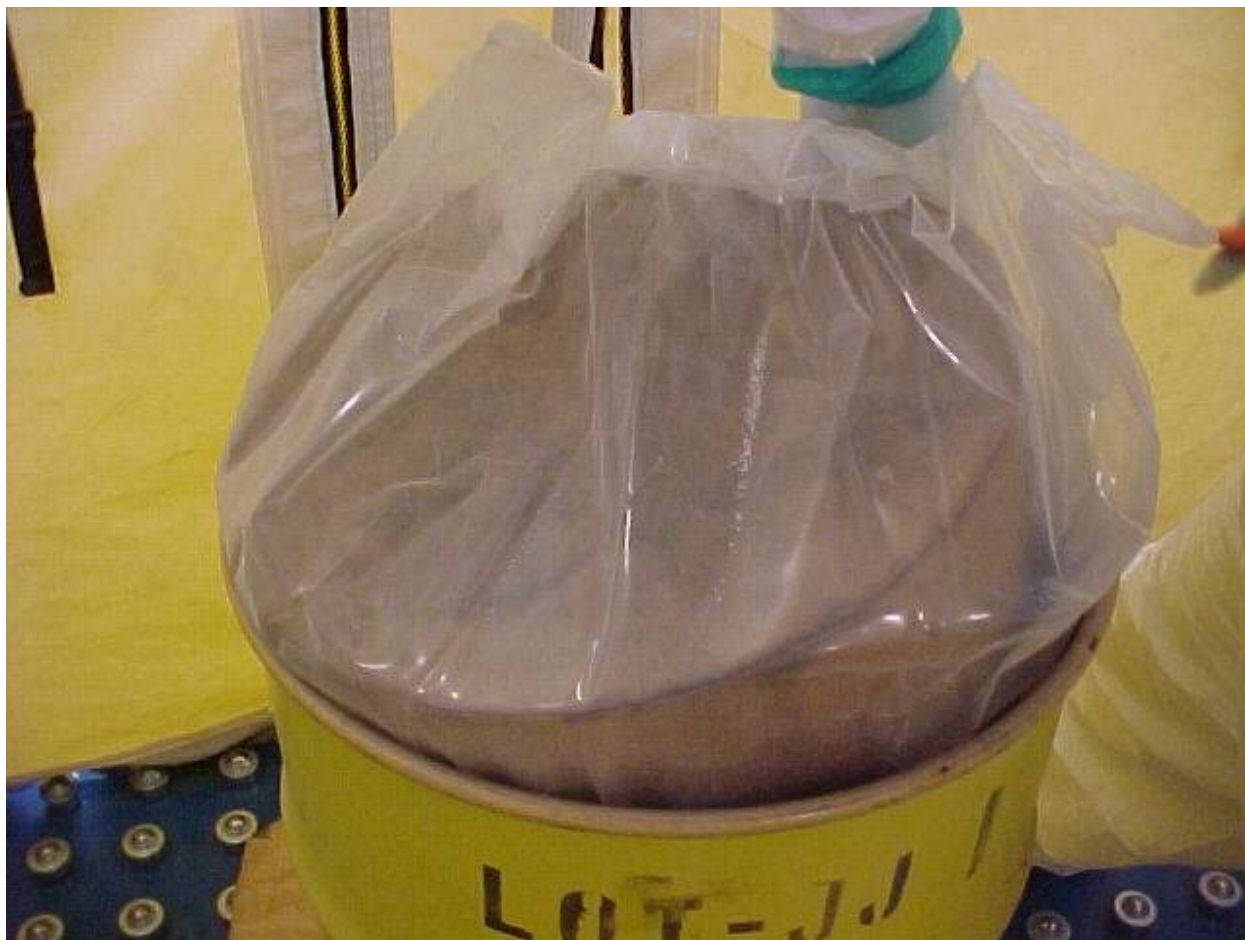
1st poly liner/bag – good condition – bag is pushed out of the drum vertically due to internal pressure buildup inside of innermost poly liner/bag (not the “thin film” poly liner around the actual ThN material).

No gasses present (in breathing zone)
