THORIUM NITRATE STOCKPILE DRUM CHARACTERIZATION REPORT

**THORIUM NITRATE STOCKPILE
DRUM CHARACTERIZATION REPORT**

Prepared for
U.S. Defense Logistics Agency
Defense National Stockpile Center
Fort Belvoir, Virginia

Prepared by
OAK RIDGE NATIONAL LABORATORY
Oak Ridge, Tennessee 37831
managed by
UT-BATTELLE, LLC
for the
U.S. DEPARTMENT OF ENERGY
under contract DE-AC05-00OR22725

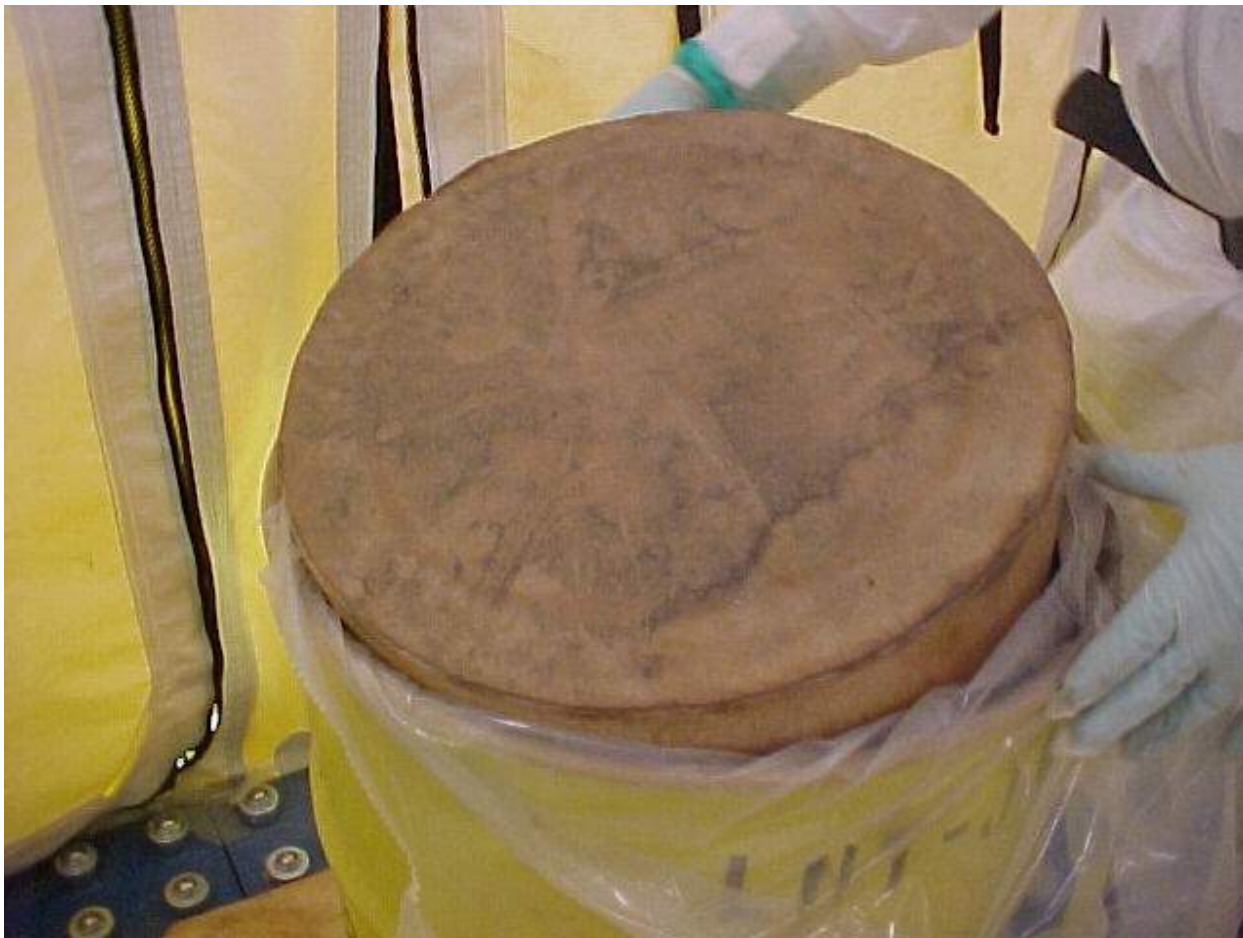
Photo shows the fiber drum lid on outermost fiber drum (inside of 30-gal drum) – good condition.
 Lid tape has separated from fiber drum due to internal pressure inside of drum.
 No gasses present (in breathing zone)

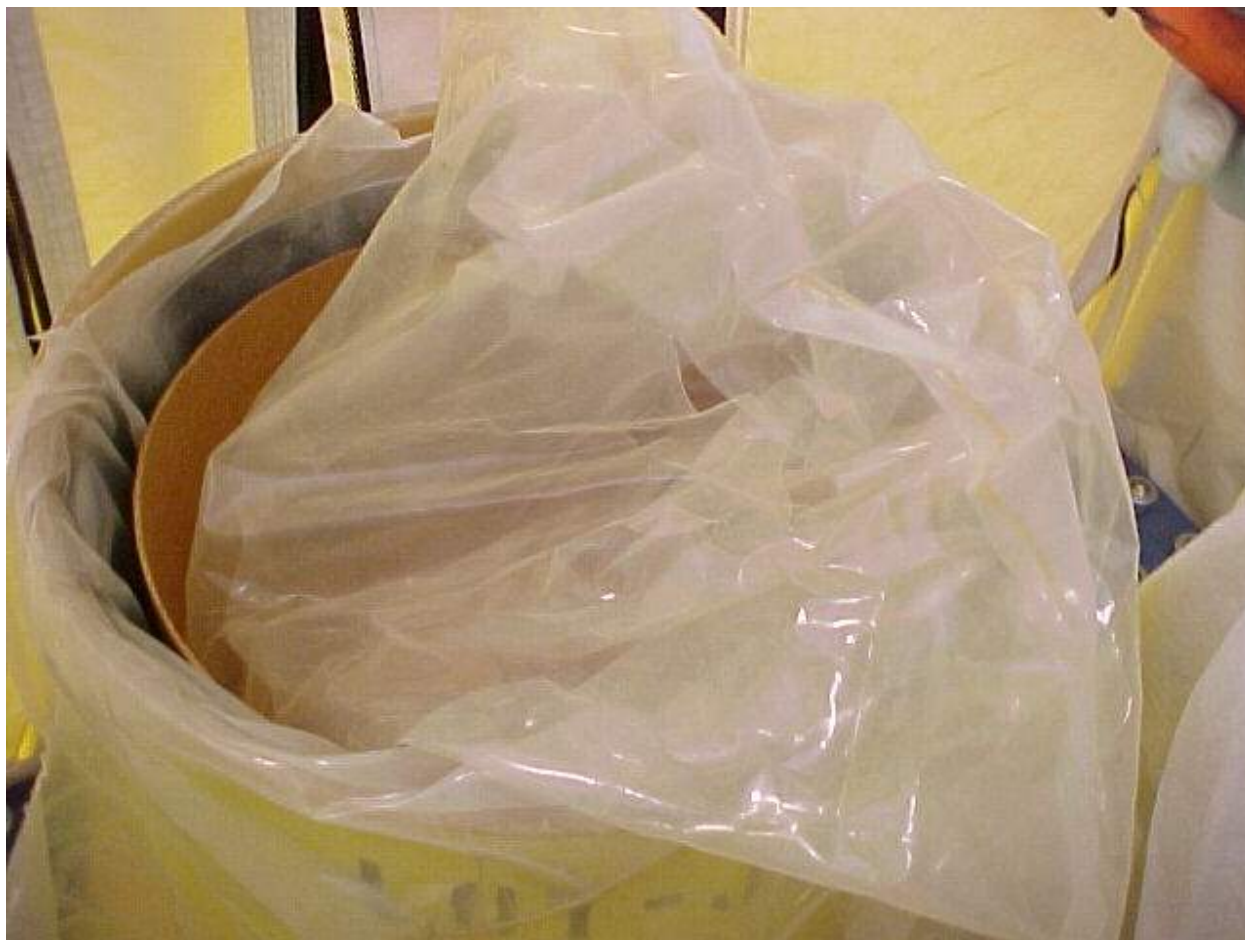
2nd poly liner/bag – good condition – pressure buildup inside container raises this poly liner/bag vertically out of container
No gasses present (in breathing zone)

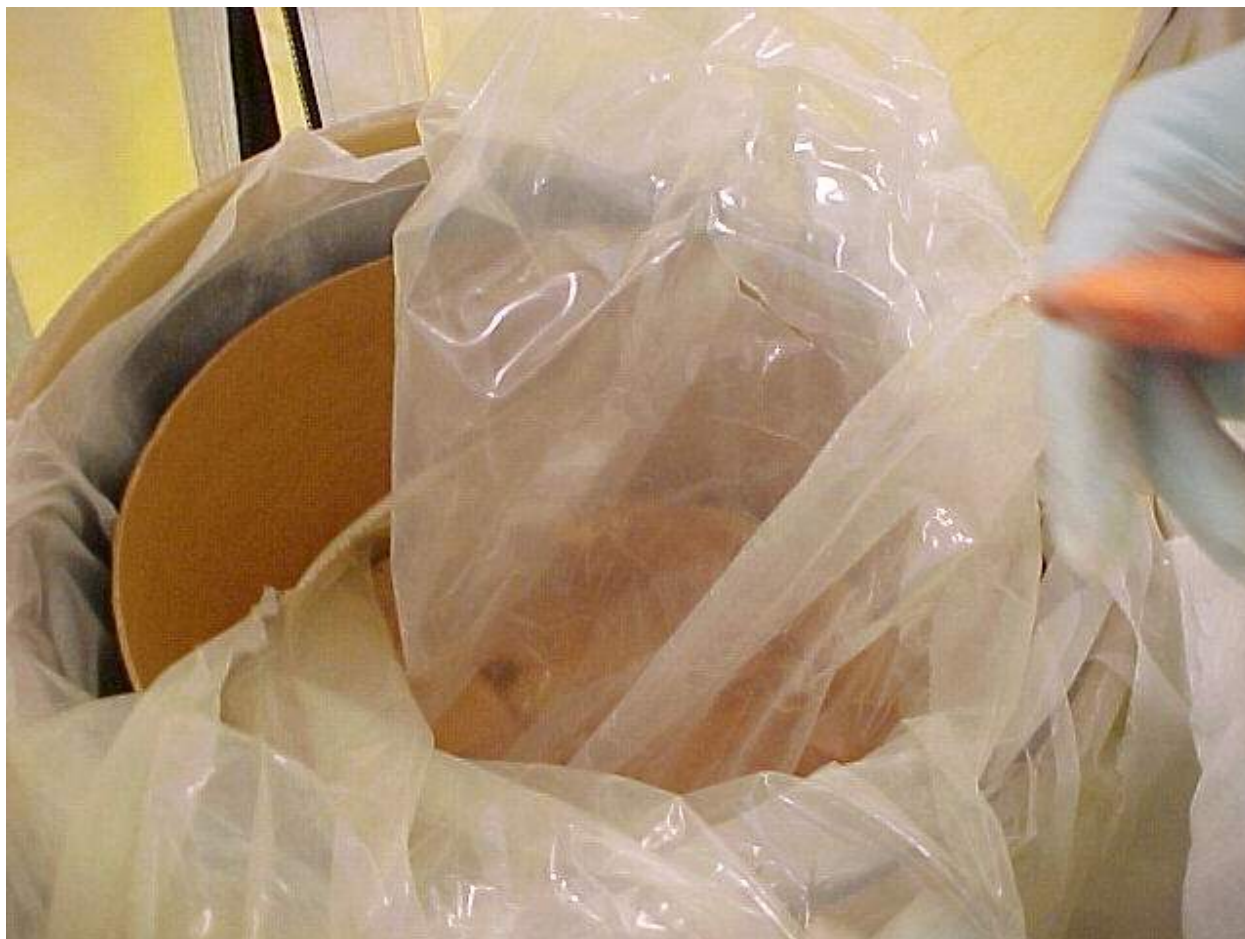
3rd poly liner/bag – good condition – this bag appears to be holding majority of gas pressure inside of drum; although, it does not “pop” when you cut the bag with an utility knife.
Opened poly liner/bag - No gasses present (in breathing zone)
Gasses in headspace – LEL – 4.6% - NO – +50.0ppm – NOx – +50.0ppm
Drum/bag vented - All gasses dissipated through HEPA blower suction directly over drum

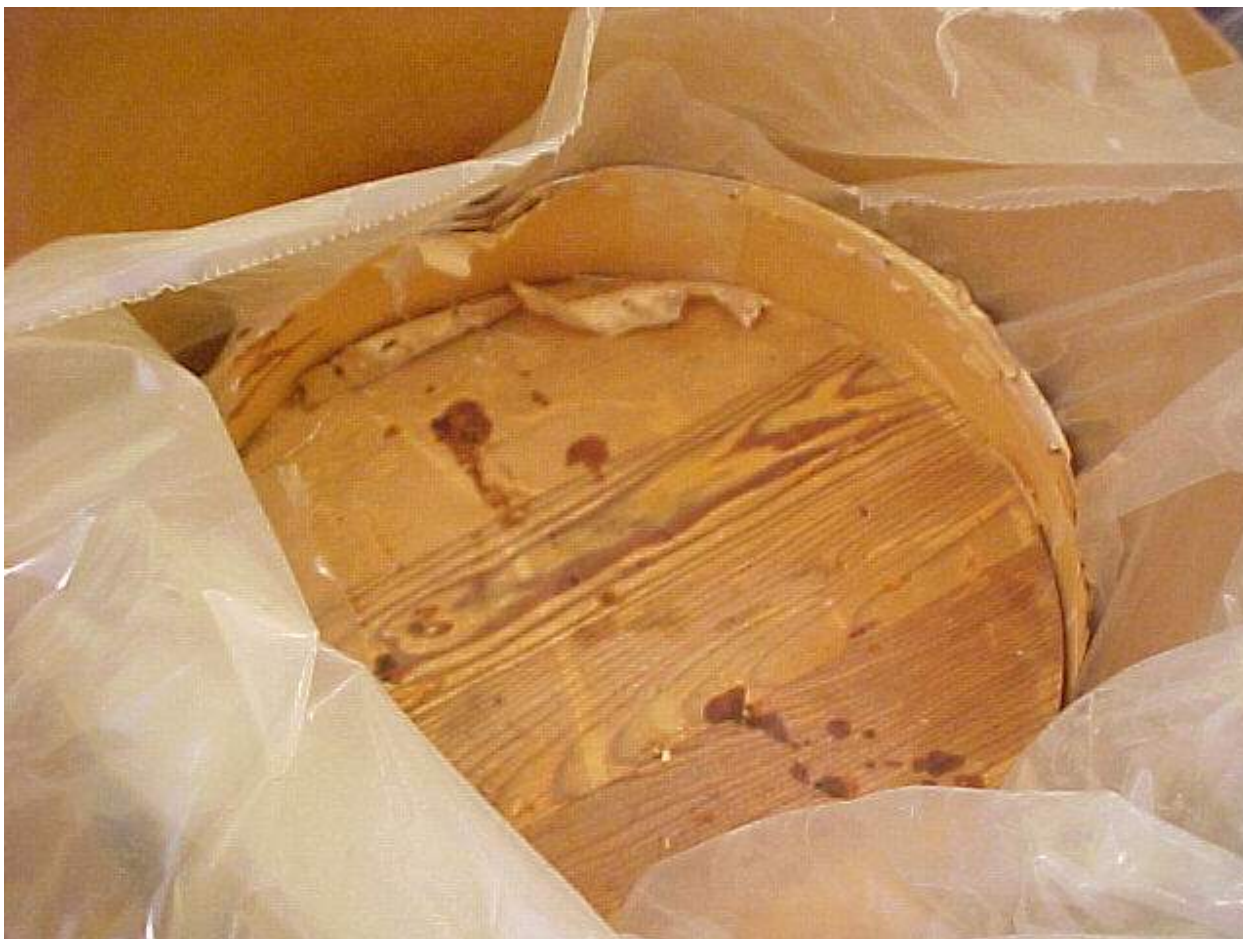
08:00**Other Information**Photo No. 7 of 10Dose Rate Surface 26 mR/hr
 1 meter 2.1 mR/hr

Wooden lid [mounted to inner fiber drum (lab-pack container)] – good condition
No gasses present (in breathing zone)

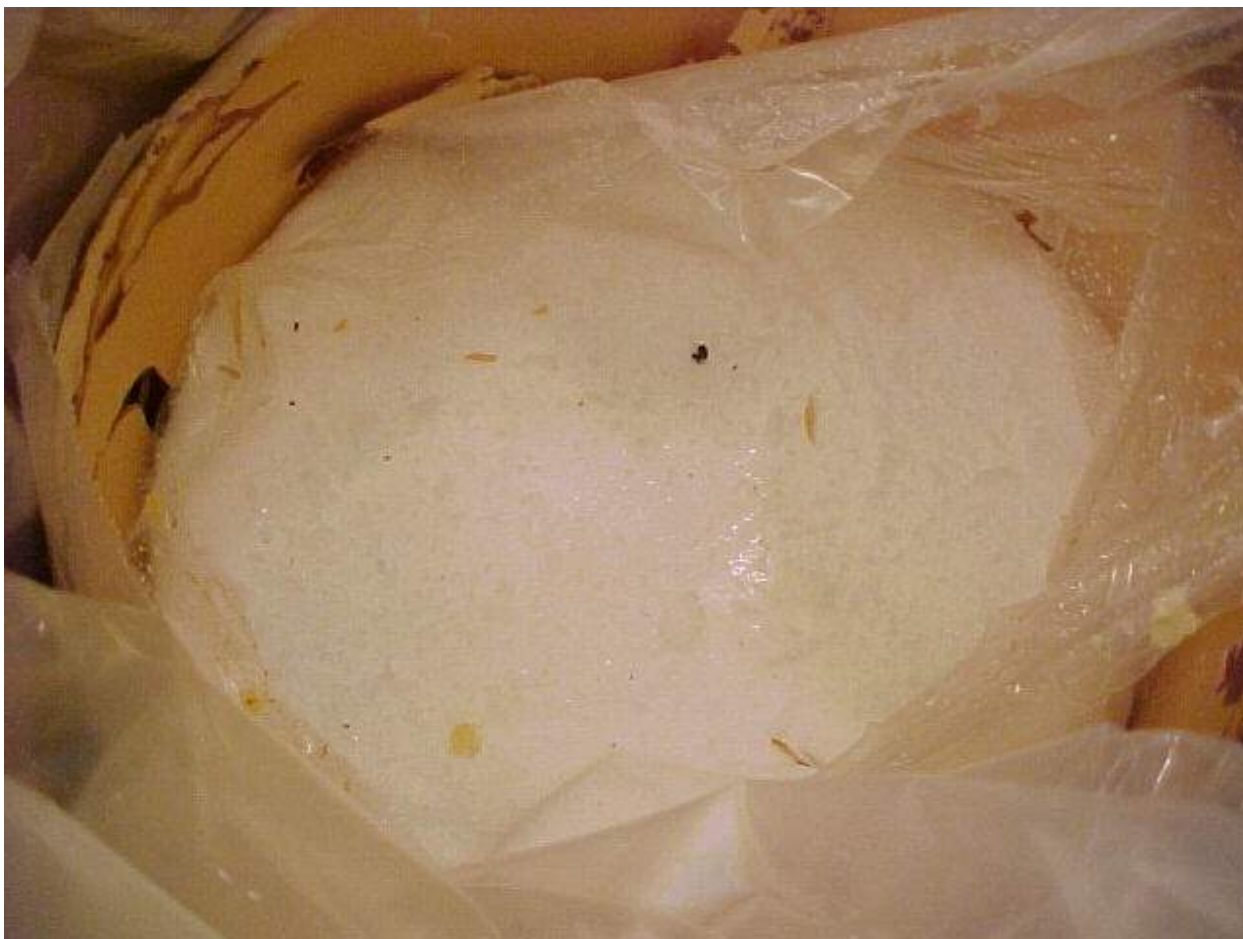
08:00**Other Information**Photo No. 9 of 10Dose Rate Surface 26 mR/hr
 1 meter 2.1 mR/hr

Thorium Nitrate – monolith – white – solid - dry
No gasses present (in breathing zone)

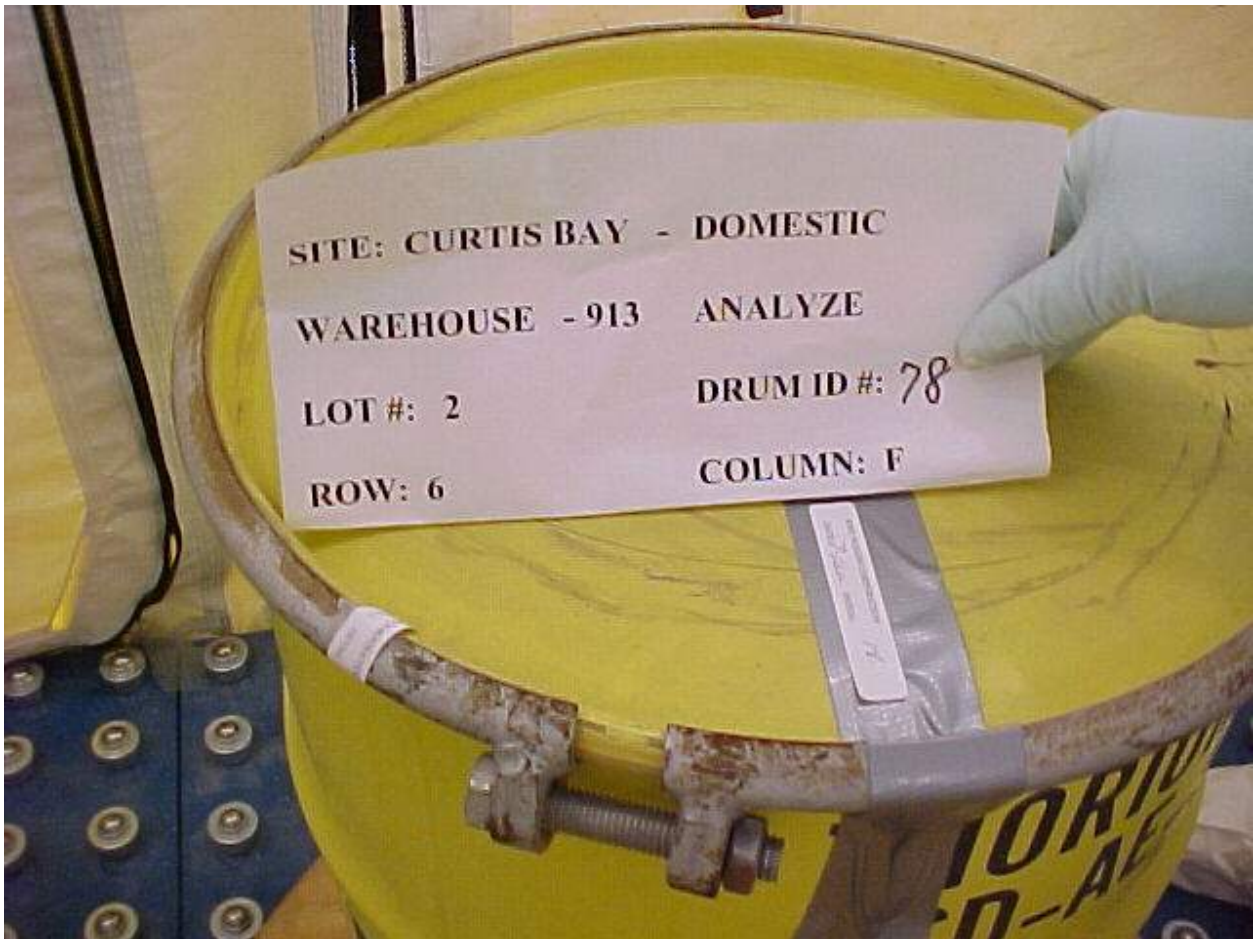
Sealed & dated - Complete

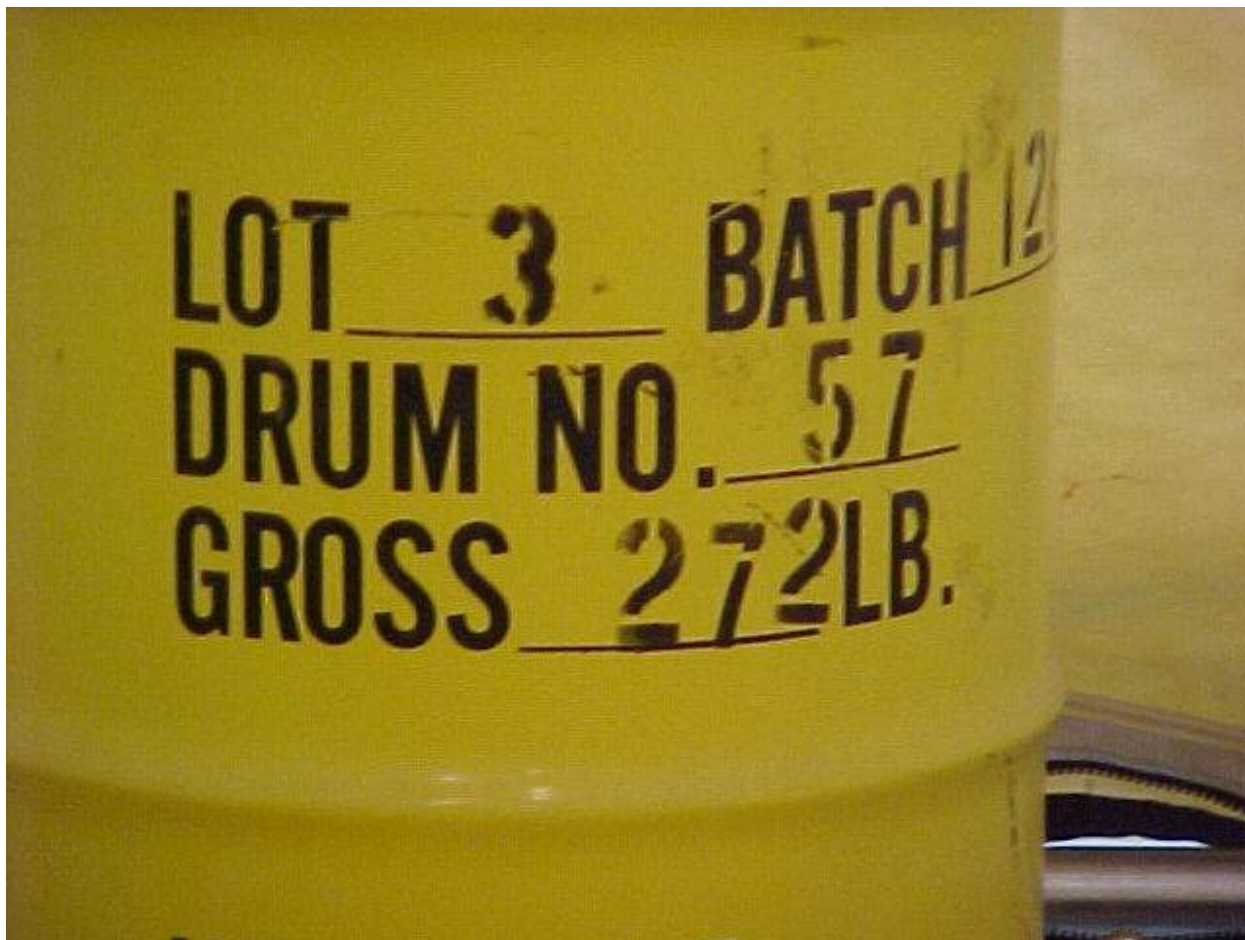
30-gal steel drum – good condition

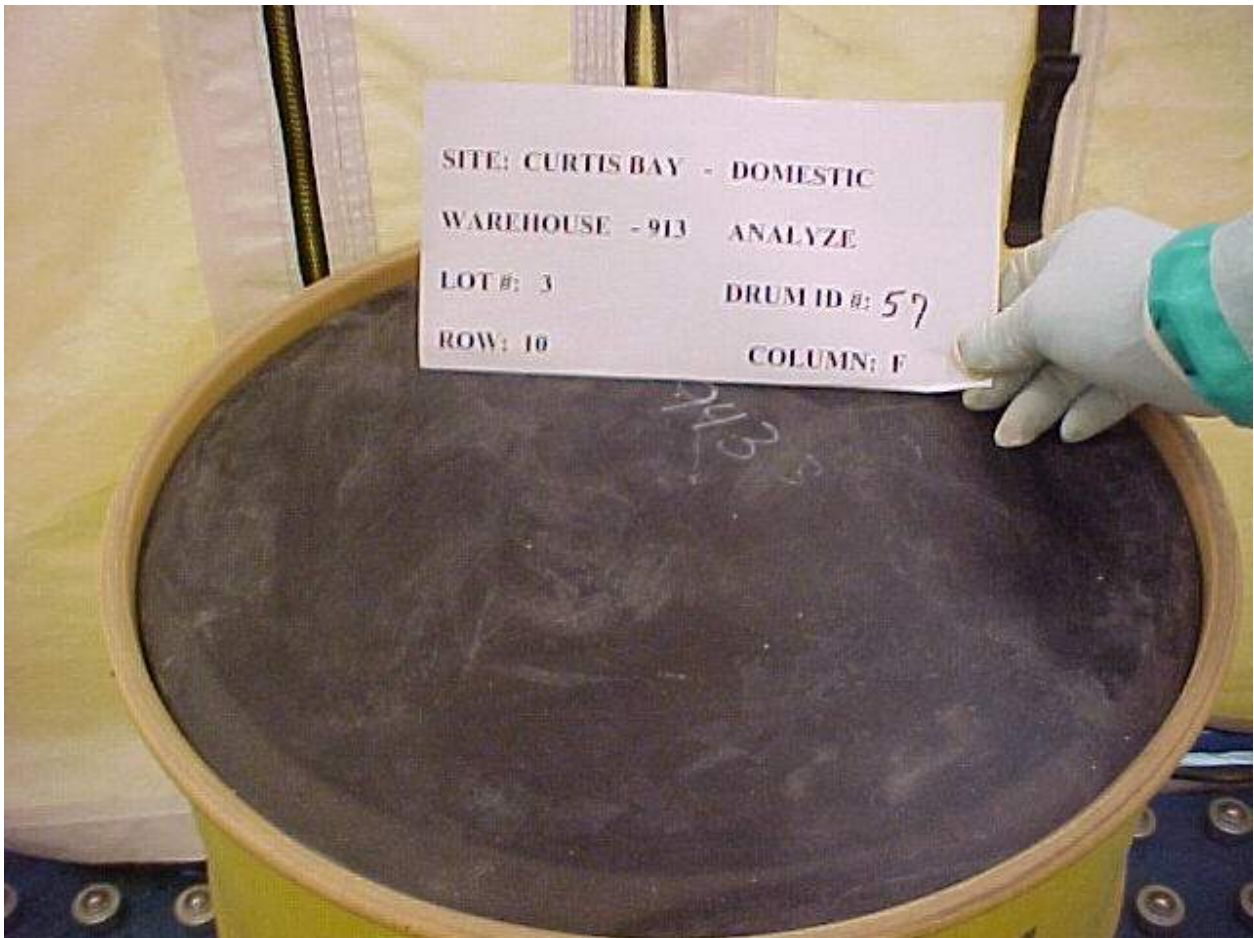
Black plastic lid (from drum liner) – good condition
No gasses present (in breathing zone)

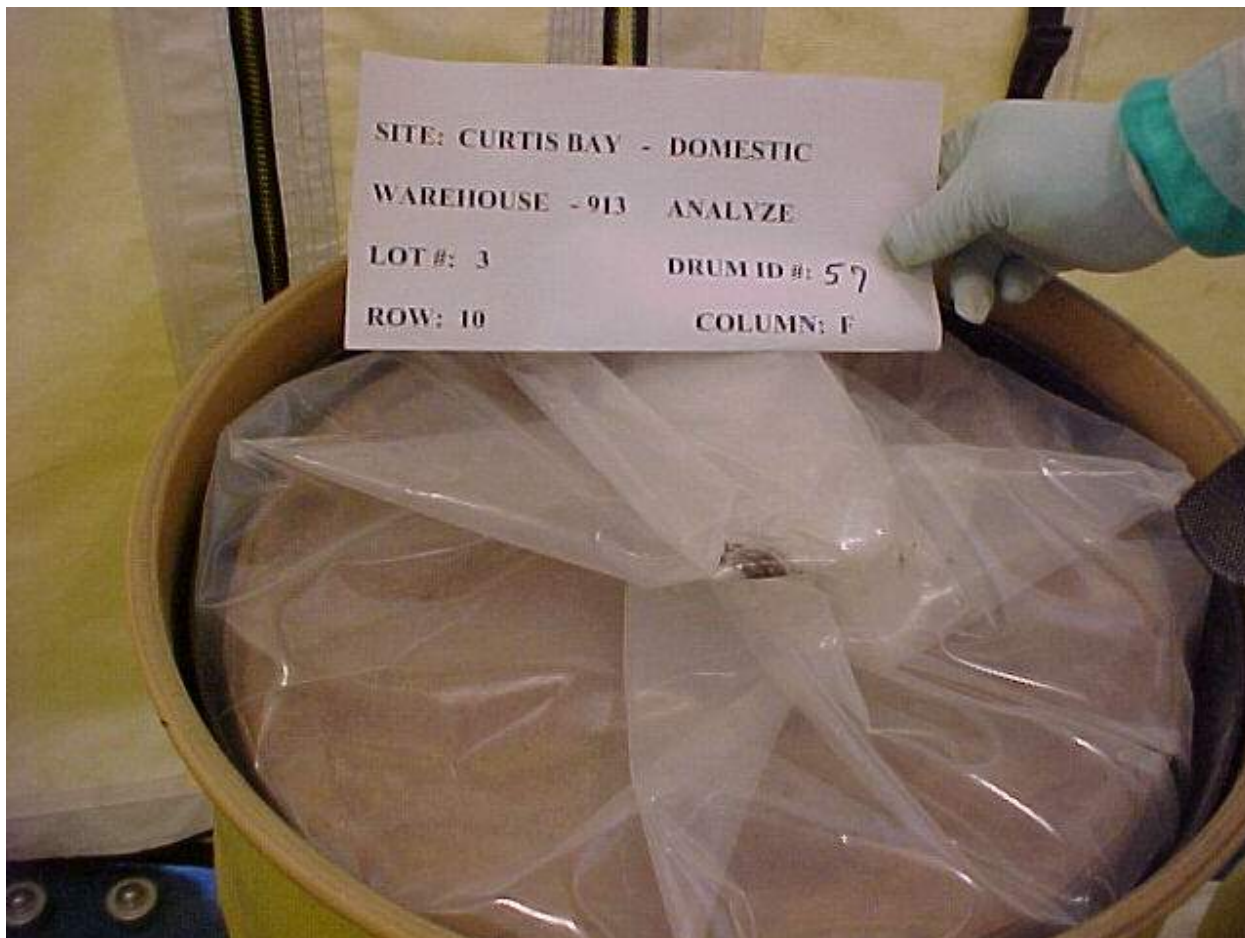
1st poly liner/bag – good condition
No gasses present (in breathing zone)

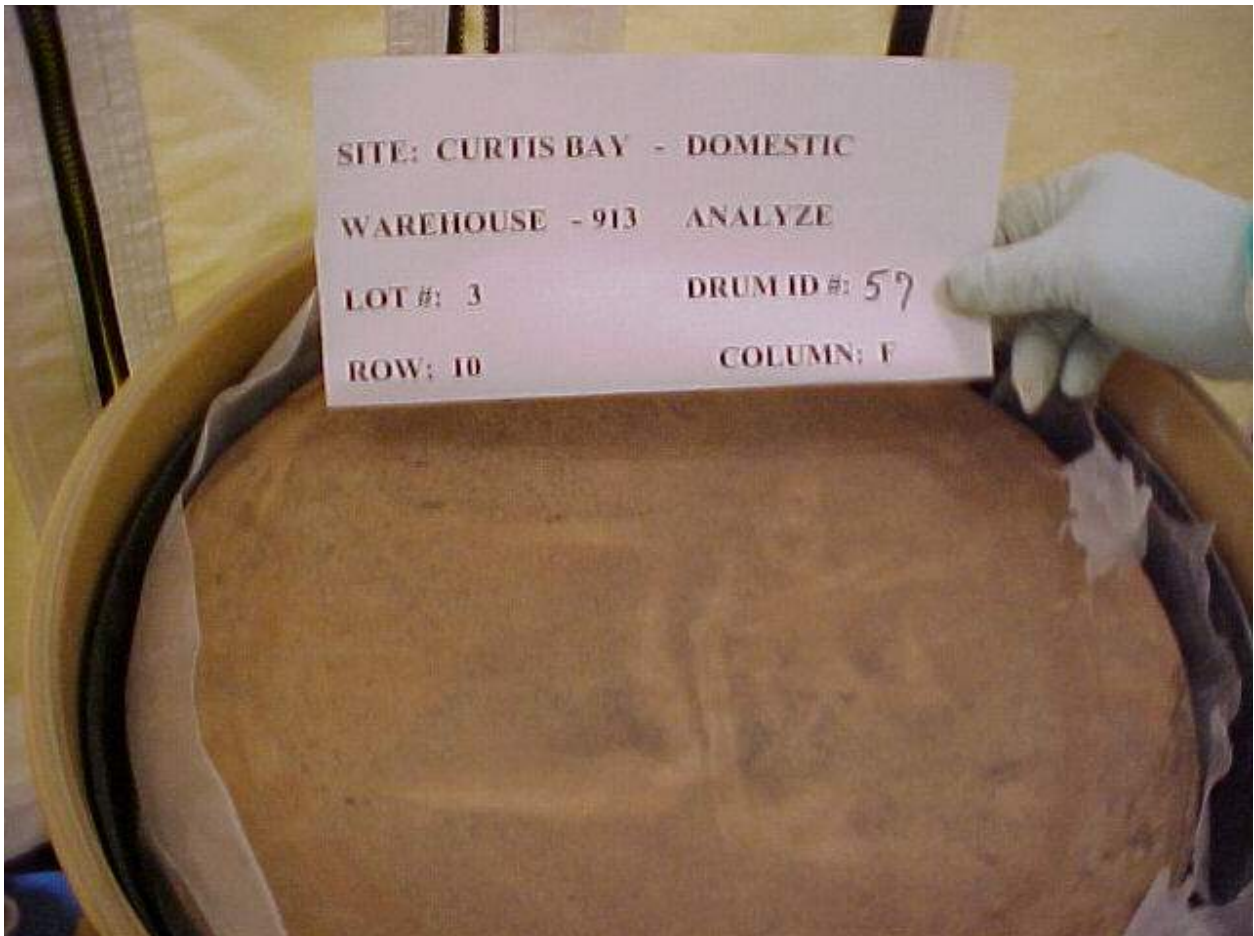
Fiber lid (from outermost fiber drum) – good condition
No gasses present (in breathing zone)

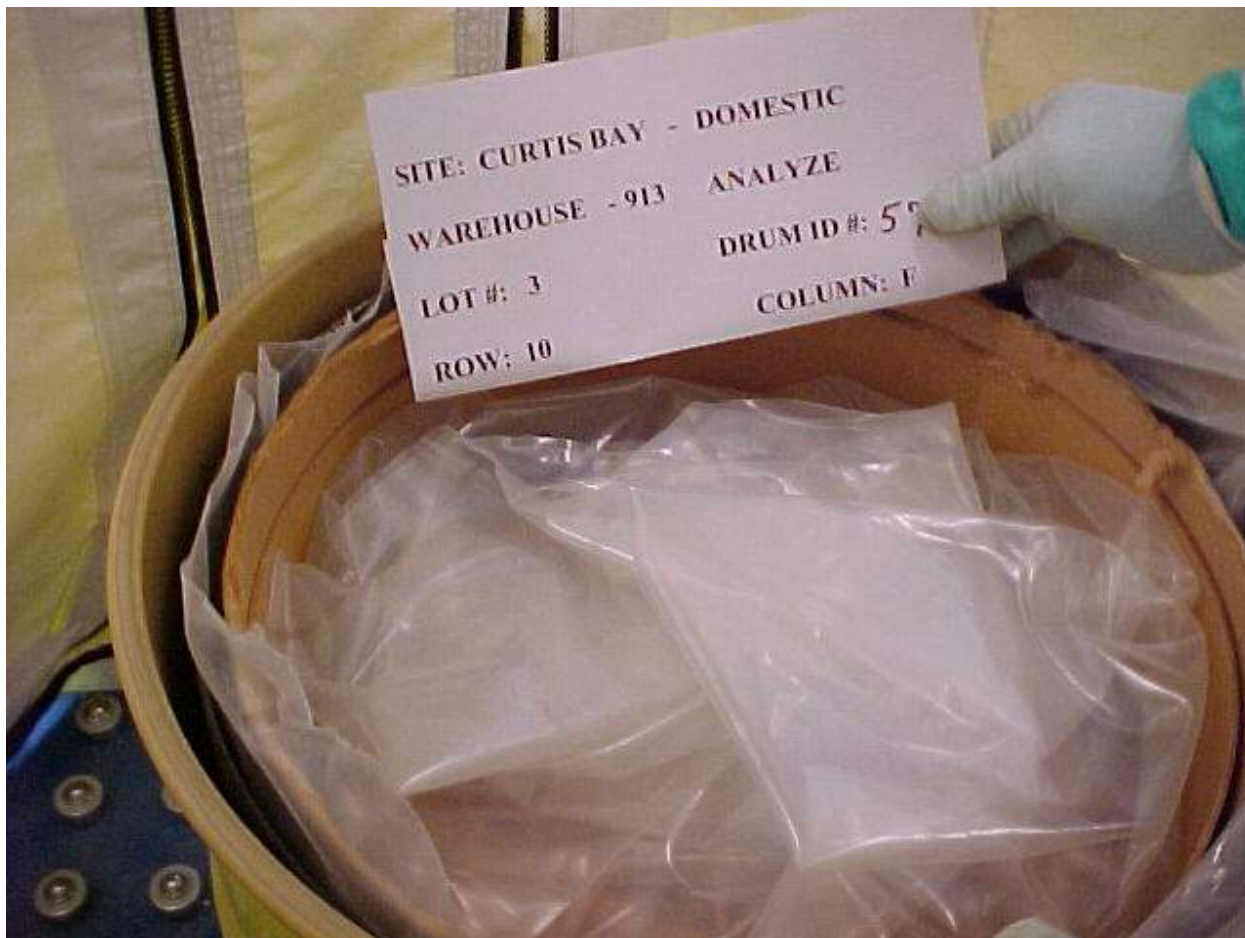
2nd poly liner/bag – good condition
No gasses present (in breathing zone)

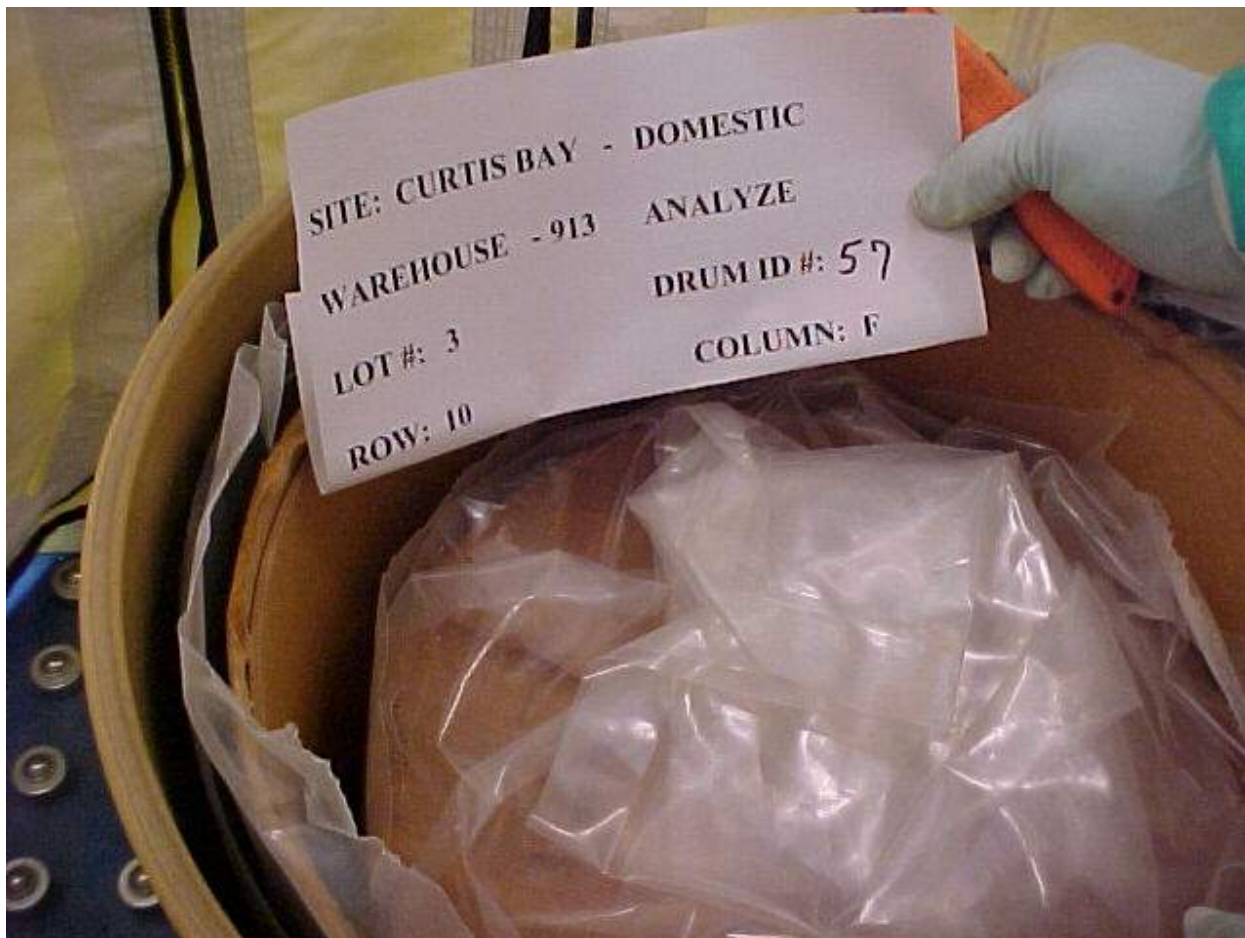
3rd poly liner/bag – good condition
No gasses present (in breathing zone)

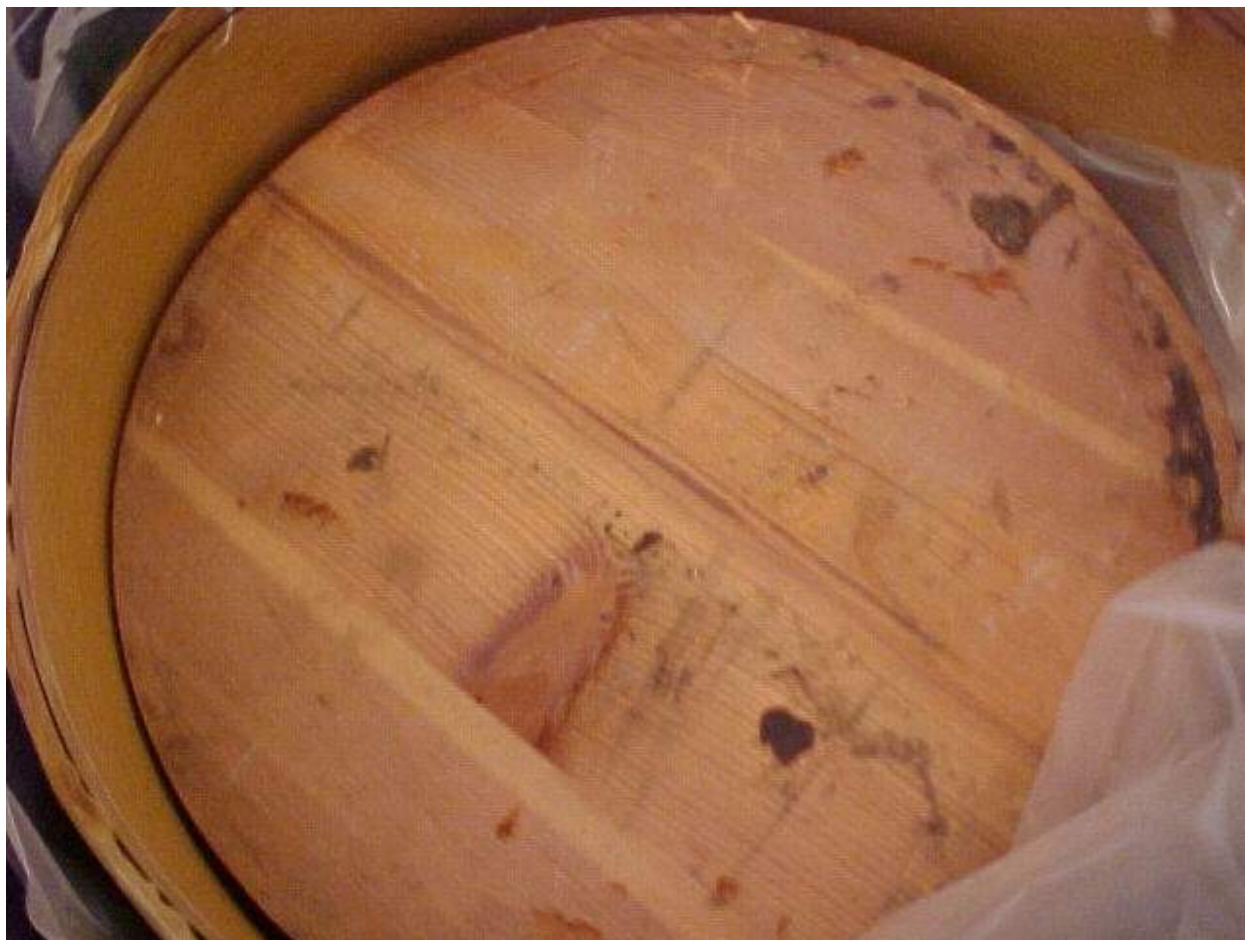
Wooden lid [mounted to inner fiber drum (lab-pack)] – good condition
No gasses present (in breathing zone)

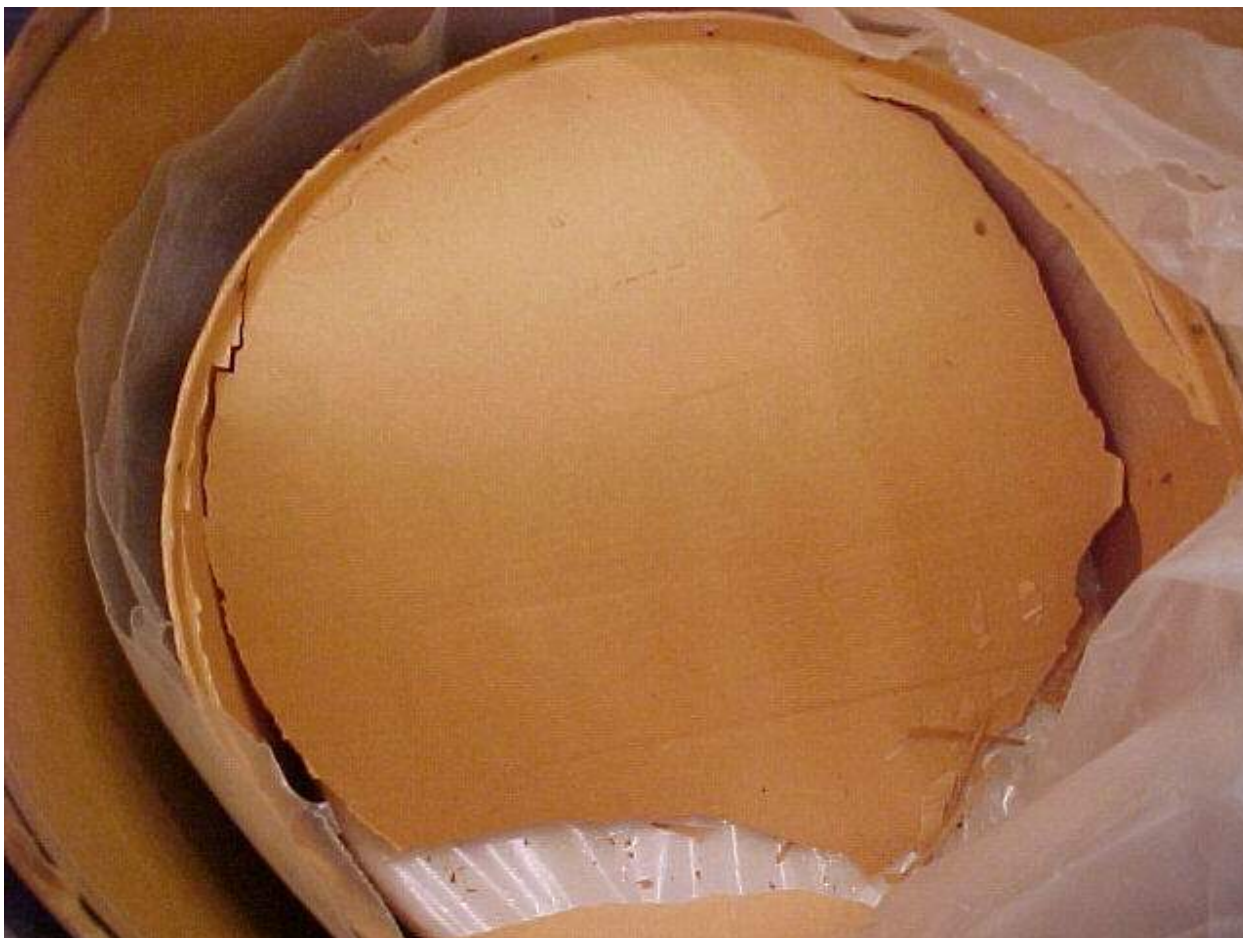
Inner fiber drum (lab-pack) is shown in this photo – there is a thin paper layer under the wooden lid (previous photo) that is part of this fiber drum – the paper typically tears when you remove the wooden lid.

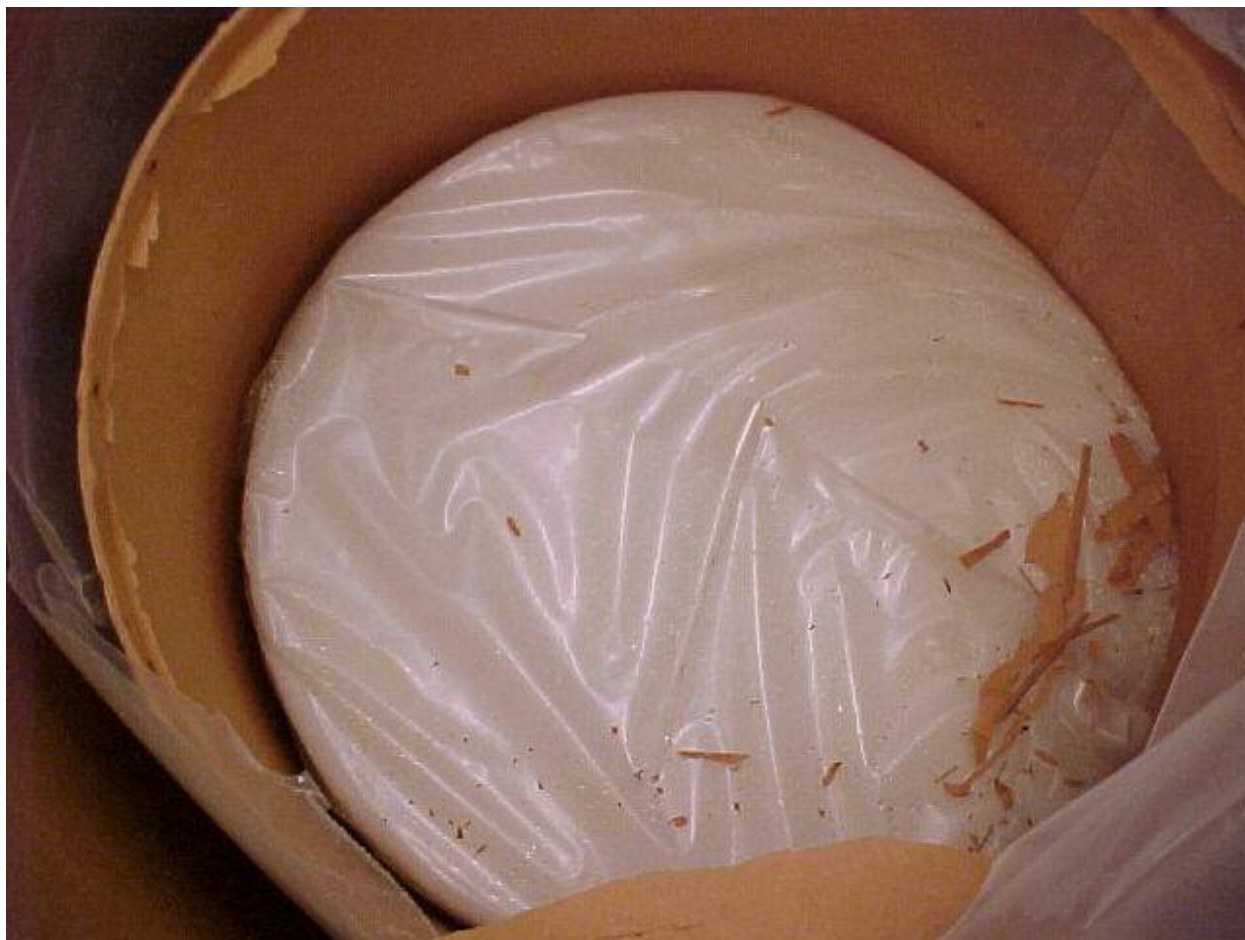
4th poly liner/bag (thin film plastic) – good condition
No gasses present (in breathing zone)

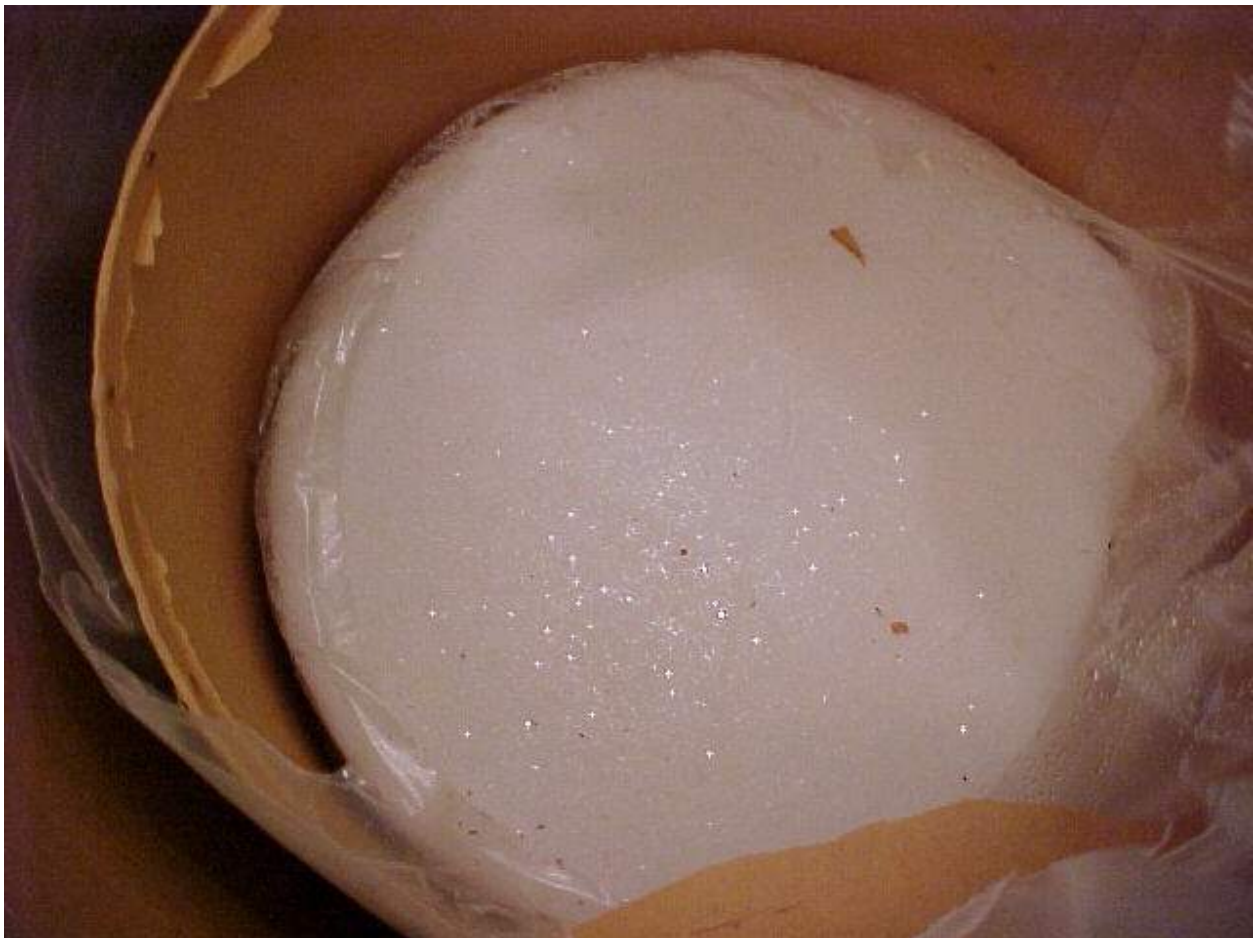
ThN material – monolith – solid – white - dry
No gasses present (in breathing zone)

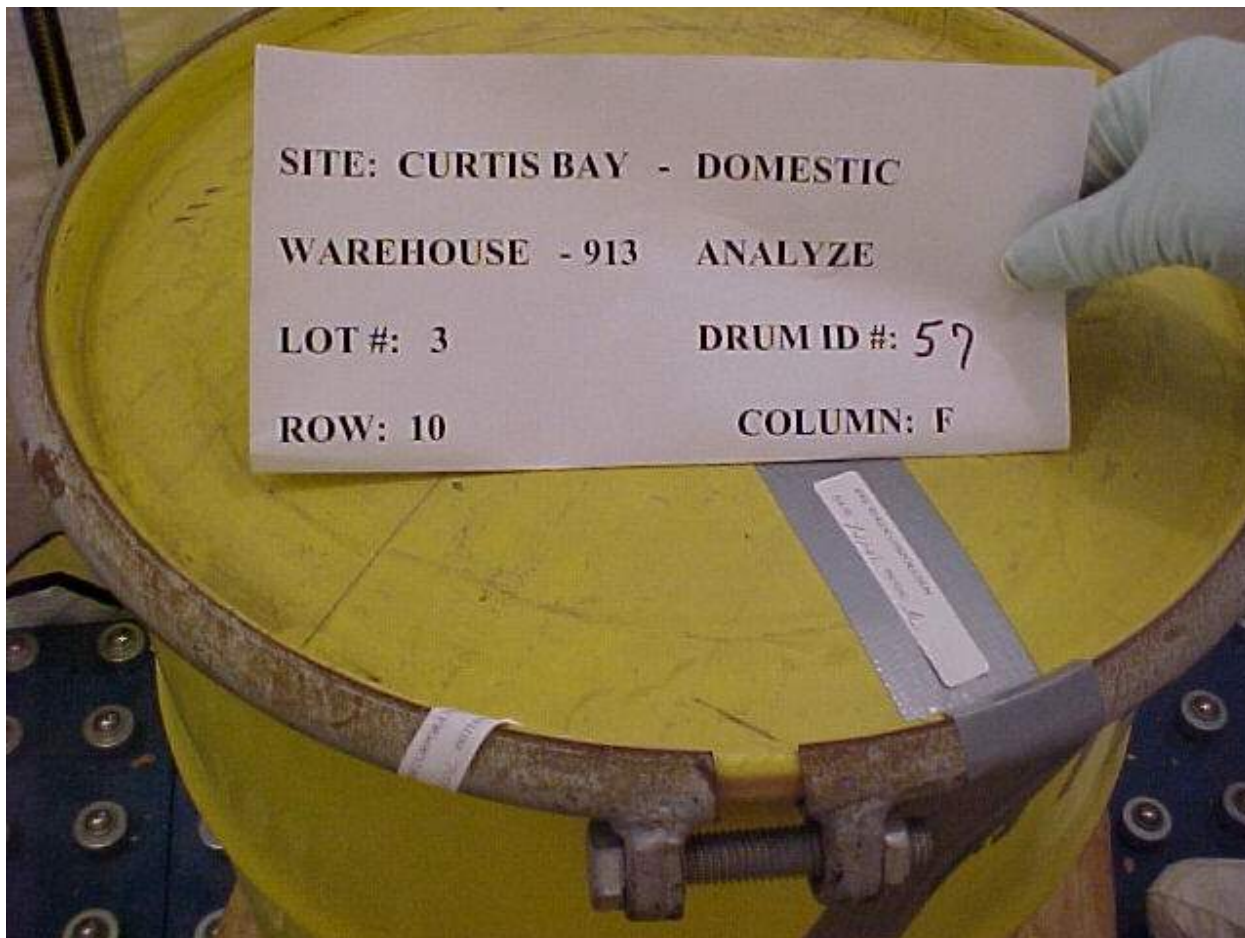
Sealed & dated - Complete

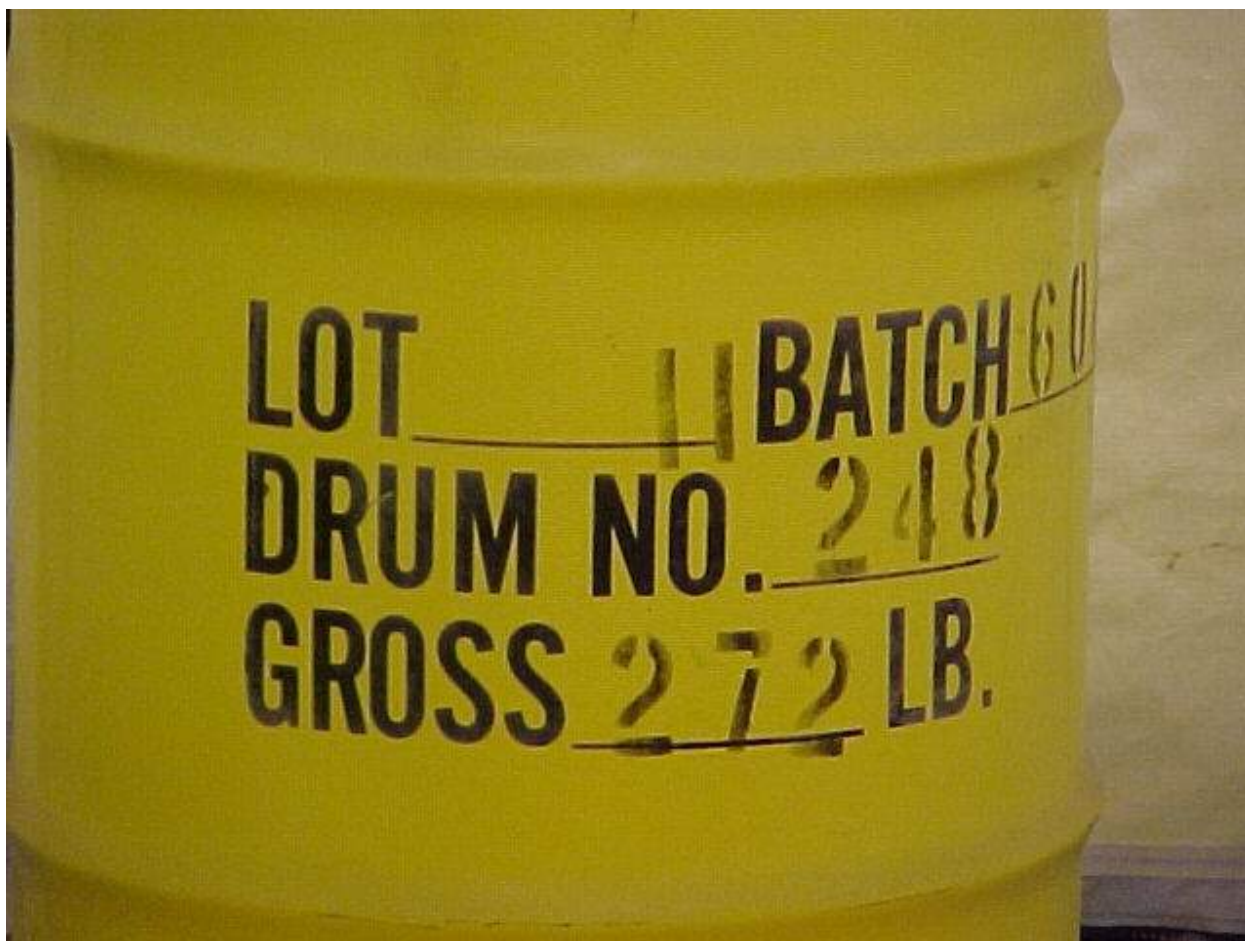
14:15**Other Information**Photo No. 1 of 10Dose Rate Surface 22 mR/hr
 1 meter 2.0 mR/hr

30-gal drum – good condition

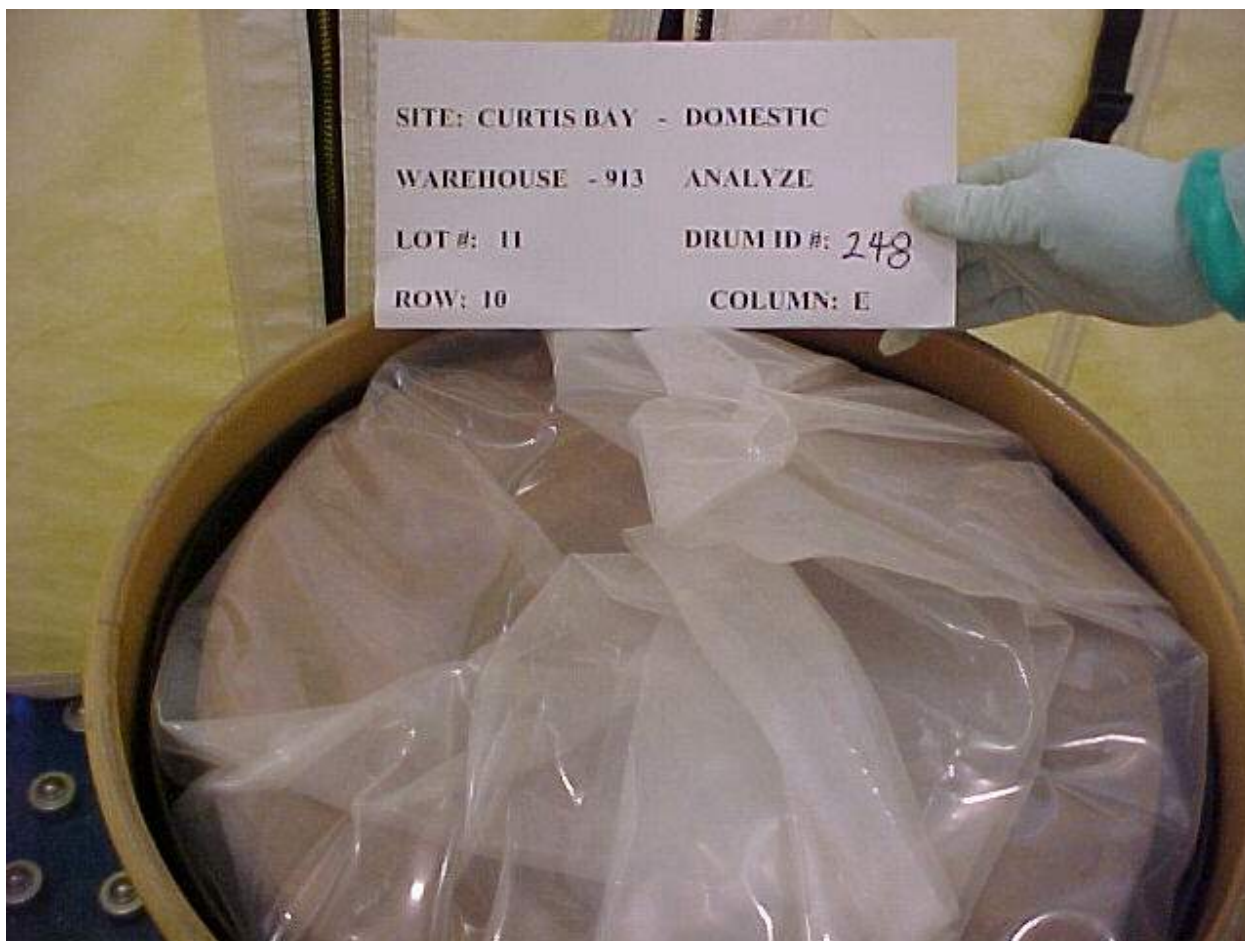
14:15**Other Information**Photo No. 3 of 10Dose Rate Surface 22 mR/hr
 1 meter 2.0 mR/hr1st poly liner/bag – good condition
No gasses present (in breathing zone)
