THORIUM NITRATE STOCKPILE DRUM CHARACTERIZATION REPORT

**THORIUM NITRATE STOCKPILE
DRUM CHARACTERIZATION REPORT**

Prepared for
U.S. Defense Logistics Agency
Defense National Stockpile Center
Fort Belvoir, Virginia

Prepared by
OAK RIDGE NATIONAL LABORATORY
Oak Ridge, Tennessee 37831
managed by
UT-BATTELLE, LLC
for the
U.S. DEPARTMENT OF ENERGY
under contract DE-AC05-00OR22725

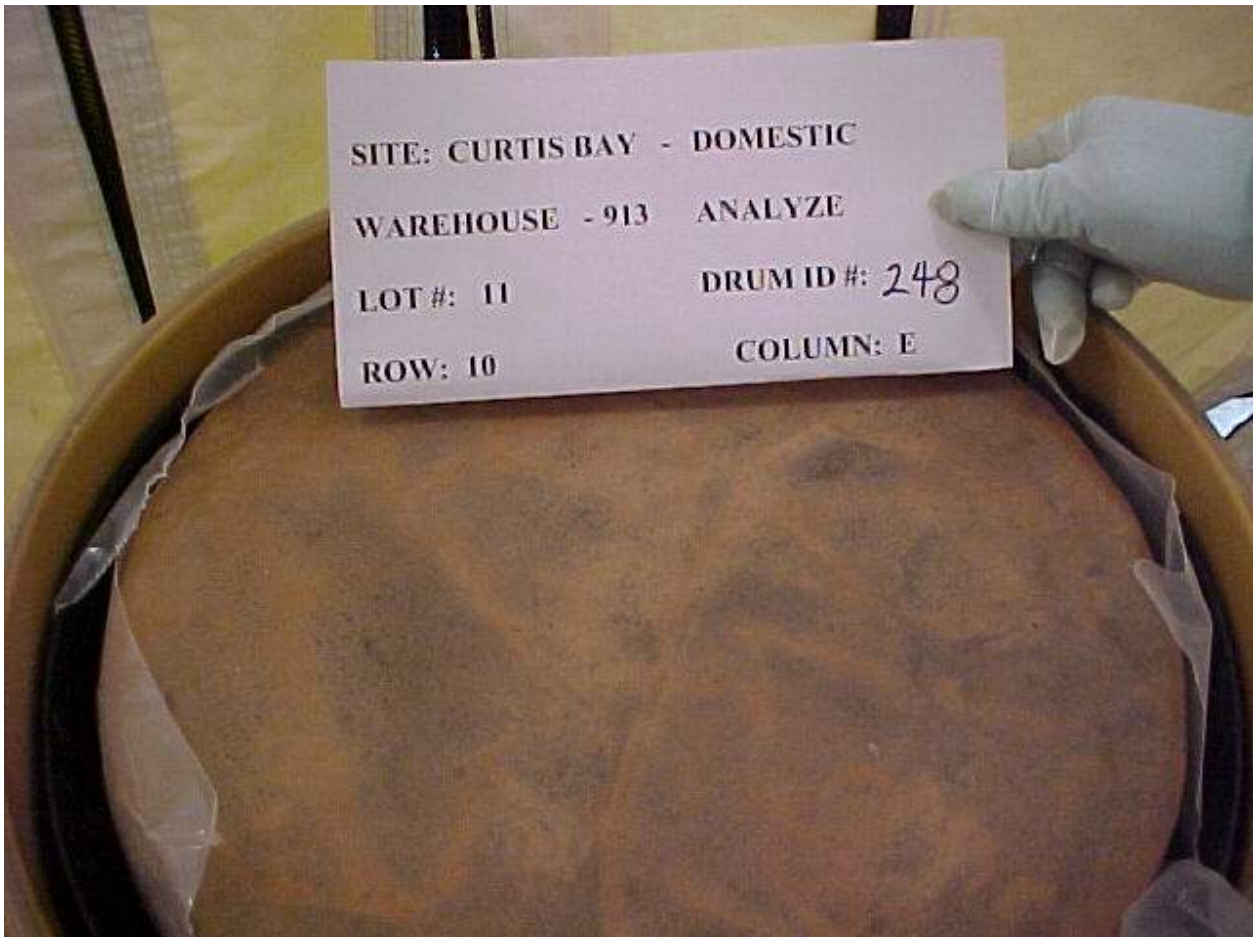
Fiber lid on outermost fiber drum – good condition
No gasses present (in breathing zone)

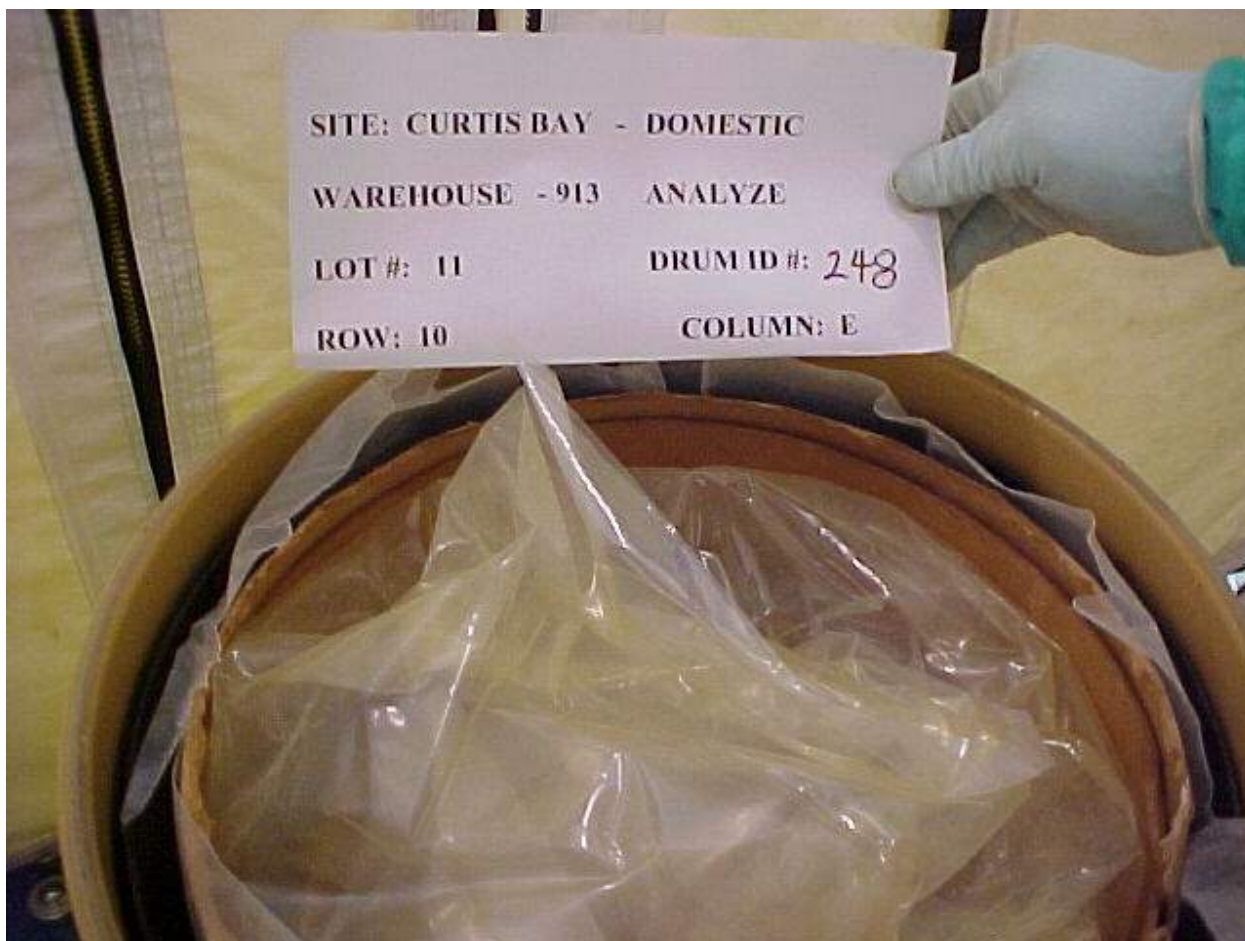
14:15**Other Information**Photo No. 5 of 10Dose Rate Surface 22 mR/hr
 1 meter 2.0 mR/hr2nd poly liner/bag – good condition
No gasses present (in breathing zone)

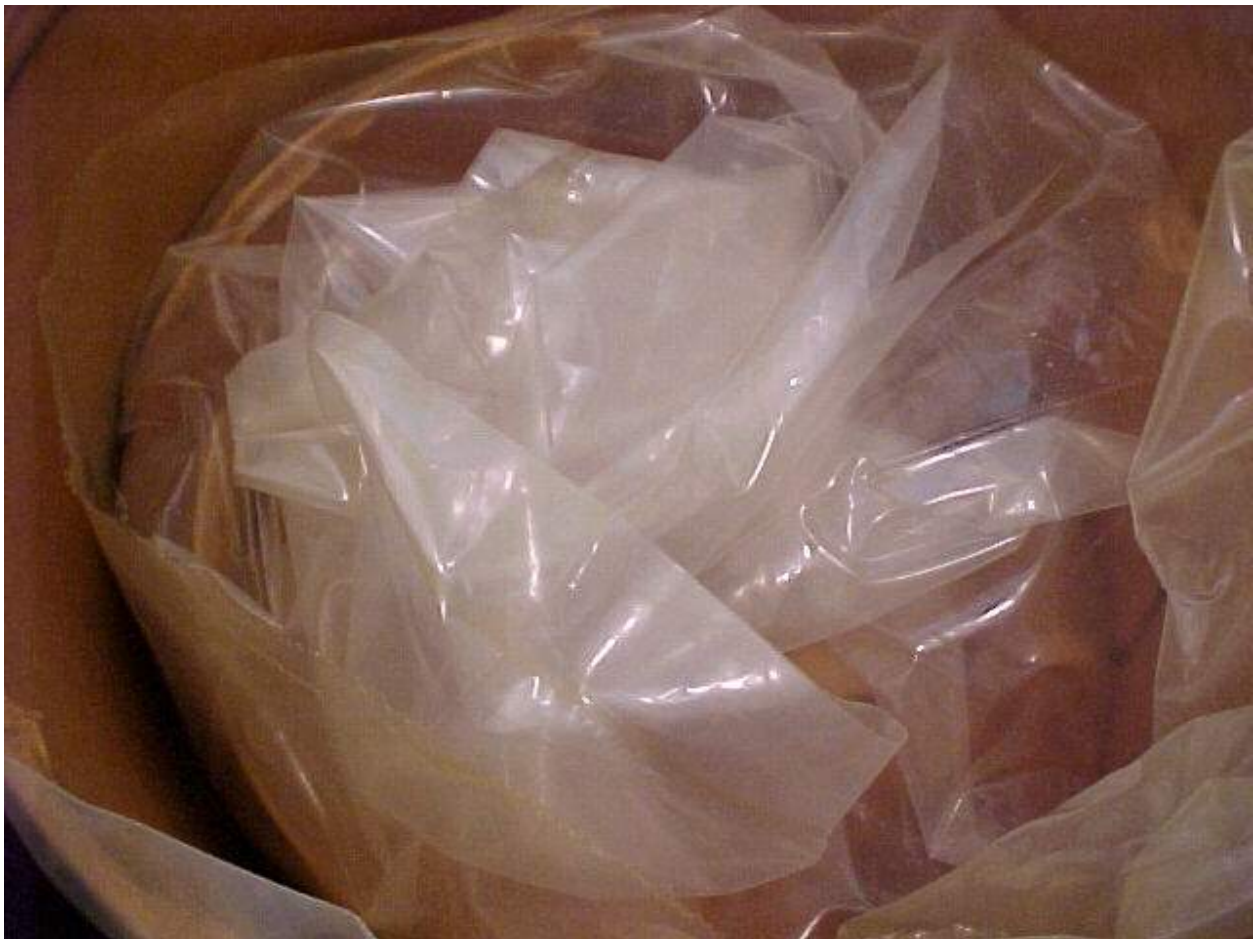
3rd poly liner/bag – good condition
No gasses present (in breathing zone)

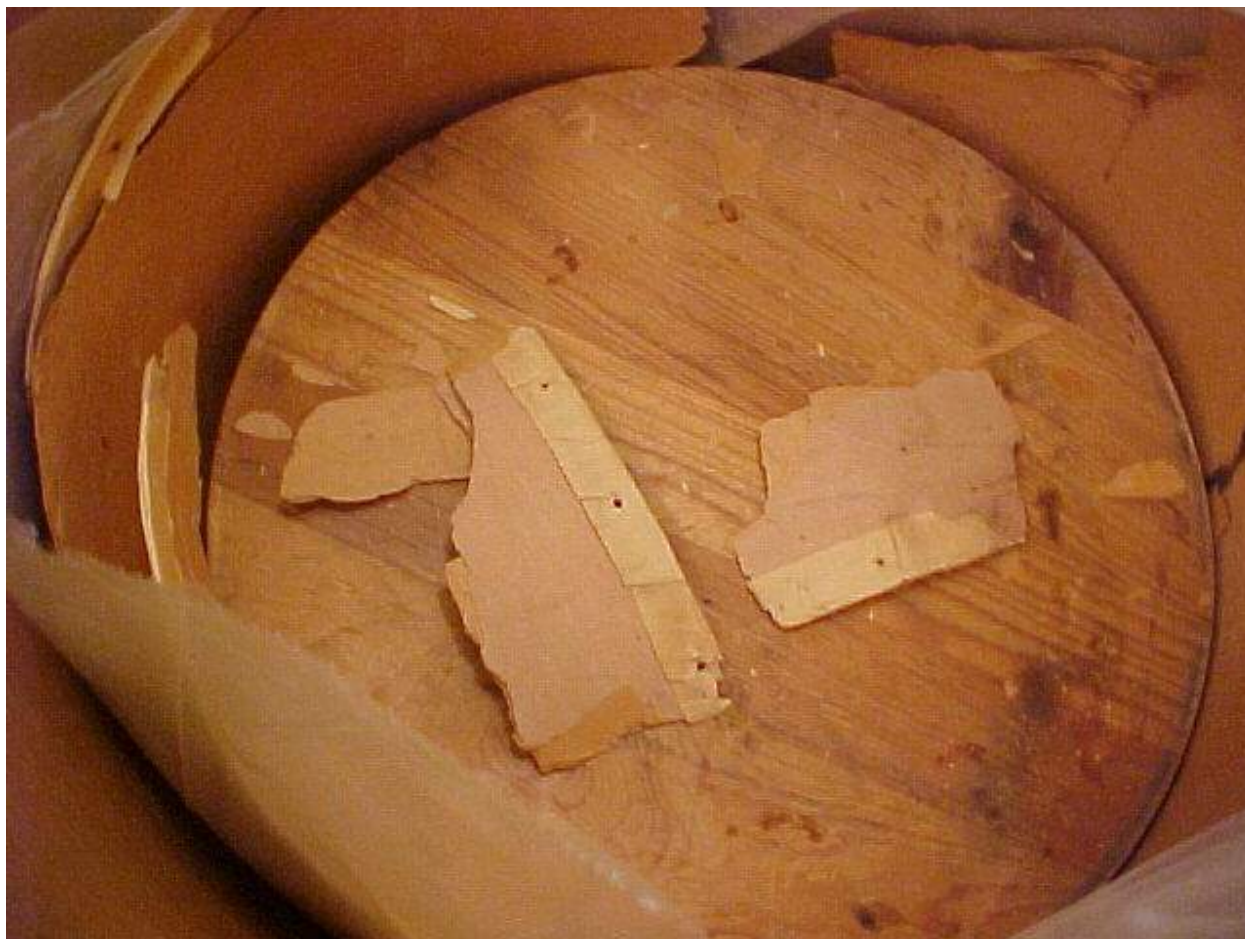
14:15**Other Information**Photo No. 7 of 10Dose Rate Surface 22 mR/hr
 1 meter 2.0 mR/hr

Wooden lid that fits onto the inner fiber drum (lab-pack) – good condition
No gasses present (in breathing zone)

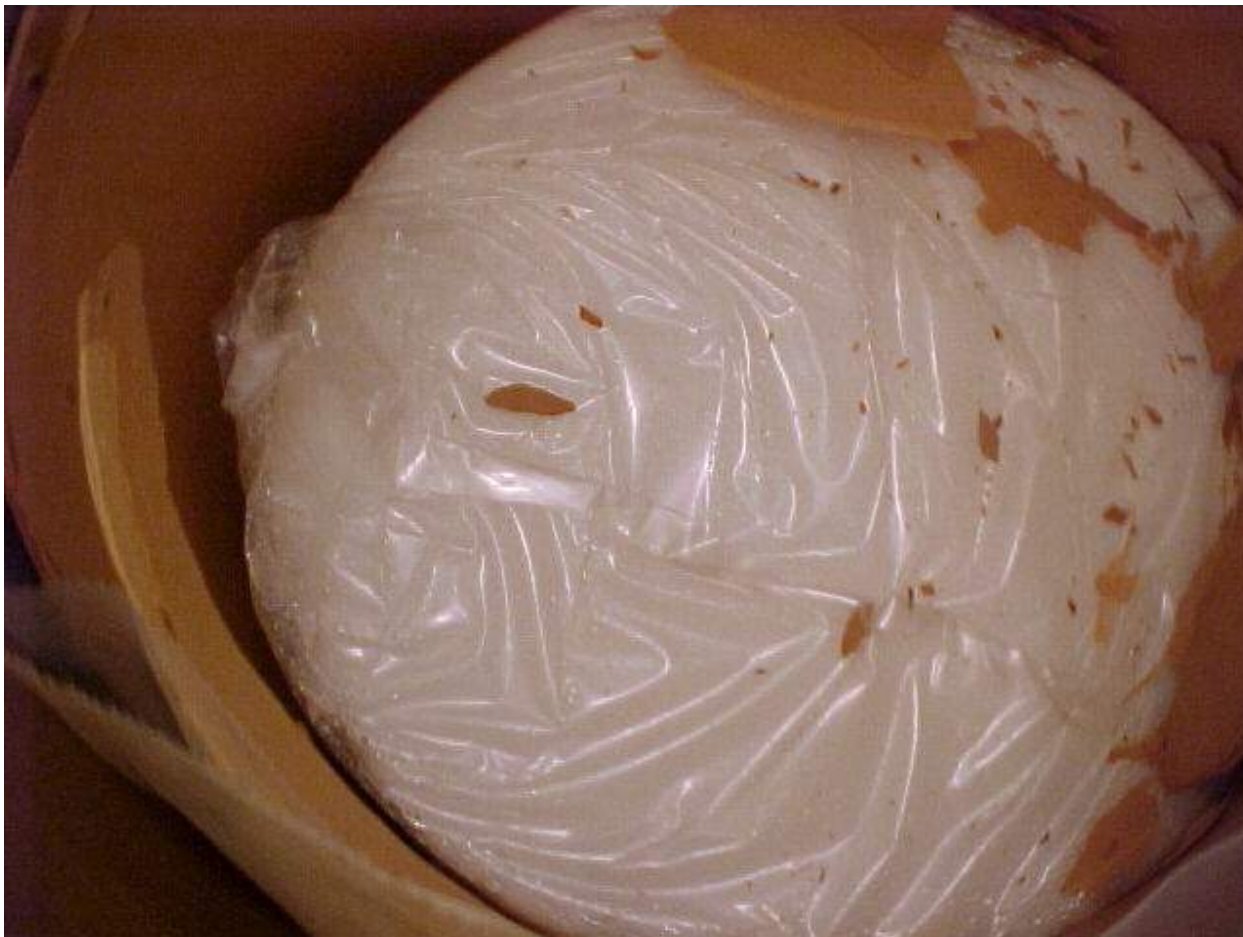
4th poly liner/bag (thin film plastic) – good condition
No gasses present (in breathing zone)

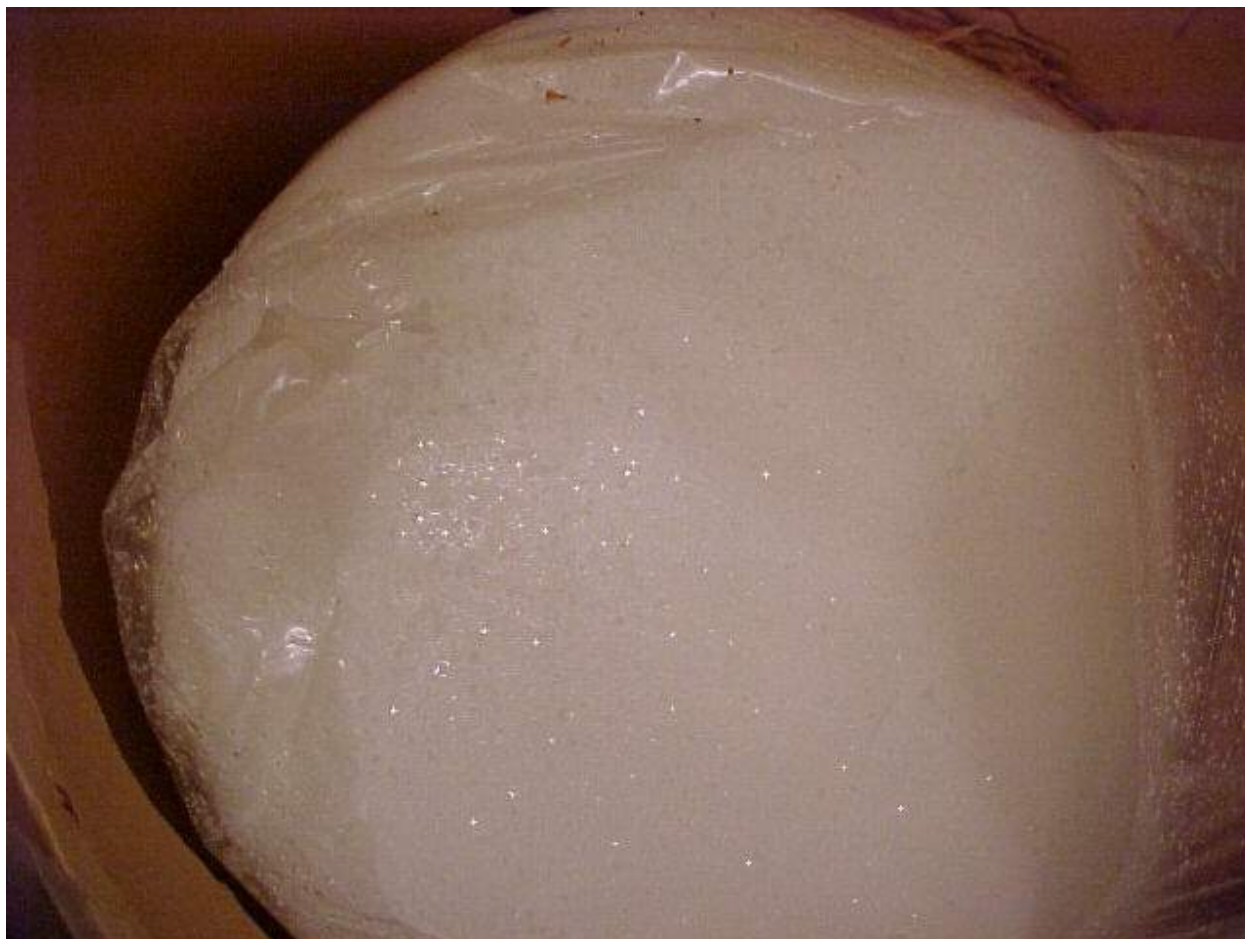
14:15**Other Information**Photo No. 9 of 10Dose Rate Surface 22 mR/hr
 1 meter 2.0 mR/hr

ThN material – monolith – solid – dry - white
No gasses present (in breathing zone)

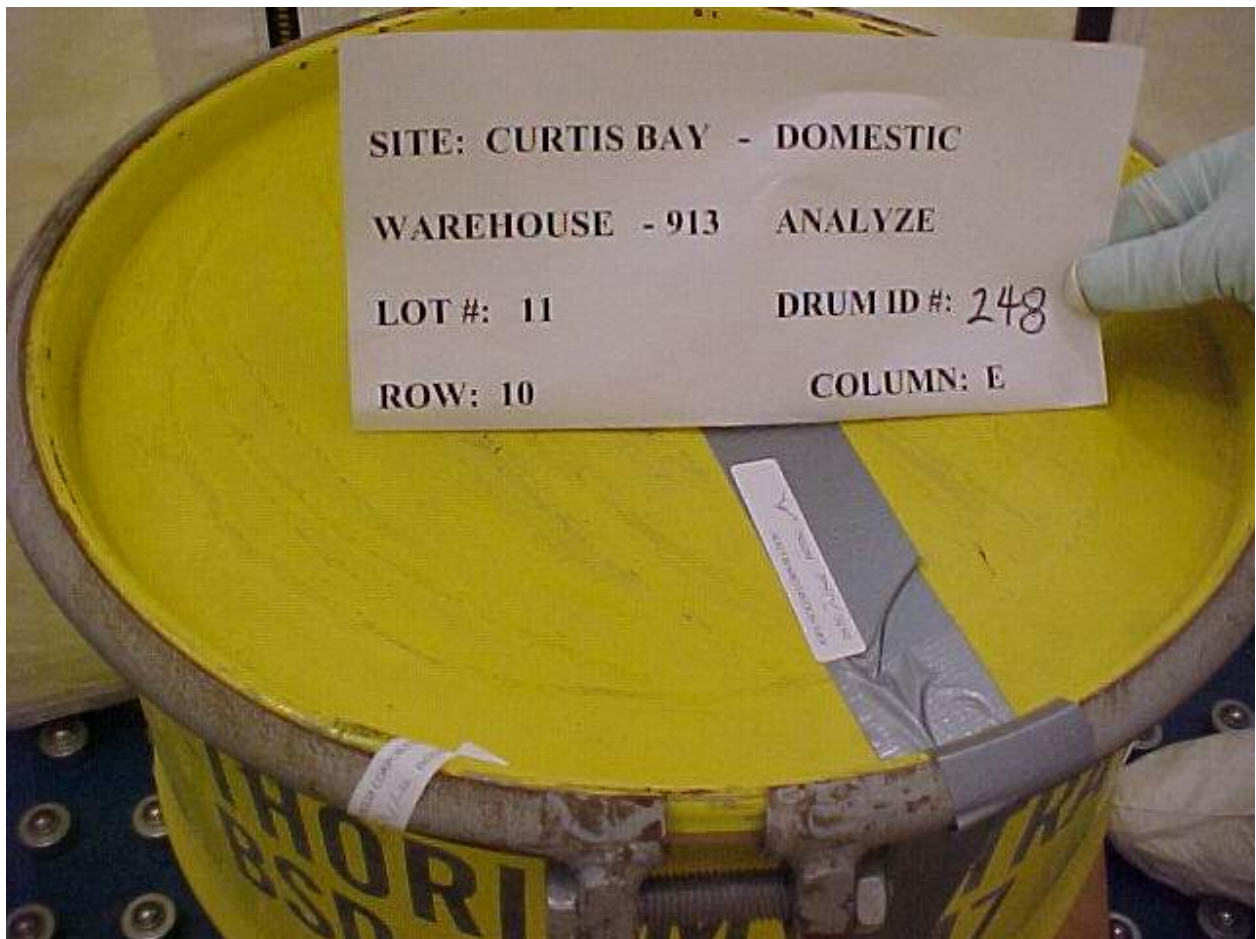
Sealed & dated - Complete

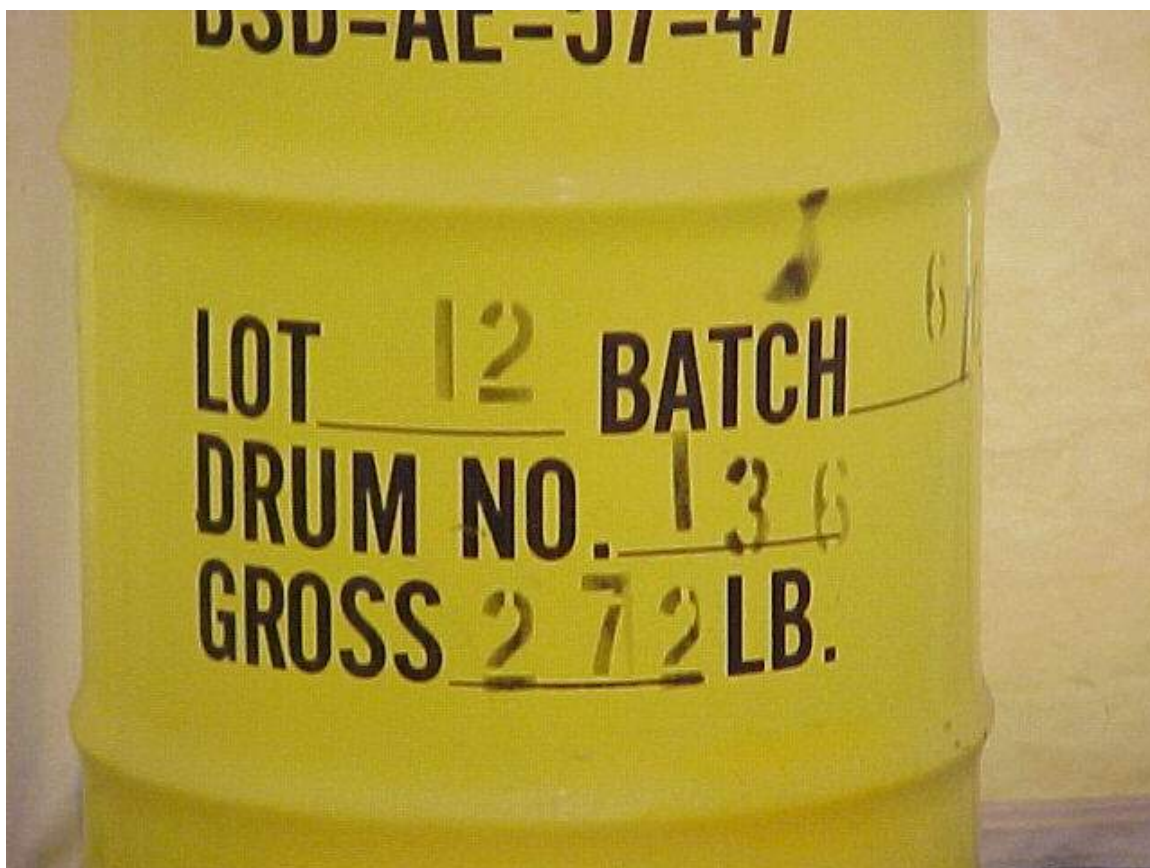
09:00**Other Information**Photo No. 1 of 11Dose Rate Surface 22 mR/hr
 1 meter 2.0 mR/hr

30-gal drum – good condition (drum released pressure when bolt was loosened on drum ring)

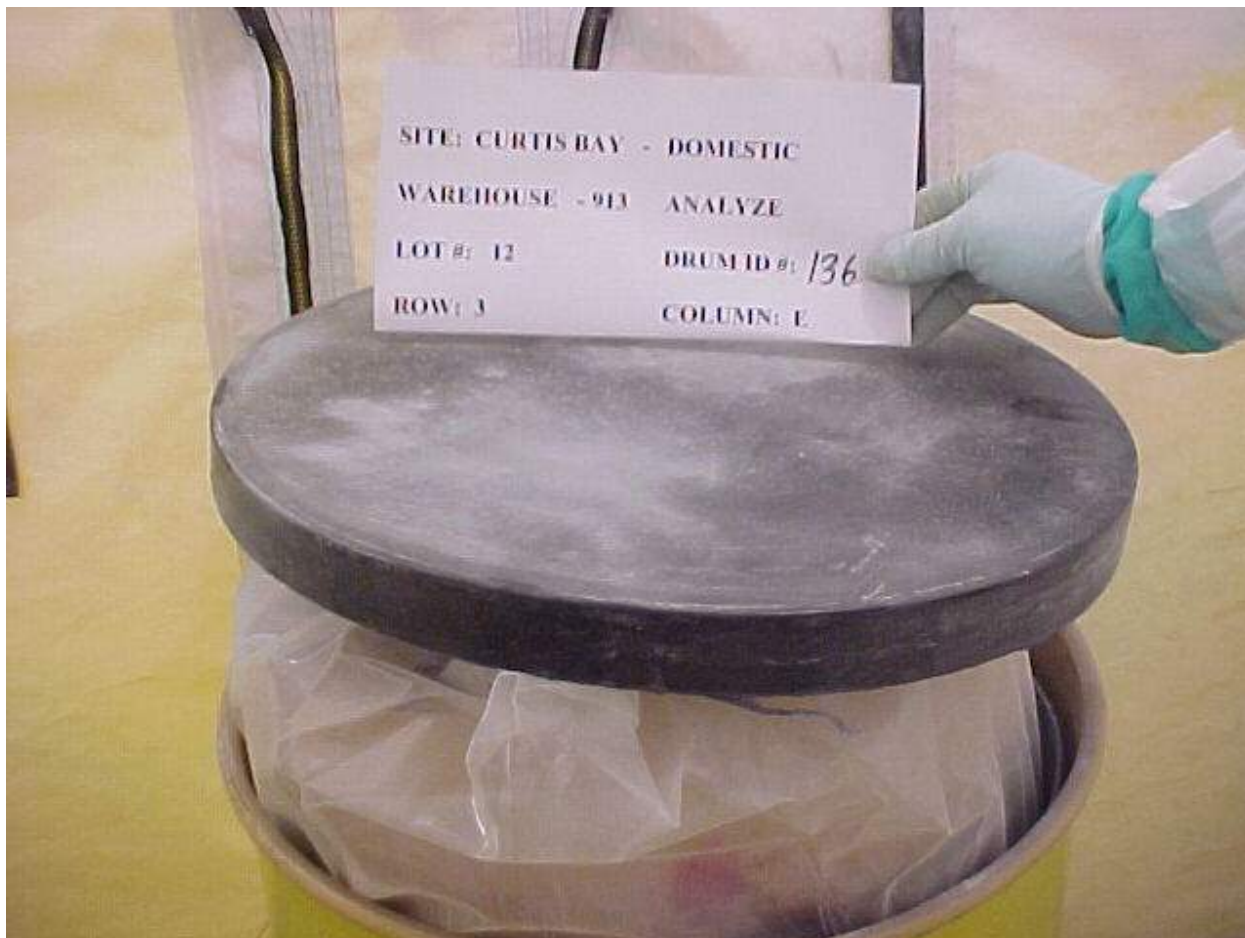
Black plastic lid (from drum liner) – good condition – lid is pushed outward due to buildup of pressure inside of an inner poly bag
No gasses present (in breathing zone)

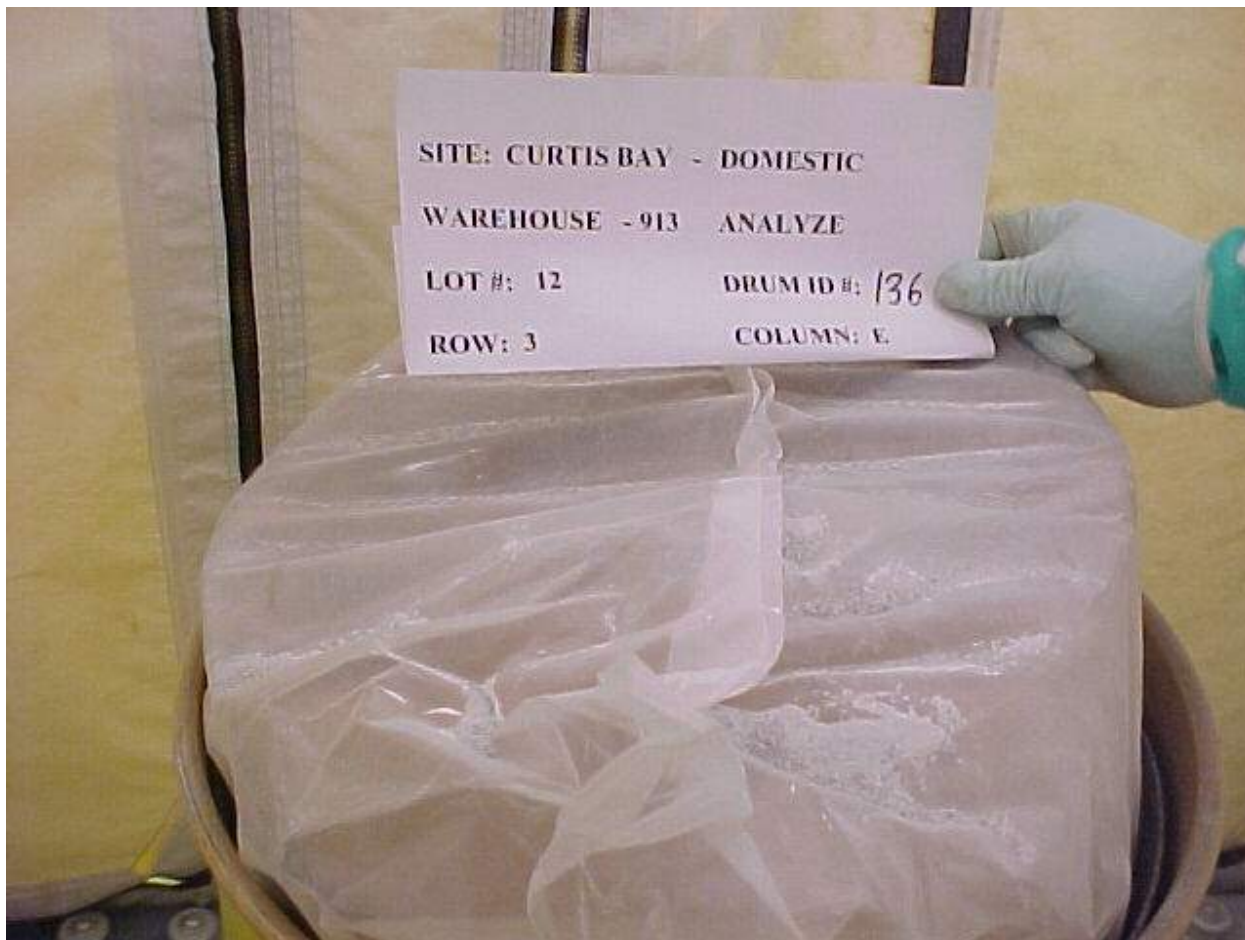
09:00**Other Information**Photo No. 3 of 11Dose Rate Surface 22 mR/hr
 1 meter 2.0 mR/hr

1st poly liner/bag – good condition – bag is pushed outward due to buildup of pressure inside of an inner poly bag
No gasses present (in breathing zone)

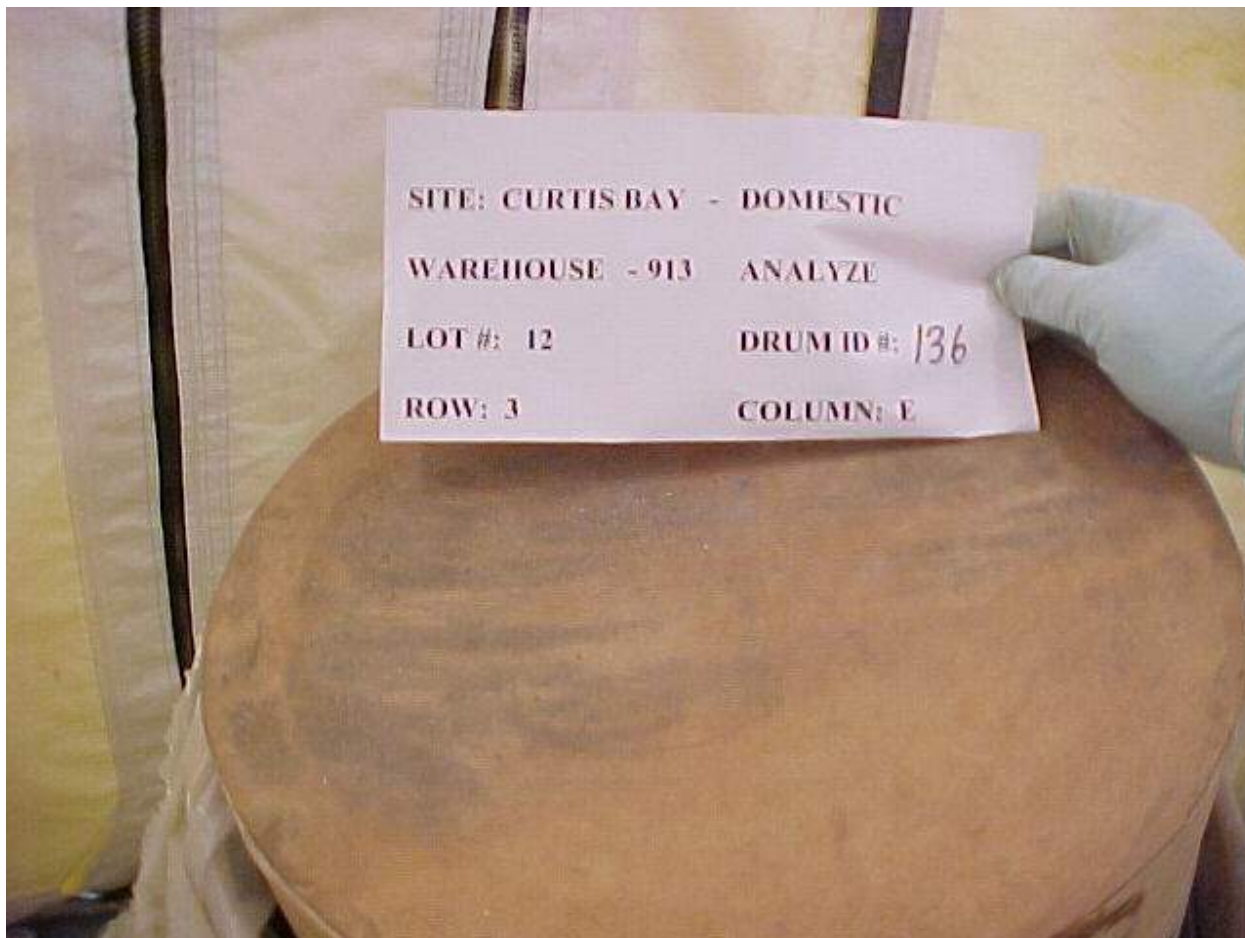
Fiber drum lid (from outermost fiber drum) – good condition – lid is pushed vertically upward due to buildup of pressure inside of an inner poly bag
No gasses present (in breathing zone)

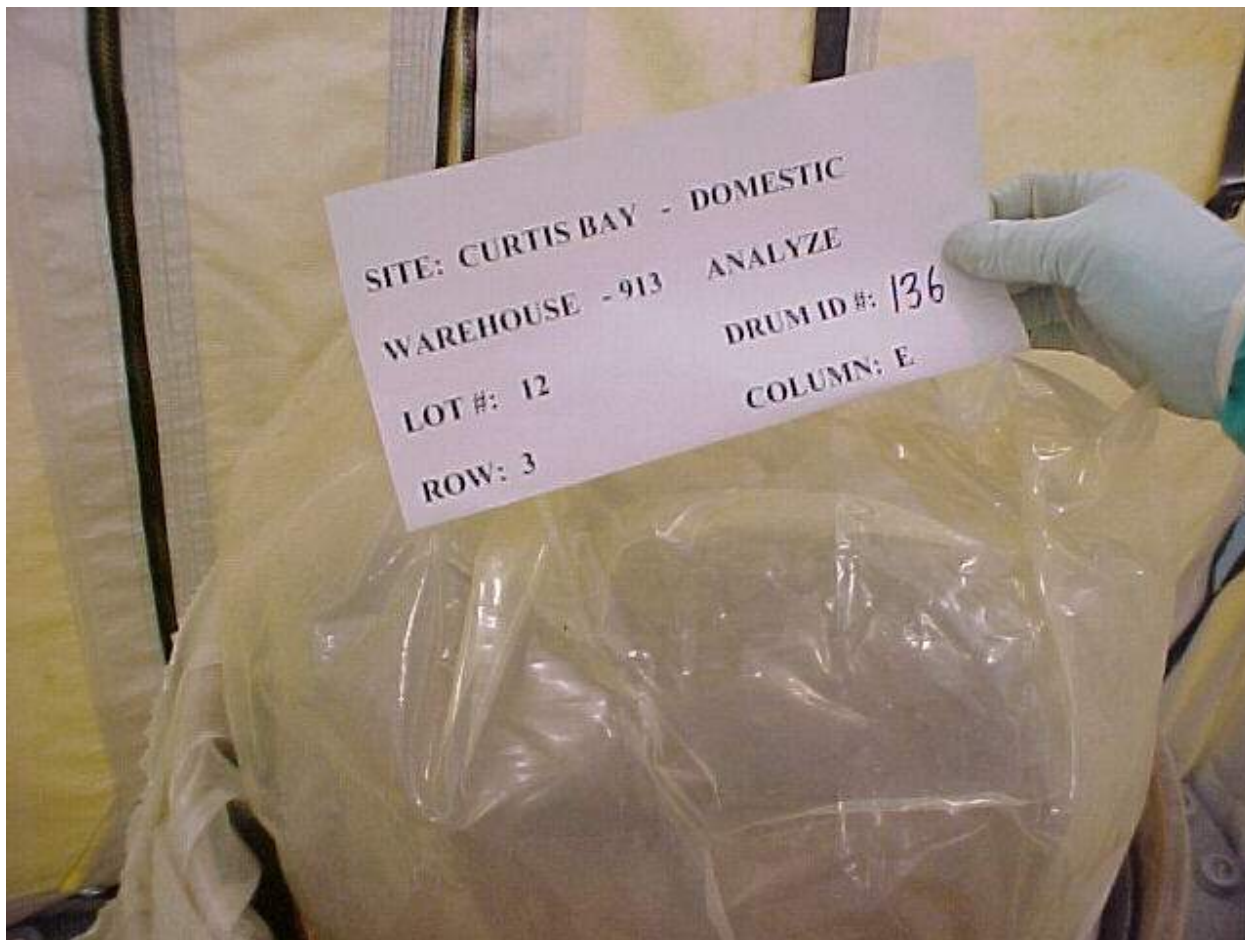
09:00**Other Information**Photo No. 5 of 11Dose Rate Surface 22 mR/hr
 1 meter 2.0 mR/hr

2nd poly liner/bag – good condition – bag is pushed vertically upward due to buildup of pressure inside of an inner poly bag
No gasses present (in breathing zone)

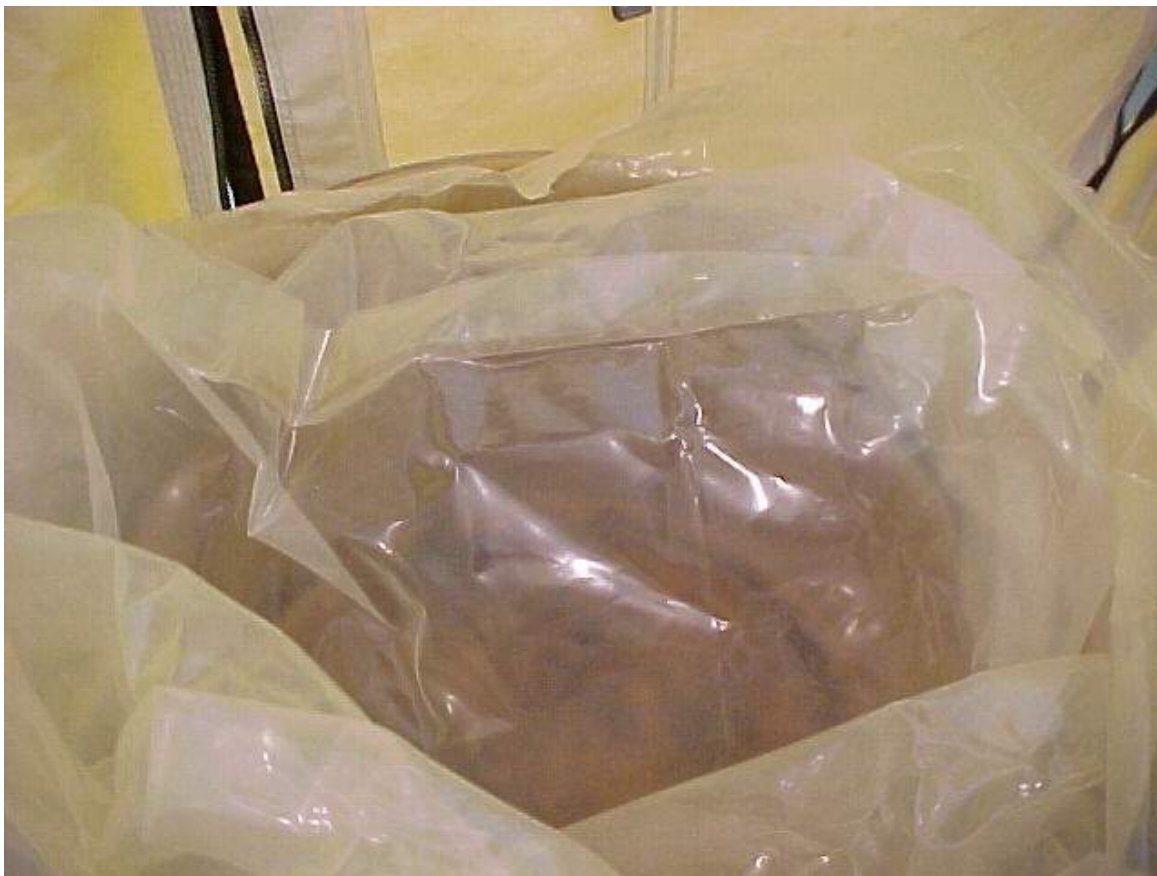
3rd poly liner/bag – good condition – this bag contains the majority of the pressure buildup inside of the drum; although, it does not “pop” when cut by a utility knife

Gasses in headspace of bag – LEL – 6.0% - NO - +50.0ppm – NOx – +50.0ppm

Drum vented - All gasses dissipated through HEPA blower exhaust positioned directly over drum being inspected.

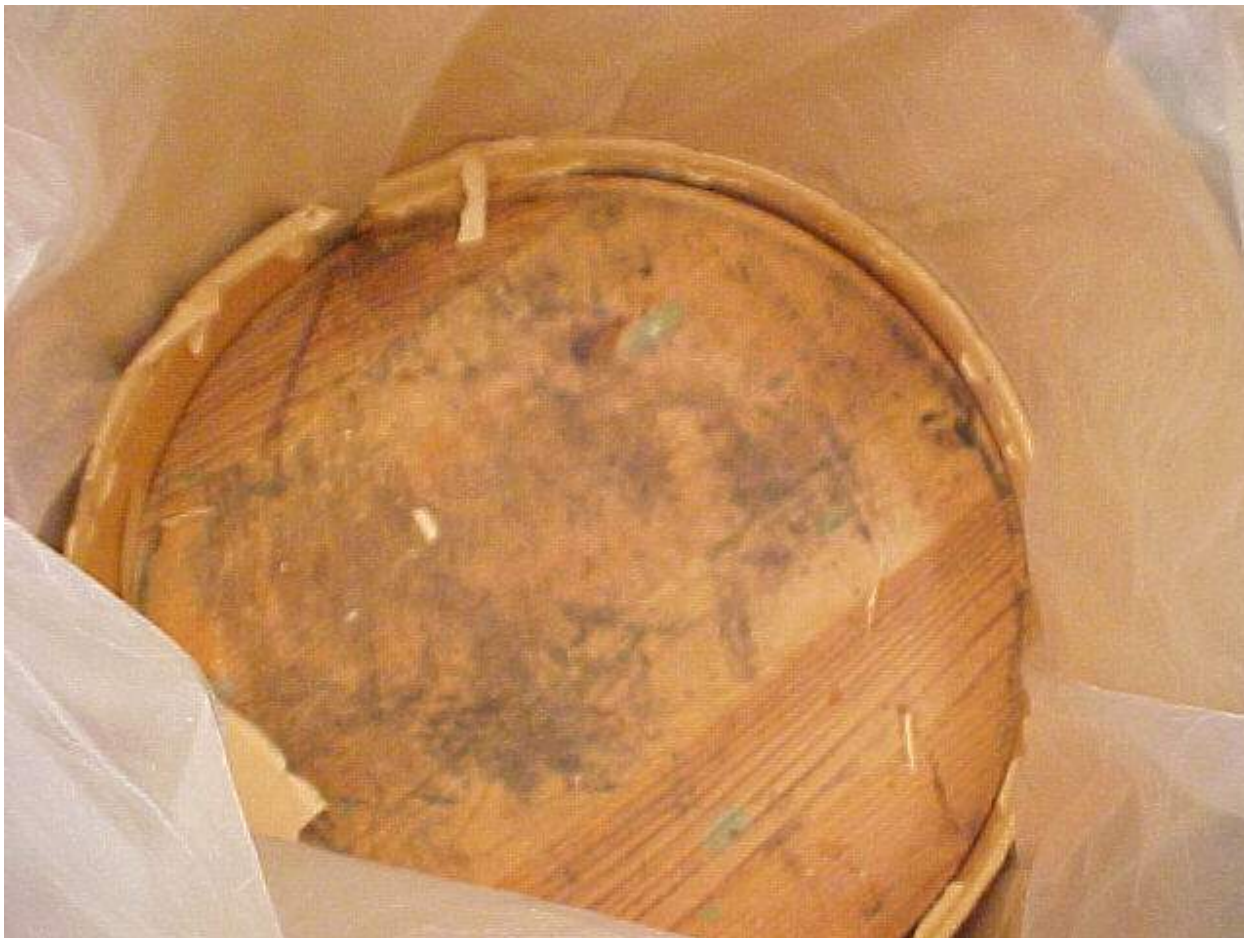
09:00**Other Information**Photo No. 7 of 11Dose Rate Surface 22 mR/hr
 1 meter 2.0 mR/hr

Wooden lid (on innermost fiber drum – sometimes referred to as a lab-pack in this documentation) – good condition
No gasses present (in breathing zone)

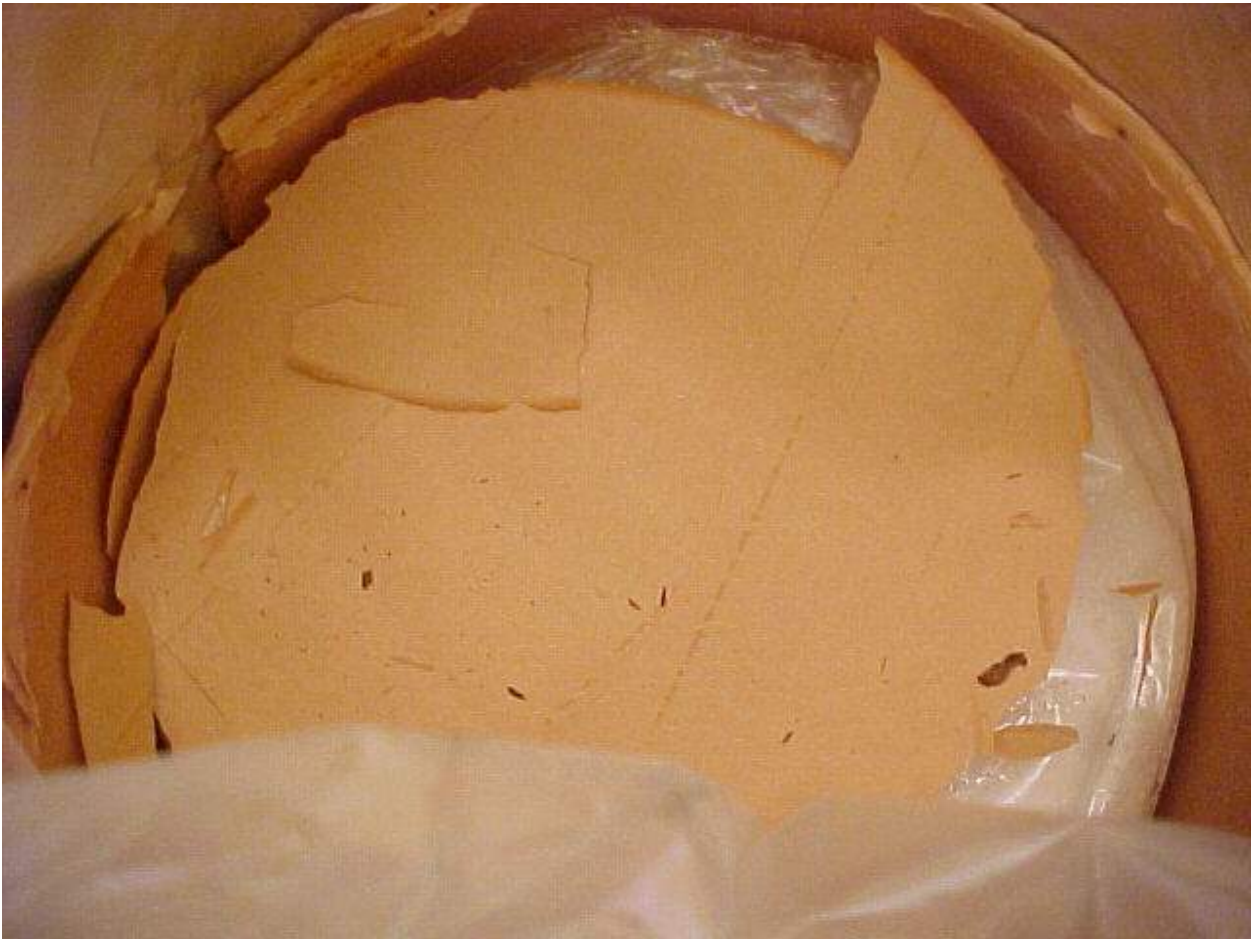
Lab-pack lid [thin paper layer – this thin layer of paper is attached to the fiber drum and is physically underneath the wooden lid (previous photograph)] – fair condition
No gasses present (in breathing zone)

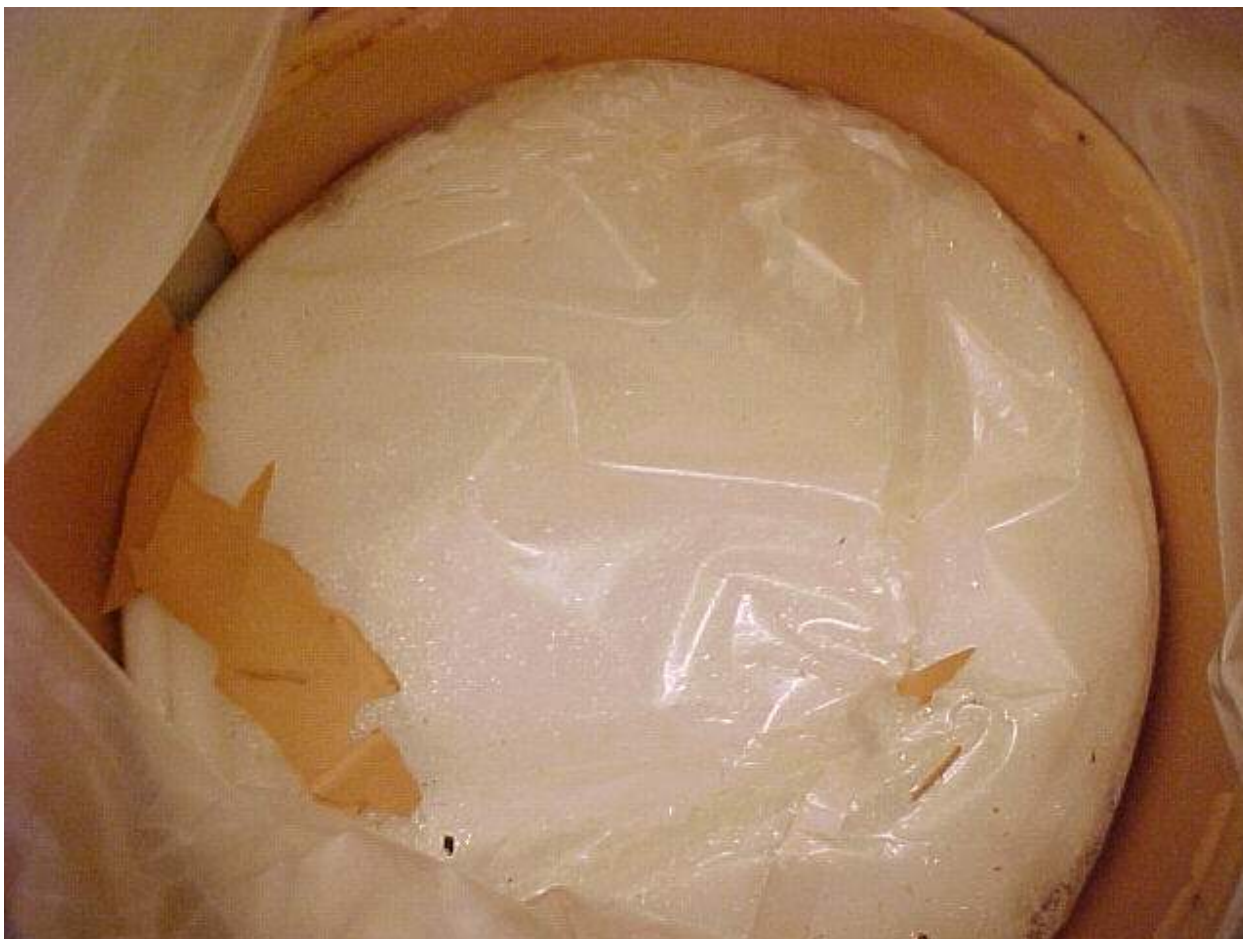
09:00**Other Information**Photo No. 9 of 11Dose Rate Surface 22 mR/hr
 1 meter 2.0 mR/hr

4th poly liner/bag (thin film plastic) – good condition
No gasses present (in breathing zone)

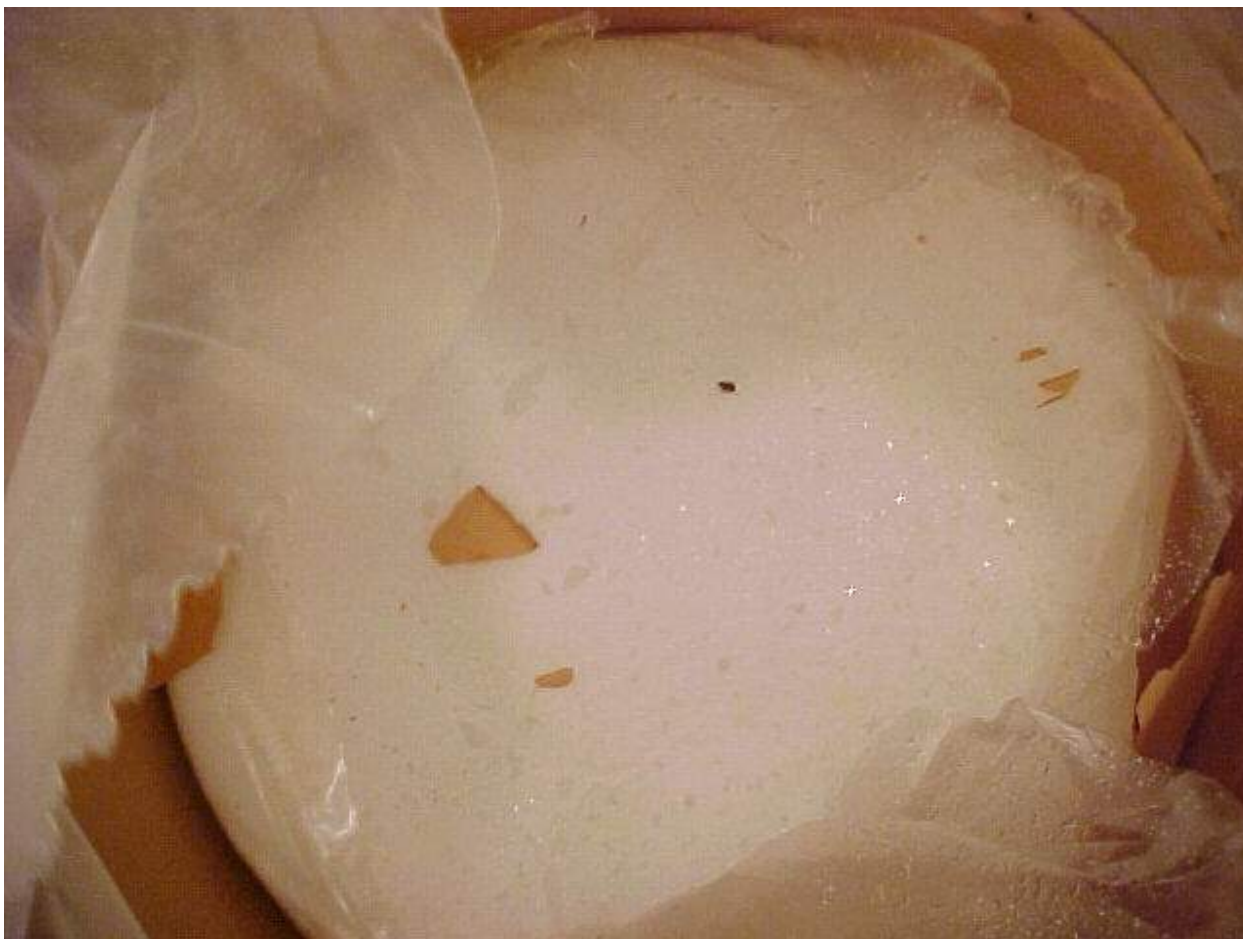
ThN material – monolith – solid – dry - white
No gasses present (in breathing zone)

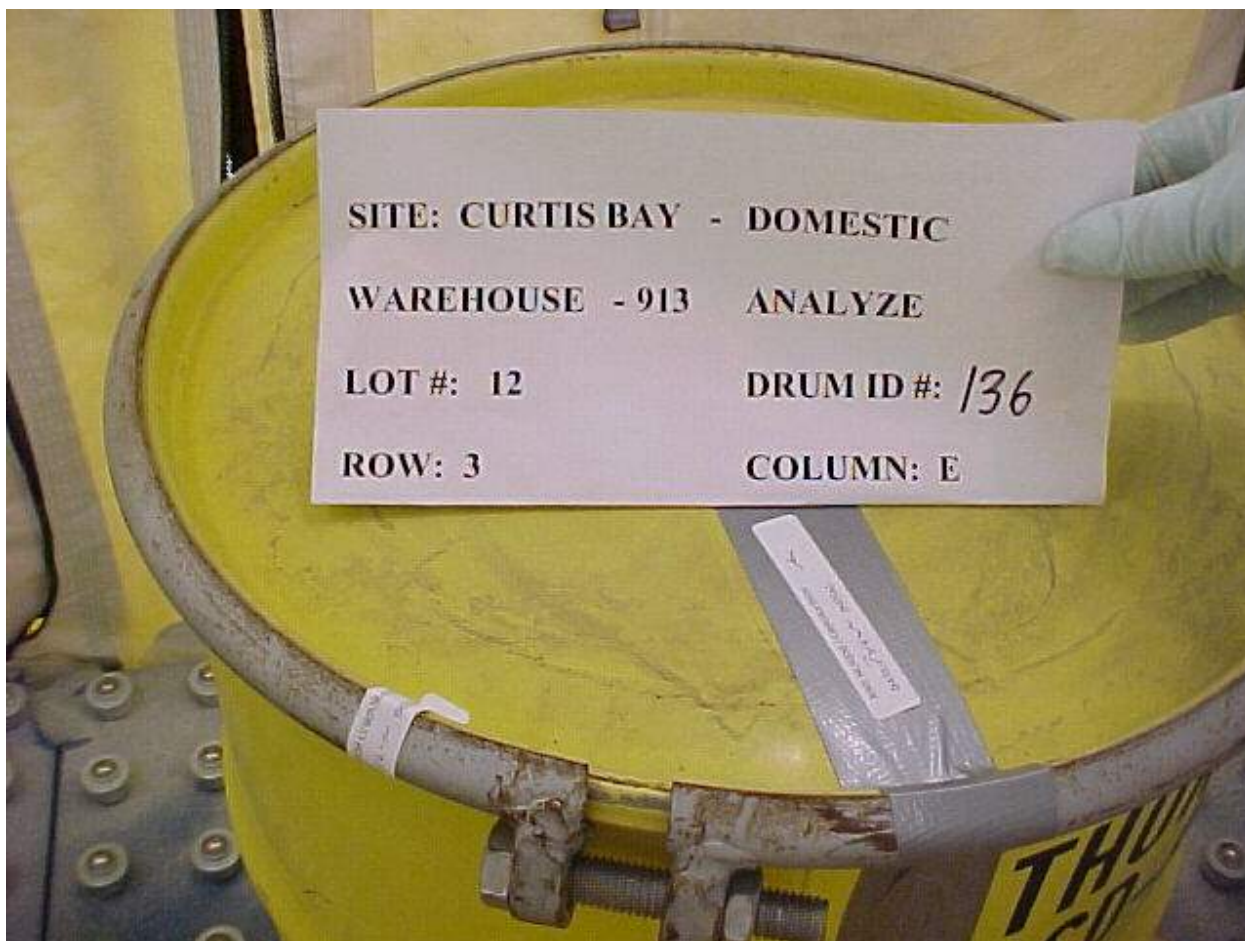
09:00**Other Information**Photo No. 11 of 11Dose Rate Surface 22 mR/hr
 1 meter 2.0 mR/hr

Sealed & dated – Complete

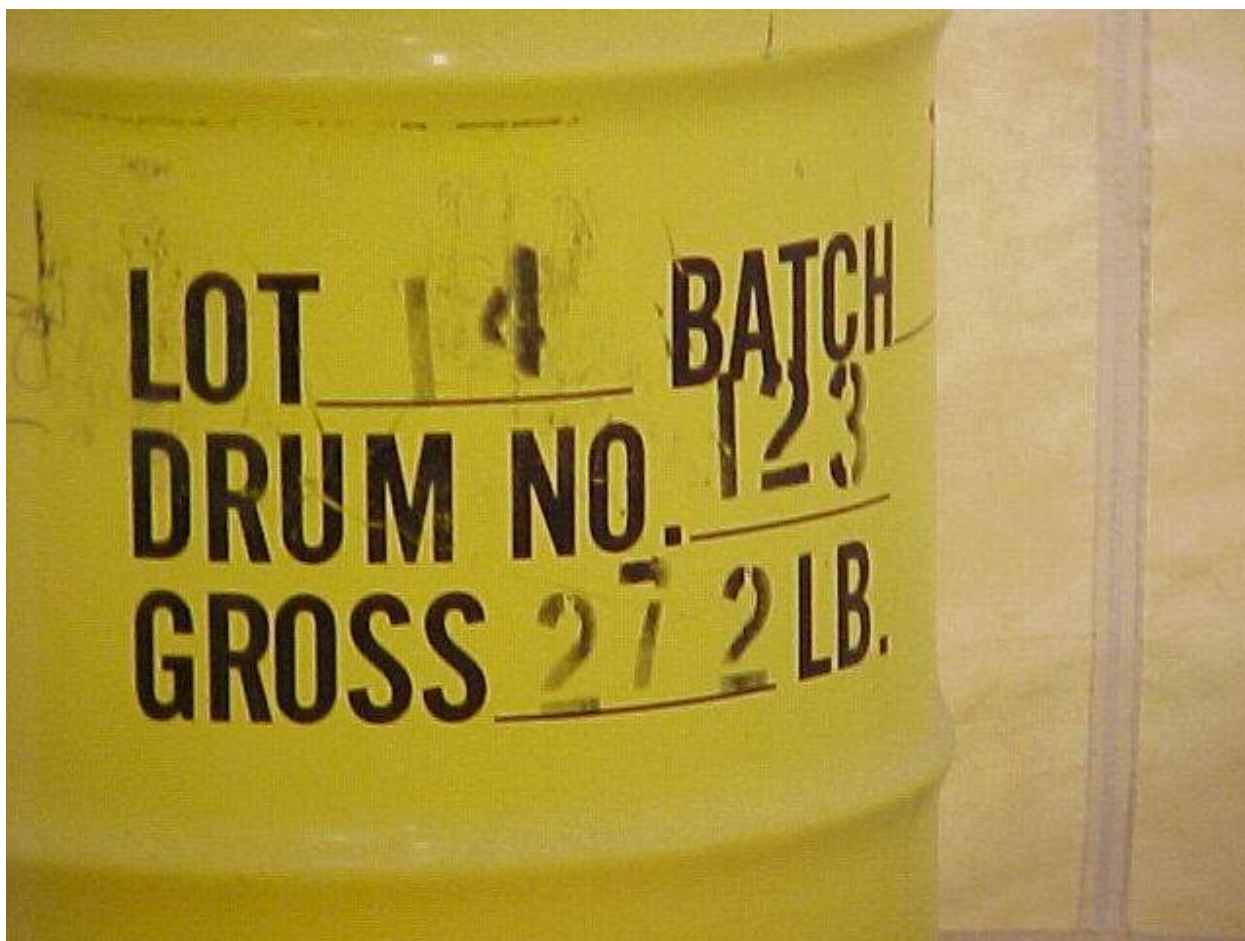
11:30**Other Information**Photo No. 1 of 10Dose Rate Surface 22 mR/hr
 1 meter 2.0 mR/hr

30-gal drum – good condition (drum released pressure as bolt was loosened on drum ring)
