THORIUM NITRATE STOCKPILE DRUM CHARACTERIZATION REPORT

**THORIUM NITRATE STOCKPILE
DRUM CHARACTERIZATION REPORT**

Prepared for
U.S. Defense Logistics Agency
Defense National Stockpile Center
Fort Belvoir, Virginia

Prepared by
OAK RIDGE NATIONAL LABORATORY
Oak Ridge, Tennessee 37831
managed by
UT-BATTELLE, LLC
for the
U.S. DEPARTMENT OF ENERGY
under contract DE-AC05-00OR22725

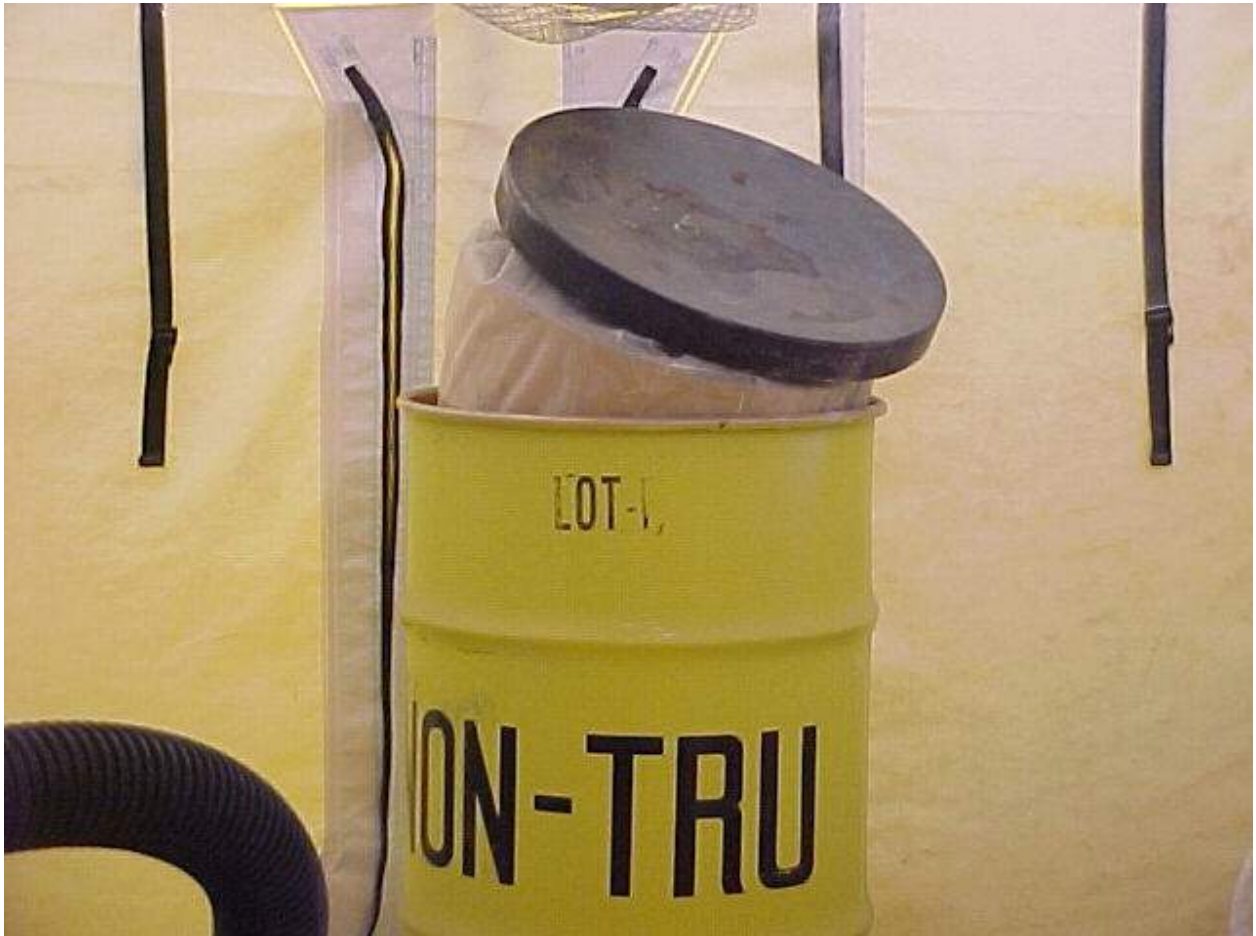
Black plastic lid (on drum liner) – good condition (photo indicates a gas pressure buildup inside of an inner poly bag that causes the lid to be pushed vertically out of top of drum)
No gasses present (in breathing zone)

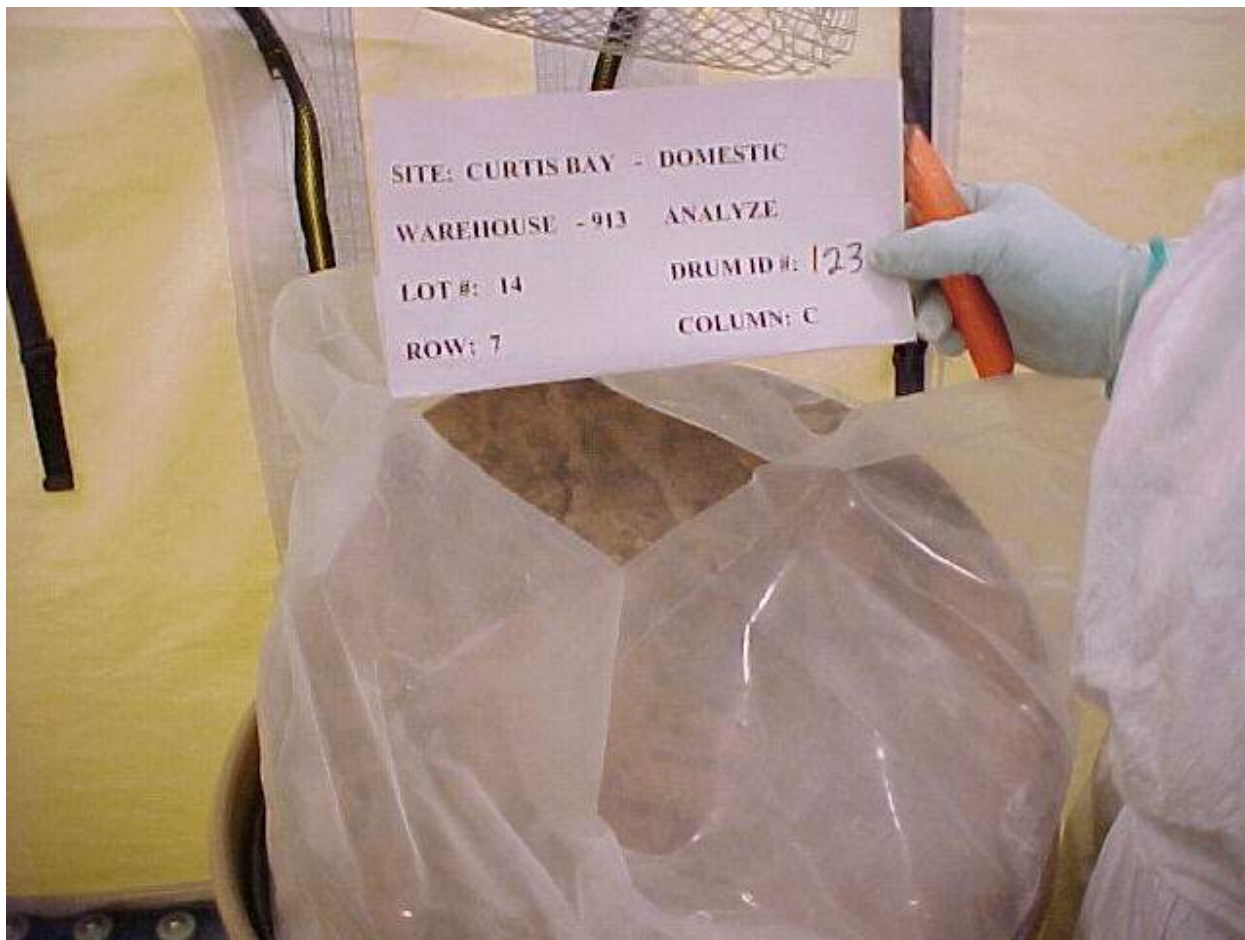
11:30**Other Information**Photo No. 3 of 10Dose Rate Surface 22 mR/hr
 1 meter 2.0 mR/hr

1st poly liner/bag – good condition (photo indicates a gas pressure buildup inside of an inner poly bag that causes the bag to be pushed vertically out of top of drum)
No gasses present (in breathing zone)

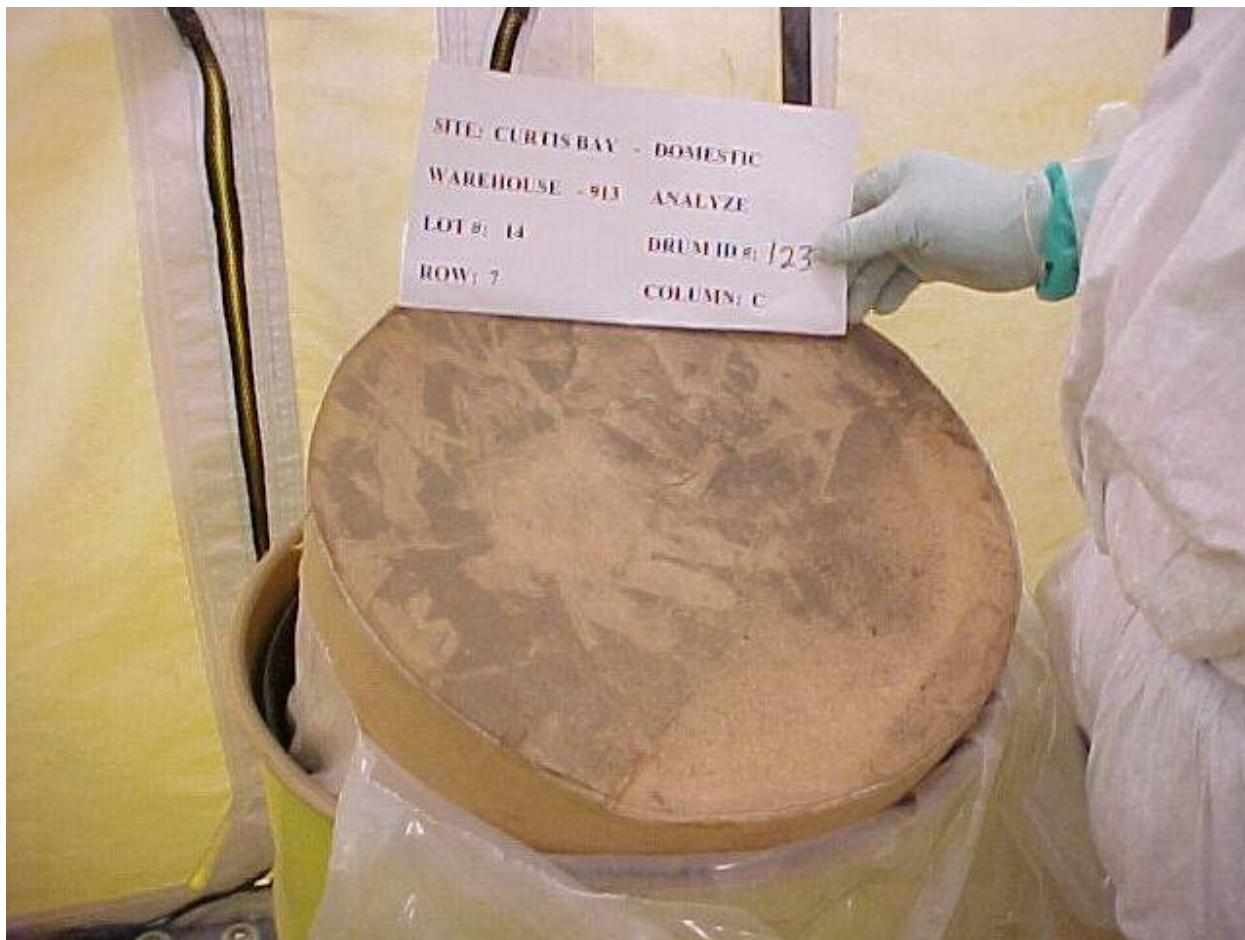
Fiber drum lid (from outermost fiber drum) – good condition (photo indicates a gas pressure buildup inside of an inner poly bag that causes the lid to be pushed vertically out of top of drum)
No gasses present (in breathing zone)

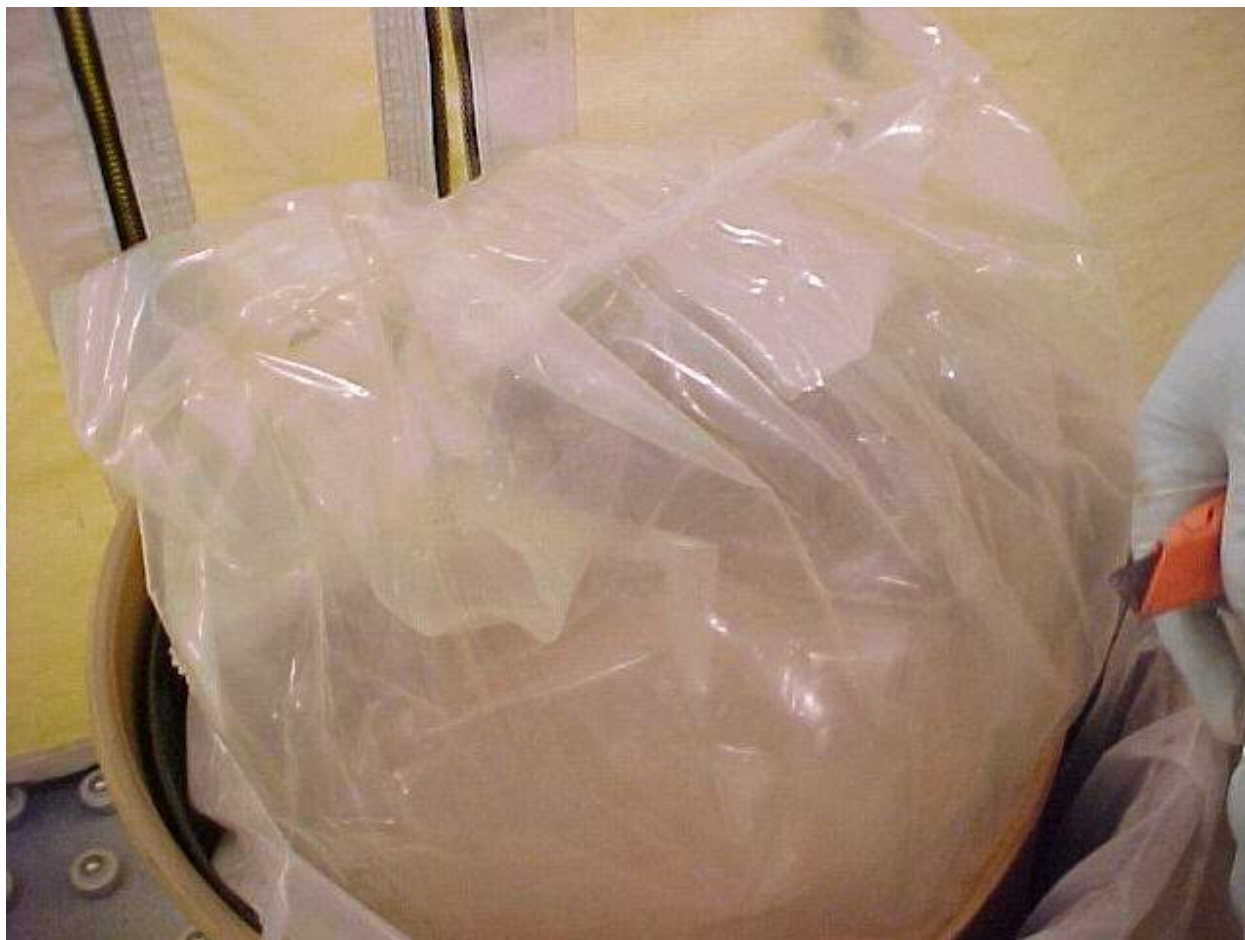
2nd poly liner/bag – good condition (photo indicates a gas pressure buildup inside of an inner poly bag that causes the bag to be pushed vertically out of top of drum)
No gasses present (in breathing zone)

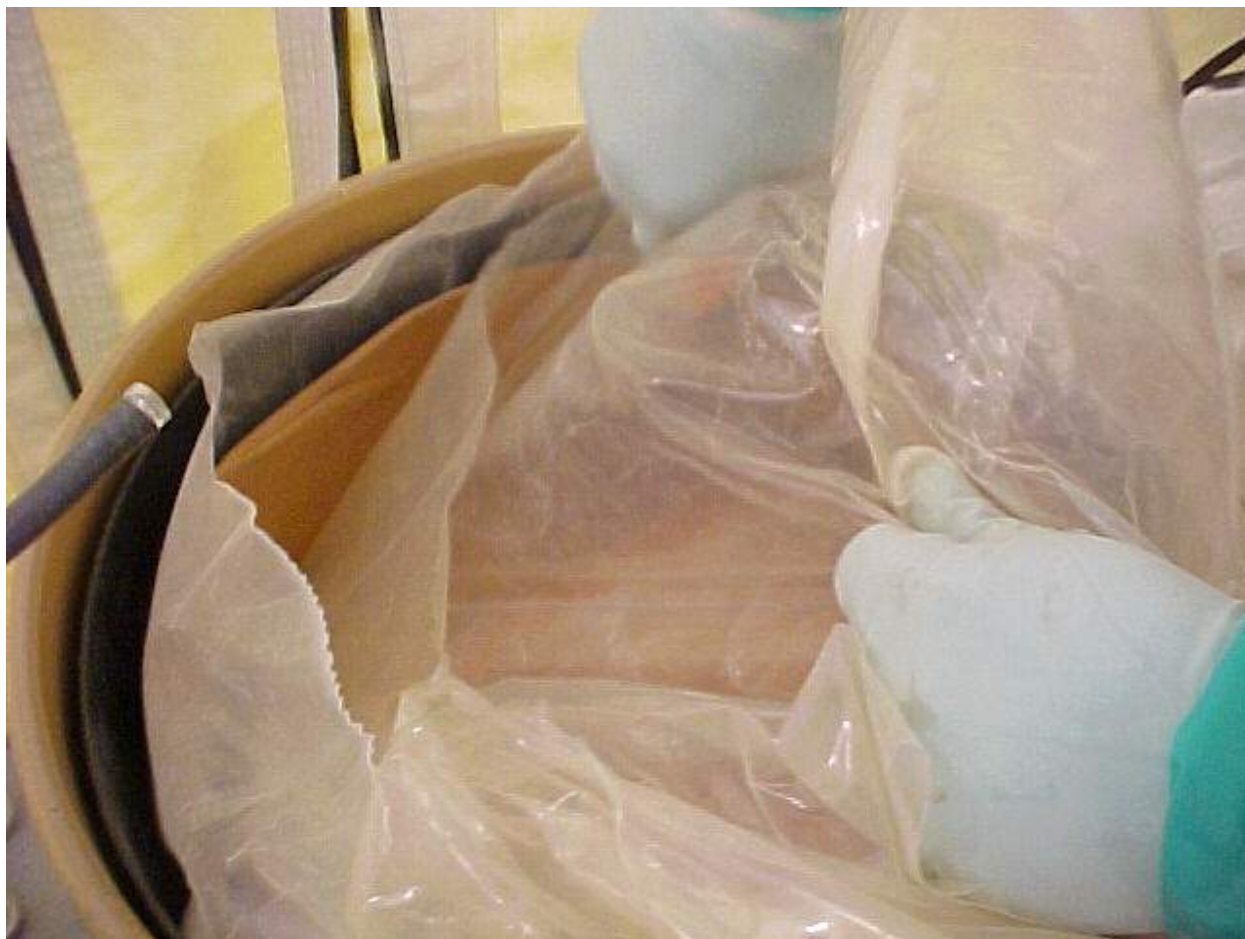
3rd poly liner/bag – this layer contains majority of gas buildup inside of the drum; although, the bag does not “pop” when cut – slowly deflates
 Opened poly liner/bag - No gasses present (in breathing zone)
 Gasses in headspace – LEL – 6.1% - NO - +50.0ppm – NOx – +50.0ppm
 Drum vented - All gasses dissipated through HEPA blower exhaust

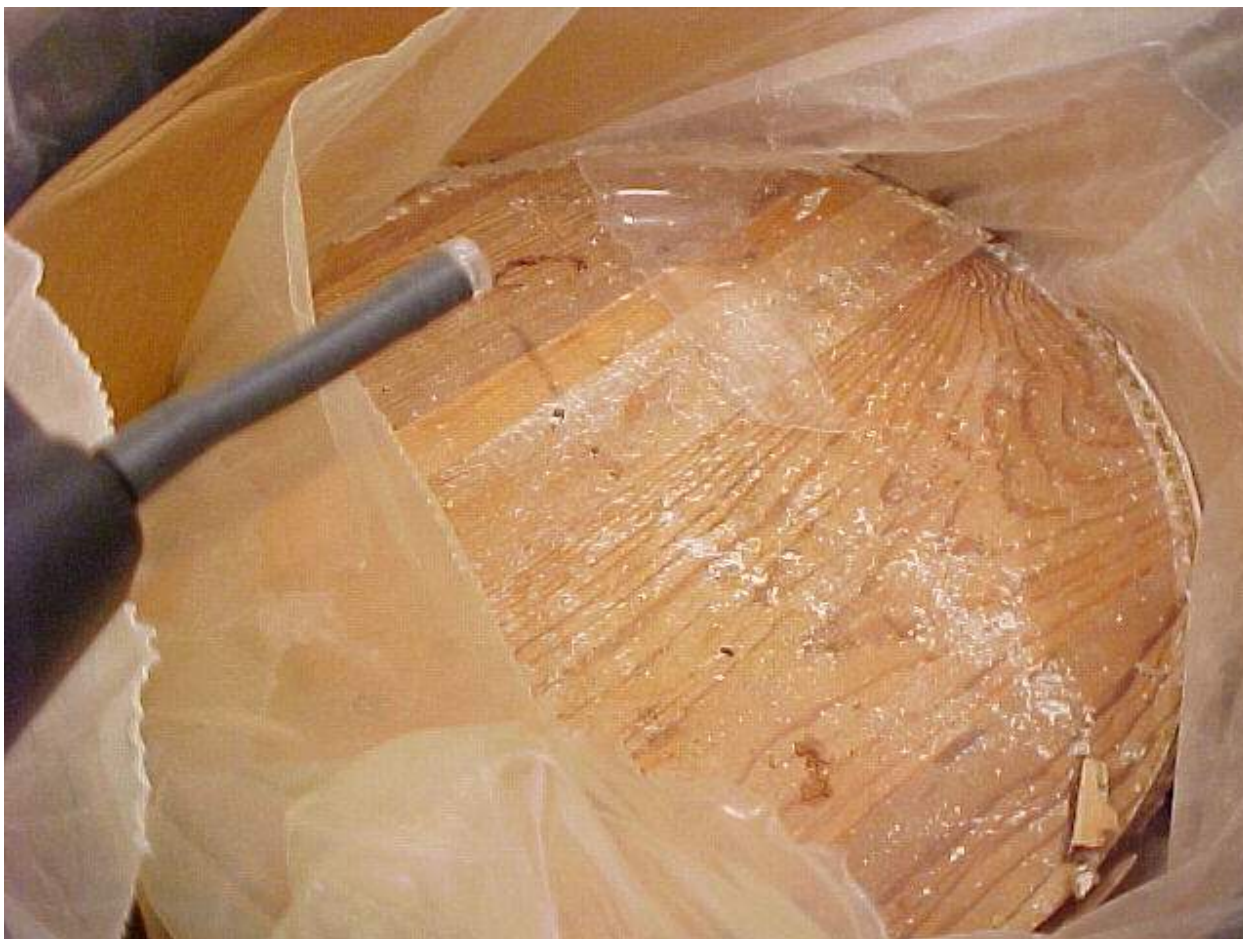
Wooden lid [on inner fiber (lab-pack) drum] – good condition
Drum vented - No gasses present (in breathing zone)

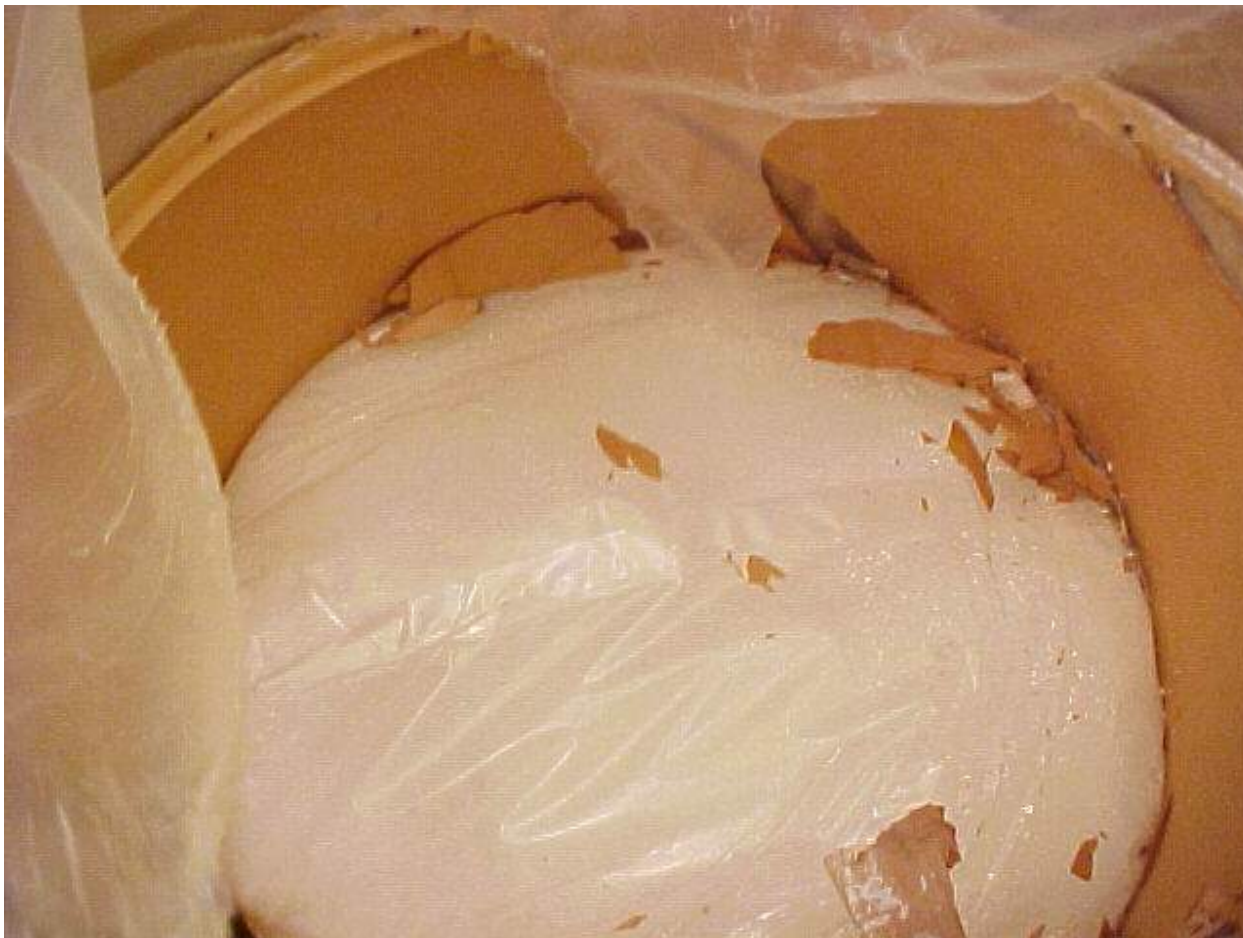
4th poly liner/bag – good condition (thin film plastic)

Gasses in headspace – LEL – 4.6% - No - +50.0ppm – NOx – +50.0ppm

Drum vented - All gasses dissipated

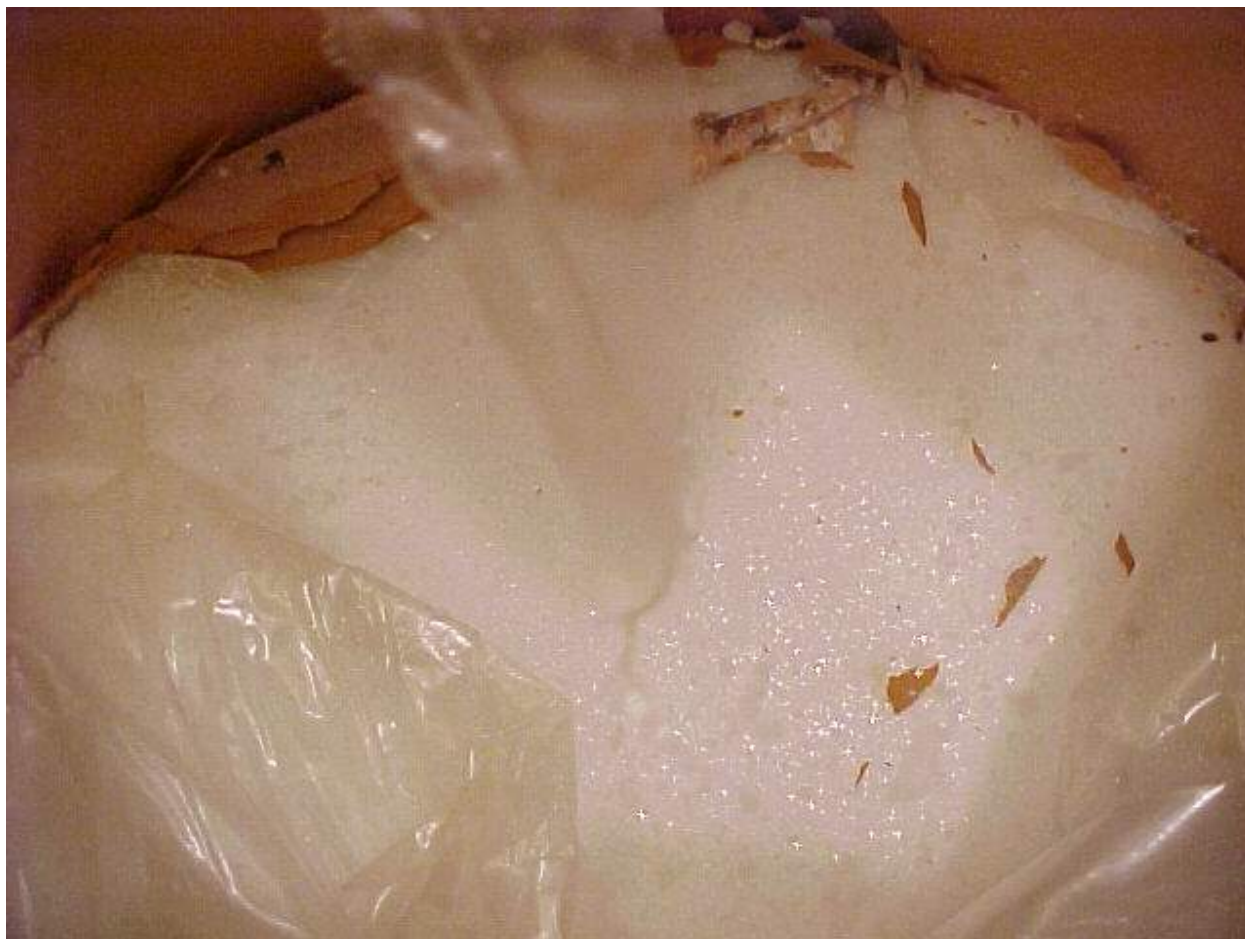
ThN material – monolith – solid – white – no liquid
No gasses present (in breathing zone)

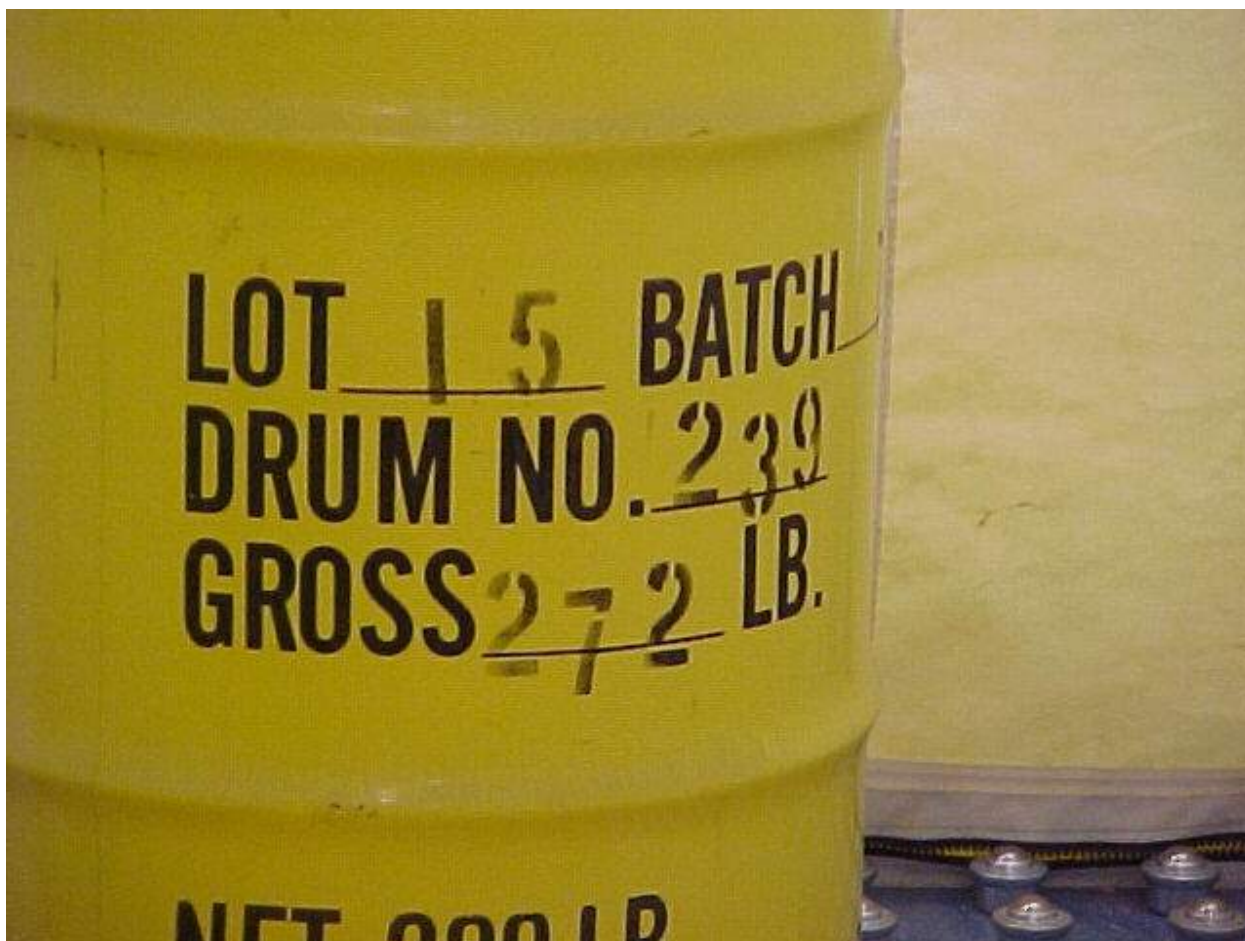
30-gal drum – good condition

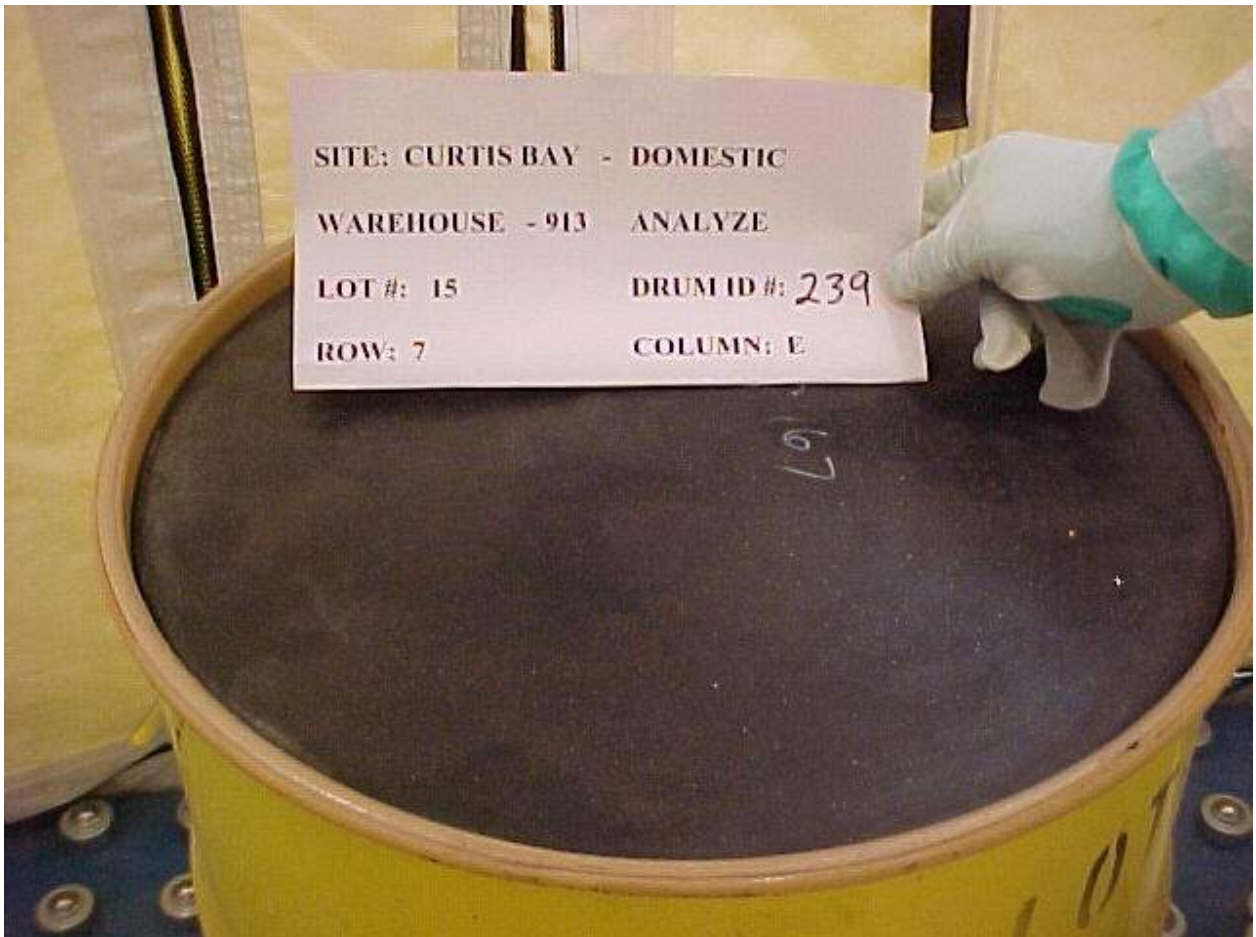
Black plastic lid (from drum liner) – good condition
No gasses present (in breathing zone)

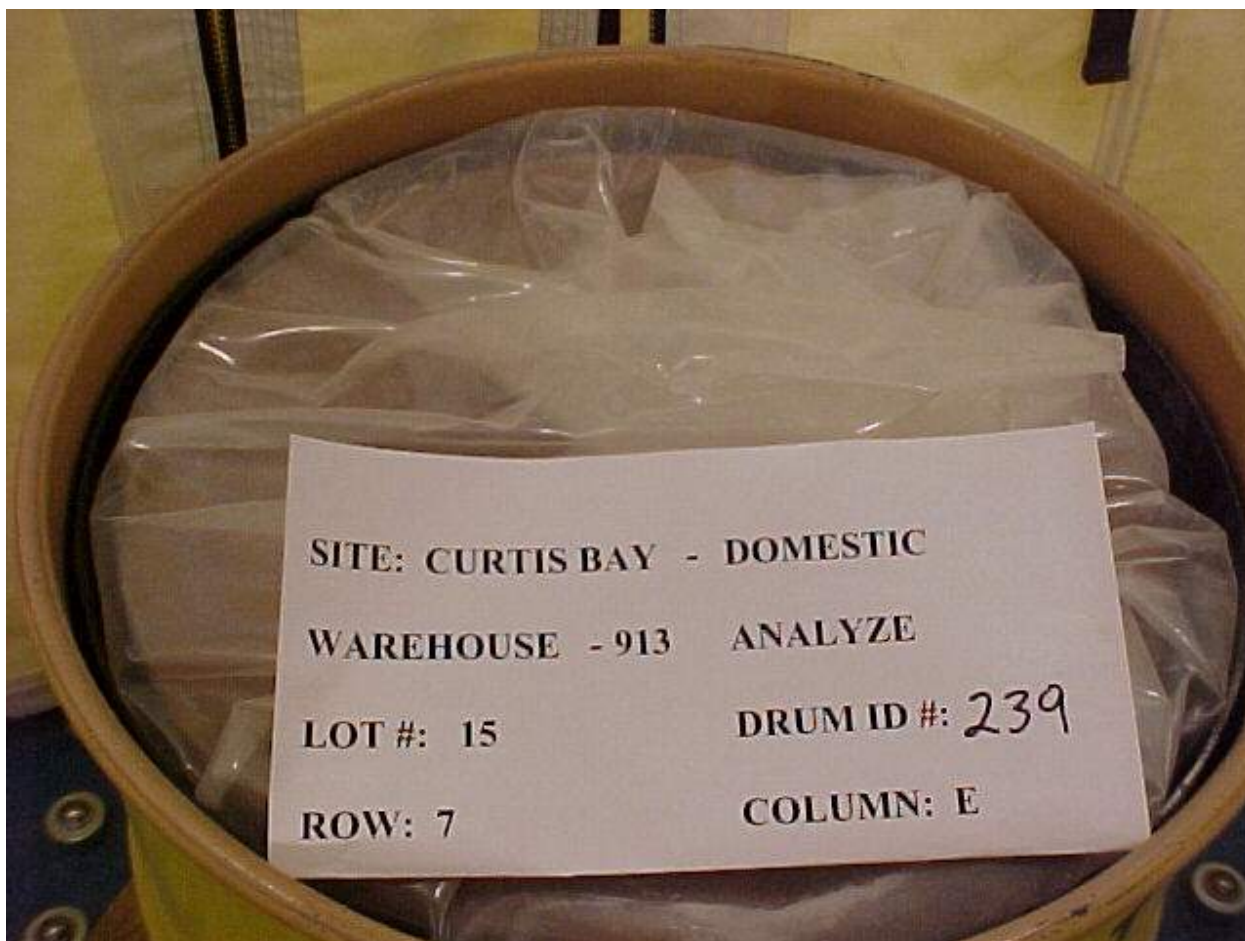
15:00**Other Information**Photo No. 3 of 9Dose Rate Surface 26 mR/hr
 1 meter 2.1 mR/hr1st poly liner/gas – good condition
No gasses present (in breathing zone)

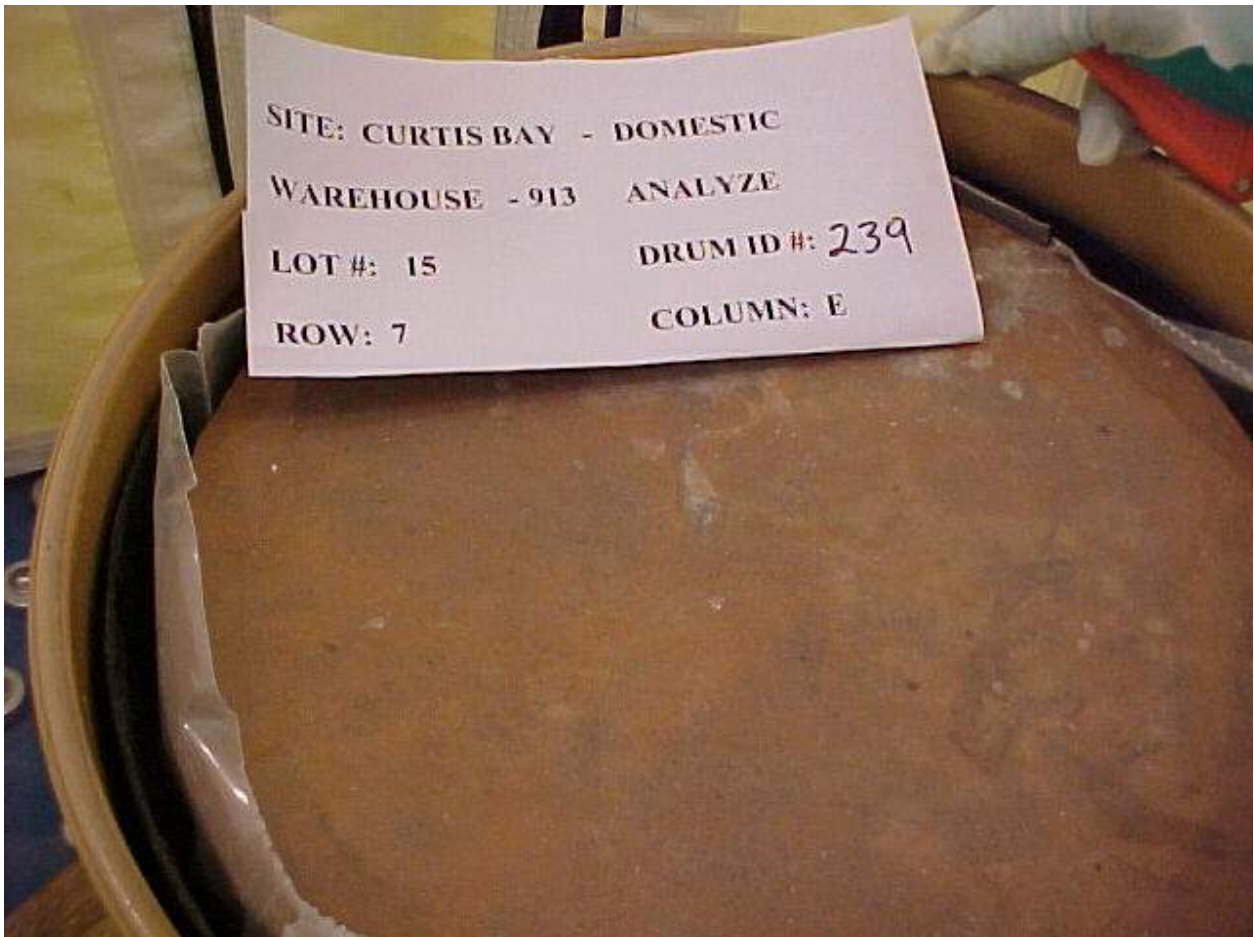
Fiber drum lid (from outermost fiber drum) good condition
No gasses present (in breathing zone)

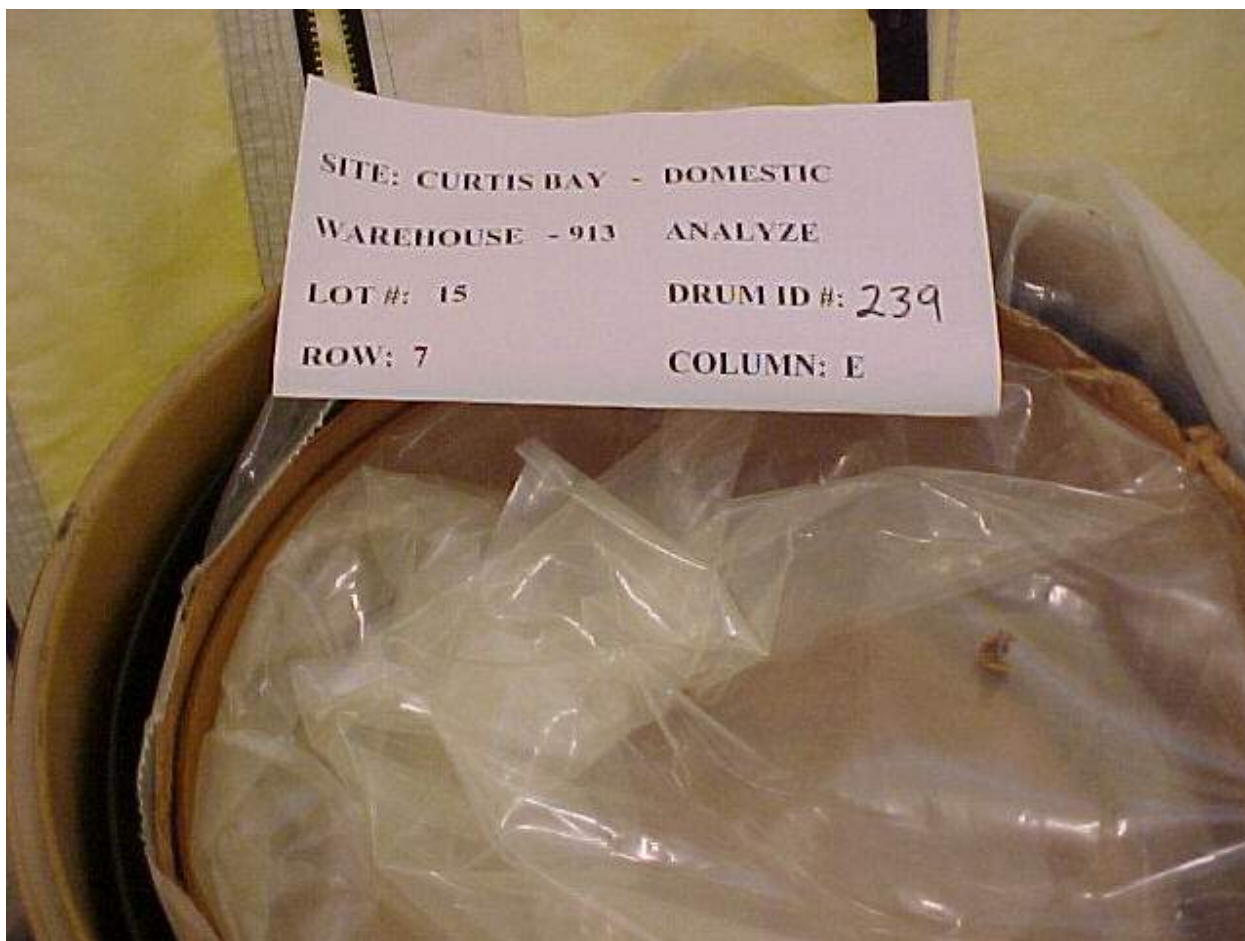
2nd poly liner/bag – good condition
No gasses present (in breathing zone)

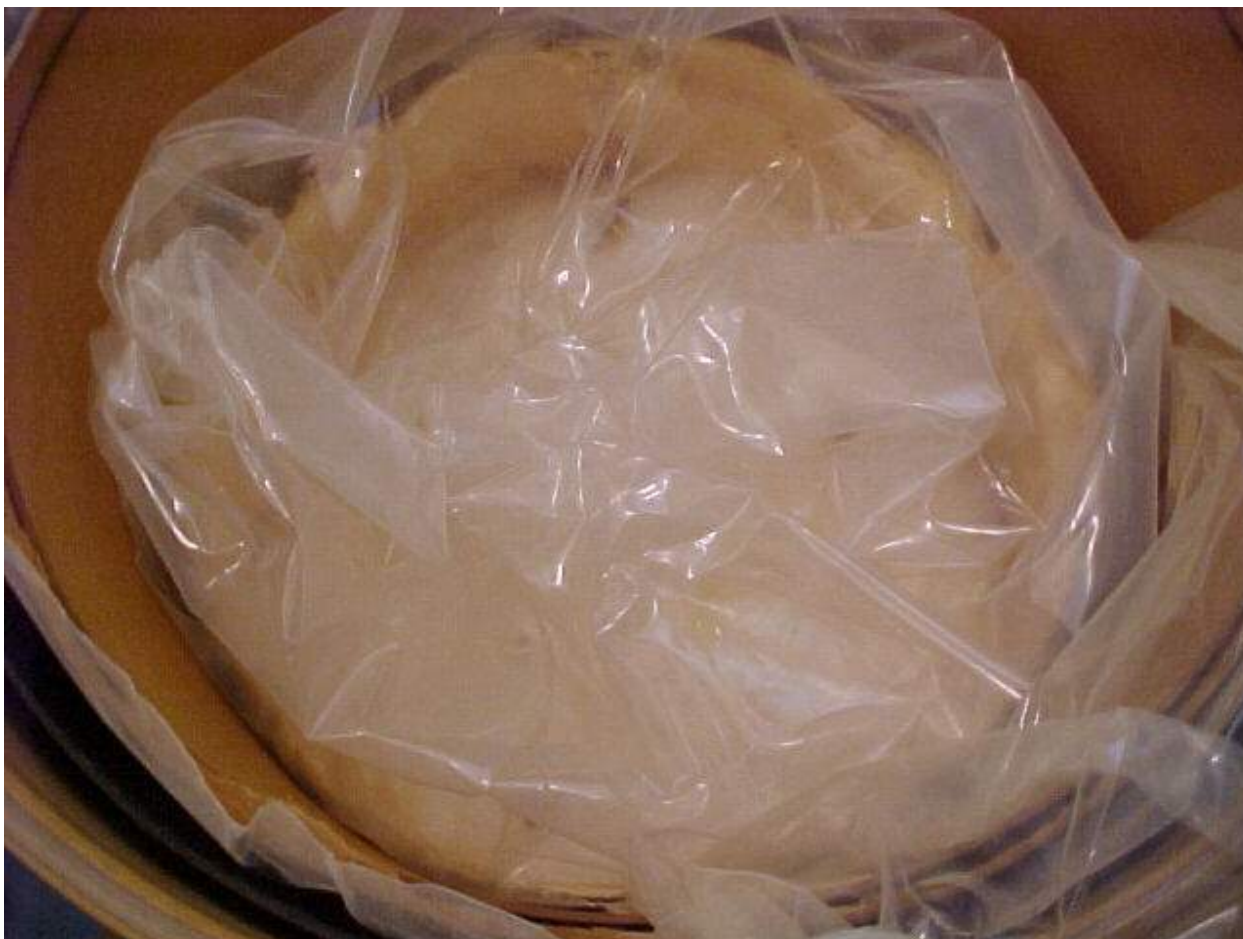
3rd poly liner/bag – good condition
No gasses present (in breathing zone)

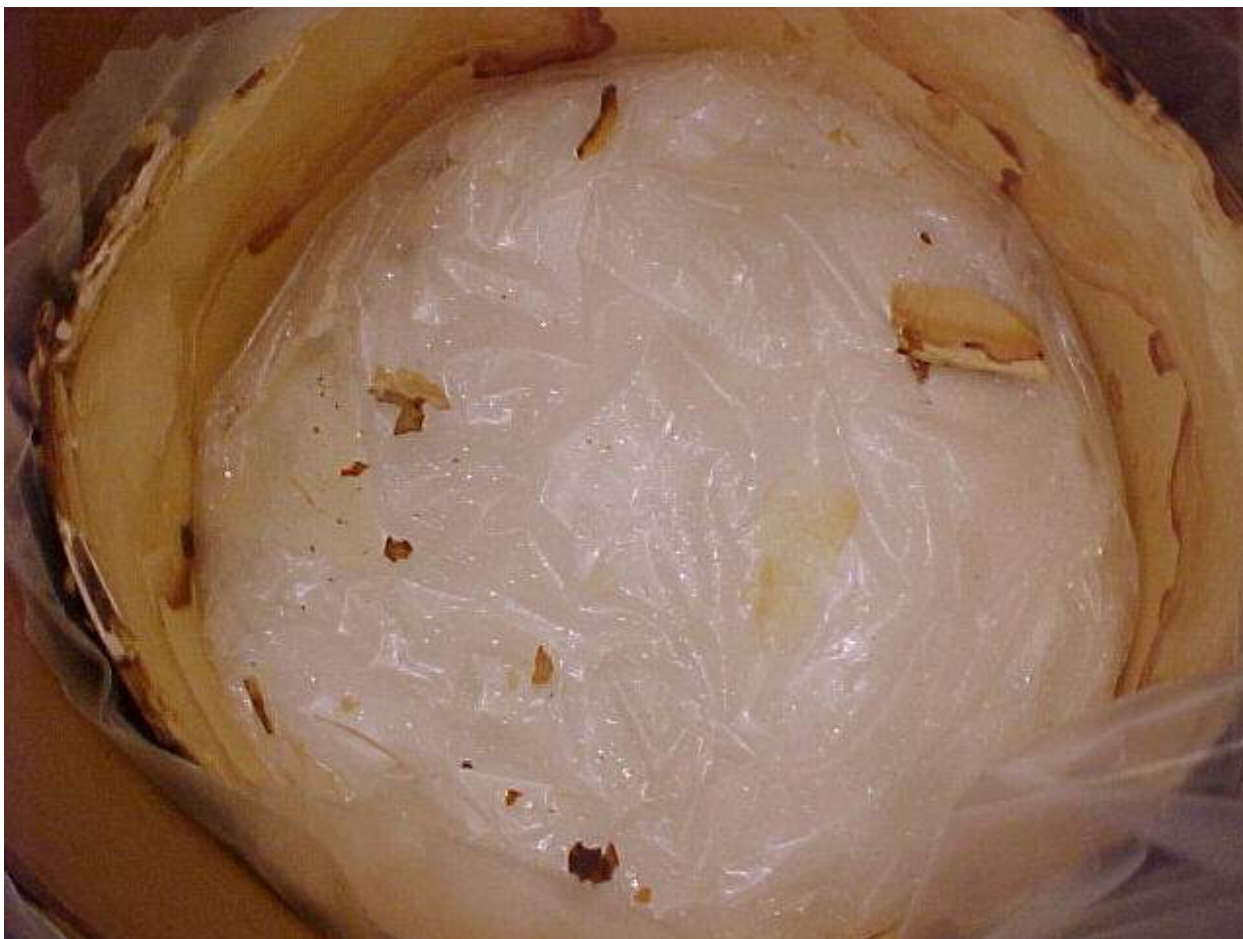
4th poly liner/bag – good condition (wooden lid not on drum)
No gasses present (in breathing zone)

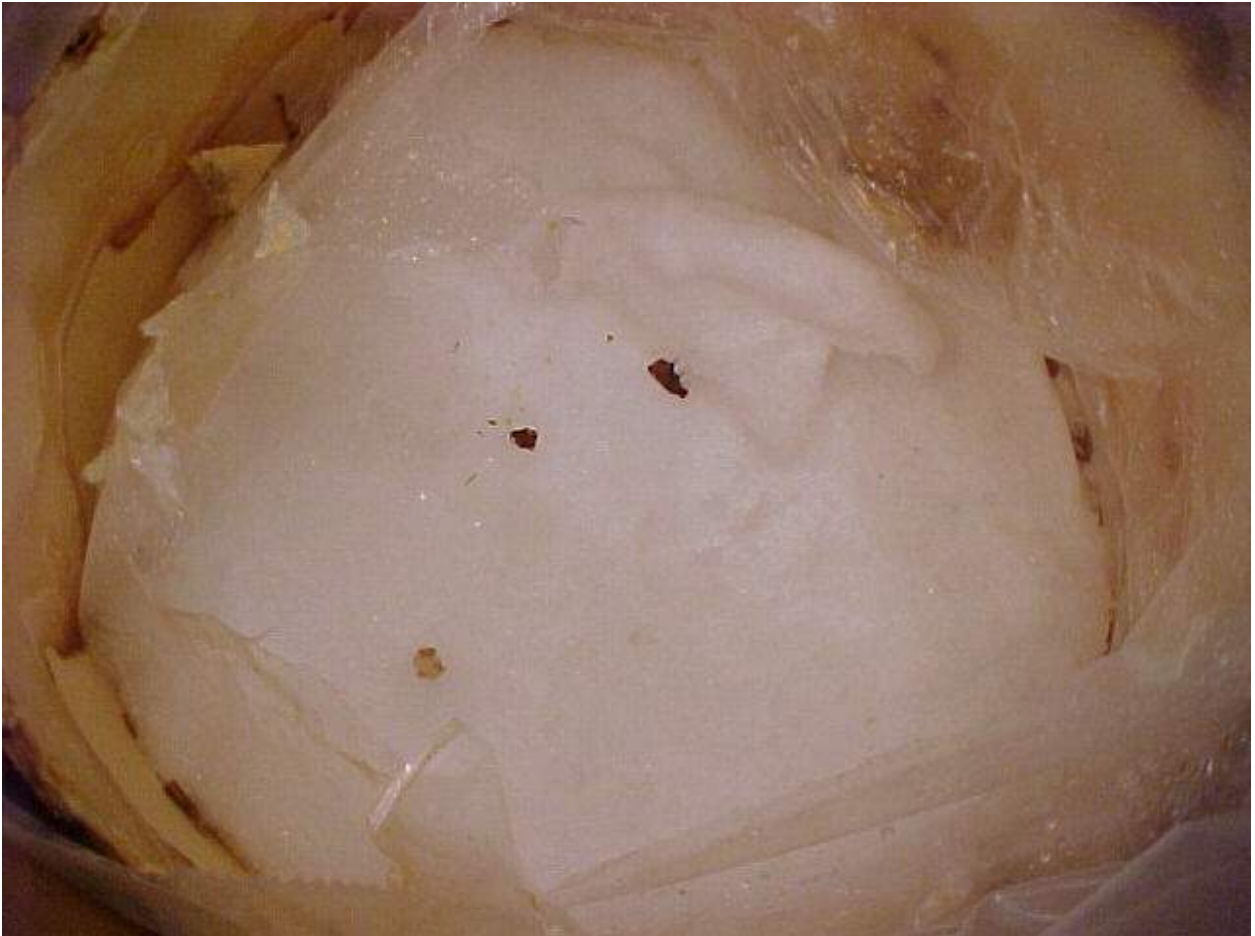
ThN material – monolith – white – solid - dry
No gasses present (in breathing zone)

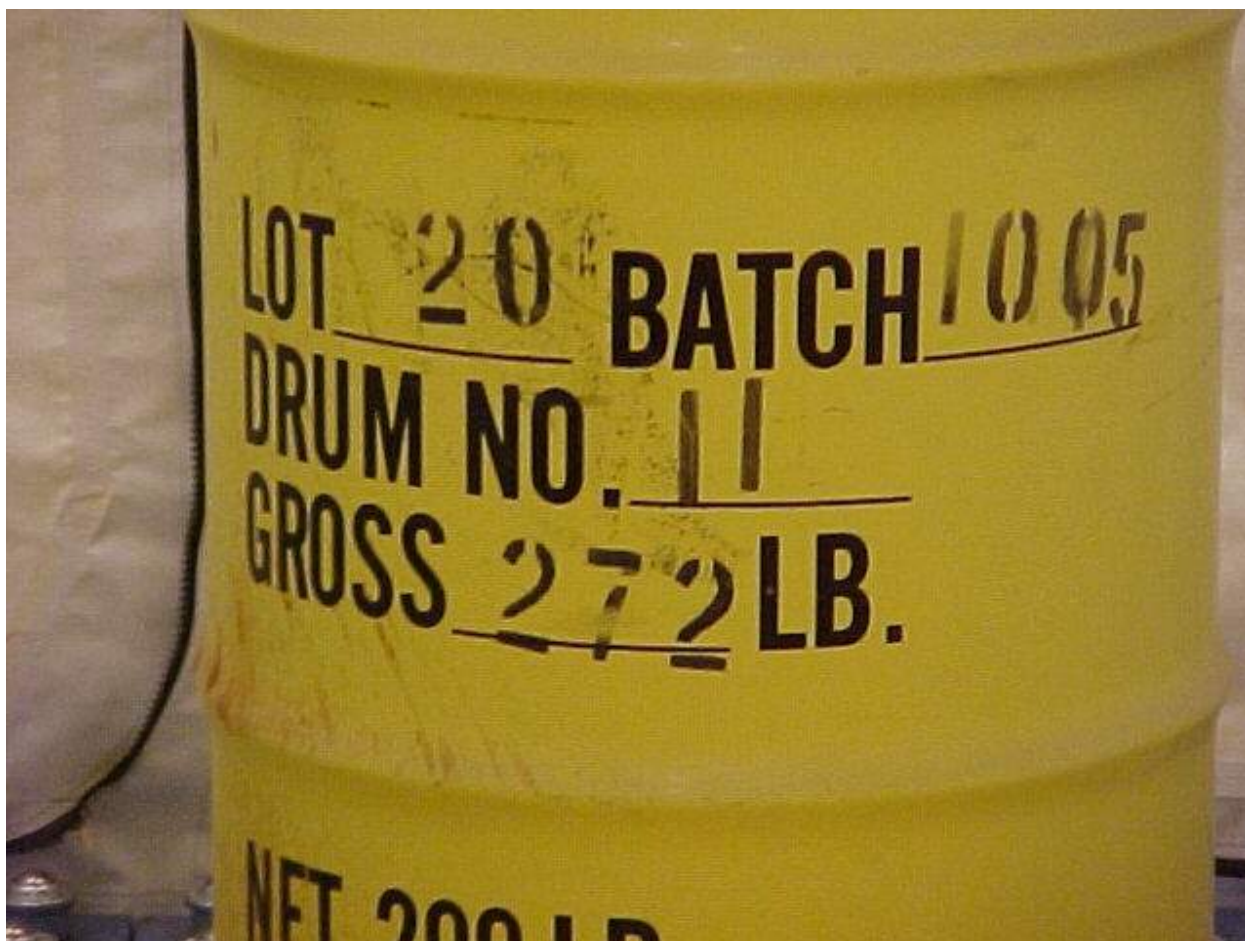
30-gal drum – good condition (released pressure as bolt on drum ring was loosened)

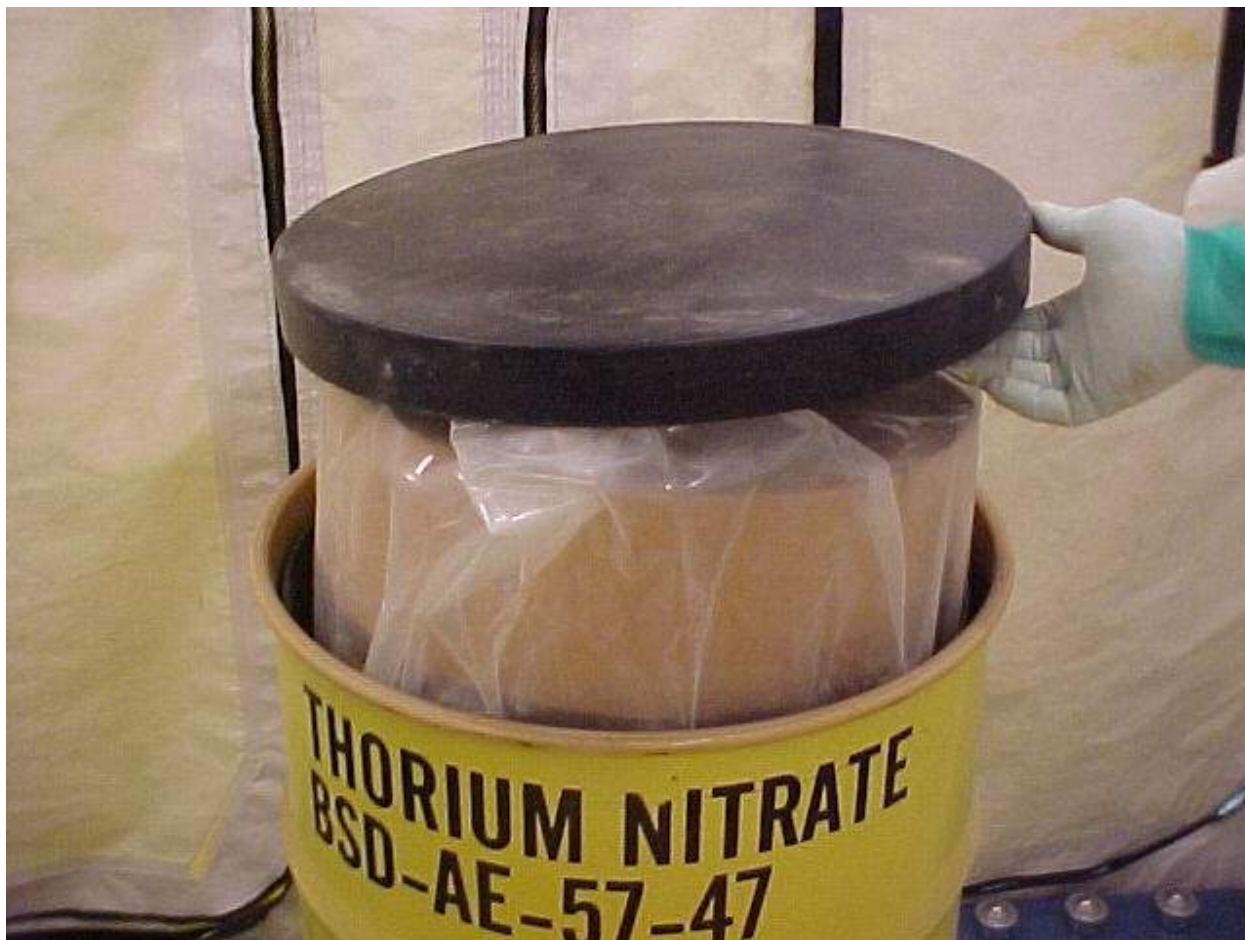
Black plastic lid (from drum liner) – good condition (raised lid indicates internal pressure inside of drum packaging)

No gasses present (in breathing zone)

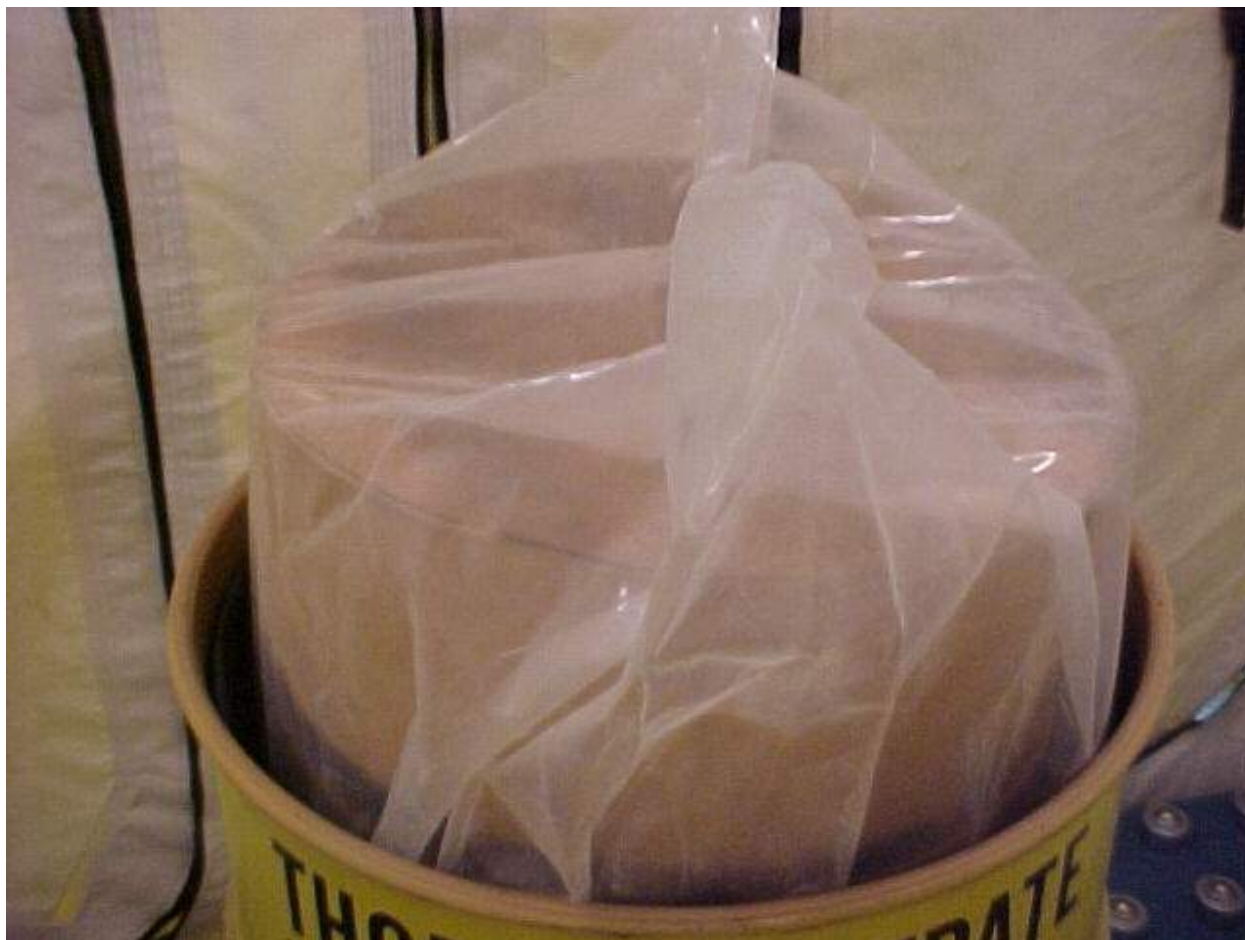
1st poly liner/bag – good condition (raised bag indicates internal pressure inside of drum packaging)

No gasses present (in breathing zone)
