THORIUM NITRATE STOCKPILE DRUM CHARACTERIZATION REPORT

**THORIUM NITRATE STOCKPILE
DRUM CHARACTERIZATION REPORT**

Prepared for
U.S. Defense Logistics Agency
Defense National Stockpile Center
Fort Belvoir, Virginia

Prepared by
OAK RIDGE NATIONAL LABORATORY
Oak Ridge, Tennessee 37831
managed by
UT-BATTELLE, LLC
for the
U.S. DEPARTMENT OF ENERGY
under contract DE-AC05-00OR22725

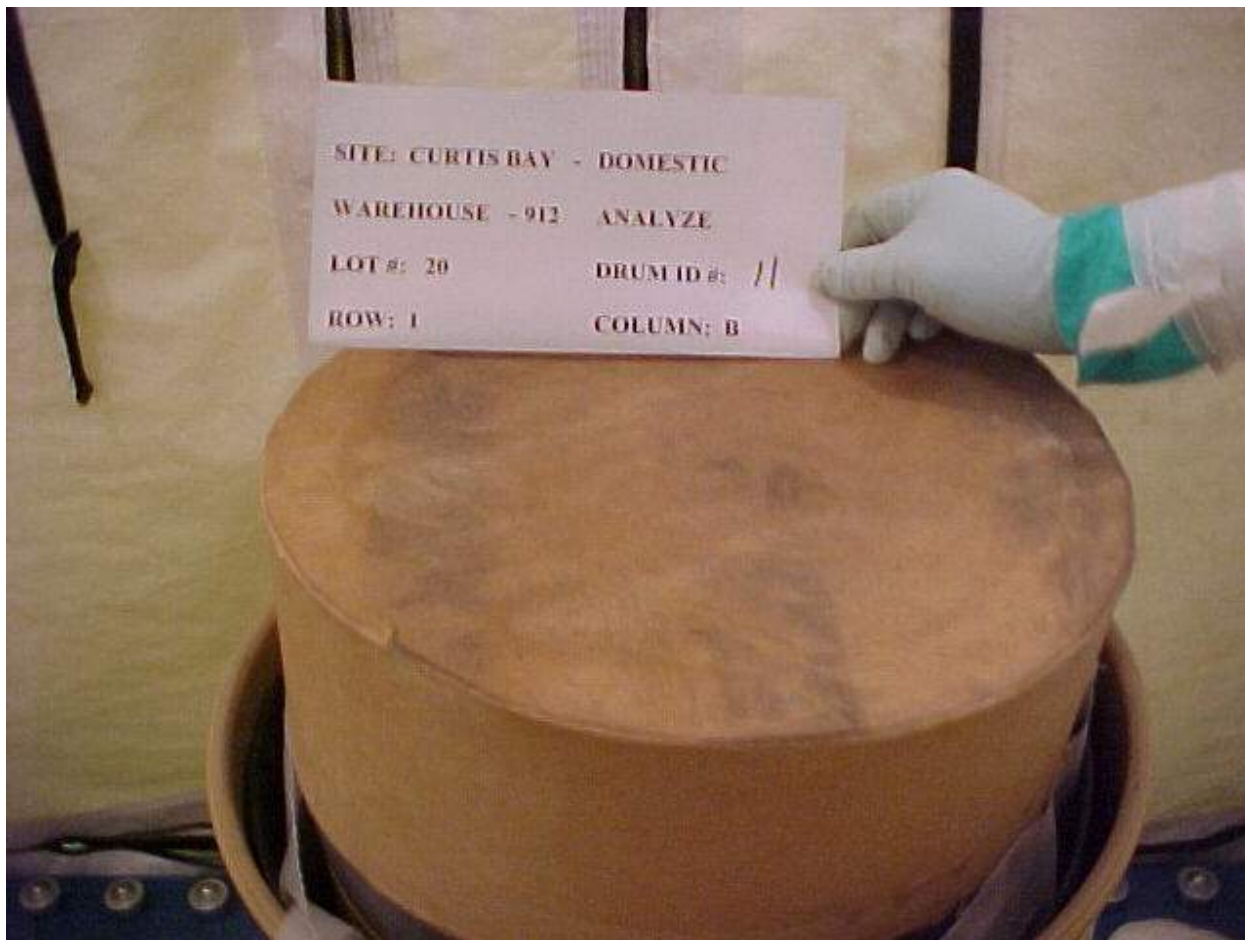
Fiber drum lid (from outermost fiber drum) – good condition (raised lid indicates internal pressure inside of drum packaging)
 No gasses present (in breathing zone)

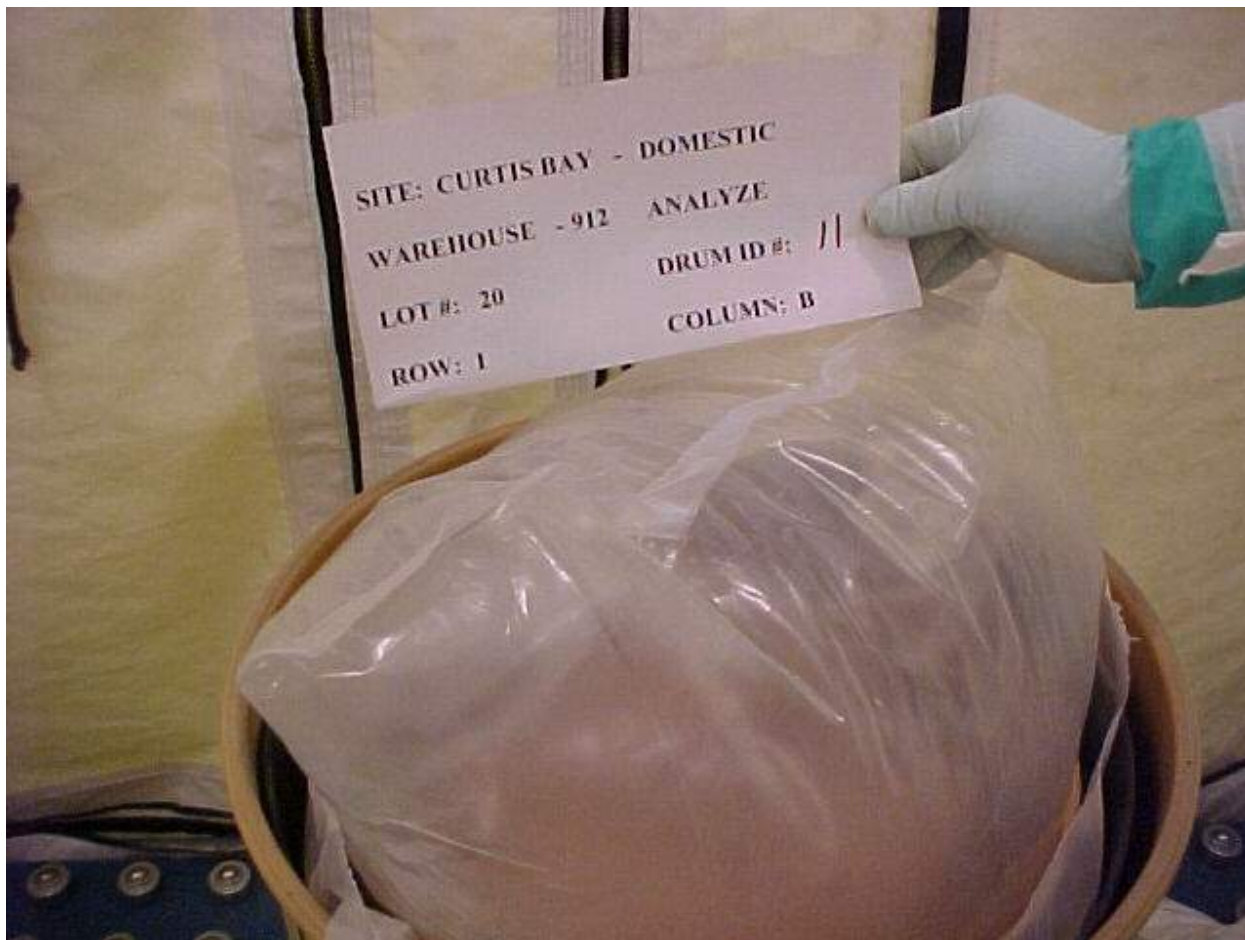
2nd poly liner/bag – good condition (raised bag indicates internal pressure inside of drum packaging)

No gasses present (in breathing zone)

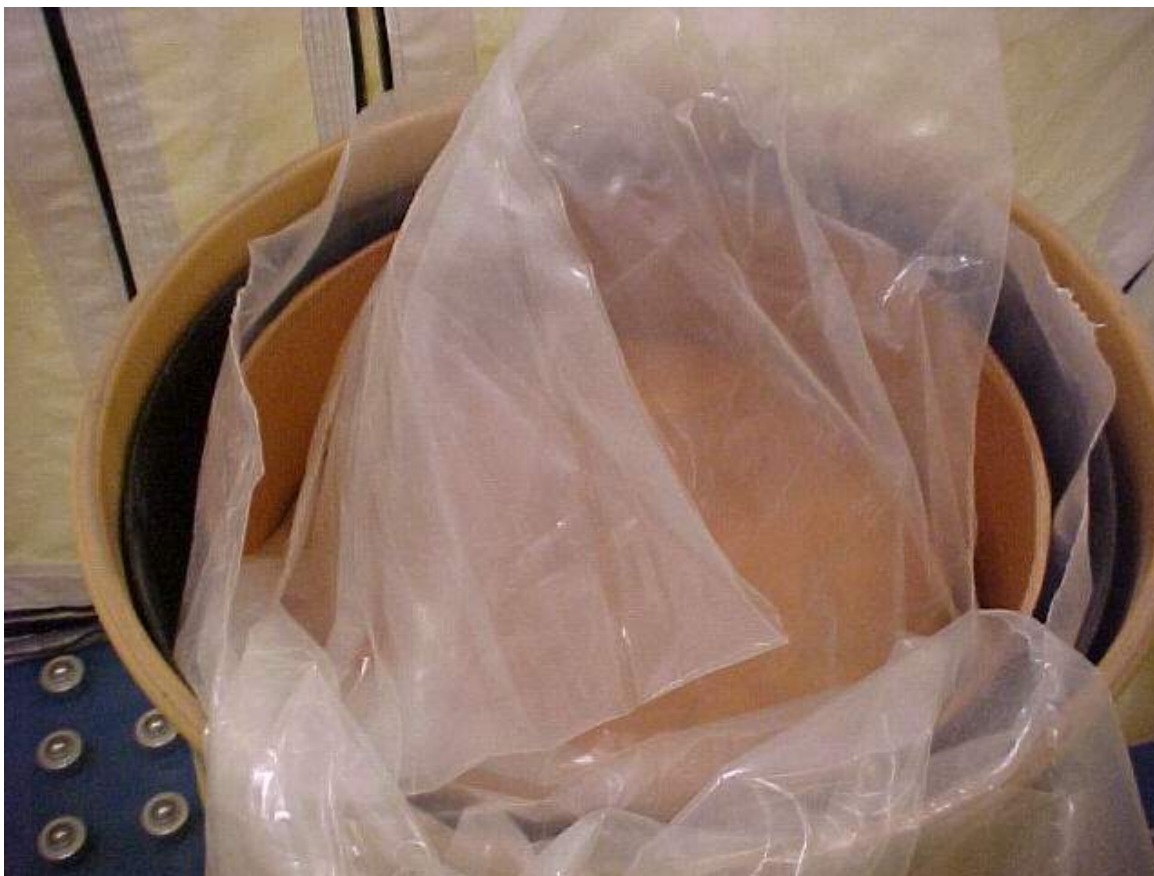
3rd poly liner/bag – good condition (raised bag indicates internal pressure inside of drum packaging) – this bag contains majority of internal pressure buildup (although, the bag does not “pop” once it is penetrated with a knife)

Gasses in bag headspace – LEL – 5.2% - NO - +50.0ppm – NOx – +50.0ppm

Drum vented - All gasses dissipated

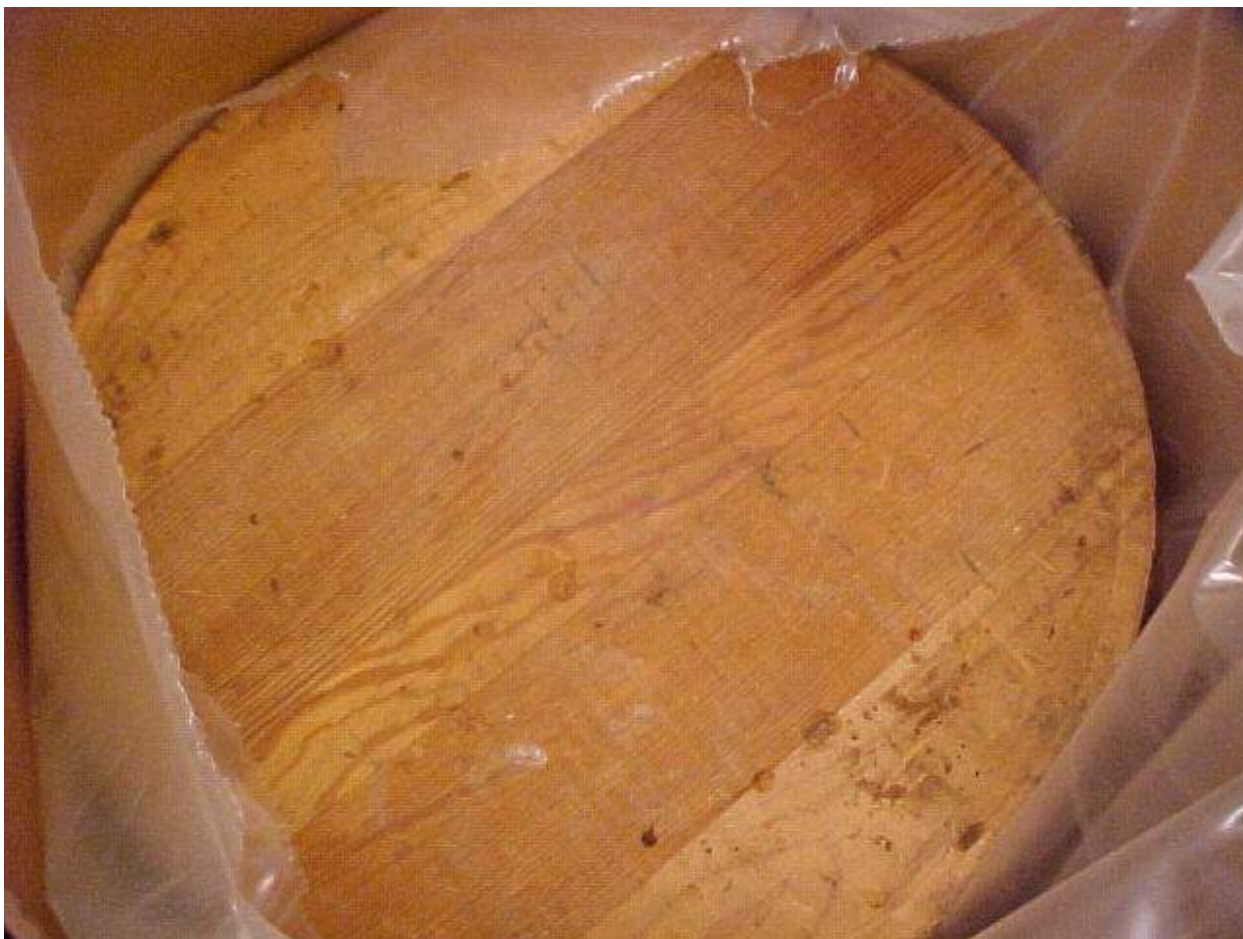
Wooden lid [on inner fiber drum (lab-pack)] – good condition
No gasses present (in breathing zone)

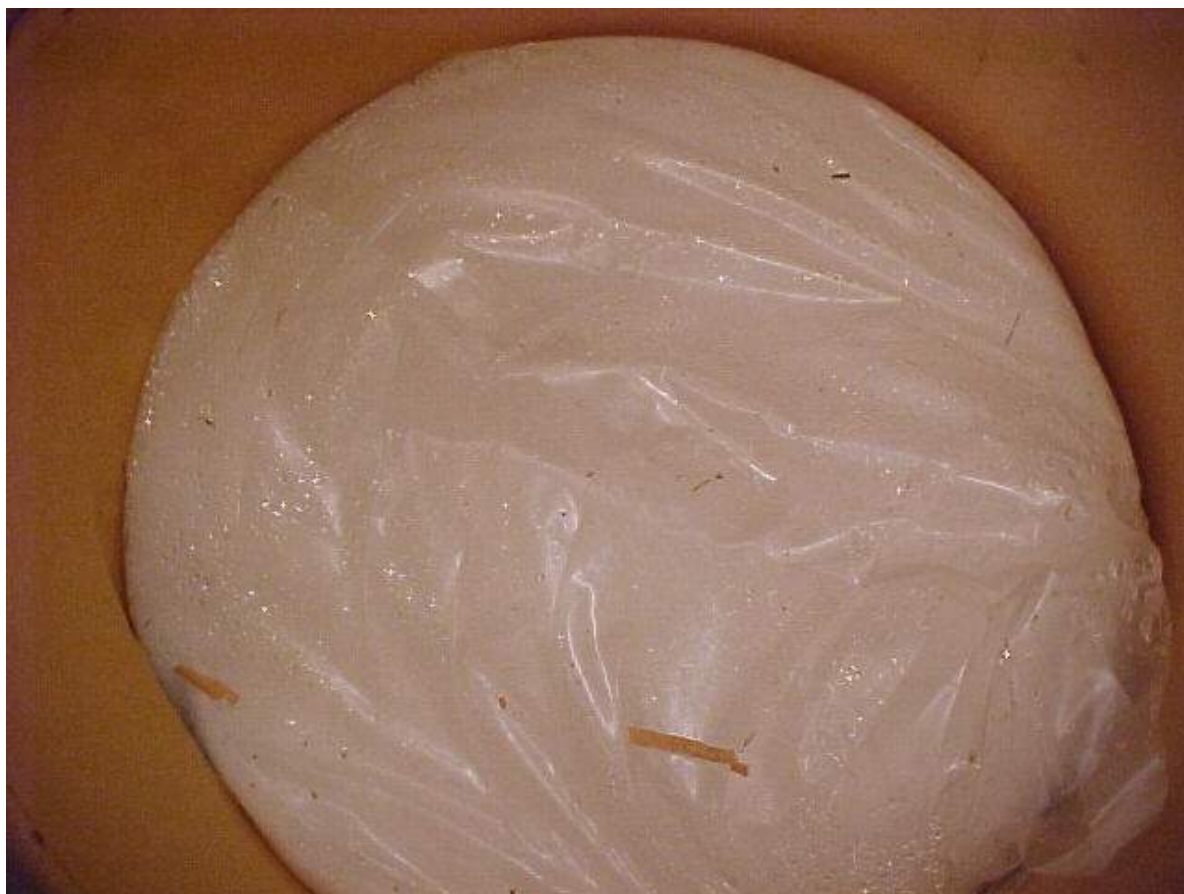
4th poly liner/bag – good condition (raised bag indicates internal pressure inside of drum packaging)

Gasses in bag headspace – LEL – 4.6% - NO - +50.0ppm – NOx – +50.0ppm

Drum vented - All gasses dissipated

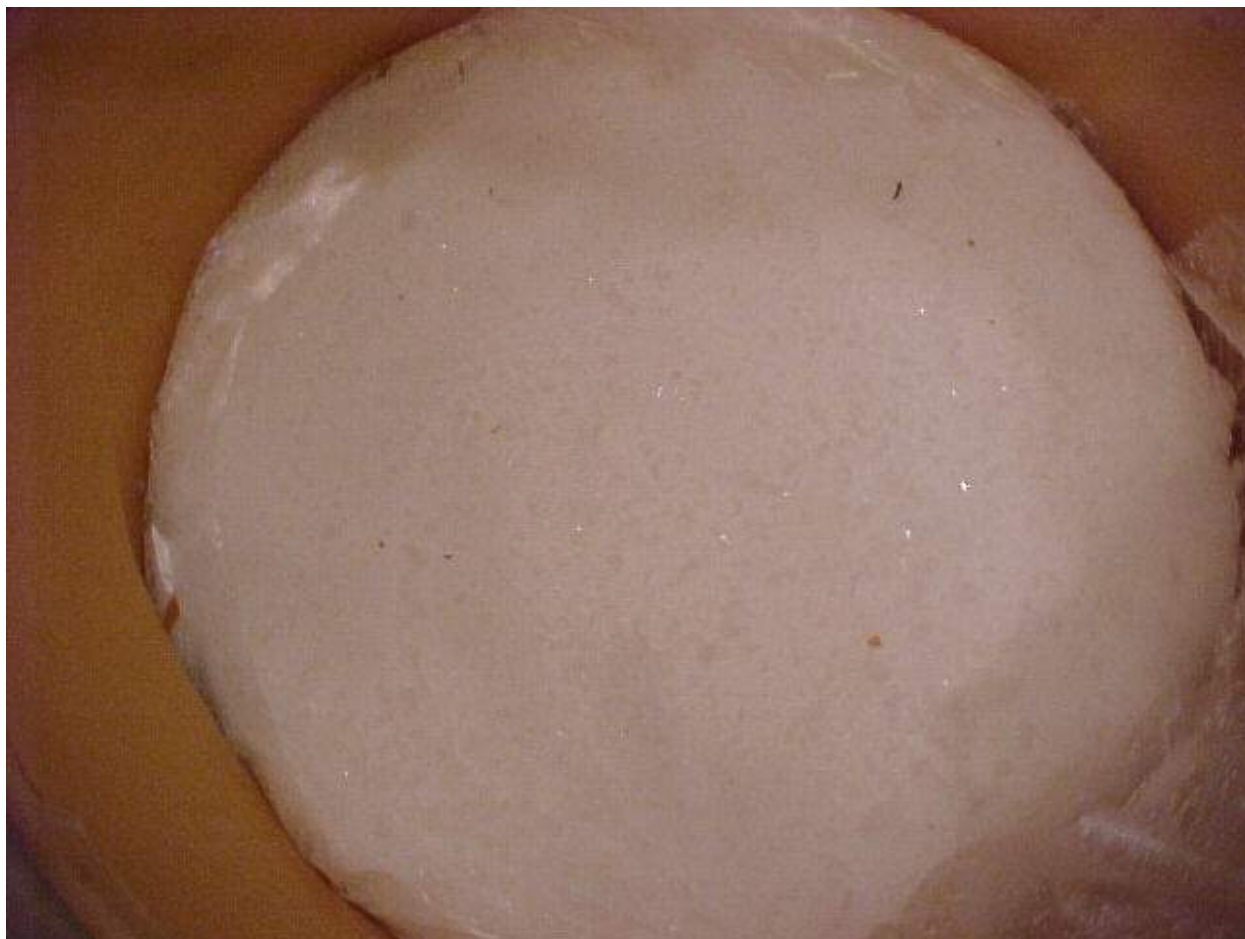
10:45**Other Information**Photo No. 9 of 10Dose Rate Surface 24 mR/hr
 1 meter 2.5 mR/hrThN material – monolith – solid – dry - white
No gasses present (in breathing zone)

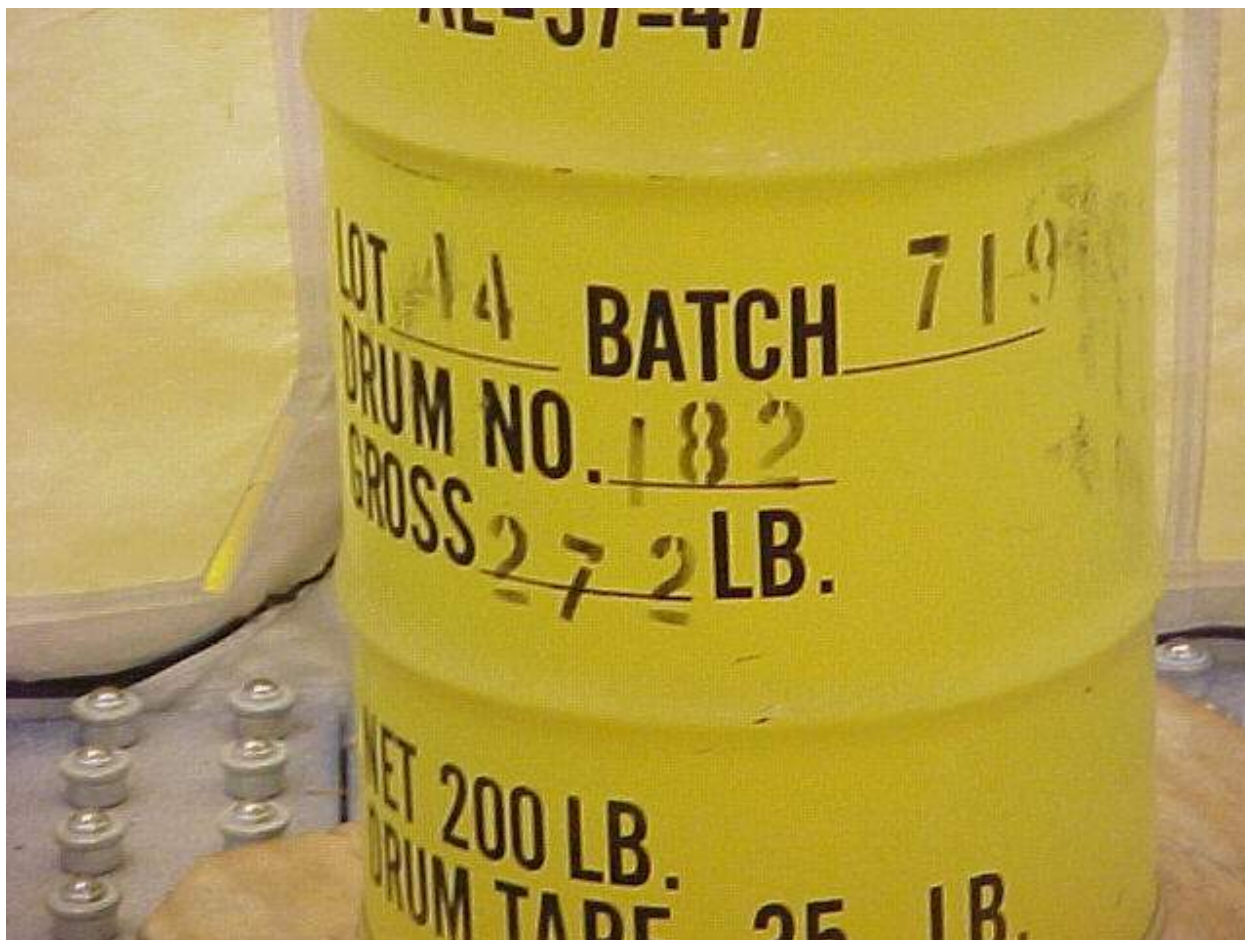
30-gal drum – good condition (released gas while loosening bolt on drum ring)

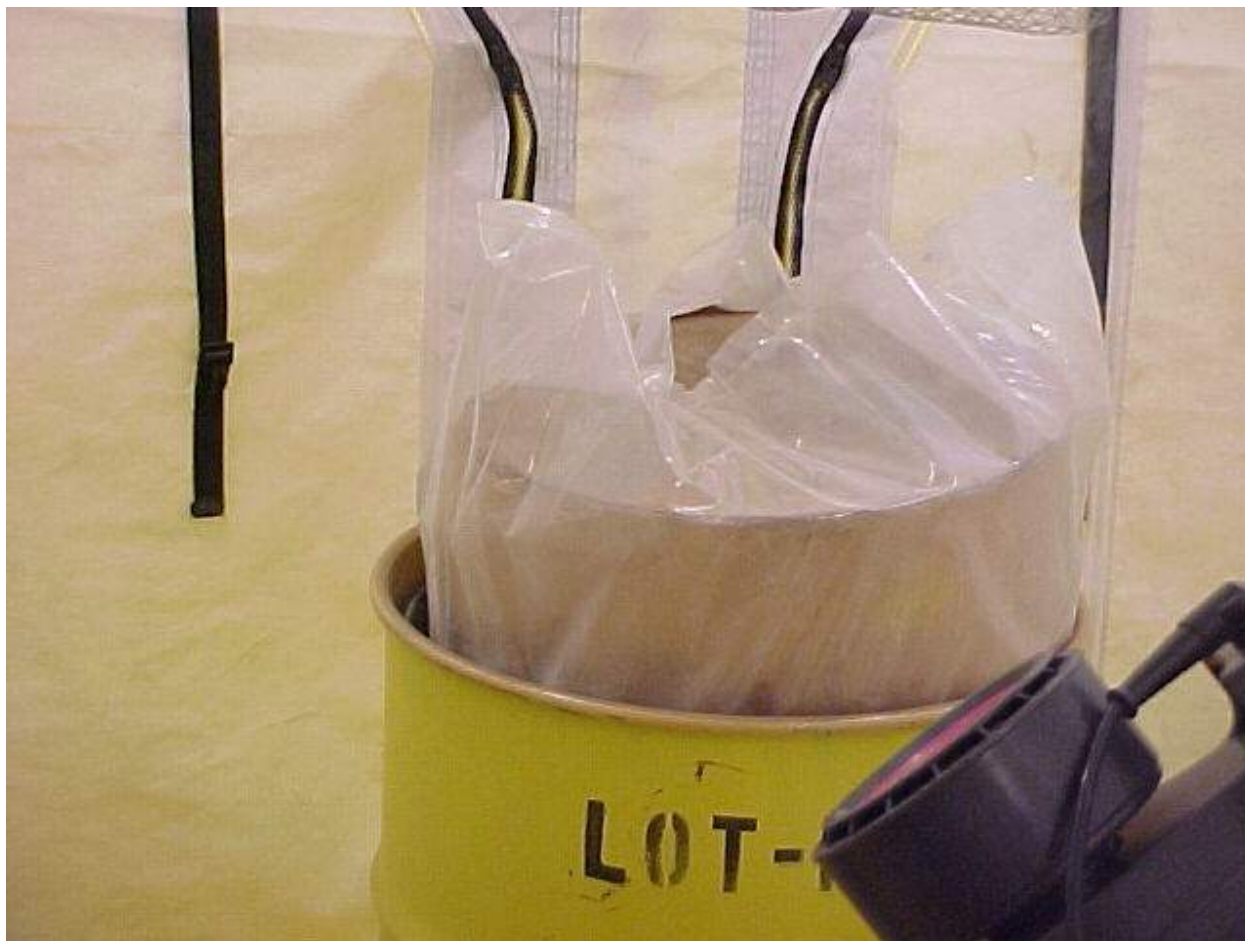
1st poly liner/bag – good condition (inflated/raised bag is a result of internal pressure buildup inside the packaging)

No gasses present (in breathing zone)

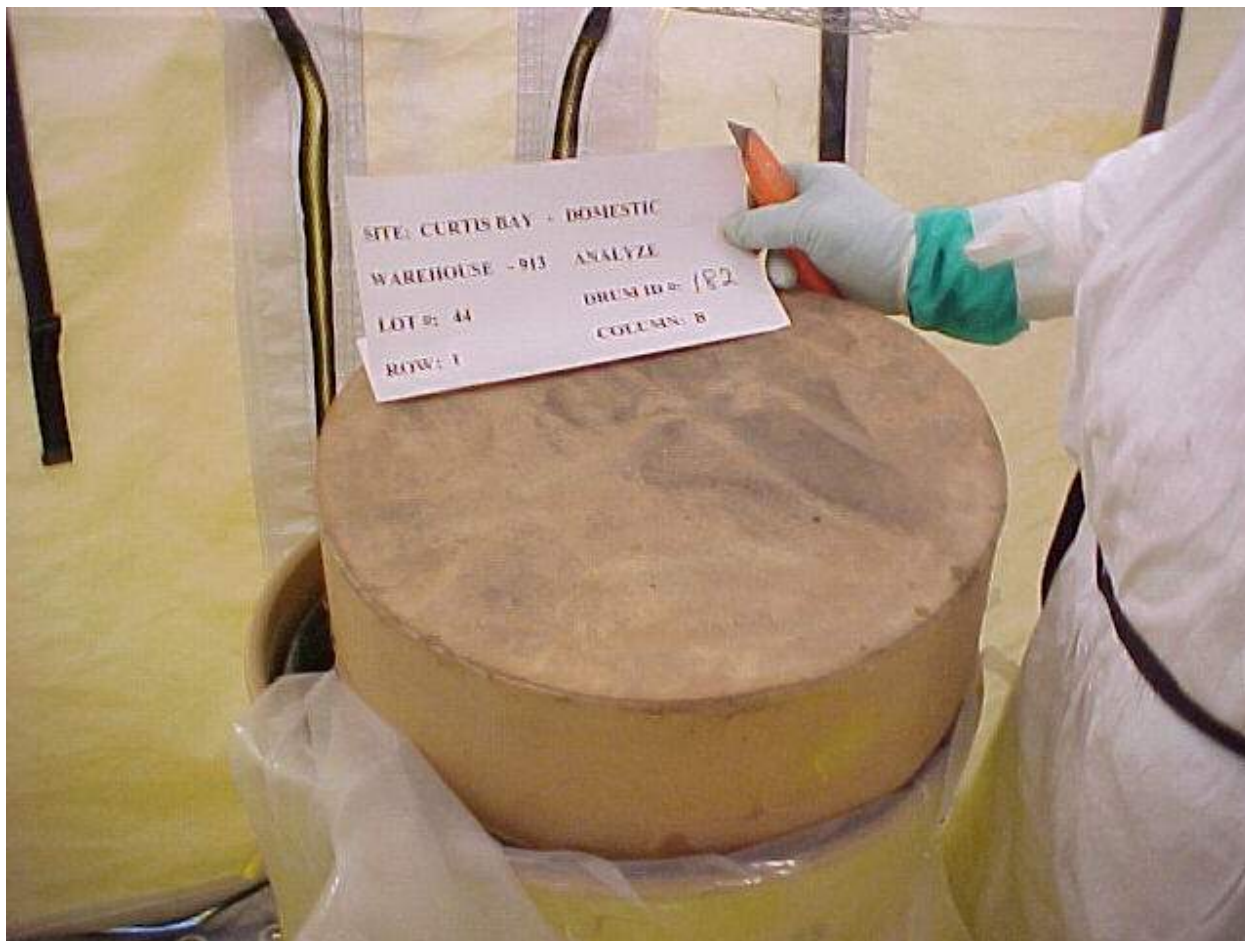
Fiber drum lid (from outermost fiber drum) – good condition (inflated/raised lid is a result of internal pressure buildup inside the packaging)

No gasses present (in breathing zone)

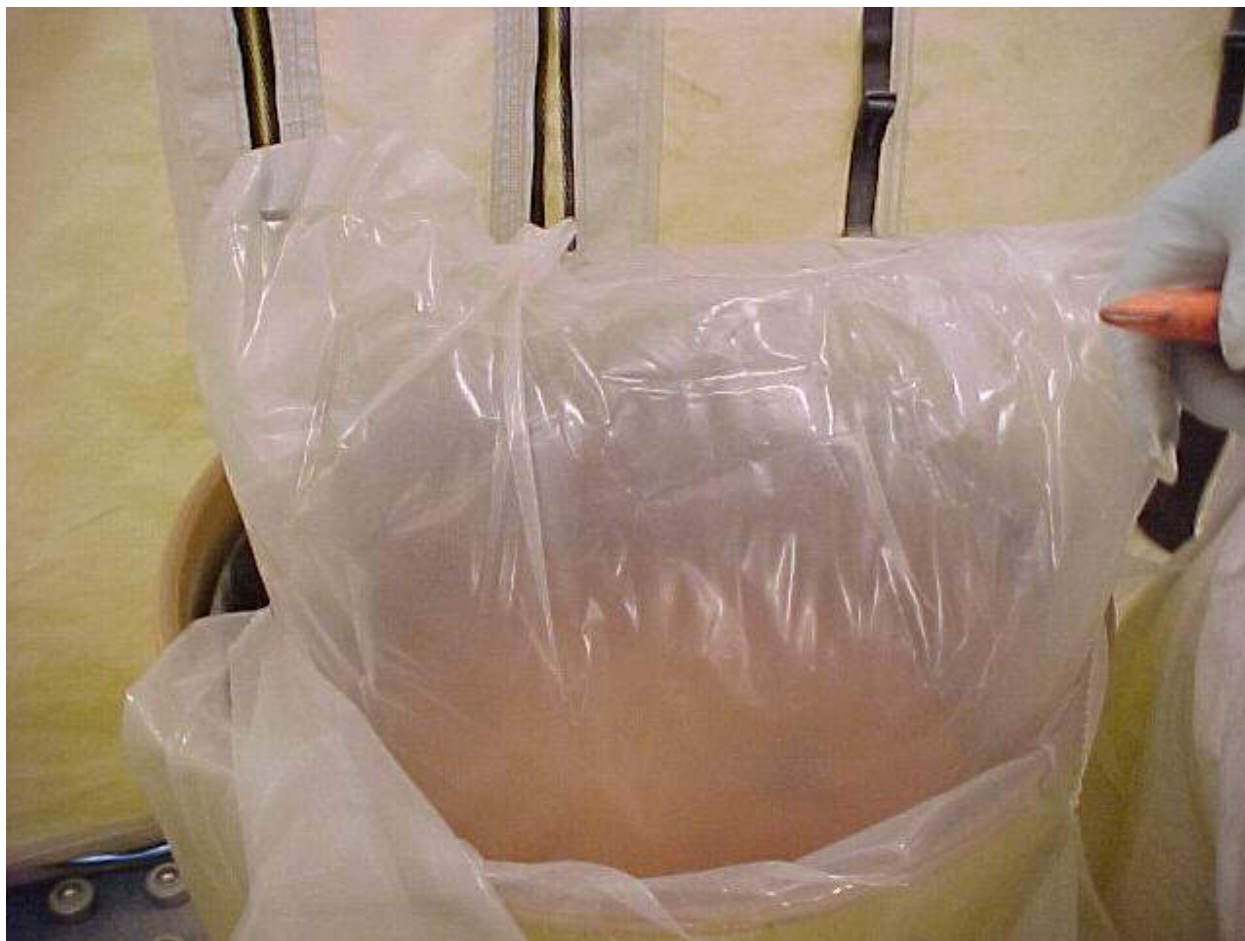
2nd poly liner/bag – good condition (inflated/raised bag is a result of internal pressure buildup inside the packaging)

No gasses present (in breathing zone)

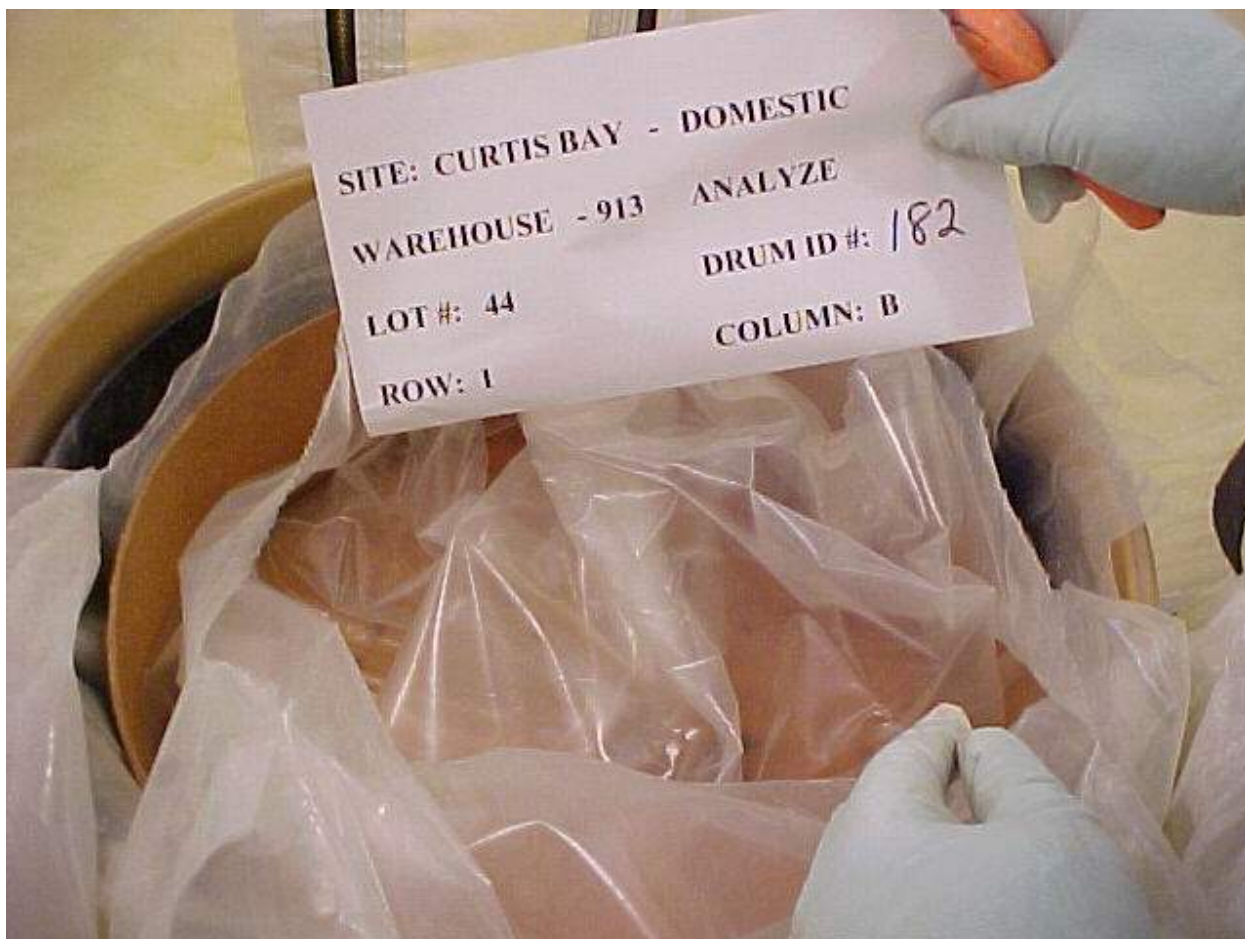
3rd poly liner/bag – good condition (inflated/raised bag is a result of internal pressure buildup inside the packaging)

Gasses in headspace – LEL – 4.6% - NO – +50.0ppm – NOx – +50.0ppm

Drum vented - All gasses dissipated

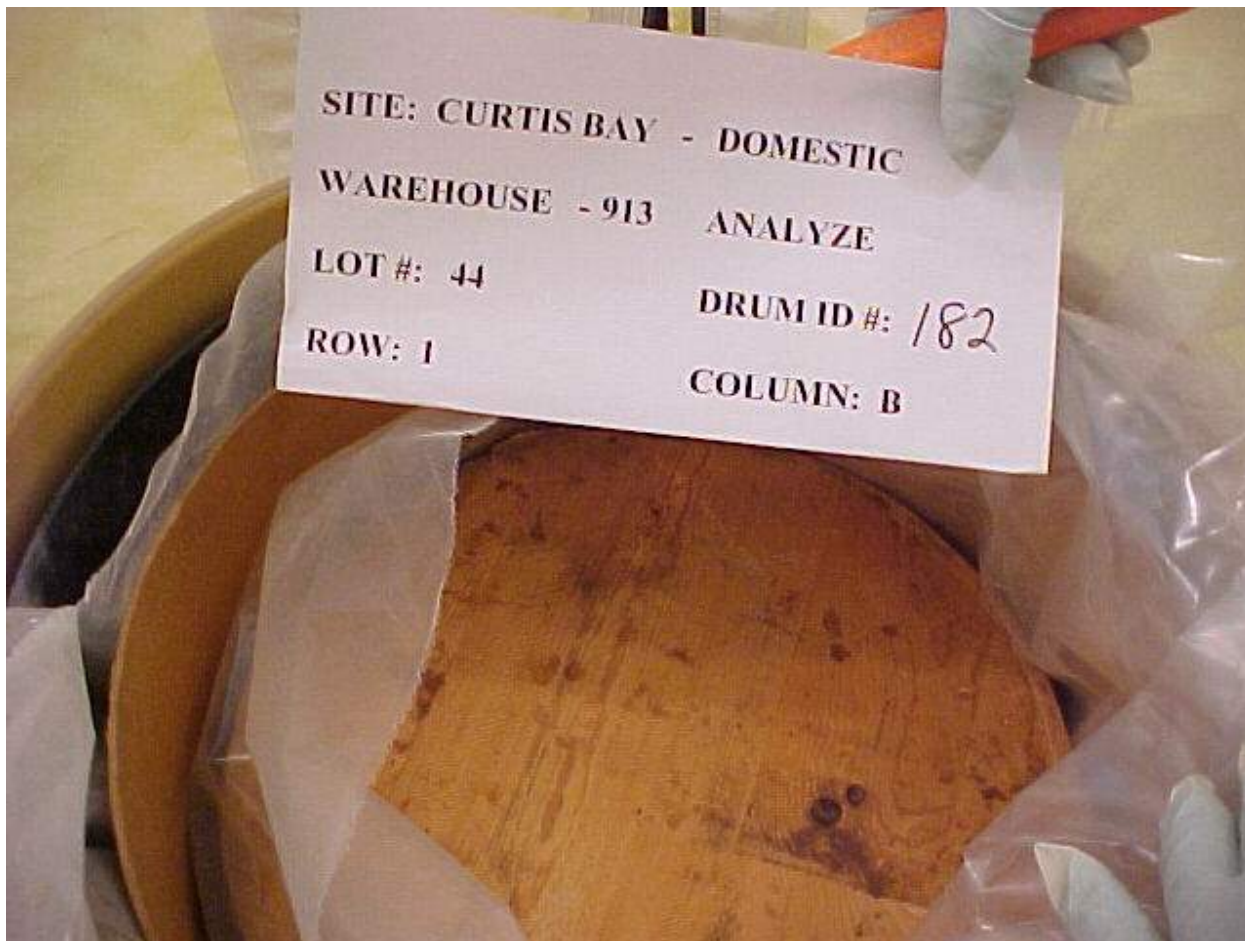
Wooden lid (cover to inner fiber drum – sometimes referred to as a lab-pack container in this documentation) – good condition

No gasses present (in breathing zone)

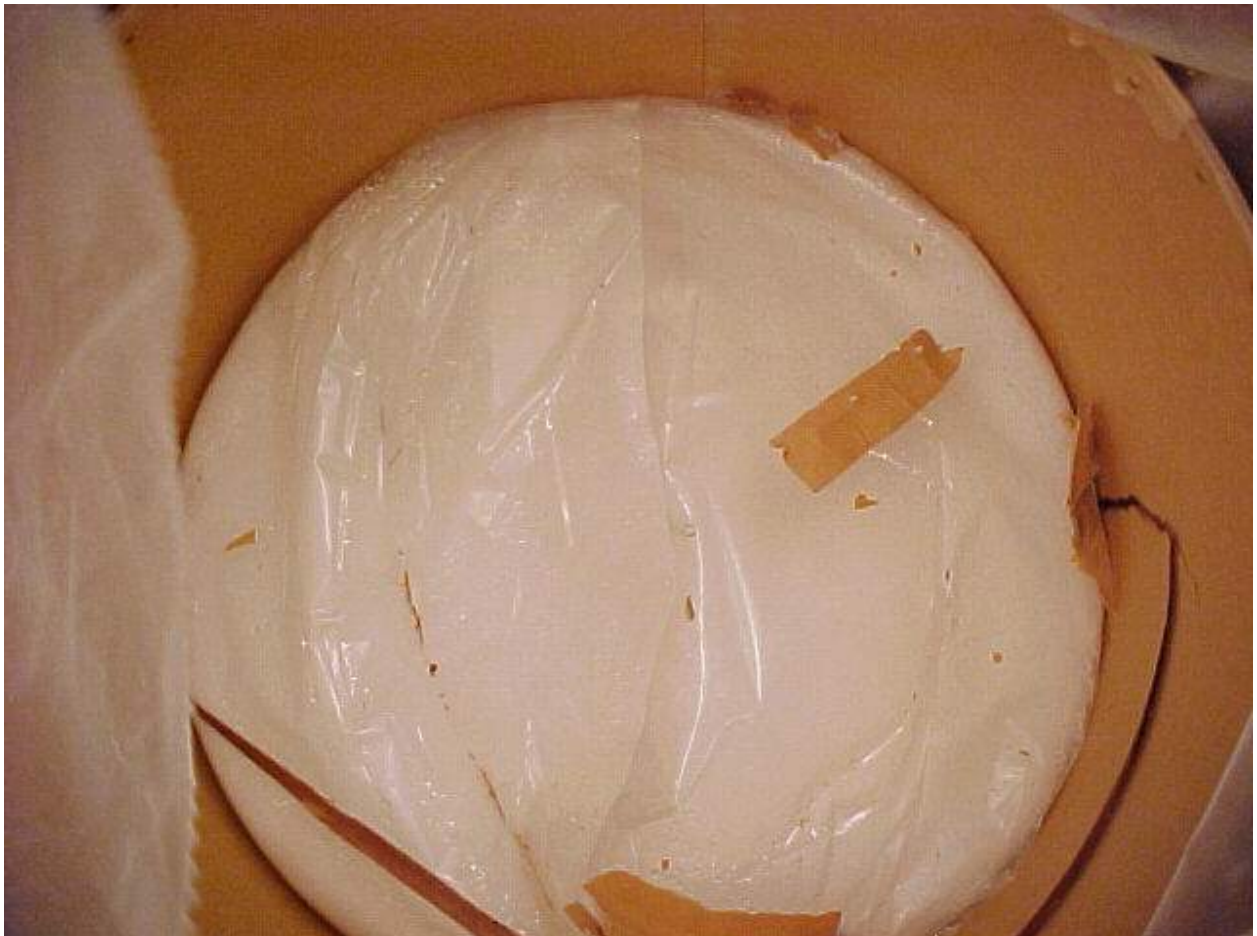
4th poly liner/bag – good condition
No gasses present (in breathing zone)

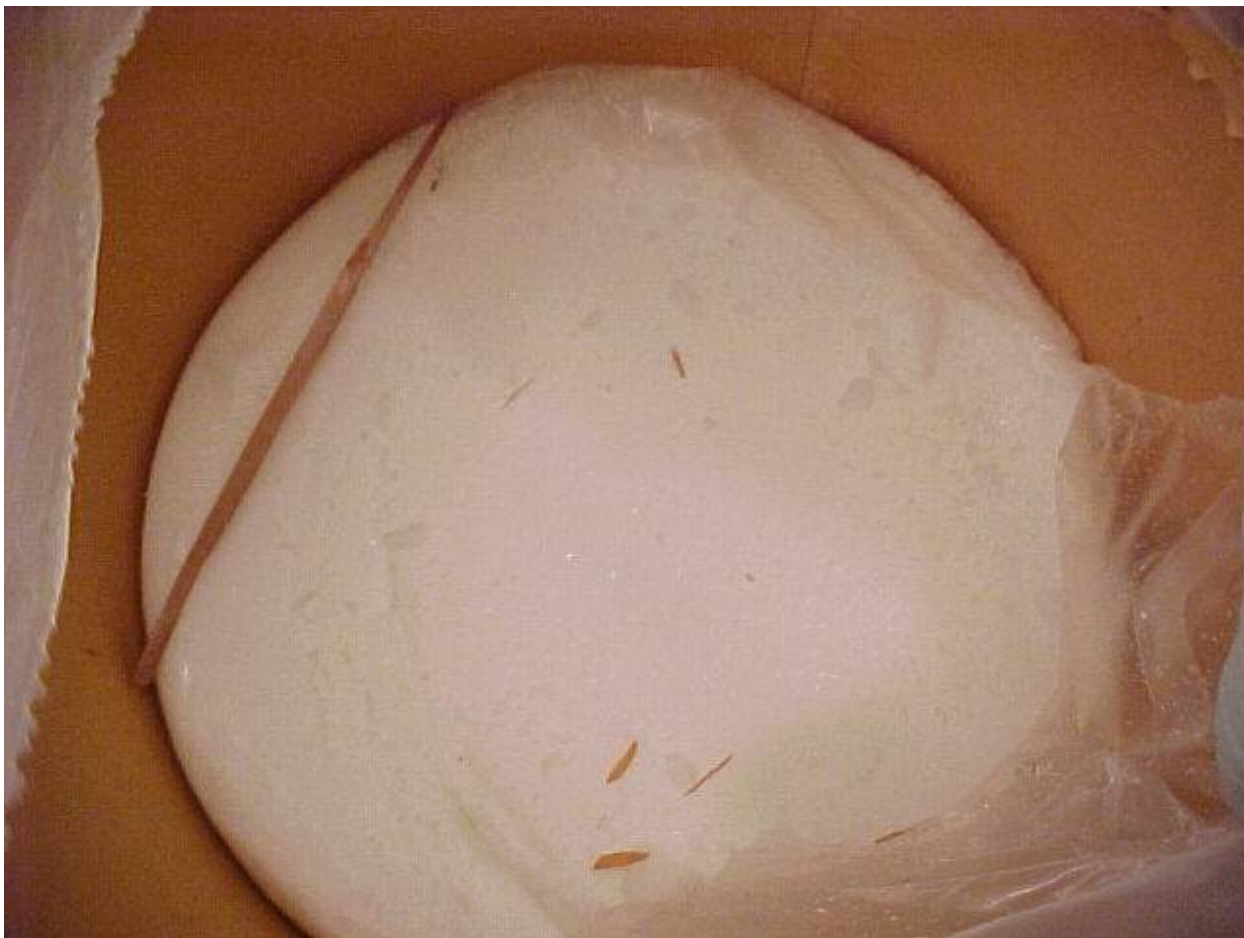
ThN material – monolith – solid – dry - white

No gasses present (in breathing zone)

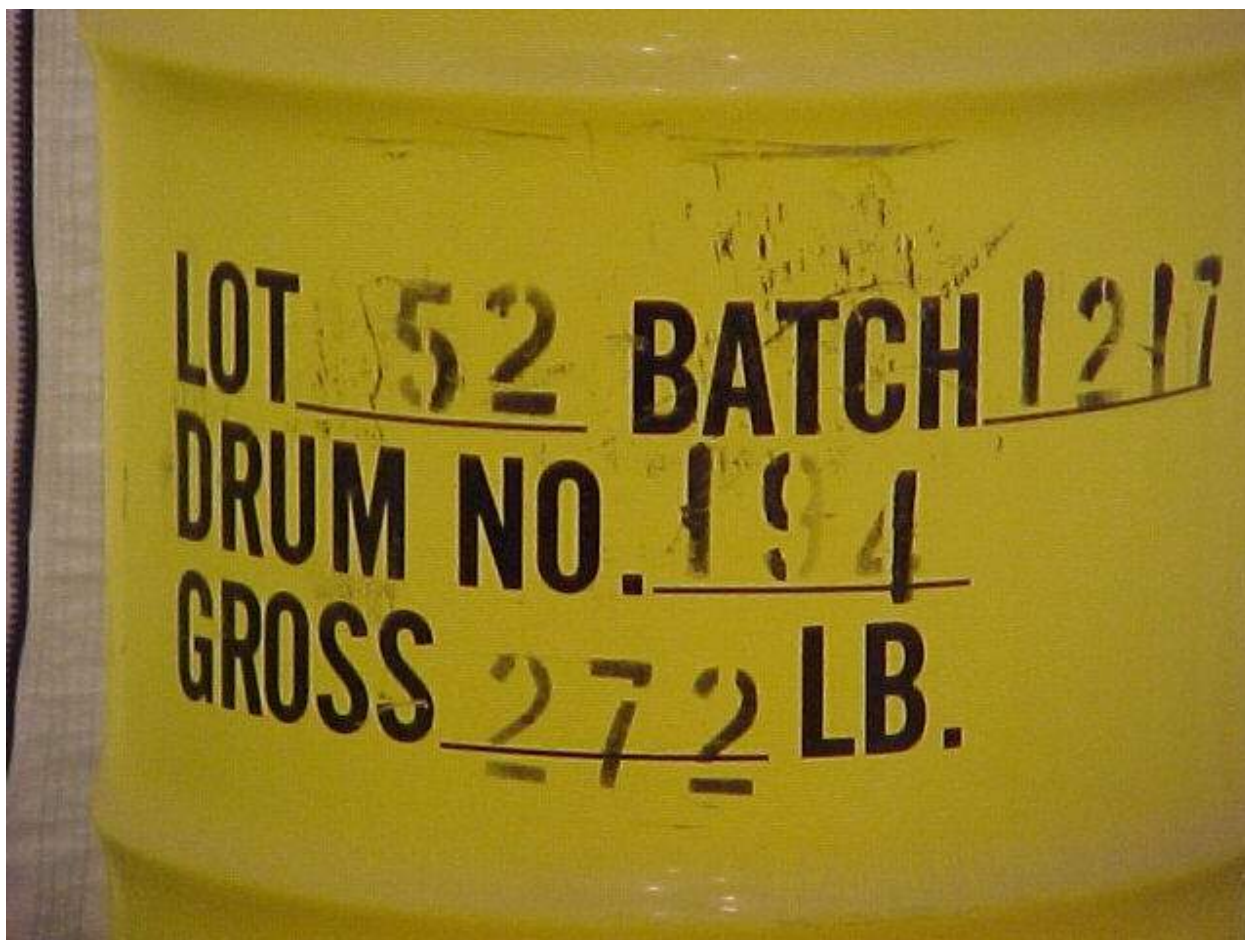
30-gal drum – good condition (drum released pressure when initially loosening bolt on drum ring – slowly opened to allow gas to dissipate inside the headspace of the drum while the lid was still being held in place with the drum ring)
No gasses present (in breathing zone)

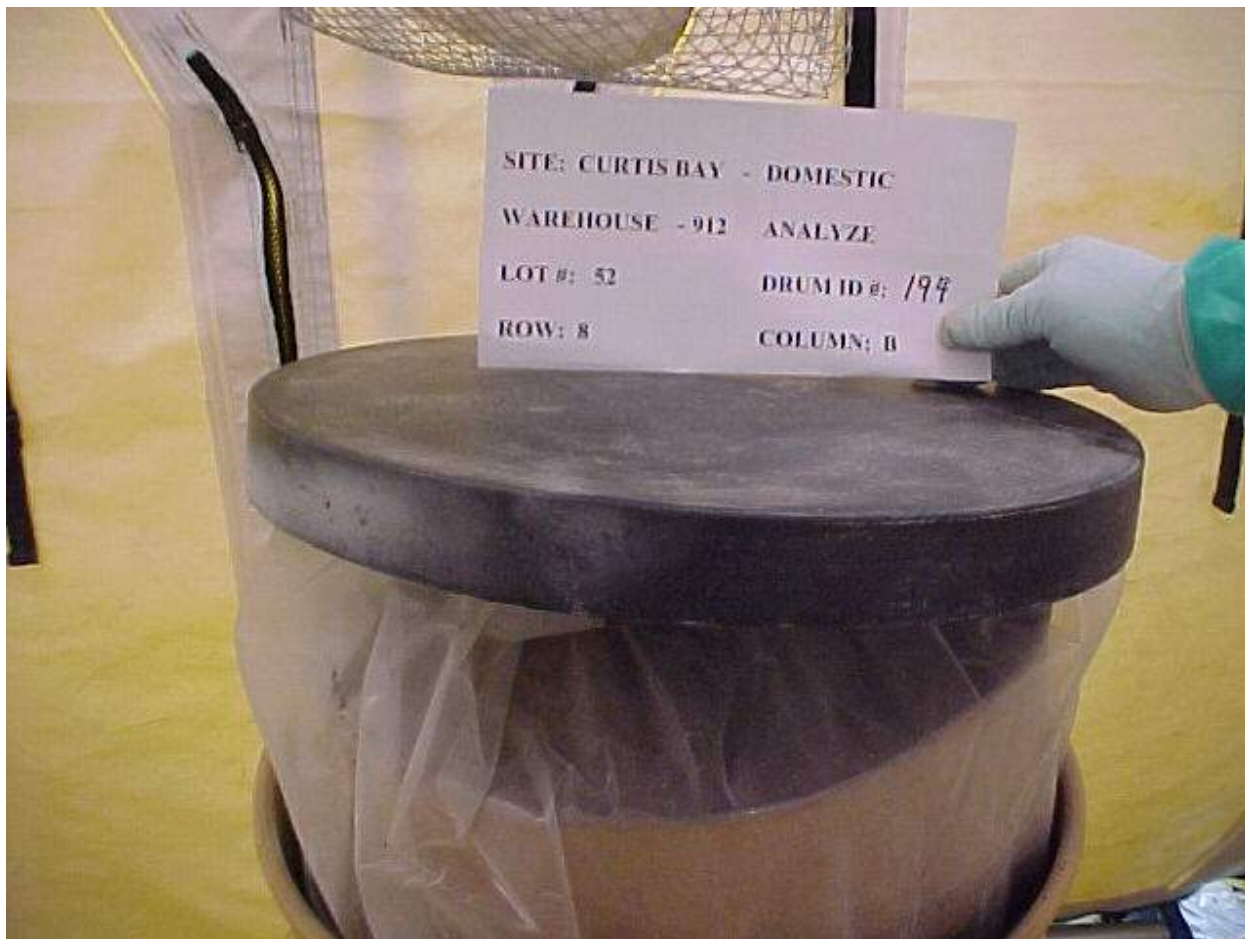
Black plastic lid of drum liner – good condition (raised lid indicates internal pressure buildup internal to the packaging)

No gasses present (in breathing zone)

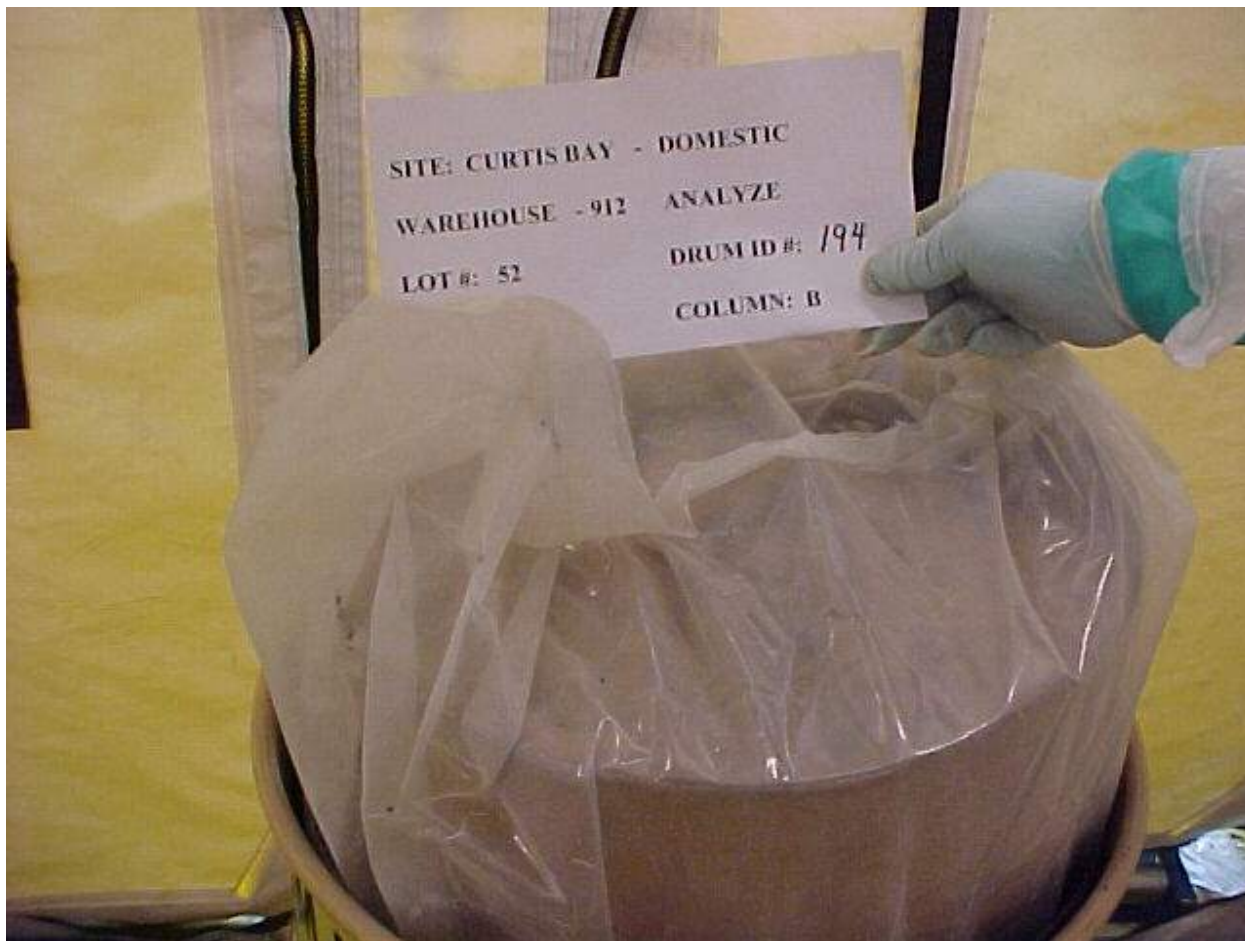
1st poly liner/bag – good condition (raised bag indicates internal pressure buildup internal to the packaging)

No gasses present (in breathing zone)

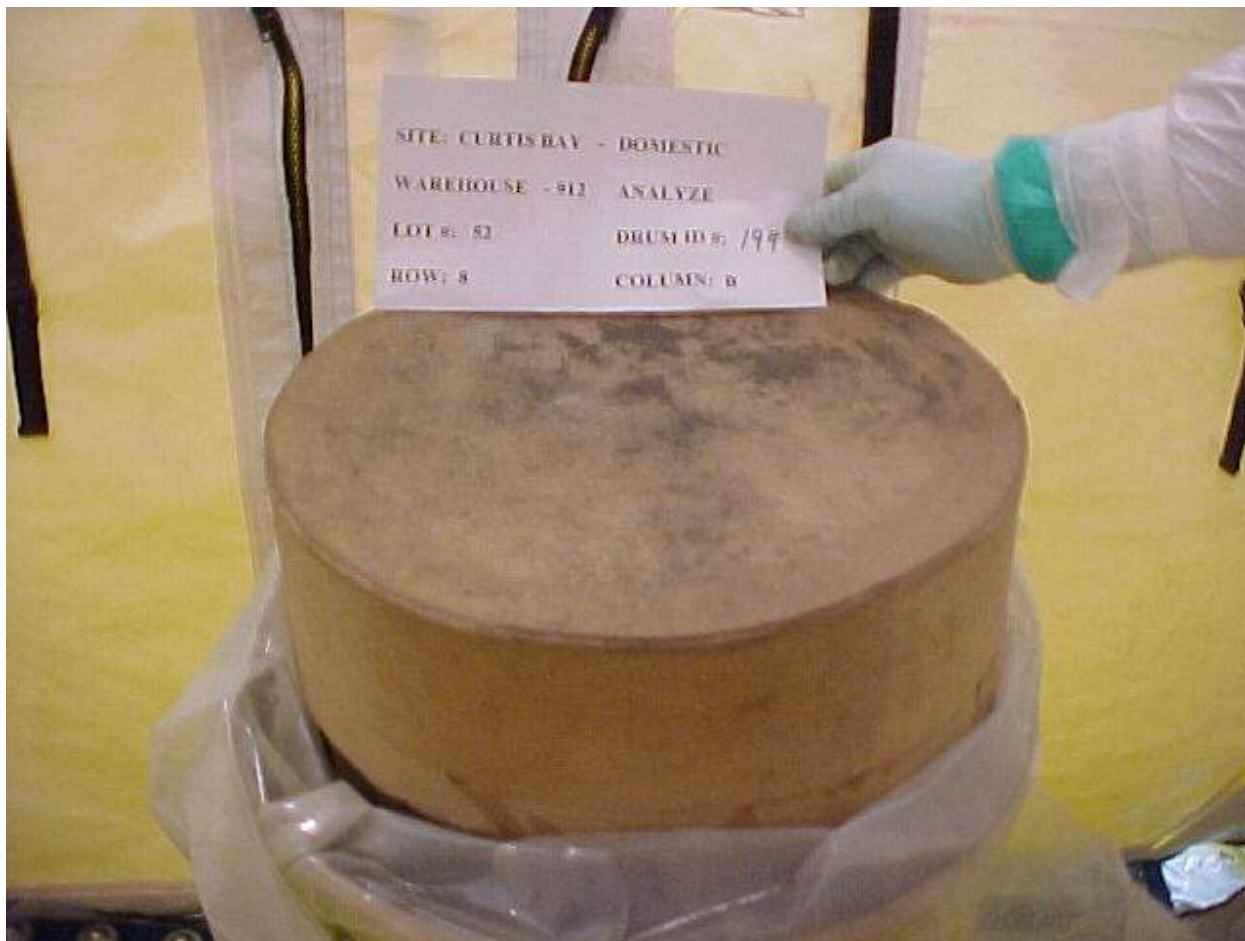
Fiber lid of outermost fiber drum – good condition (raised lid indicates internal pressure buildup internal to the packaging)

No gasses present (in breathing zone)

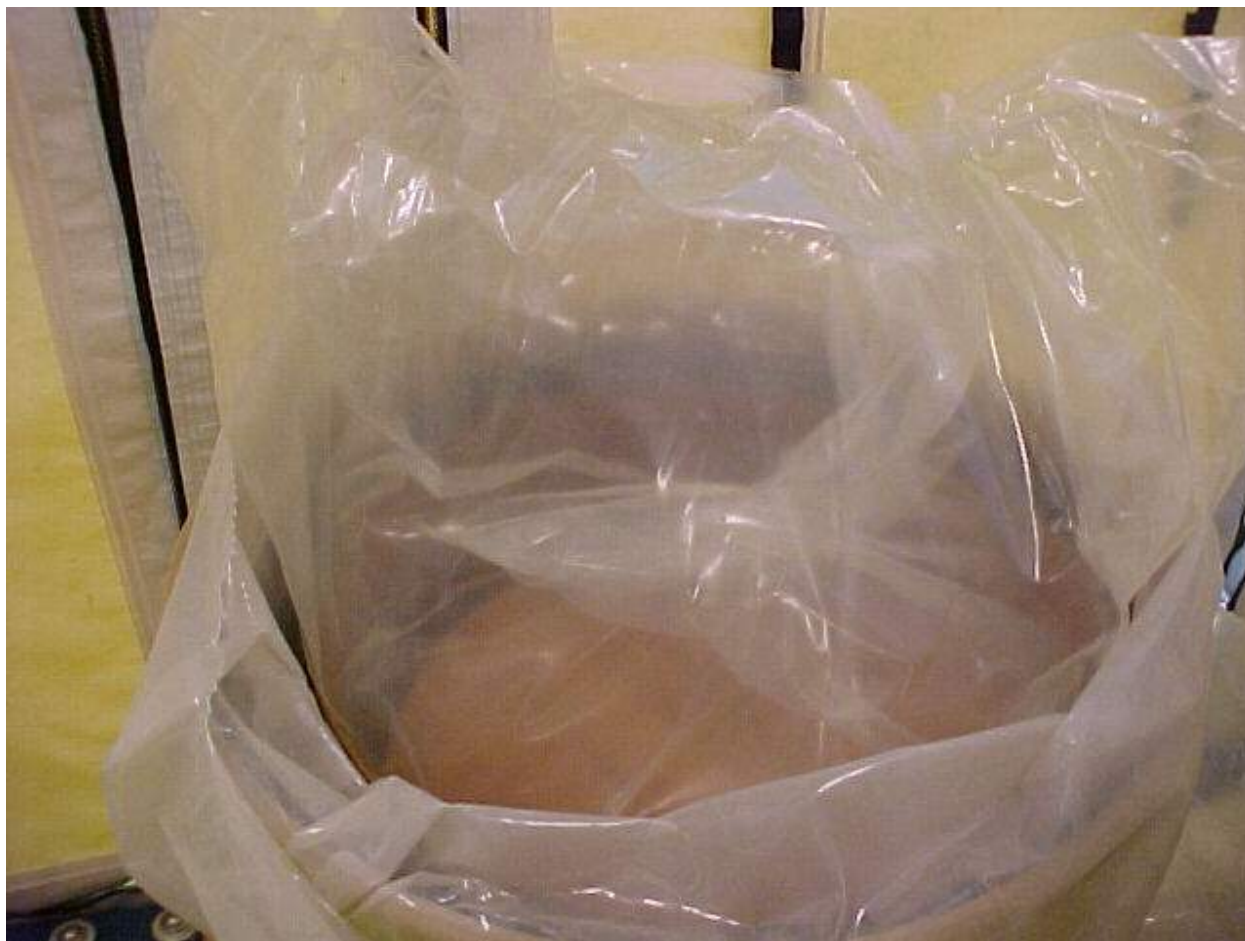
2nd poly liner/bag – good condition (raised bag indicates internal pressure buildup internal to the packaging)

No gasses present (in breathing zone)
