THORIUM NITRATE STOCKPILE DRUM CHARACTERIZATION REPORT

**THORIUM NITRATE STOCKPILE
DRUM CHARACTERIZATION REPORT**

Prepared for
U.S. Defense Logistics Agency
Defense National Stockpile Center
Fort Belvoir, Virginia

Prepared by
OAK RIDGE NATIONAL LABORATORY
Oak Ridge, Tennessee 37831
managed by
UT-BATTELLE, LLC
for the
U.S. DEPARTMENT OF ENERGY
under contract DE-AC05-00OR22725

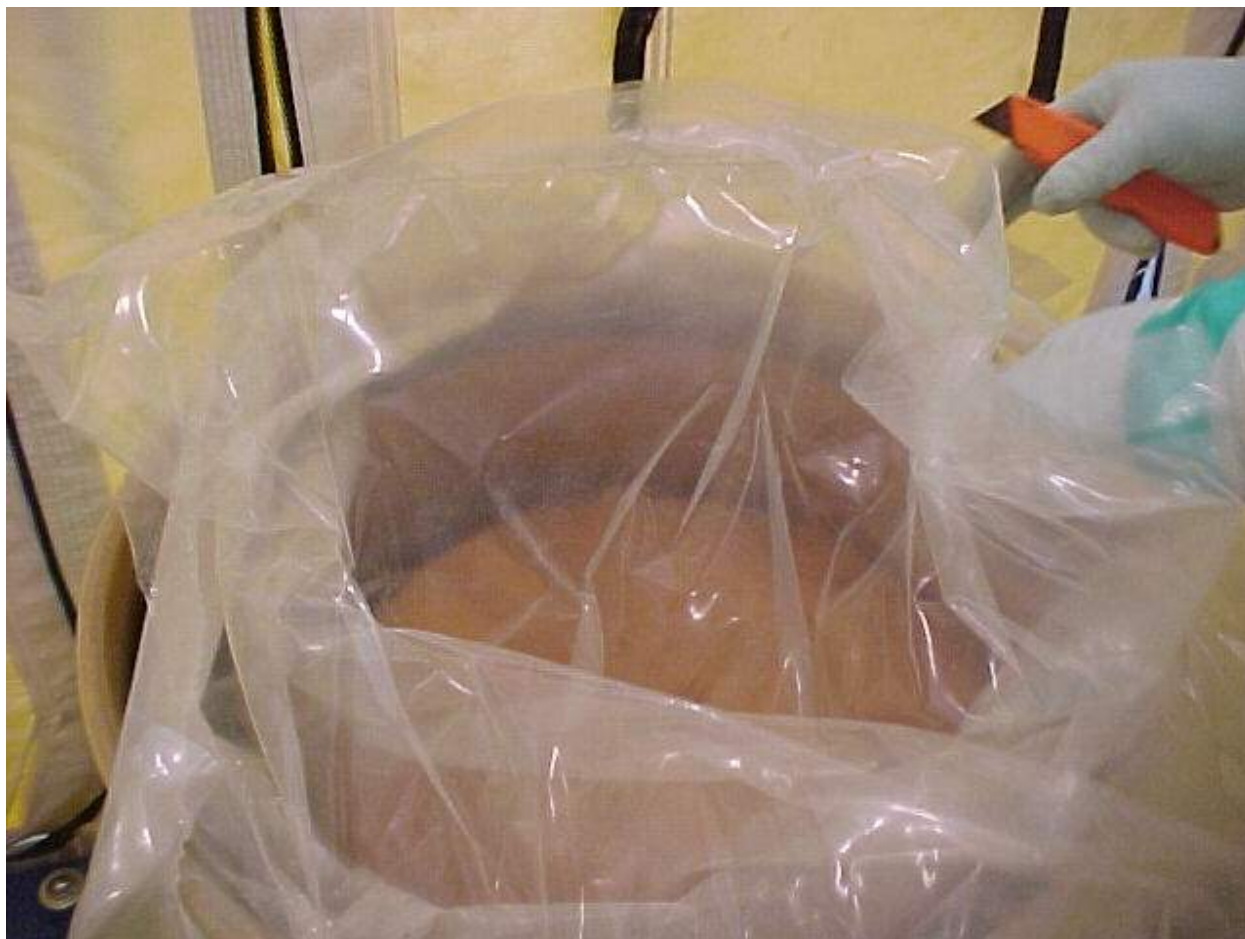
3rd poly liner/bag – good condition (this bag contains majority of internal pressure buildup – bag similar to inflated balloon; although, it does not “pop” when penetrated with a utility knife)

Gasses in headspace – LEL – 4.6% - NO - +50.0ppm – NOx – +50.0ppm

Drum vented - All gasses dissipated

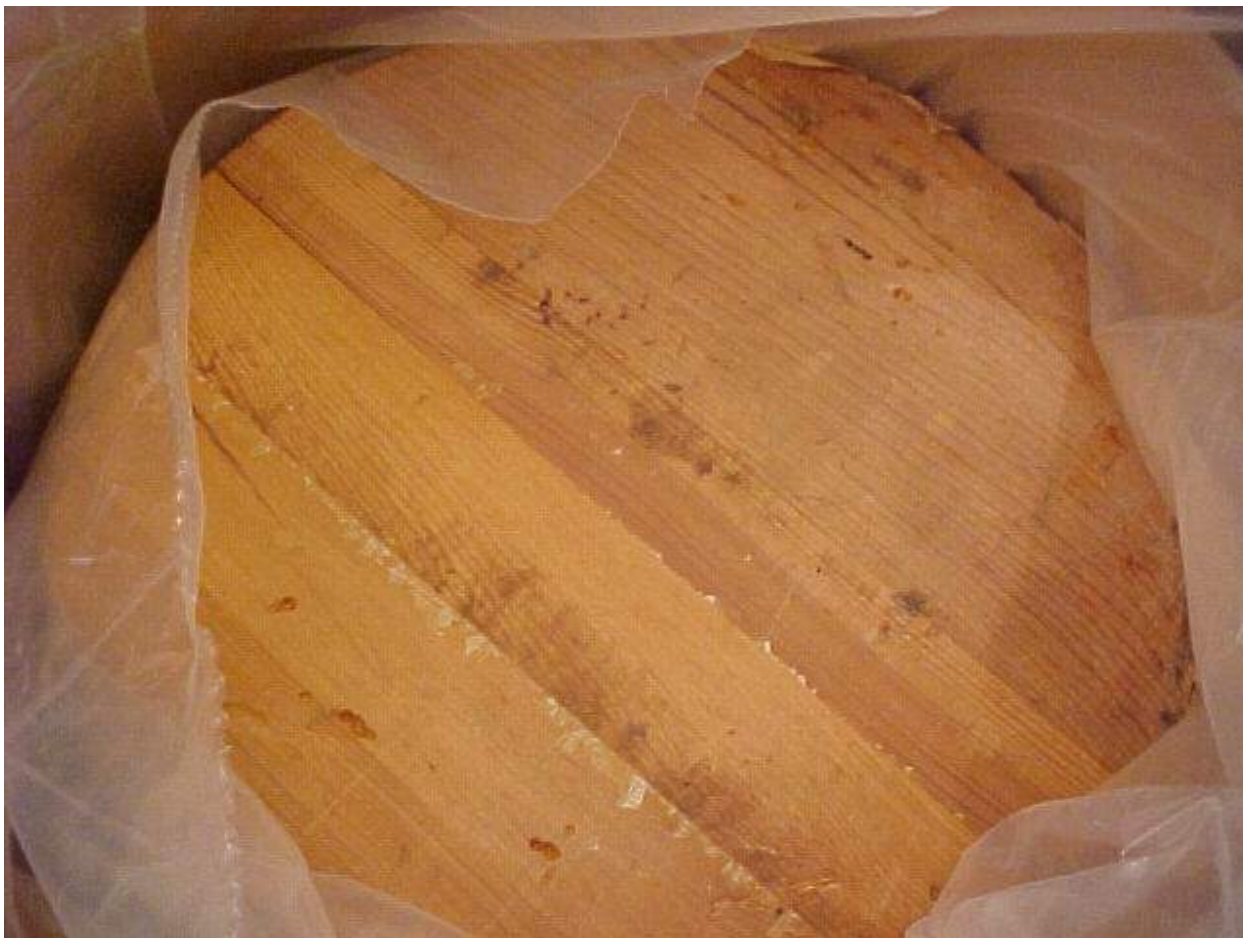
Wooden lid (mounted to top of inner fiber drum) – good condition

No gasses present (in breathing zone)

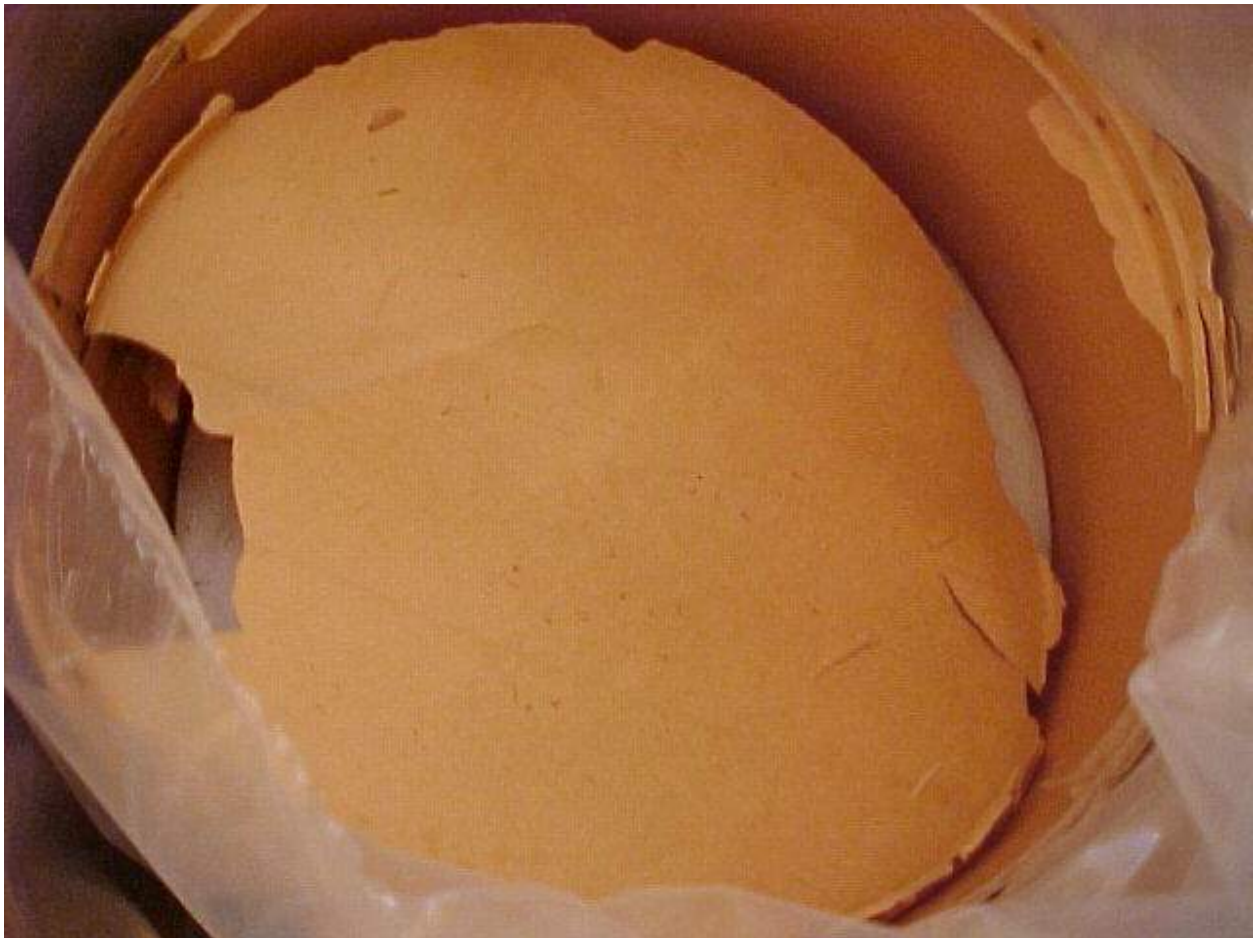
Inner fiber drum (lab-pack) – good condition

No gasses present (in breathing zone)

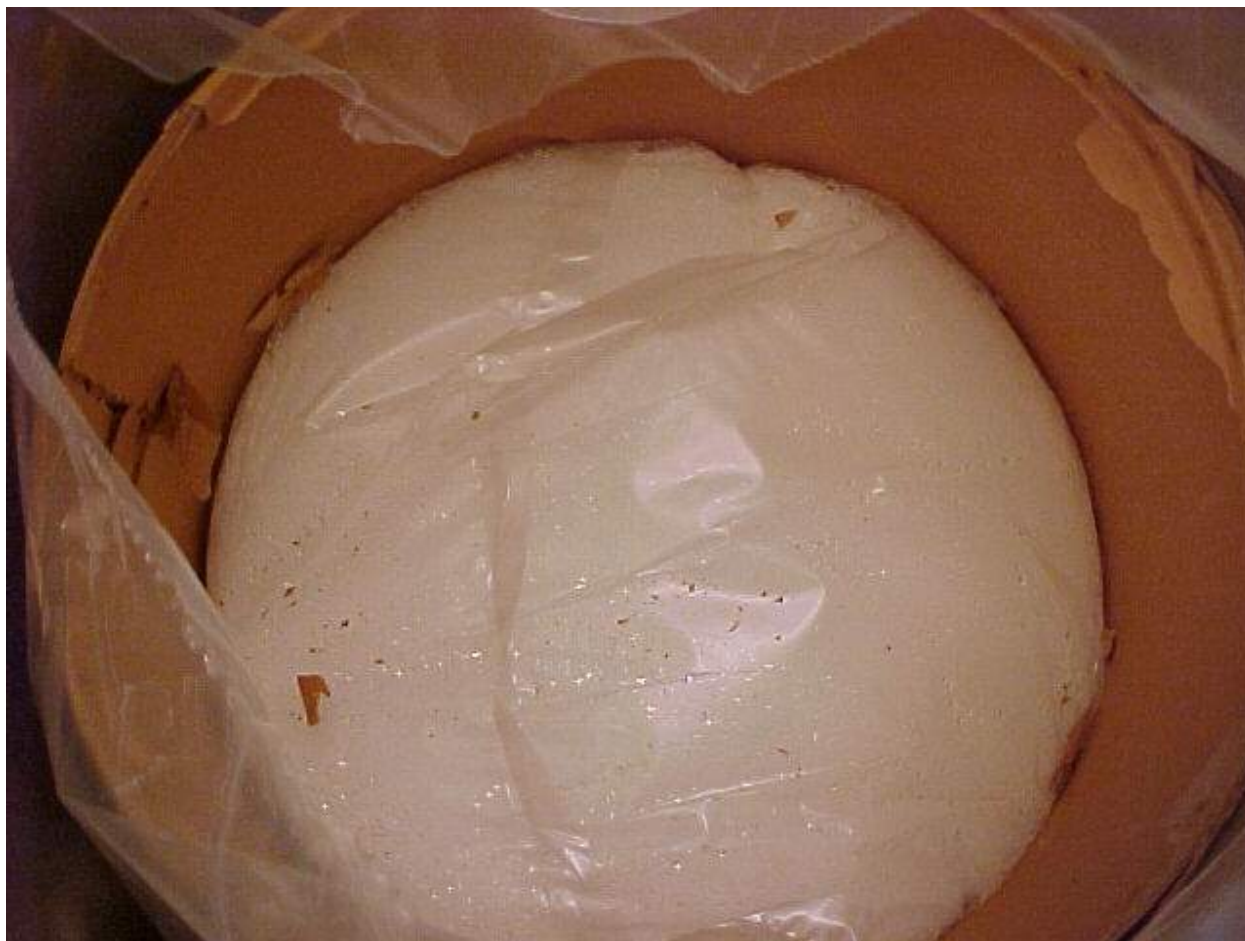
4th poly liner/bag – good condition (bag slightly inflated indicating some internal pressure buildup in the bag)

No gasses present (in breathing zone)

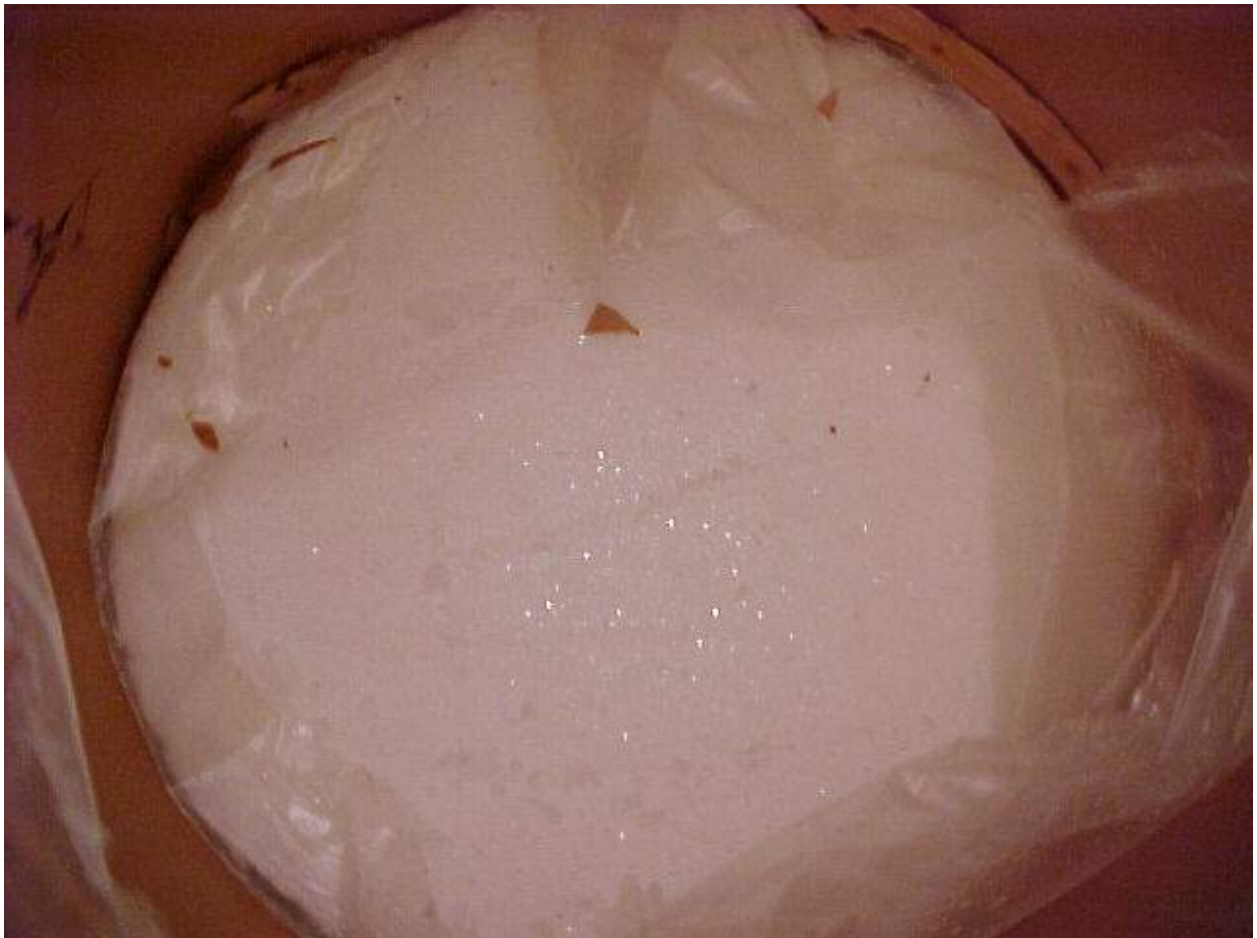
ThN material – monolith – solid – white - dry

No gasses present (in breathing zone)

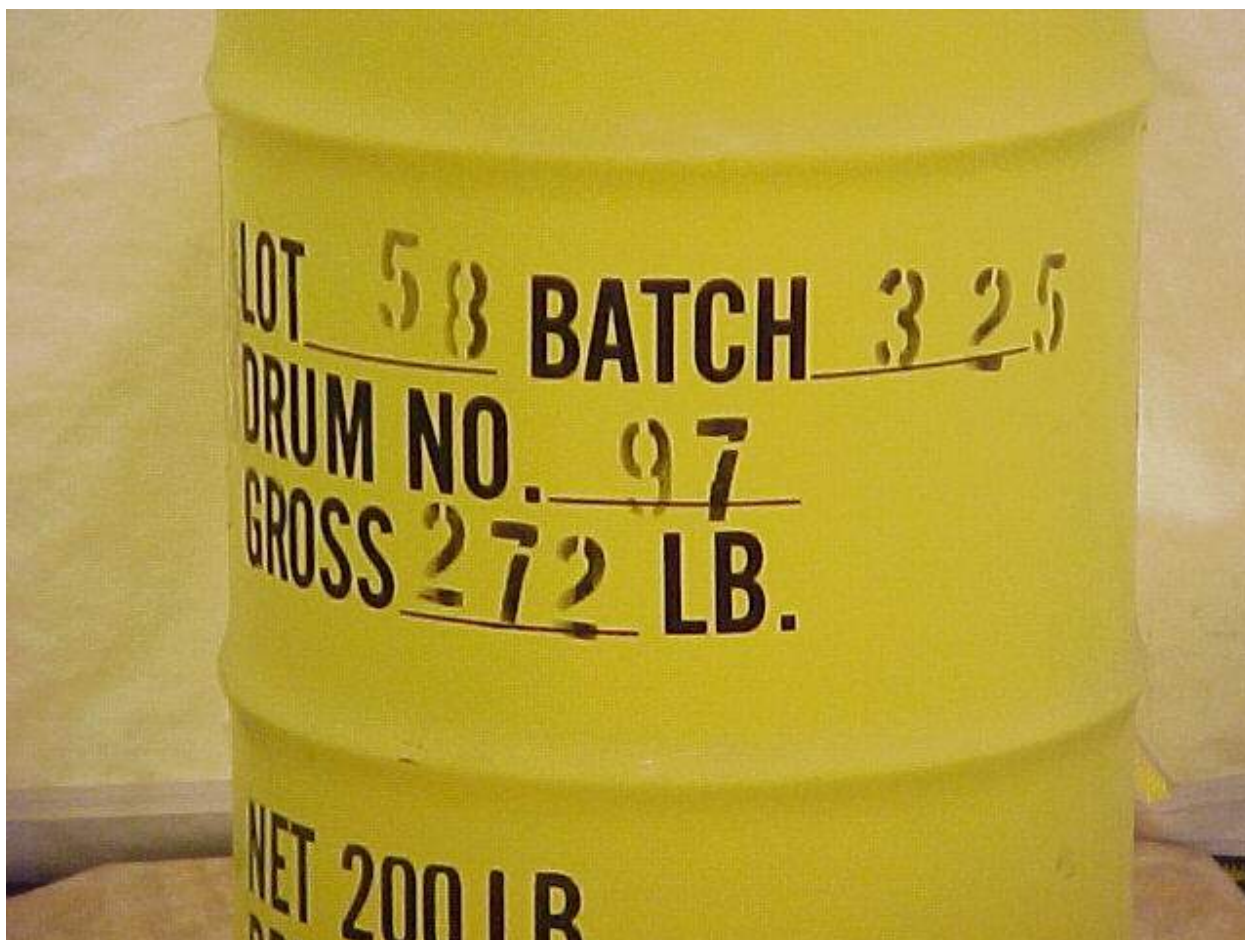
30-gal drum – good condition (drum released pressure while loosening bolt on drum ring – the tap test on the drum lid was an excellent aid to determine if a pressure buildup was present in the drum)

No gasses present (in breathing zone)

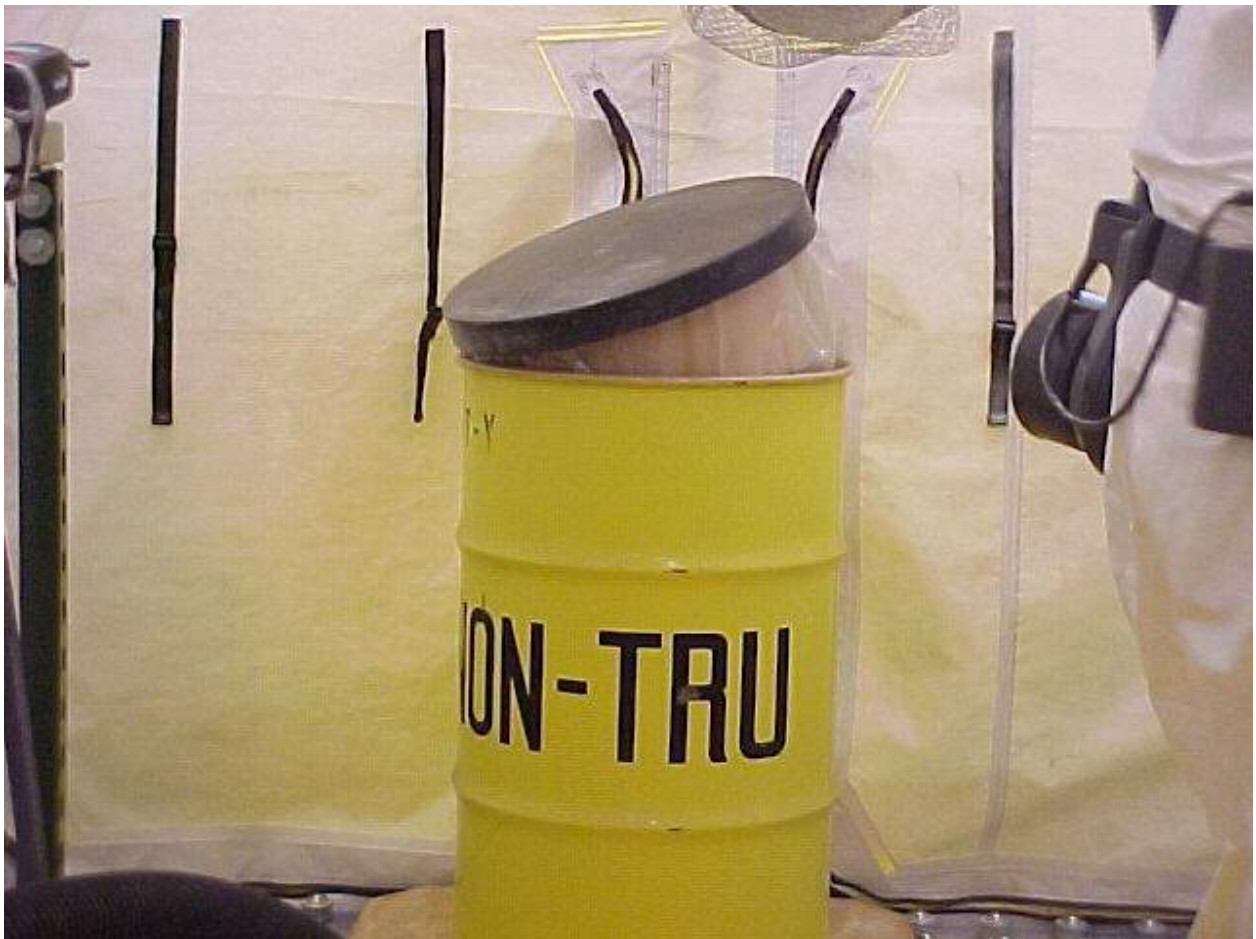
Black plastic lid (from drum liner) – good condition (raised lid indicates internal gas pressure buildup inside of packaging)

No gasses present (in breathing zone)

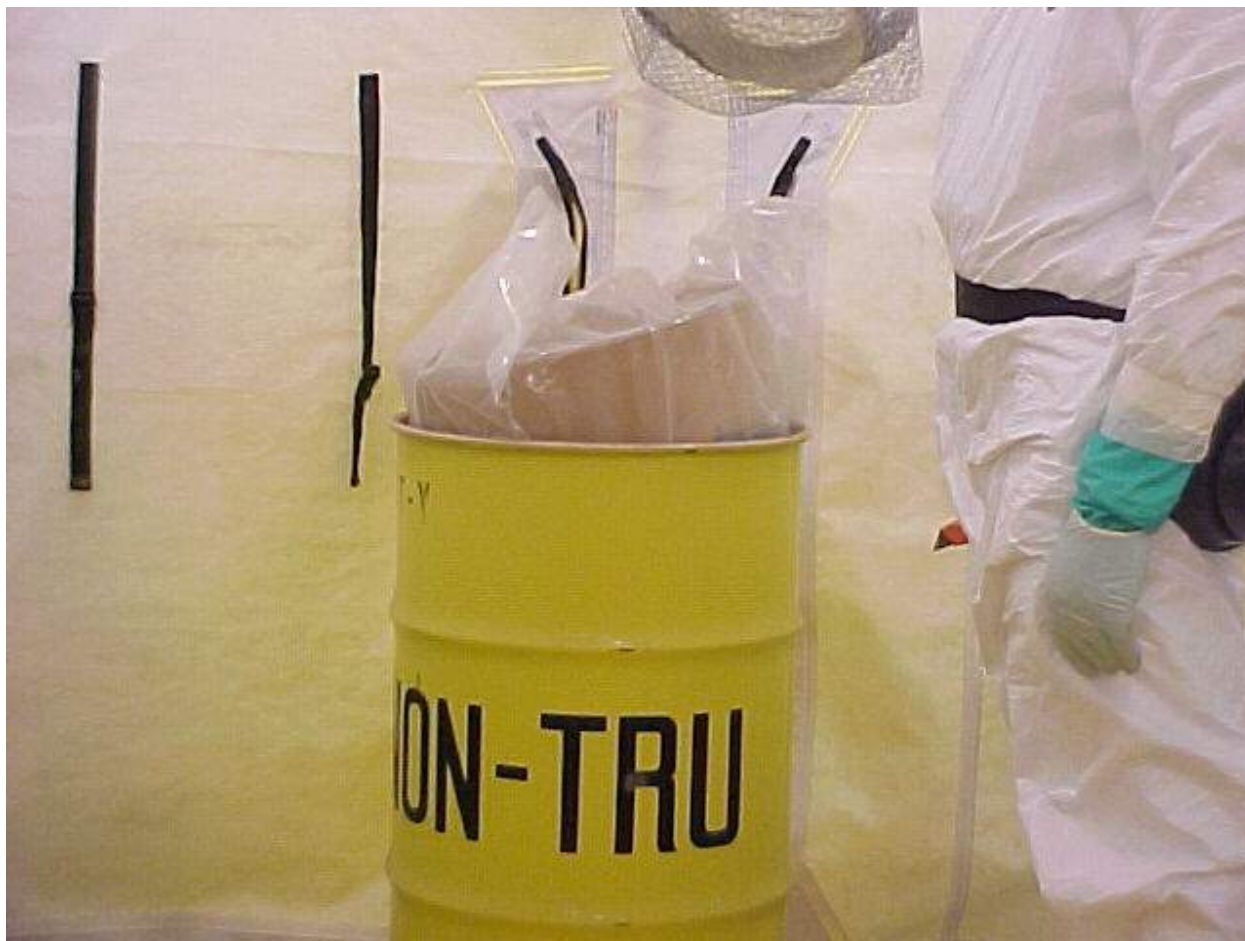
1st poly liner/bag – good condition (raised bag indicates internal gas pressure buildup inside of packaging)

No gasses present (in breathing zone)

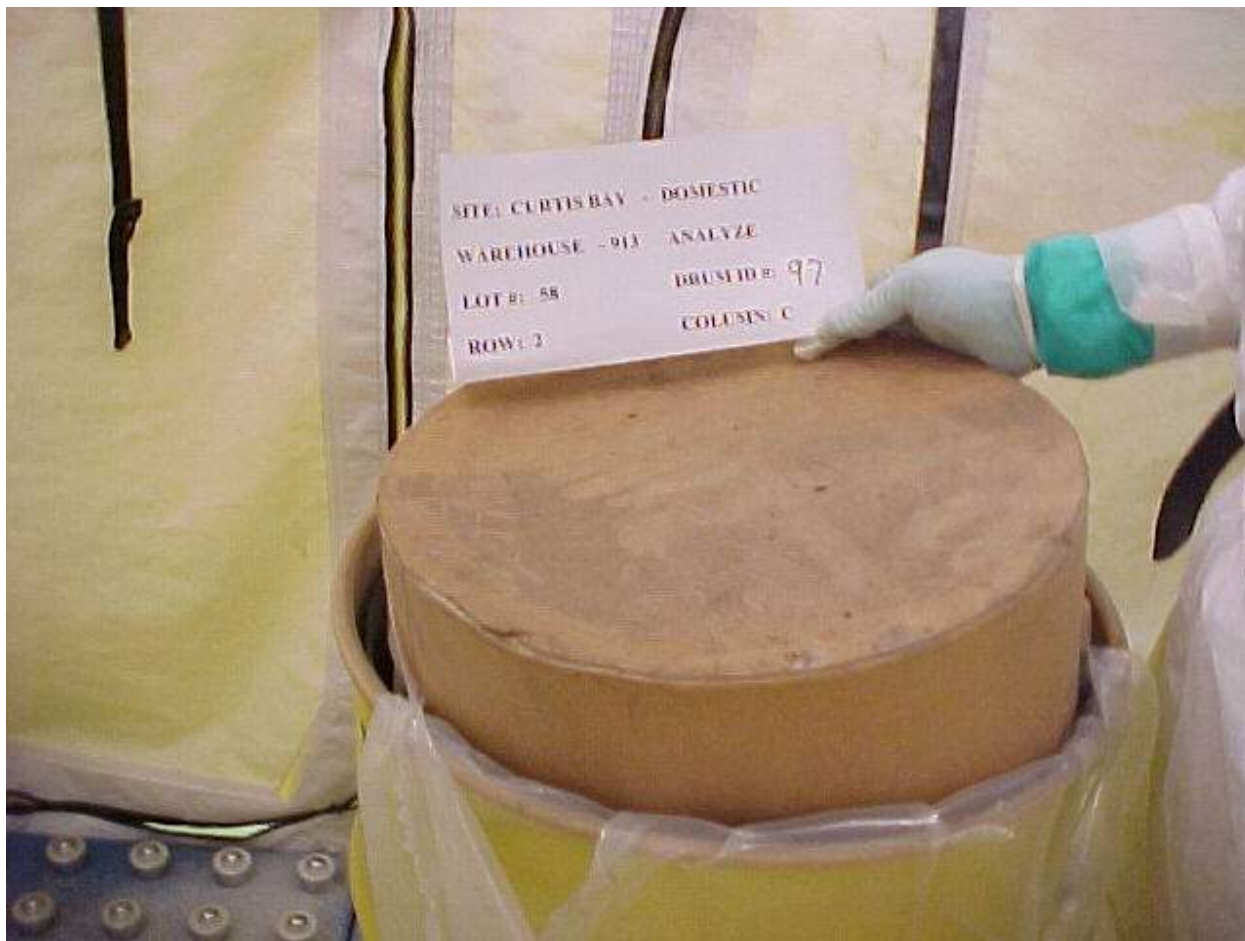
Fiber drum lid (from outermost fiber drum within the 30-gal drum) – good condition (raised lid indicates internal gas pressure buildup inside of packaging)
 No gasses present (in breathing zone)

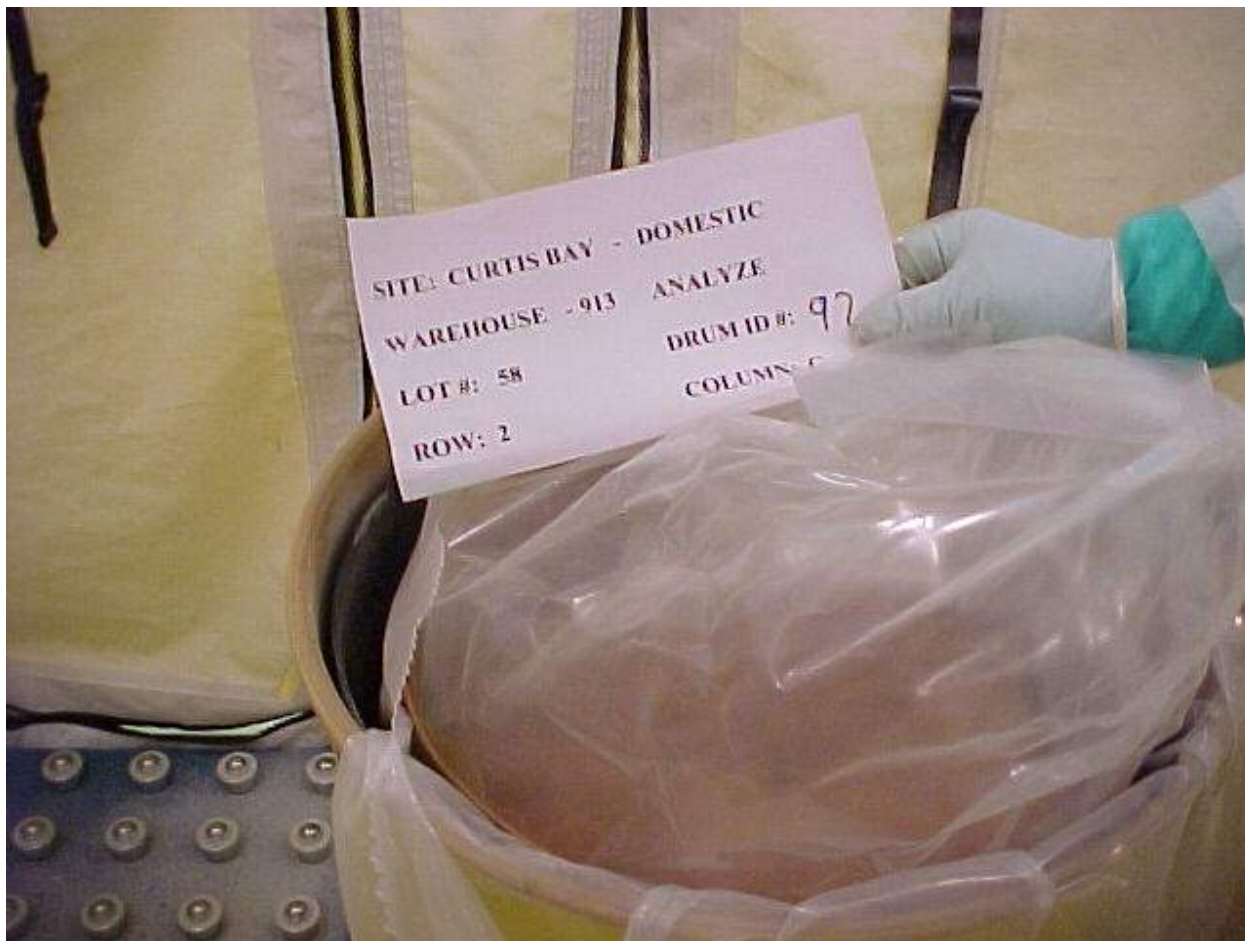
2nd poly liner/bag – good condition (raised bag indicates internal gas pressure buildup inside of packaging)

No gasses present (in breathing zone)

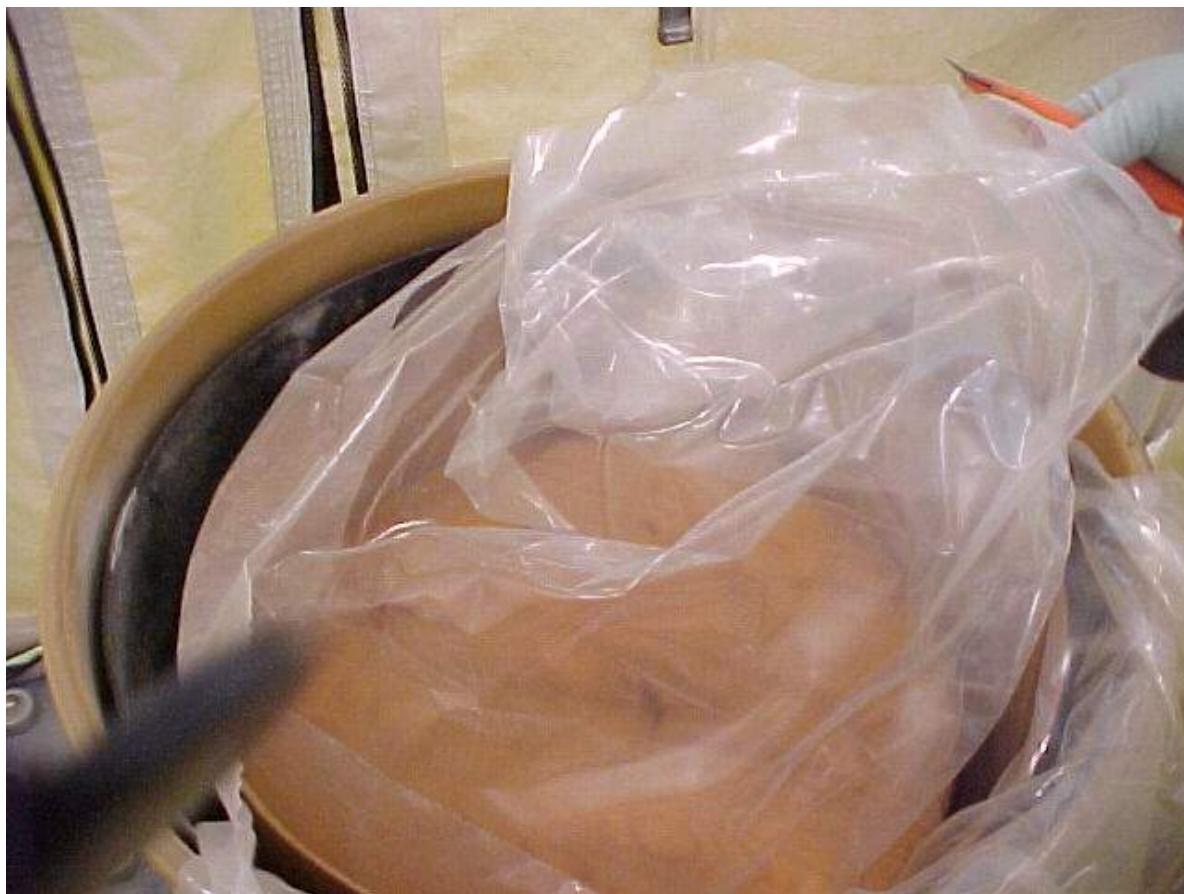
3rd poly liner/bag – good condition (raised bag indicates internal gas pressure buildup inside of packaging) (this bag contains majority of gas volume creating internal pressure within the packaging)

Gasses in headspace – LEL – 4.2% - NO – +50.0ppm – NOx – +50.0ppm

Drum vented - All gasses dissipated

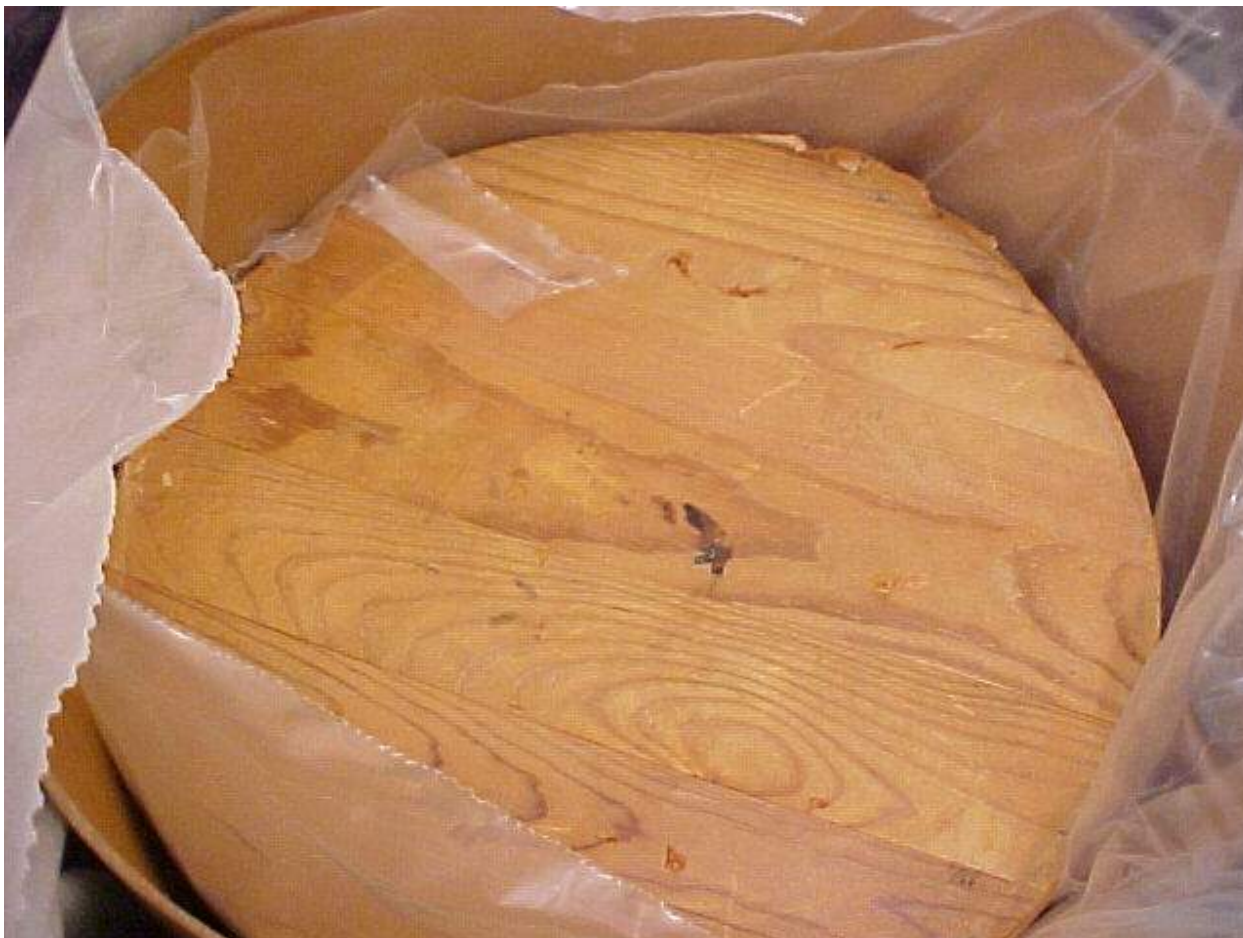
Wooden lid (mounted on inner fiber/lab-pack drum) – good condition
No gasses present (in breathing zone)

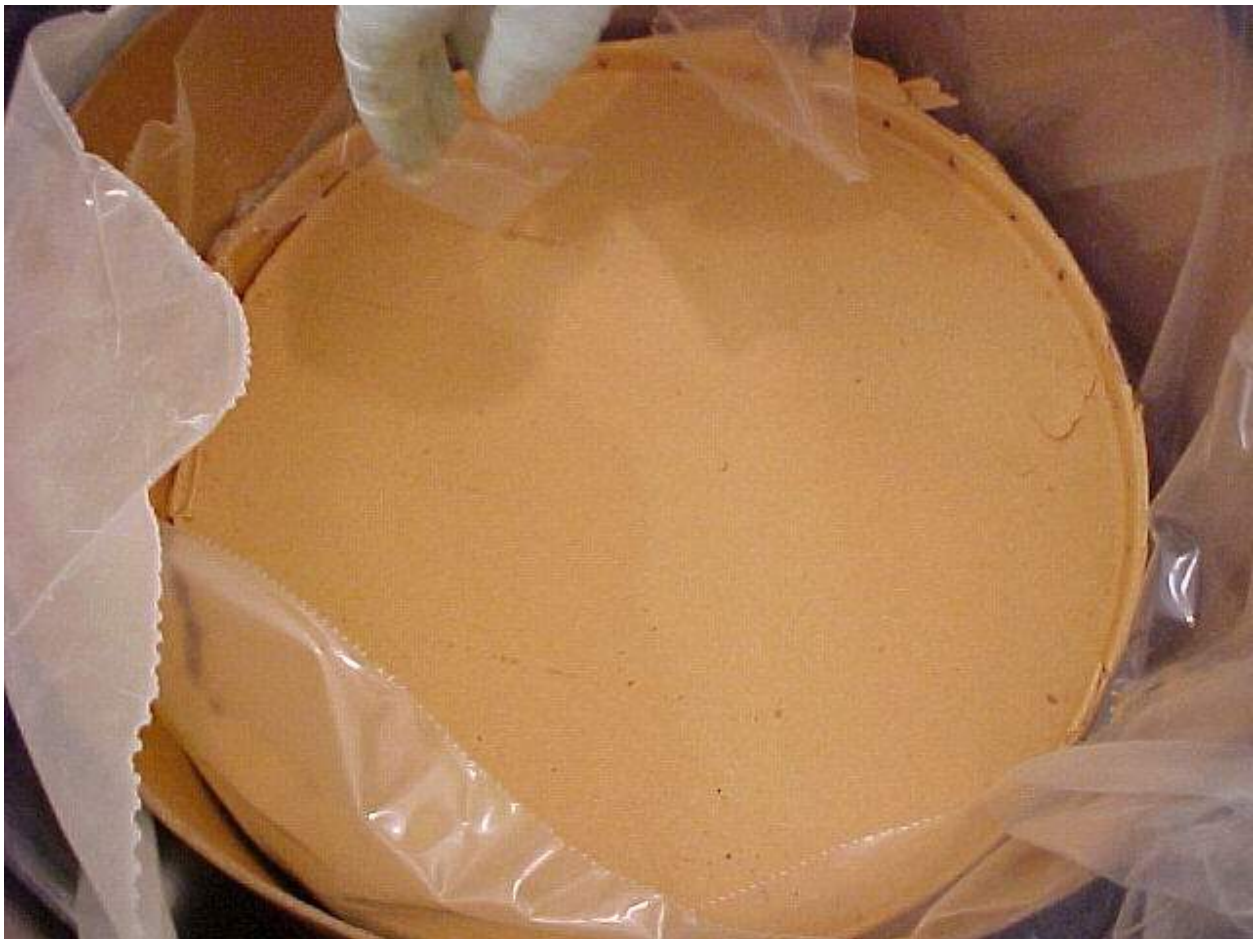
Thin paper lid layer on the inner fiber/lab-pack drum – good condition (paper typically tears when removing wooden lid)

No gasses present (in breathing zone)

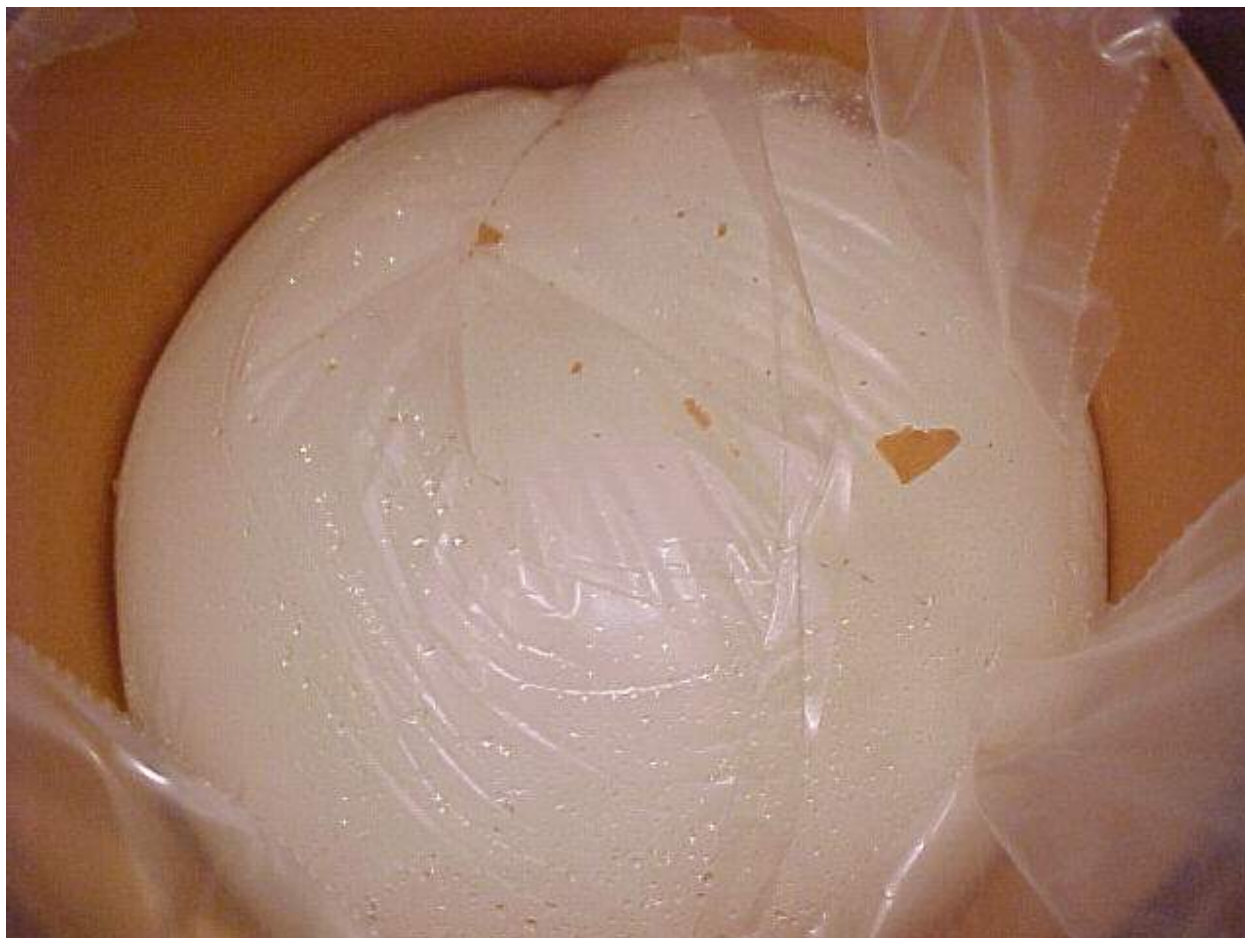
4th poly liner/bag – good condition (inflated bag indicates internal pressure buildup in this thin film plastic liner)

No gasses present (in breathing zone)

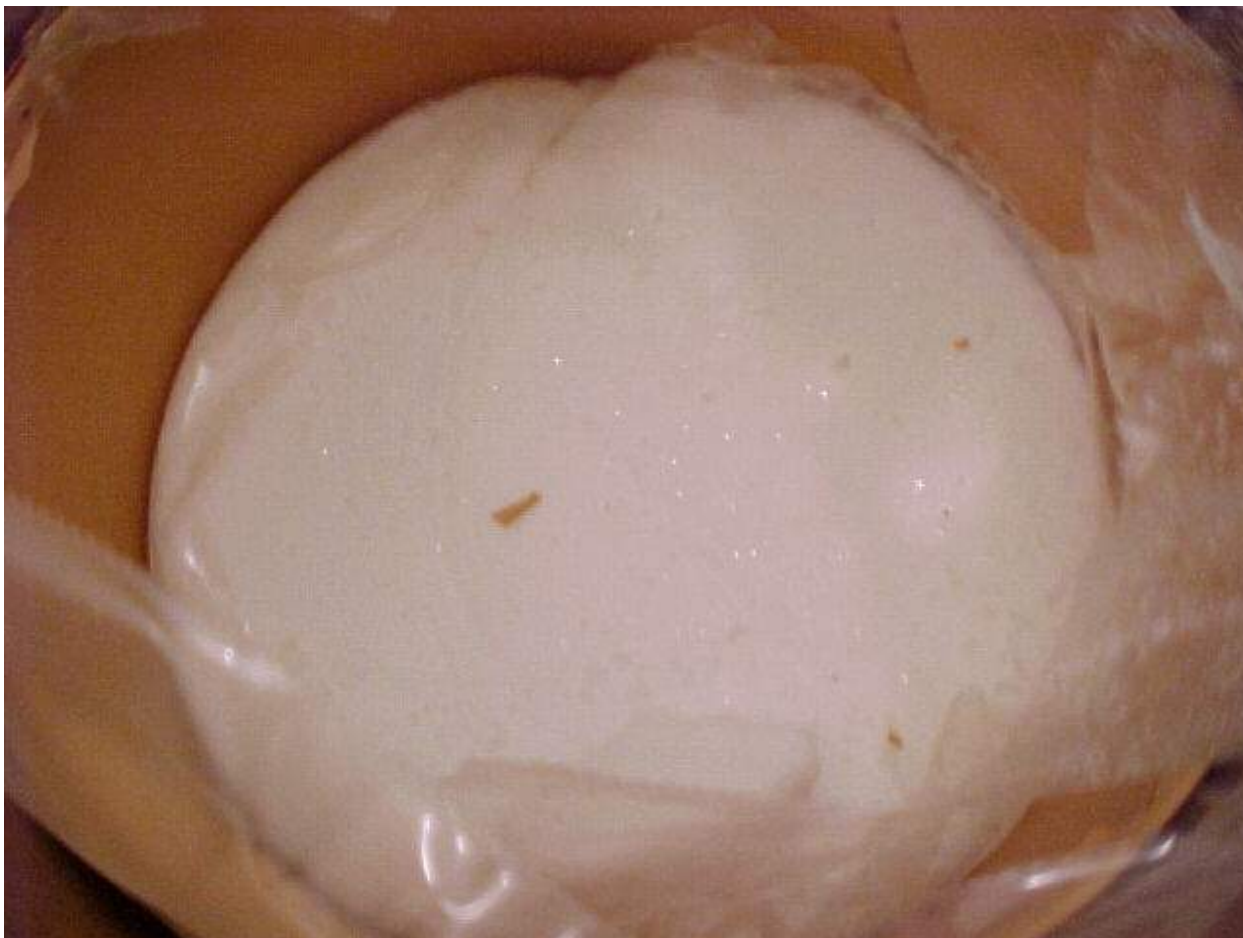
ThN material – monolith – solid – dry - white

No gasses present (in breathing zone)

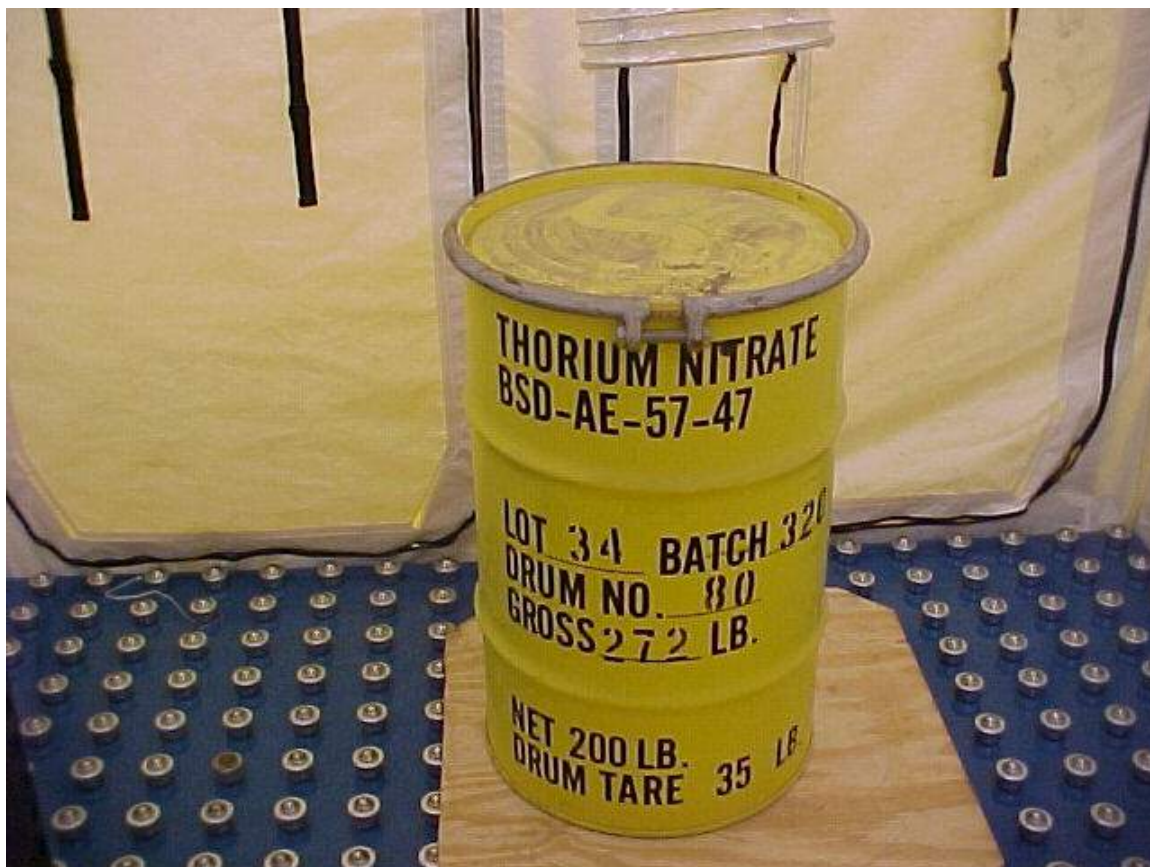
Drum released pressure as bolt on drum ring was loosened – prior to complete removal of the drum ring, the drum lid pushed through the center of the ring springing off the drum 1' to 2' vertically. Utilized remote extension on air ratchet to loosen bolt to provide safe distance between operator and drum lid.

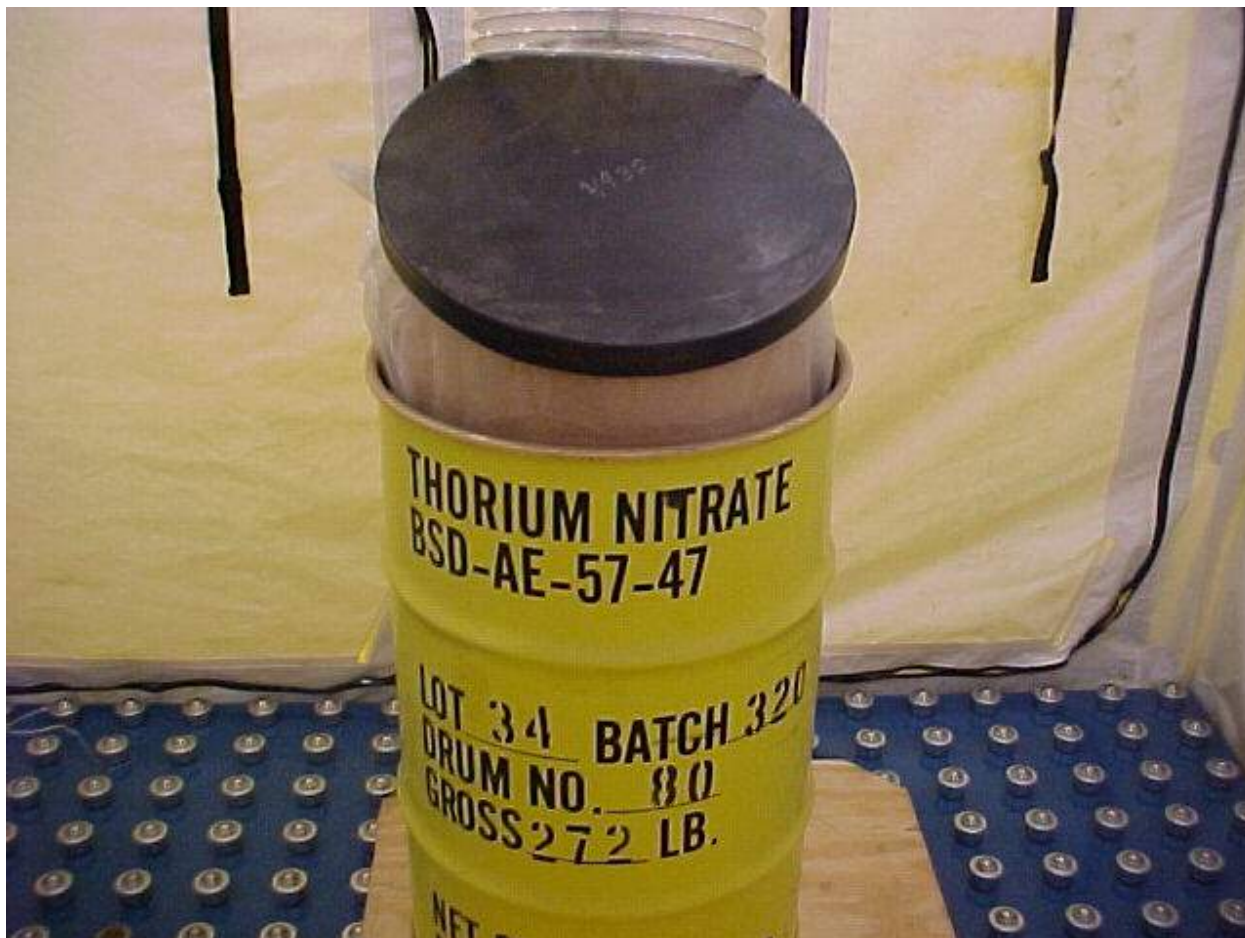
Black plastic lid of inner drum liner – internal pressure in the packaging pushes the lid vertically out of the drum after the outer lid is removed.

No gasses present in the headspace

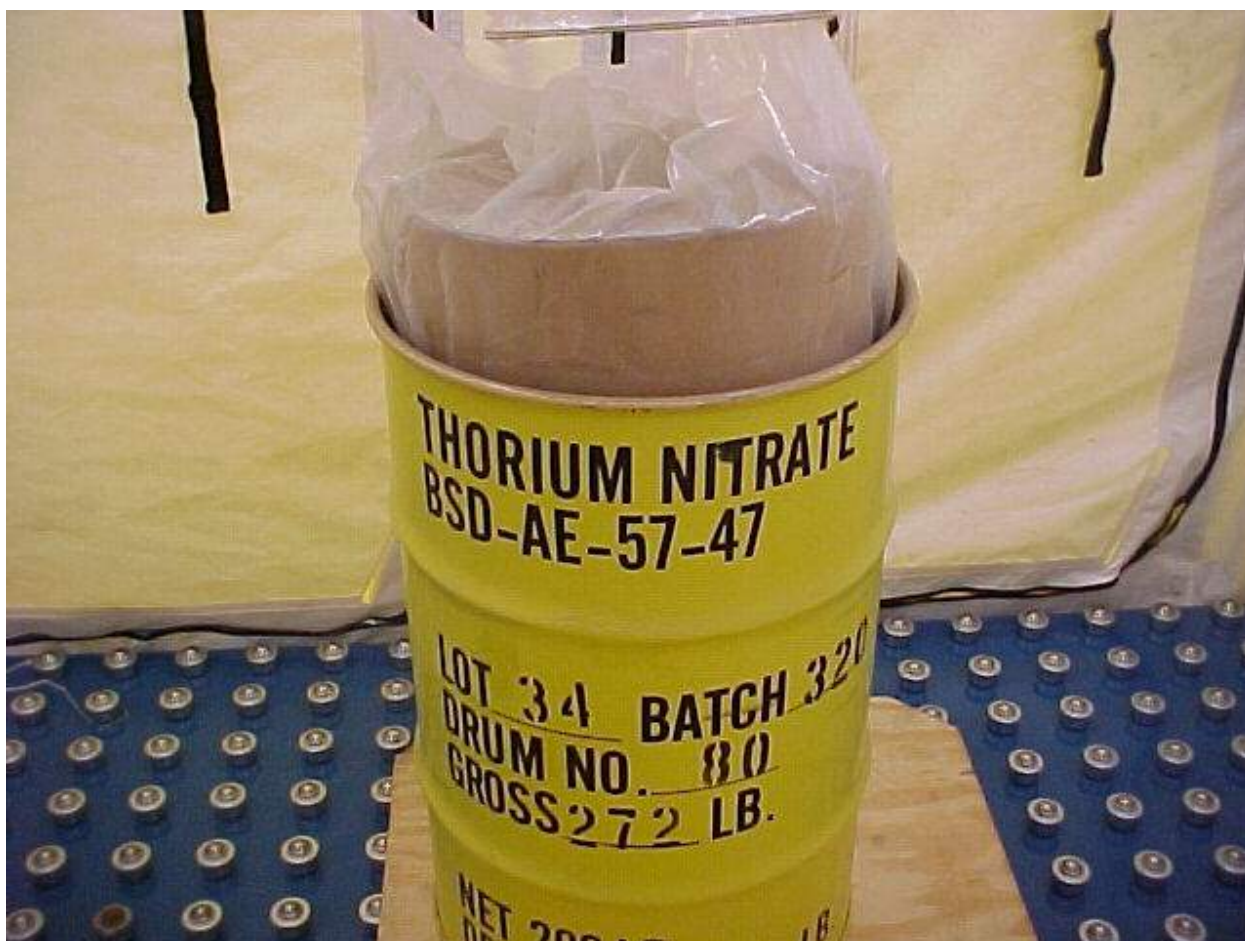
1st poly liner/bag – good condition
No gasses present in the headspace

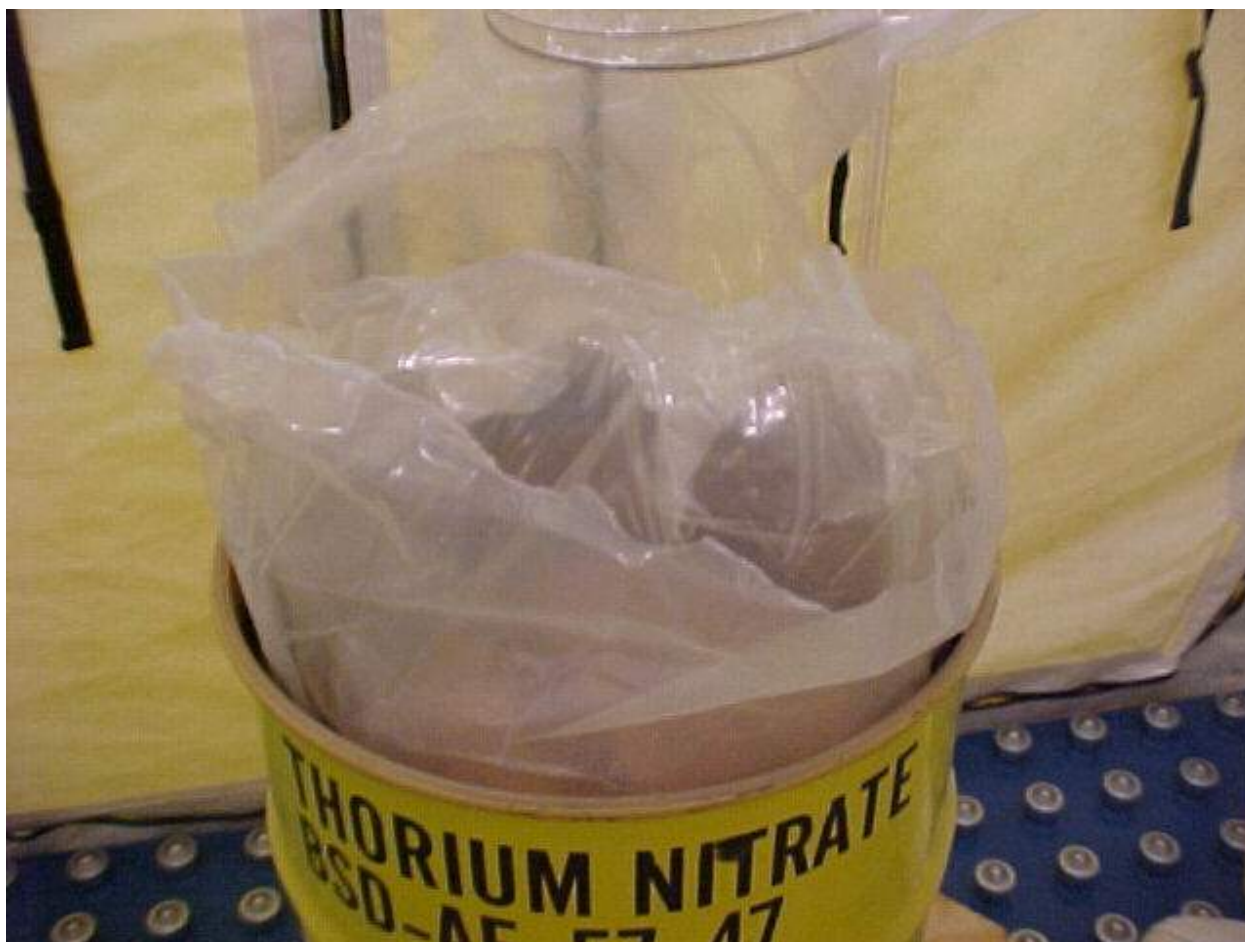
2nd poly liner/bag – good condition

No gasses present in the headspace

Picture shows where pressure has built up inside of the container packaging materials (i.e. 3rd poly bag)
