THORIUM NITRATE STOCKPILE DRUM CHARACTERIZATION REPORT

**THORIUM NITRATE STOCKPILE
DRUM CHARACTERIZATION REPORT**

Prepared for
U.S. Defense Logistics Agency
Defense National Stockpile Center
Fort Belvoir, Virginia

Prepared by
OAK RIDGE NATIONAL LABORATORY
Oak Ridge, Tennessee 37831
managed by
UT-BATTELLE, LLC
for the
U.S. DEPARTMENT OF ENERGY
under contract DE-AC05-00OR22725

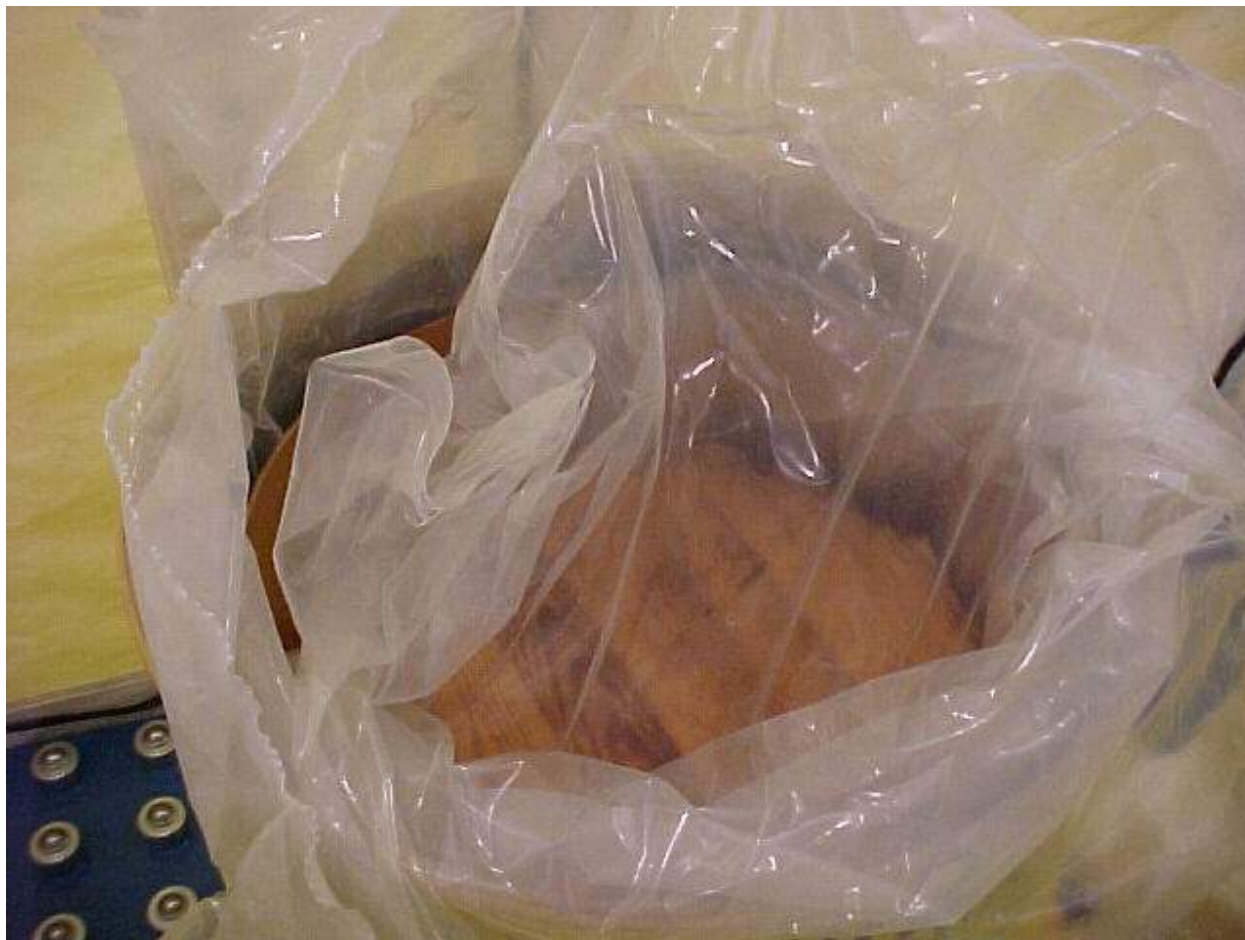
3rd poly liner/bag – good condition
No gasses present in the breathing zone
Picture shows where pressure has built up inside of this poly bag.

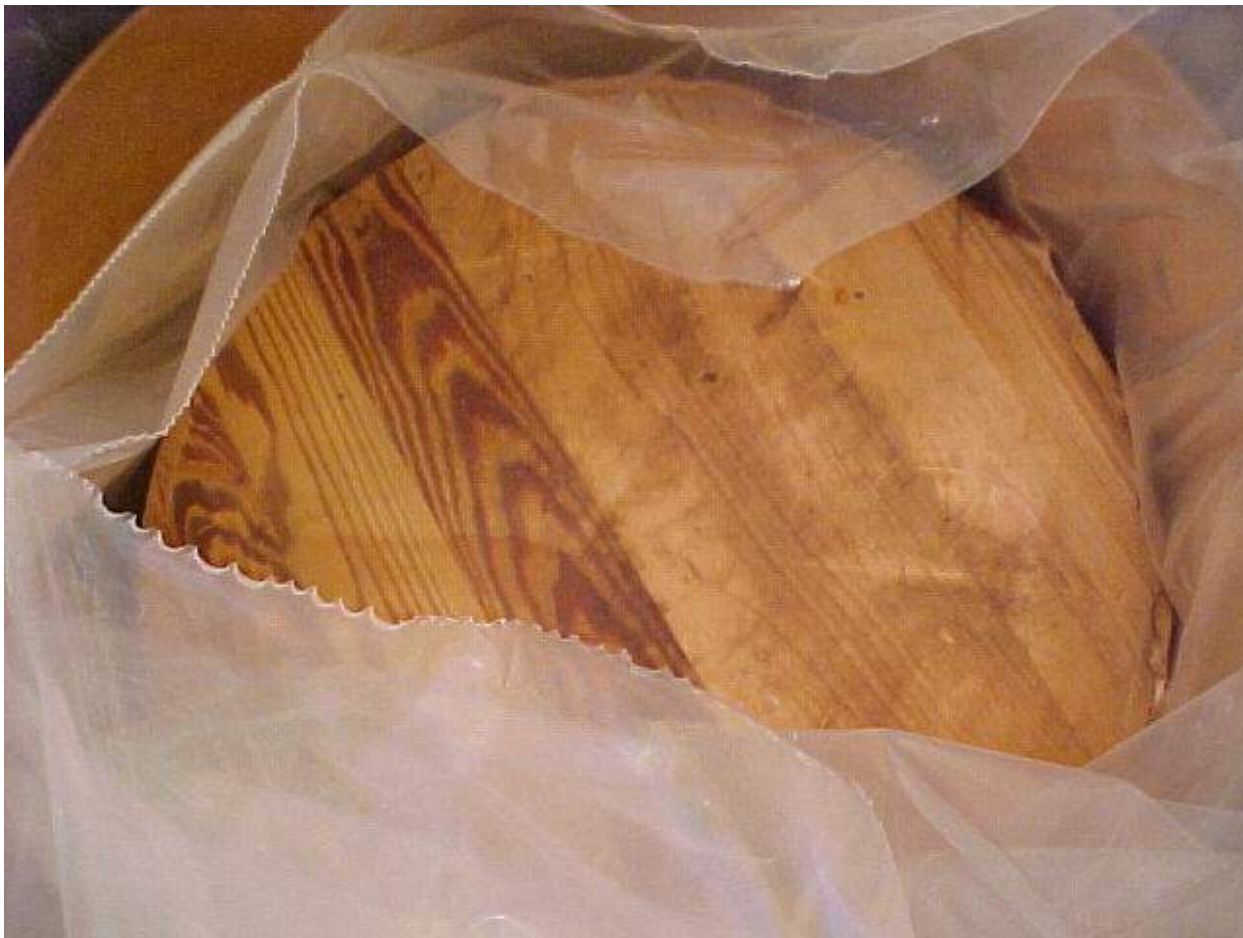
Wooden lid (mounted on inner fiber drum) – good condition
No gasses present in the breathing zone

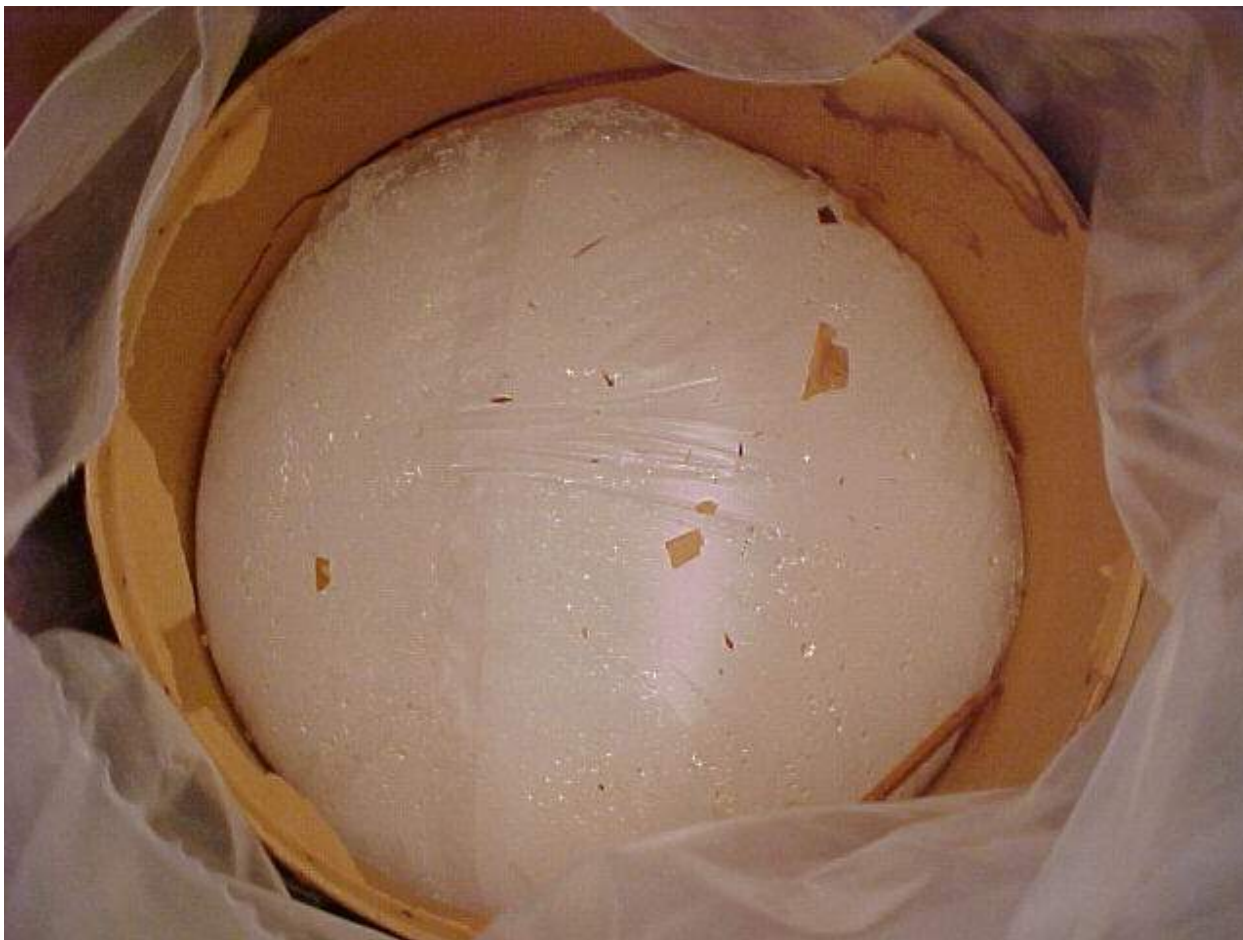
11:15**Other Information**Photo No. 7 of 9Dose Rate Surface 22 mR/hr
 1 meter 3.2 mR/hrFinal (4th) poly bag (thin film plastic lining) – good condition

No gasses present in the breathing zone

Picture shows where this poly bag is slightly inflated

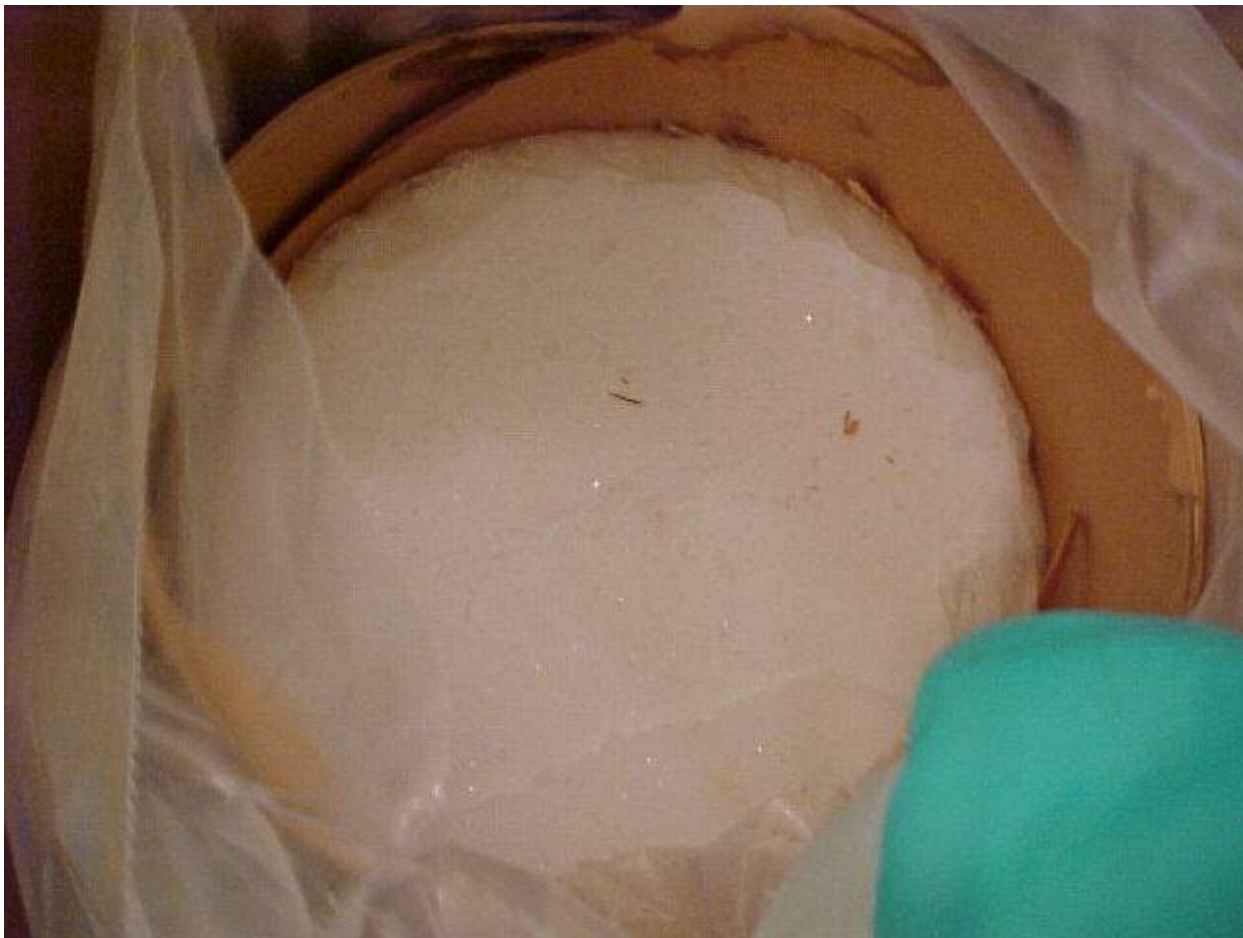
Thorium nitrate material – solid – very dry - white
No gasses present (in breathing zone)
Picture shows where this poly bag is slightly inflated

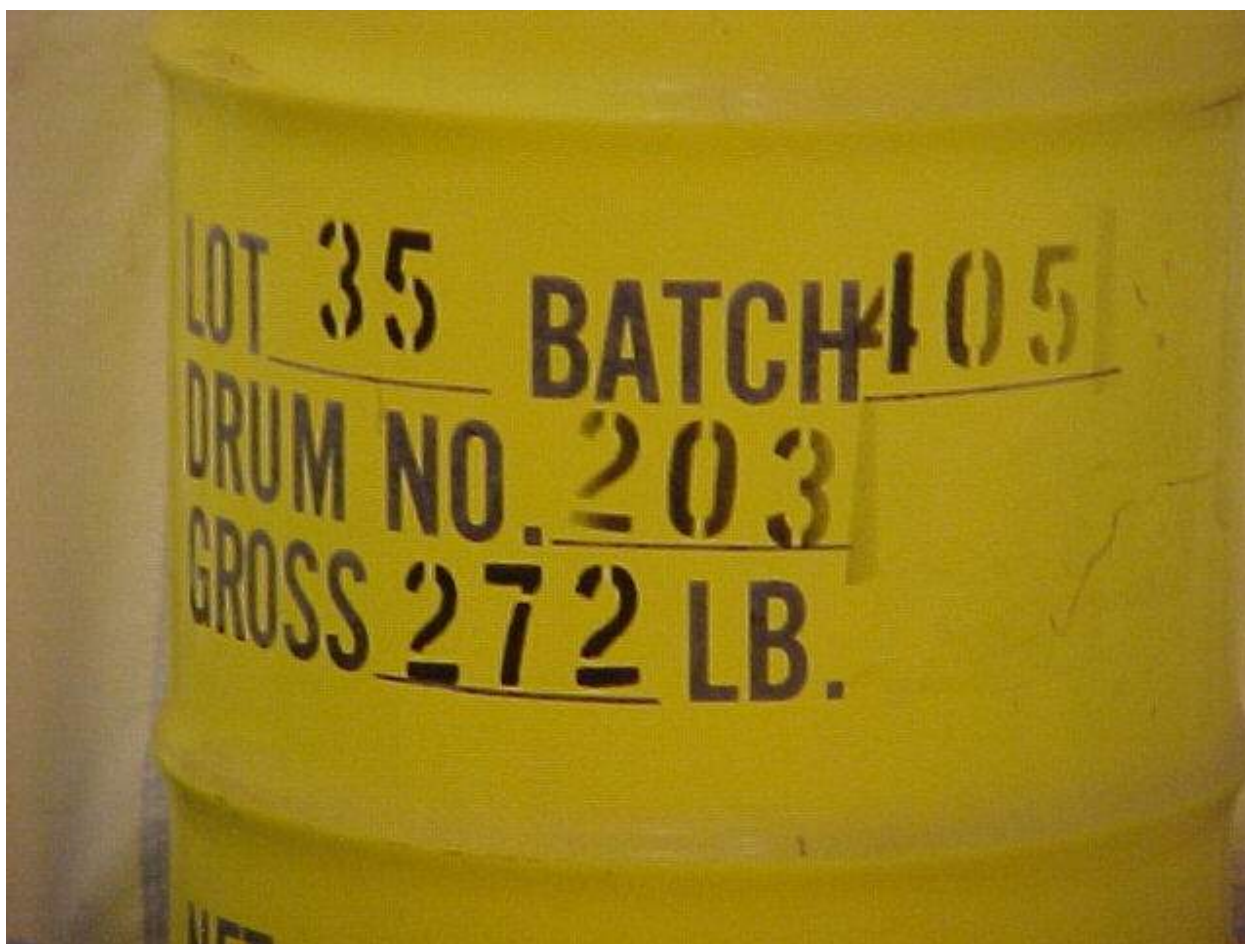
30-gal drum in good condition

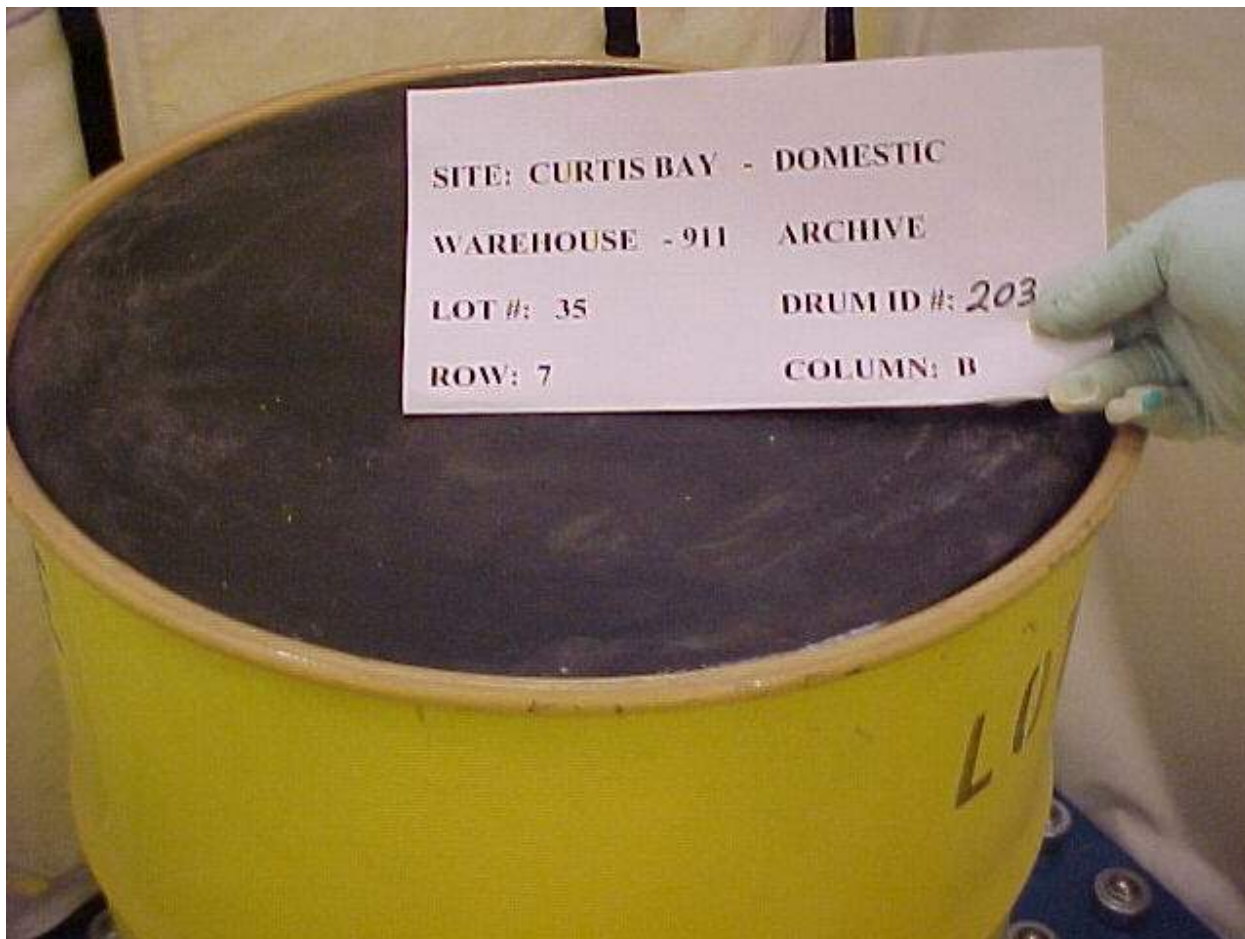
Opened 30-gal drum in good condition – pressure in headspace of drum during removal – vented by loosening bolt on drum ring – gases measured during inspection and sampling process documented on Inspection Checklist

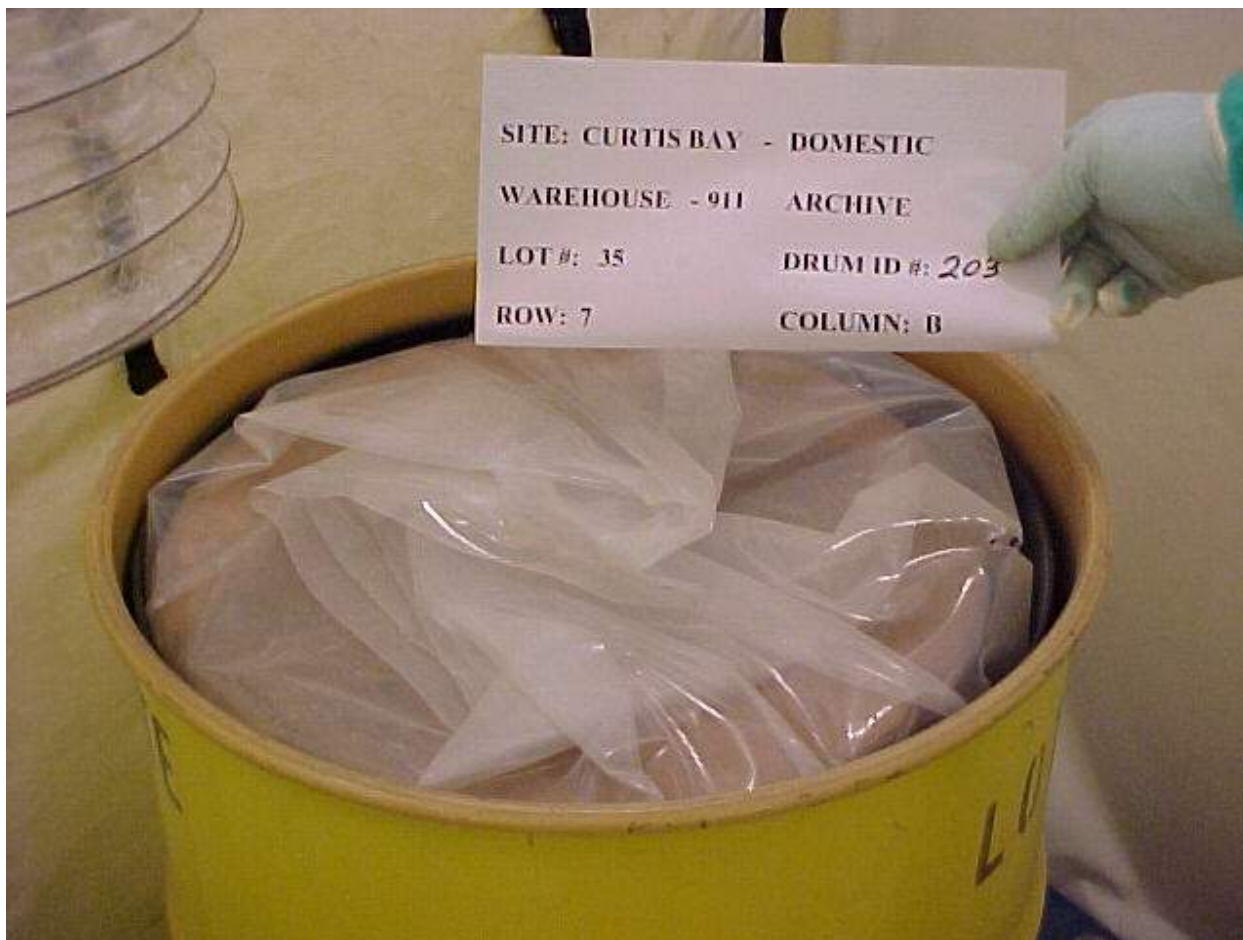
1st poly bag/liner – good condition
No gasses present in poly bag/liner headspace

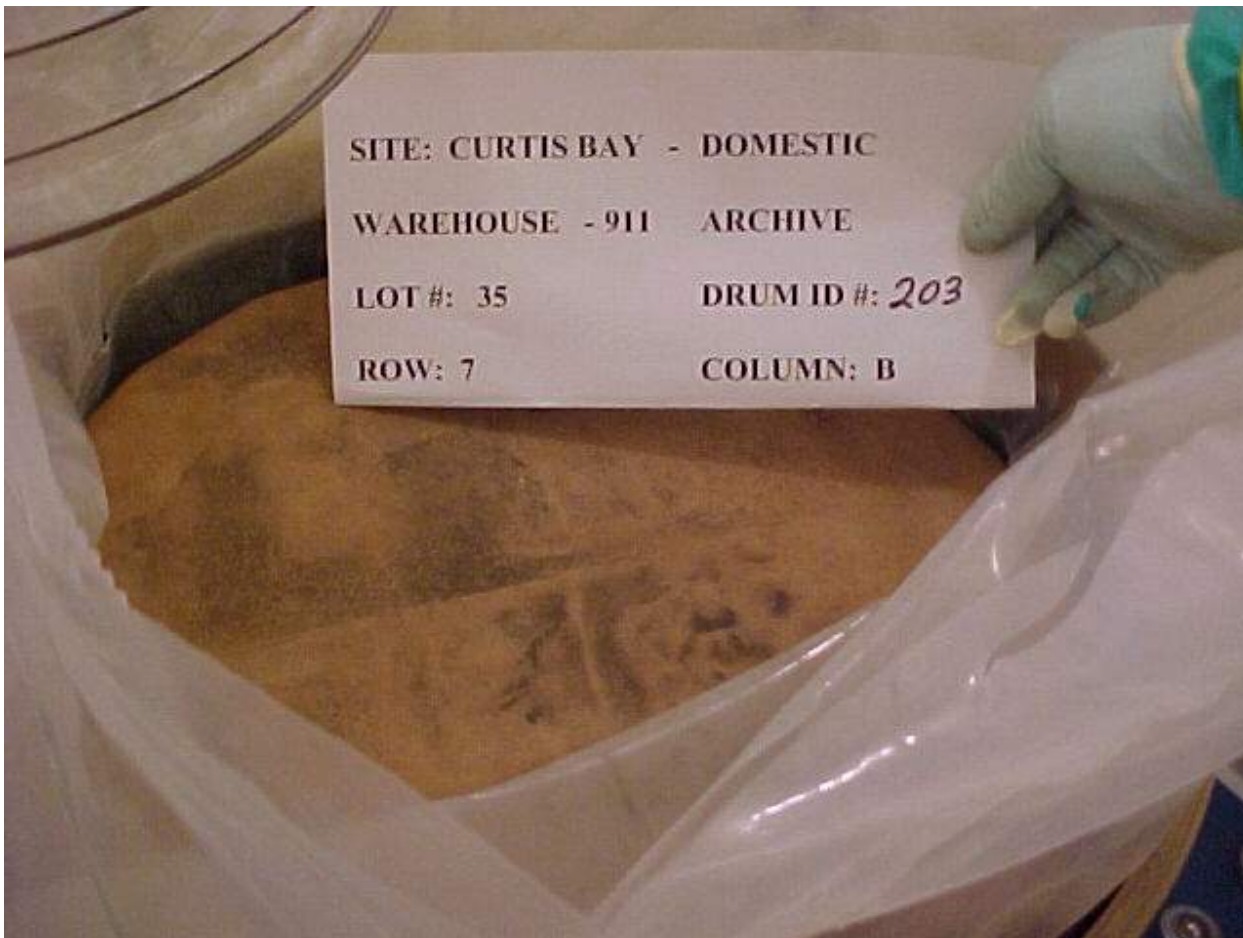
Fiber lid (on outermost fiber drum inside of container) – good condition
No gasses present in fiber drum's headspace

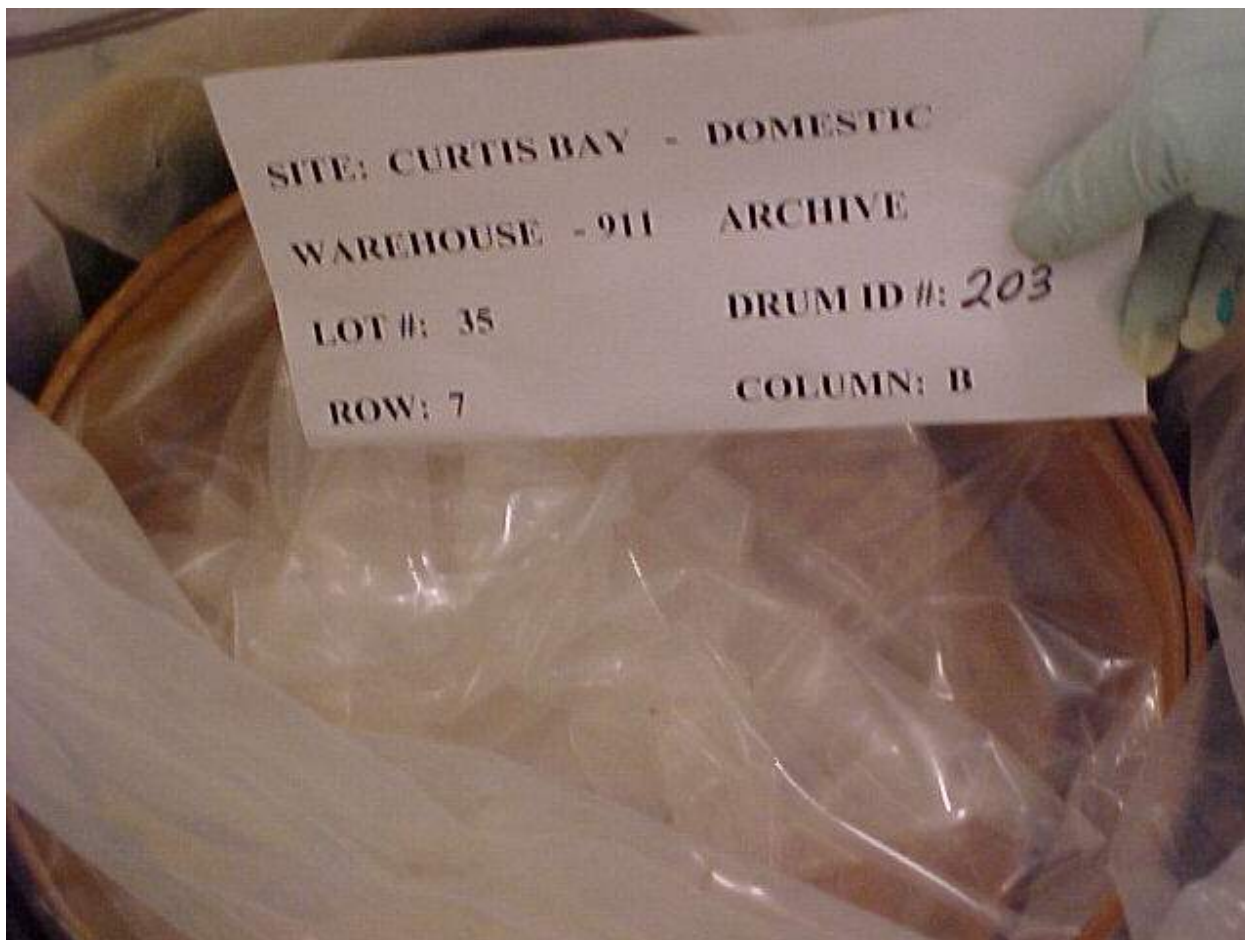
10:00**Other Information**Photo No. 5 of 12Dose Rate Surface 26 mR/hr
 1 meter 3.4 mR/hr2nd poly liner/bag – good condition

No gasses present in bag's headspace

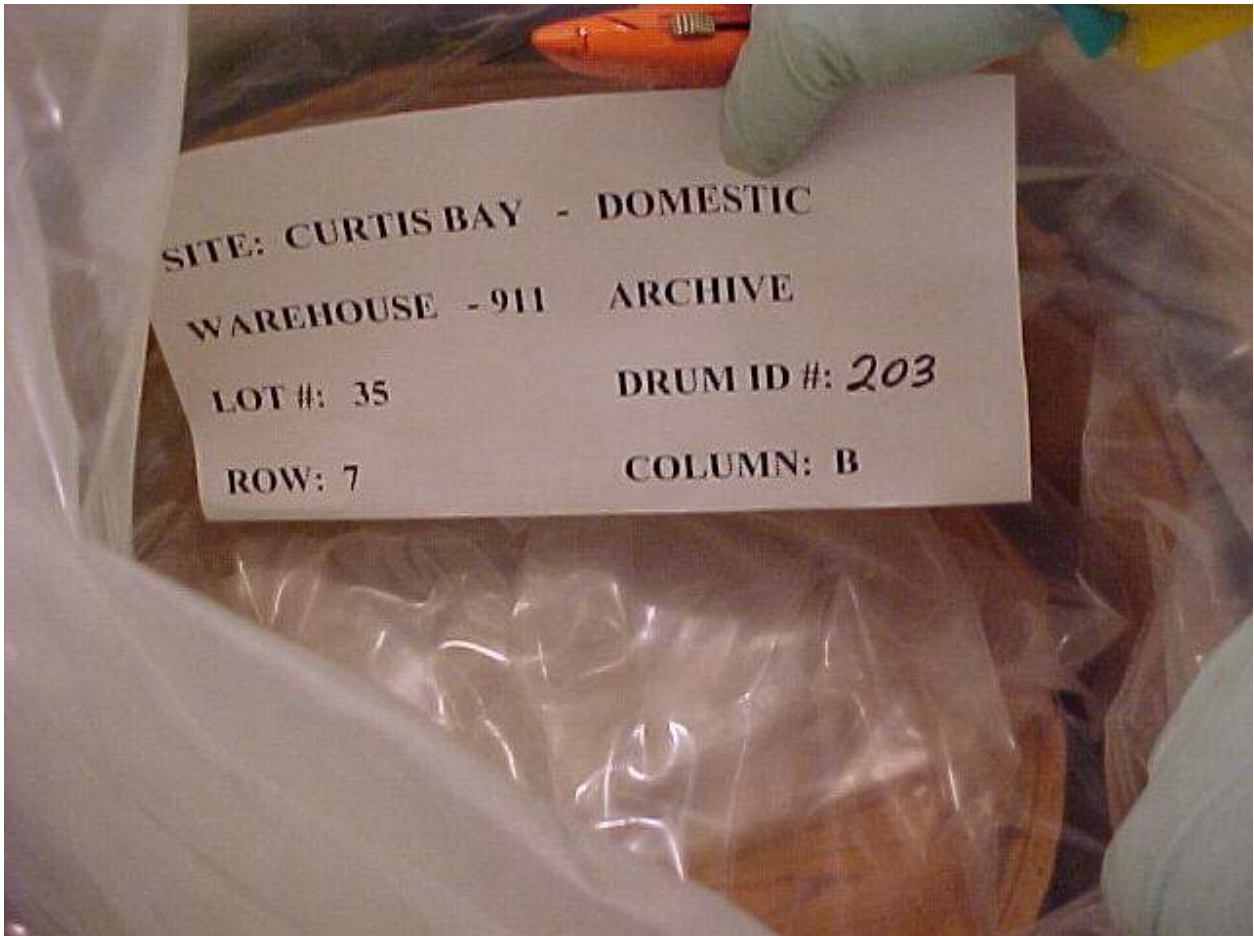
3rd poly liner/bag – good condition
No gasses present in breathing zone

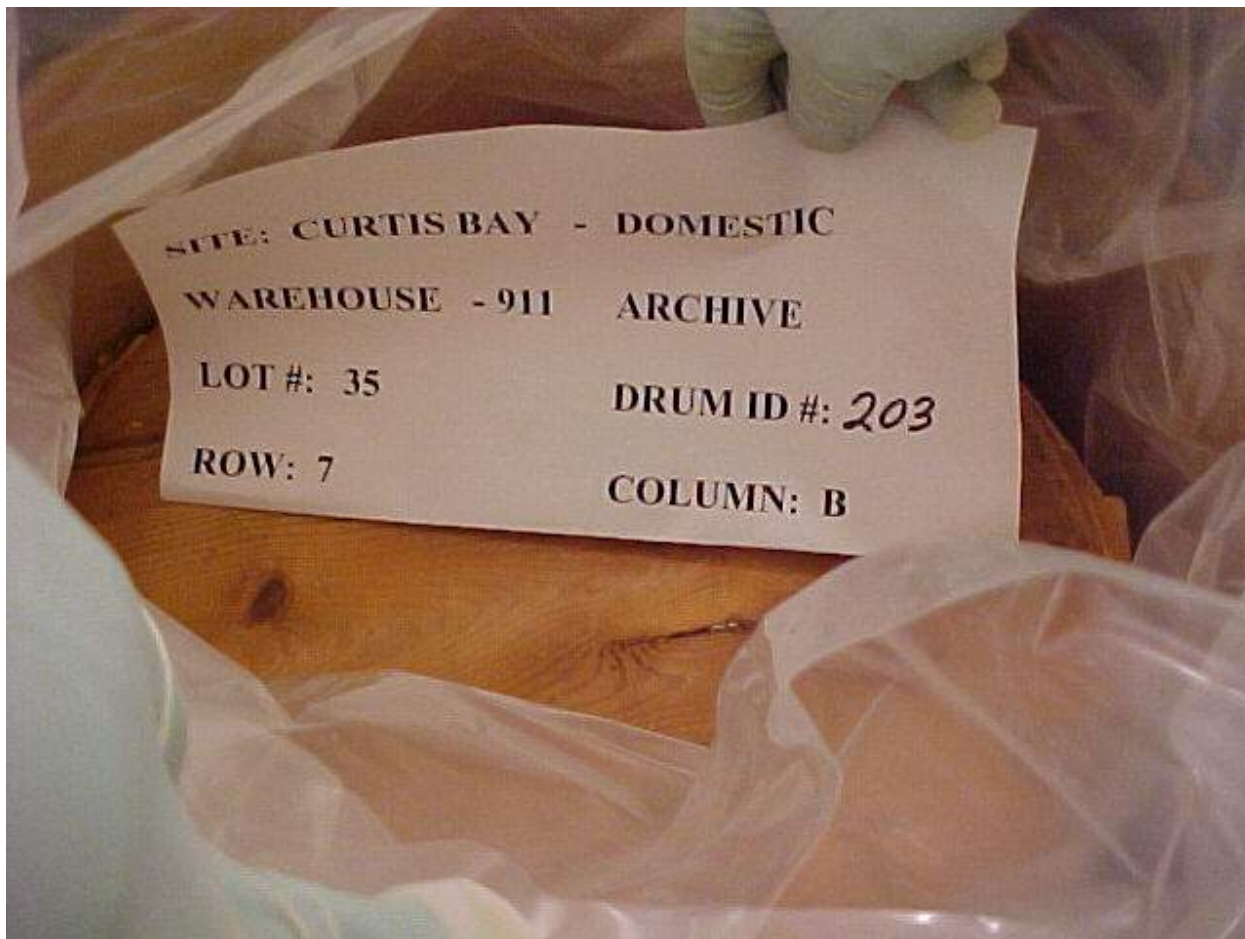
Wooden lid (mounted on inner fiber drum) – good condition (lid protects the poly liner/bag before you actual ThN material)

No gasses present in breathing zone

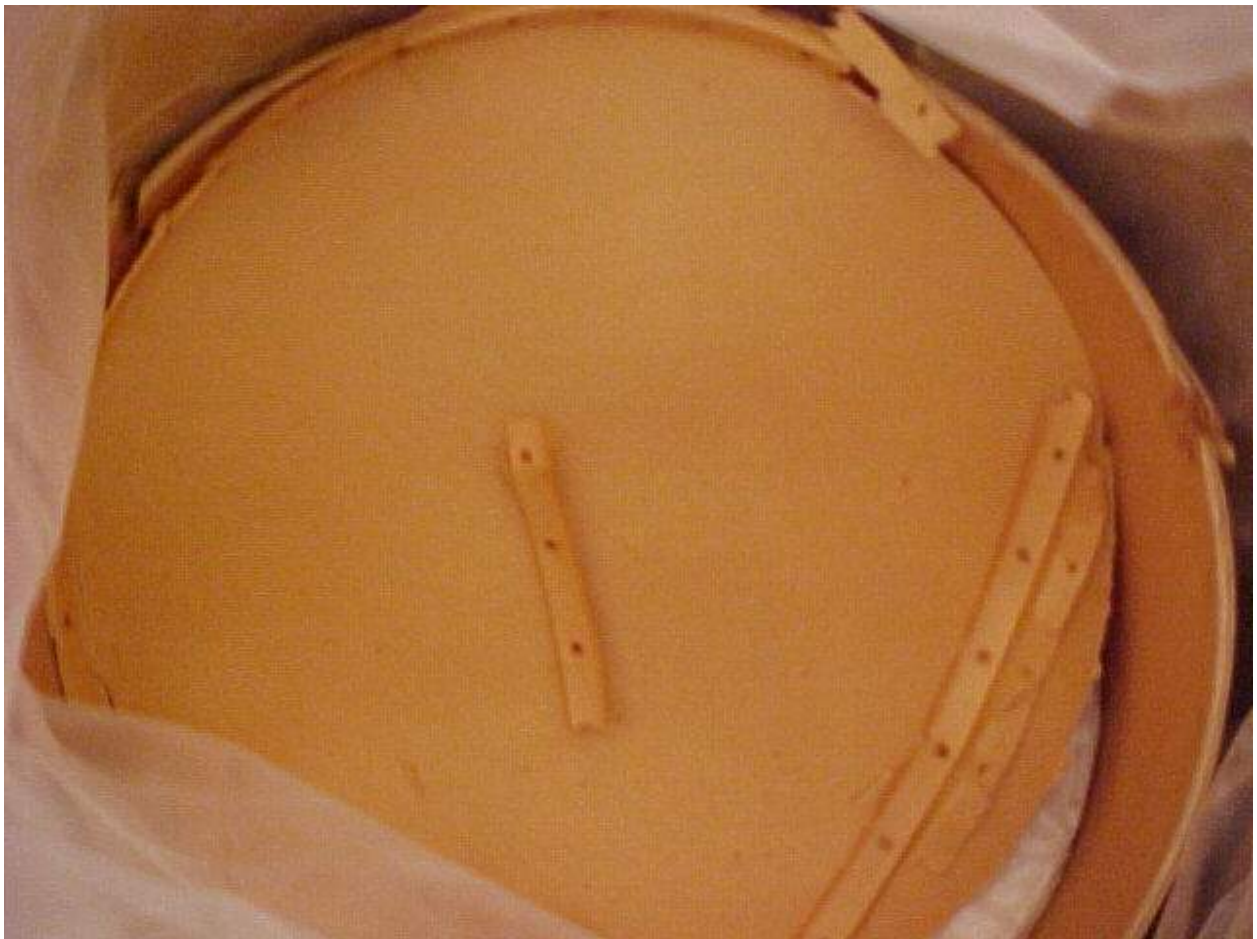
“Paper thin” lid on the lab-pack (innermost fiber drum) comes off when you pull the wooden lid off.

No gasses present in breathing zone

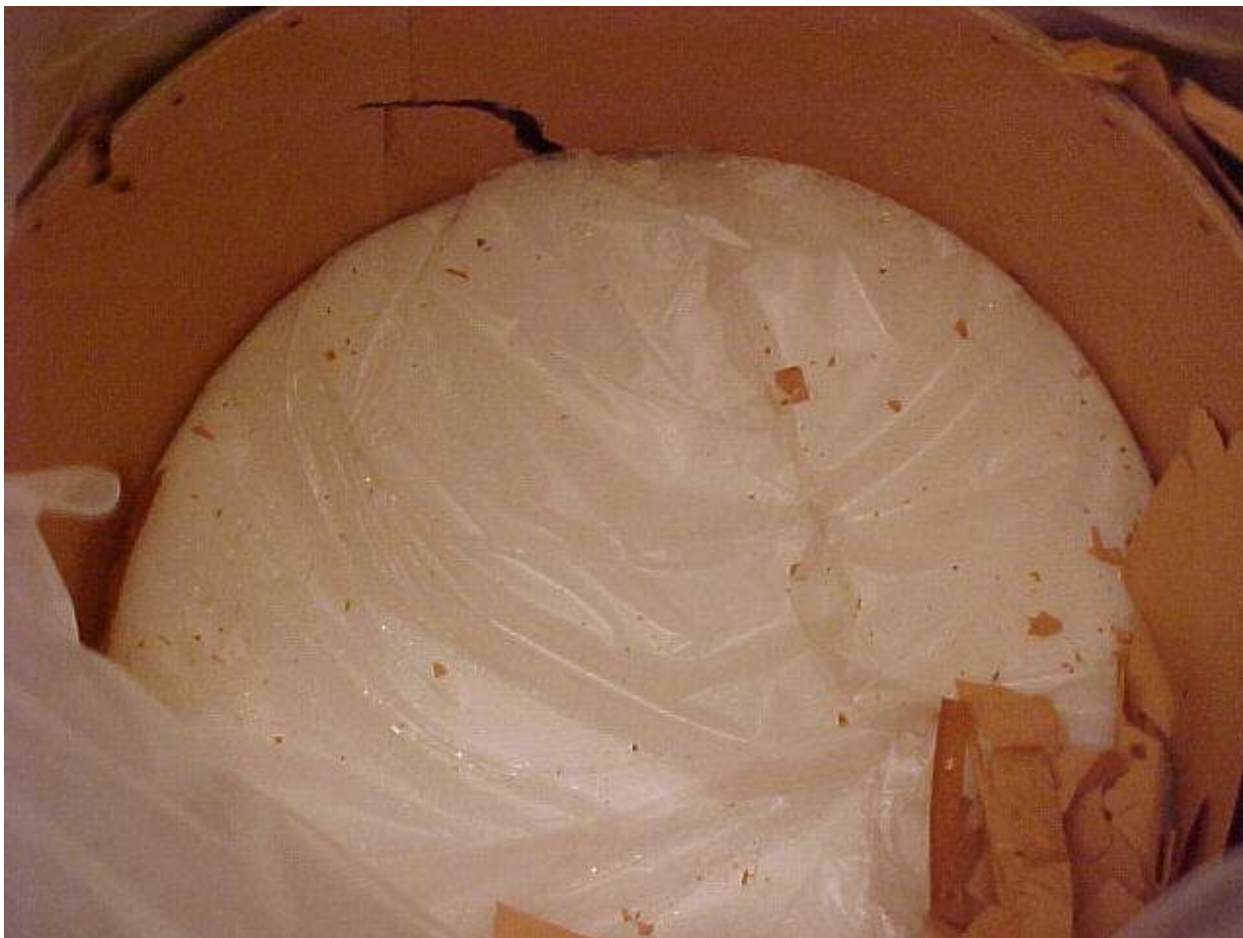
4th poly liner/bag – good condition
No gasses present in breathing zone

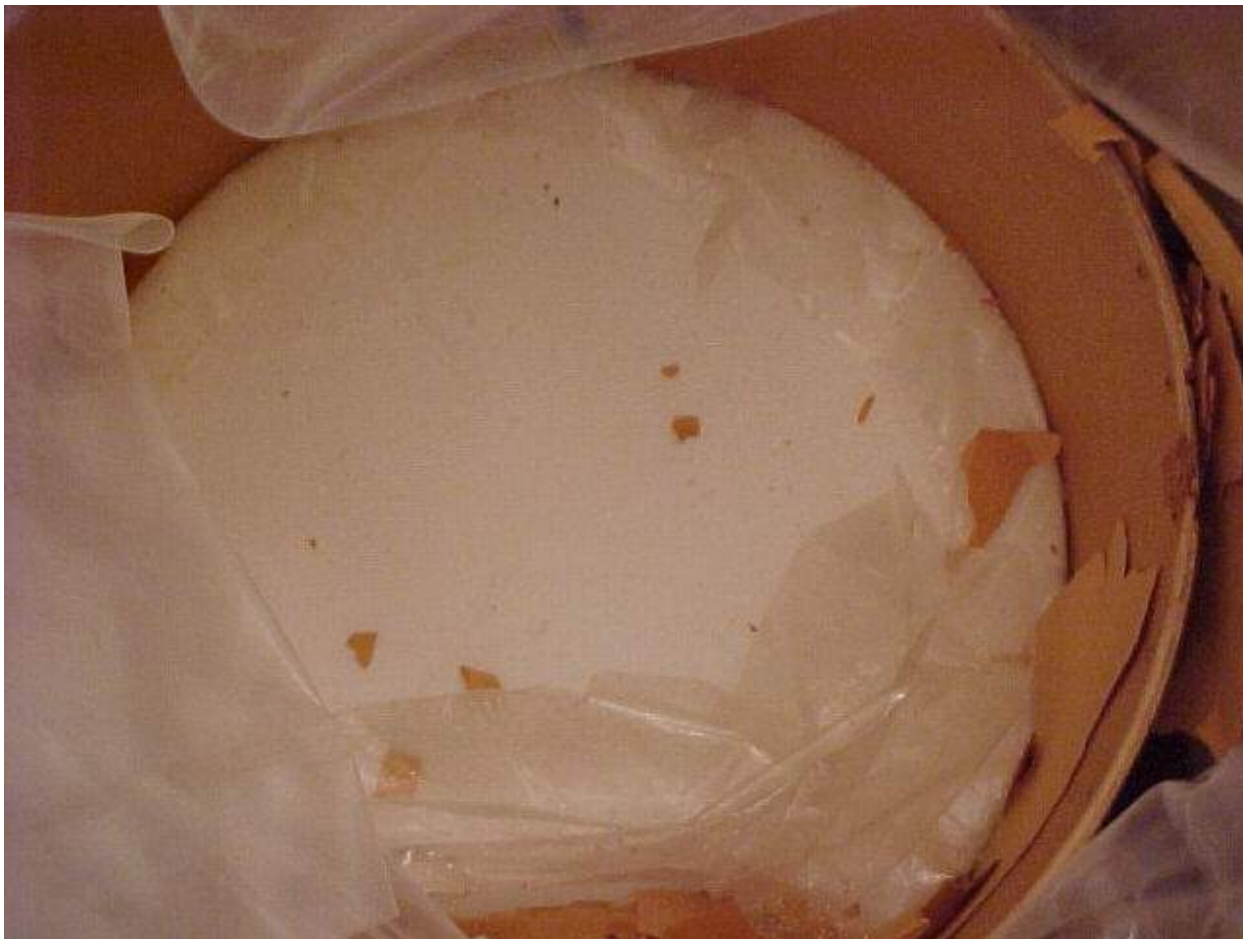
ThN material prior to coring for a sample – good condition – very dry

Gasses present in headspace of fiber drum after opening inner poly liner: NO – 3.4 ppm & NOx – 27.4 ppm

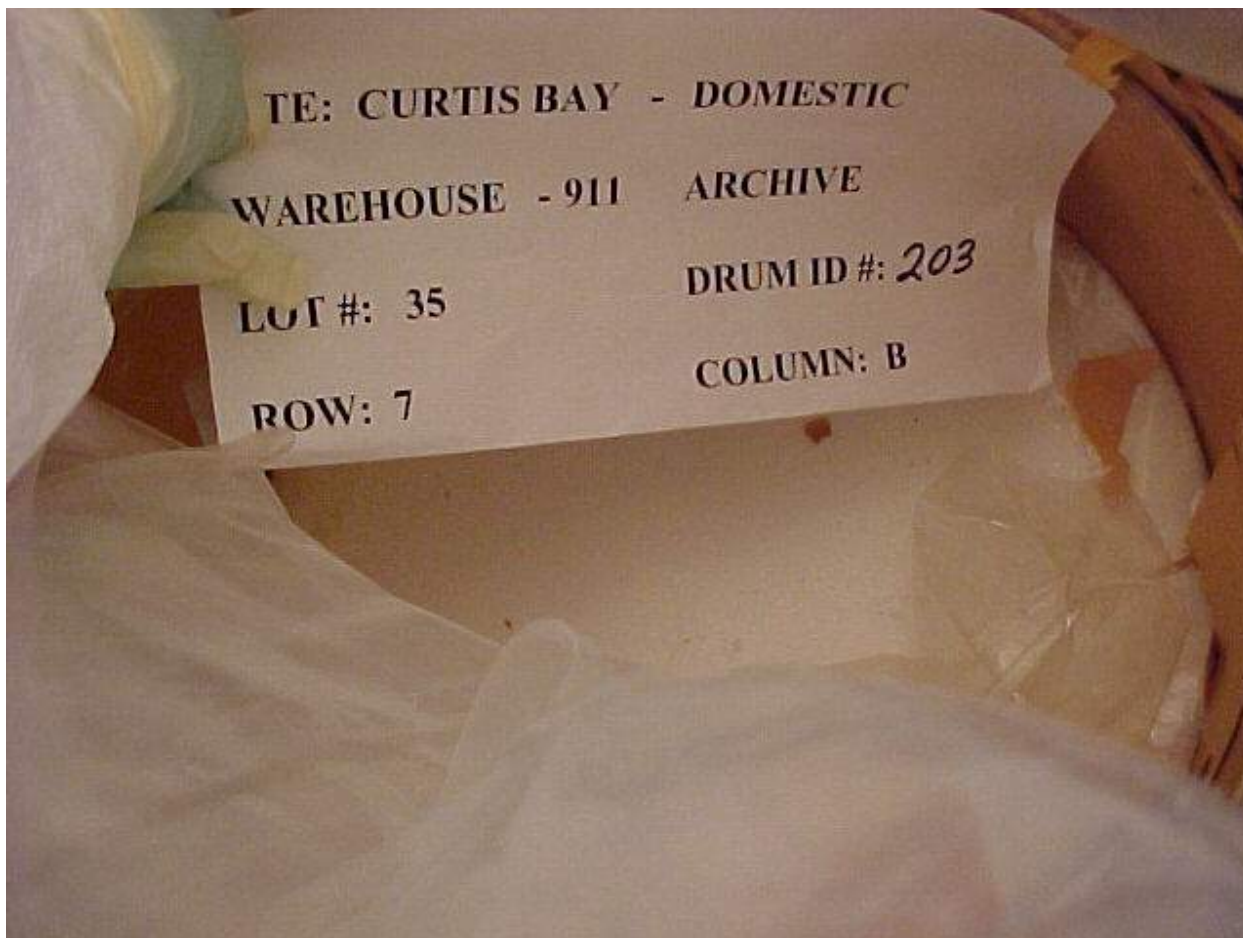
10:00**Other Information**Photo No. 11 of 12Dose Rate Surface 26 mR/hr
 1 meter 3.4 mR/hr

Another photograph of the ThN material prior to sampling – good condition
No gases present in headspace following exhausting by HEPA blower discharge

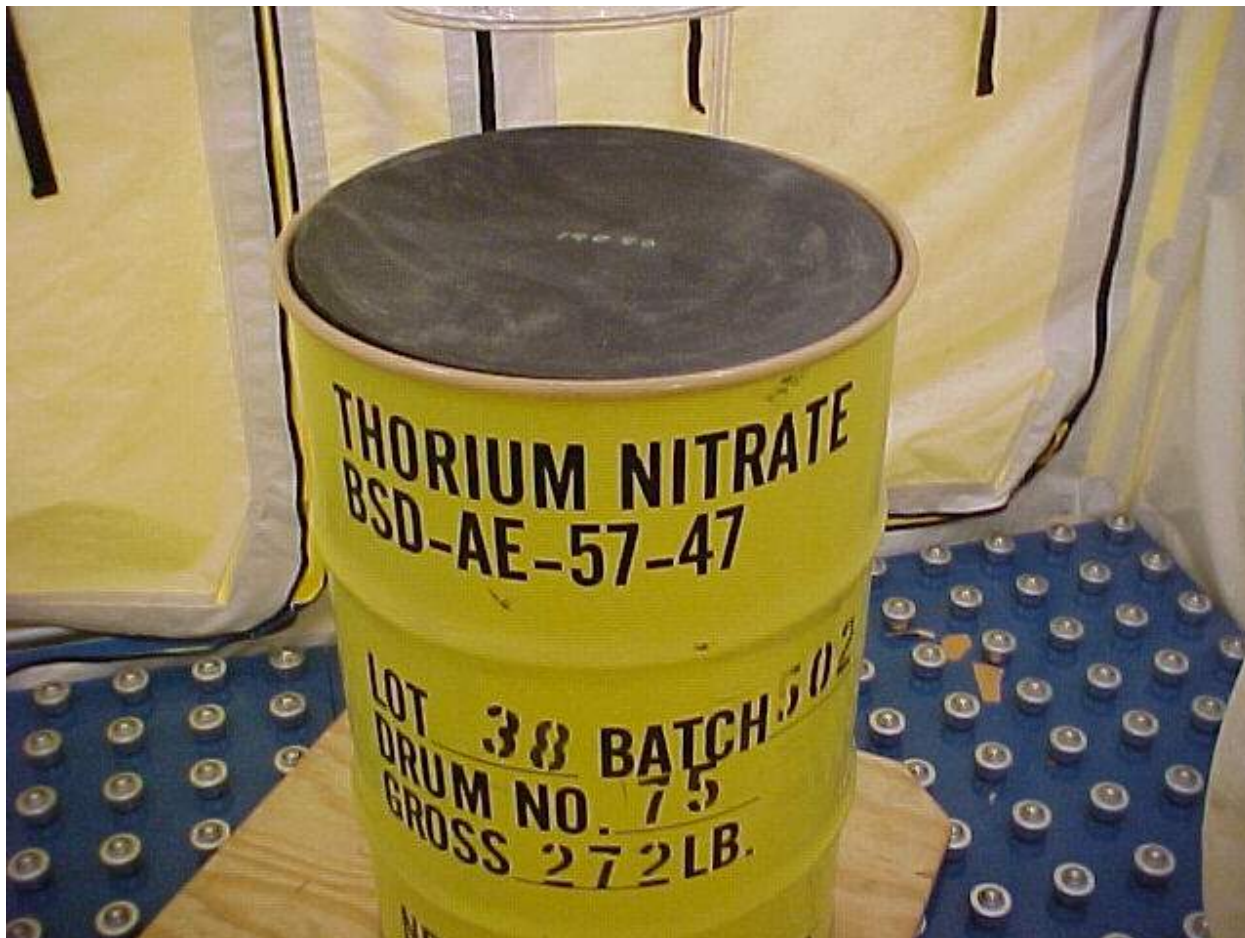
Picture of black “poly” lid from drum liner inside of 30-gal drum – good condition
No pressure present in drum – no gases present in breathing zone

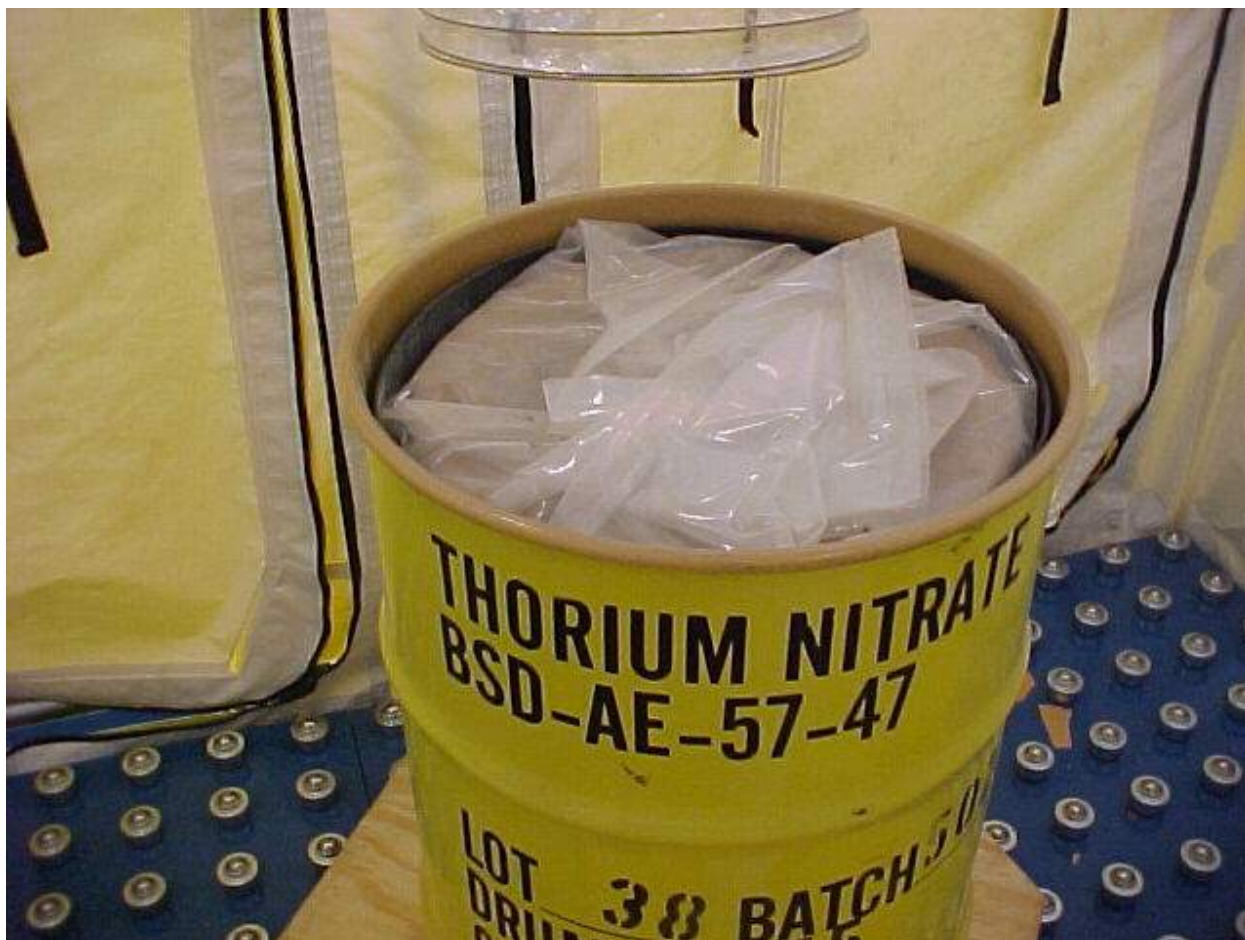
11:55**Other Information**Photo No. 3 of 11Dose Rate Surface 24 mR/hr
 1 meter 3.0 mR/hr1st poly liner/bag – good condition

No pressure present in bag – no gases present in breathing zone

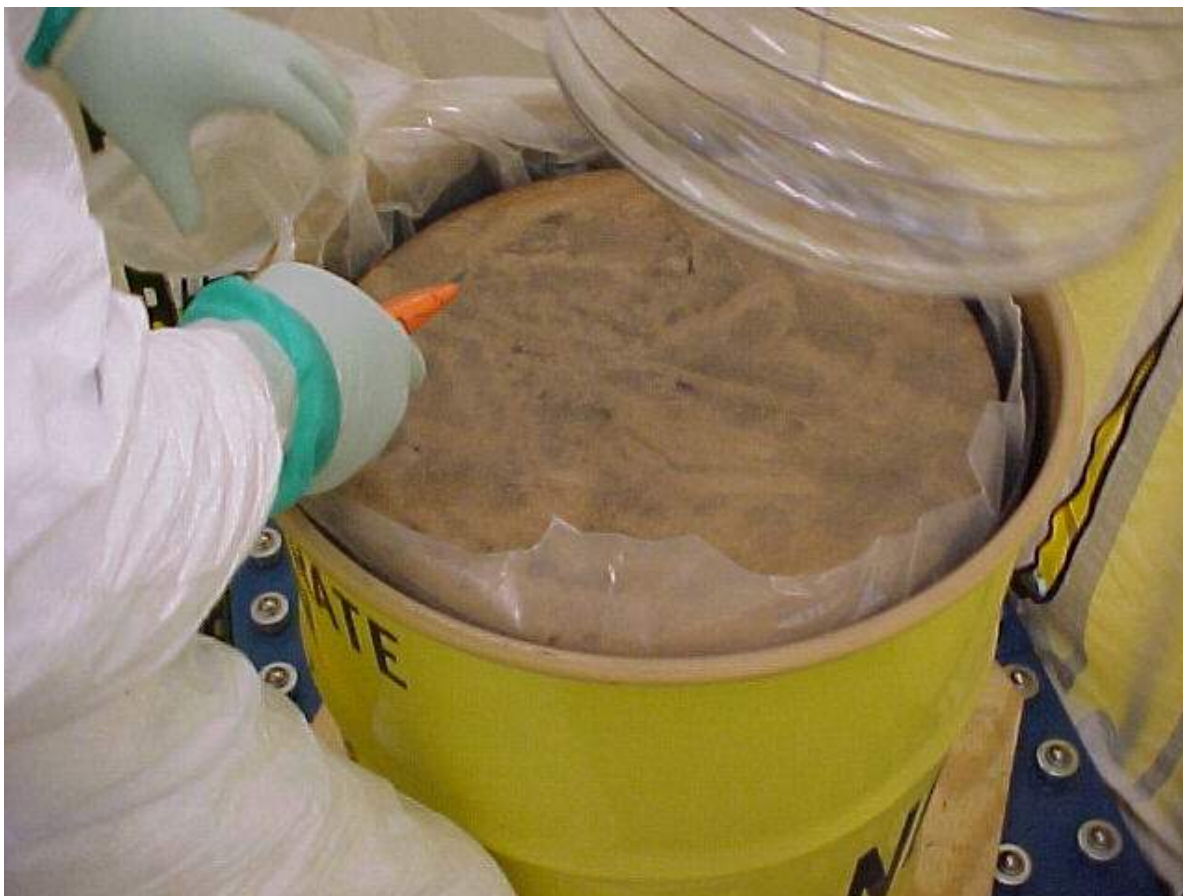
Fiber lid (on outermost fiber drum inside of drum) – good condition

No gases present in breathing zone

Fiber lid still in place – no internal pressure in inner packagings – had to cut lid open to access inner packagings.

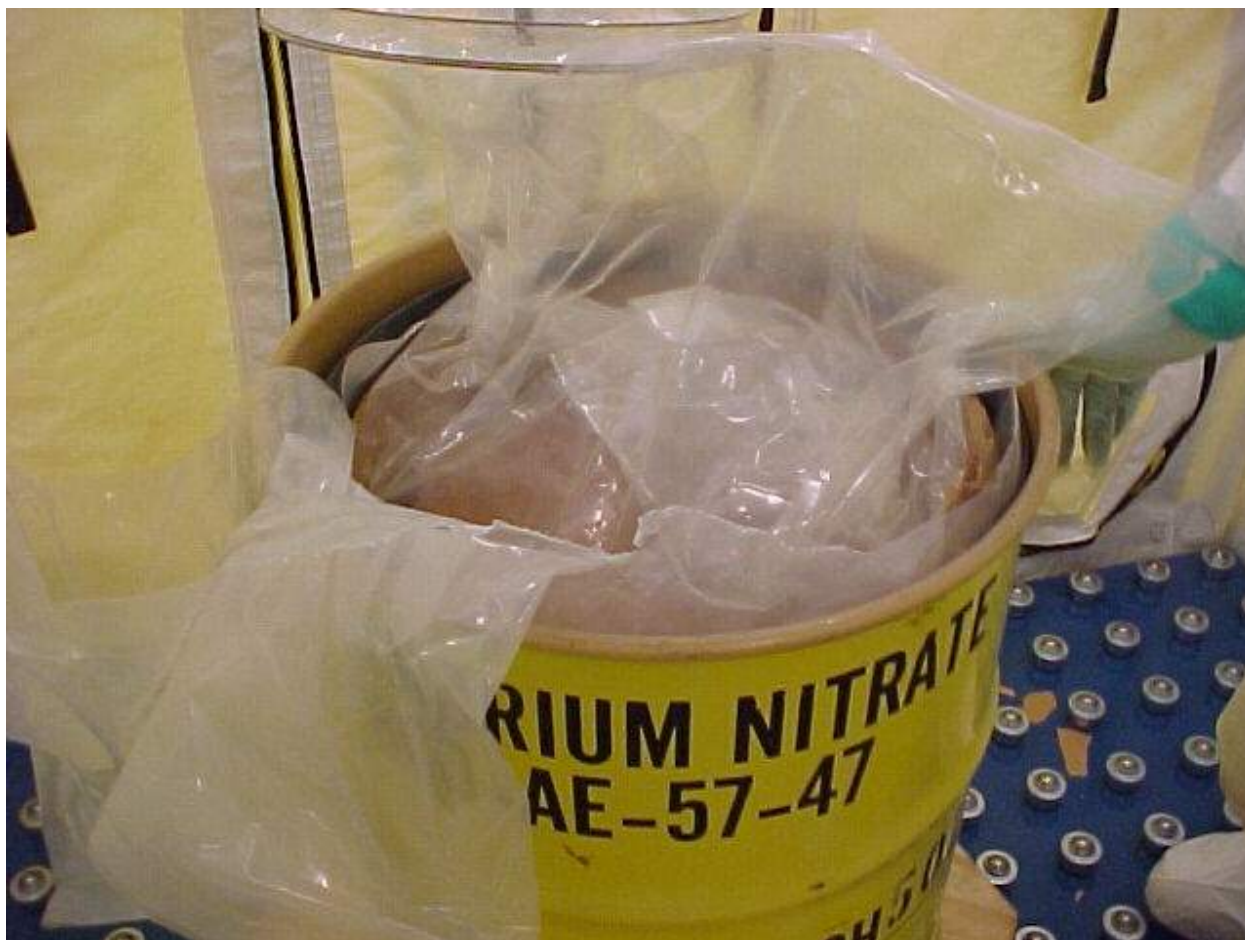
2nd poly liner/bag – good condition
No gases present in breathing zone.
