THORIUM NITRATE STOCKPILE DRUM CHARACTERIZATION REPORT

**THORIUM NITRATE STOCKPILE
DRUM CHARACTERIZATION REPORT**

Prepared for
U.S. Defense Logistics Agency
Defense National Stockpile Center
Fort Belvoir, Virginia

Prepared by
OAK RIDGE NATIONAL LABORATORY
Oak Ridge, Tennessee 37831
managed by
UT-BATTELLE, LLC
for the
U.S. DEPARTMENT OF ENERGY
under contract DE-AC05-00OR22725

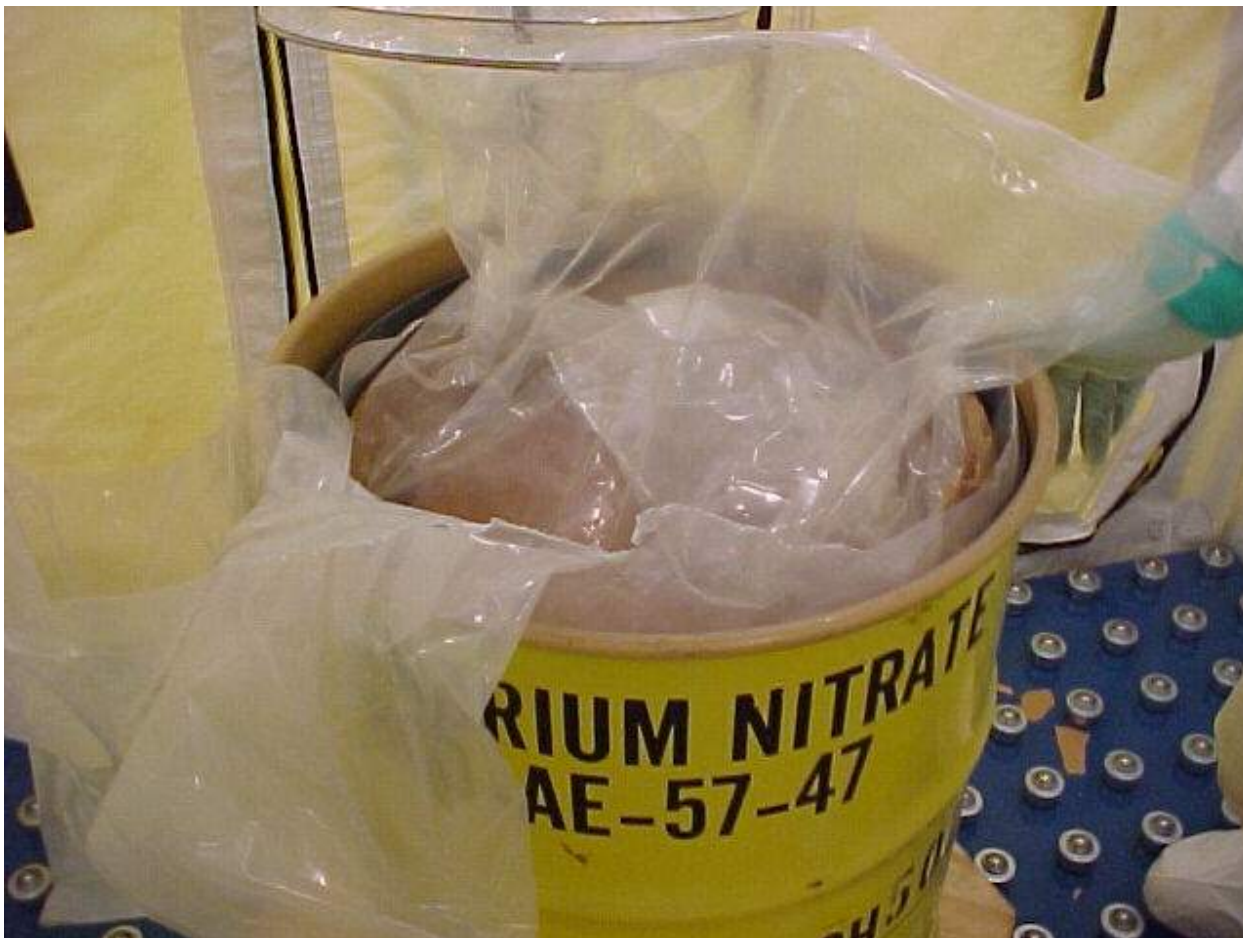
3rd poly liner/bag – good condition
No gases present in breathing zone.

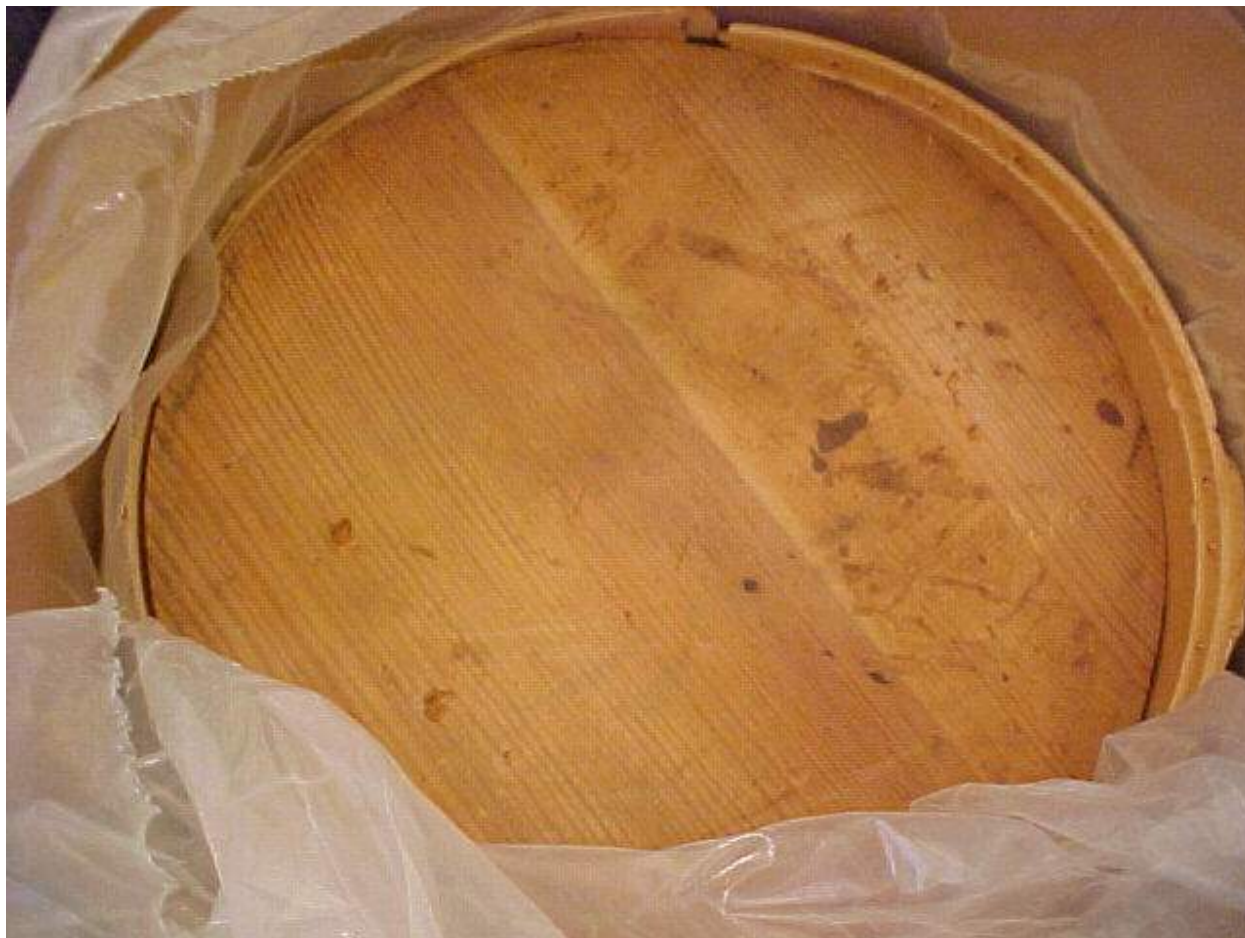
Wooden lid [mounted on innermost fiber drum (lab-pack container)] – good condition
No gases present in breathing zone.

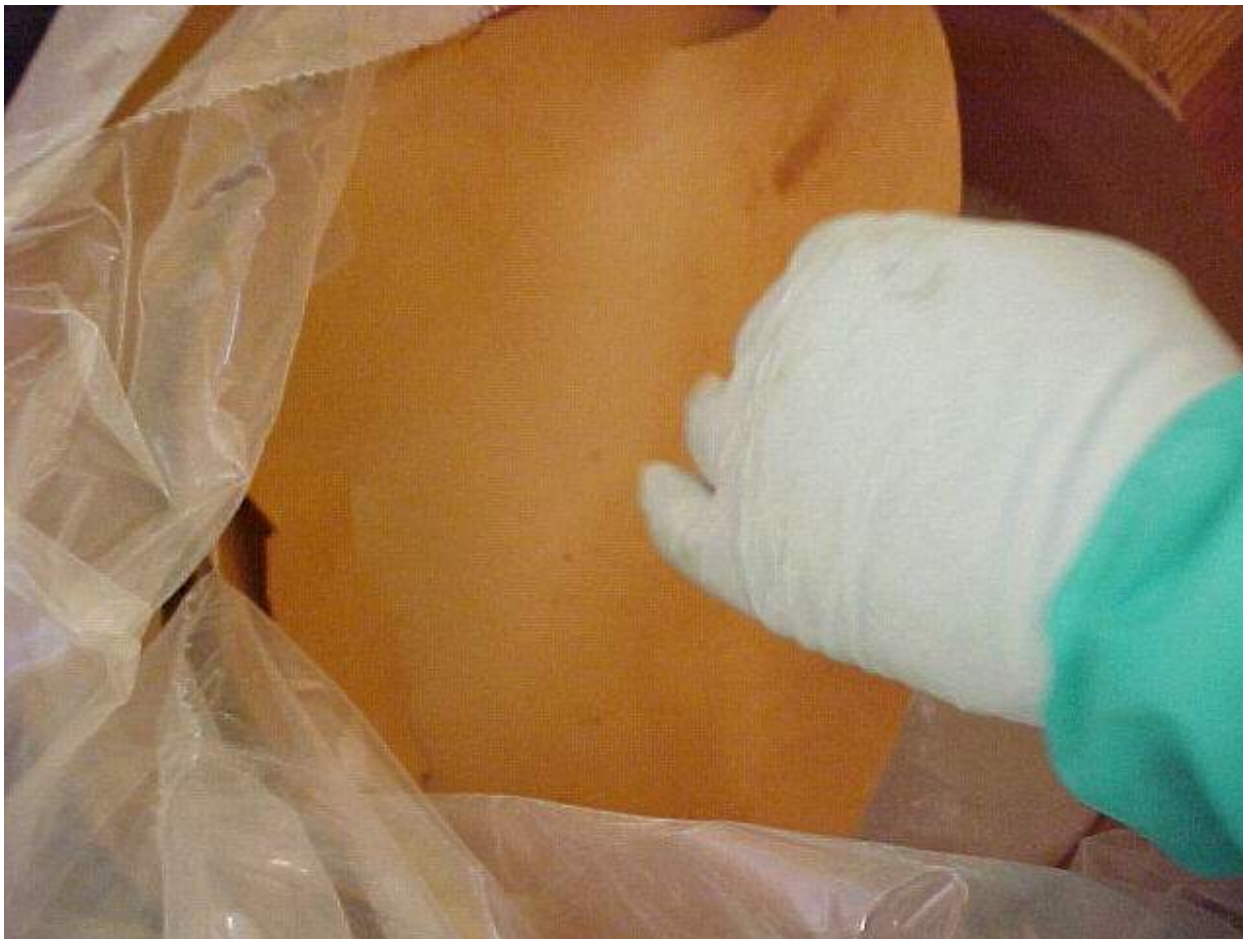
Lab-pack container lid – fair condition [thin layer paper underneath wooden lid and attached to this lab-pack container (innermost fiber drum)]

No gases present in breathing zone.

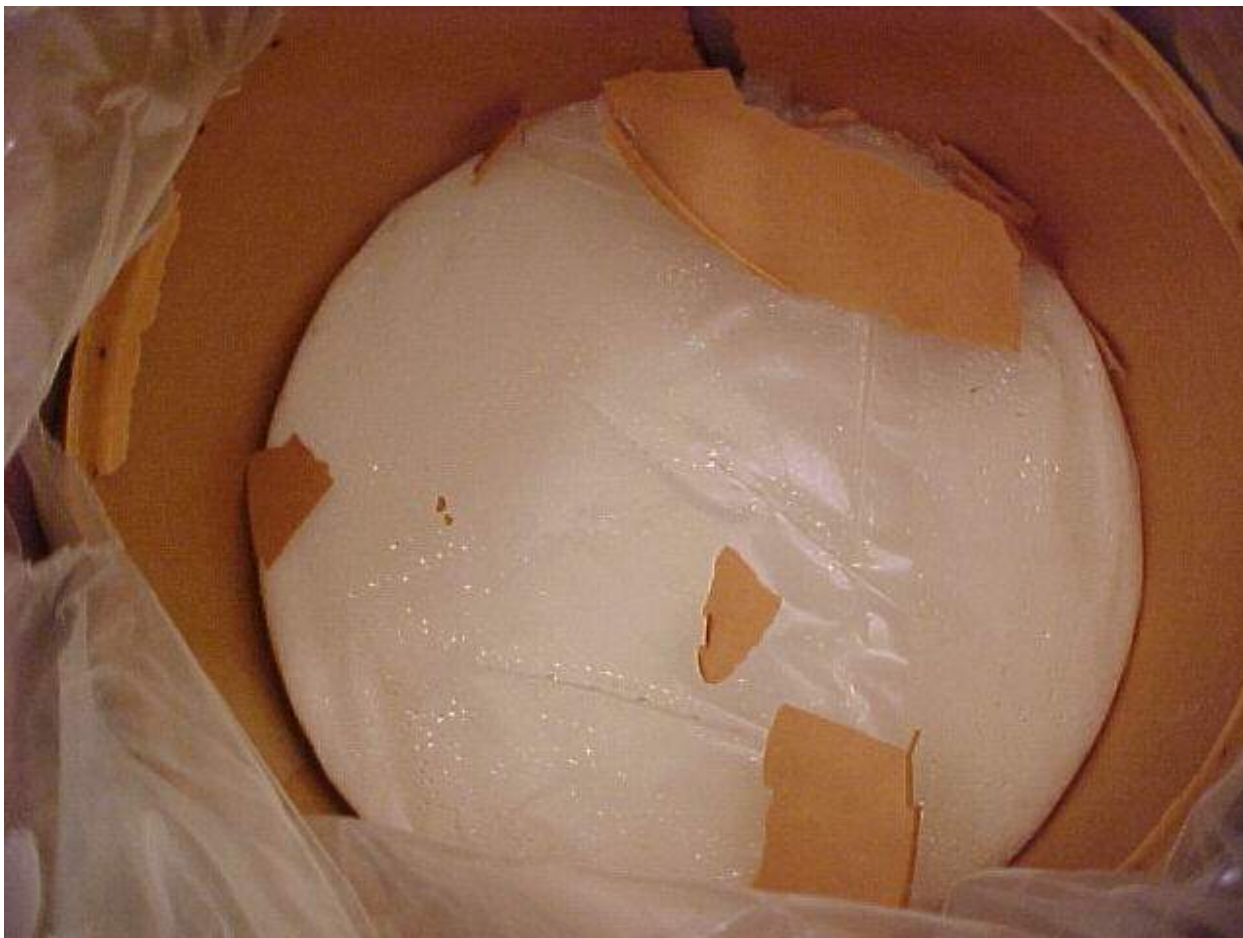
11:55**Other Information**Photo No. 9 of 11Dose Rate Surface 24 mR/hr
 1 meter 3.0 mR/hr

4th poly liner/bag – good condition (thin layer plastic film that covers the ThN material)
No gases present in breathing zone.

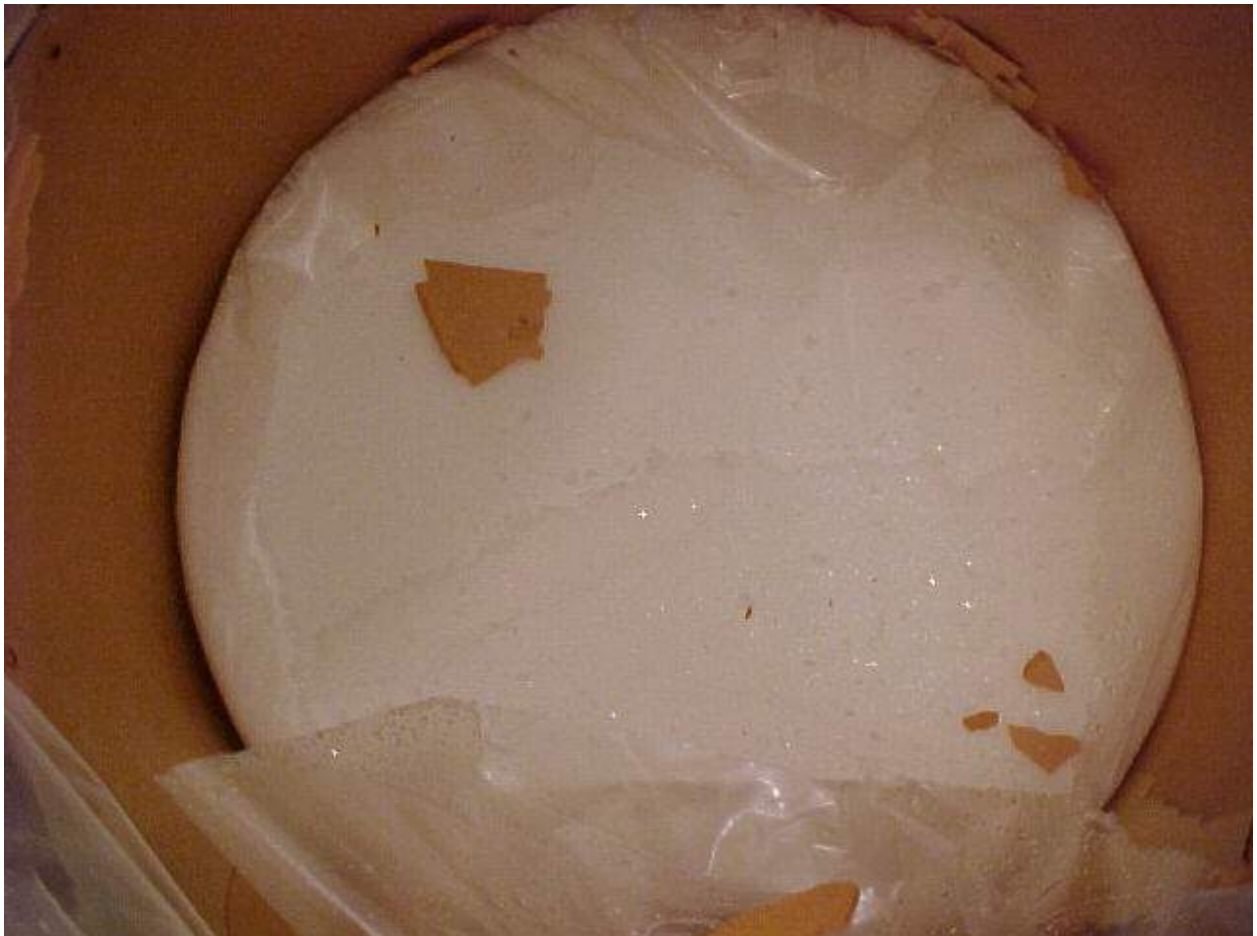
ThN material – dry – solid – monolith - white
No gases present in breathing zone.

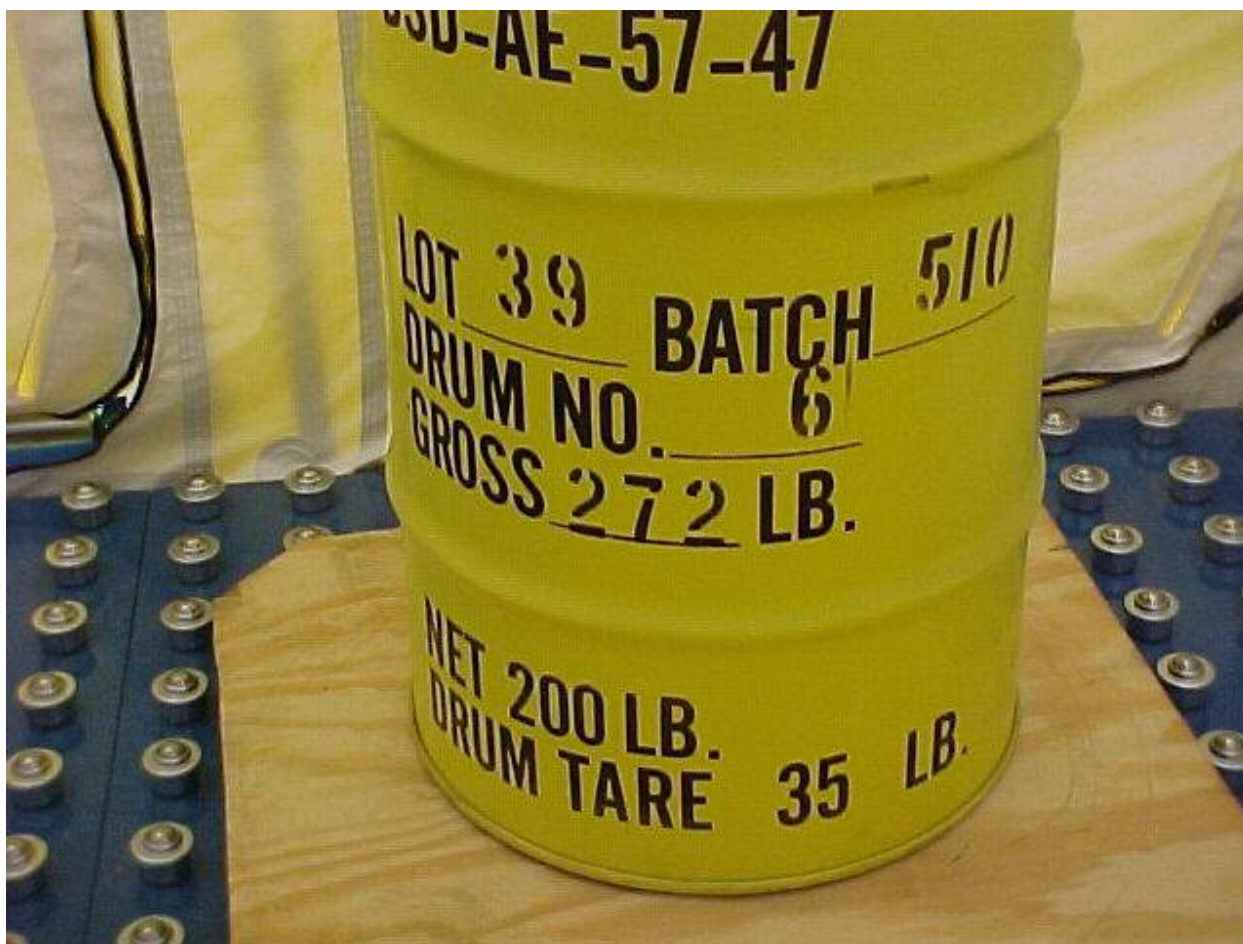
10:00**Other Information**Photo No. 1 of 9Dose Rate Surface 22 mR/hr
 1 meter 3.2 mR/hr

30-gal drum – good condition (container vented gas during drum lid opening operations)

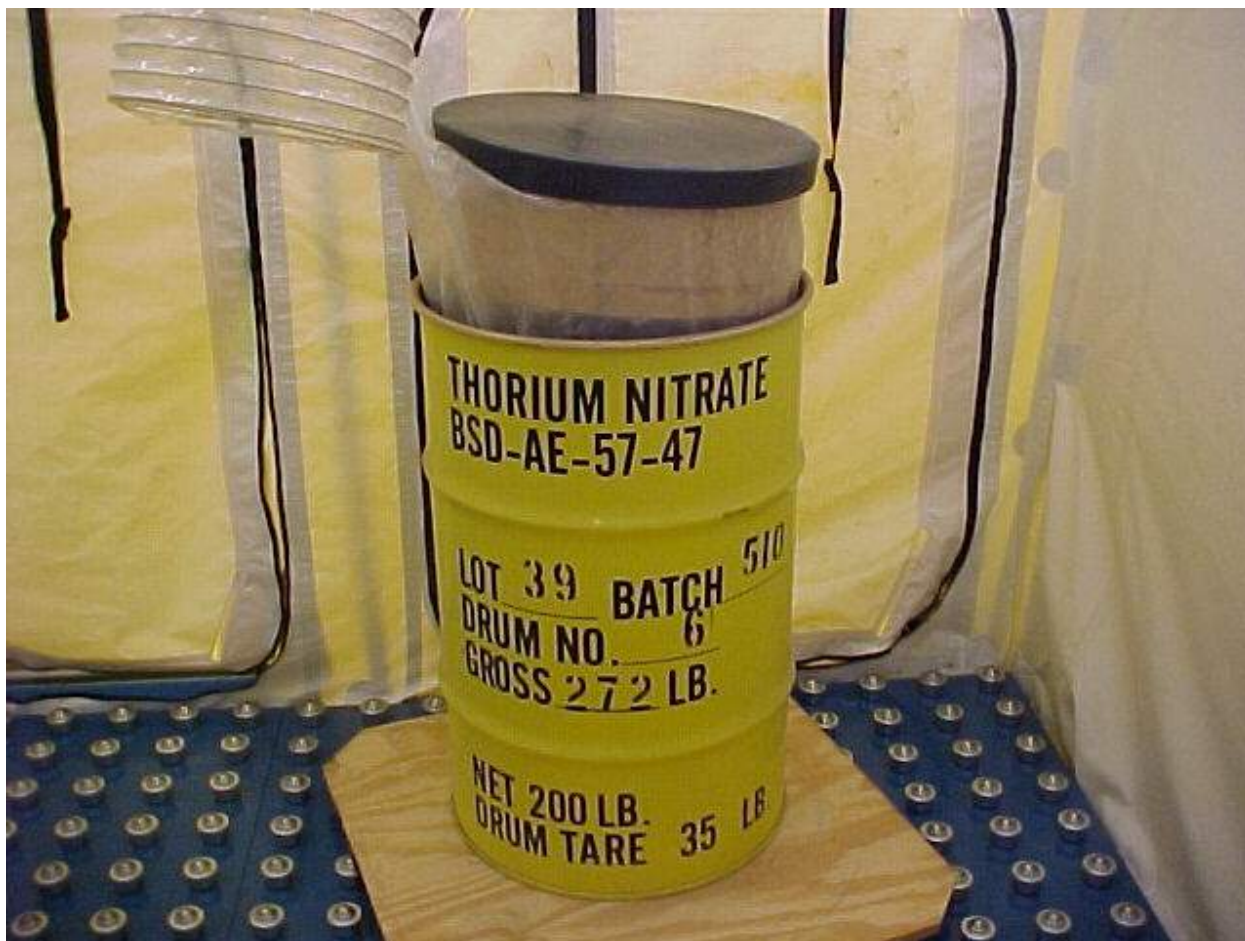
Black plastic lid (lid to black drum liner inside of metal drum) – good condition – this lid is raised due to the internal pressure inside of the drum packaging materials (poly bags)
No gasses present in the breathing zone

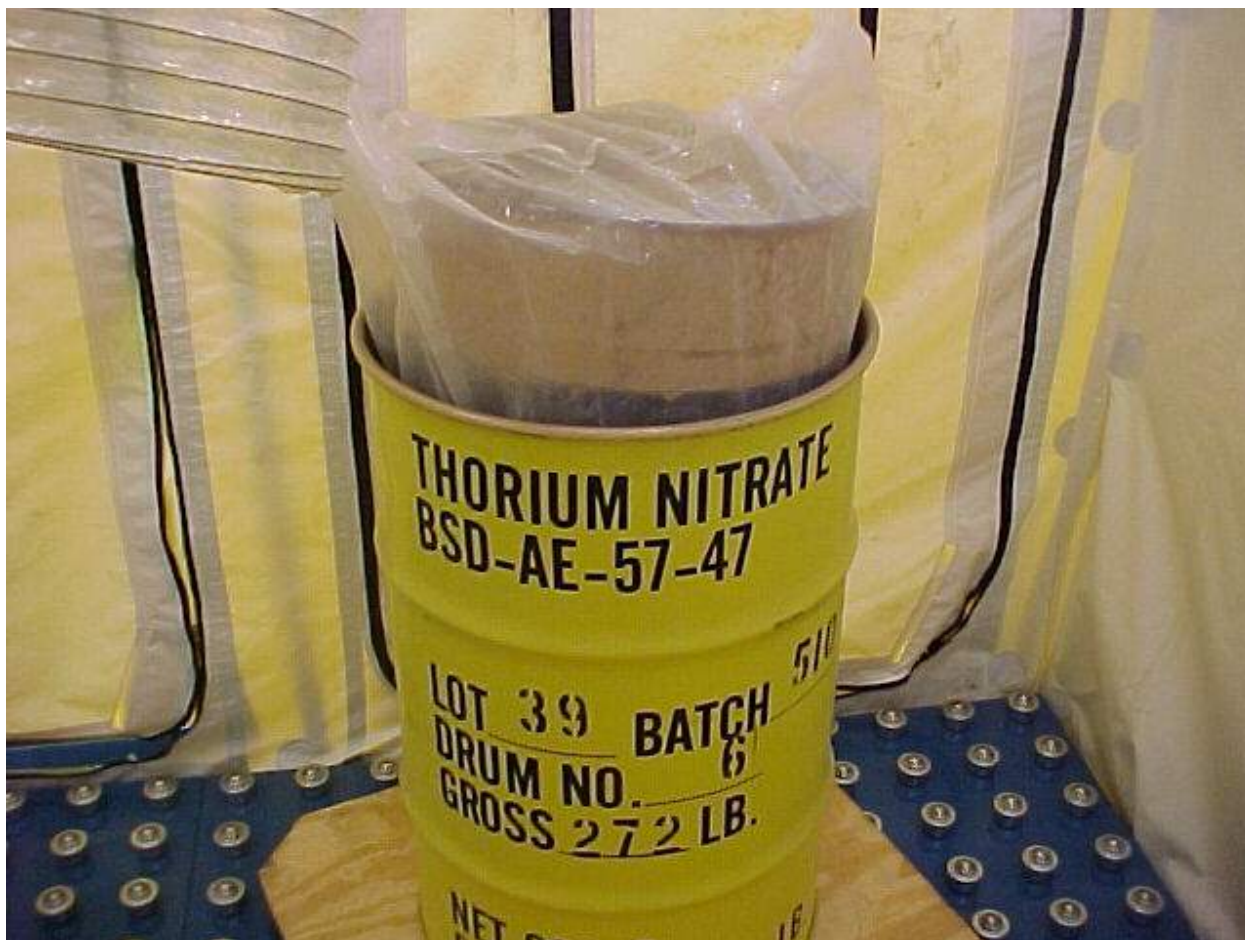
1st poly liner/bag – good condition
No gasses present in the breathing zone

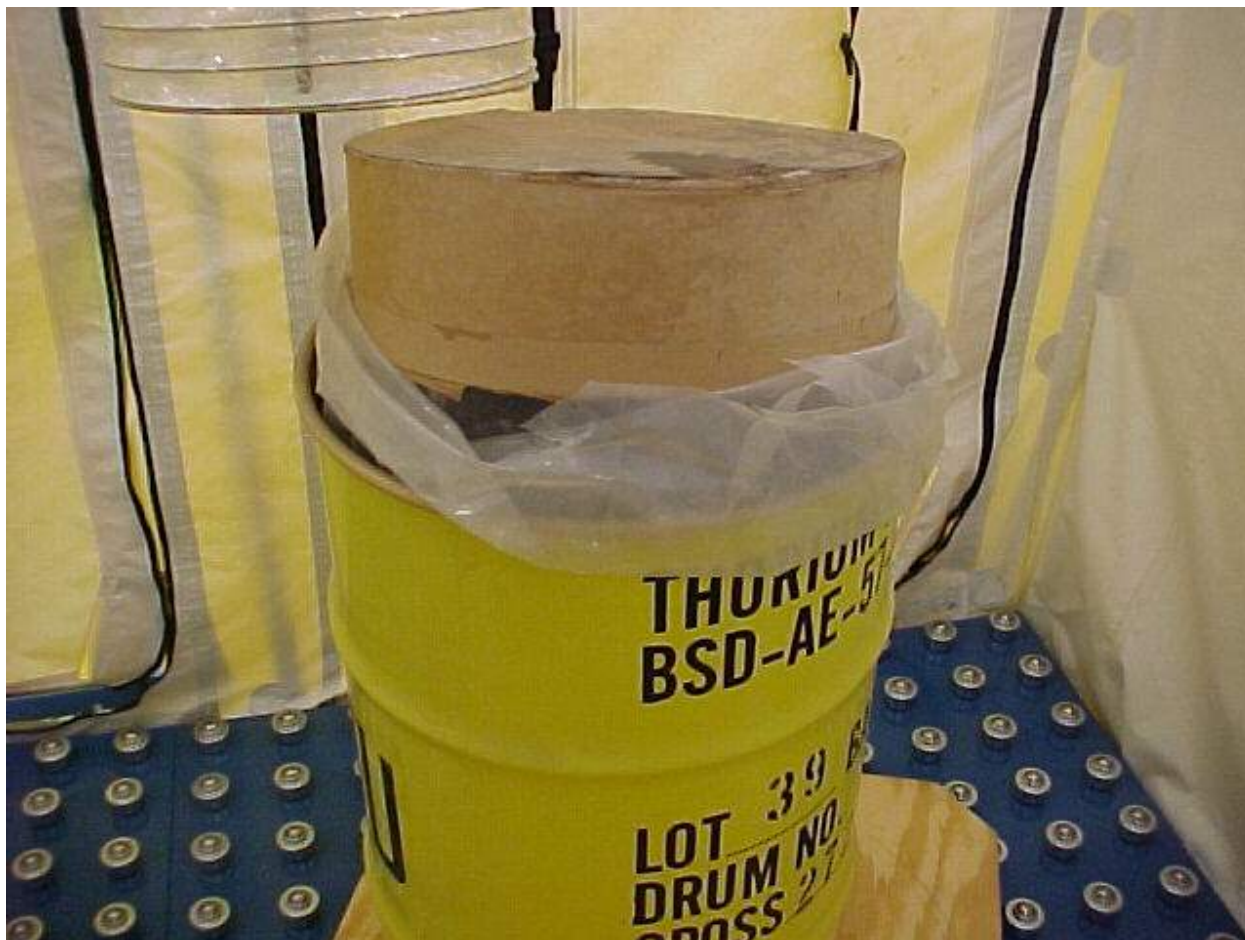
Fiber drum lid – good condition

No gasses present in the breathing zone

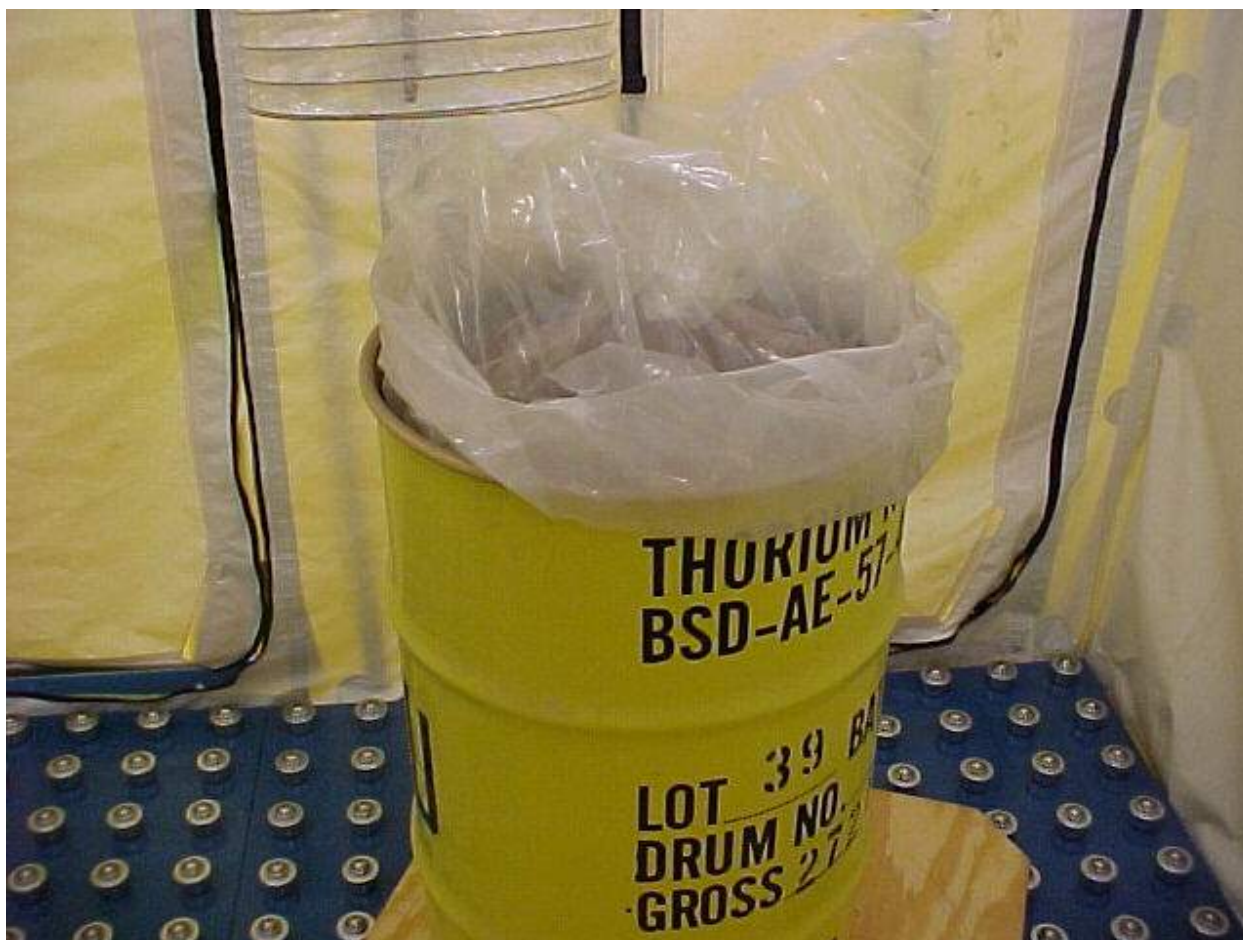
10:00**Other Information**Photo No. 5 of 9Dose Rate Surface 22 mR/hr
 1 meter 3.2 mR/hr

2nd poly liner/bag – good condition
No gases present in the breathing zone

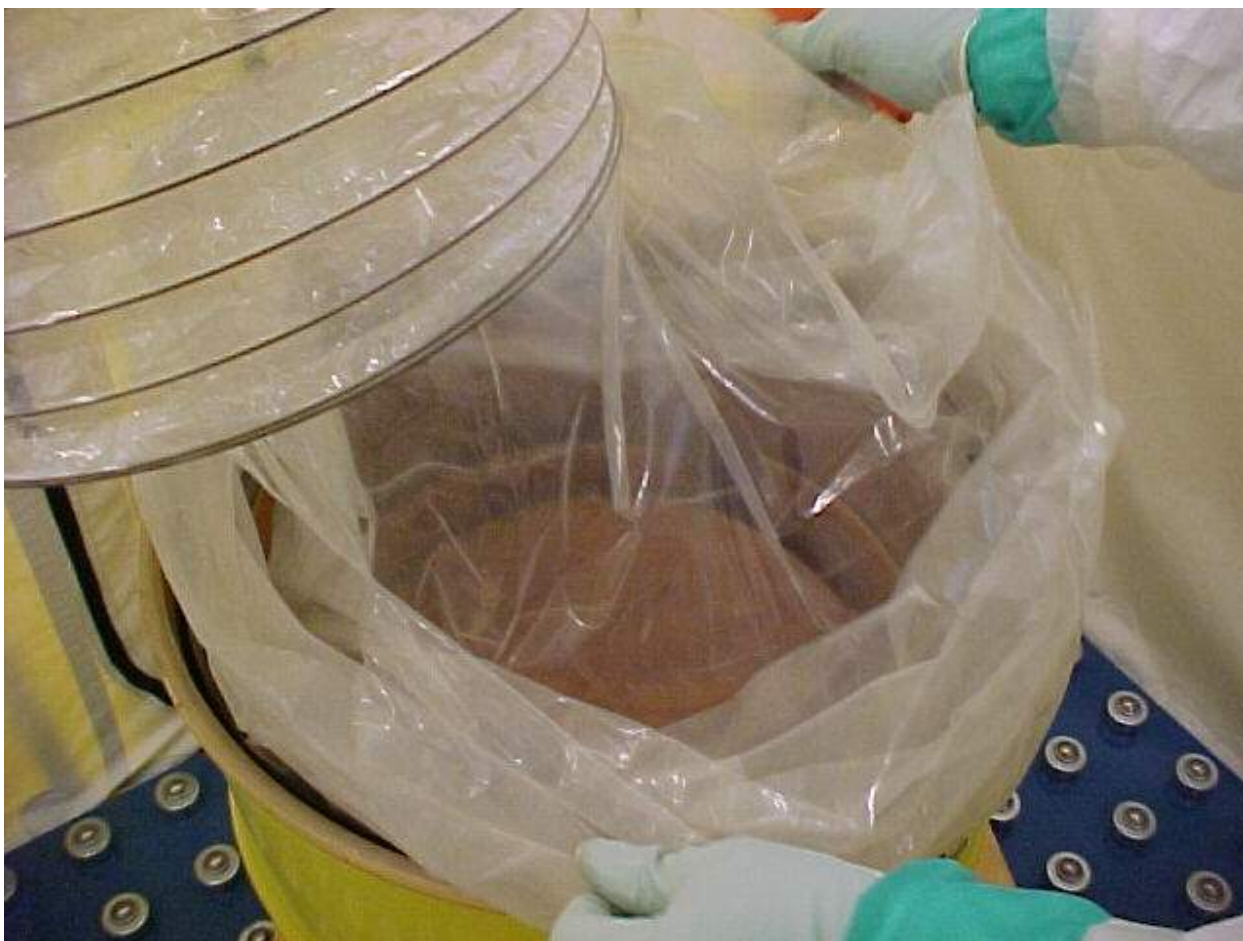
3rd poly liner/bag – good condition (this poly bag appears to contain the majority of the internal pressure buildup inside the drum that did not vent during initial drum lid opening)
No gases present in the breathing zone

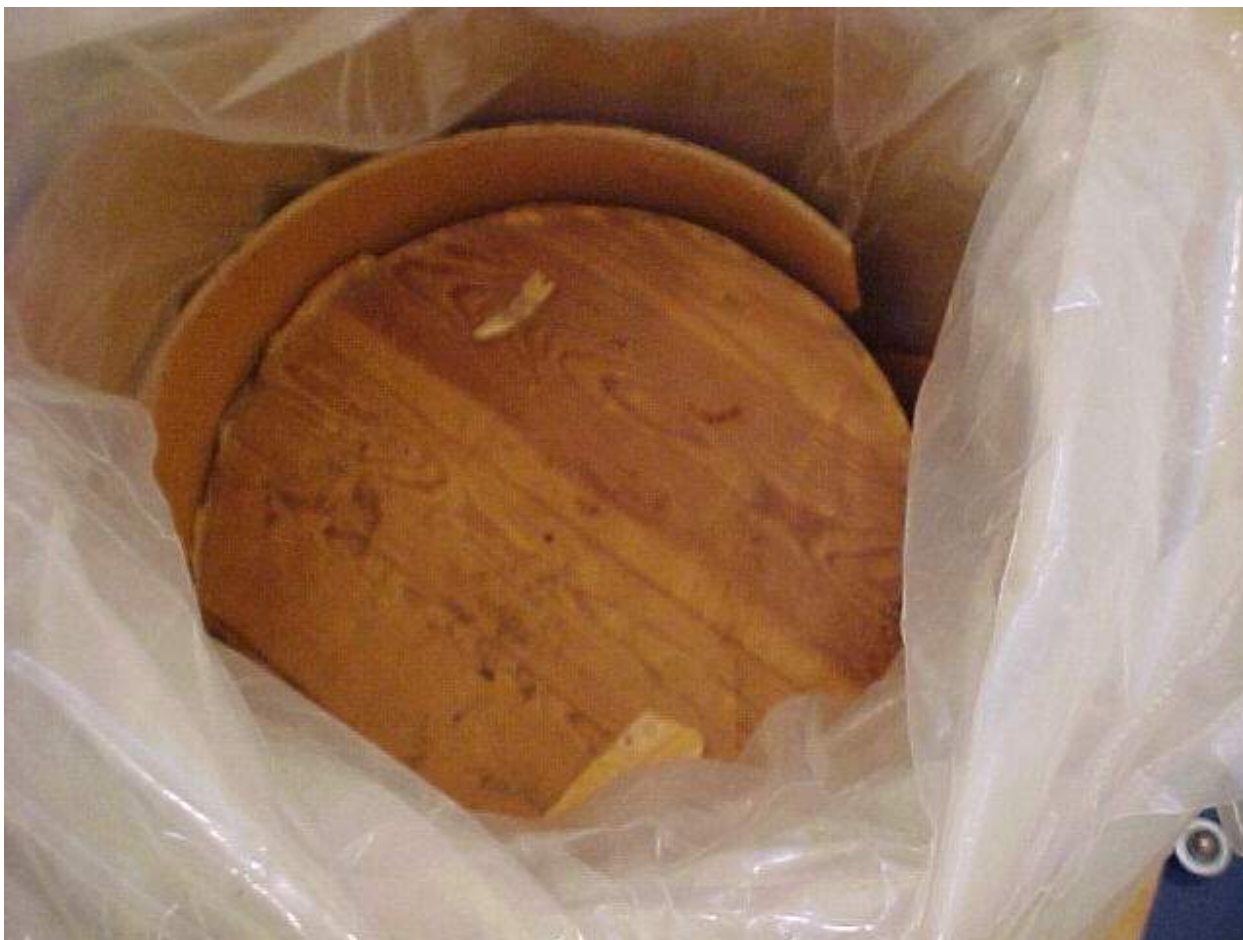
10:00**Other Information**Photo No. 7 of 9Dose Rate Surface 22 mR/hr
 1 meter 3.2 mR/hr

Wooden lid (on innermost fiber drum) – good condition
No gases present in the breathing zone

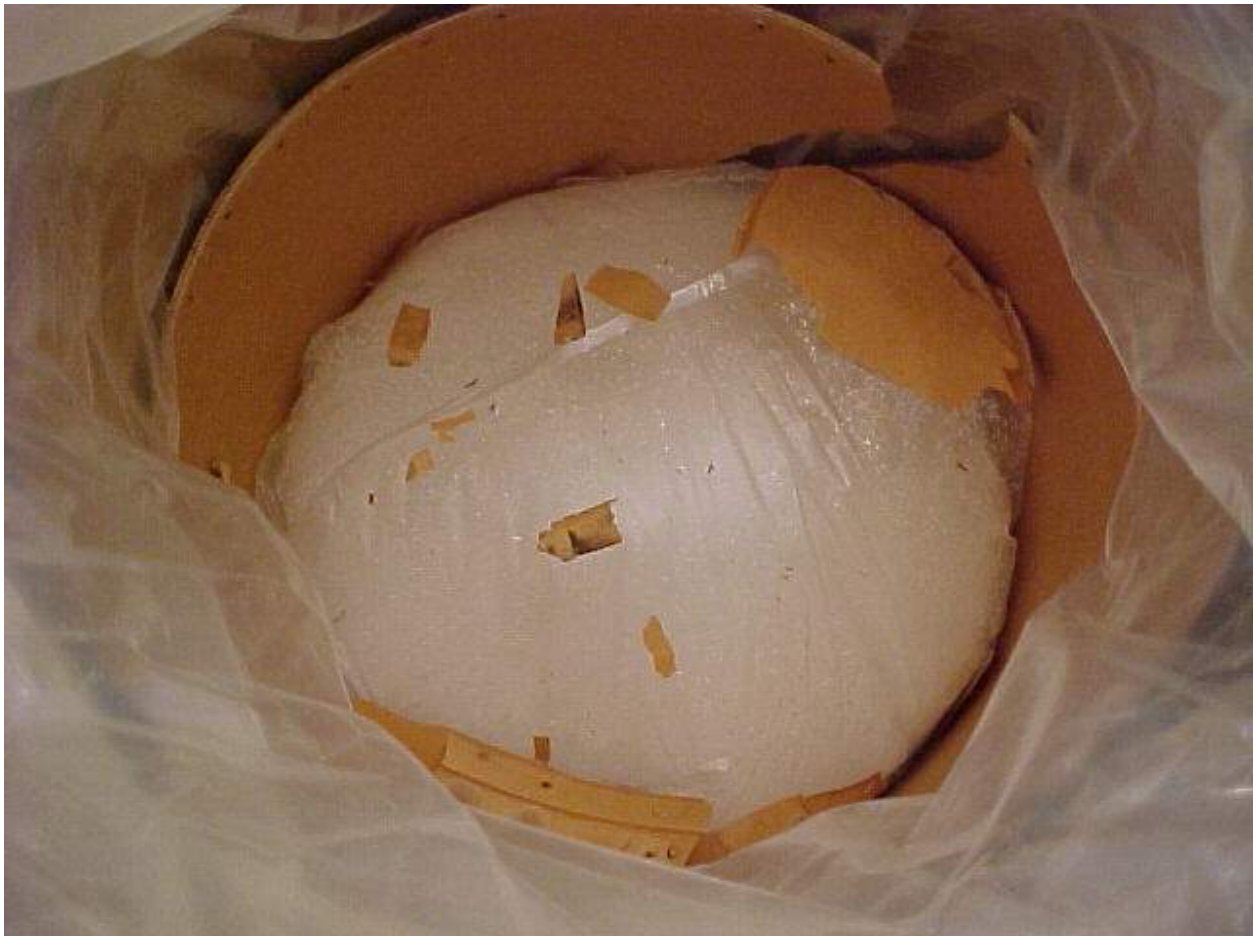
4th poly liner/bag – good condition (picture shows inflated bag – this bag is a thin film plastic material)

ThN material – dry – good condition

No gases present in the breathing zone

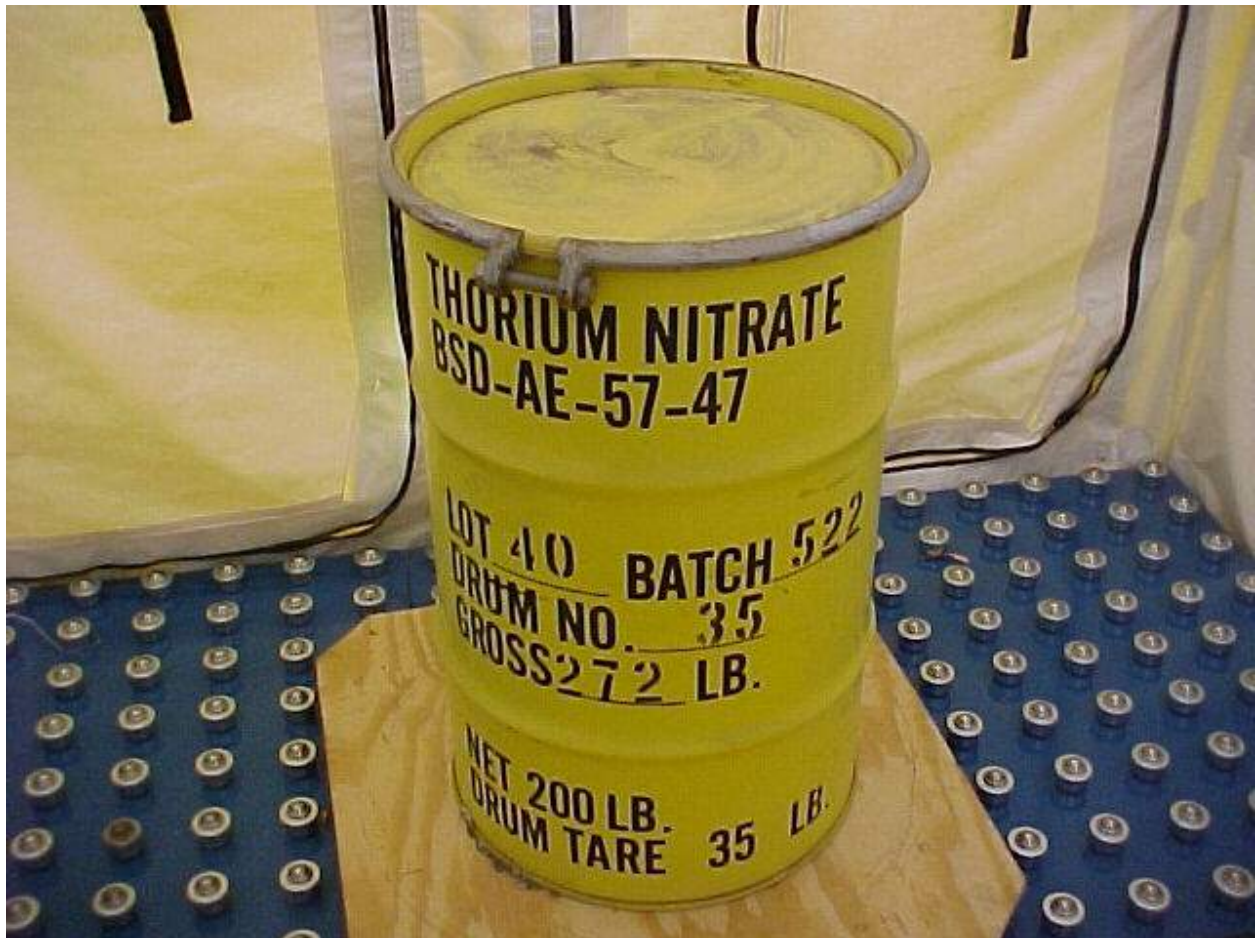
11:35**Other Information**Photo No. 1 of 11Dose Rate Surface 26 mR/hr
 1 meter 3.4 mR/hr

30-gal container – good condition

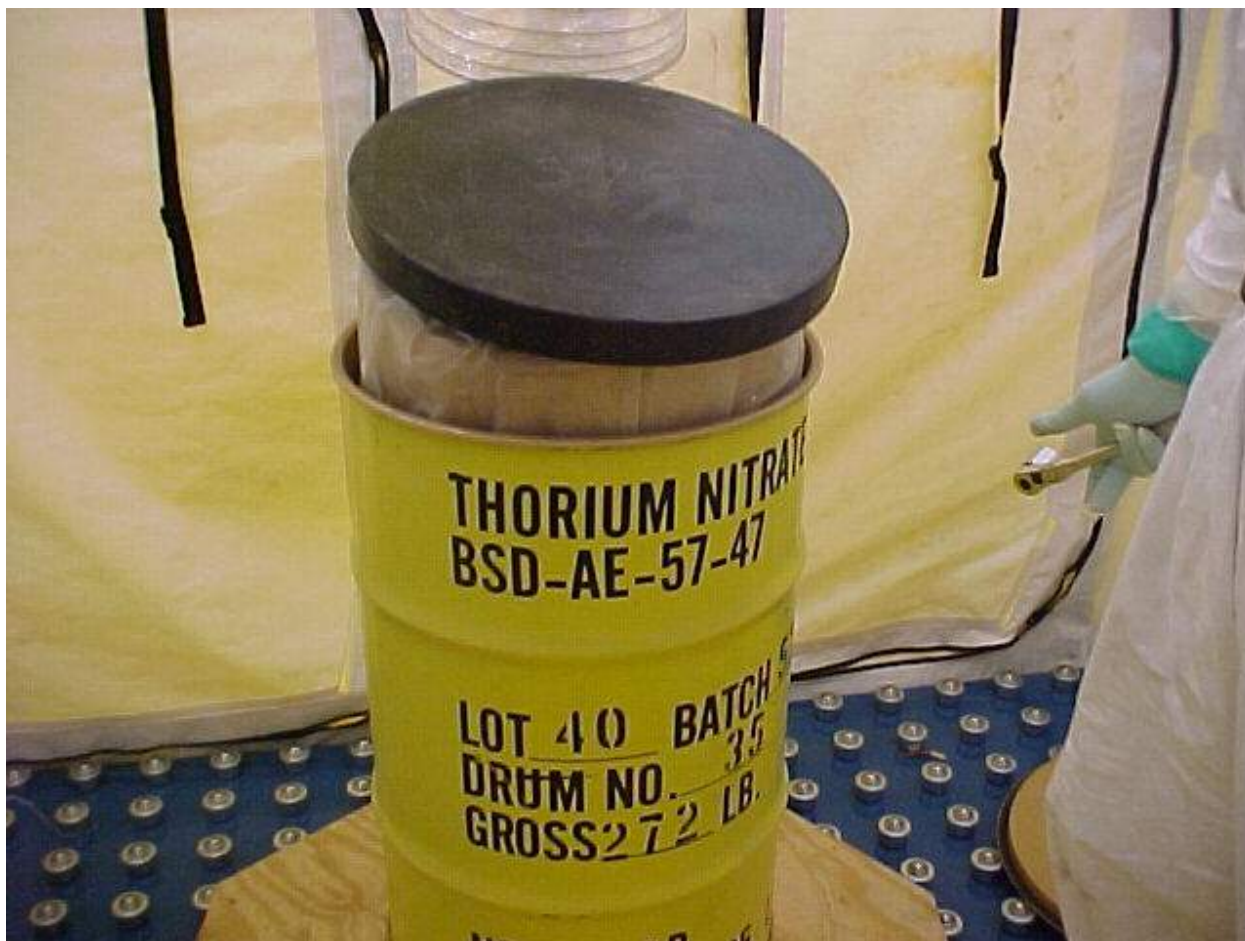
Black plastic lid (on inner drum liner) – good condition – raised condition delineates pressure buildup inside of inner drum packagings
No gasses present in breathing zone

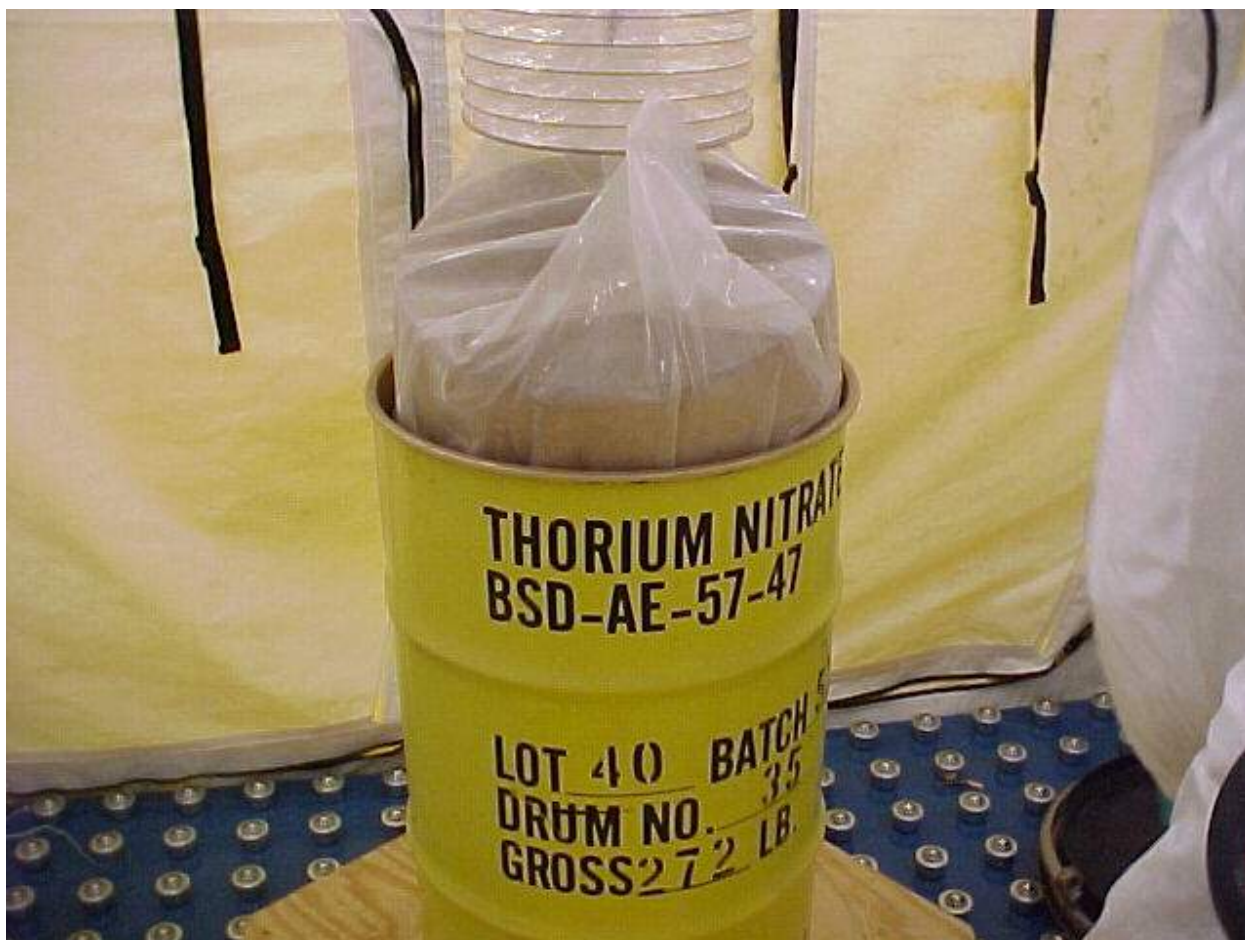
11:35**Other Information**Photo No. 3 of 11Dose Rate Surface 26 mR/hr
 1 meter 3.4 mR/hr

1st poly liner/bag – good condition
No gasses present in breathing zone

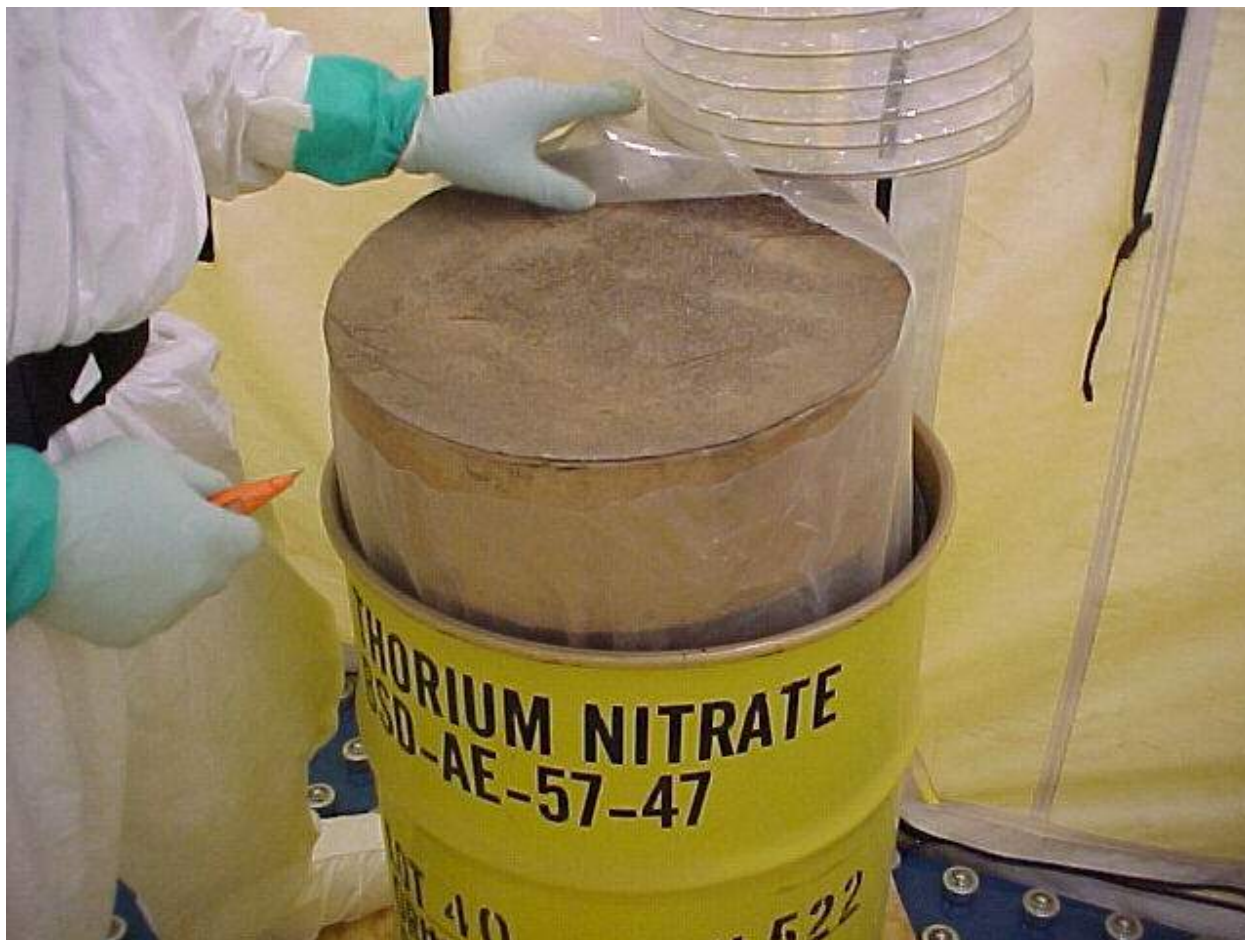
Fiber drum lid (on outermost fiber drum) – good condition

No gases present in breathing zone

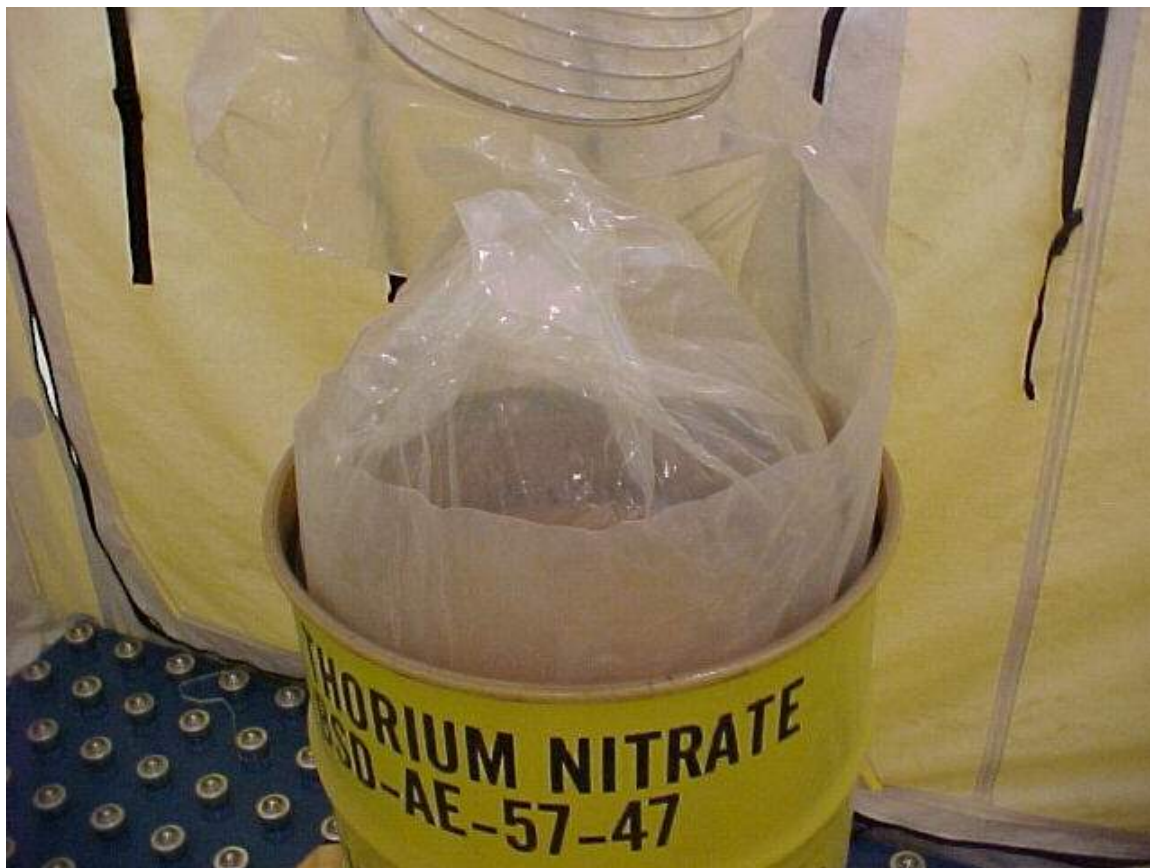
11:35**Other Information**Photo No. 5 of 11Dose Rate Surface 26 mR/hr
 1 meter 3.4 mR/hr2nd poly liner/bag – good condition

No gases present in breathing zone

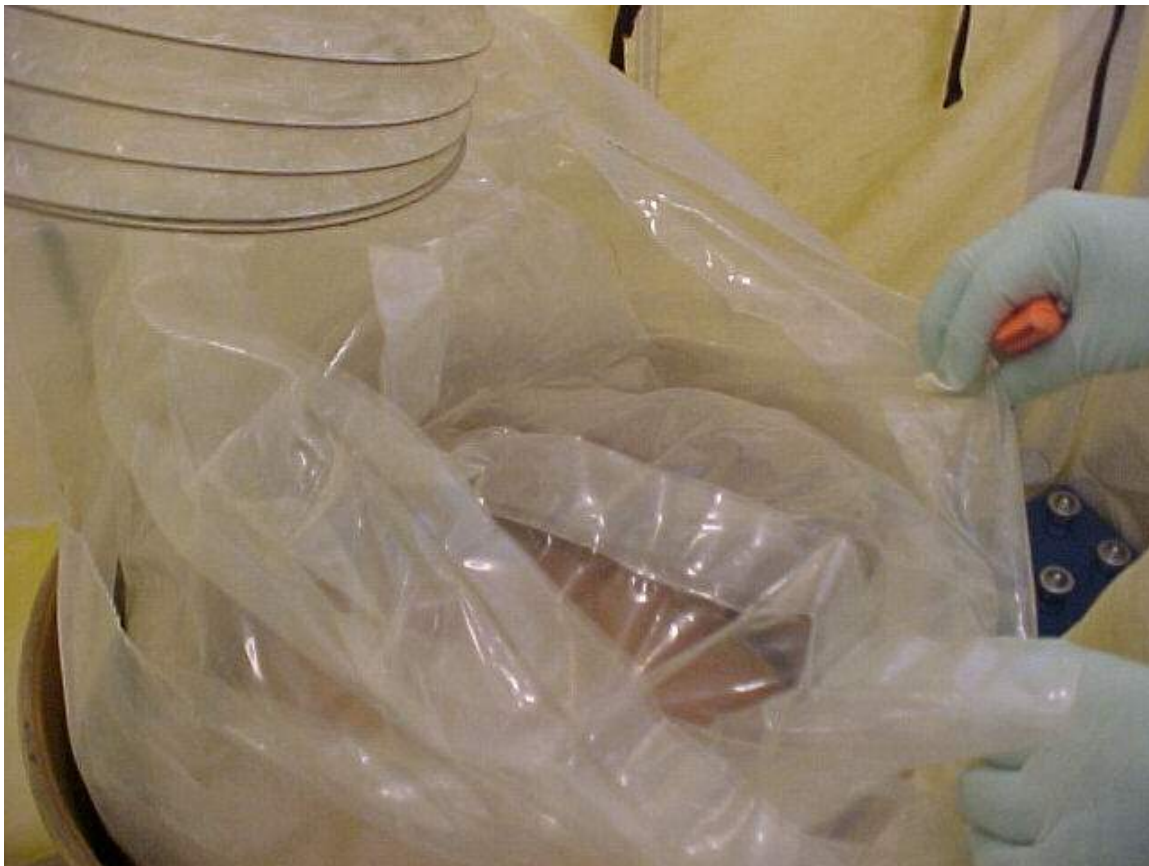
3rd poly liner/bag – good condition
No gases present in breathing zone
