THORIUM NITRATE STOCKPILE DRUM CHARACTERIZATION REPORT

**THORIUM NITRATE STOCKPILE
DRUM CHARACTERIZATION REPORT**

Prepared for
U.S. Defense Logistics Agency
Defense National Stockpile Center
Fort Belvoir, Virginia

Prepared by
OAK RIDGE NATIONAL LABORATORY
Oak Ridge, Tennessee 37831
managed by
UT-BATTELLE, LLC
for the
U.S. DEPARTMENT OF ENERGY
under contract DE-AC05-00OR22725

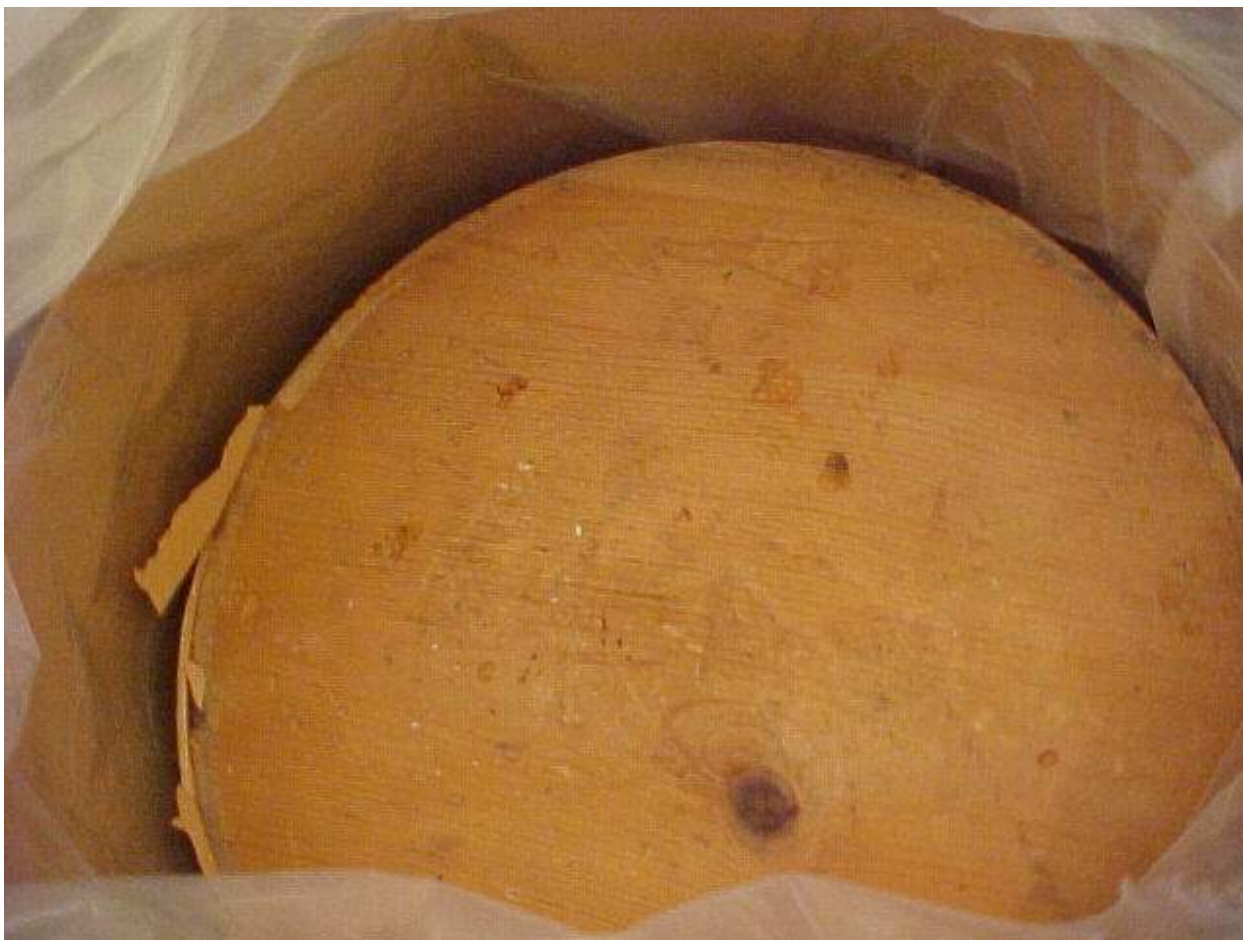
Wooden lid (mounted on inner most fiber drum) – good condition

No gases present in breathing zone

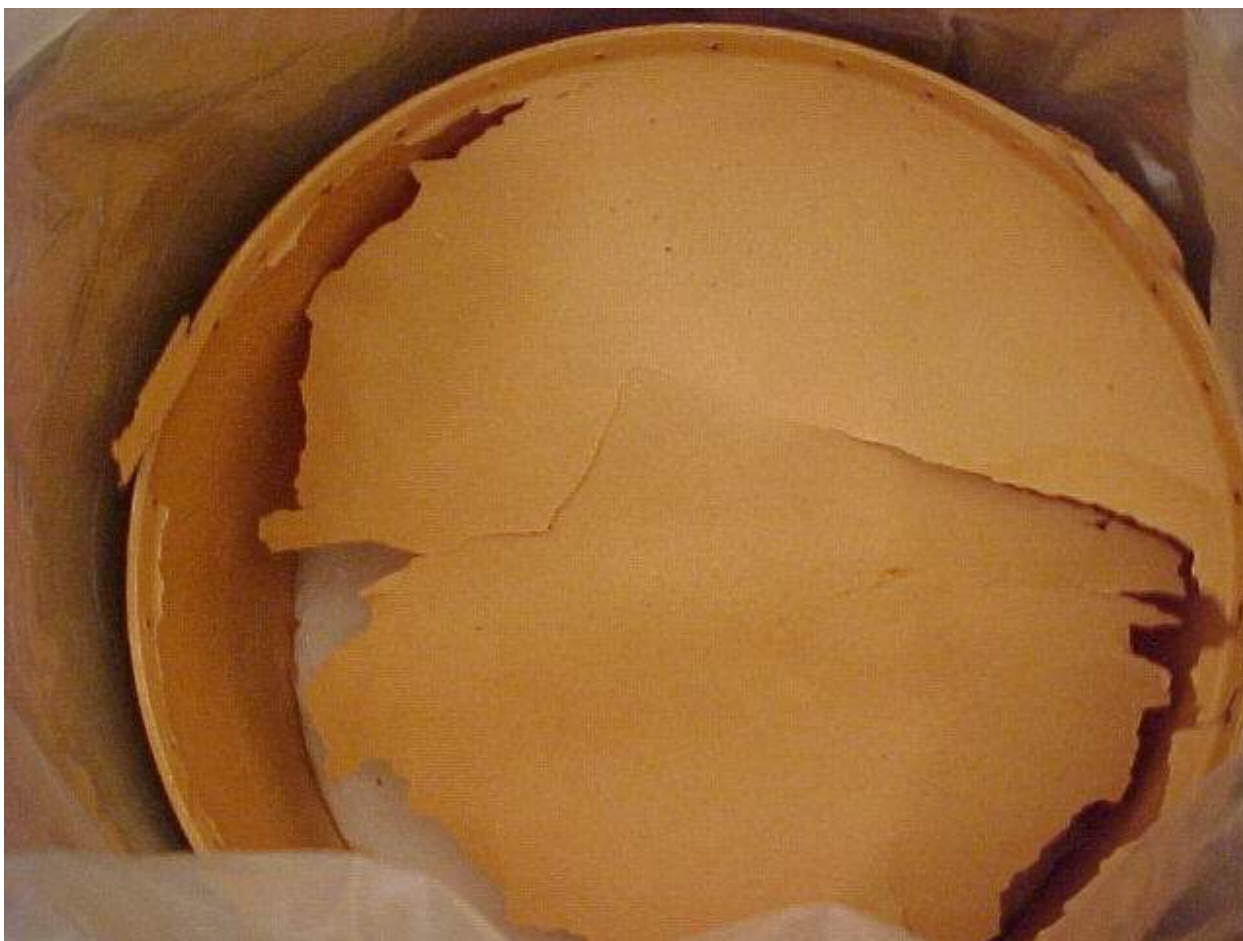
This picture shows the thin paper cover/lid on the lab-pack container (inner most fiber drum) – cover/lid typically disintegrates when the wooden lid is removed
No gases present in breathing zone

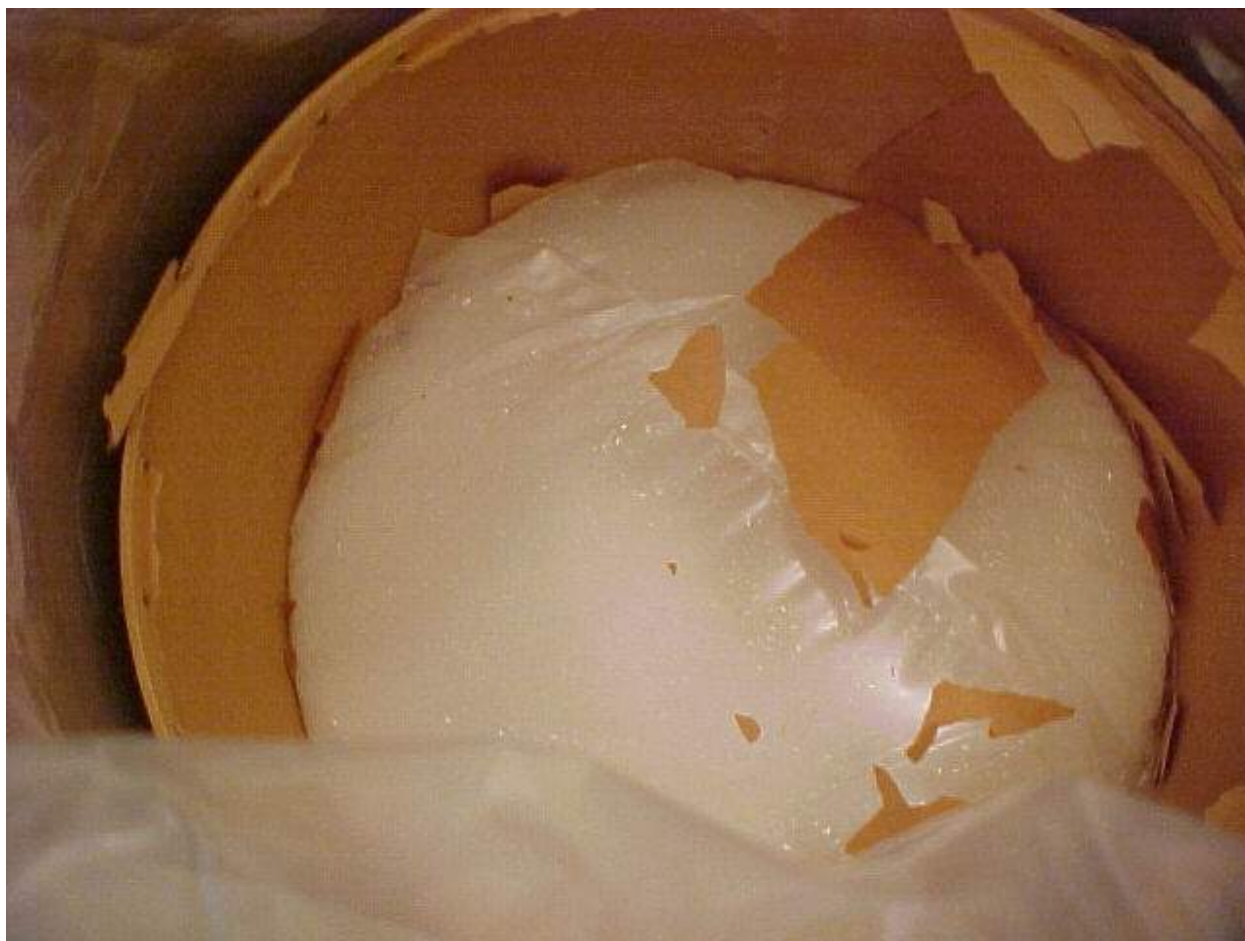
11:35**Other Information**Photo No. 9 of 11Dose Rate Surface 26 mR/hr
 1 meter 3.4 mR/hr

4th (final) poly liner/bag – good condition – inflated condition shows buildup of gas inside this bag – gas is apparently being generated by ThN material
No gases present in breathing zone

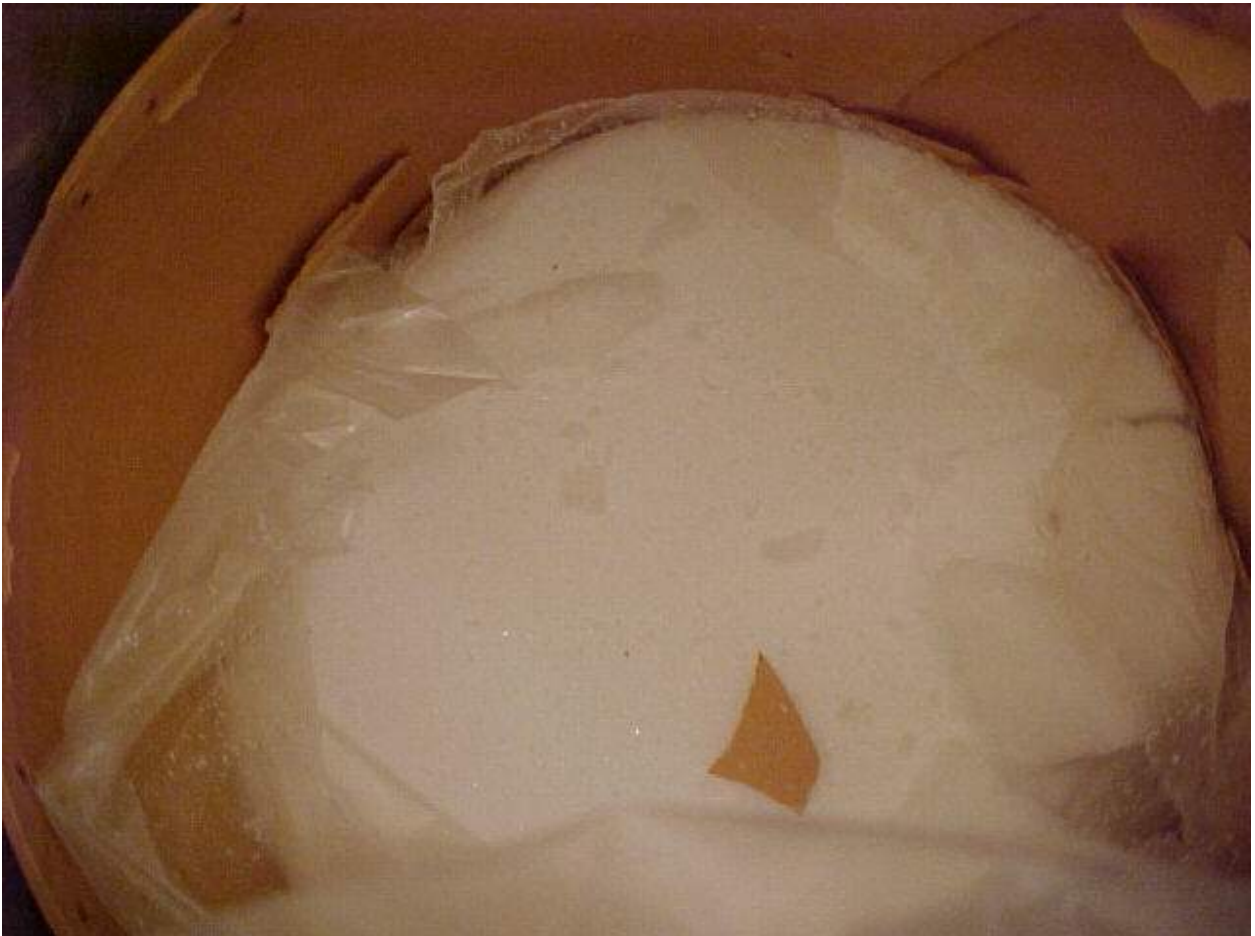
ThN material – white, solid, monolithic structure - dry
No gases present in breathing zone

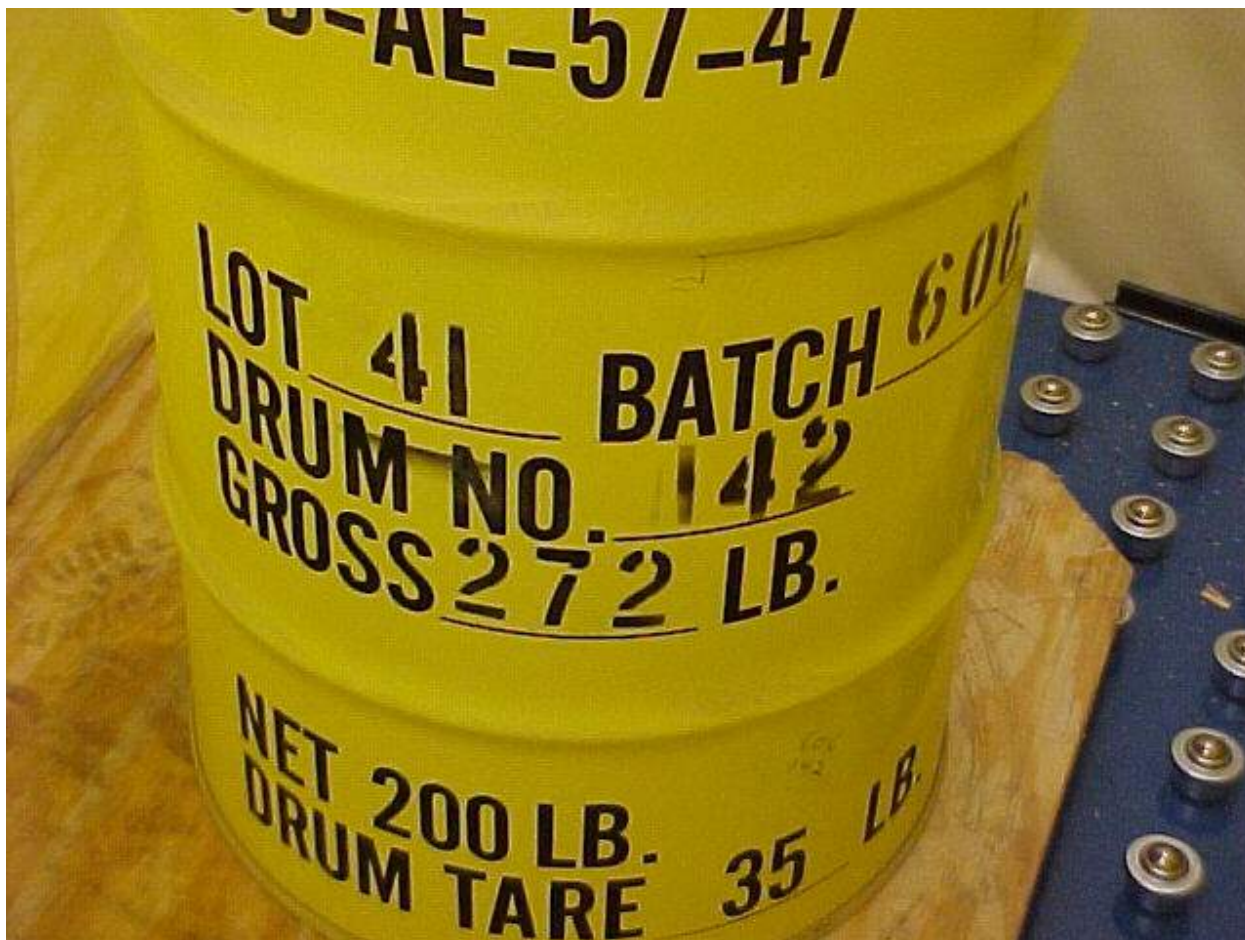
30-gal drum in good condition

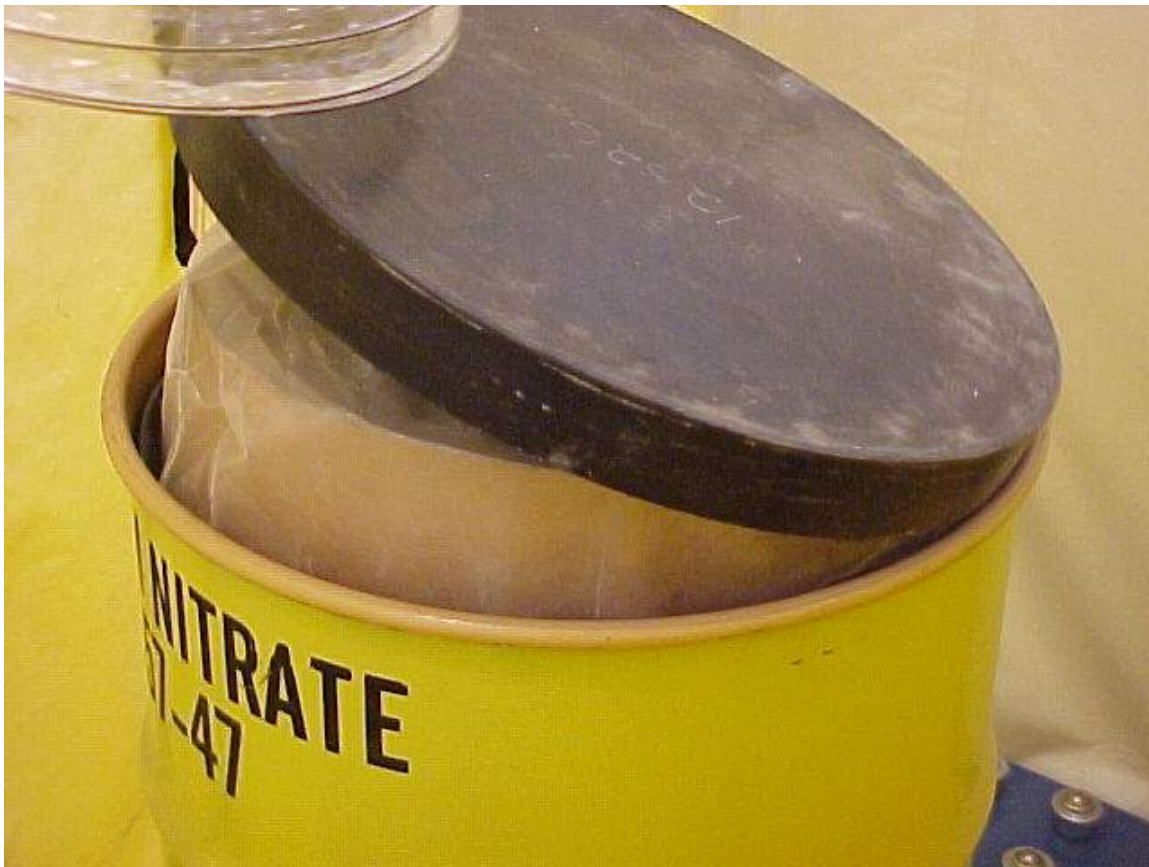
30-gal drum – black drum liner lid in good condition – raised position indicates buildup of gas in internal packagings

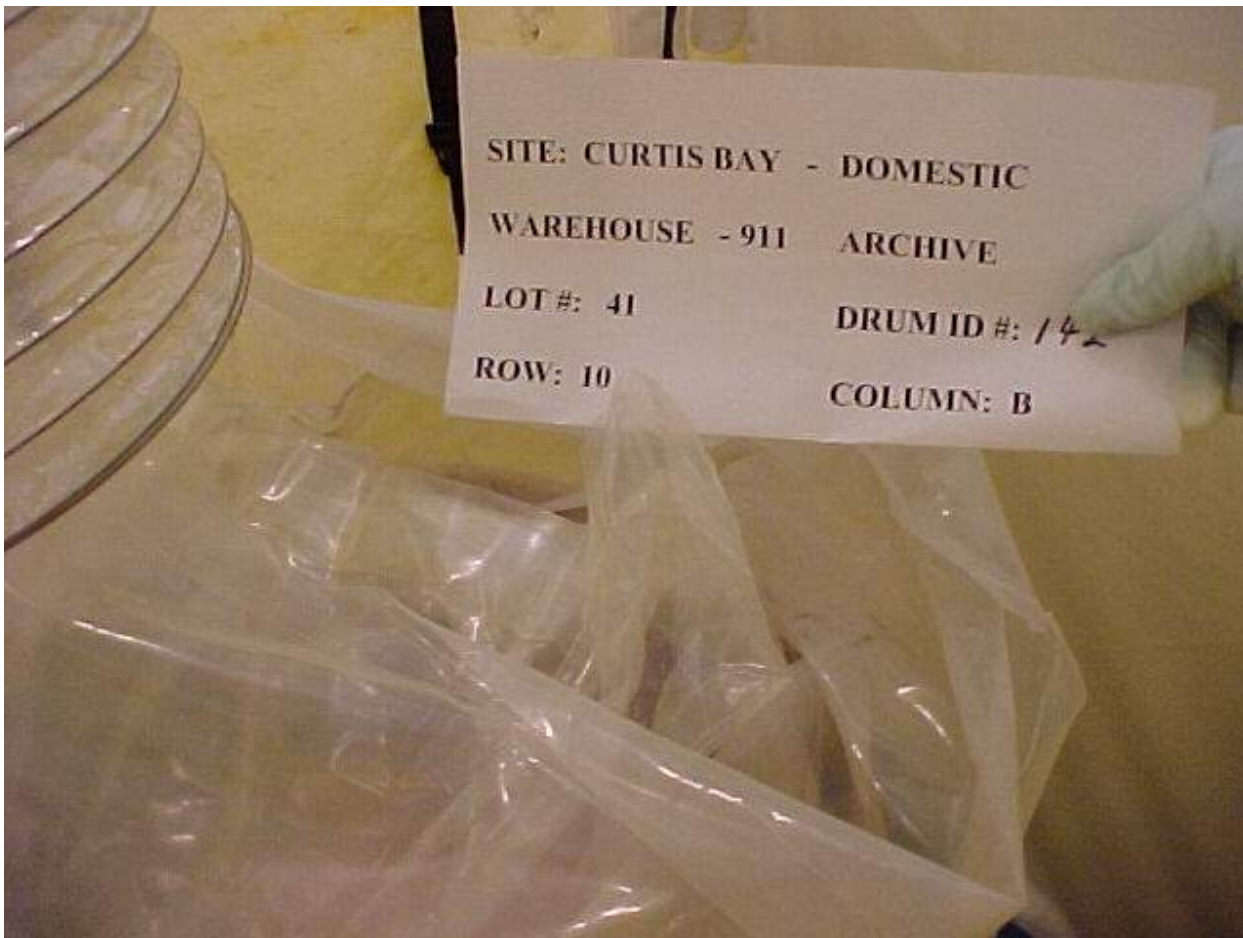
This picture shows the fiber drum lid on the outermost fiber drum – good condition
No gases present in breathing zone

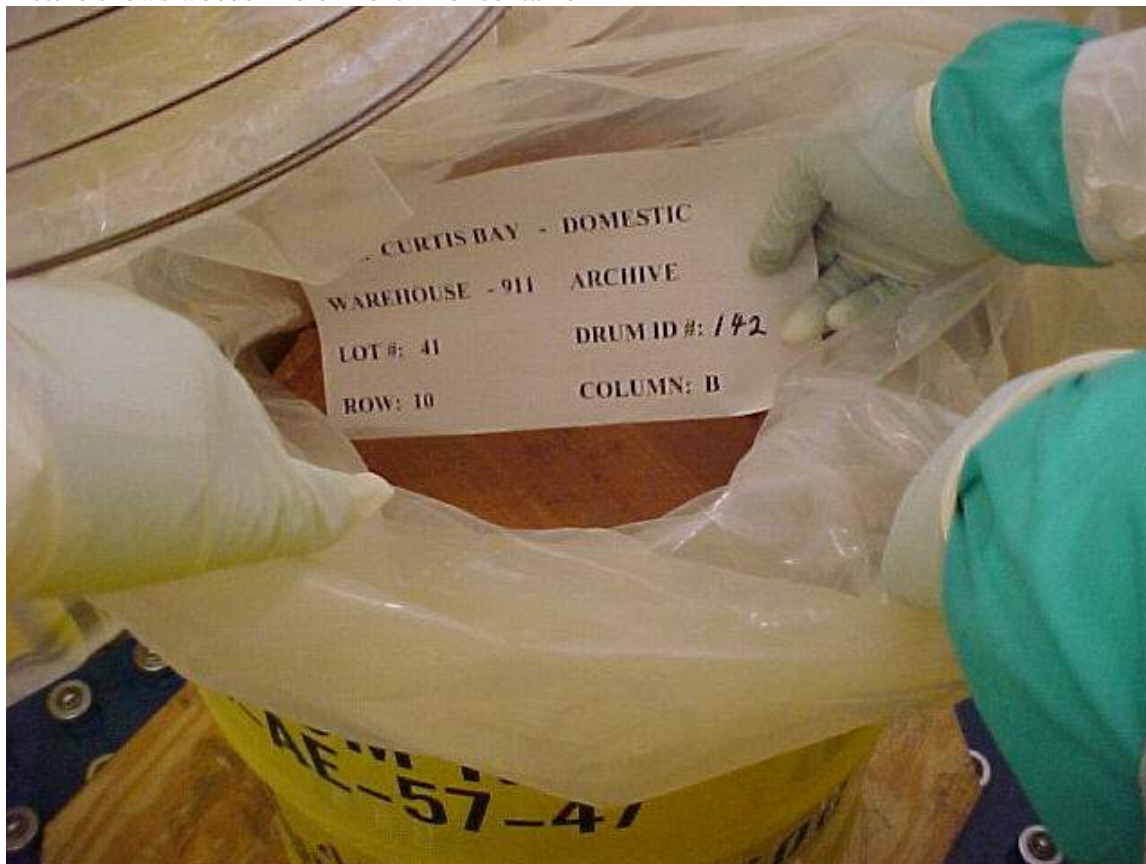
12:30**Other Information**Photo No. 5 of 10Dose Rate Surface 22 mR/hr
 1 meter 2.6 mR/hr2nd & 3rd poly liner/bag in good condition

No gases present in breathing zone

Picture shows wooden lid on next inner container

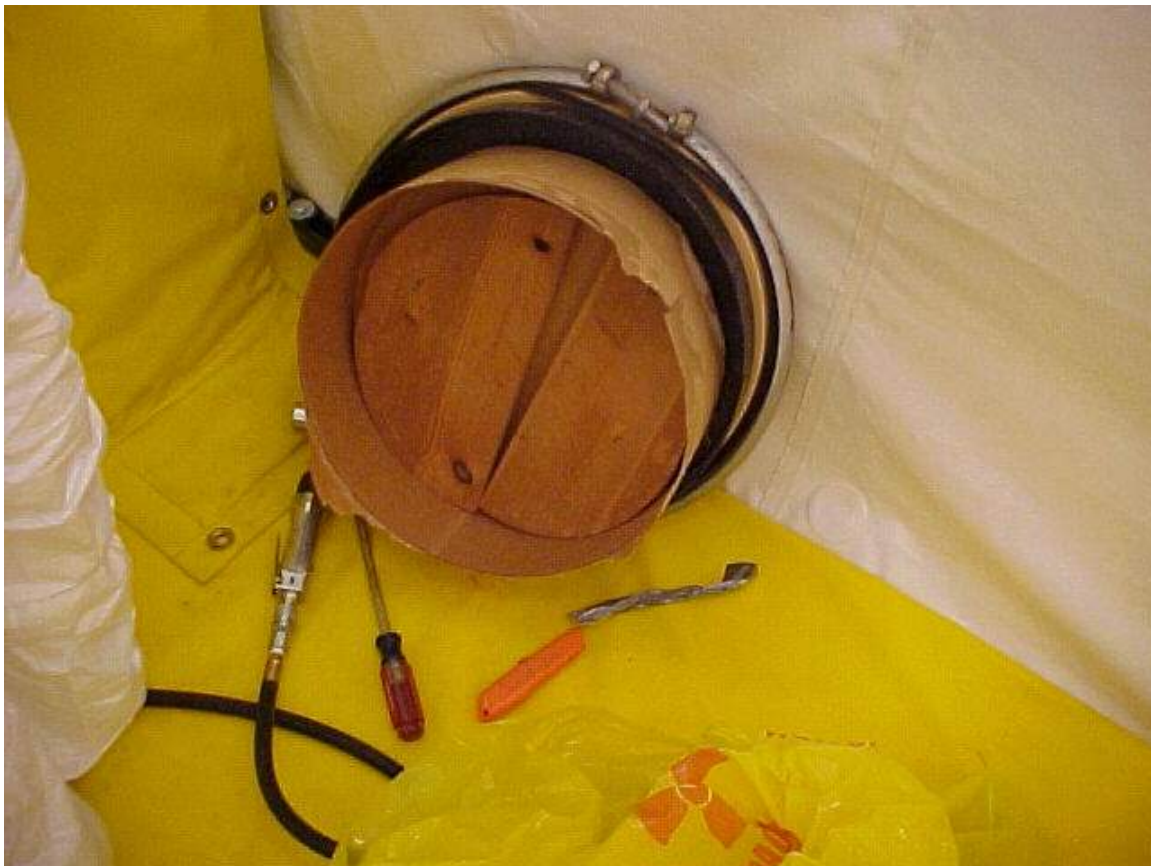
Picture shows the wooden lid removed from the container
No gases present in breathing zone

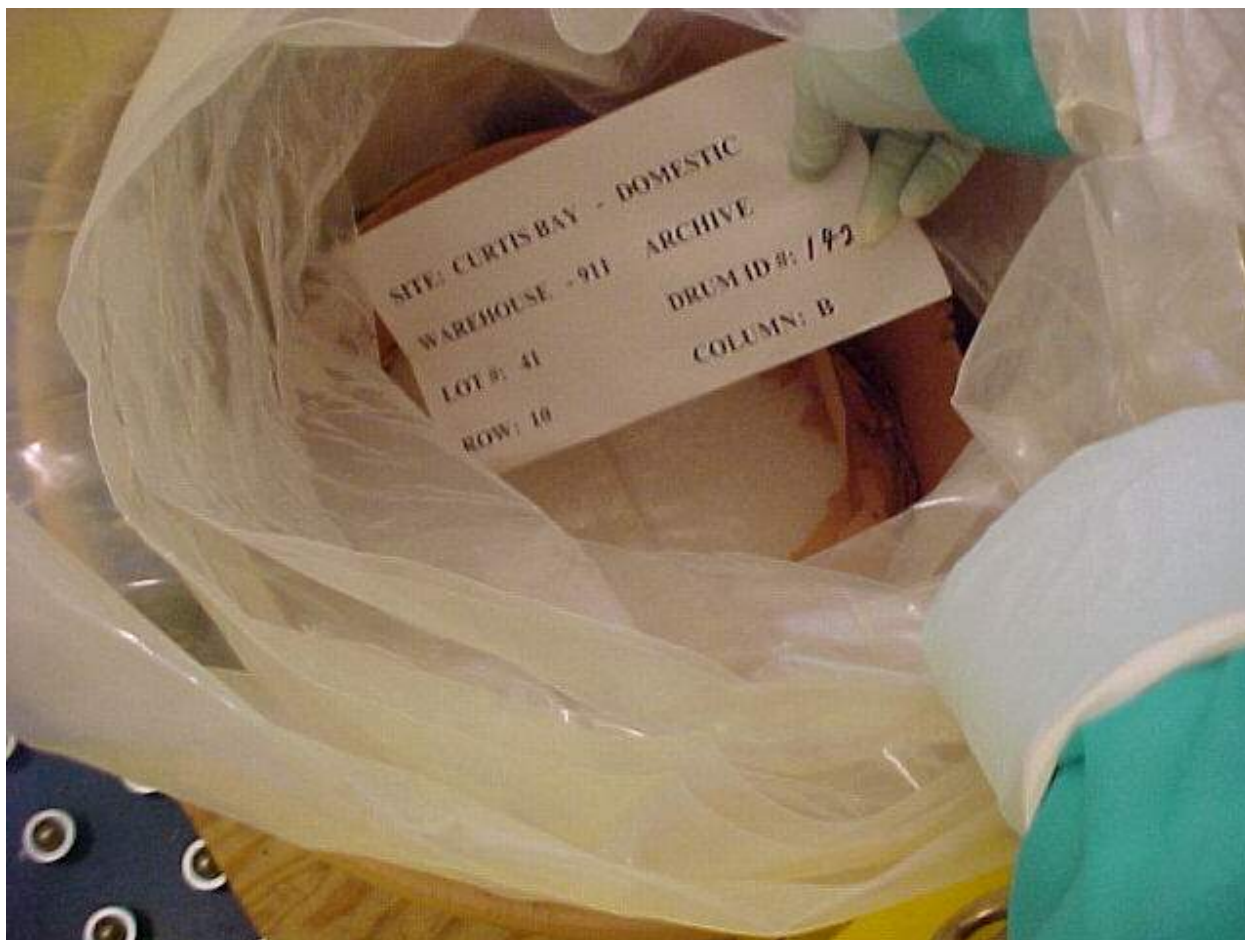
12:30**Other Information**Photo No. 7 of 10Dose Rate Surface 22 mR/hr
 1 meter 2.6 mR/hr

This picture shows the final plastic bag in good condition (4th poly liner/bag)
No gases present in breathing zone

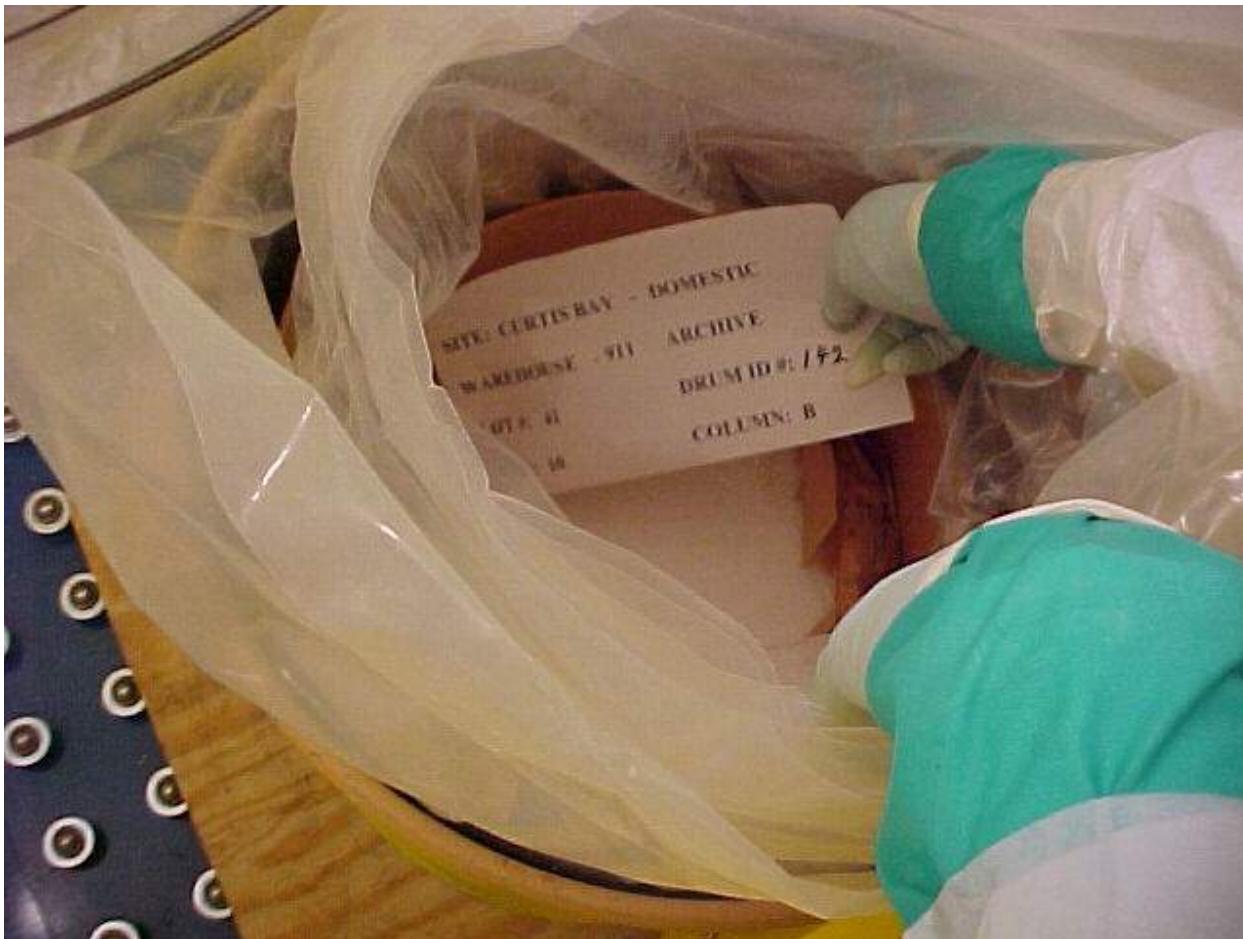
ThN material prior to coring – gases in headspace above ThN material – NO – 1.3 ppm & NOx – 22.1 ppm

No gases present in breathing zone

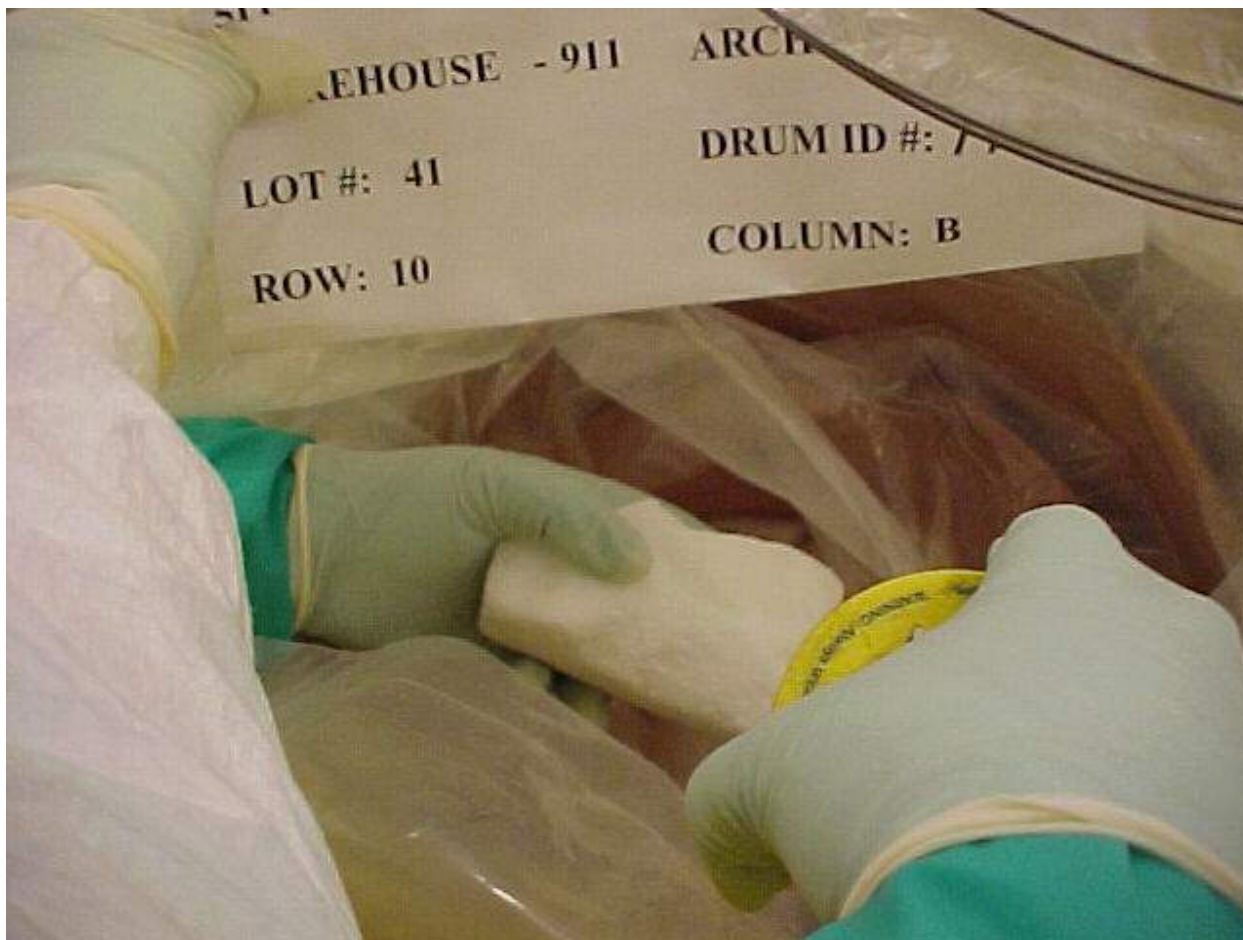
12:30**Other Information**Photo No. 9 of 10Dose Rate Surface 22 mR/hr
 1 meter 2.6 mR/hr

This picture shows the actual sample of the ThN material
No gases present in breathing zone

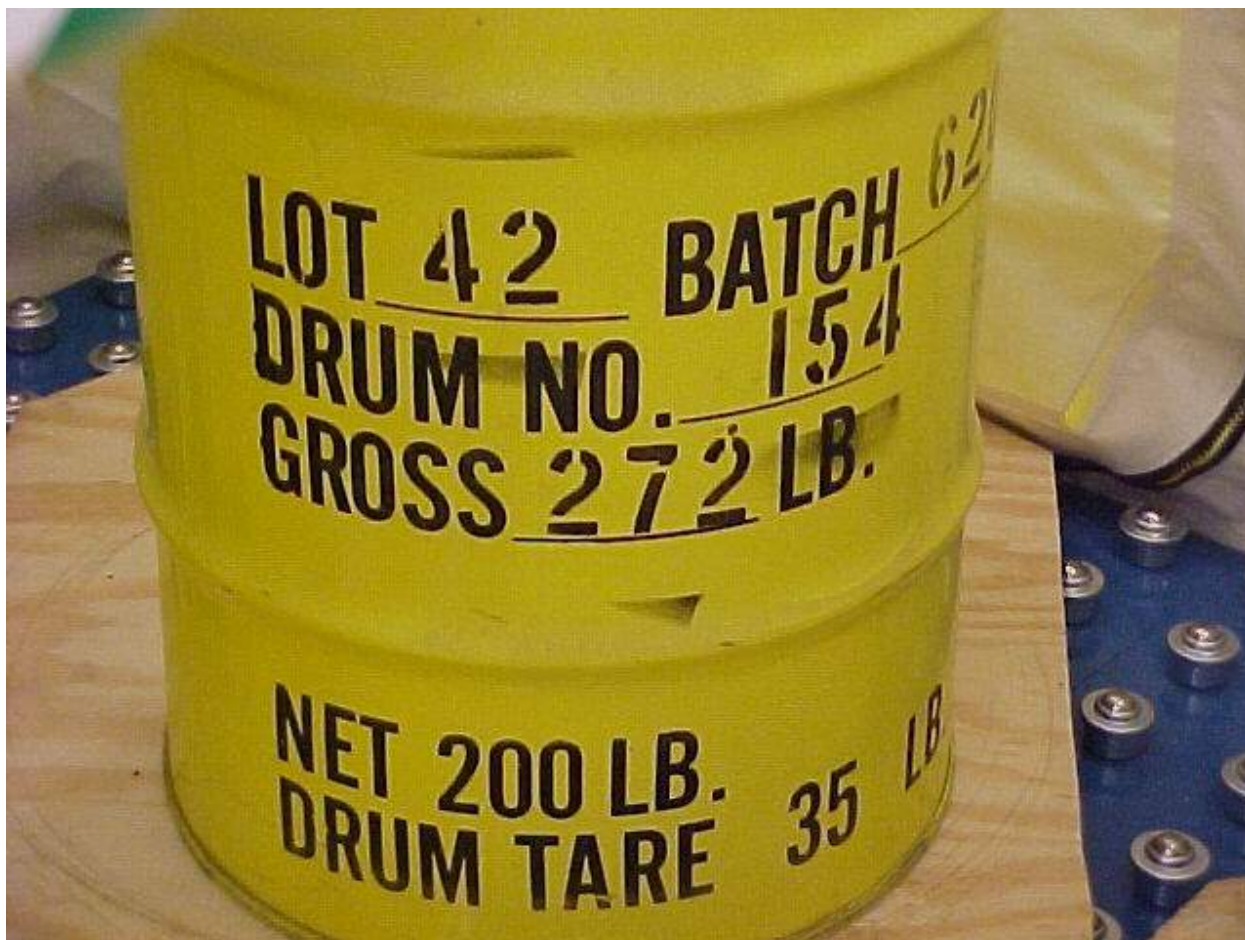
30-gal drum – good condition

Drum vented gases during removal of bolt ring

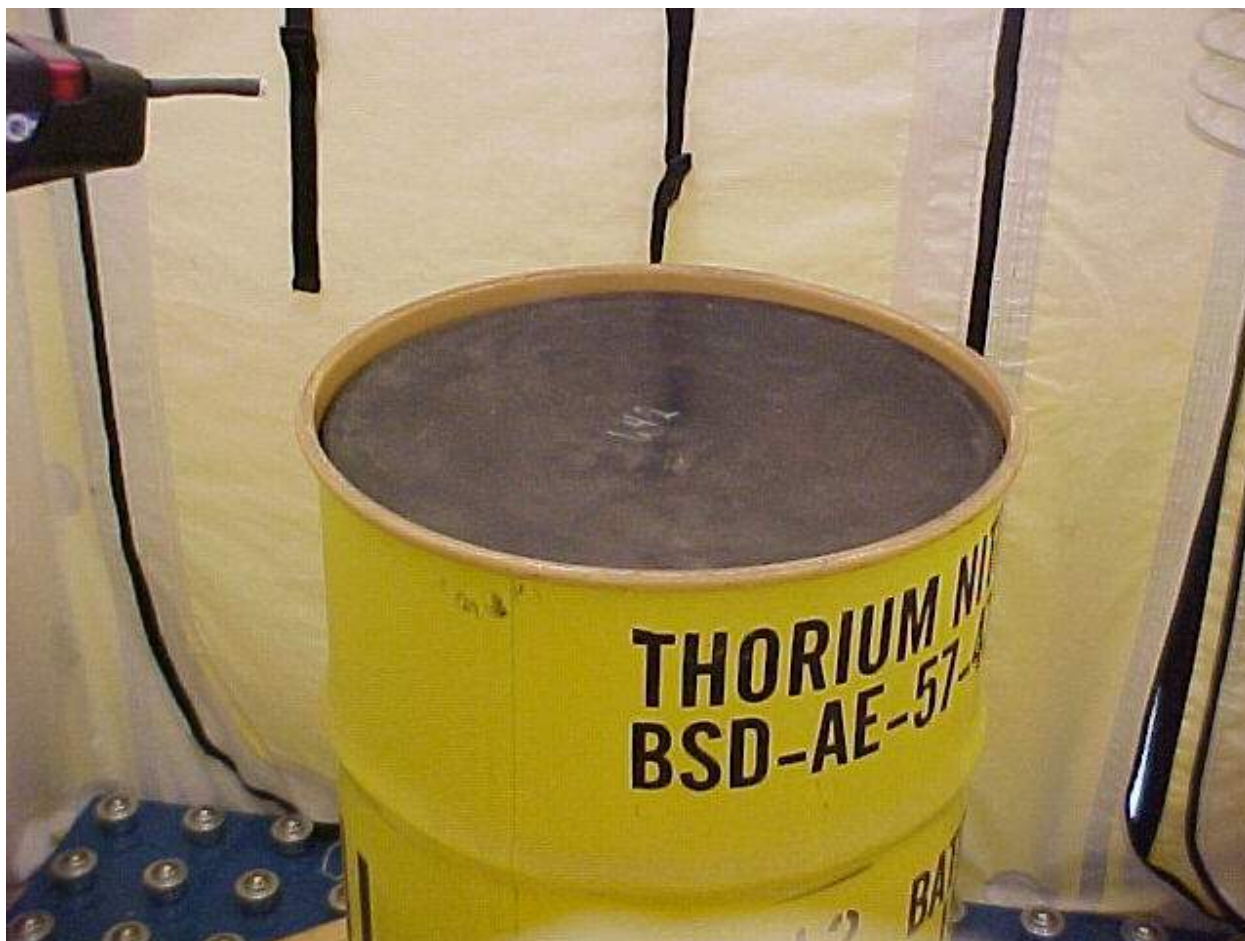
After removal of 30-gal metal lid – the black plastic interior lid (for the drum liner) is visible – good condition

No gases present in the breathing zone.

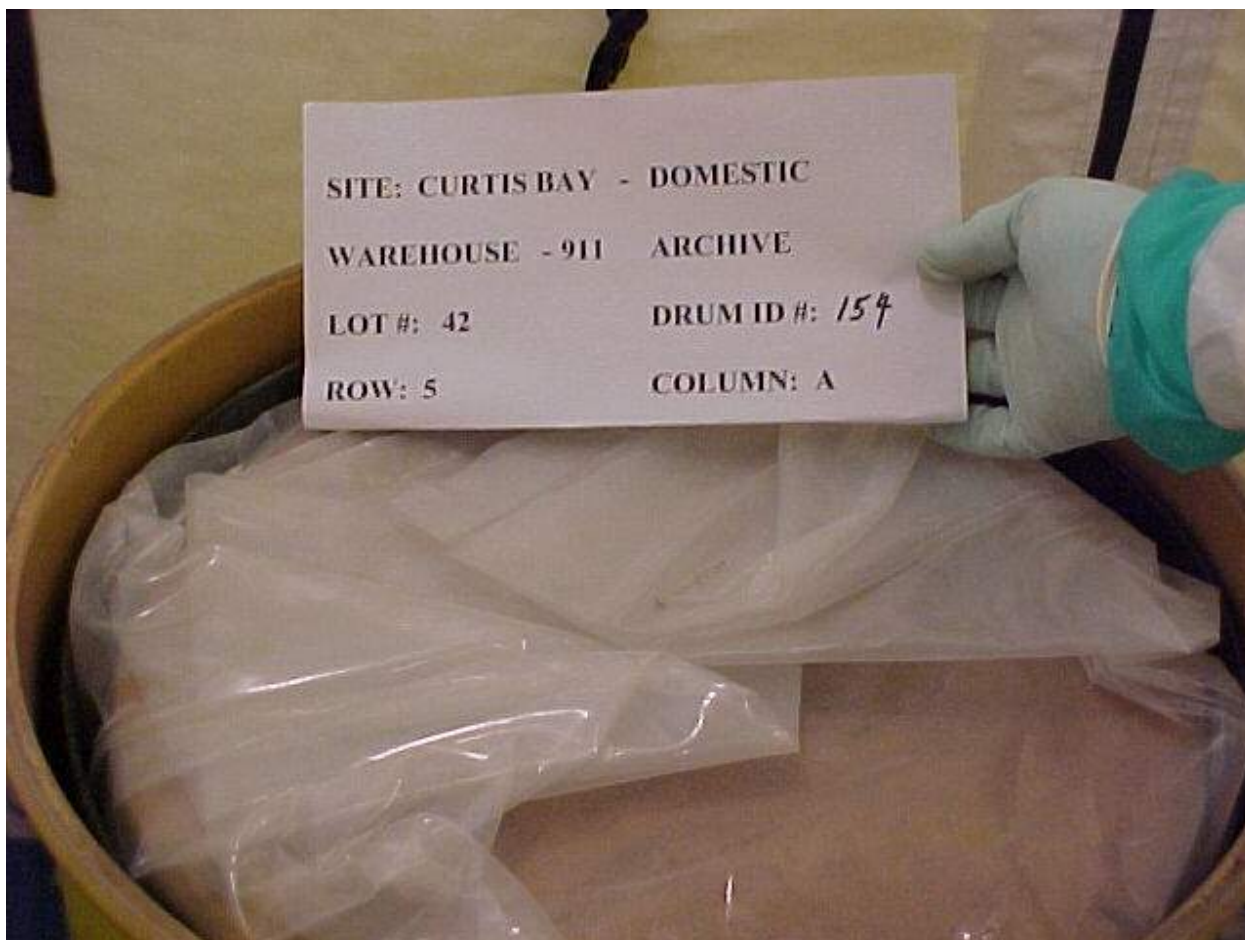
09:00**Other Information**Photo No. 3 of 13Dose Rate Surface 22 mR/hr
 1 meter 3.0 mR/hr

1st poly liner/bag – good condition
No gases present in the breathing zone.

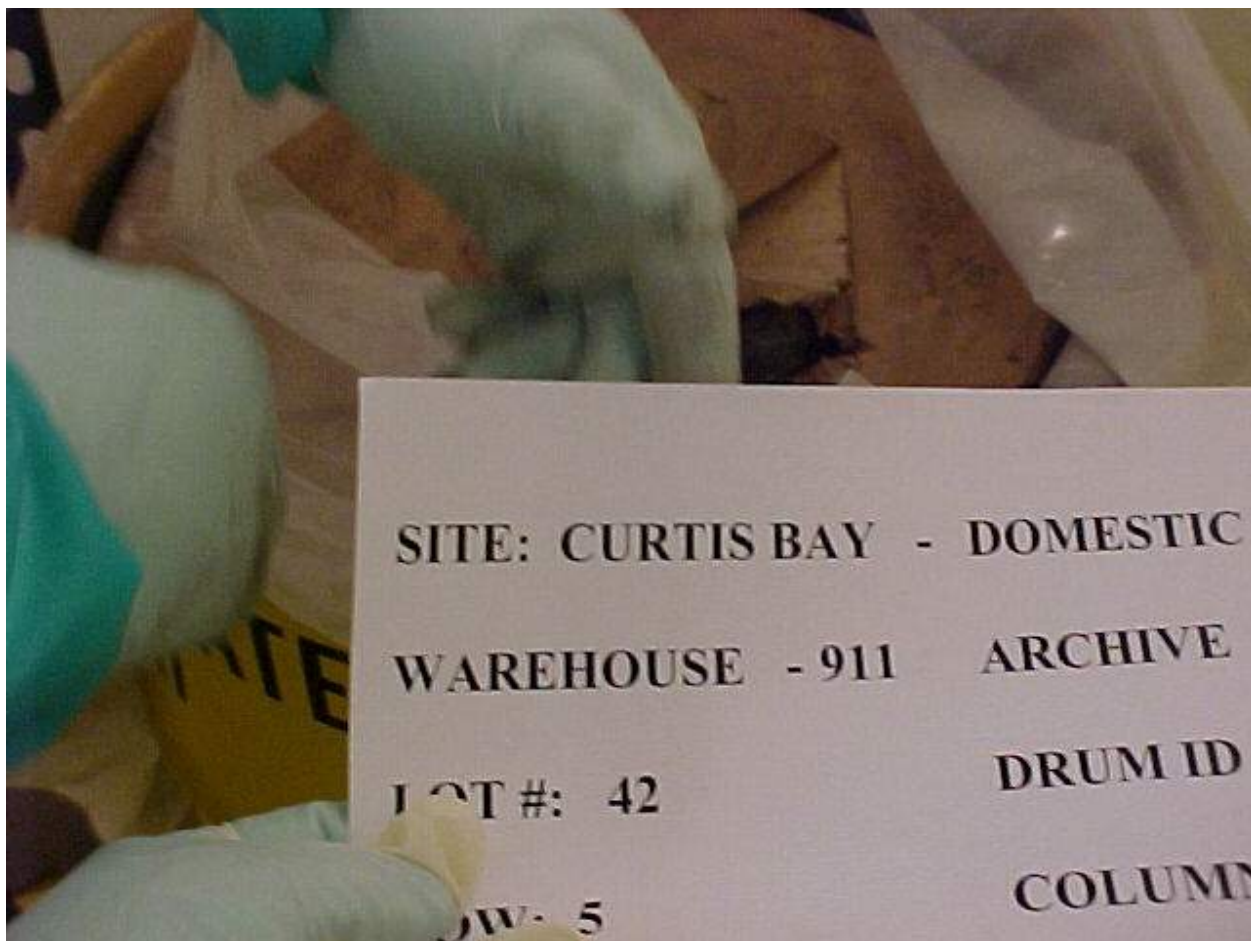
The fiber lid (on the outermost fiber drum) is taped to the drum – had to cut the lid in order to access inner packagings and ThN material
No gases present in the breathing zone.

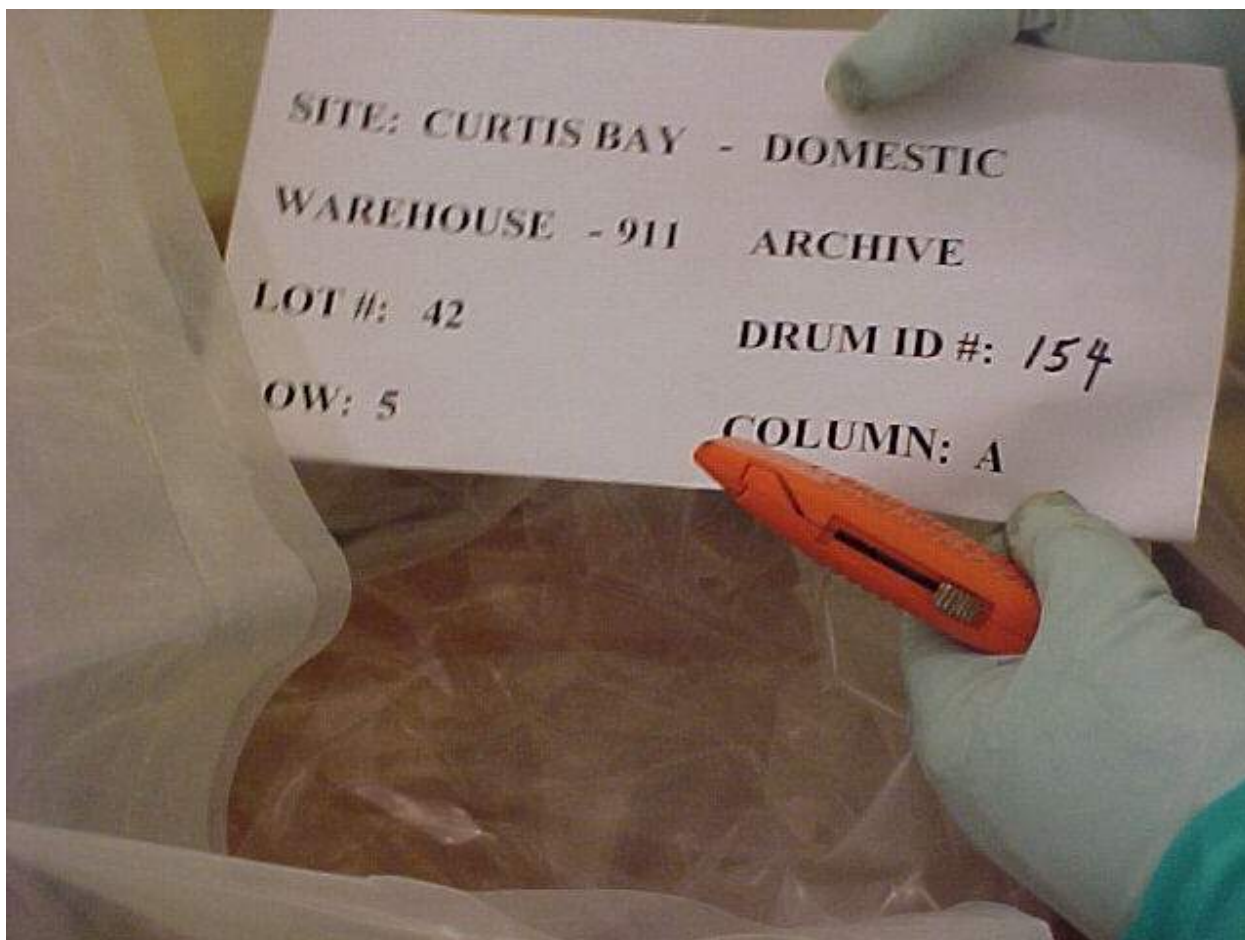
09:00**Other Information**Photo No. 5 of 13Dose Rate Surface 22 mR/hr
 1 meter 3.0 mR/hr

2nd poly liner/bag – good condition
No gases present in the breathing zone.

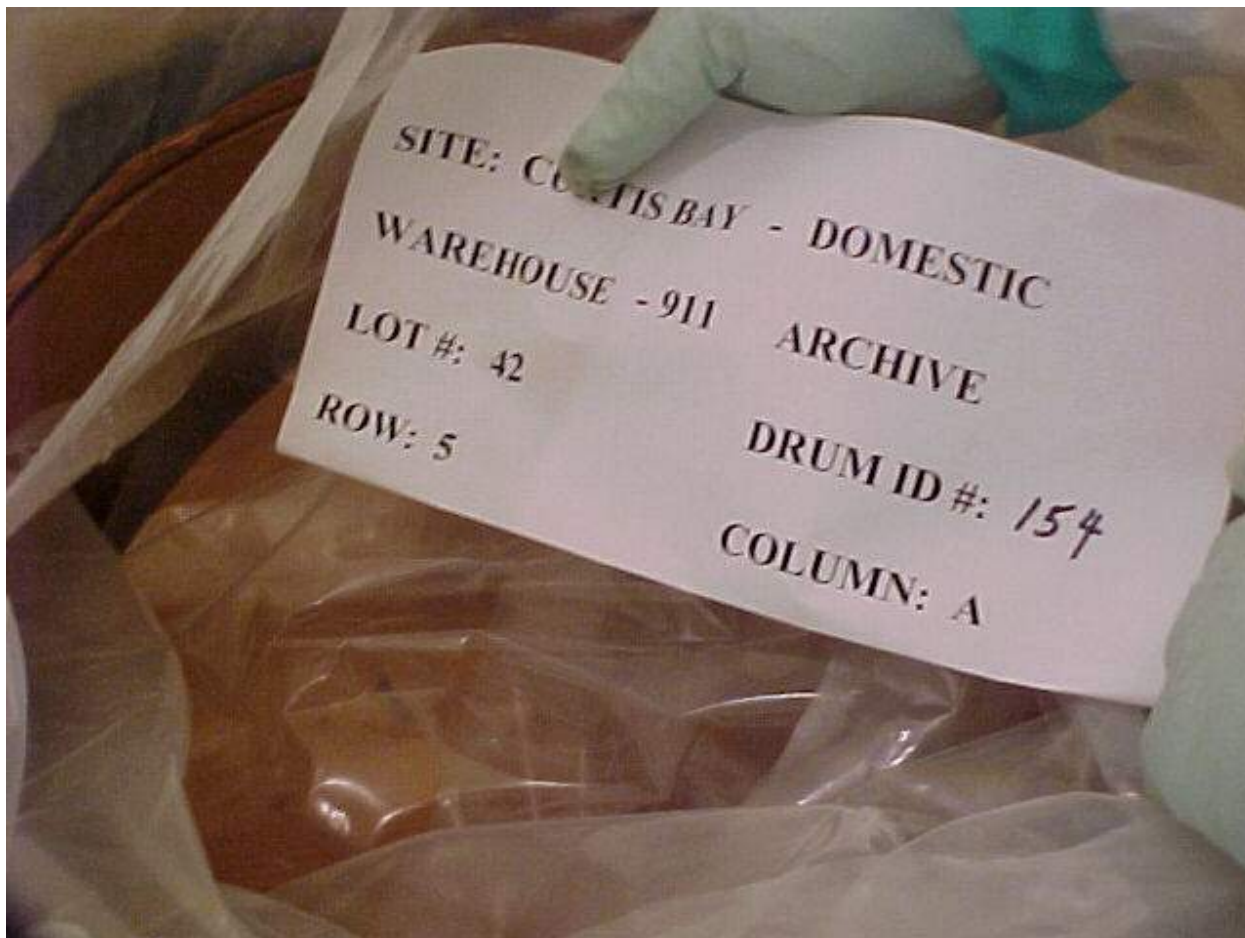
3rd poly liner/bag – good condition
No gases present in the breathing zone.

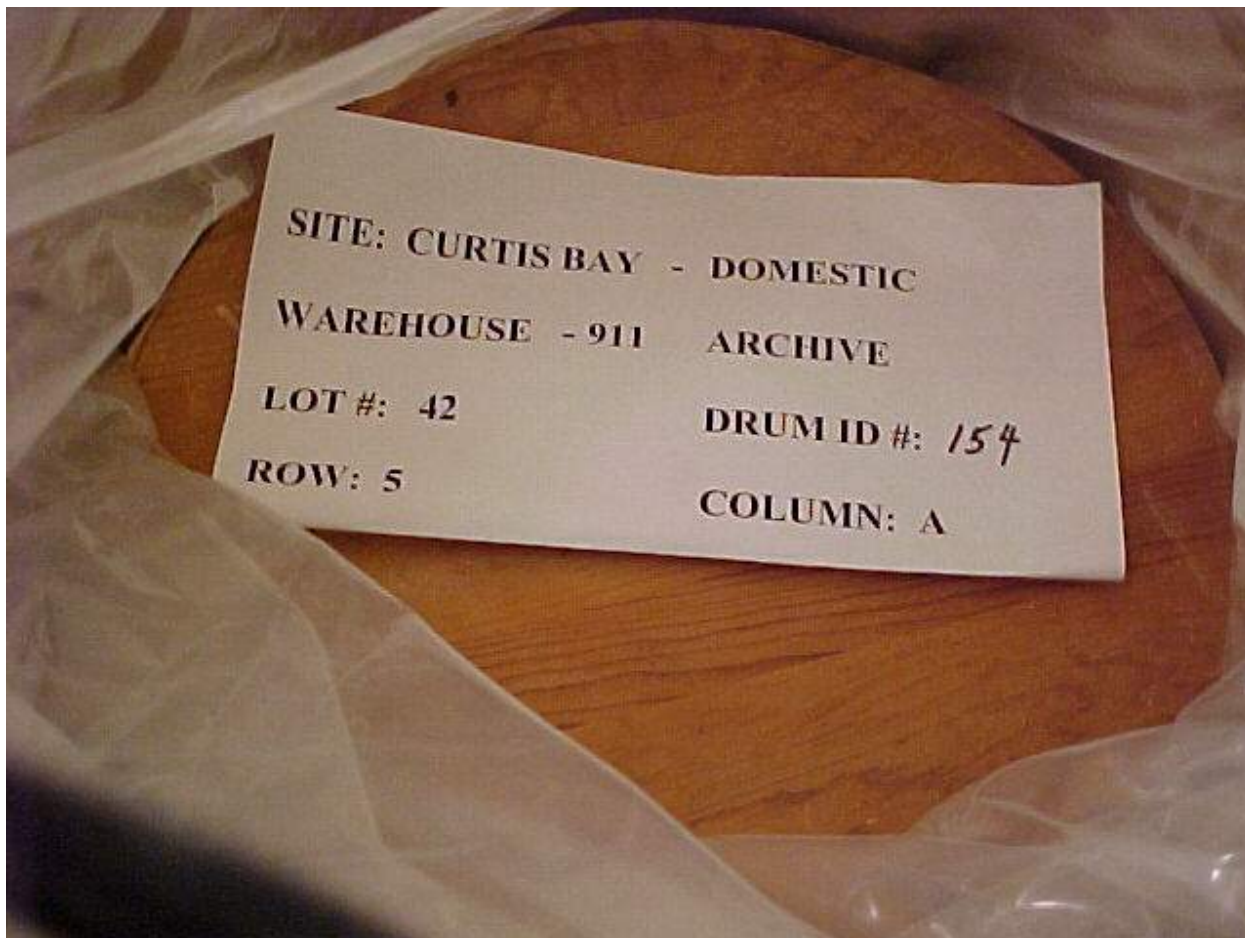
09:00**Other Information**Photo No. 7 of 13Dose Rate Surface 22 mR/hr
 1 meter 3.0 mR/hr

Wooden lid (on innermost fiber drum) – good condition
No gases present in the breathing zone.
