THORIUM NITRATE STOCKPILE DRUM CHARACTERIZATION REPORT

**THORIUM NITRATE STOCKPILE
DRUM CHARACTERIZATION REPORT**

Prepared for
U.S. Defense Logistics Agency
Defense National Stockpile Center
Fort Belvoir, Virginia

Prepared by
OAK RIDGE NATIONAL LABORATORY
Oak Ridge, Tennessee 37831
managed by
UT-BATTELLE, LLC
for the
U.S. DEPARTMENT OF ENERGY
under contract DE-AC05-00OR22725

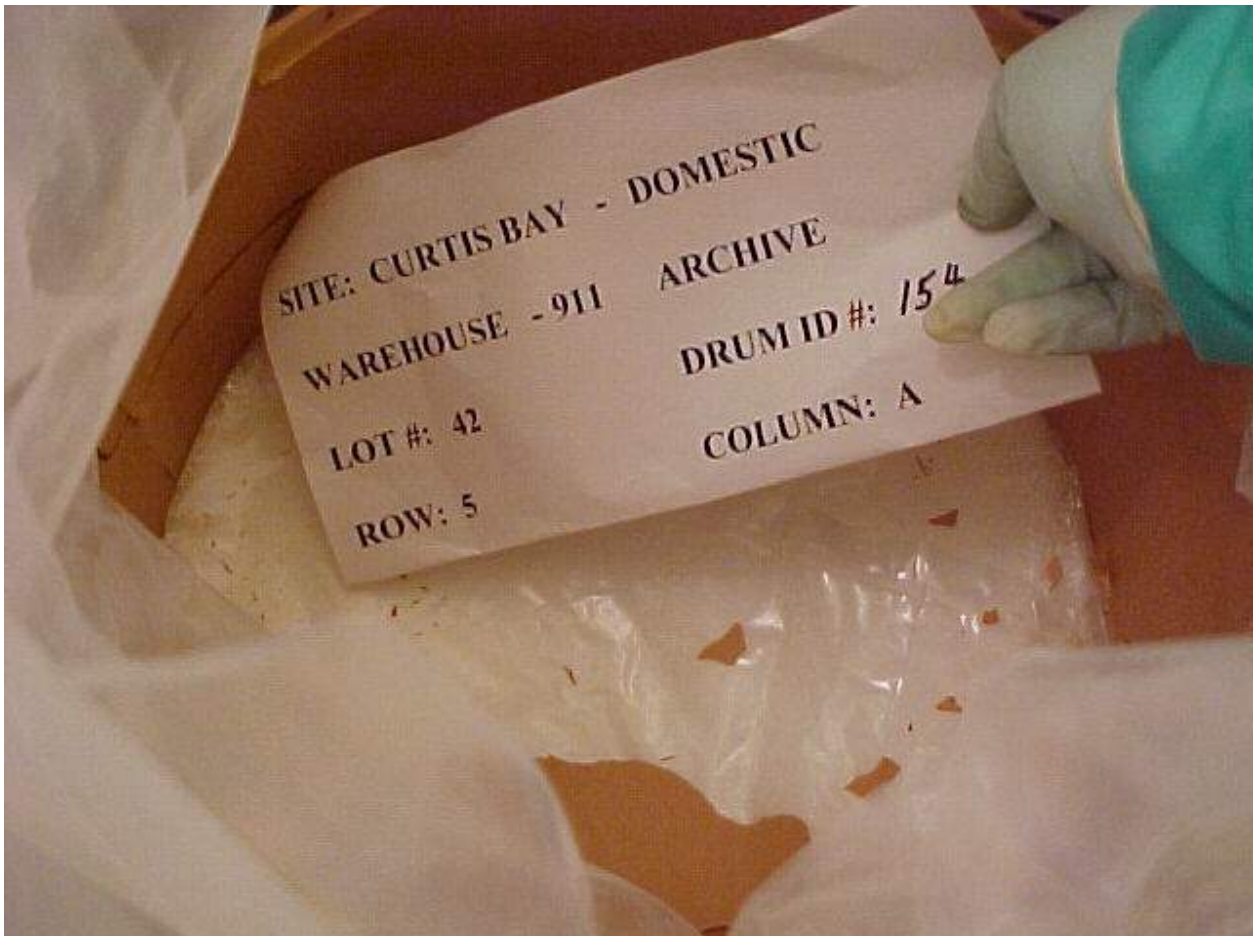
09:00**Other Information**Photo No. 9 of 13Dose Rate Surface 22 mR/hr
 1 meter 3.0 mR/hr

Final (4th) poly liner/bag (thin film plastic) before accessing the ThN material
No gases present in the breathing zone.

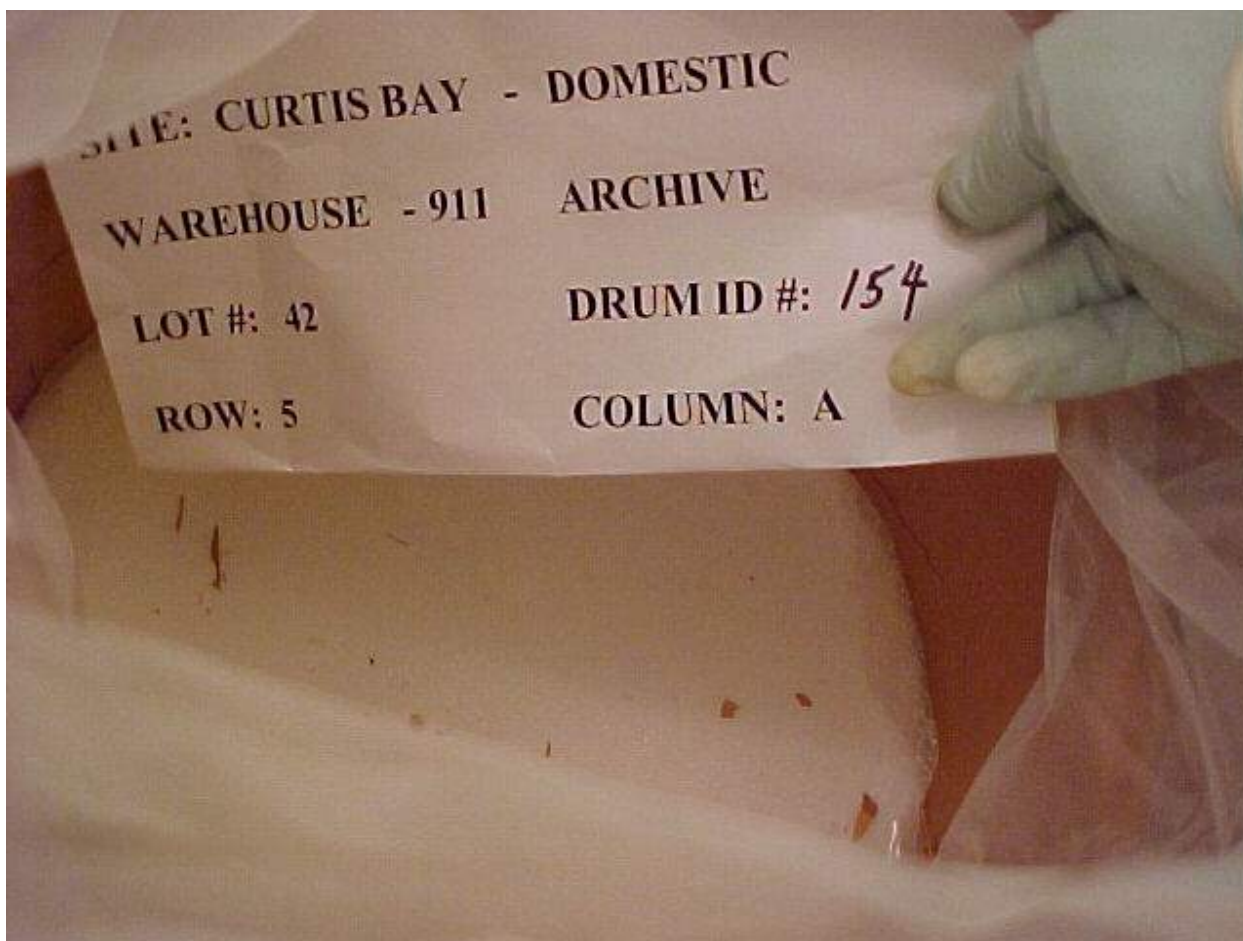
Gases present in headspace above ThN material: NO – 6.9 ppm & NOx – 31.5 ppm

No gases present in the breathing zone.

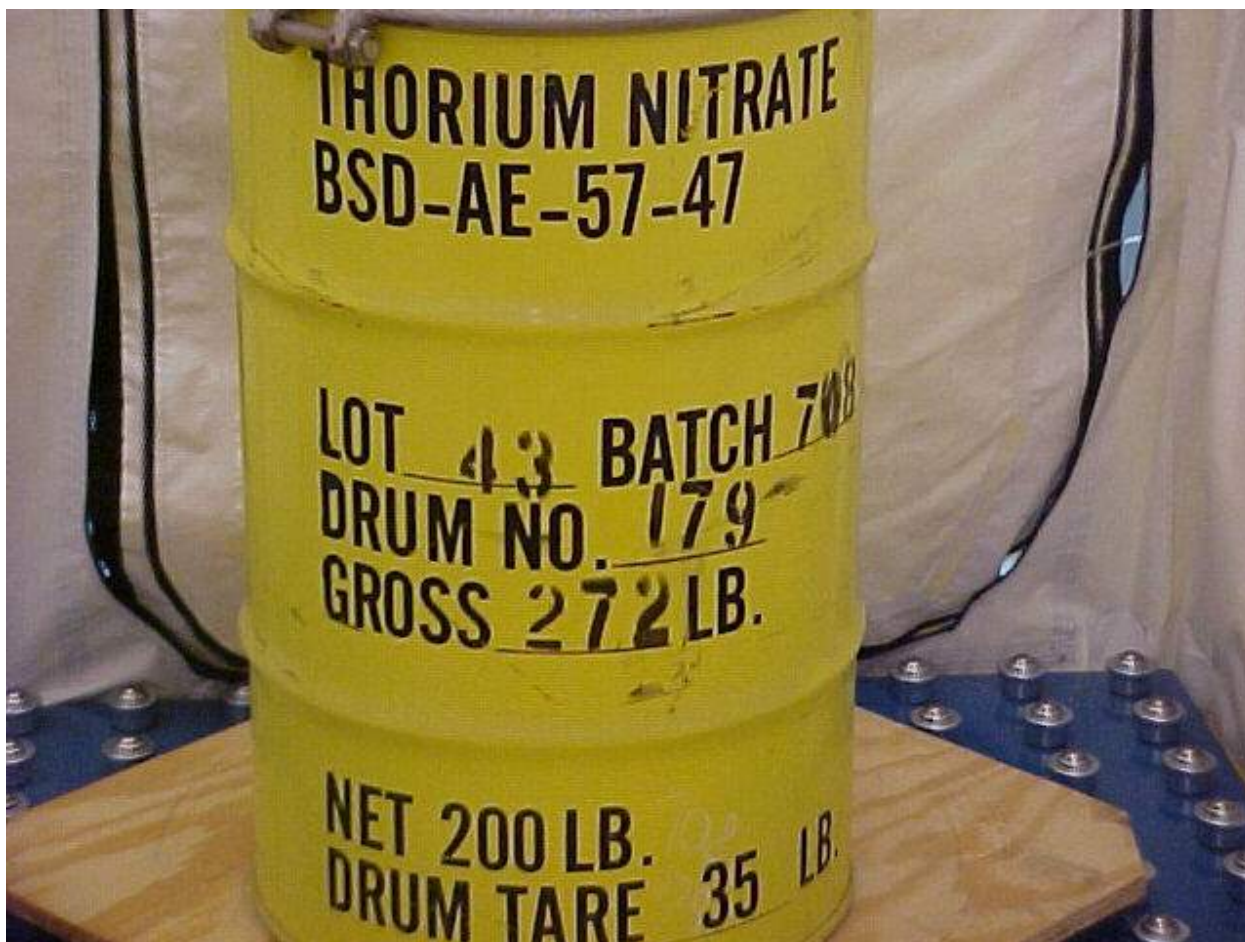
30-gal drum – good condition

Drum vented gas as bolt on drum ring was loosened for removal.

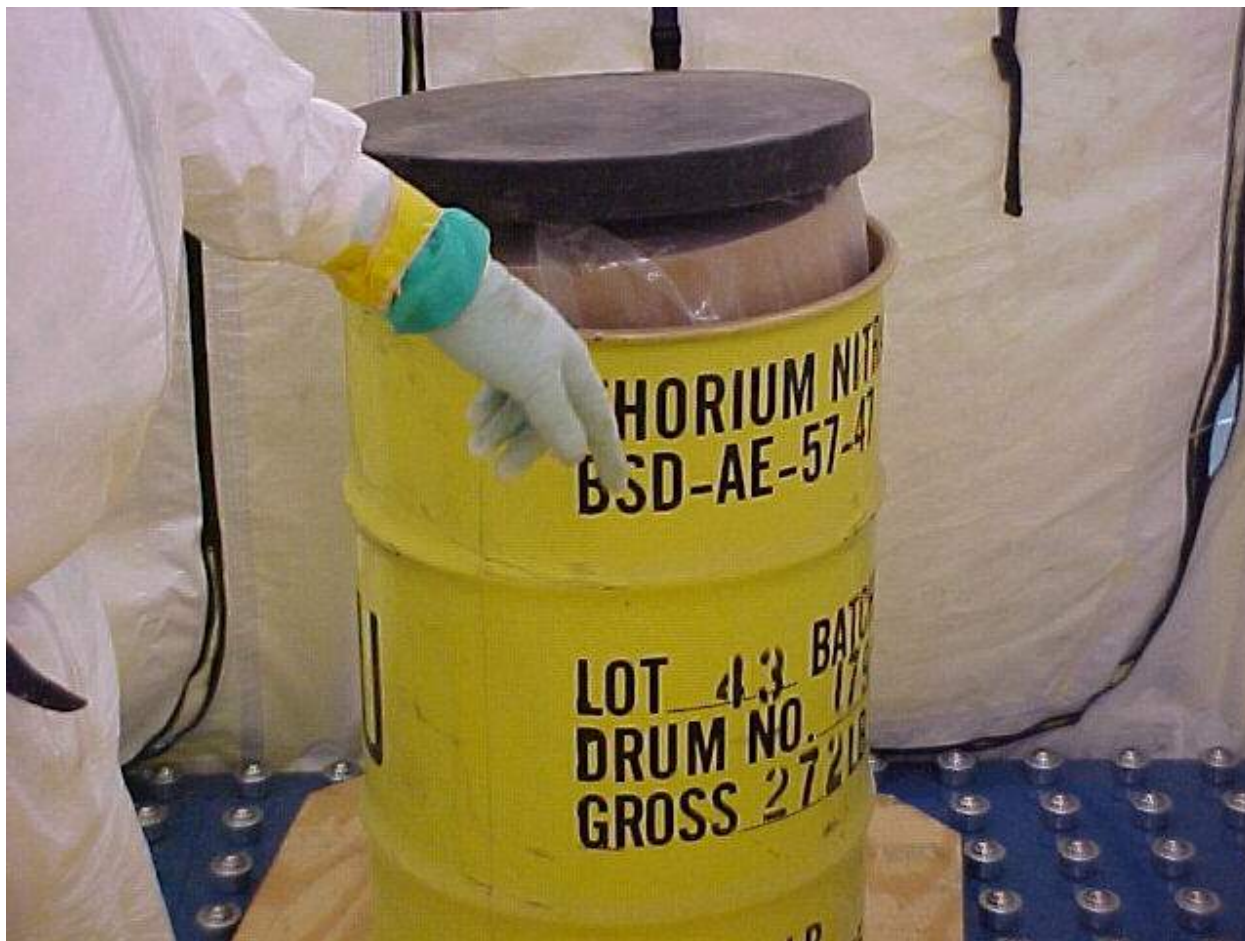
Black plastic lid (on drum liner) – good condition – raised condition indicates gas pressure buildup in internal packaging materials in this drum
No gases present in the breathing zone

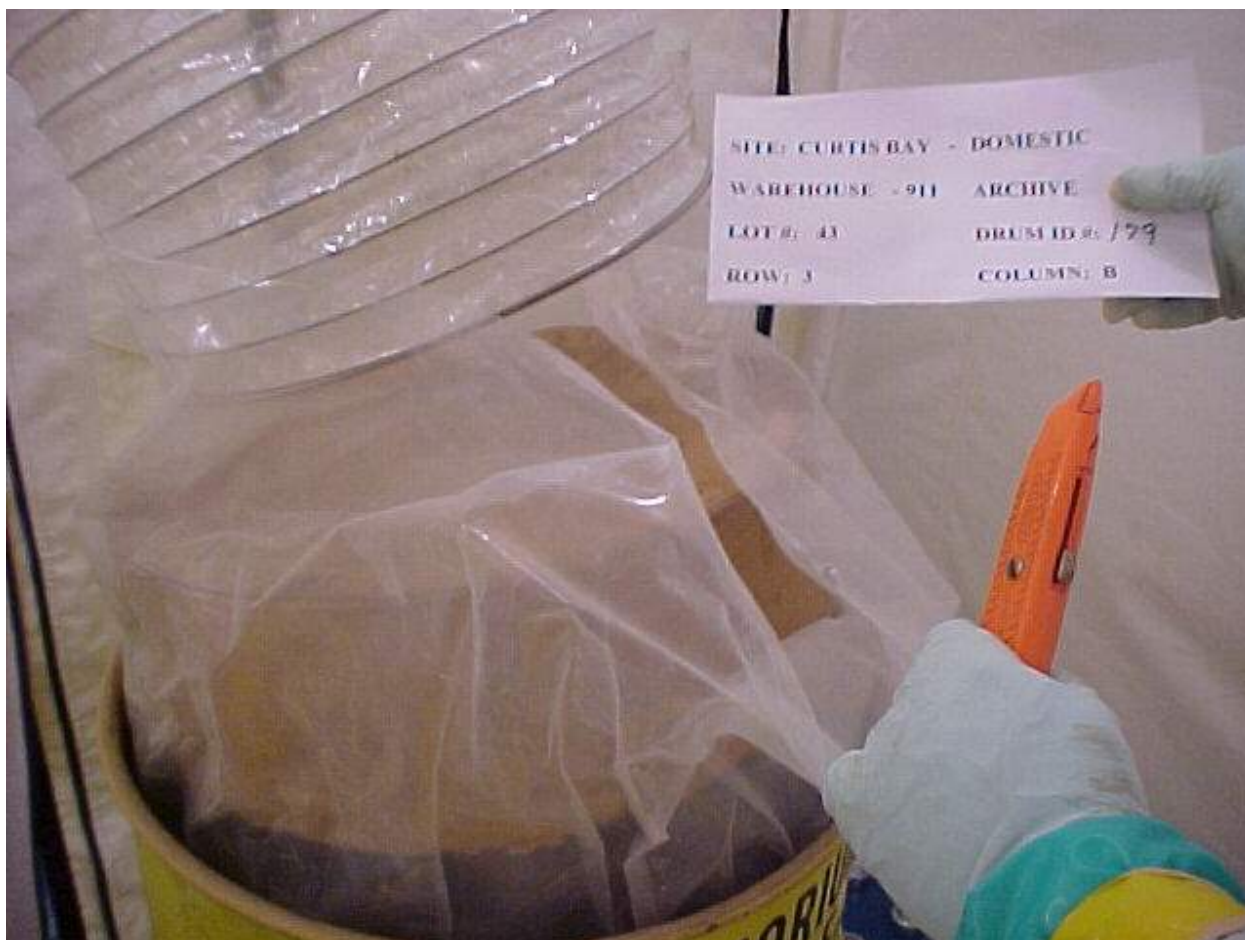
11:00**Other Information**Photo No. 3 of 9Dose Rate Surface 24 mR/hr
 1 meter 2.8 mR/hrWhile making a cut in 3rd poly liner/bag –pressure is releasedPrior to accessing the 3rd poly bag, opened the first poly liner/bag, then removed the fiber drum lid from outermost fiber drum inside of this package and removed the 2nd poly liner/bag

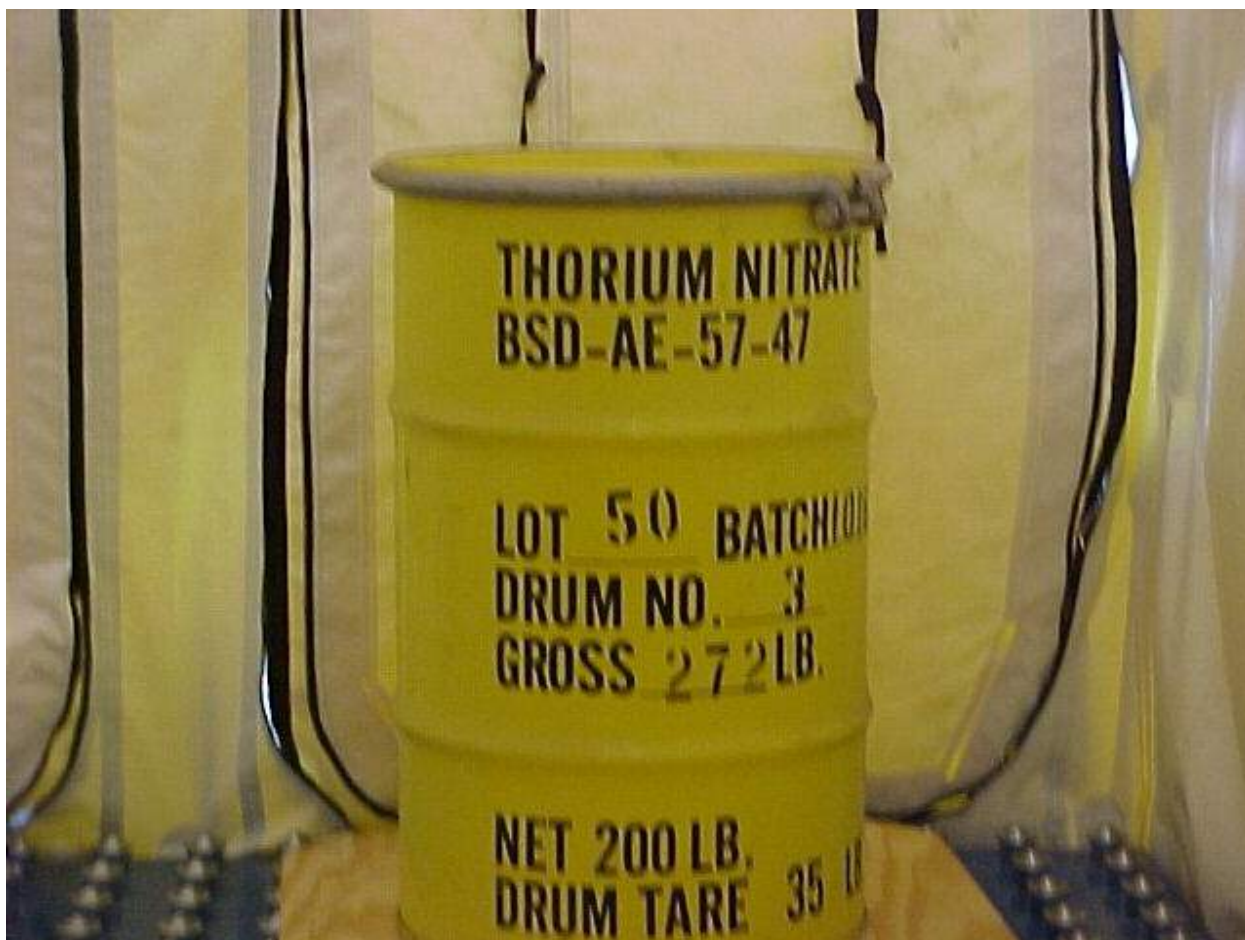
11:15**Other Information**Photo No. 1 of 10Dose Rate Surface 24 mR/hr
 1 meter 3.2 mR/hr

30-gal drum – good condition

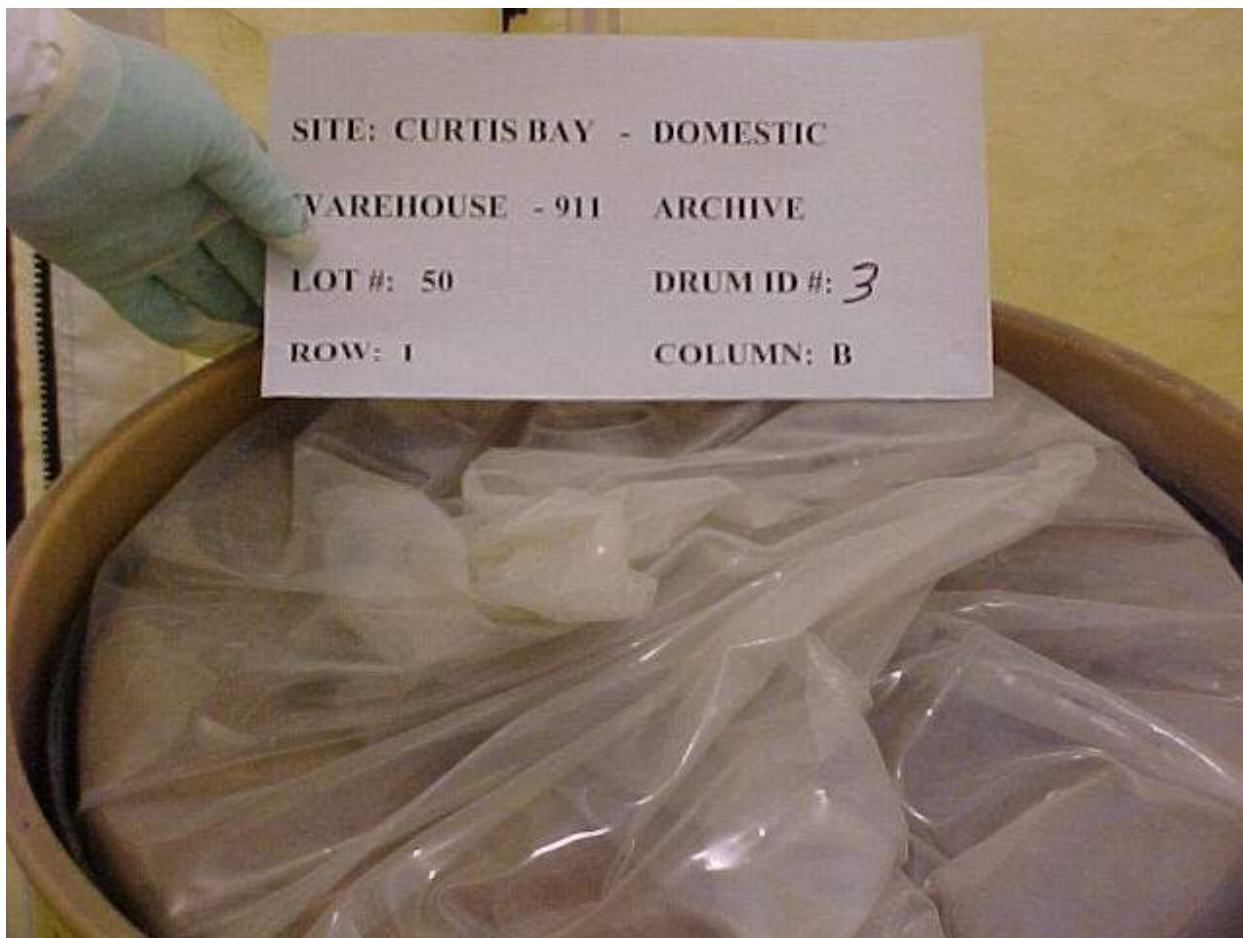
11:15**Other Information**Photo No. 3 of 10Dose Rate Surface 24 mR/hr
 1 meter 3.2 mR/hr

1st poly liner/bag – good condition
No gases present in breathing zone

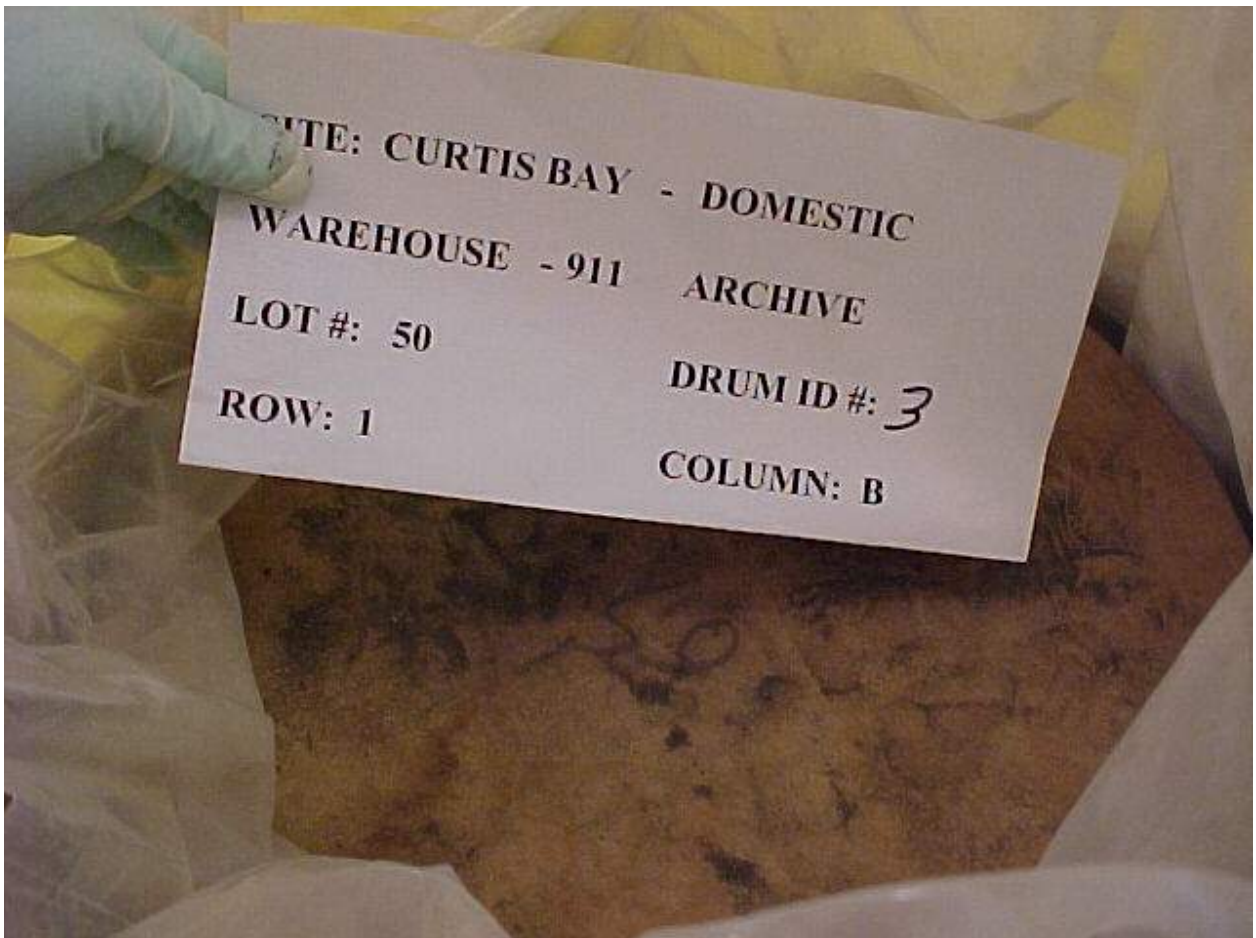
The cardboard/fiber drum lid – good condition
No gases present in breathing zone

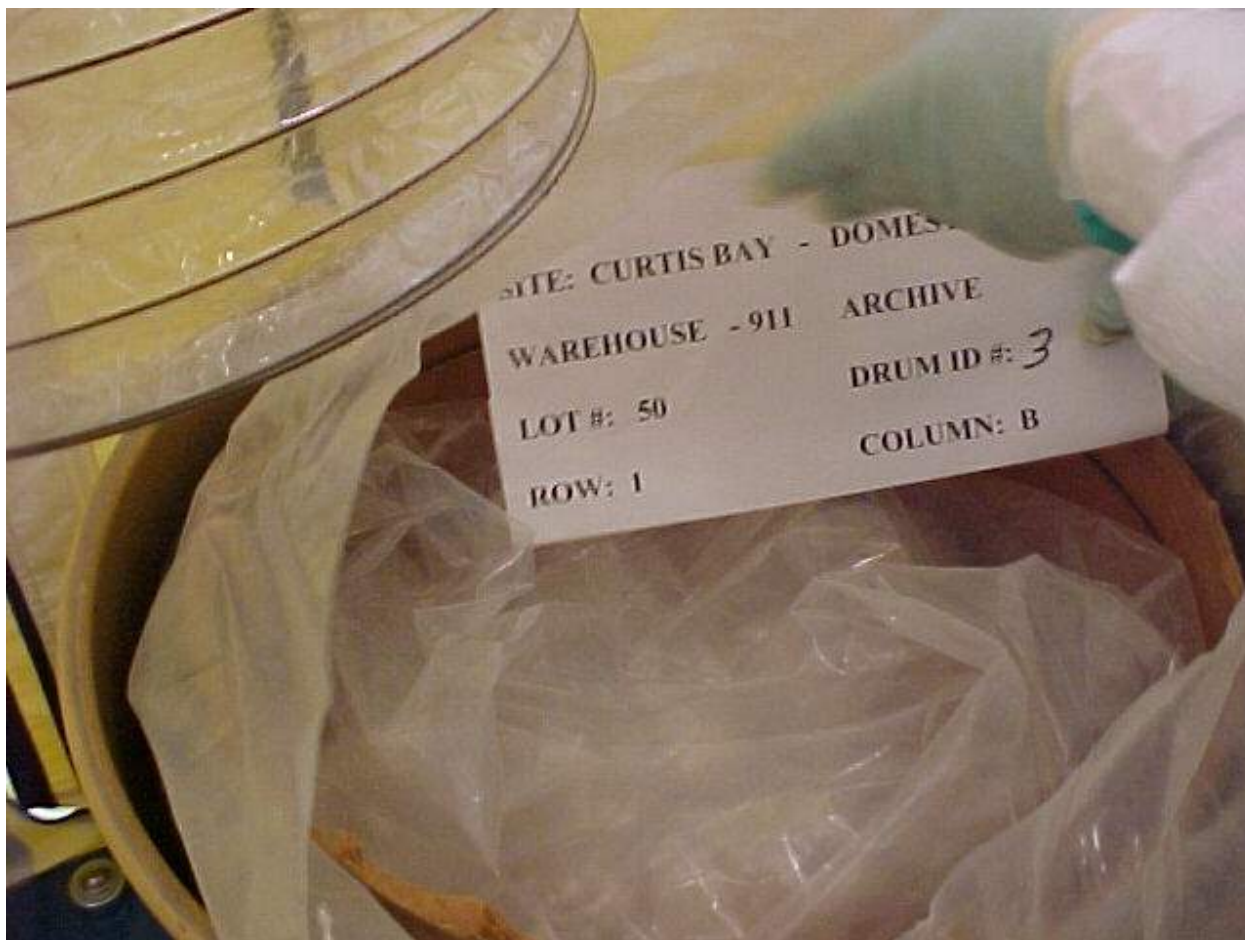
11:15**Other Information**Photo No. 5 of 10Dose Rate Surface 24 mR/hr
 1 meter 3.2 mR/hr

2nd poly liner/bag – good condition
No gases present in breathing zone

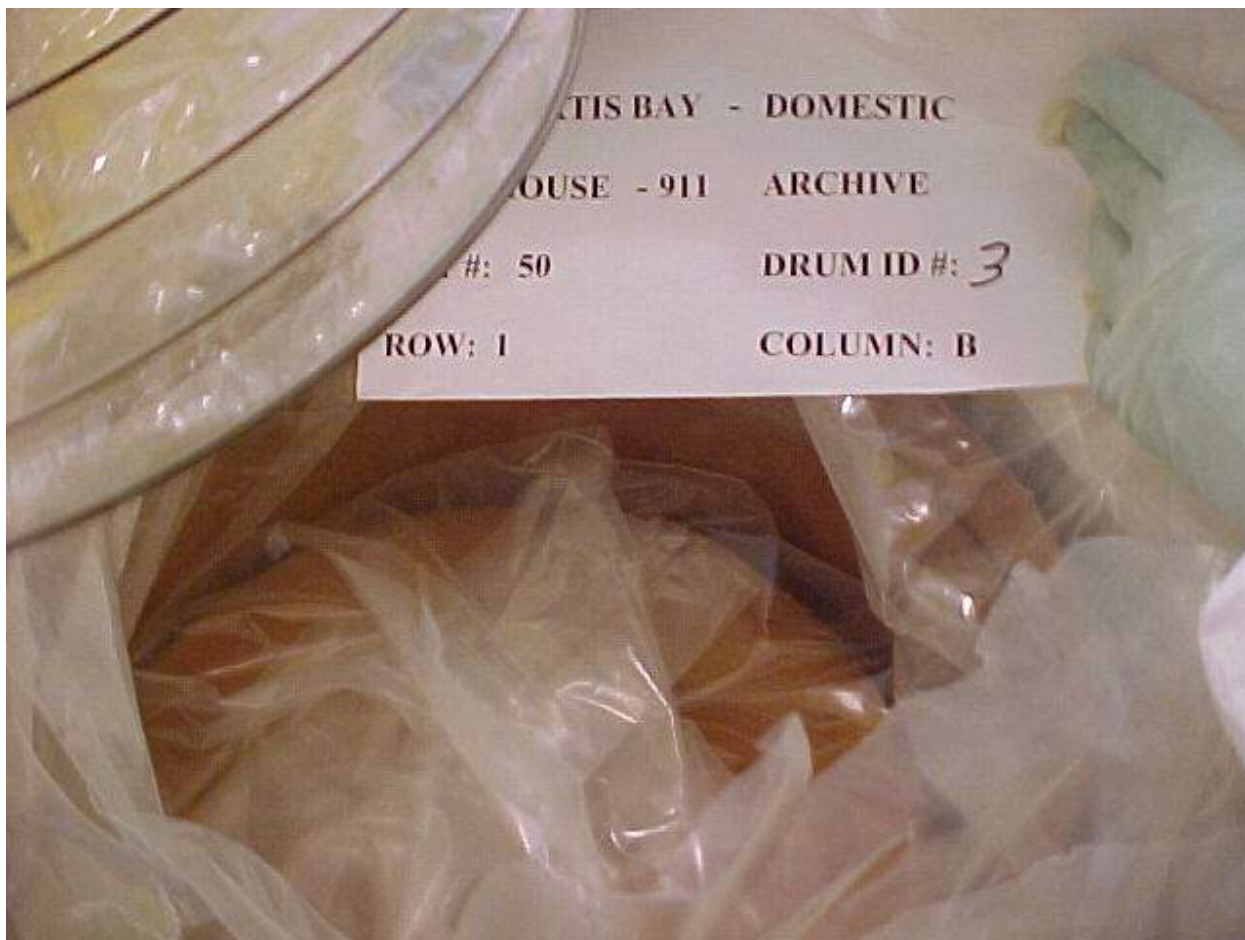
3rd poly liner/bag – good condition
No gases present in breathing zone

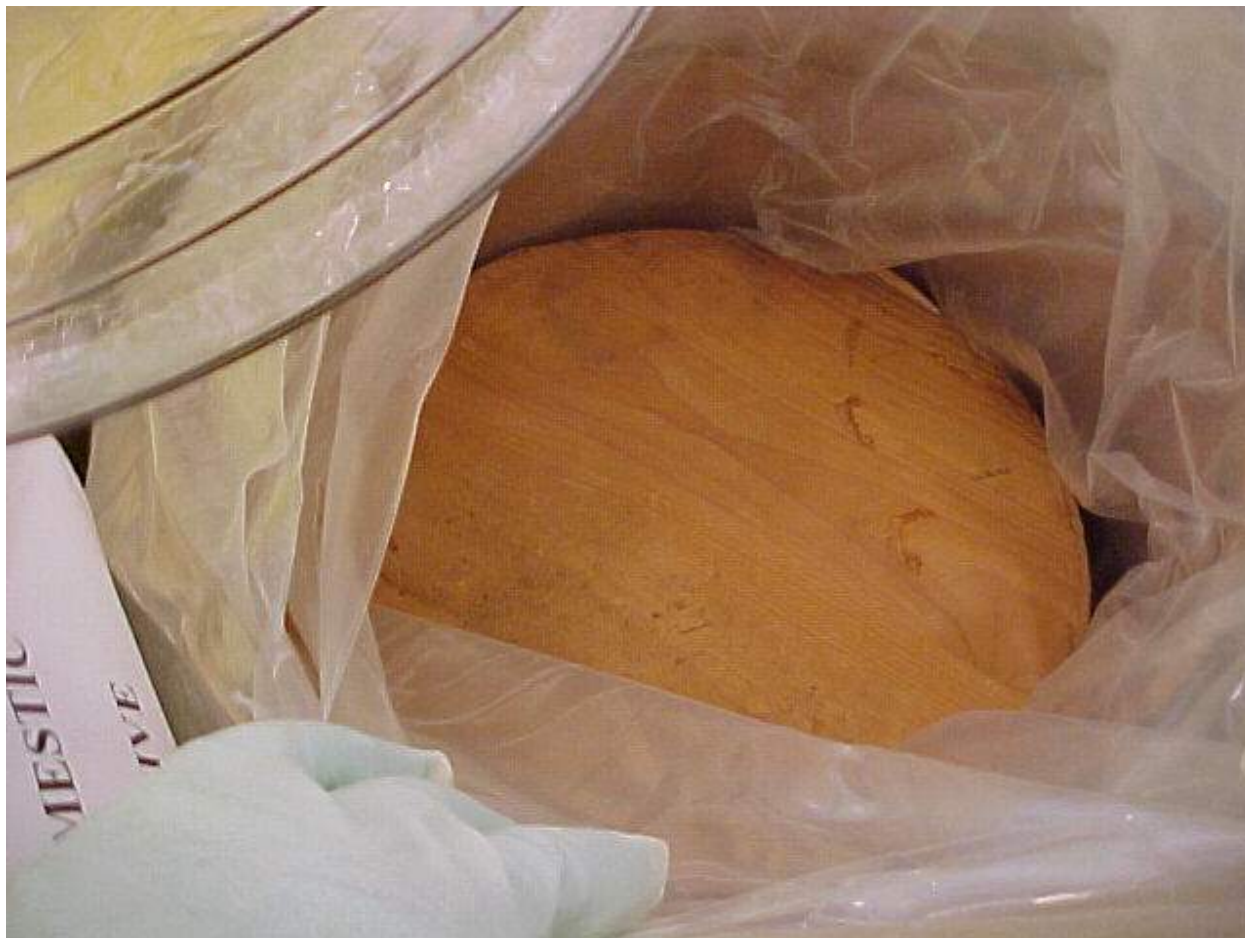
Wooden lid (mounted on interior fiber drum) – good condition

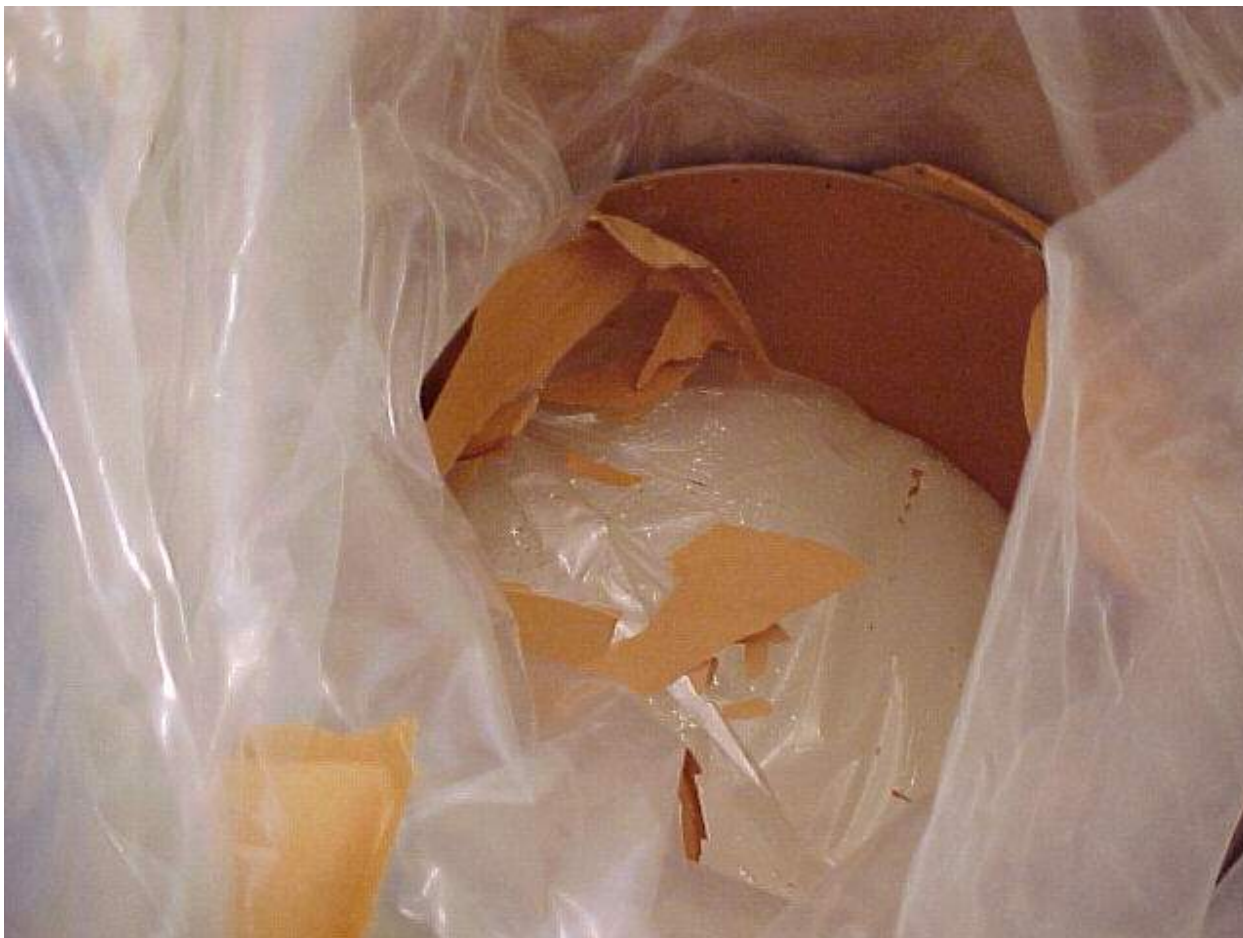
4th (final) poly liner/bag – good condition
No gases present in breathing zone

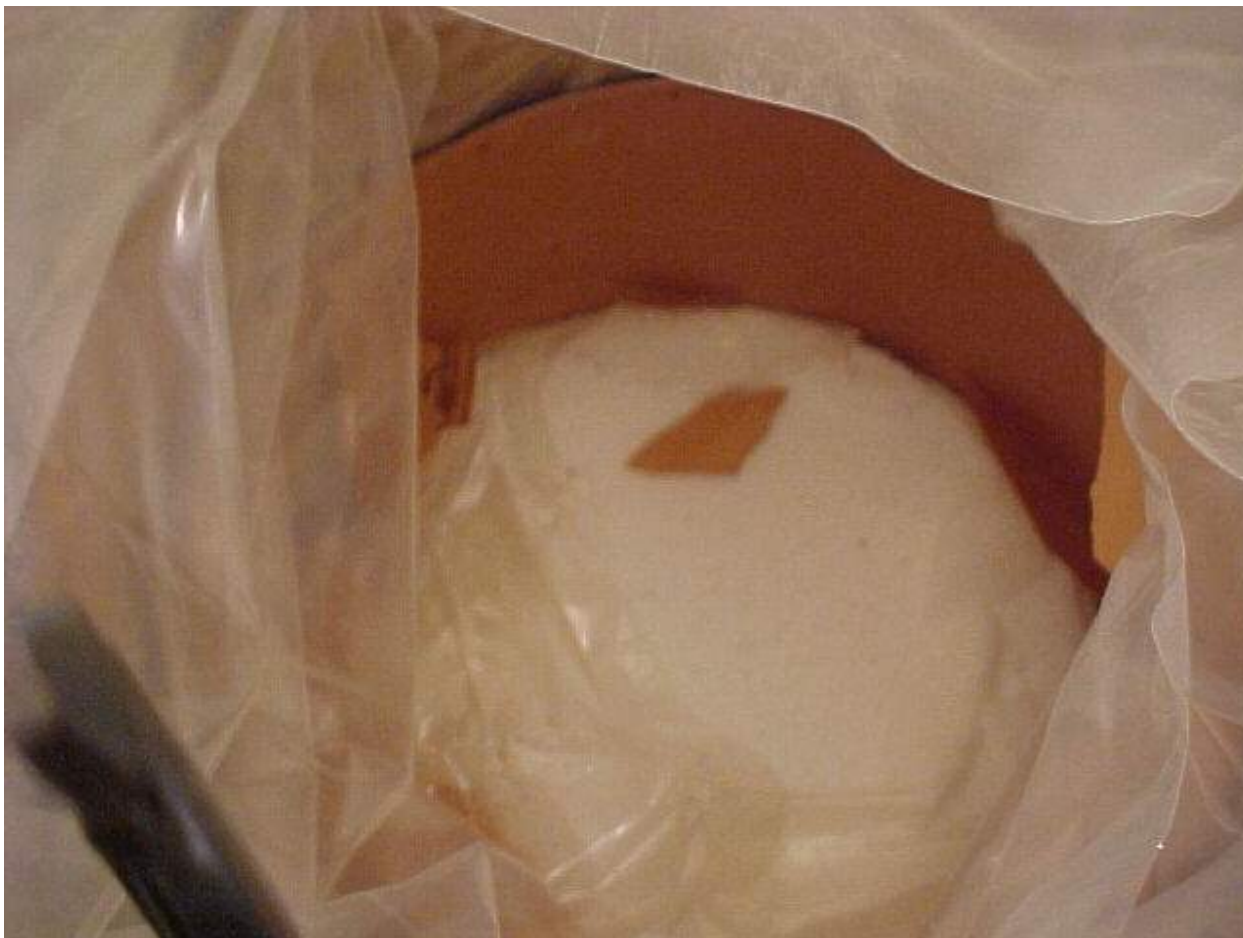
11:15**Other Information**Photo No. 9 of 10Dose Rate Surface 24 mR/hr
 1 meter 3.2 mR/hr

ThN material – white – solid – monolith – very dry
No gases present in breathing zone

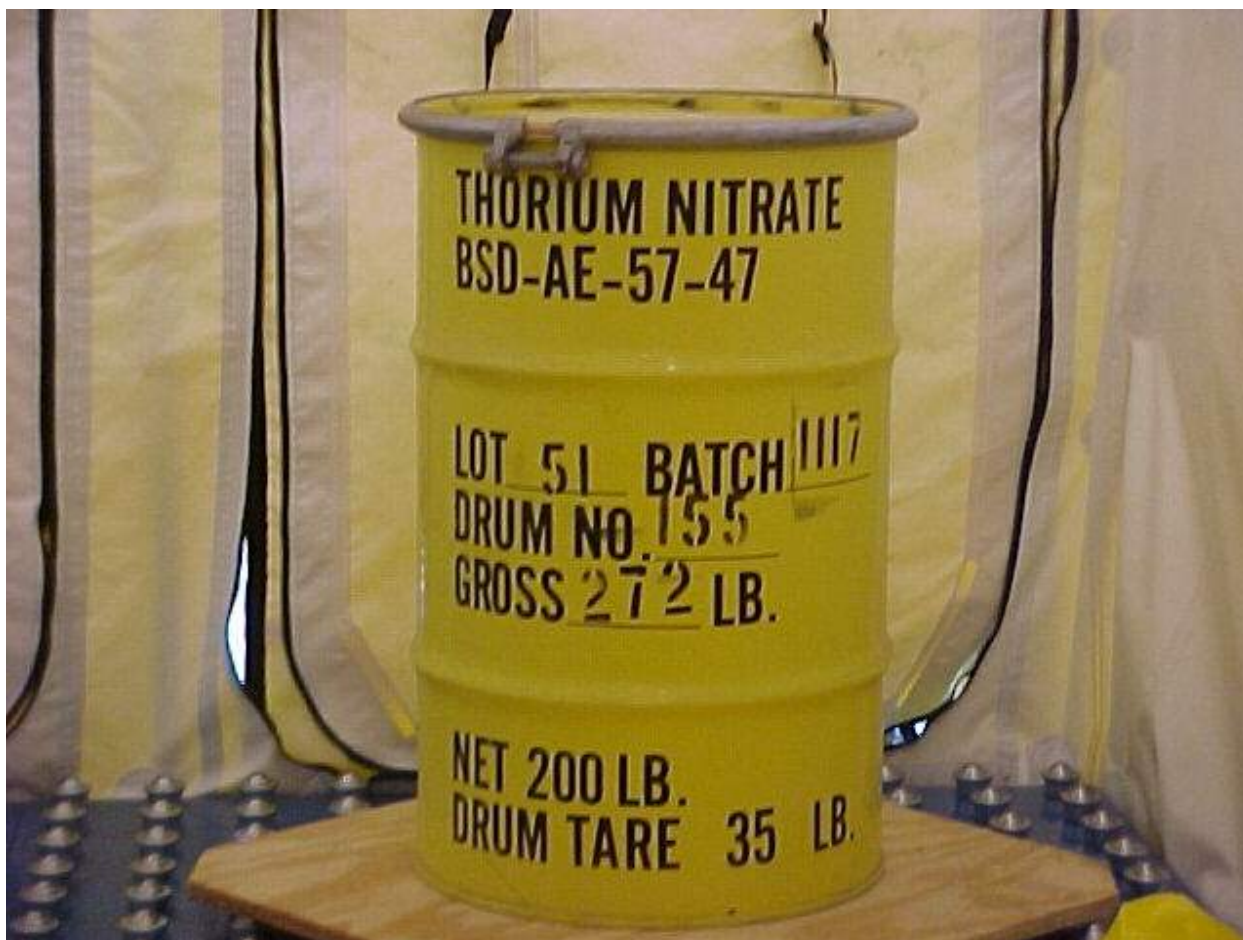
30-gal drum – good condition

Drum vented gas during removal of drum ring

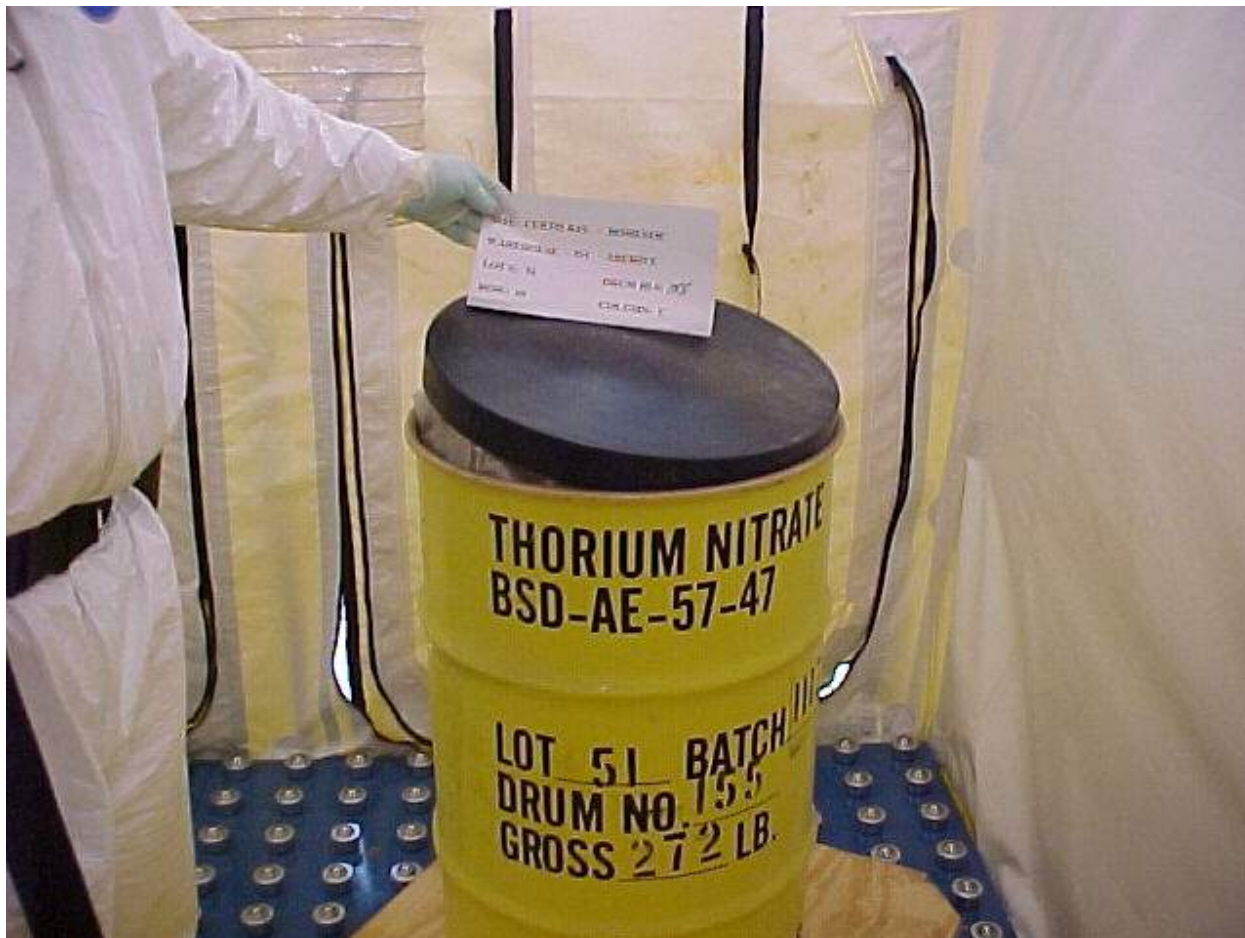
Picture shows black plastic lid of drum liner – good condition
No gases present in breathing zone.

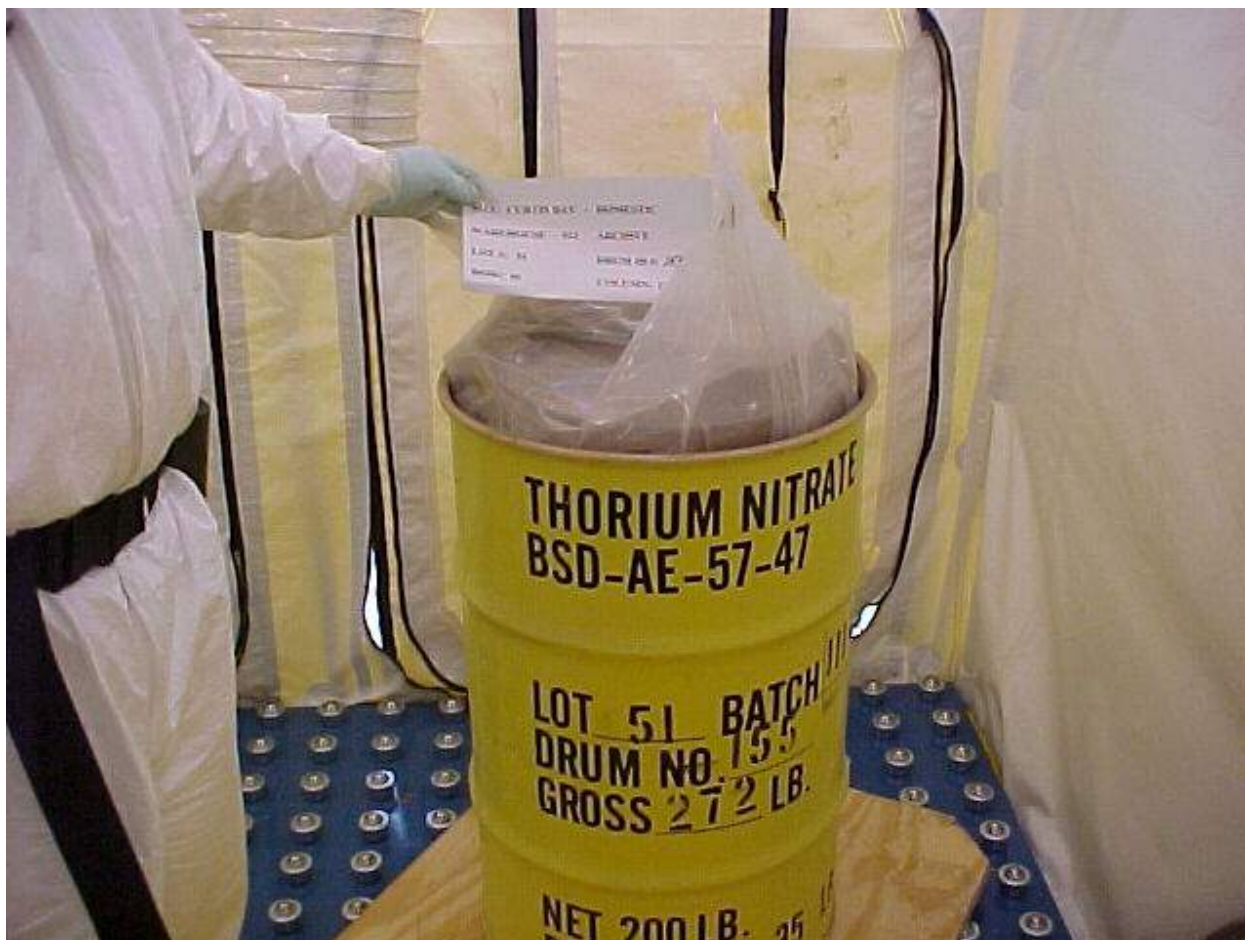
1st poly liner/bag – good condition
 No gases present in breathing zone.

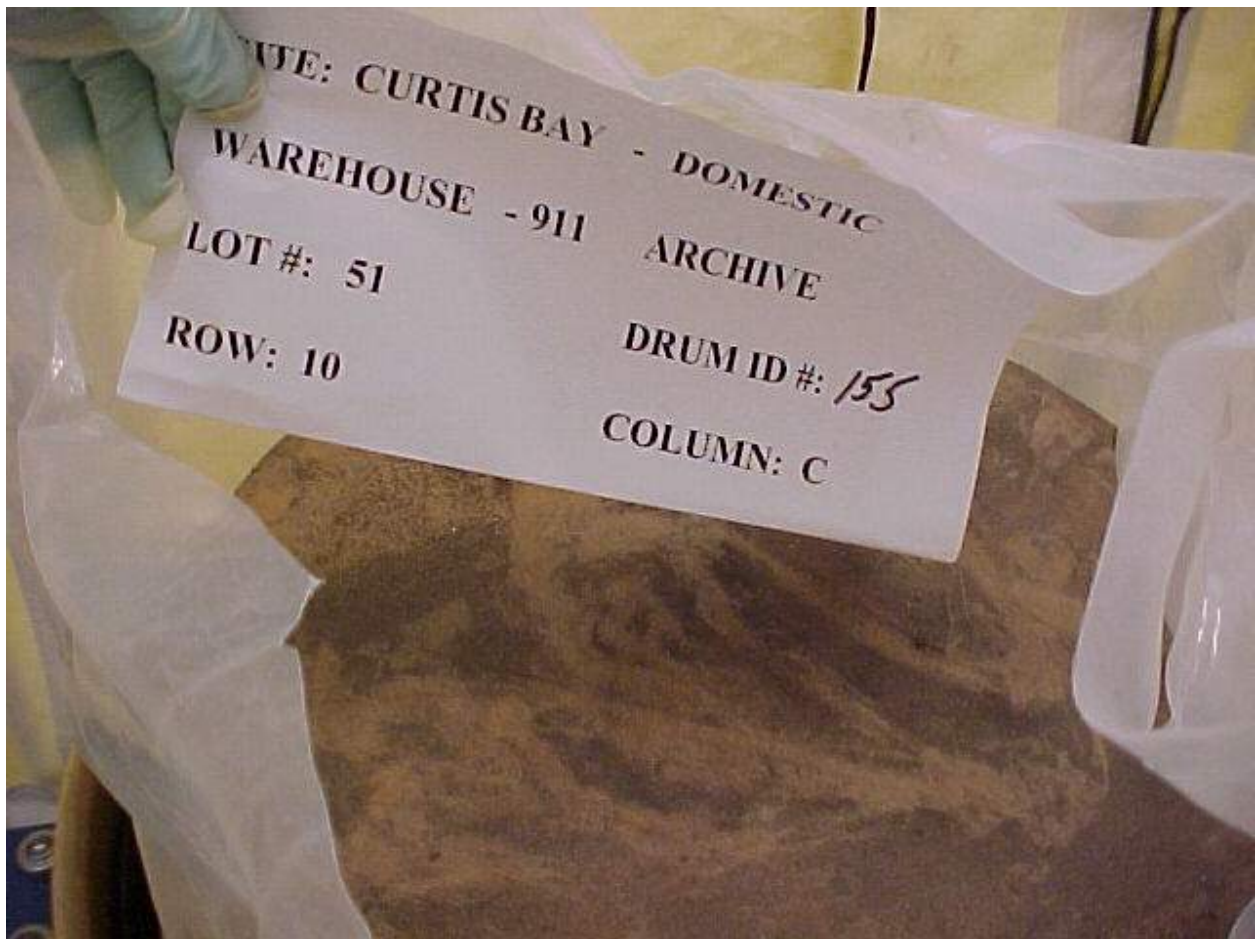
After opening the 1st poly liner/bag, the next package object is the cardboard/fiber lid of the outermost fiber drum – good condition

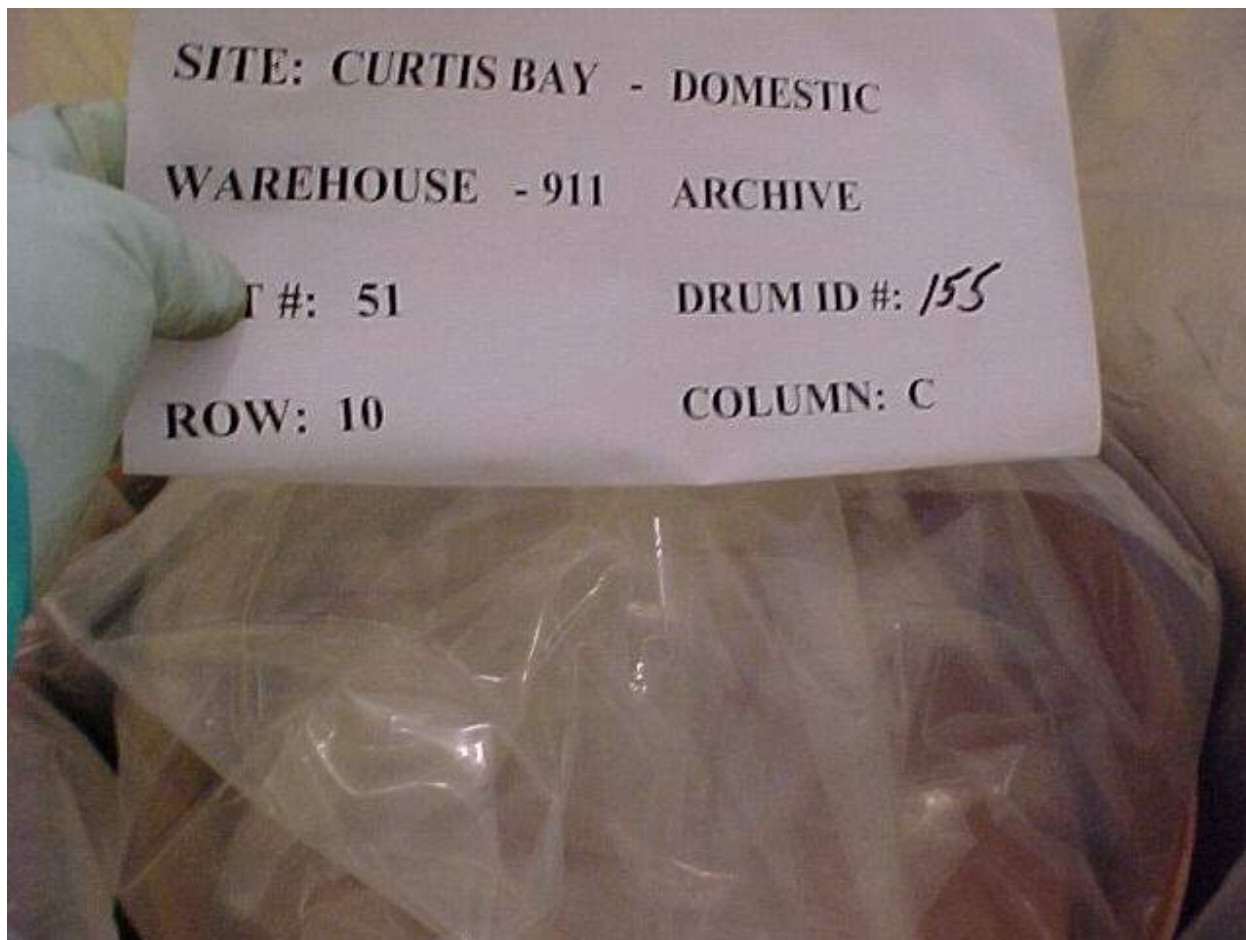
2nd poly liner/bag – good condition
No gases present in the breathing zone

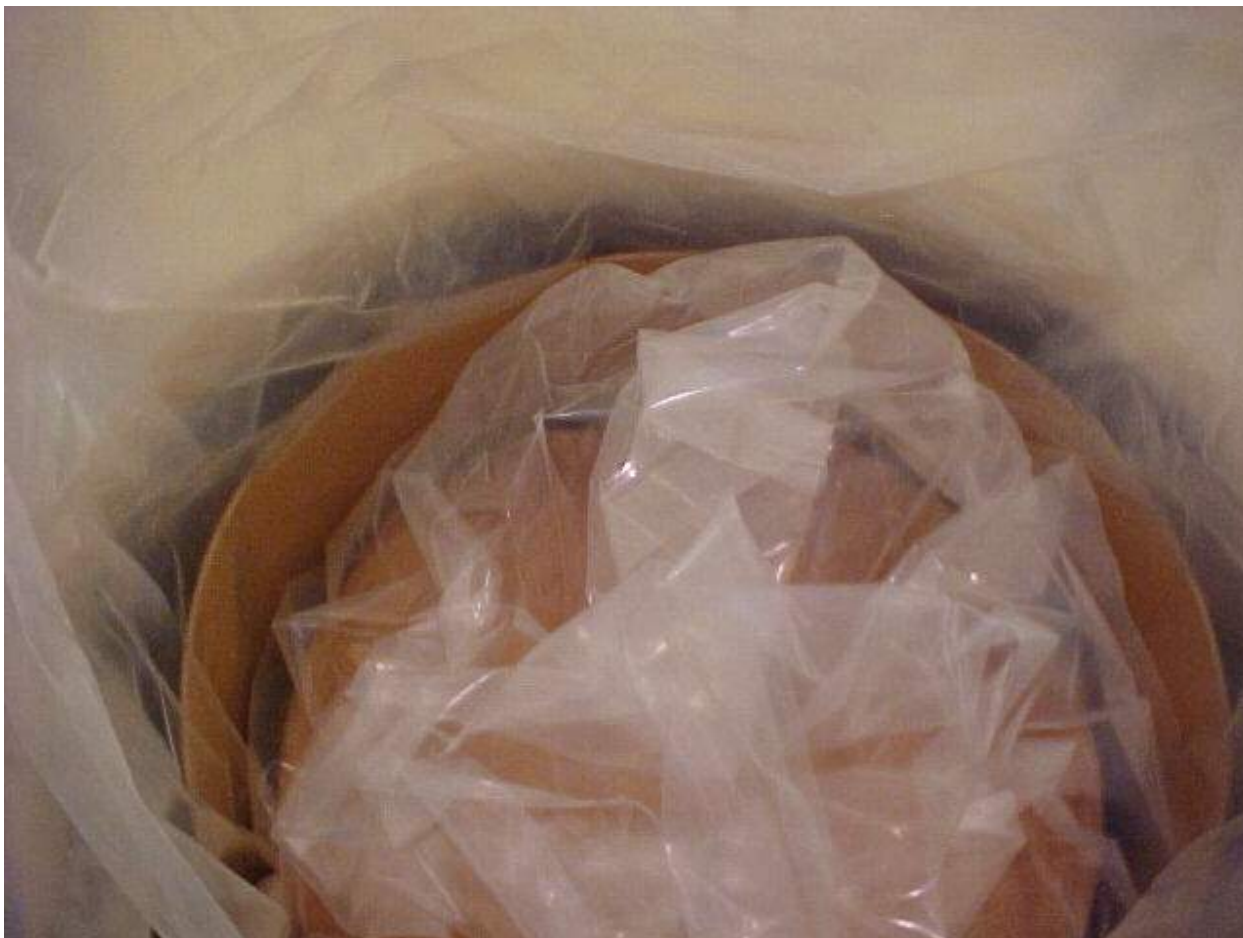
3rd poly liner/bag – good condition
No gases present in the breathing zone
