THORIUM NITRATE STOCKPILE DRUM CHARACTERIZATION REPORT

**THORIUM NITRATE STOCKPILE
DRUM CHARACTERIZATION REPORT**

Prepared for
U.S. Defense Logistics Agency
Defense National Stockpile Center
Fort Belvoir, Virginia

Prepared by
OAK RIDGE NATIONAL LABORATORY
Oak Ridge, Tennessee 37831
managed by
UT-BATTELLE, LLC
for the
U.S. DEPARTMENT OF ENERGY
under contract DE-AC05-00OR22725

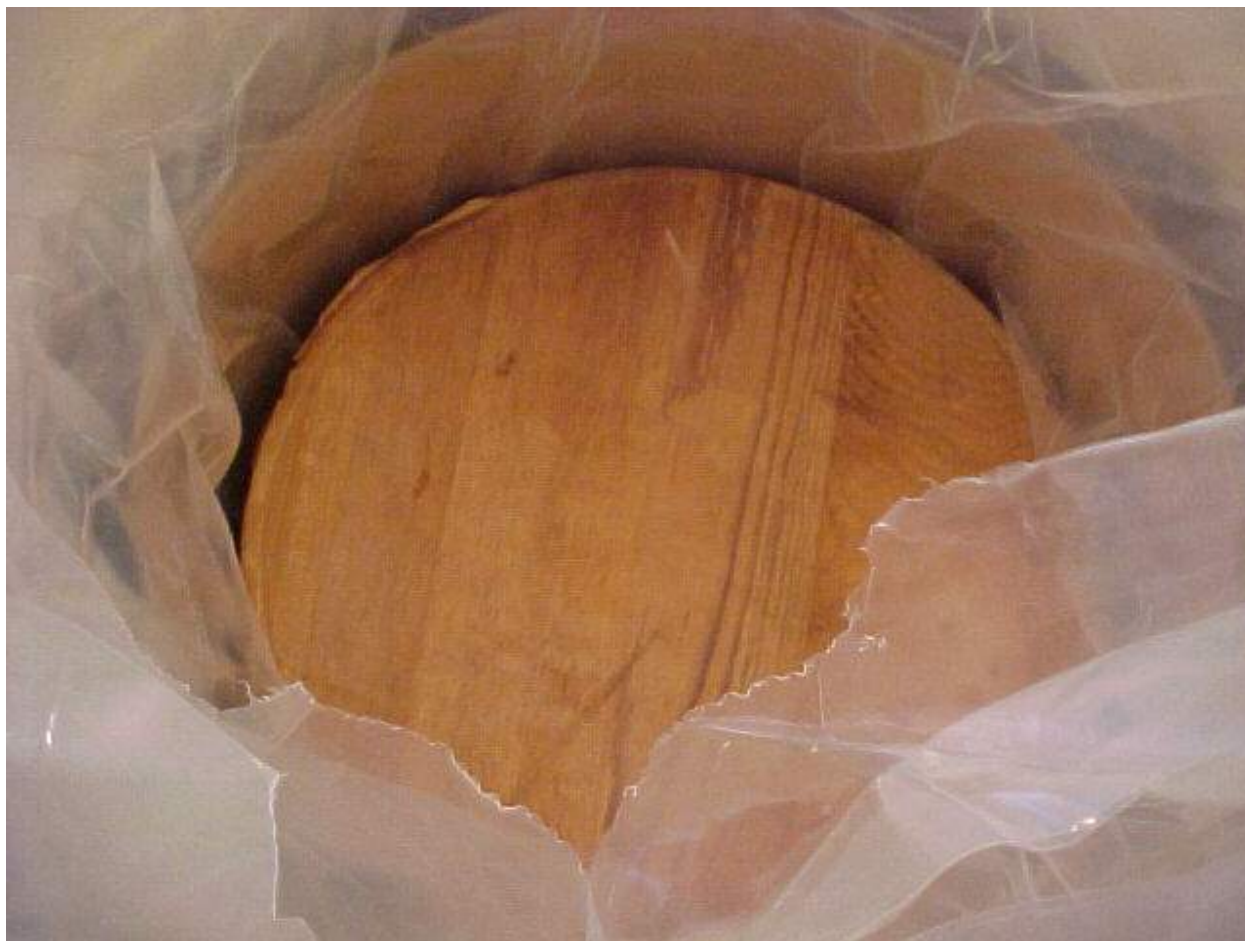
This picture shows the wooden lid covering the final fiber drum, 4th poly liner/bag & ThN material

No gases present in the breathing zone

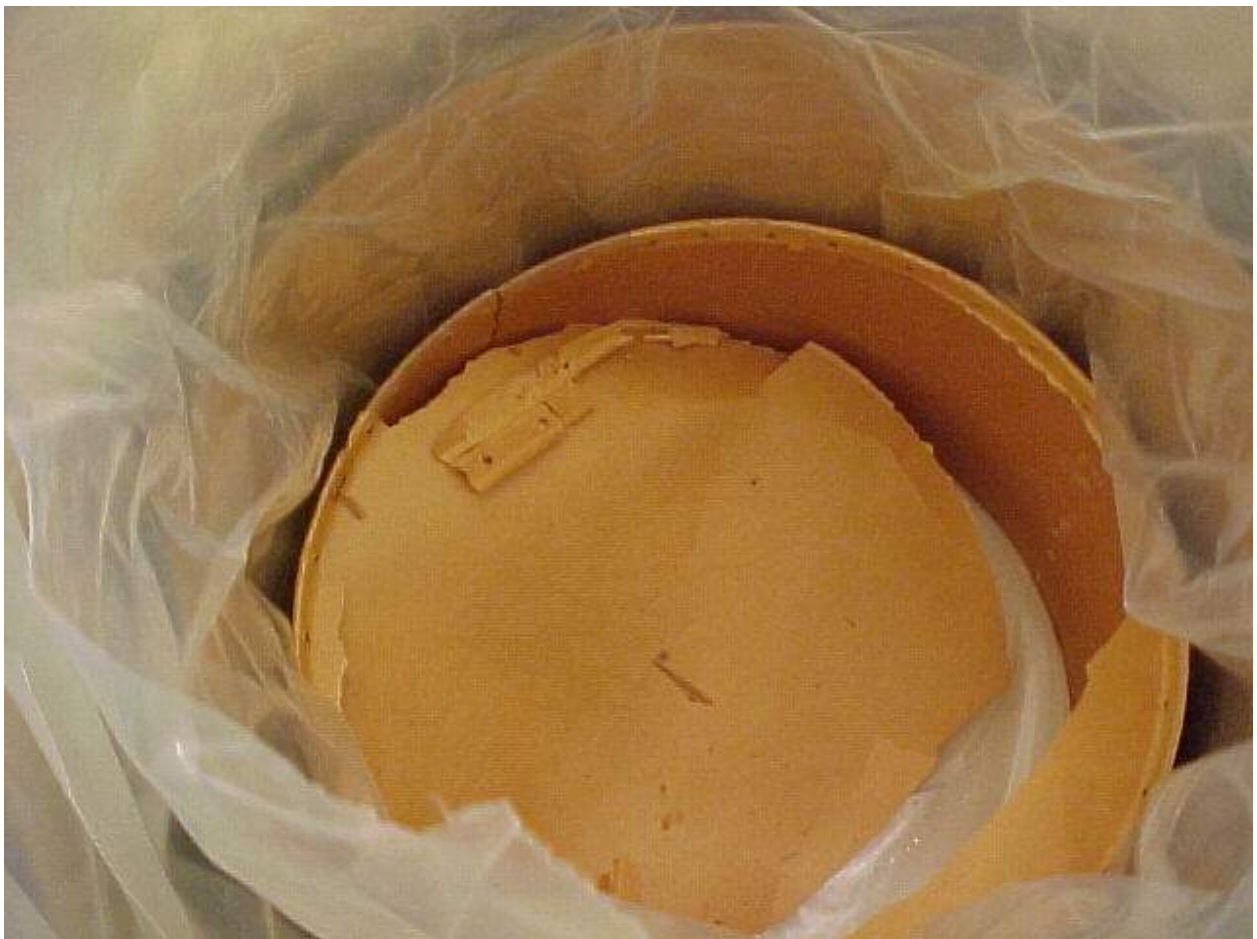
The lab-pack (inner fiber drum) lid was in good condition until the wooden lid mounted to the drum is removed.

No gases present in the breathing zone

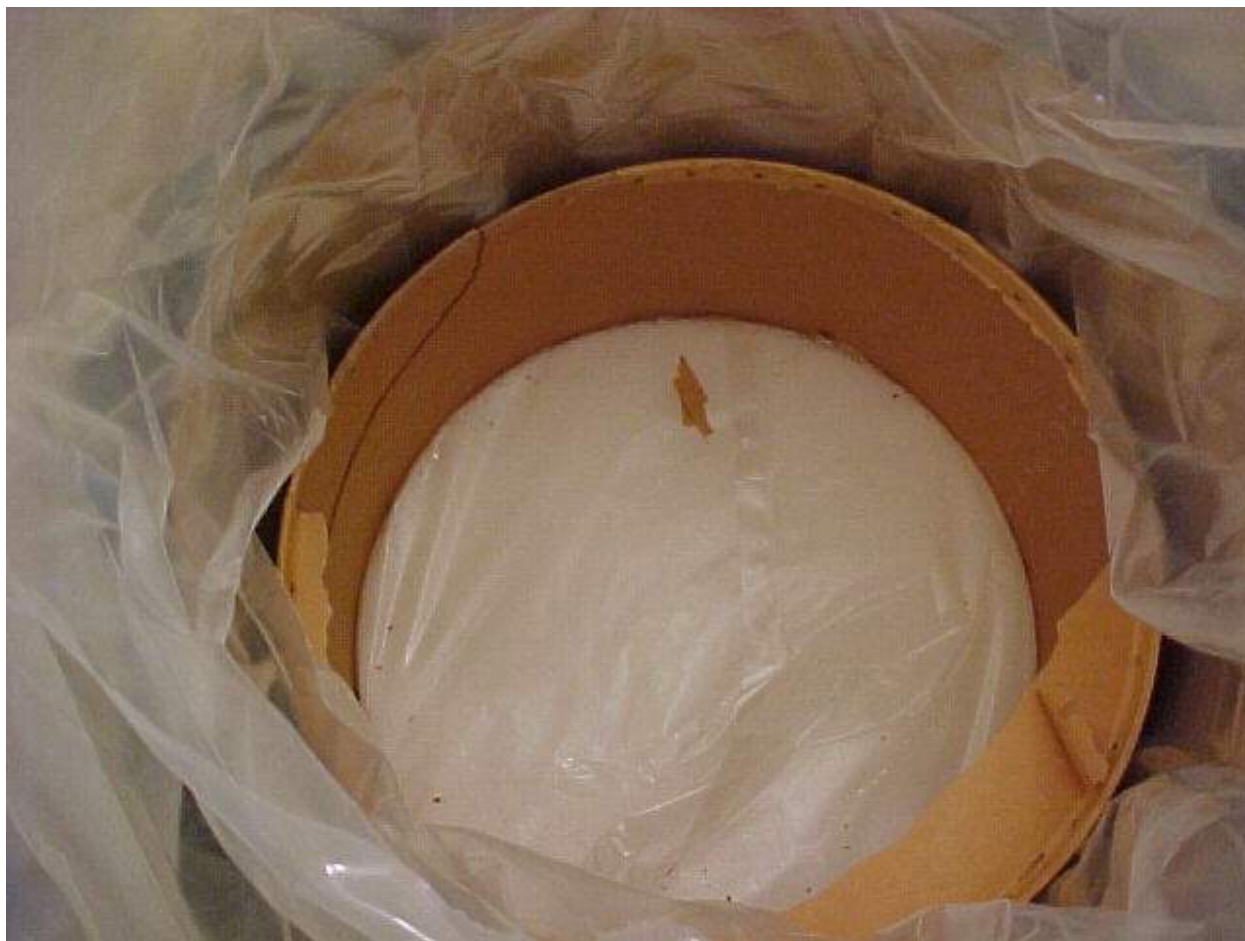
Final (4th) poly liner/bag – good condition
ThN material is solid & dry
No gases present in the breathing zone

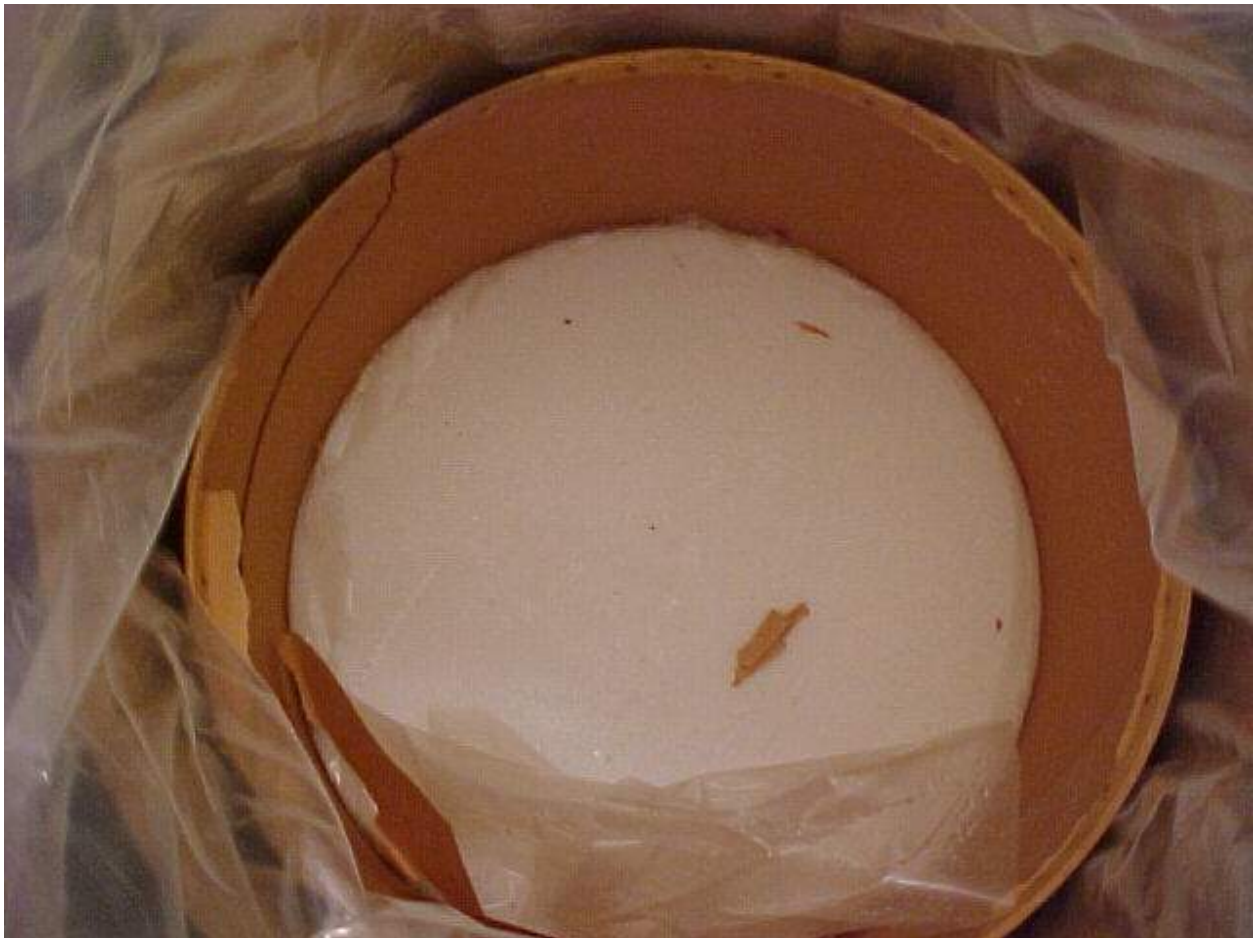
Thorium nitrate material – solid - dry
No gases present in the breathing zone

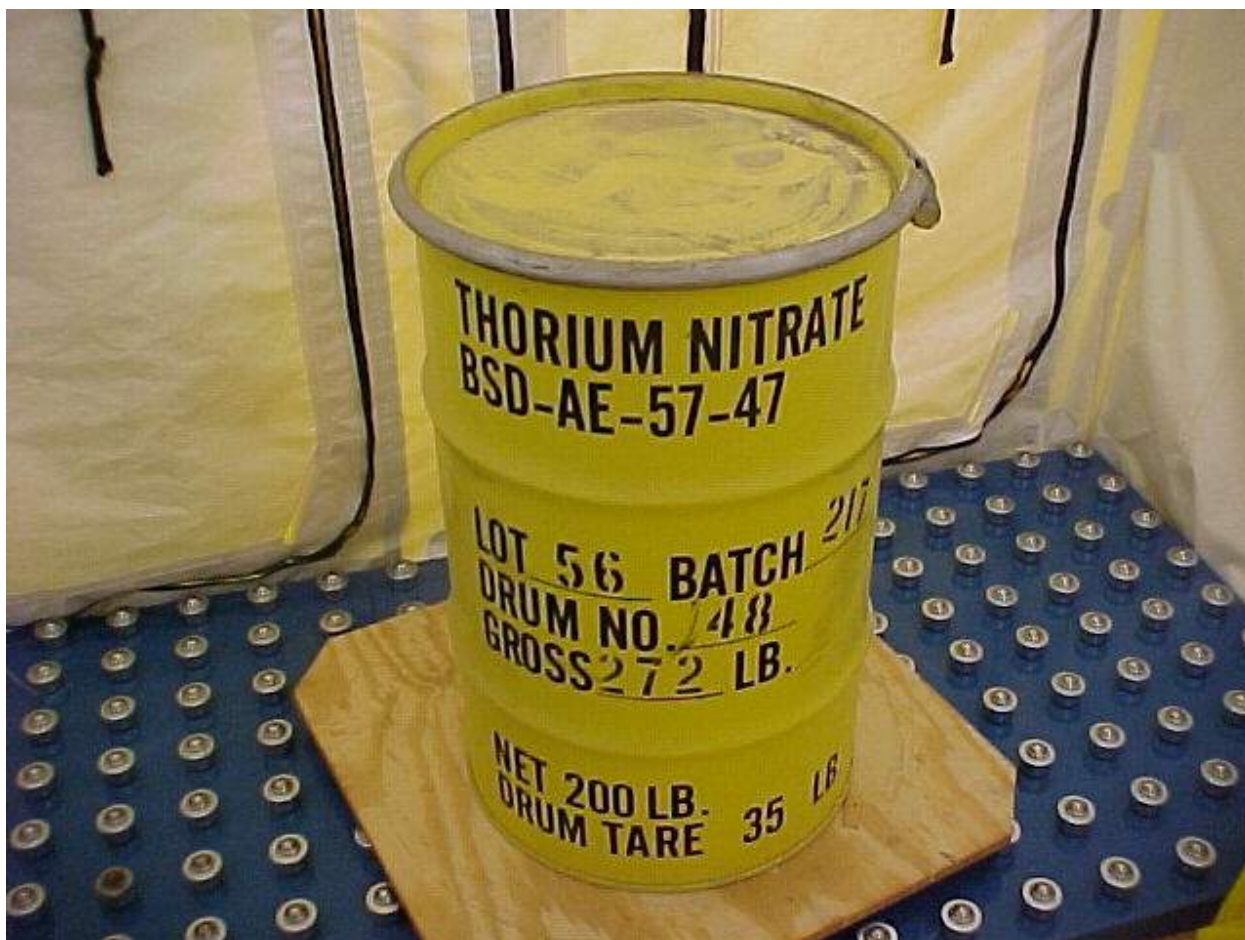
30-gal container – good condition

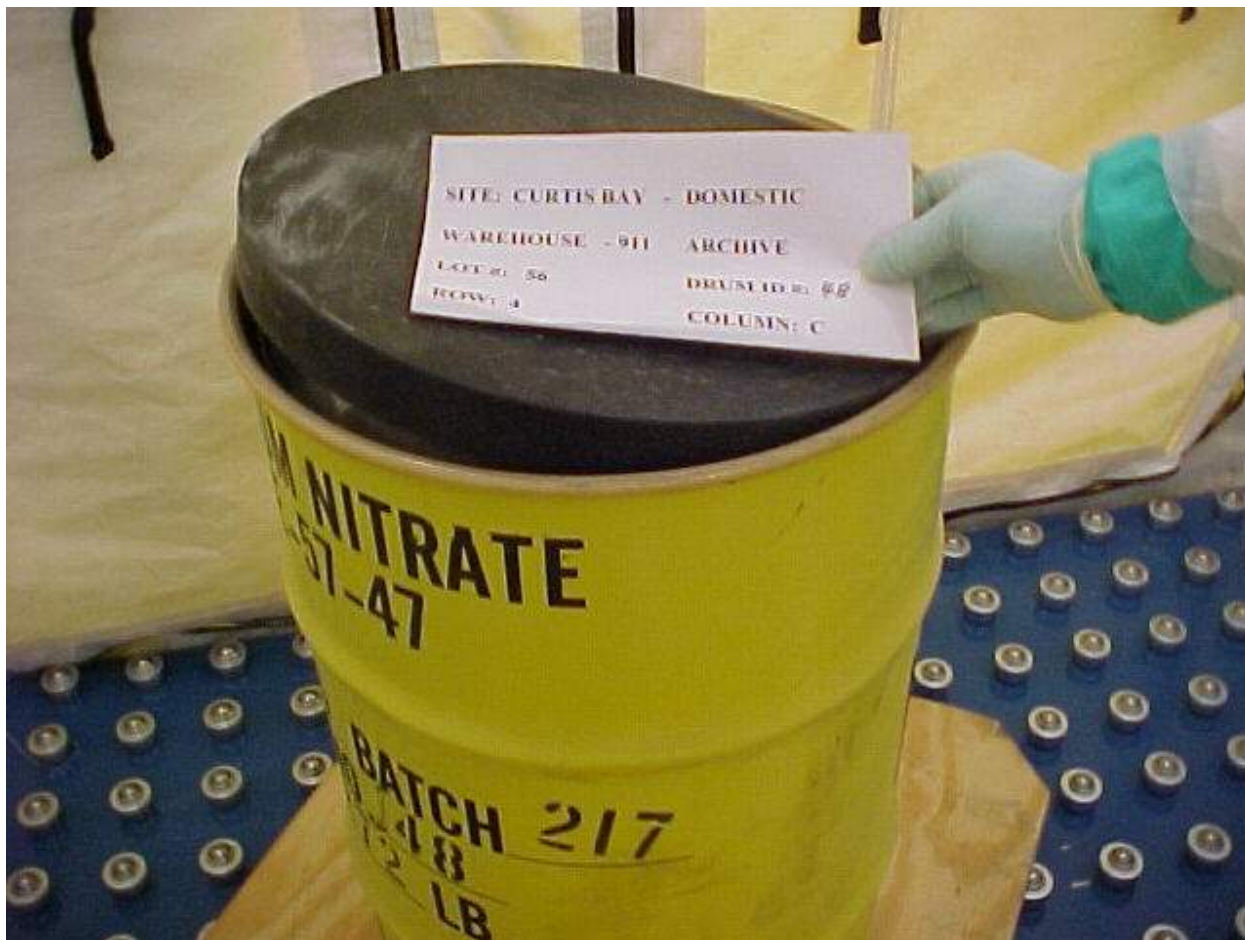
This picture shows the first lid in good condition (black plastic lid from drum liner)
No gases present in breathing zone

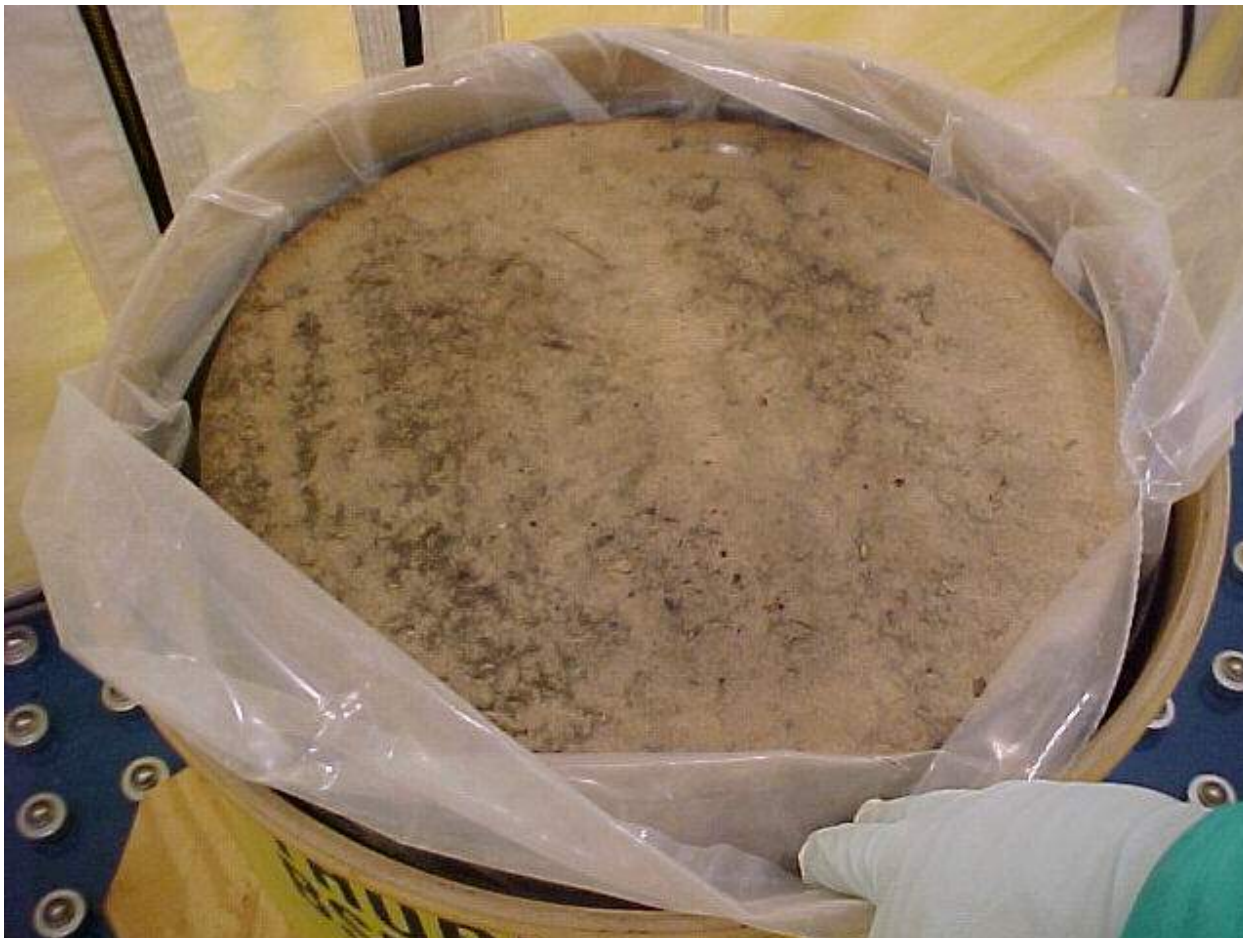
Fiber lid from outermost fiber drum – raised from pressure in the drum
No gases present in breathing zone

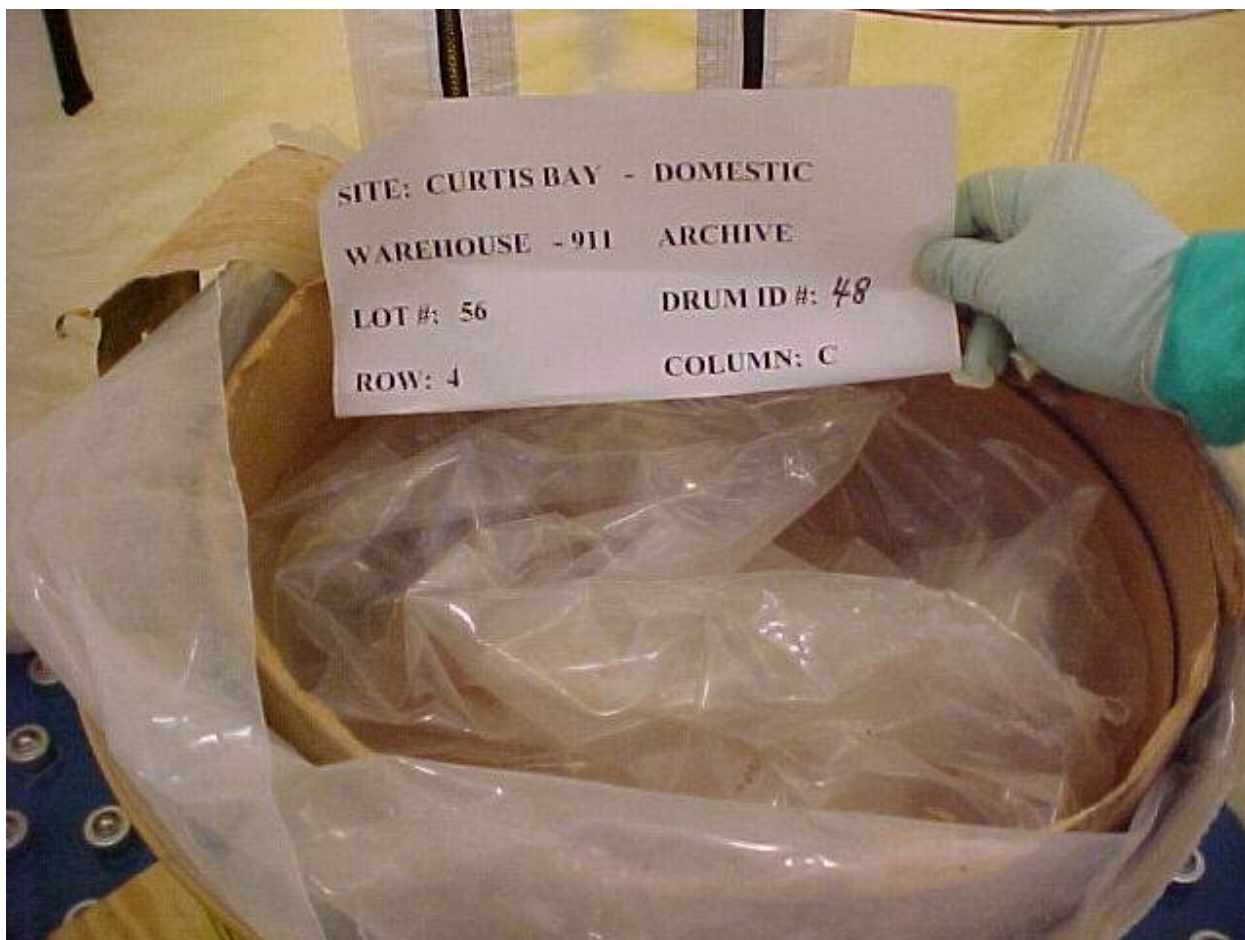
After removing the fiber lid – you see the 2nd poly liner/bag in good condition
No gases present in breathing zone

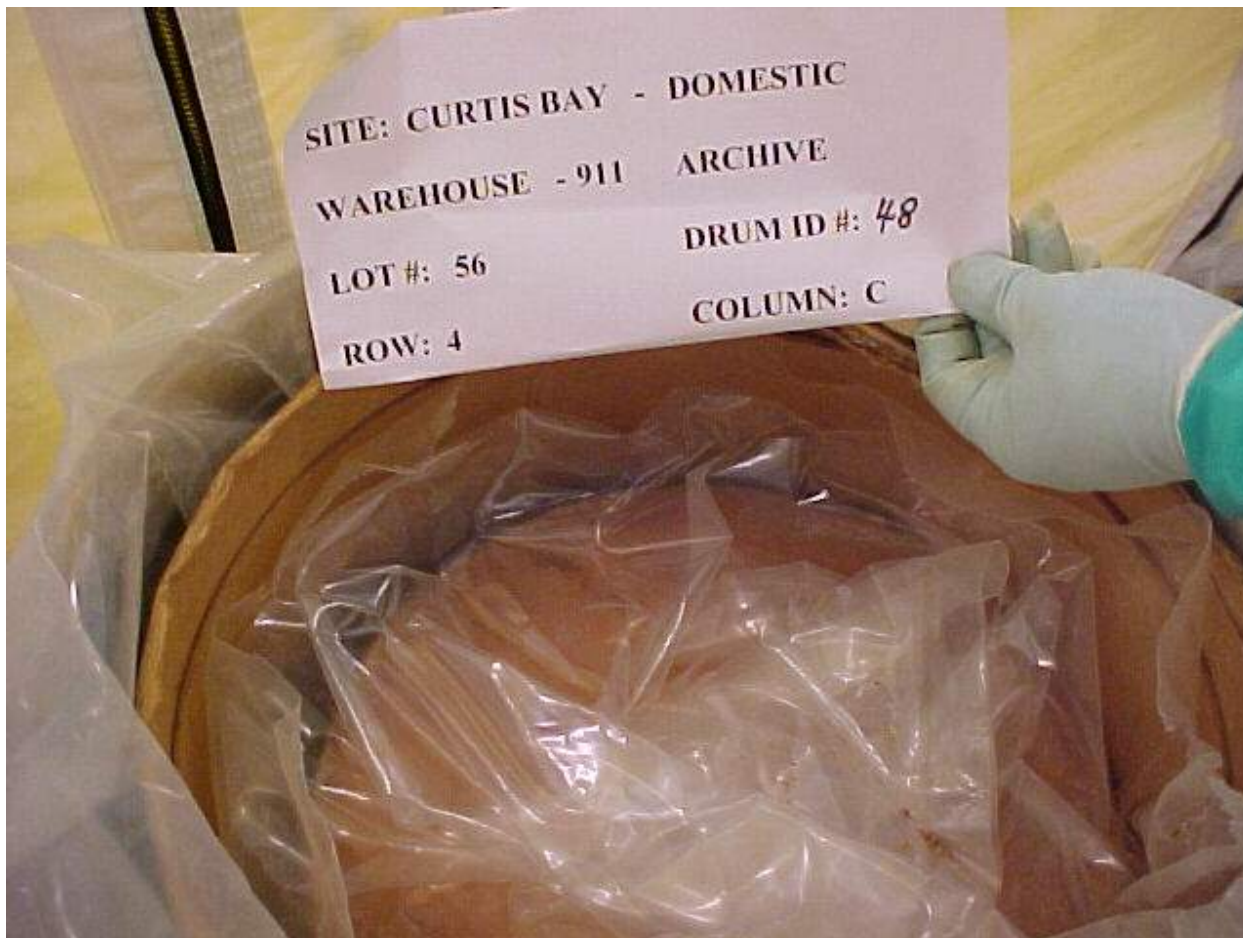
3rd poly liner/bag – good condition
No gases present in breathing zone

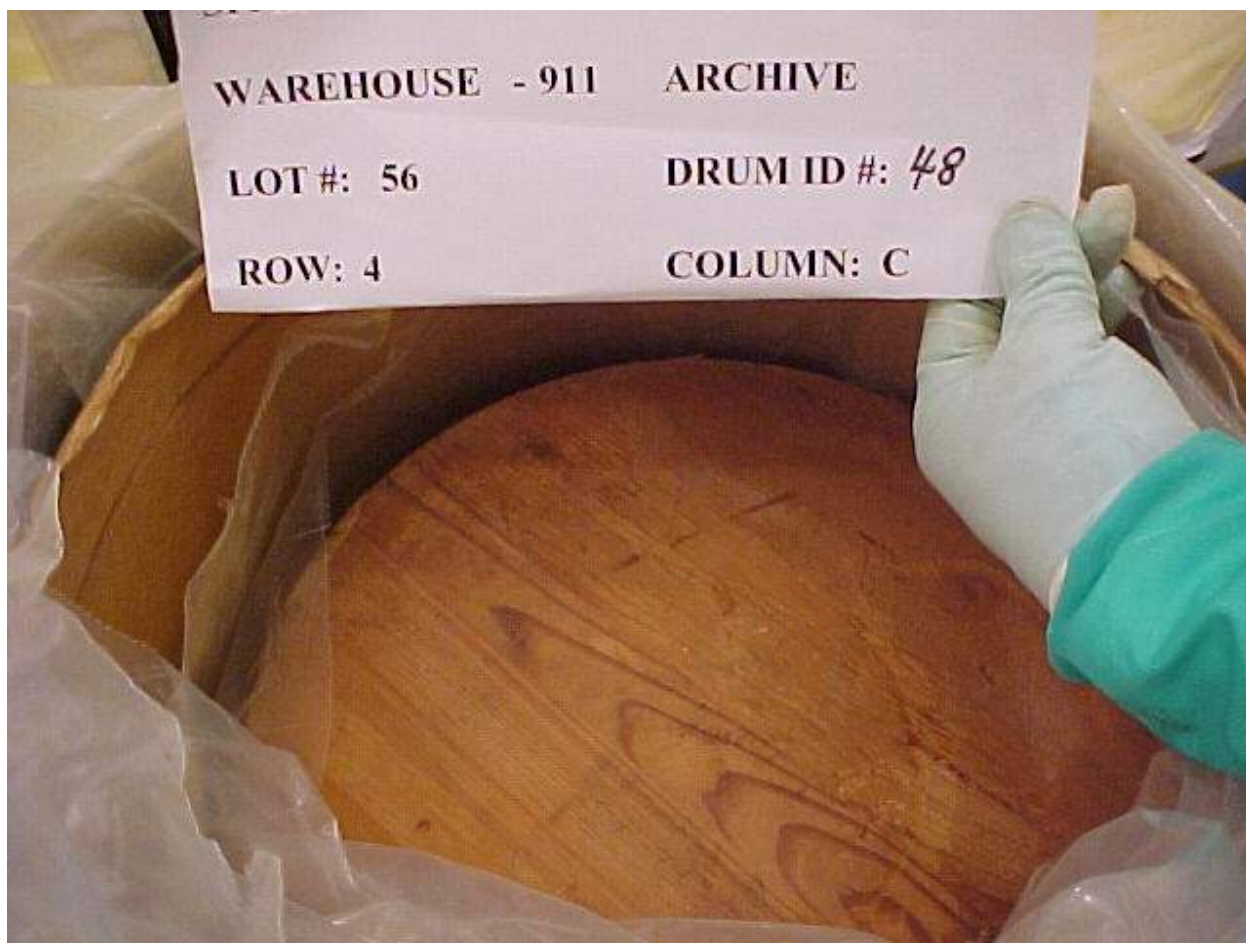
Wooden lid (mounted to interior fiber/lab-pack drum) – good condition (lid protects ThN material)

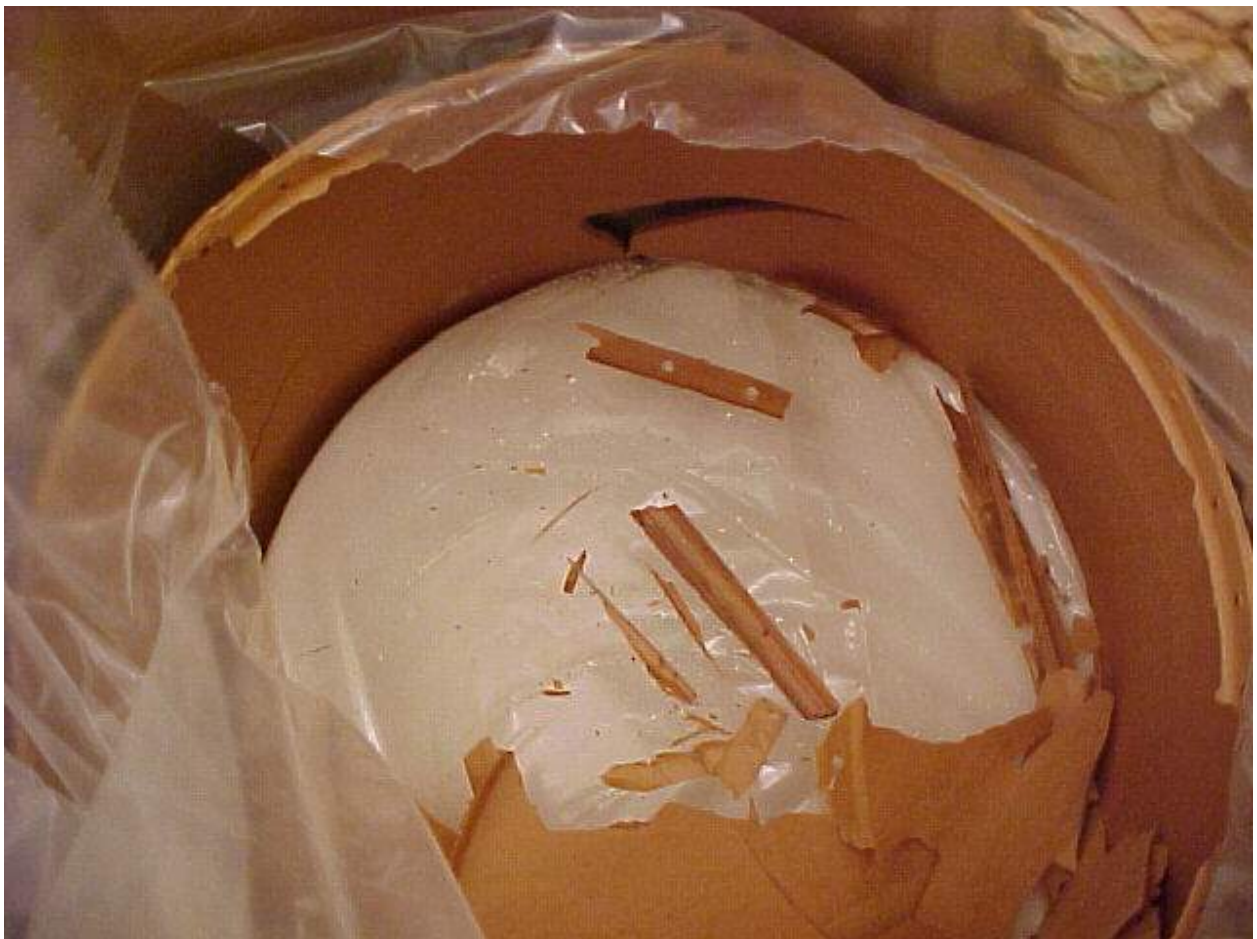
Picture shows paper layer covering inner fiber/lab-pack drum broken – paper layer is attached to wooden lid

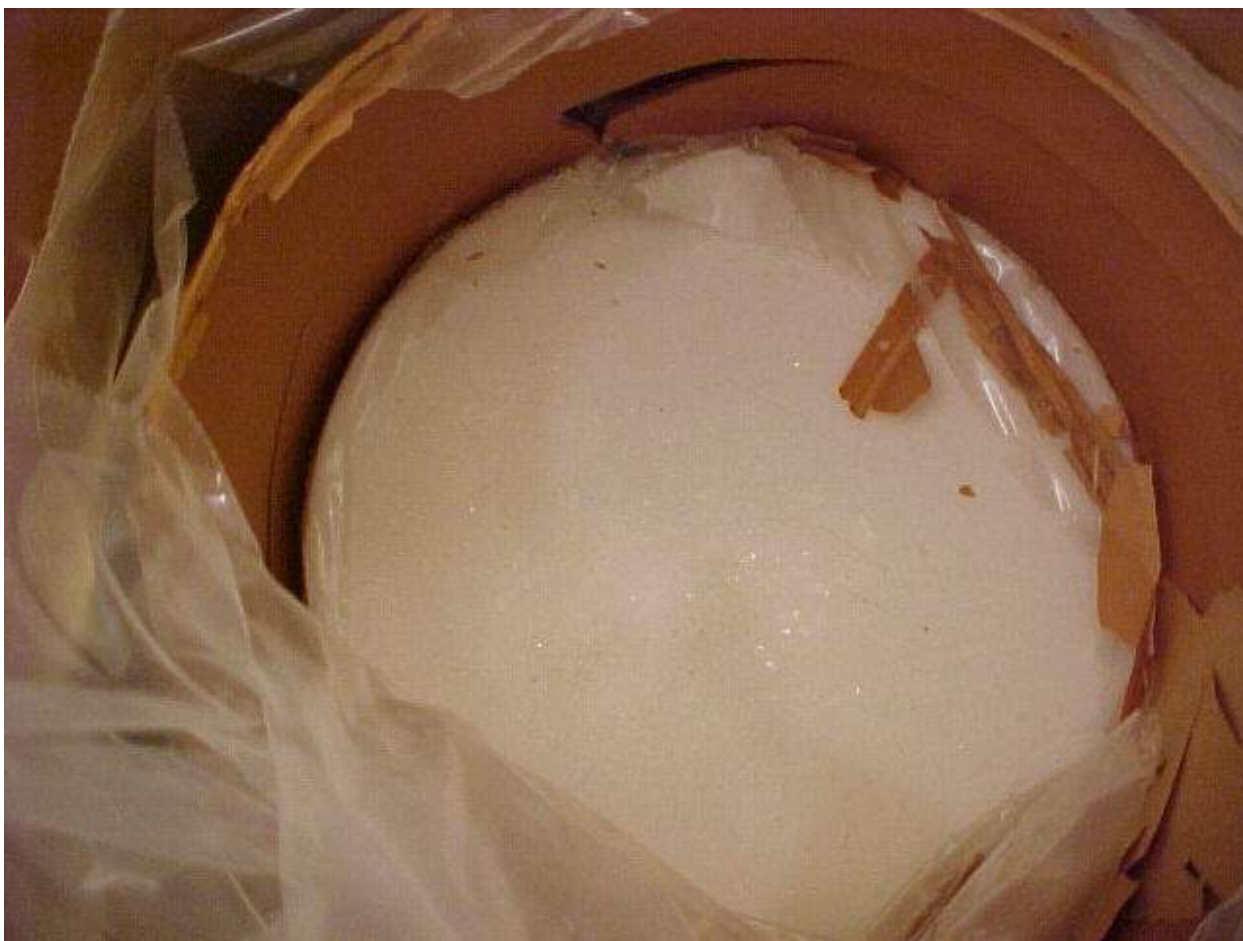
4th (final) poly liner/bag (thin film plastic) – good condition (picture shows ThN material following the removal of this liner/bag)
No gases present in breathing zone

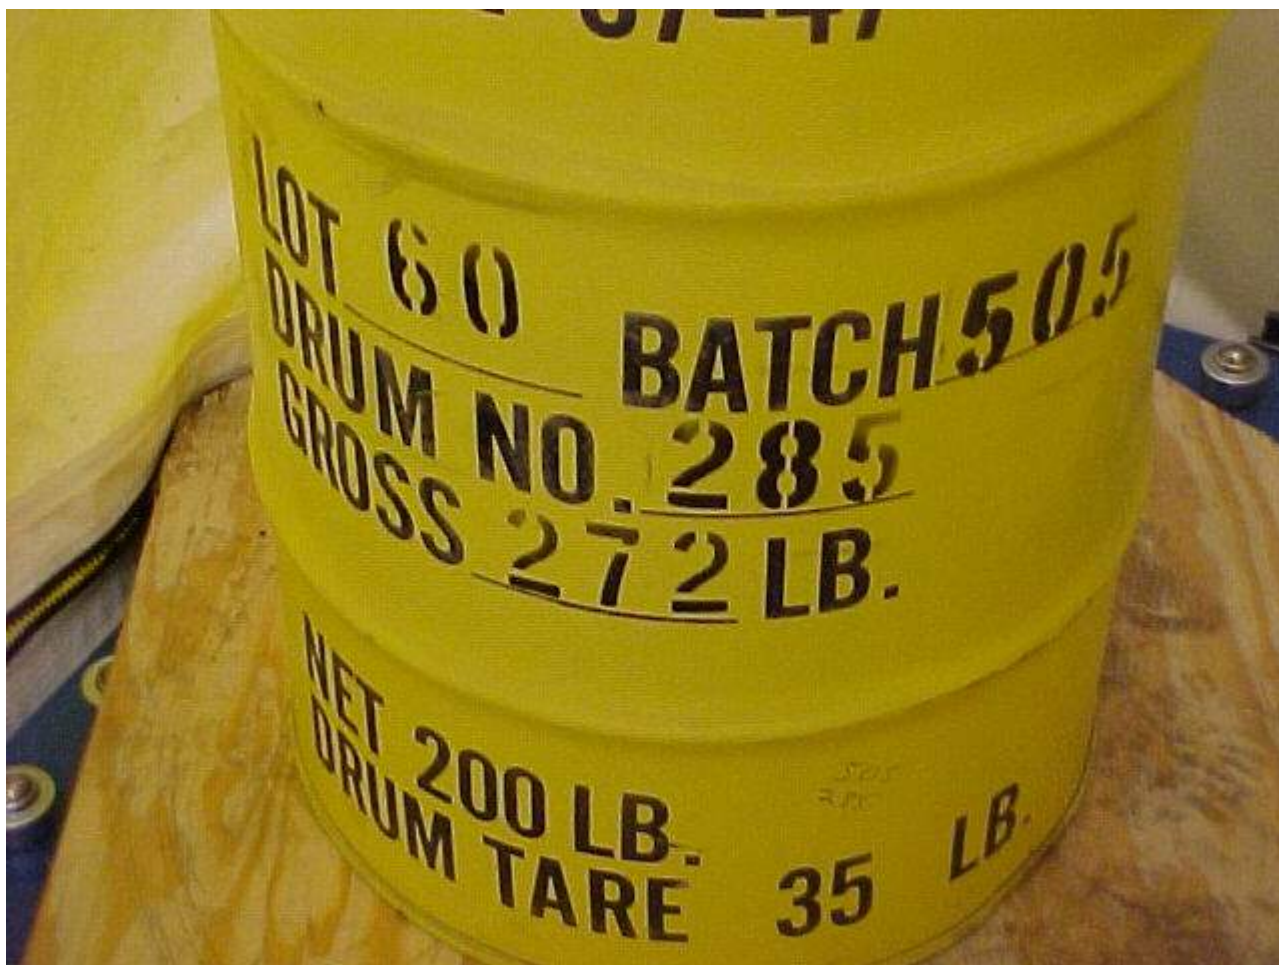
30-gal drum – good condition

Gases vented from container when and during drum ring removal

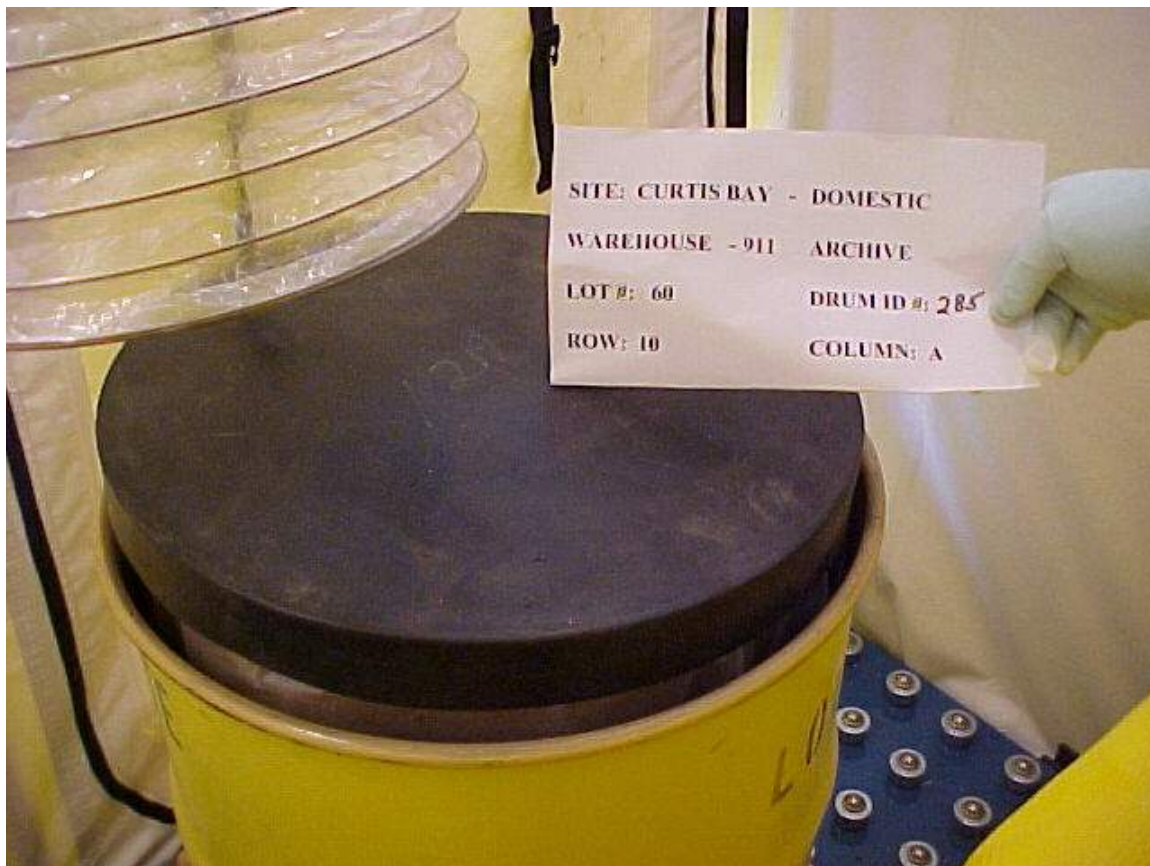
Open 30-gal drum – Black plastic drum lid (for drum liner) is visible – good condition
No gases present in breathing zone

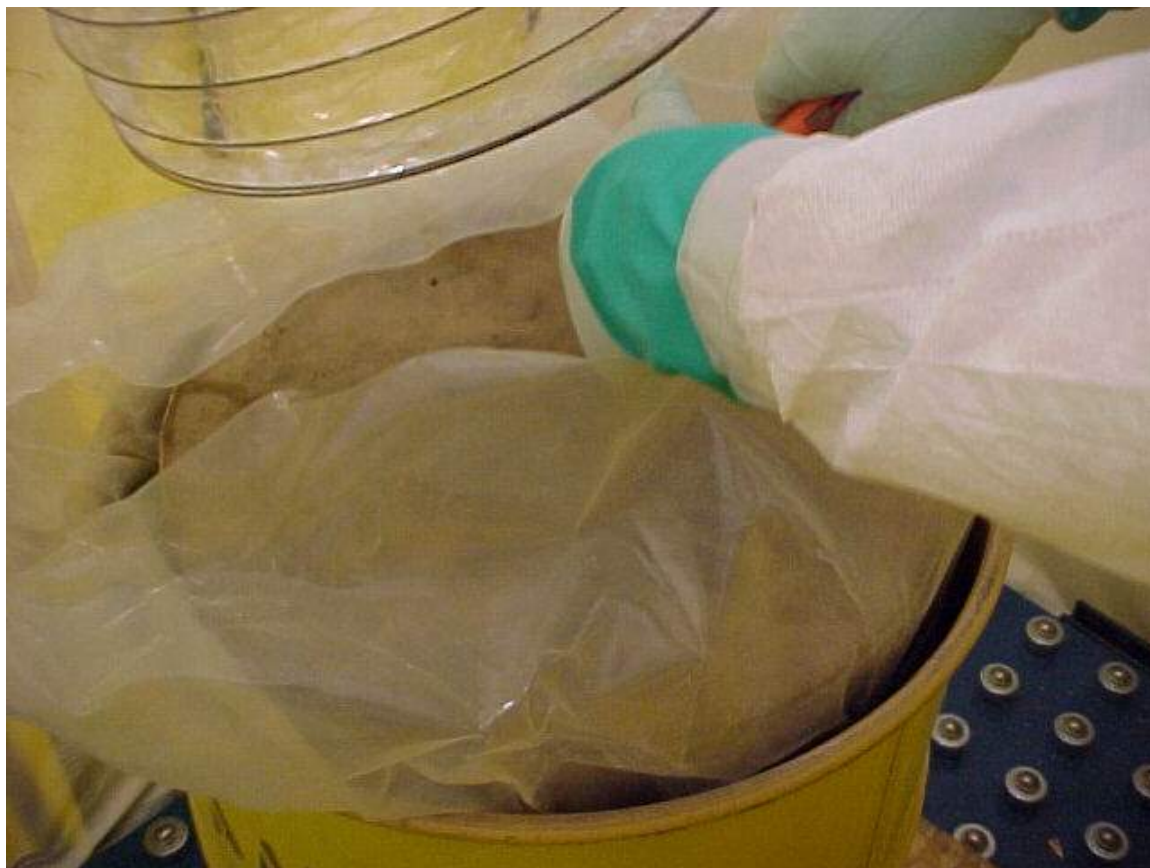
1st poly liner/bag – good condition (opening bag with utility knife)
No gases present in breathing zone

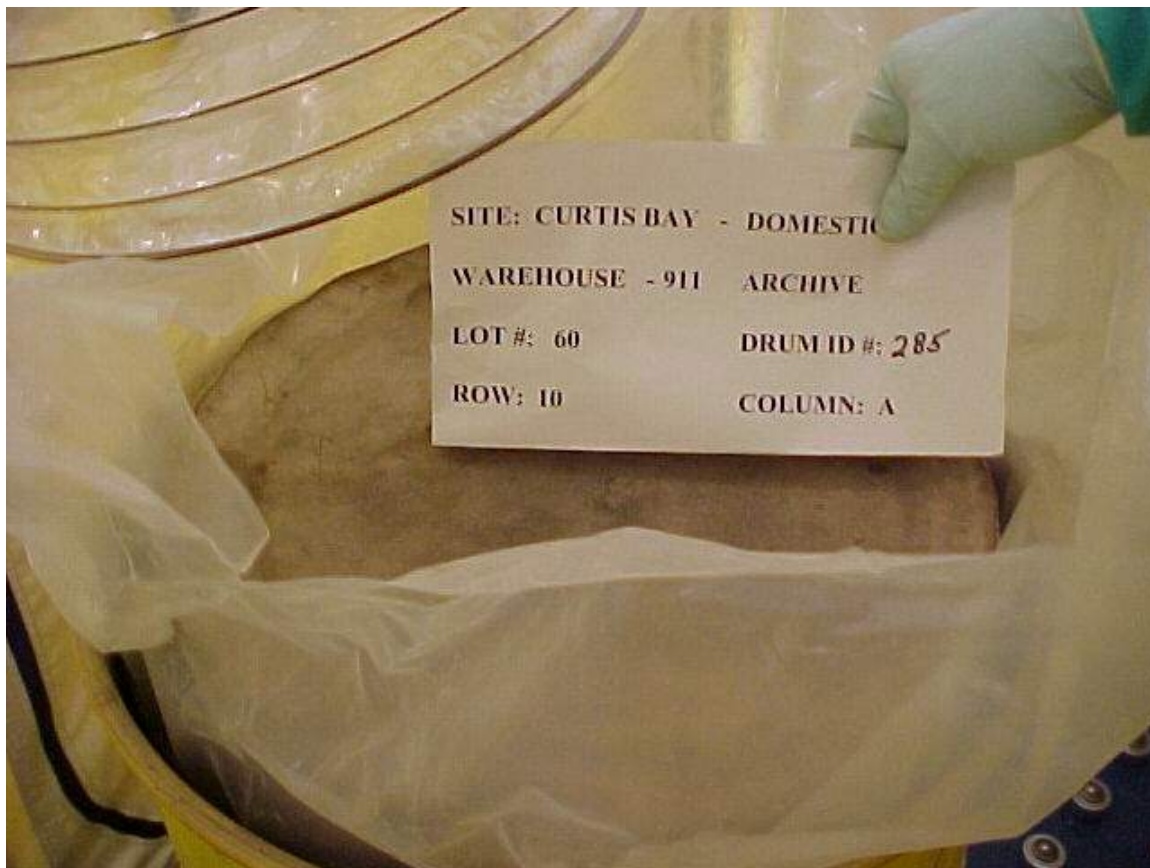
Picture shows the fiber drum lid (on outermost fiber drum) – good condition
No gases present in breathing zone

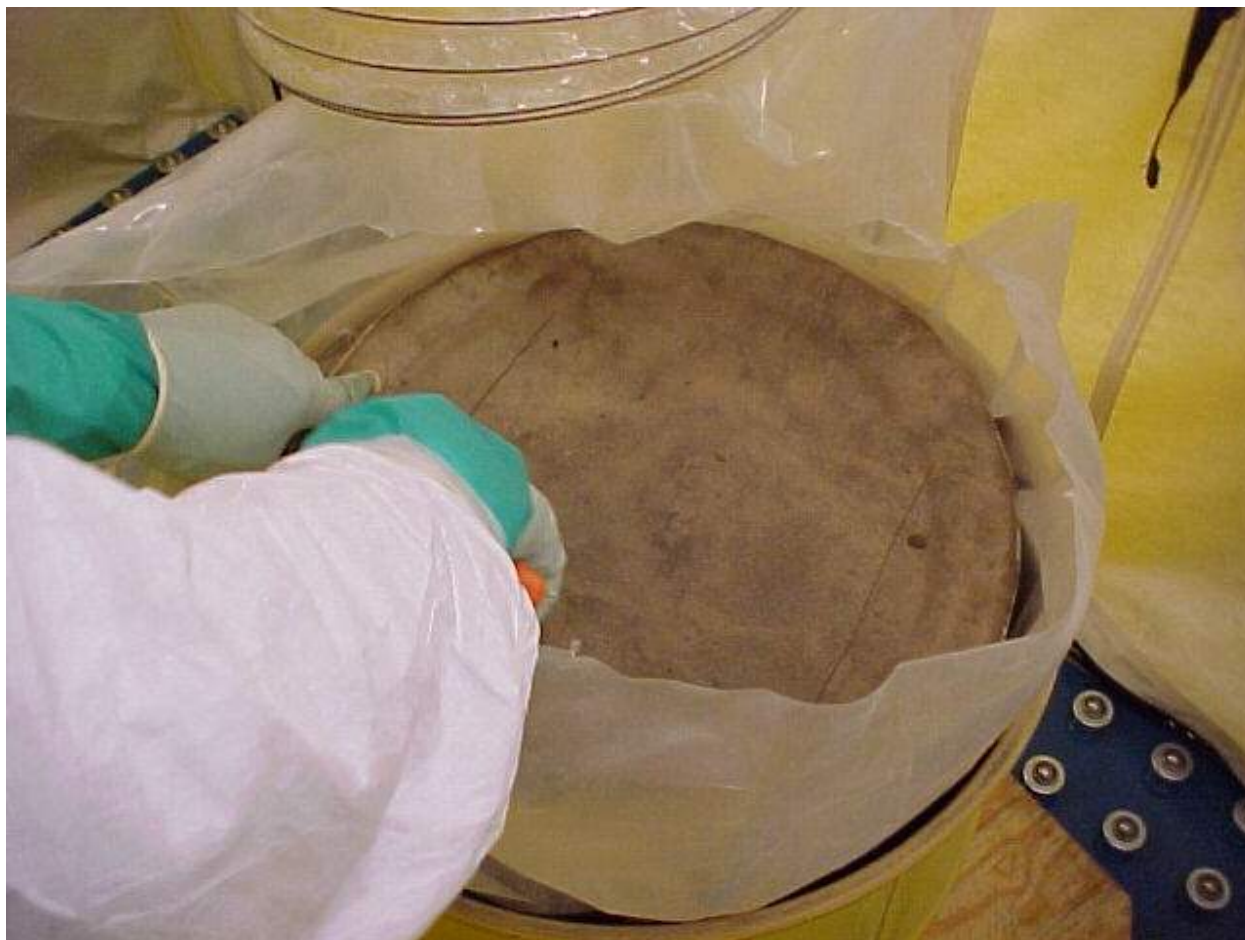
Fiber drum lid – Lid had to be cut off to complete lid removal
No gases present in breathing zone

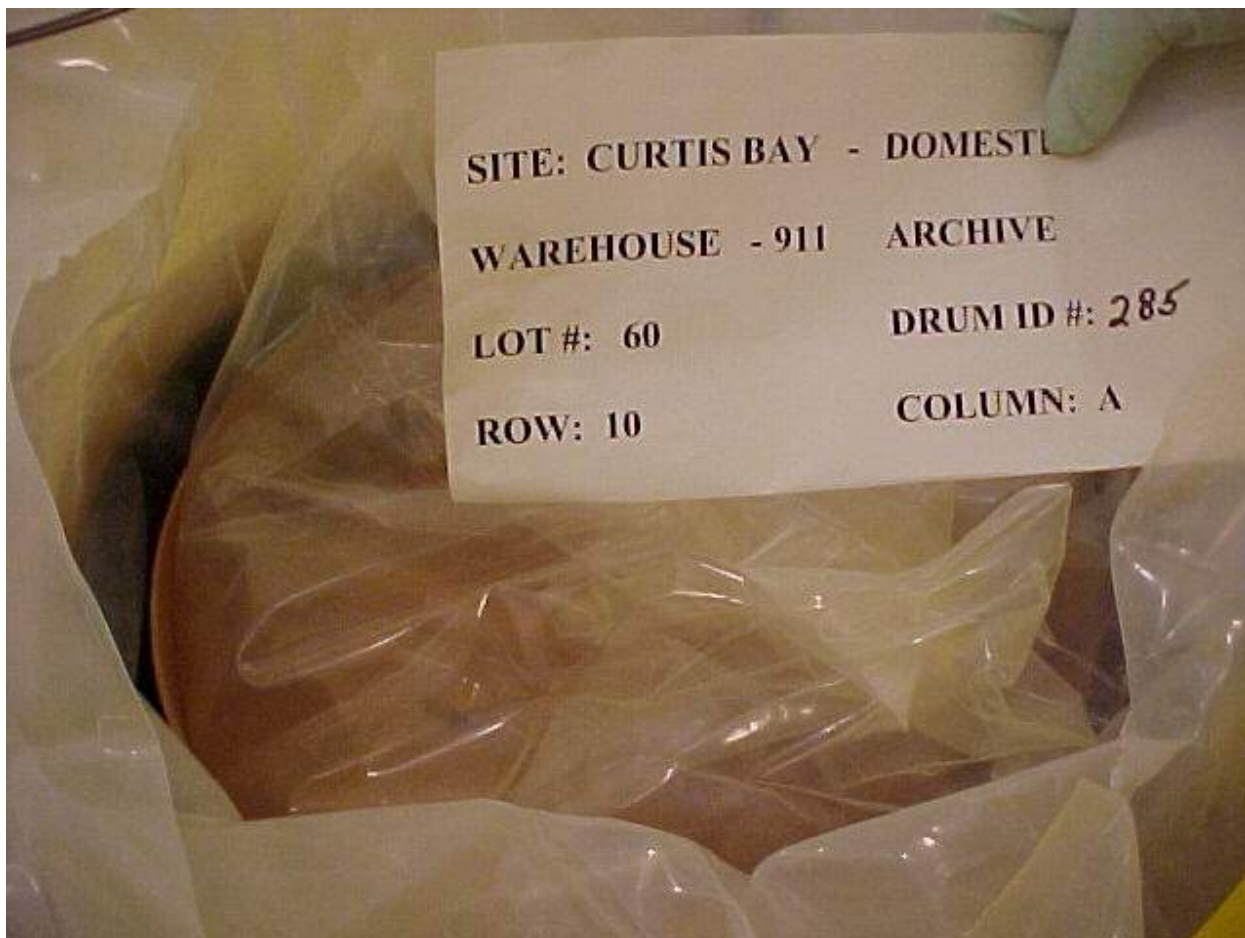
2nd poly liner/bag – good condition
No gases present in breathing zone

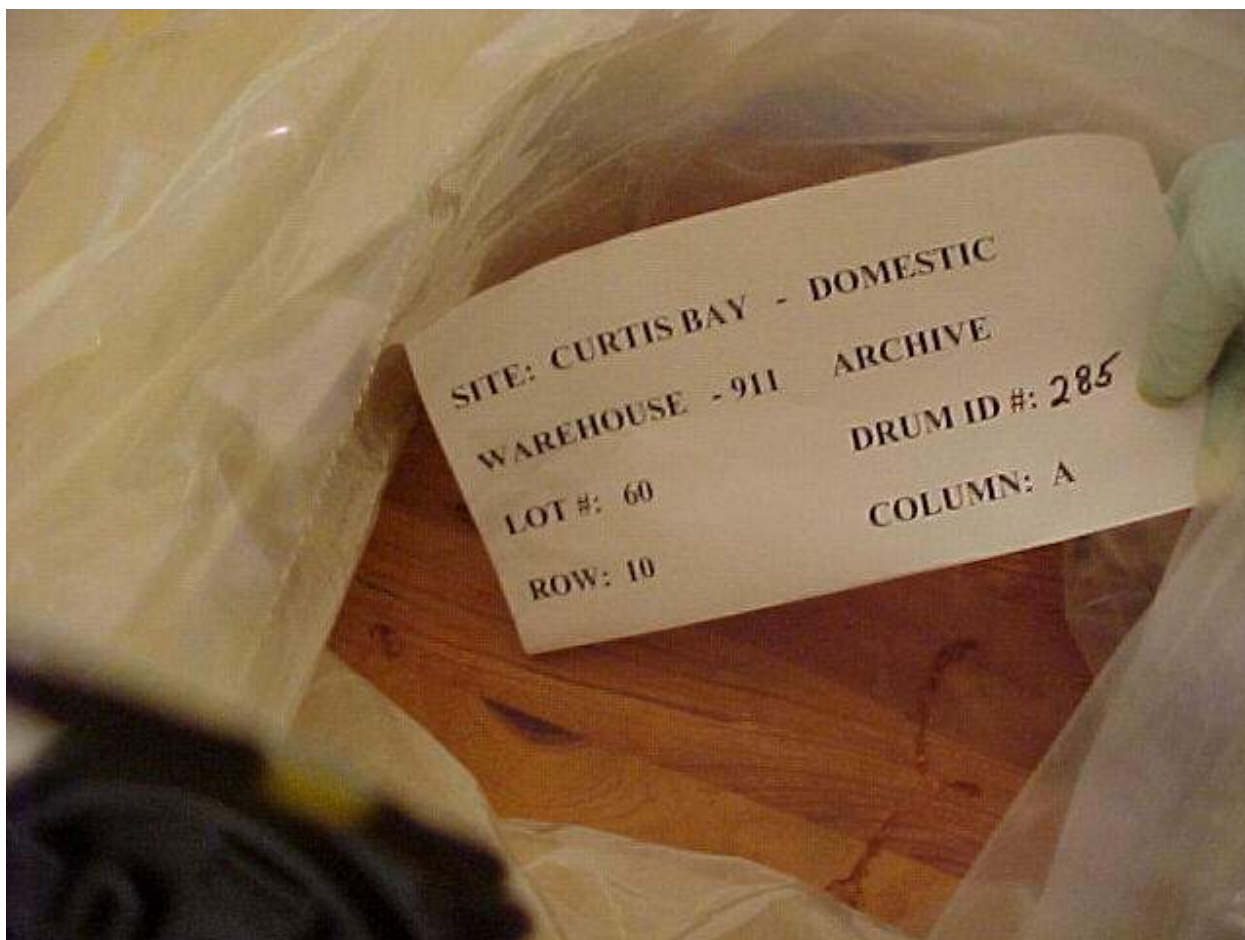
Wooden lid (mounted on inner fiber/lab-pack drum) good condition
