THORIUM NITRATE STOCKPILE DRUM CHARACTERIZATION REPORT

**THORIUM NITRATE STOCKPILE
DRUM CHARACTERIZATION REPORT**

Prepared for
U.S. Defense Logistics Agency
Defense National Stockpile Center
Fort Belvoir, Virginia

Prepared by
OAK RIDGE NATIONAL LABORATORY
Oak Ridge, Tennessee 37831
managed by
UT-BATTELLE, LLC
for the
U.S. DEPARTMENT OF ENERGY
under contract DE-AC05-00OR22725

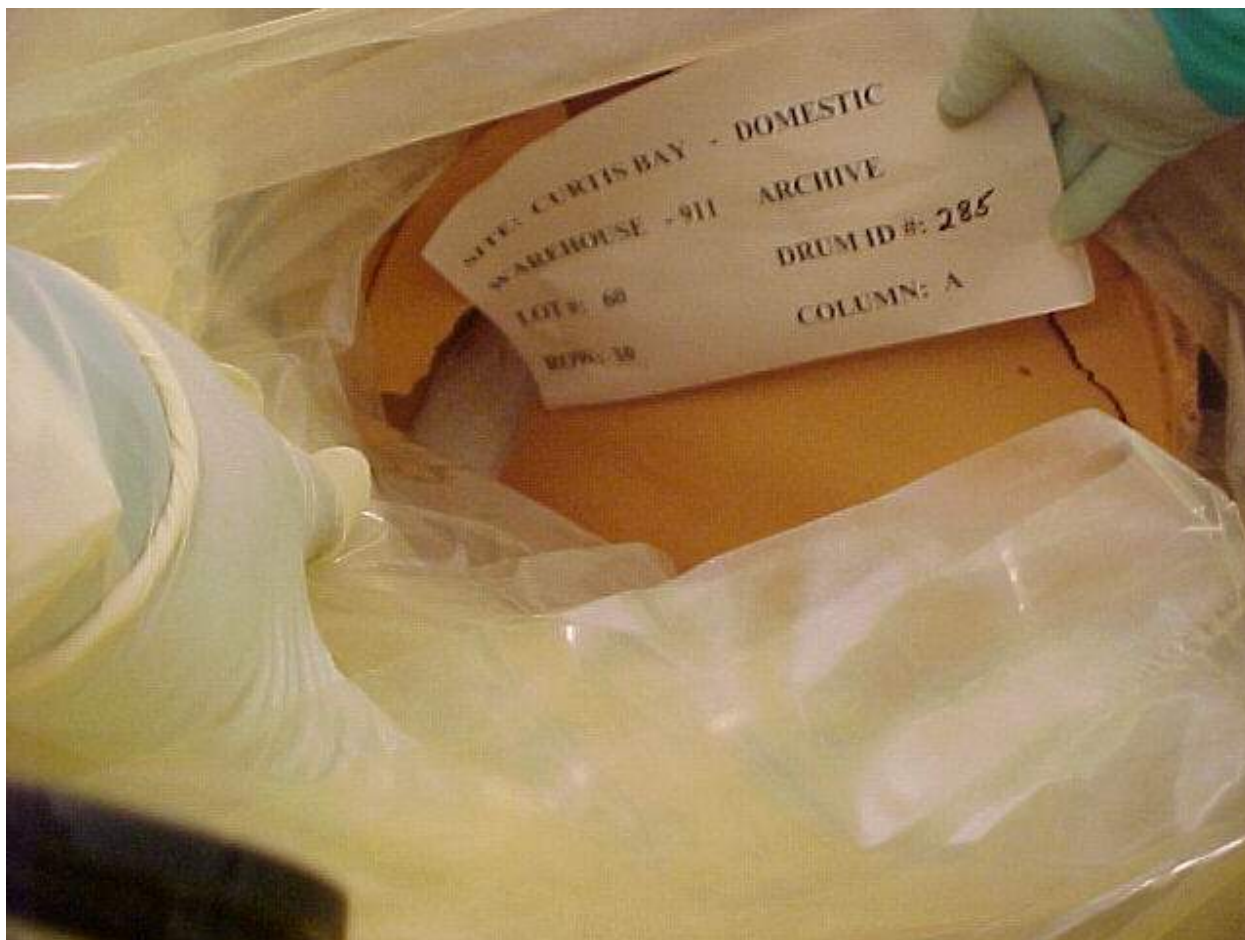
Picture shows the lab-pack paper layer/lid broken up and partially stuck on the wooden lid
No gases present in breathing zone

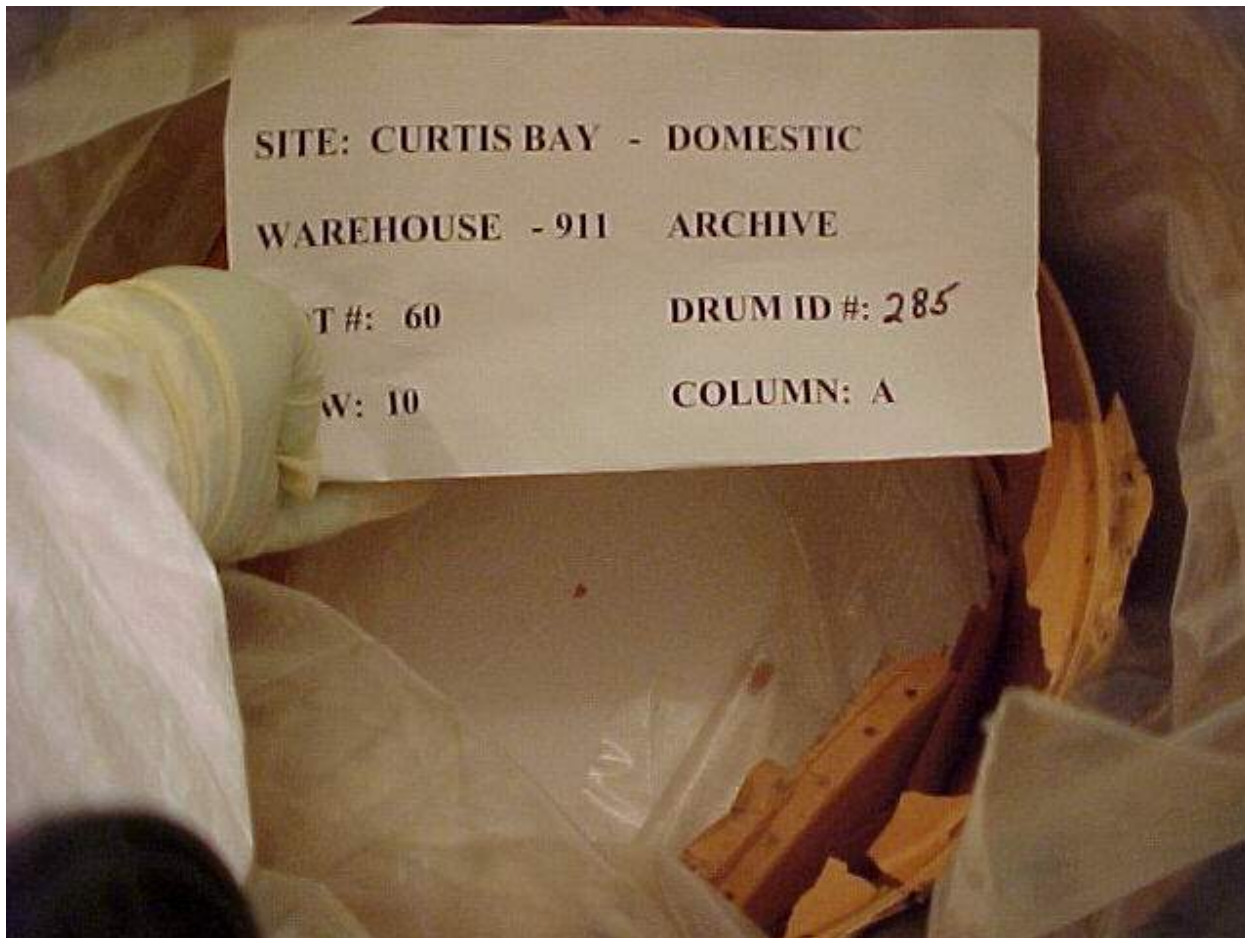
Picture shows final (4th) poly liner/bag in good condition
No gases present in breathing zone

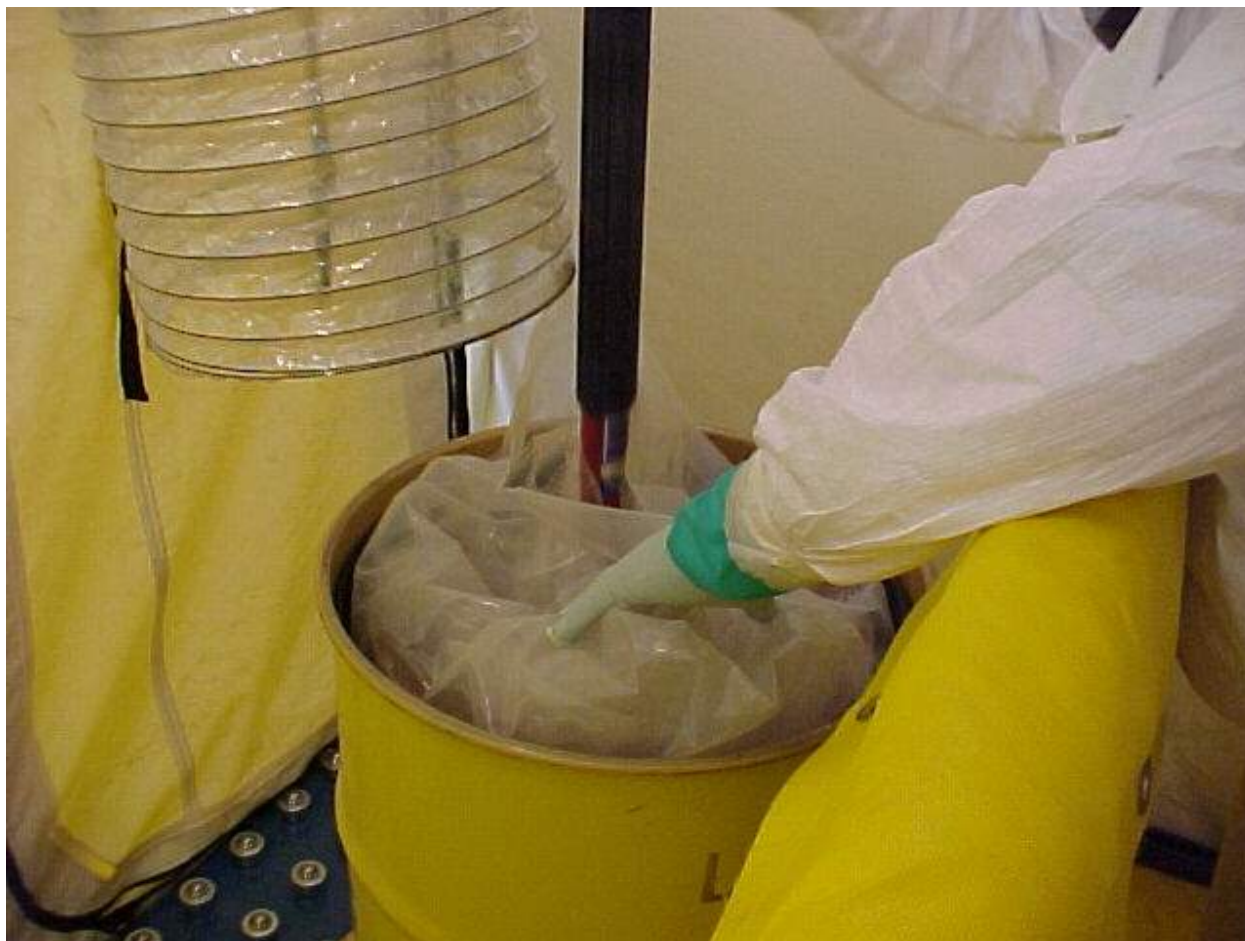
Open final plastic bag to access the ThN material – utilizing coring rig to hammer/crack the ThN into chunks for placement into the 2-liter container

Gases present in the drum headspace: NO – 8.7 ppm & NO_x – 37.2 ppm

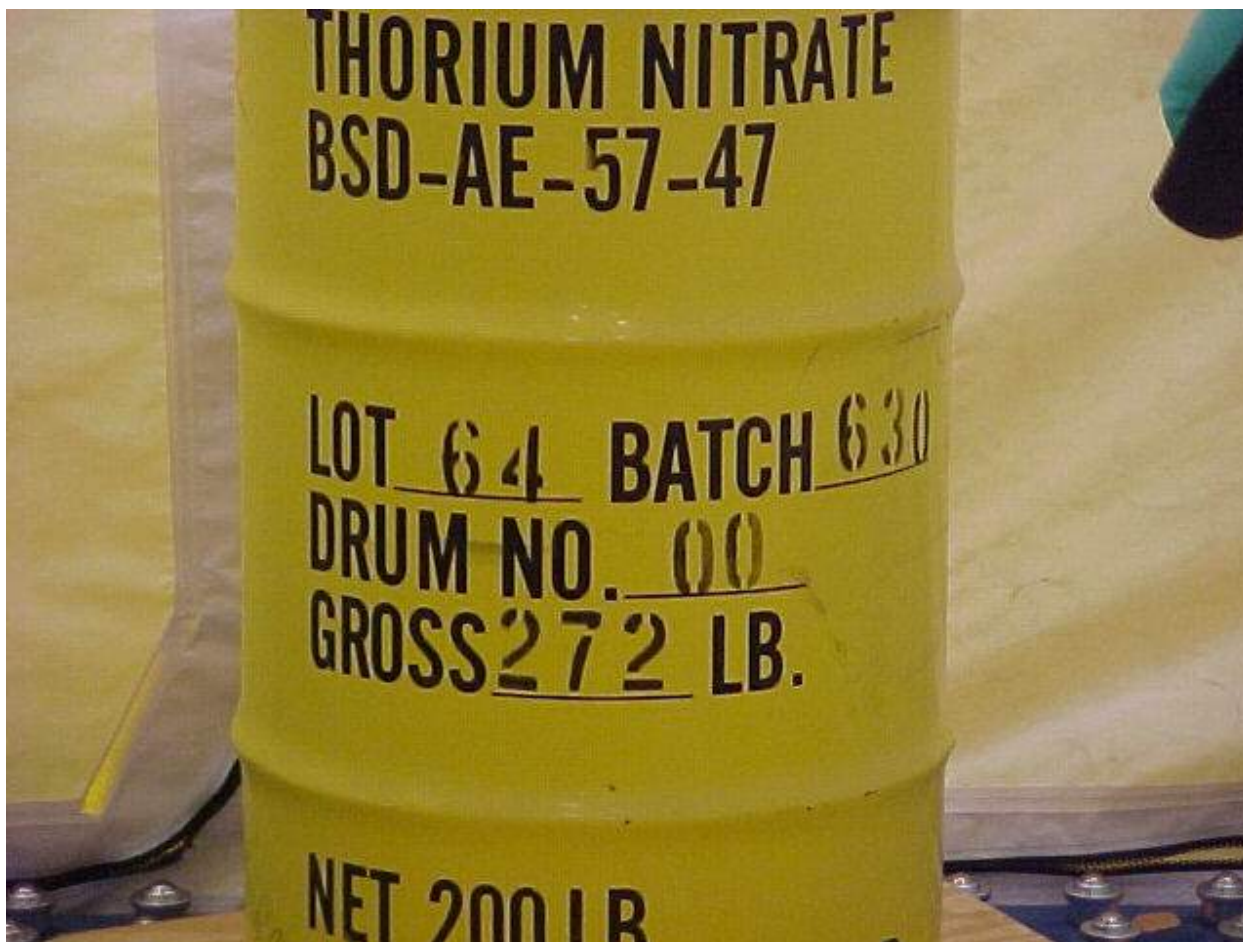
30-gal drum – good condition

Drum vented gas when initially loosening the bolt on the drum ring.

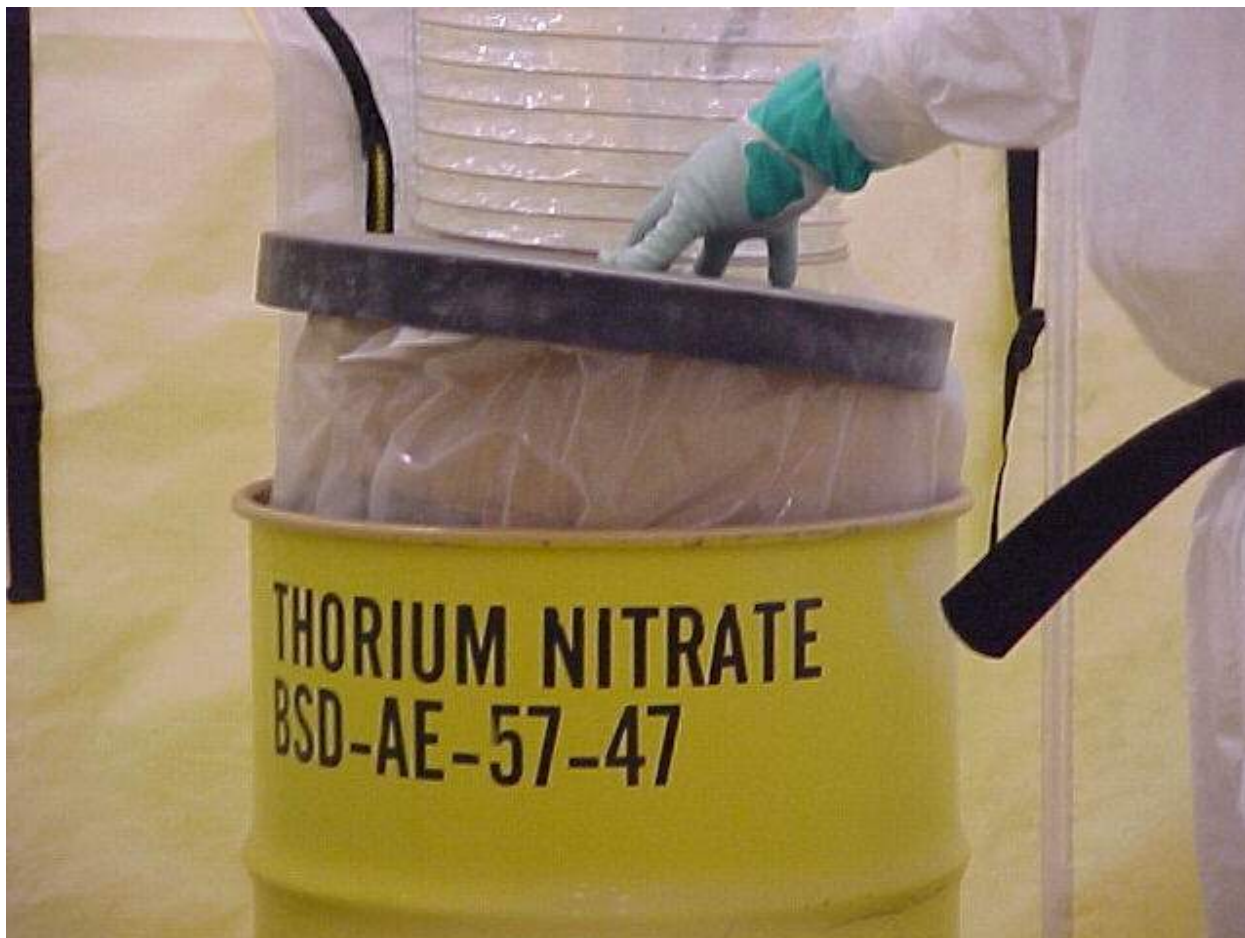
Black plastic lid (from inner drum liner) – good condition
Pressurized interior packaging raises the lid vertically out of the container.

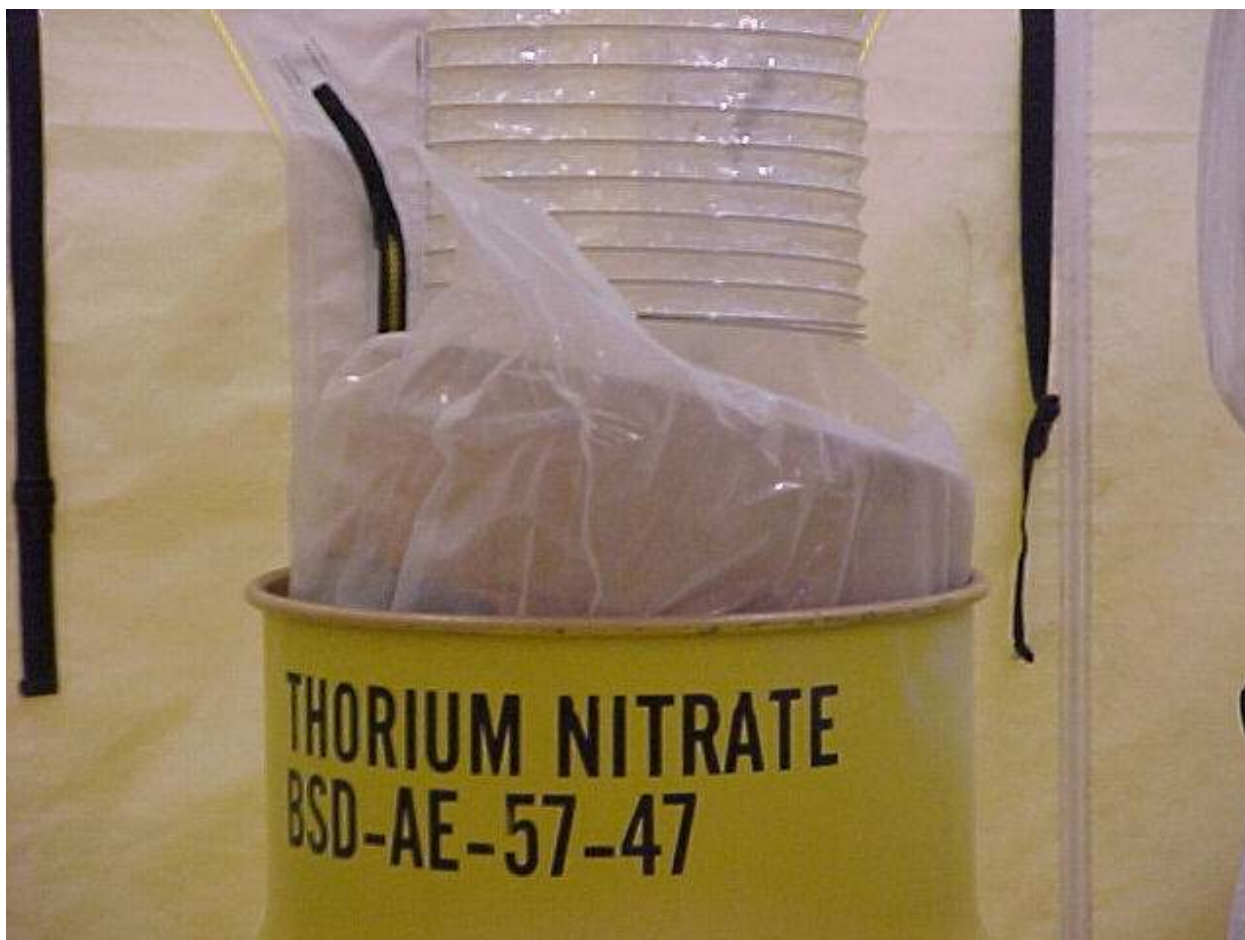
1st poly liner/bag – good condition
No gasses present in breathing zone

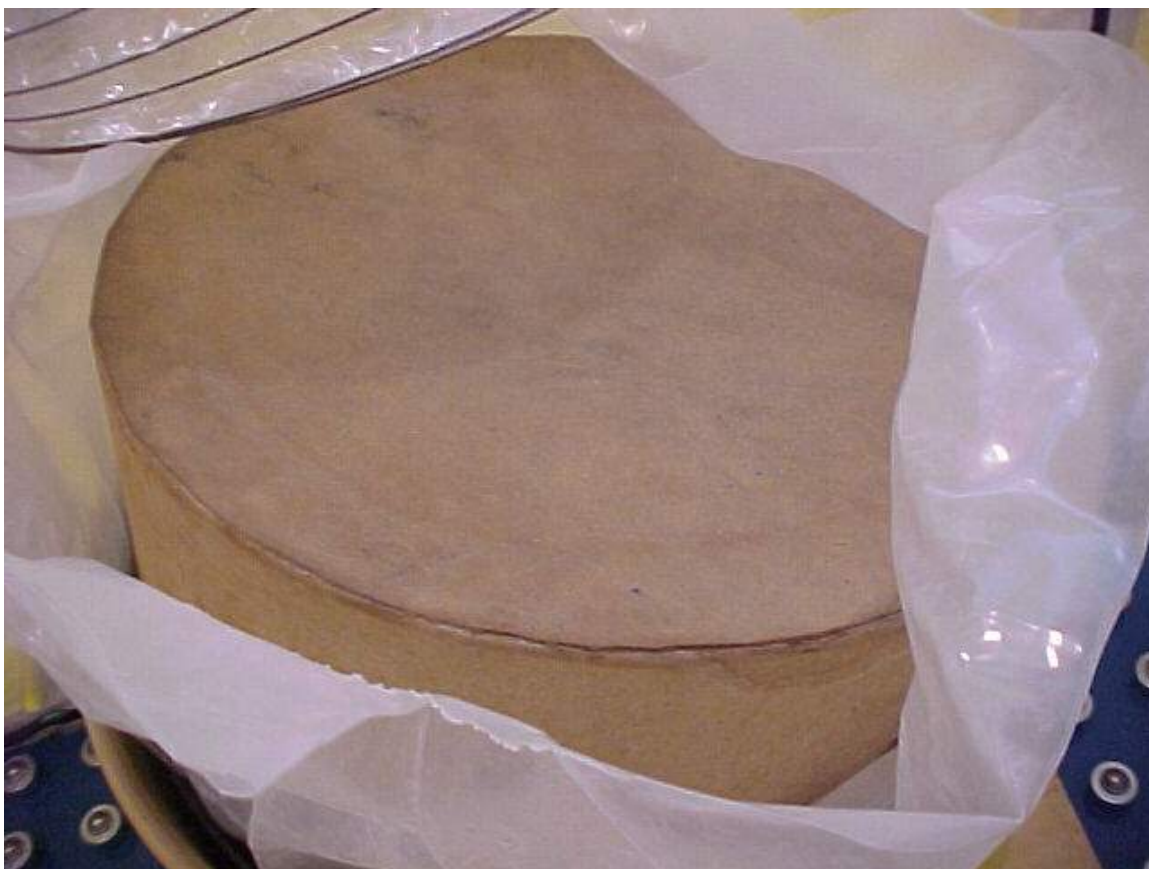
Fiber drum lid – good condition (Fiber drum typically taped to outermost fiber drum – interior pressure on one of the poly bags caused tape to separate)
No gasses present in breathing zone

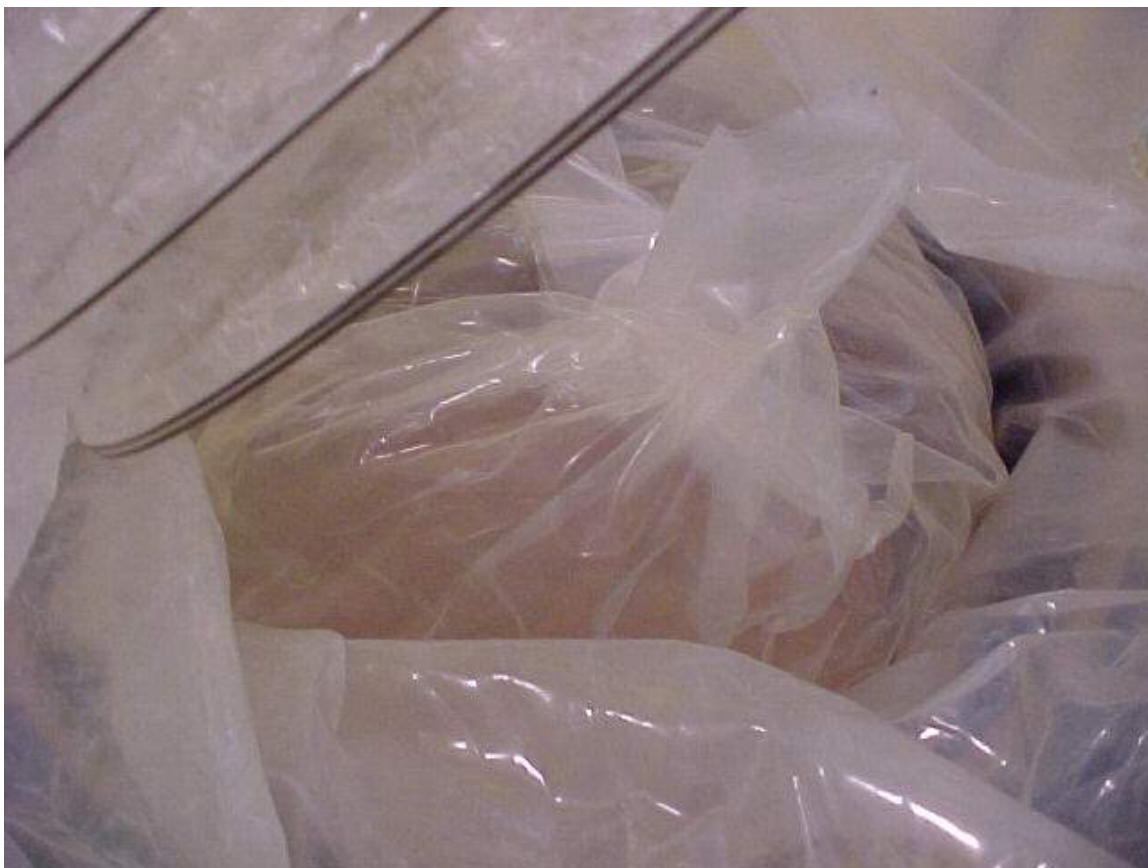
2nd poly liner/bag looking on top of the 3rd poly liner/bag
No gasses present in breathing zone

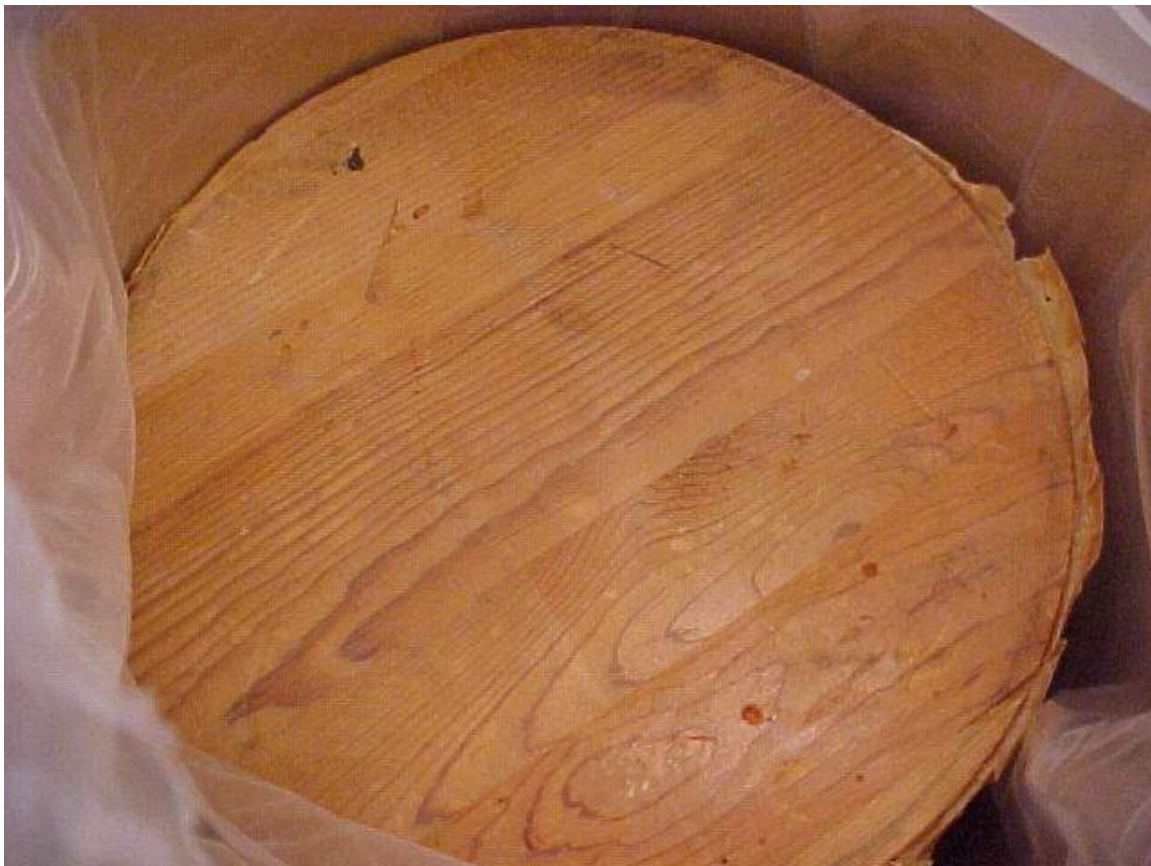
Wooden lid (mounted on inner fiber/lab-pack drum) – good condition
No gasses present in breathing zone

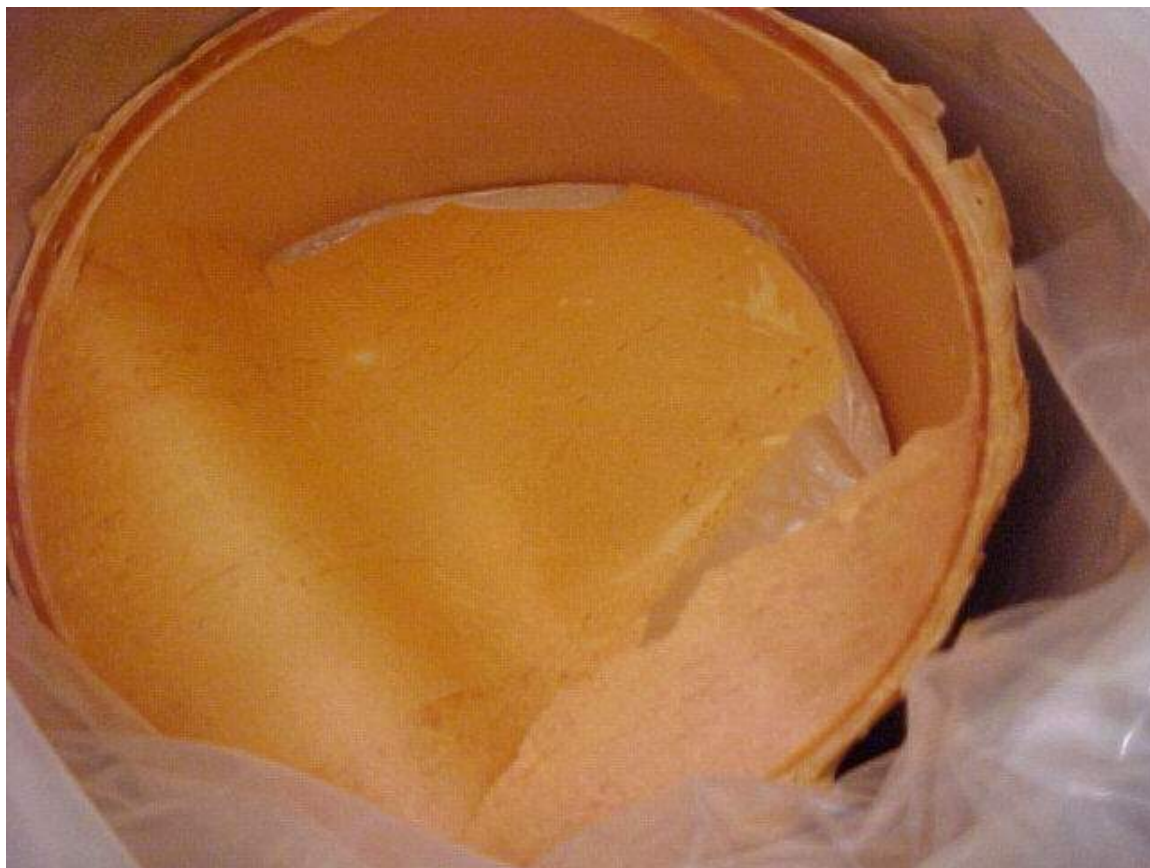
The lab-pack paper layer lid pulled off when the wooden lid was removed.
No gasses present in breathing zone

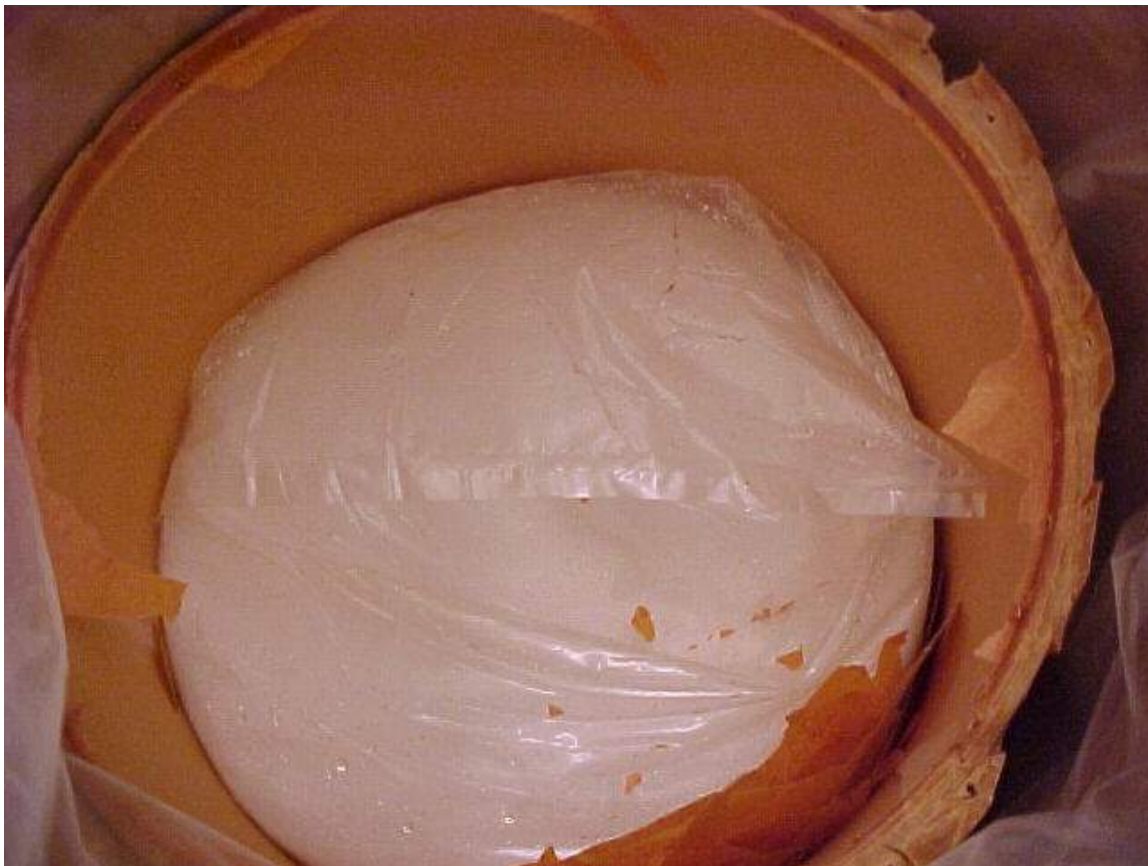
4th poly liner/bag – good condition (thin film plastic)
No gasses present in breathing zone

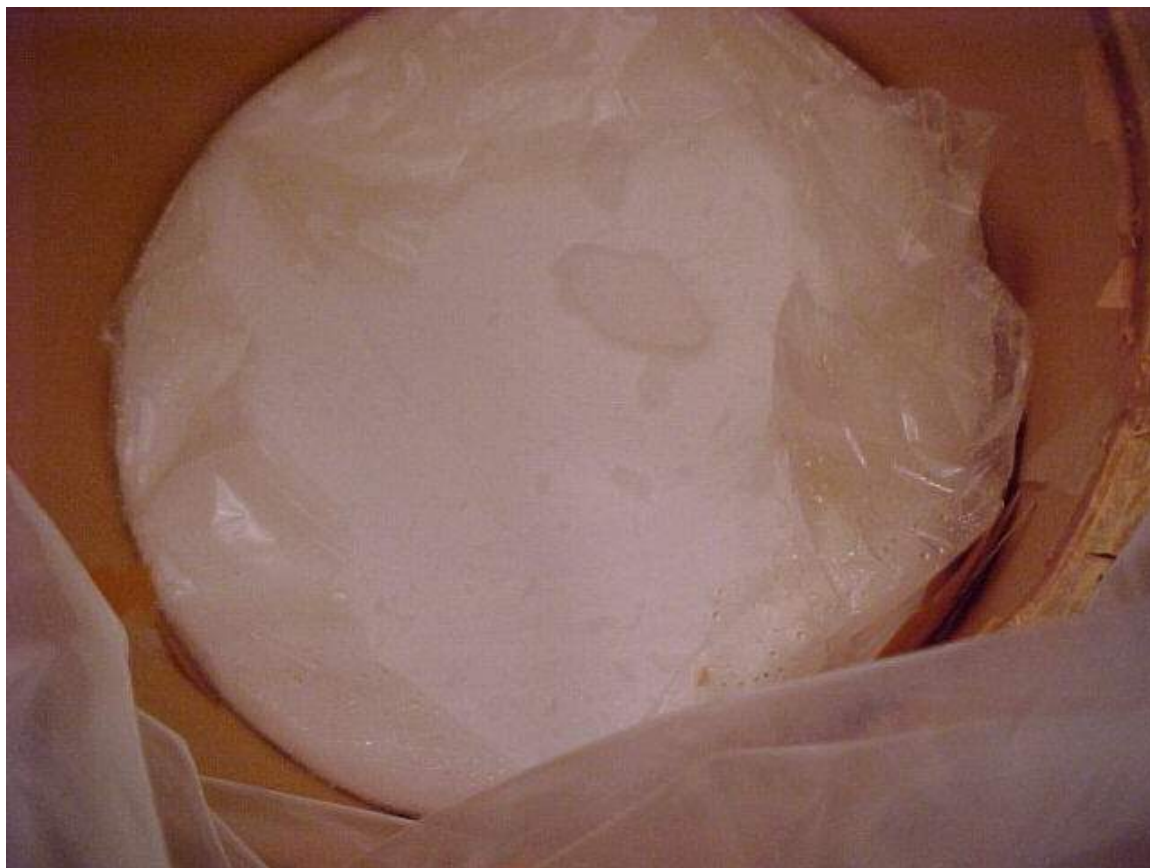
ThN material – white, solid, monolith, dry
No gasses present in breathing zone

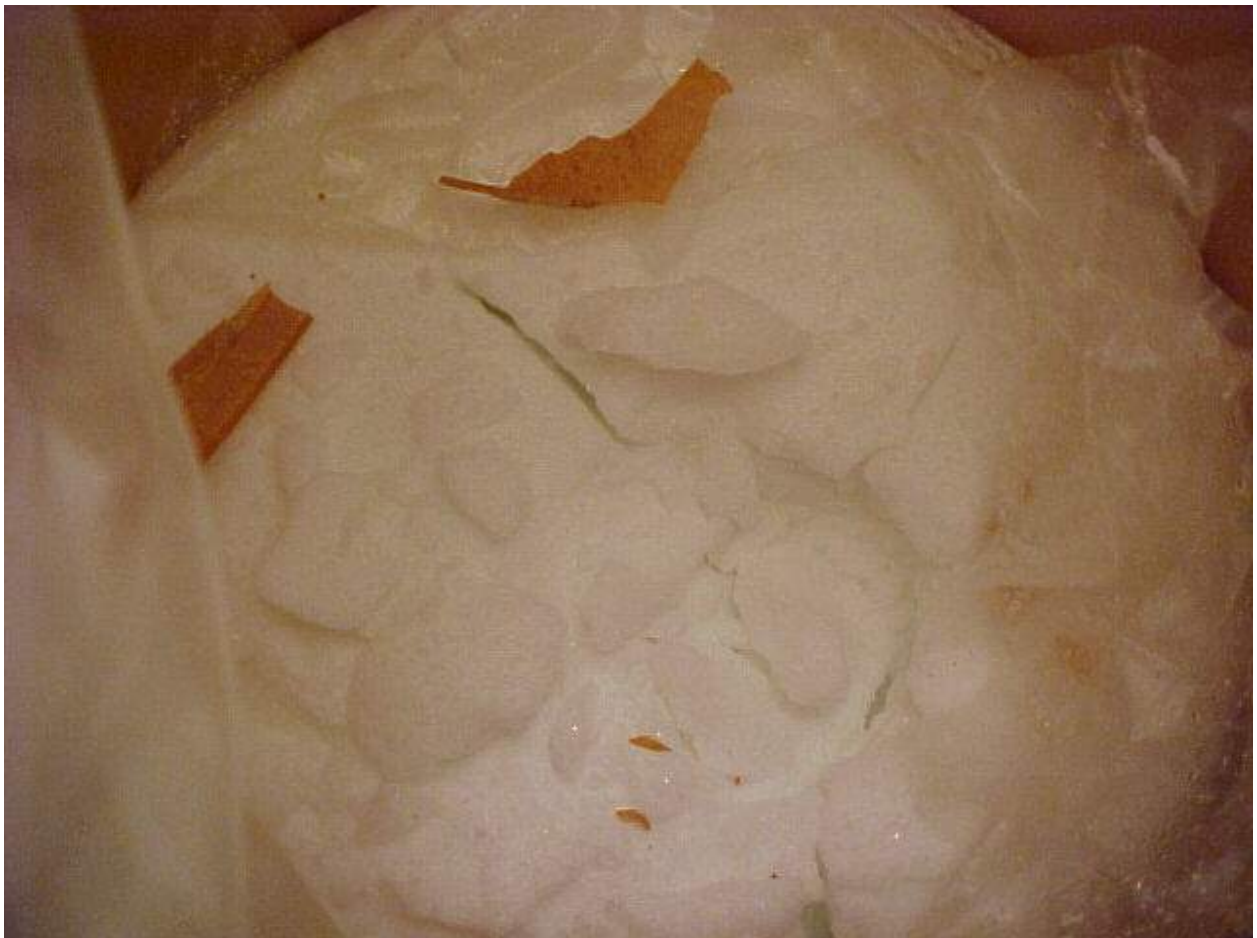
A picture of the sample after it was broken up with sampling tool to collect “chunk” samples
No gasses present in breathing zone

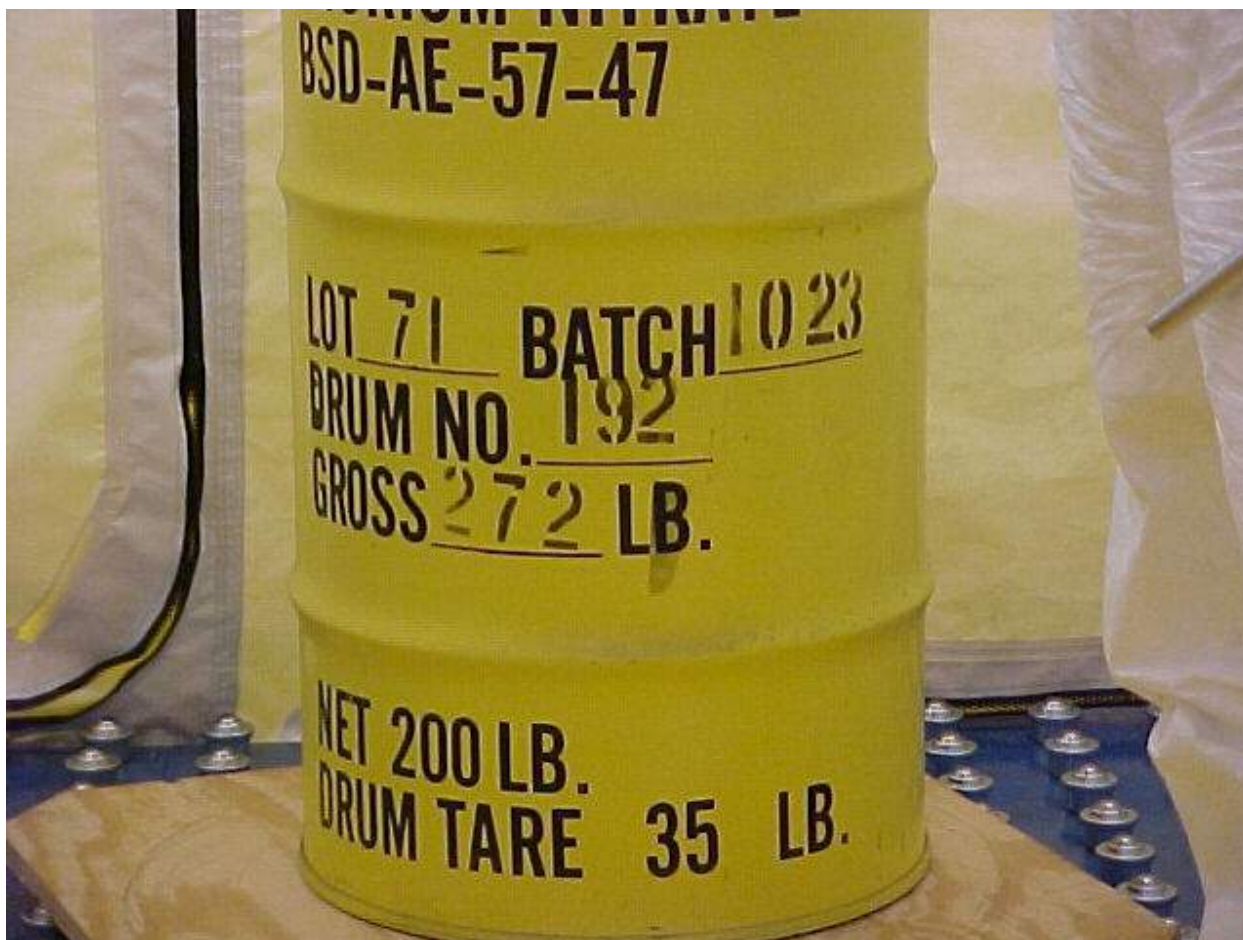
30-gal drum – good condition

Gases vented from drum when bolt on drum ring was loosened.

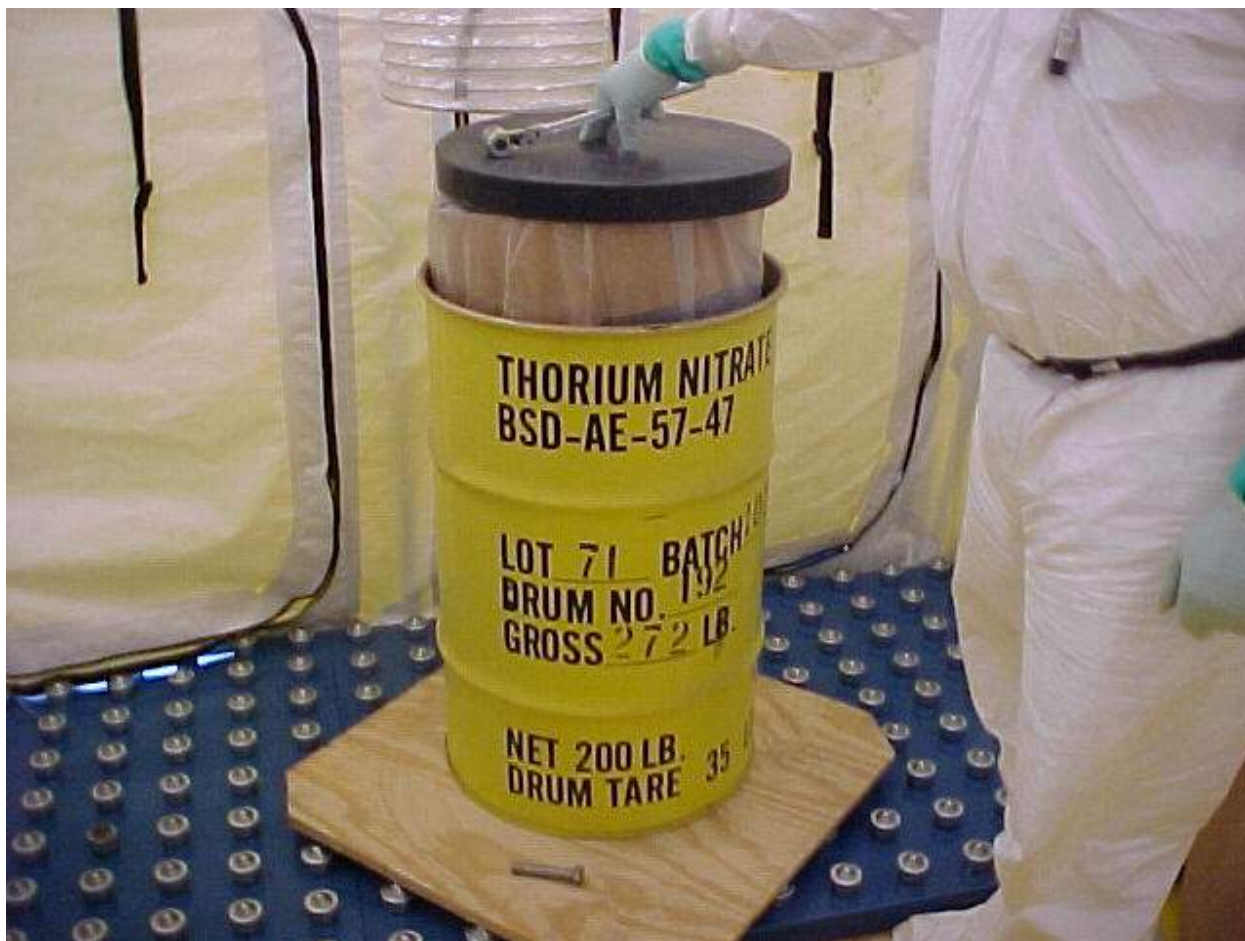
Black plastic lid (from inner drum liner) – raised lid indicates gas pressure buildup in one of the inner packaging layers in the drum – lid – good condition
No gases present in breathing zone.

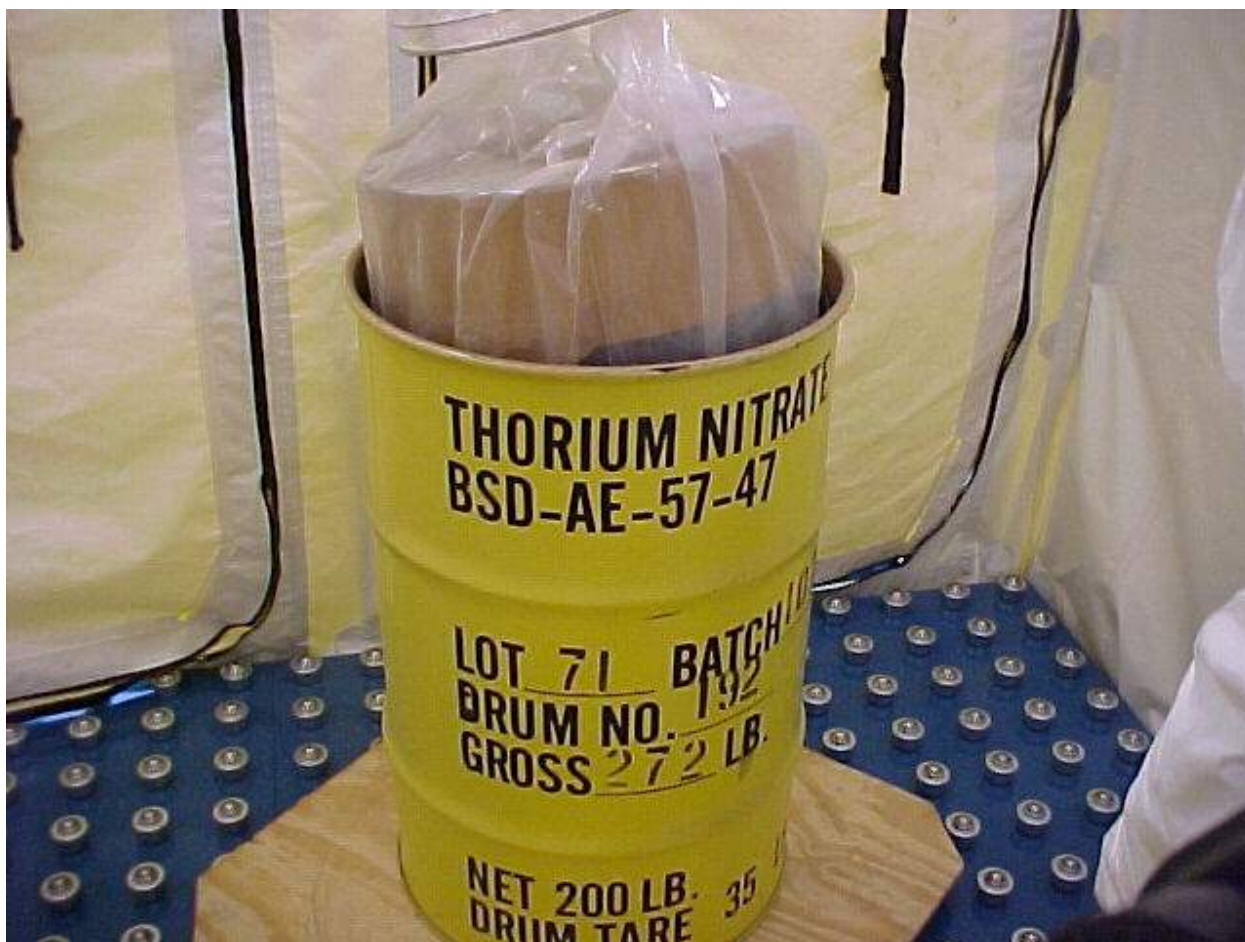
Another picture showing the pressure buildup in the drum – 1st poly liner/bag
No gases present in breathing zone.

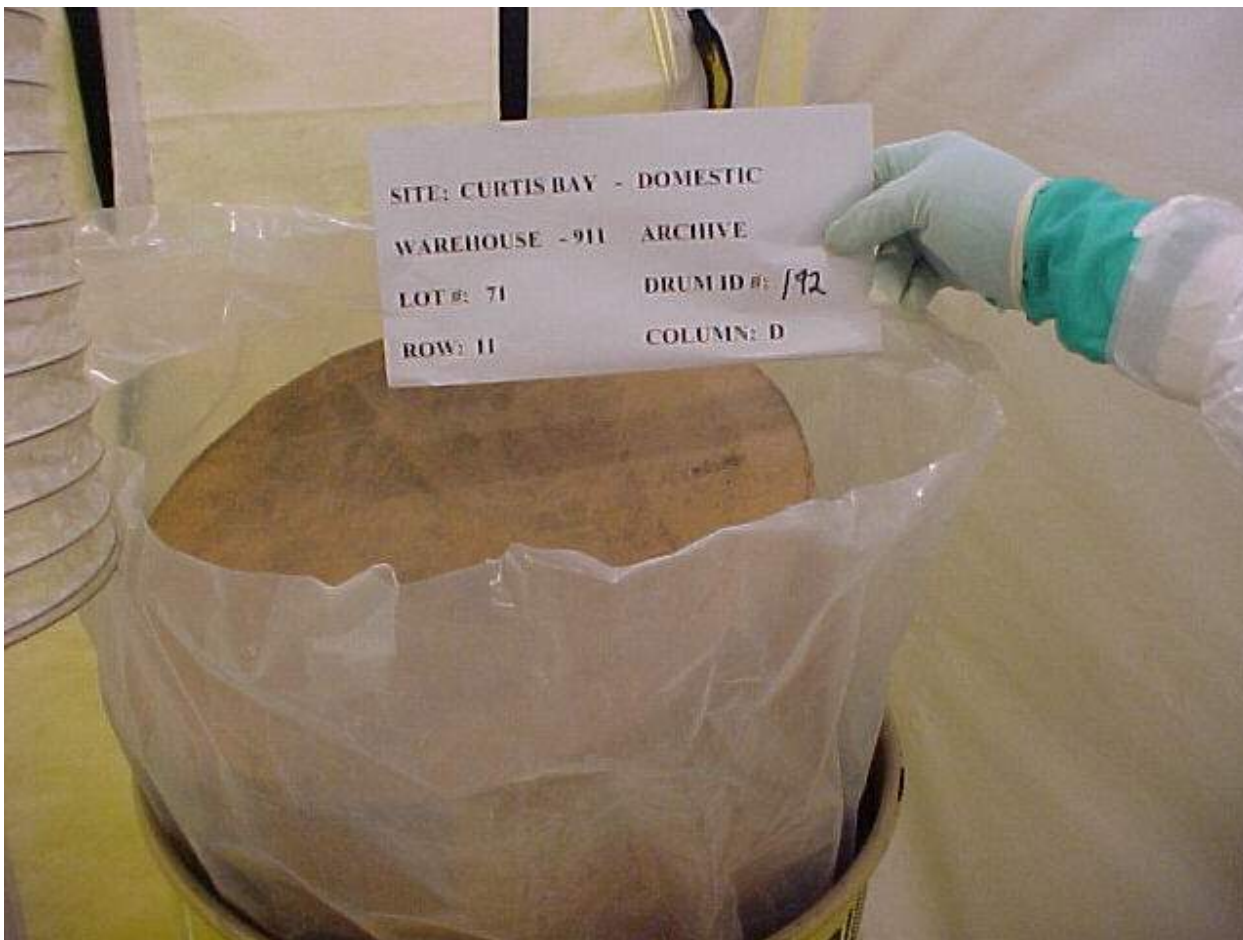
Fiber drum lid (after opening 1st poly liner/bag) – fiber lid good condition
No gases present in breathing zone.

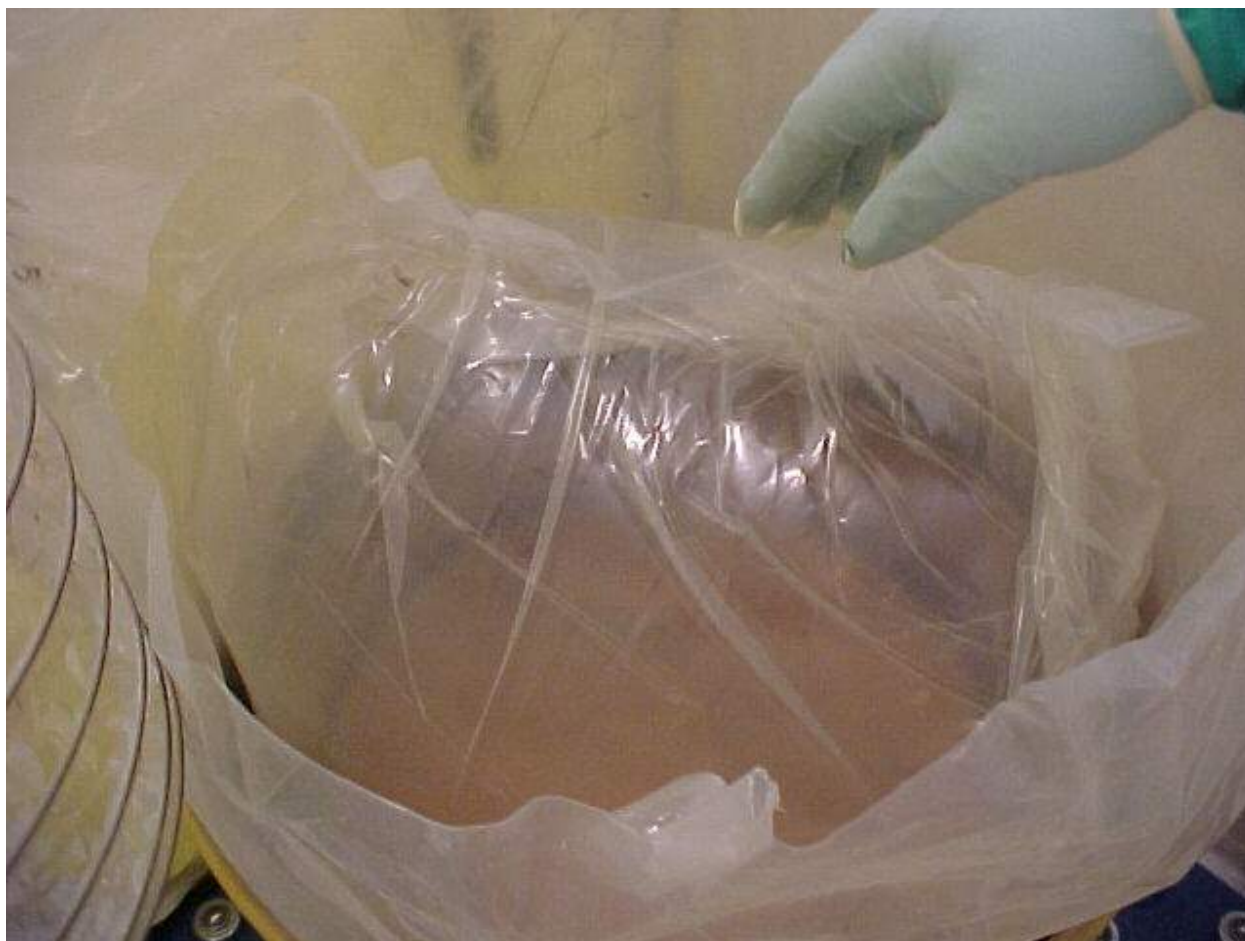
2nd poly liner/bag cut open – 3rd poly liner/bag shows significant pressure buildup – bag in good condition

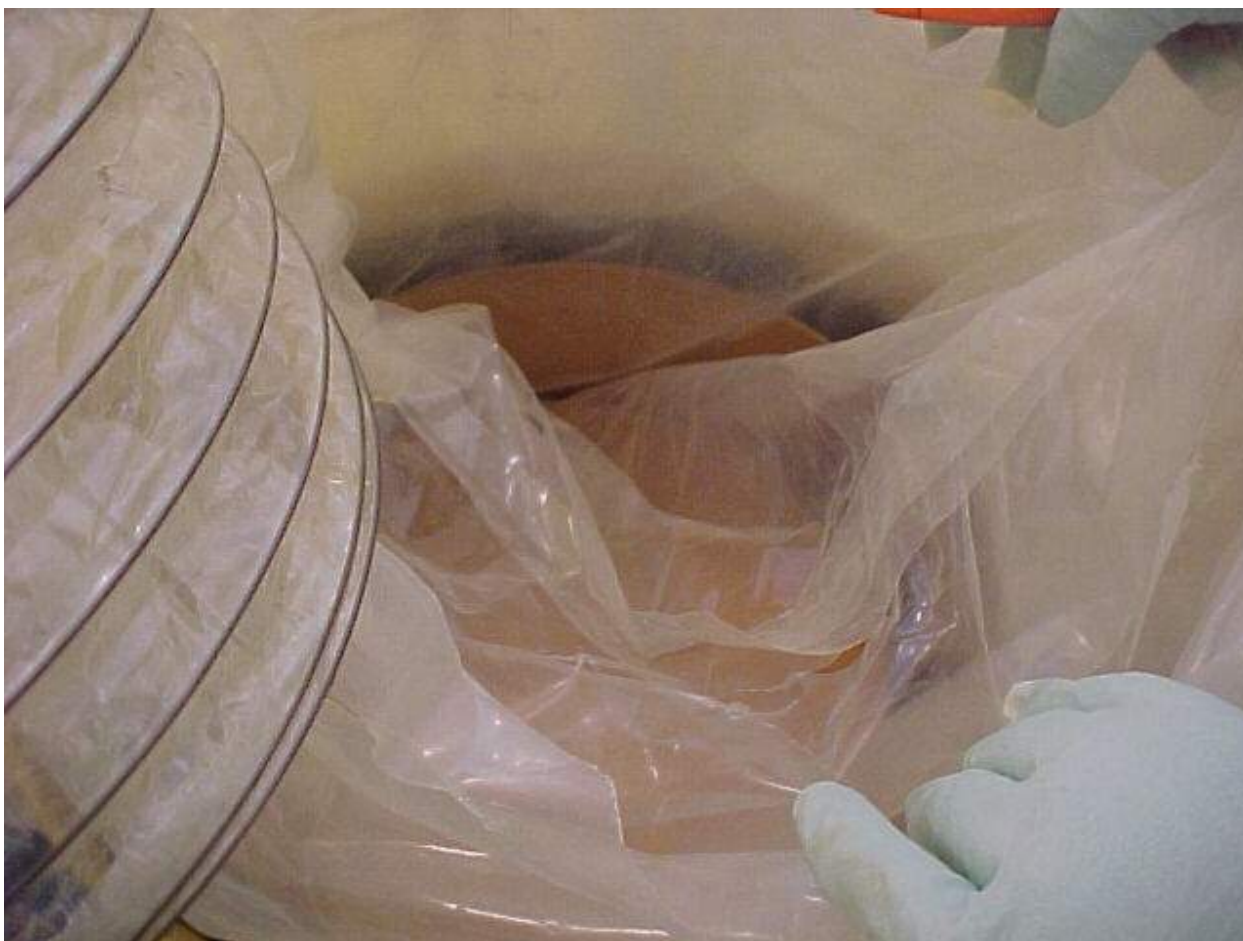
Cut open 3rd liner/bag – good condition – HEPA exhaust evacuated gases that had built up inside of bag.

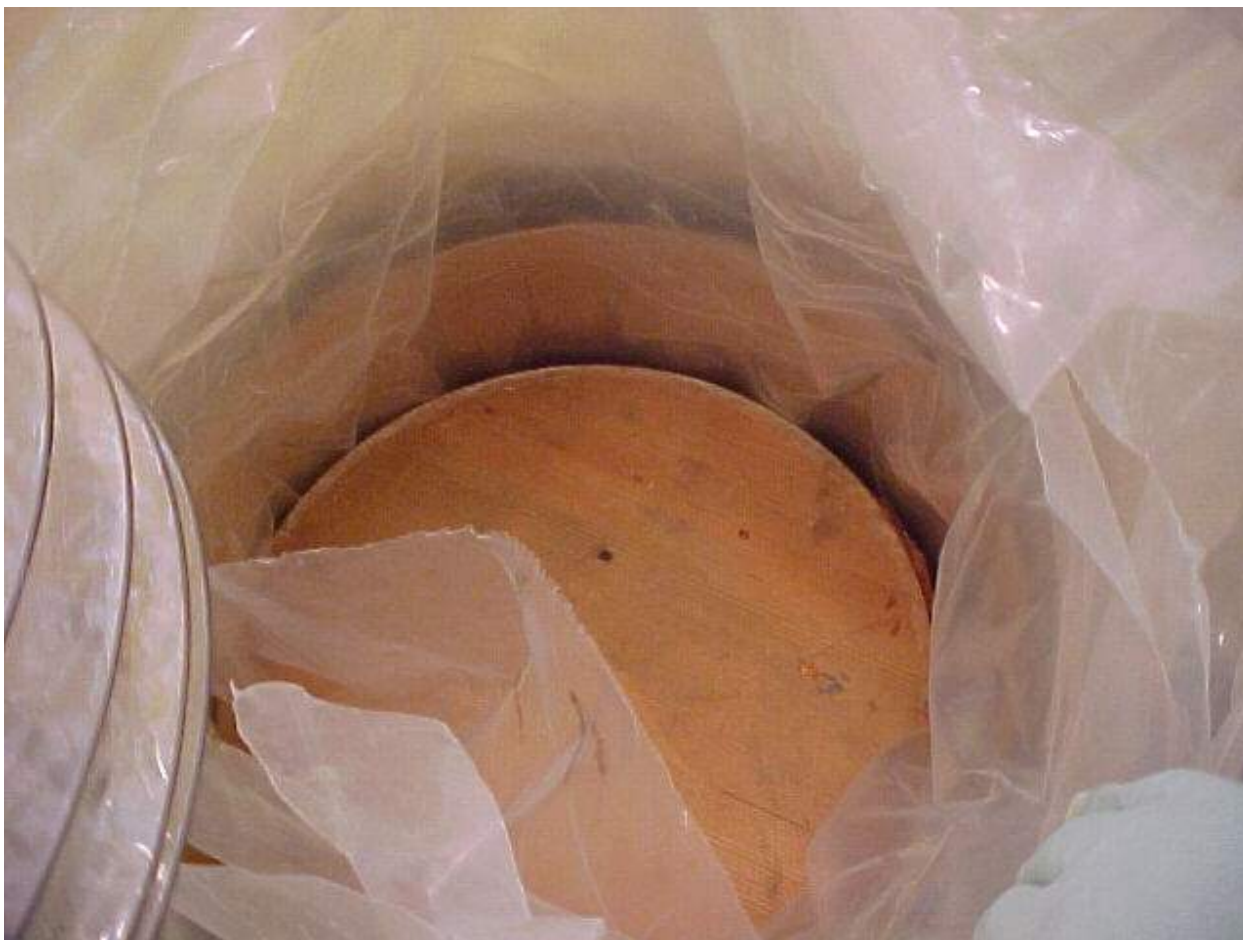
Wooden lid (mounted on inner fiber/lab-pack drum) – good condition
No gases present in breathing zone.
