THORIUM NITRATE STOCKPILE DRUM CHARACTERIZATION REPORT

**THORIUM NITRATE STOCKPILE
DRUM CHARACTERIZATION REPORT**

Prepared for
U.S. Defense Logistics Agency
Defense National Stockpile Center
Fort Belvoir, Virginia

Prepared by
OAK RIDGE NATIONAL LABORATORY
Oak Ridge, Tennessee 37831
managed by
UT-BATTELLE, LLC
for the
U.S. DEPARTMENT OF ENERGY
under contract DE-AC05-00OR22725

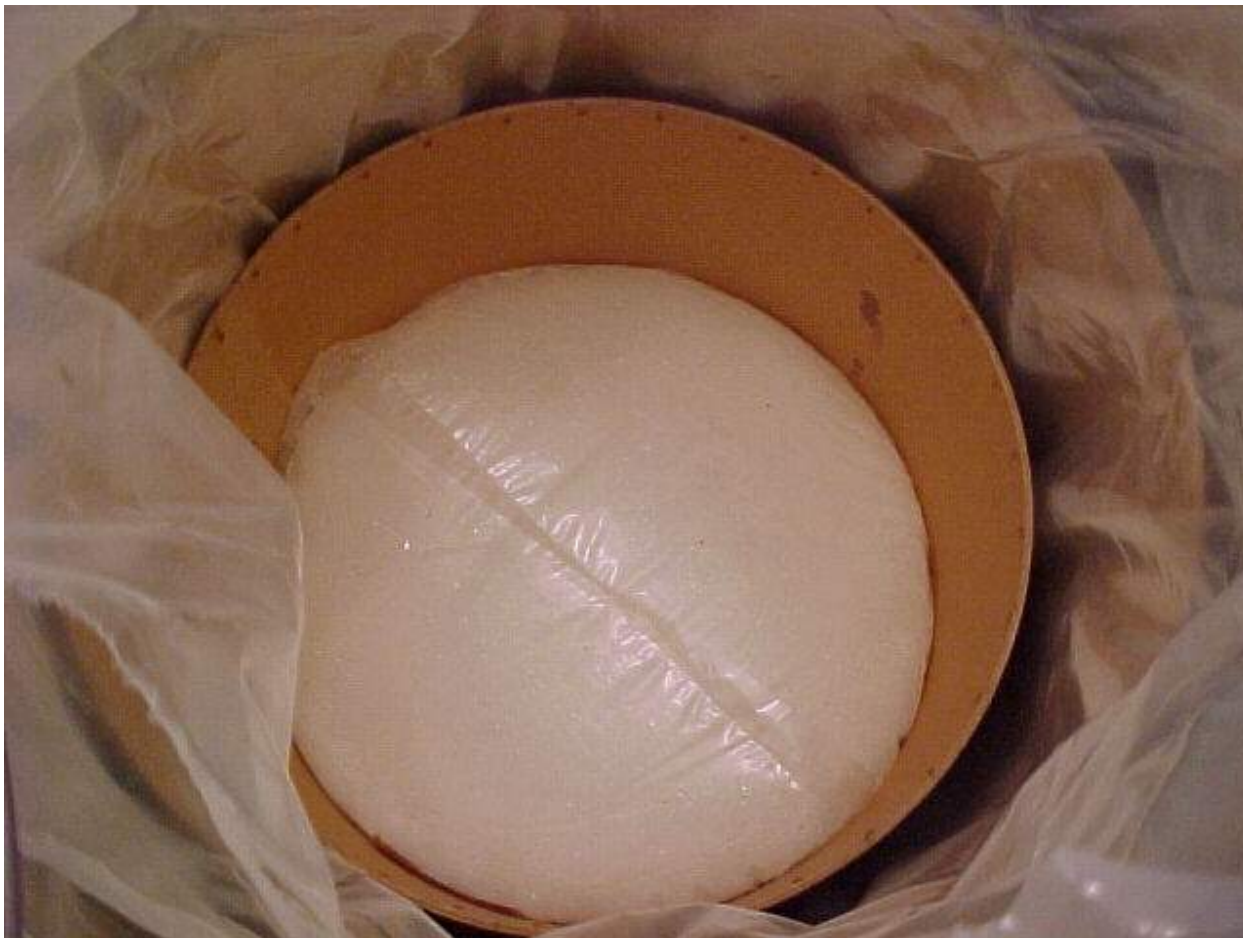
4th poly liner/bag – good condition (picture shows inflated condition of bag)
No gases present in breathing zone.

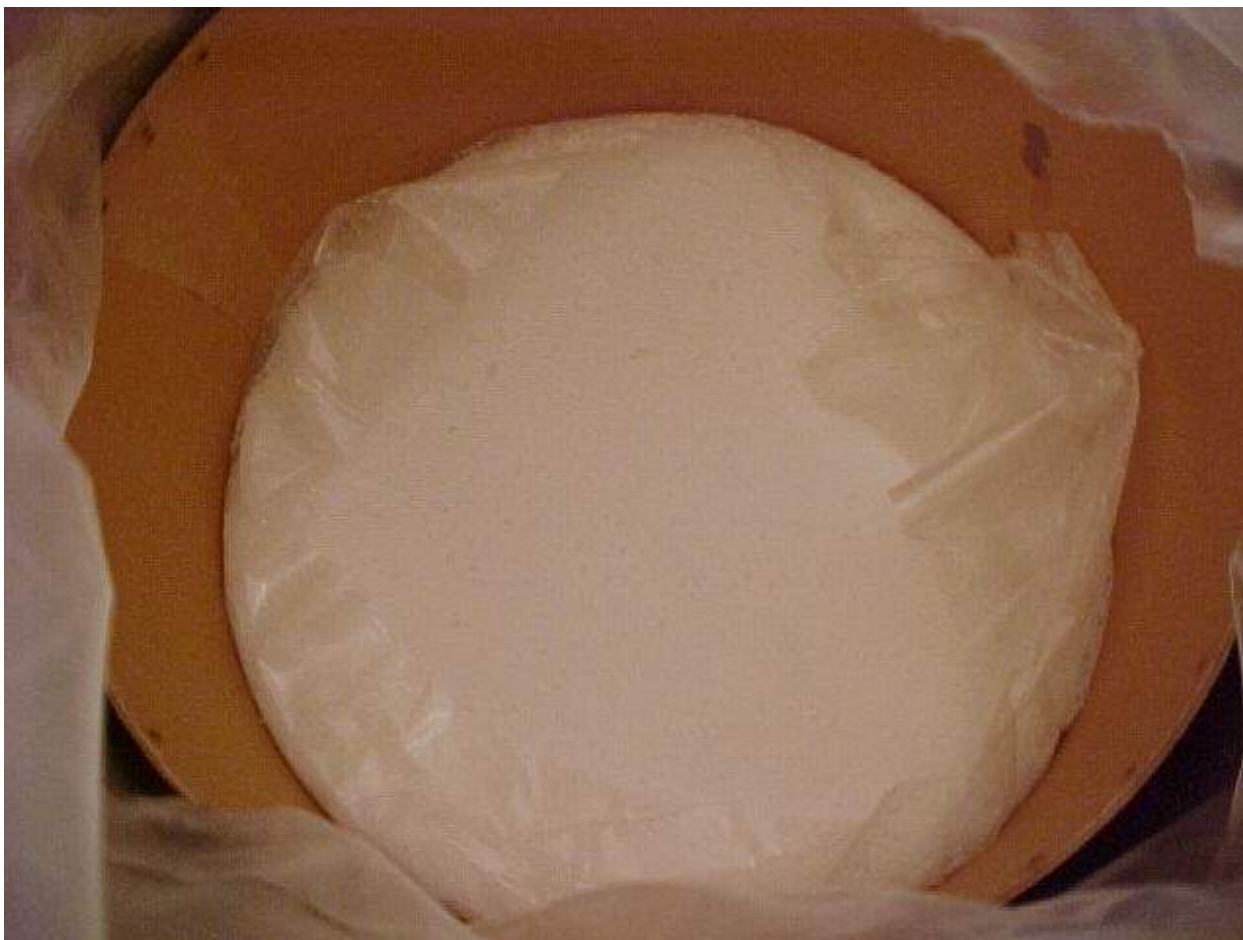
ThN material – solid form – white – monolith - dry
No gases present in breathing zone.

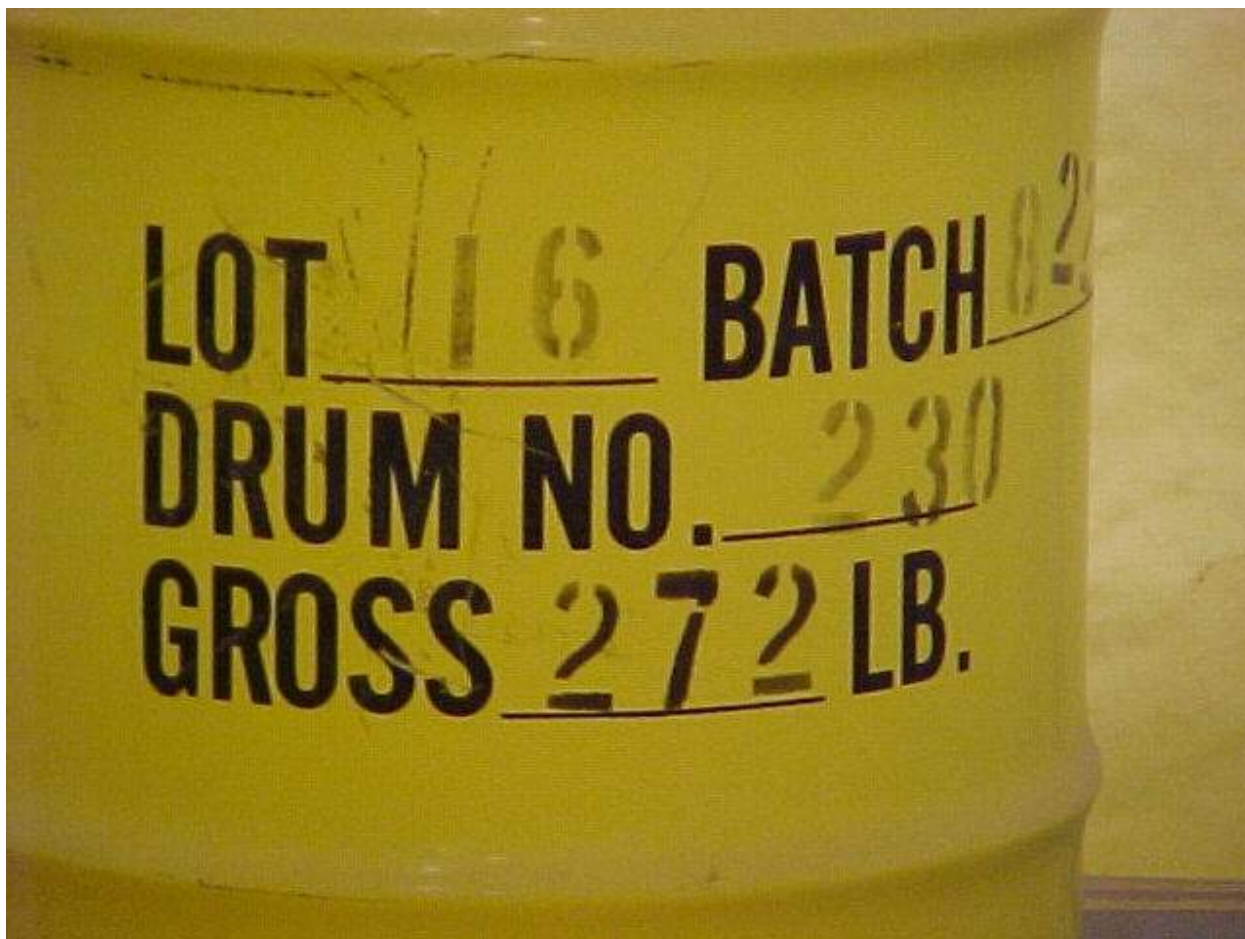
Drum released pressure as bolt on drum ring was loosened – prior to complete removal of the drum ring, the drum lid pushed through the center of the ring springing off the drum 1' to 2' vertically. Utilized remote extension on air ratchet to loosen bolt to provide safe distance between operator and drum lid.

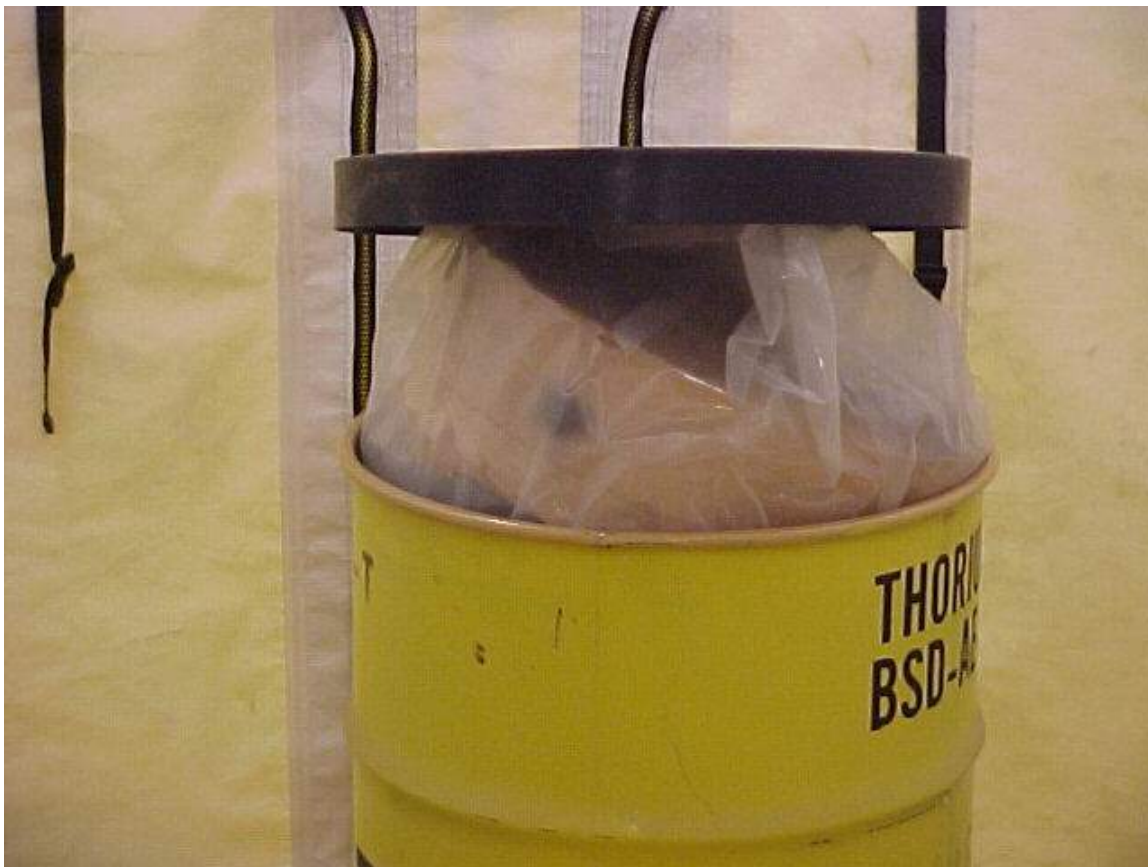
Black plastic lid – good condition (lid fits around drum liner)

Pressure built up inside of the container raises the poly liner/bag vertically out of the drum

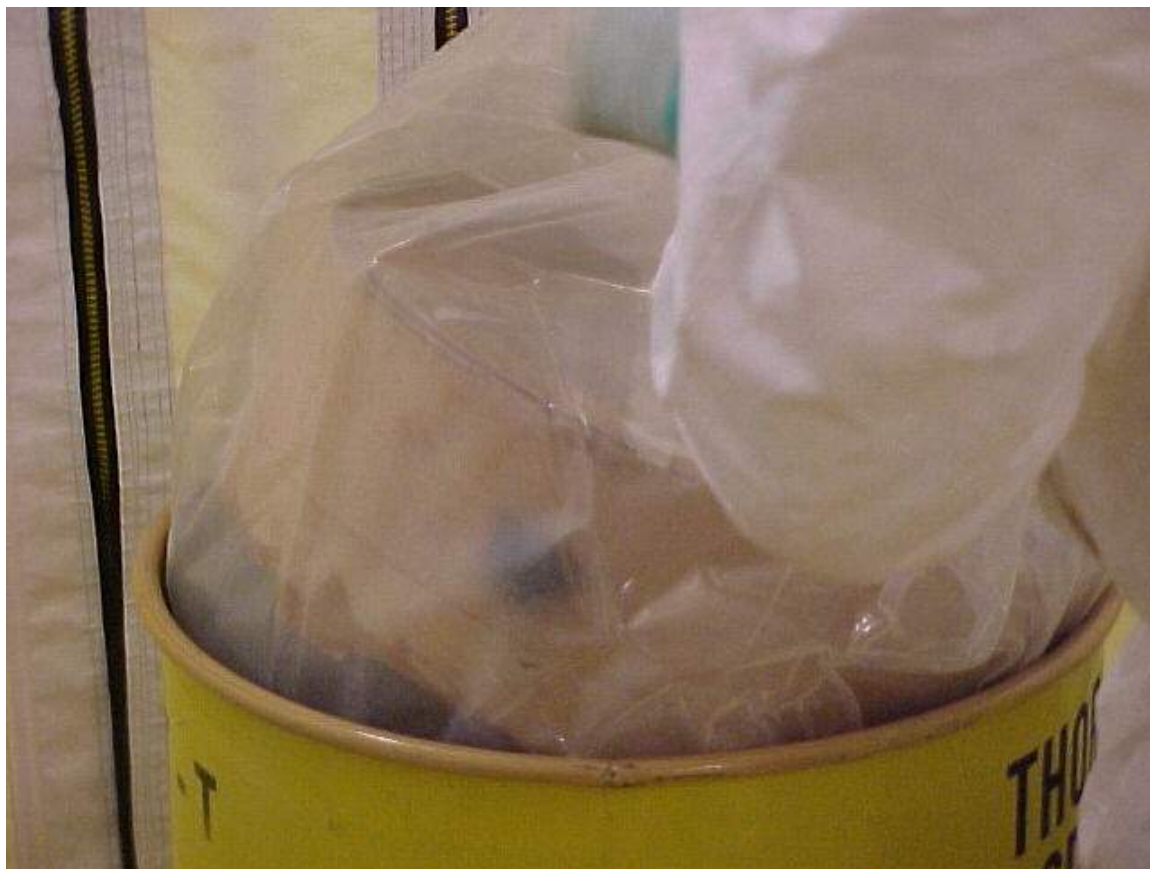
10:10**Other Information**Photo No. 3 of 10Dose Rate Surface 24 mR/hr
 1 meter 2.5 mR/hr1st poly liner/bag – good condition

Pressure buildup inside of the container raises the poly liner/bag vertically out of the drum

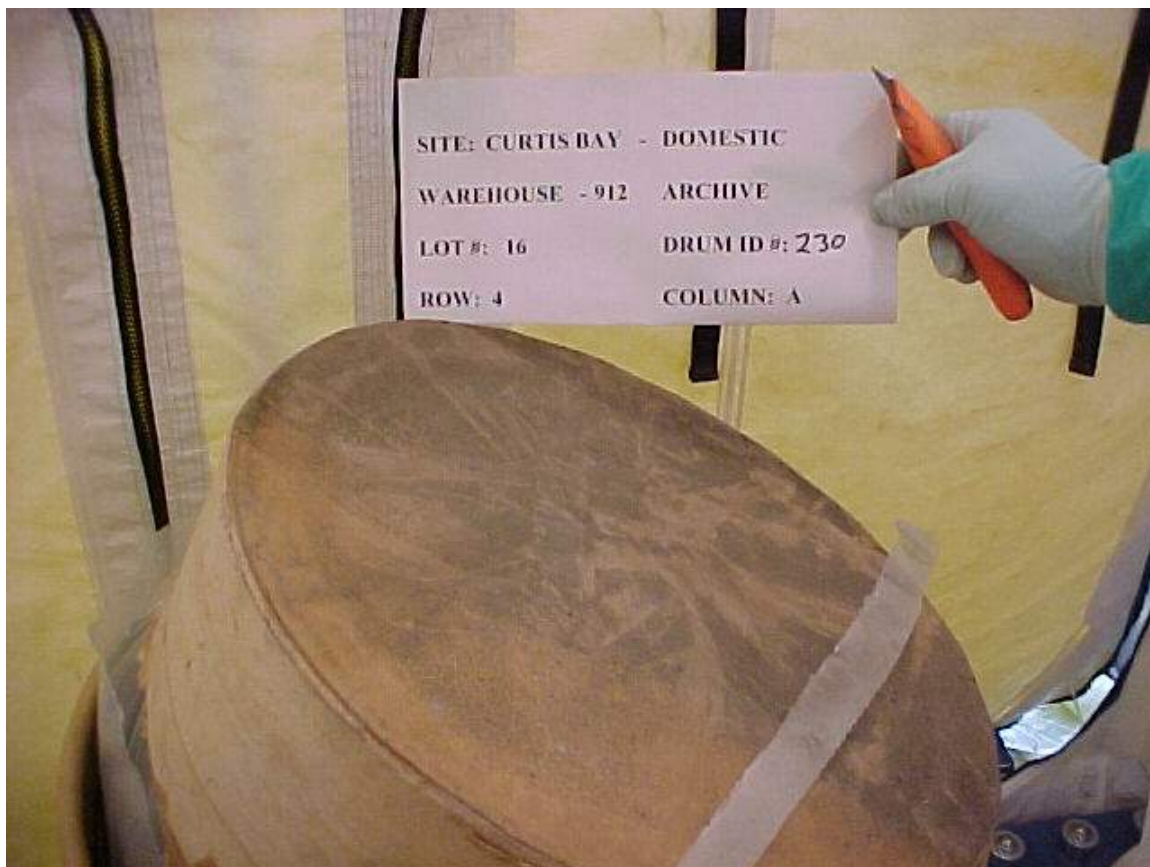
Fiber drum lid (on outermost fiber drum) – good condition
No gases present in the breathing zone.

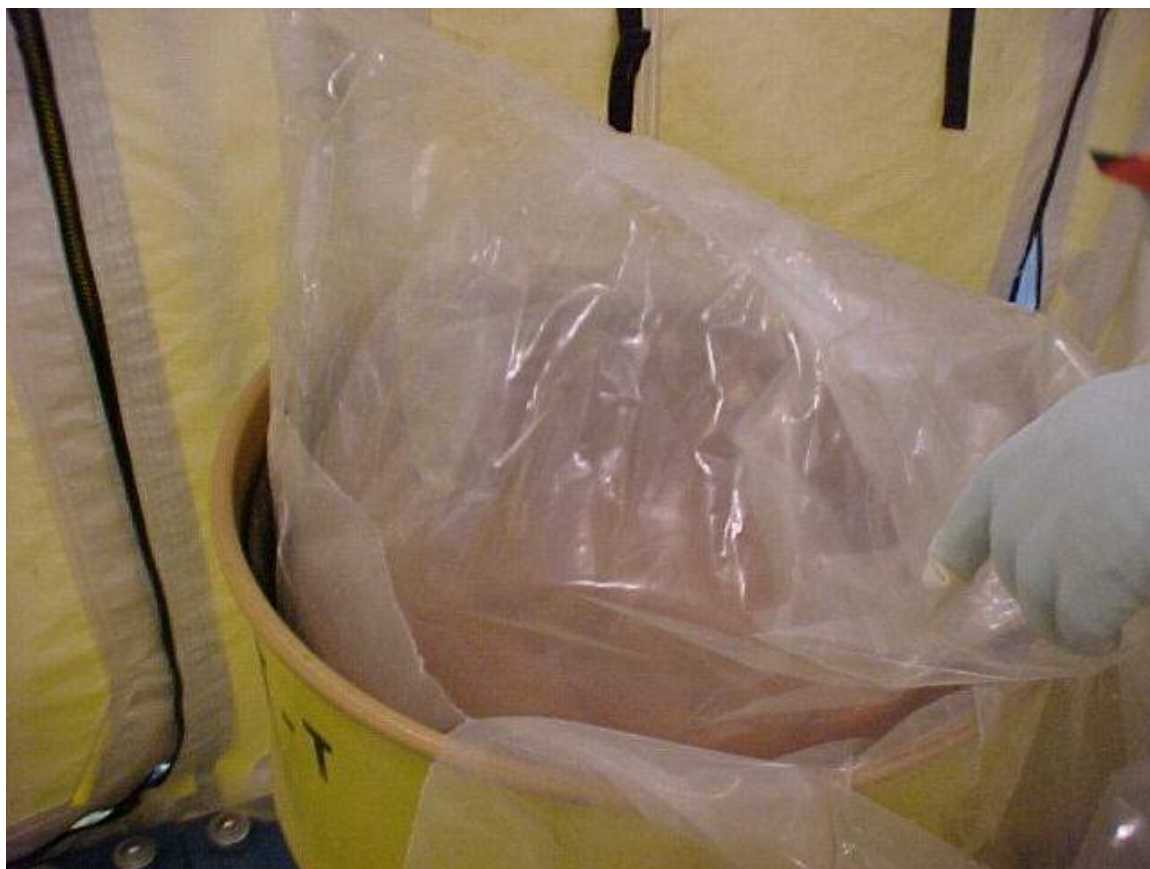
2nd poly liner/bag – good condition
No gases present in the breathing zone.

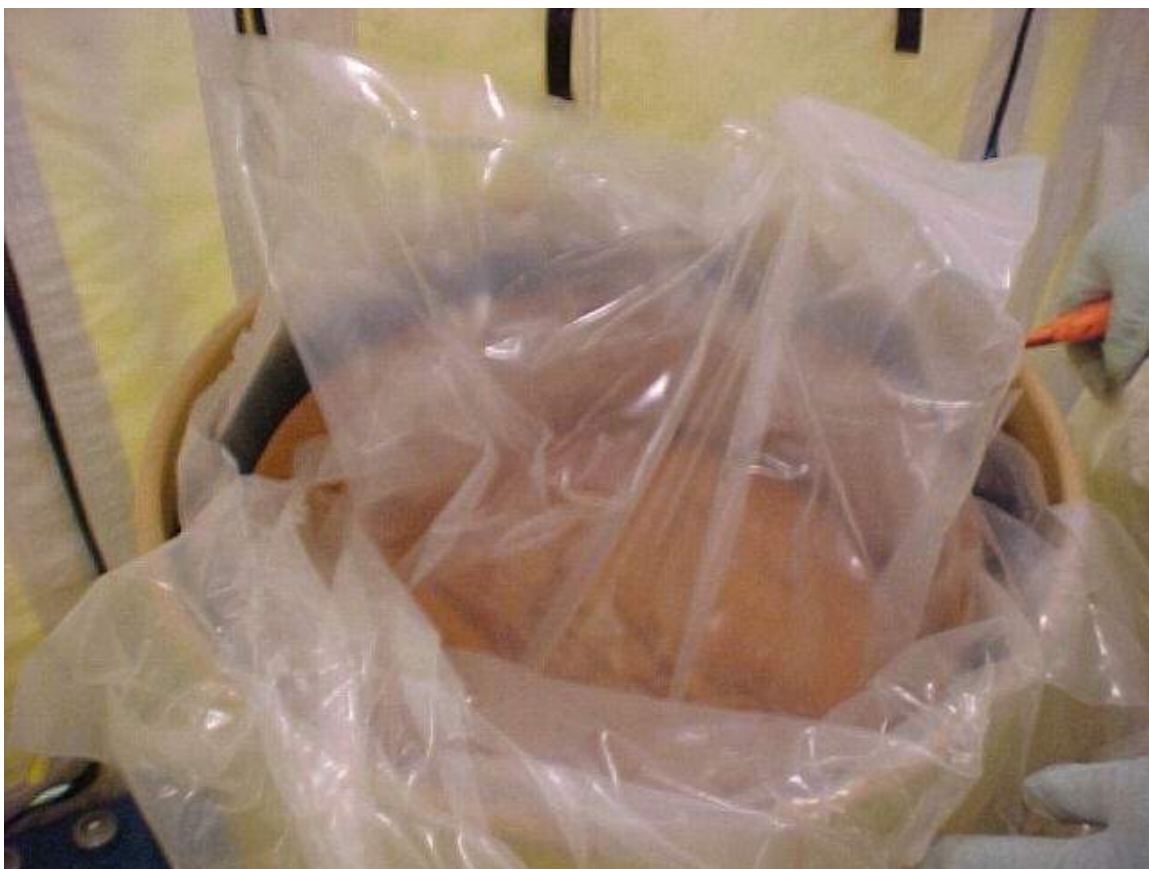
3rd poly liner/bag – good condition

Gases in headspace – LEL – 4.6% LEL – NO – +50 ppm – NOx – +50 ppm

Drum vented – all gases evacuated through HEPA exhaust

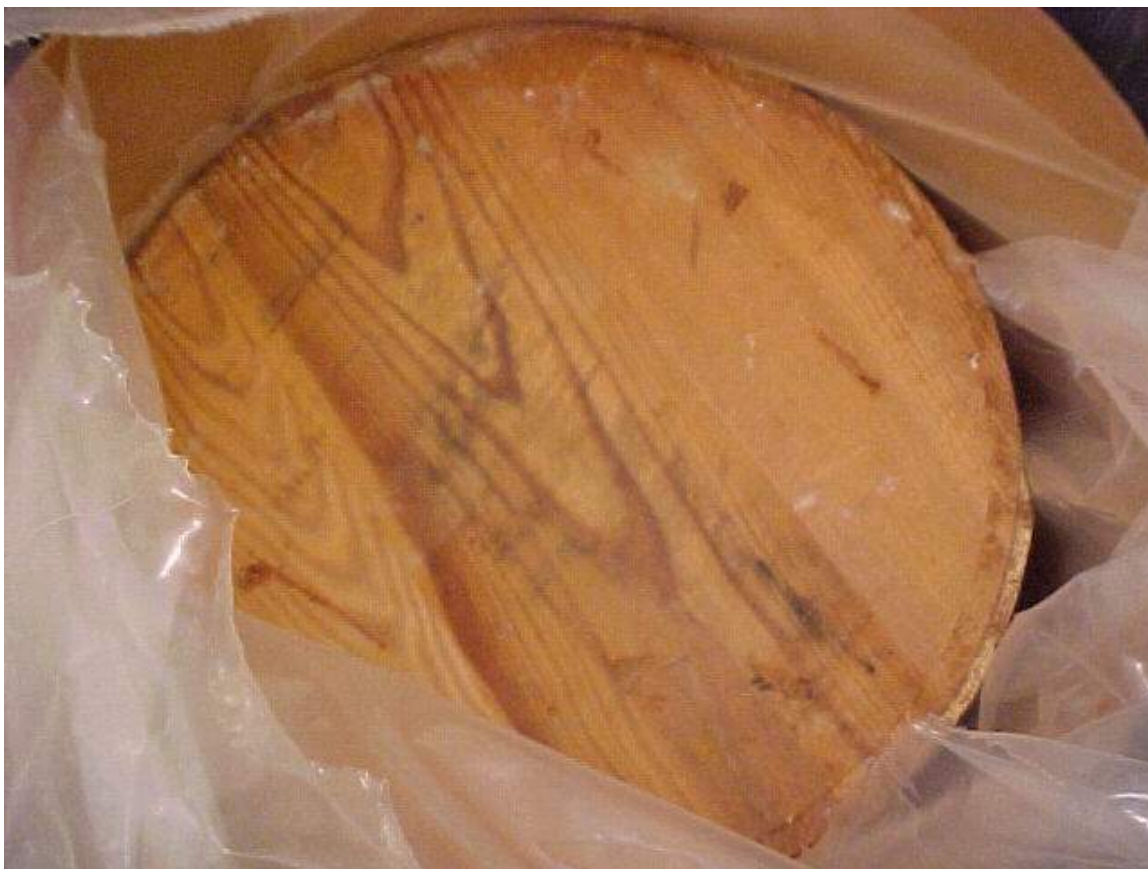
Wooden lid (on inner lab-pack/fiber drum) – good condition
Drum vented – all gases evacuated through HEPA exhaust
No gases present in breathing zone.

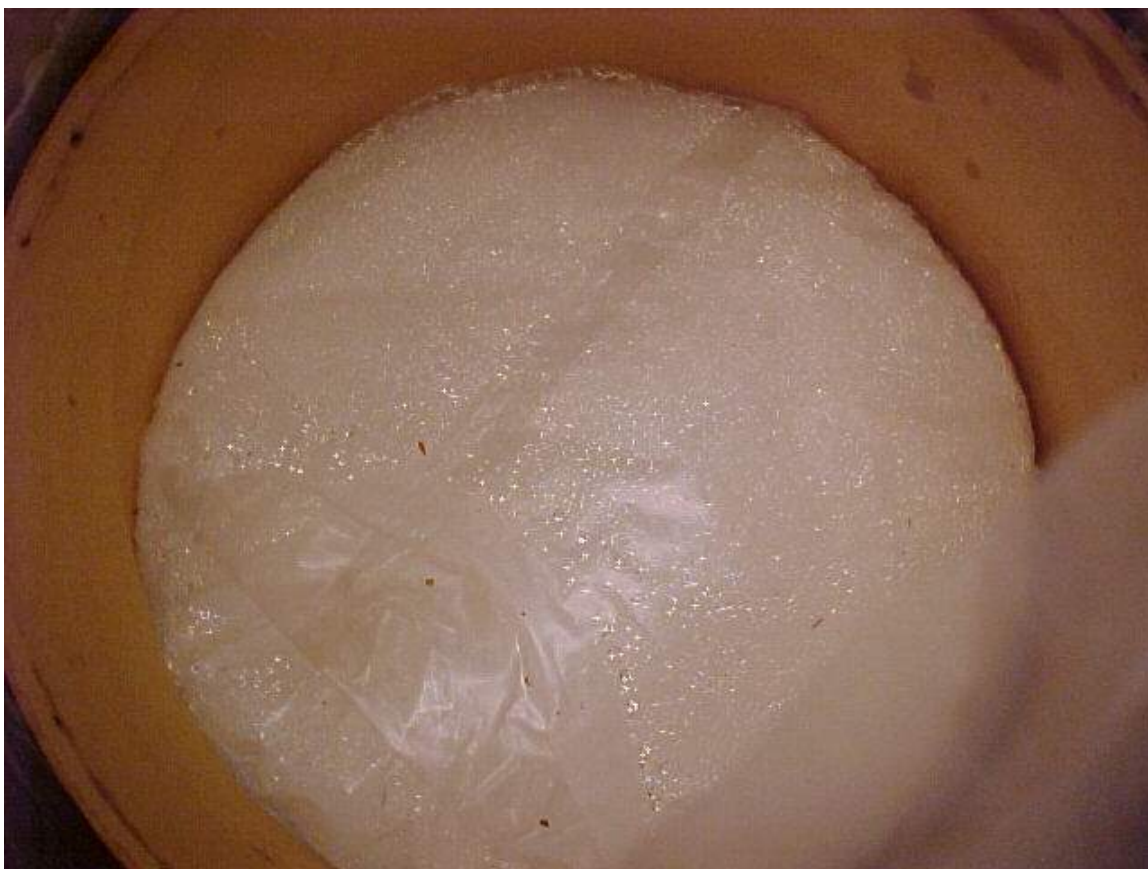
4th poly liner/bag (thin film plastic) – good condition (inflated condition of bag delineates gas buildup from the ThN material)
Drum vented – all gases evacuated through HEPA exhaust
No gases present in breathing zone.

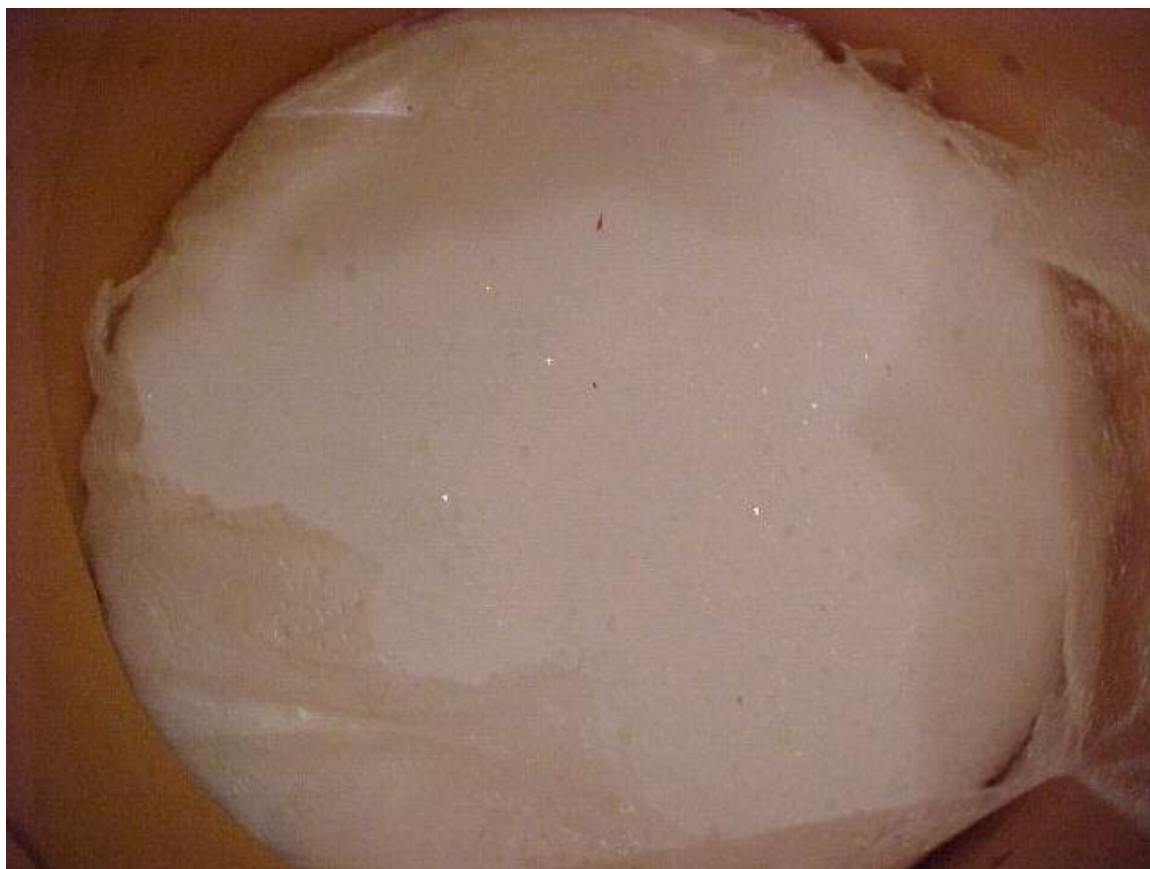
ThN material – monolith – solid – white - dry

Drum vented – all gases evacuated through HEPA exhaust

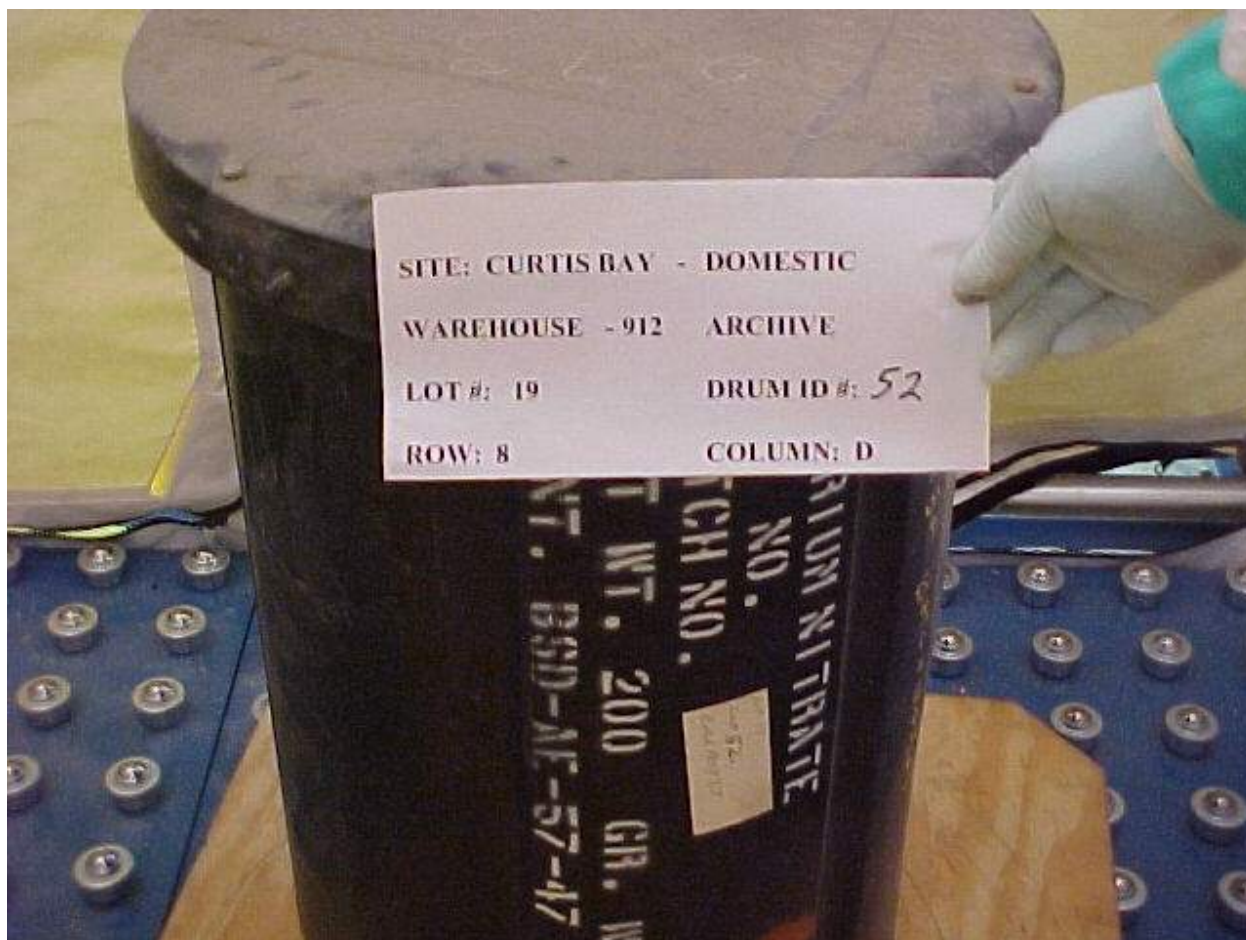
40-gal polyethylene container – good condition
 Container did not vent any gases during opening operations
 No gases present in the breathing zone

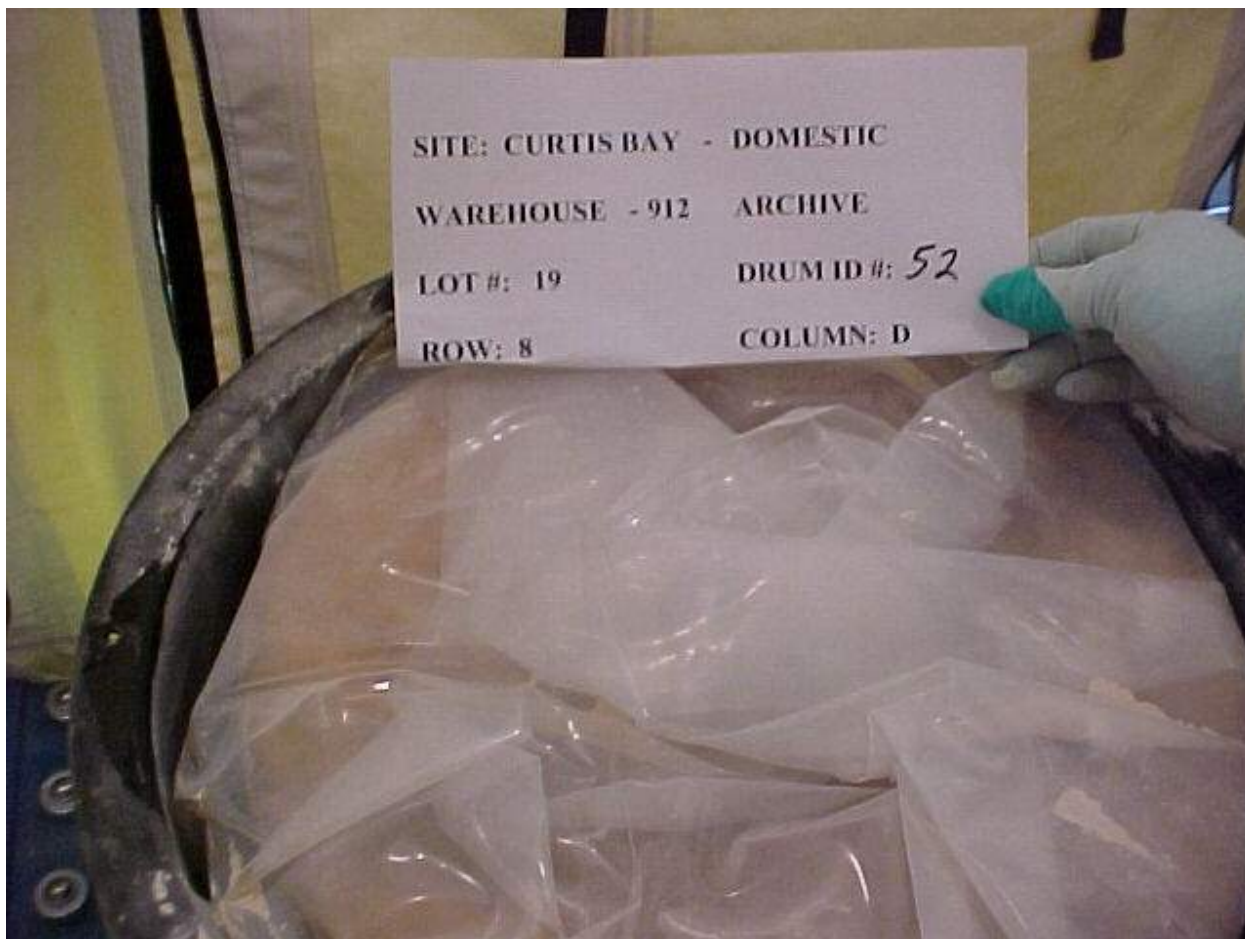
1st poly liner/bag – good condition
No gases present in the breathing zone

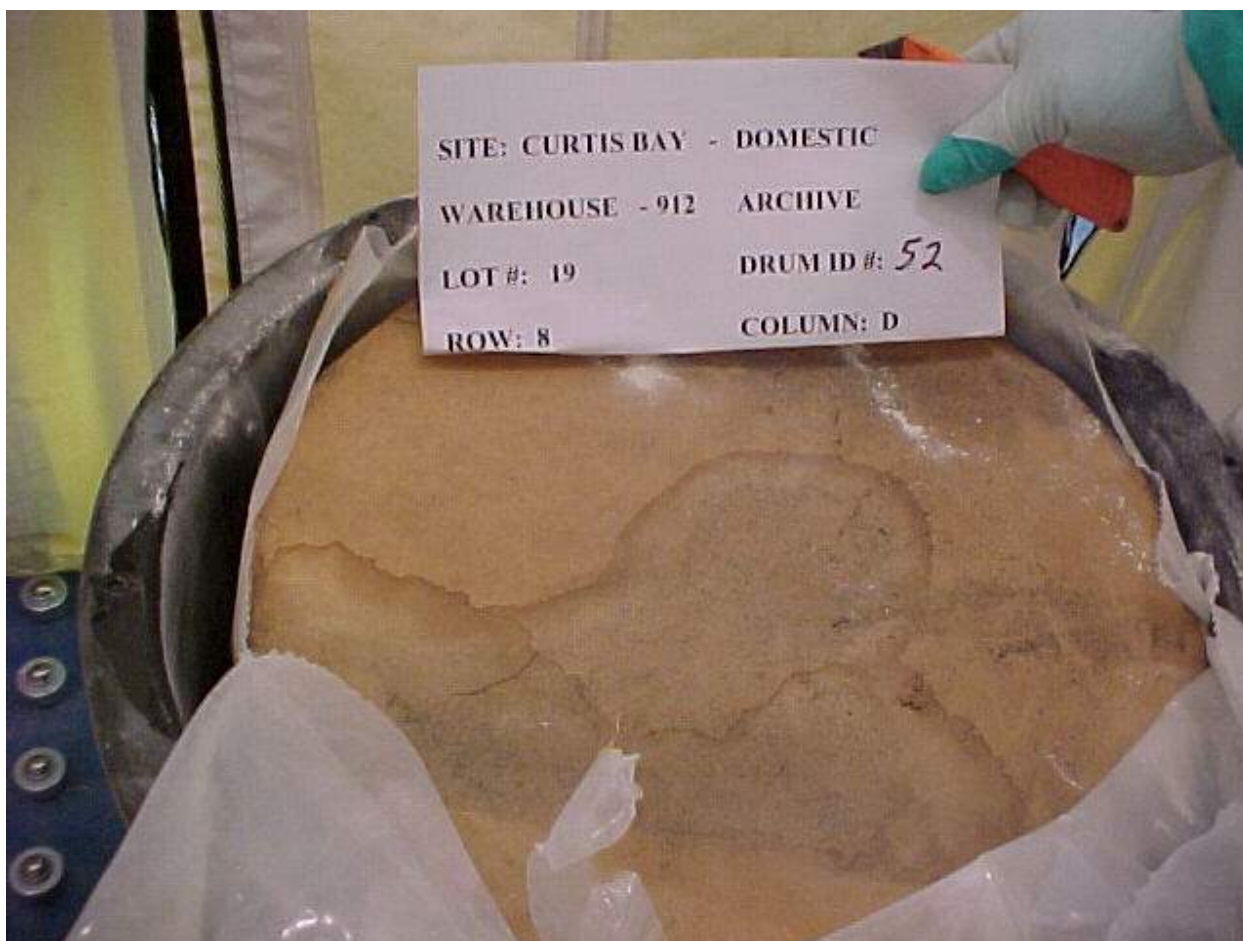
Fiber lid (from outermost fiber drum inside of container) – good condition
No gases present in the breathing zone

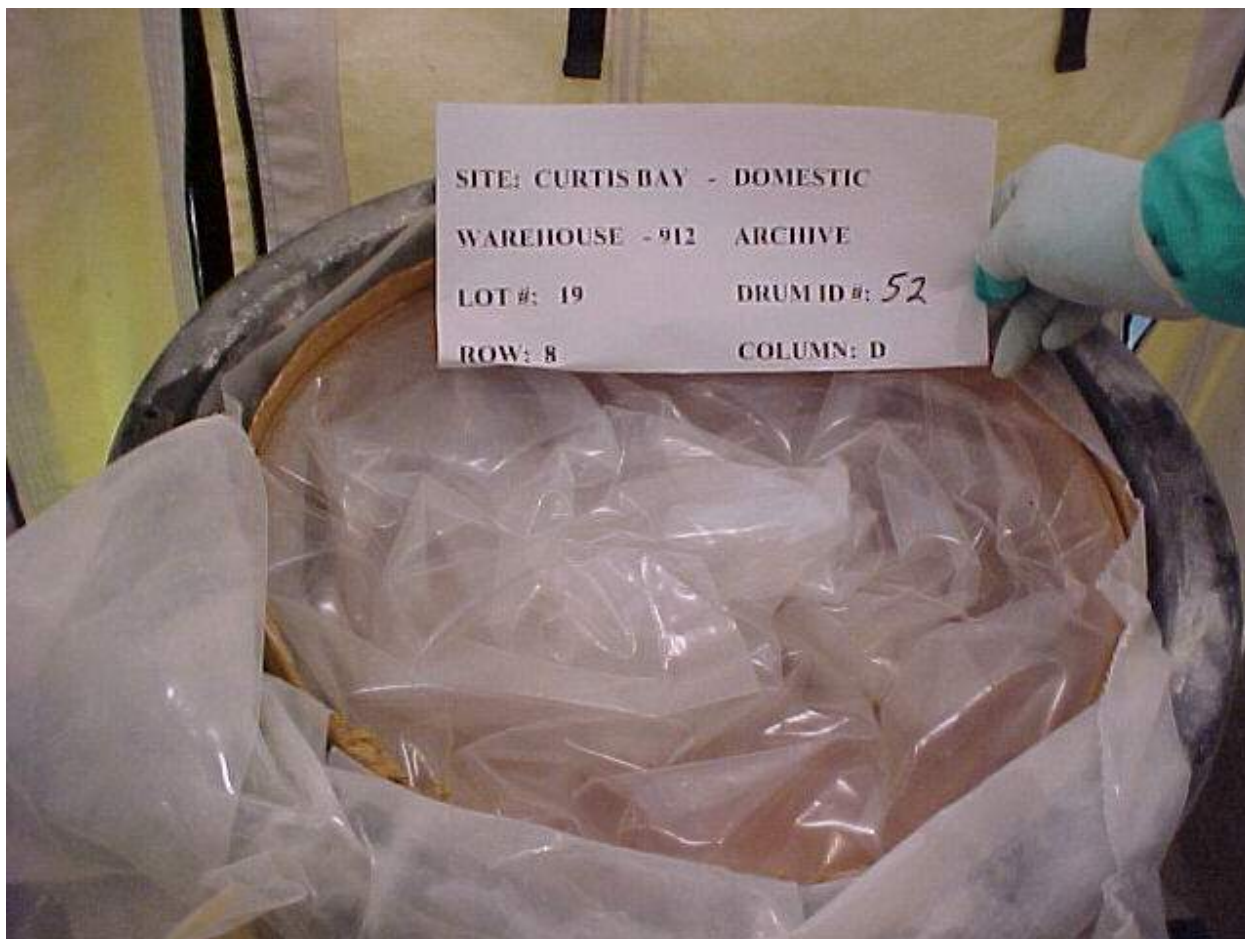
2nd poly liner/bag – good condition
No gases present in the breathing zone

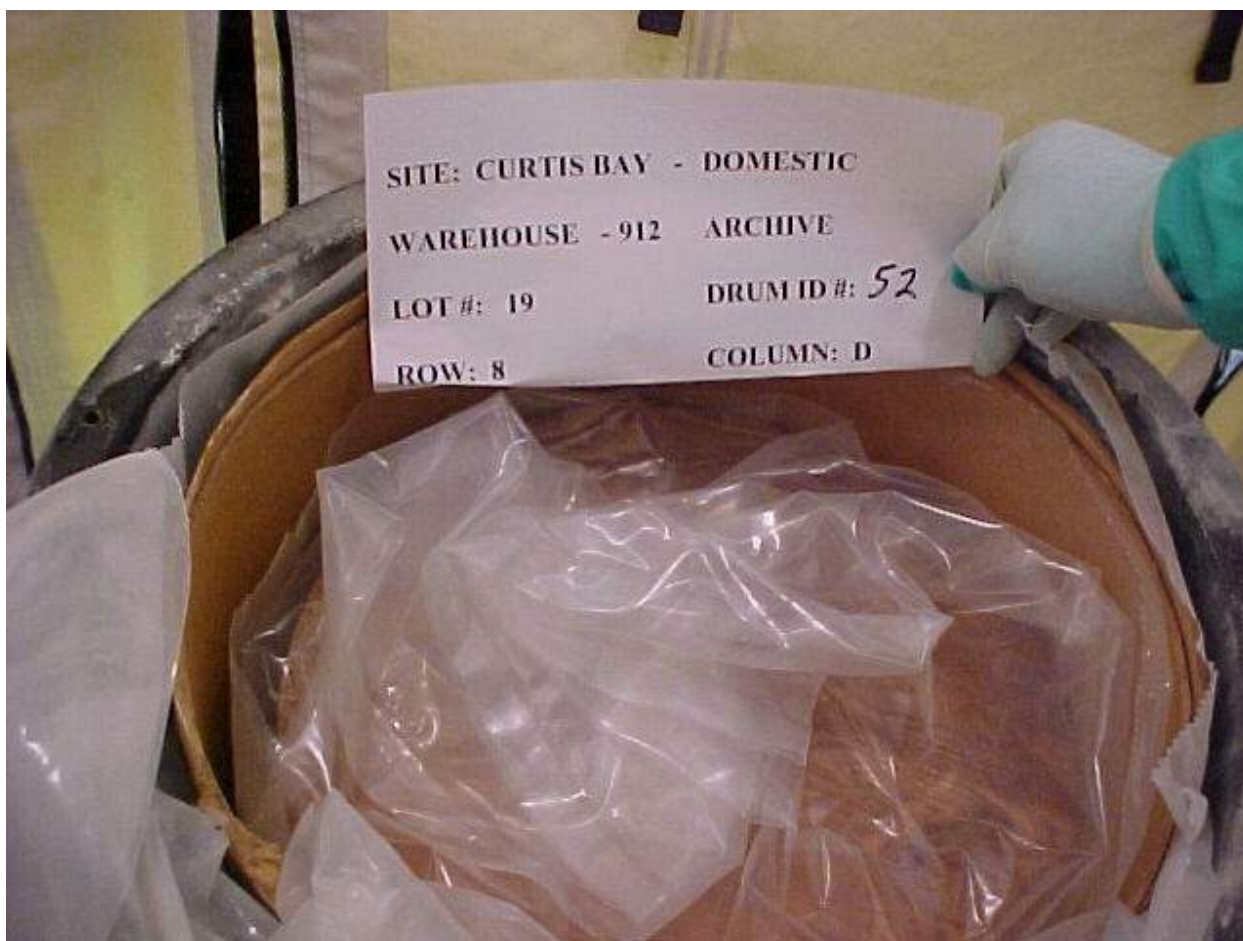
14:30**Other Information**Photo No. 5 of 10Dose Rate Surface 22 mR/hr
 1 meter 2.2 mR/hr3rd poly liner/bag – good condition
No gases present in the breathing zone

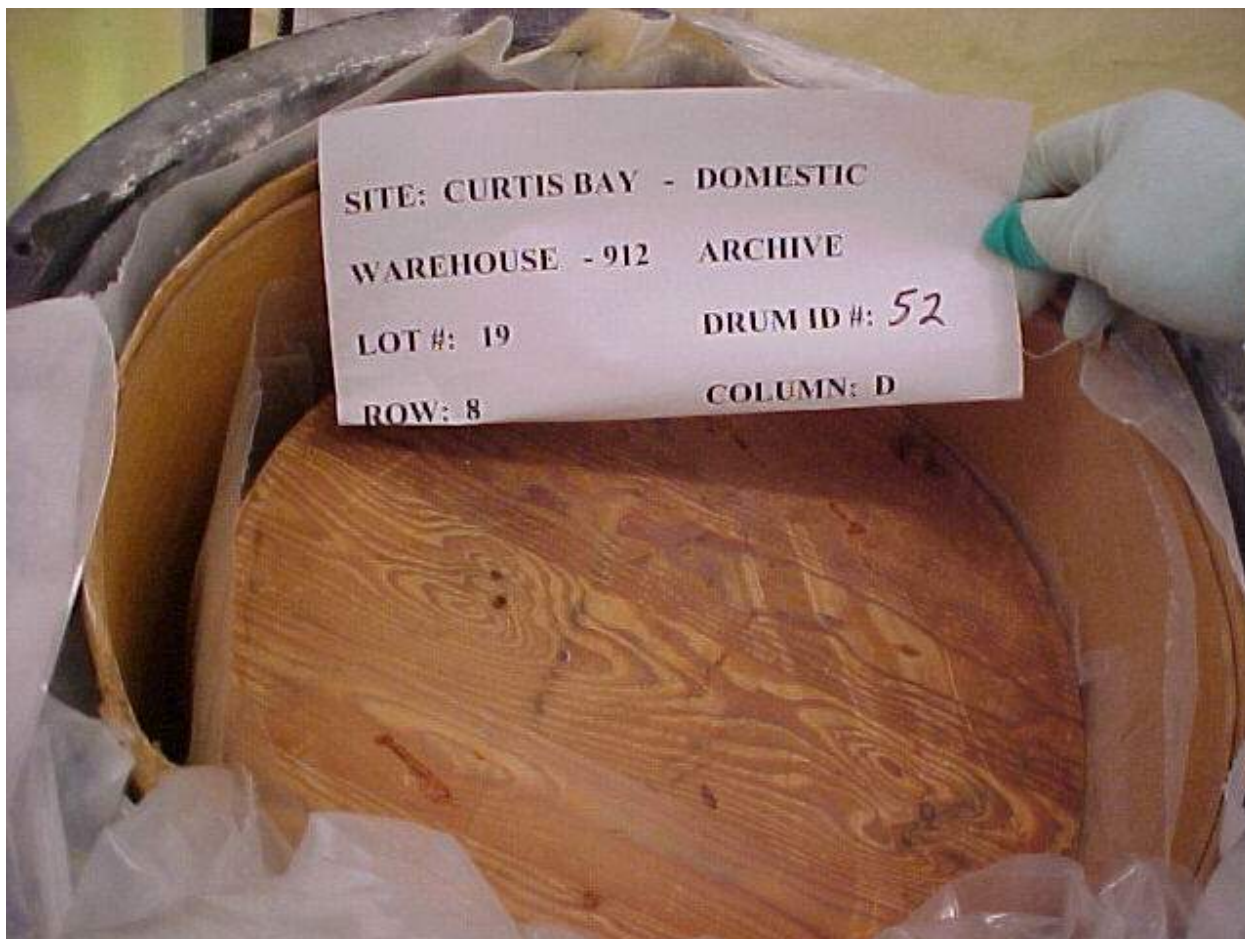
Wooden lid (mounted to innermost lab-pack/fiber drum) – good condition
No gases present in the breathing zone

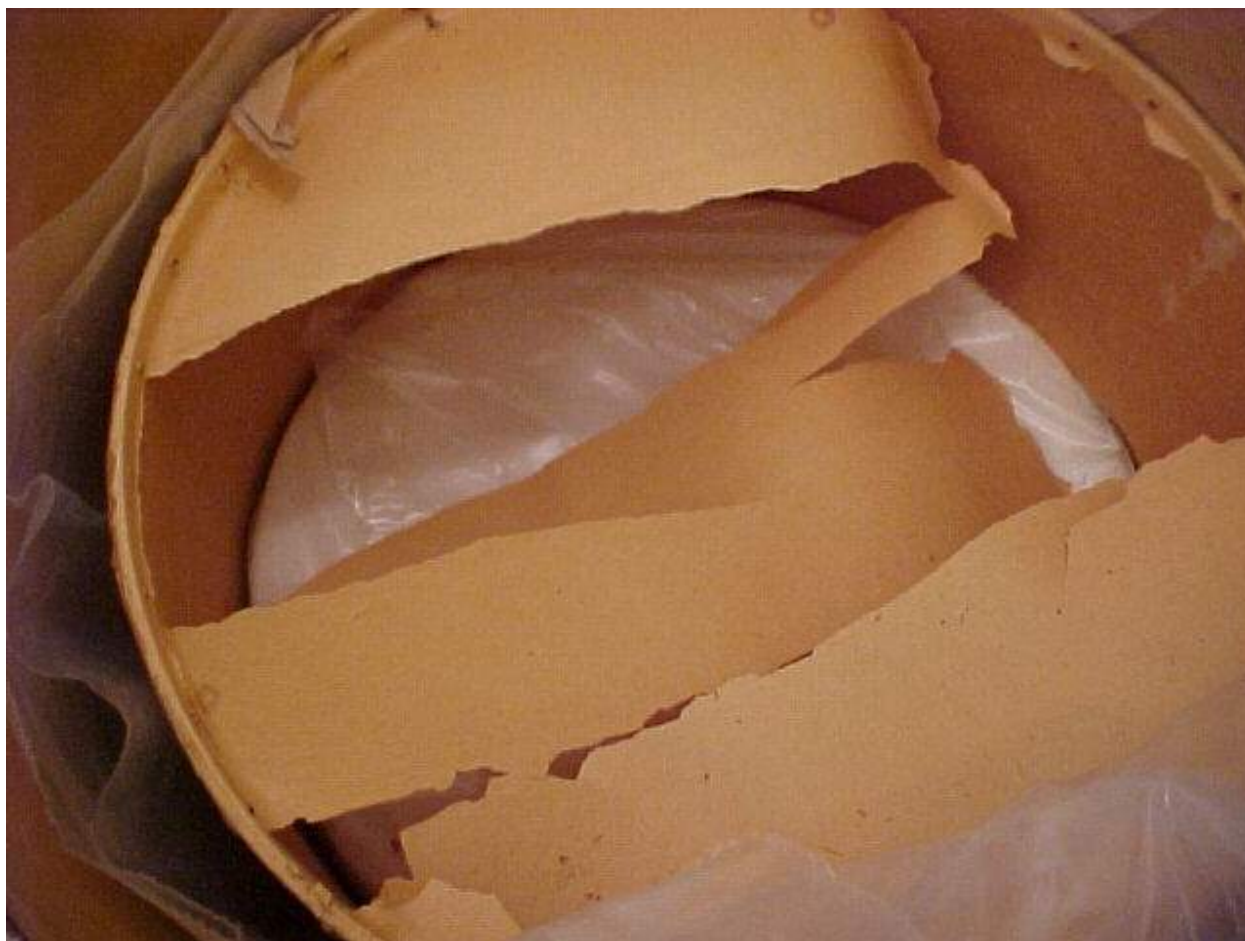
Paper layer lid on lab-pack underneath the wooden lid typically tears upon wooden lid removal
No gases present in the breathing zone

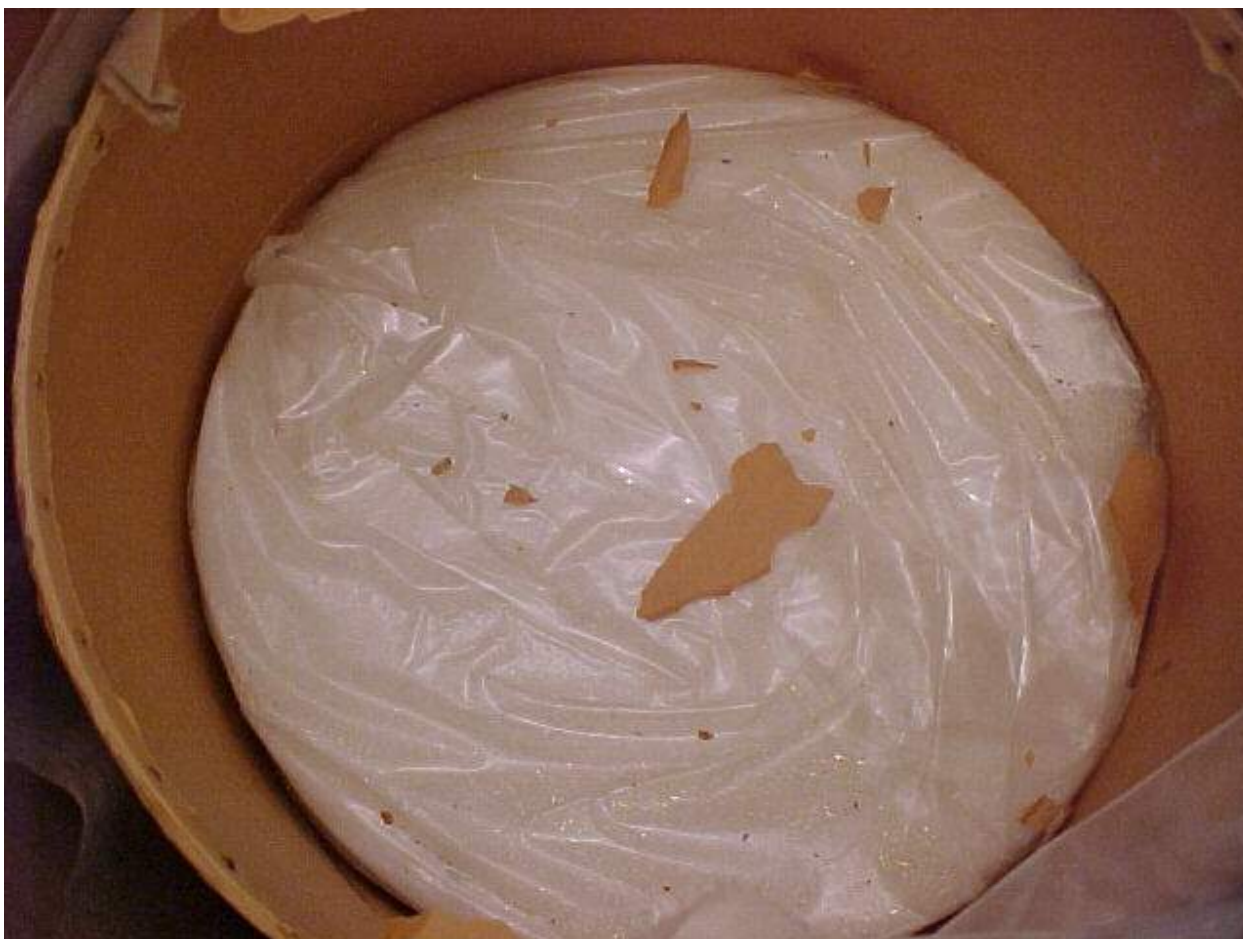
4th poly liner/bag – good condition
No gases present in the breathing zone

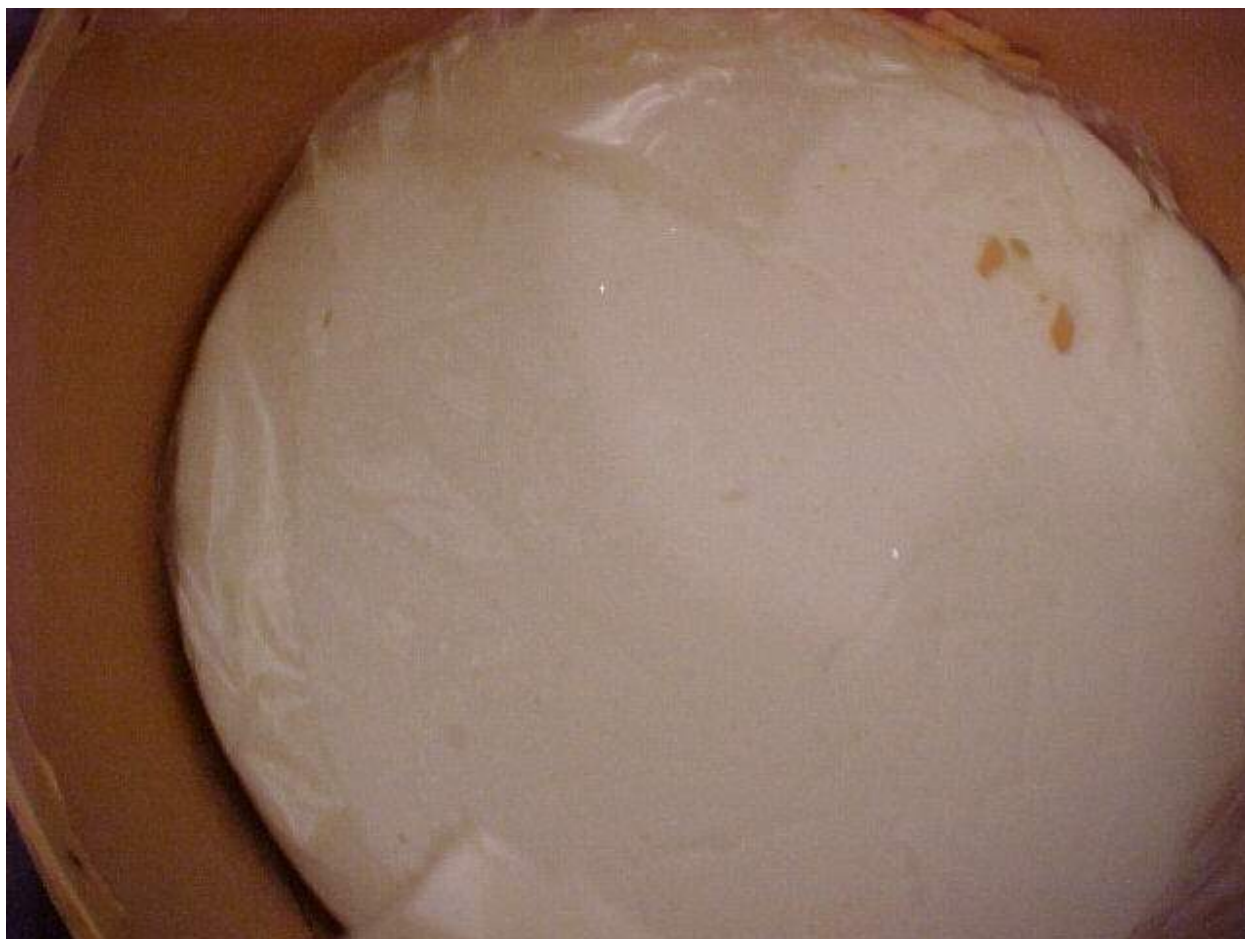
14:30**Other Information**Photo No. 9 of 10Dose Rate Surface 22 mR/hr
 1 meter 2.2 mR/hrThN material – solid – dry – white - monolith
No gases present in the breathing zone
