THORIUM NITRATE STOCKPILE DRUM CHARACTERIZATION REPORT

**THORIUM NITRATE STOCKPILE
DRUM CHARACTERIZATION REPORT**

Prepared for
U.S. Defense Logistics Agency
Defense National Stockpile Center
Fort Belvoir, Virginia

Prepared by
OAK RIDGE NATIONAL LABORATORY
Oak Ridge, Tennessee 37831
managed by
UT-BATTELLE, LLC
for the
U.S. DEPARTMENT OF ENERGY
under contract DE-AC05-00OR22725

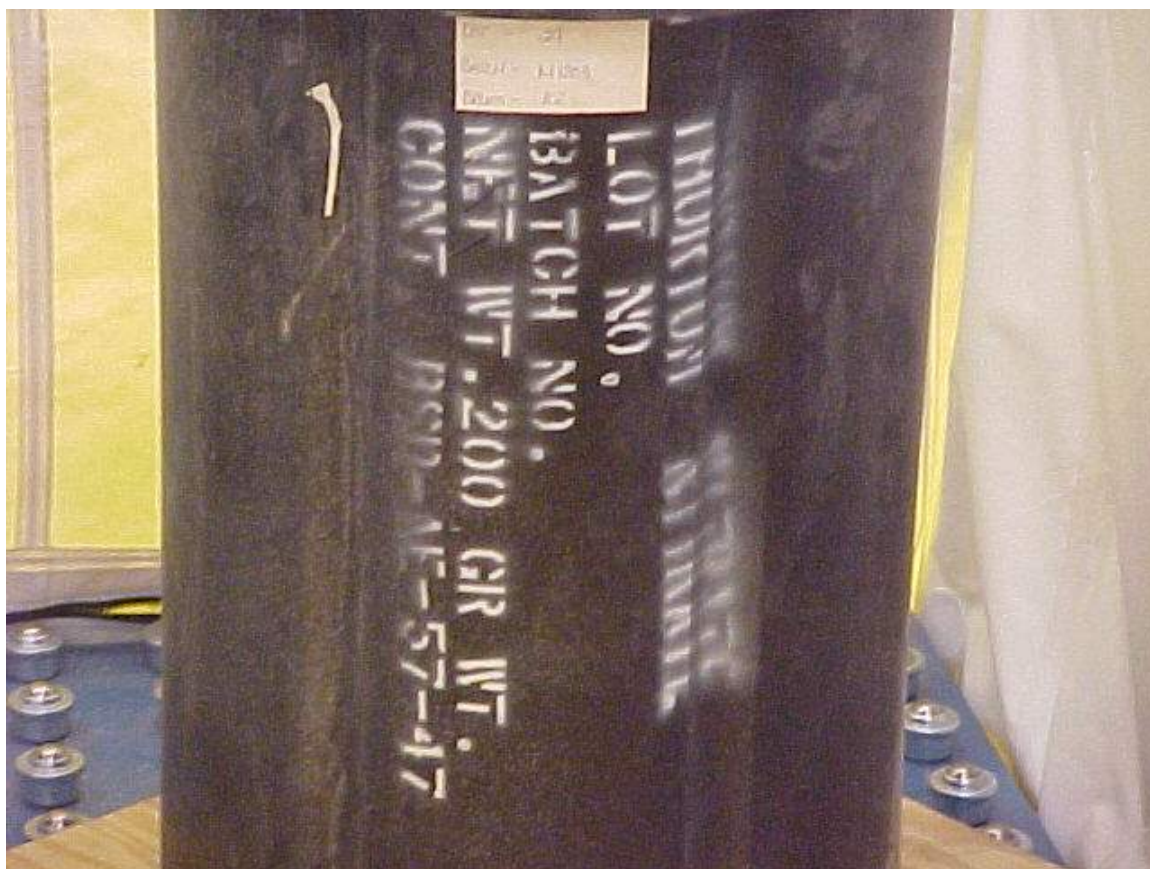
40-gal polyethylene container – good condition
No gases vented from container during lid removal operations

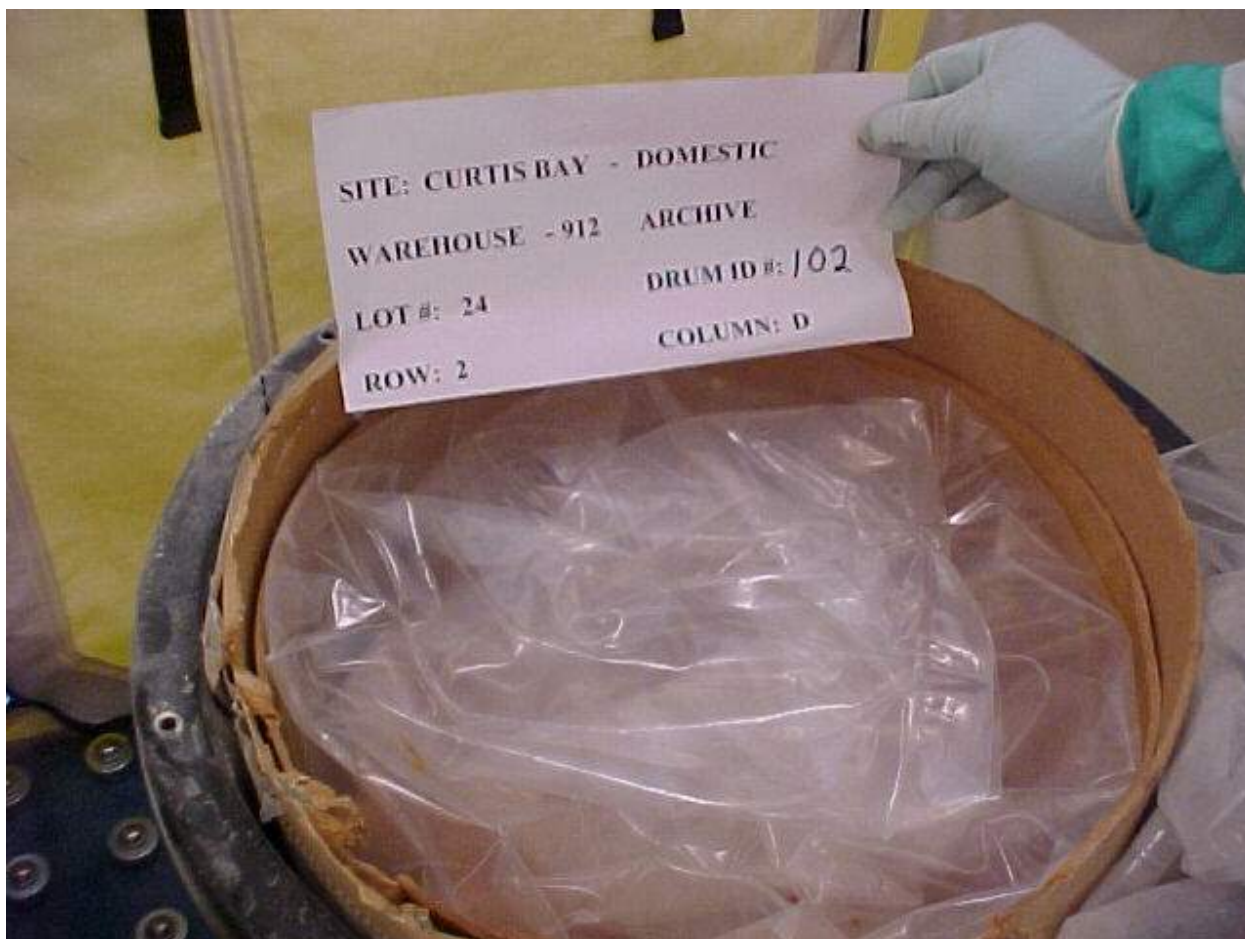
14:00**Other Information**Photo No. 7 of 12Dose Rate Surface 22 mR/hr
 1 meter 2.1 mR/hr3rd poly liner/bag – good condition
No gases present in the breathing zone

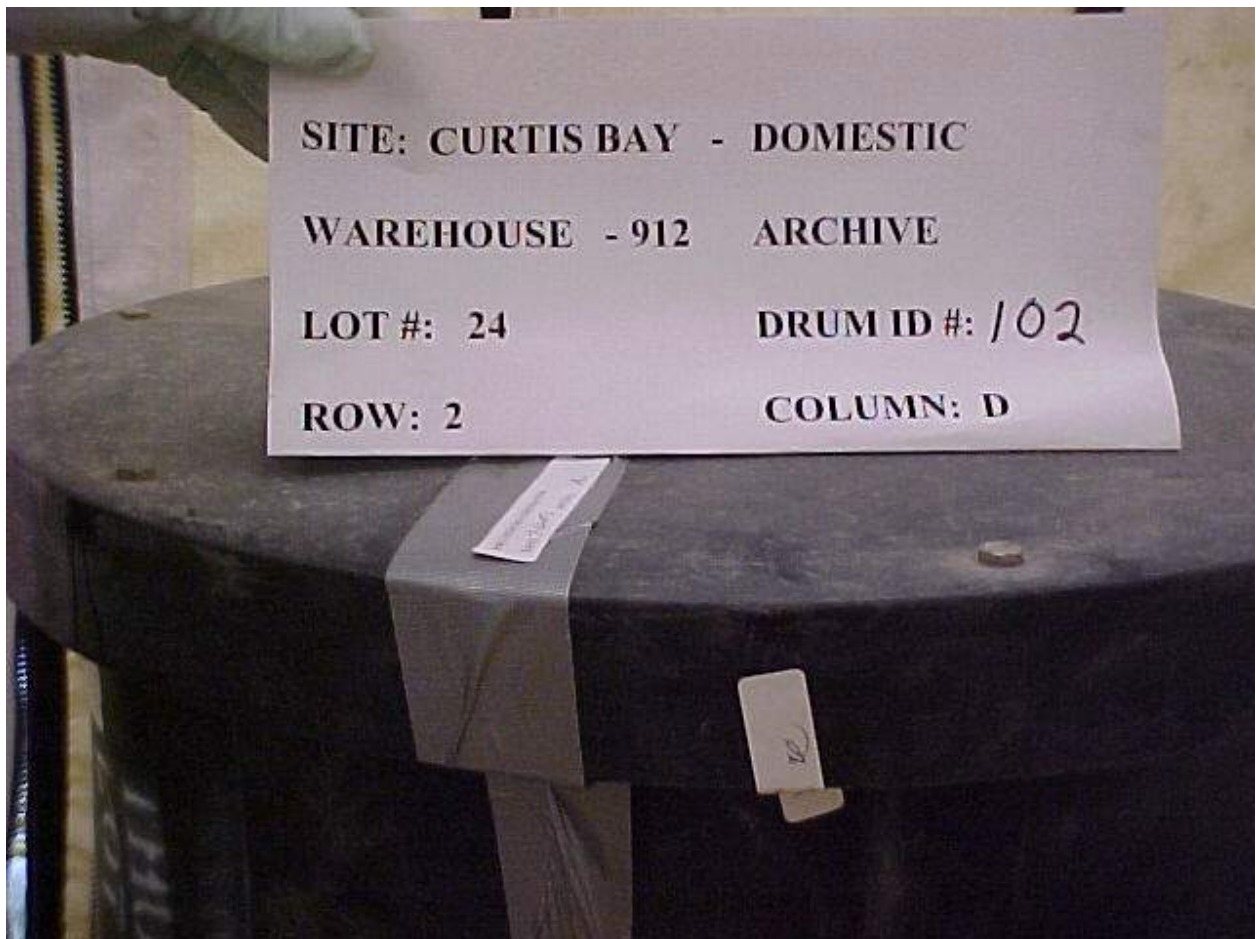
30-gal metal drum container – good condition
Gases vented from drum during lid removal operations

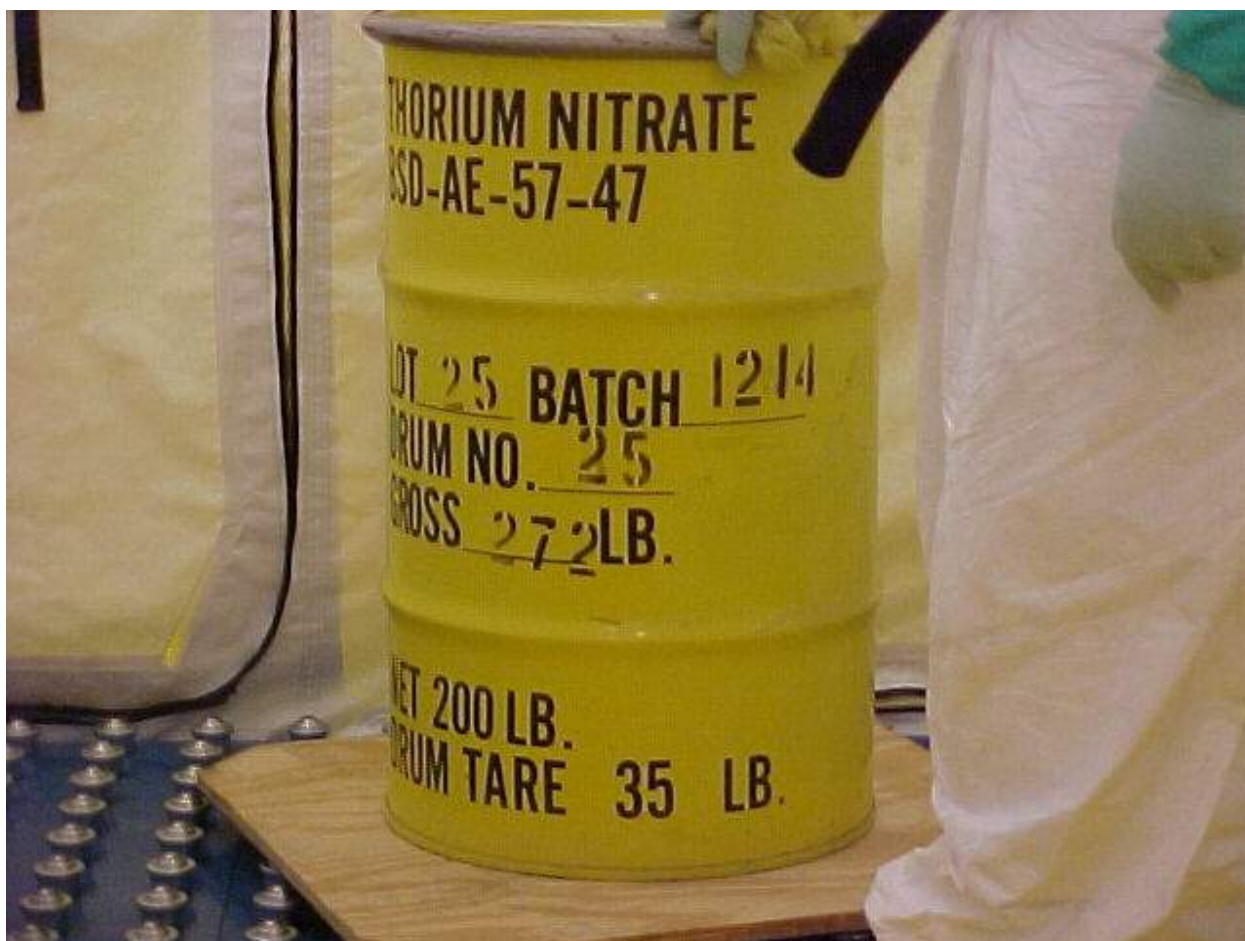
This picture shows the pressure inside of the drum that has lifted the plastic lid vertically out of the drum.
No gases present in the breathing zone.

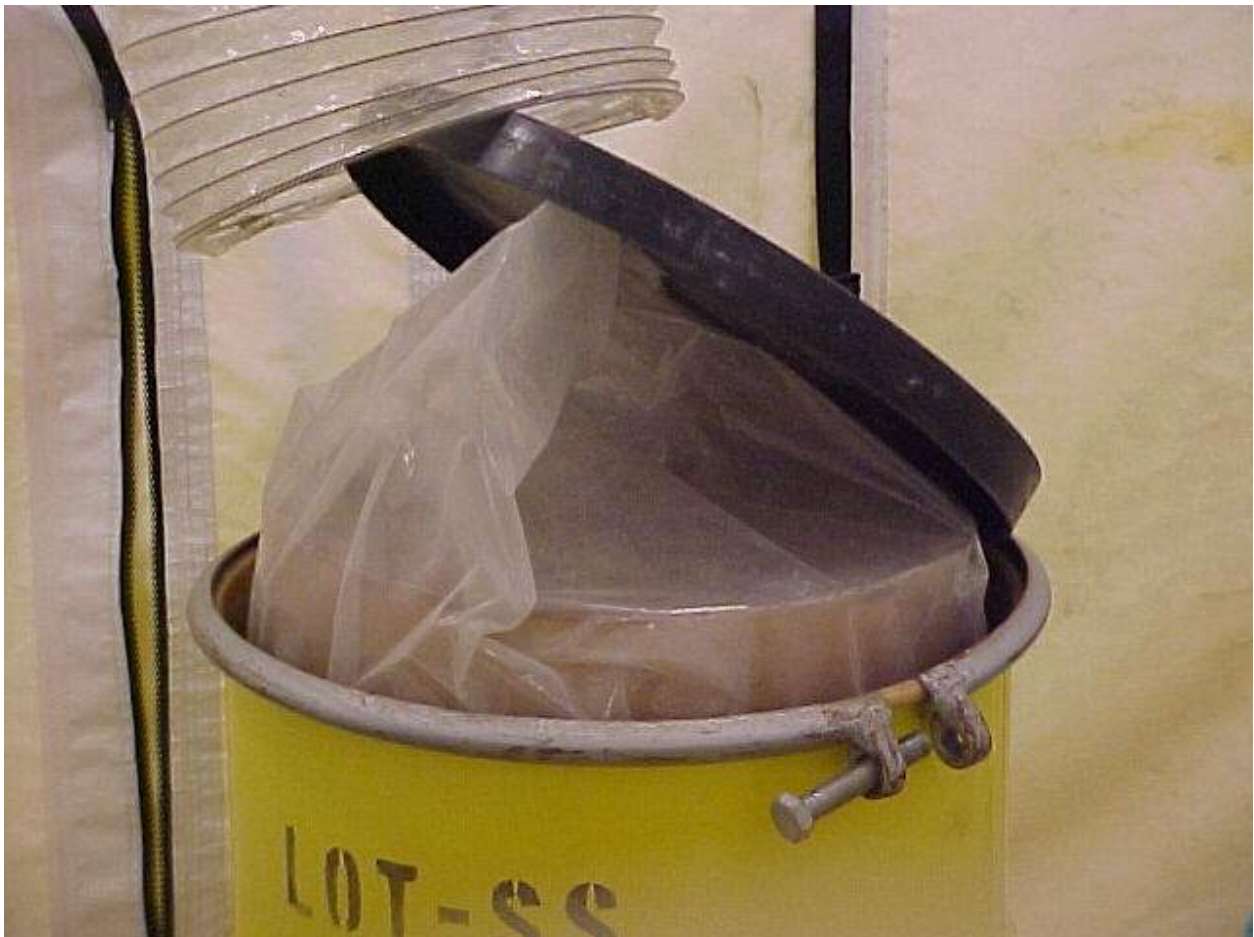
This picture shows the pressure inside of the drum that has lifted the plastic bag vertically out of the drum.
1st poly liner/bag – good condition
No gases present in the breathing zone.

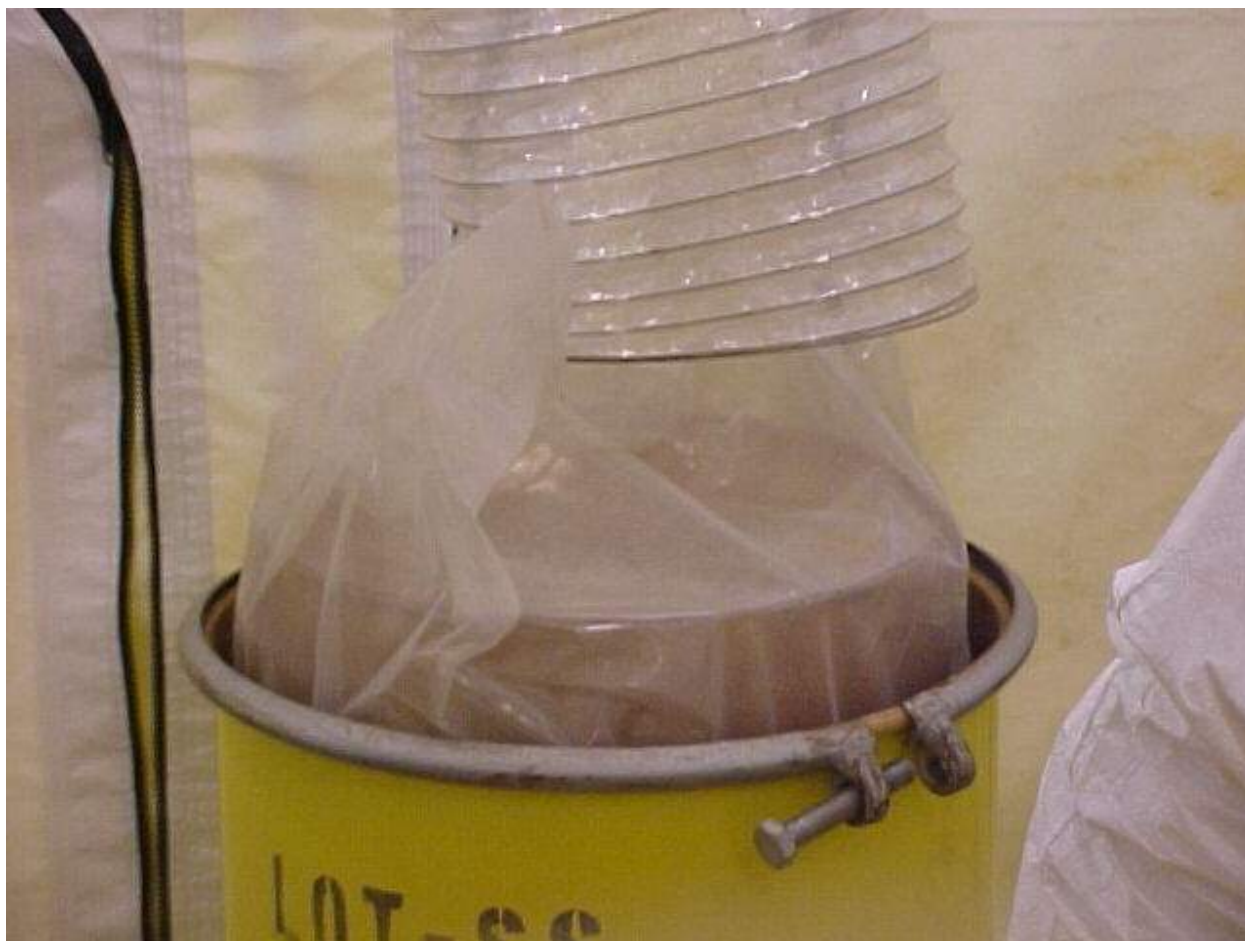
Opening the 1st poly bag shows the fiber drum lid raised but in good condition
No gases present in the breathing zone.

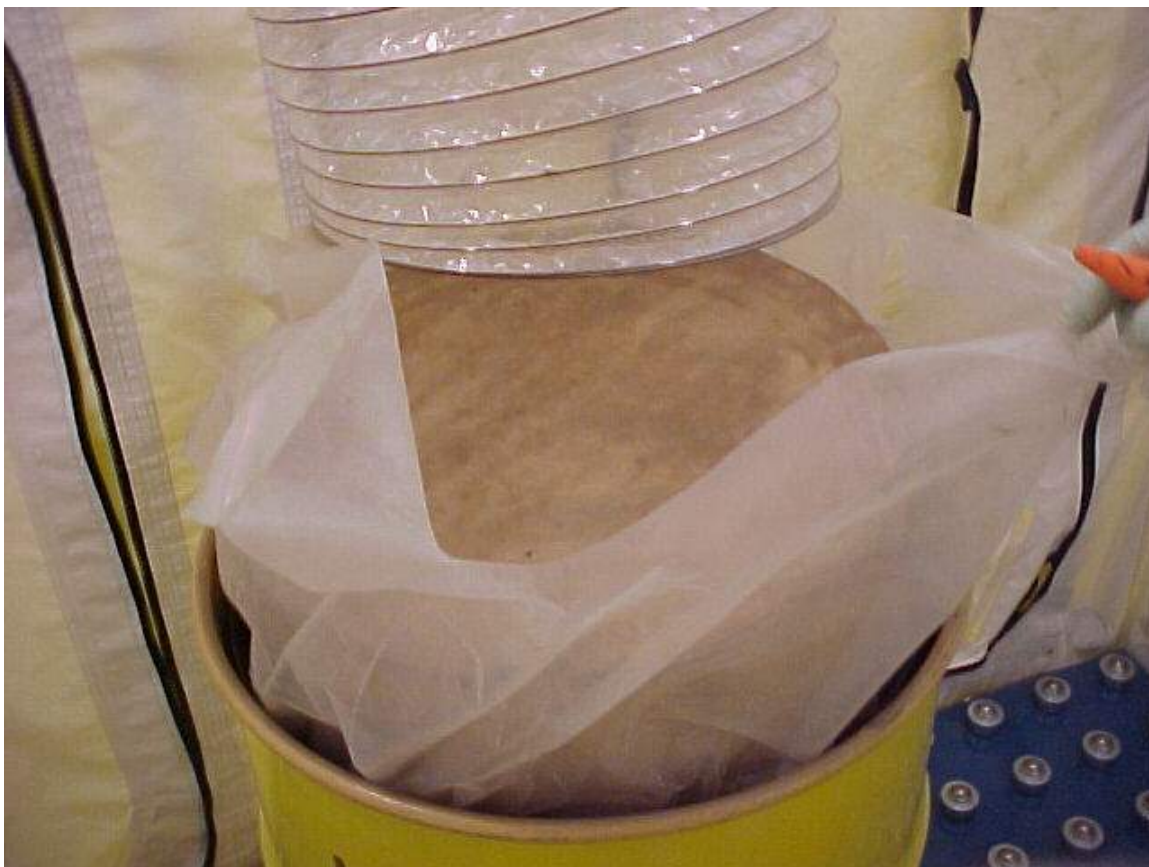
14:55**Other Information**Photo No. 5 of 10Dose Rate Surface 24 mR/hr
 1 meter 2.6 mR/hr2nd poly liner/bag – good conditionPicture still shows inflated condition of bags indicating internal pressure buildup inside of this bag.
No gases present in the breathing zone.

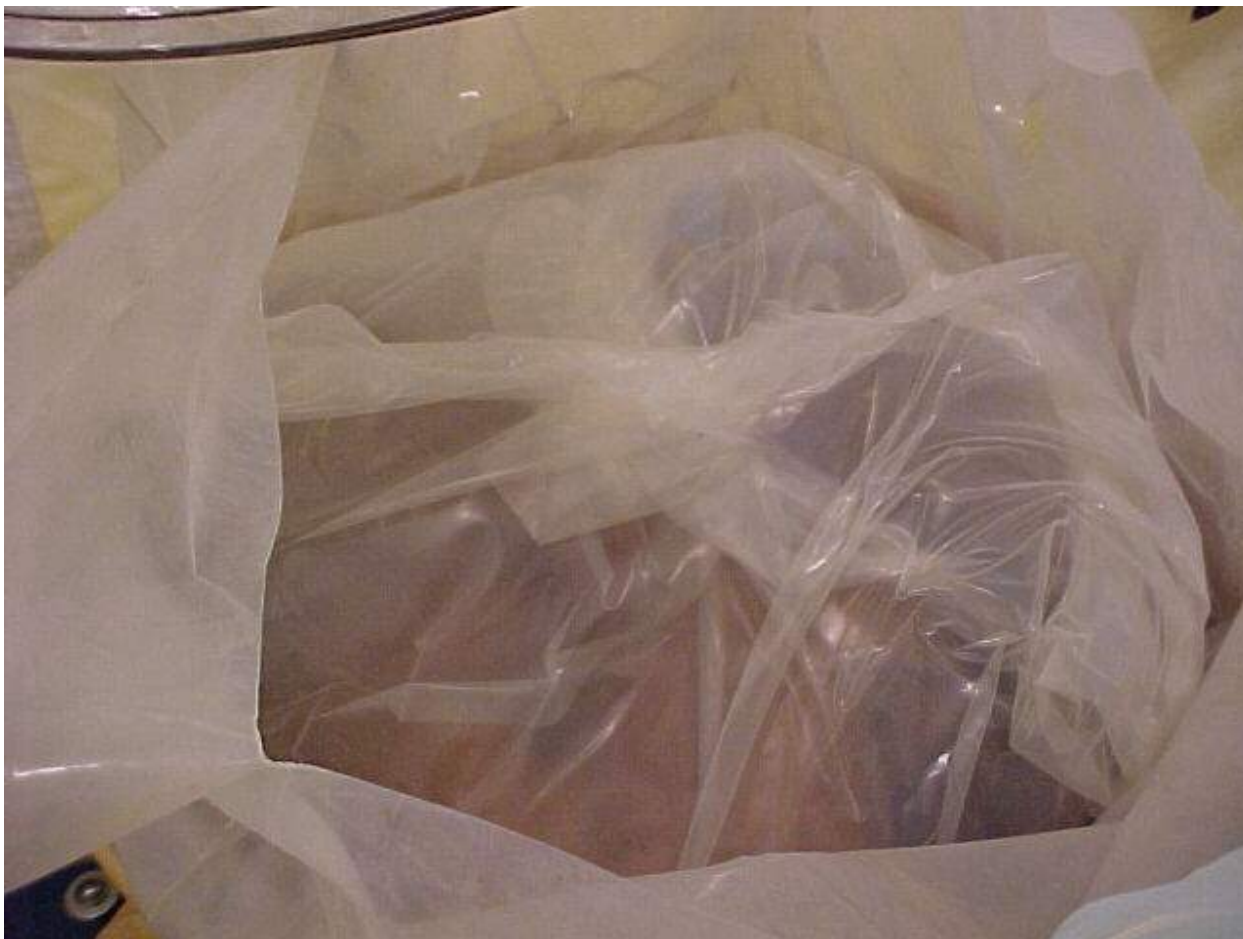
3rd poly liner/bag – good condition
No gases present in the breathing zone.

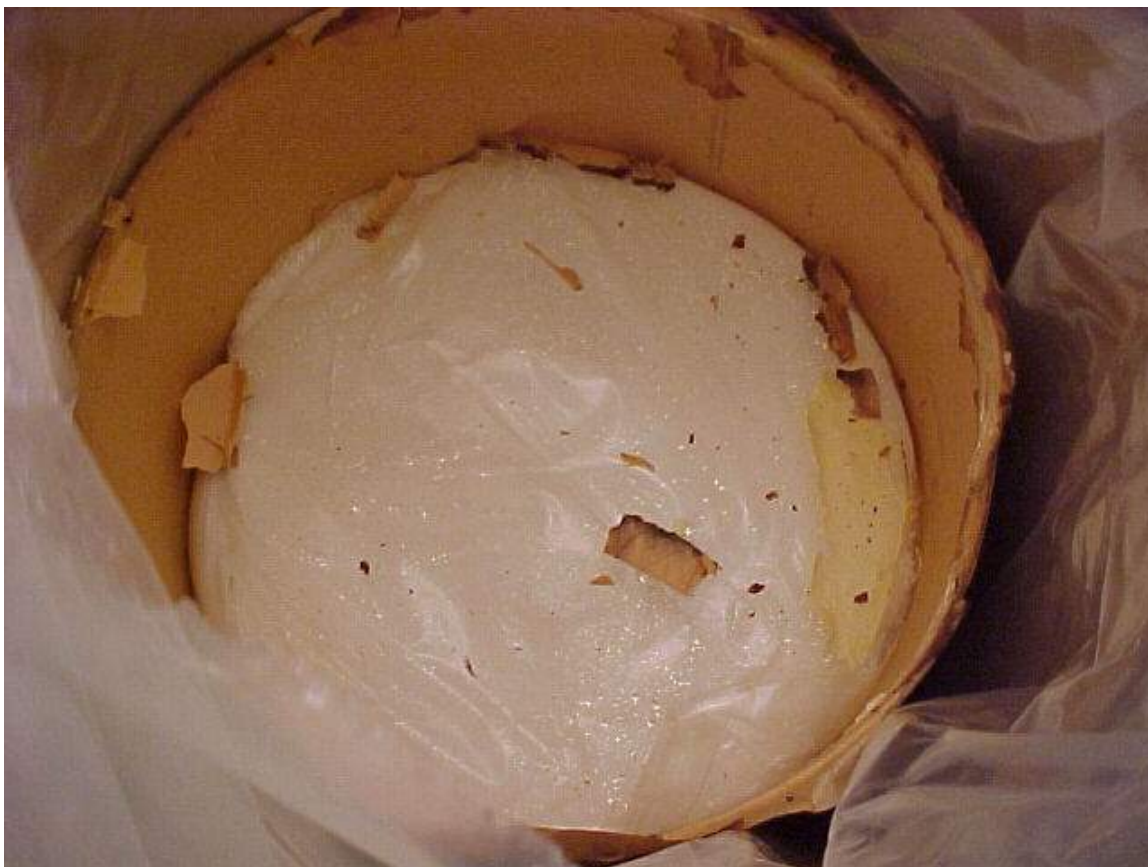
ThN material – solid – dry – white – good condition
No gases present in the breathing zone.

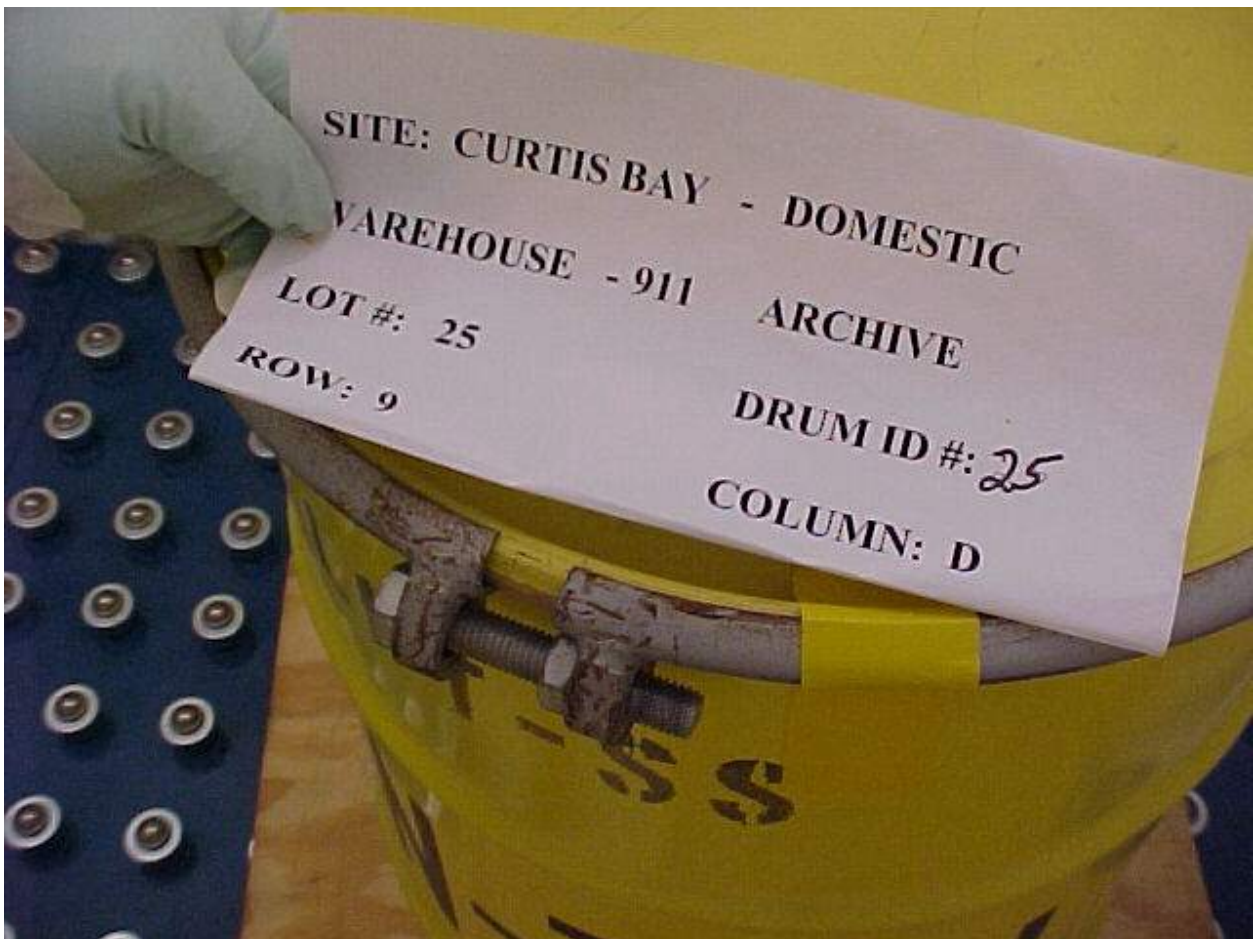
30-gal drum – good condition

Gases vented from drum during drum lid removal operations.

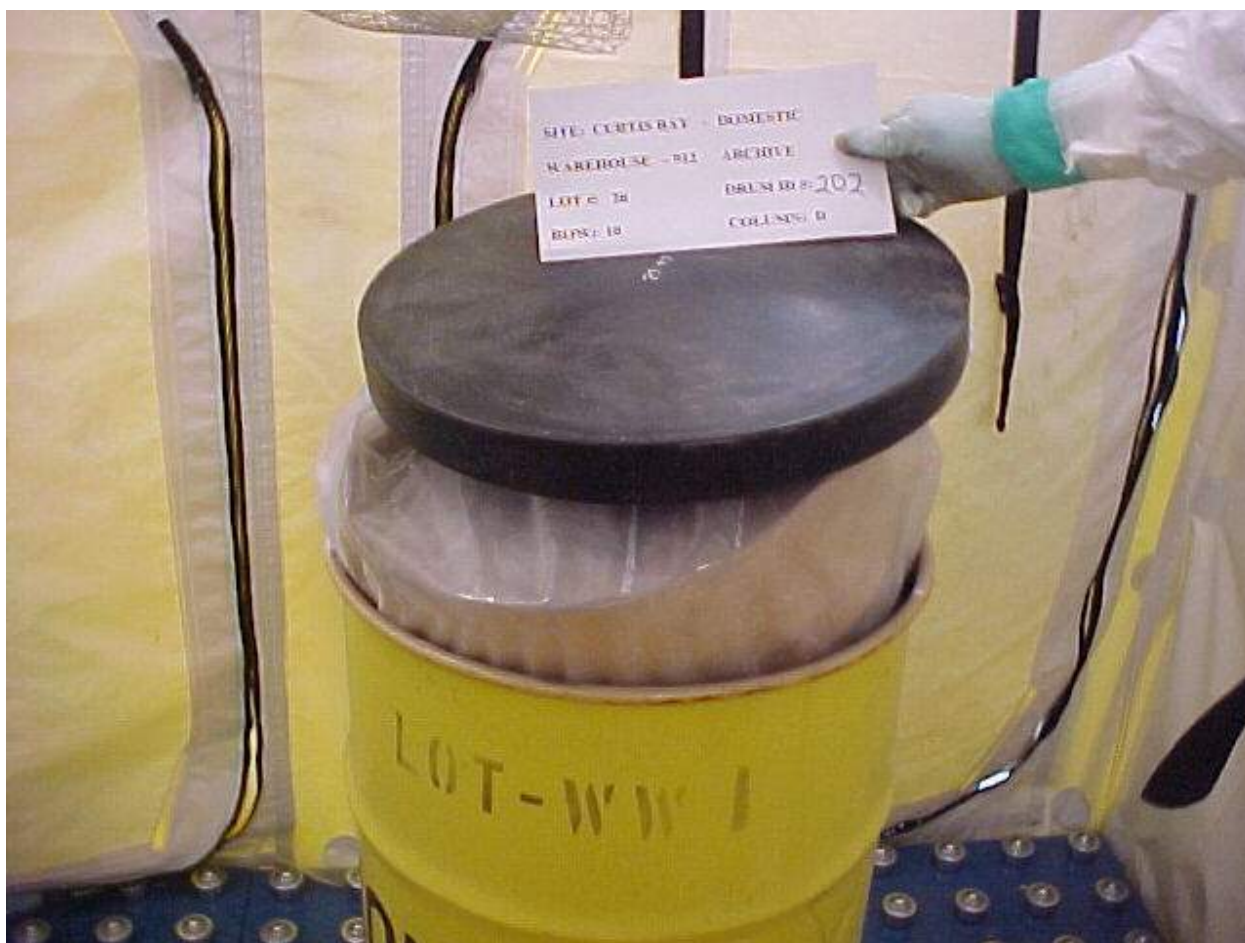
13:30**Other Information**Photo No. 3 of 10Dose Rate Surface 22 mR/hr
 1 meter 2.2 mR/hr1st poly liner/bag – good condition

Pressure buildup internal to this packaging layer has resulted in this layer being pushed out of the container vertically.

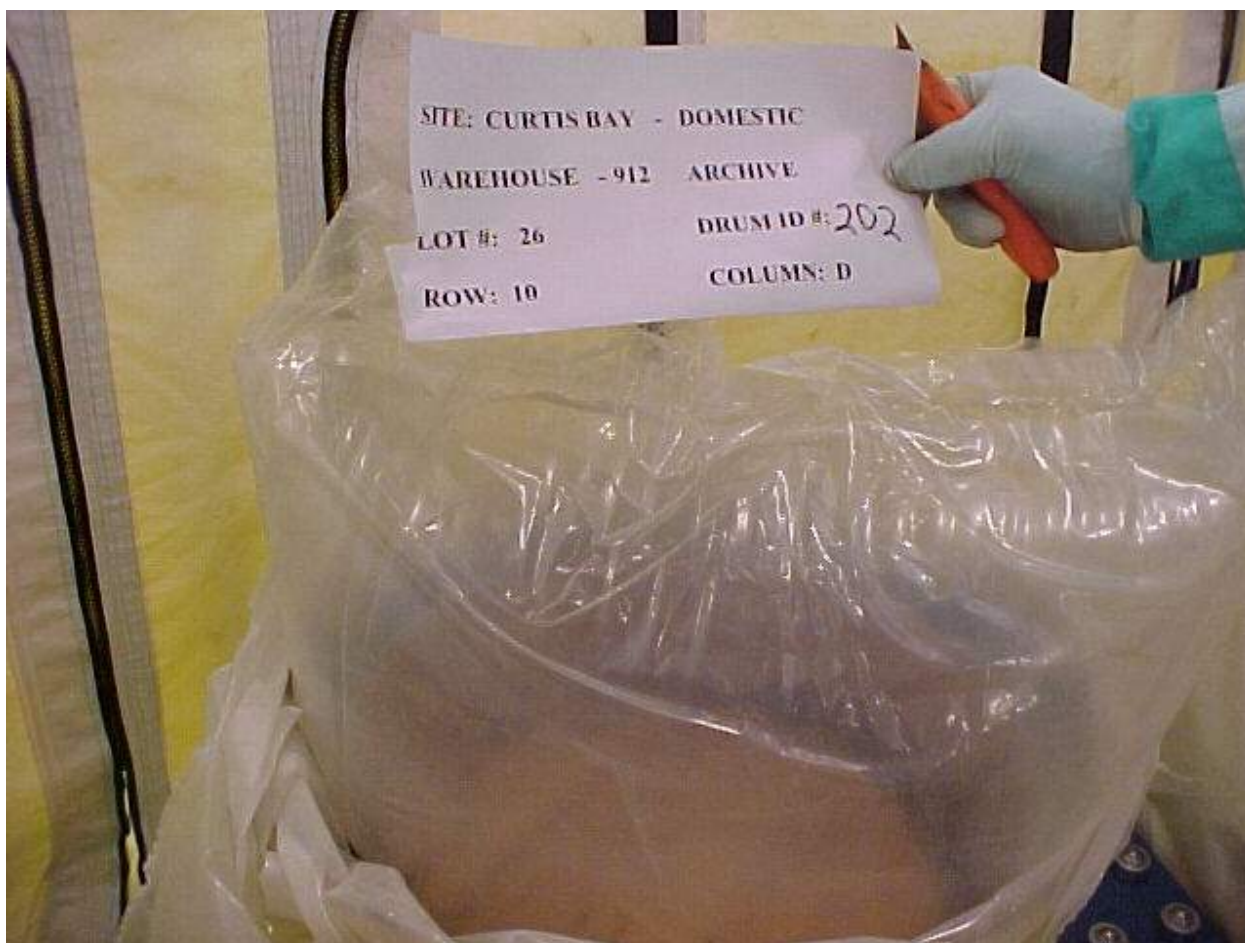
3rd poly liner/bag – good condition

Gases in headspace of bag – CH₄ – 5.2% LEL - NO - +50 ppm - NO_x - +50 ppm

Drum vented – all gases dissipated via HEPA exhaust.

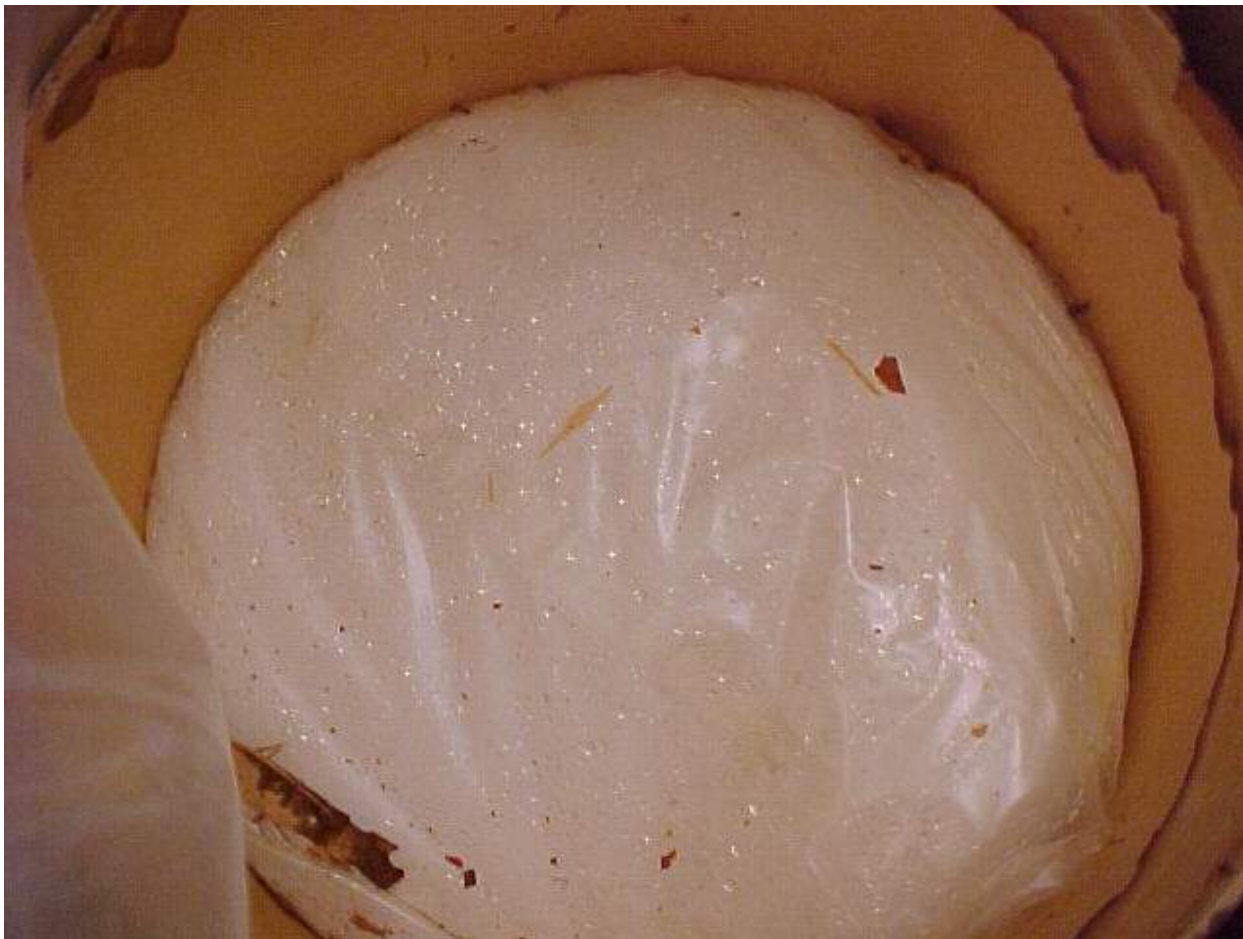
ThN material – monolith – white – solid - dry
No gases present in the breathing zone.

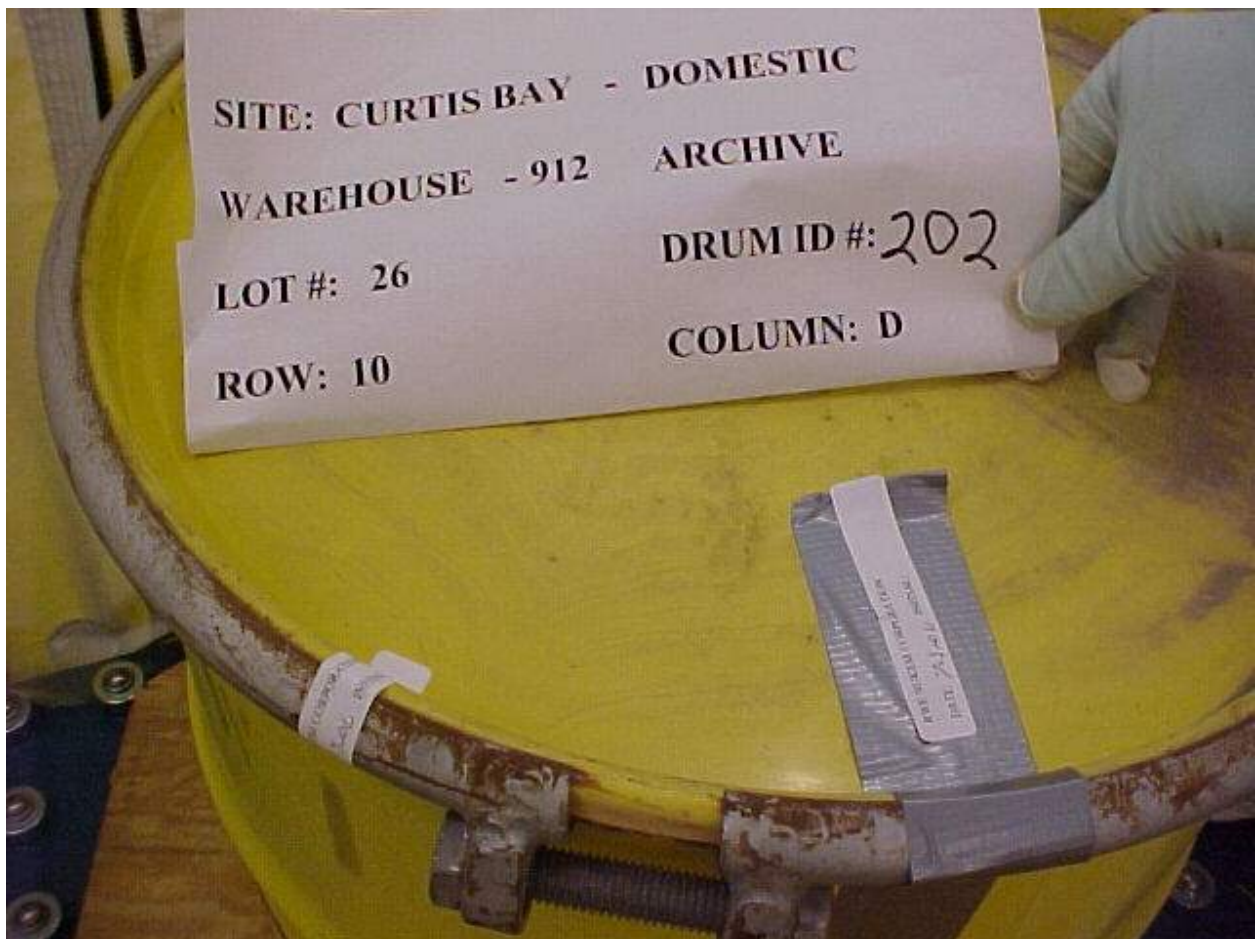
30-gal drum – drum lid had a significant “kink” (drum pressurization sign)
Gases vented from drum during drum lid removal operations.

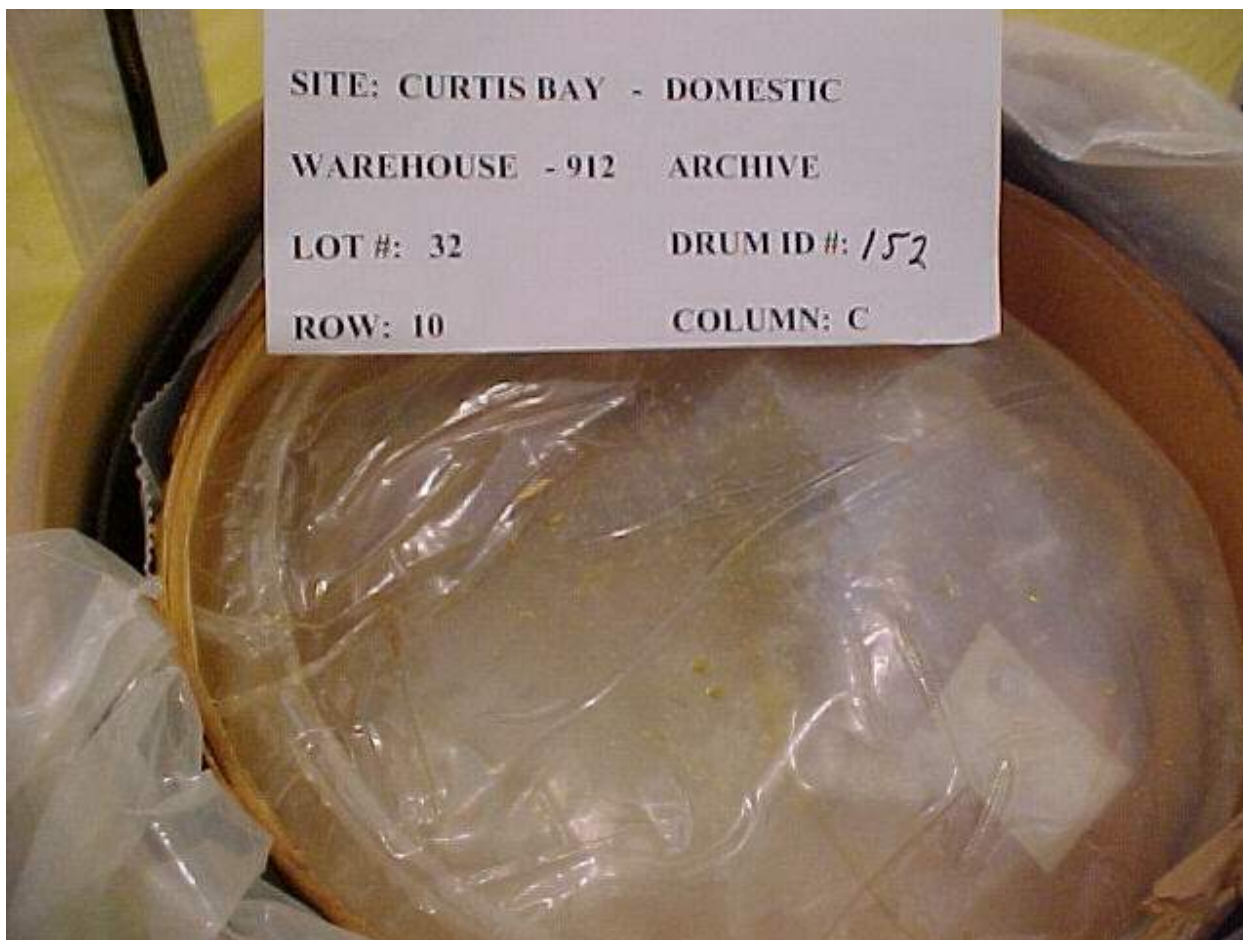
3rd poly liner/bag – hole in bag & damp inside the bag
 No wooden lid on the inner fiber/lab-pack drum
 Pressure built up inside container raises the poly liner/bag.
 Opened poly liner/bag - No gases present in the breathing zone
 Gases present in bag's headspace – CH₄ – 4.6% LEL - NO – +50 ppm - NO_x - +50 ppm
 Drum vented – gases dissipated out of containment tent via HEPA blower

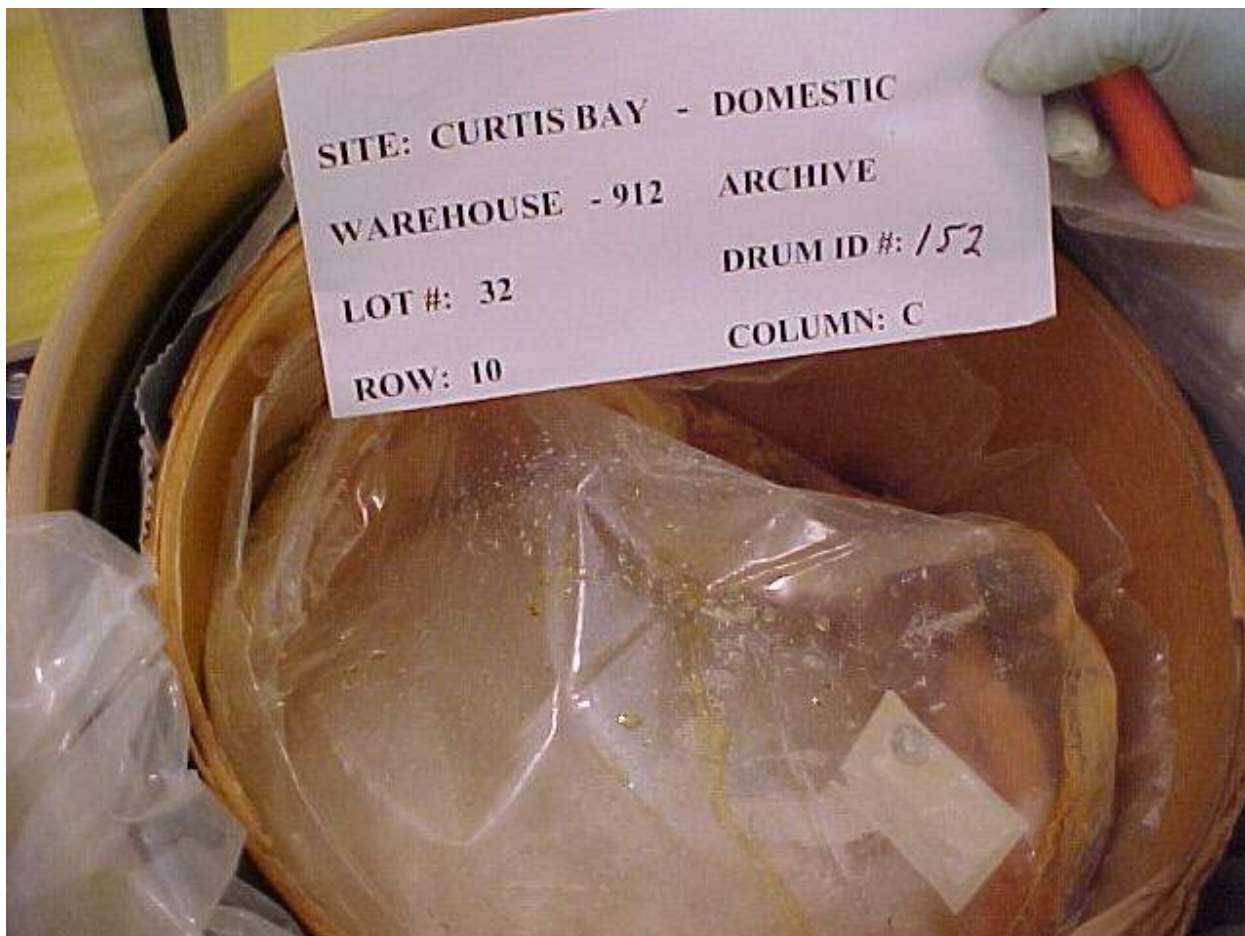
4th poly liner/bag – good condition (thin film plastic lining)
The lab-pack/fiber drum is badly damaged and damp.
No gases present in the breathing zone

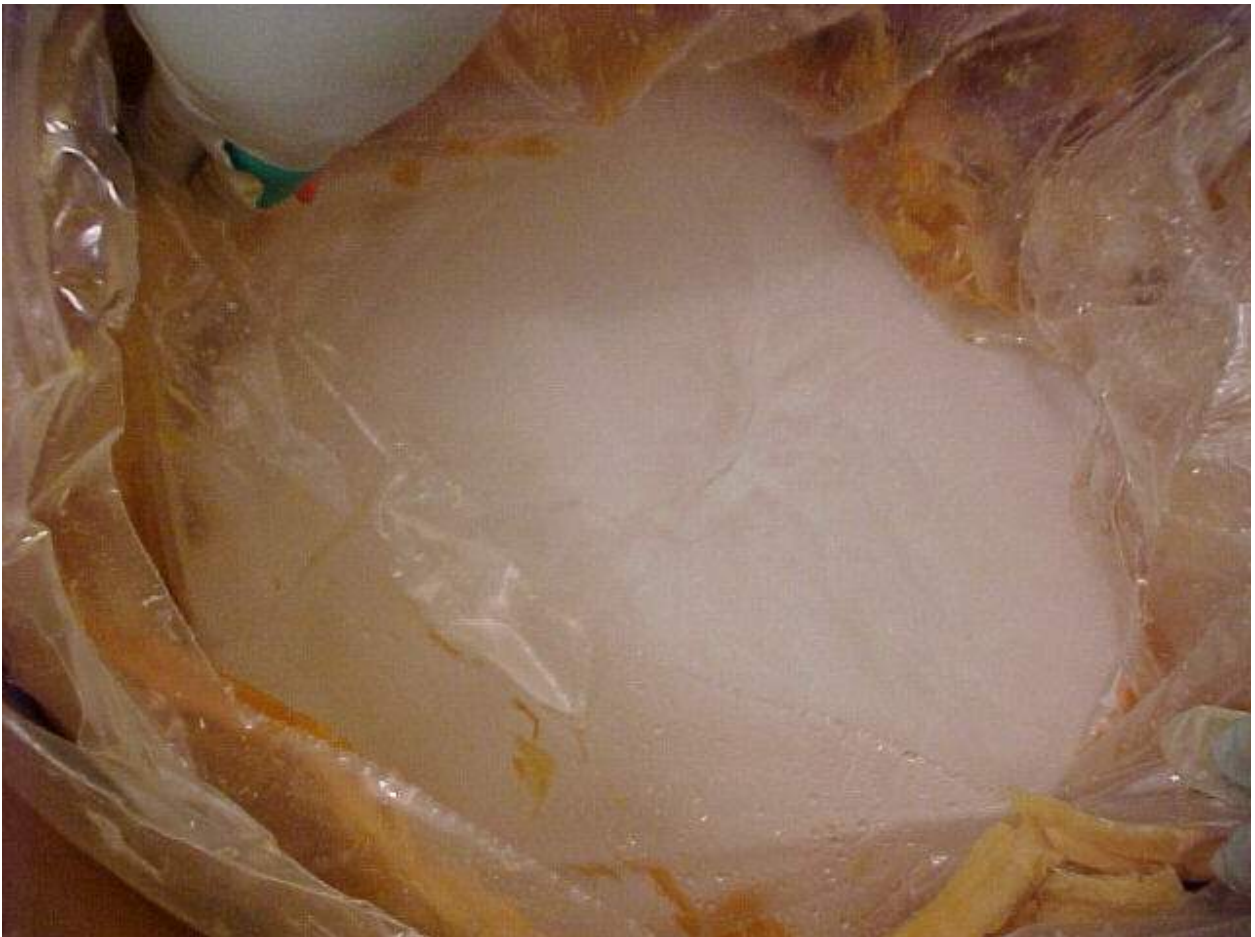
ThN material – monolith – white – solid - dry
No gases present in the breathing zone

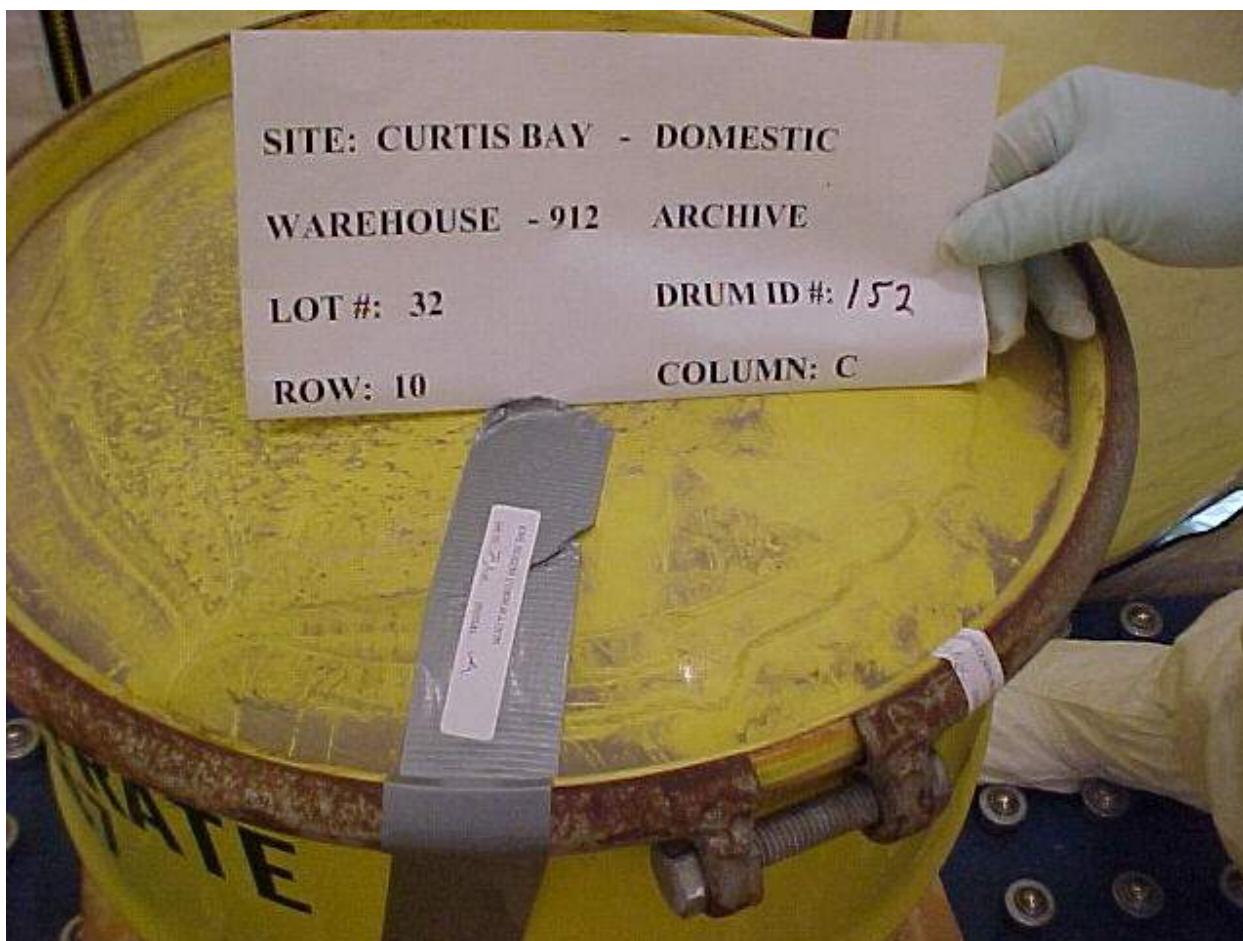
13:50**Other Information**Photo No. 9 of 9Dose Rate Surface 24 mR/hr
 1 meter 3.2 mR/hr

Sealed & dated - Complete

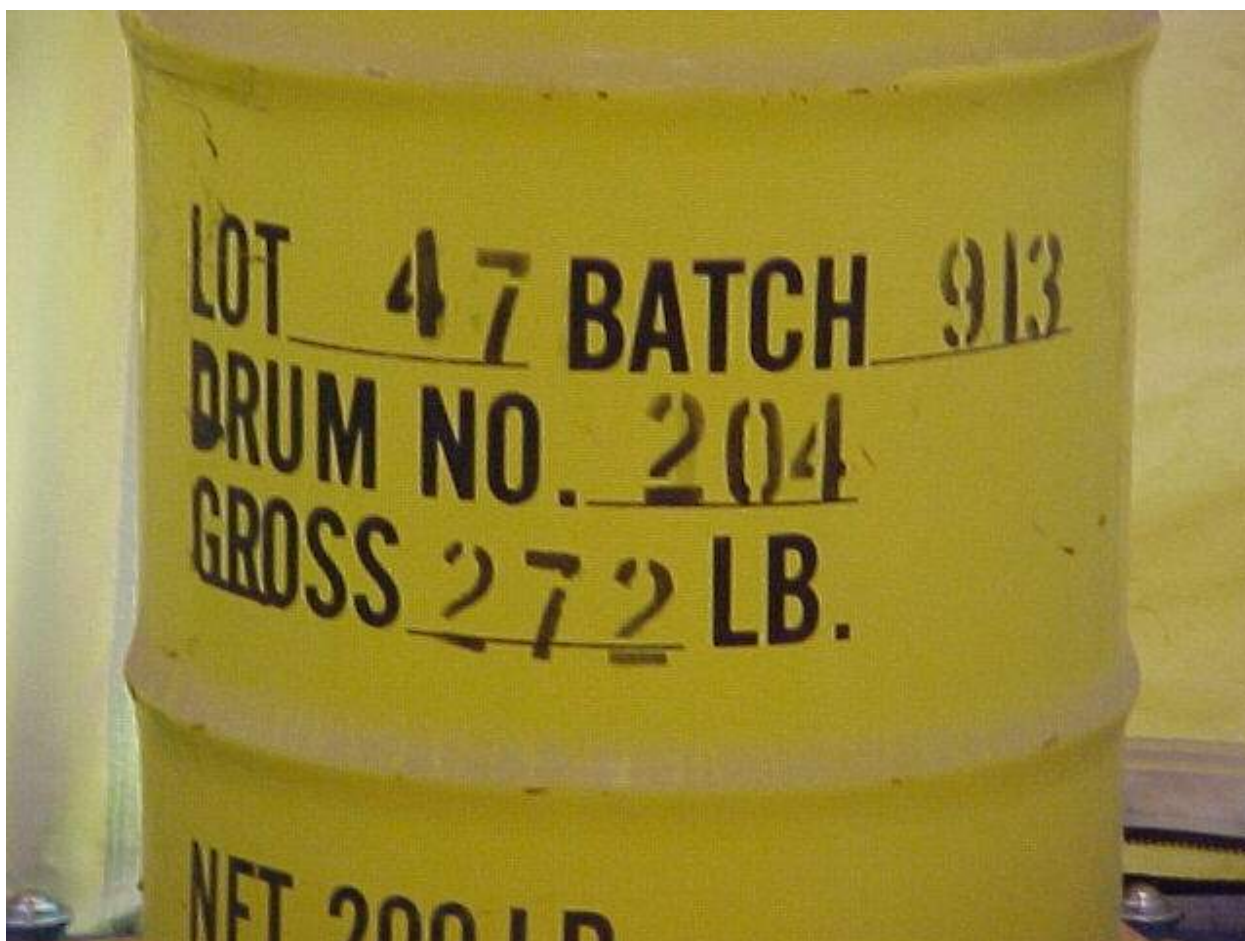
30-gal metal drum – good condition

Gases vented from drum during drum lid removal operations
