THORIUM NITRATE STOCKPILE DRUM CHARACTERIZATION REPORT

**THORIUM NITRATE STOCKPILE
DRUM CHARACTERIZATION REPORT**

Prepared for
U.S. Defense Logistics Agency
Defense National Stockpile Center
Fort Belvoir, Virginia

Prepared by
OAK RIDGE NATIONAL LABORATORY
Oak Ridge, Tennessee 37831
managed by
UT-BATTELLE, LLC
for the
U.S. DEPARTMENT OF ENERGY
under contract DE-AC05-00OR22725

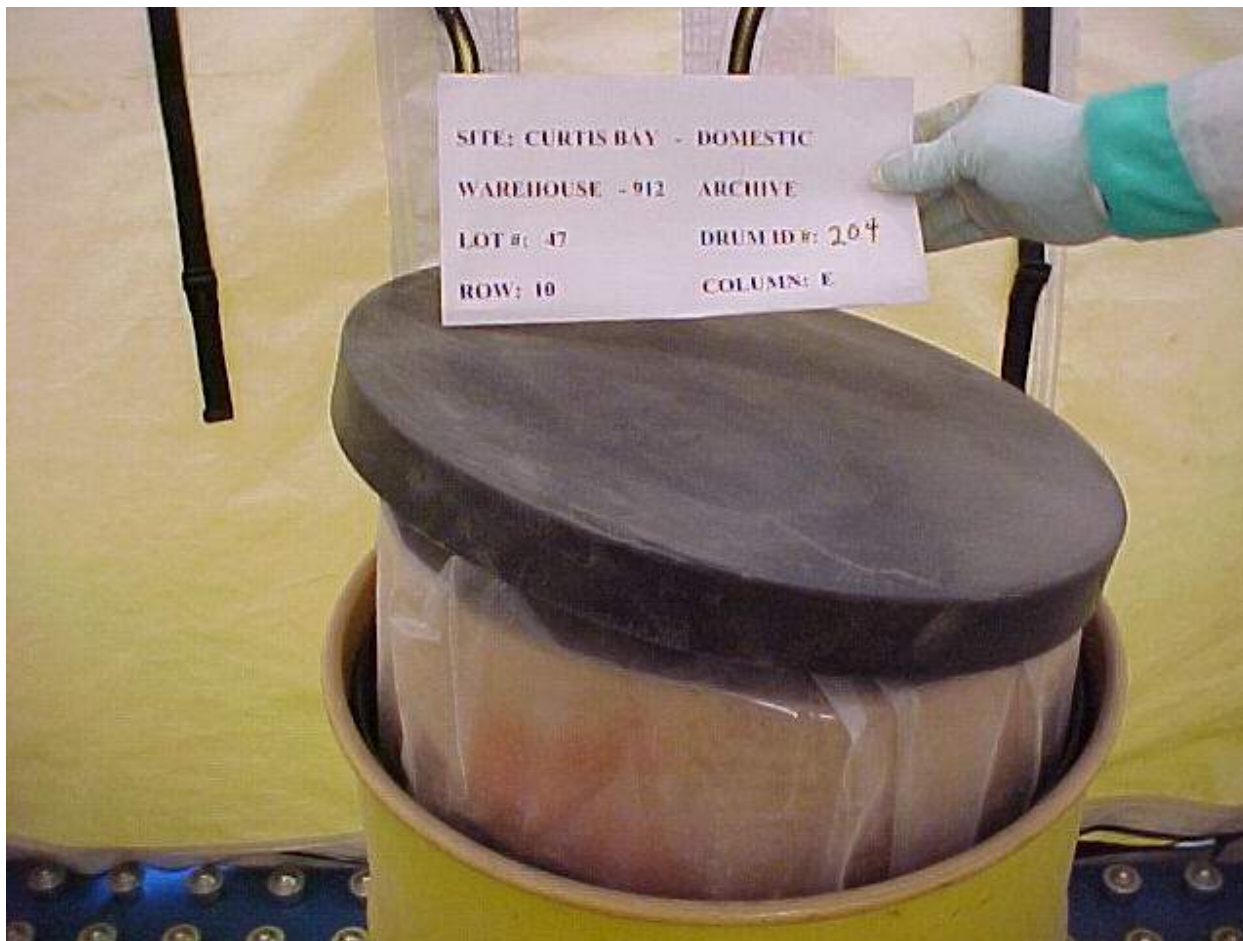
Black plastic lid – good condition

Pressure buildup internal to this packaging layer raises this layer vertically out of the container.

No gases present in the breathing zone.

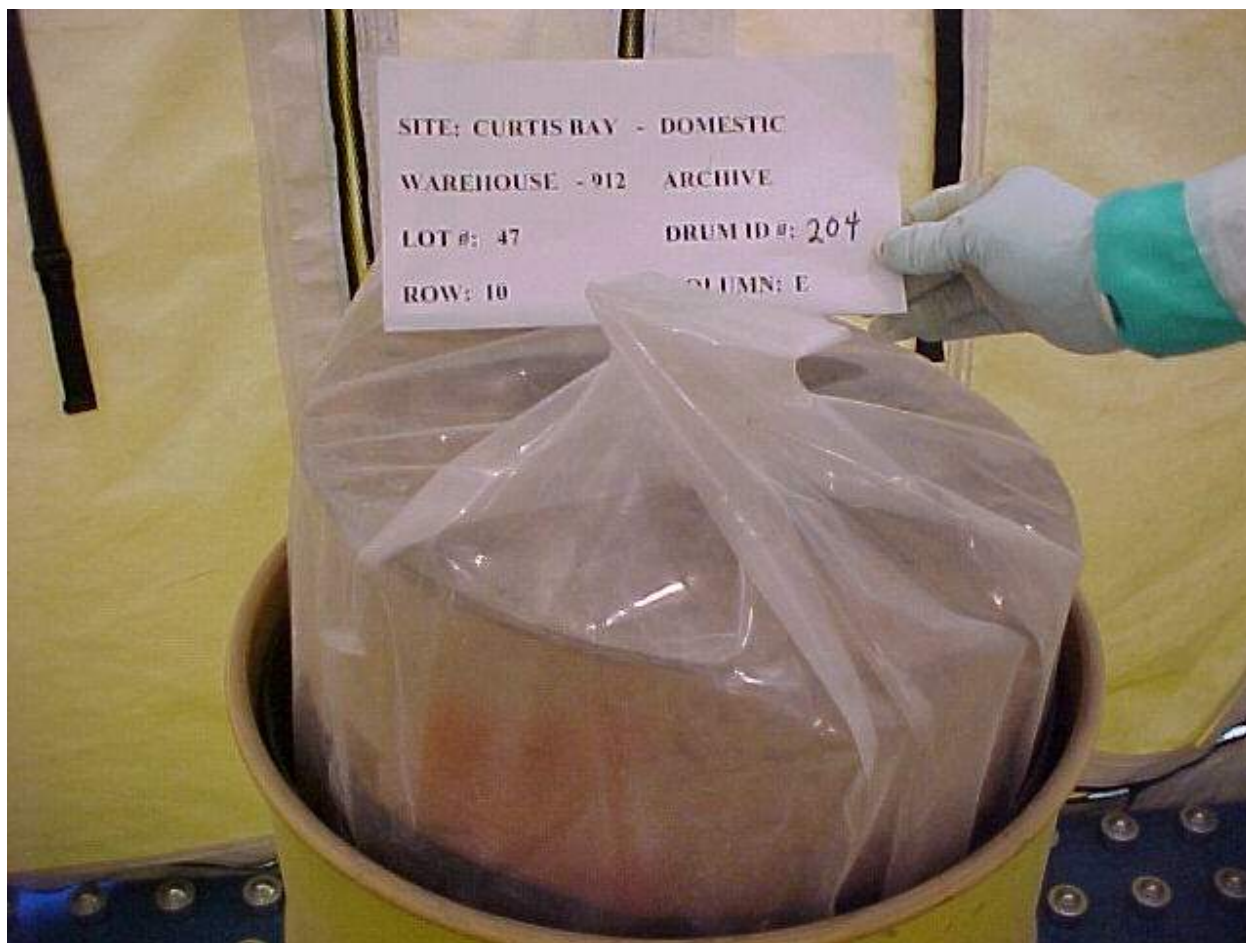
13:00**Other Information**Photo No. 3 of 10Dose Rate Surface 22 mR/hr
 1 meter 1.7 mR/hr1st poly liner/bag – good conditionPressure buildup internal to this packaging layer raises this layer vertically out of the container.
No gases present in the breathing zone.

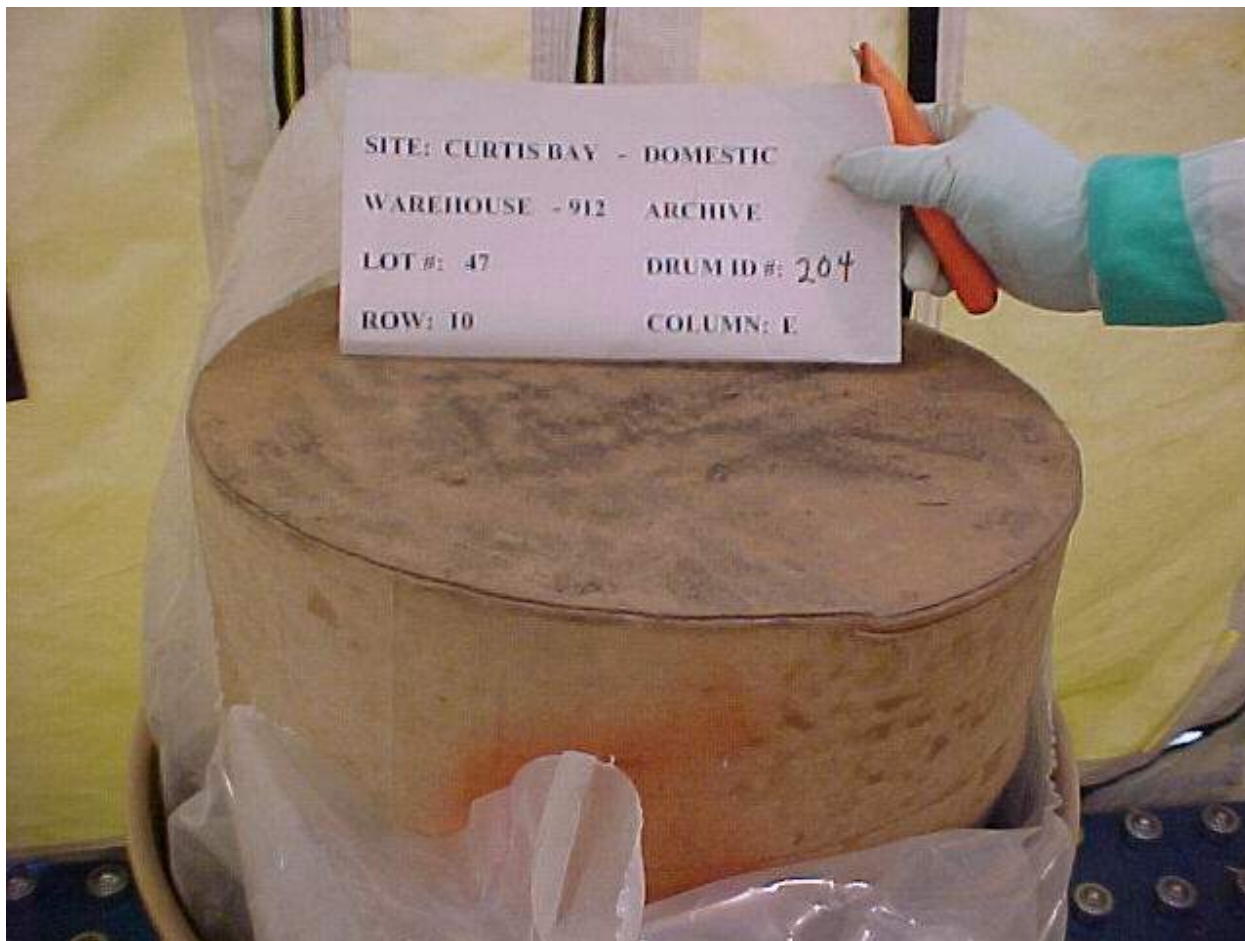
Fiber lid (from outermost fiber drum internal to container) – good condition
Pressure buildup internal to this packaging layer raises this layer vertically out of the container.
No gases present in the breathing zone.

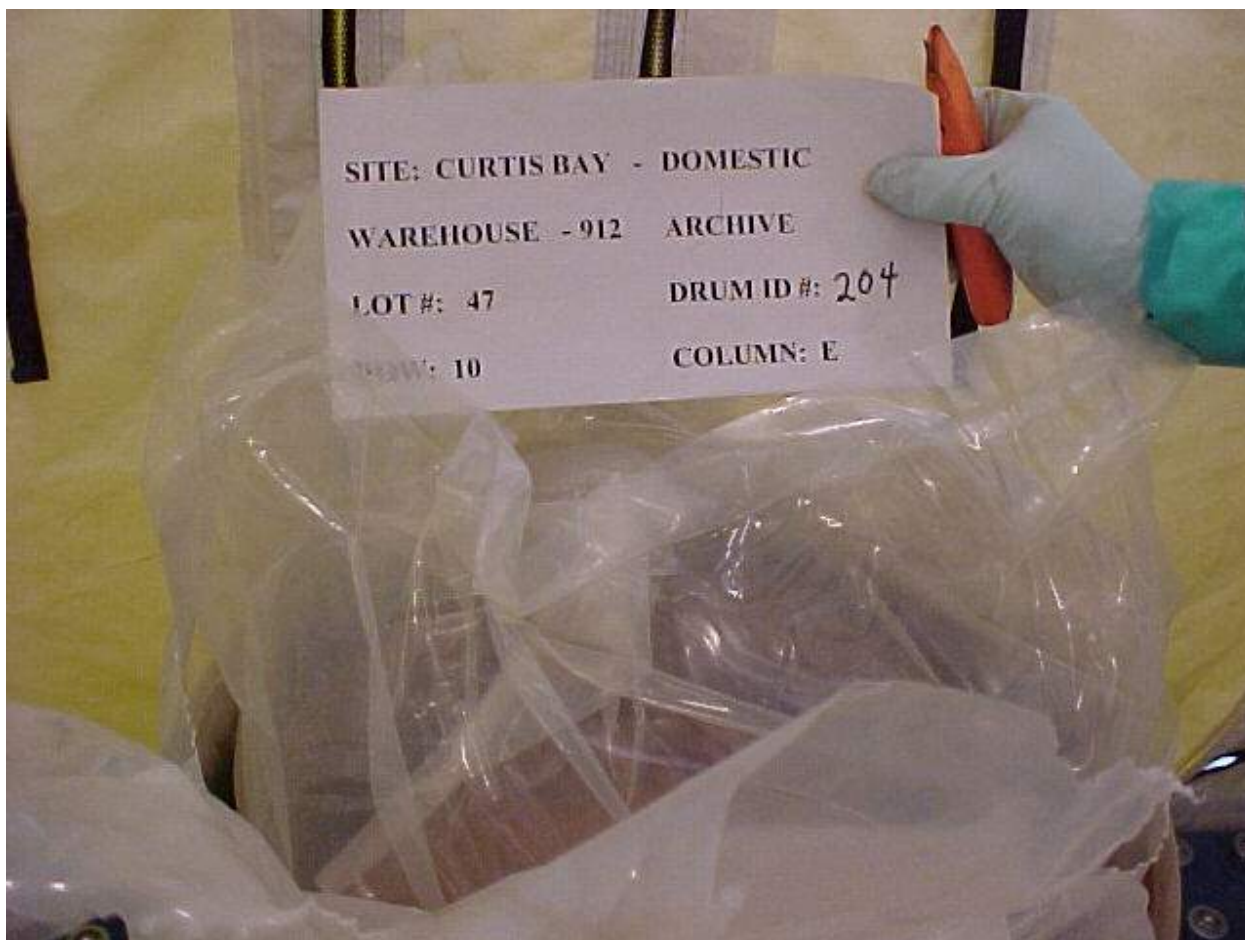
General InformationSite Curtis BayThN Origin DomesticLot No. 47Drum ID No. 204Inspection/Sample
DispositionVisual Inspection & Sampling
Archive**Physical Location of Drum**Warehouse 912Row 10
Column E**Inspection/Sample Date & Time**Date 7-9-2002Time 13:00**Other Information**Photo No. 5 of 10Dose Rate Surface 22 mR/hr
 1 meter 1.7 mR/hr2nd poly liner/bag – good conditionPressure buildup internal to this packaging layer raises this layer vertically out of the container.
No gases present in the breathing zone.

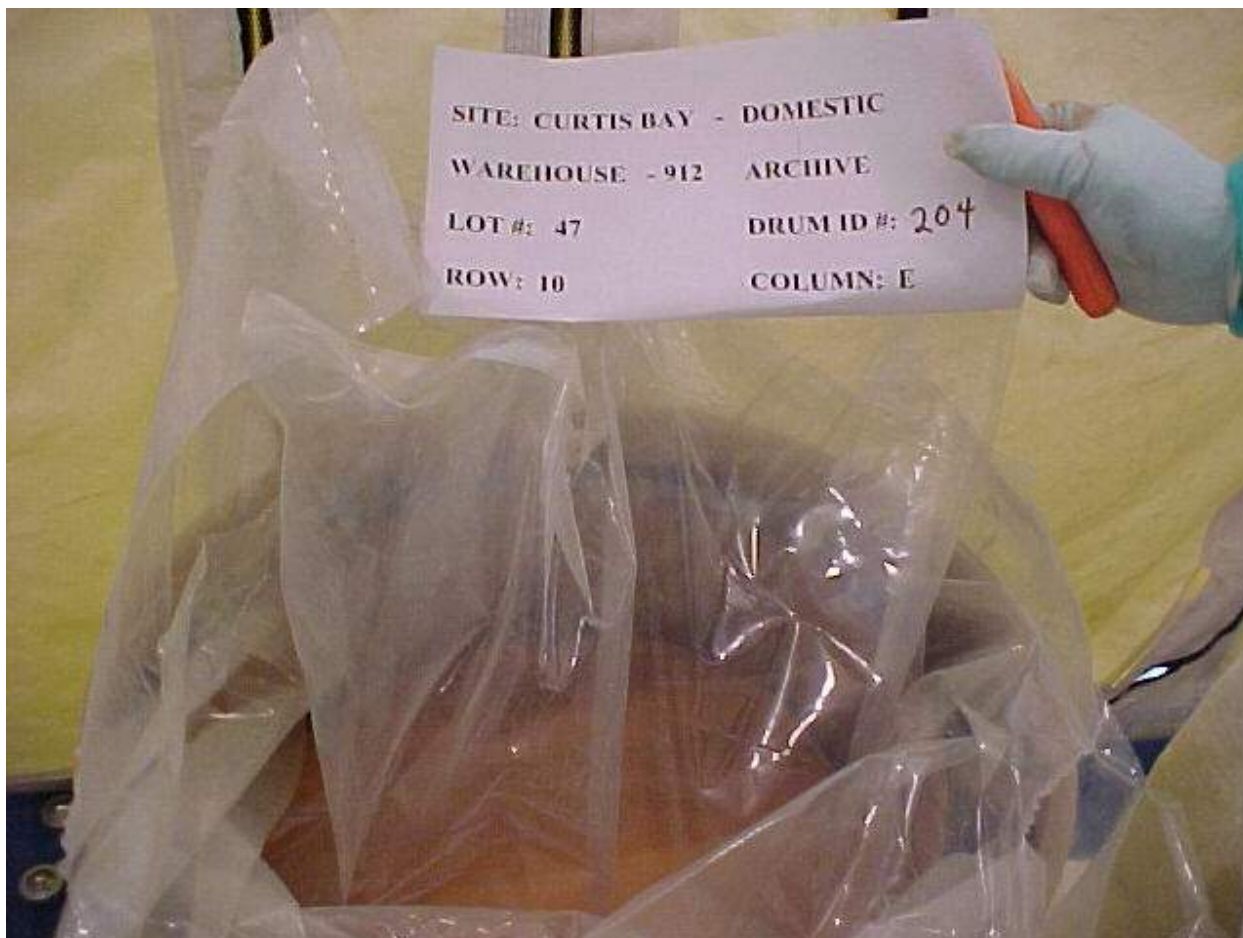
3rd poly liner/bag – good condition

Gases in poly bag headspace – CH₄ – 4.6% LEL - NO - +50 ppm - NO_x - +50 ppm

Gases exhausted utilizing HEPA blower.

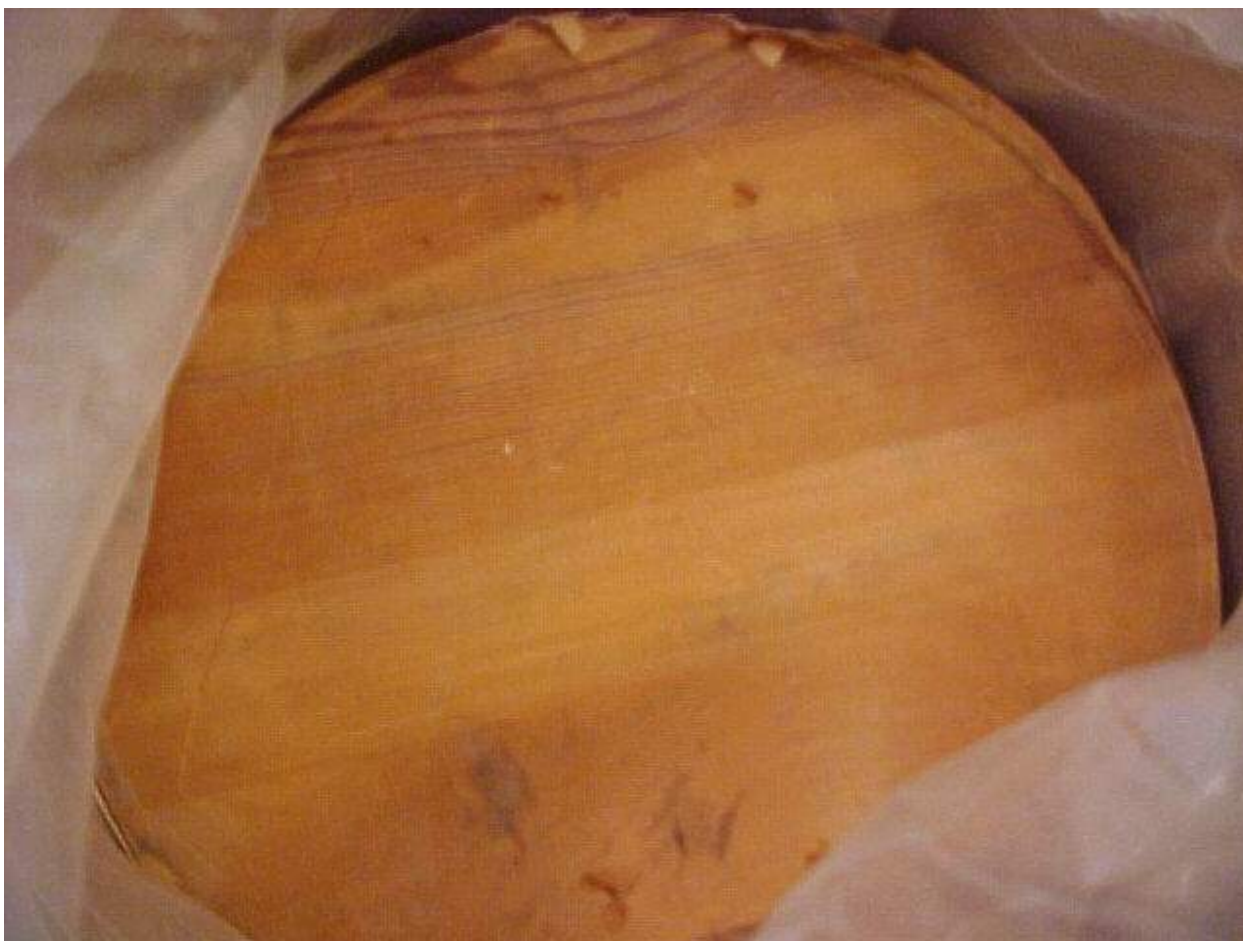
13:00**Other Information**Photo No. 7 of 10Dose Rate Surface 22 mR/hr
 1 meter 1.7 mR/hr

Wooden lid (mounted on innermost fiber/lab-pack drum) – good condition
No gases present in the breathing zone.

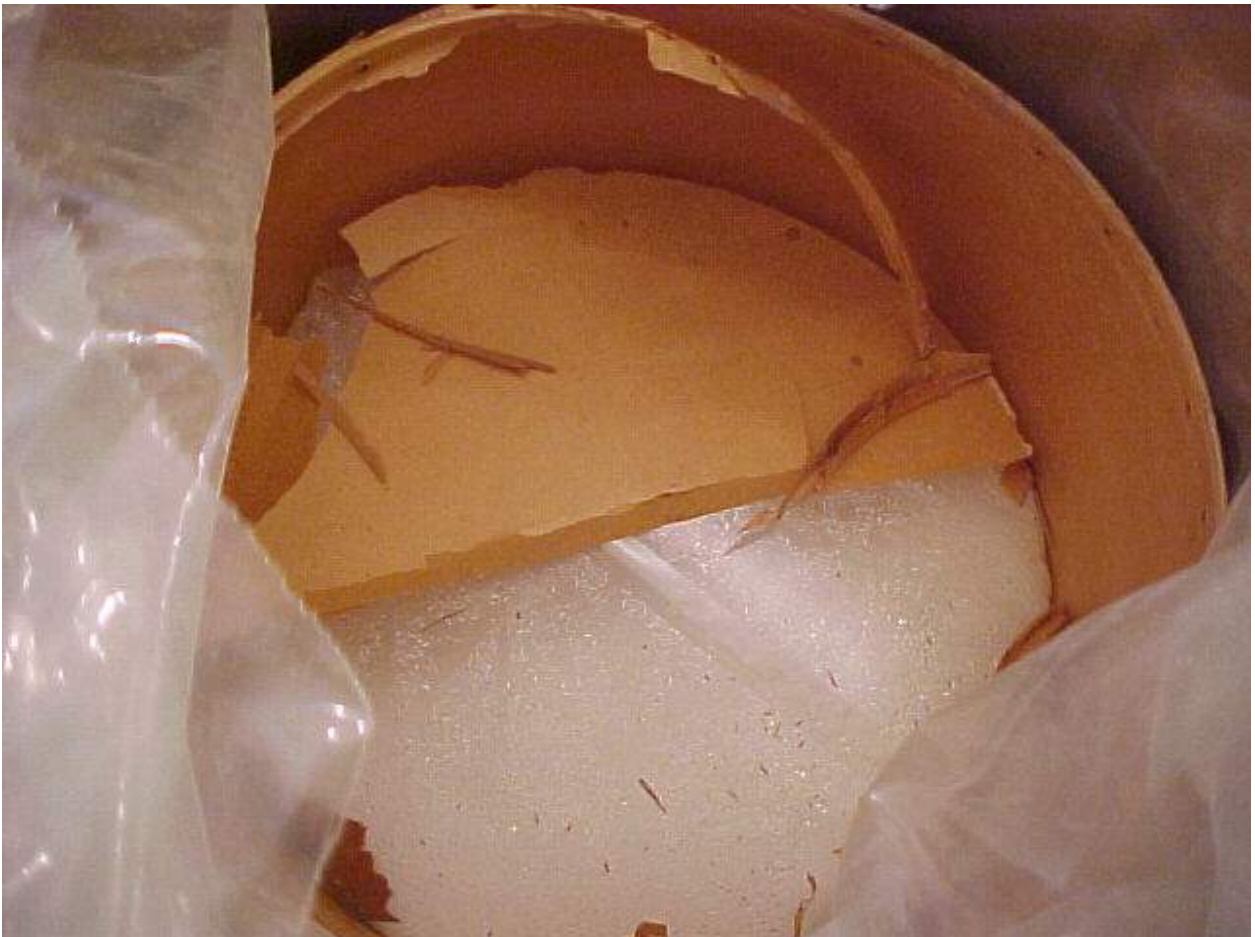
Lab-pack (paper layer) lid broke apart after (or during) wooden lid removal
No gases present in the breathing zone.

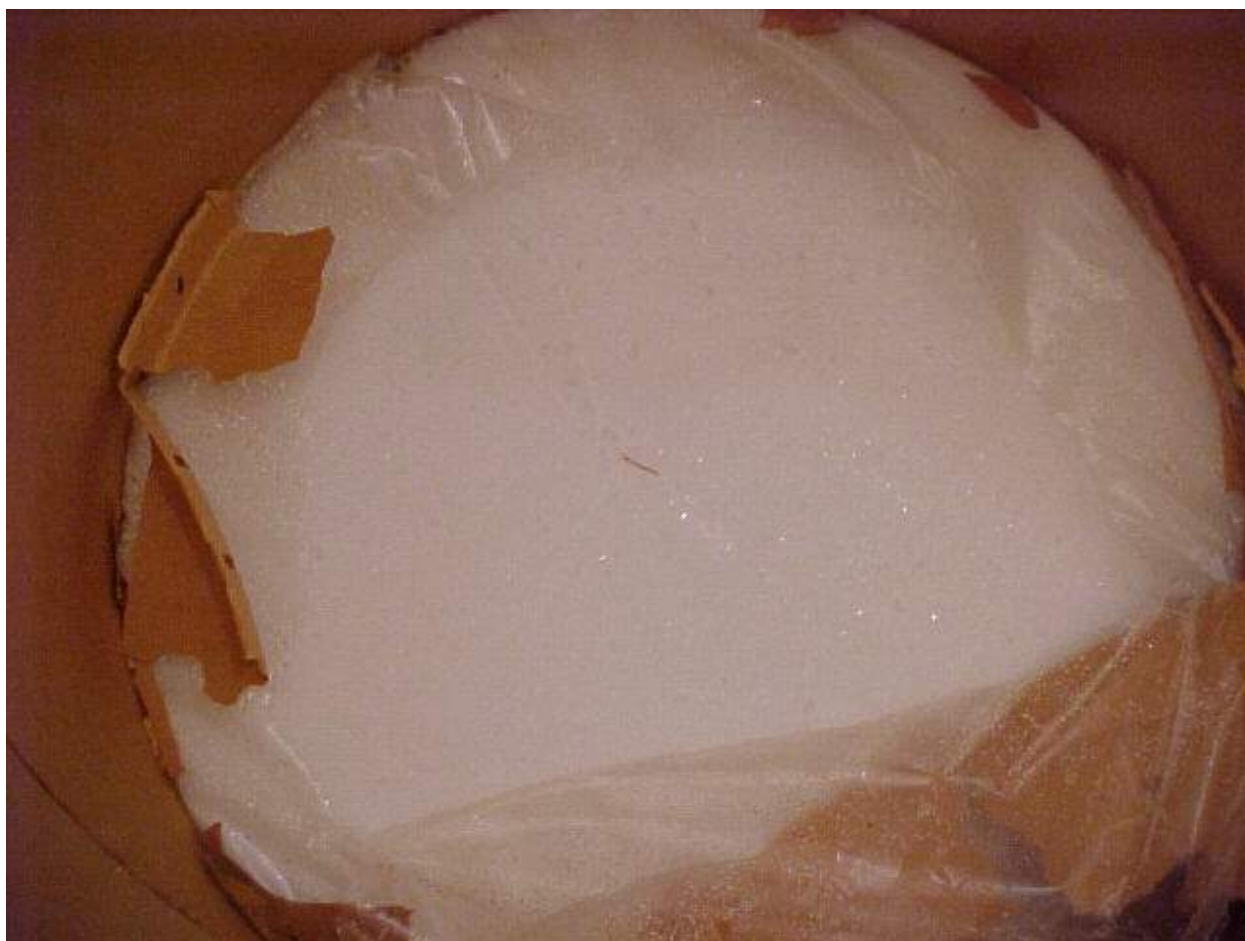
13:00**Other Information**Photo No. 9 of 10Dose Rate Surface 22 mR/hr
 1 meter 1.7 mR/hr

ThN material – solid – monolith – white - dry
No gases present in the breathing zone.

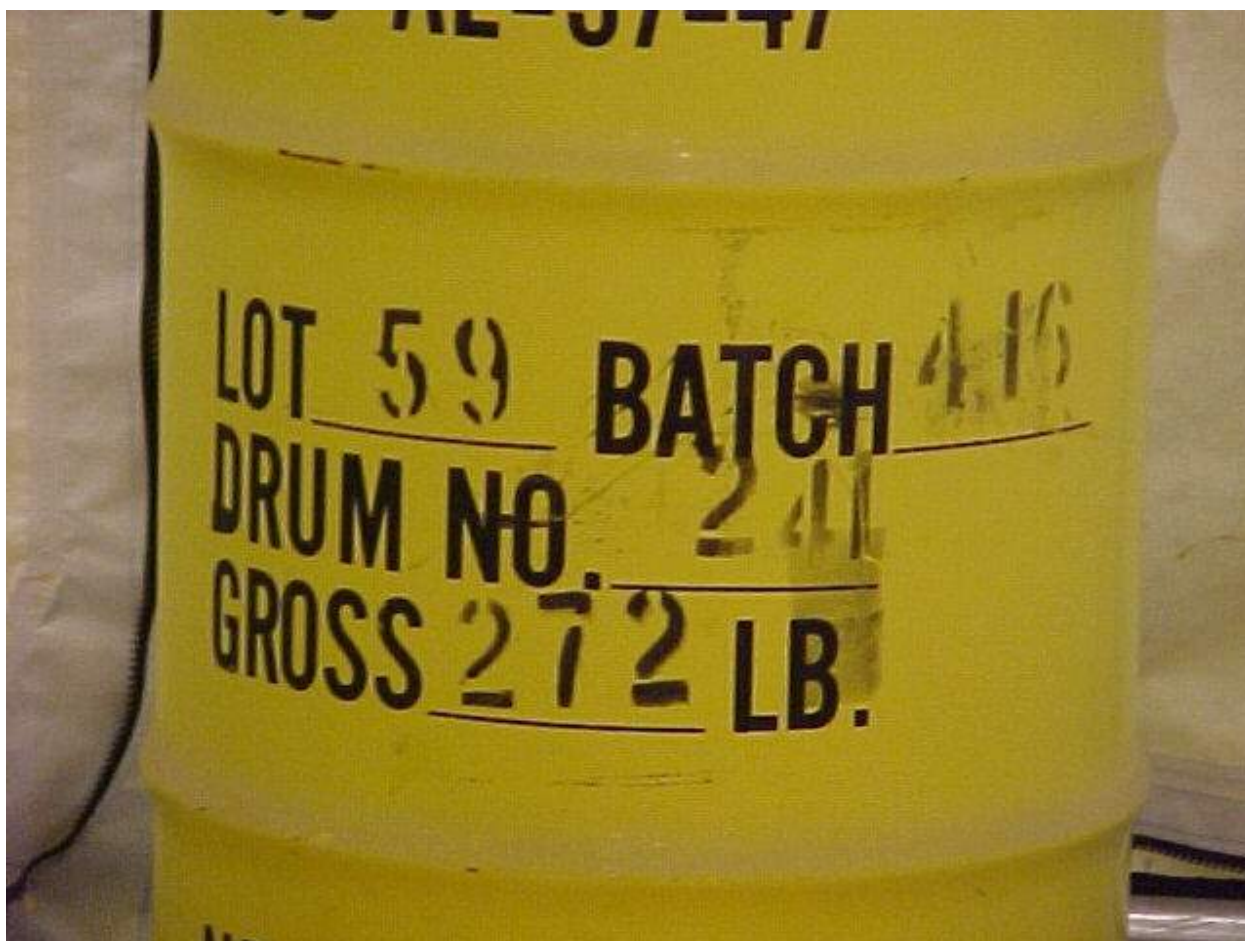
30-gal drum – good condition

Gases vented from drum during lid removal operations

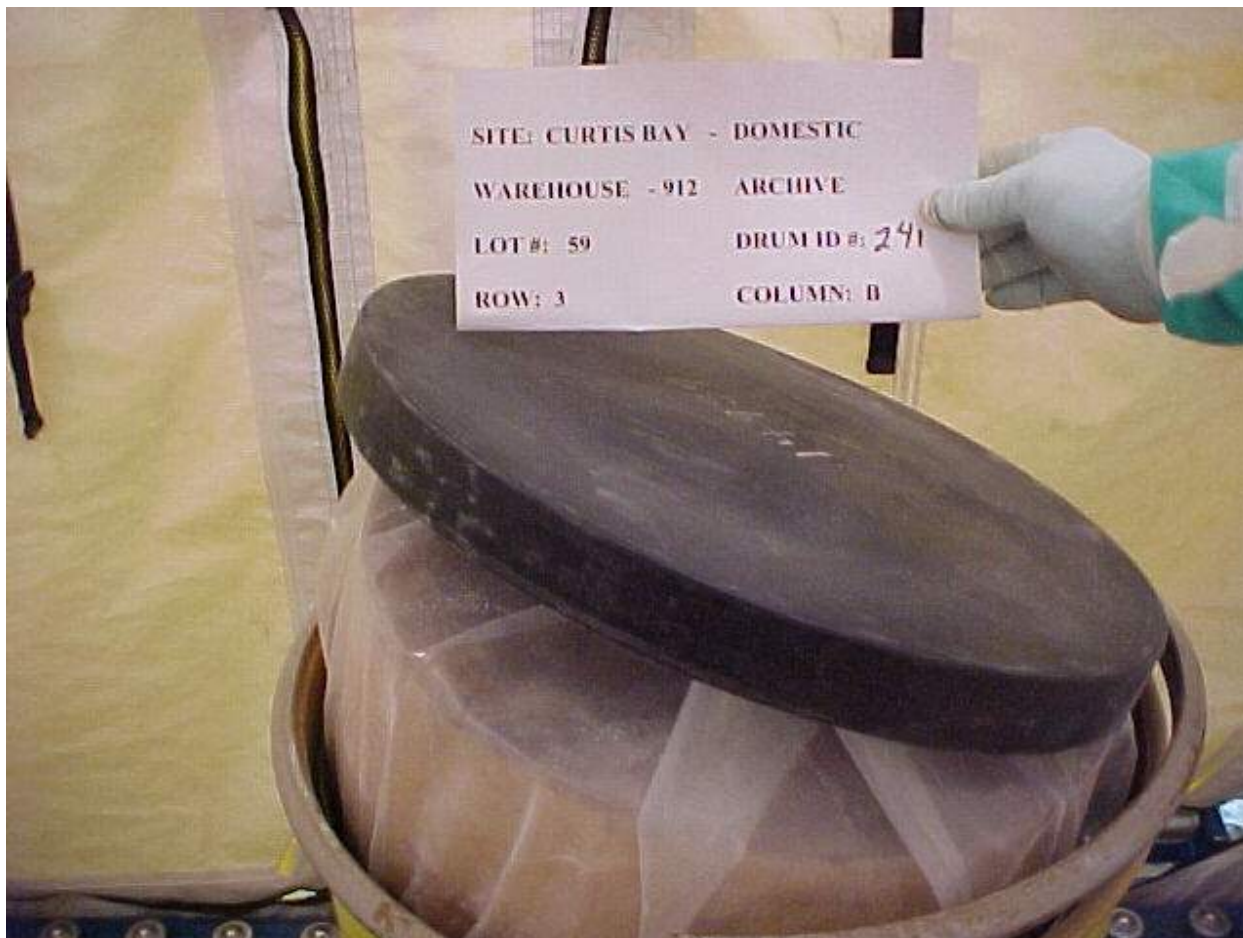
Black plastic lid – good condition

Pressure buildup inside of packaging layer raises packaging layer vertically out of container.

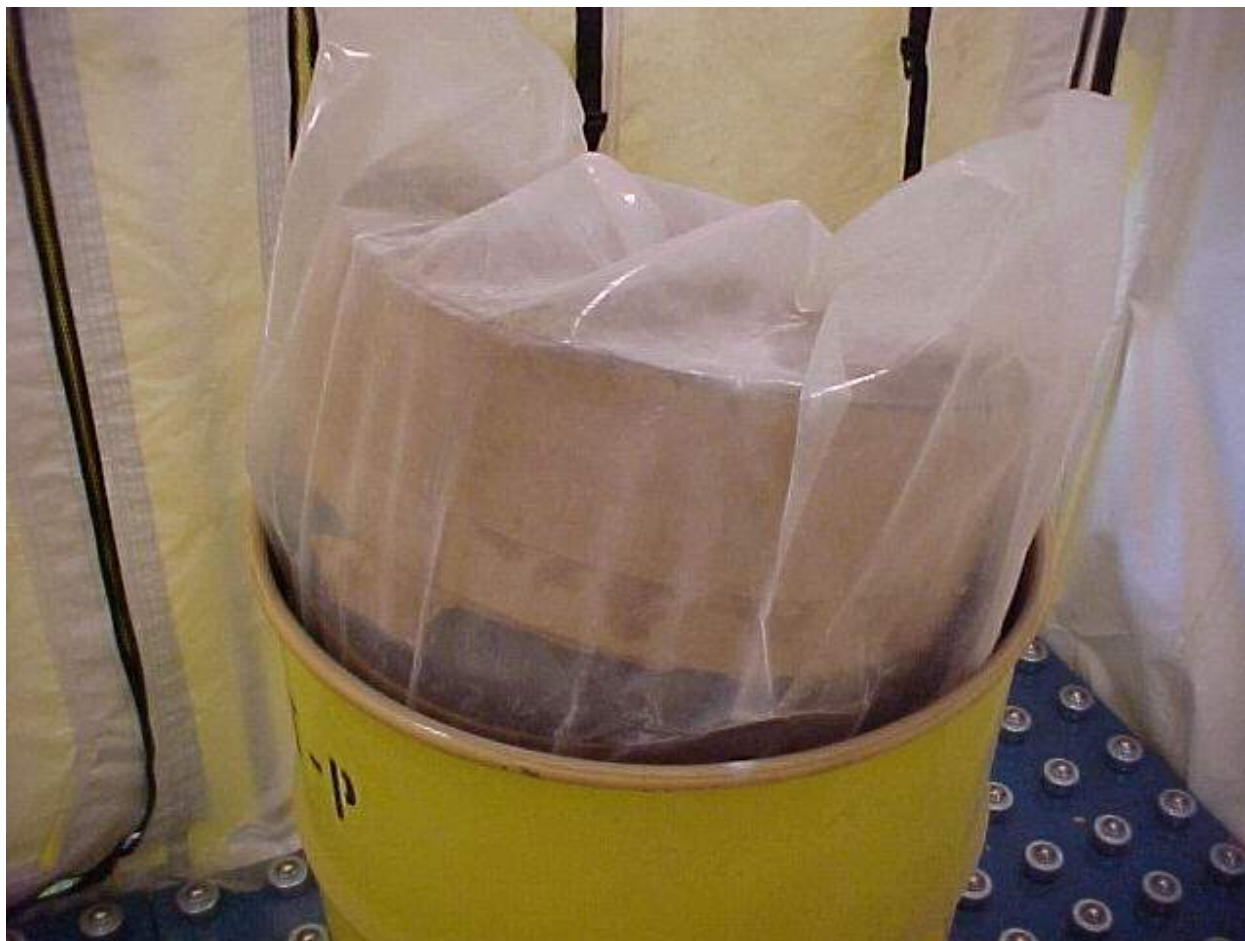
1st poly liner/bag – good condition

Pressure buildup inside of packaging layer raises packaging layer vertically out of container.

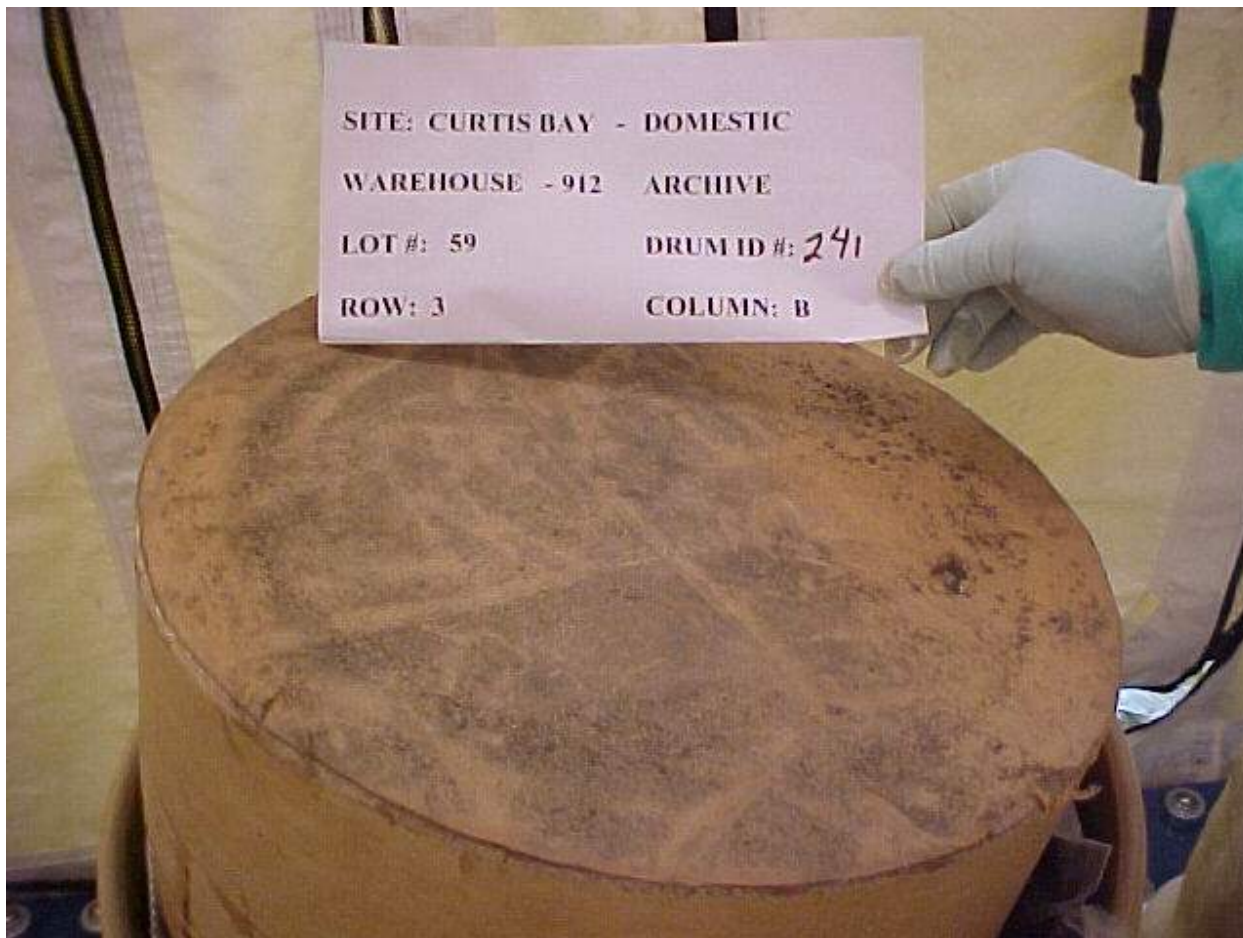
Fiber drum lid – good condition

Pressure buildup inside of packaging layer raises packaging layer vertically out of container.

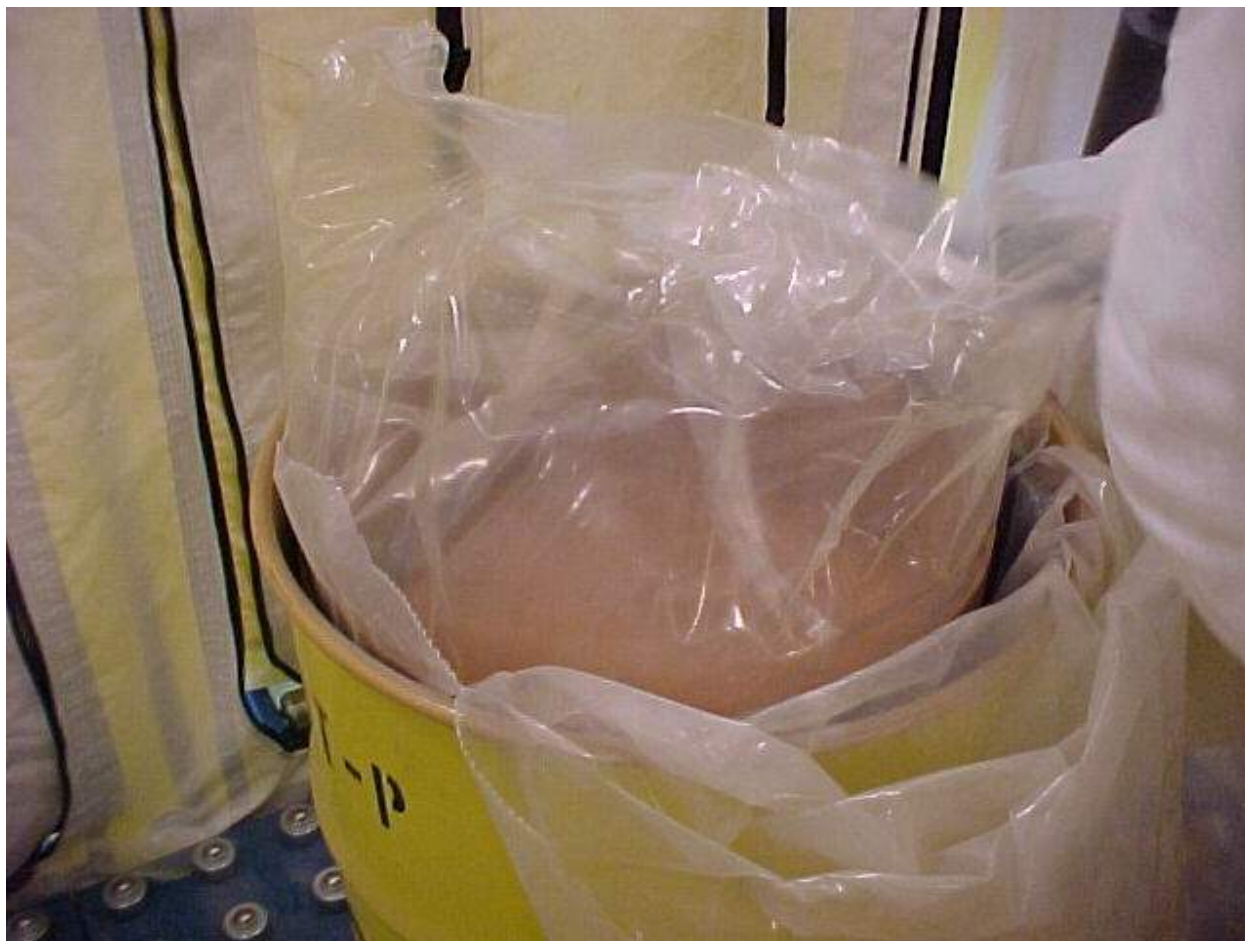
10:40**Other Information**Photo No. 5 of 10Dose Rate Surface 22 mR/hr
 1 meter 2.6 mR/hr2nd poly liner/bag – good condition

Pressure buildup inside of packaging layer raises packaging layer vertically out of container.

Opened poly bag - No gases present in the breathing zone

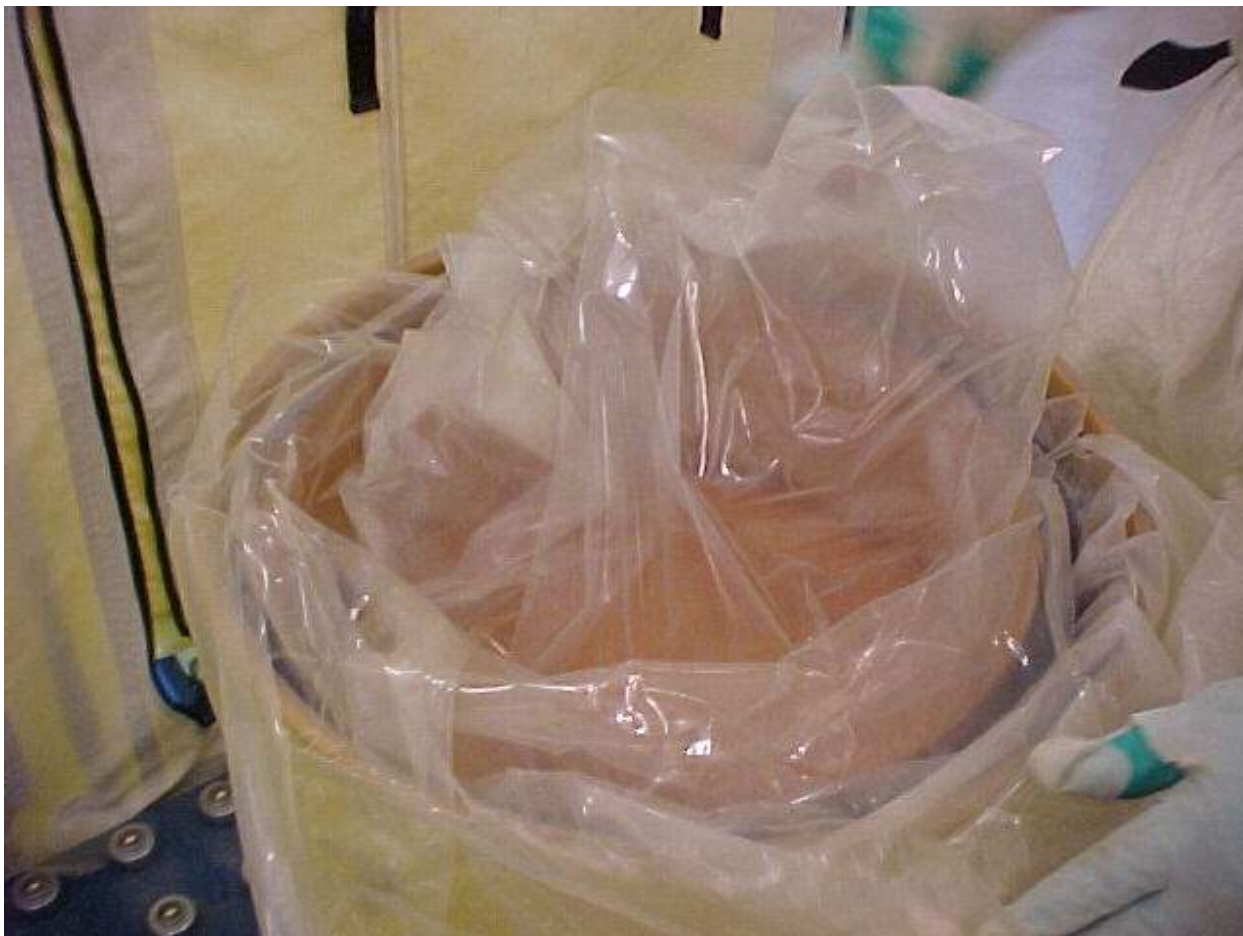
3rd poly liner/bag – good condition

Gases present in poly bag headspace – CH₄ – 6.0% LEL - NO - +50 ppm - NO_x - +50 ppm

Drum dissipated to 0% / 0 ppm utilizing HEPA exhaust

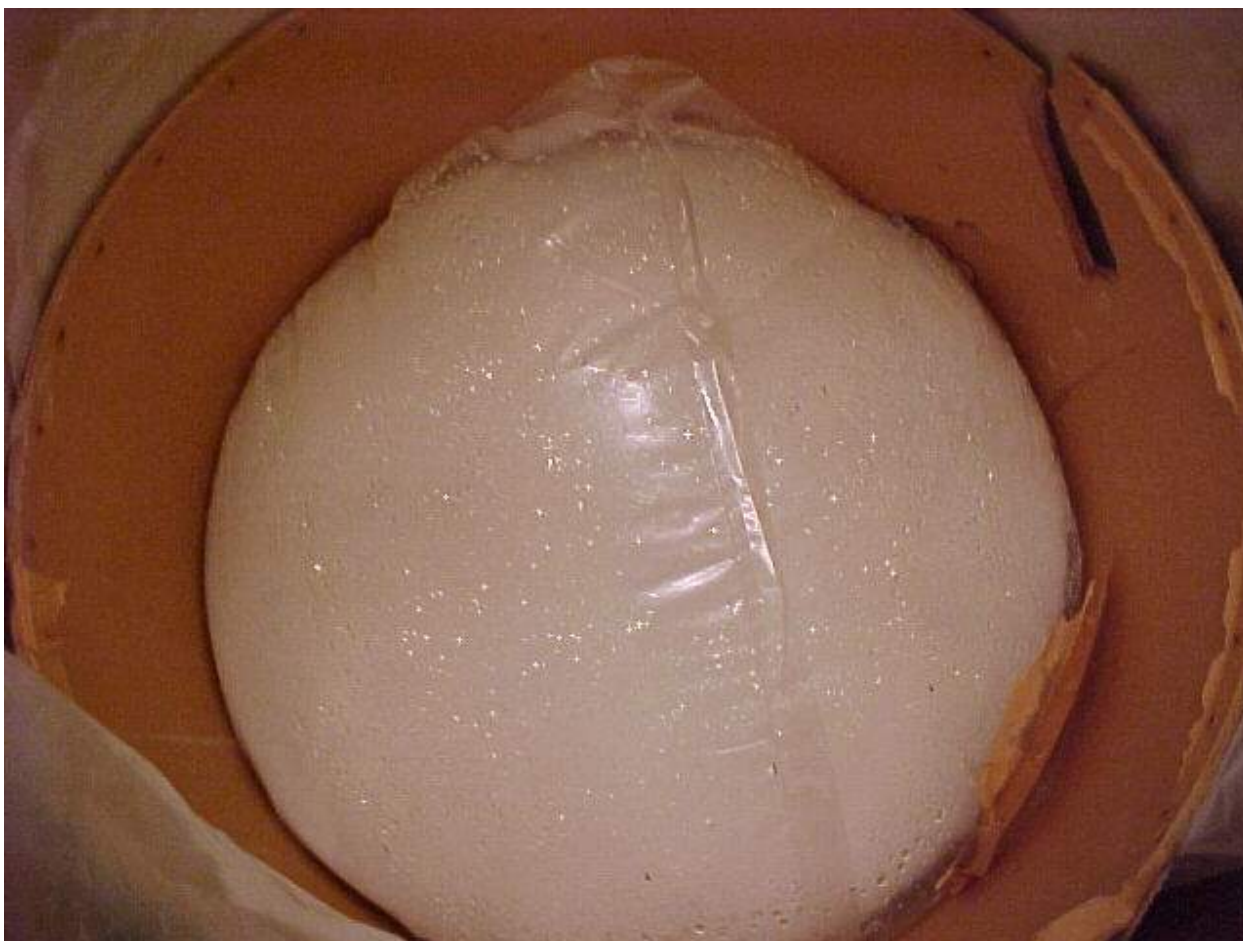
4th poly liner/bag – good condition (picture shows inflated condition of bag)

Gases present in poly bag headspace – CH₄ – 6.0% LEL - NO - +50 ppm - NO_x - +50 ppm

Drum dissipated to 0% / 0 ppm utilizing HEPA exhaust

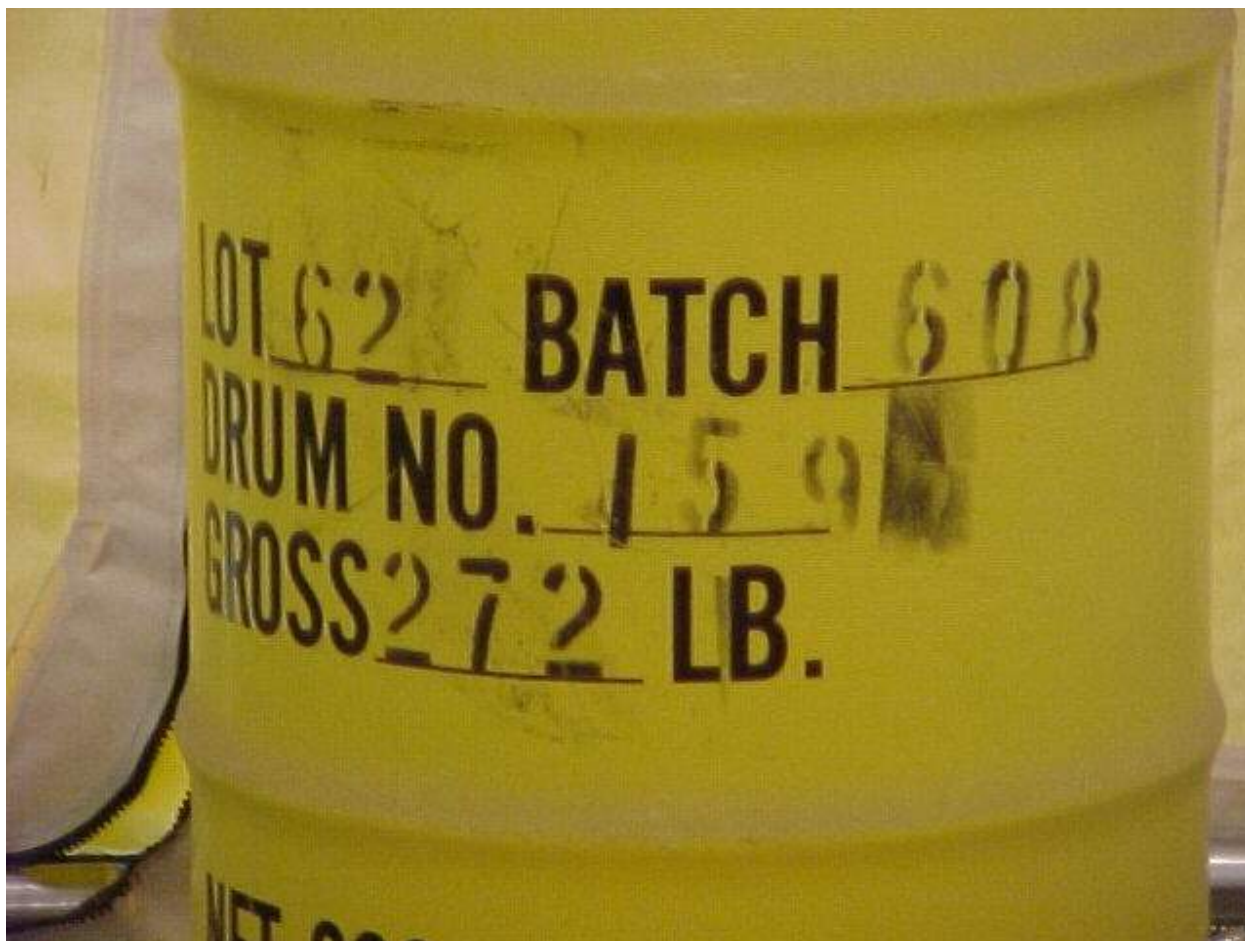
30-gal drum – good condition

Drum vented gases during lid removal operations

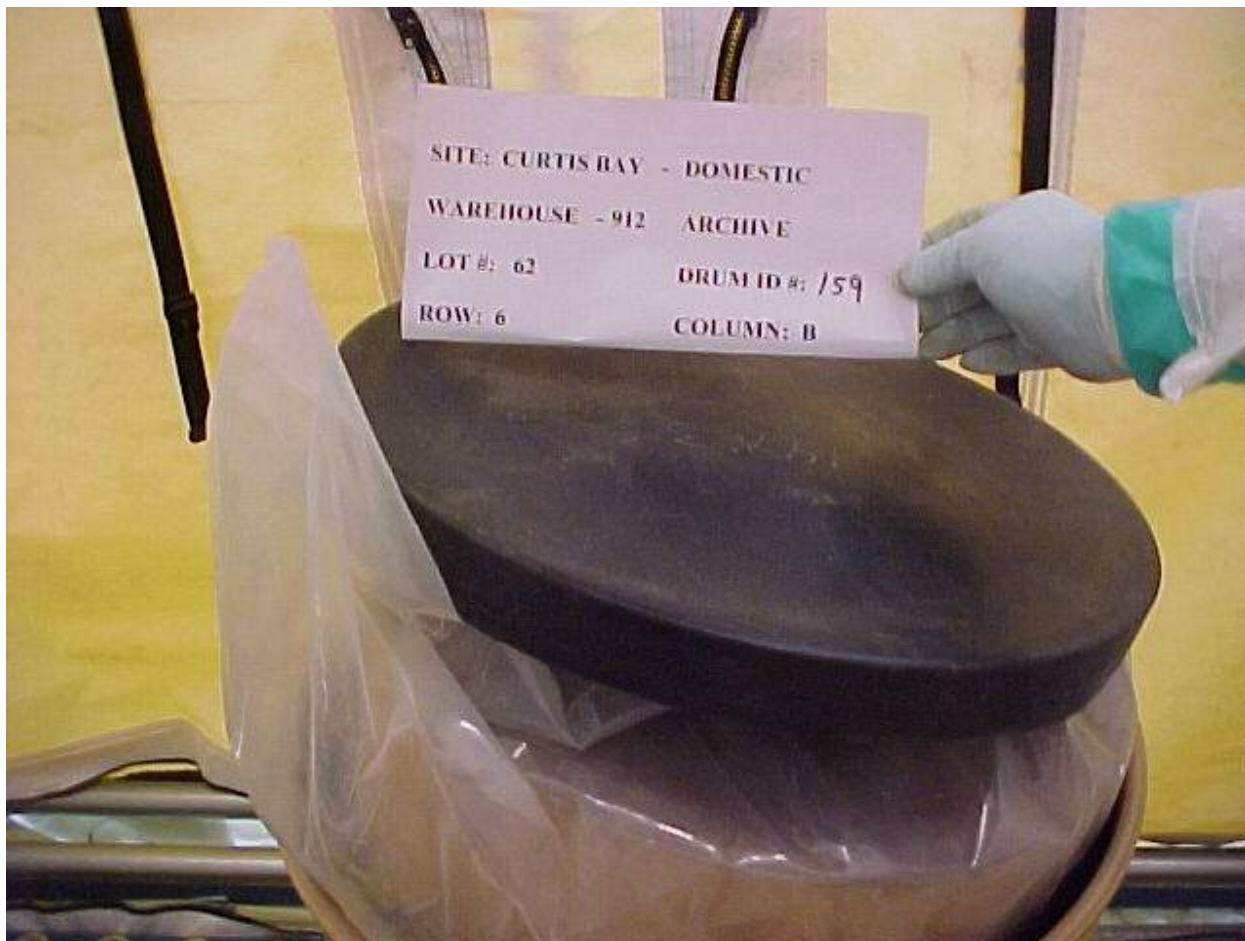
Black plastic lid (mounted on inner rigid drum liner) – good condition
Pressure buildup inside of packaging layer raises packaging layer vertically out of container.
No gases present in the breathing zone.

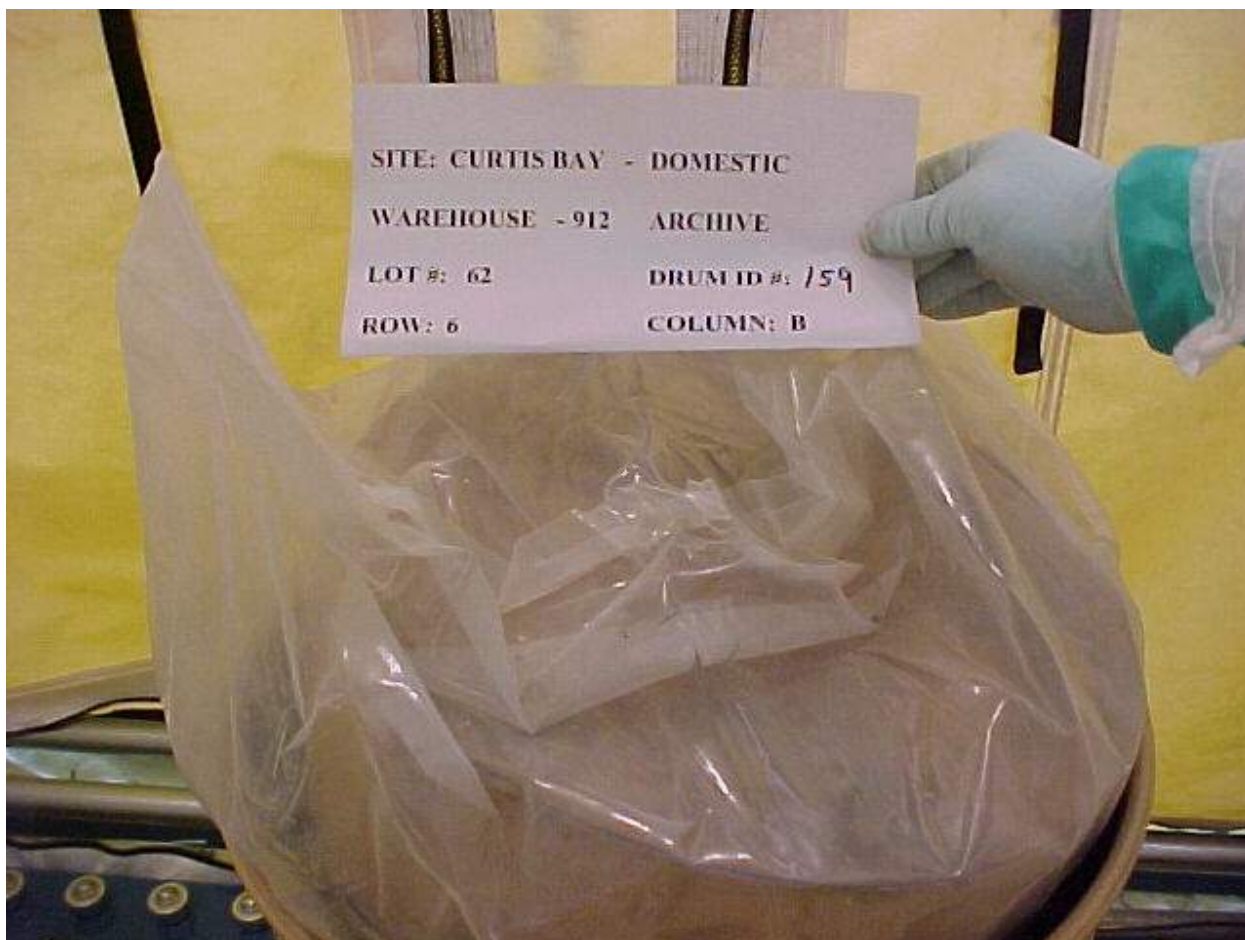
10:15**Other Information**Photo No. 3 of 10Dose Rate Surface 24 mR/hr
 1 meter 2.6 mR/hr1st poly liner/bag – good condition

Pressure buildup inside of packaging layer raises packaging layer vertically out of container.

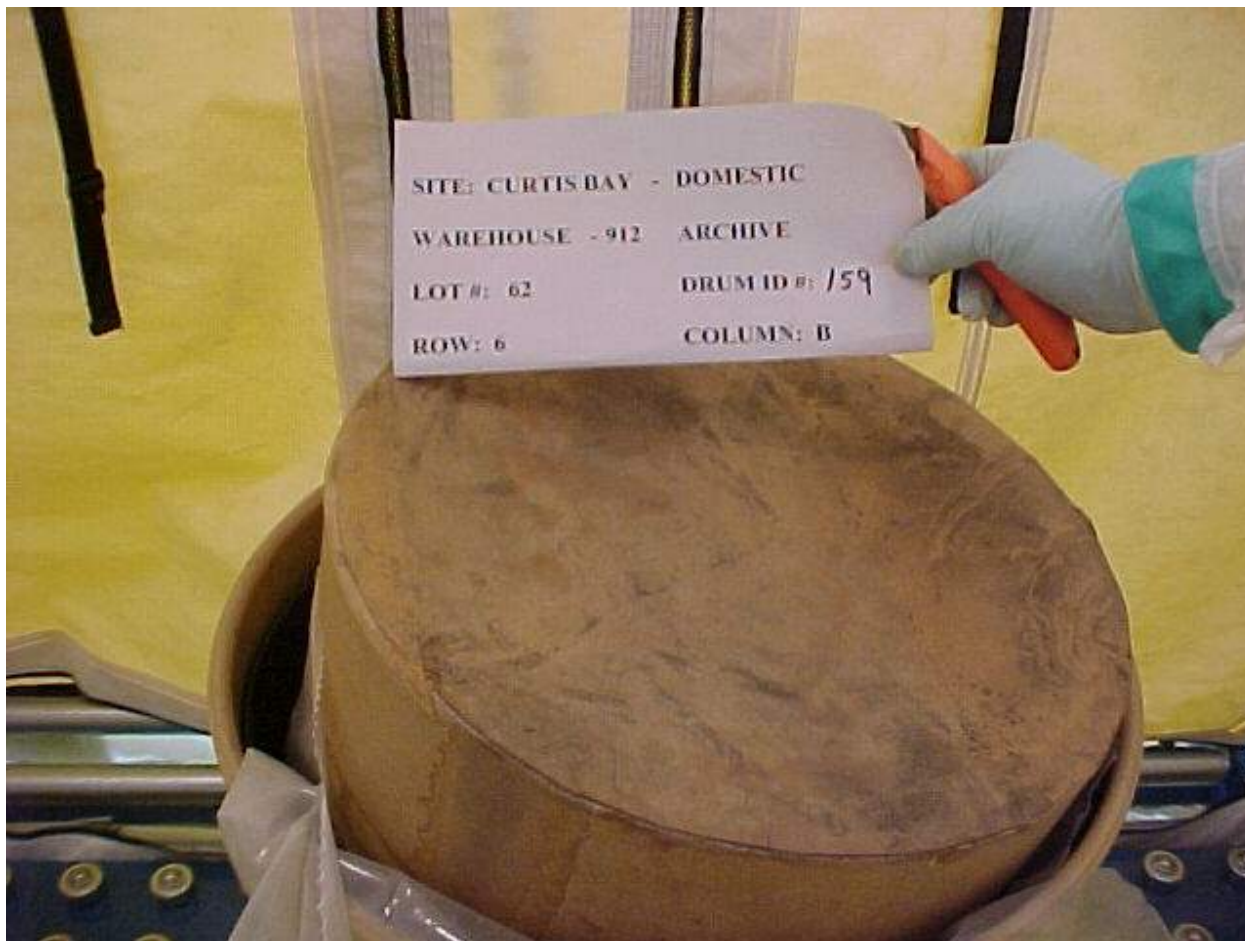
Fiber drum lid – good condition

Pressure buildup inside of packaging layer raises packaging layer vertically out of container.
