THORIUM NITRATE STOCKPILE DRUM CHARACTERIZATION REPORT

**THORIUM NITRATE STOCKPILE
DRUM CHARACTERIZATION REPORT**

Prepared for
U.S. Defense Logistics Agency
Defense National Stockpile Center
Fort Belvoir, Virginia

Prepared by
OAK RIDGE NATIONAL LABORATORY
Oak Ridge, Tennessee 37831
managed by
UT-BATTELLE, LLC
for the
U.S. DEPARTMENT OF ENERGY
under contract DE-AC05-00OR22725

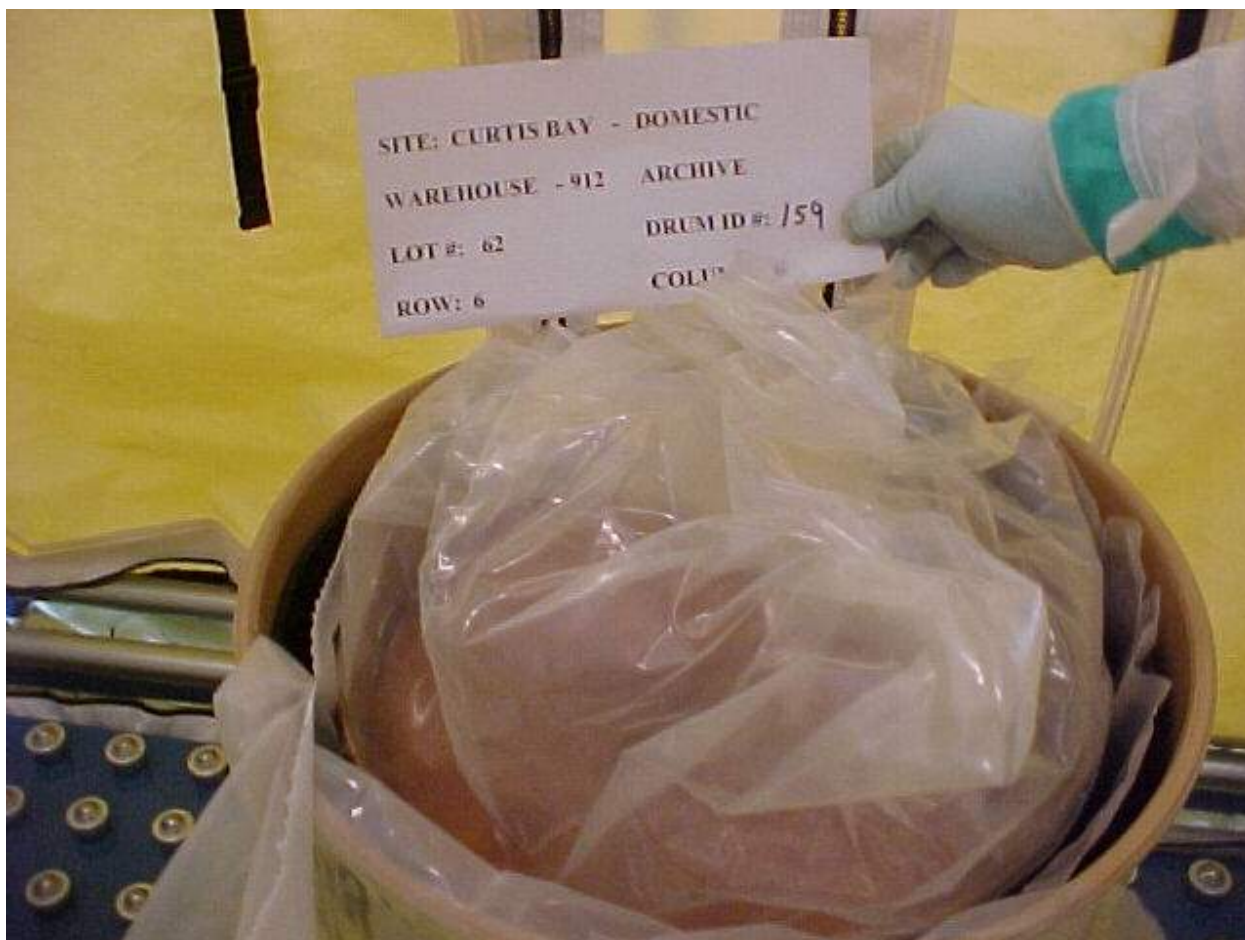
10:15**Other Information**Photo No. 5 of 10Dose Rate Surface 24 mR/hr
 1 meter 2.6 mR/hr2nd poly liner/bag – good condition

Pressure buildup inside of packaging layer raises packaging layer vertically out of container.

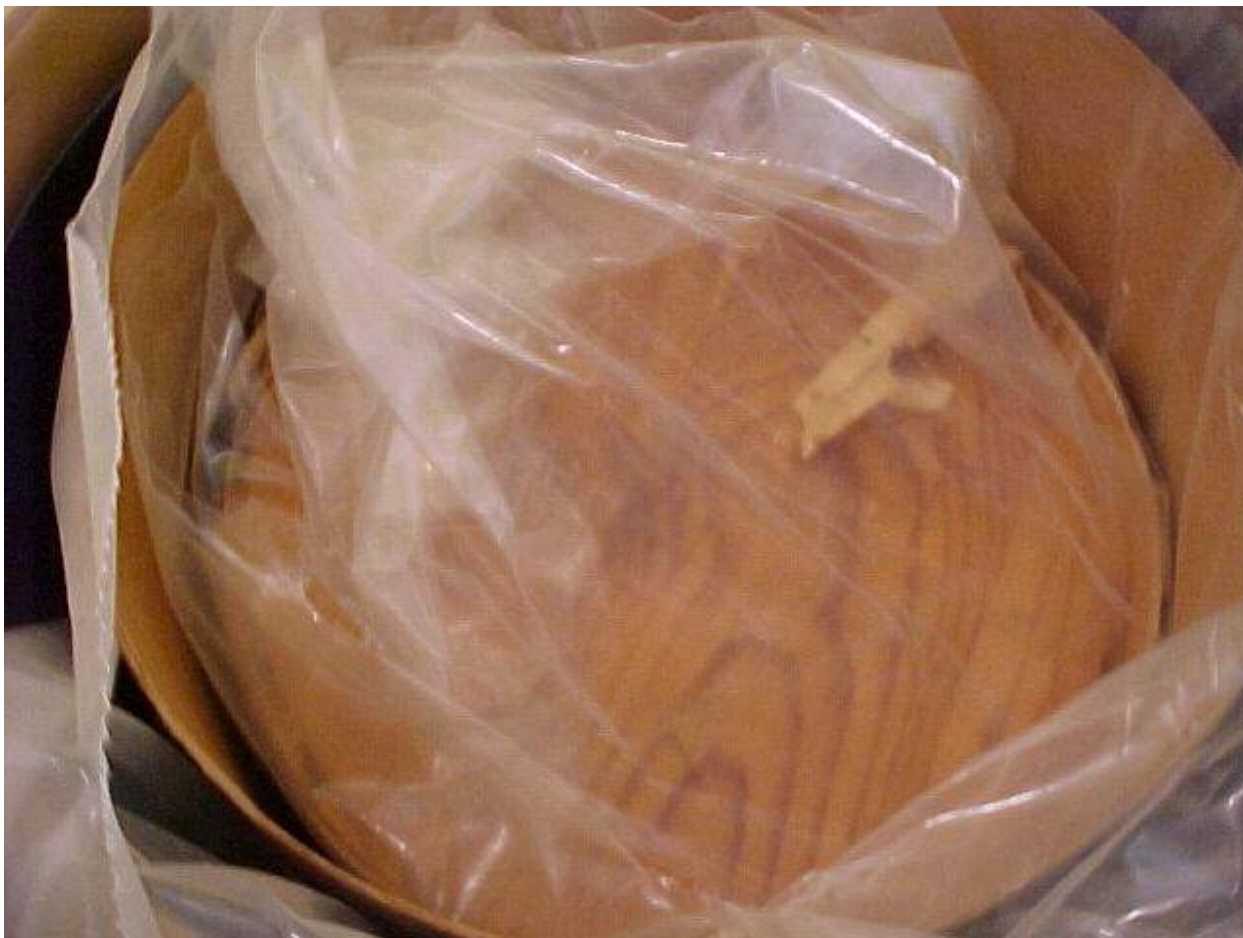
3rd poly liner/bag – good condition

Gases in bag's headspace – CH₄ – 4.2% LEL - NO - +50 ppm - NO_x - +50 ppm

All gases in headspace were dissipated utilizing HEPA exhaust

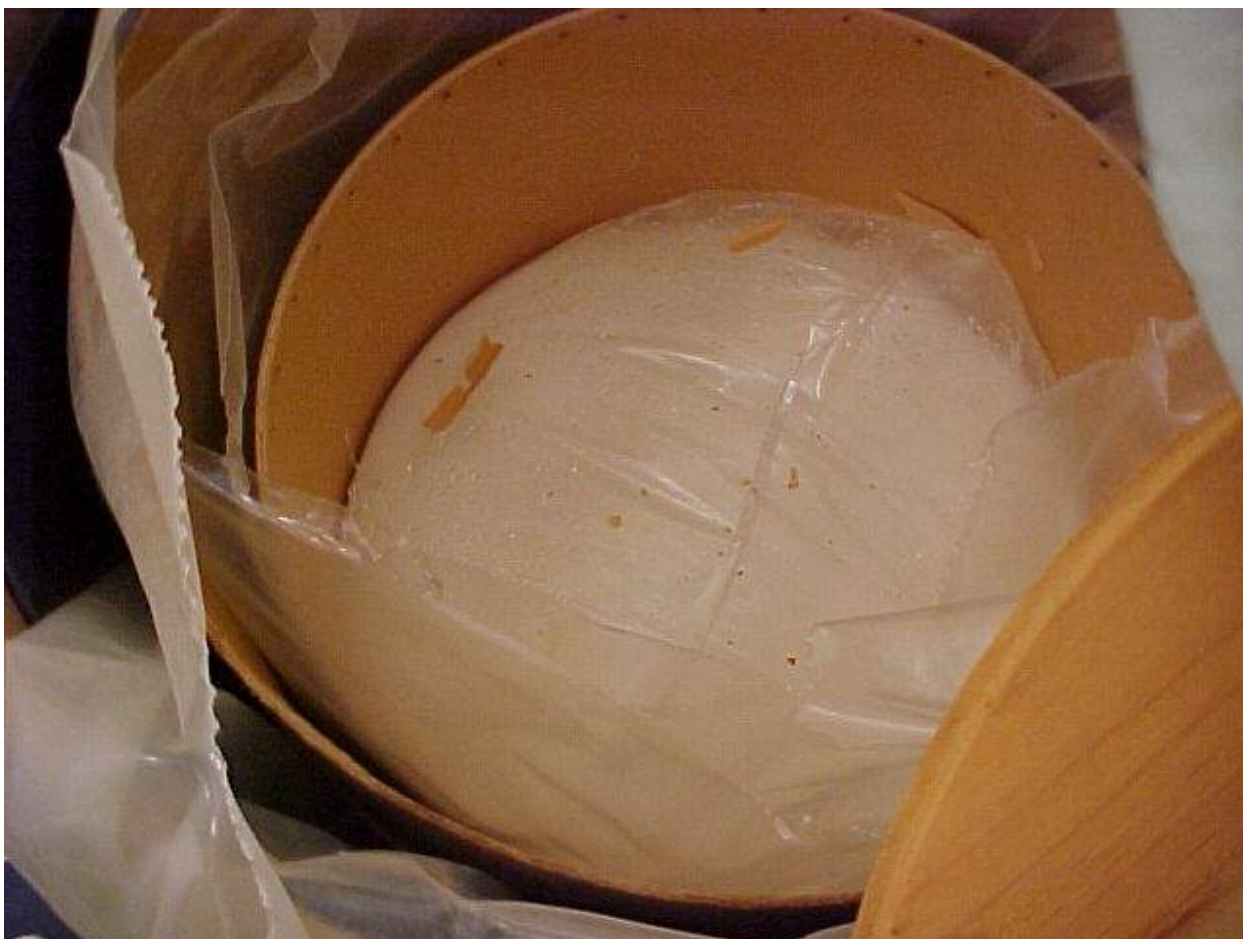
4th poly liner/bag – good condition (inflated condition of bag shows gas generation from the ThN material)
No gases present in the breathing zone.

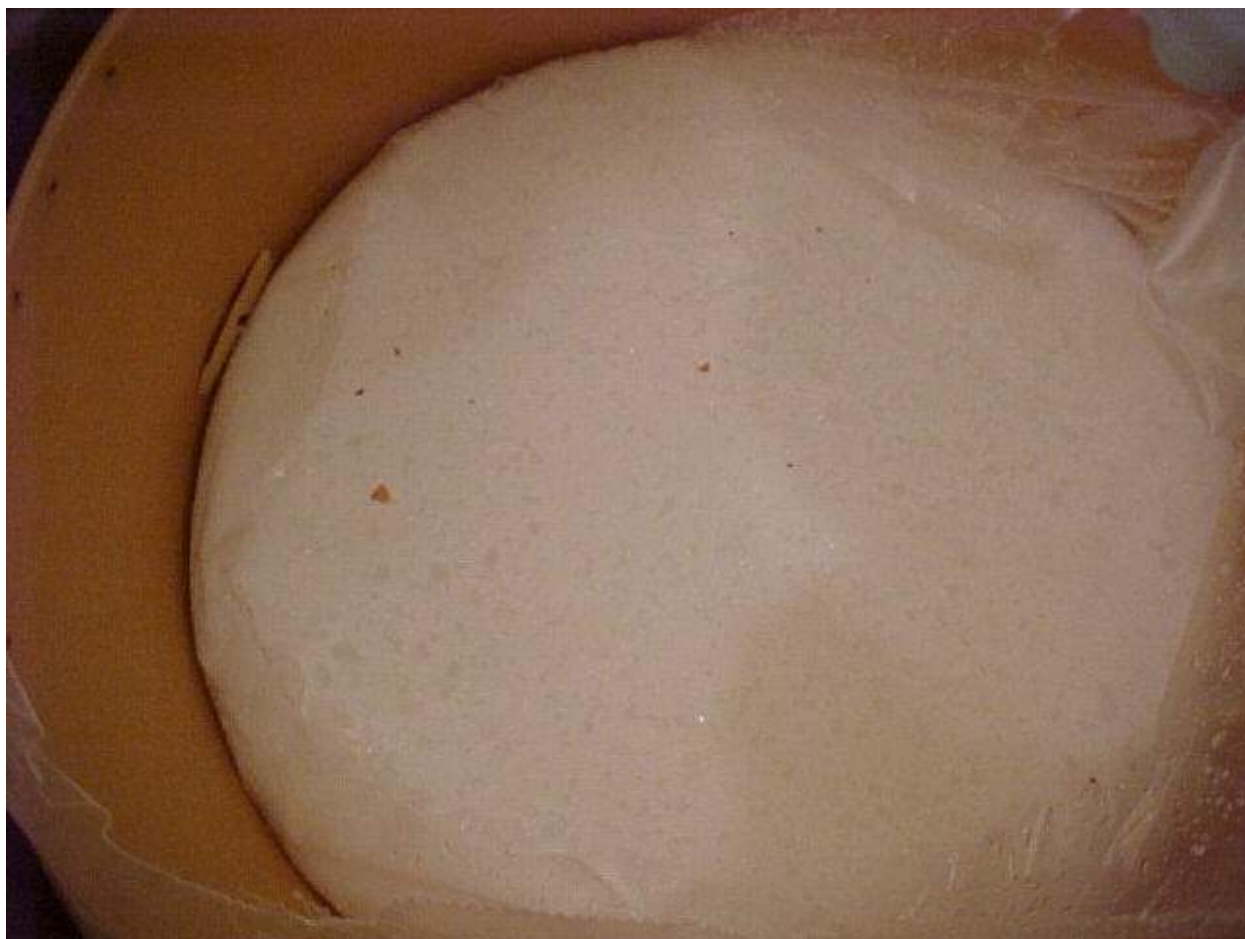
ThN material – white – solid – monolith - dry
No gases present in the breathing zone.

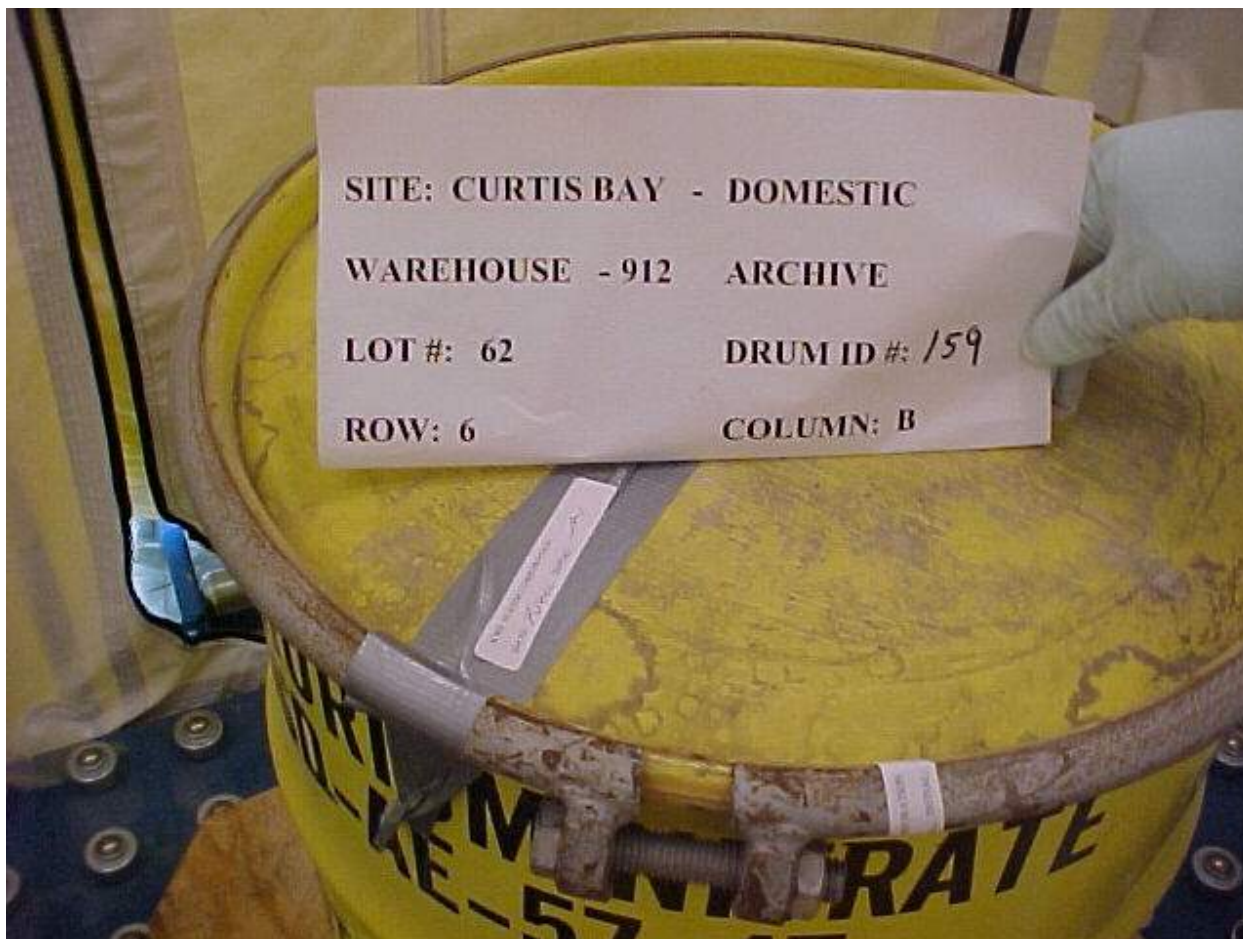
Sealed & dated - Complete

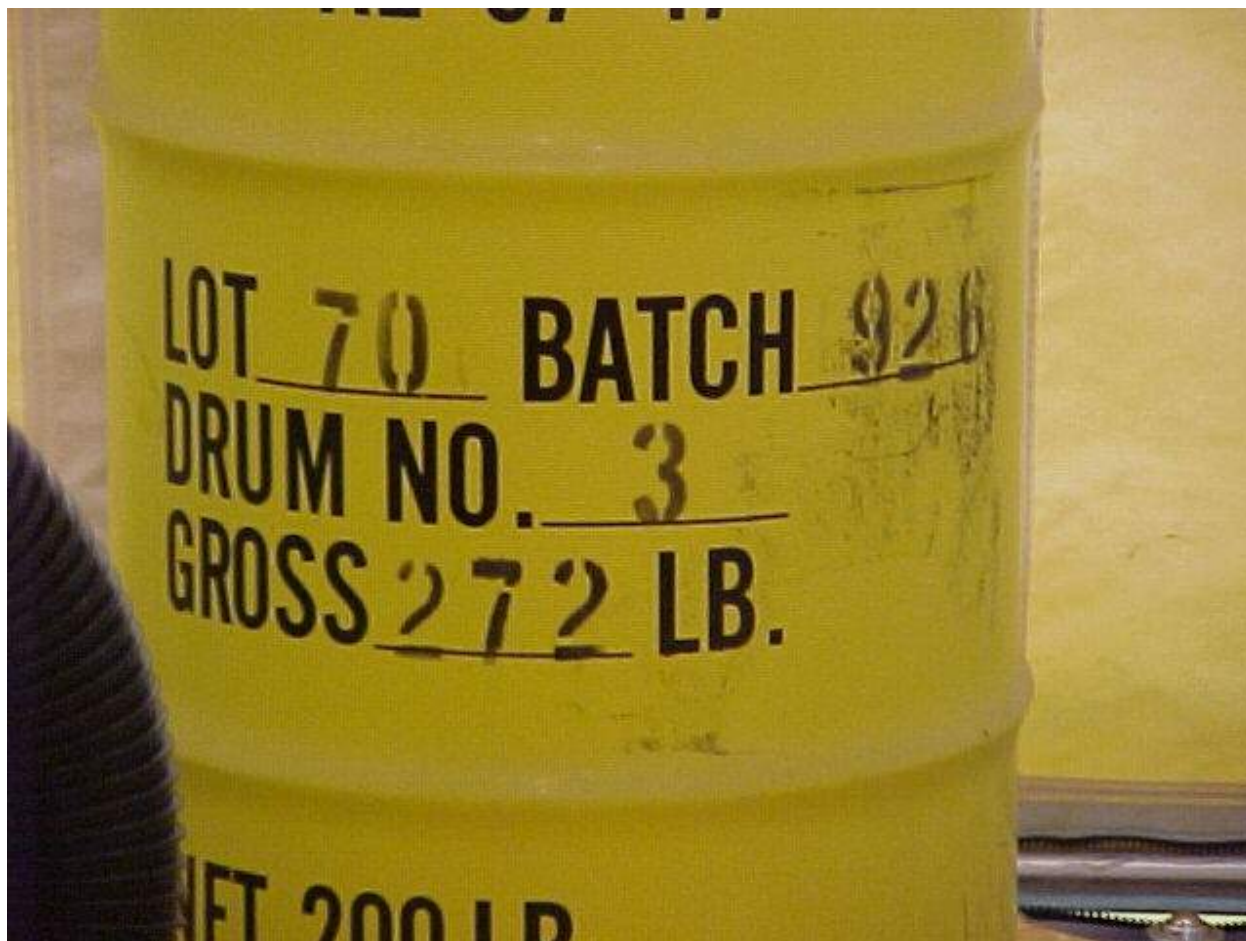
30-gal drum – good condition

Drum vented gases during lid removal operations.

No gases present in the breathing zone.

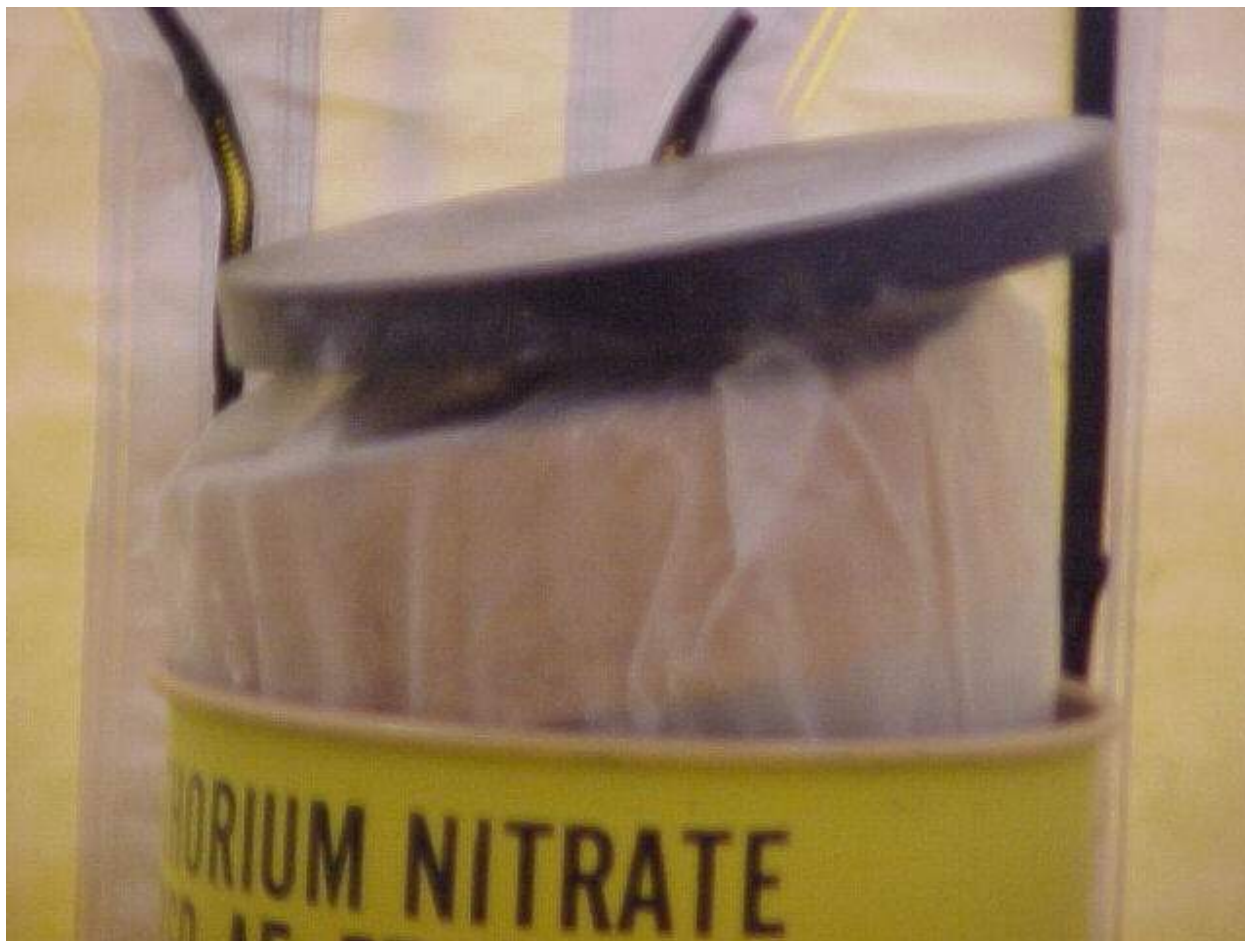
Black plastic lid – good condition

Pressure buildup inside of packaging layer raises packaging layer vertically out of container.

No gases present in the breathing zone.

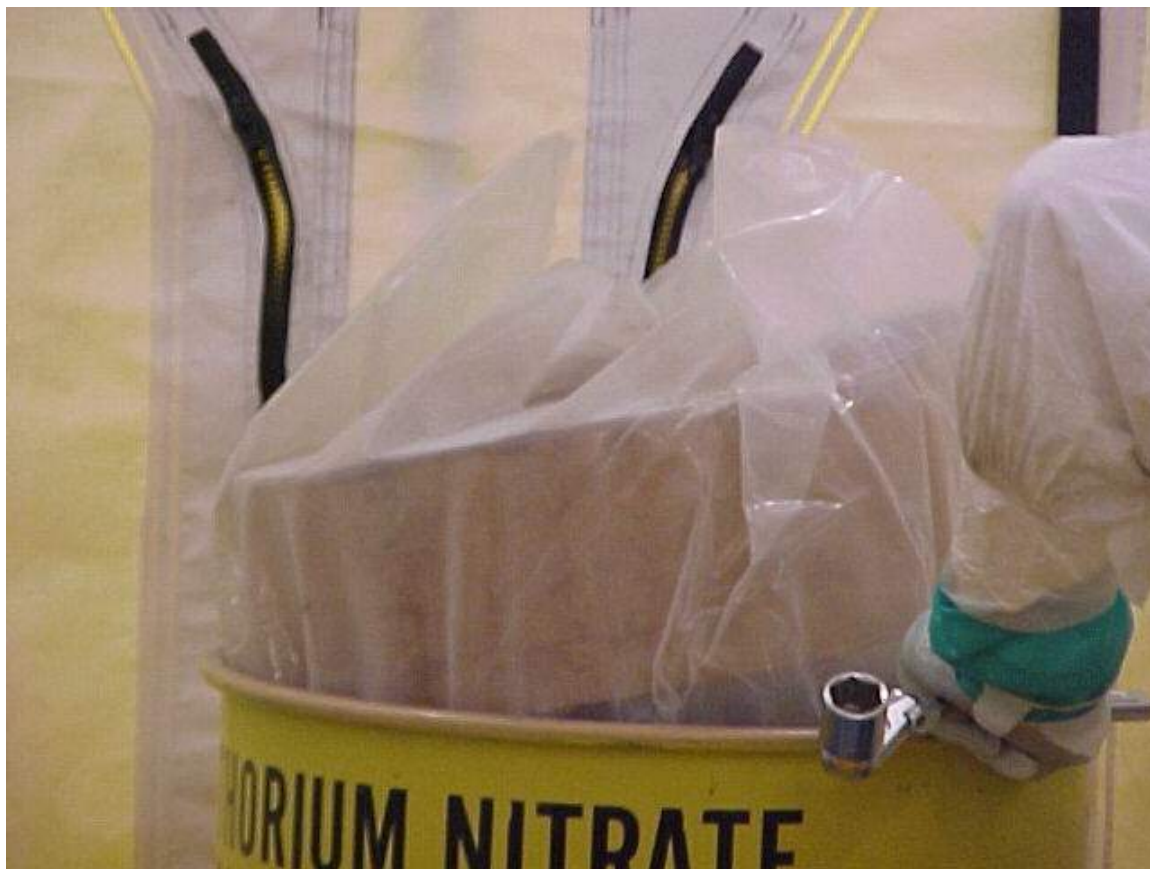
10:00**Other Information**Photo No. 3 of 10Dose Rate Surface 24 mR/hr
 1 meter 2.5 mR/hr1st poly liner/bag – good condition

Pressure buildup inside of packaging layer raises packaging layer vertically out of container.

No gases present in the breathing zone.

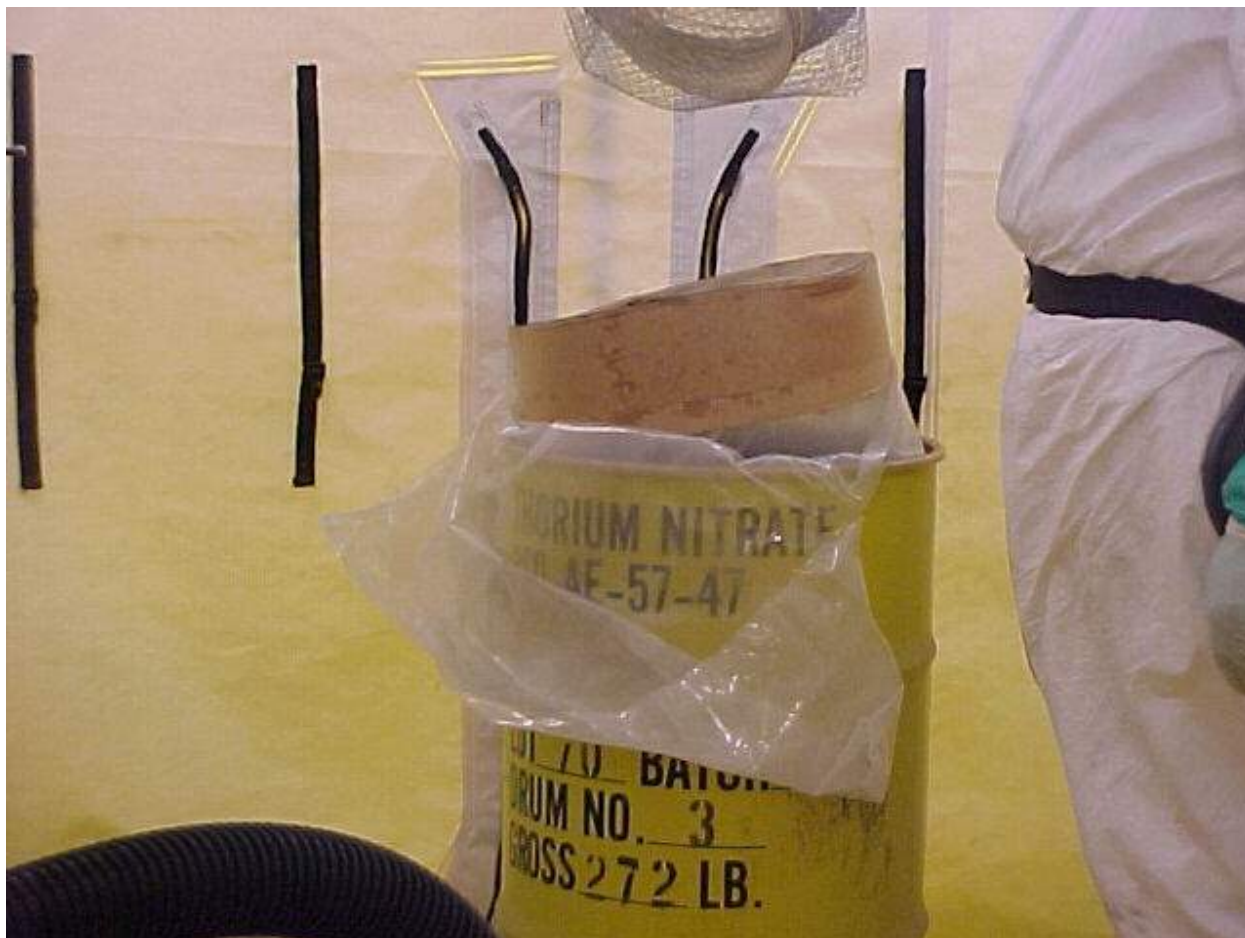
Fiber drum lid – good condition

Pressure buildup inside of packaging layer raises packaging layer vertically out of container.

No gases present in the breathing zone.

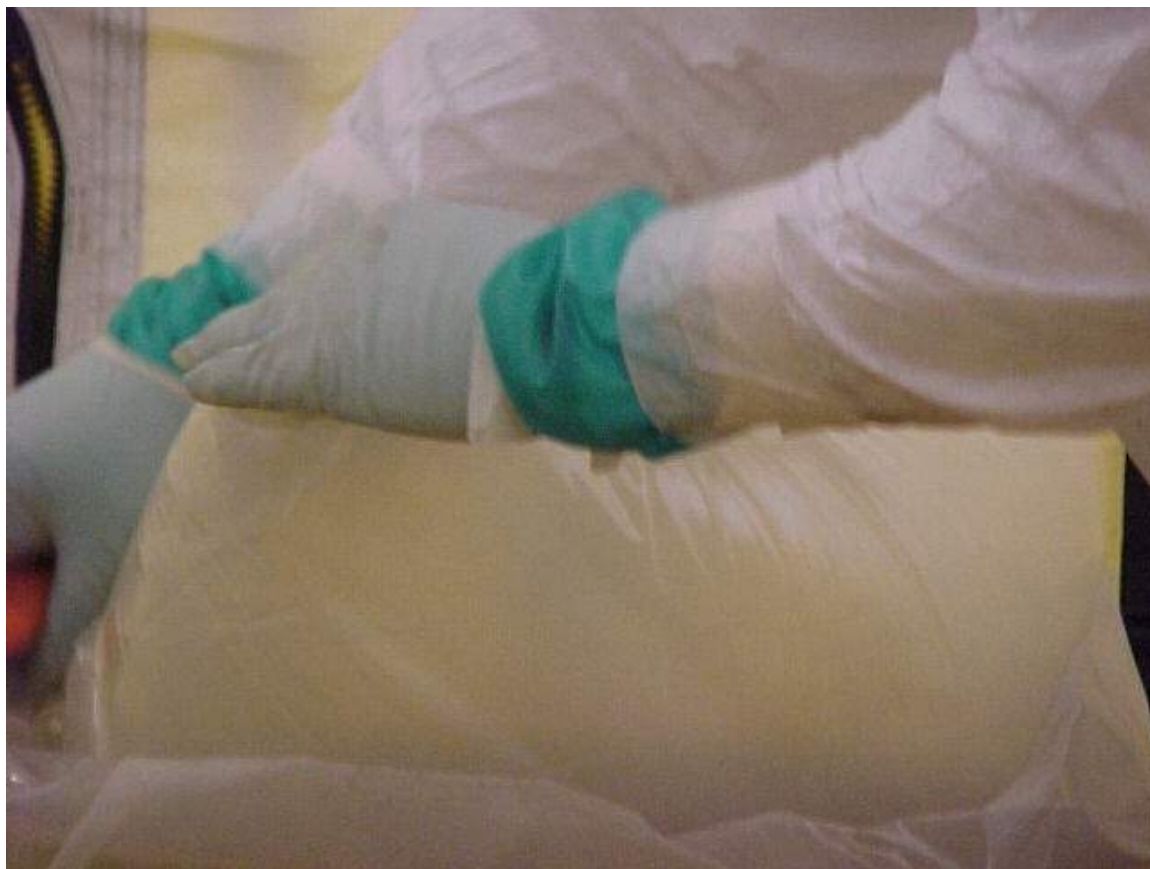
10:00**Other Information**Photo No. 5 of 10Dose Rate Surface 24 mR/hr
 1 meter 2.5 mR/hr2nd poly liner/bag – good condition

Pressure buildup inside of packaging layer raises packaging layer vertically out of container.

No gases present in the breathing zone.

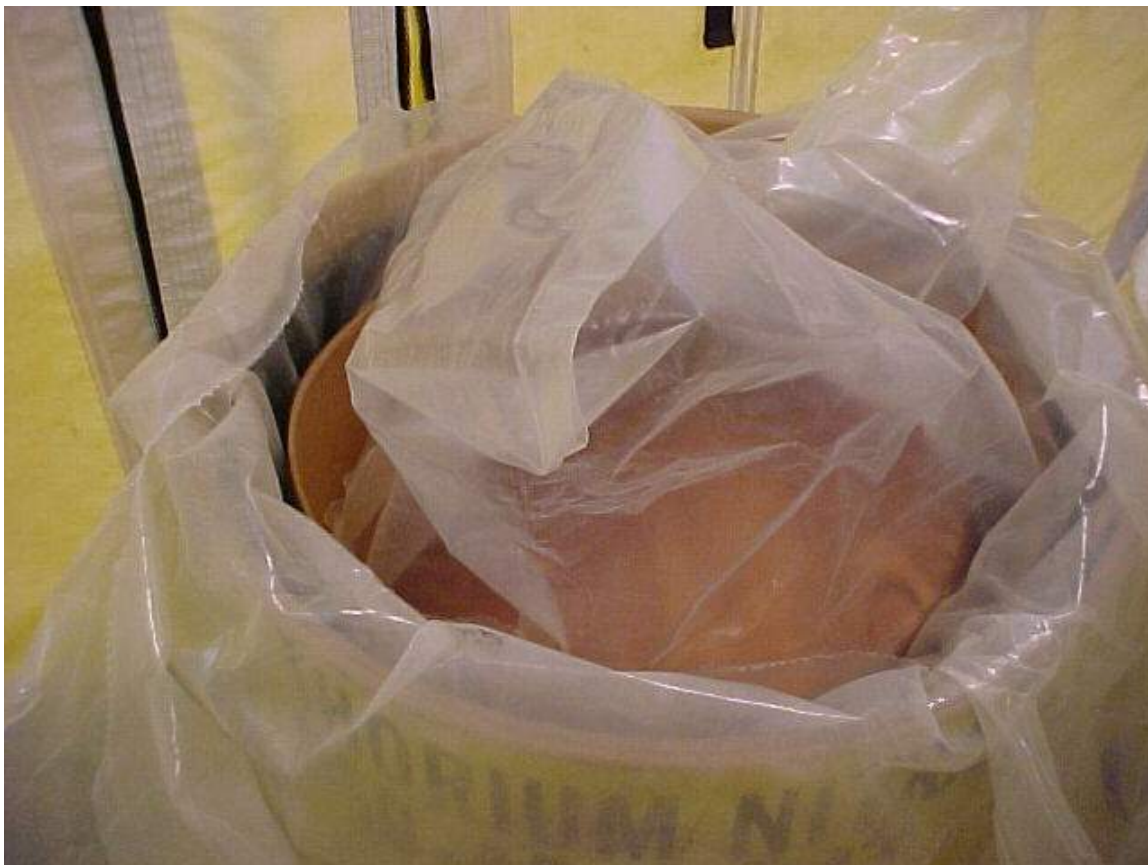
3rd poly liner/bag – good condition

Gases in headspace – CH₄ – 4.6% LEL - NO - +50 ppm - NO_x - +50 ppm

Drum vented – all gases dissipated via HEPA exhaust.

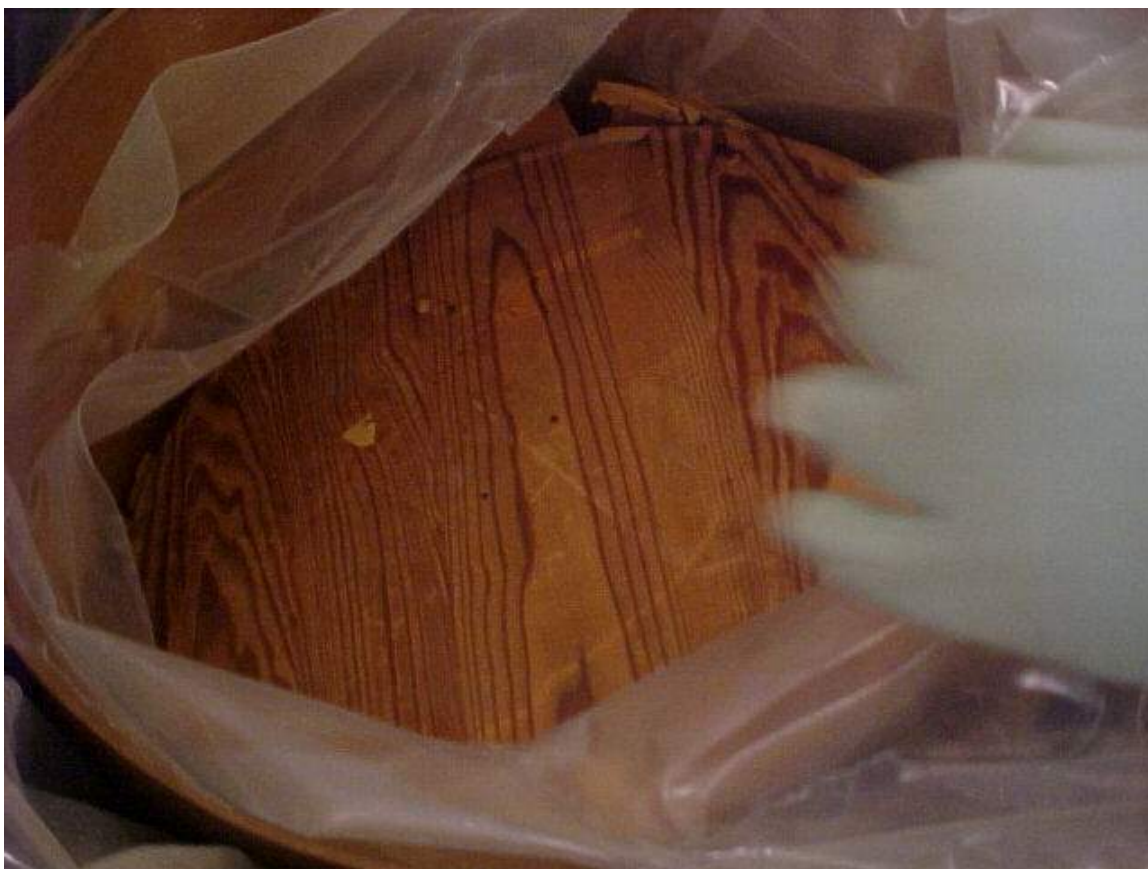
10:00**Other Information**Photo No. 7 of 10Dose Rate Surface 24 mR/hr
 1 meter 2.5 mR/hrWooden lid – good condition
No gases present in the breathing zone.

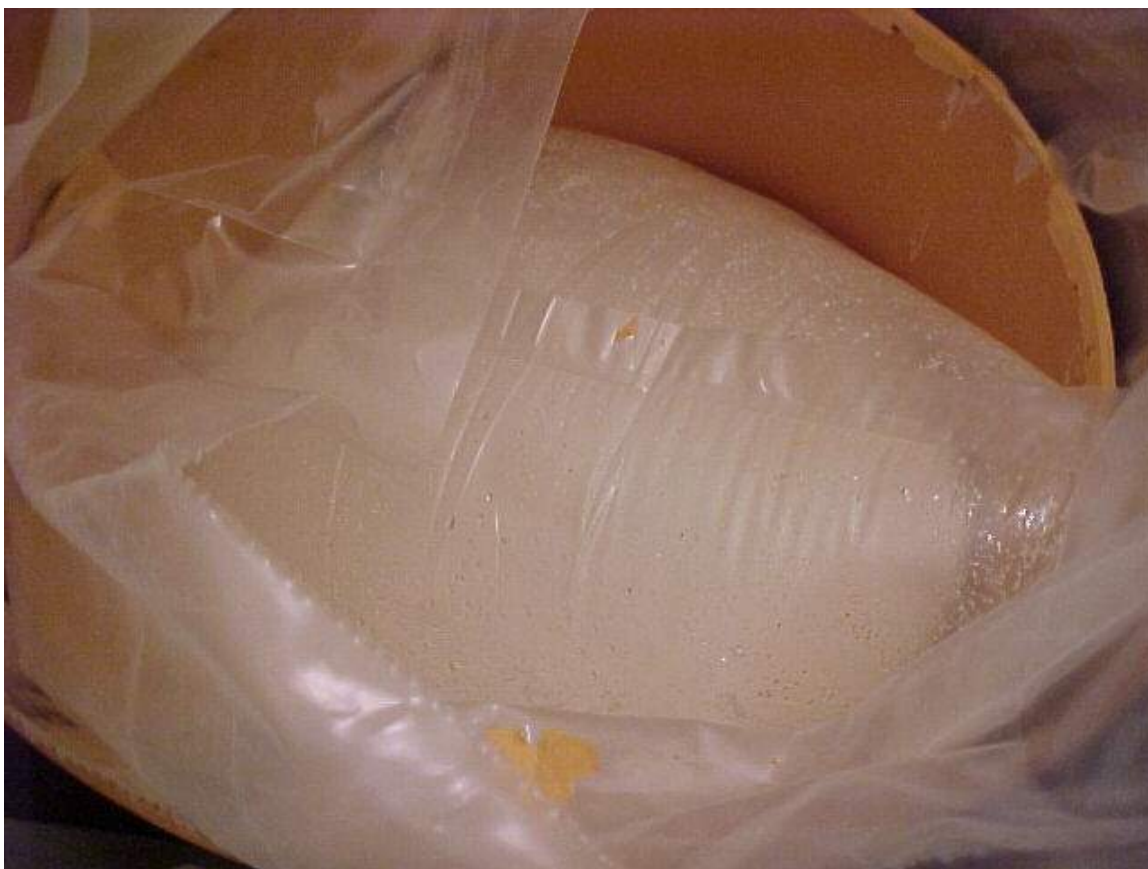
4th poly liner/bag – good condition (inflated condition of bag shows gas generation from ThN material)

Gases in headspace – CH₄ – 4.6% LEL - NO - +50 ppm - NO_x - +50 ppm

Drum vented – all gases dissipated via HEPA exhaust.

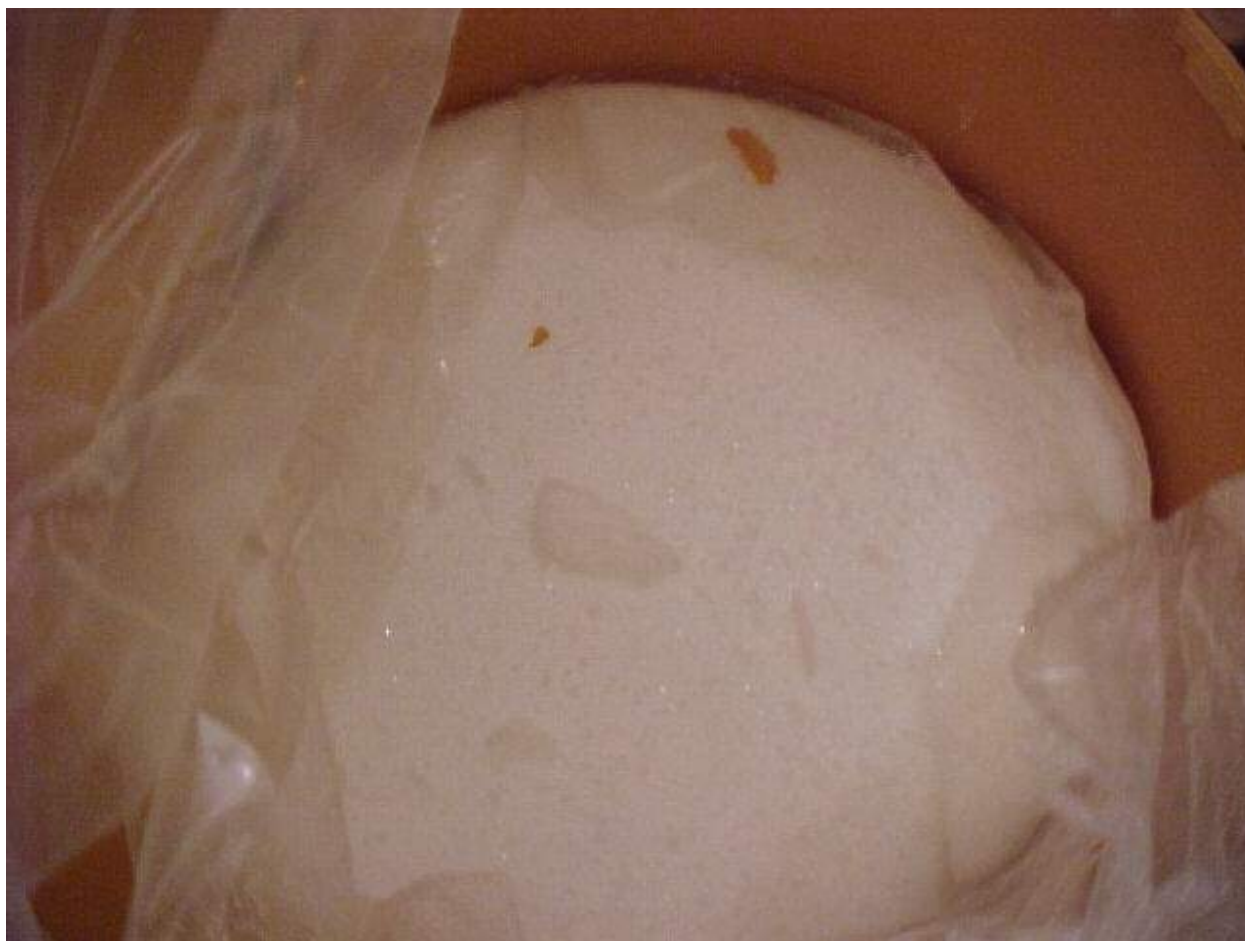
ThN material – white – solid – monolith - dry
No gases present in the breathing zone.

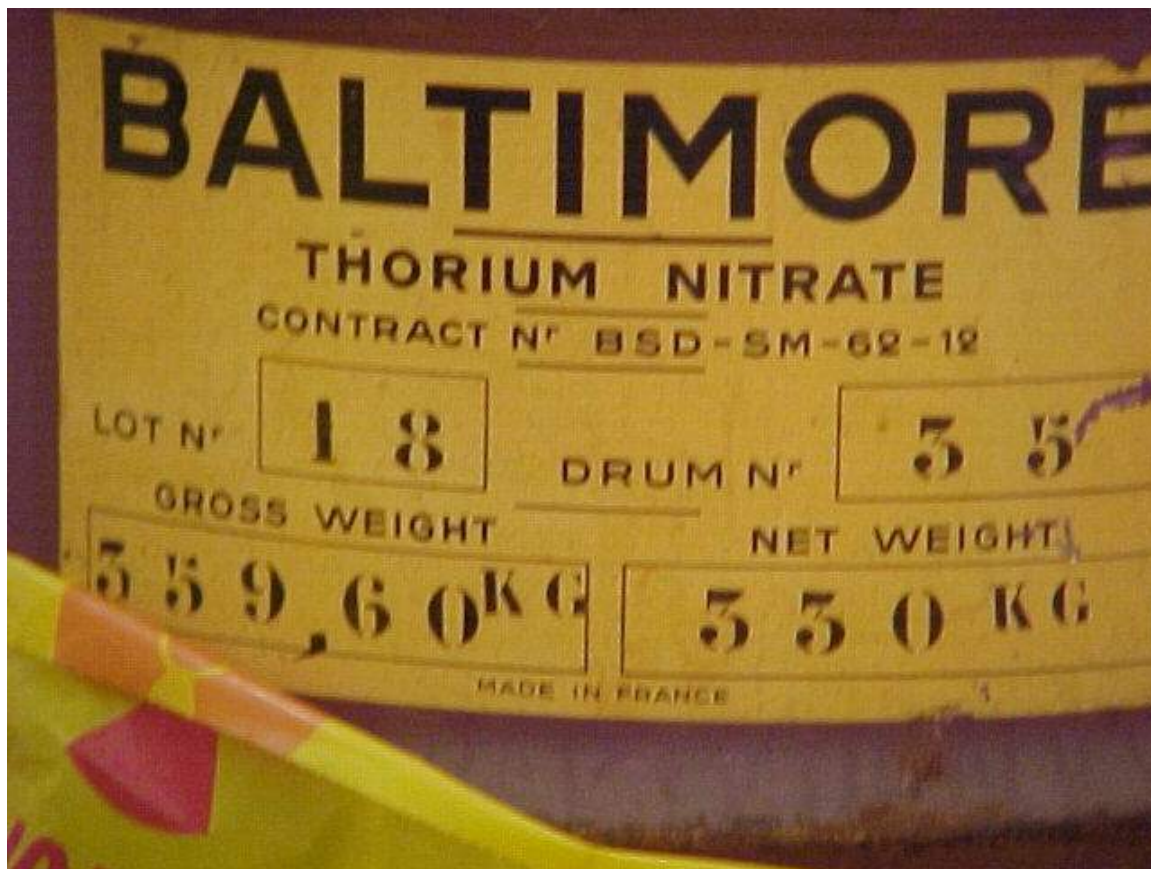
French (purple) 55-gal drum – fair condition – extensive surface rust on drum
 No gases present in the breathing zone.
 Wrapped drum in yellow poly bags prior to movement due to external contamination.

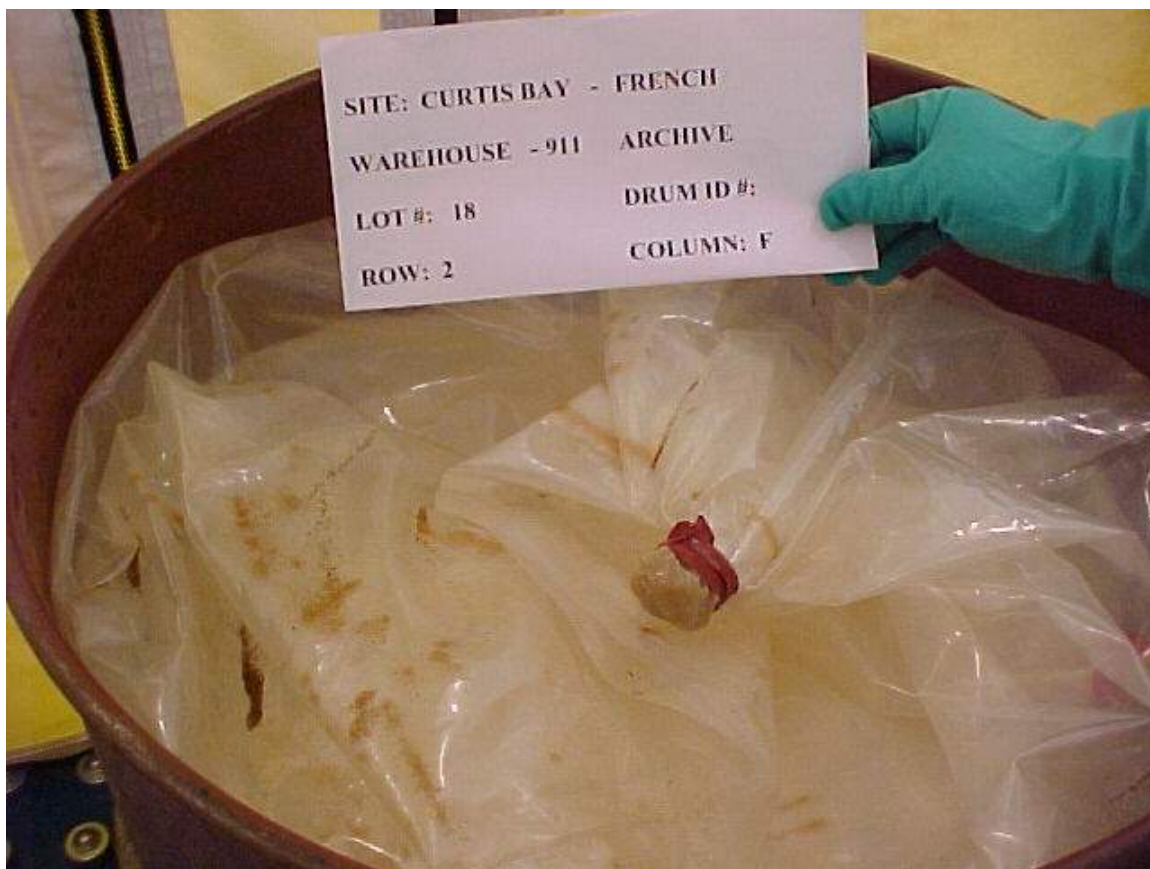
1st poly liner/bag – good condition
No gases present in the breathing zone.

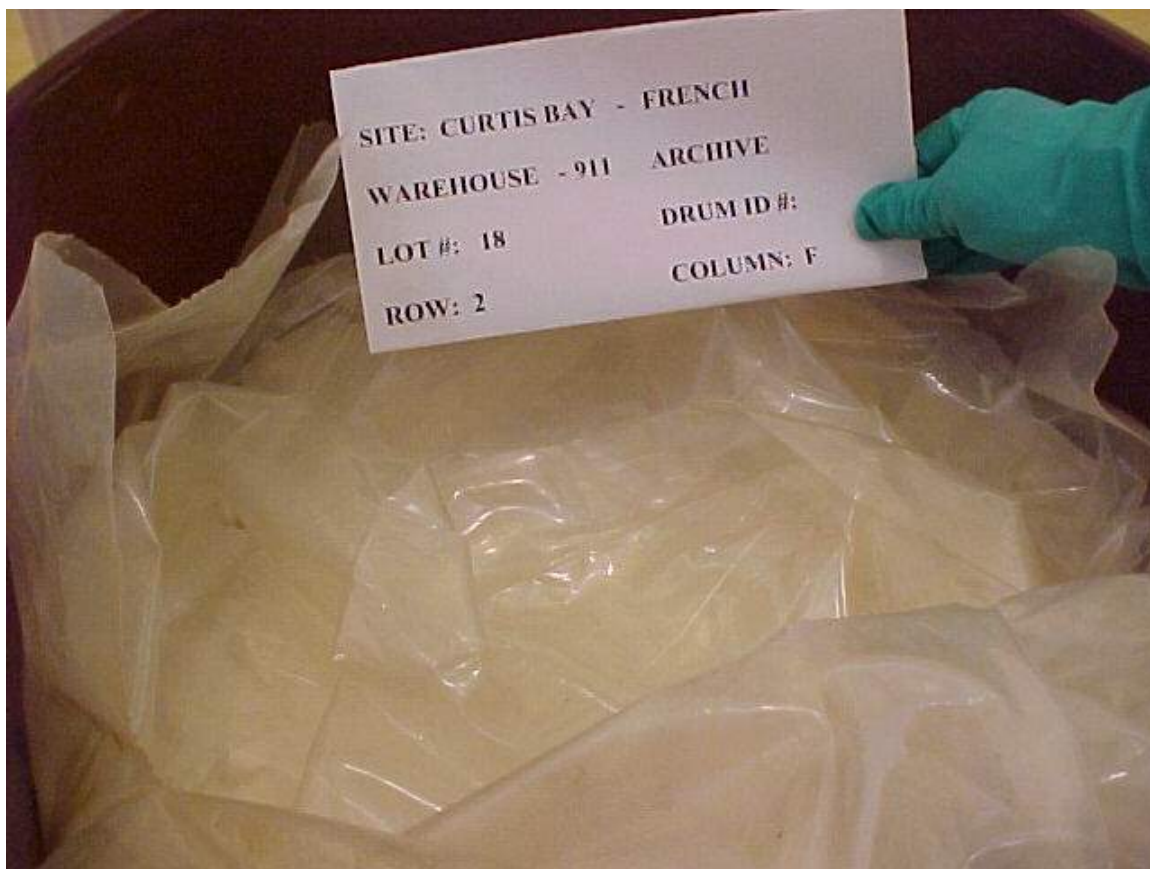
2nd poly liner/bag – good condition
No gases present in the breathing zone.

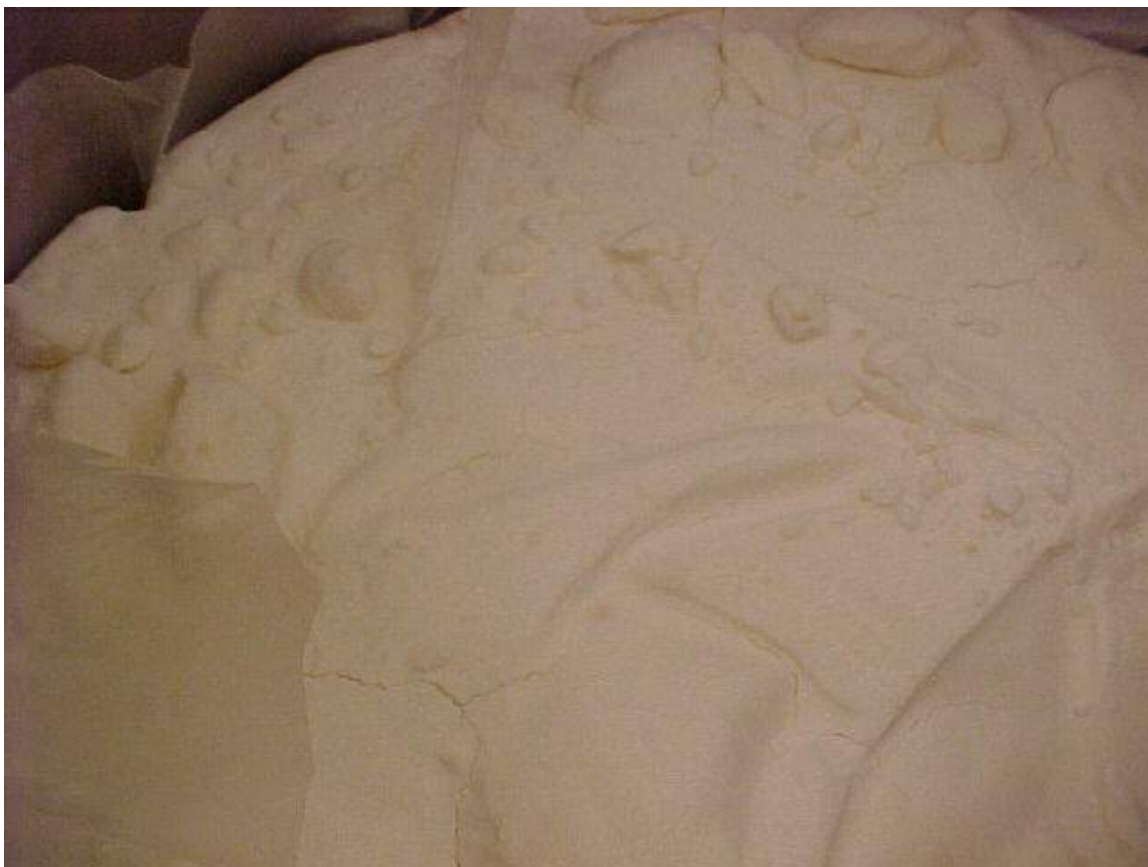
French ThN material – powder form – some chunky pieces – dry – white
No gases present in the breathing zone.

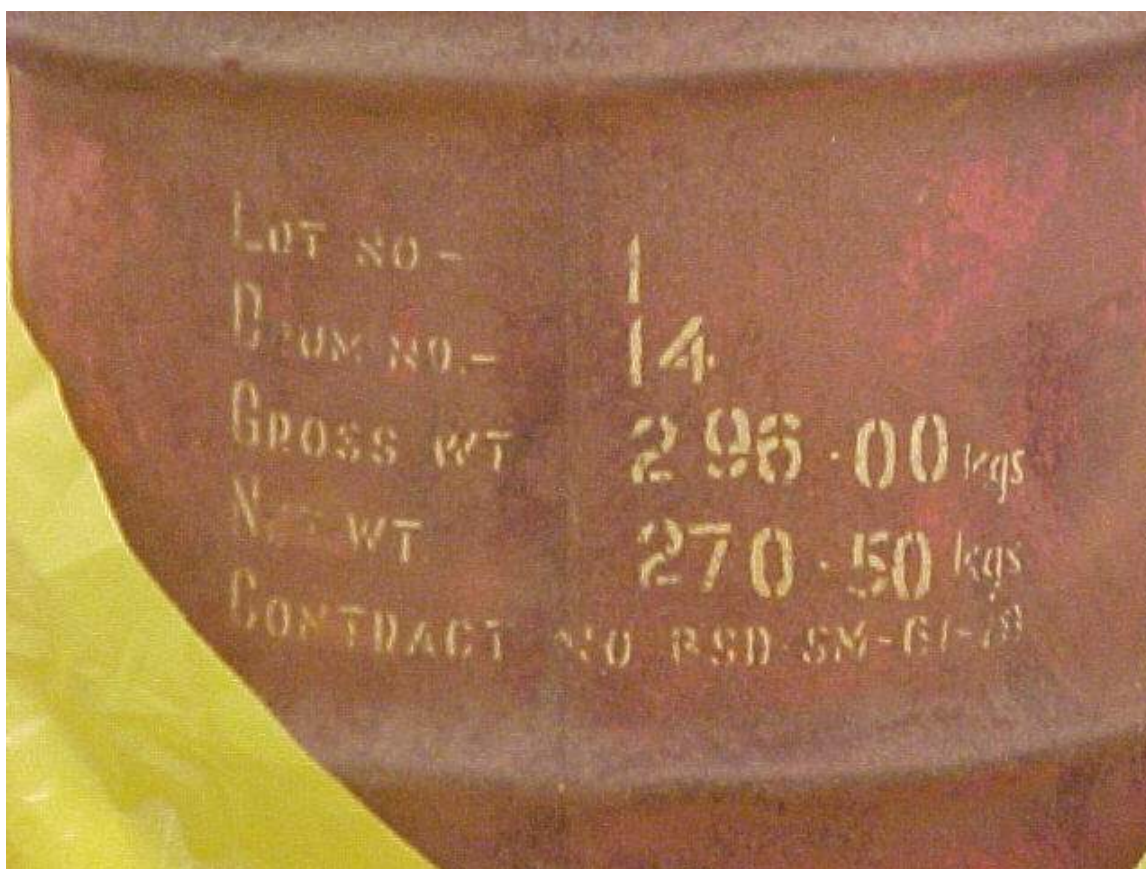
Indian (red) 55-gal drum – fair condition – extensive surface rust on drum
No gases present in the breathing zone.

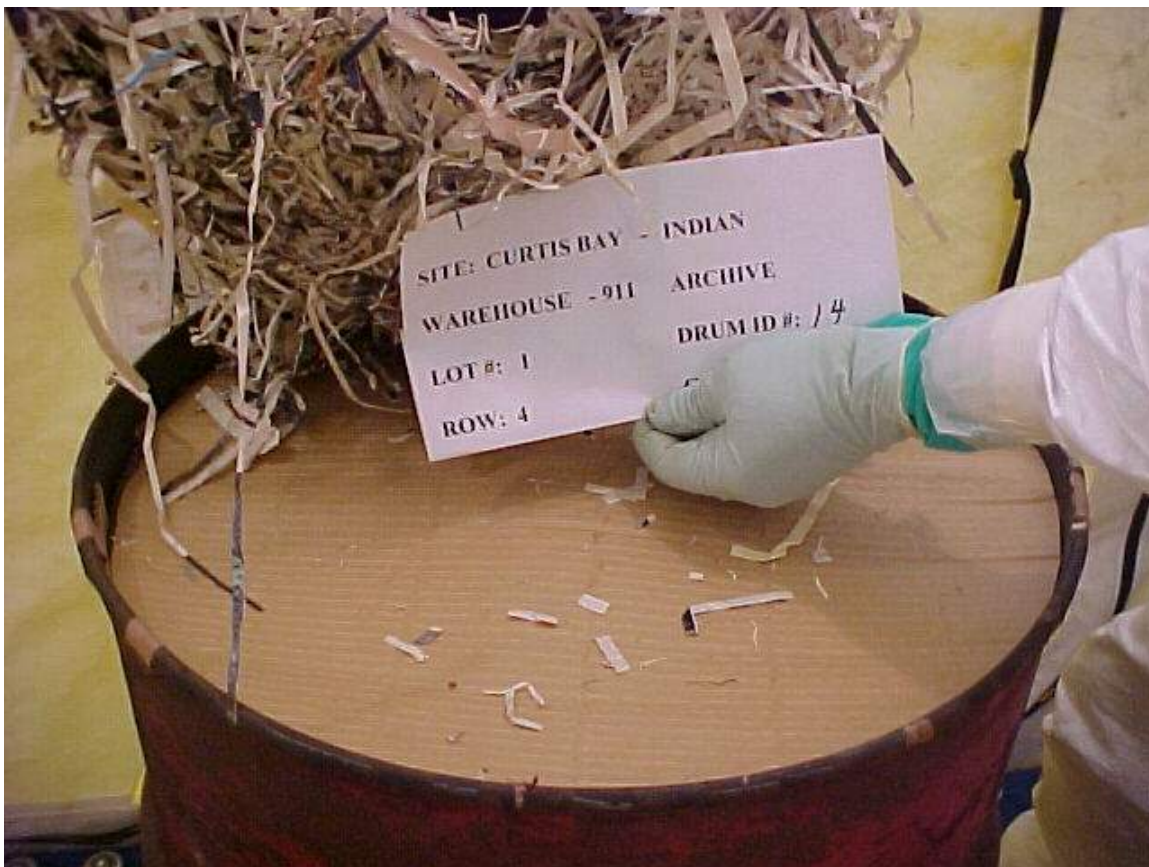
Shredded paper for storage – good condition
No gases present in the breathing zone.
