THORIUM NITRATE STOCKPILE DRUM CHARACTERIZATION REPORT

**THORIUM NITRATE STOCKPILE
DRUM CHARACTERIZATION REPORT**

Prepared for
U.S. Defense Logistics Agency
Defense National Stockpile Center
Fort Belvoir, Virginia

Prepared by
OAK RIDGE NATIONAL LABORATORY
Oak Ridge, Tennessee 37831
managed by
UT-BATTELLE, LLC
for the
U.S. DEPARTMENT OF ENERGY
under contract DE-AC05-00OR22725

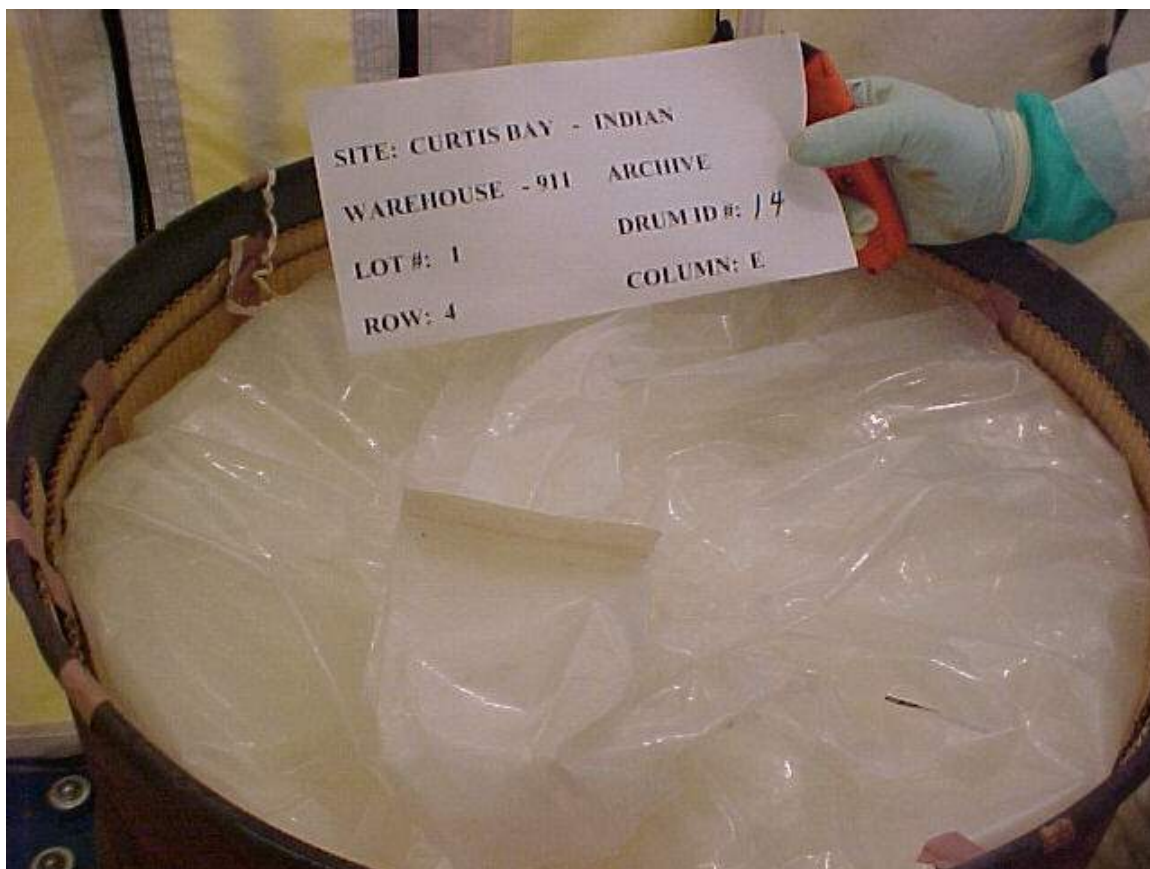
1st poly liner/bag – good condition
No gases present in the breathing zone.

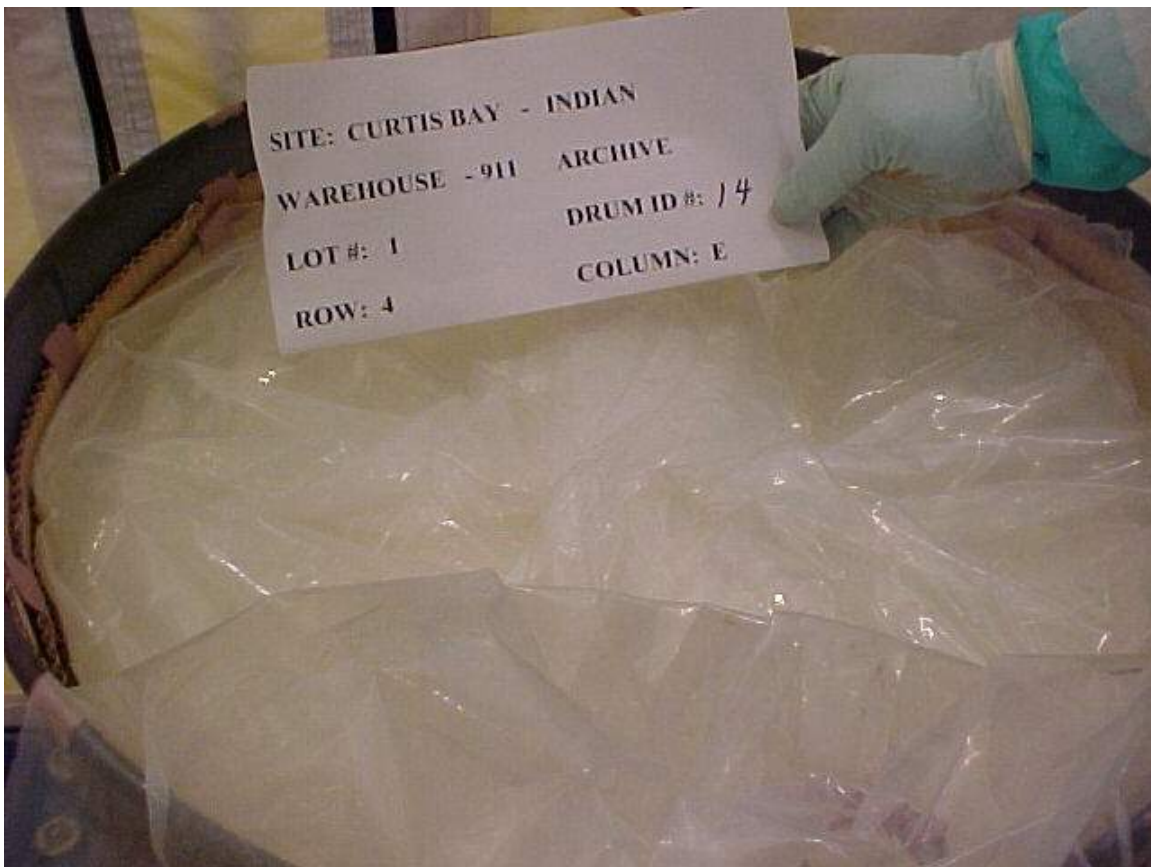
2nd poly liner/bag – good condition
No gases present in the breathing zone.

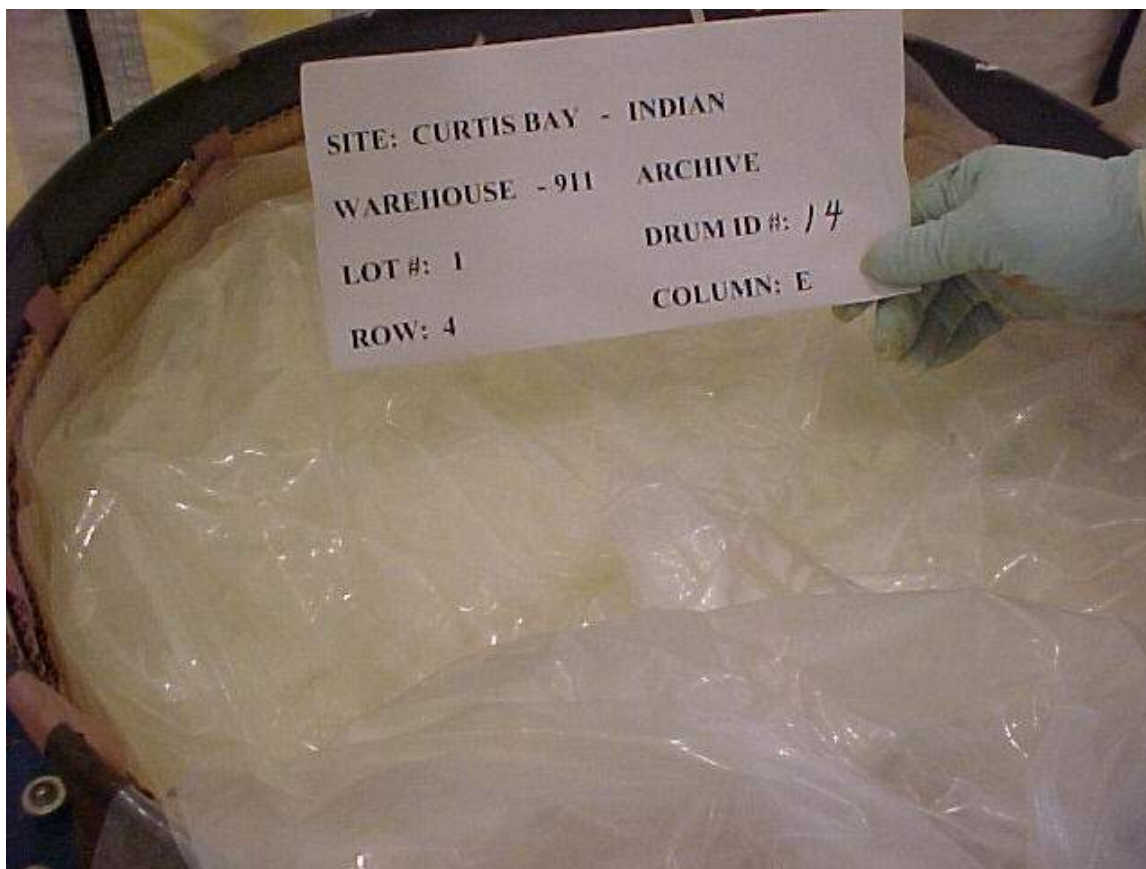
3rd poly liner/bag – good condition
No gases present in the breathing zone.

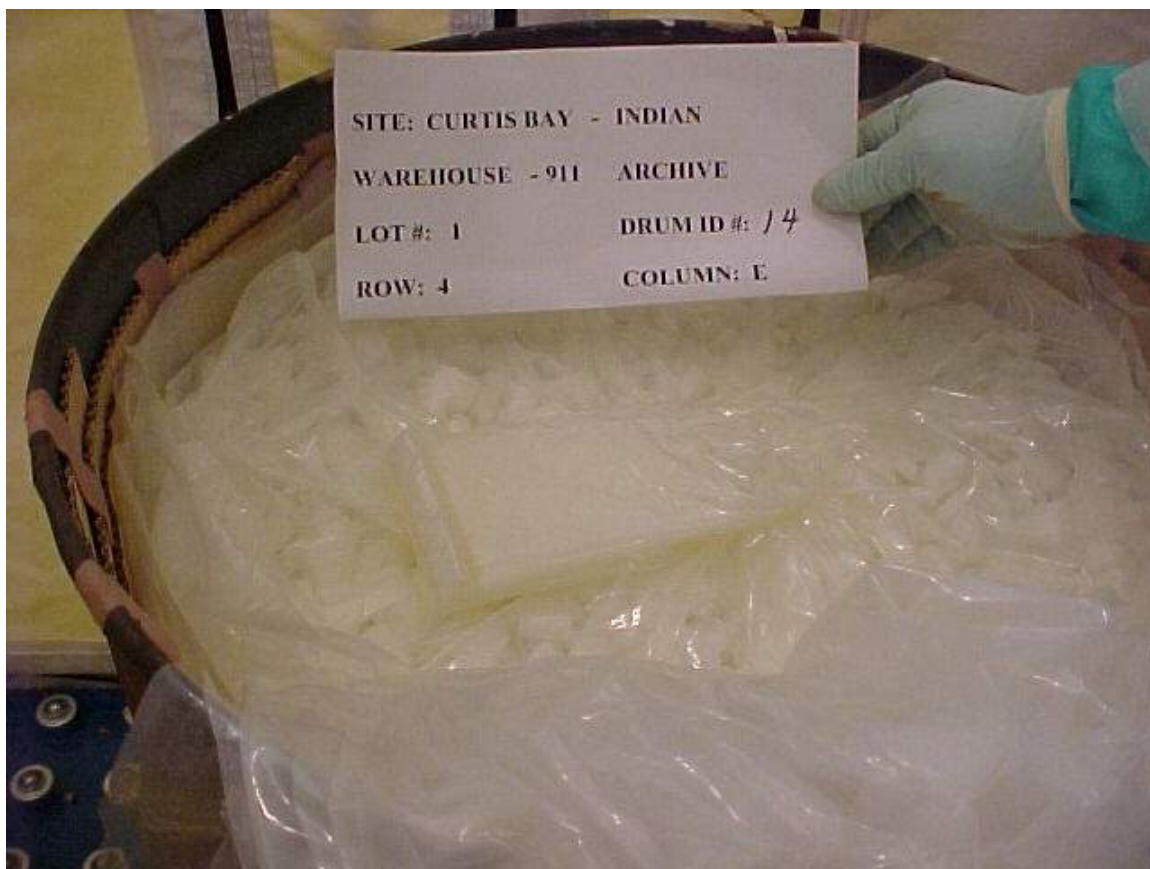
4th poly liner/bag – good condition
No gases present in the breathing zone.

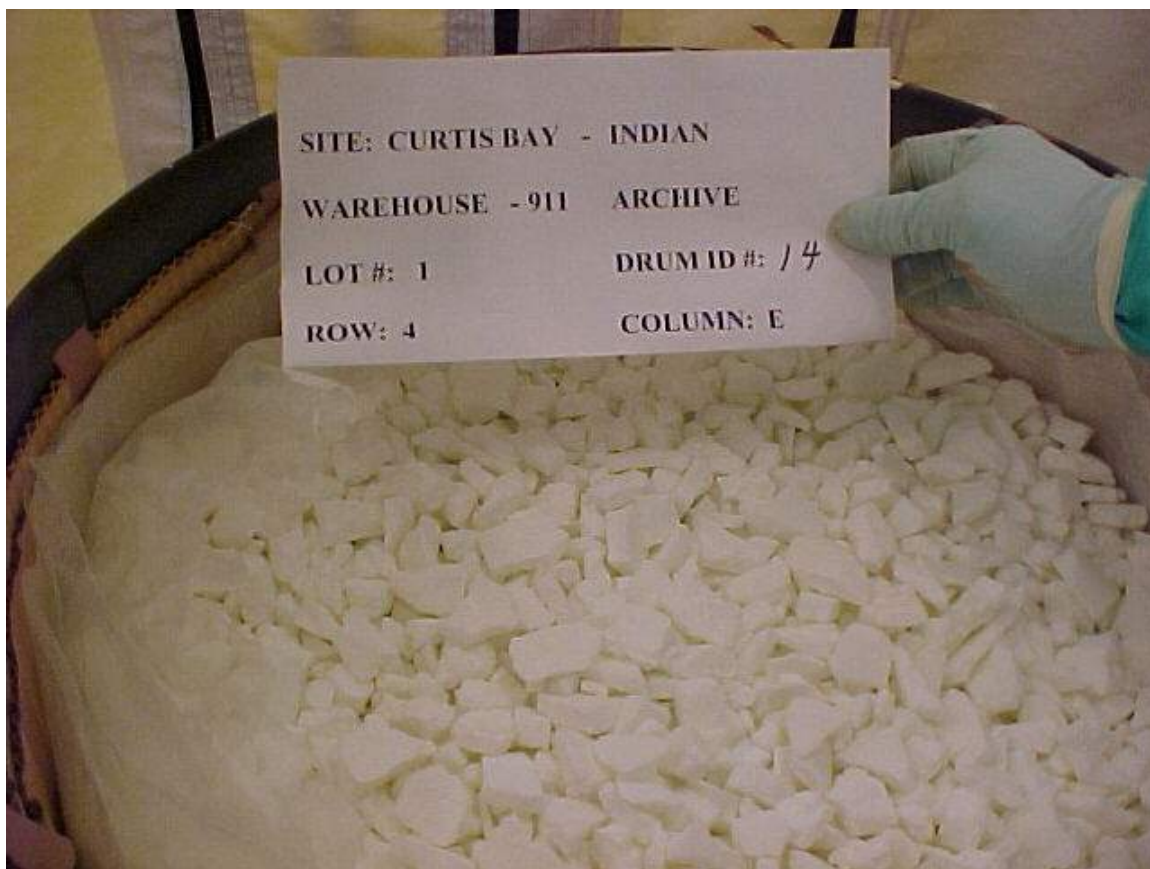
ThN material – Indian – cubes / chunks - dry
No gases present in the breathing zone.

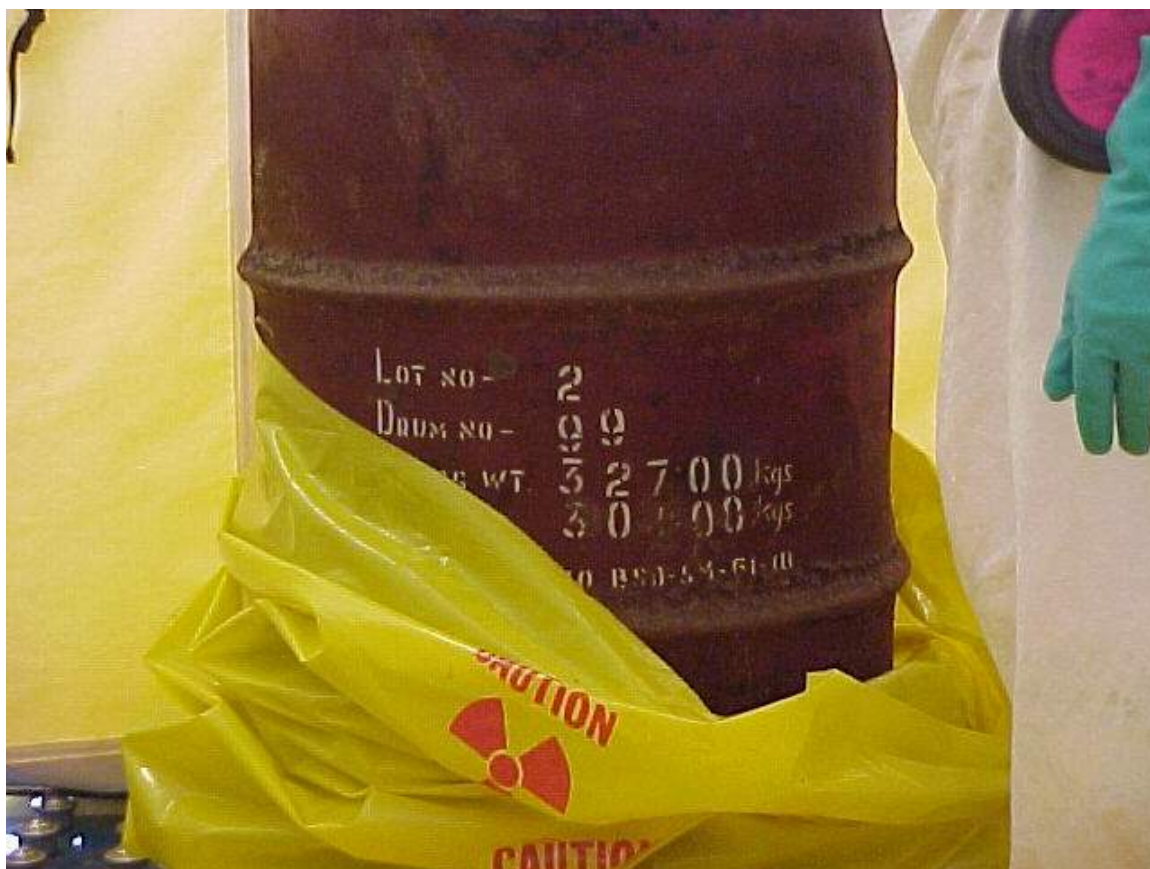
Indian (red) 55-gal drum – fair condition – extensive surface rust on drum
No gases present in the breathing zone.

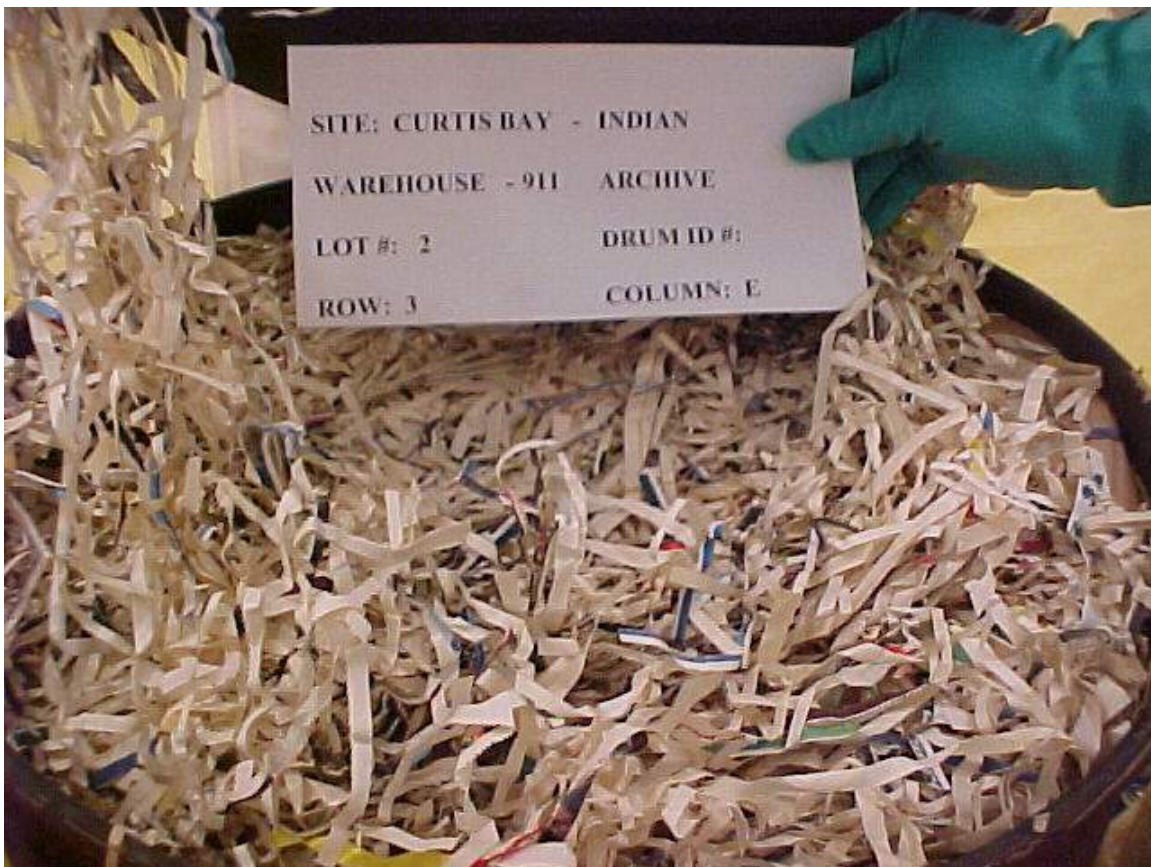
Shredded paper for packaging – good condition
No gases present in the breathing zone.

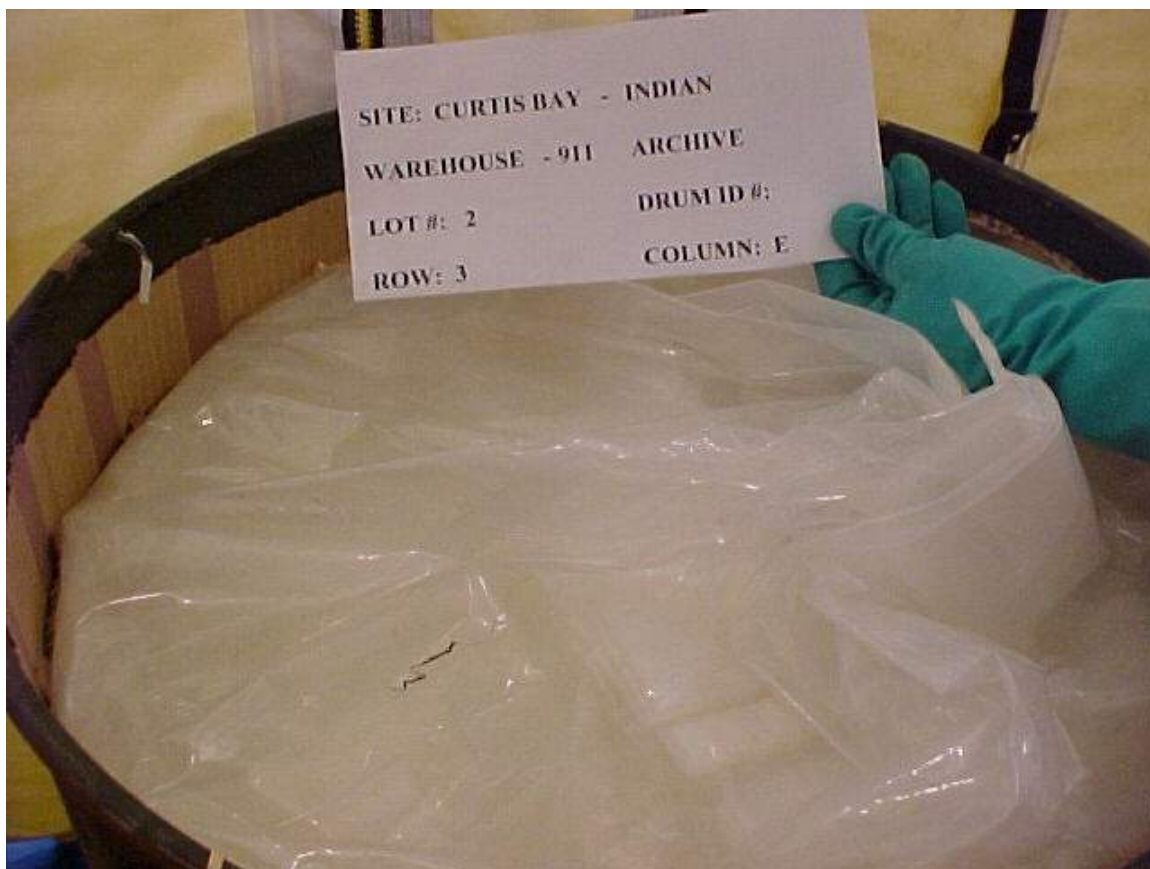
1st poly liner/bag – good condition
No gases present in the breathing zone.

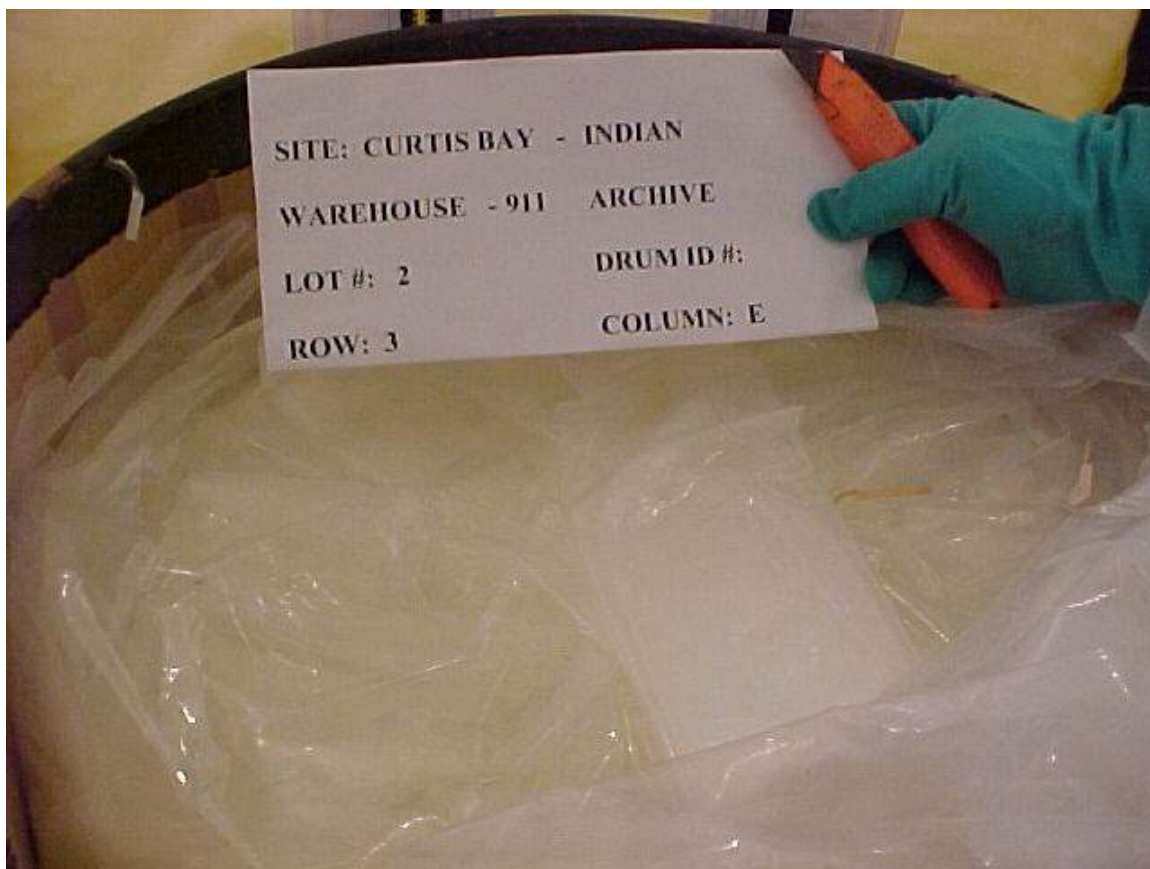
2nd poly liner/bag – good condition
No gases present in the breathing zone.

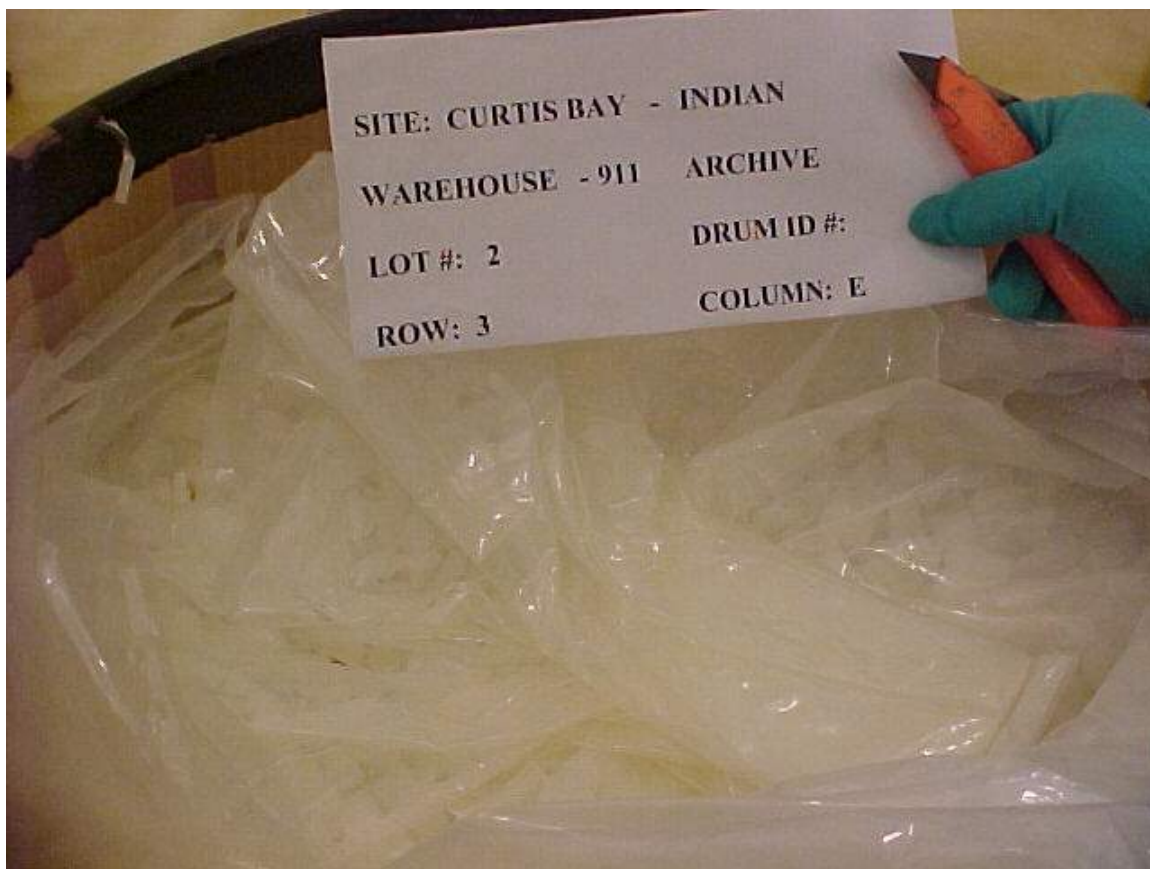
11:00**Other Information**Photo No. 5 of 7Dose Rate Surface 42 mR/hr
 1 meter 4.6 mR/hr3rd poly liner/bag – good condition
No gases present in the breathing zone.

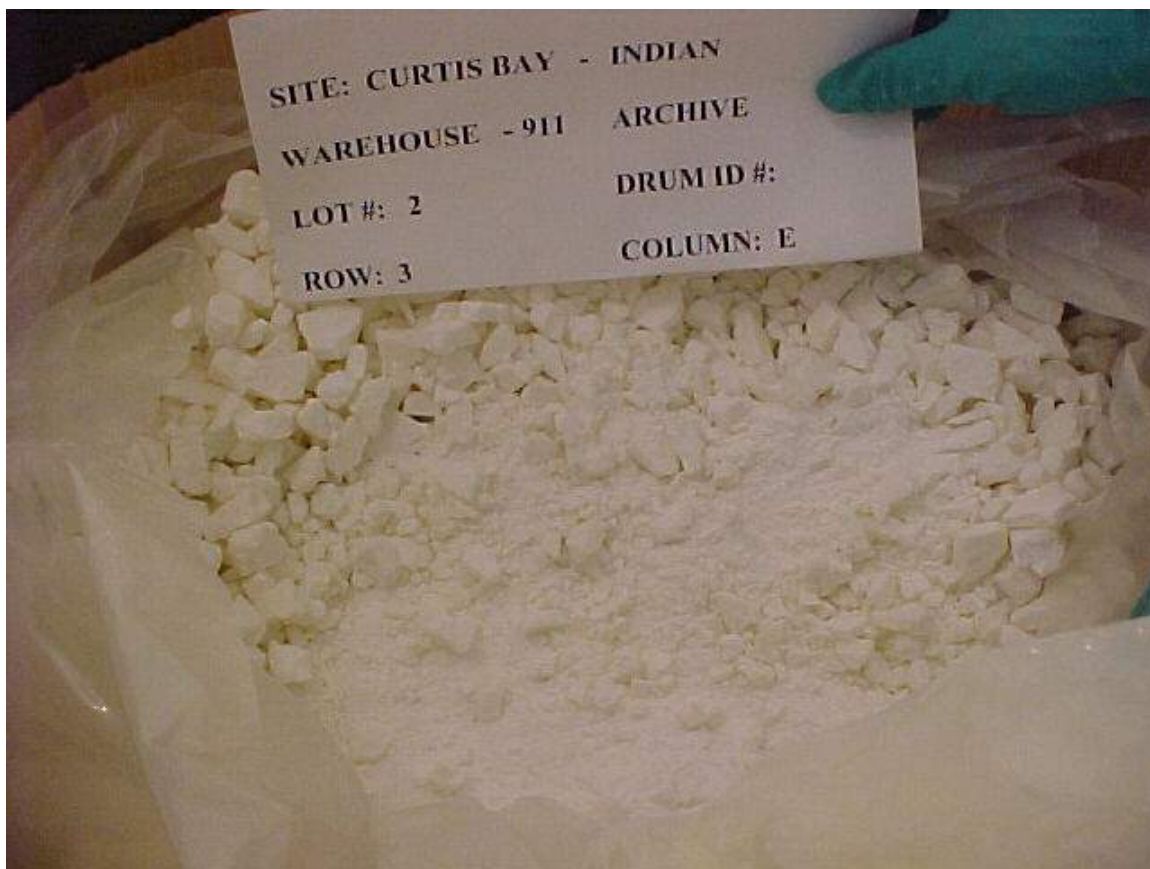
Closeup of ThN material – white – dry – solid – cubes / chunks
No gases present in the breathing zone.

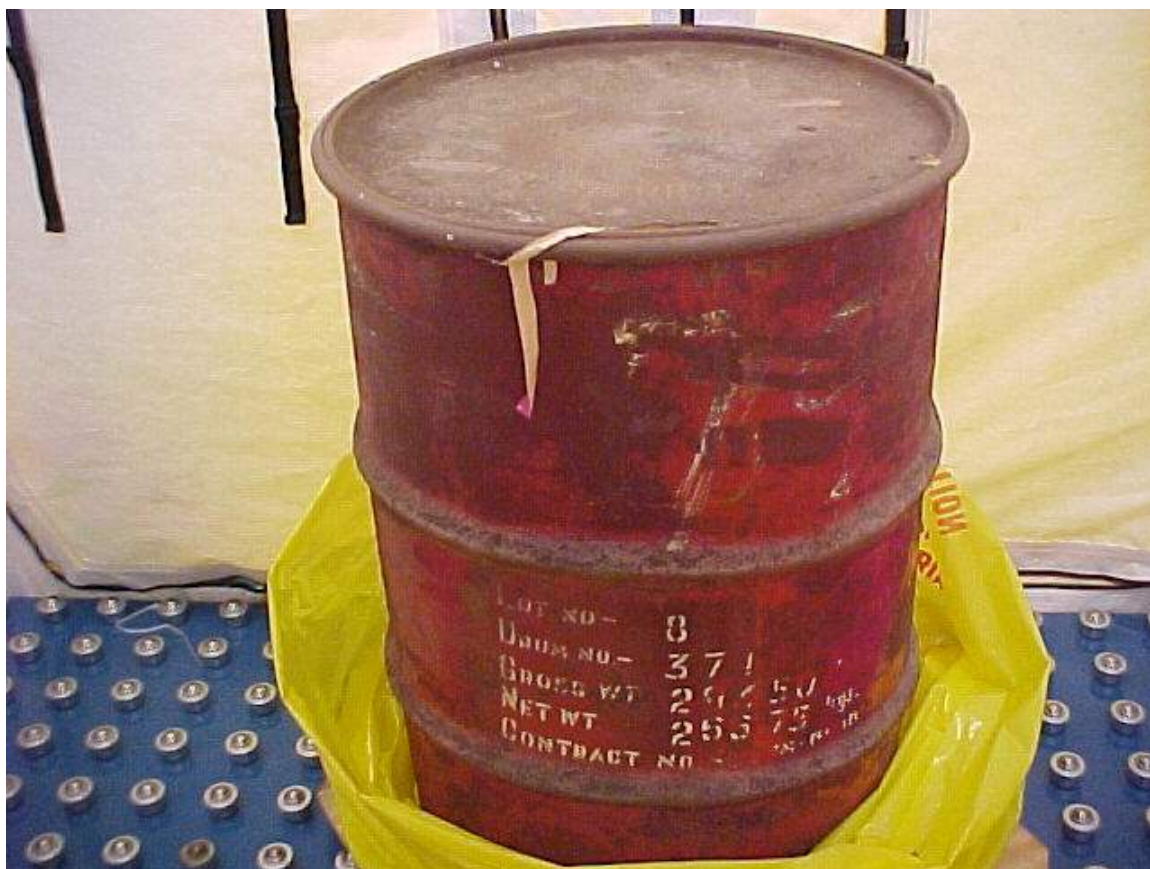
55-gal drum – fair condition – extensive surface rust on drum

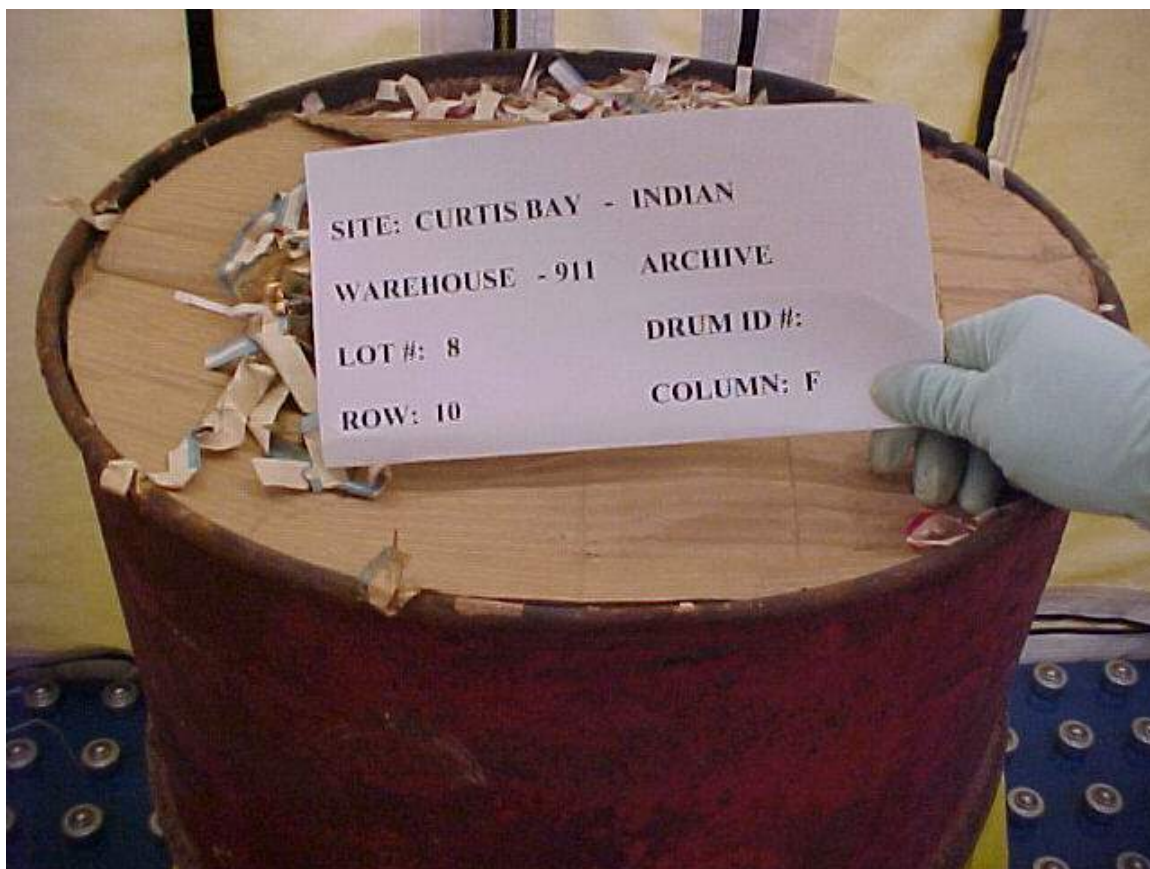
Cover / Shredded paper – good condition
No gases present in breathing zone

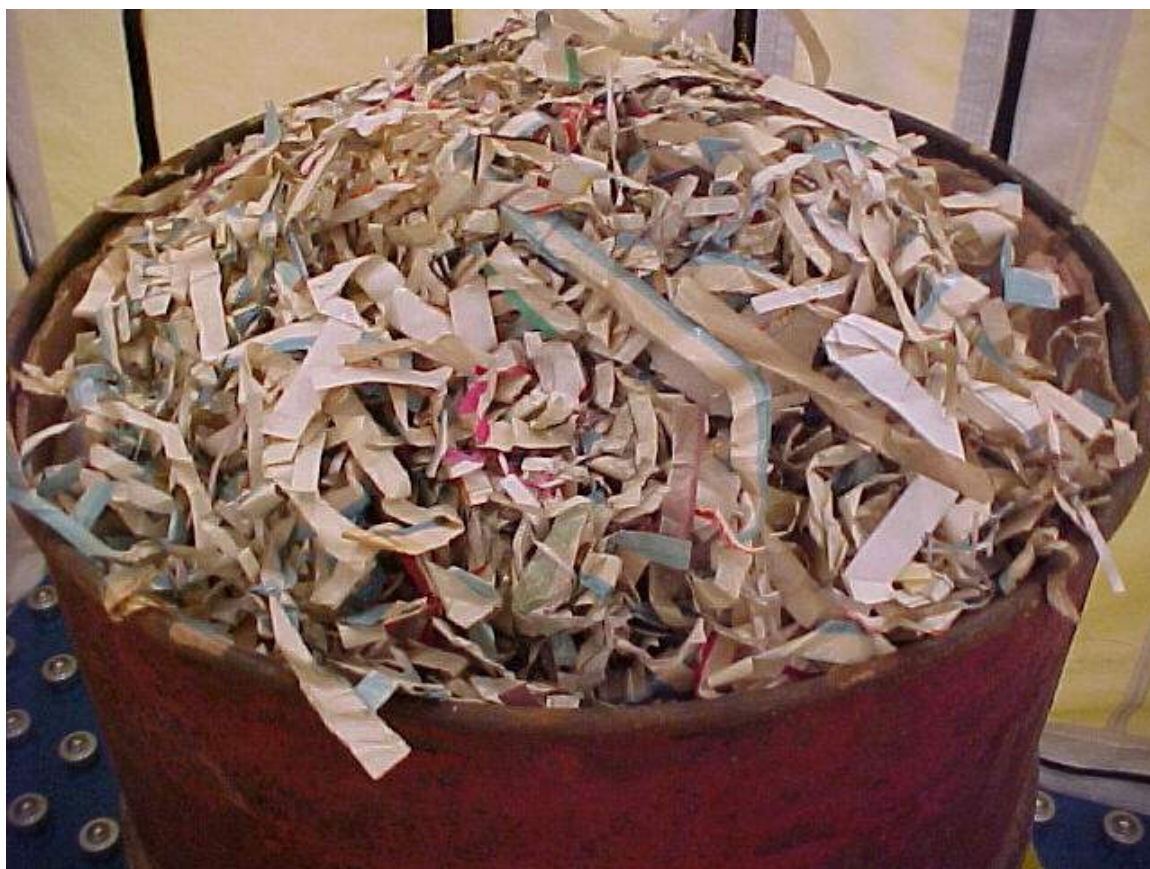
Another picture of shredded paper inside of drum
No gases present in the breathing zone.

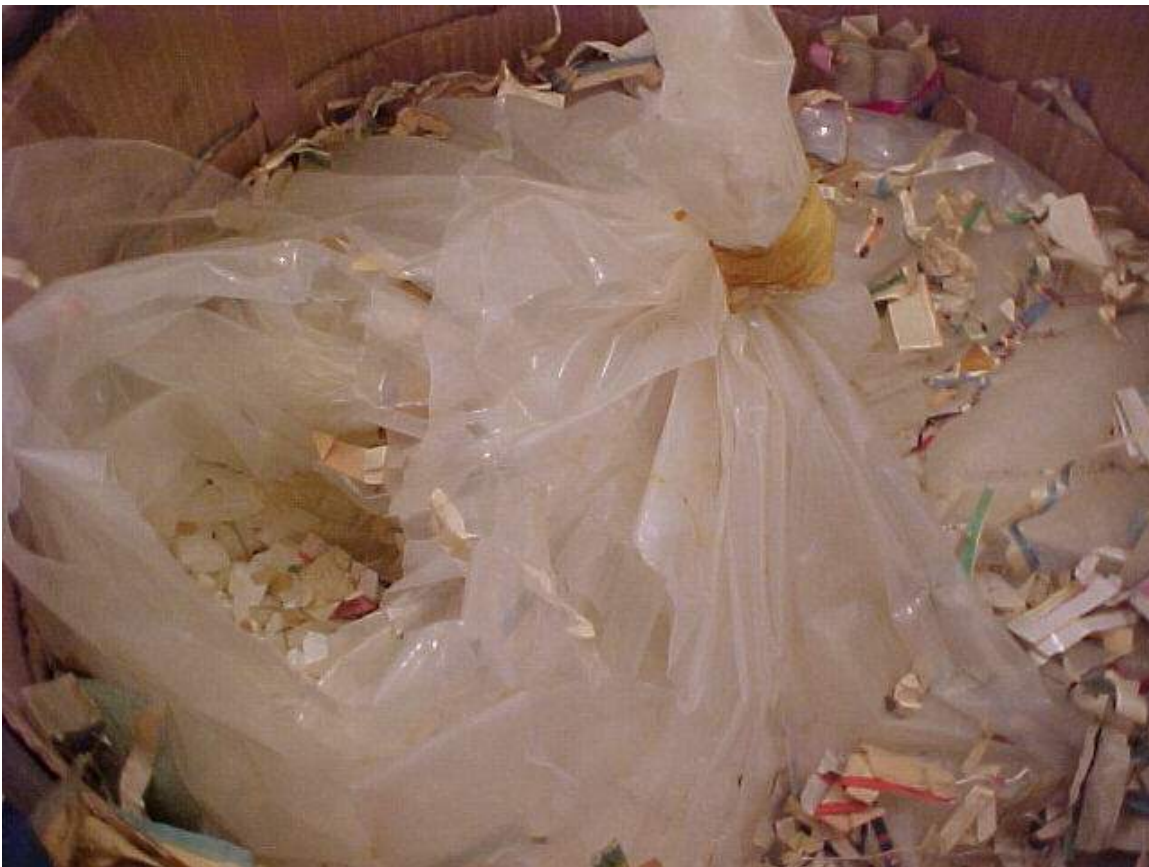
1st poly liner/bag – good condition
No gases present in the breathing zone.

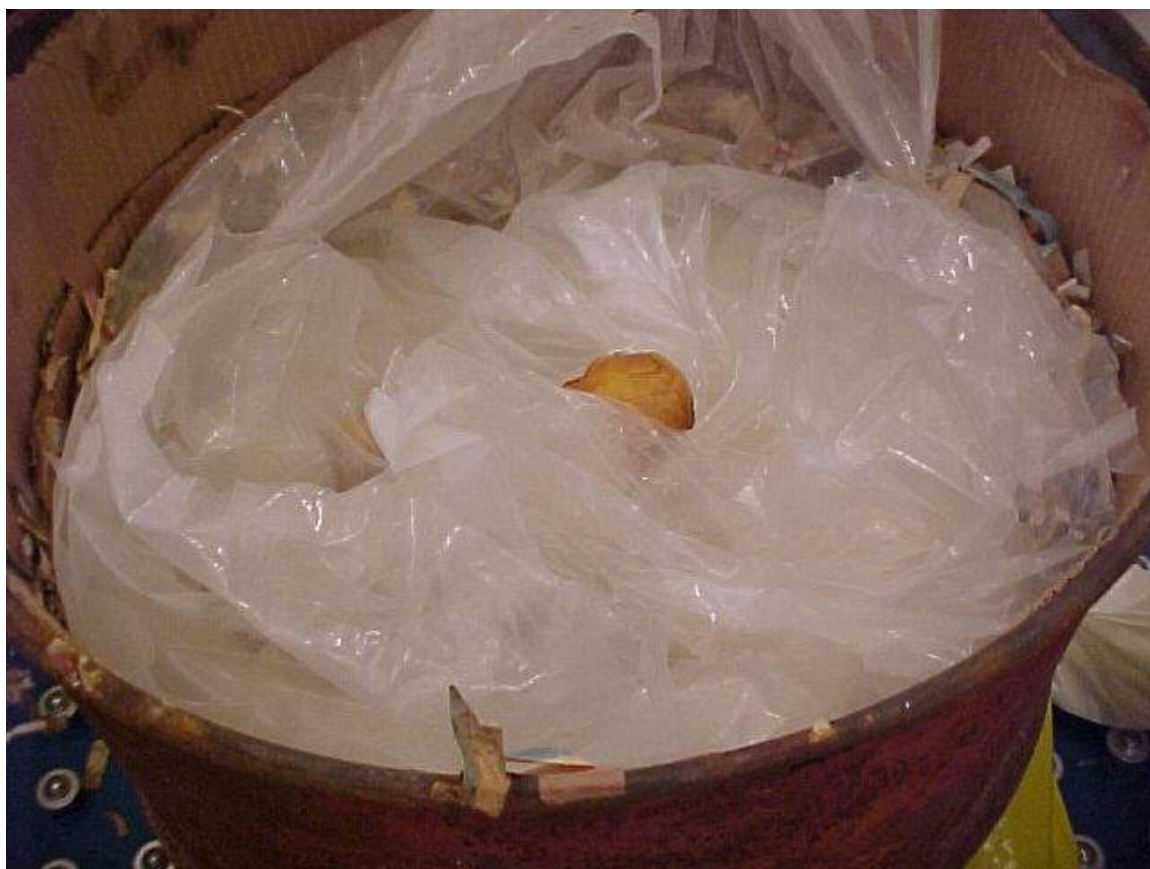
2nd poly liner/bag – good condition
No gases present in the breathing zone.

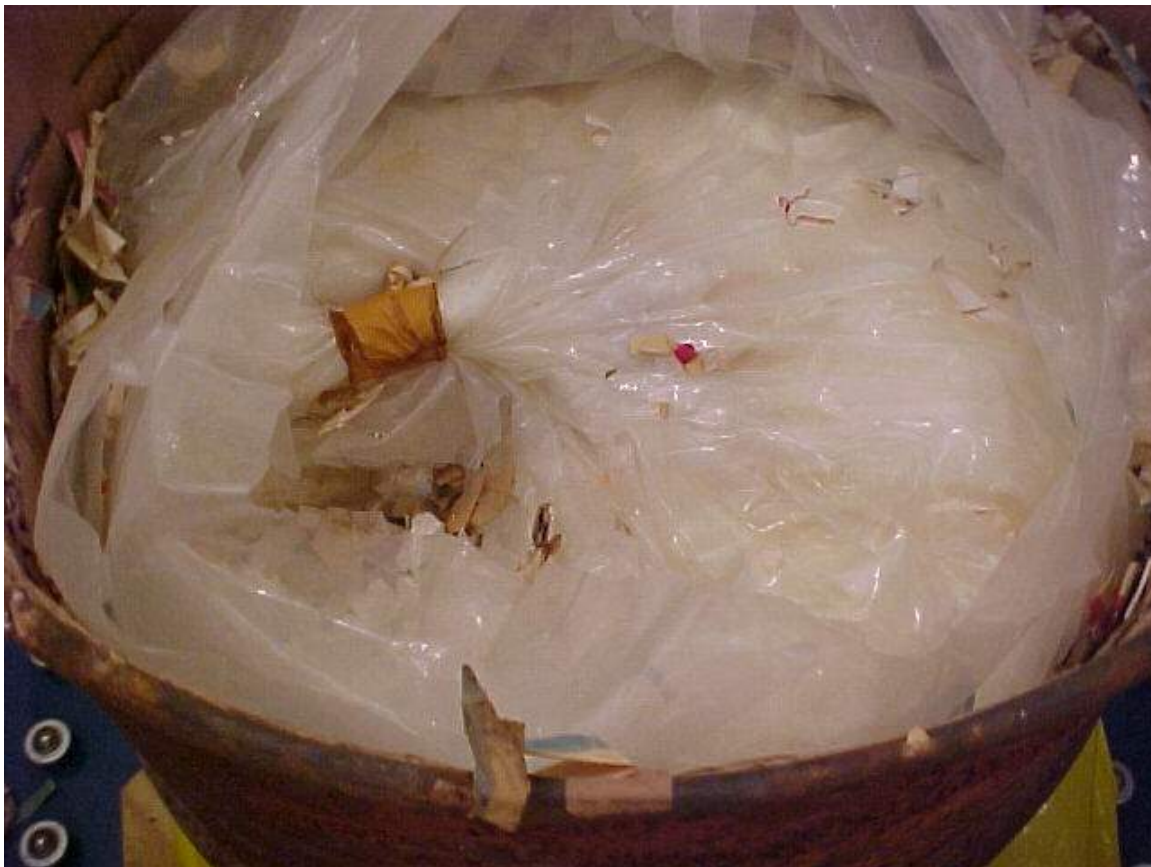
3rd poly liner/bag – good condition
No gases present in the breathing zone.

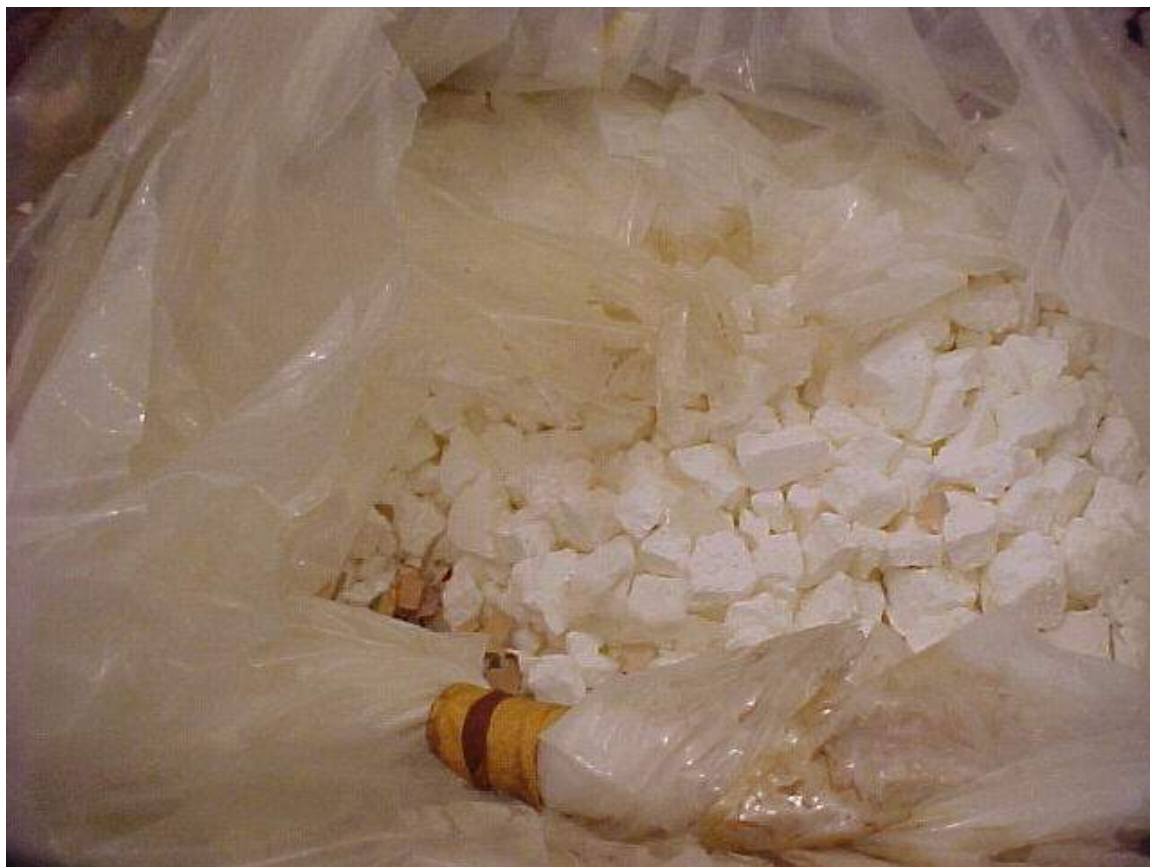
ThN material – Indian – dry – white – cubes / chunks

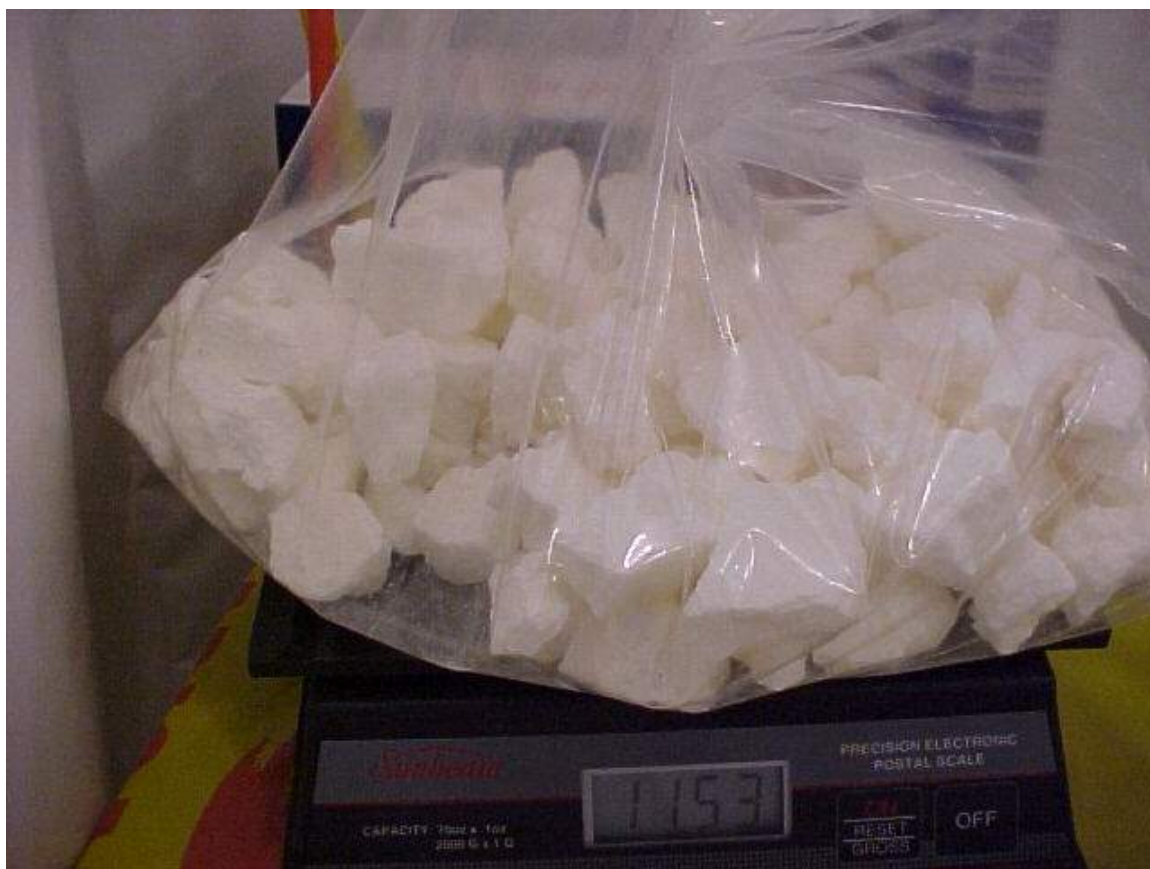
Indian ThN material in bag being weighed on scales
No gases present in the breathing zone.

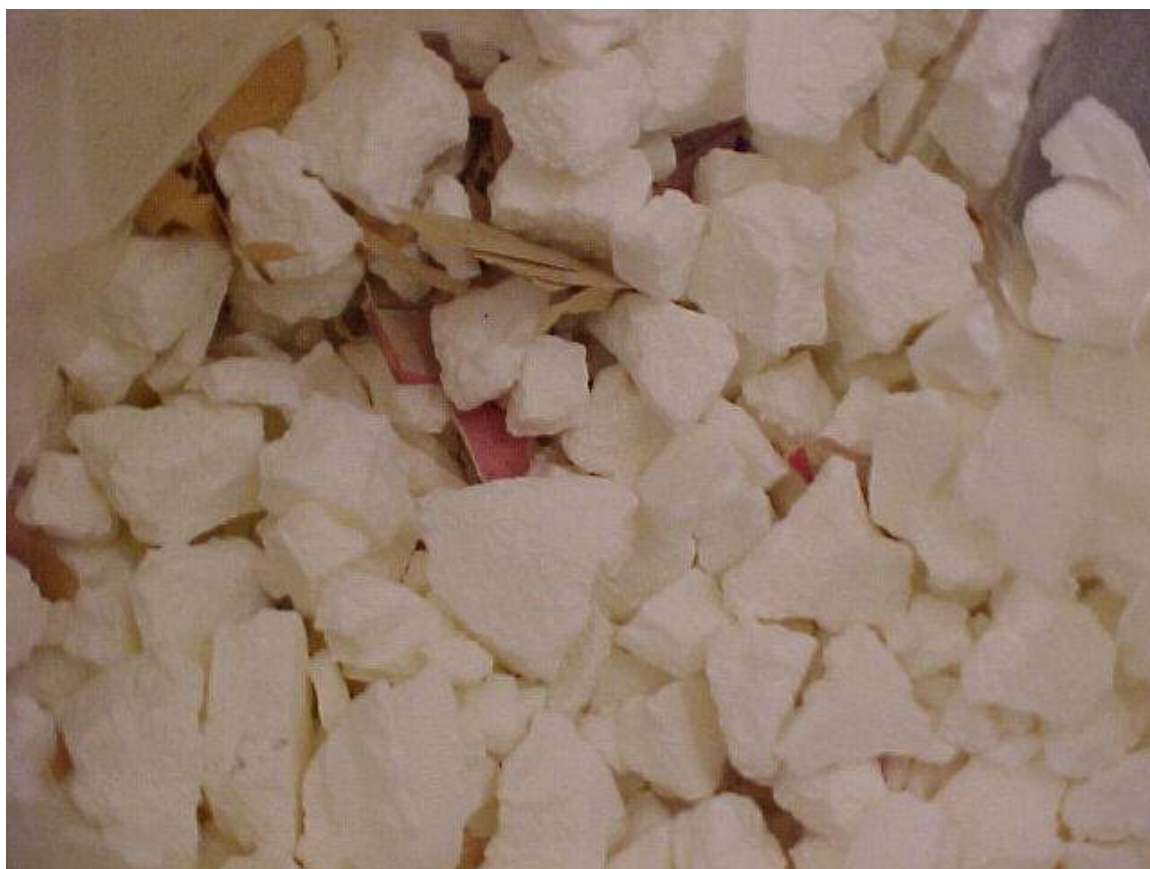
9:10**Other Information**Photo No. 9 of 10Dose Rate Surface 42 mR/hr1 meter 4.5 mR/hr

Closeup of ThN material cubes/chunks in the drum
No gases present in the breathing zone.

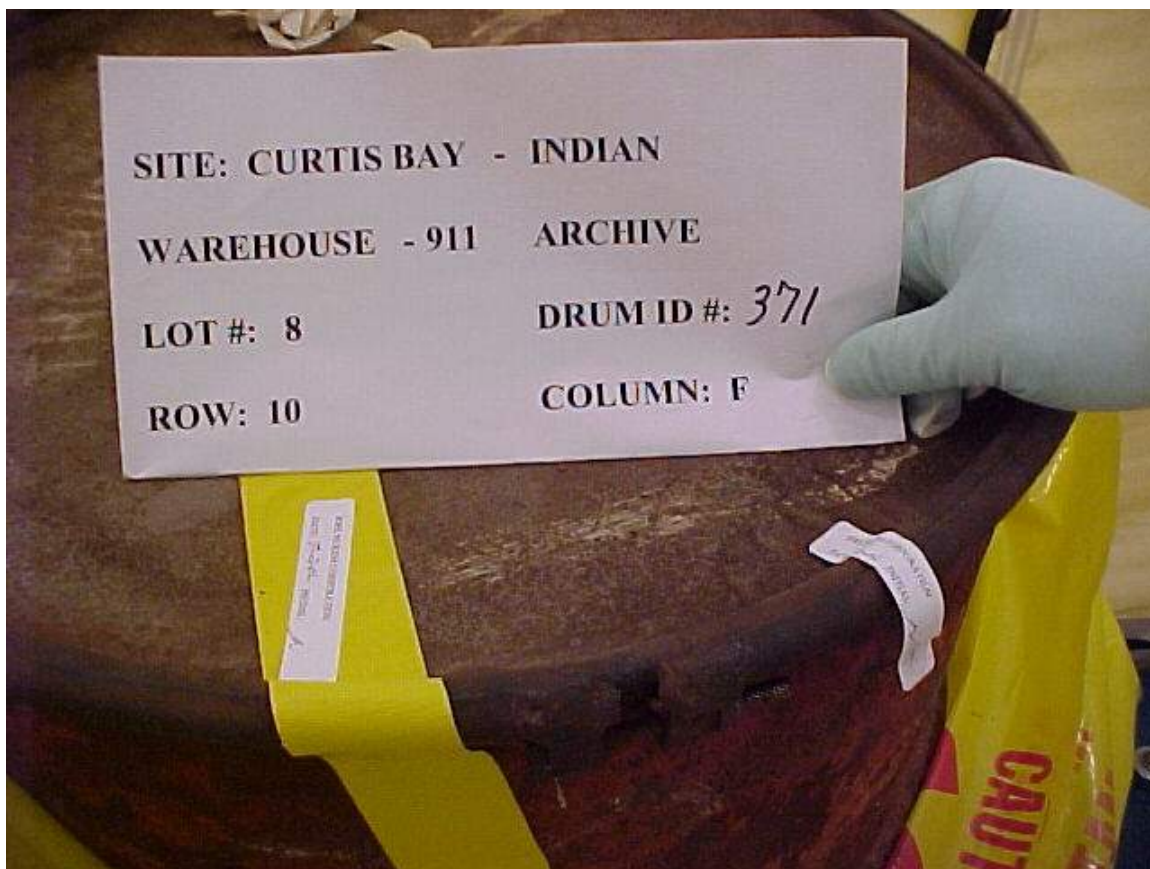
Sealed & dated - Complete

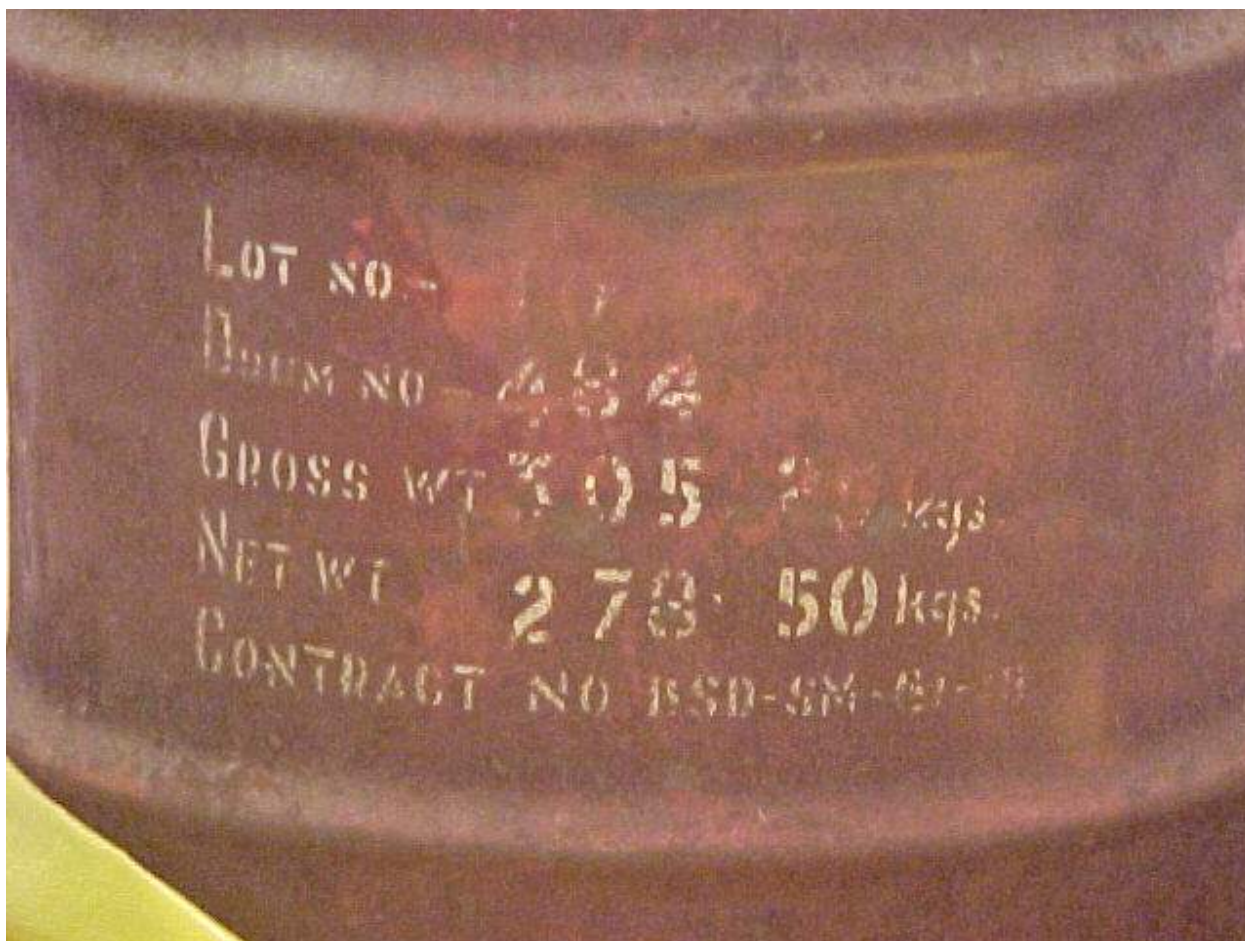
09:35**Other Information**Photo No. 1 of 9Dose Rate Surface 42 mR/hr
 1 meter 4.0 mR/hr

55-gal drum – fair condition – exterior rust on drum surface
No gases present in the breathing zone.
