THORIUM NITRATE STOCKPILE DRUM CHARACTERIZATION REPORT

**THORIUM NITRATE STOCKPILE
DRUM CHARACTERIZATION REPORT**

Prepared for
U.S. Defense Logistics Agency
Defense National Stockpile Center
Fort Belvoir, Virginia

Prepared by
OAK RIDGE NATIONAL LABORATORY
Oak Ridge, Tennessee 37831
managed by
UT-BATTELLE, LLC
for the
U.S. DEPARTMENT OF ENERGY
under contract DE-AC05-00OR22725

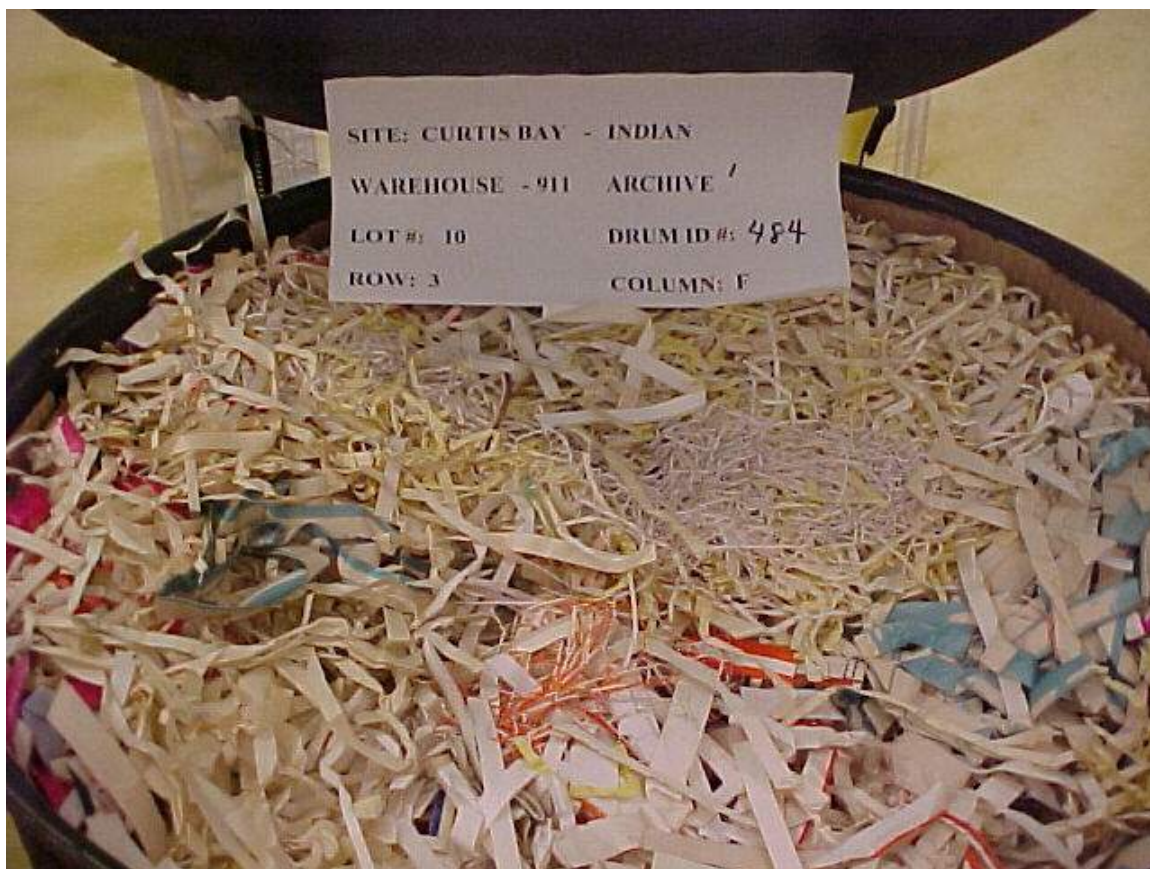
Shredded paper packaging in top of drum
No gases present in the breathing zone.

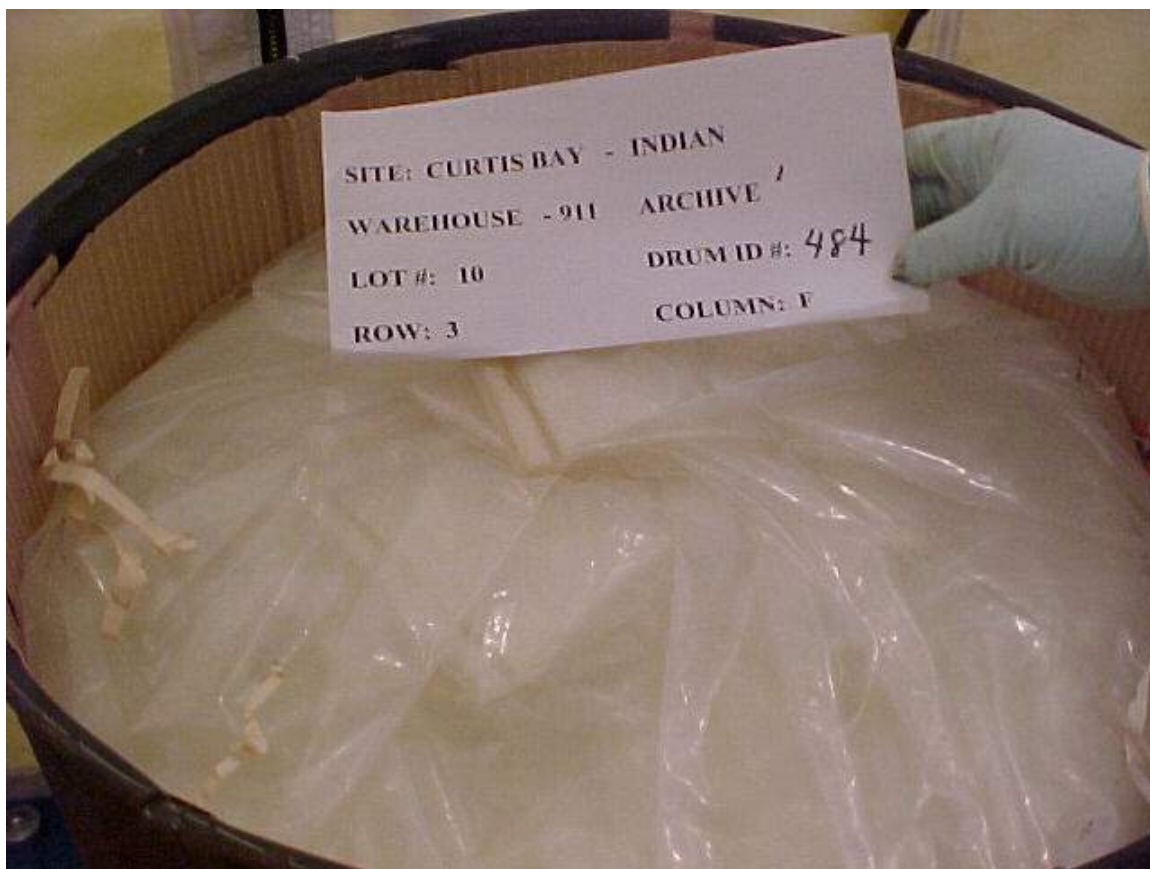
09:35**Other Information**Photo No. 3 of 9Dose Rate Surface 42 mR/hr
 1 meter 4.0 mR/hr

1st poly liner/bag – good condition
No gases present in the breathing zone.

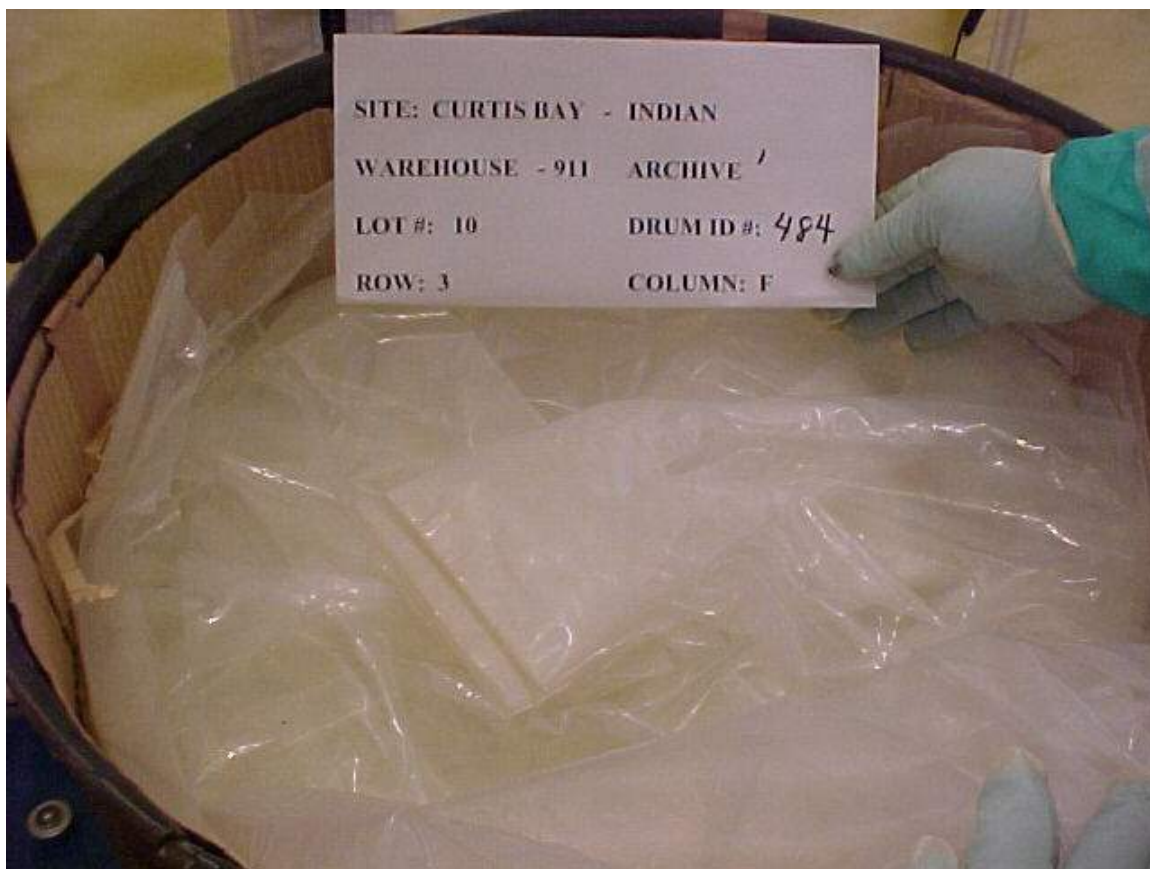
2nd poly liner/bag – good condition
No gases present in the breathing zone.

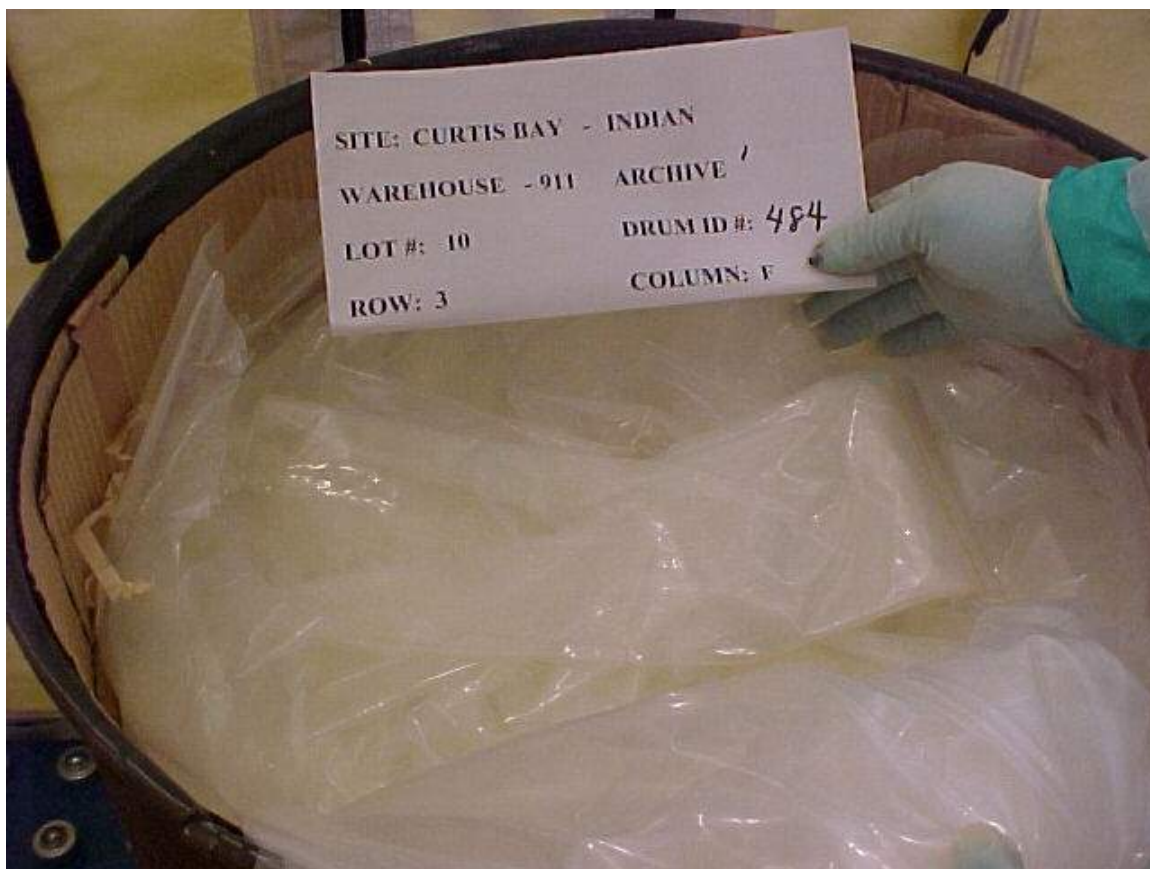
09:35**Other Information**Photo No. 5 of 9Dose Rate Surface 42 mR/hr
 1 meter 4.0 mR/hr

3rd poly liner/bag – good condition
No gases present in the breathing zone.

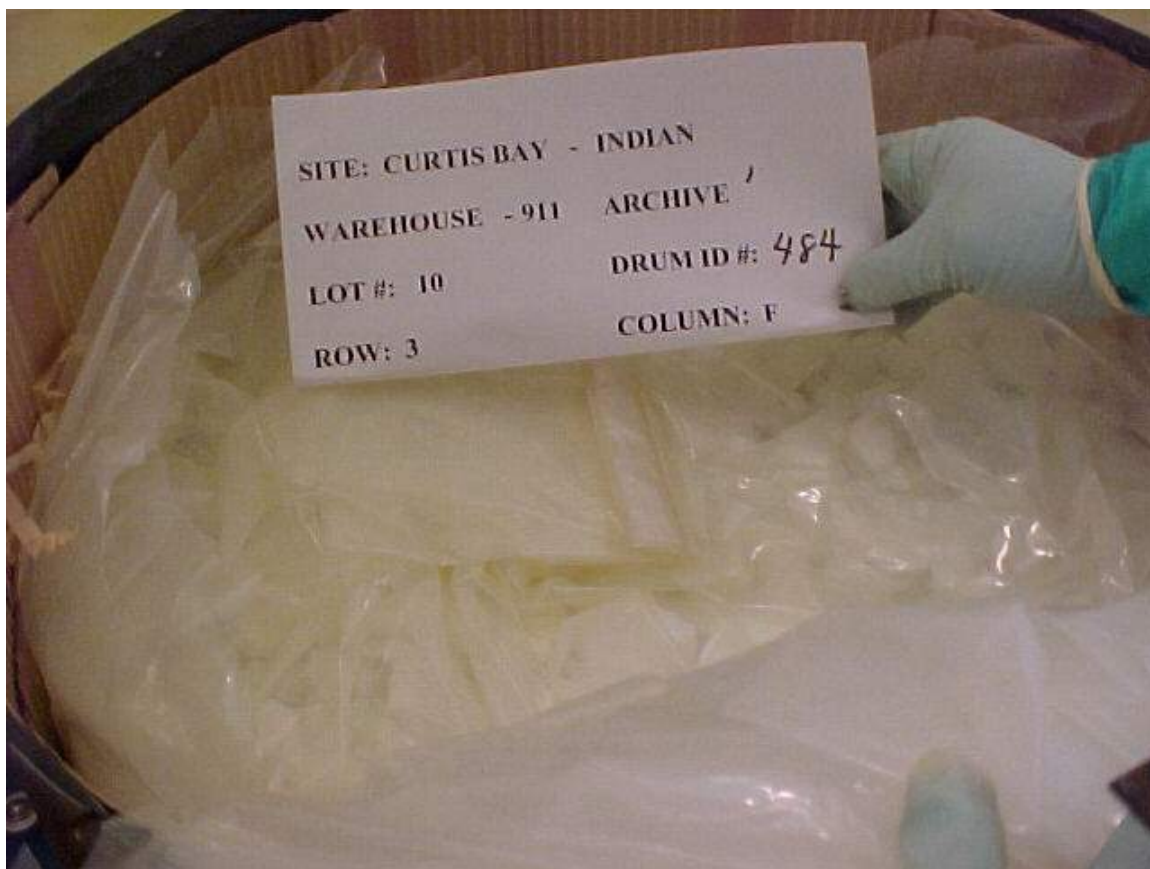
4th poly liner/bag – good condition
No gases present in the breathing zone.

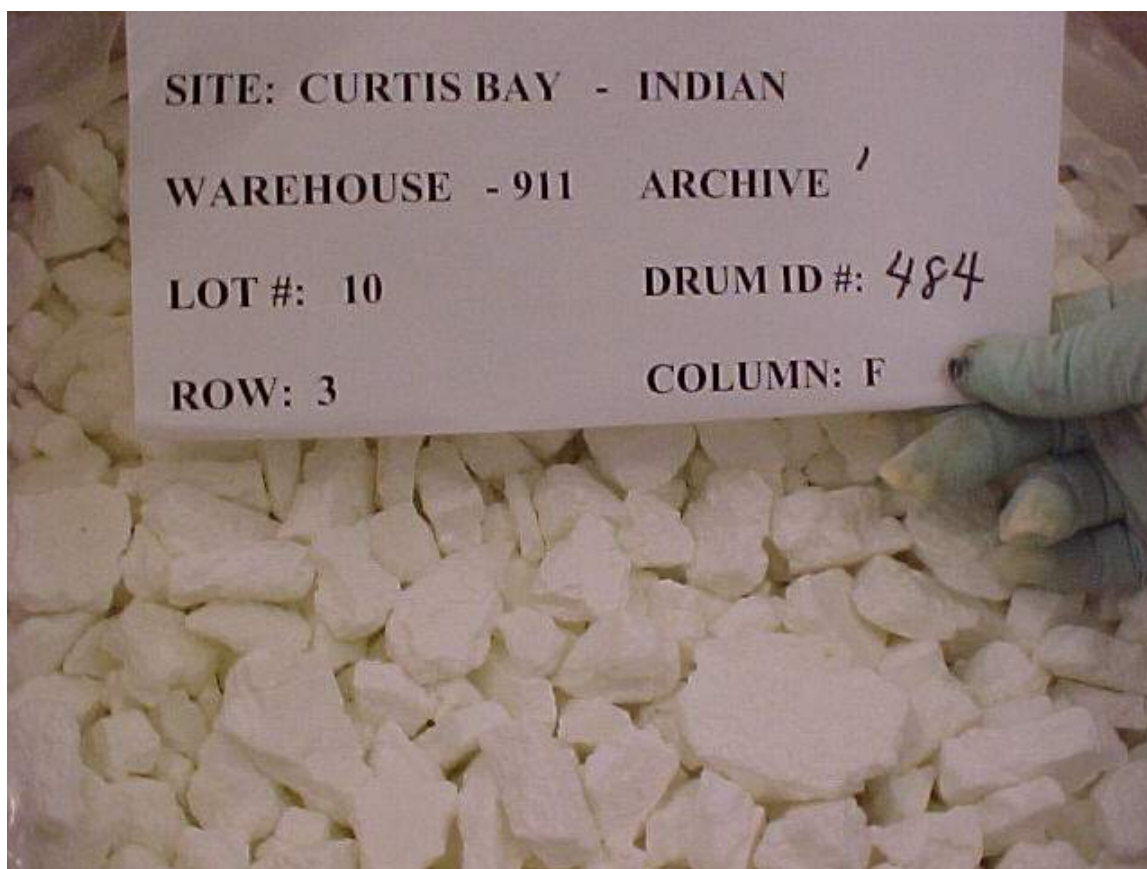
09:35**Other Information**Photo No. 7 of 9Dose Rate Surface 42 mR/hr
 1 meter 4.0 mR/hr

ThN material – Indian – cubes / chunks – solid - white
No gases present in the breathing zone.

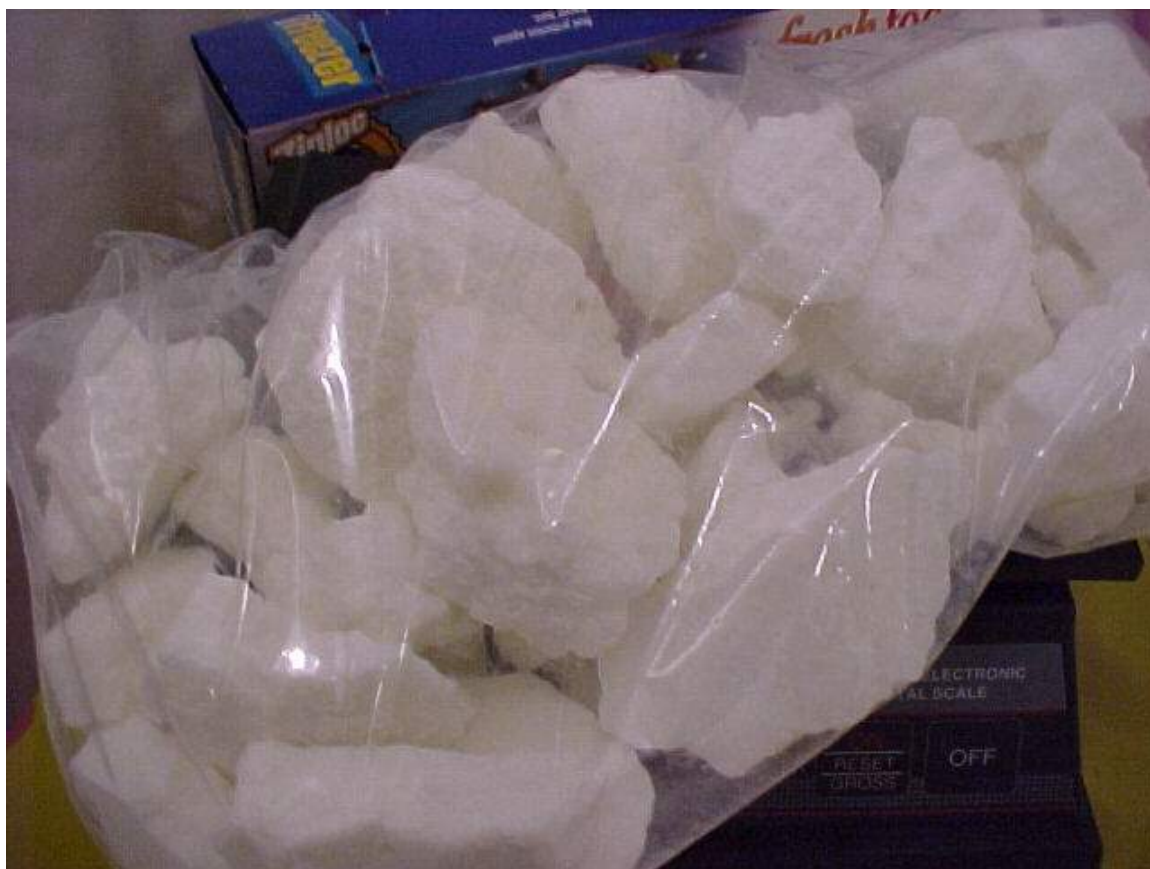
Closeup of ThN material while the material is being weighed in sample bag.
No gases present in the breathing zone.

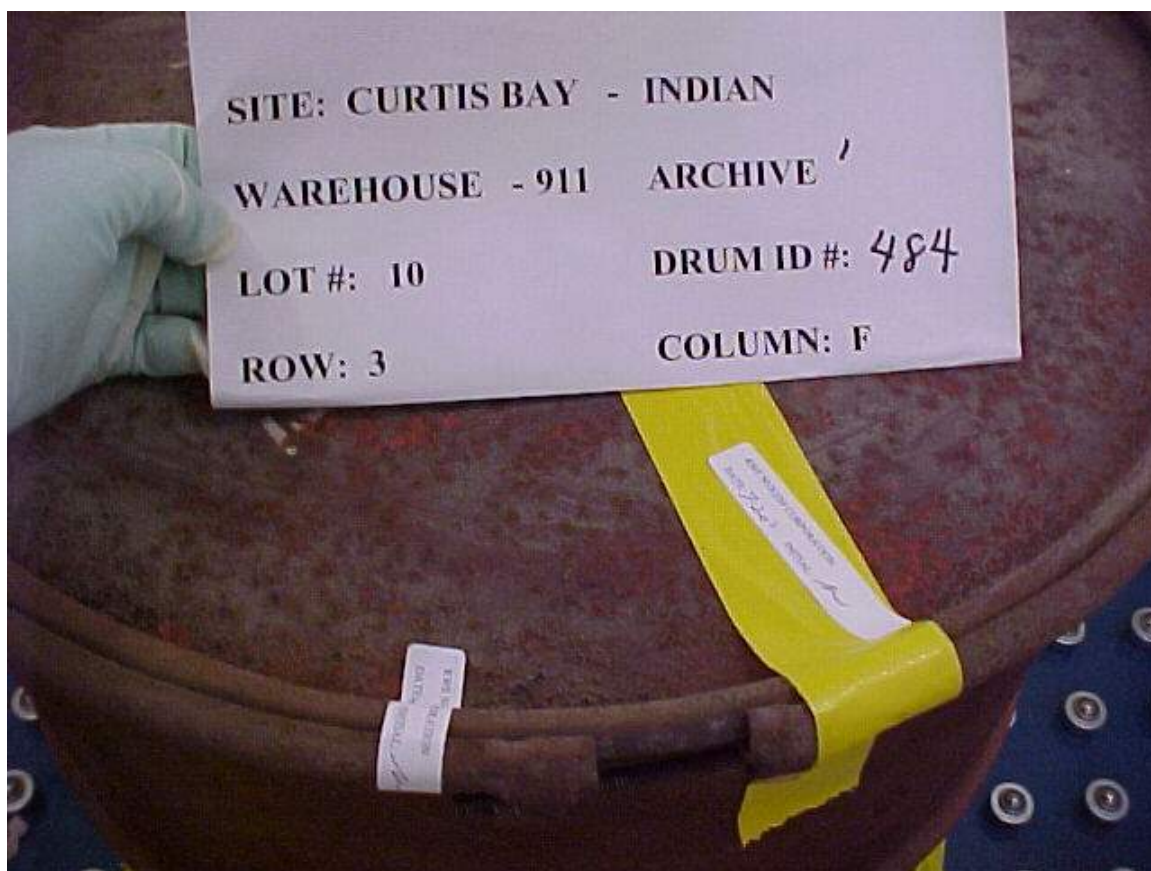
09:35**Other Information**Photo No. 9 of 9Dose Rate Surface 42 mR/hr
 1 meter 4.0 mR/hr

Sealed & dated – Complete

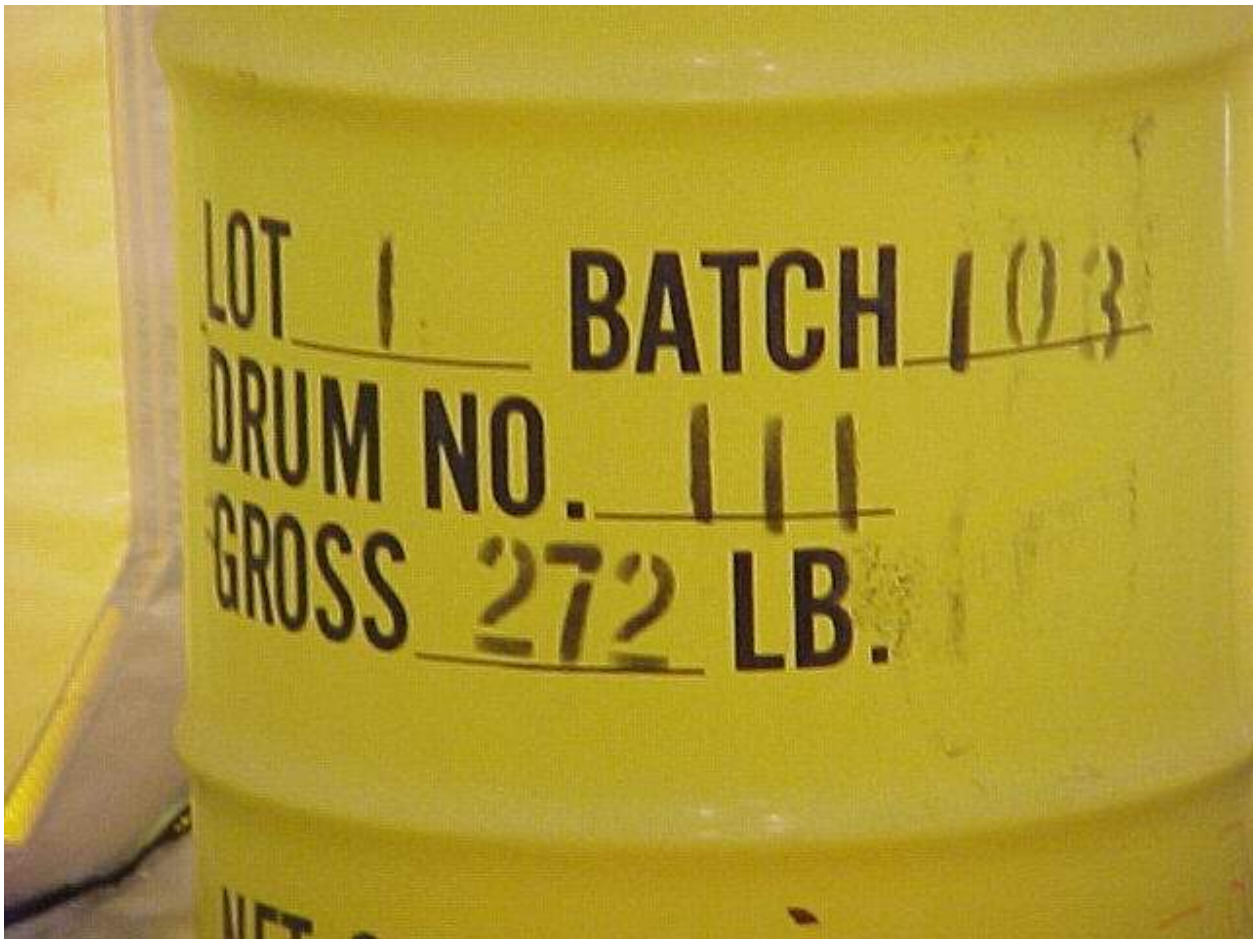
30-gal drum – good condition
 Gases vented from drum during bolt ring removal operations
 No gases present in the breathing zone.

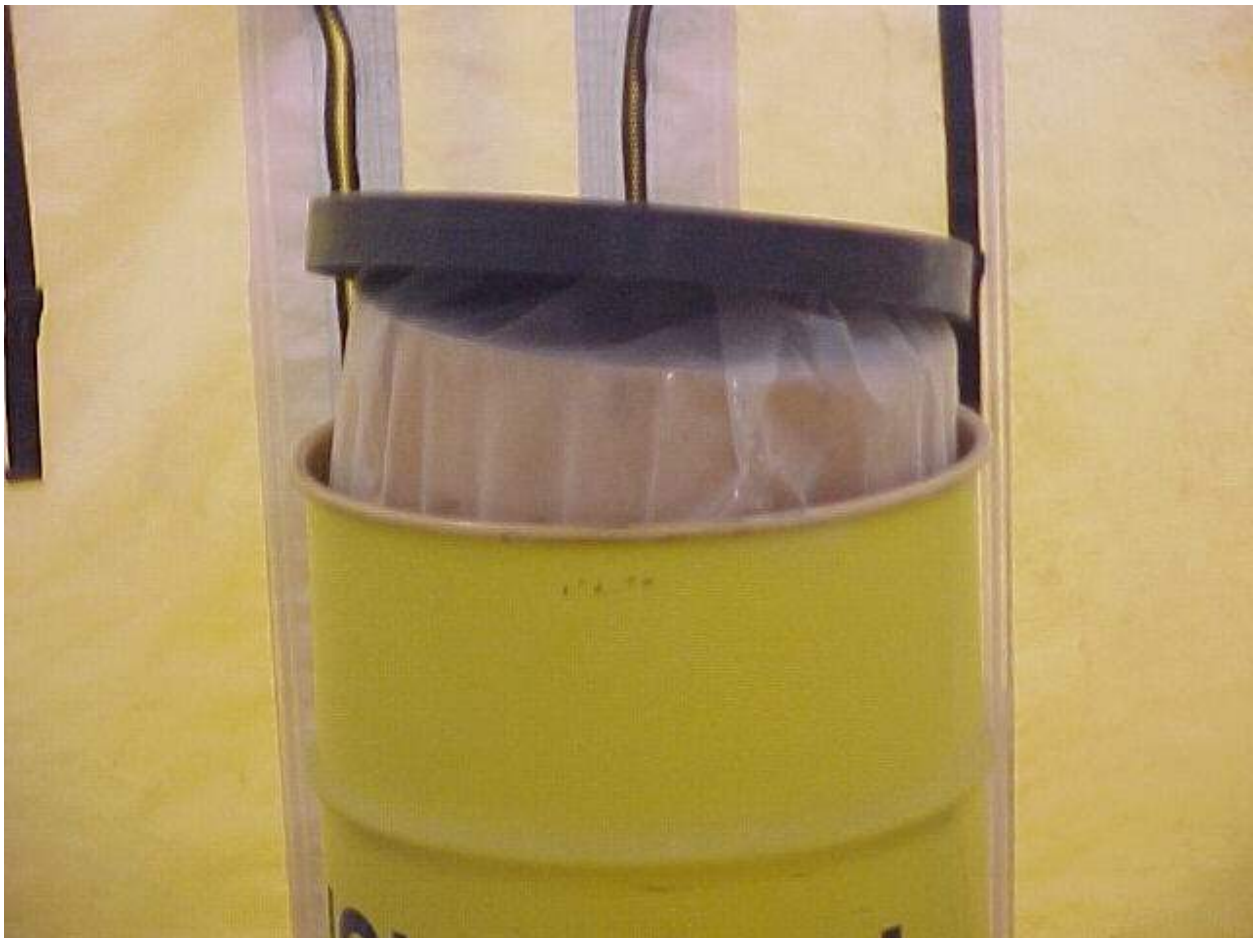
Black plastic lid (mounted on inner rigid drum liner) – good condition
Pressure buildup inside the packaging layers results in this packaging layer rising vertically out of the container.
No gases present in the breathing zone.

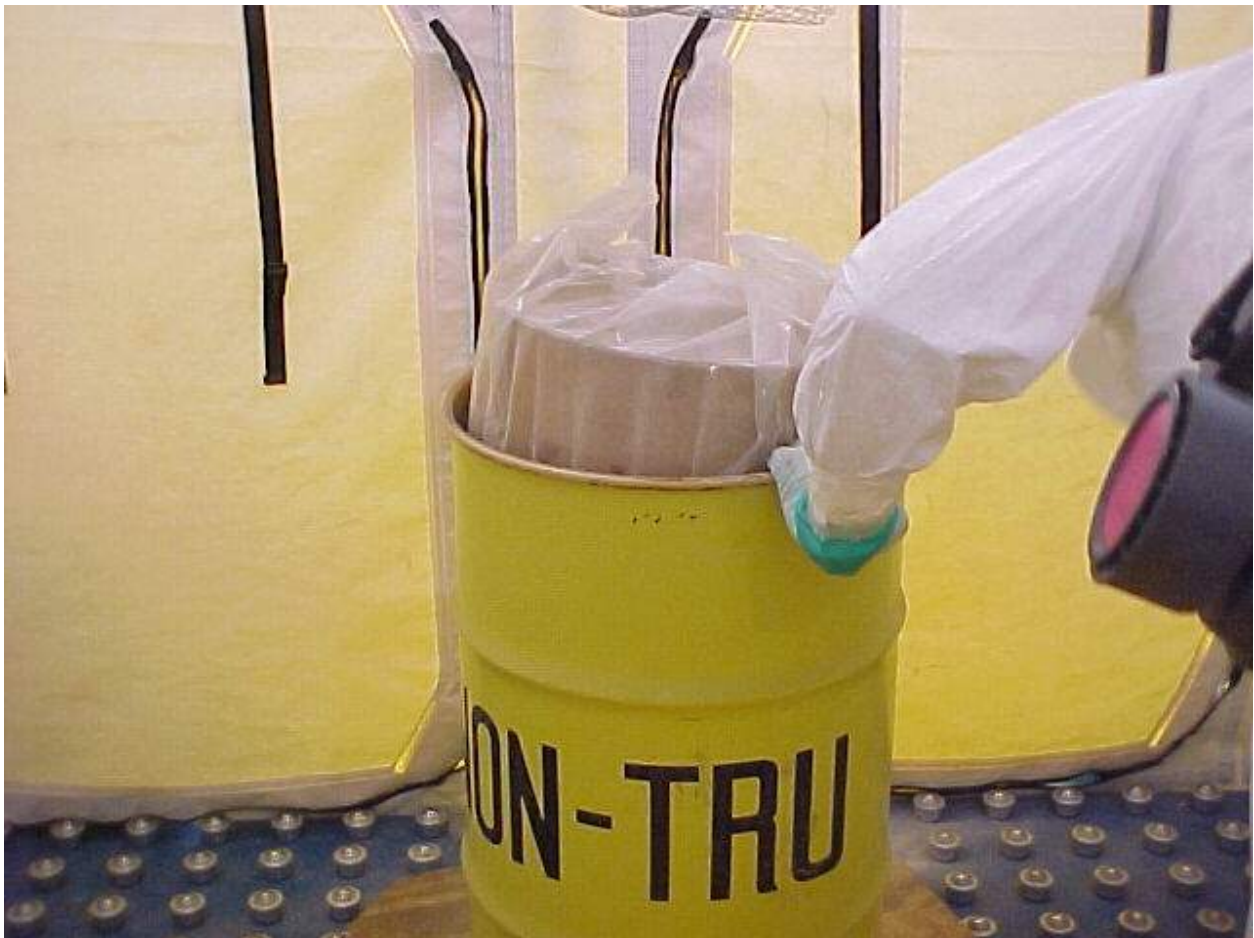
08:15**Other Information**Photo No. 3 of 9Dose Rate Surface 22 mR/hr
 1 meter 2.6 mR/hr1st poly liner/bag – good condition

Pressure buildup inside the packaging layers results in this packaging layer rising vertically out of the container.

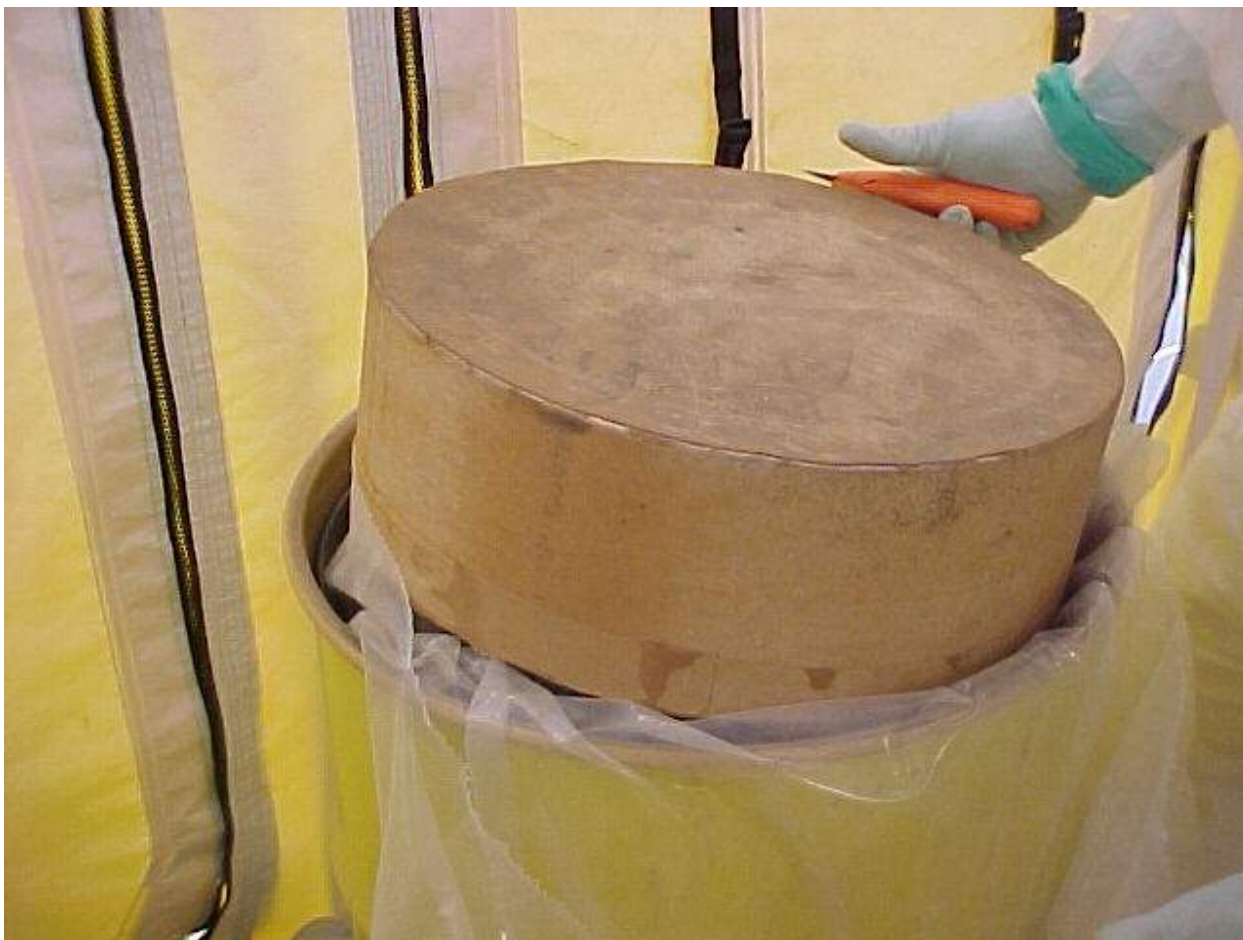
Fiber drum lid (fiber drum is outermost fiber drum inside of the 30-gal metal drum) – good condition
Pressure buildup inside the packaging layers results in this packaging layer rising vertically out of the container.

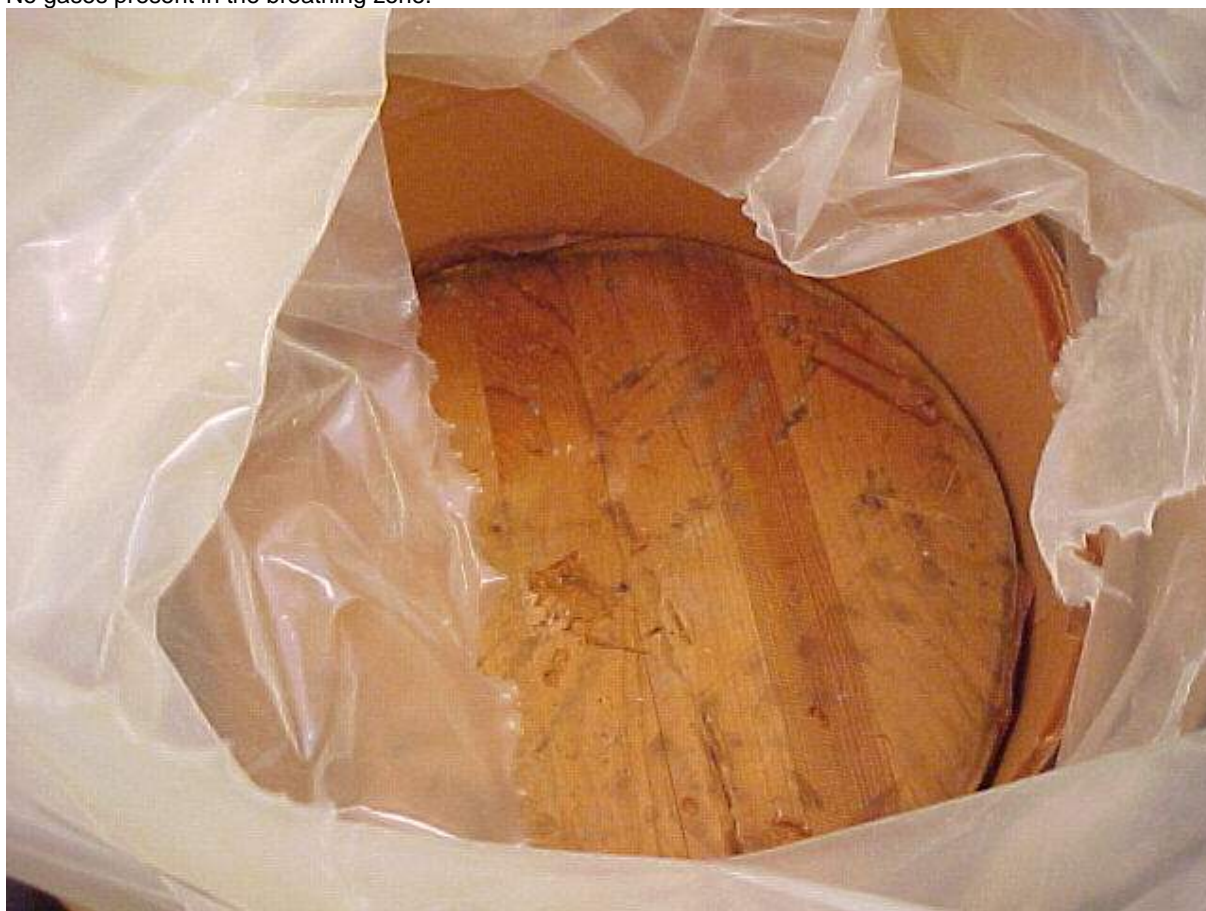
Wooden lid (mounted on inner fiber/lab-pack drum) – good condition

Picture shows where this wooden lid has slid down inside of this inner fiber/lab-pack drum vs. remaining on the lip of the fiber drum shown in the picture. Picture also shows where we have cut through the 2nd & 3rd poly liner/bags.

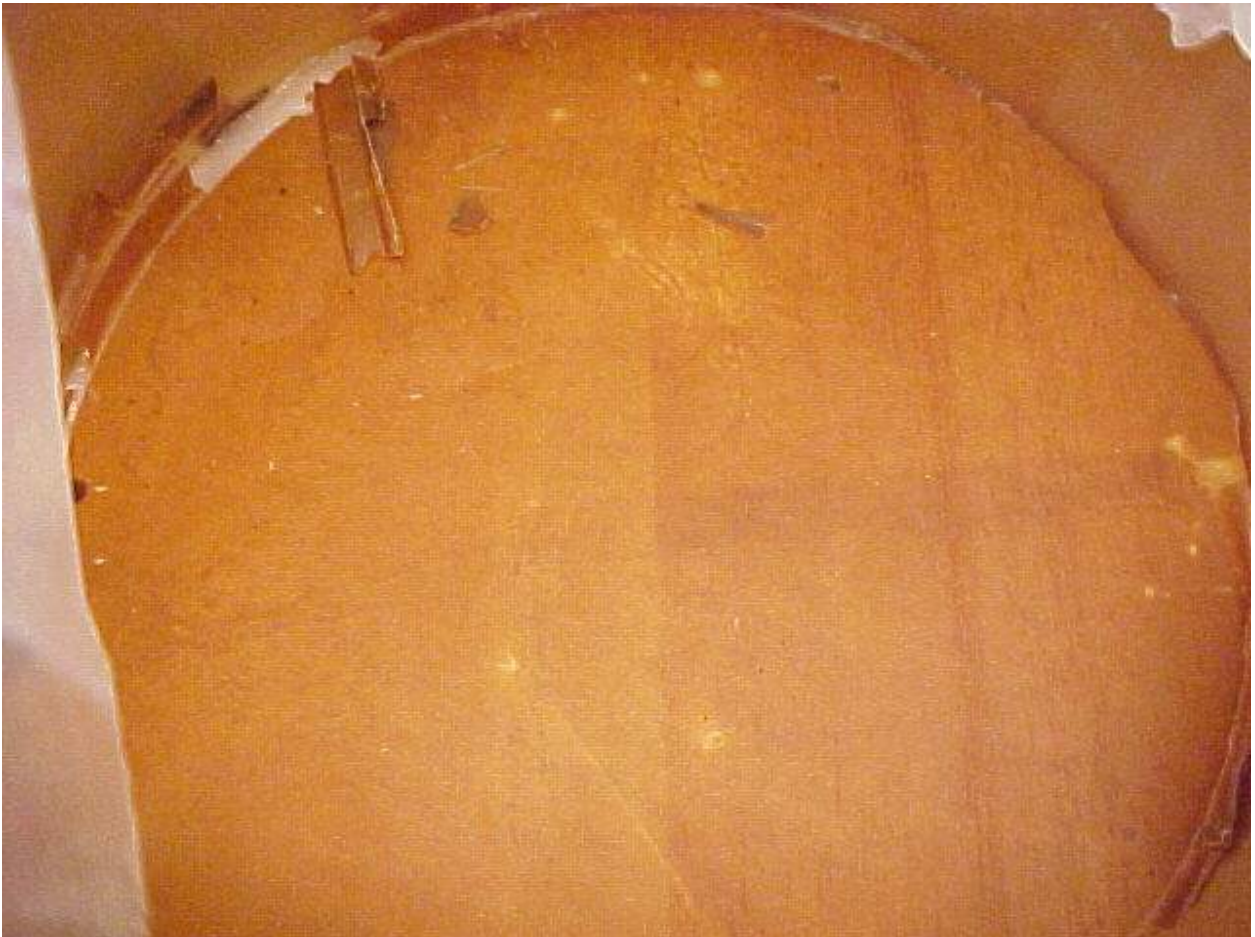
Fiber/Lab-pack drum lid – fair condition
No gases present in the breathing zone.

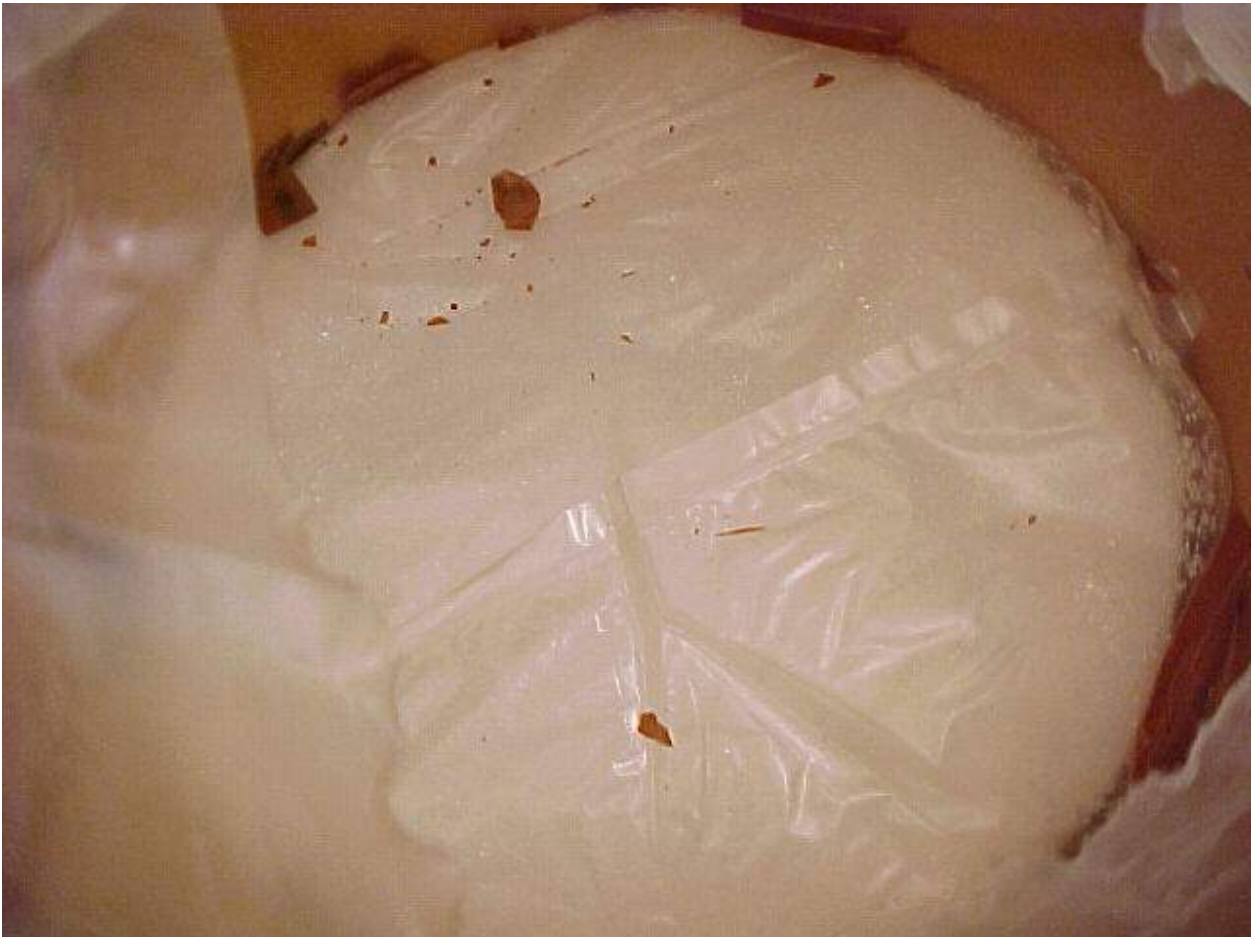
4th poly liner/bag – good condition
No gases present in the breathing zone.

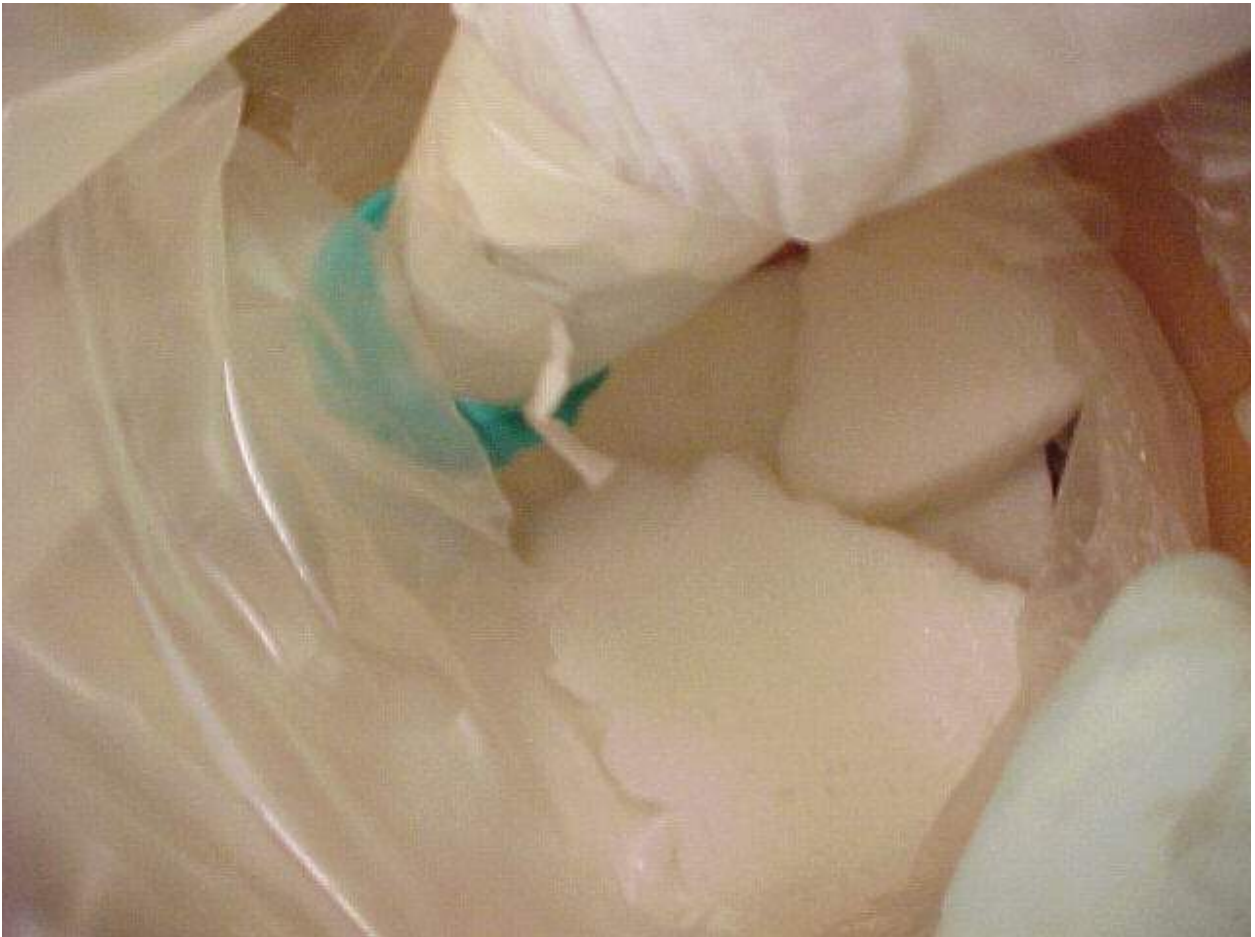
ThN material – monolith – white – solid - dry
No gases present in the breathing zone.

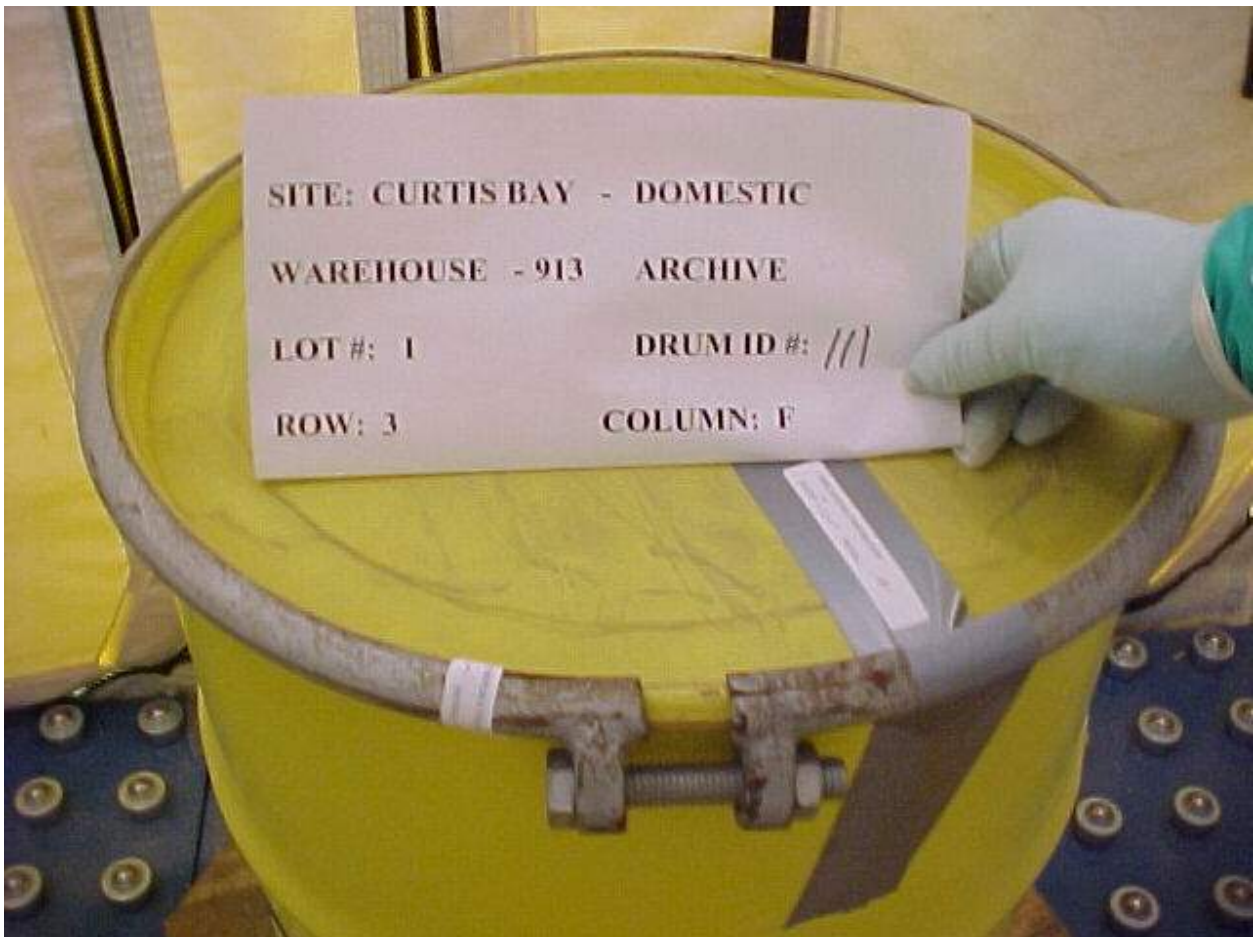
Sealed & dated - Complete

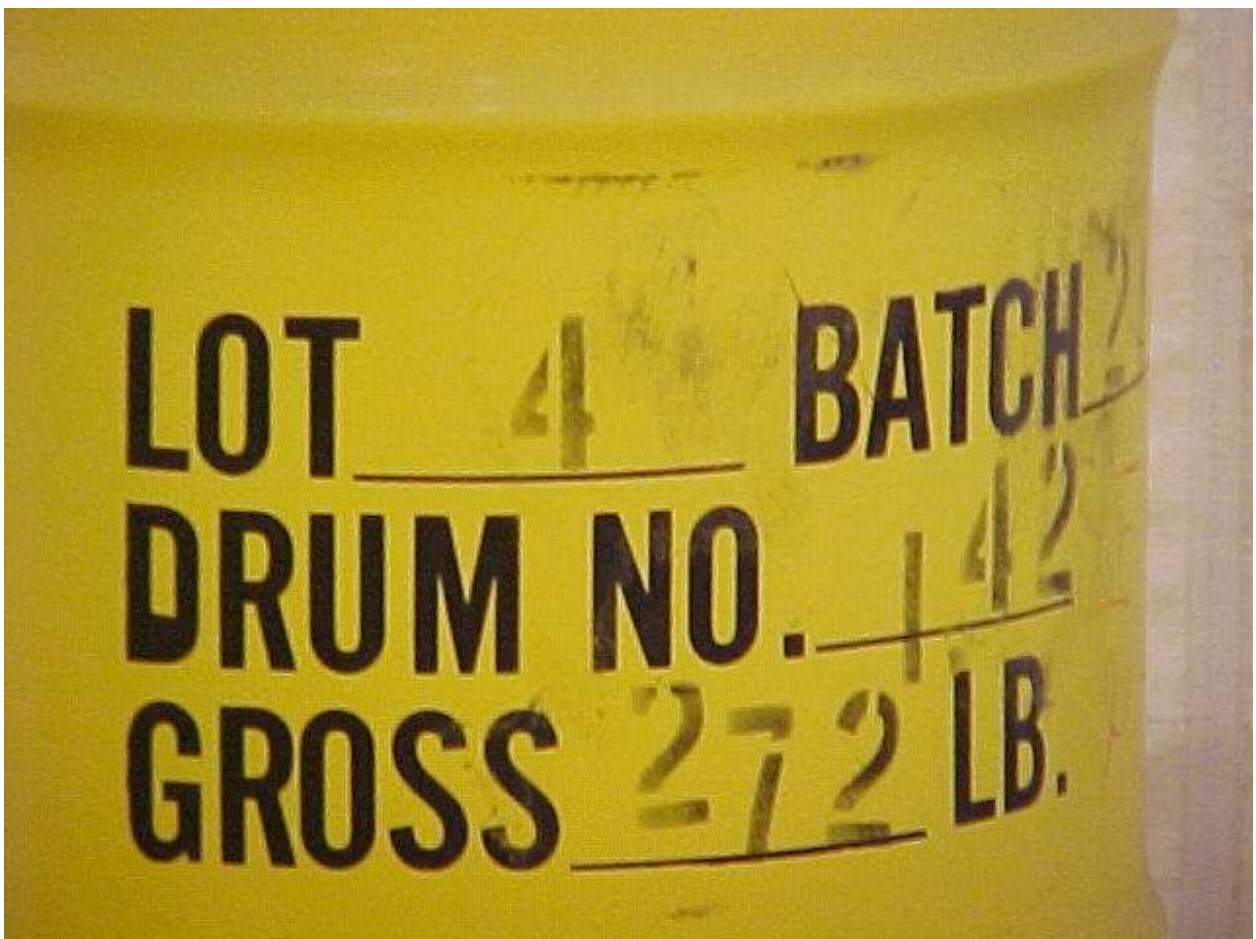
30-gal drum – good condition

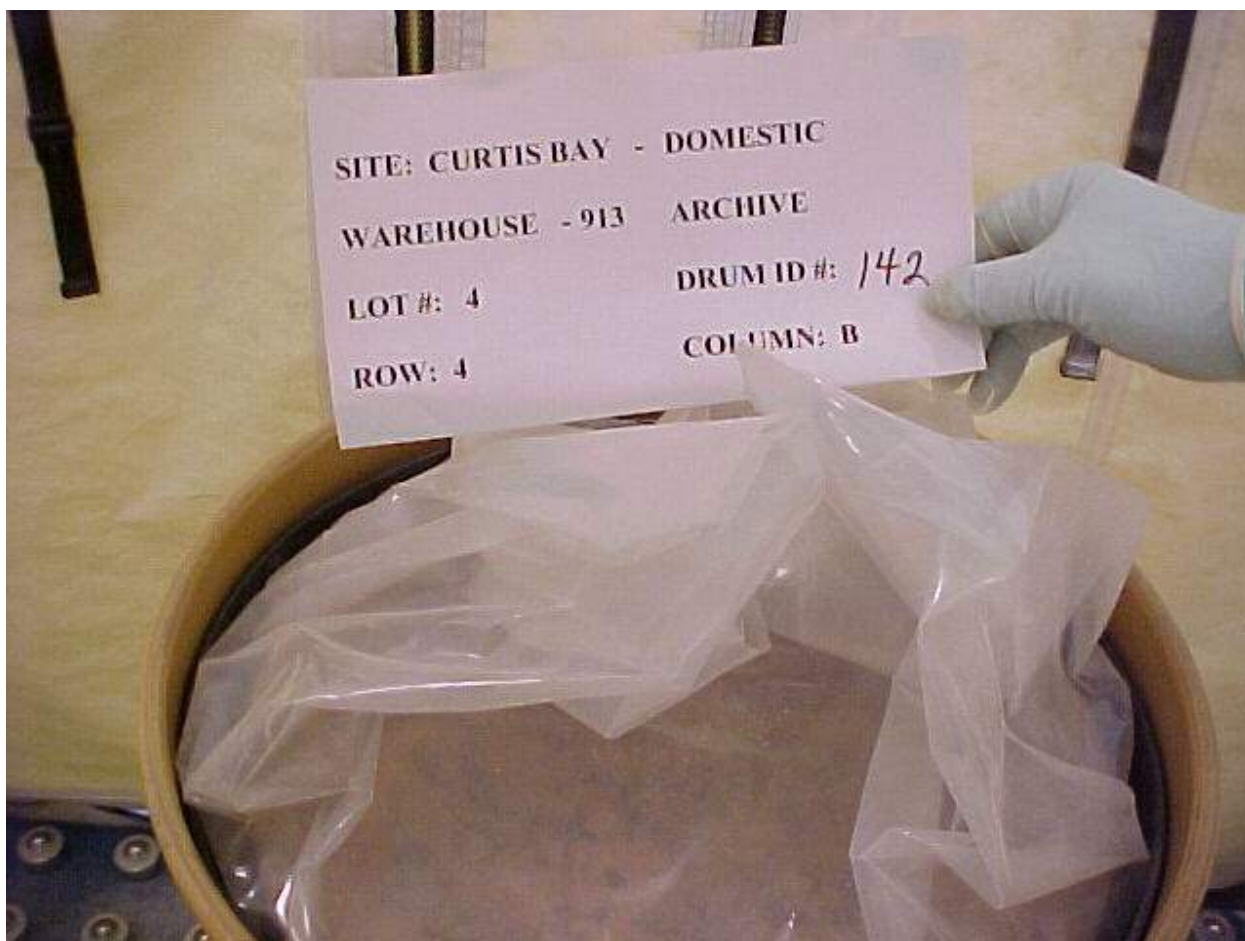
1st poly liner/bag – good condition
No gases present in the breathing zone.

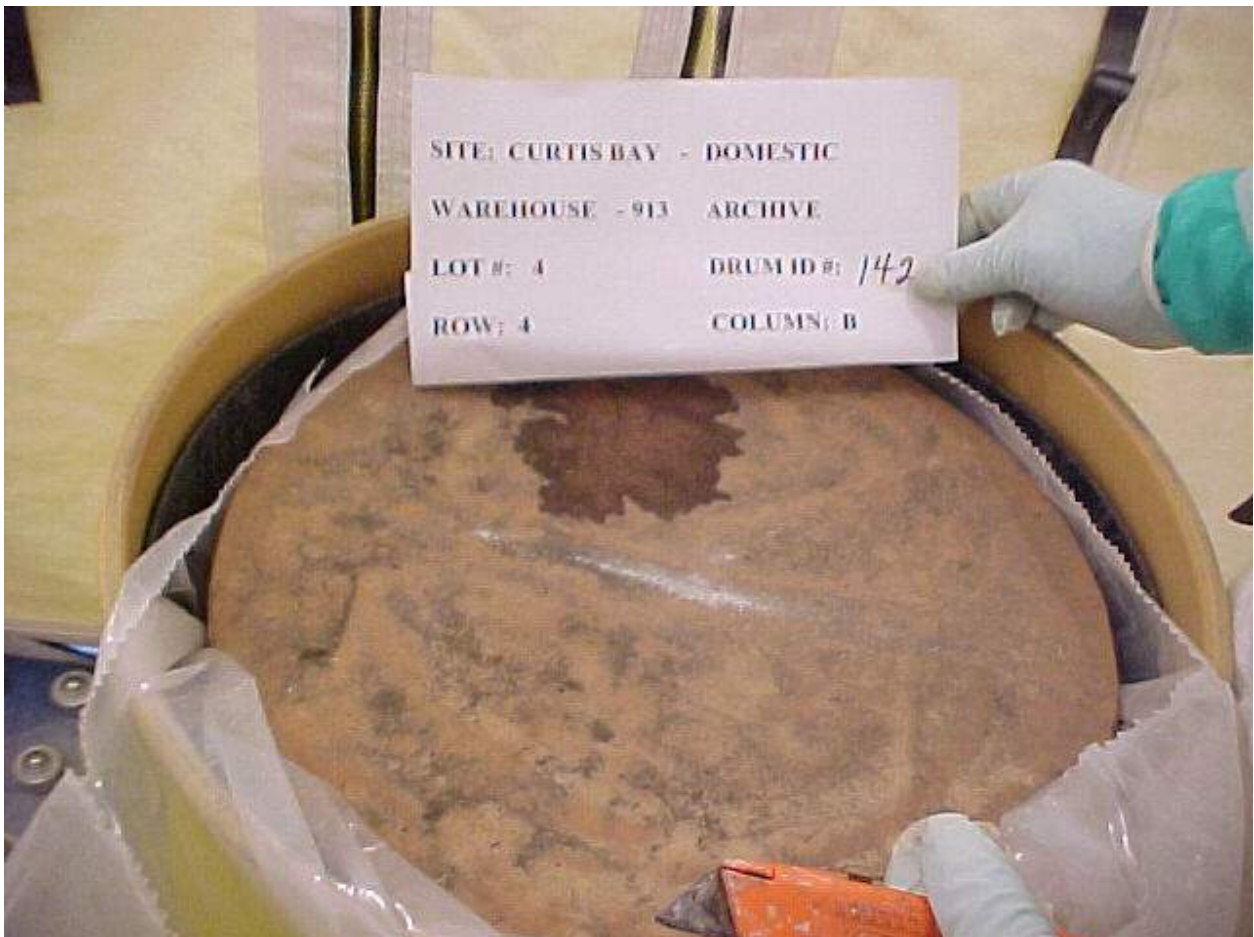
14:30**Other Information**Photo No. 3 of 9Dose Rate Surface 22 mR/hr
 1 meter 2.6 mR/hr

Fiber drum lid – good condition
No gases present in the breathing zone.
