THORIUM NITRATE STOCKPILE DRUM CHARACTERIZATION REPORT

**THORIUM NITRATE STOCKPILE
DRUM CHARACTERIZATION REPORT**

Prepared for
U.S. Defense Logistics Agency
Defense National Stockpile Center
Fort Belvoir, Virginia

Prepared by
OAK RIDGE NATIONAL LABORATORY
Oak Ridge, Tennessee 37831
managed by
UT-BATTELLE, LLC
for the
U.S. DEPARTMENT OF ENERGY
under contract DE-AC05-00OR22725

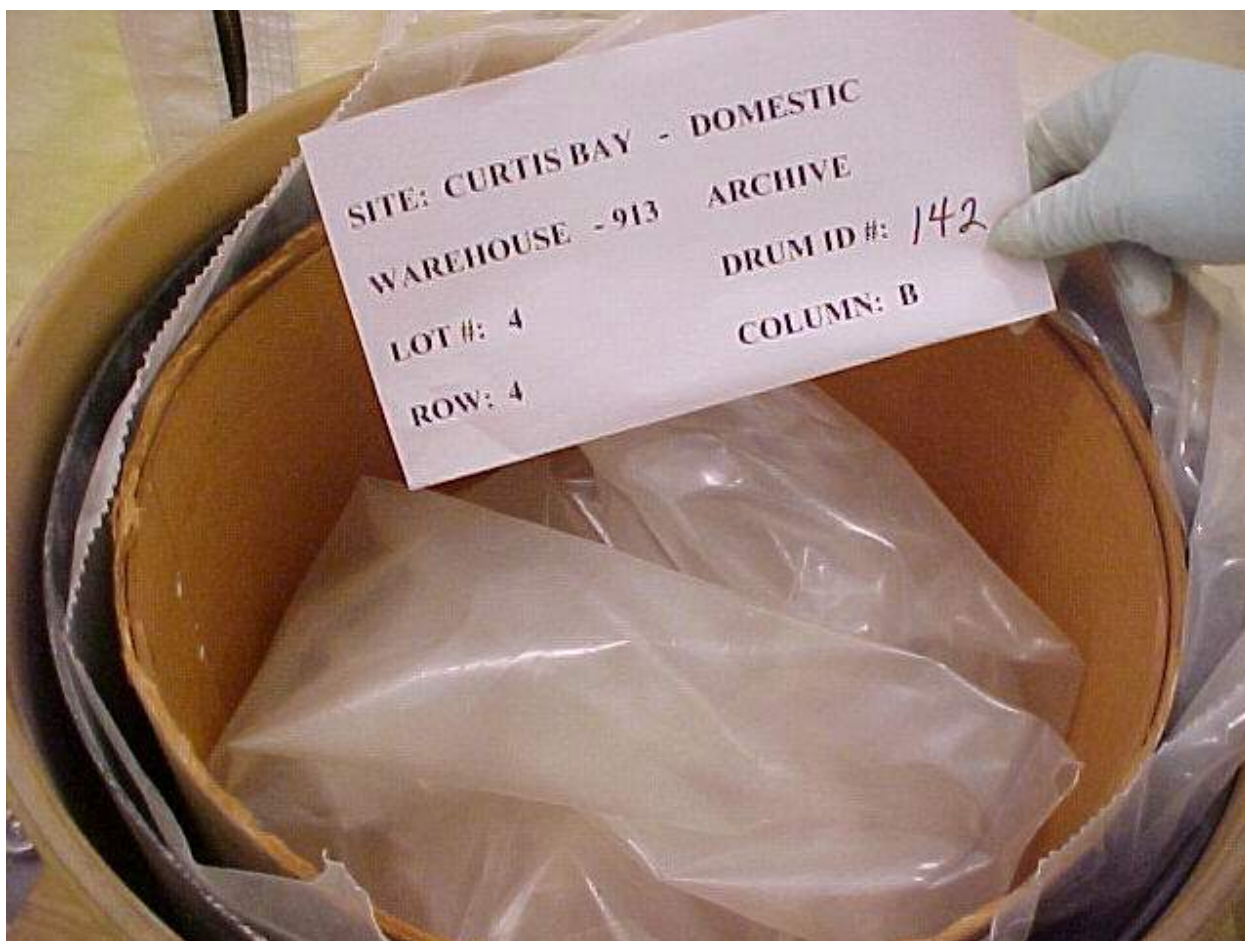
2nd poly liner/bag – good condition
No gases present in the breathing zone

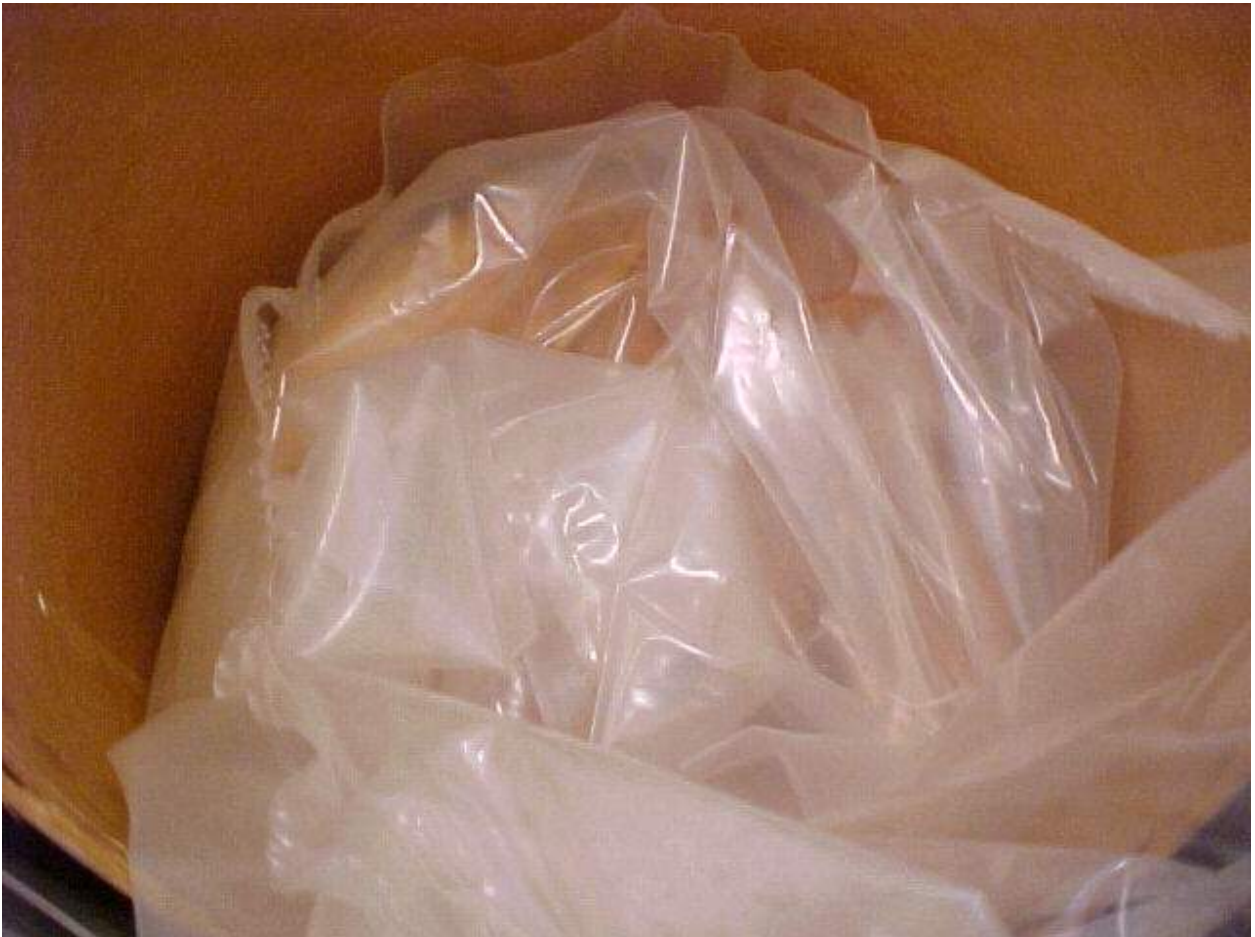
14:30**Other Information**Photo No. 5 of 9Dose Rate Surface 22 mR/hr
 1 meter 2.6 mR/hr

3rd poly liner/bag – good condition
No gases present in the breathing zone.

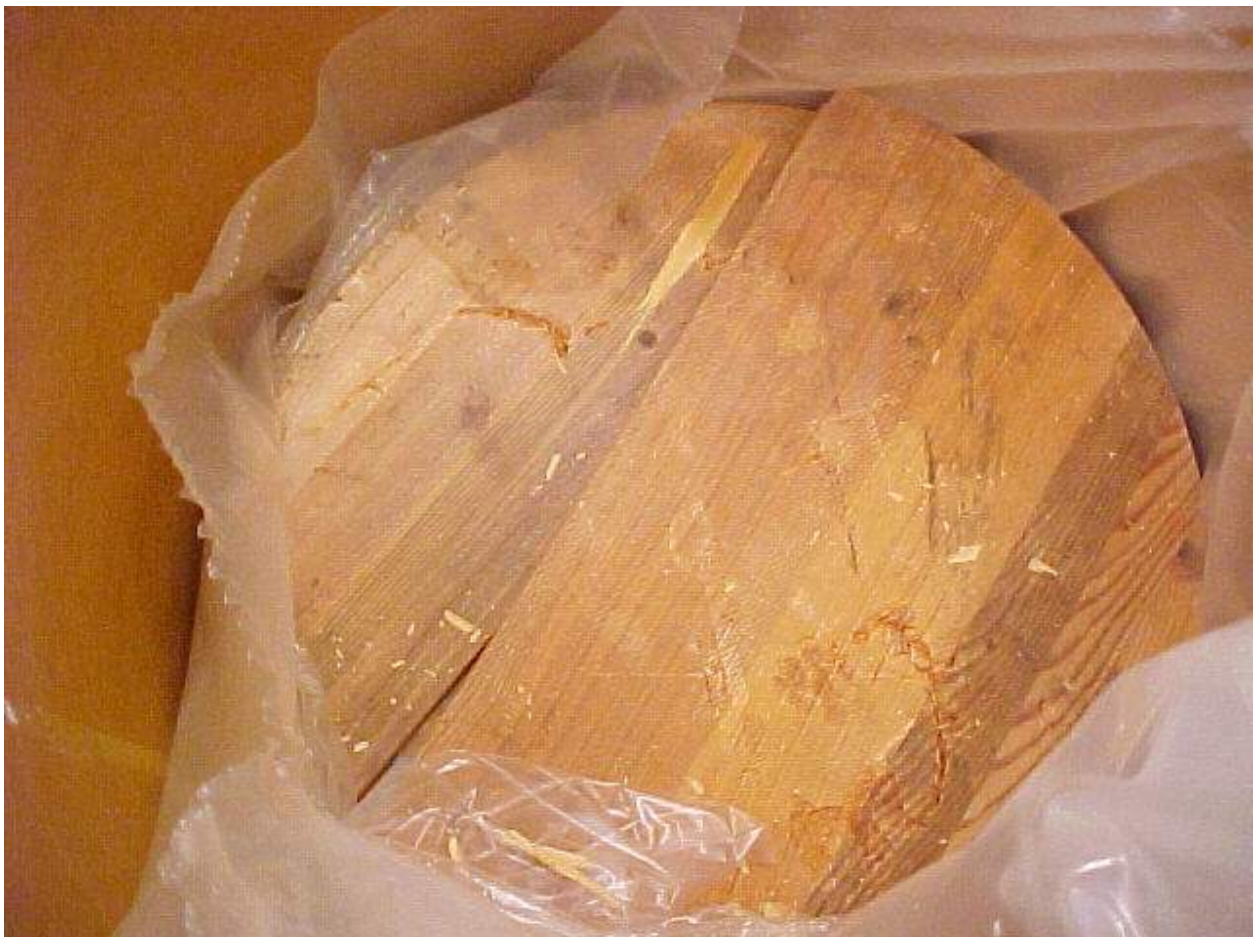
Wooden lid – good condition
No gases present in the breathing zone.

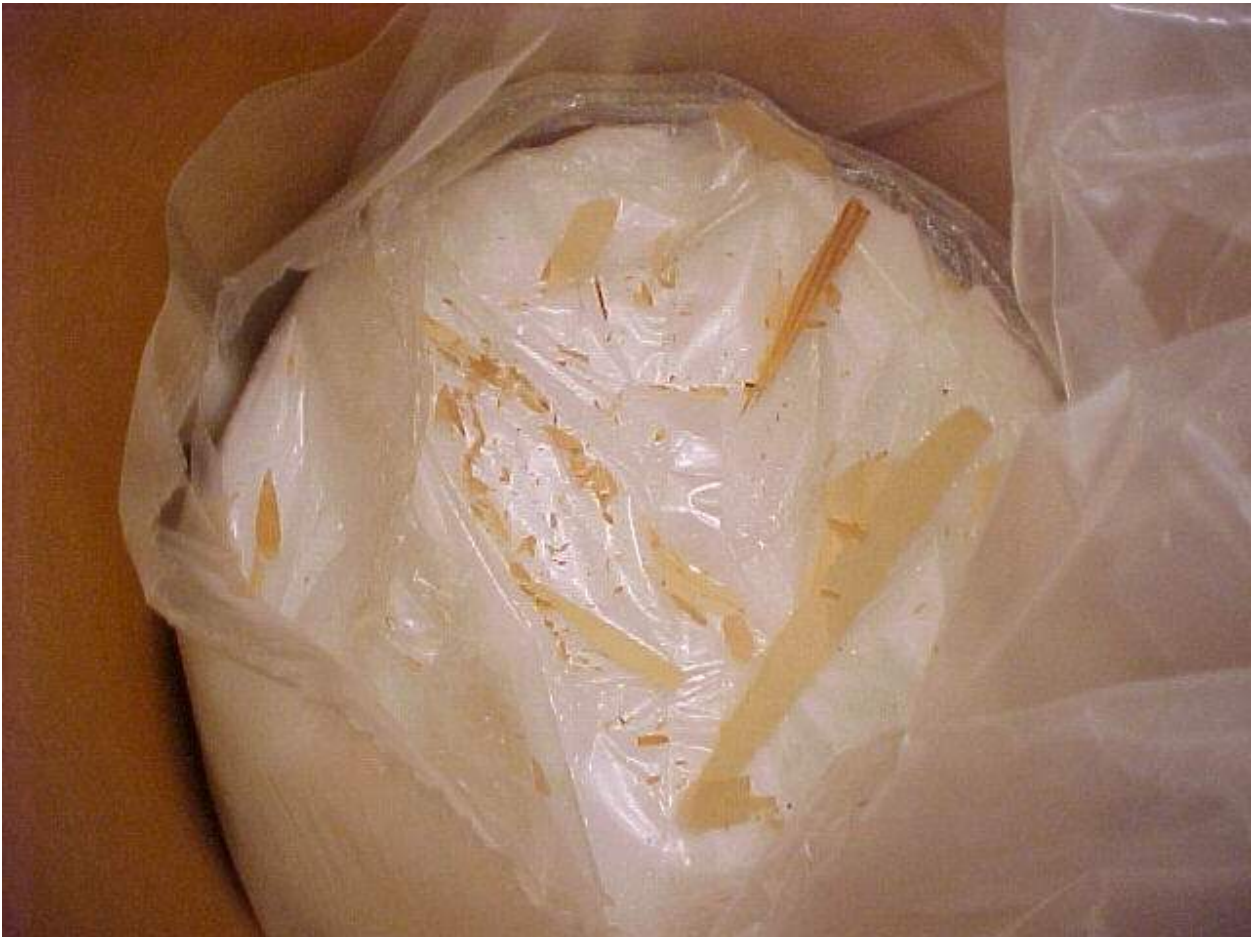
14:30**Other Information**Photo No. 7 of 9Dose Rate Surface 22 mR/hr
 1 meter 2.6 mR/hr

4th poly liner/bag – good condition
No gases present in the breathing zone.

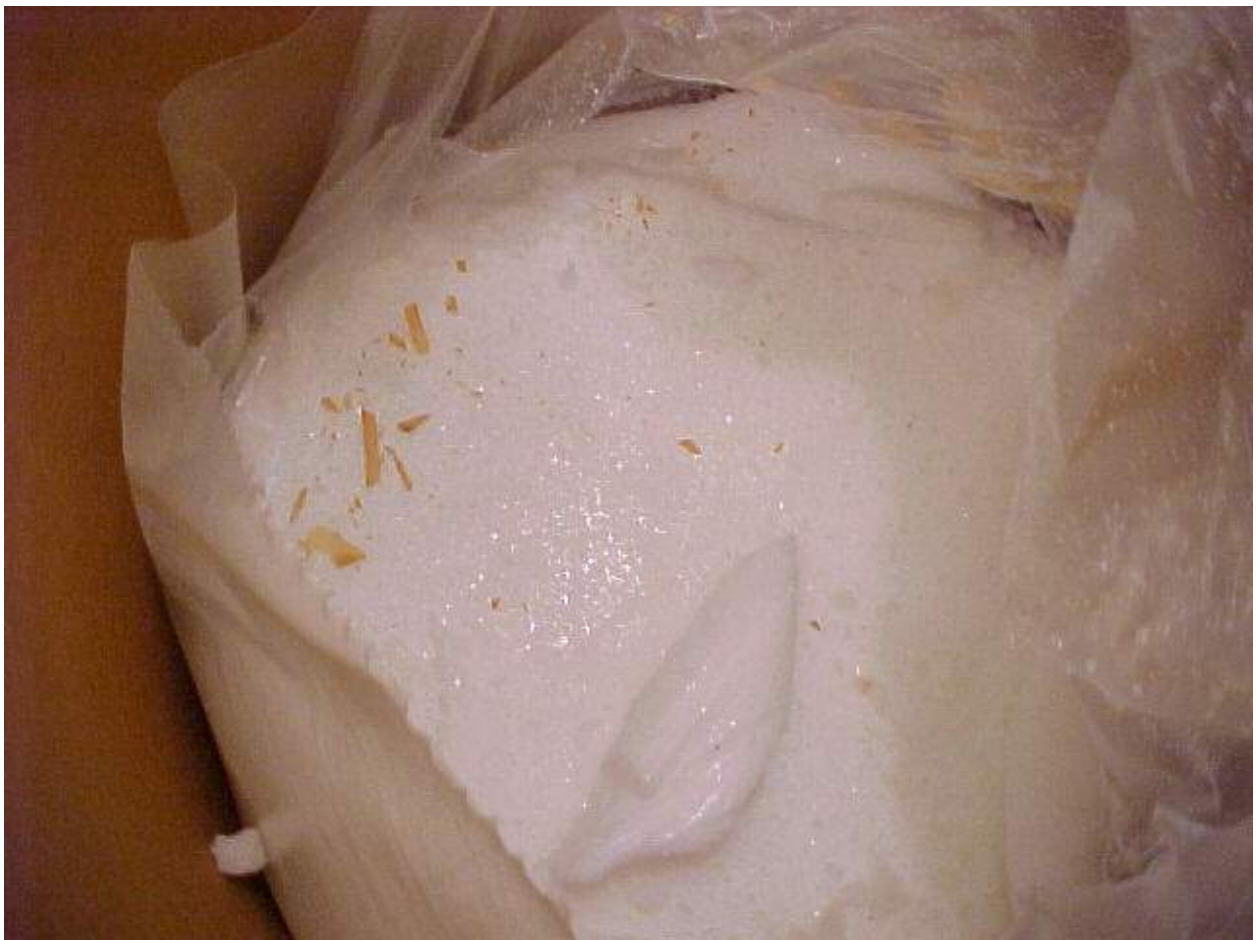
ThN material – monolith – white – solid – dry
No gases present in the breathing zone.

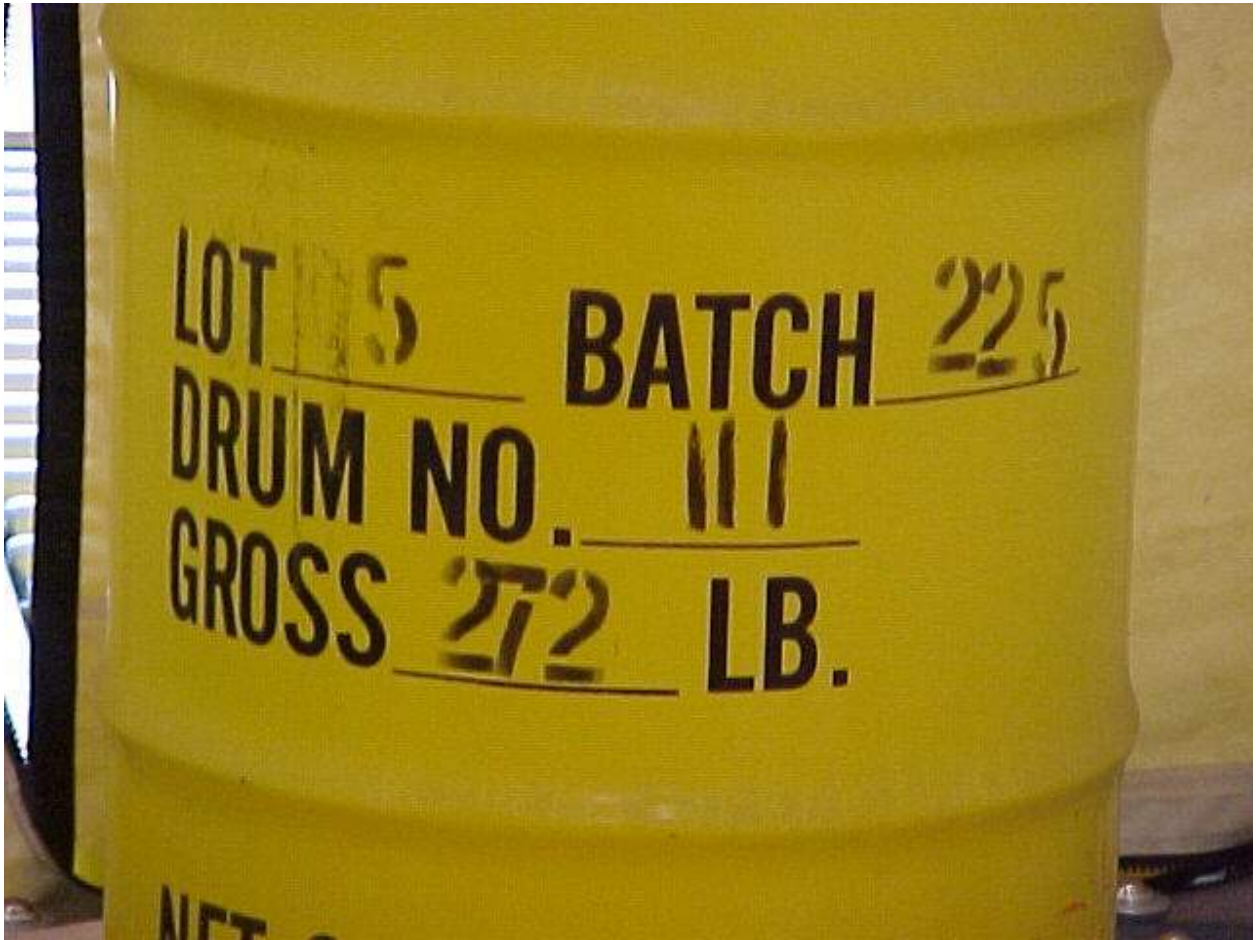
30-gal drum – good condition

Drum vented gases during drum ring removal operations (drum did not have any pressure buildup internal to the container)

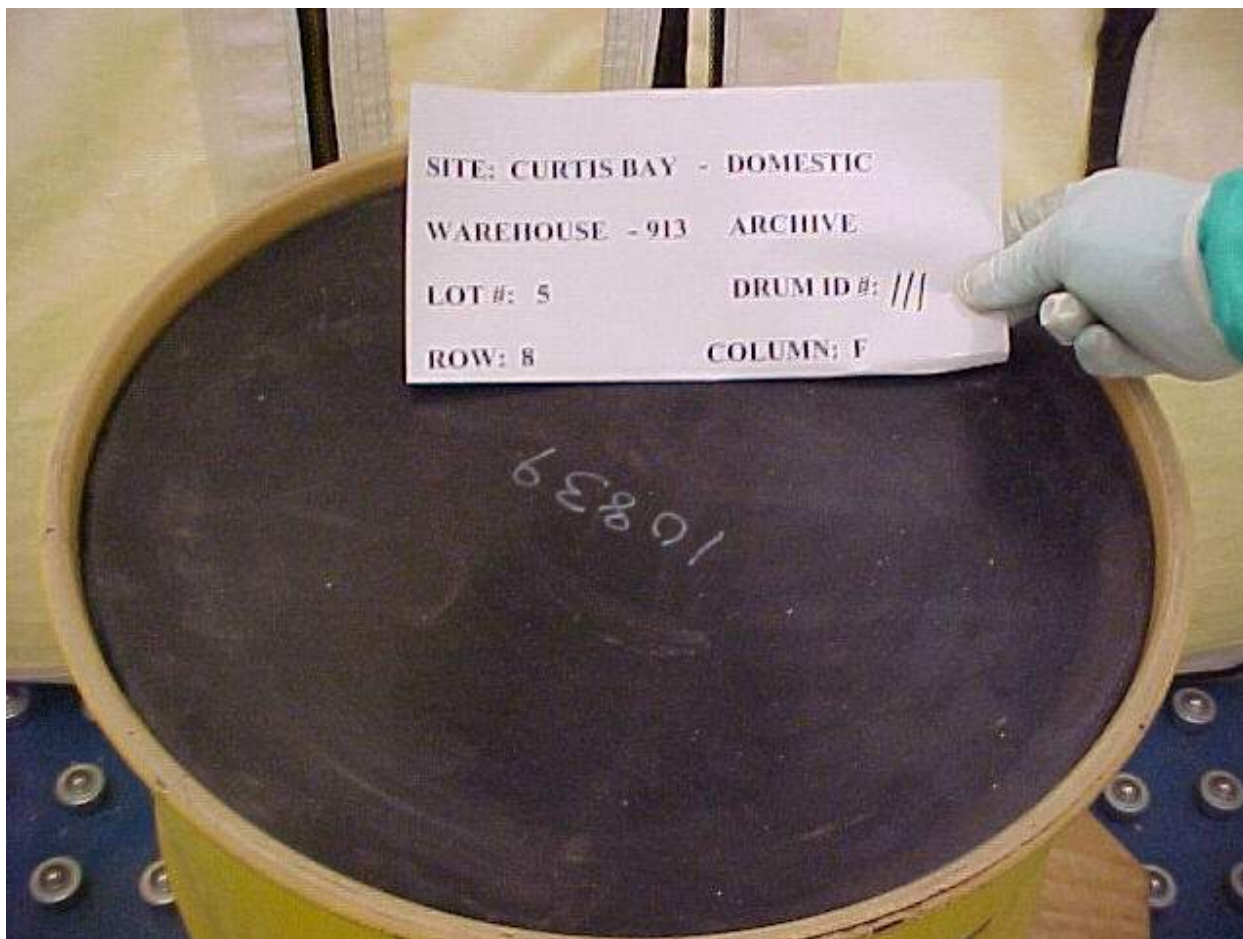
Black plastic lid – good condition
No gases present in the breathing zone.

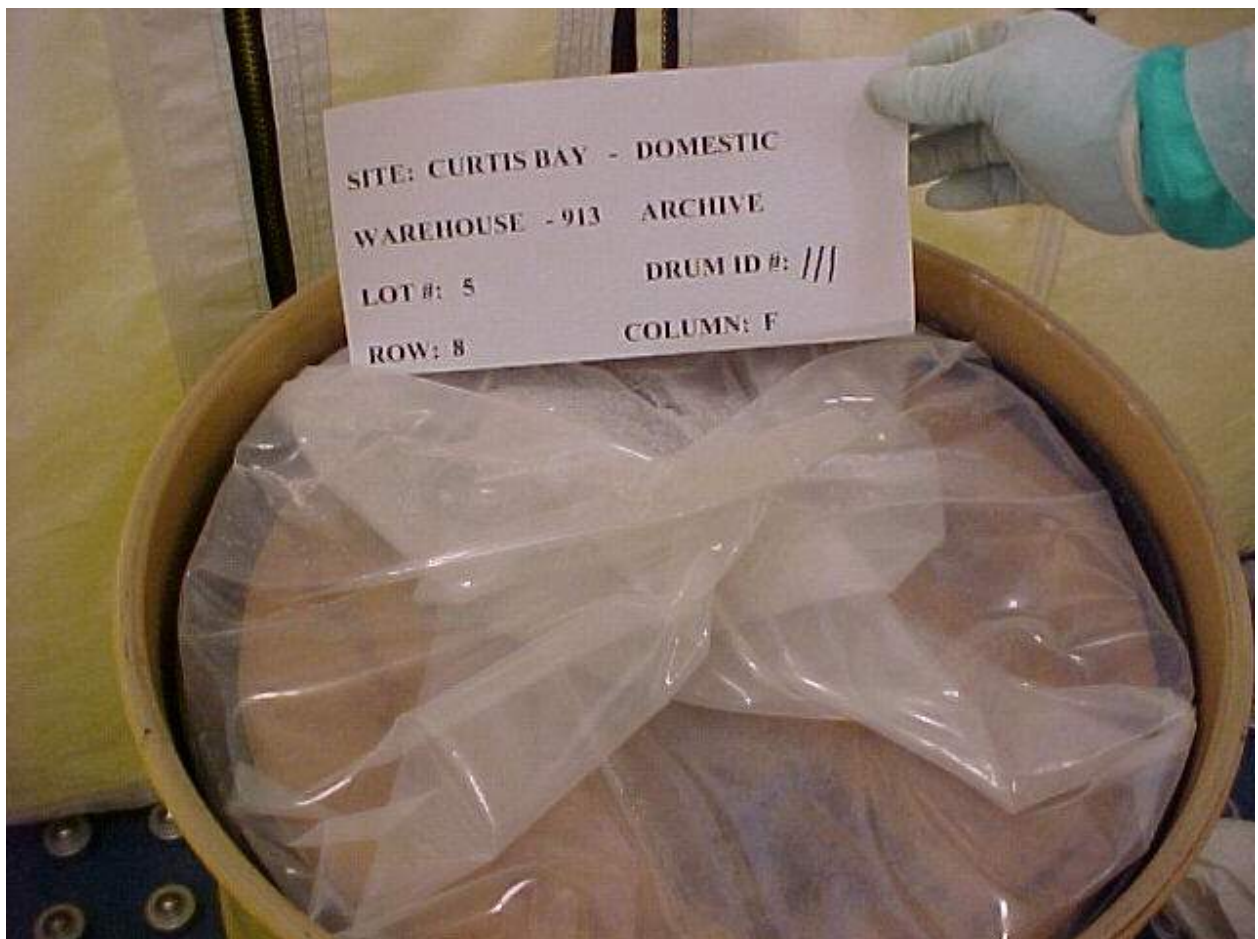
13:45**Other Information**Photo No. 3 of 9Dose Rate Surface 22 mR/hr
 1 meter 2.6 mR/hr

1st poly liner/bag – good condition
No gases present in the breathing zone

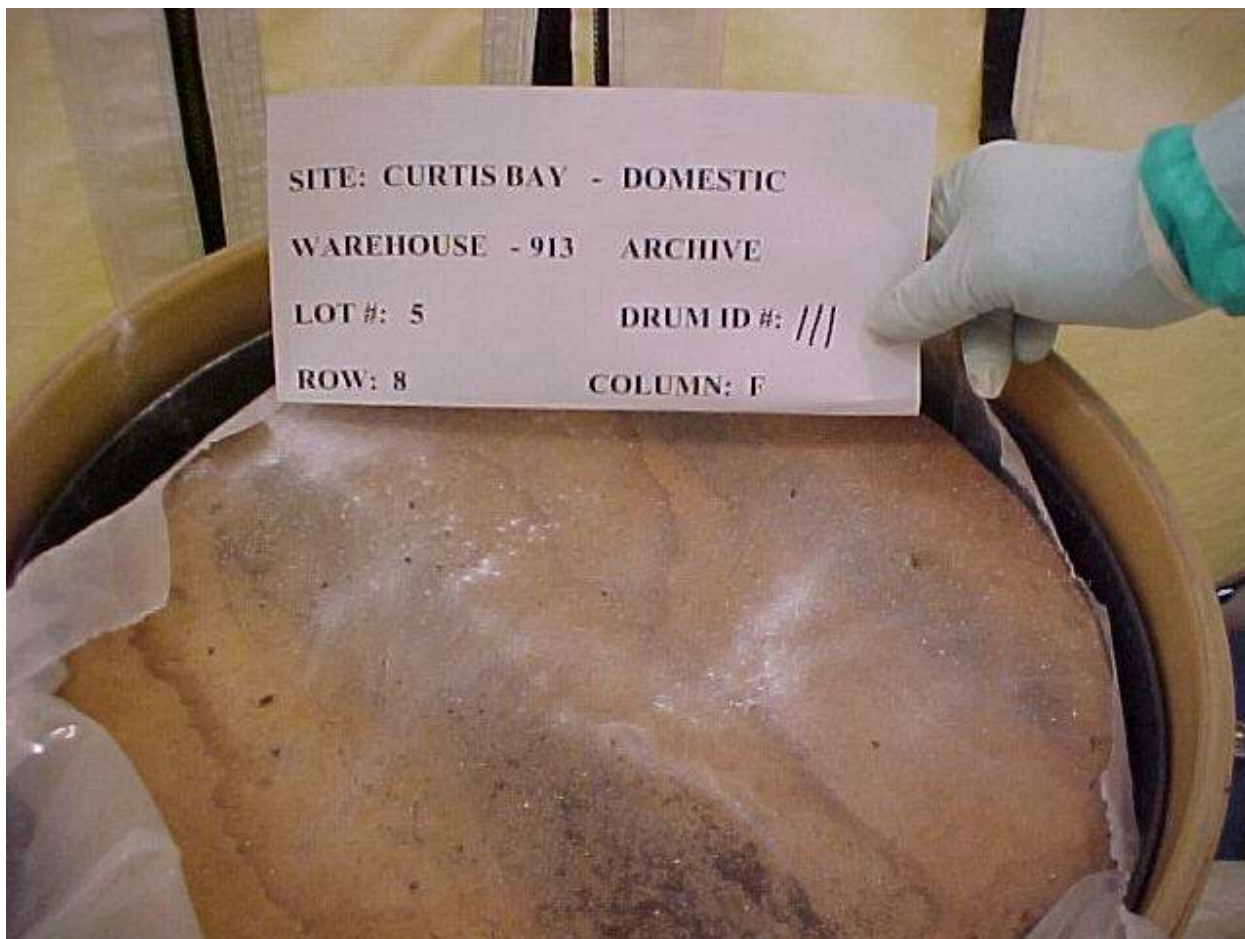
Fiber drum lid (outermost fiber drum) – good condition
No gases present in the breathing zone.

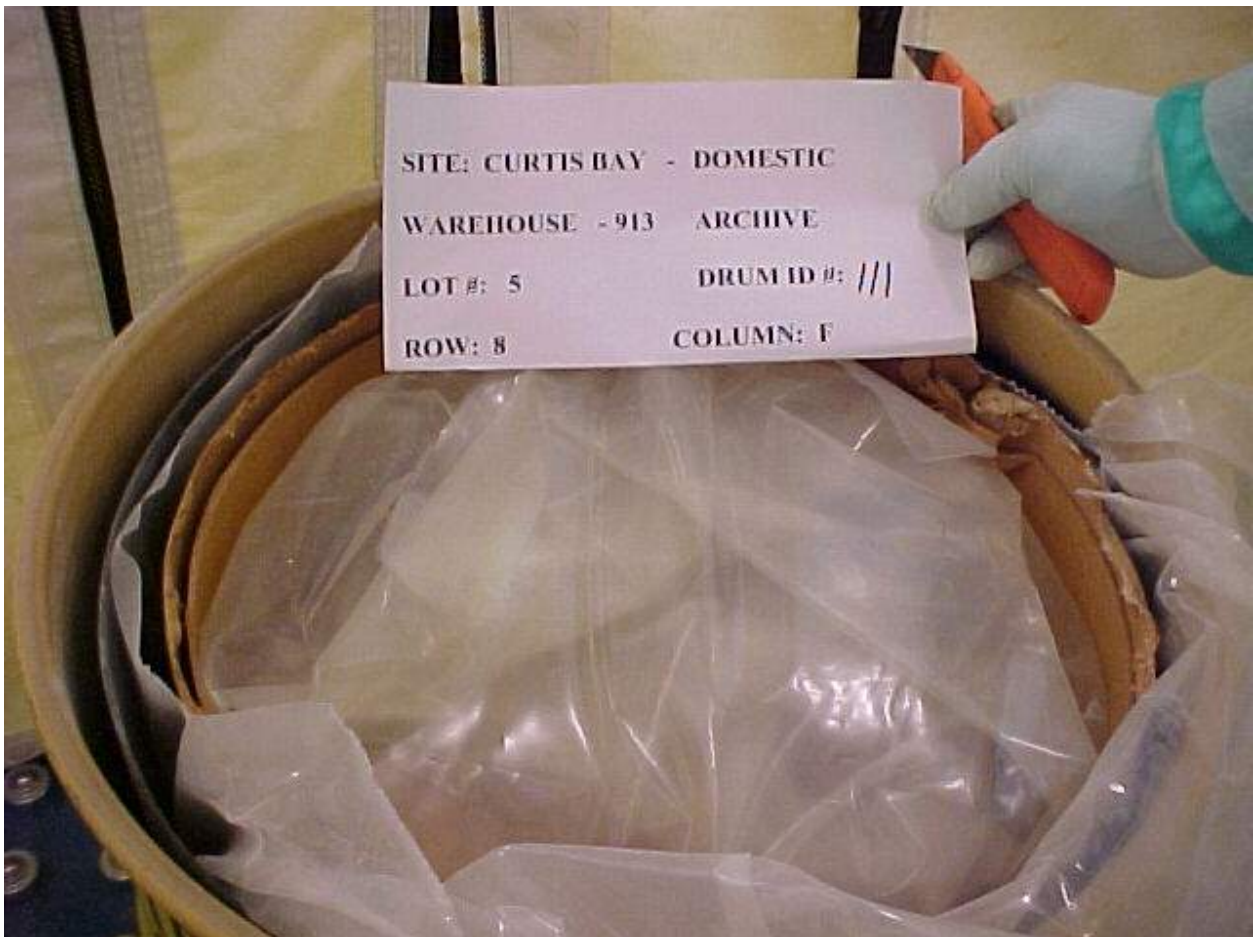
13:45**Other Information**Photo No. 5 of 9Dose Rate Surface 22 mR/hr
 1 meter 2.6 mR/hr

2nd poly liner/bag – good condition
No gases present in the breathing zone.

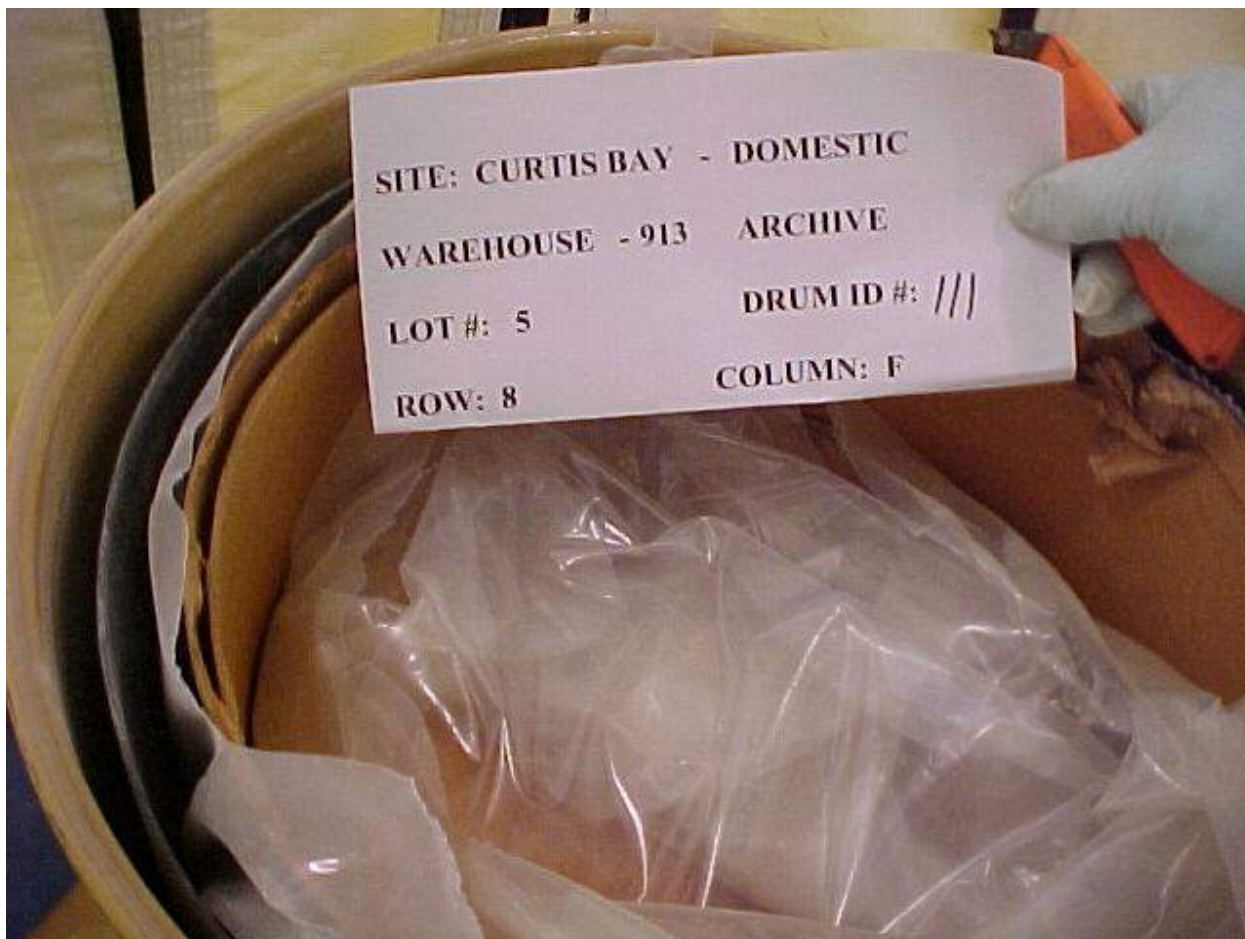
3rd poly liner/bag – good condition
No gases present in the breathing zone.

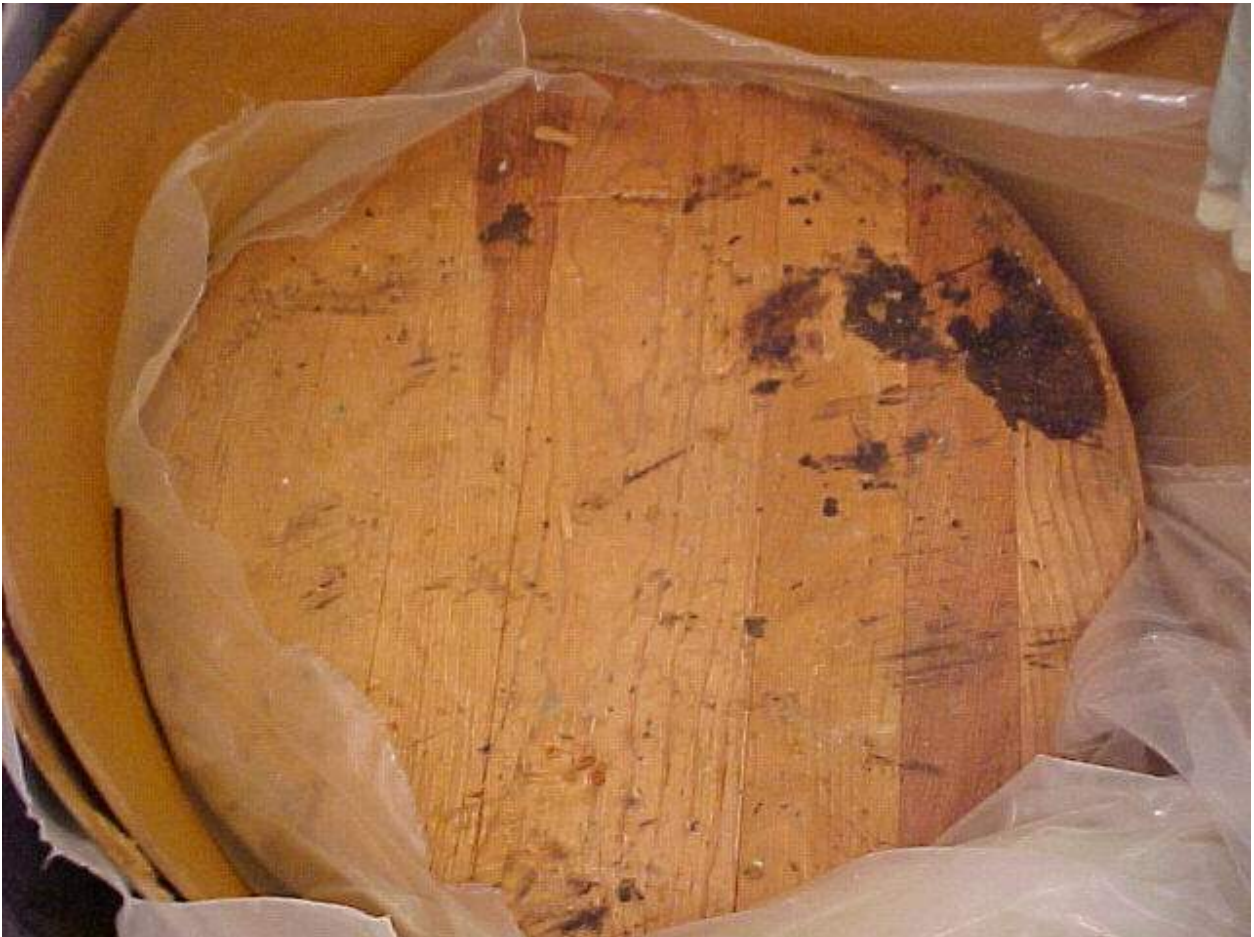
Wooden lid – good condition
 No gases present in the breathing zone.

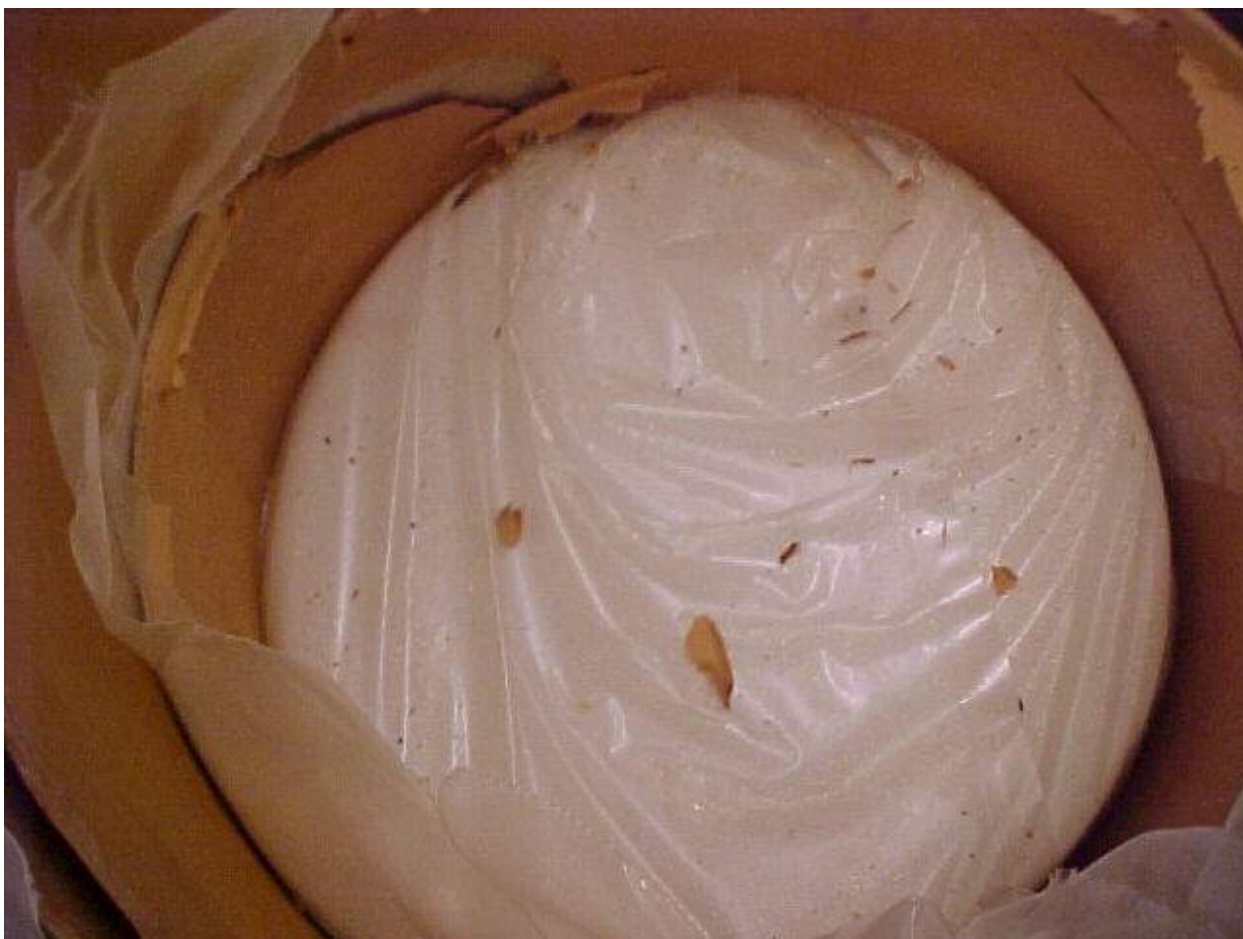
4th poly liner/bag – good condition – photo also shows interior walls of inner lab-pack/fiber drum.
No gases present in the breathing zone.

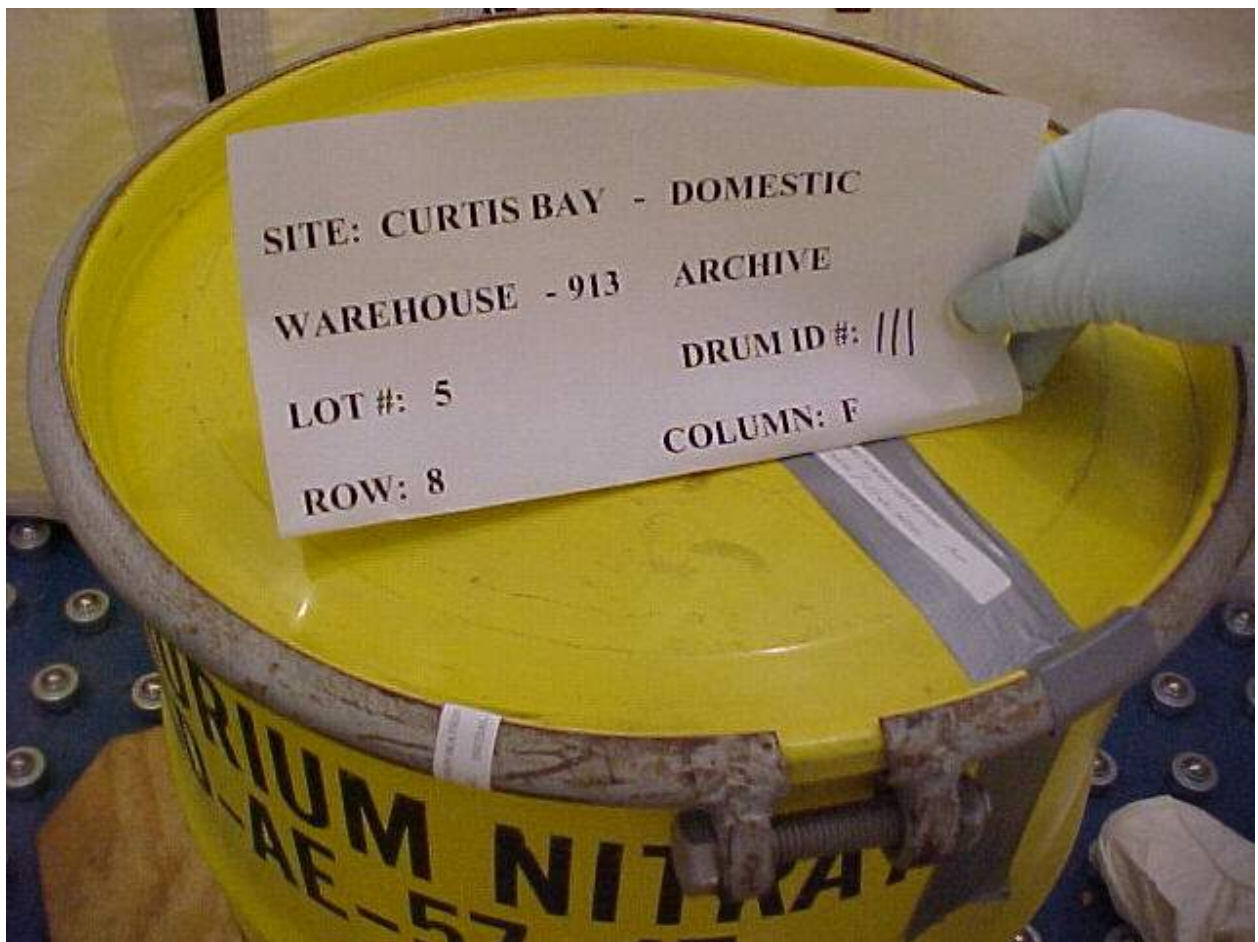
13:45**Other Information**Photo No. 9 of 9Dose Rate Surface 22 mR/hr
 1 meter 2.6 mR/hr

Sealed & dated – Complete

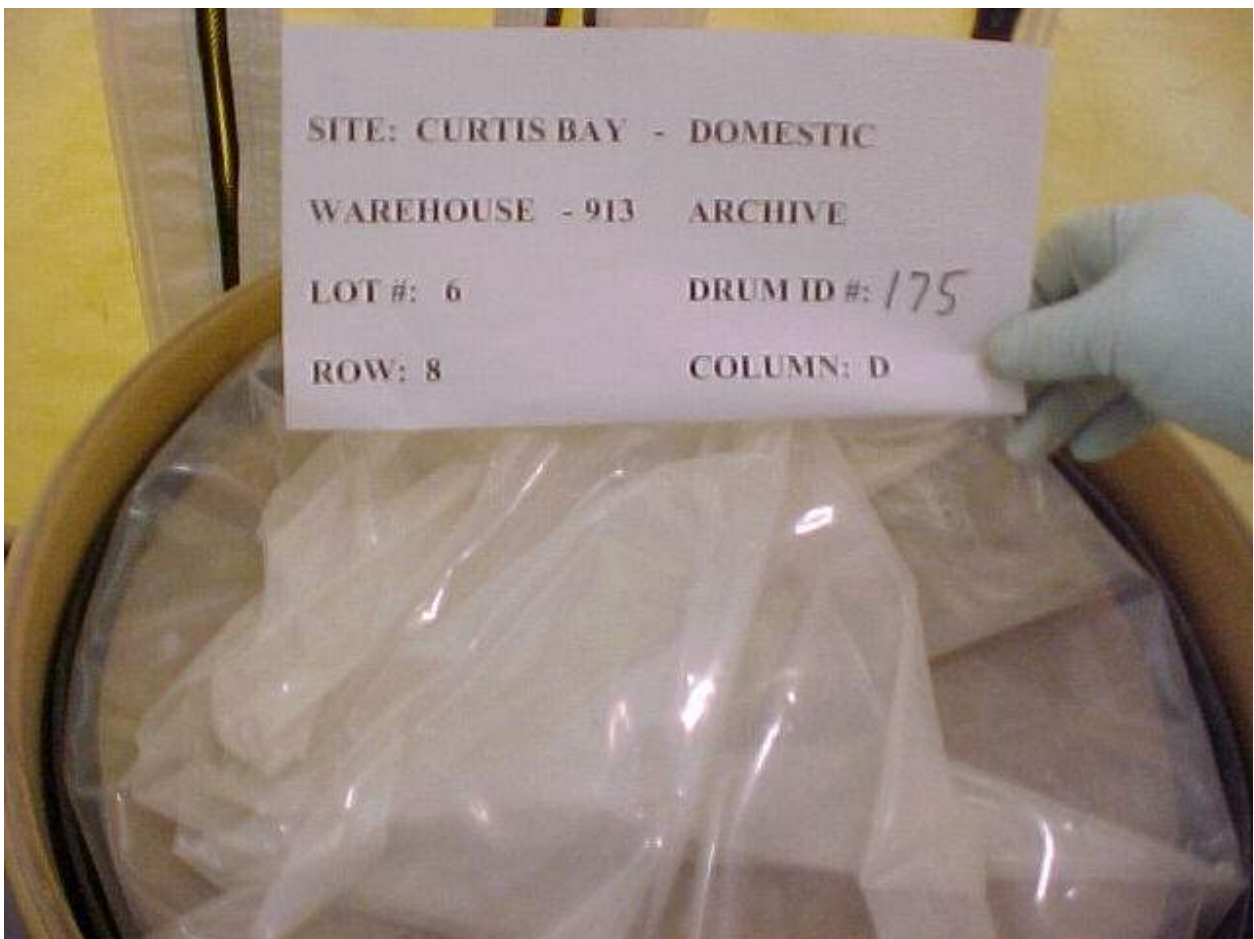
10:00**Other Information**Photo No. 3 of 10Dose Rate Surface 22 mR/hr
 1 meter 2.6 mR/hr

1st poly liner/bag – good condition
No gases present in the breathing zone

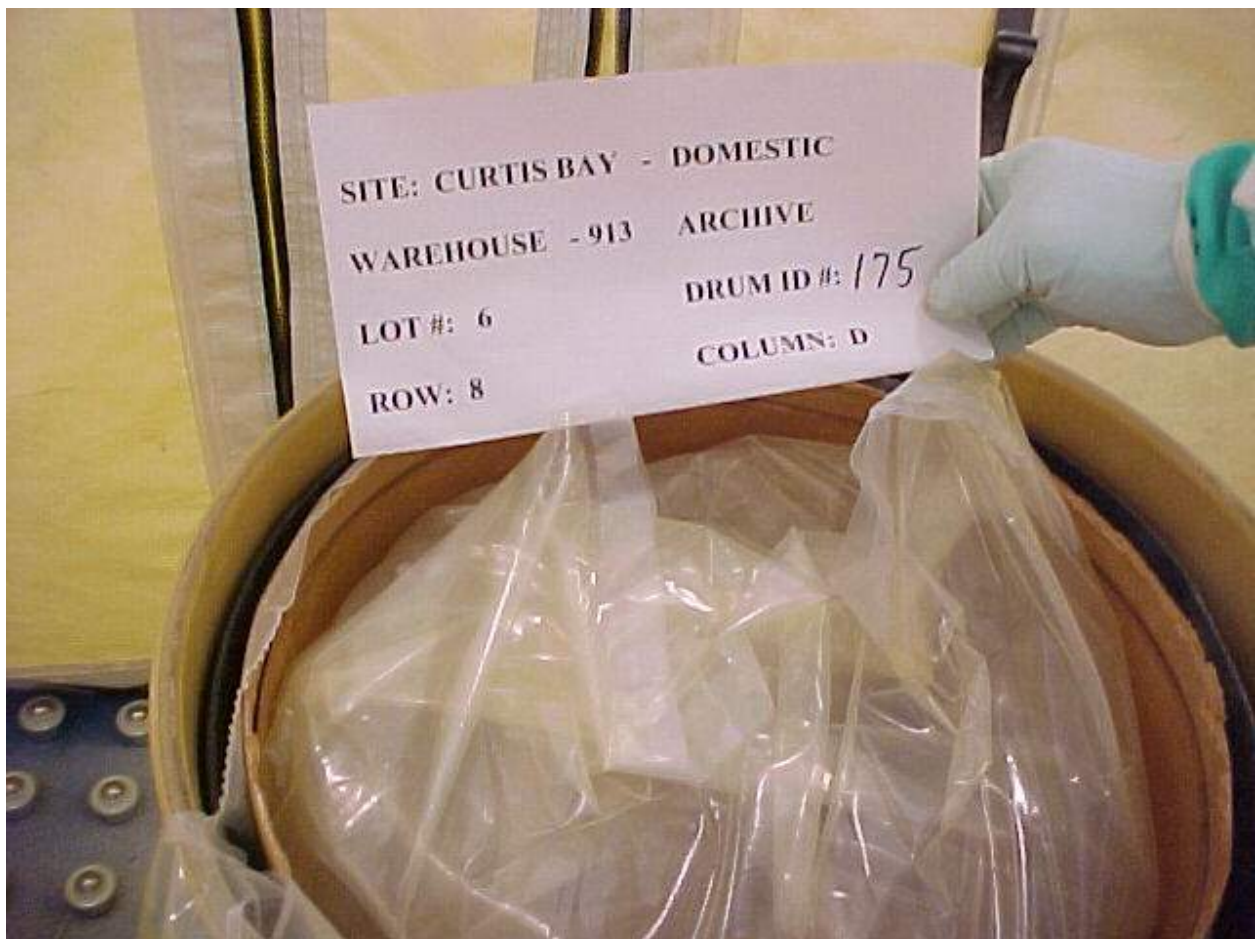
2nd poly liner/bag – good condition
 No gases present in the breathing zone

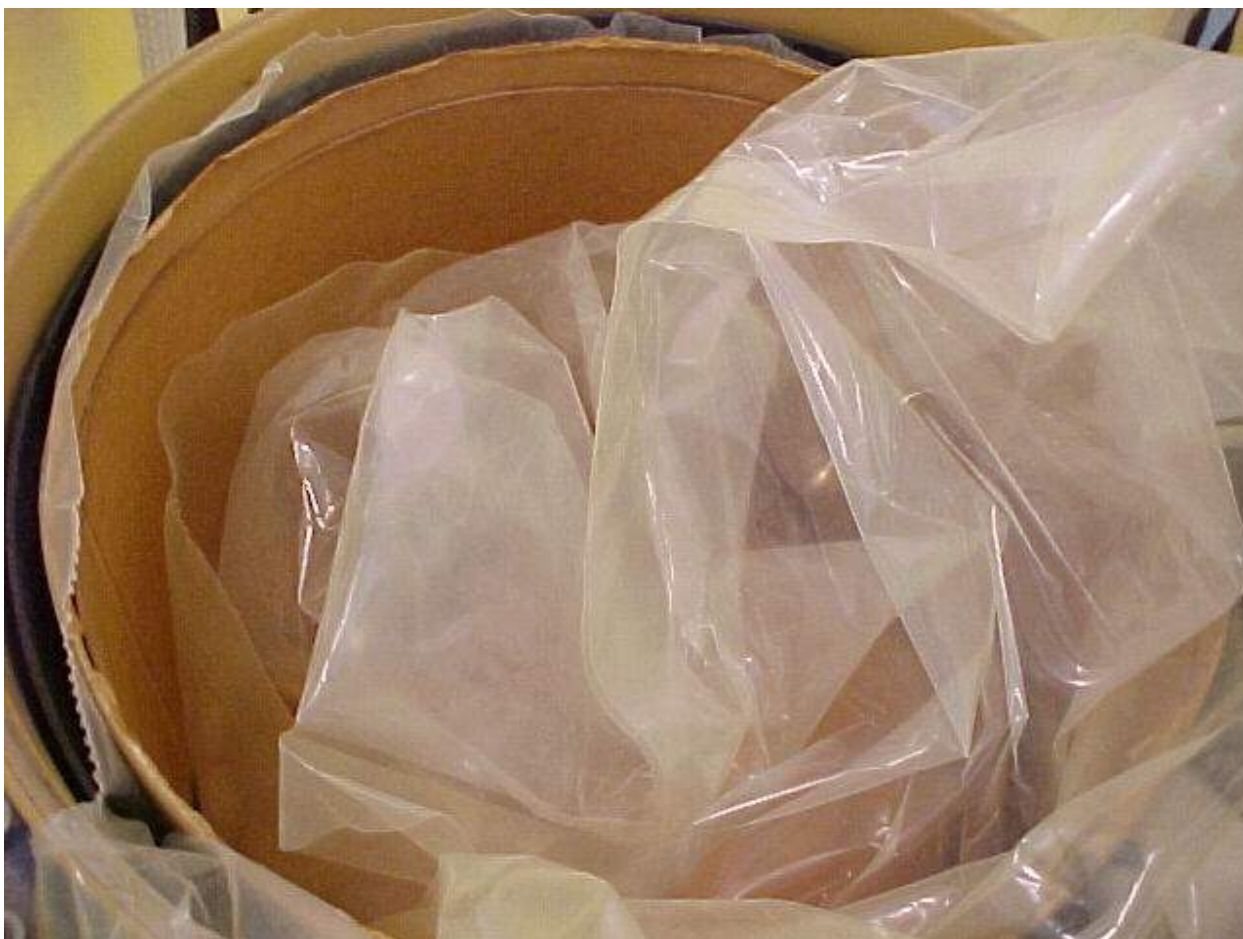
3rd poly liner/bag – good condition
No gases present in the breathing zone.

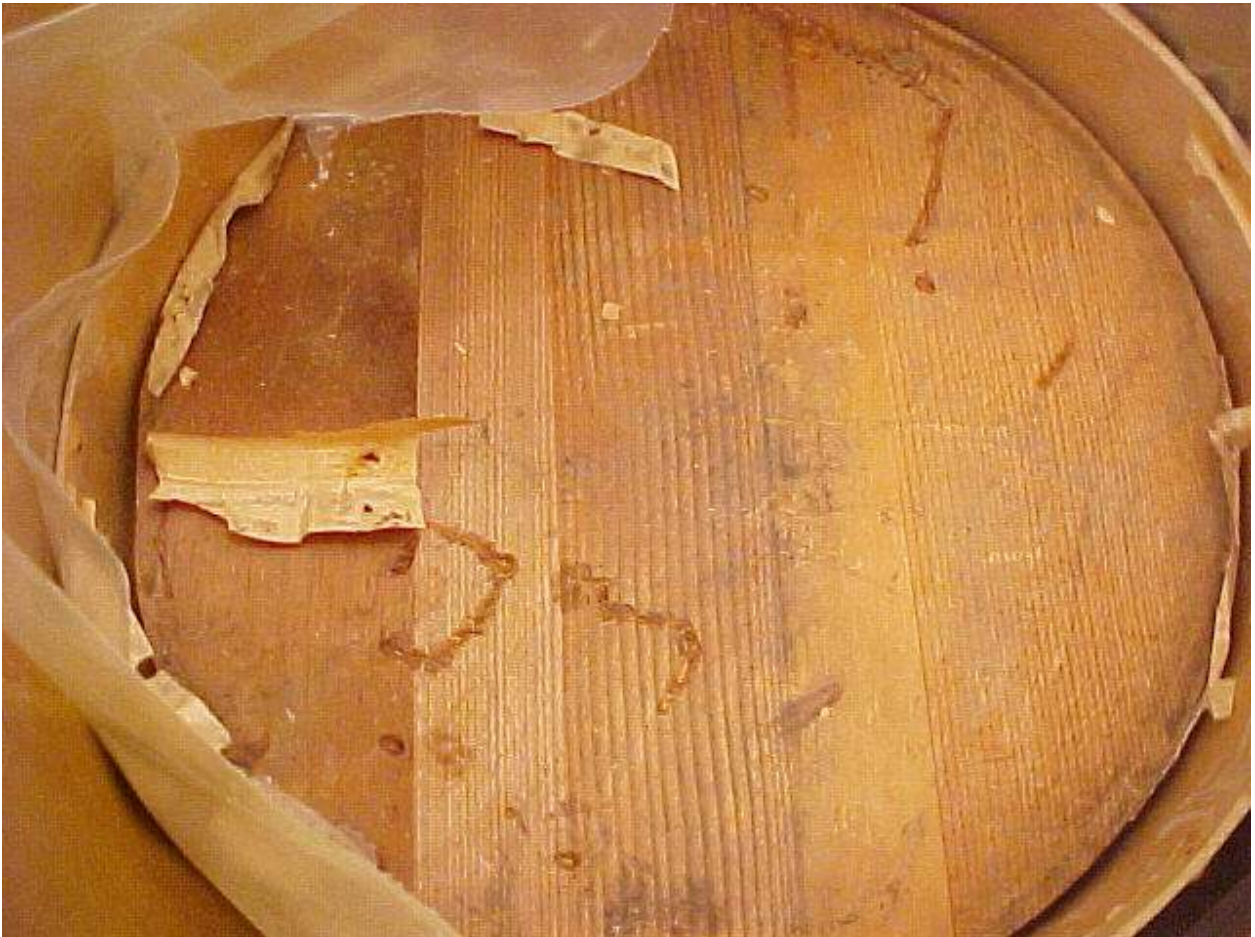
Wooden lid – good condition
No gases present in the breathing zone.

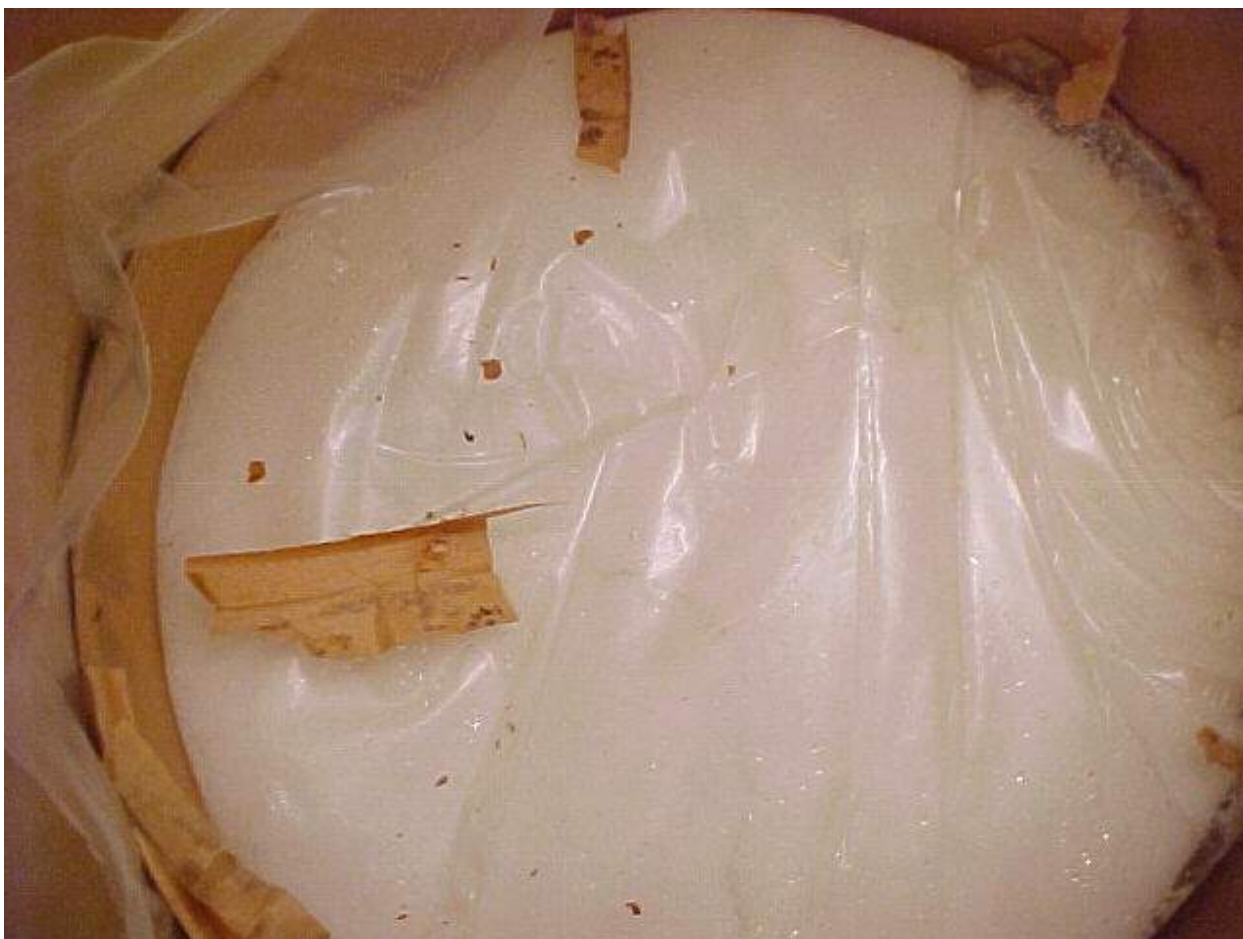
4th poly liner/bag – good condition
No gases present in the breathing zone.
