THORIUM NITRATE STOCKPILE DRUM CHARACTERIZATION REPORT

**THORIUM NITRATE STOCKPILE
DRUM CHARACTERIZATION REPORT**

Prepared for
U.S. Defense Logistics Agency
Defense National Stockpile Center
Fort Belvoir, Virginia

Prepared by
OAK RIDGE NATIONAL LABORATORY
Oak Ridge, Tennessee 37831
managed by
UT-BATTELLE, LLC
for the
U.S. DEPARTMENT OF ENERGY
under contract DE-AC05-00OR22725

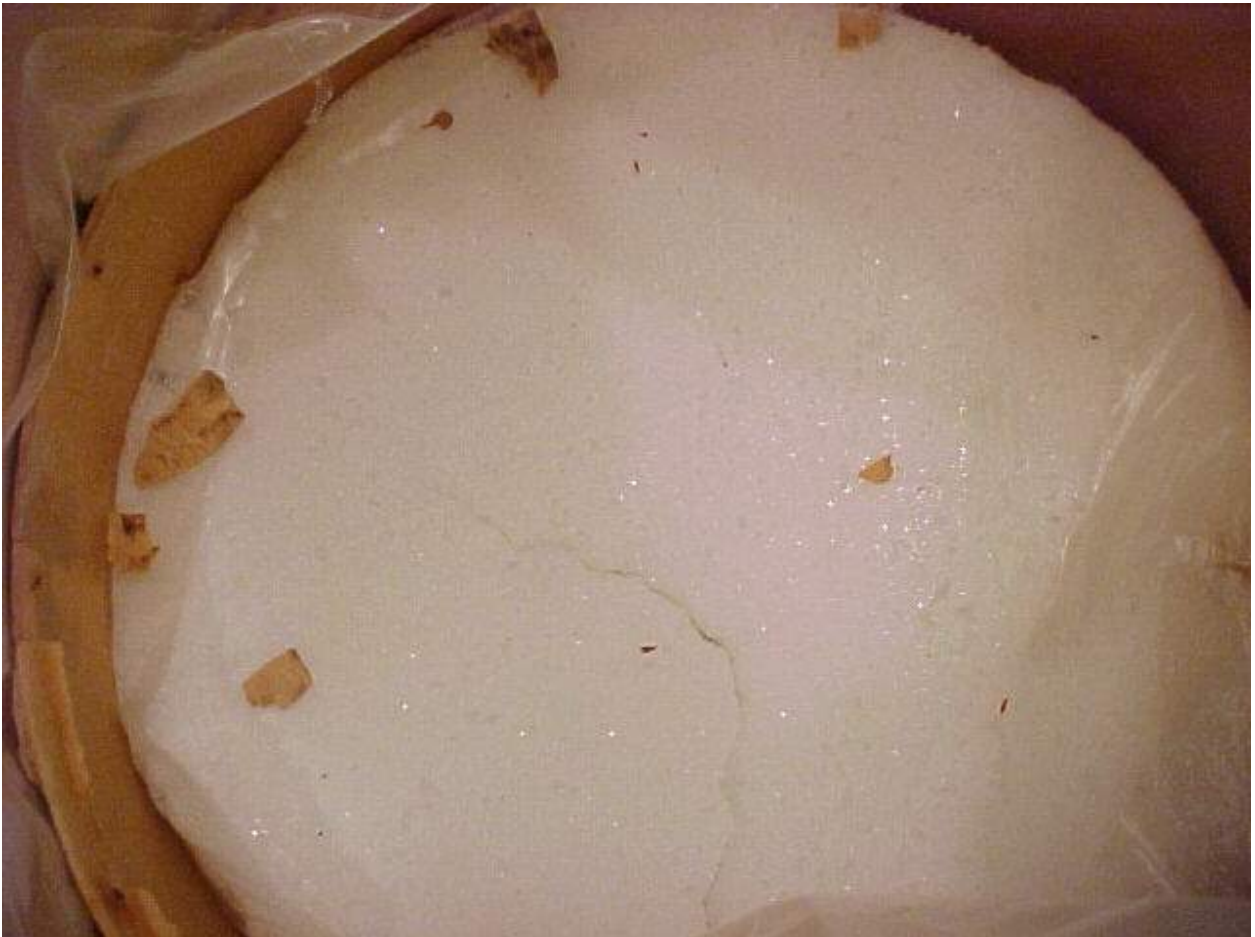
ThN material – monolith – white – solid – dry
No gases present in the breathing zone.

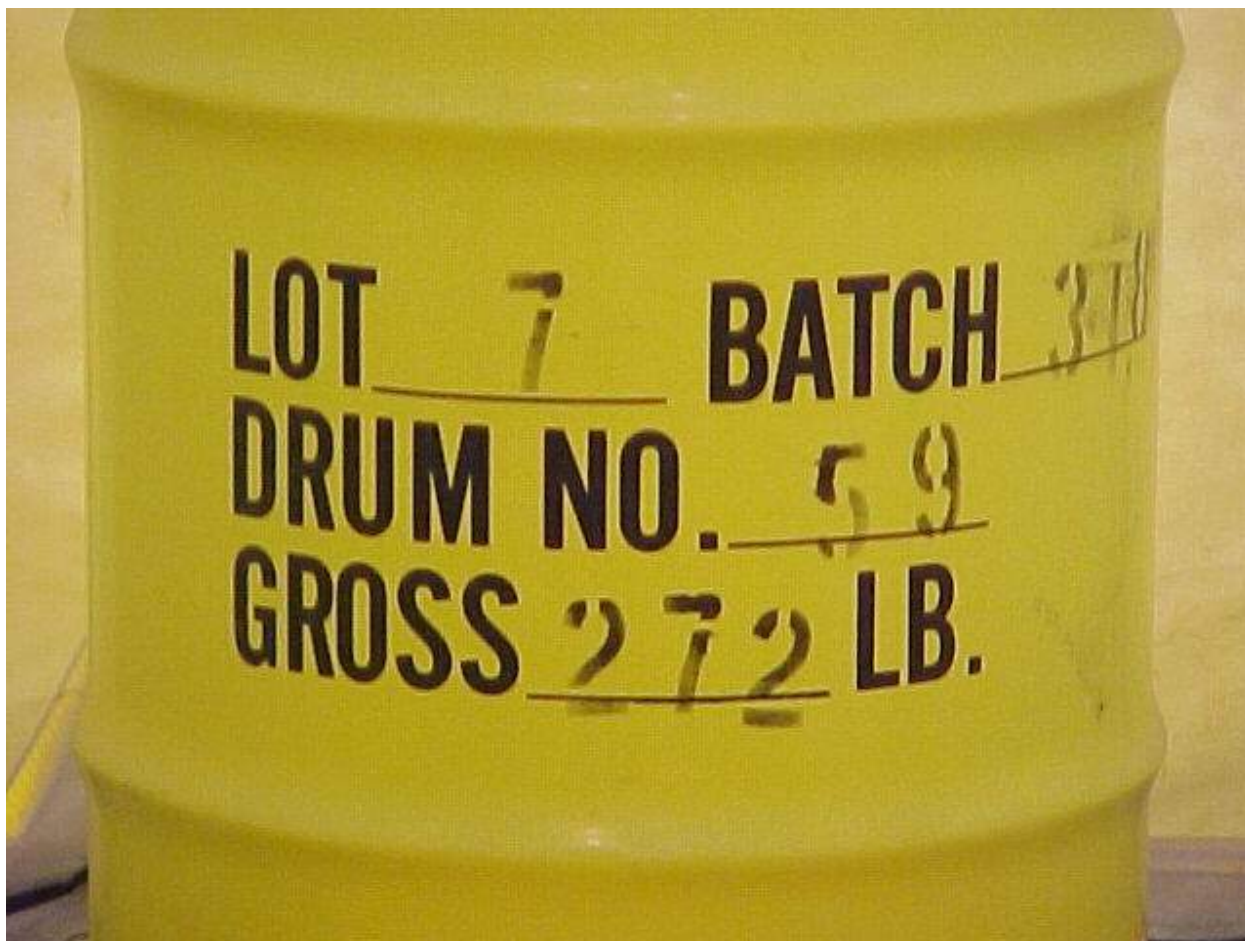
30-gal drum – good condition

Drum vented gases during drum ring removal operations – although there was not internal pressure buildup internal to the container.

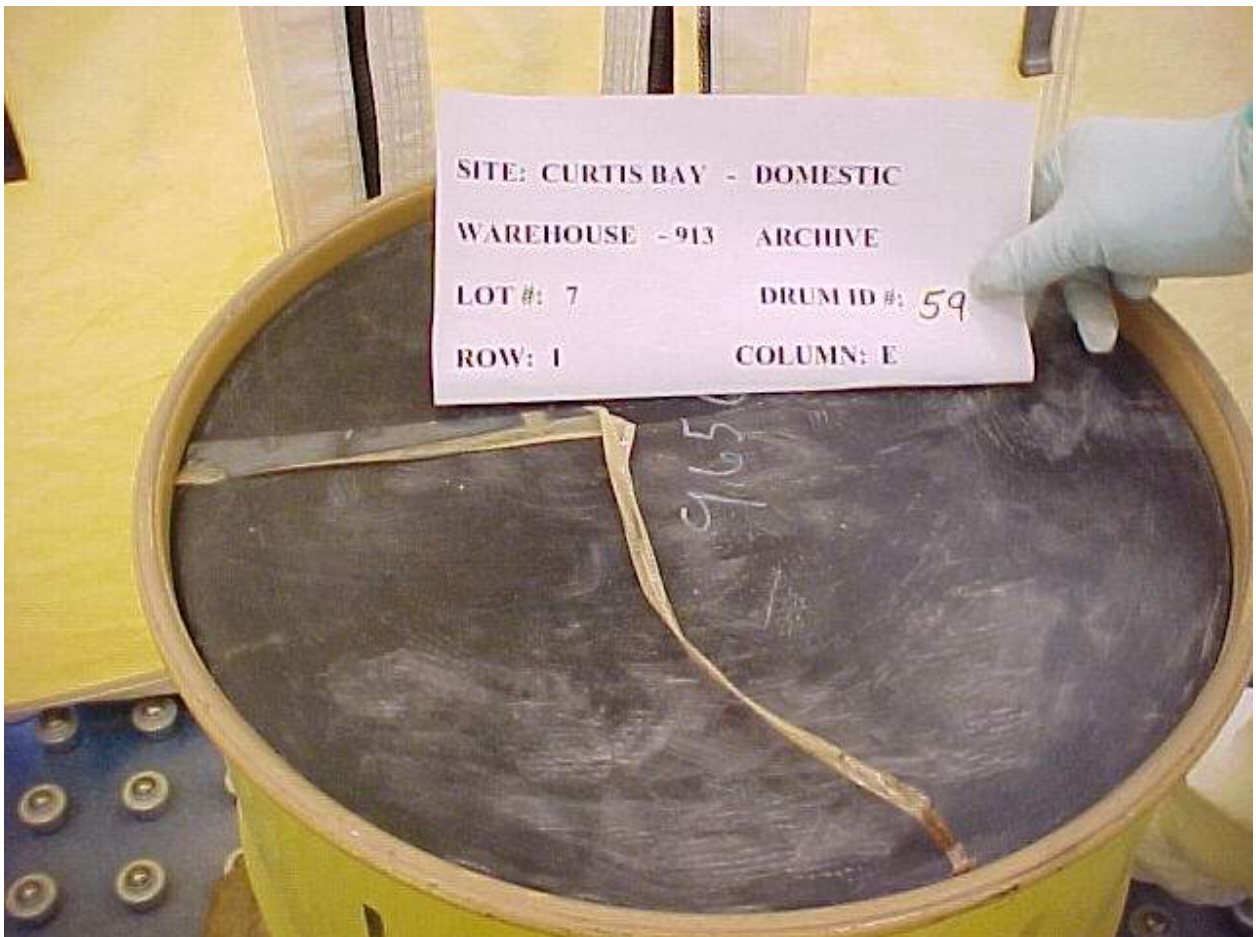
Black plastic lid – good condition
No gases present in the breathing zone.

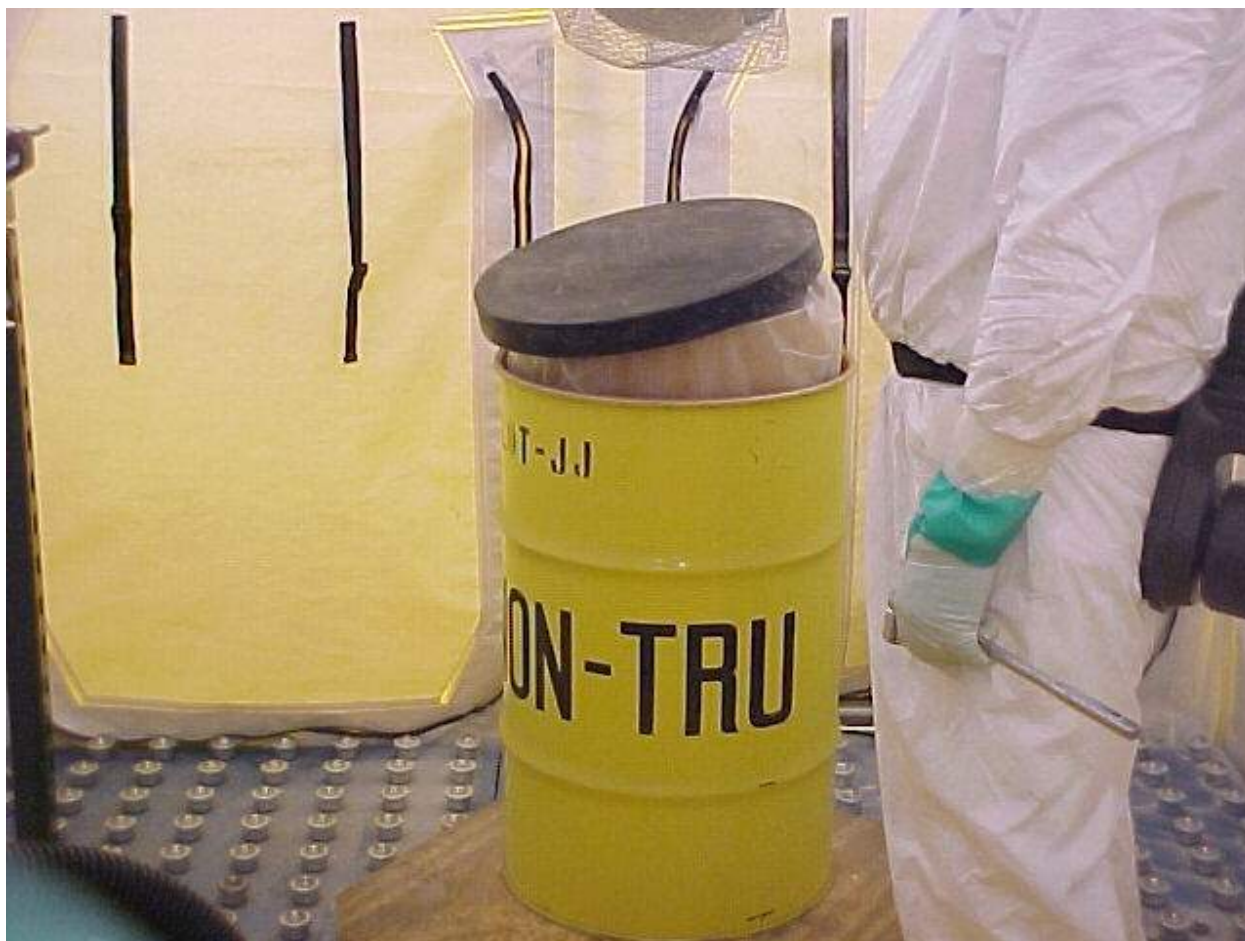
Black plastic lid – good condition

Pressure buildup inside of container results in this packaging layer rising vertically out of the container.

No gases present in the breathing zone.

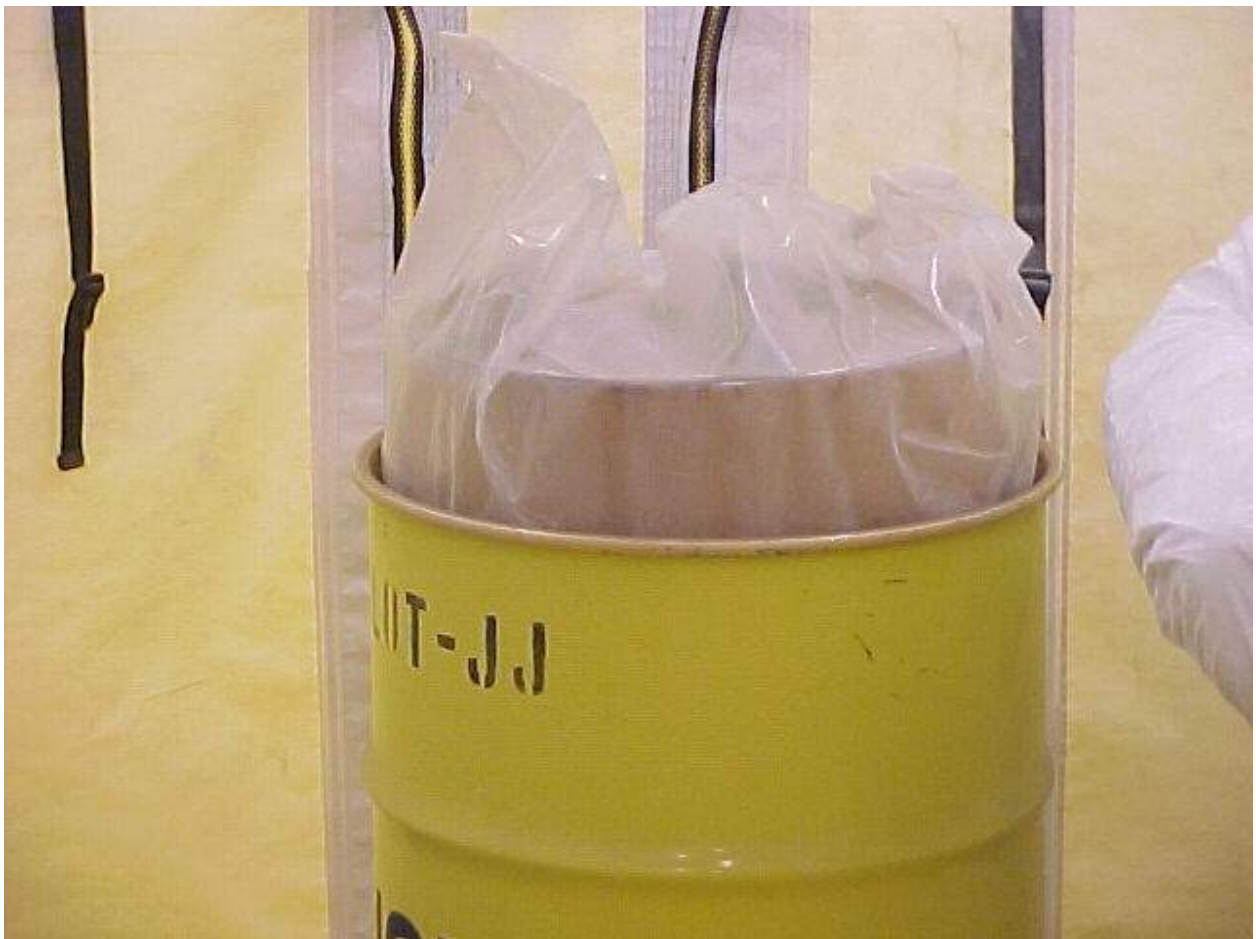
1st poly liner/bag – good condition
 Pressure buildup inside of container results in this packaging layer rising vertically out of the container.
 No gases present in the breathing zone.

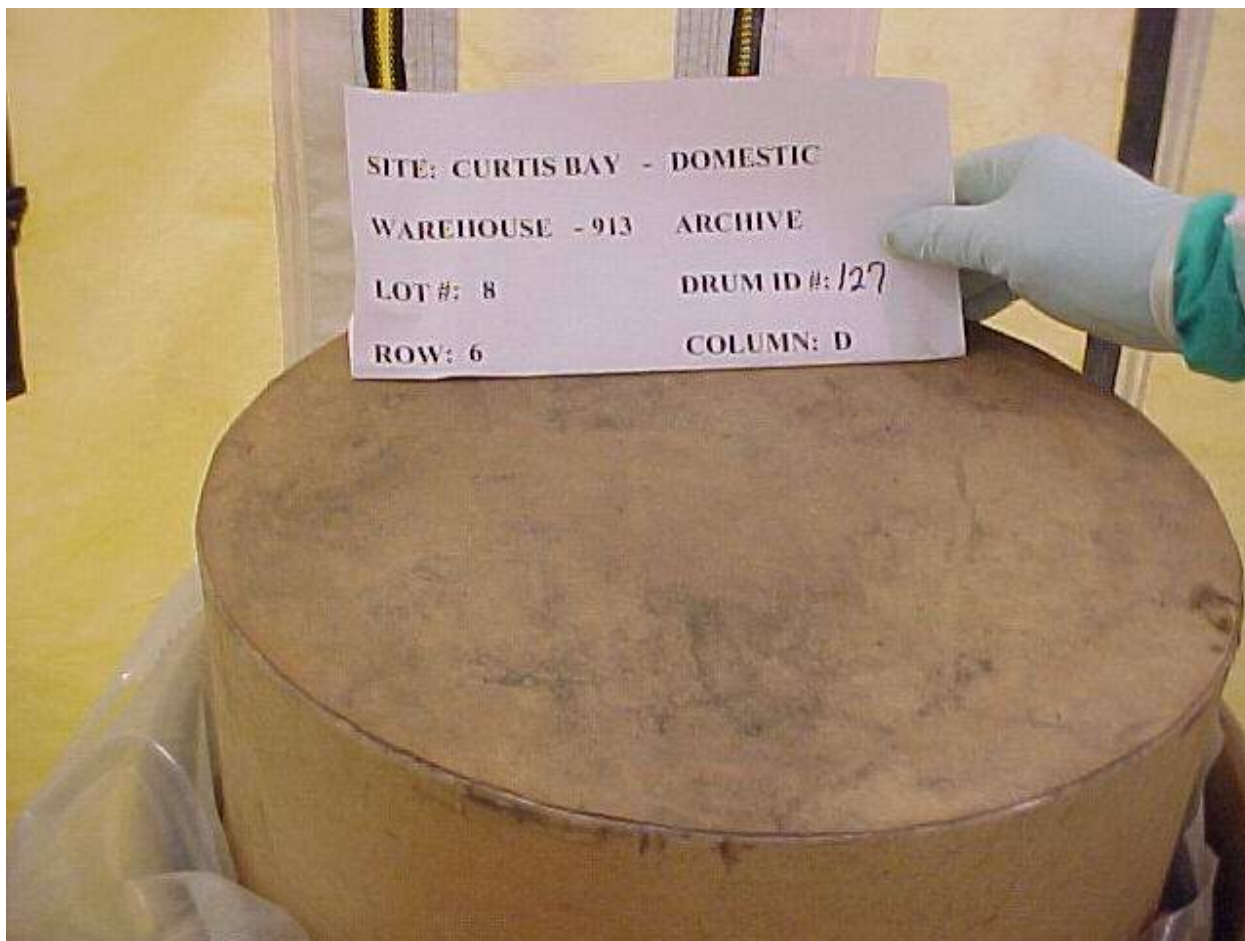
Fiber drum lid – good condition

Pressure buildup inside of container results in this packaging layer rising vertically out of the container.

No gases present in the breathing zone.

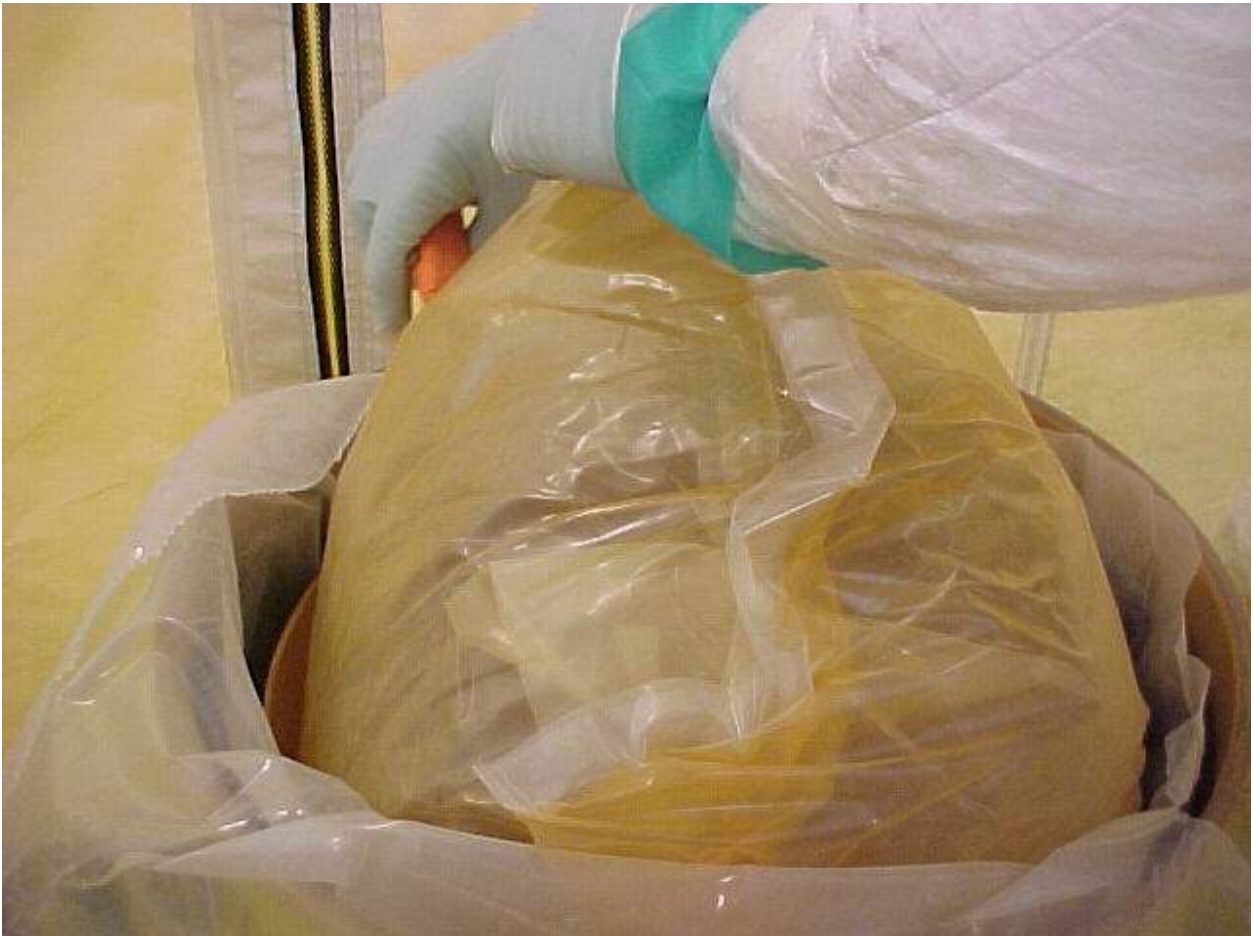
10:15**Other Information**Photo No. 5 of 11Dose Rate Surface 22 mR/hr
 1 meter 2.6 mR/hr2nd poly liner/bag – good conditionPressure buildup inside of container results in this packaging layer rising vertically out of the container.
No gases present in the breathing zone.

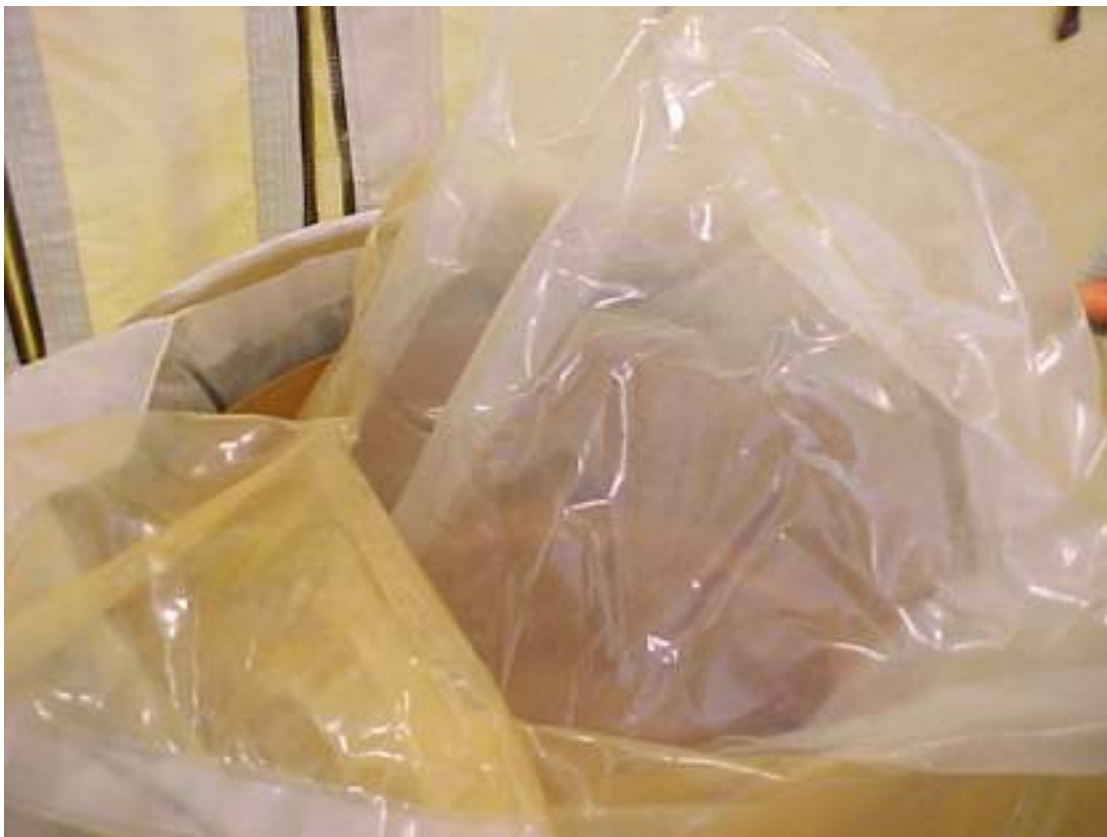
3rd poly liner/bag – good condition

Gases present in bag headspace – CH₄ – 5.0% LEL - NO - +50 ppm - NO_x - +50 ppm

Drum vented with HEPA exhaust – all gases dissipated to 0% LEL and/or 0 ppm

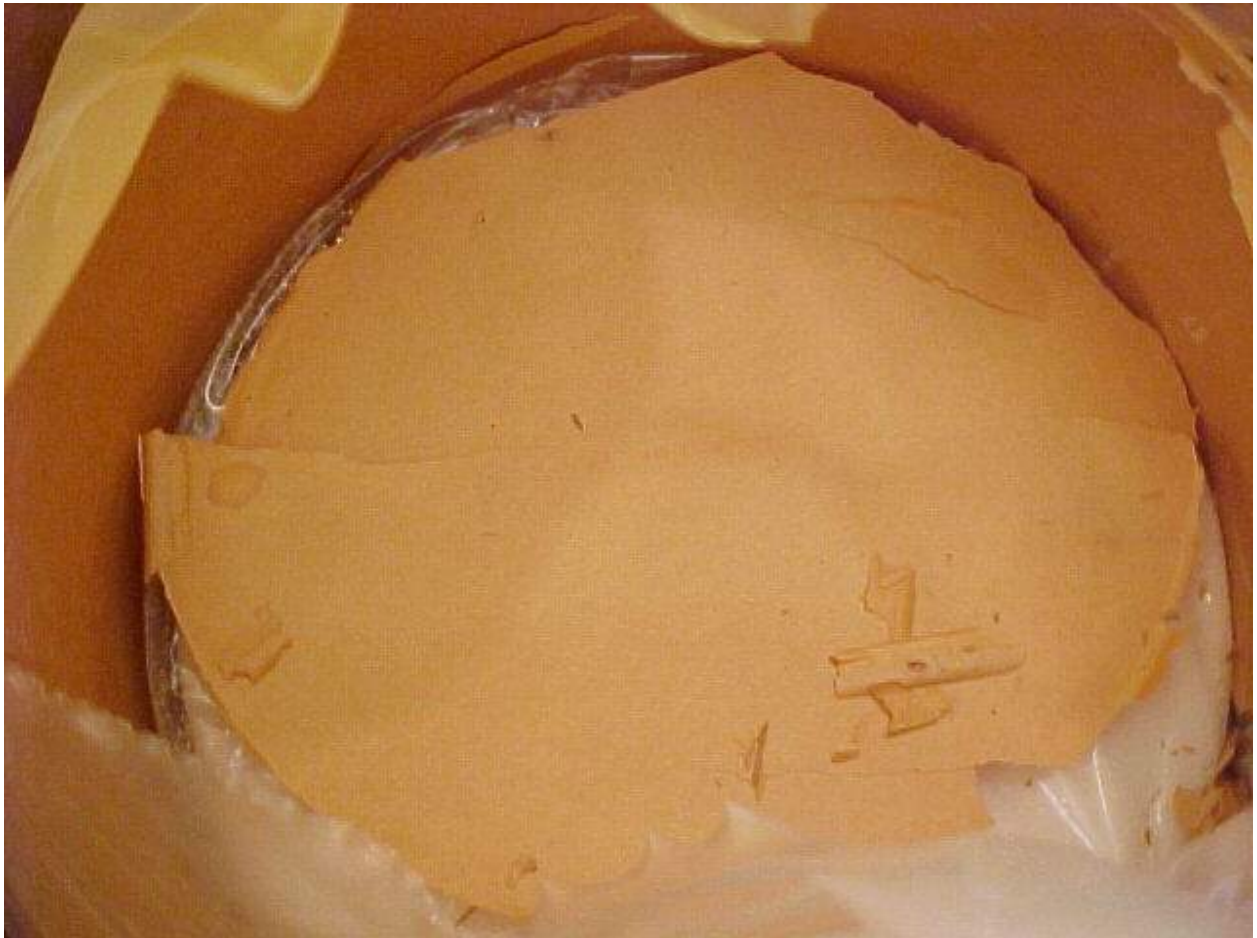
Lab-pack container lid – fair condition – paper layer typically tears off of container when the wooden lid is removed.
No gases present in the breathing zone.

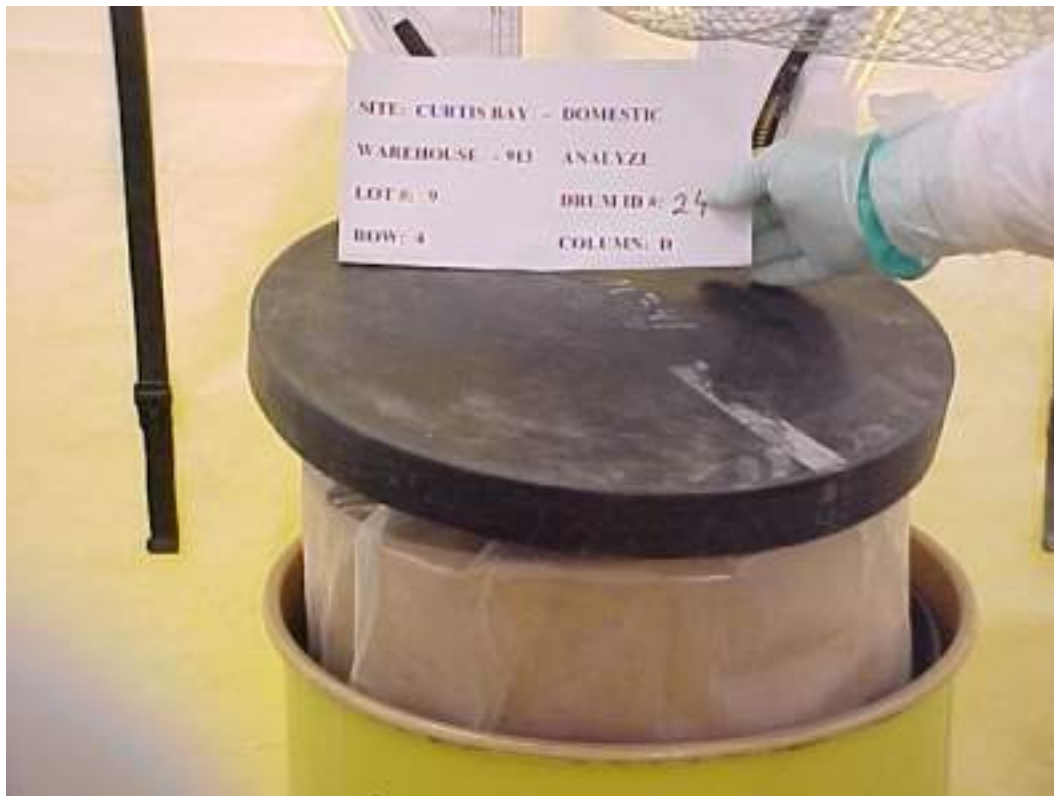
Black plastic lid – good condition

Pressure buildup inside the container results in raising this packaging layer vertically out of the container.
 No gases present in the breathing zone.

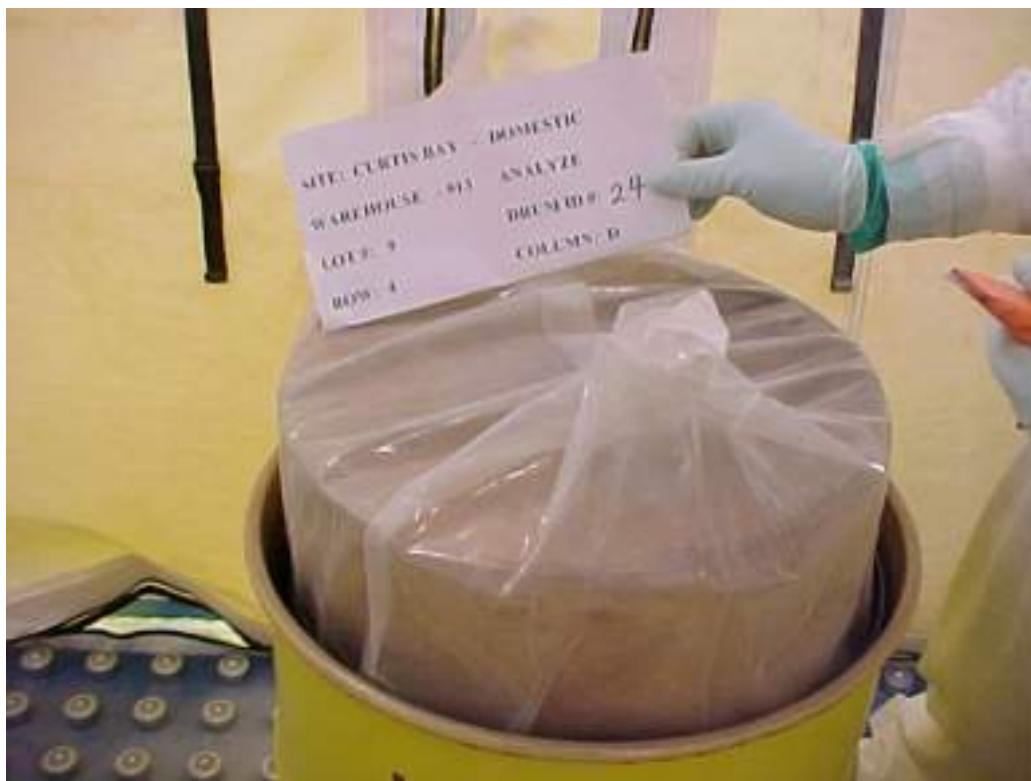
1st poly liner/bag – good condition

Pressure buildup inside the container results in raising this packaging layer vertically out of the container.
 No gases present in the breathing zone.

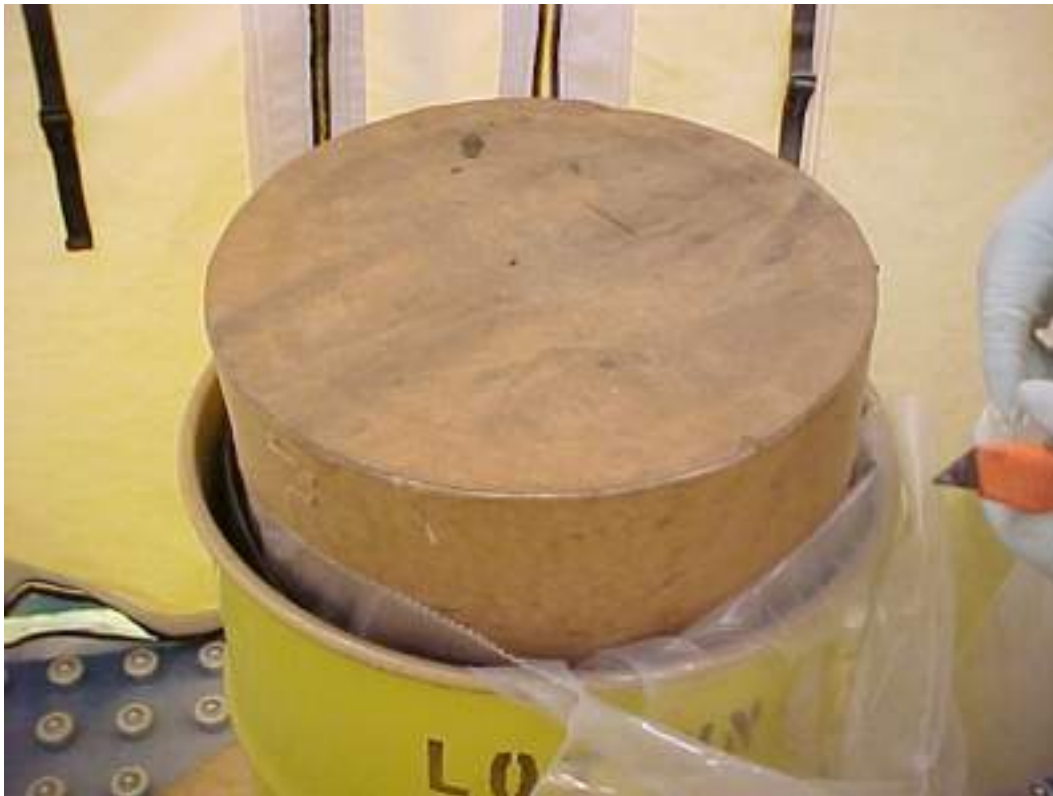
Fiber drum lid – good condition

Pressure buildup inside the container results in raising this packaging layer vertically out of the container.
No gases present in the breathing zone.

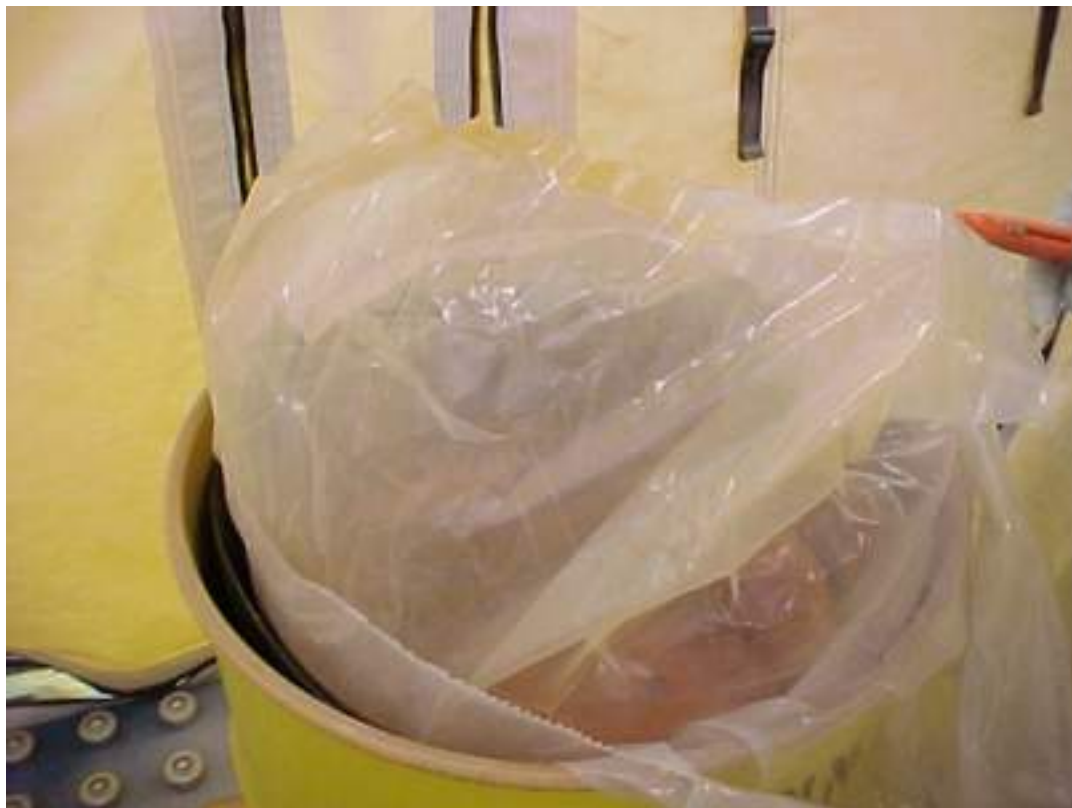
2nd poly liner/bag – good condition

Pressure buildup inside the container results in raising this packaging layer vertically out of the container.
 No gases present in the breathing zone.

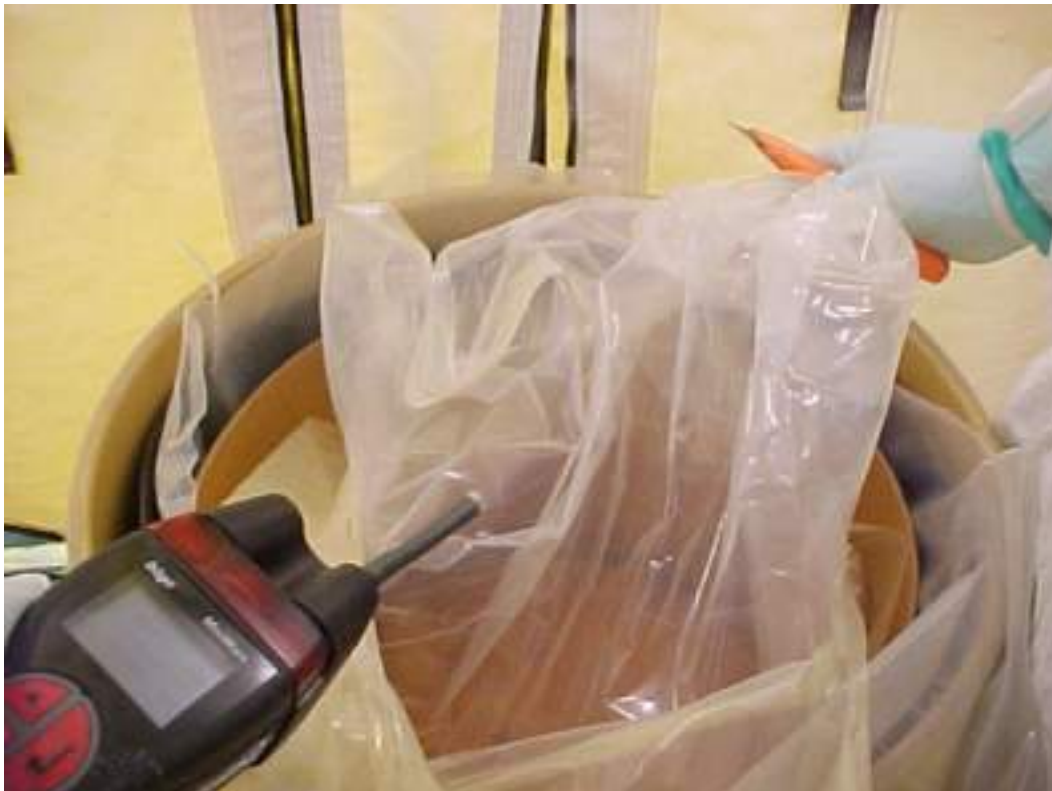
3rd poly liner/bag – good condition

Gases in headspace – CH₄ – 4.6% LEL - NO - +50 ppm - NO_x - +50 ppm

Drum vented via HEPA exhaust – All gases dissipated to 0.0% and/or 0 ppm

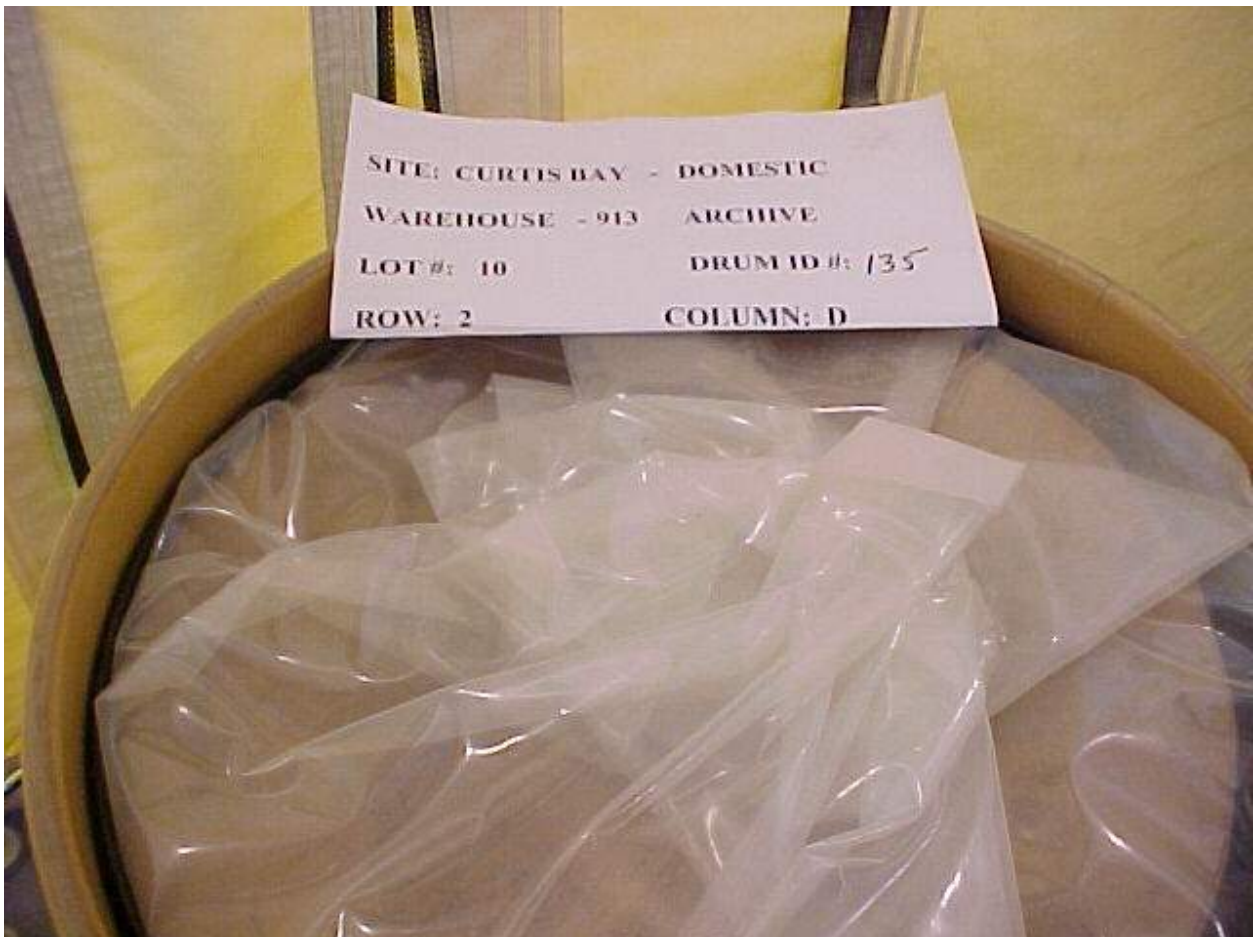
1st poly liner/bag – good condition
No gases present in the breathing zone.

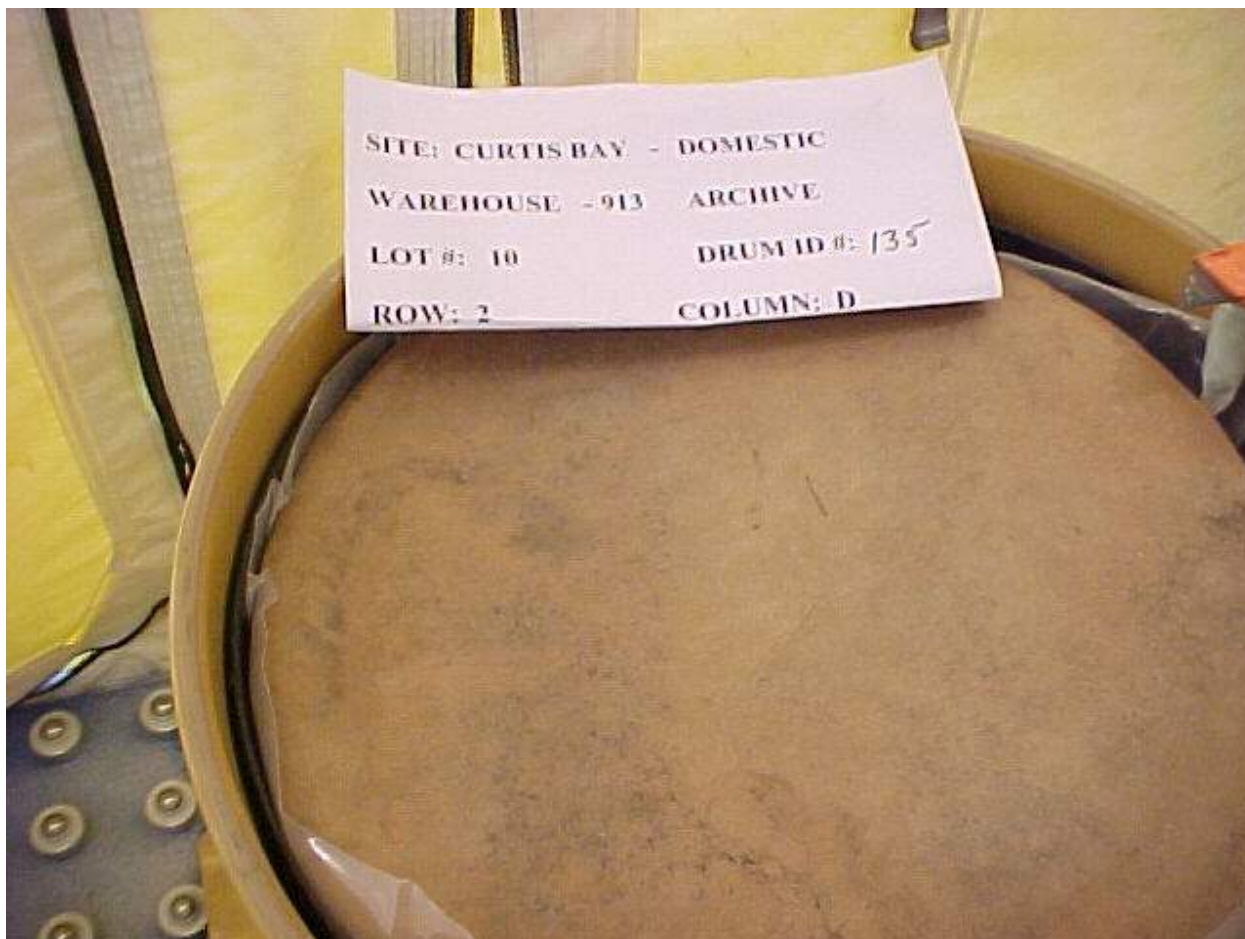
Fiber drum lid – good condition
No gases present in the breathing zone.

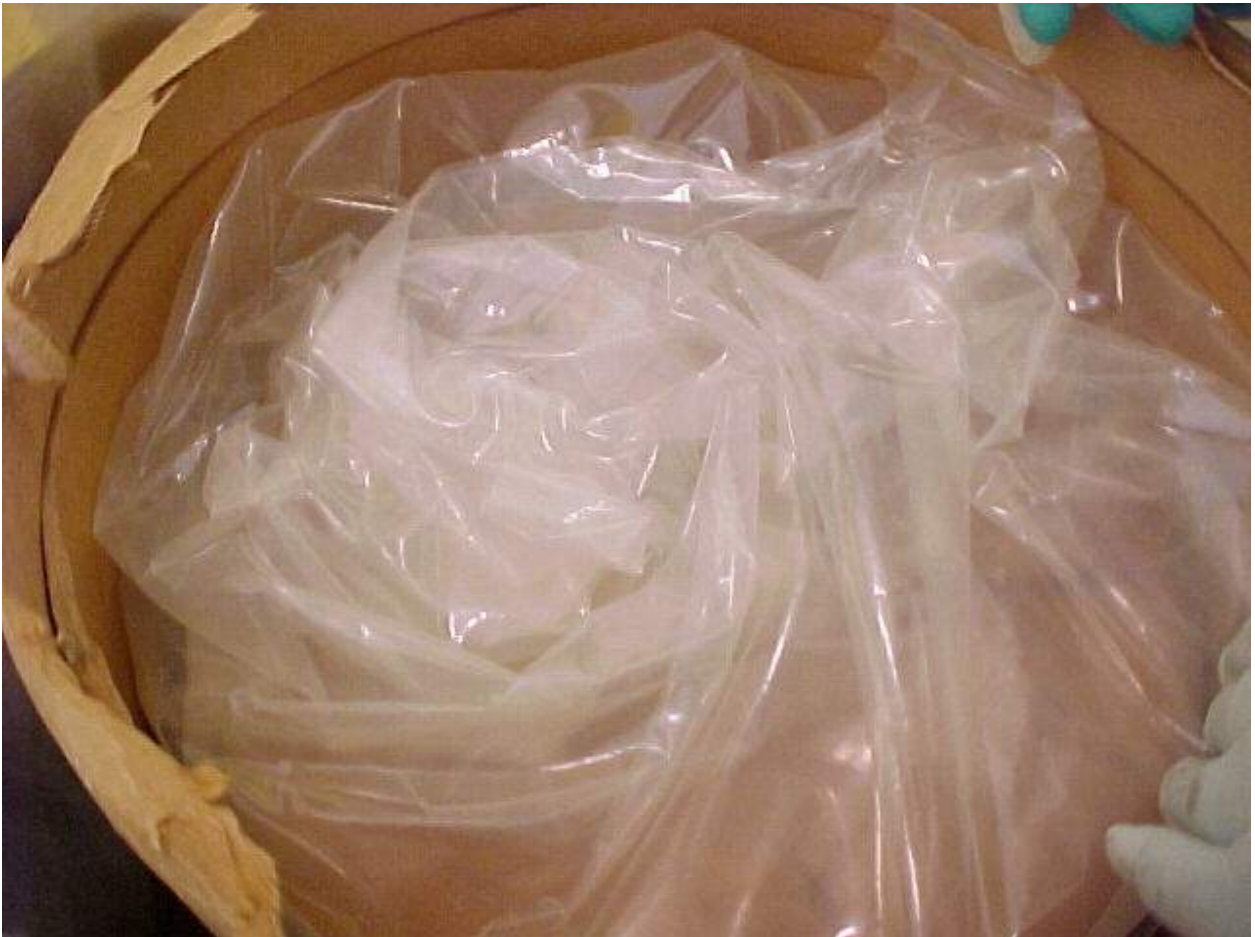
2nd poly liner/bag – good condition
No gases present in the breathing zone.

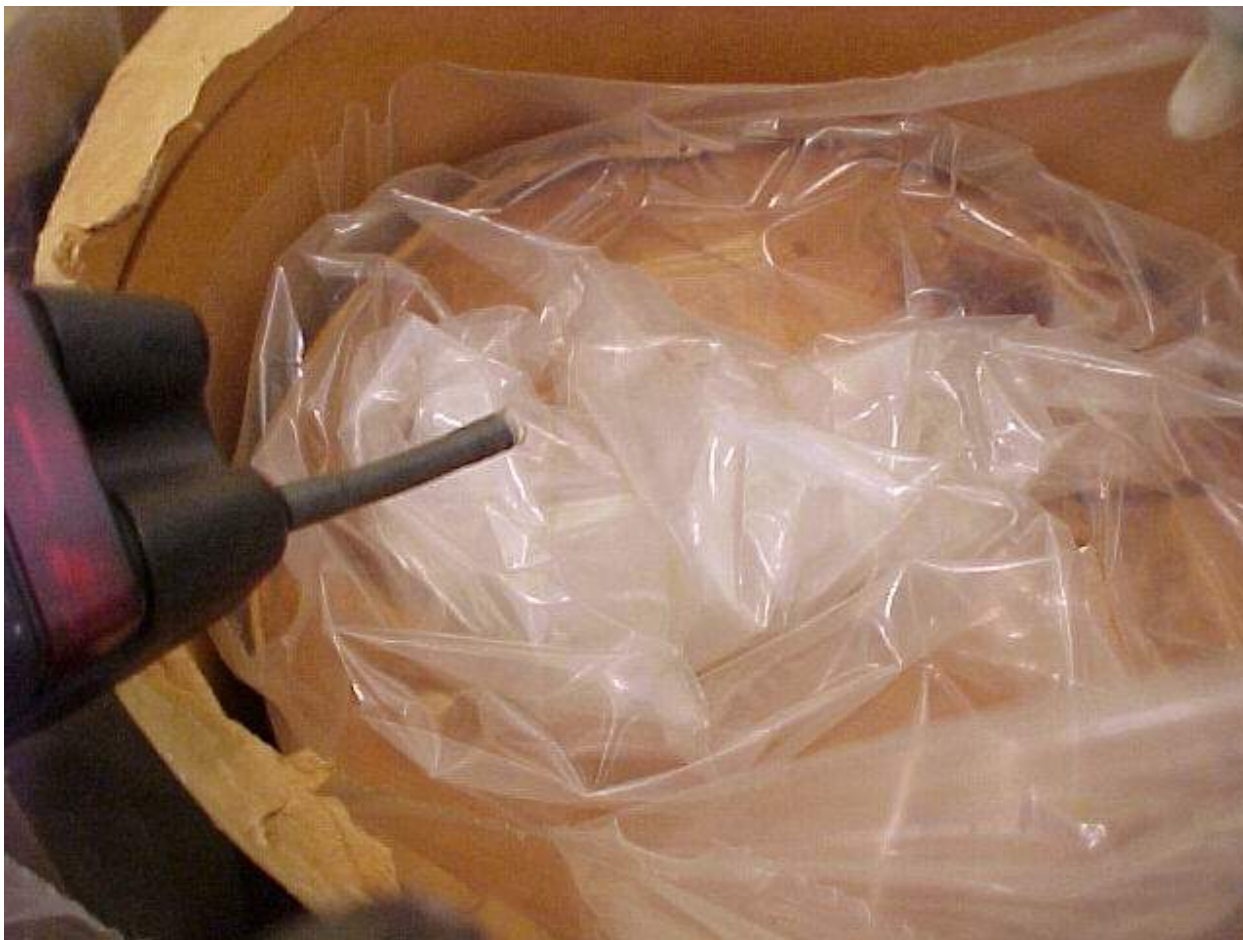
3rd poly liner/bag – good condition
No gases present in the breathing zone.

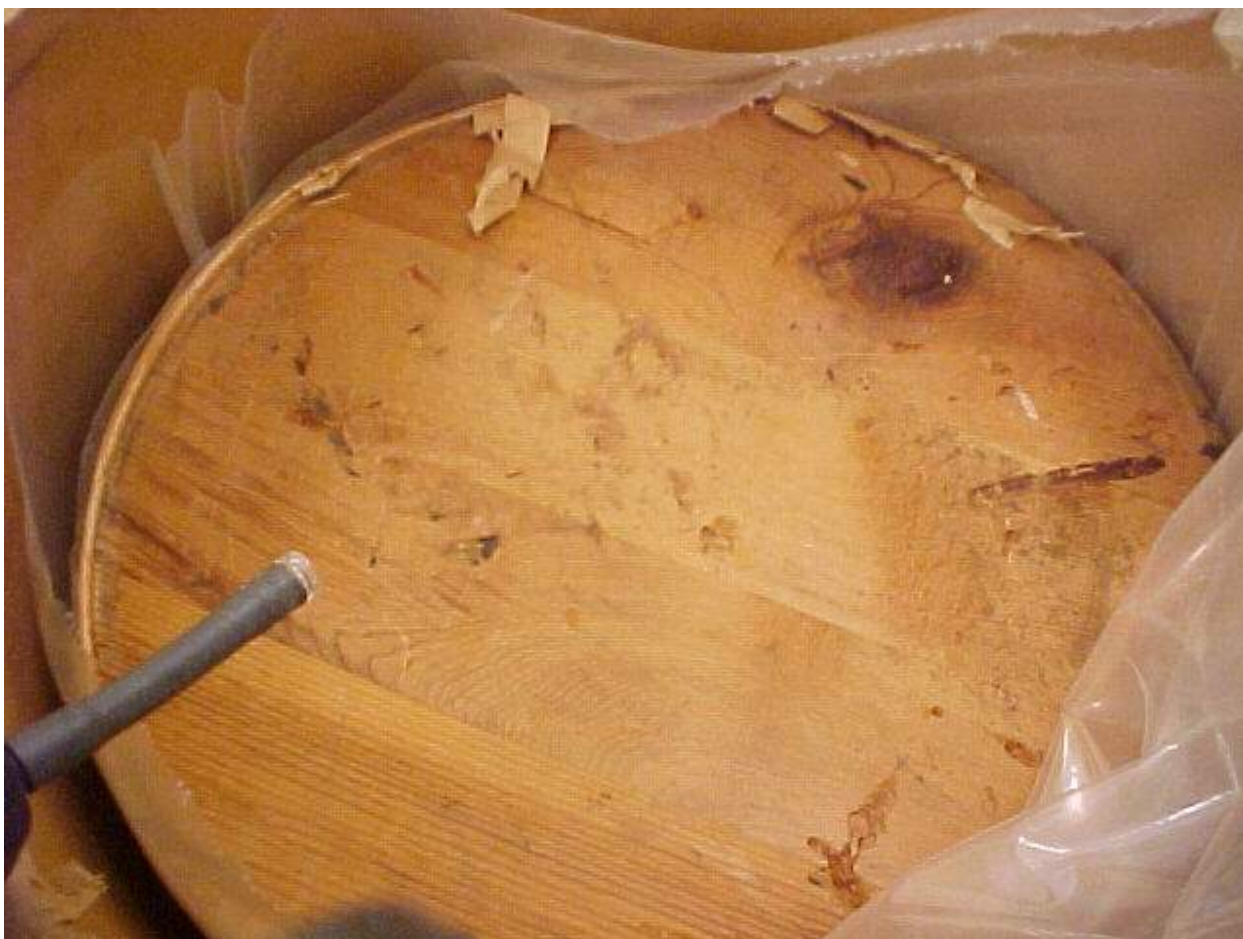
Wooden lid – good condition
No gases present in the breathing zone.

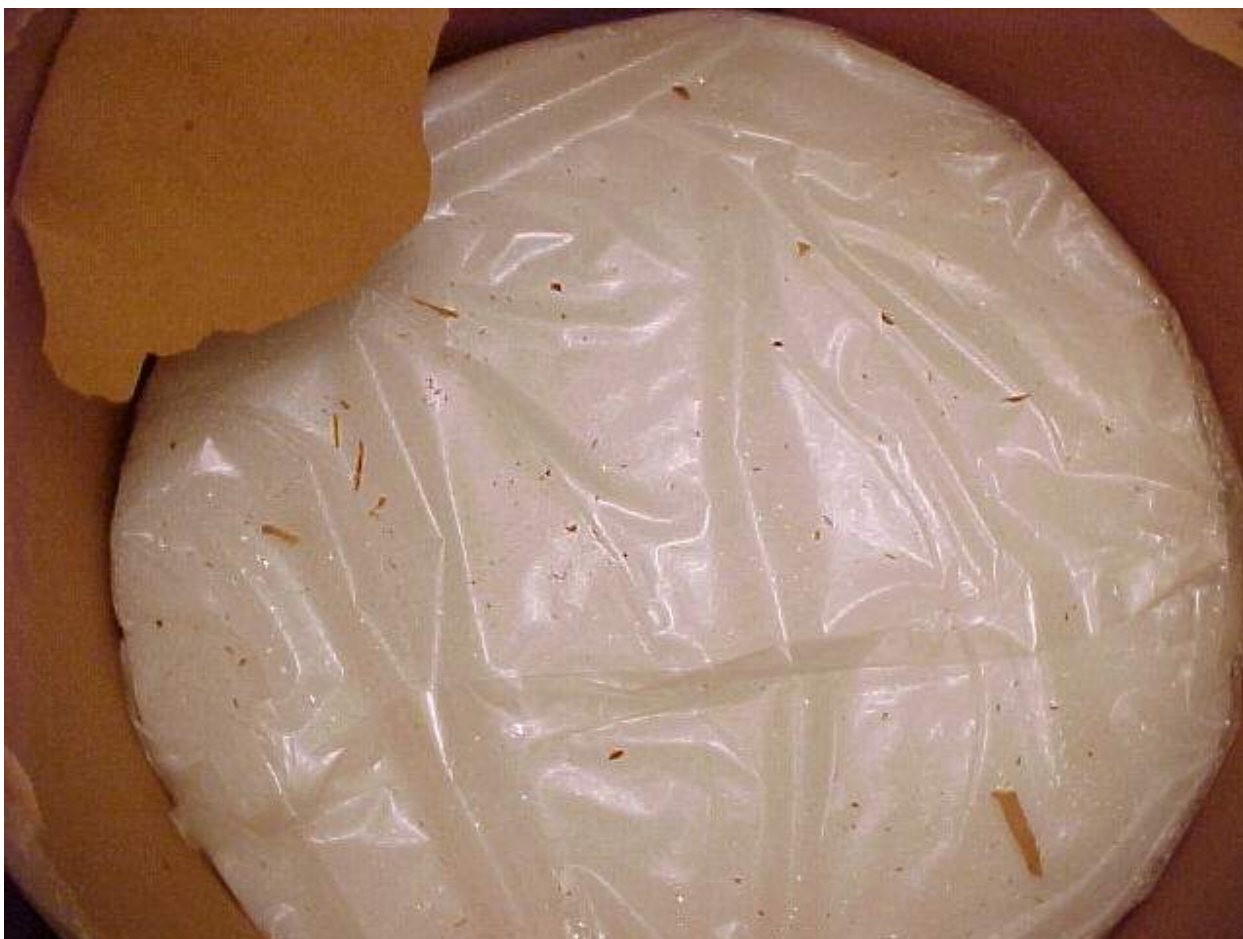
4th poly liner/bag – good condition (photo shows inside of inner fiber drum – lab-pack container)
No gases present in the breathing zone.
