THORIUM NITRATE STOCKPILE DRUM CHARACTERIZATION REPORT

**THORIUM NITRATE STOCKPILE
DRUM CHARACTERIZATION REPORT**

Prepared for
U.S. Defense Logistics Agency
Defense National Stockpile Center
Fort Belvoir, Virginia

Prepared by
OAK RIDGE NATIONAL LABORATORY
Oak Ridge, Tennessee 37831
managed by
UT-BATTELLE, LLC
for the
U.S. DEPARTMENT OF ENERGY
under contract DE-AC05-00OR22725

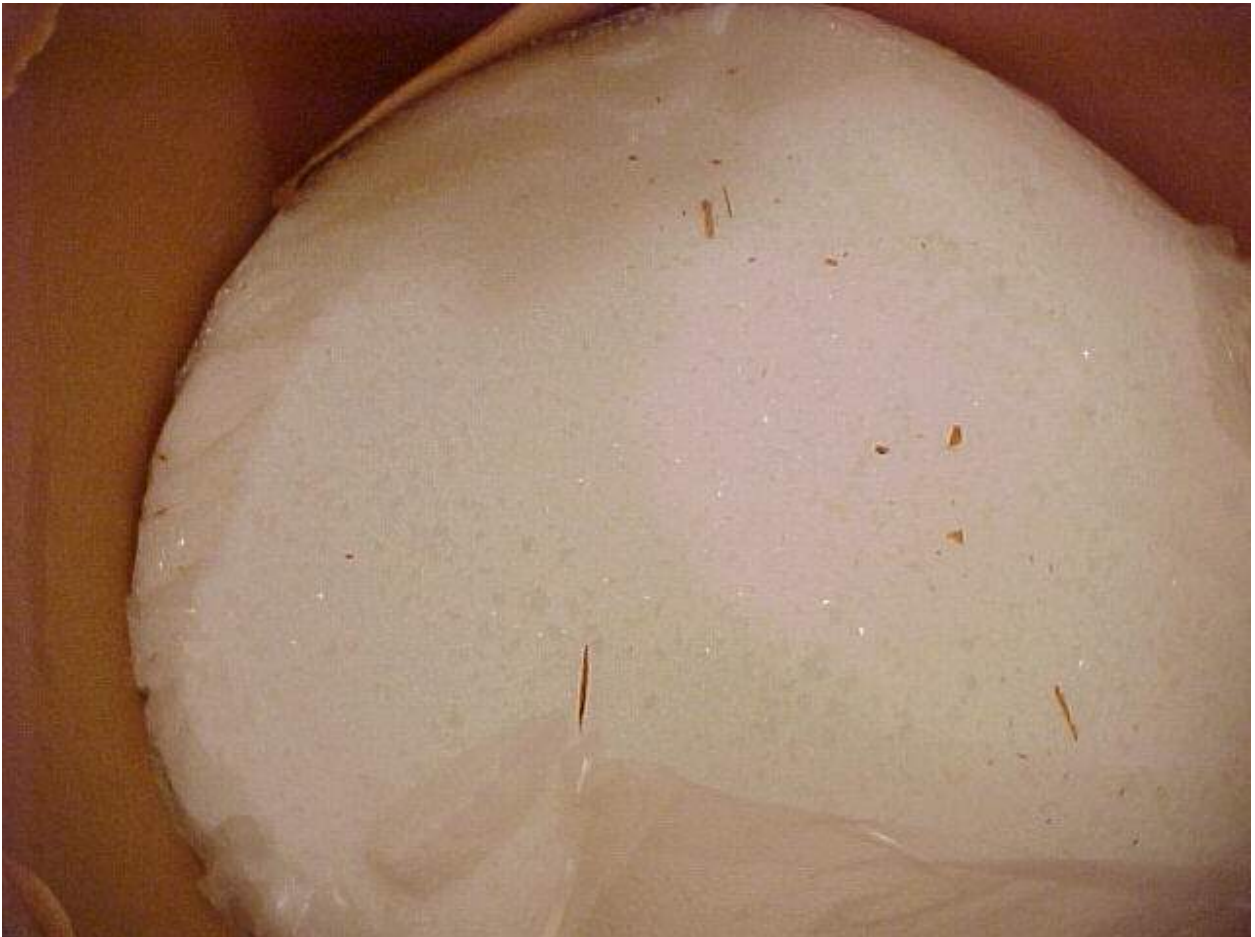
ThN material – monolith – white – solid – dry
No gases present in the breathing zone.

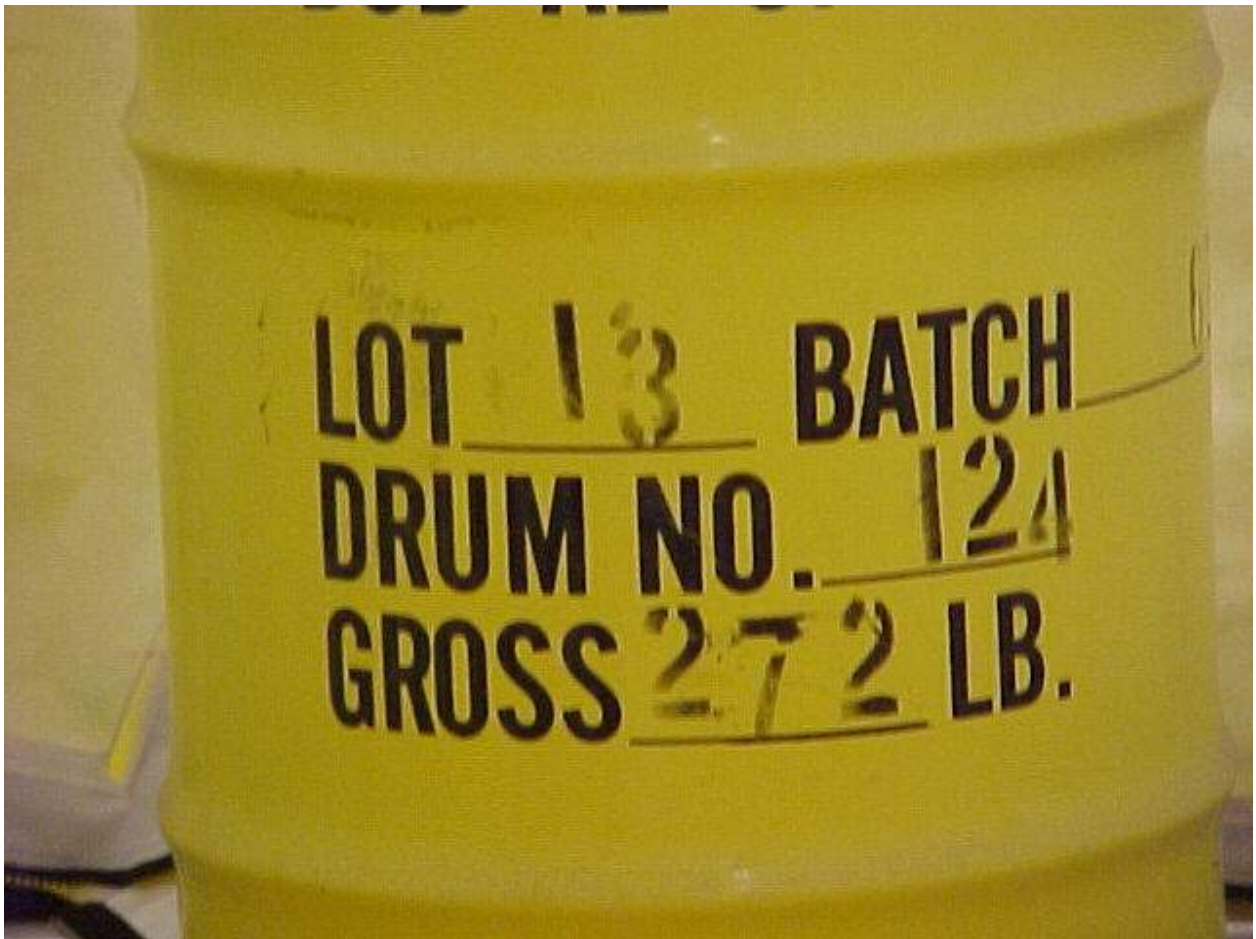
30-gal drum – good condition

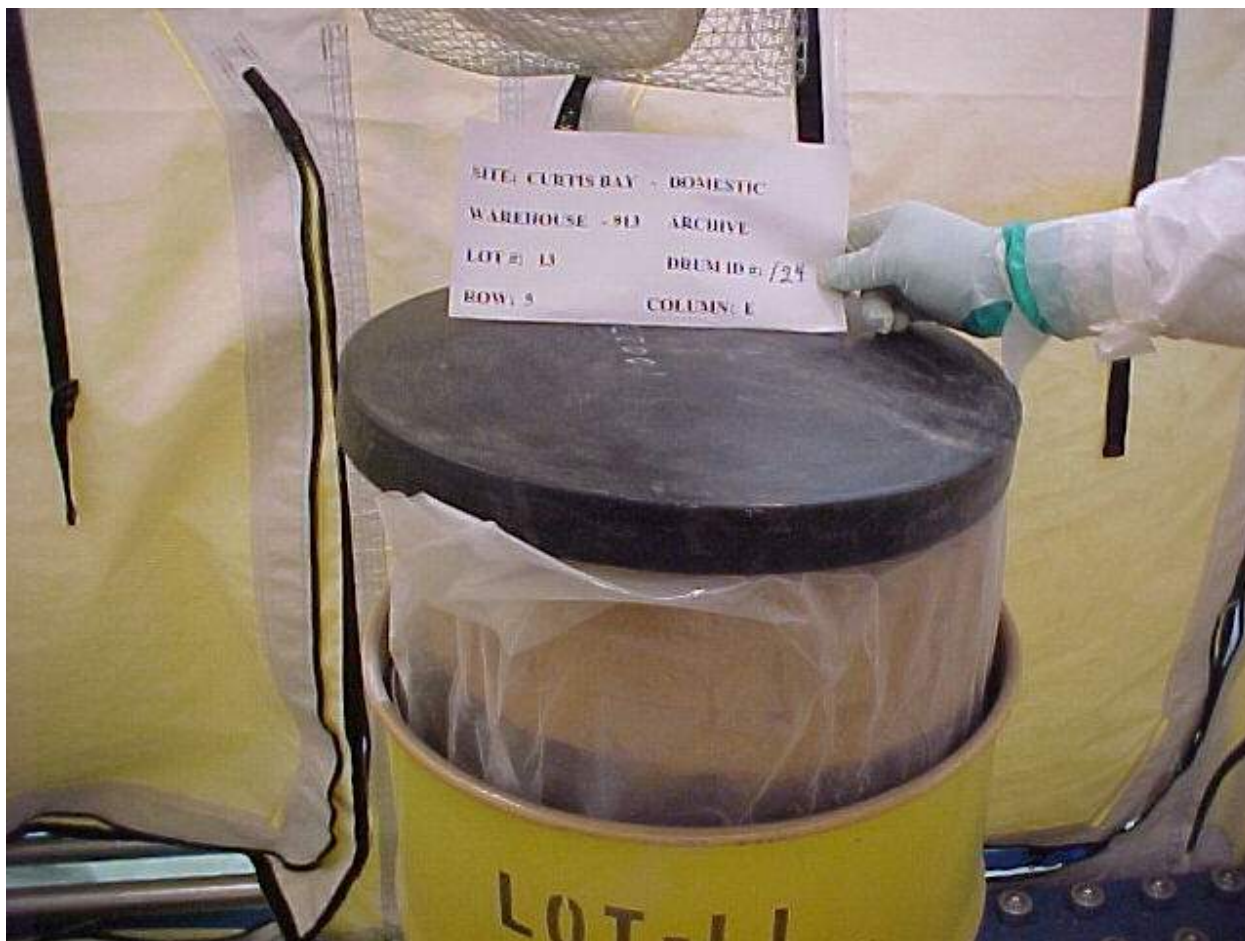
Black plastic lid – good condition

Pressure buildup inside of the container results in this packaging layer rising out of the container

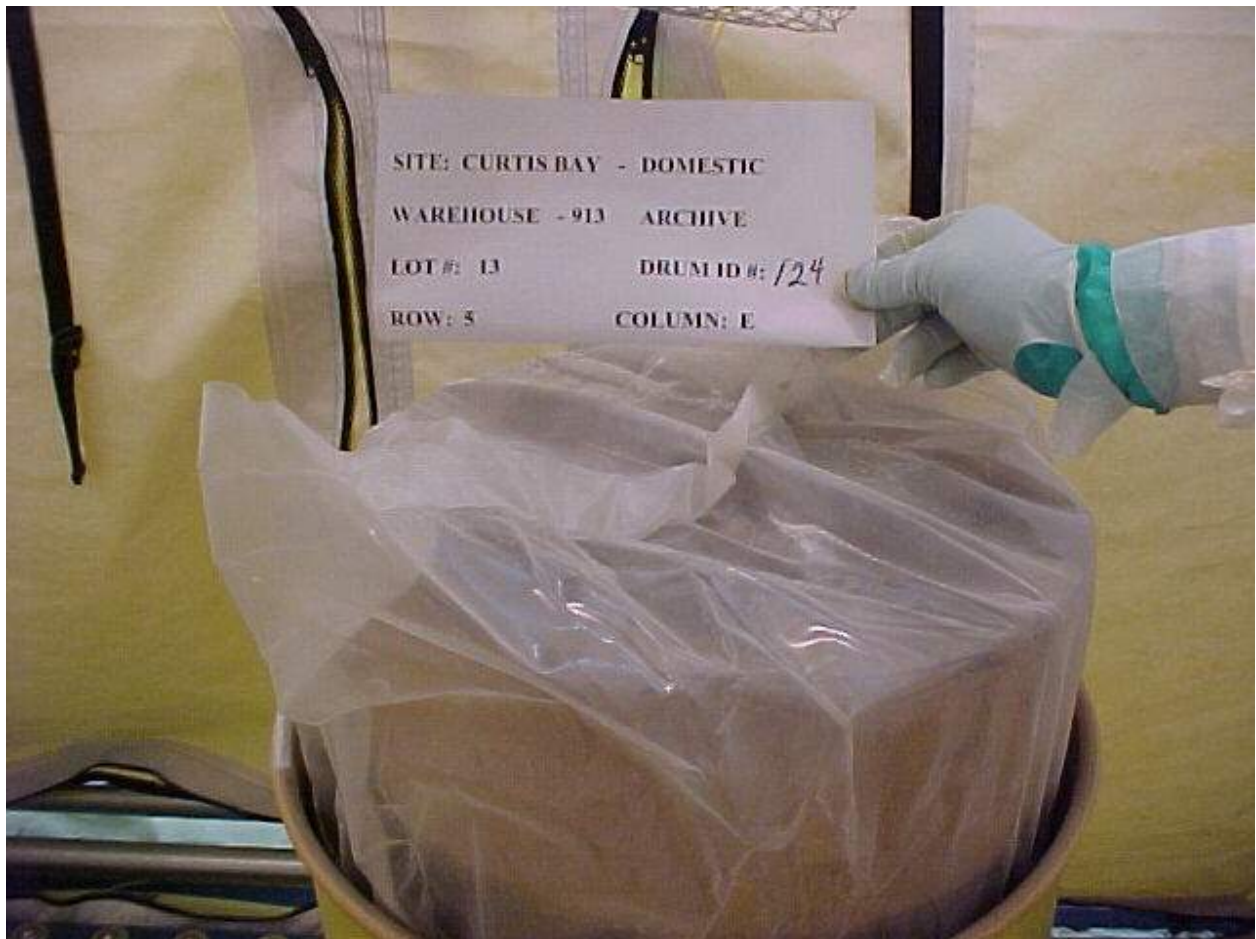
14:30**Other Information**Photo No. 3 of 11Dose Rate Surface 22 mR/hr
 1 meter 2.6 mR/hr1st poly liner/bag – good condition

Pressure buildup inside of the container results in this packaging layer rising out of the container

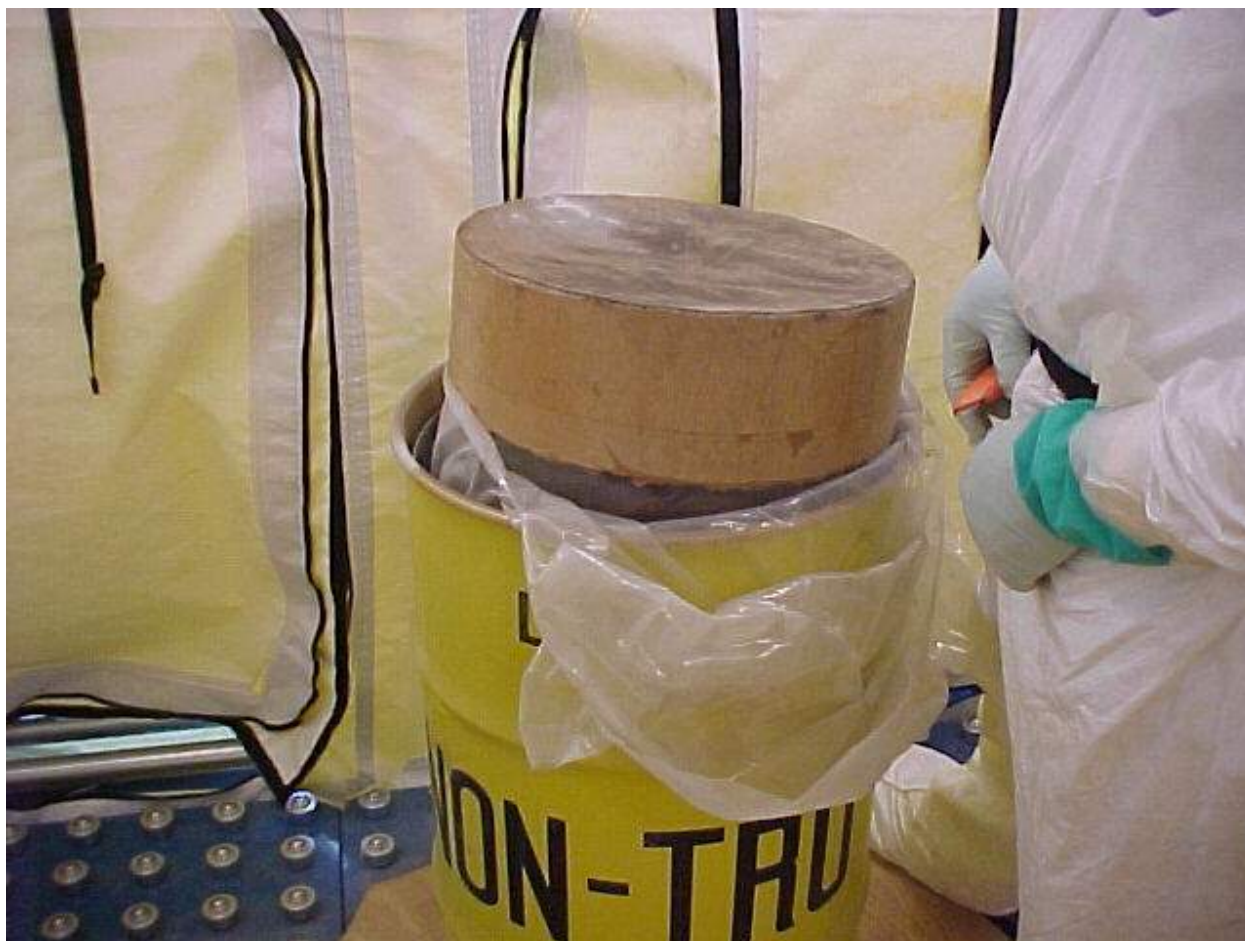
Fiber drum lid – good condition

Pressure buildup inside of the container results in this packaging layer rising out of the container

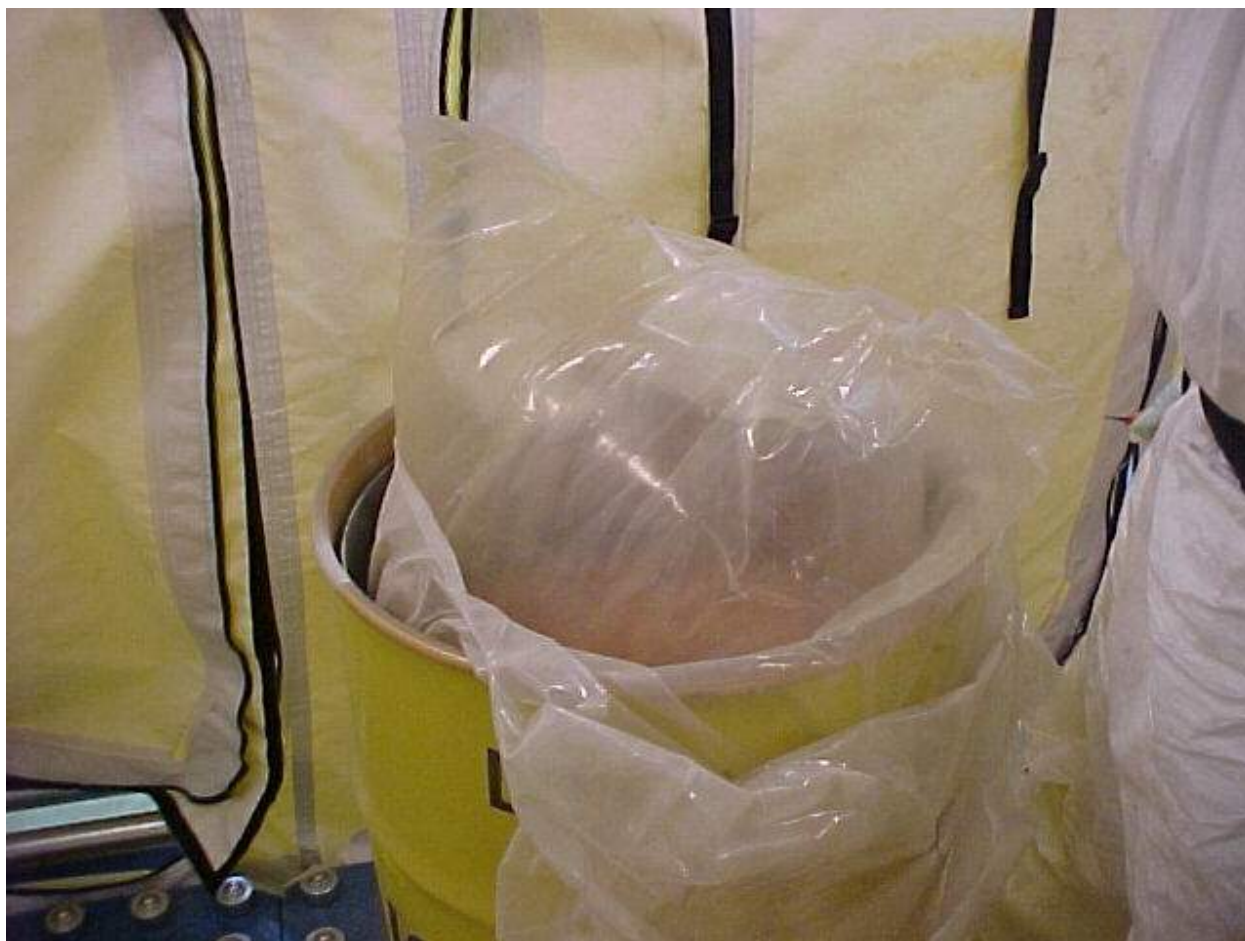
14:30**Other Information**Photo No. 5 of 11Dose Rate Surface 22 mR/hr
 1 meter 2.6 mR/hr2nd poly liner/bag – good conditionPressure buildup inside of the container results in this packaging layer rising out of the container
No gases present in the breathing zone.

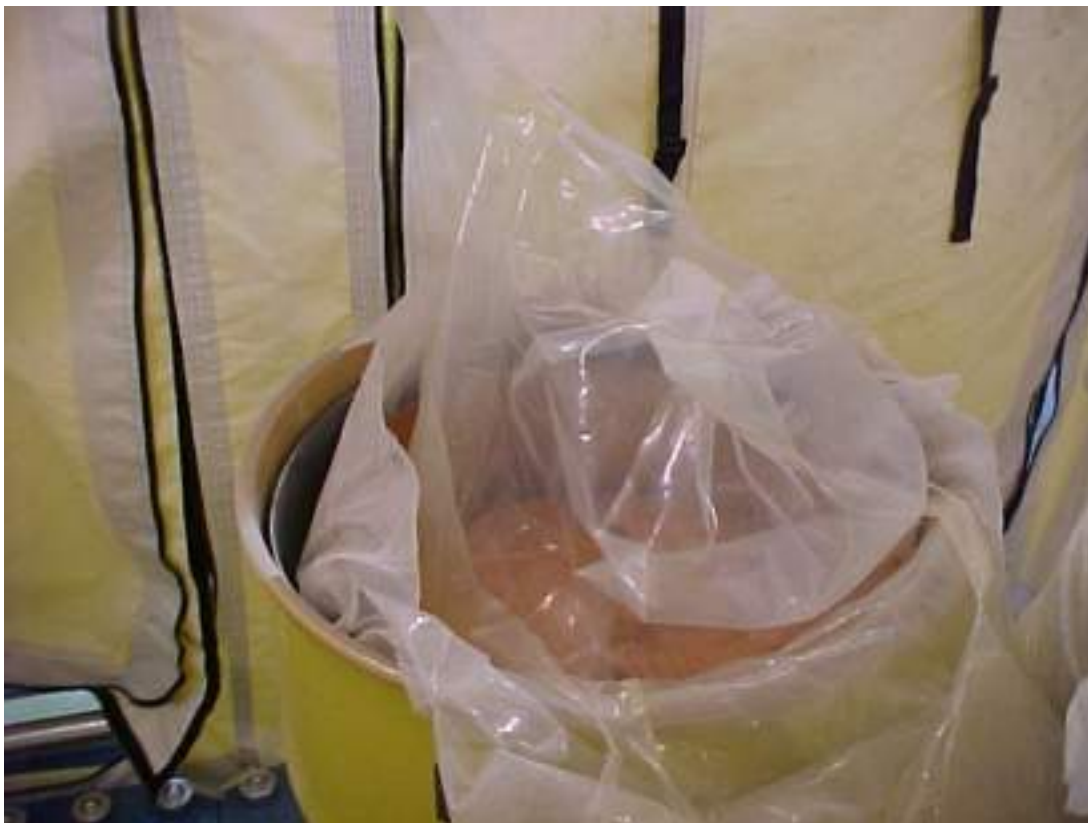
30-gal drum – good condition

Gases present in bag's headspace – CH₄ – 4.6% LEL - NO - +50 ppm - NO_x - +50 ppm

Drum vented with HEPA exhaust blower – all gases dissipated to 0% LEL and/or 0 ppm

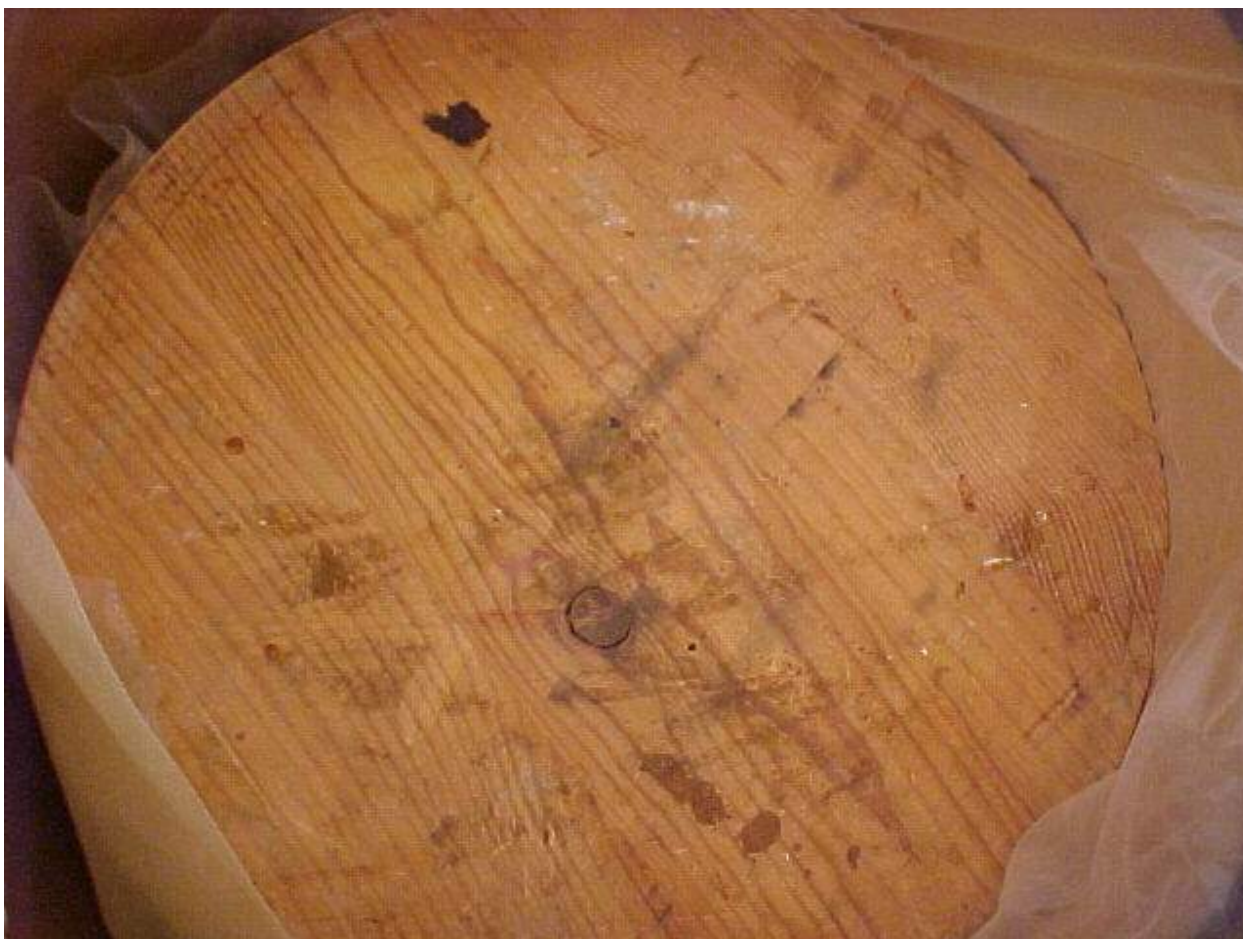
Wooden lid – good condition
No gases present in the breathing zone.

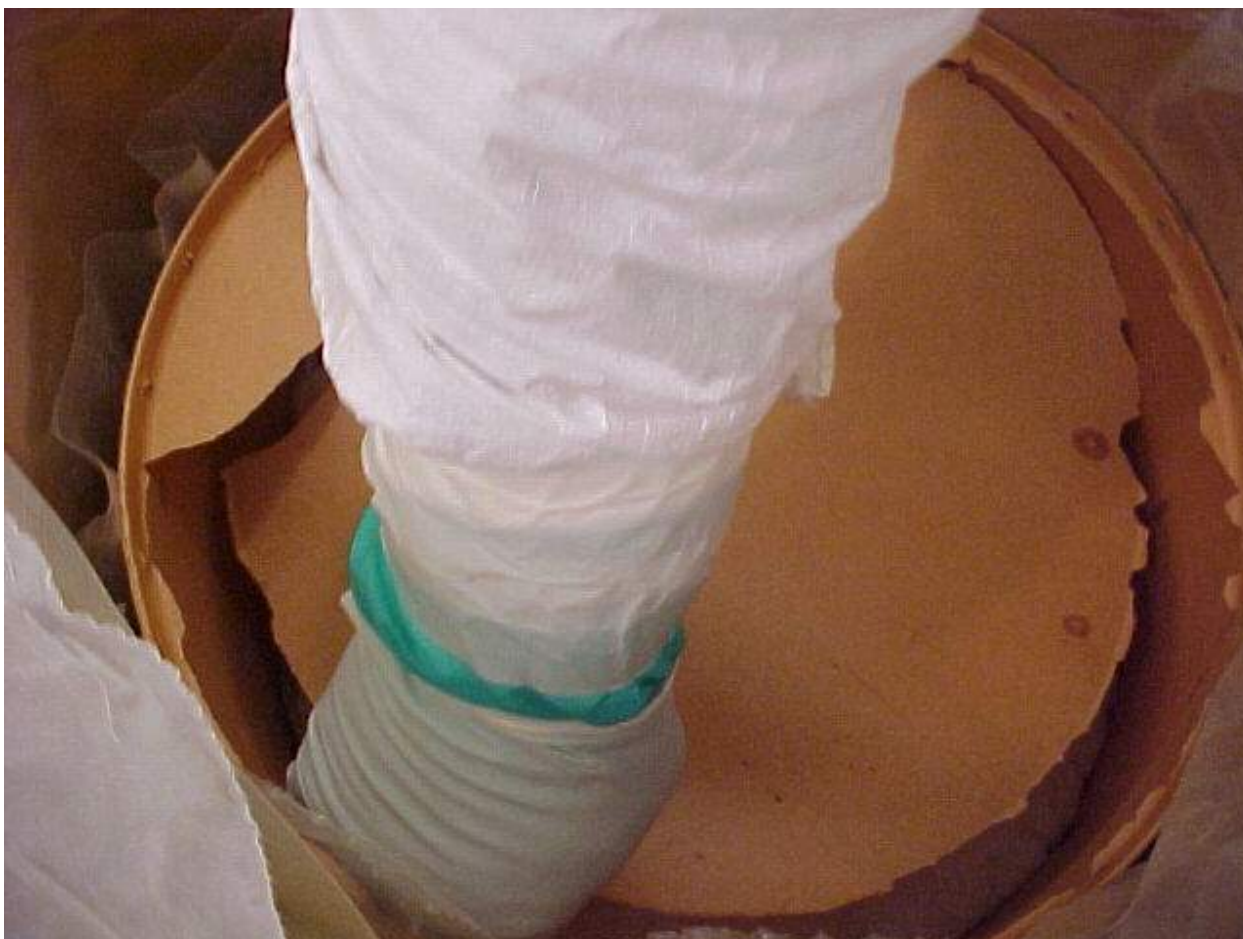
Lab-pack (inner fiber drum) lid (paper layer) shown in this photo is under the wooden lid
No gases present in the breathing zone.

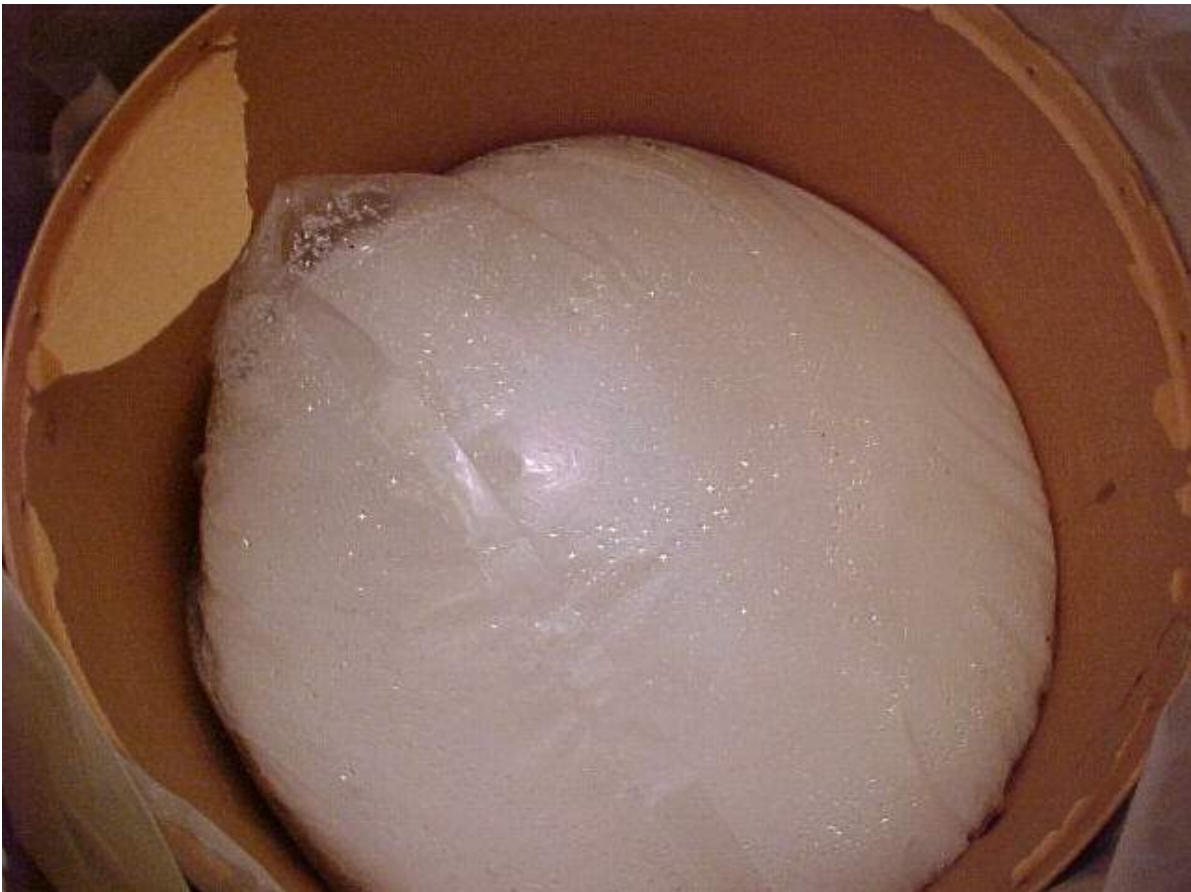
4th poly liner/bag – good condition

Gases in headspace – CH₄ – 4.6% LEL - NO - +50 ppm - NO_x - +50 ppm

Drum vented with HEPA exhaust dissipating the gases to 0% LEL and/or 0 ppm

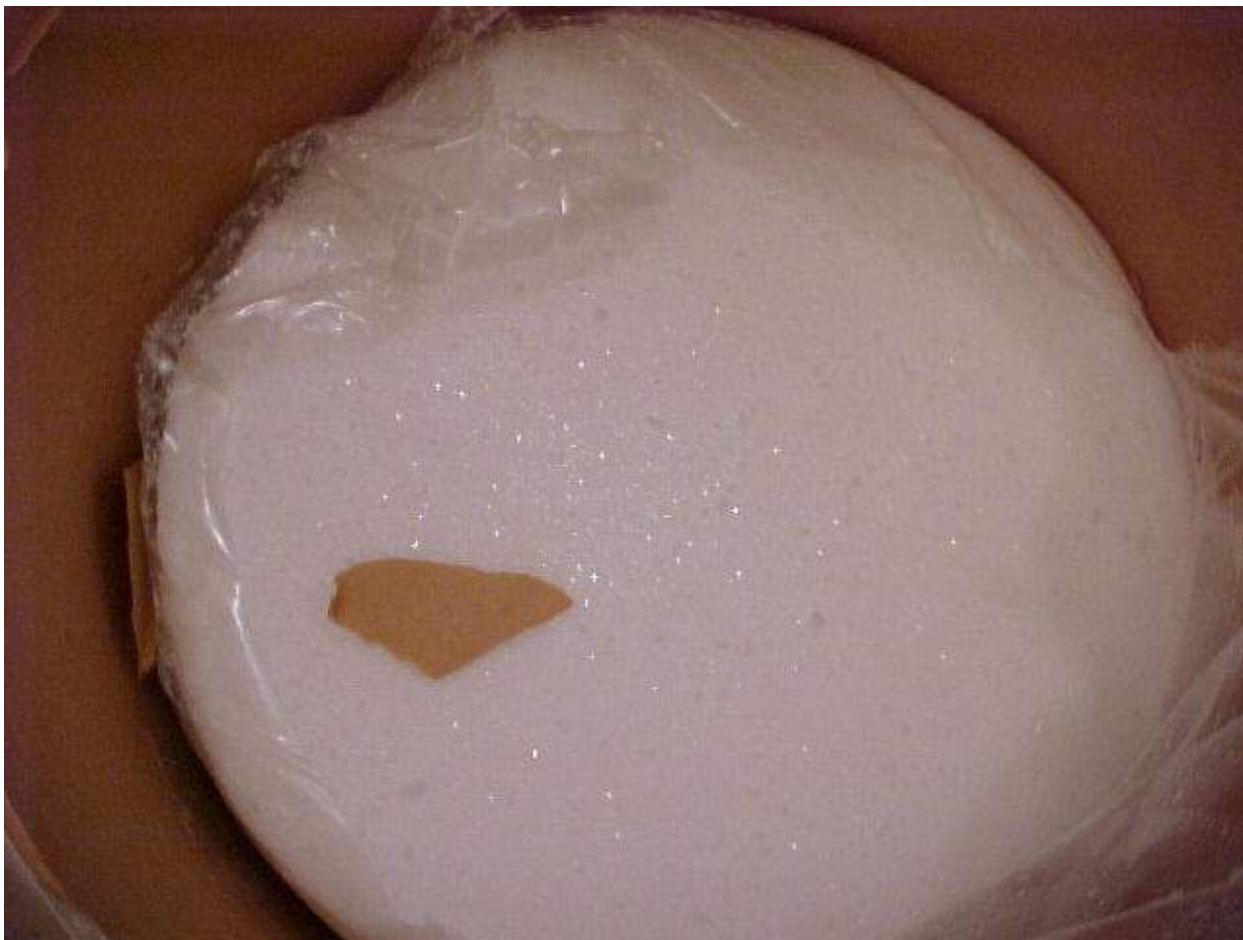
ThN material – monolith – white – solid – dry
No gases present in the breathing zone.

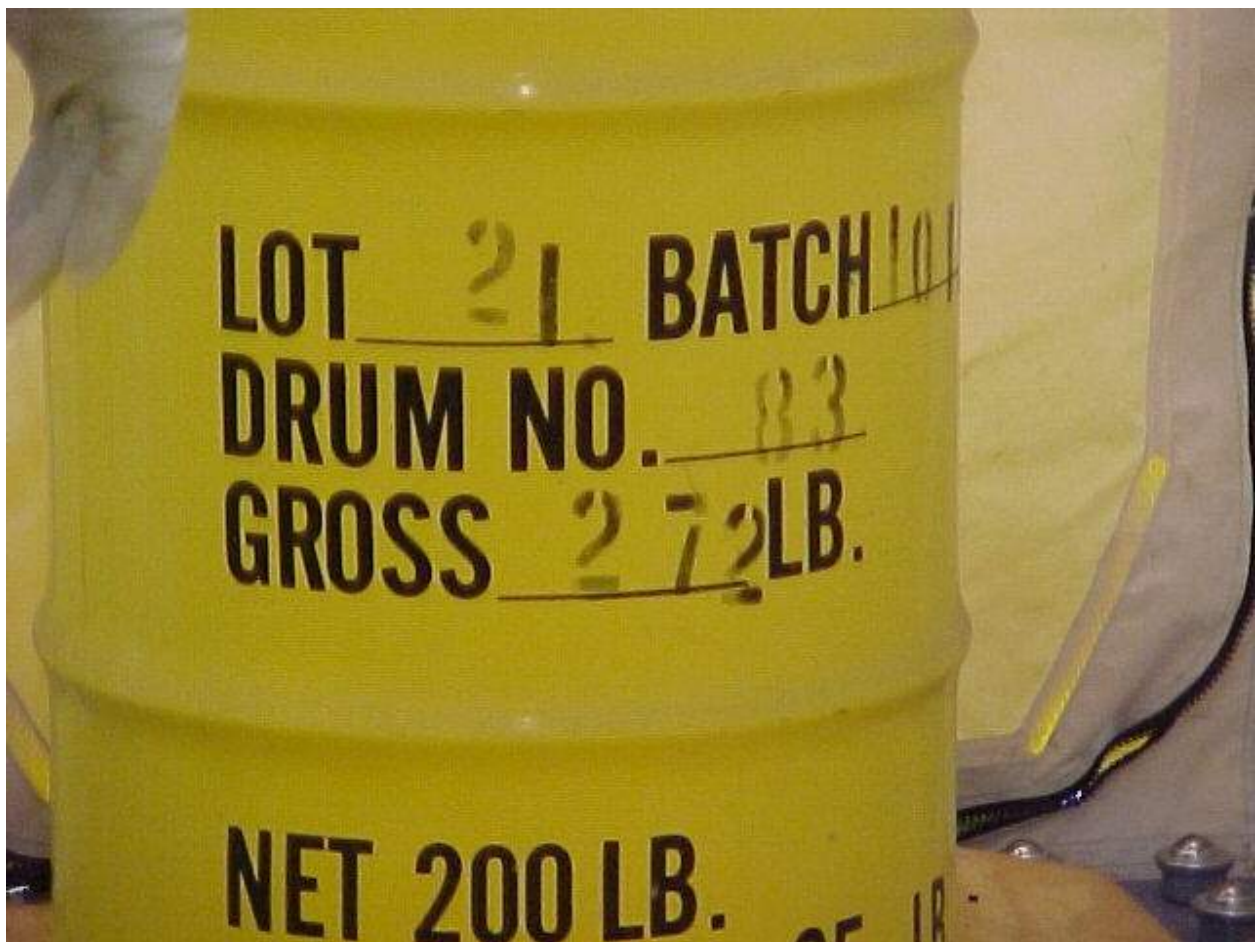
30-gal drum – good condition

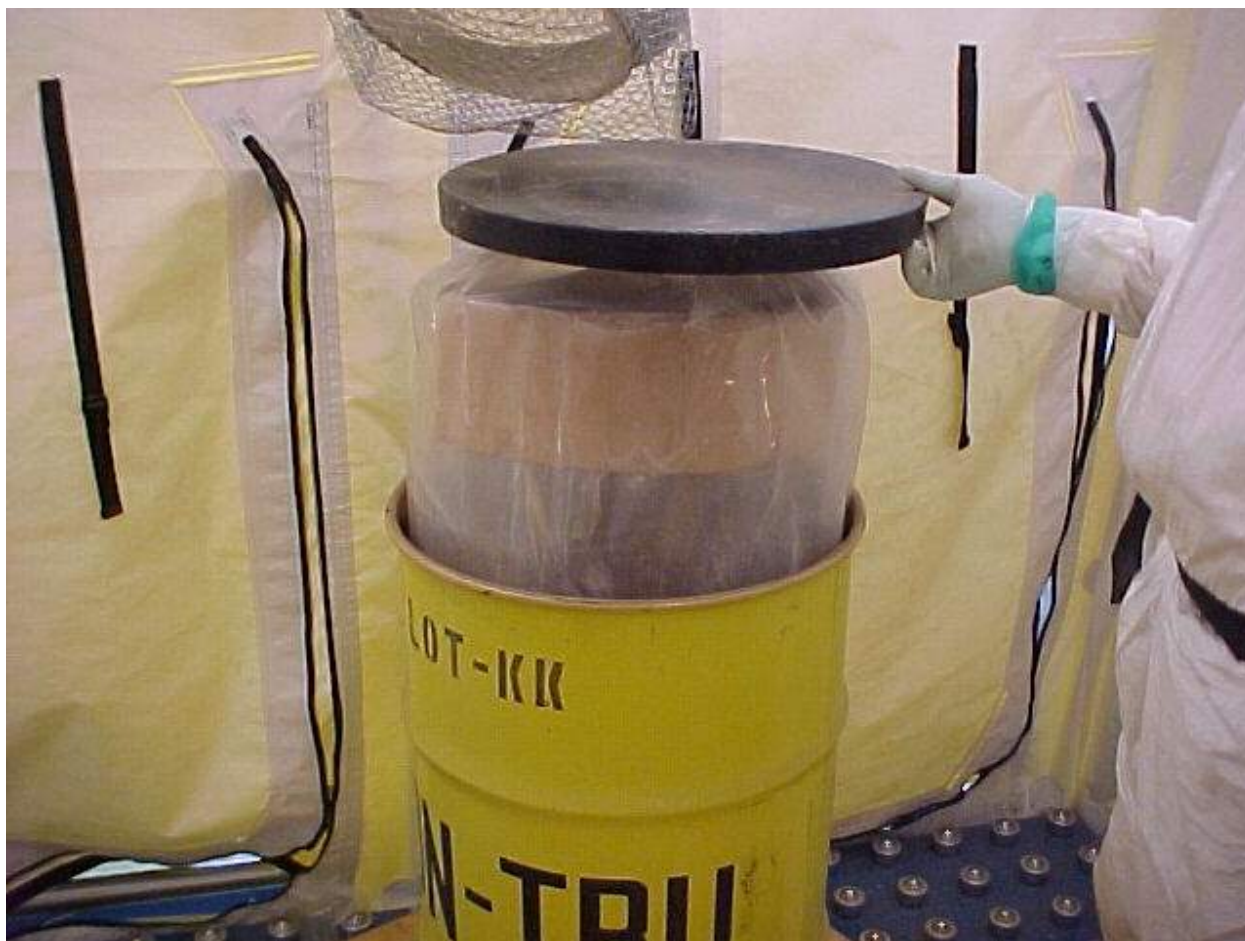
Black plastic lid – good condition

Pressure buildup internal to the container results in this packaging layer rising out of the container

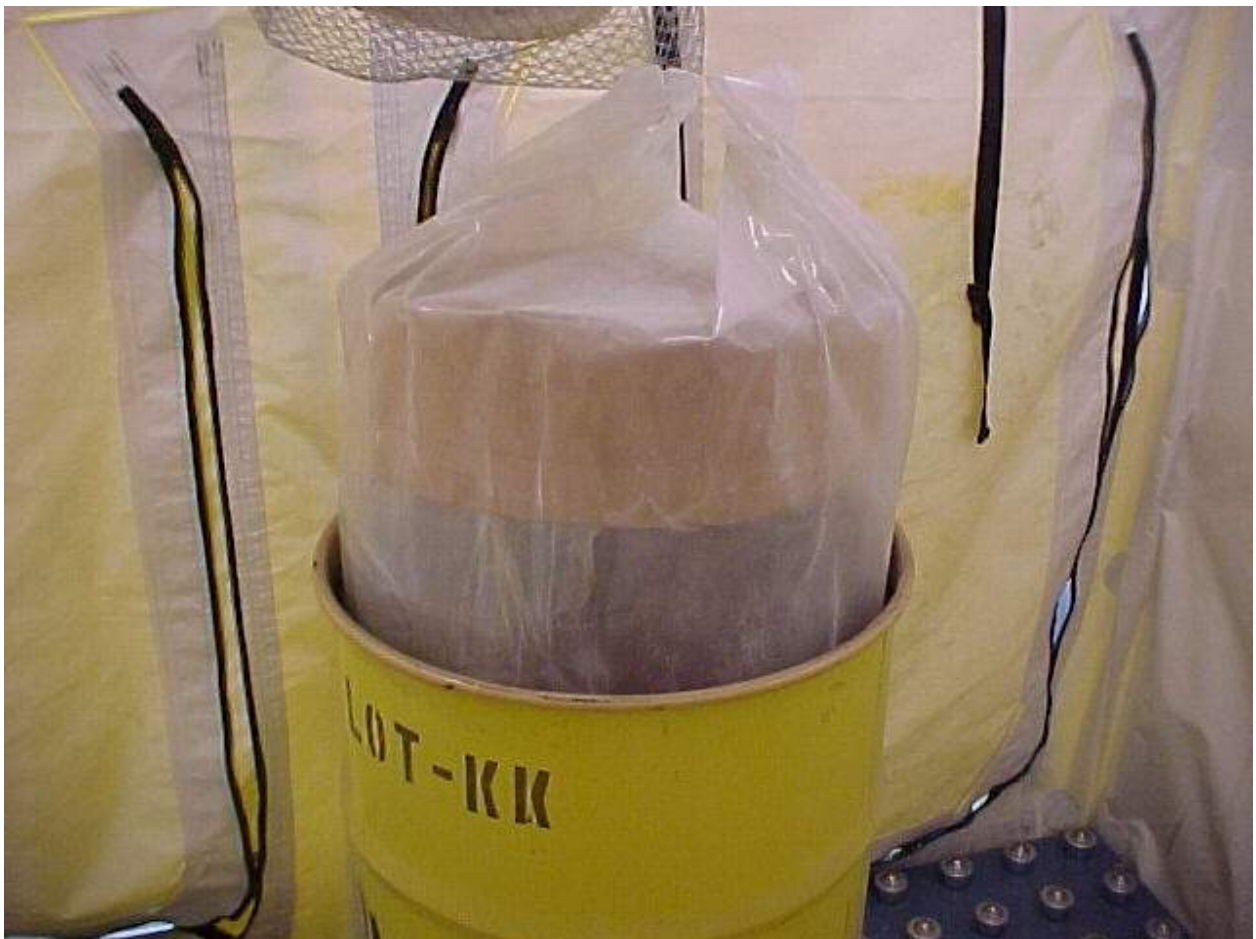
14:45**Other Information**Photo No. 3 of 10Dose Rate Surface 22 mR/hr
 1 meter 2.6 mR/hr1st poly liner/bag – good conditionPressure buildup internal to the container results in this packaging layer rising out of the container
No gases present in the breathing zone.

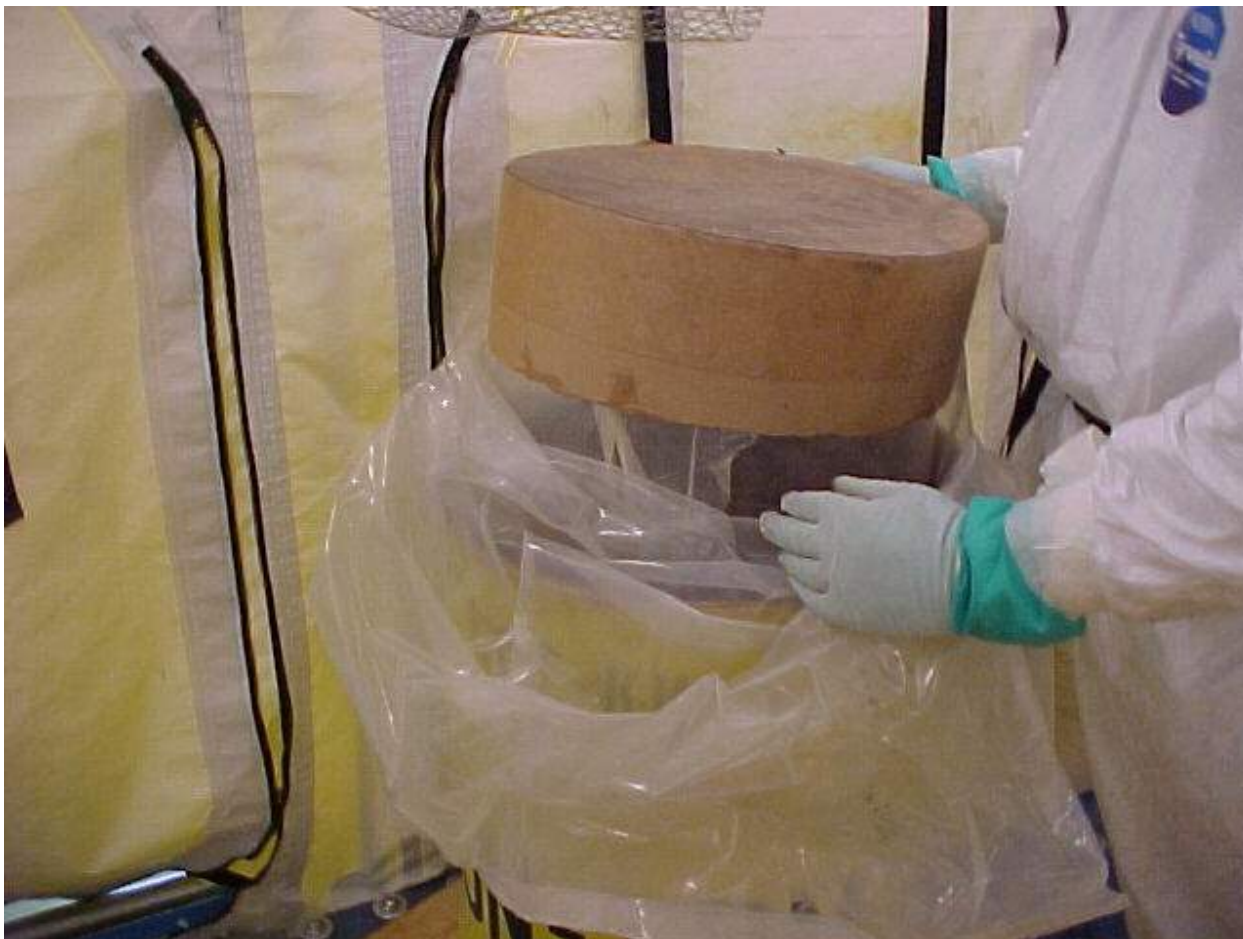
Fiber drum lid – good condition

Pressure buildup internal to the container results in this packaging layer rising out of the container
No gases present in the breathing zone.

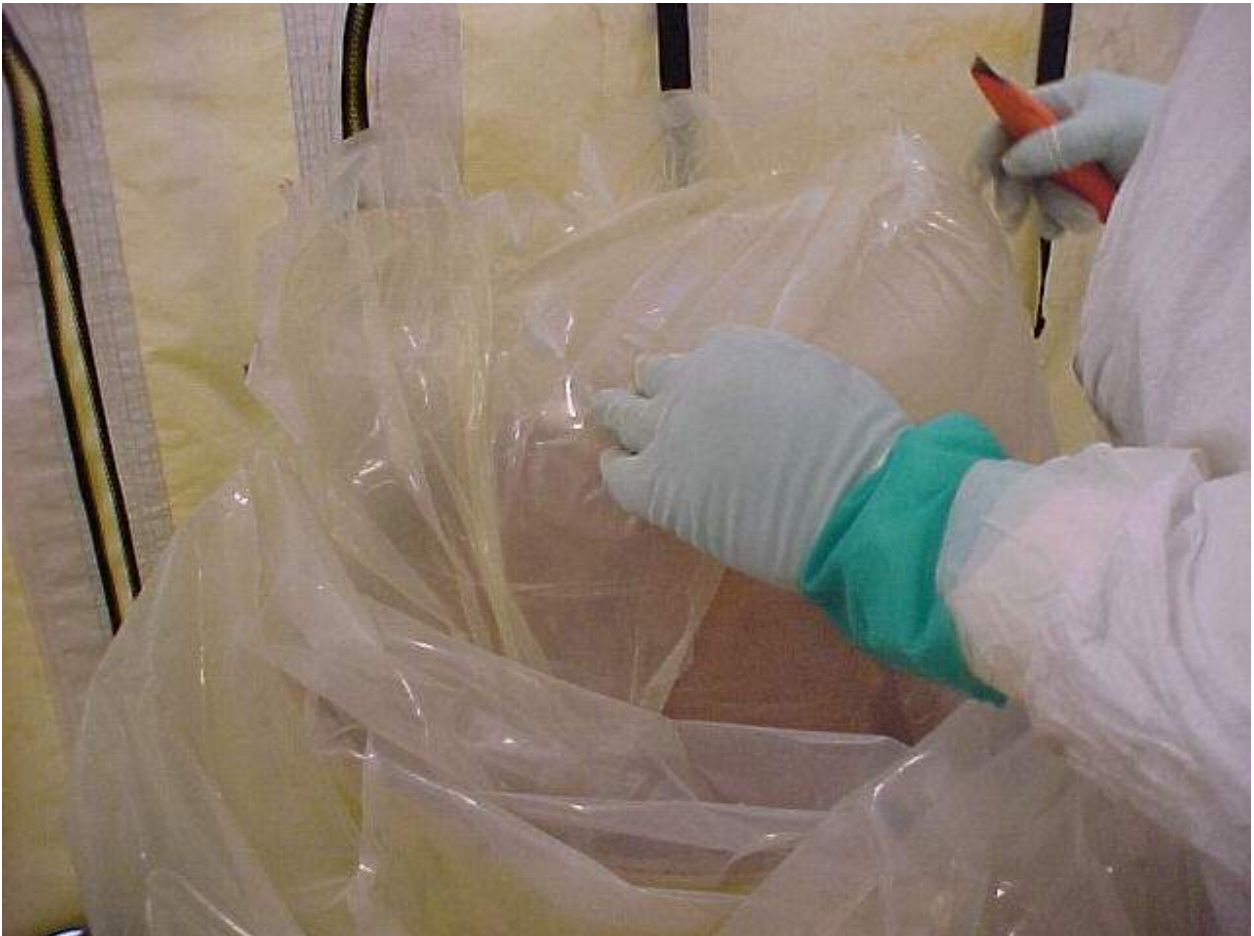
14:45**Other Information**Photo No. 5 of 10Dose Rate Surface 22 mR/hr
 1 meter 2.6 mR/hr2nd poly liner/bag – good conditionPressure buildup internal to the container results in this packaging layer rising out of the container
No gases present in the breathing zone.

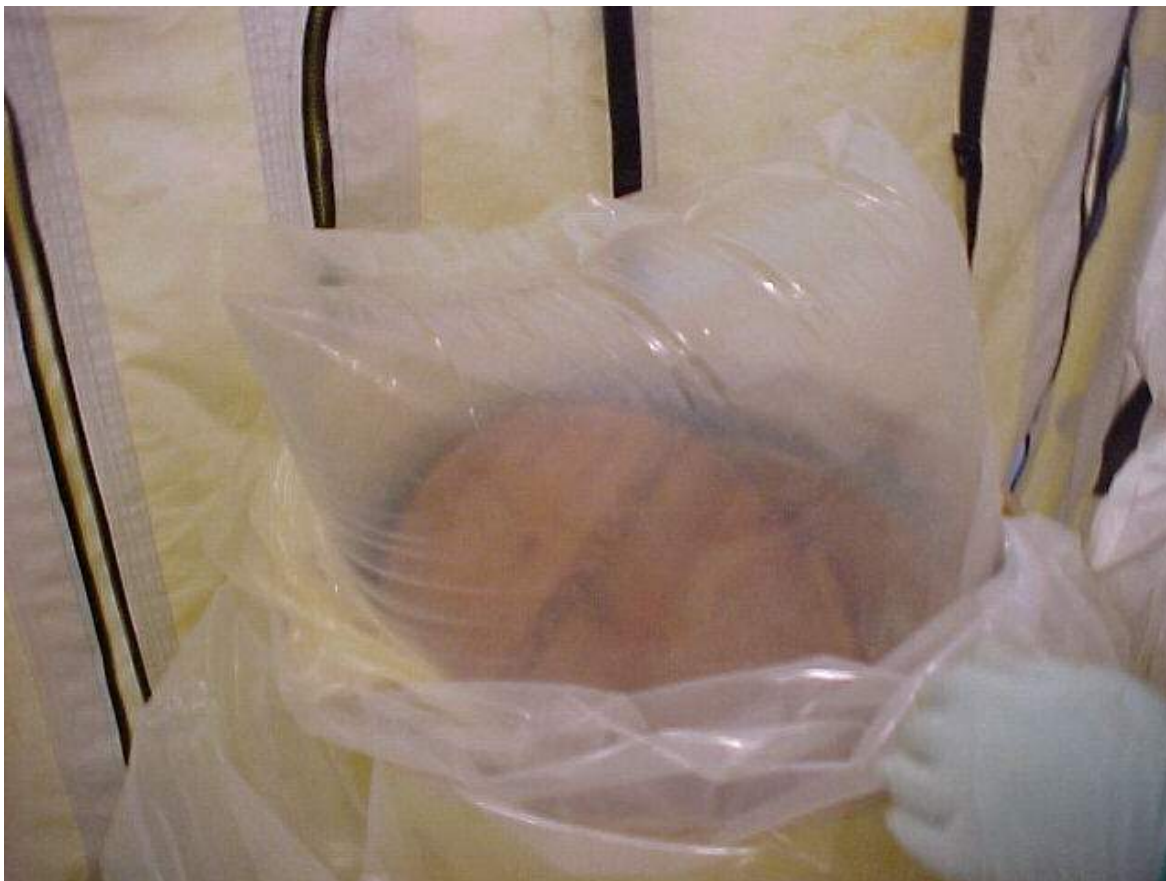
3rd poly liner/bag – good condition

Gases in headspace – CH₄ – 4.1% LEL - NO – +50 ppm - NO_x - +50 ppm

Drum vented with HEPA exhaust to 0% LEL and 0 ppm respectively

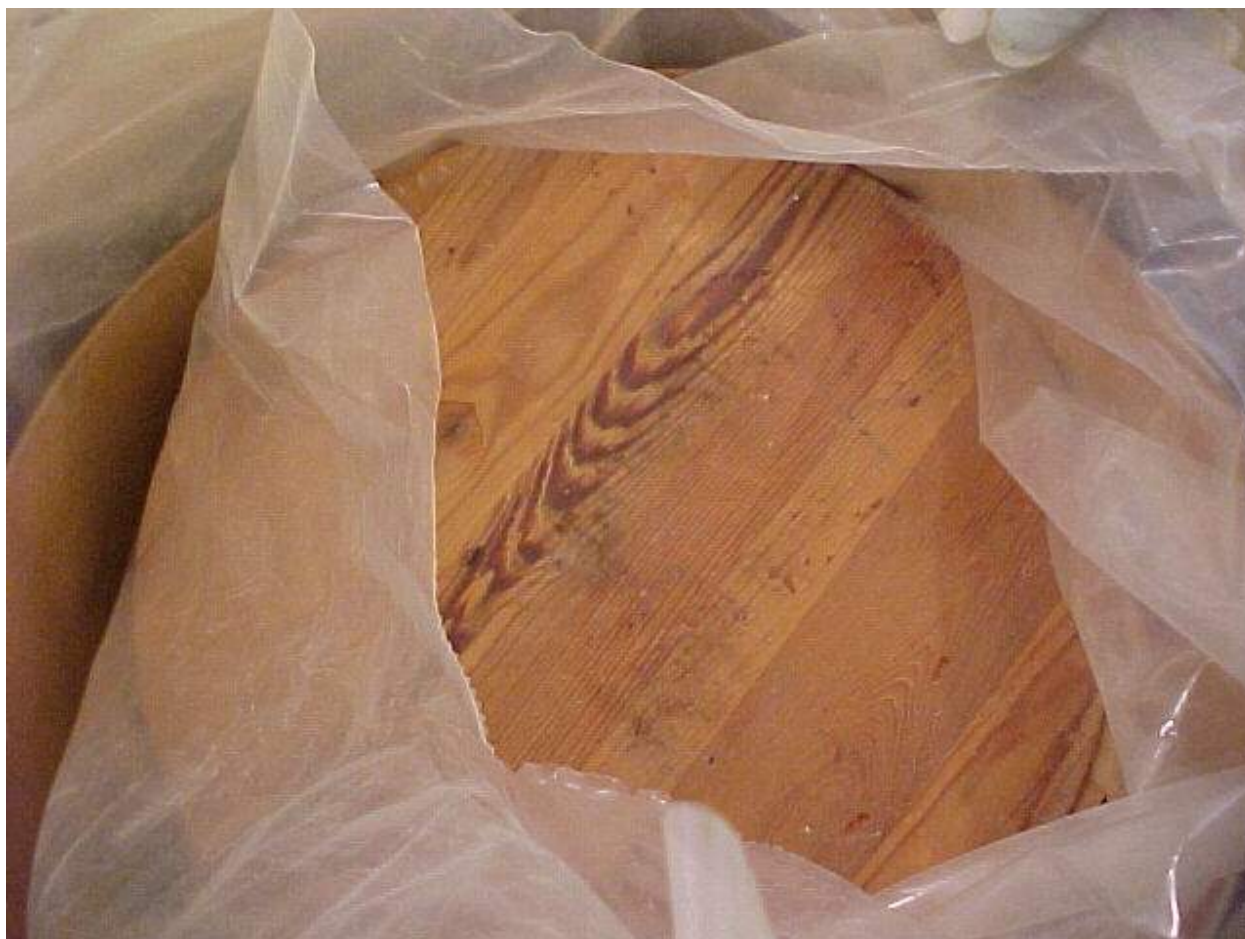
Wooden lid – good condition
No gases present in the breathing zone.

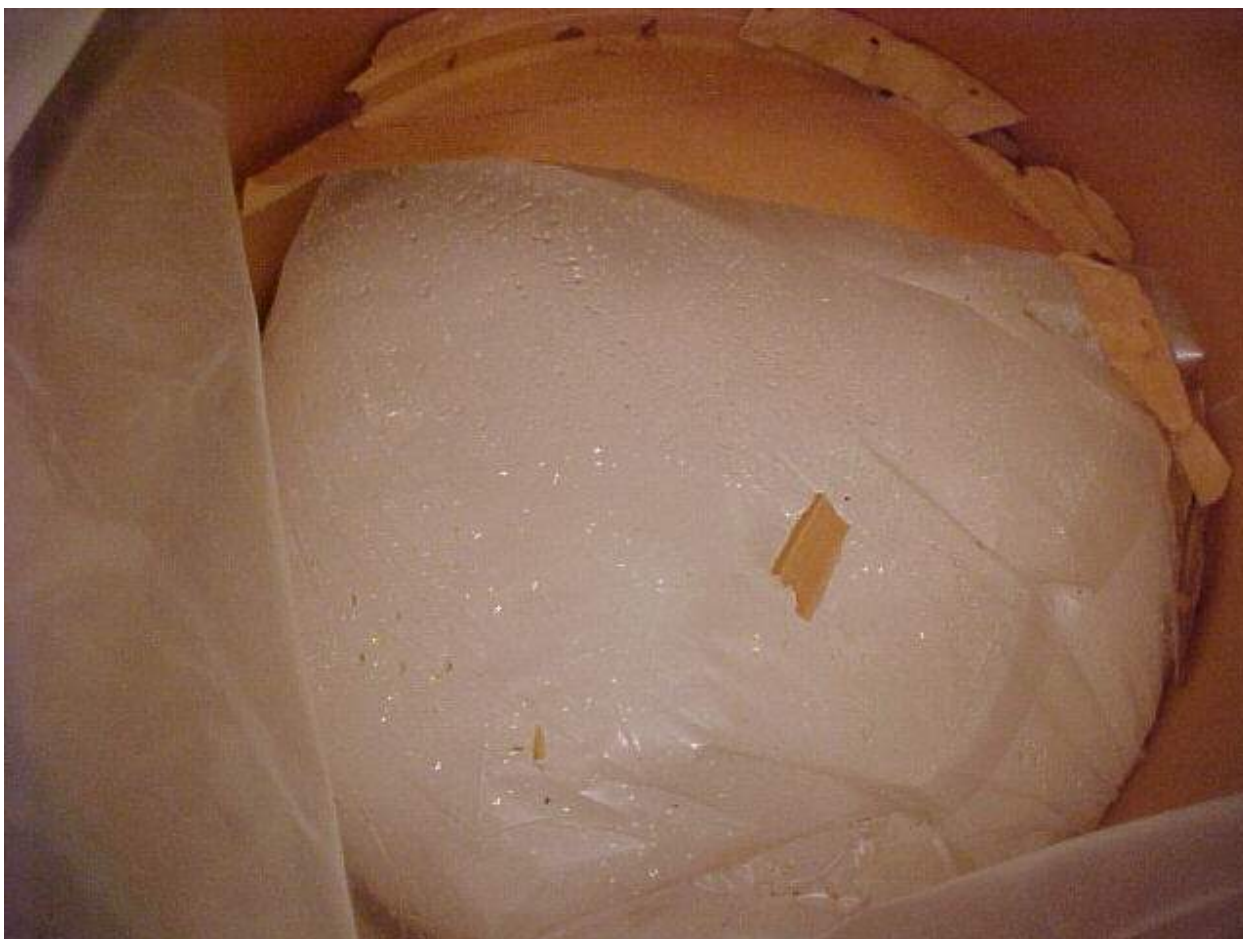
4th poly liner/bag – good condition (inflated bag delineates gas generation from ThN material)
No gases present in the breathing zone.
