THORIUM NITRATE STOCKPILE DRUM CHARACTERIZATION REPORT

**THORIUM NITRATE STOCKPILE
DRUM CHARACTERIZATION REPORT**

Prepared for
U.S. Defense Logistics Agency
Defense National Stockpile Center
Fort Belvoir, Virginia

Prepared by
OAK RIDGE NATIONAL LABORATORY
Oak Ridge, Tennessee 37831
managed by
UT-BATTELLE, LLC
for the
U.S. DEPARTMENT OF ENERGY
under contract DE-AC05-00OR22725

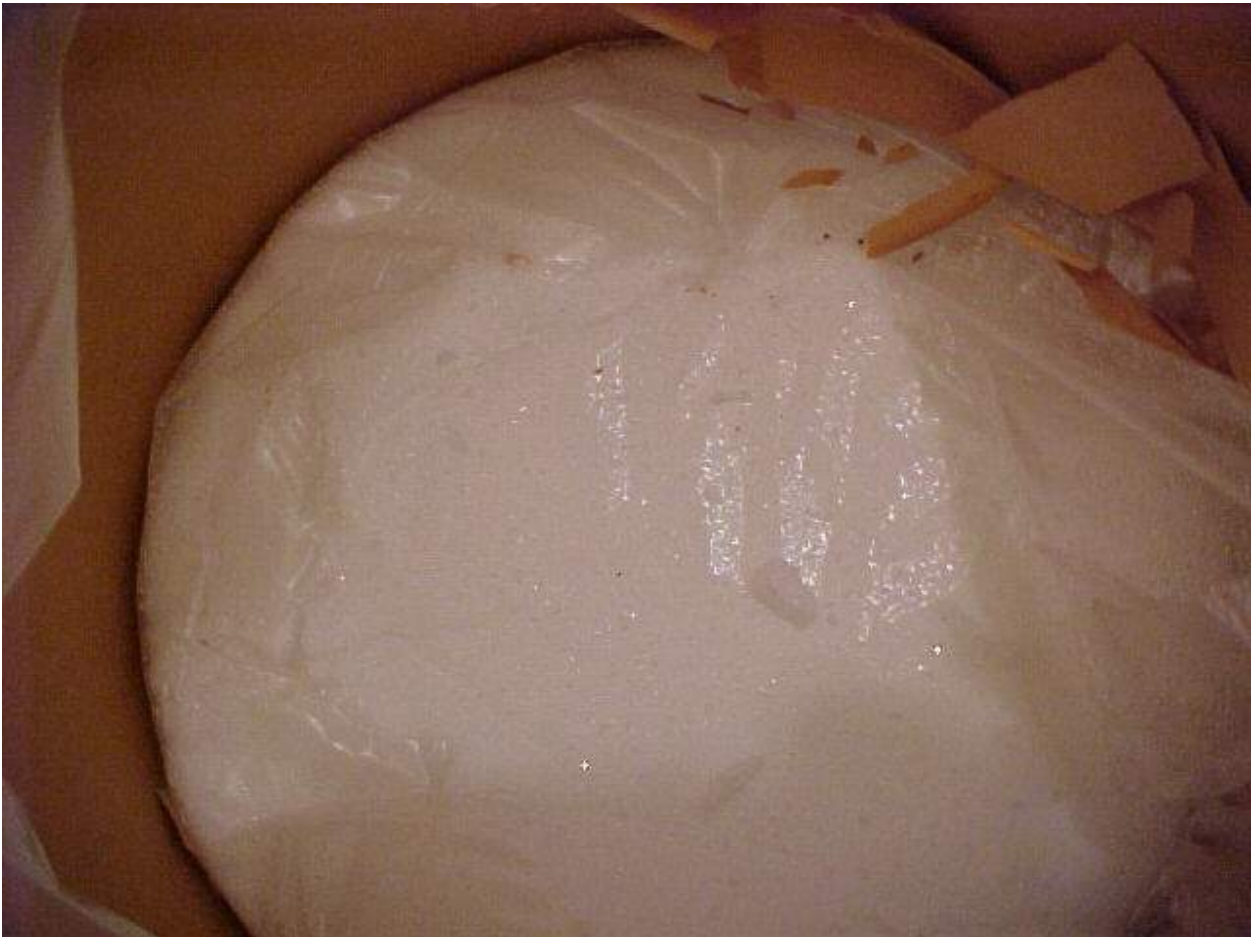
14:45**Other Information**Photo No. 9 of 10Dose Rate Surface 22 mR/hr
 1 meter 2.6 mR/hrThN material – monolith – white – solid – dry
No gases present in the breathing zone

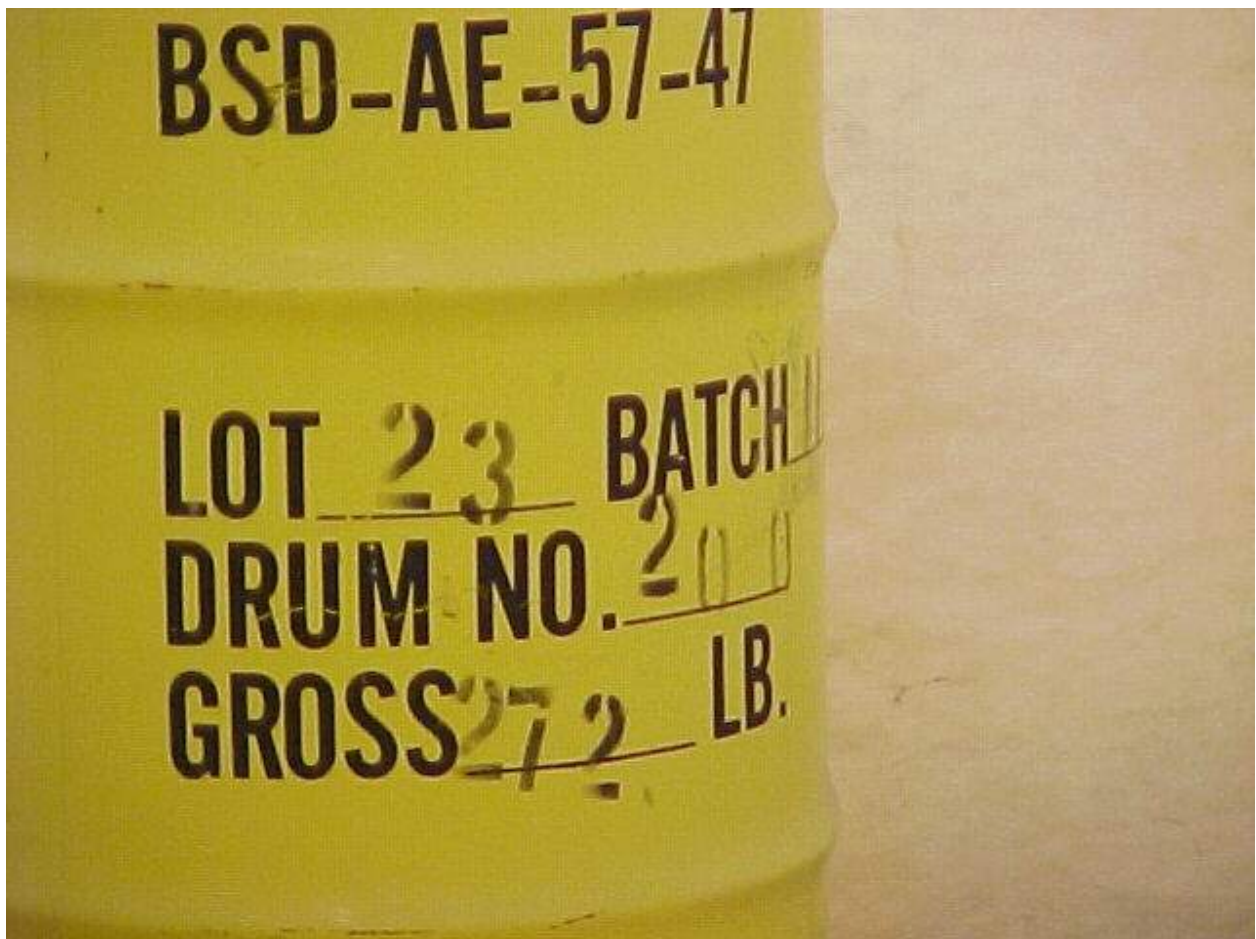
30-gal drum – good condition

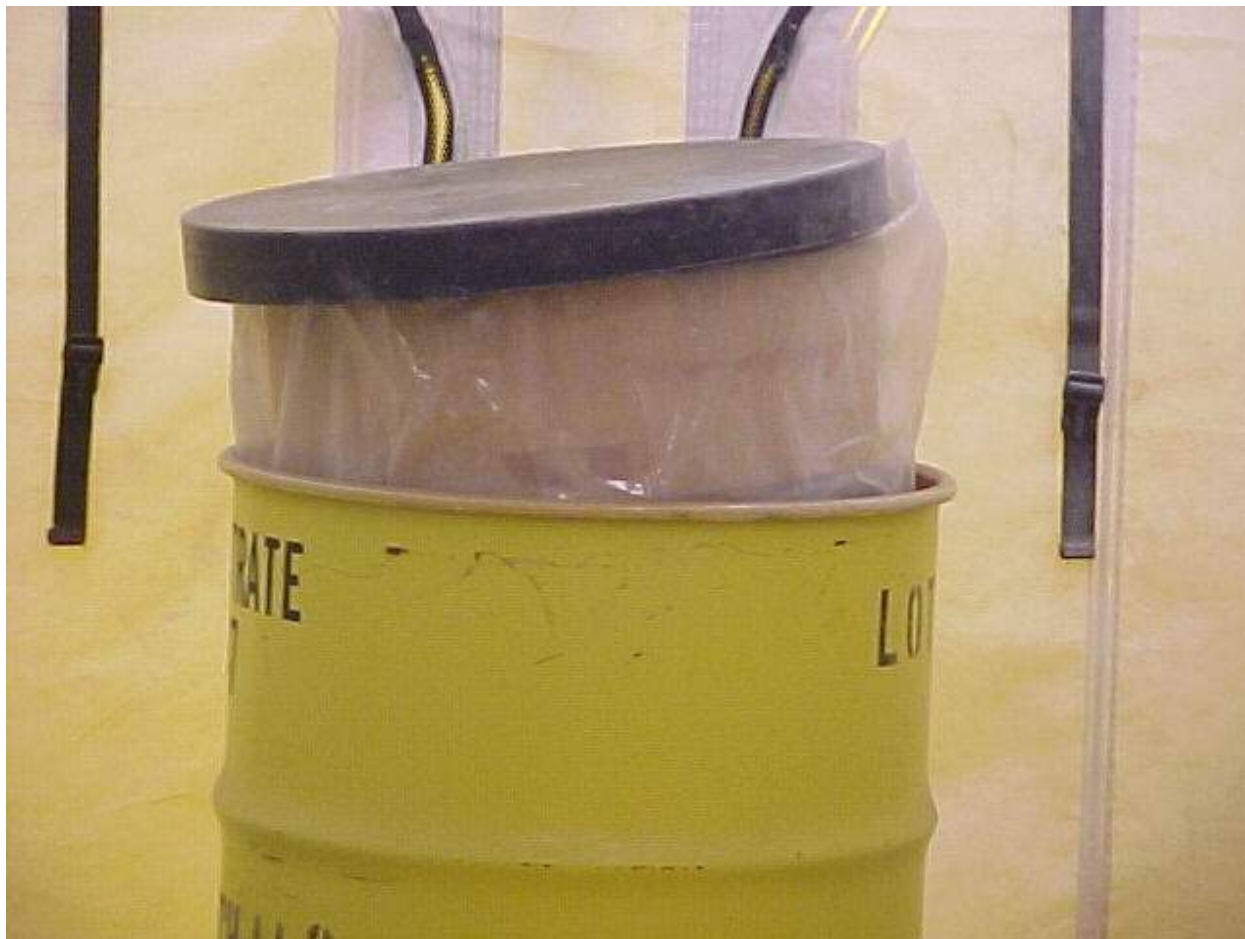
Black plastic lid – good condition

Pressure buildup inside of the container results in raising this layer vertically out of the container.

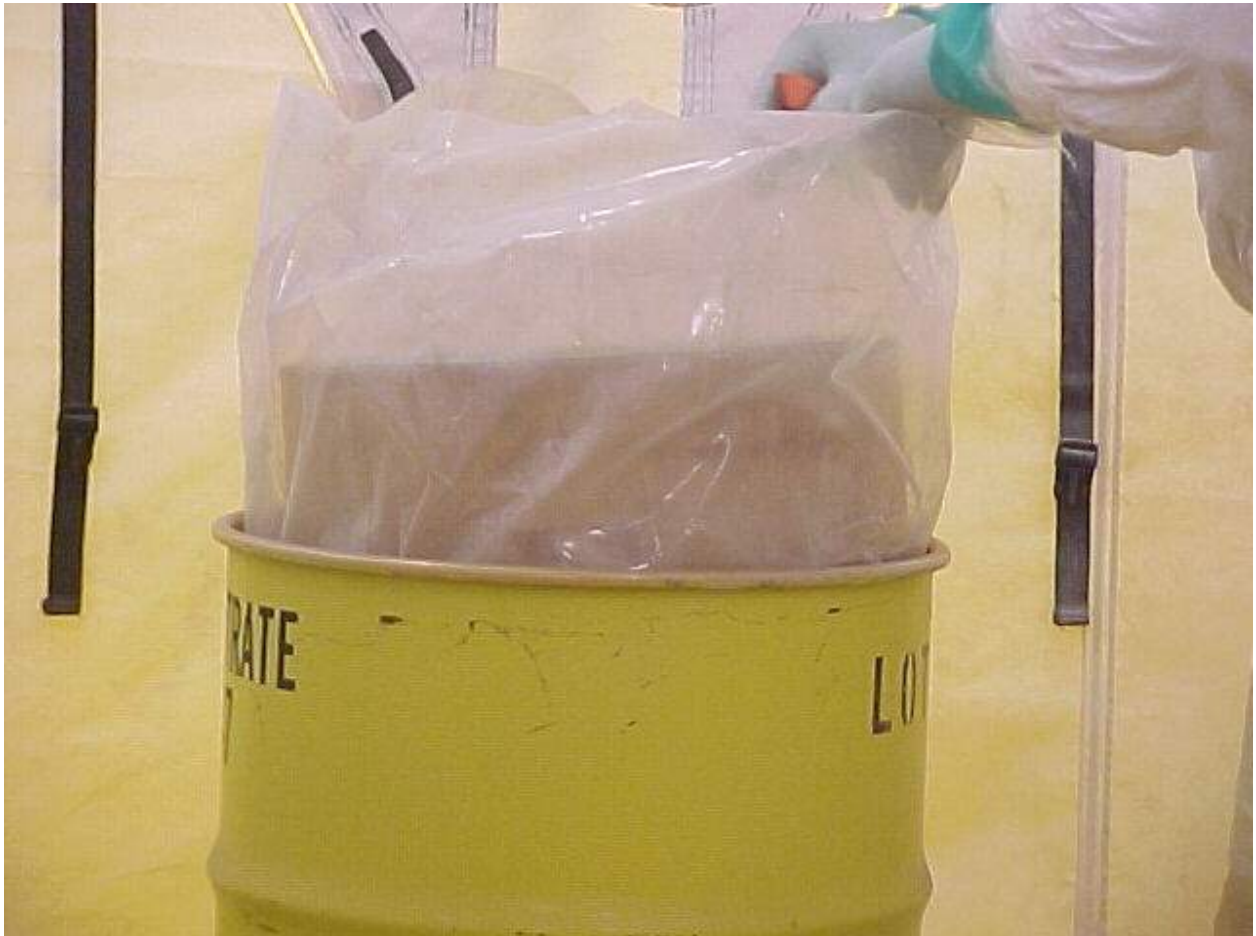
10:30**Other Information**Photo No. 3 of 11Dose Rate Surface 22 mR/hr
 1 meter 2.6 mR/hr1st poly liner/bag – good condition

Pressure buildup inside of the container results in raising this layer vertically out of the container.

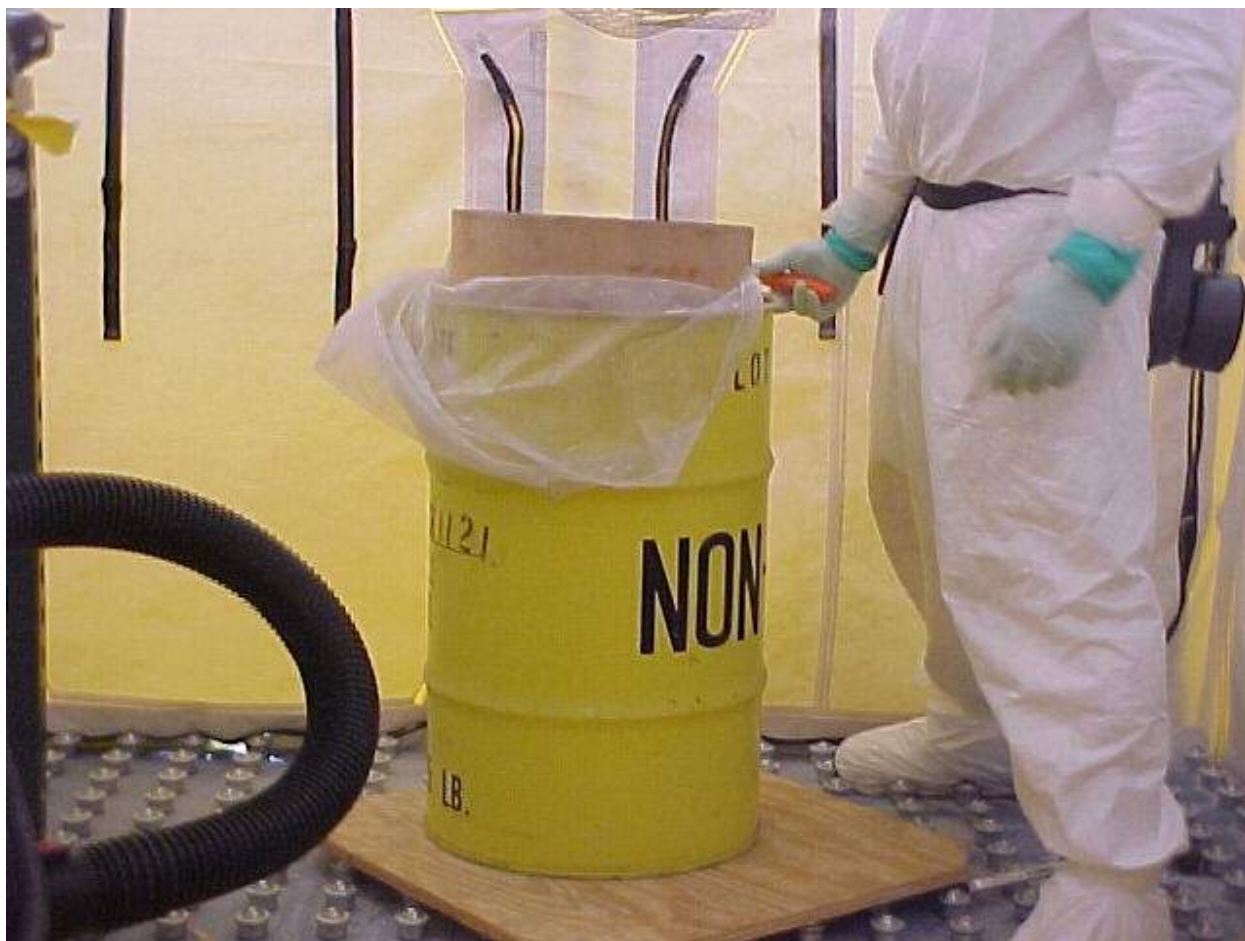
Fiber lid (on outermost fiber drum inside of the 30-gal drum) – good condition
Pressure buildup inside of the container results in raising this layer vertically out of the container.
No gases present in the breathing zone.

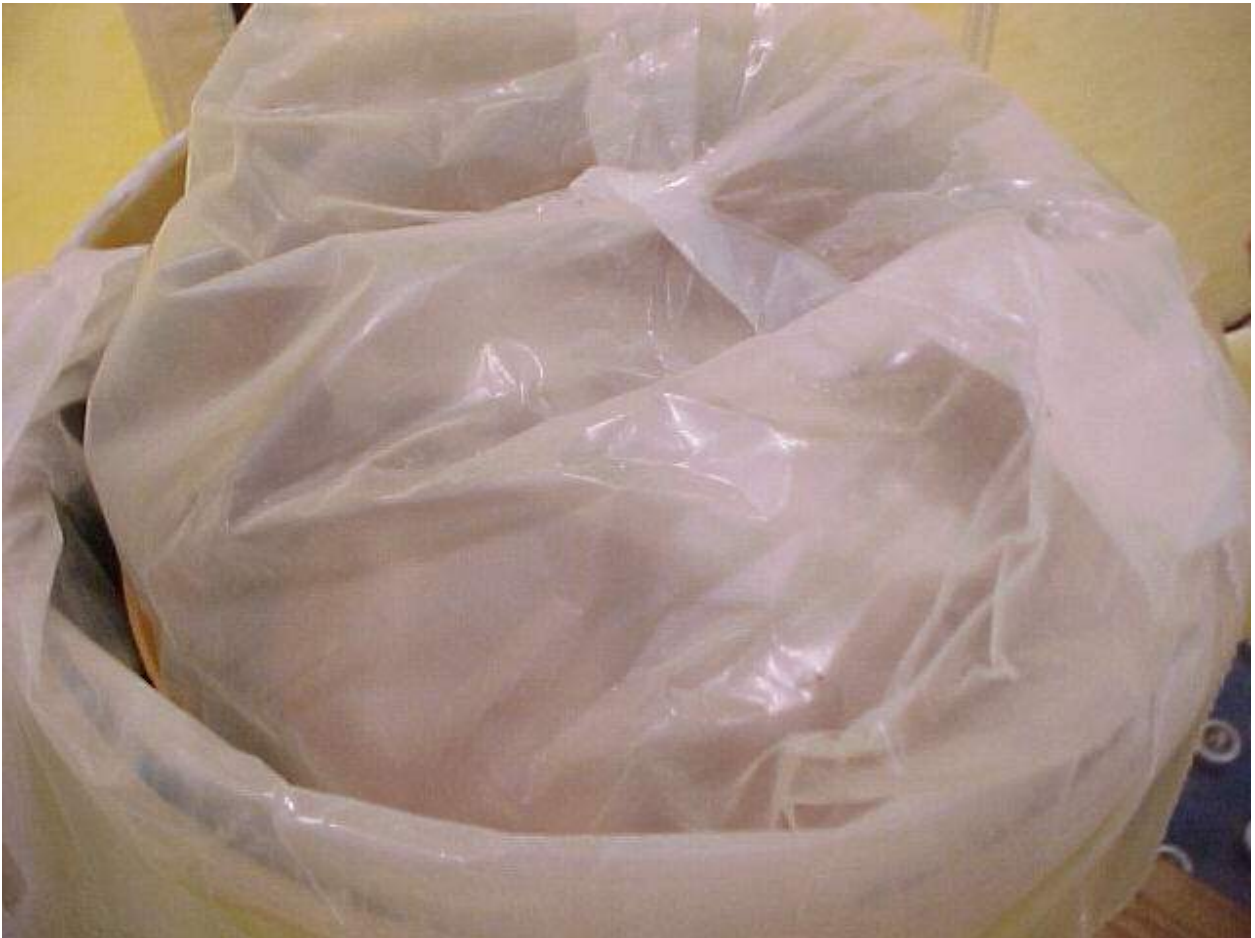
10:30**Other Information**Photo No. 5 of 11Dose Rate Surface 22 mR/hr
 1 meter 2.6 mR/hr2nd poly liner/bag – good condition

Pressure buildup internal to container results in raising this layer vertically out of the container.

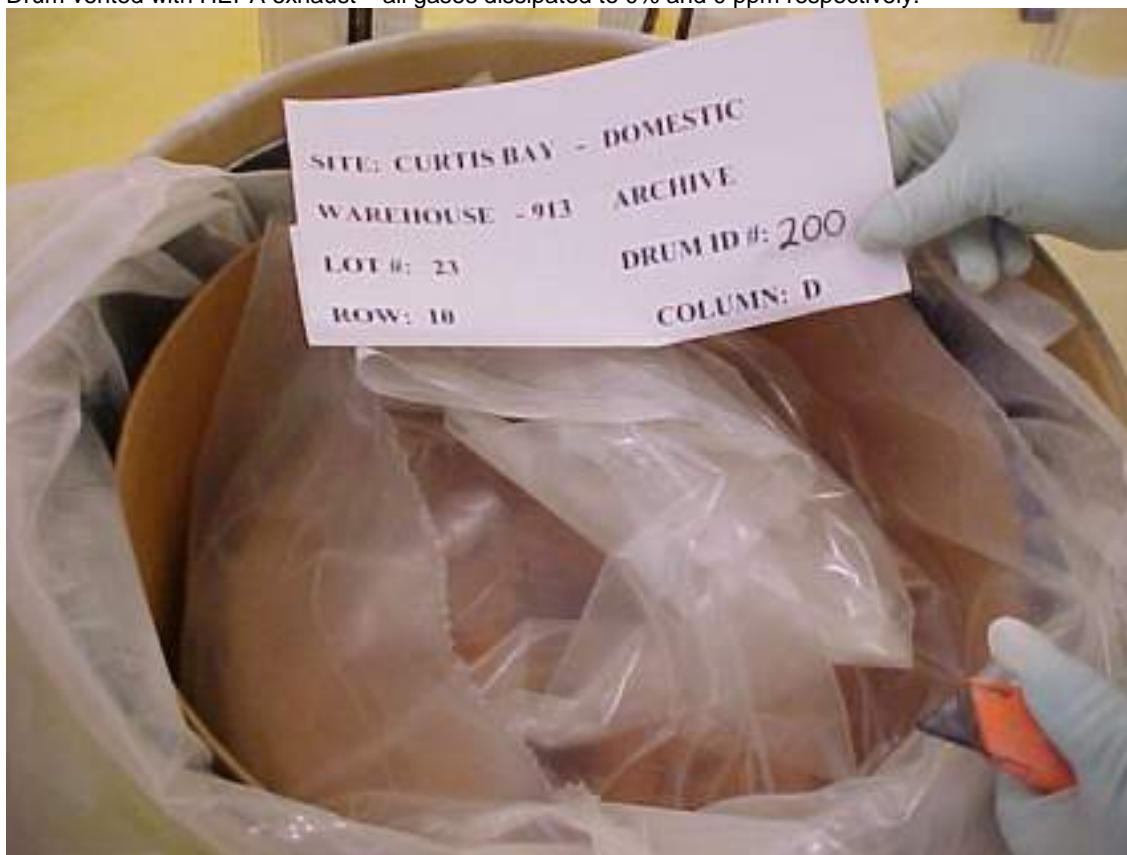
3rd poly liner/bag – good condition

Gases in headspace – CH₄ – 4.6% LEL - NO - +50 ppm - NO_x - +50 ppm

Drum vented with HEPA exhaust – all gases dissipated to 0% and 0 ppm respectively.

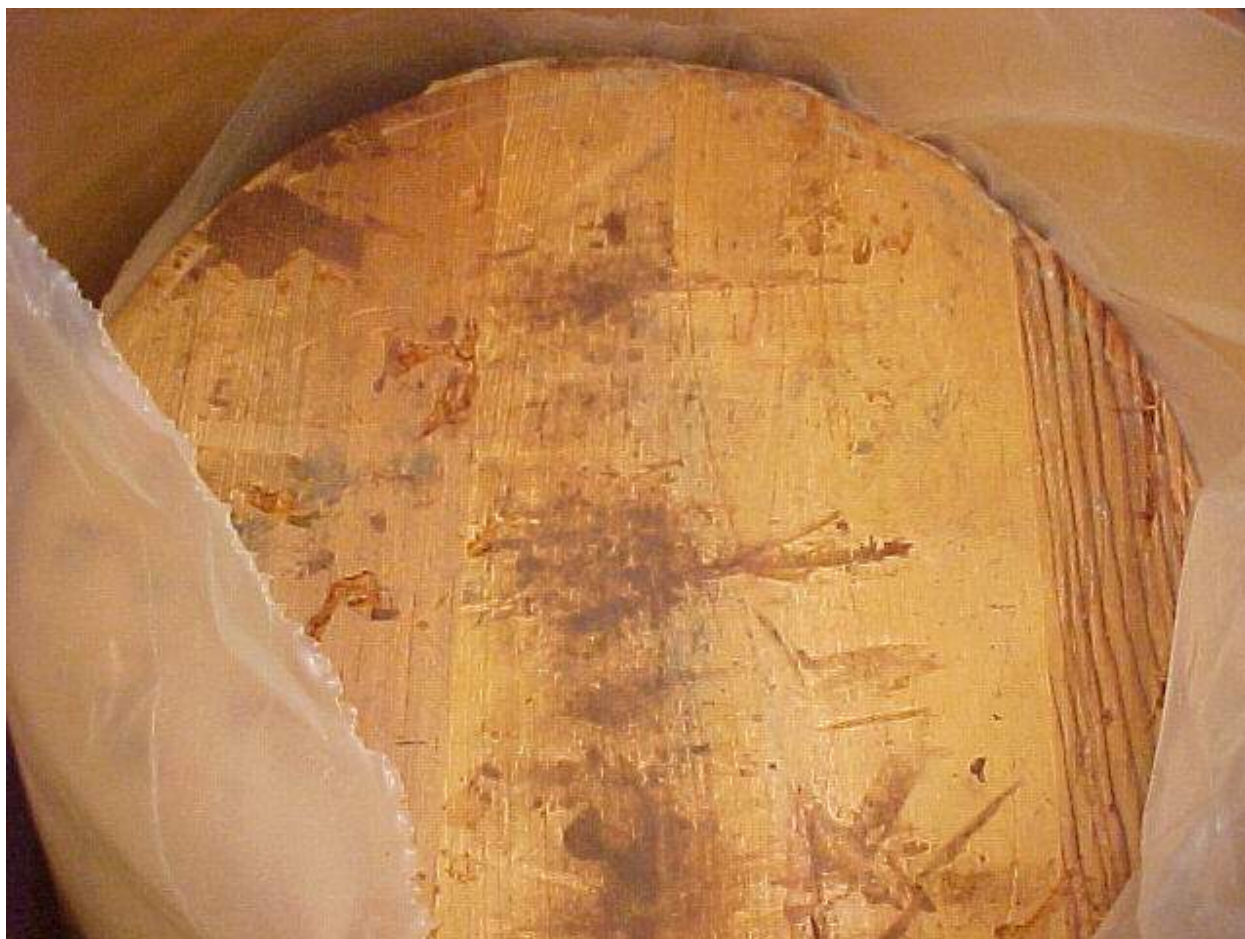
Wooden lid (mounted on lab-pack/fiber drum container) – good condition
No gases present in the breathing zone.

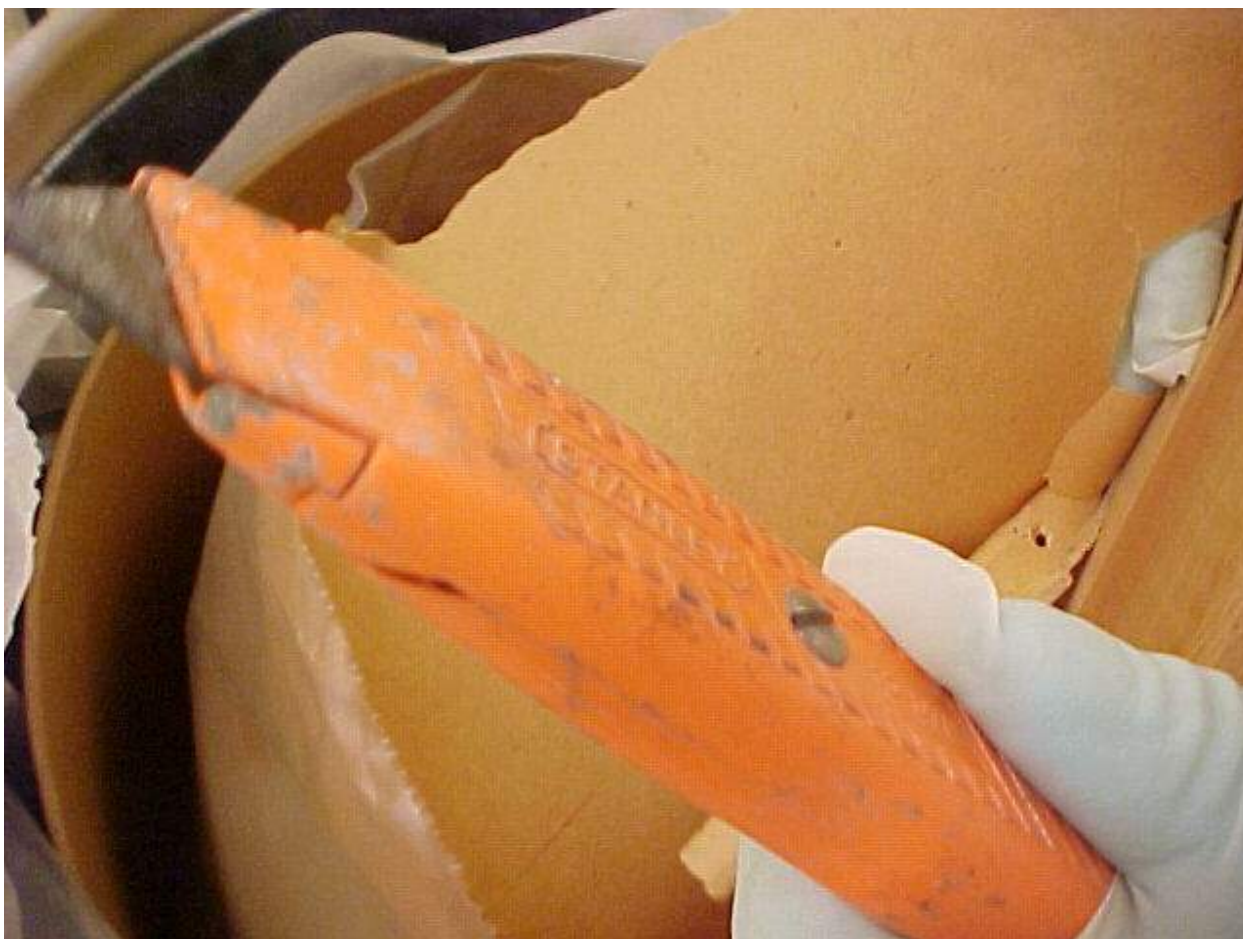
Lab-pack container lid (paper layer below wooden lid)
No gases present in the breathing zone.

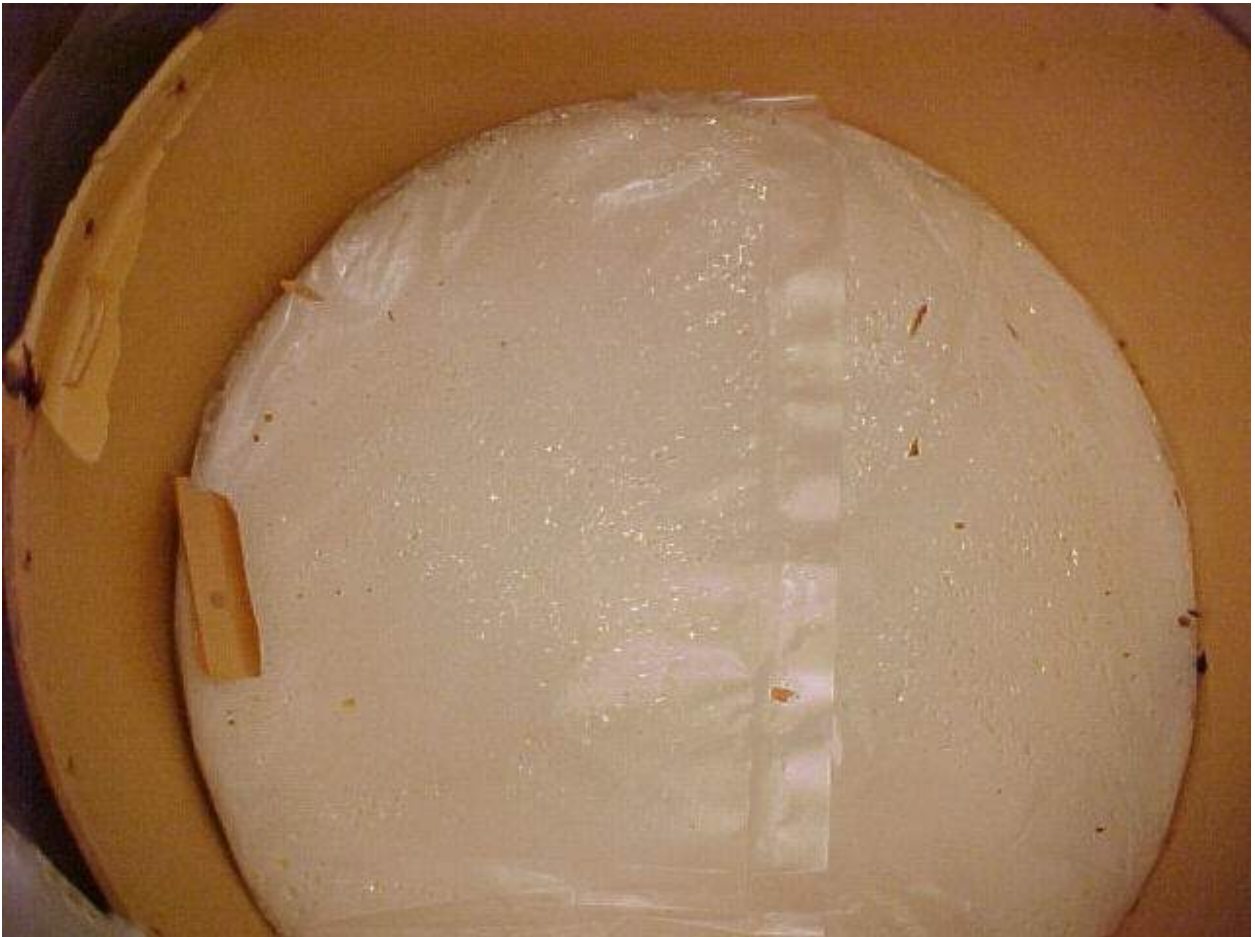
4th poly liner/bag – good condition (inflated bag indicates gas generation from ThN material)
No gases present in the breathing zone.

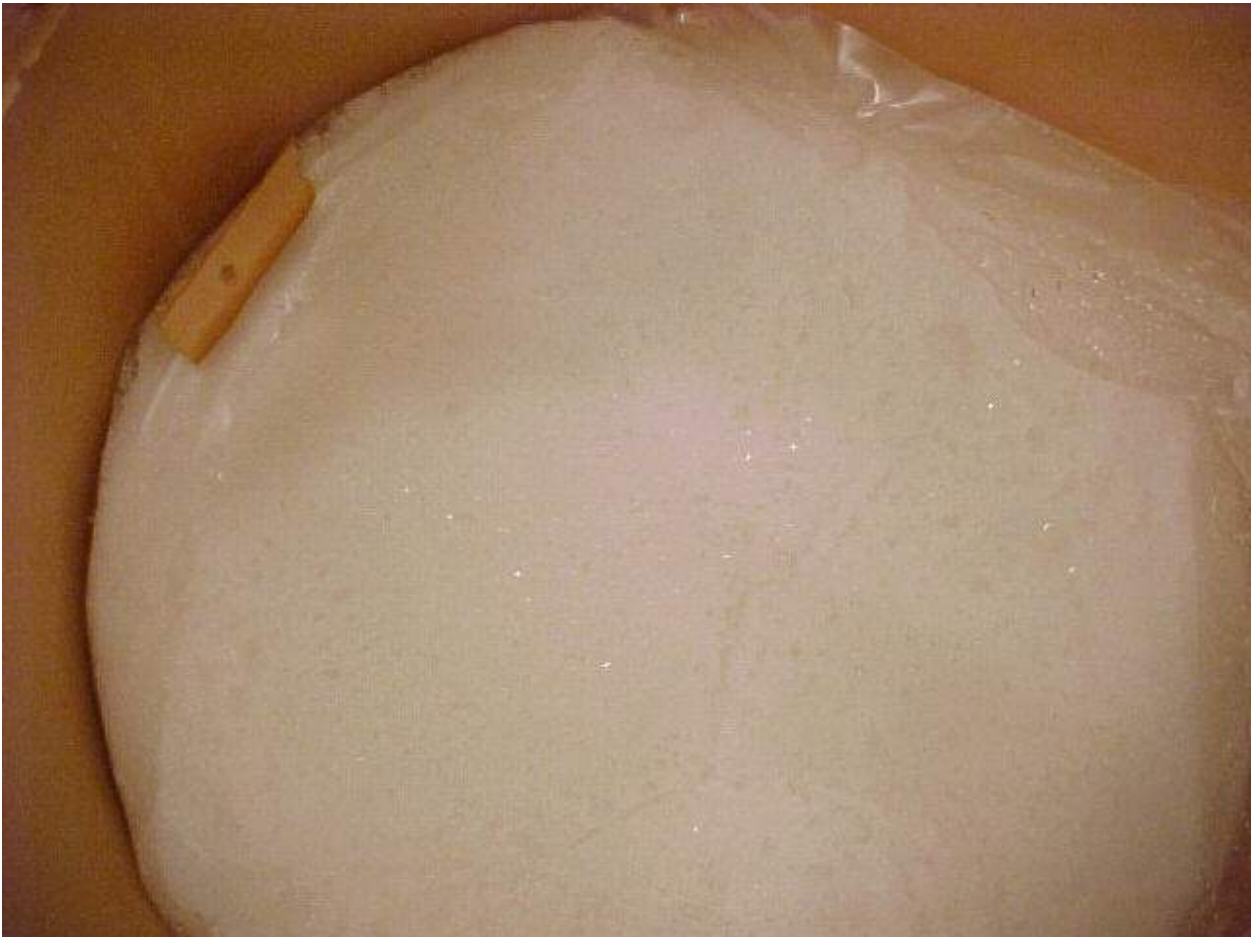
ThN material – monolith – white – solid – dry
No gases present in the breathing zone.

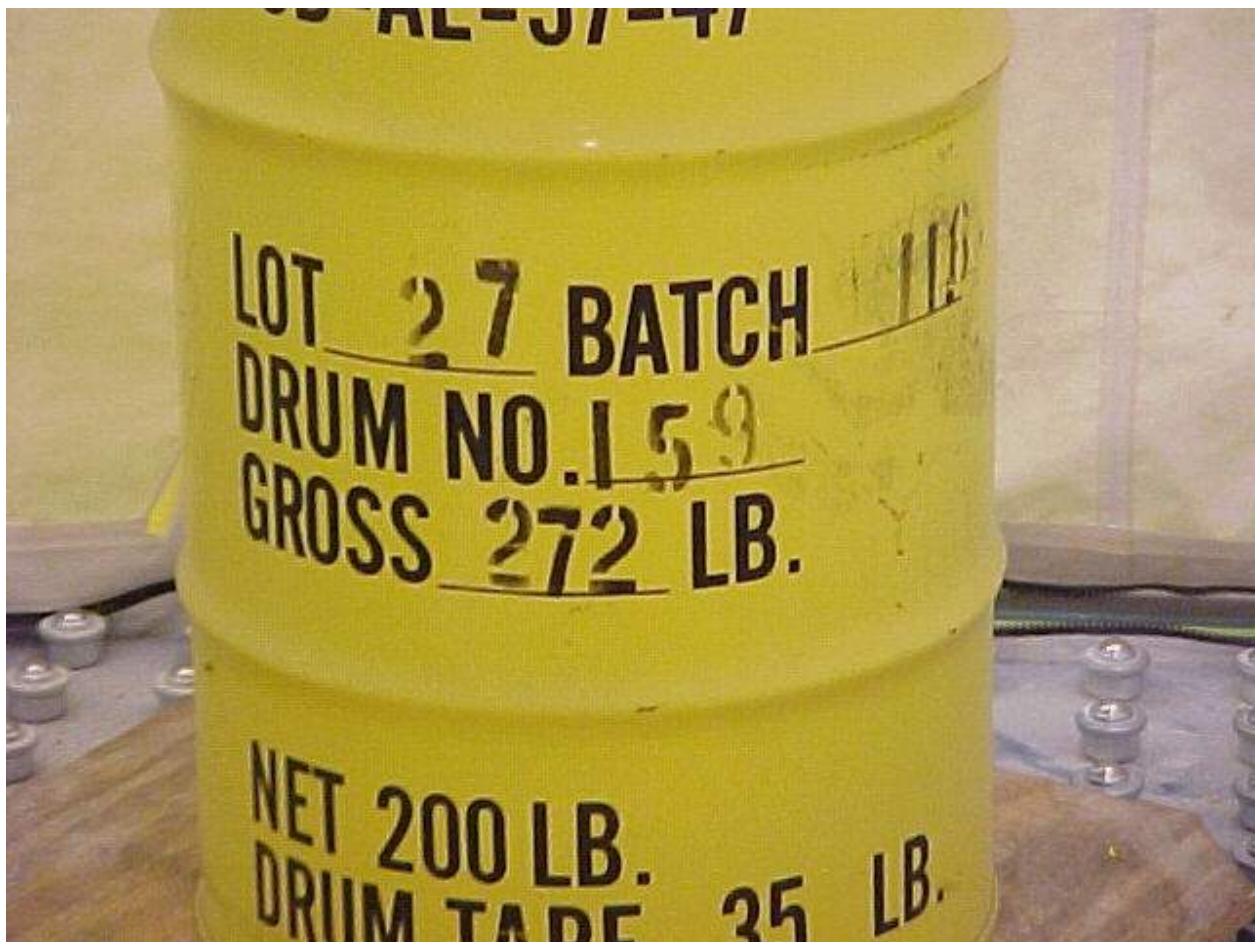
14:00**Other Information**Photo No. 1 of 11Dose Rate Surface 22 mR/hr
 1 meter 2.6 mR/hr

30-gal drum – good condition

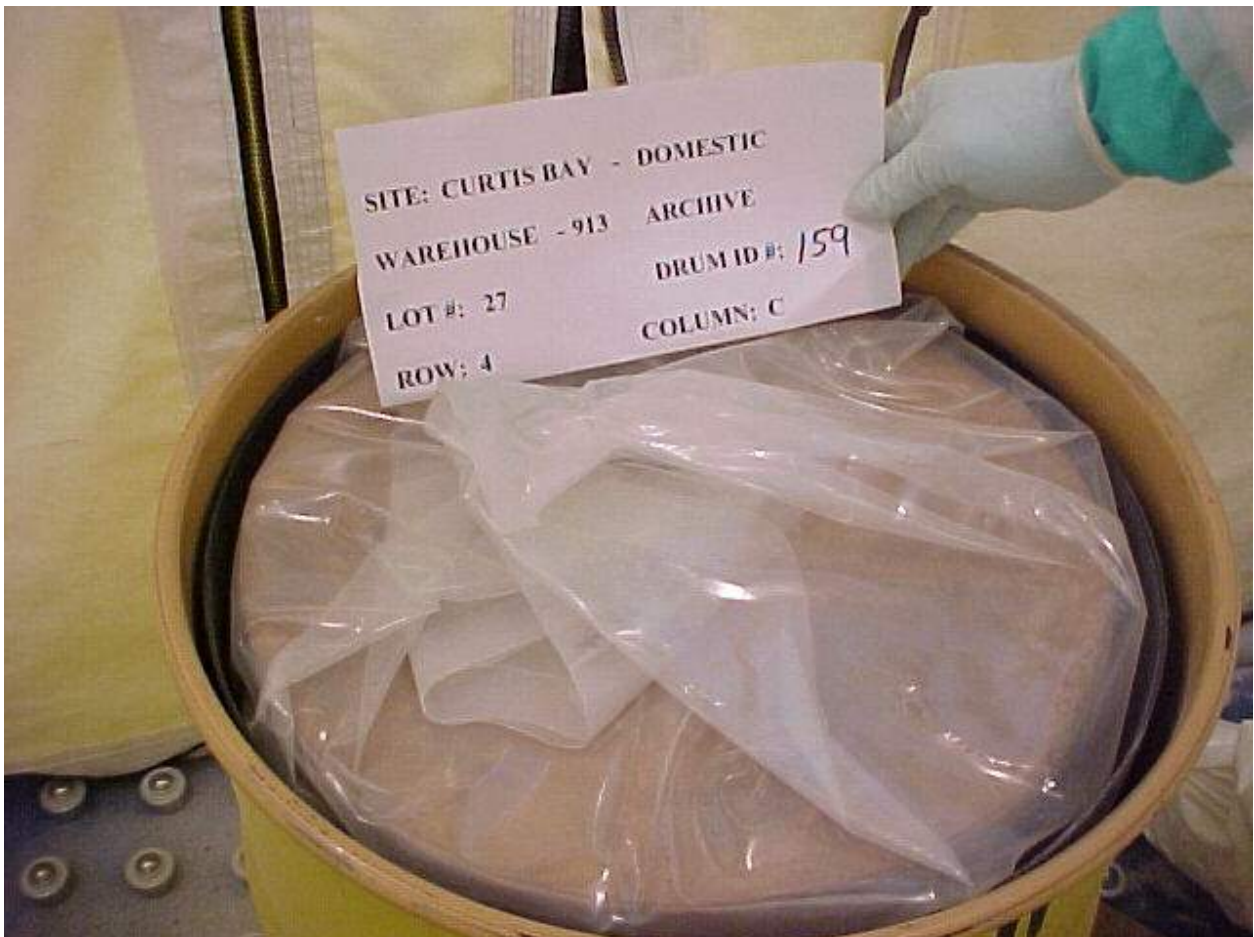
1st poly liner/bag – good condition
 No gases present in the breathing zone.

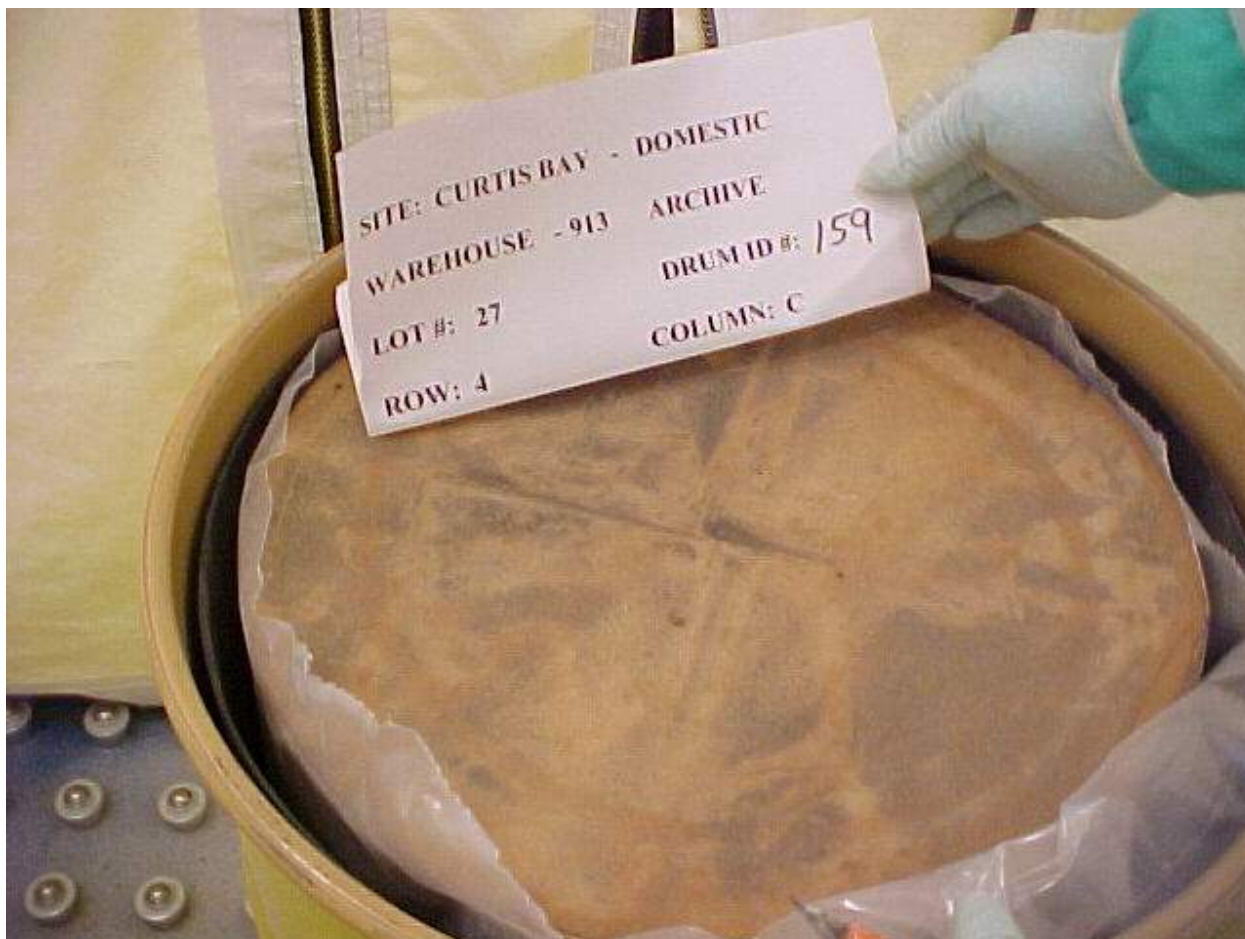
Fiber drum lid (on outermost fiber drum inside of 30-gal drum) – good condition
No gases present in breathing zone.

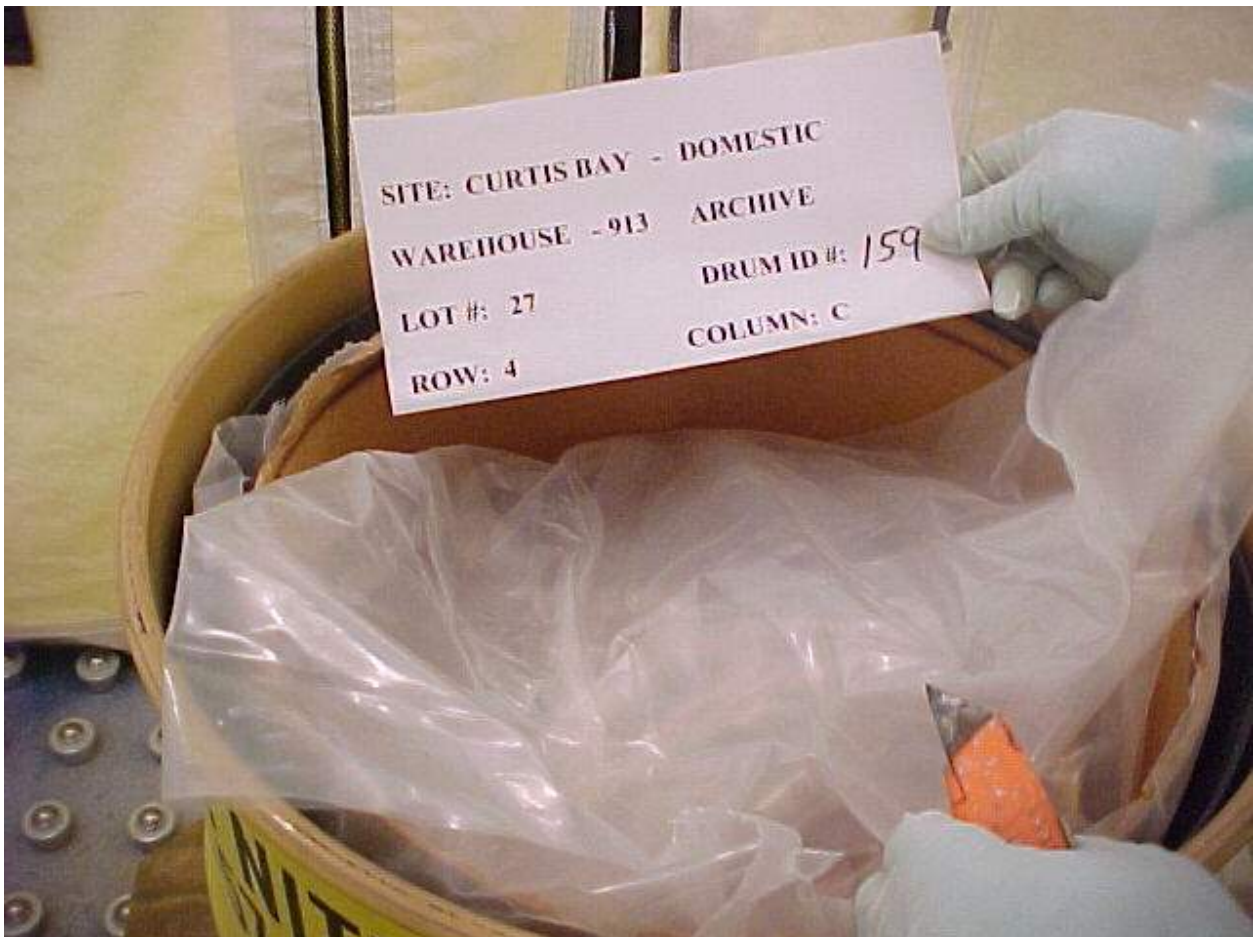
14:00**Other Information**Photo No. 5 of 11Dose Rate Surface 22 mR/hr
 1 meter 2.6 mR/hr

2nd poly liner/bag – good condition
No gases present in the breathing zone.

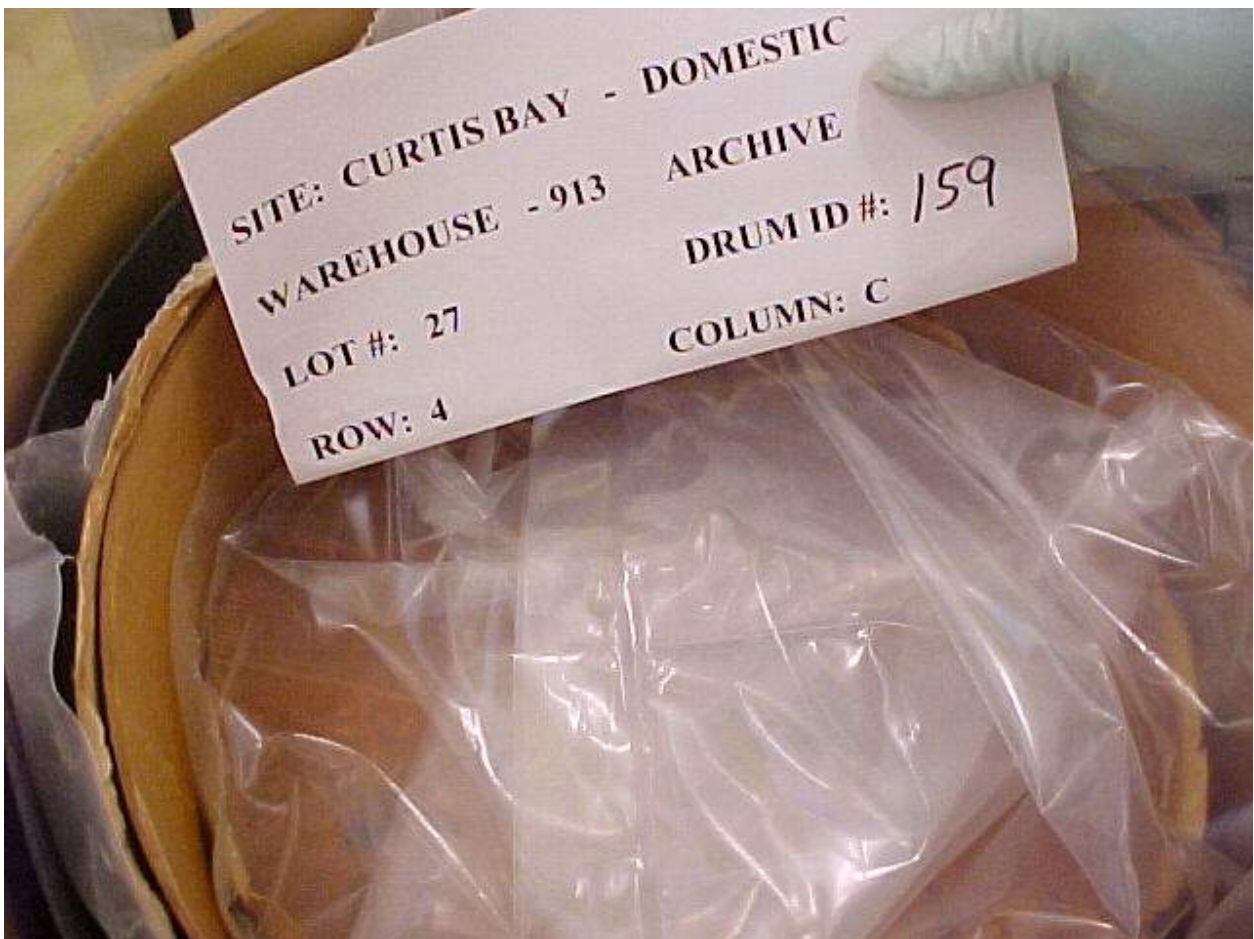
3rd poly liner/bag – good condition
No gases present in the breathing zone.

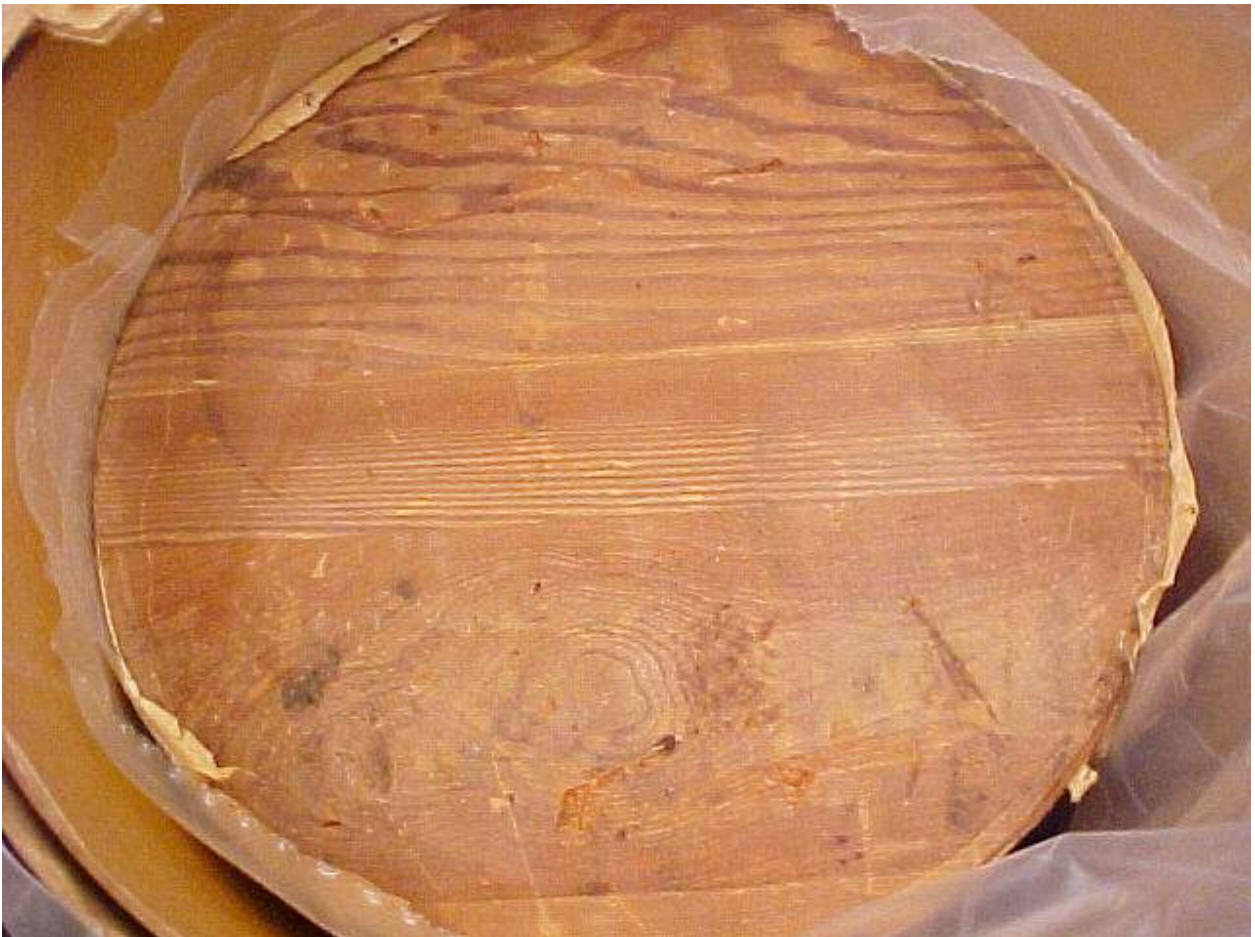
Wooden lid – good condition
No gases present in the breathing zone.

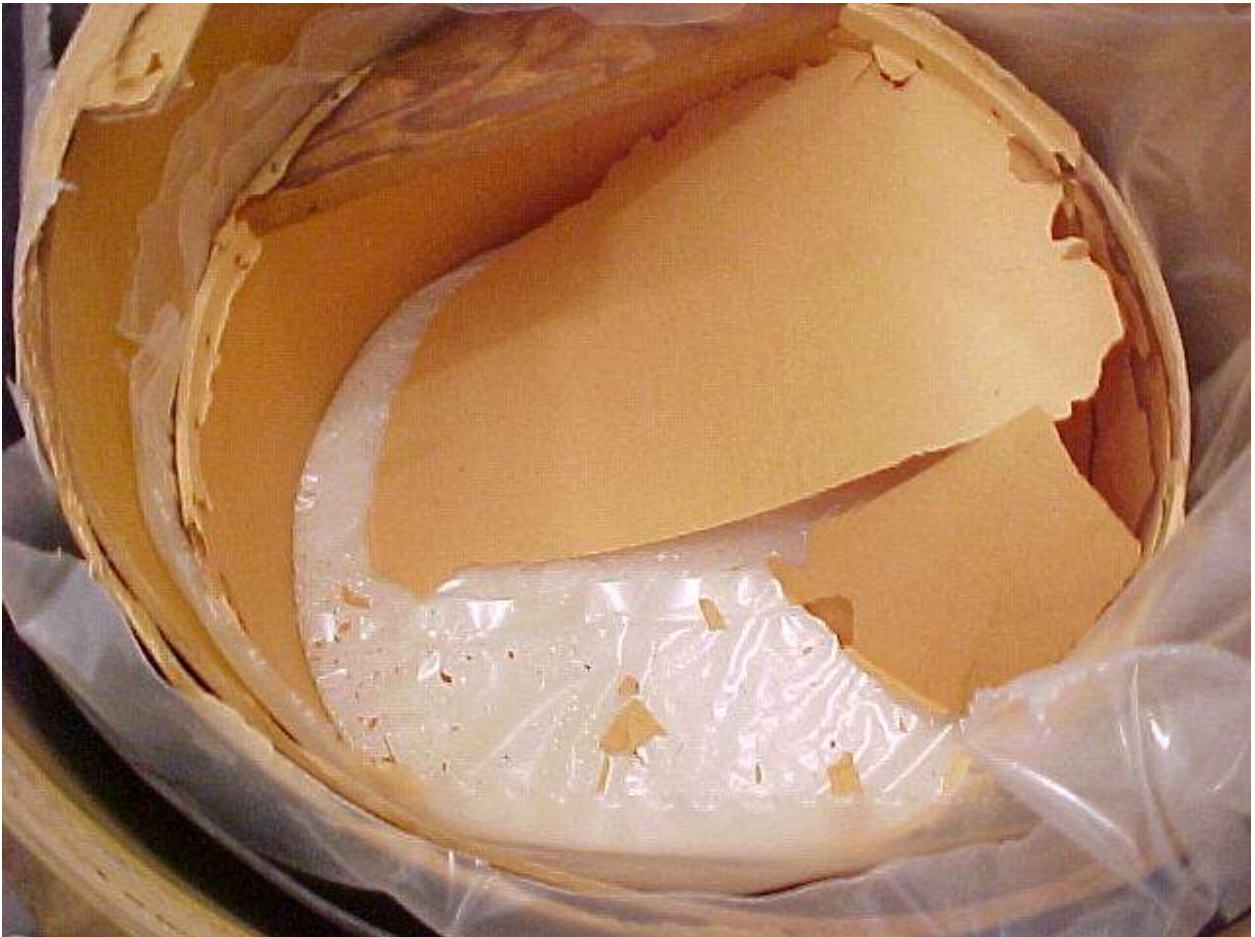
Lab-pack paper layer lid – broken upon removal of wooden lid
No gases present in the breathing zone.

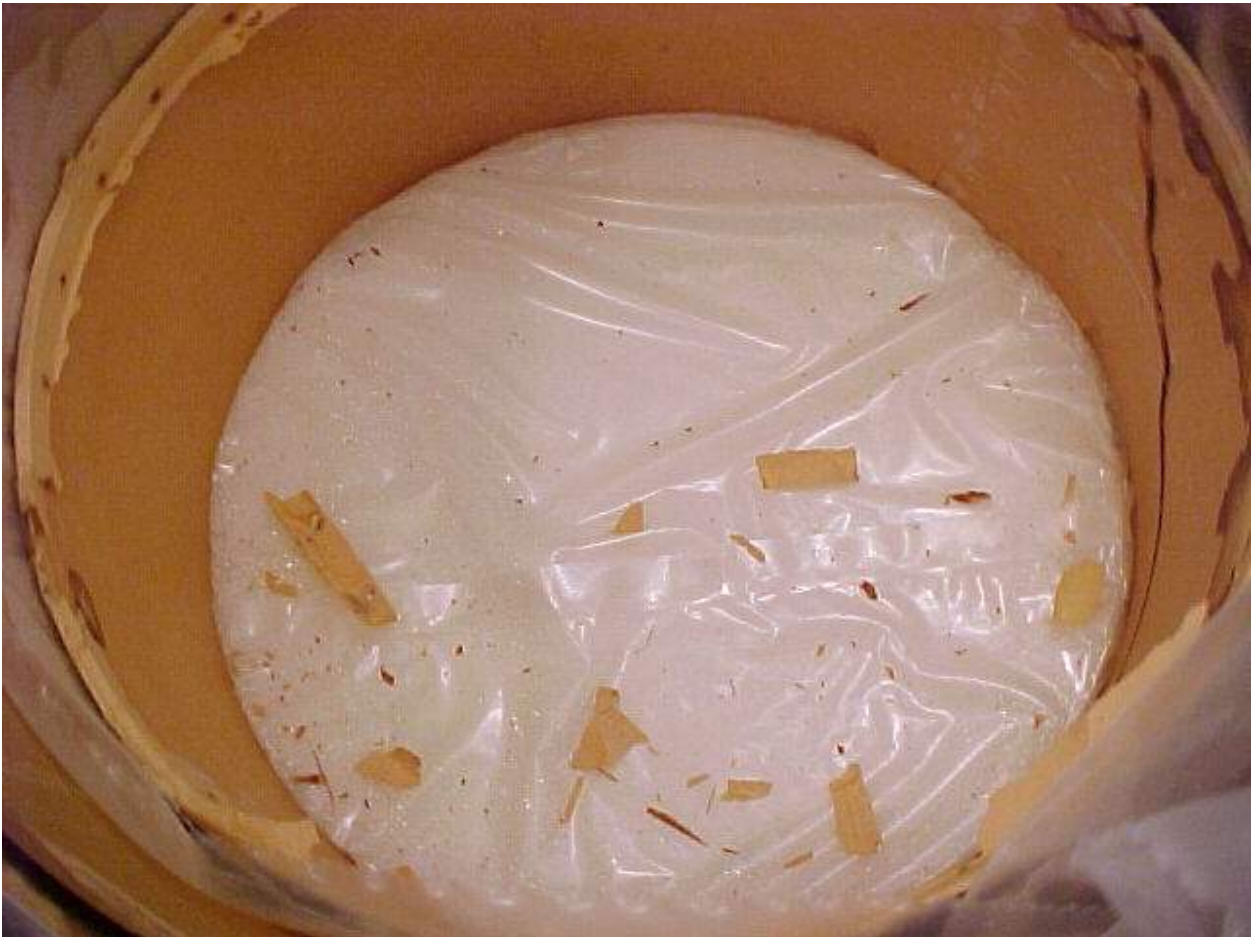
14:00**Other Information**Photo No. 9 of 11Dose Rate Surface 22 mR/hr
 1 meter 2.6 mR/hr

4th poly liner/bag – good condition
No gases present in the breathing zone.
