THORIUM NITRATE STOCKPILE DRUM CHARACTERIZATION REPORT

**THORIUM NITRATE STOCKPILE
DRUM CHARACTERIZATION REPORT**

Prepared for
U.S. Defense Logistics Agency
Defense National Stockpile Center
Fort Belvoir, Virginia

Prepared by
OAK RIDGE NATIONAL LABORATORY
Oak Ridge, Tennessee 37831
managed by
UT-BATTELLE, LLC
for the
U.S. DEPARTMENT OF ENERGY
under contract DE-AC05-00OR22725

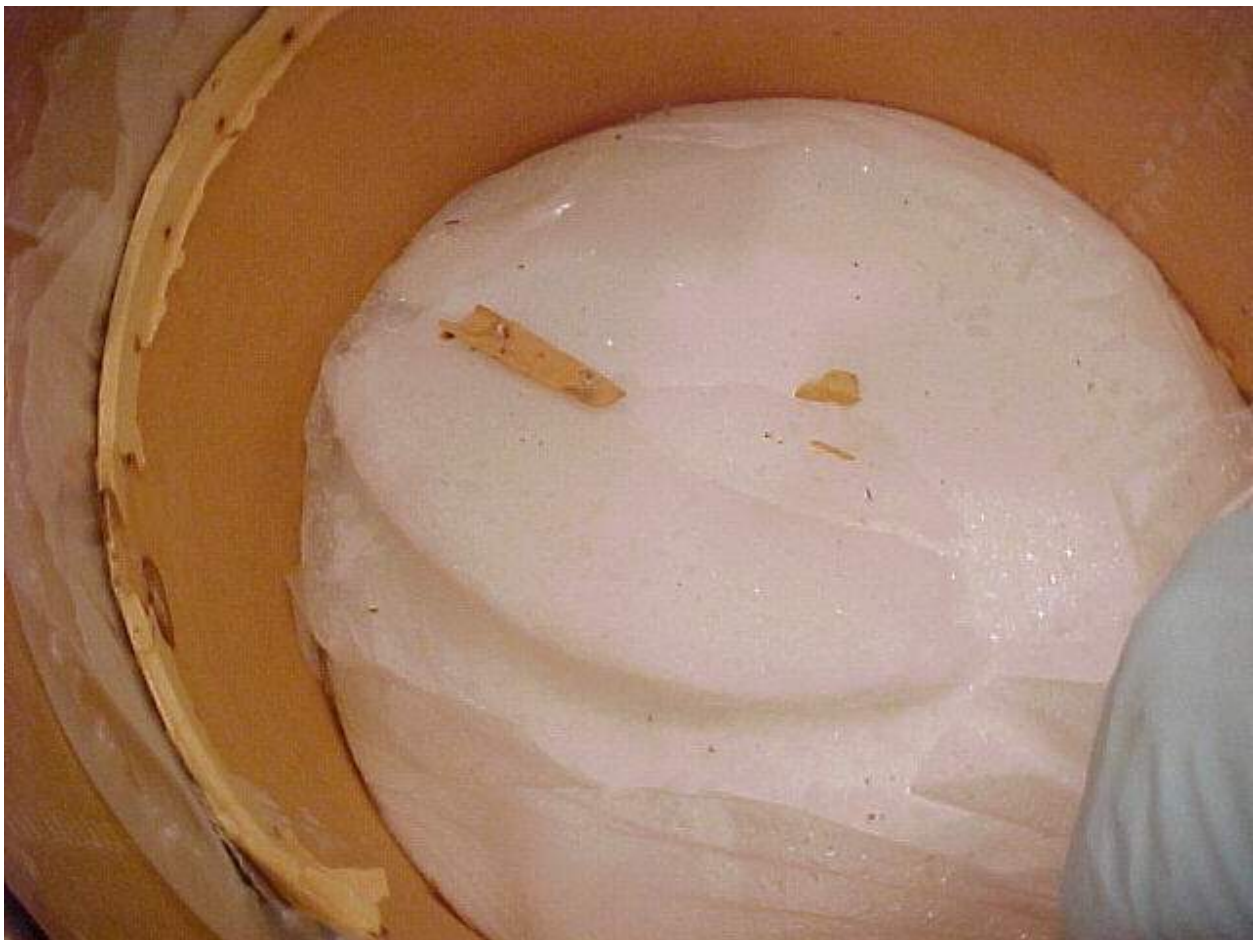
ThN material – monolith – white – solid – dry
No gases present in the breathing zone.

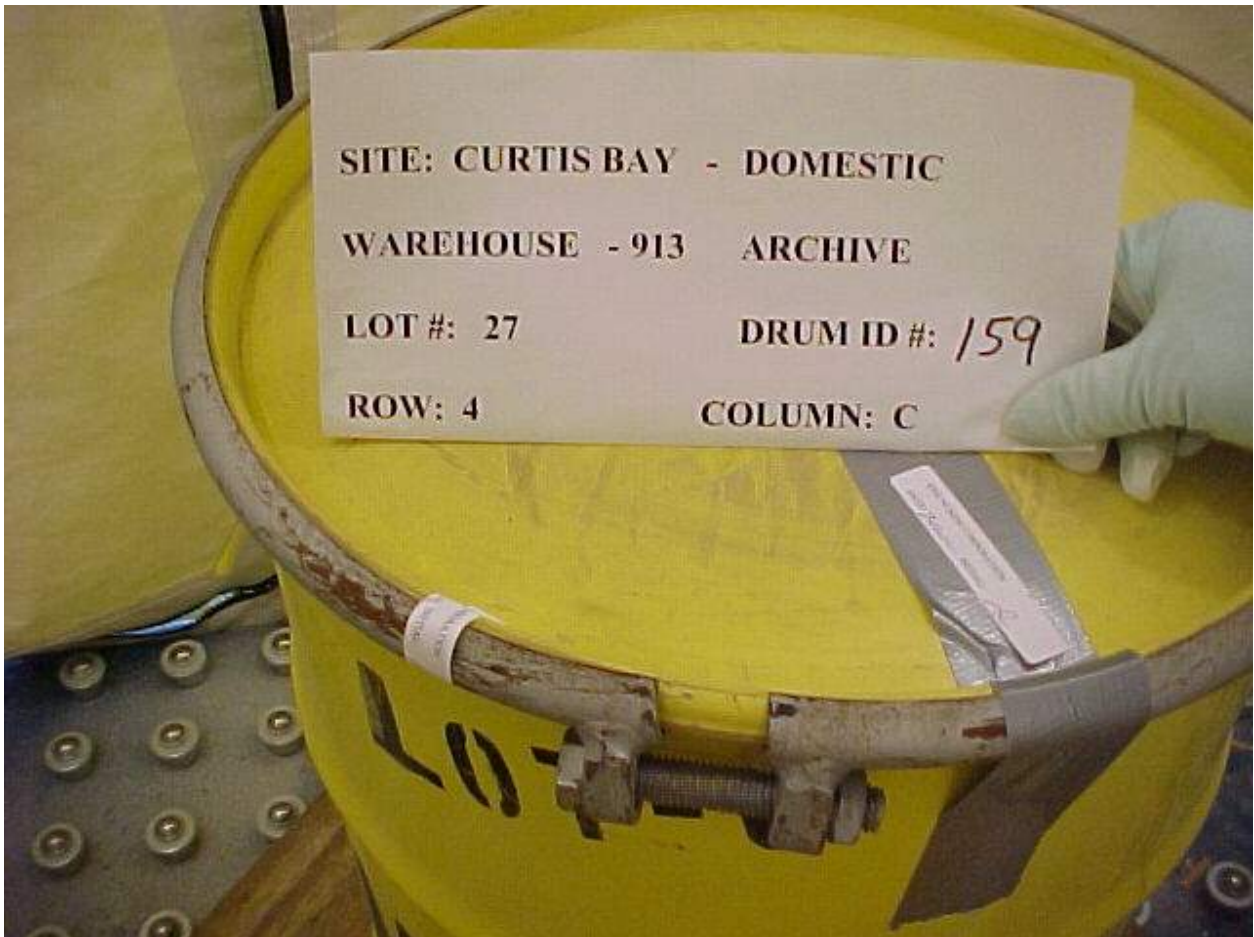
14:00**Other Information**Photo No. 11 of 11Dose Rate Surface 22 mR/hr
 1 meter 2.6 mR/hr

Sealed & dated – Complete

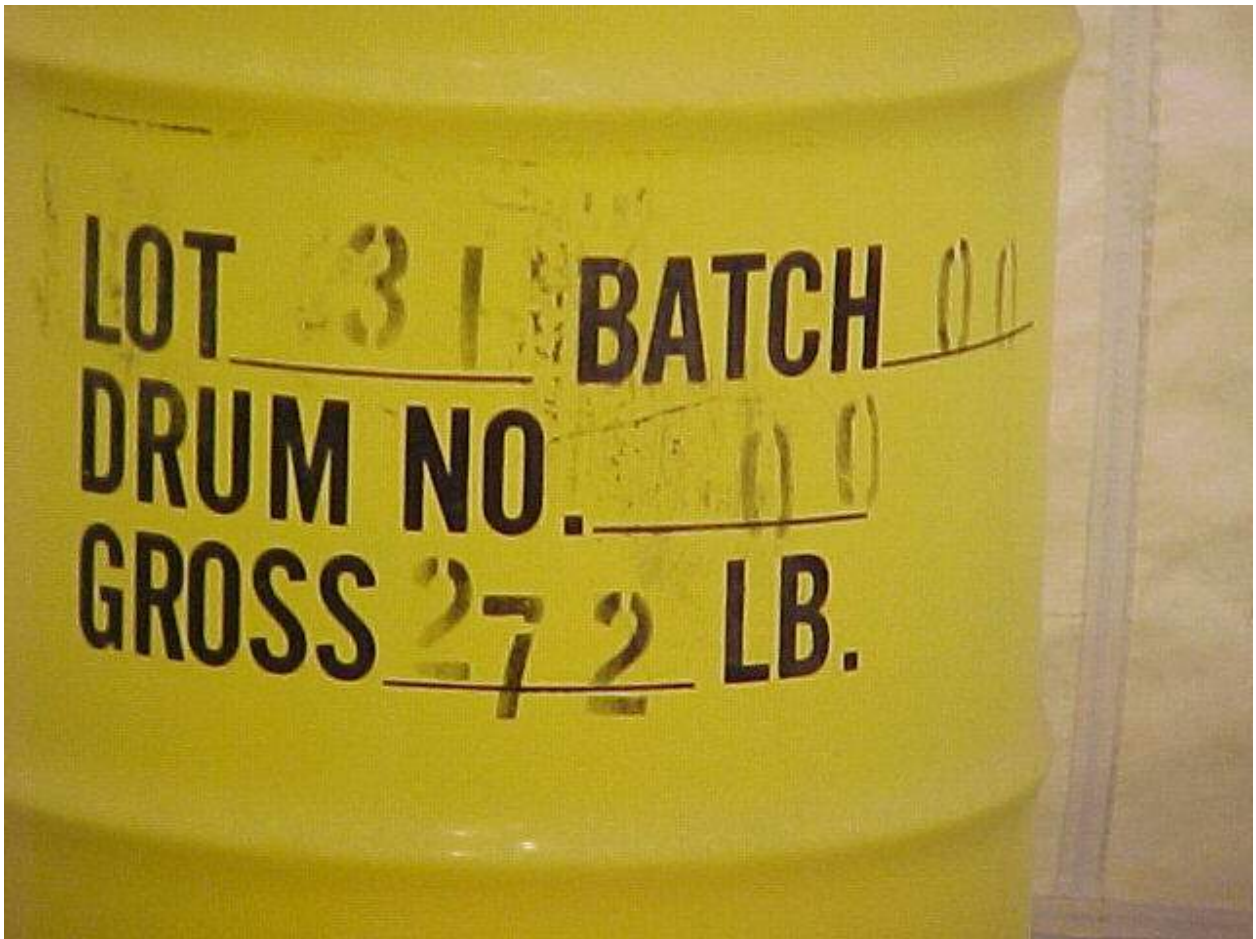
11:00**Other Information**Photo No. 1 of 8Dose Rate Surface 22 mR/hr
 1 meter 2.6 mR/hr

30-gal drum – good condition

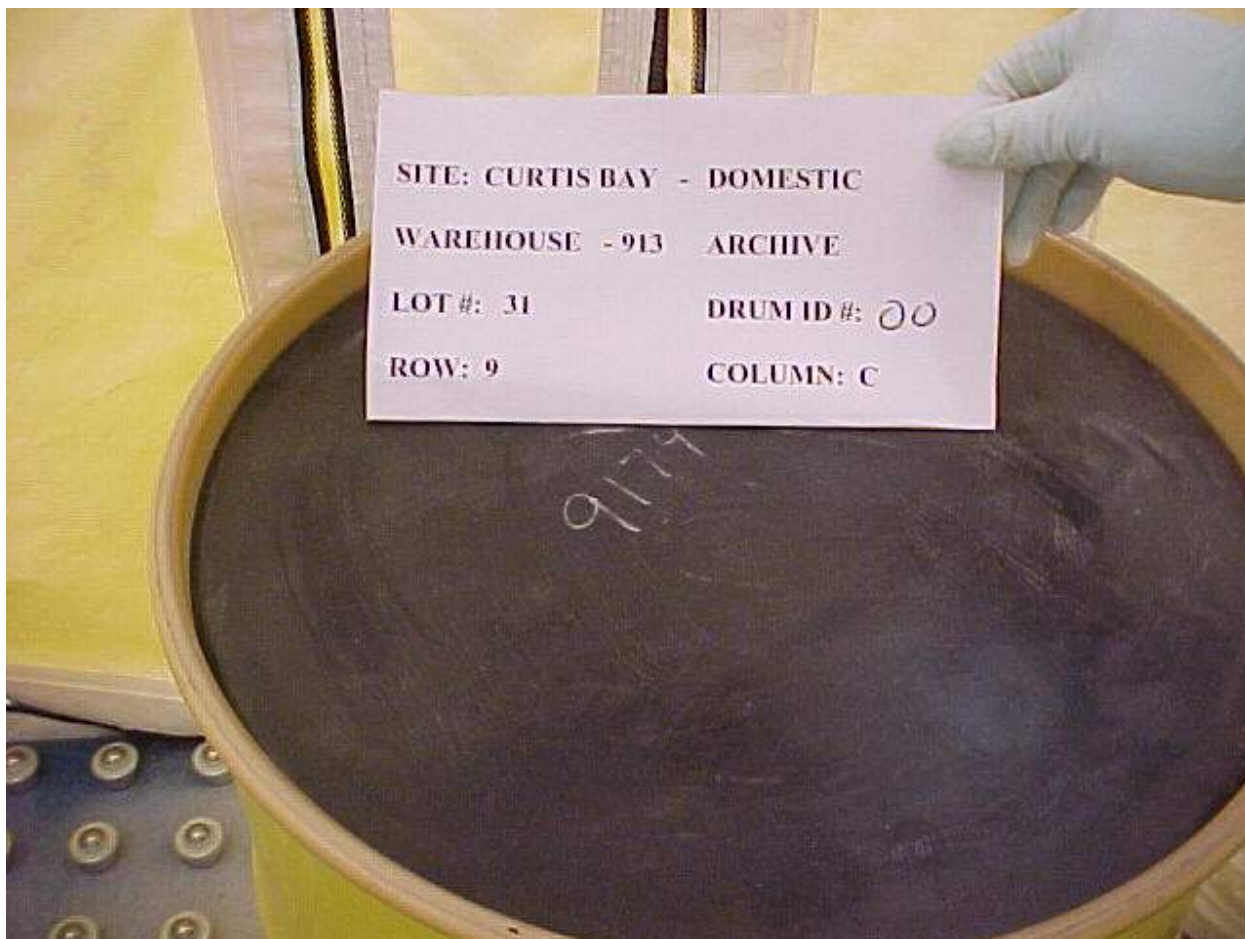
Black plastic lid – good condition
No gases present in the breathing zone.

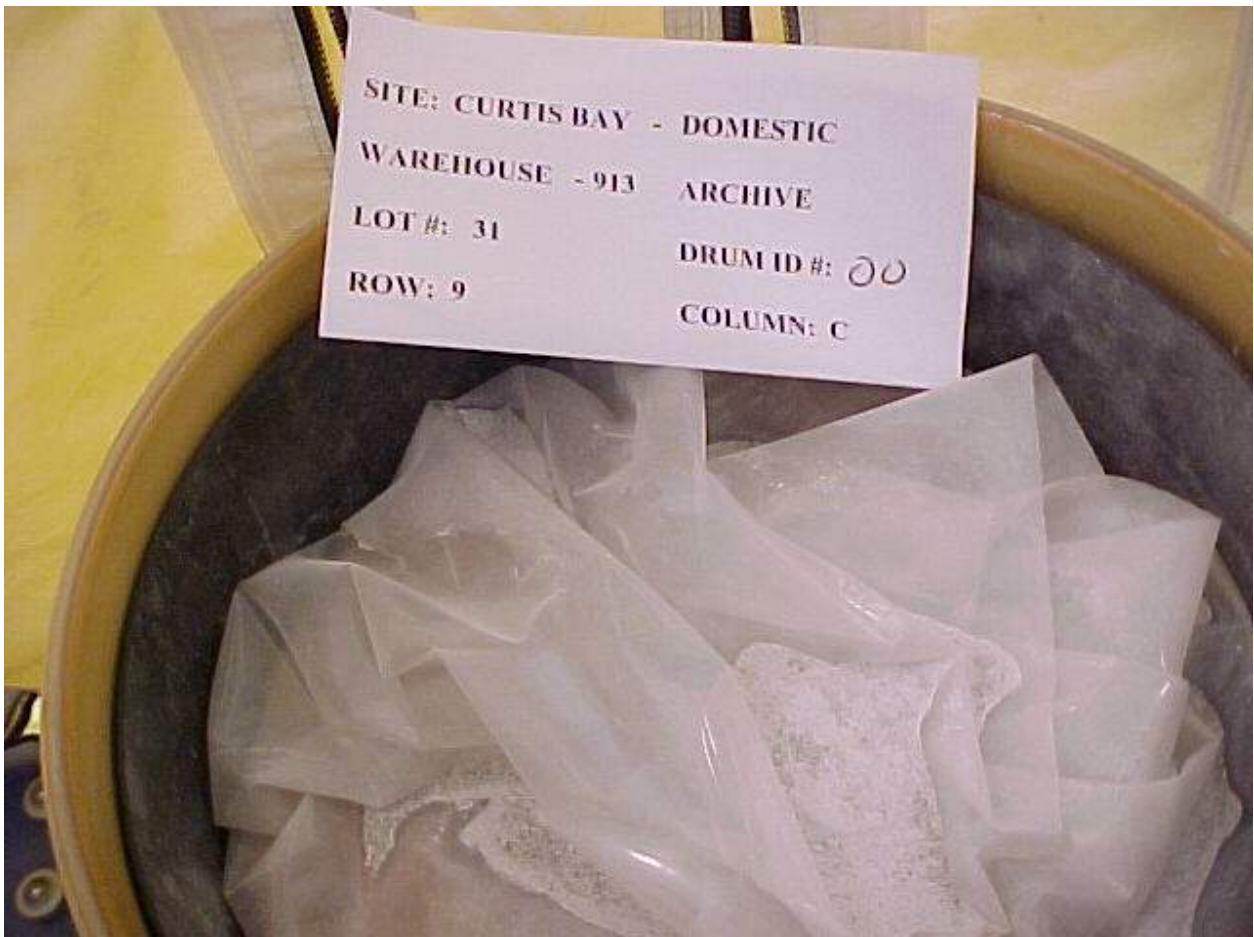
11:00**Other Information**Photo No. 3 of 8Dose Rate Surface 22 mR/hr
 1 meter 2.6 mR/hr

1st poly liner/bag – good condition
No gases present in the breathing zone.

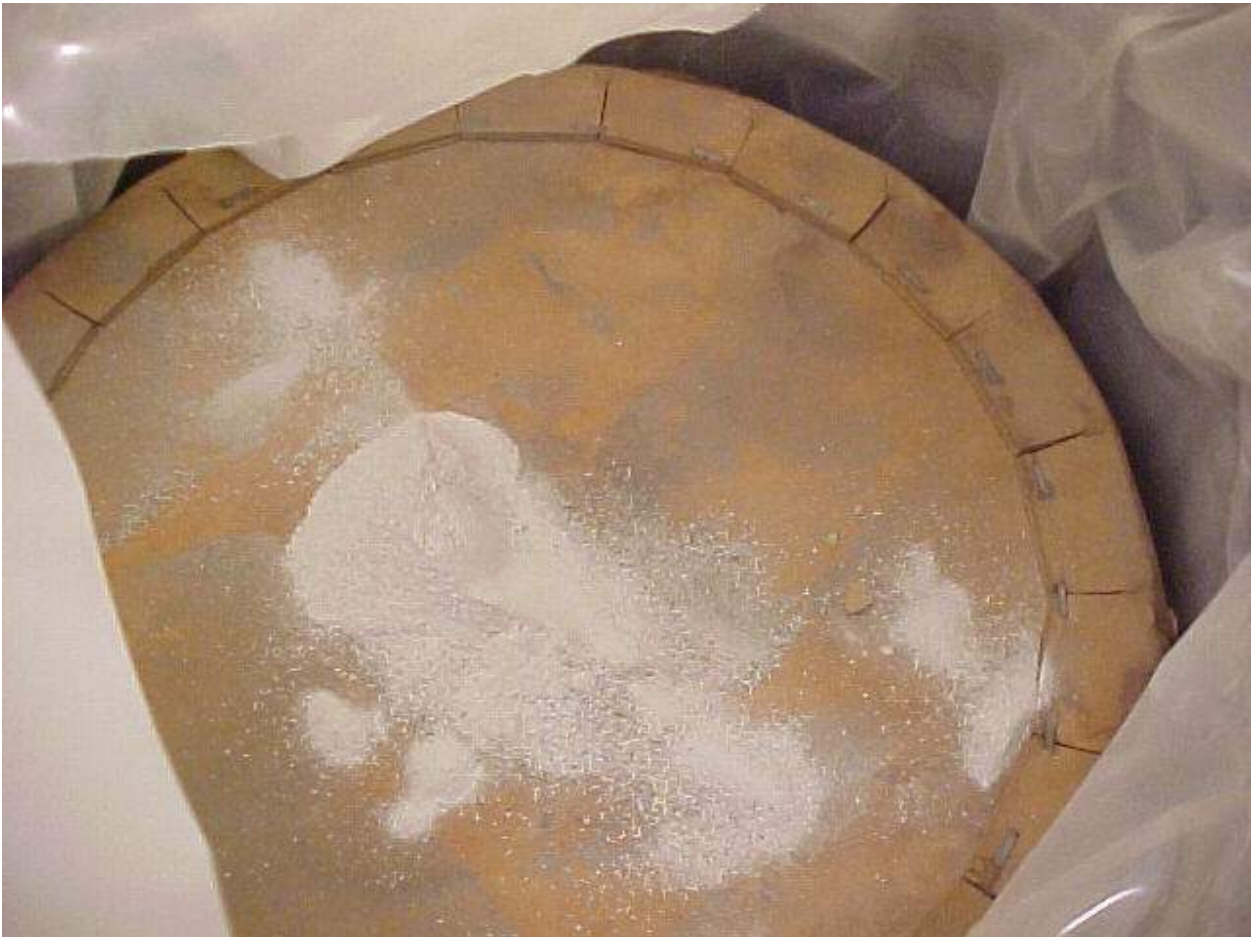
Fiber drum lid – good condition
No gases present in the breathing zone.

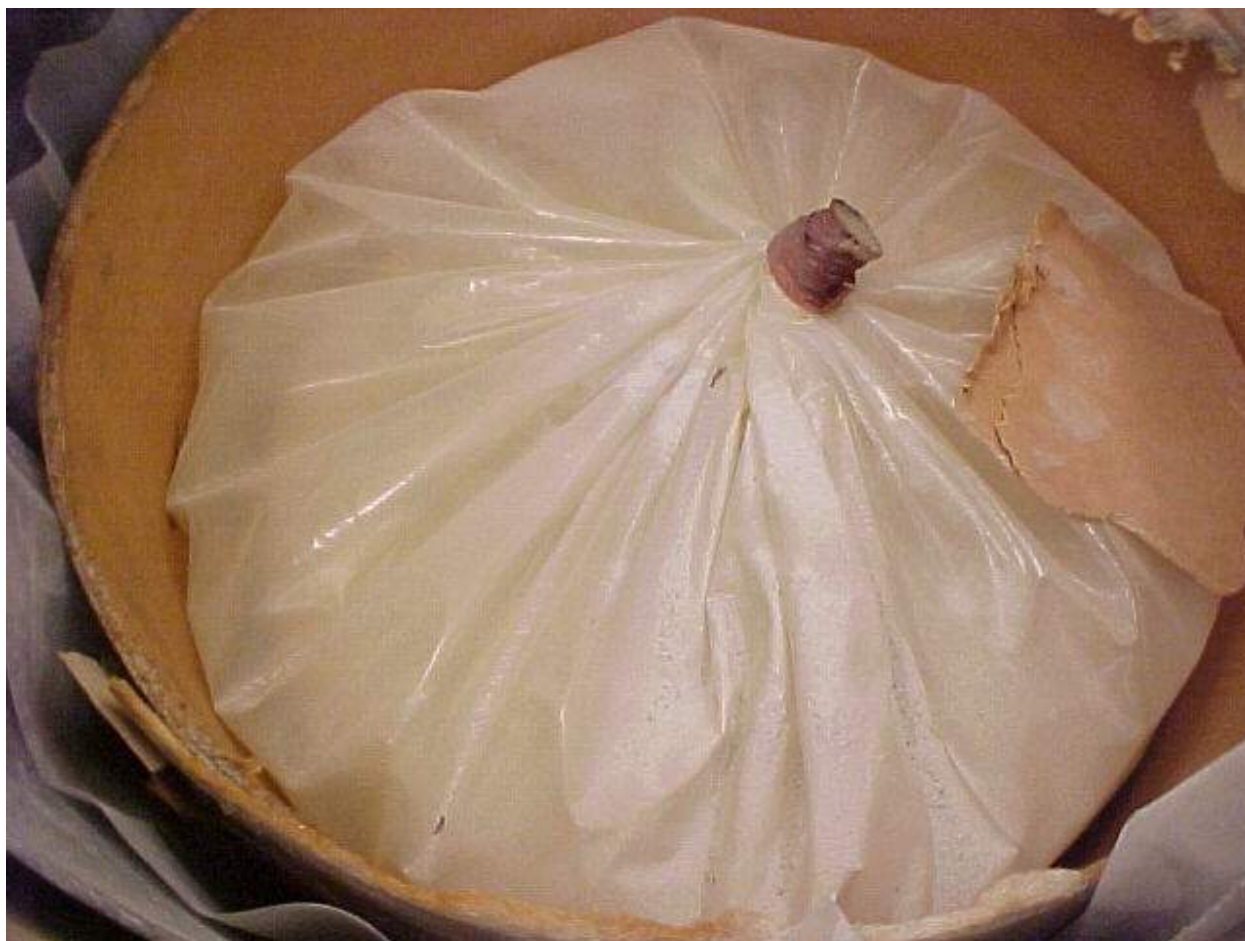
11:00**Other Information**Photo No. 5 of 8Dose Rate Surface 22 mR/hr
 1 meter 2.6 mR/hr2nd poly liner/bag – good conditionThis bag was not heat sealed like the other bags encountered in MD-1 drums.
No gases present in the breathing zone.

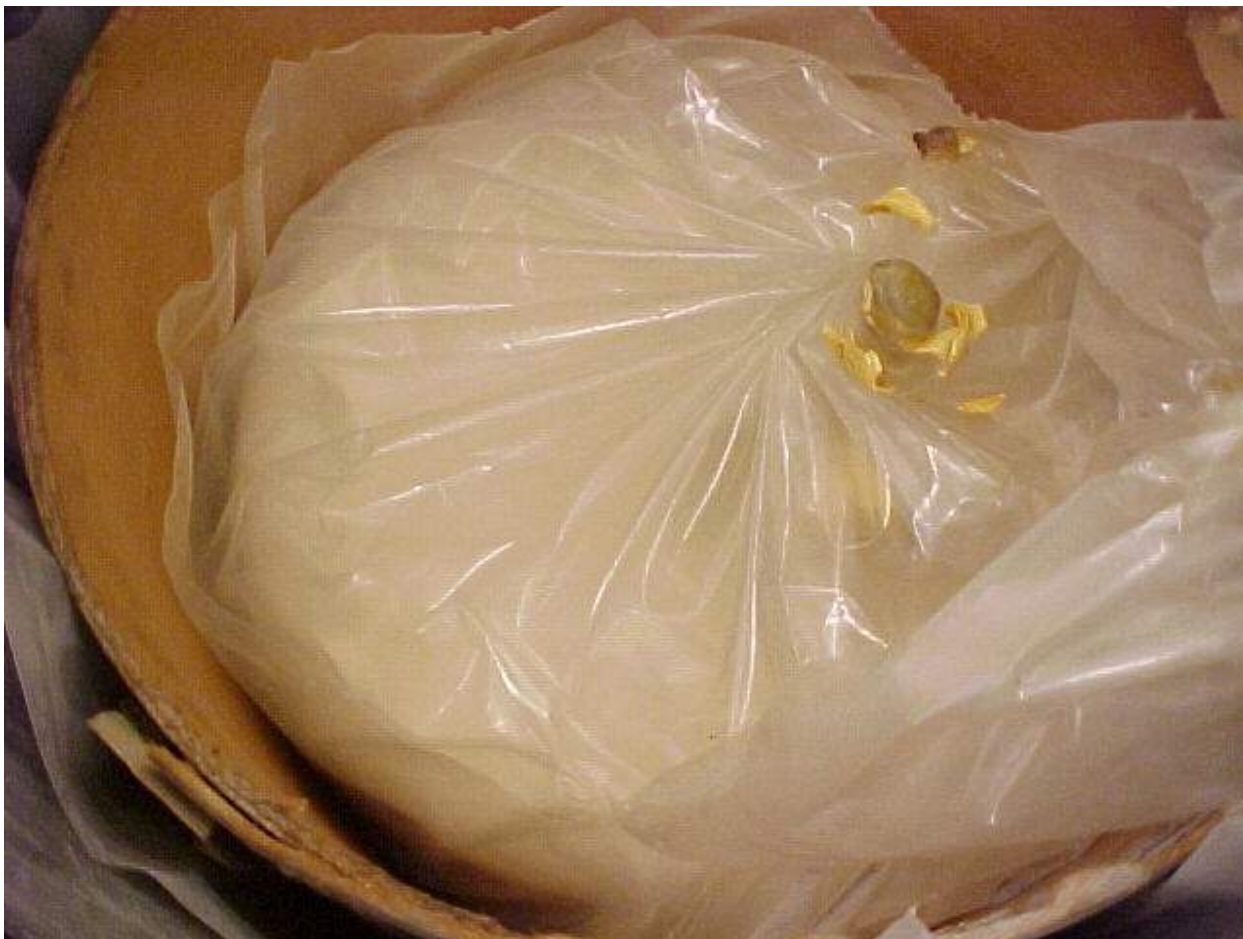
3rd poly liner/bag – good condition

There is no internal fiber drum in this container (i.e. no wooden lid or 4th poly liner/bag).

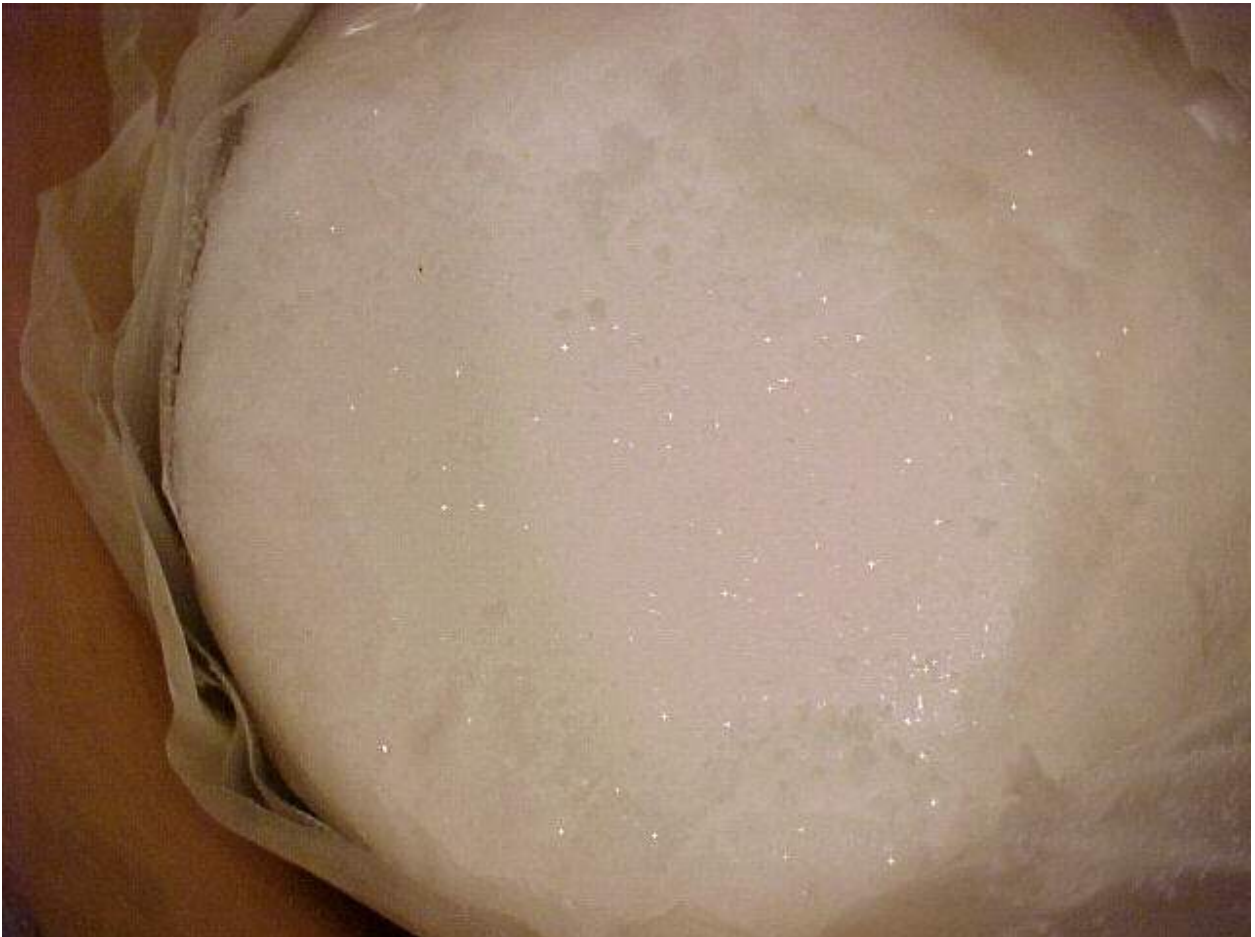
11:00**Other Information**Photo No. 7 of 8Dose Rate Surface 22 mR/hr
 1 meter 2.6 mR/hr

ThN material – monolith – white – solid – dry
No gases present in the breathing zone.

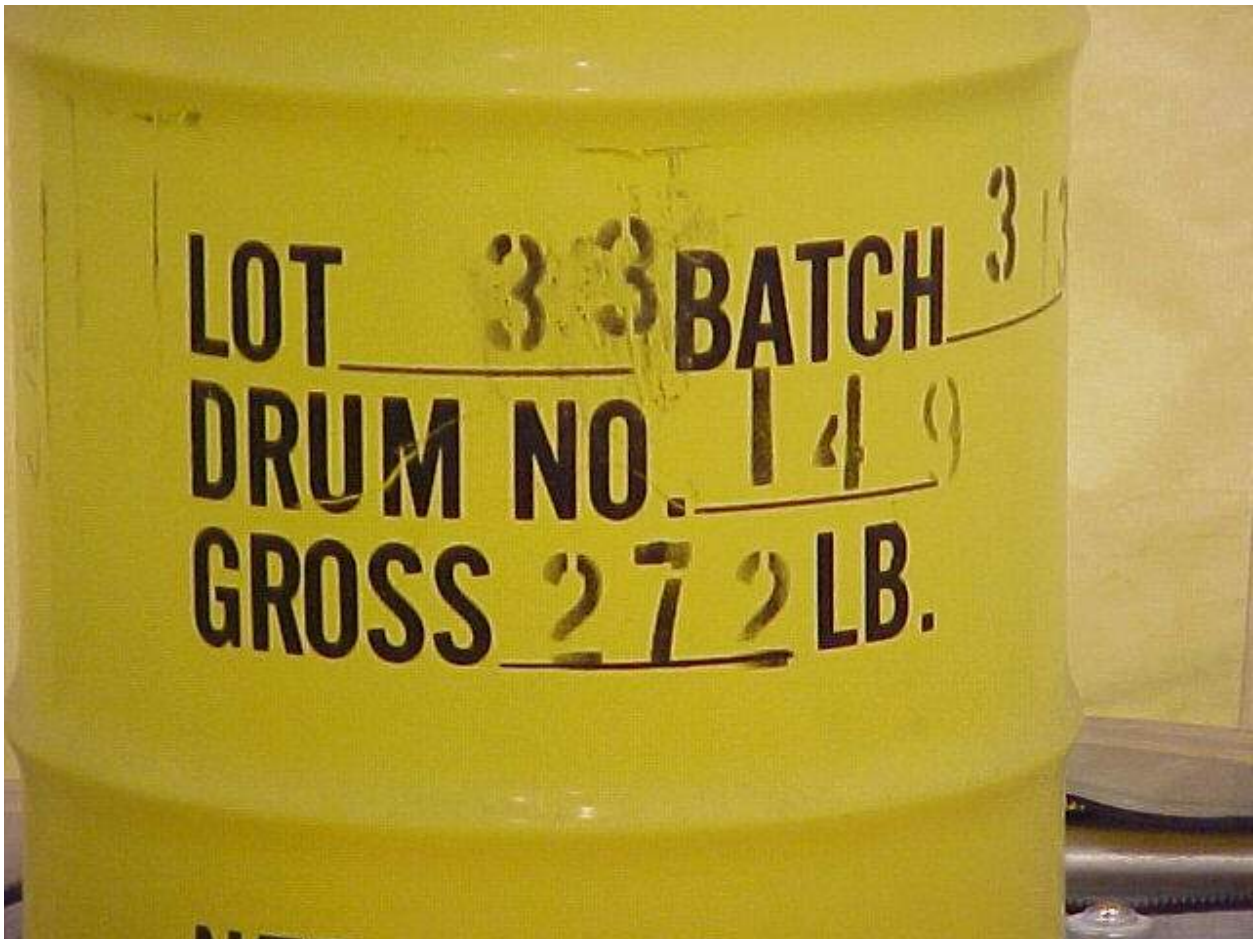
11:15**Other Information**Photo No. 1 of 11Dose Rate Surface 22 mR/hr
 1 meter 2.6 mR/hr

30-gal drum – good condition

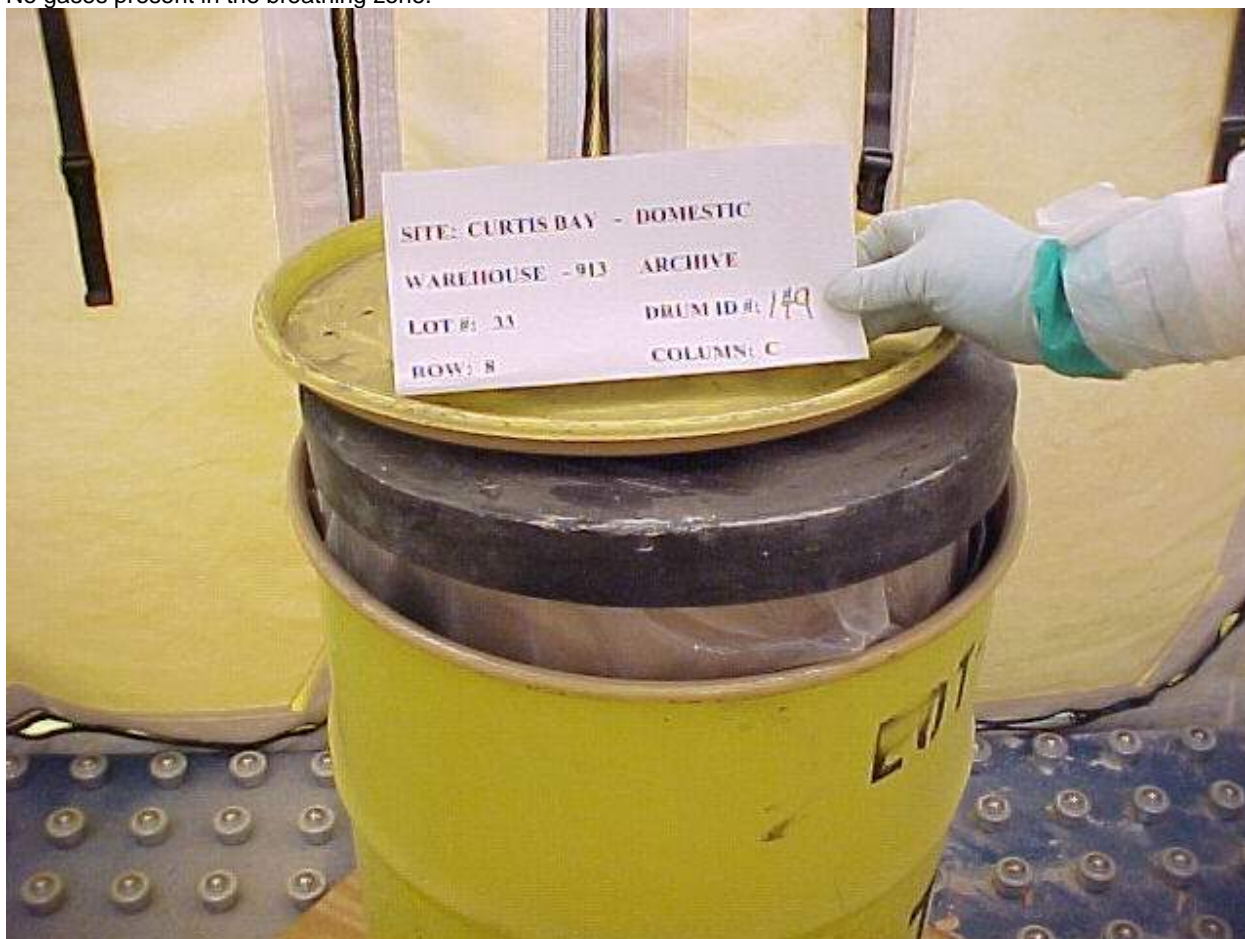
Black plastic lid – good condition

Pressure buildup inside container results in raising this layer vertically out of container.

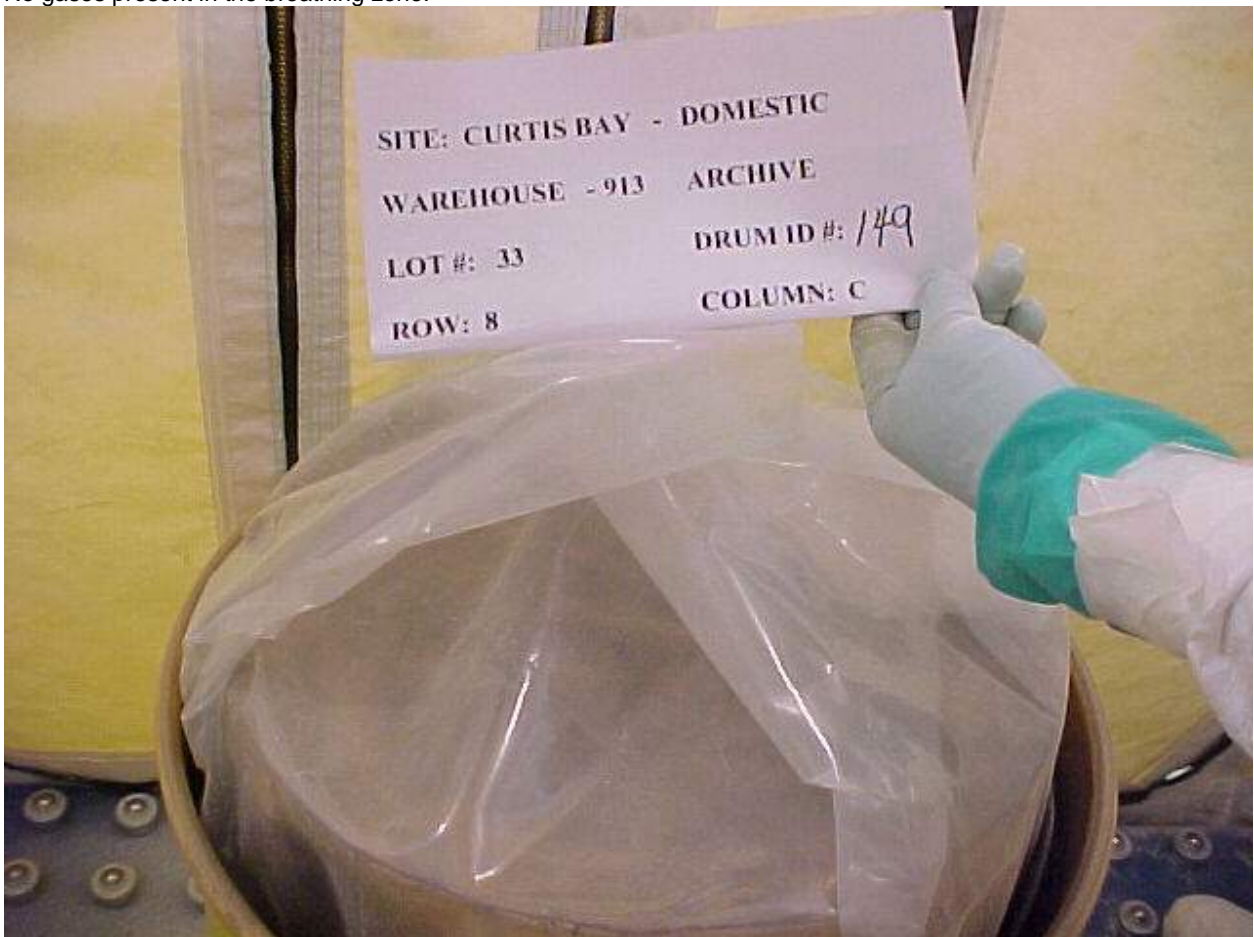
11:15**Other Information**Photo No. 3 of 11Dose Rate Surface 22 mR/hr
 1 meter 2.6 mR/hr1st poly liner/bag – good condition

Pressure buildup inside container results in raising this layer vertically out of container.

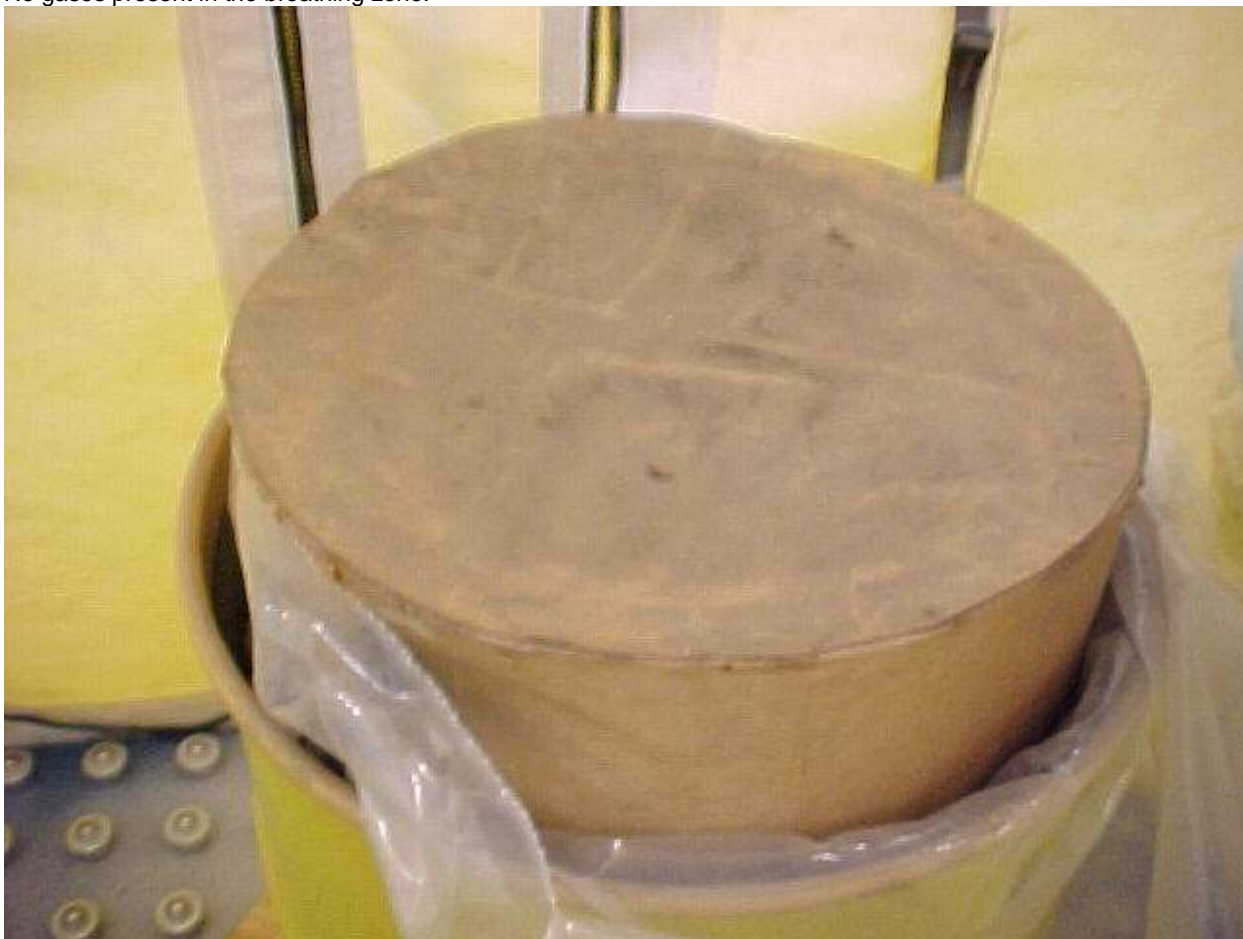
Fiber lid – good condition

Pressure buildup inside container results in raising this layer vertically out of container.

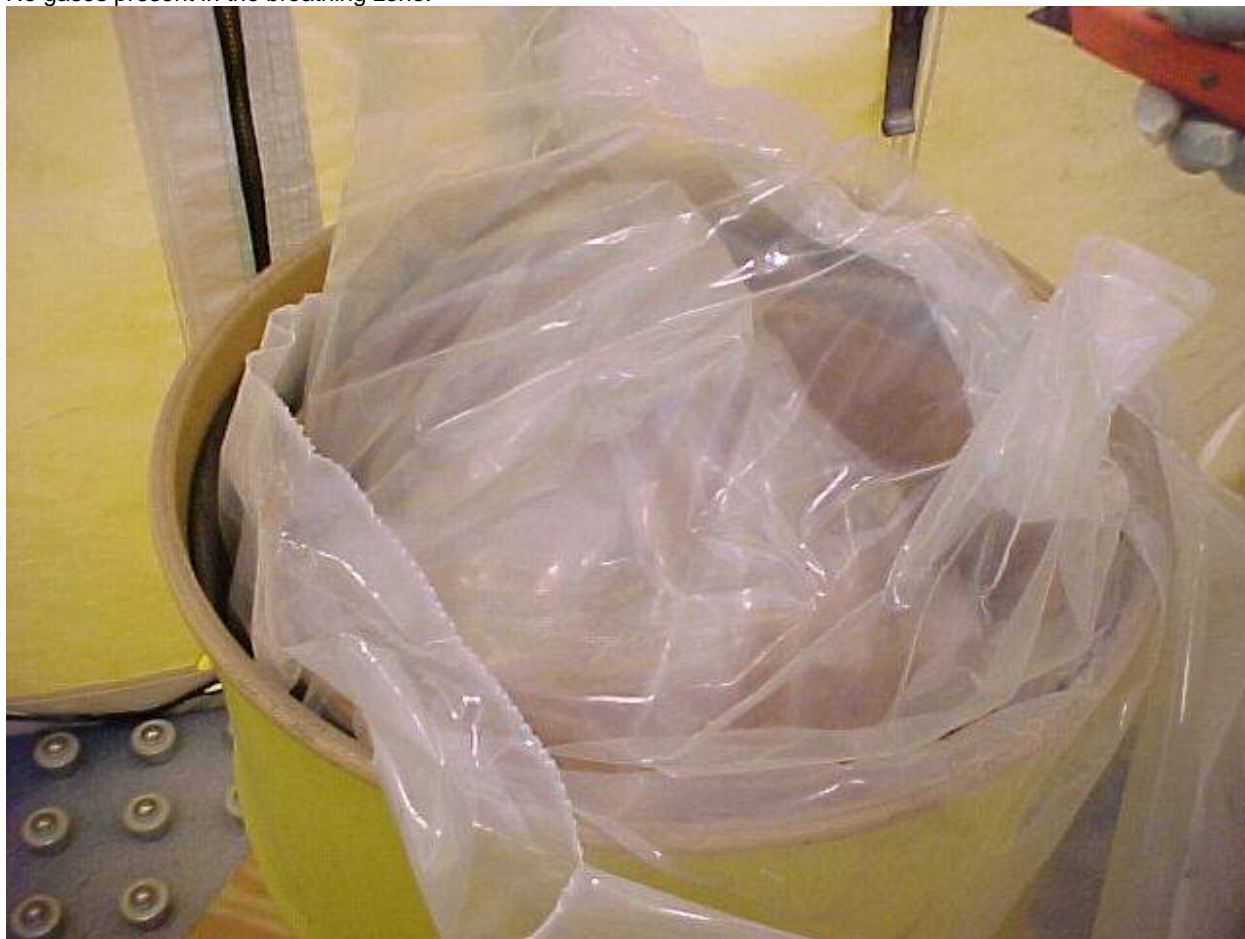
11:15**Other Information**Photo No. 5 of 11Dose Rate Surface 22 mR/hr
 1 meter 2.6 mR/hr2nd poly liner/bag – good condition

Pressure buildup inside container results in raising this layer vertically out of container.

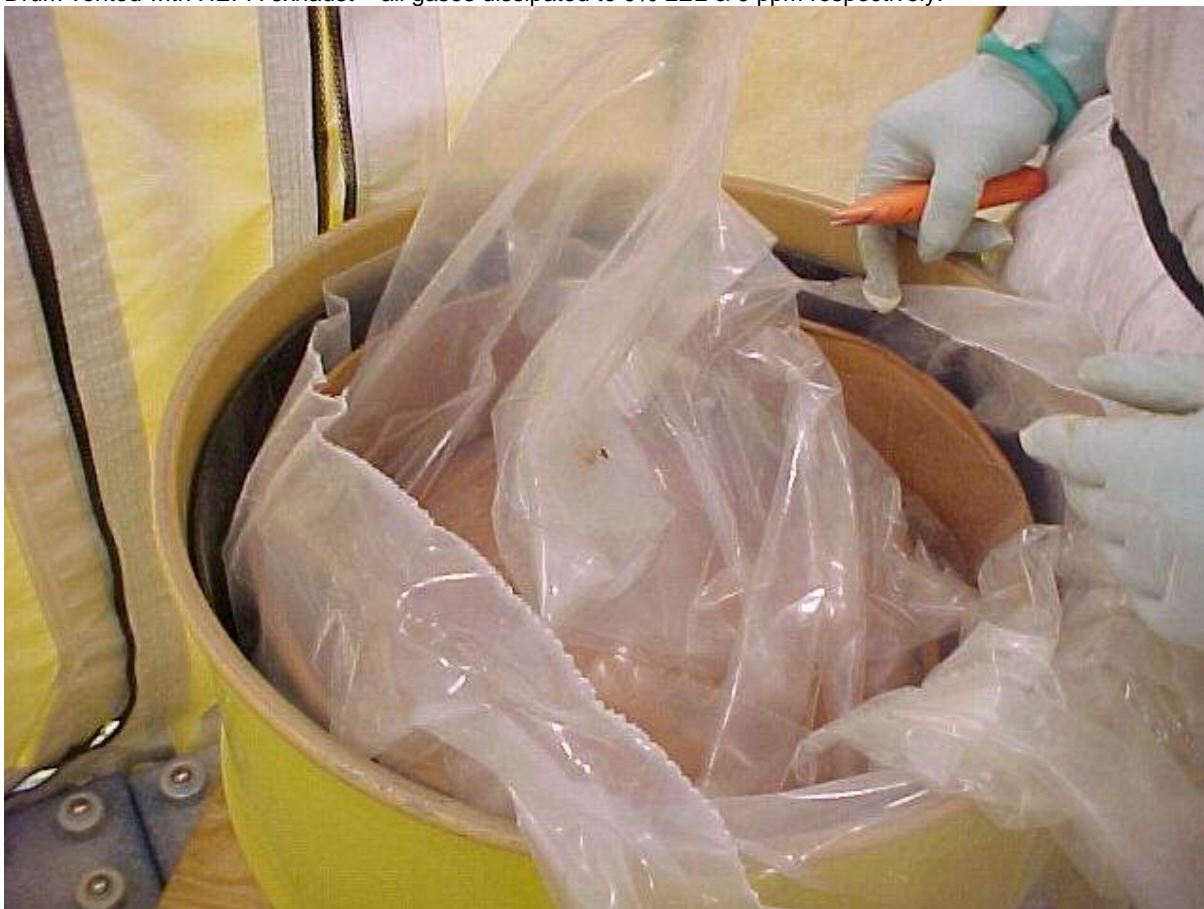
3rd poly liner/bag – good condition

Gases in headspace – CH₄ – 4.1% LEL - NO - +50 ppm - NO_x - +50 ppm

Drum vented with HEPA exhaust – all gases dissipated to 0% LEL & 0 ppm respectively.

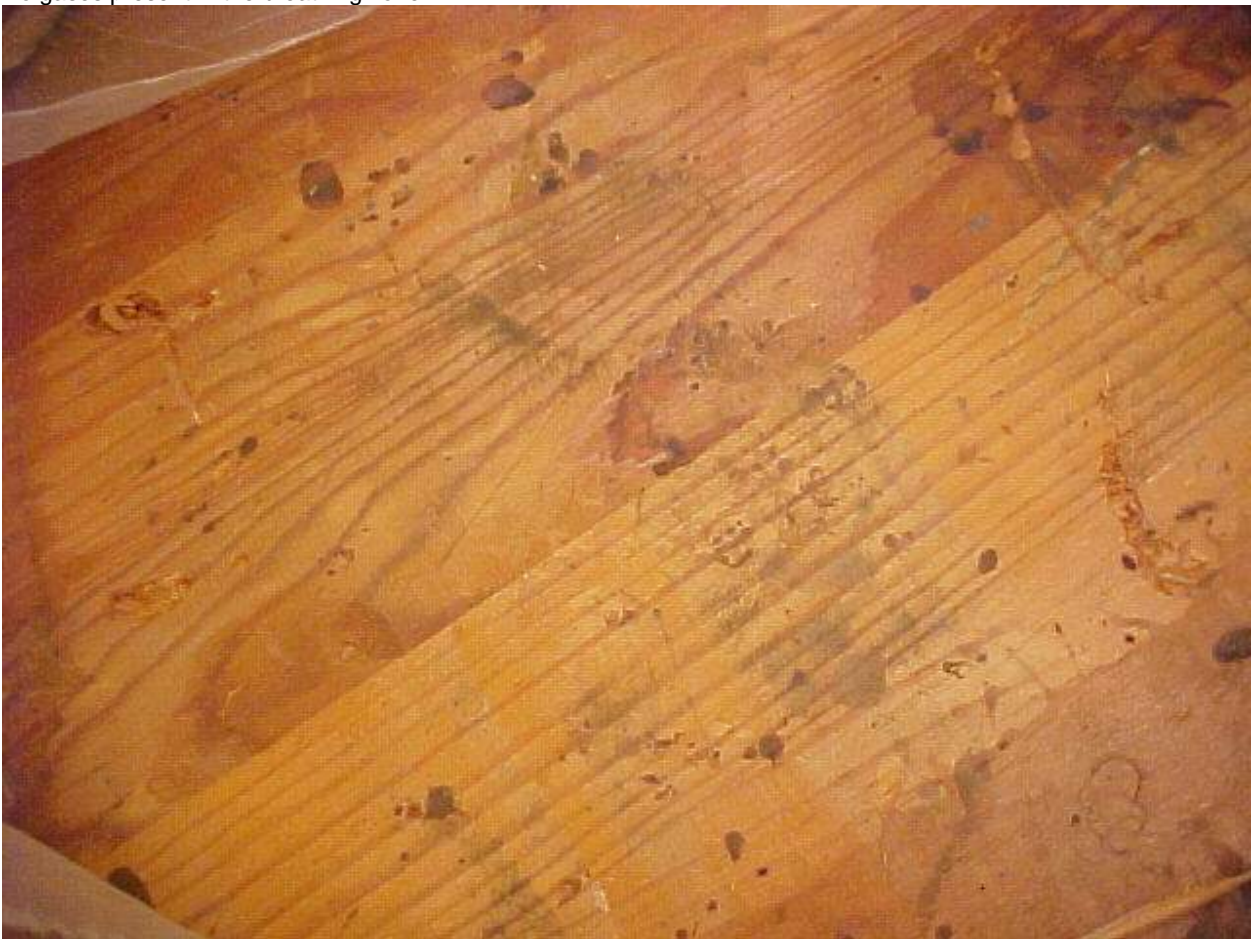
Wooden lid – good condition
 No gases present in the breathing zone.

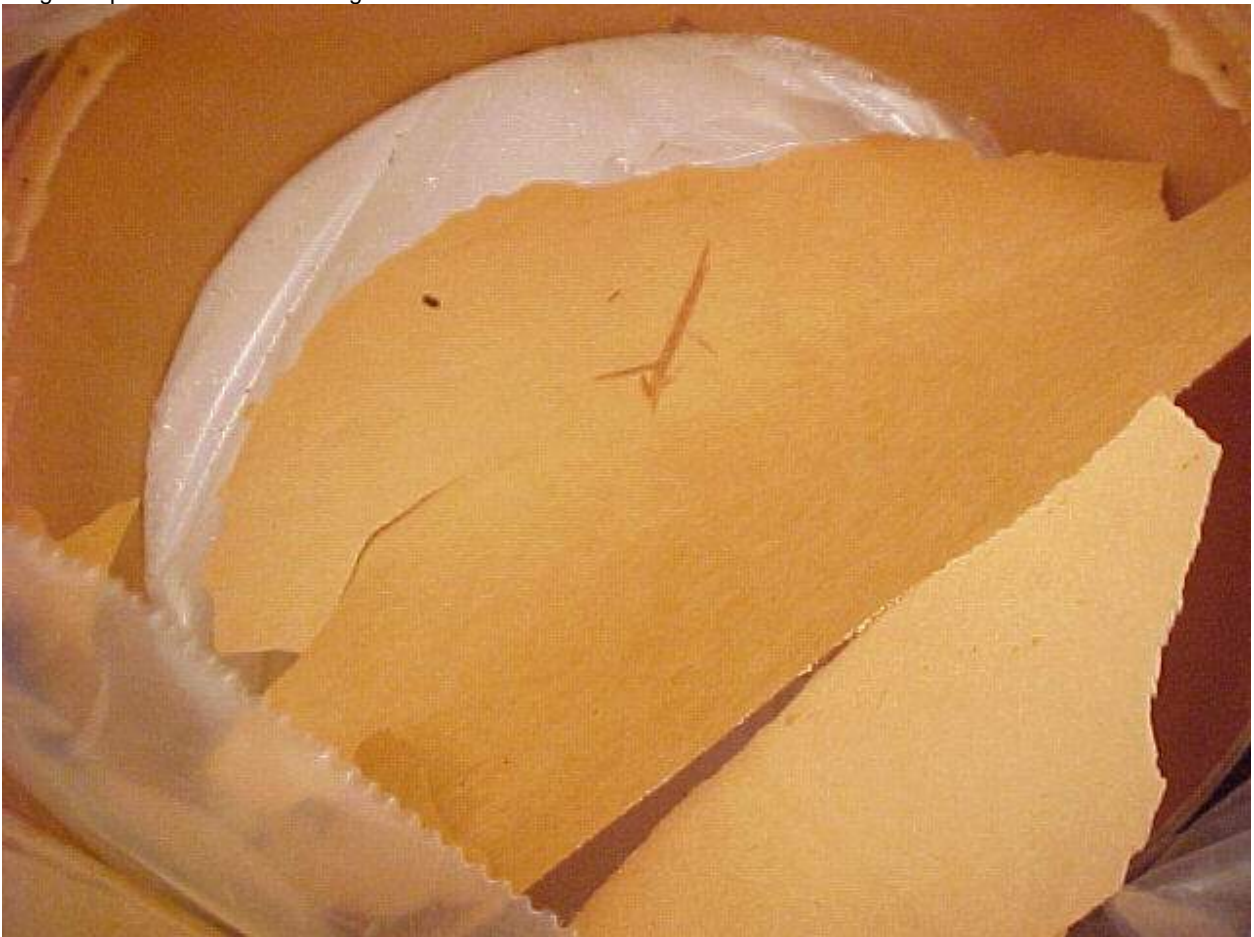
Lab-pack lid shown in this photo – essentially a thin paper layer that is underneath wooden lid – paper layer typically breaks up upon removal of the wooden lid.
No gases present in the breathing zone.

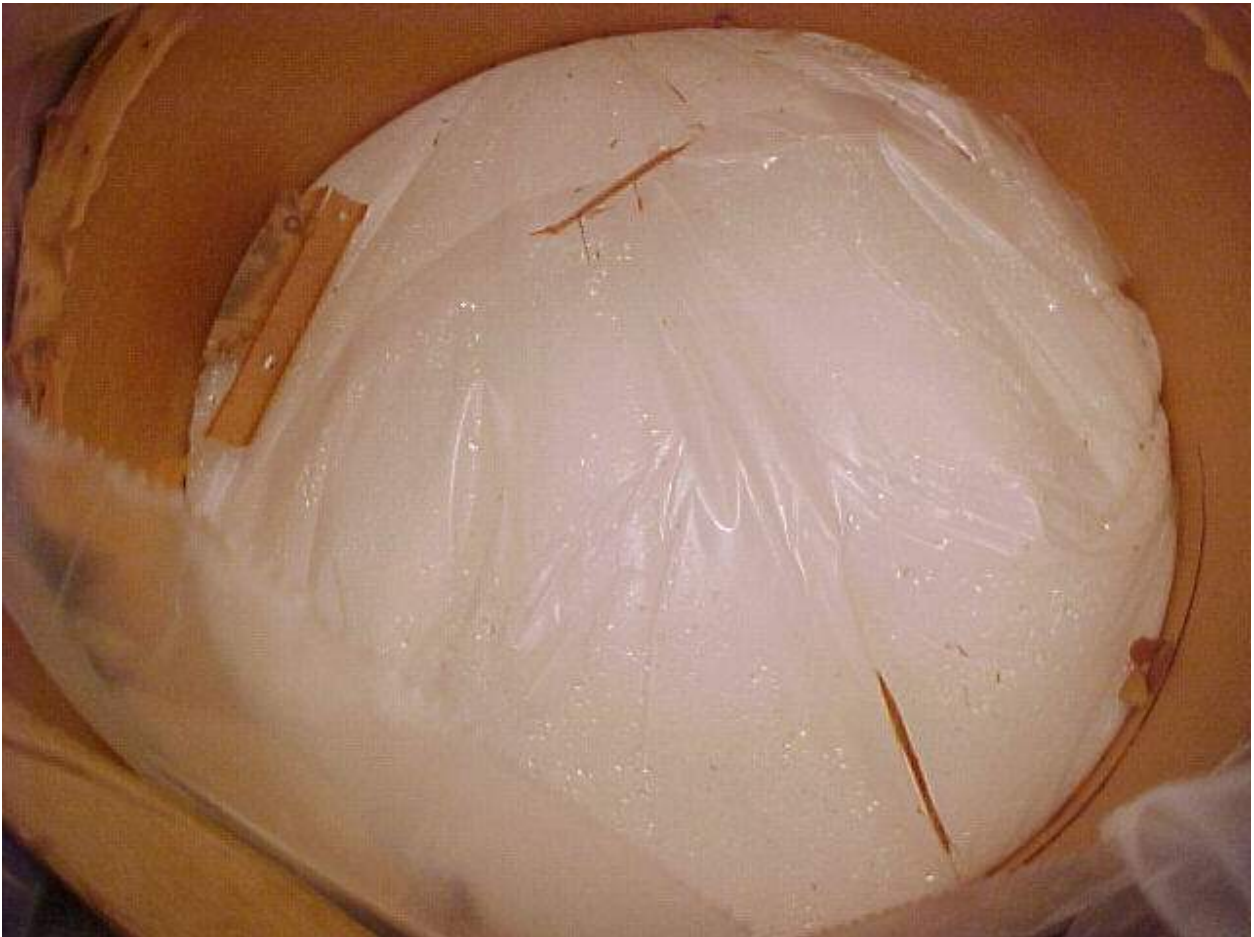
4th poly liner/bag – good condition (inflated bag shows where gas is being generated from the ThN material)
 No gases present in the breathing zone.

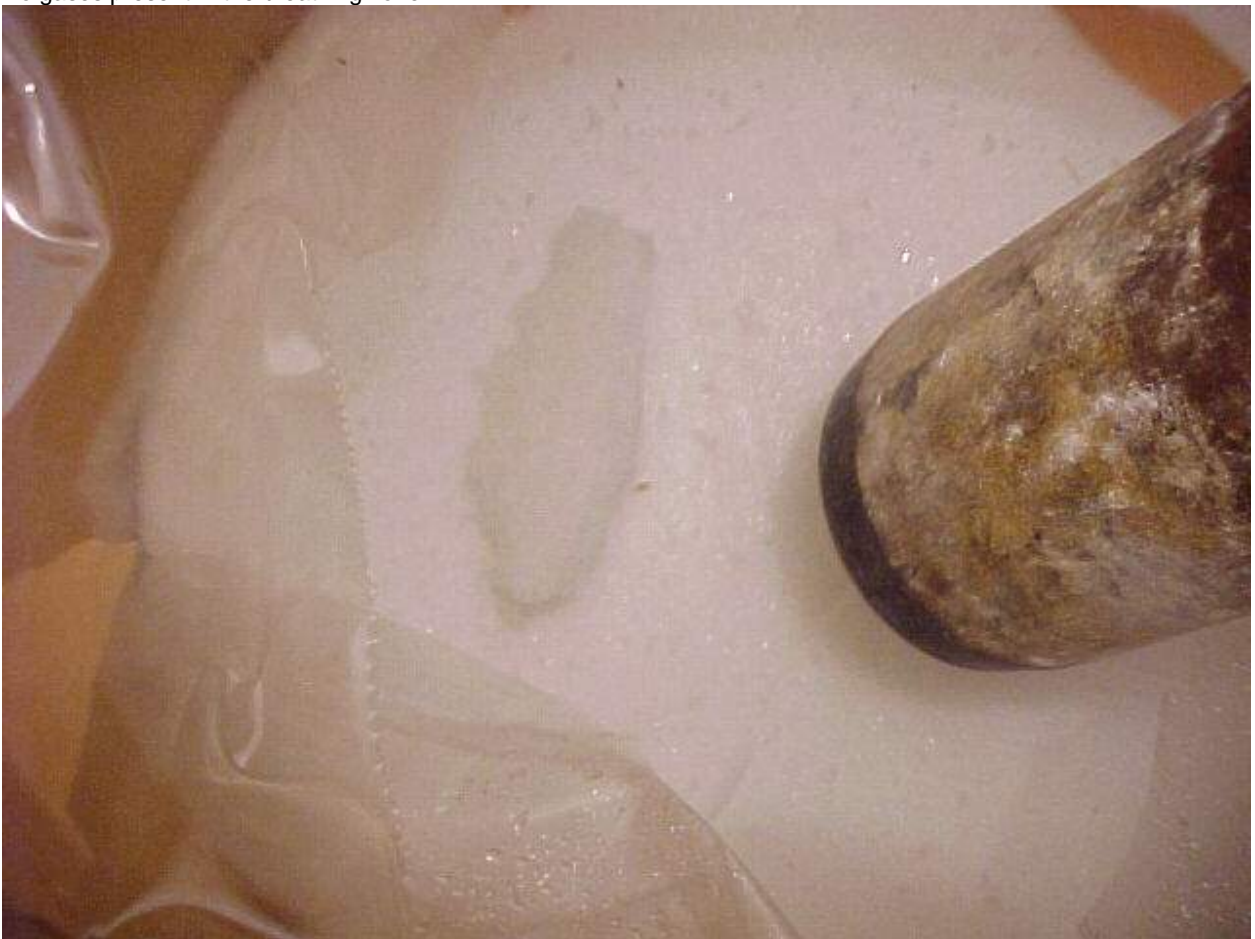
ThN material – monolith – white – solid – dry
No gases present in the breathing zone.
