THORIUM NITRATE STOCKPILE DRUM CHARACTERIZATION REPORT

**THORIUM NITRATE STOCKPILE
DRUM CHARACTERIZATION REPORT**

Prepared for
U.S. Defense Logistics Agency
Defense National Stockpile Center
Fort Belvoir, Virginia

Prepared by
OAK RIDGE NATIONAL LABORATORY
Oak Ridge, Tennessee 37831
managed by
UT-BATTELLE, LLC
for the
U.S. DEPARTMENT OF ENERGY
under contract DE-AC05-00OR22725

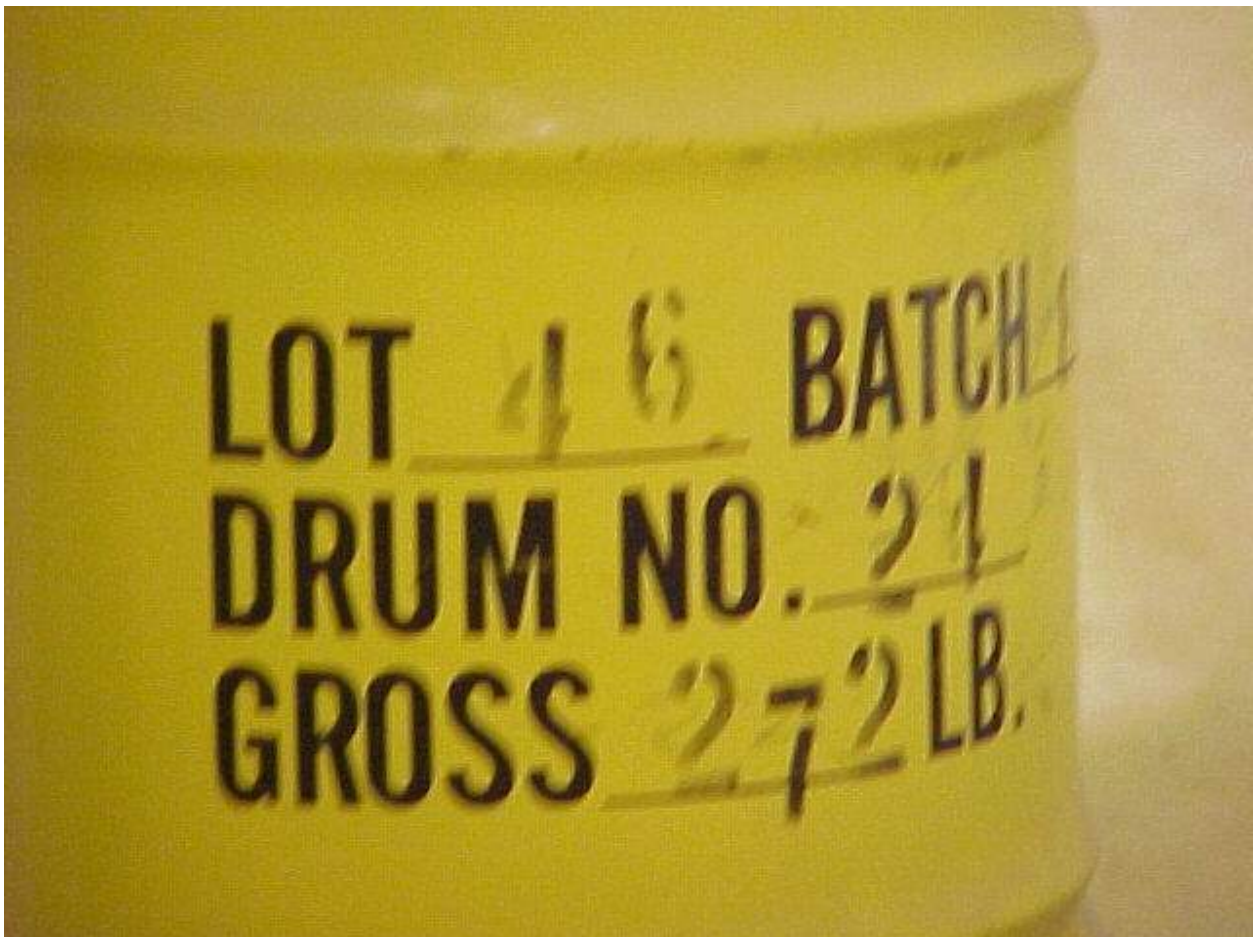
14:45**Other Information**Photo No. 1 of 11Dose Rate Surface 22 mR/hr
 1 meter 2.0 mR/hr

30-gal drum – good condition
No gases present in the breathing zone.

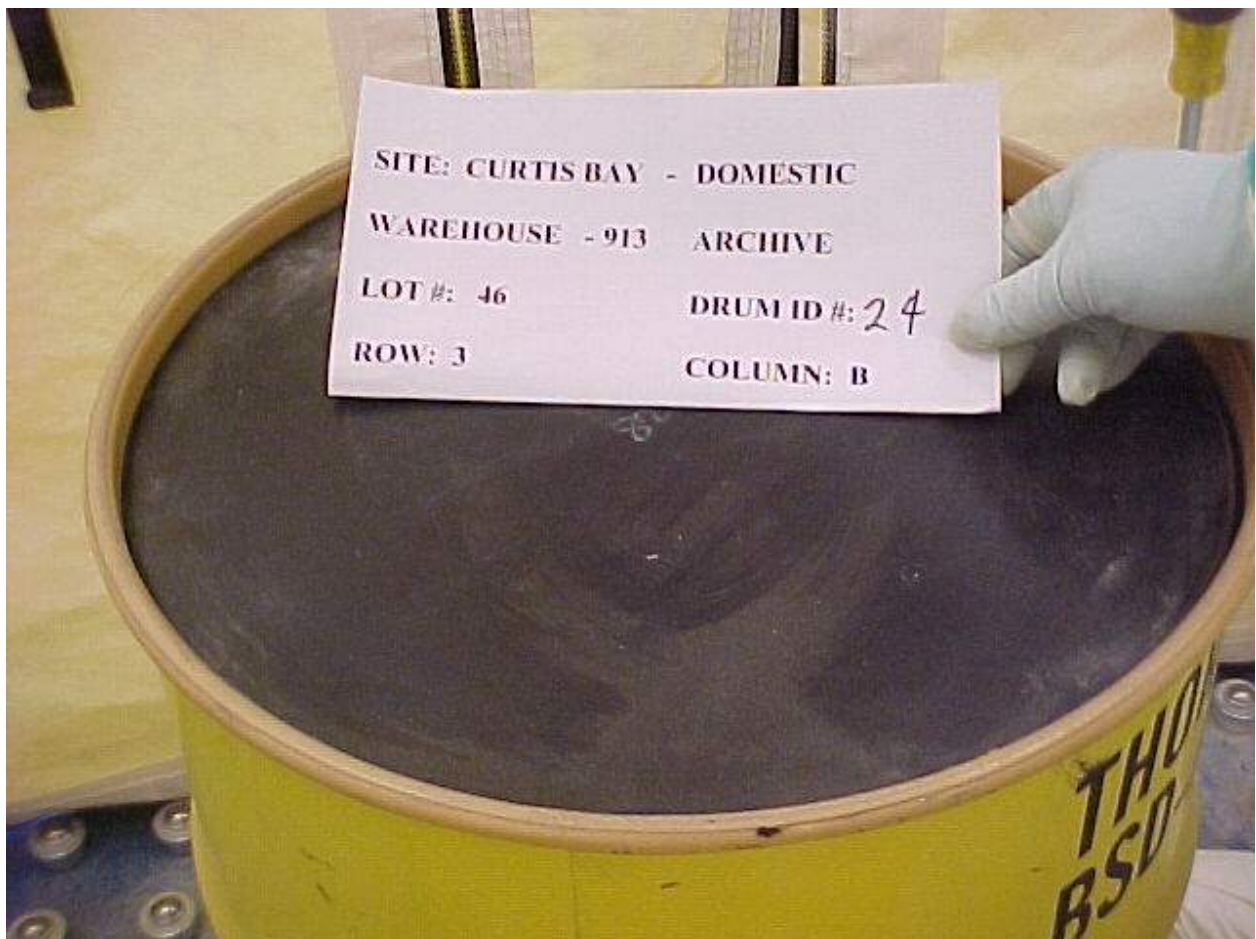
Black plastic lid – good condition
No gases present in the breathing zone.

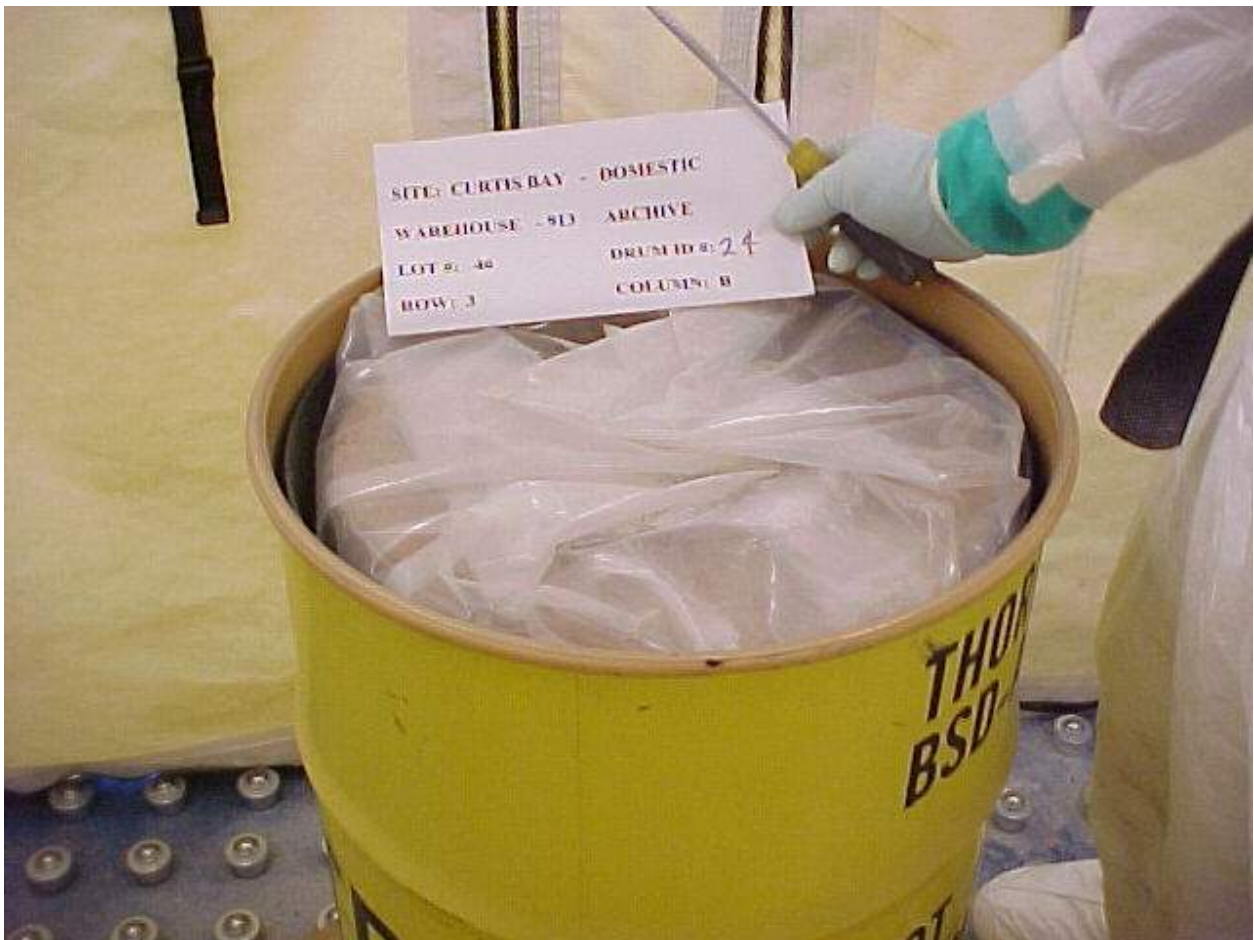
1st poly liner/bag – good condition
No gases present in the breathing zone.

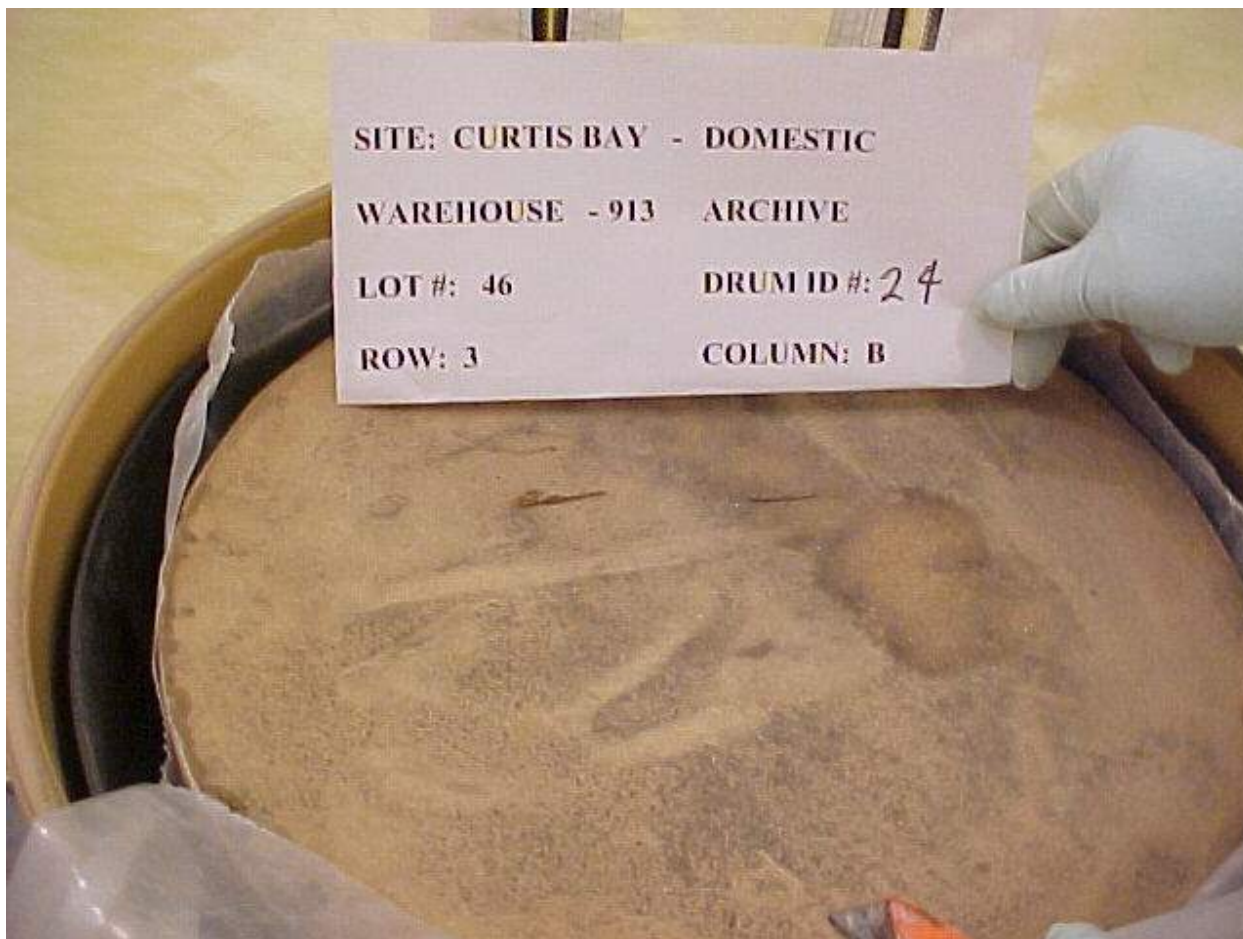
Fiber drum lid – good condition
No gases present in the breathing zone.

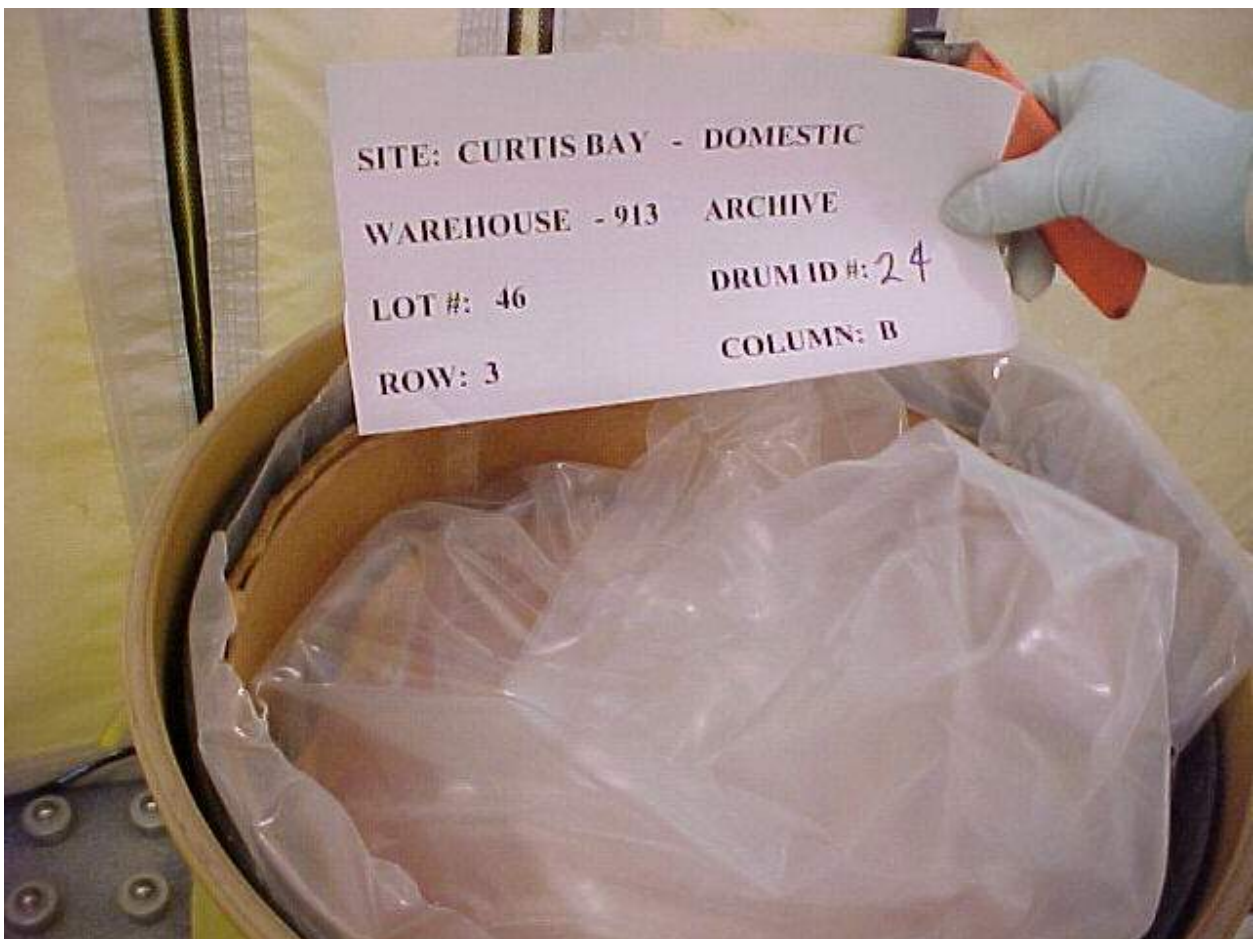
14:45**Other Information**Photo No. 5 of 11Dose Rate Surface 22 mR/hr
 1 meter 2.0 mR/hr

2nd poly liner/bag – good condition
No gases present in the breathing zone.

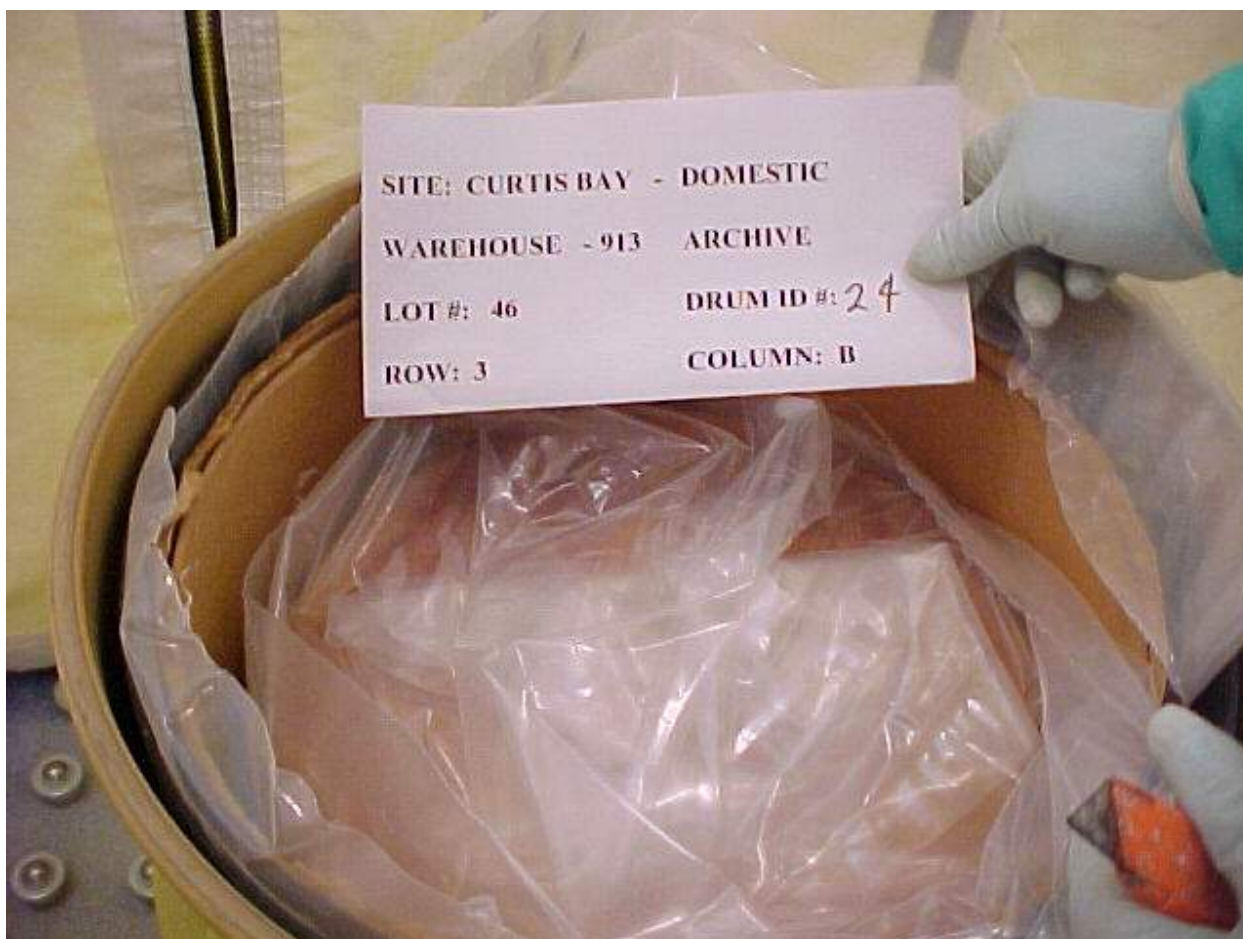
3rd poly liner/bag – good condition
No gases present in the breathing zone.

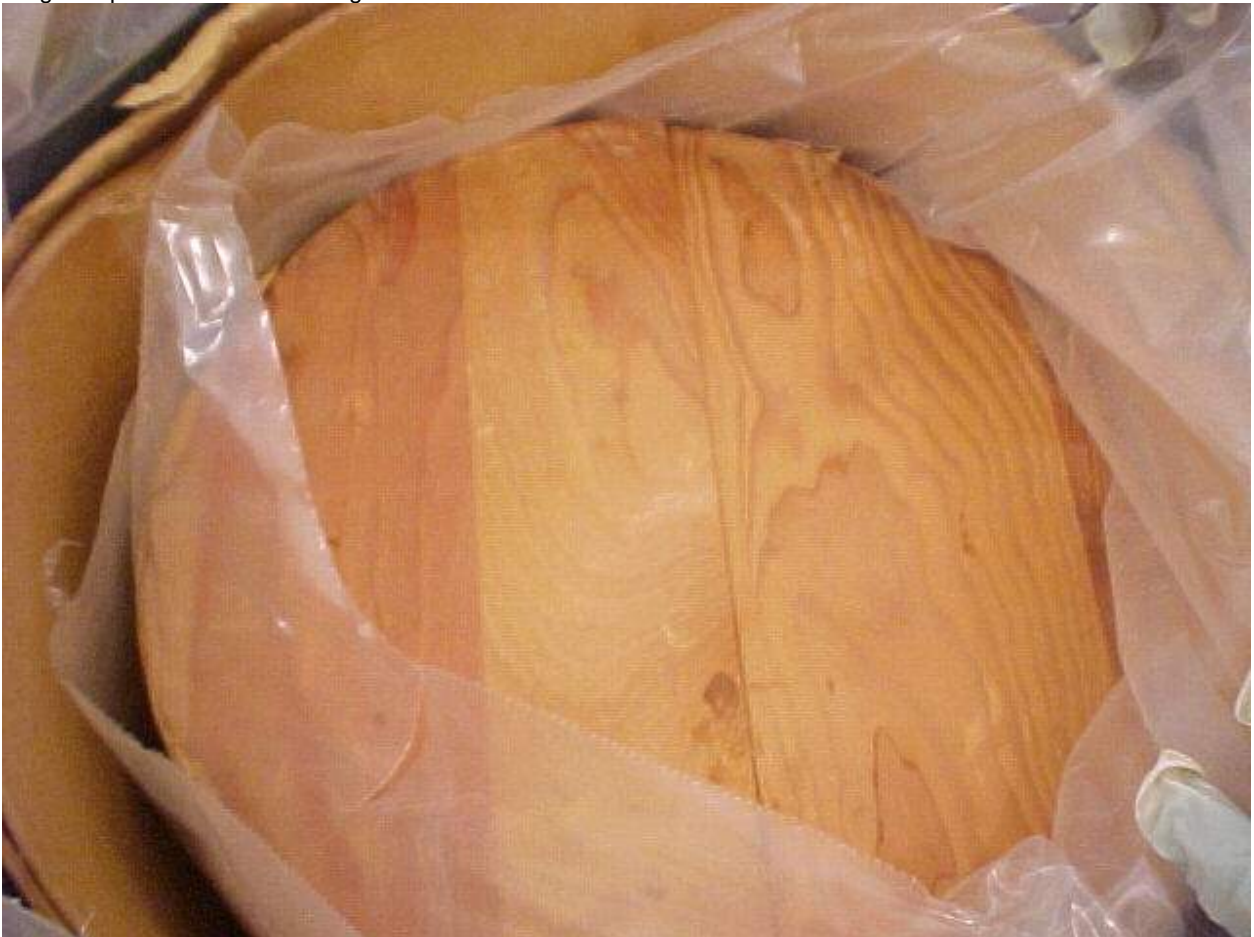
Wooden lid – good condition
 No gases present in the breathing zone.

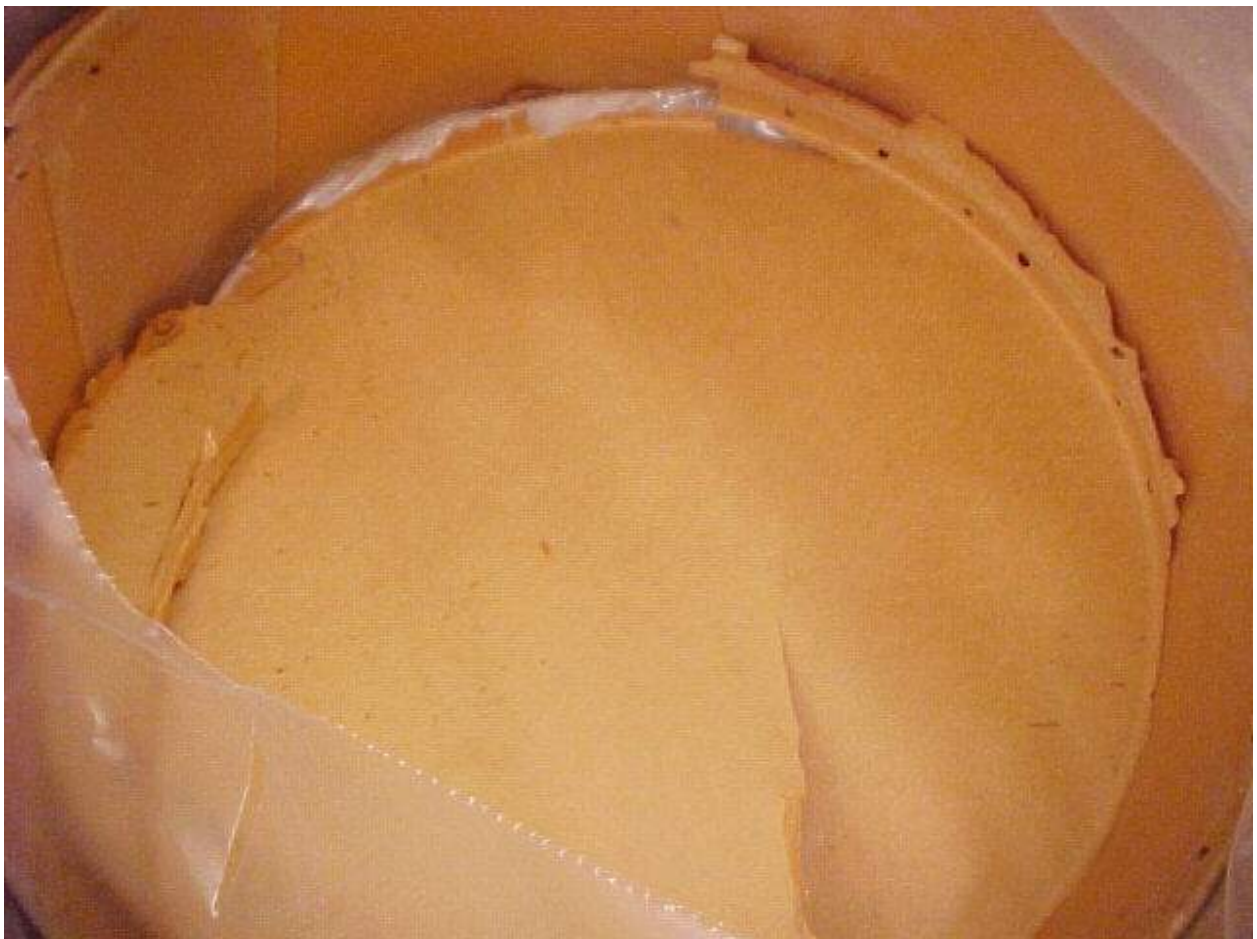
Lab-pack (inner fiber drum) paper layer lid – fair condition – typically breaks apart upon removal of the wooden lid.
No gases present in the breathing zone.

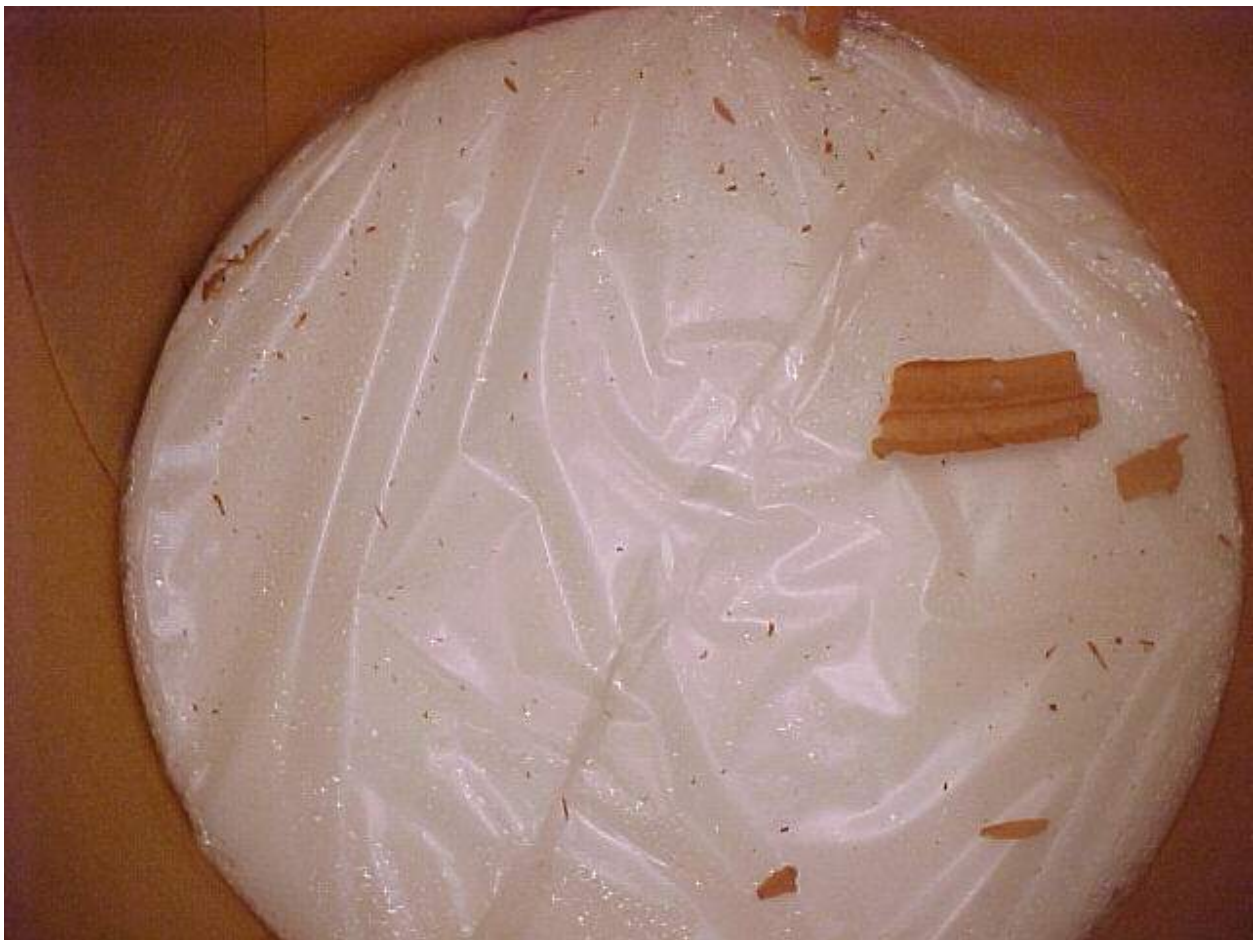
14:45**Other Information**Photo No. 9 of 11Dose Rate Surface 22 mR/hr
 1 meter 2.0 mR/hr

4th poly liner/bag – good condition
No gases present in the breathing zone.

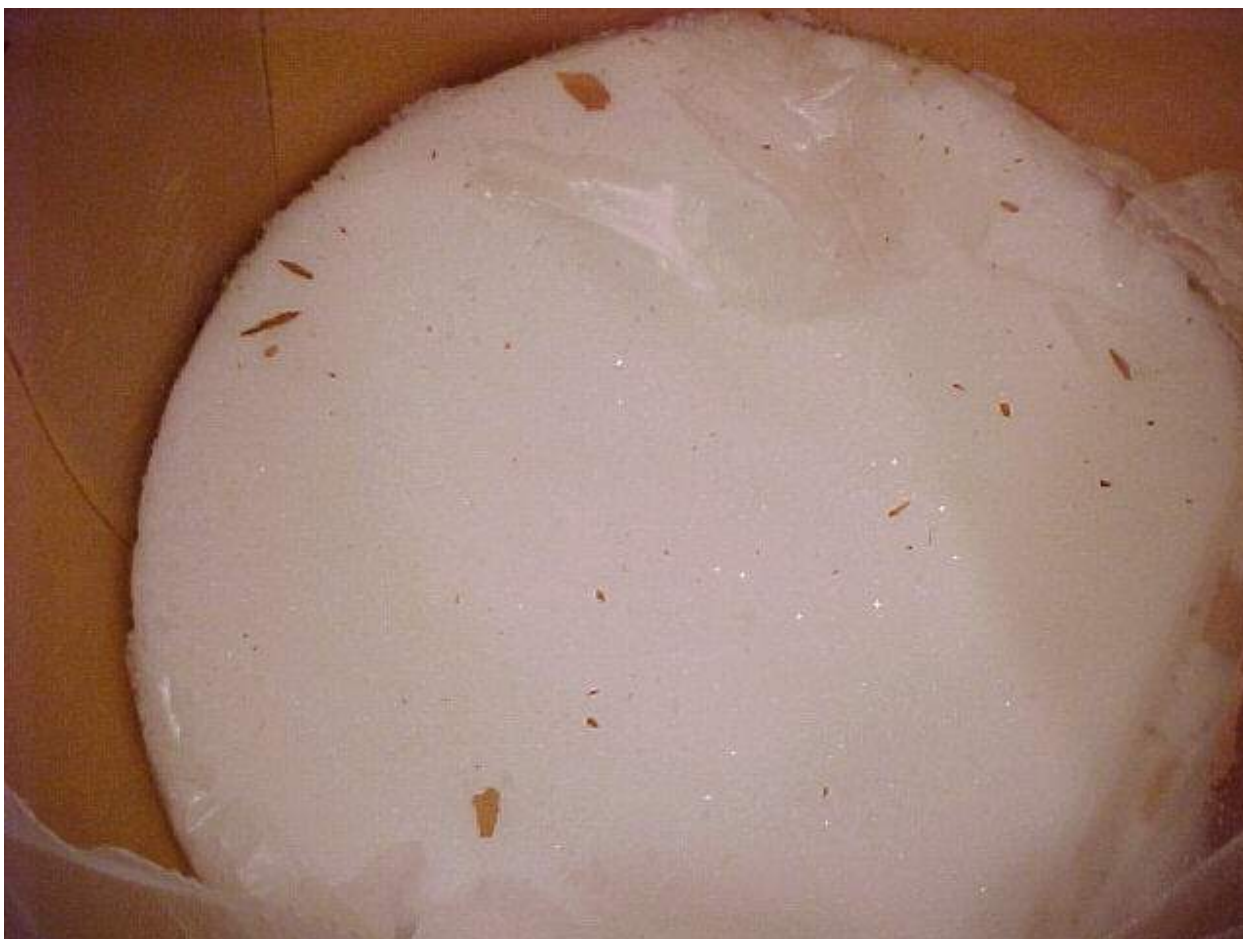
ThN material – monolith – white – solid - dry
No gases present in the breathing zone.

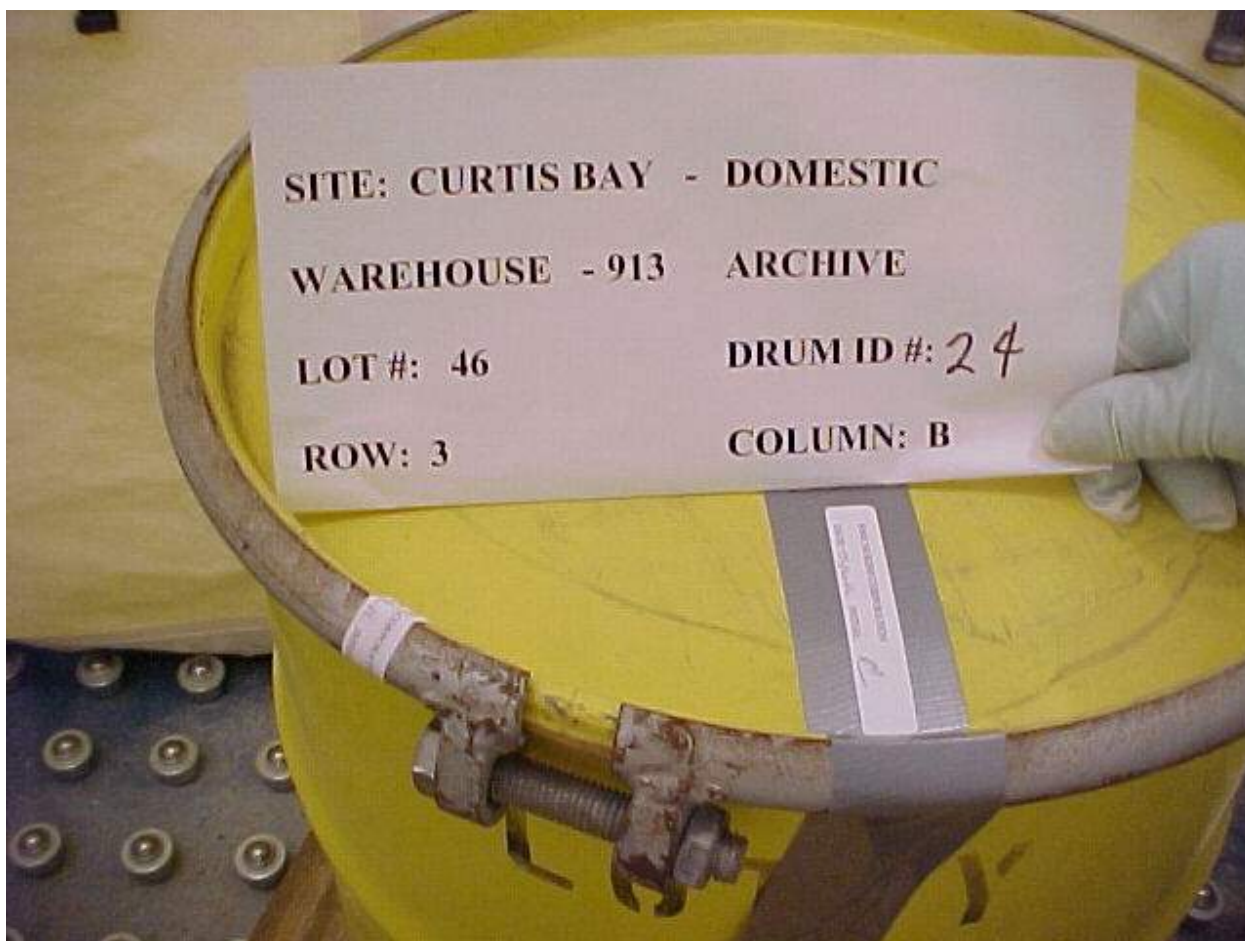
14:45**Other Information**Photo No. 11 of 11Dose Rate Surface 22 mR/hr
 1 meter 2.0 mR/hr

Sealed & dated - Complete

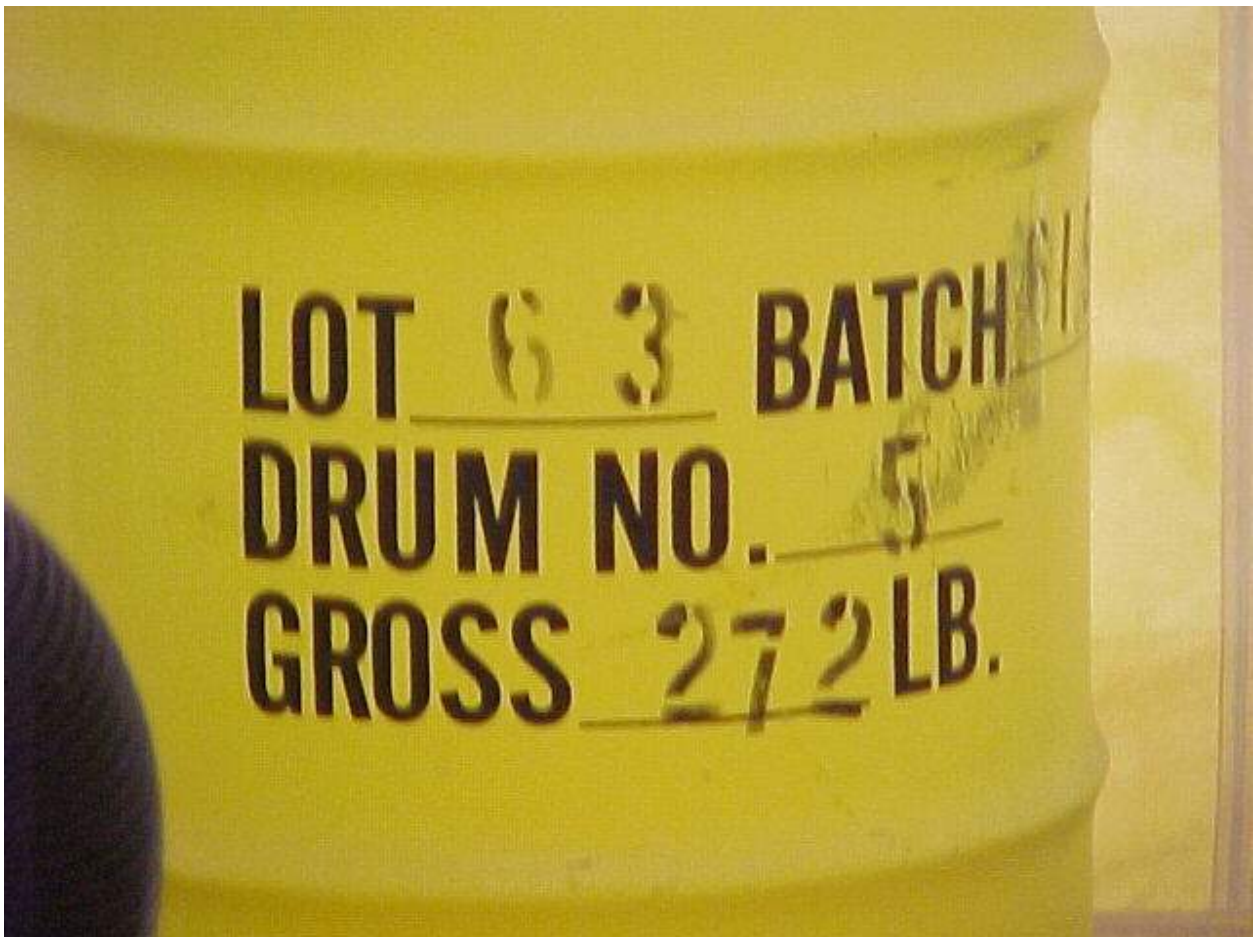
11:30**Other Information**Photo No. 1 of 11Dose Rate Surface 22 mR/hr
 1 meter 2.6 mR/hr

30-gal drum – good condition
No gases present in the breathing zone.

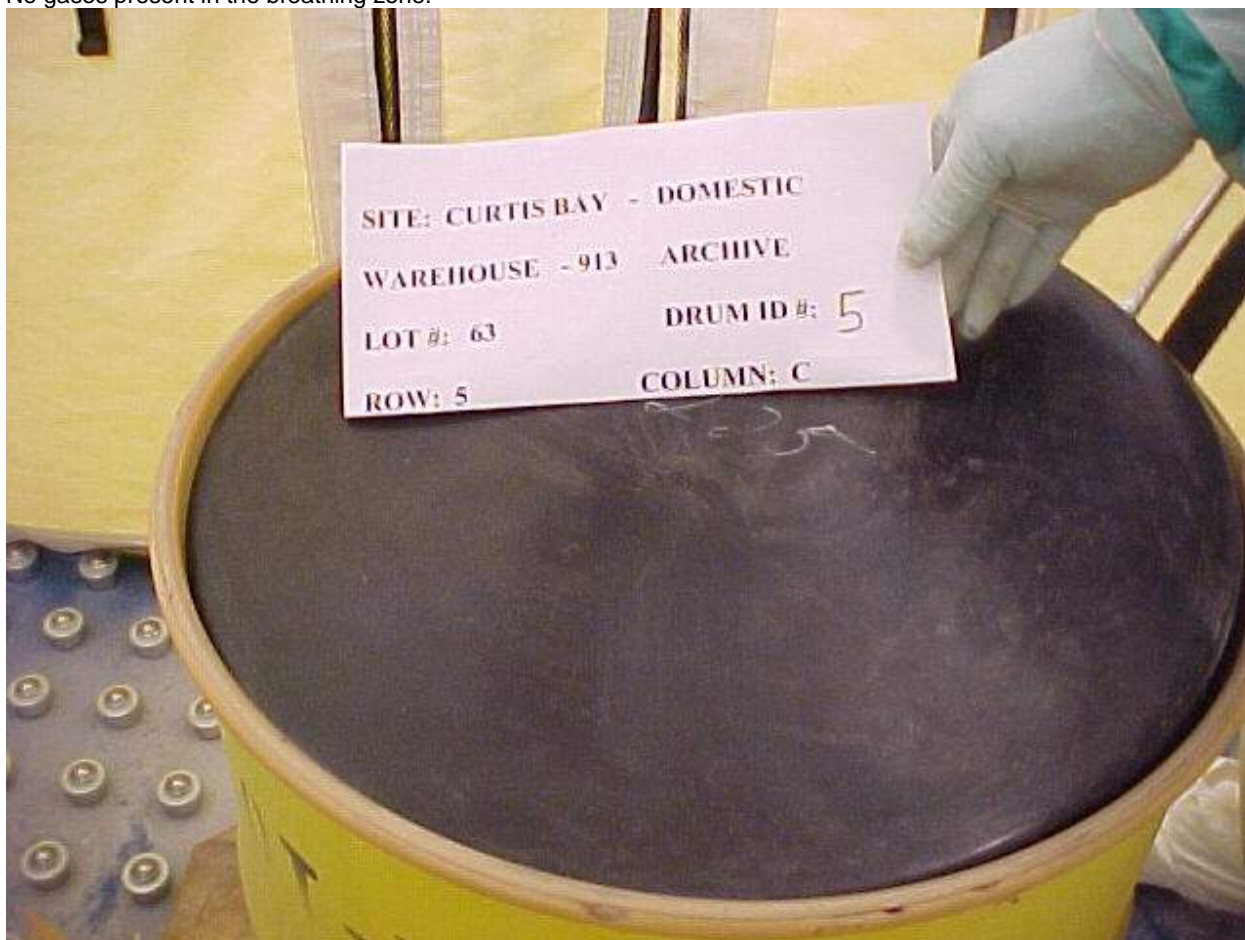
Black plastic lid – good condition
No gases present in the breathing zone.

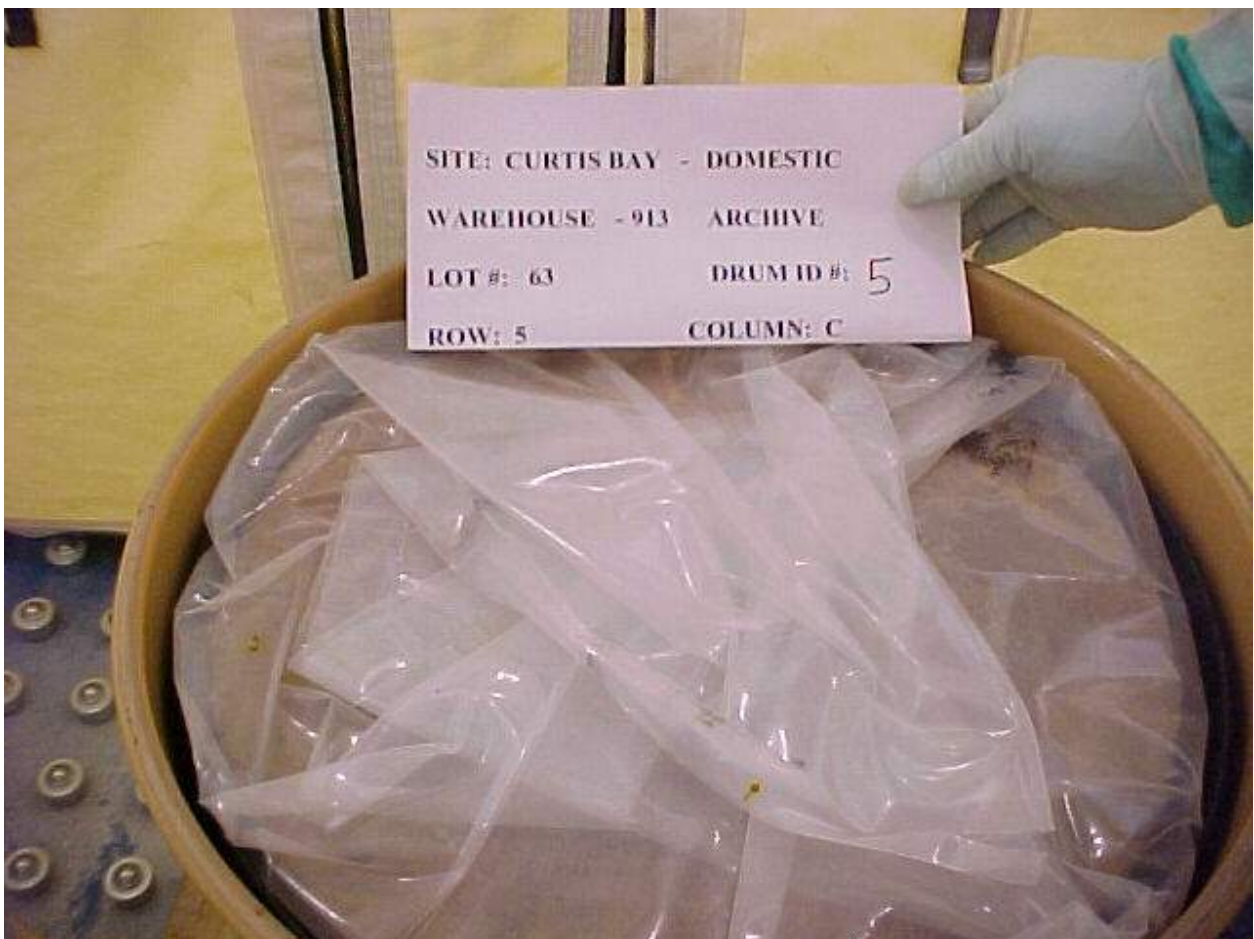
11:30**Other Information**Photo No. 3 of 11Dose Rate Surface 22 mR/hr
 1 meter 2.6 mR/hr

1st poly liner/bag – good condition
No gases present in the breathing zone.

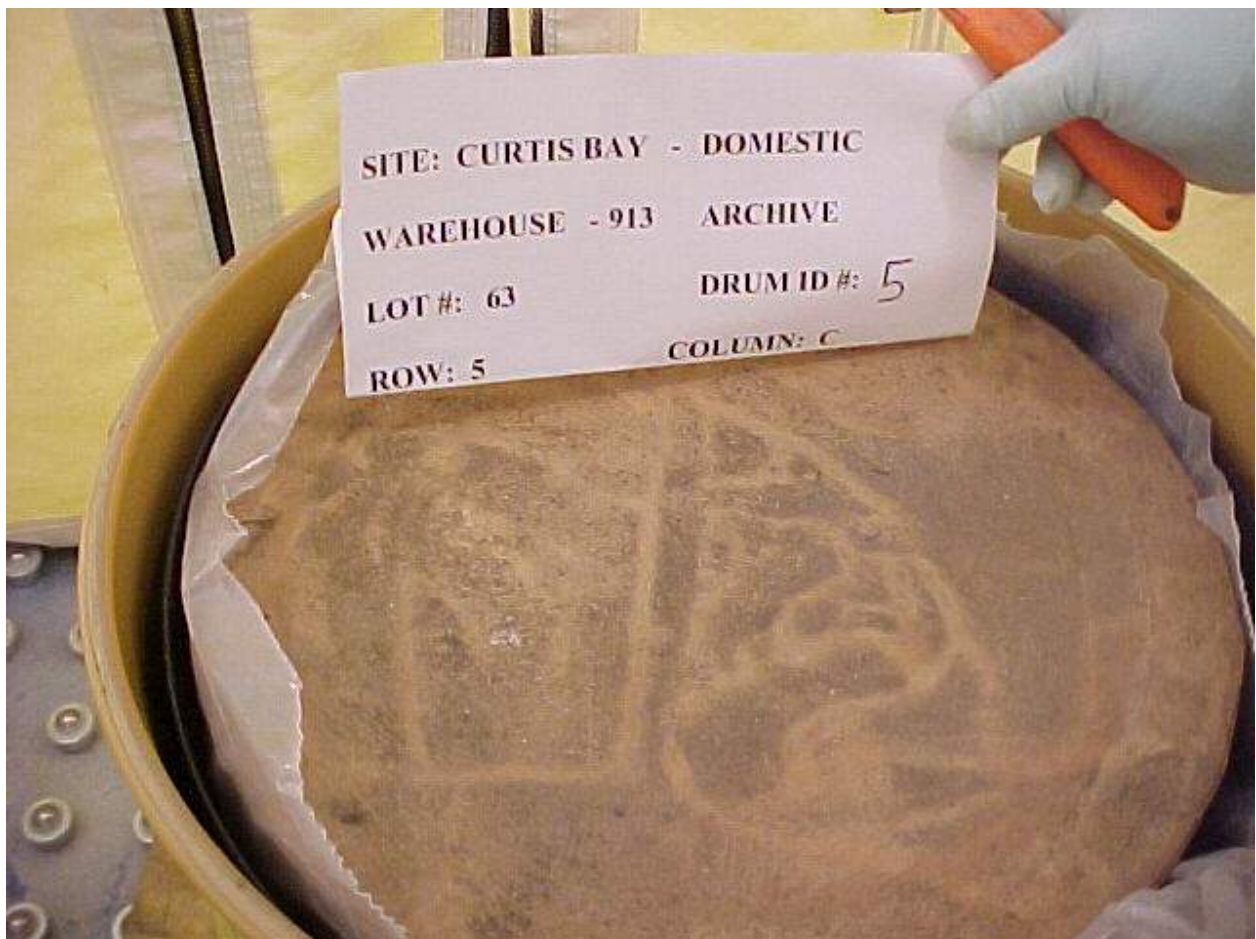
Fiber drum lid – good condition
No gases present in the breathing zone.

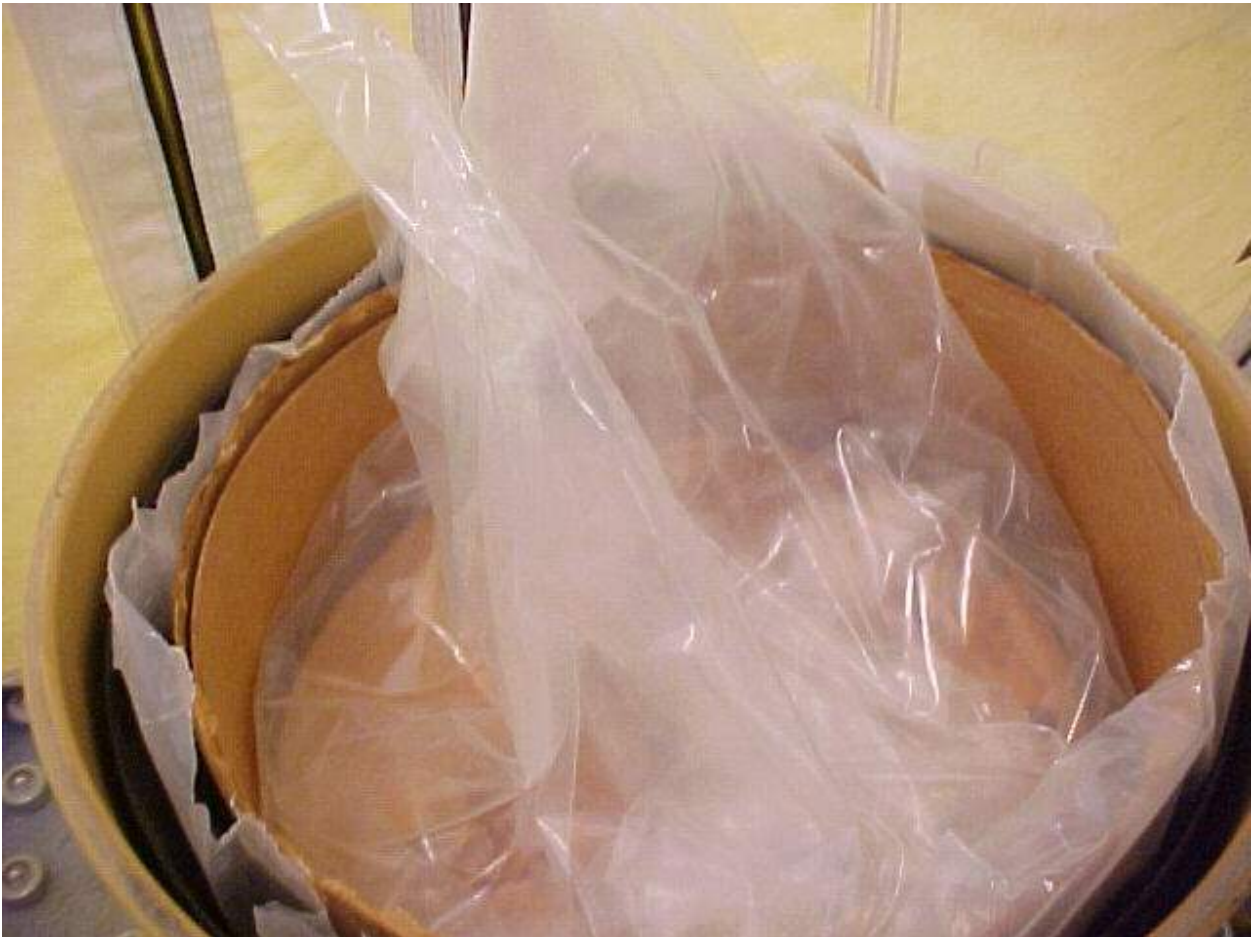
11:30**Other Information**Photo No. 5 of 11Dose Rate Surface 22 mR/hr
 1 meter 2.6 mR/hr

2nd poly liner/bag – good condition
No gases present in the breathing zone.

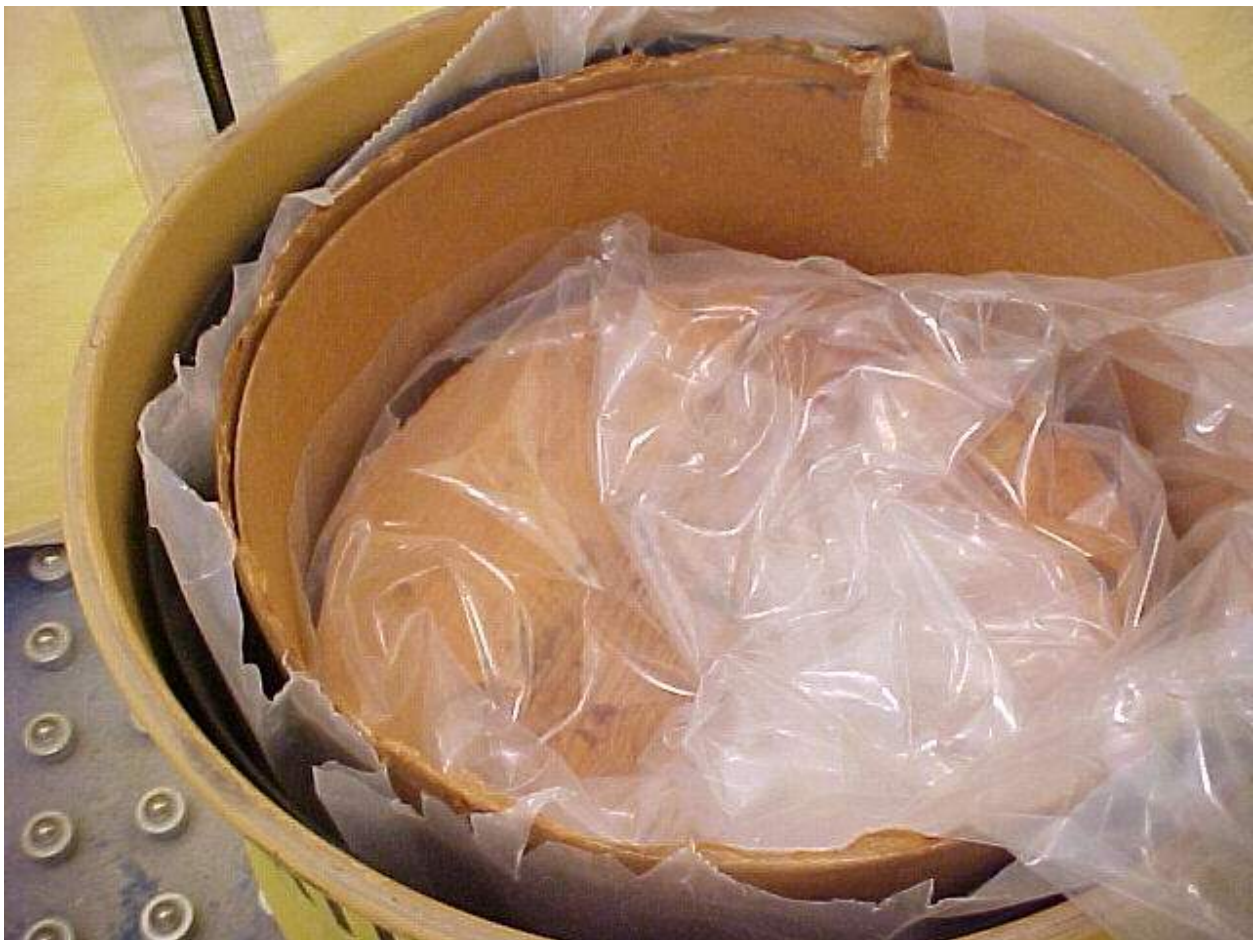
3rd poly liner/bag – good condition
No gases present in the breathing zone.

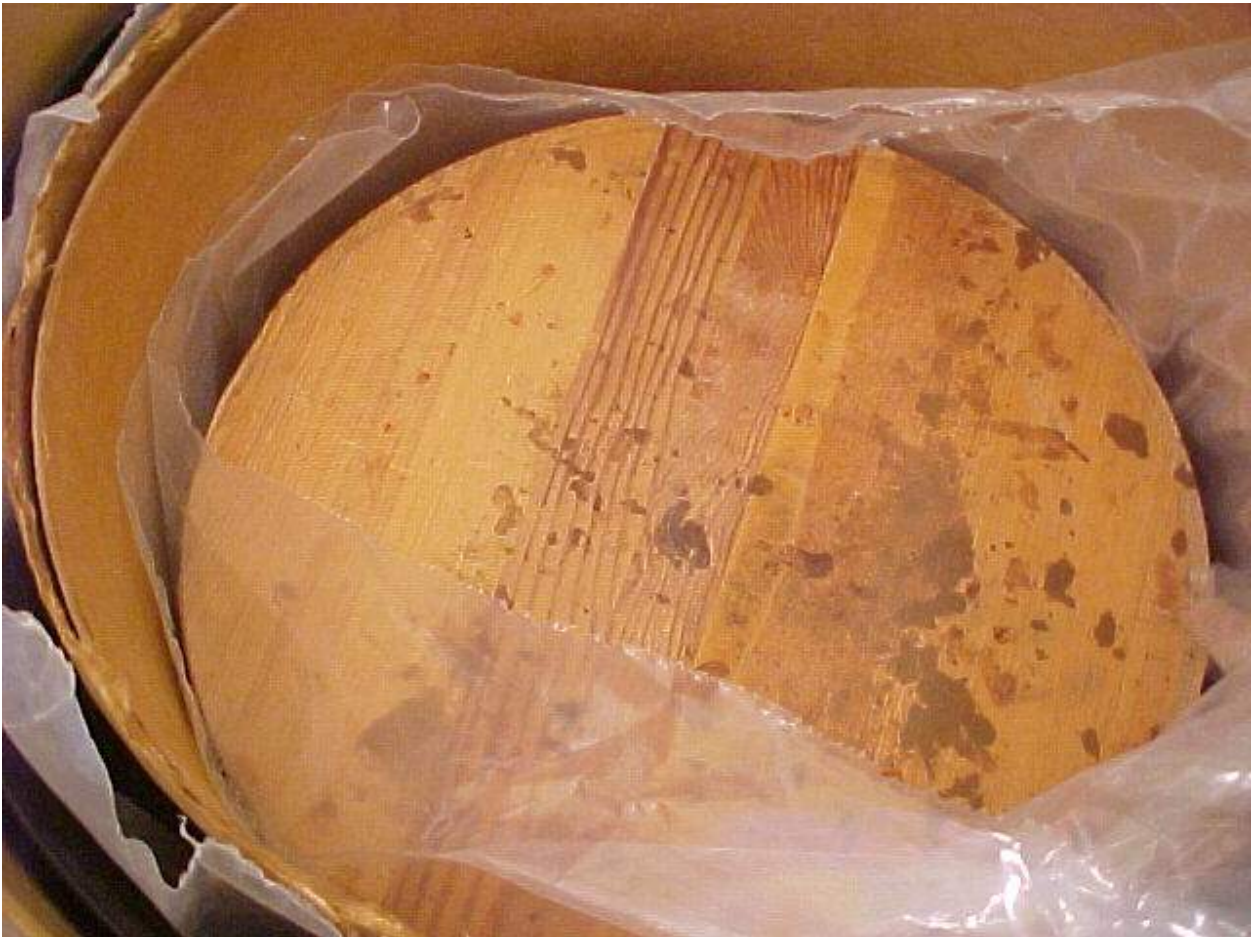
Fiber drum lid – good condition
No gases present in the breathing zone.

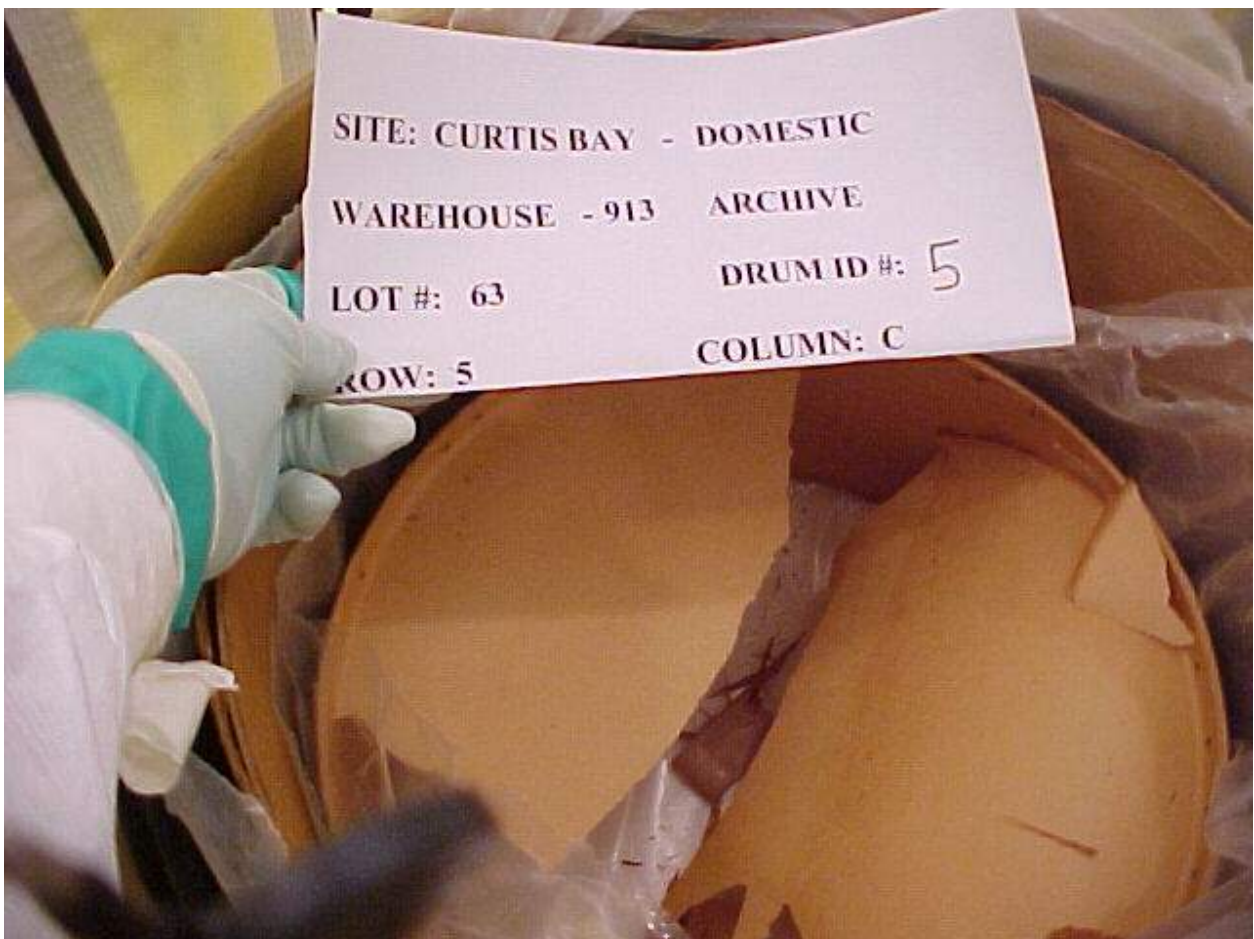
Lab-pack paper layer lid – broken upon removal of the wooden lid.
No gases present in the breathing zone.
