THORIUM NITRATE STOCKPILE DRUM CHARACTERIZATION REPORT

**THORIUM NITRATE STOCKPILE
DRUM CHARACTERIZATION REPORT**

Prepared for
U.S. Defense Logistics Agency
Defense National Stockpile Center
Fort Belvoir, Virginia

Prepared by
OAK RIDGE NATIONAL LABORATORY
Oak Ridge, Tennessee 37831
managed by
UT-BATTELLE, LLC
for the
U.S. DEPARTMENT OF ENERGY
under contract DE-AC05-00OR22725

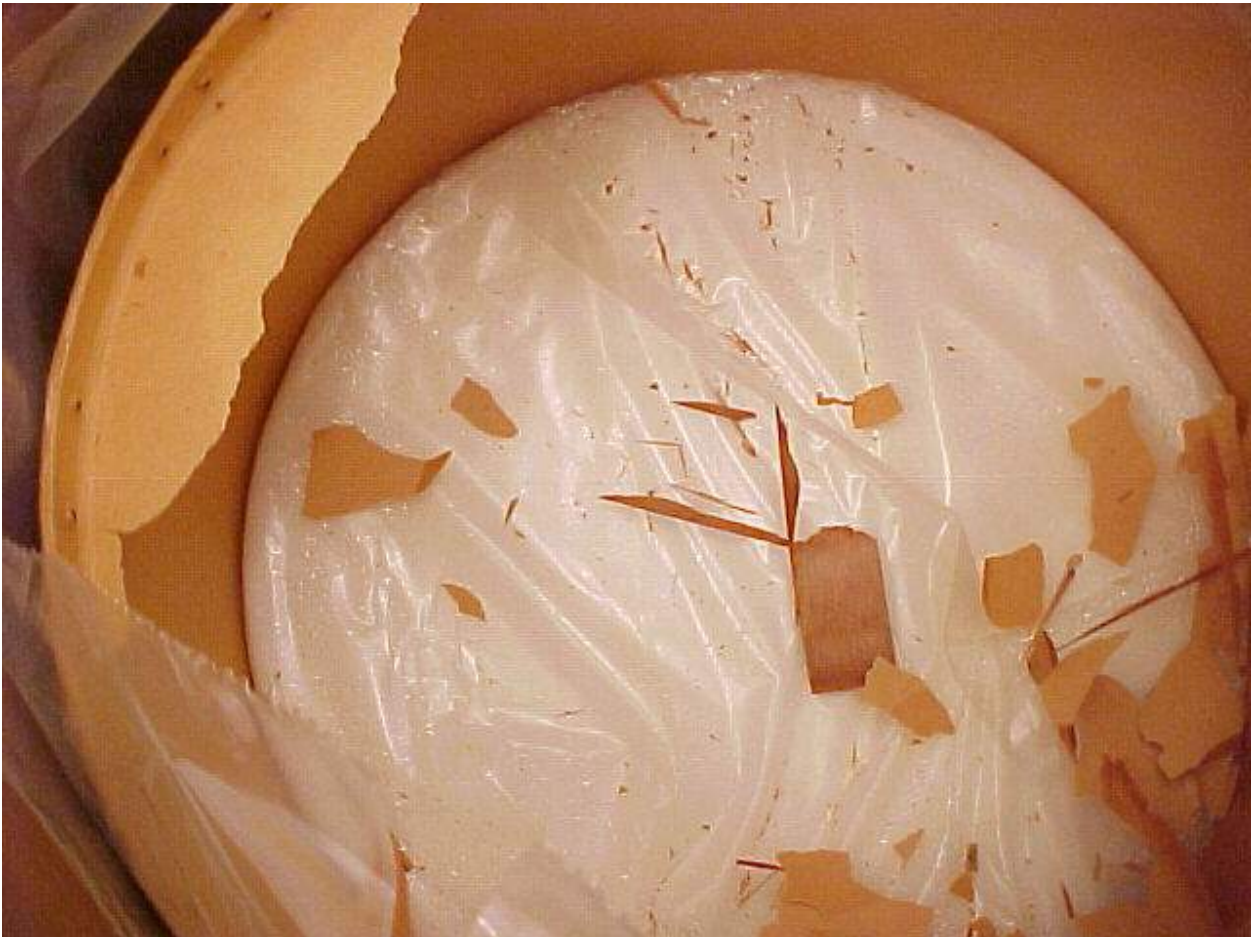
11:30**Other Information**Photo No. 9 of 11Dose Rate Surface 22 mR/hr
 1 meter 2.6 mR/hr

4th poly liner/bag – good condition
No gases present in the breathing zone.

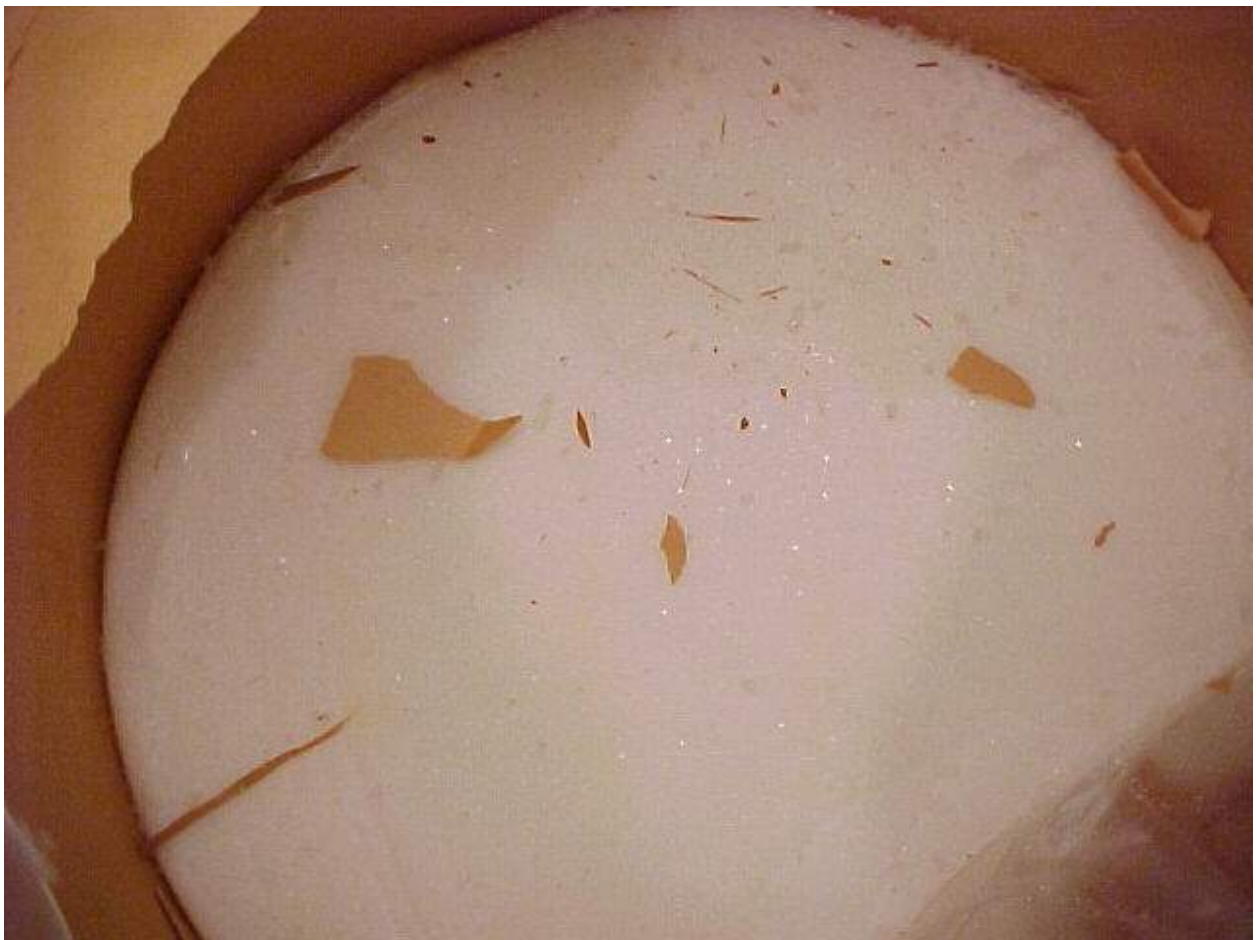
ThN material – monolith – white – solid - dry
No gases present in the breathing zone.

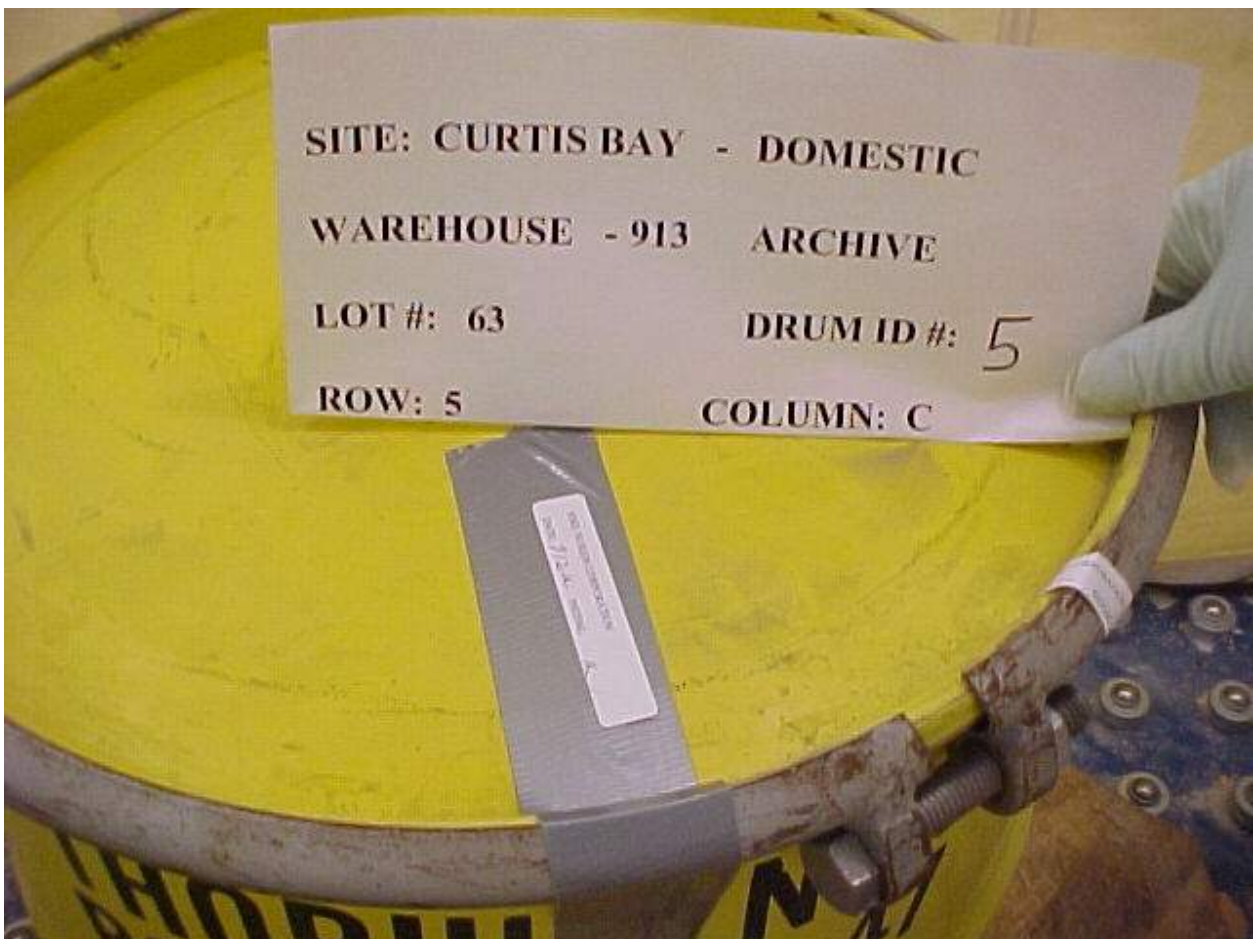
11:30**Other Information**Photo No. 11 of 11Dose Rate Surface 22 mR/hr
 1 meter 2.6 mR/hr

Sealed & dated - Complete

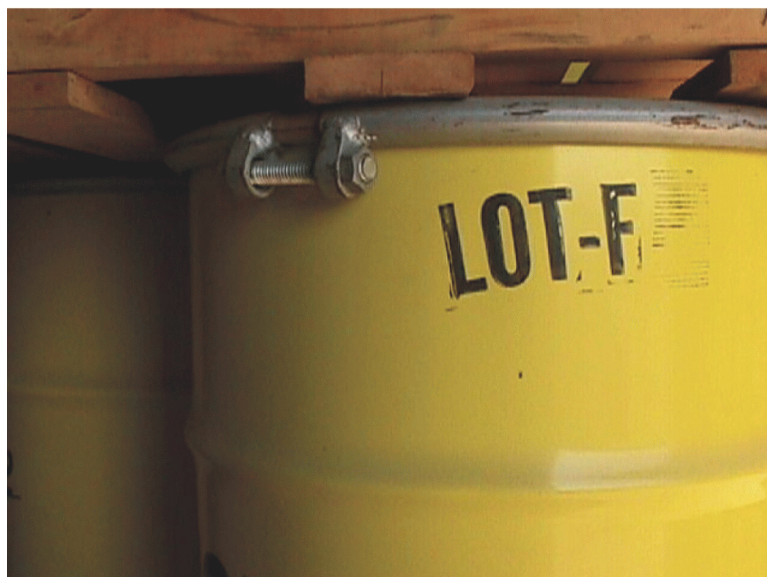
In addition to investigating how to ensure a good seal on the MD-1, the effect of the amount of torque placed on the closure bolt was investigated. This is an issue because the MD-1 drums are closed in a very consistent manner with the jam nut on the outside of the lock ring lugs and one or two threads of the locking bolt showing through the jam nut. Figure O-7 shows the closure bolt on a typical MD-1 package in a Curtis Bay warehouse. During the preliminary investigations this type of closure was replicated (Fig. O-8). The amount of torque required to produce this closure configuration

Fig. O-7. MD-1 drum at Curtis Bay Depot showing the typical closure bolt configuration.

was about 15 ft/lb. This is considerably less than the 40 – 50 ft/lb called for in most current hazardous materials drum closing instructions. However, the closure observed on the MD-1 packages was shown to hold pressure, over the range tested, as well as the same package with the higher closure bolt torque.

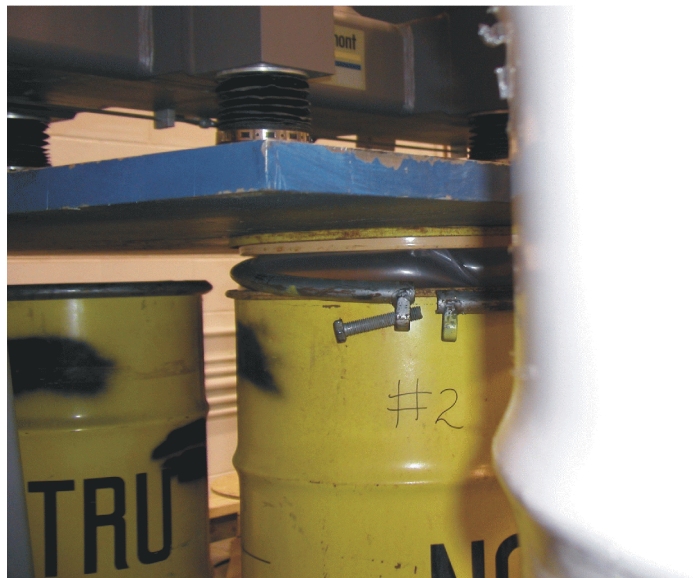
A package configuration similar to the MD-1 configuration in the field was tested (e.g., a pressurized plastic bag inside an MD-1 with a loosened locking ring). The goal of the test was to quantify and bound the pressure required to produce the sort of drumhead "pop," observed in the field. Drumhead movement was not monitored because the shock of the sudden final movement of the drumhead would have destroyed the dial micrometer.

Fig. O-10. MD-1 with popped drumhead showing still inflated polyethylene bag and captured drumhead.

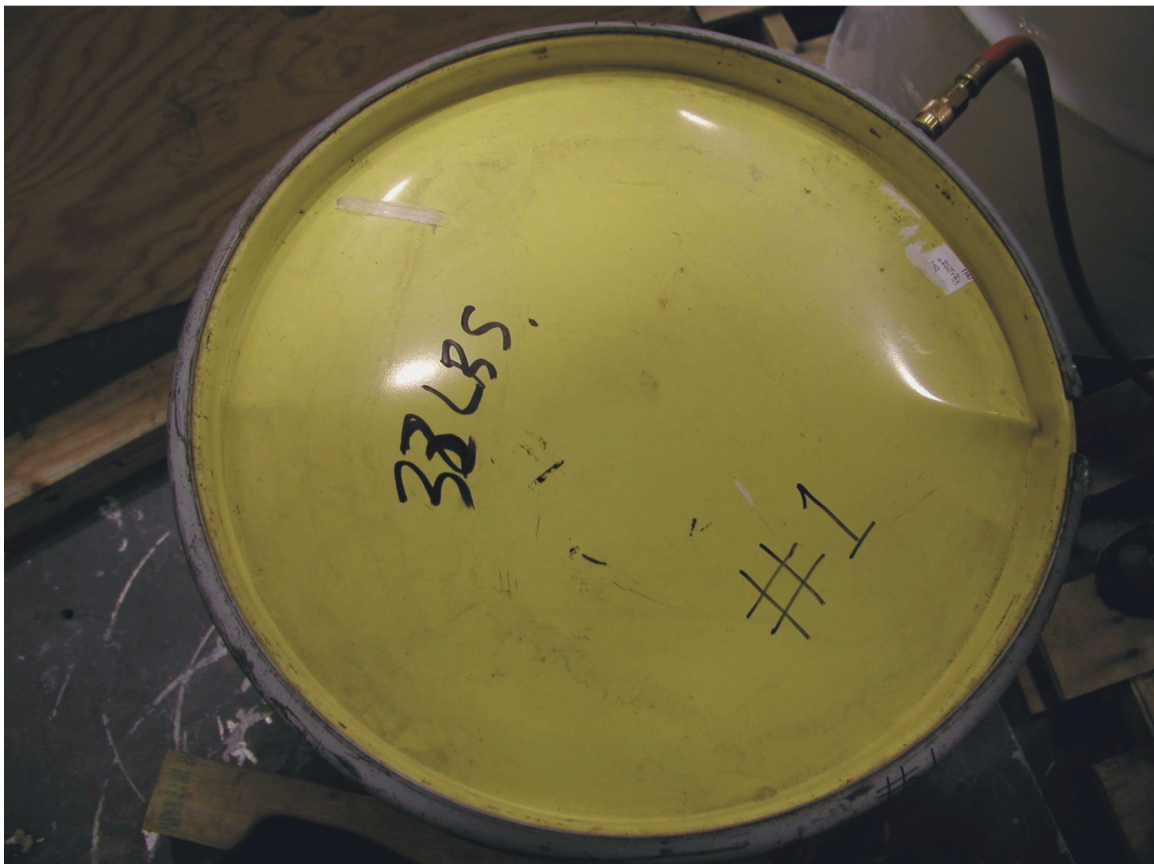
Pressure reading (psig)	Drumhead deflection (in.)	Comments
5	0.030	No leak
10	0.251	No leak
12	0.408	Leak between ends of locking ring
10	0.400	No leak
11	0.408	No leak
12	0.420	Leak between ends of locking ring
13	0.432	More severe leak
0	0.265	Permanent drum deformation. A similar permanent deformation of the drum bottom was observed.

The second test was performed to more fully document the onset of plastic deformation of the drumhead. In this test, the pressure was raised to a selected point, the drumhead deflection was read, the pressure was released, and the drumhead deflection was again read. This drum did not leak up to the ending test pressure of 15 psig. At 13 psig, a crease began to form in the drumhead at the locking ring gap. The size of the crease continued to increase with increasing pressure. Slight (e.g., a few thousandths of an inch) permanent deformation of the drumhead was observed immediately. At 11 psig, the permanent deformation reached 0.018 in. and began a rapid increase up to an ending value of 0.468 in. at 15 psig. Figure O-12 shows the final conformation of the drumhead. Table O-2 shows the results of the second test. Drumhead deflection readings at 0 psig indicate permanent deformation induced by the previously applied pressure.

Fig. O-12. MD-1 package showing lid deformation due to application of 15 psig air pressure.
