**Correlation of Process Data and Electrochemical Noise to Assess Kraft Digester
Corrosion: Second Year at Spring Grove**

S. J. Pawel*
D. W. Townley†
D. E. Roy‡
D. F. Wilson*

Date Published: April 2004

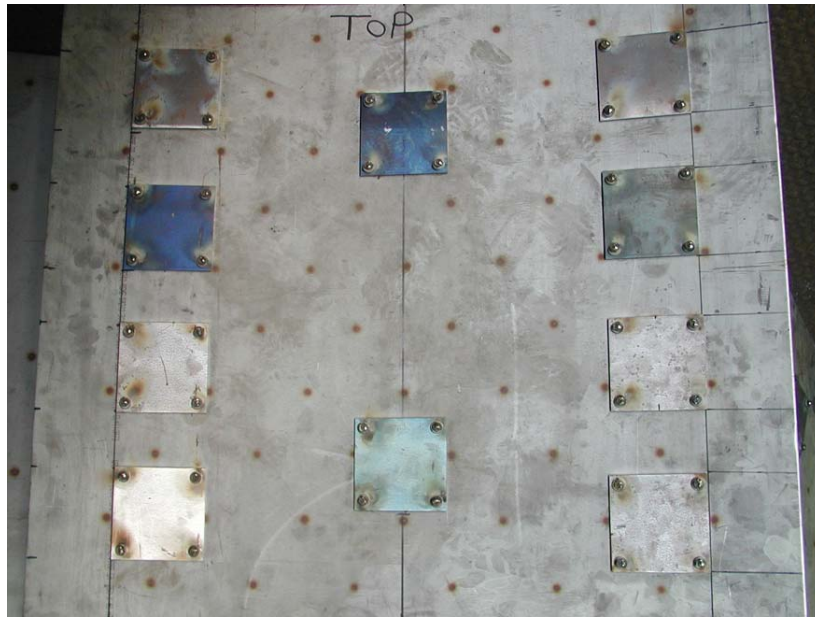
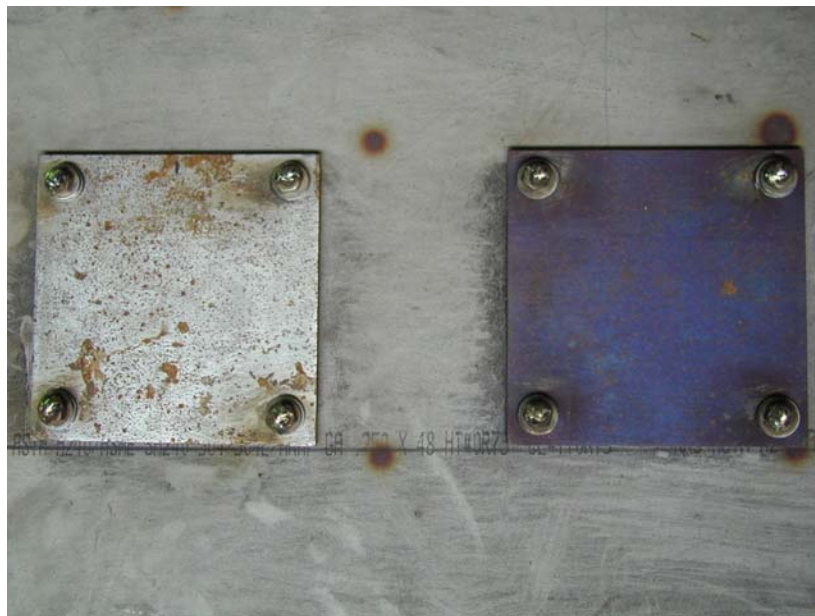
Fig. 2. Views of the new dummy plate with steel coupons attached. Top: one of two blank plates with test panels attached. Bottom: close-up view of test panels with different heat treatments. Note that the stainless steel nut and bolt have been welded together on the end to prevent loosening during operation.

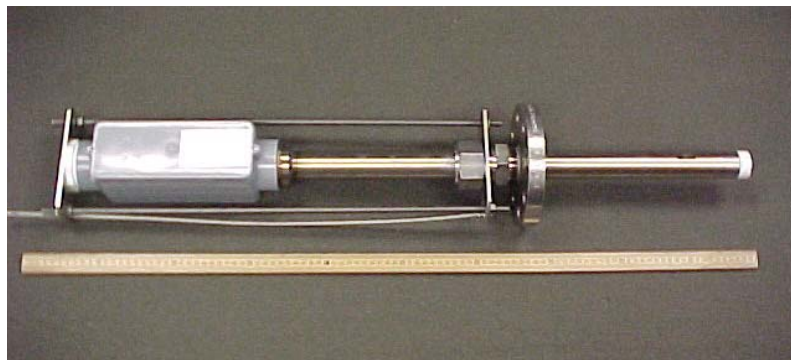
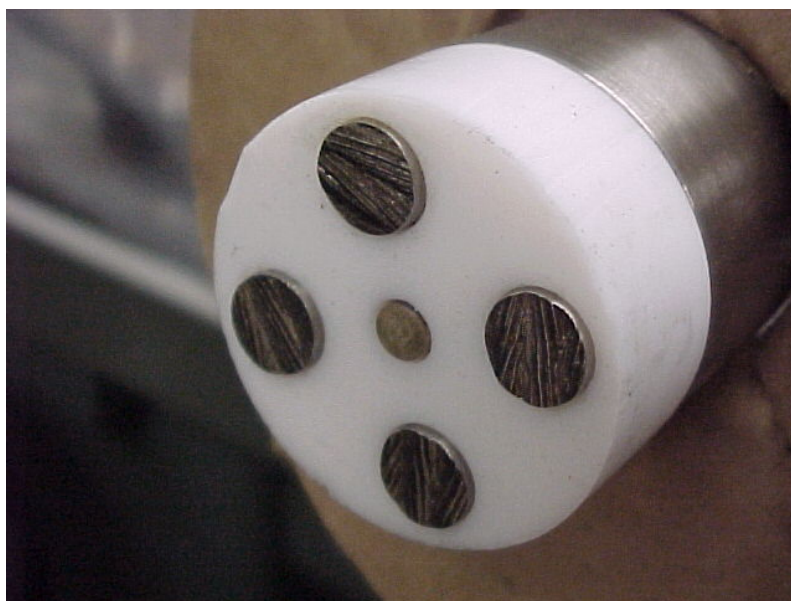
The basic design of the probes used in the second year at Spring Grove was identical to that used in the previous year, including an adjustable working length so that the surface of the probe could be placed precisely flush with the vessel ID at each probe location (see Fig. 10). However, rather than using electrodes representing mild steel and 309LSi overlay, there were electrodes of

Fig. 10. Adjustable length dual probe used in the Spring Grove digester experiment.

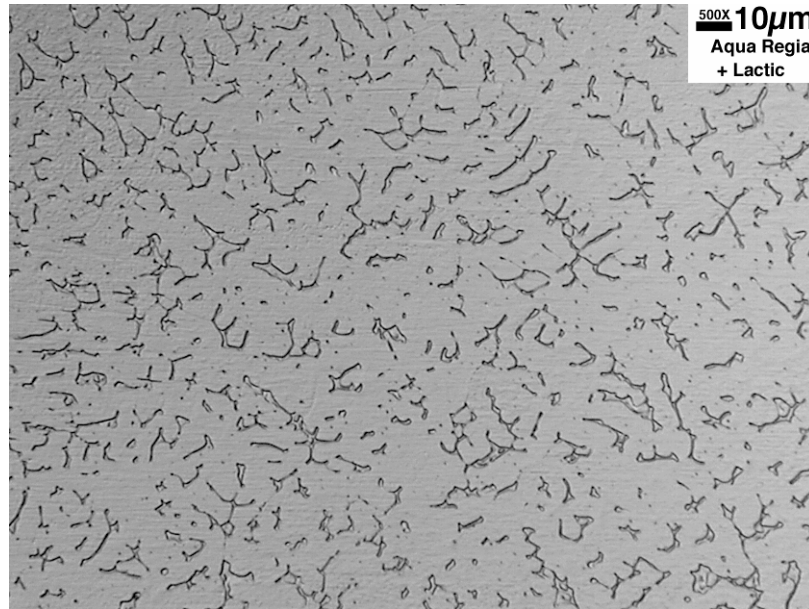
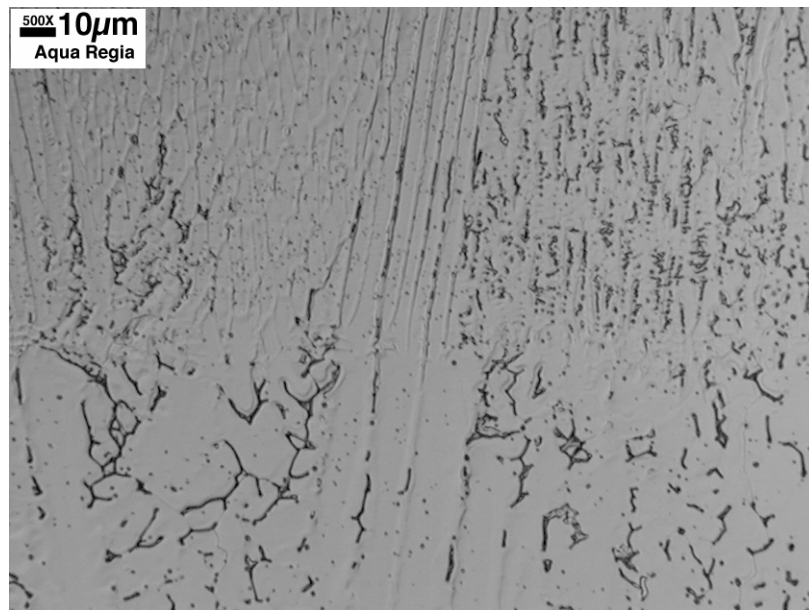
Fig. 11. Photomicrographs of the 309LSi overlays. Top: representative of the laboratory applied overlay. Bottom: representative of the 309LSi field overlay in the digester.

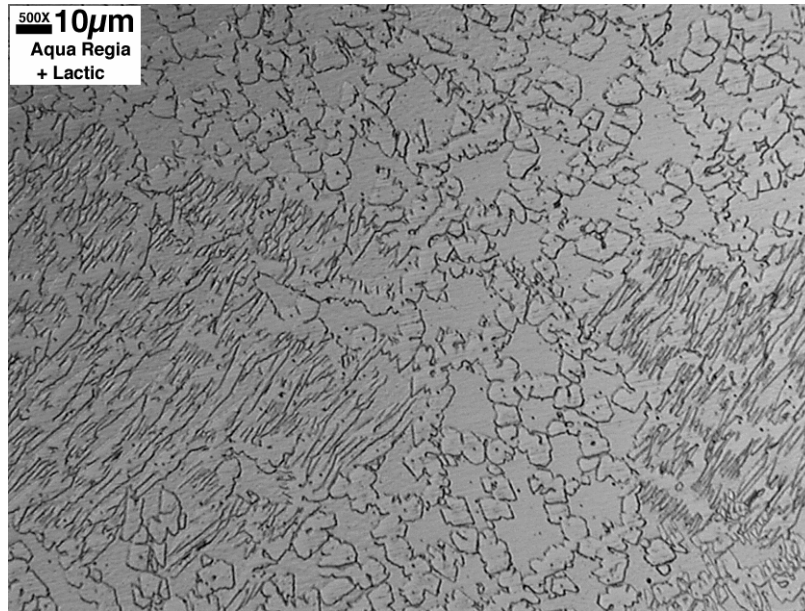
Fig. 12. Photomicrograph of 312 overlay applied in the laboratory.

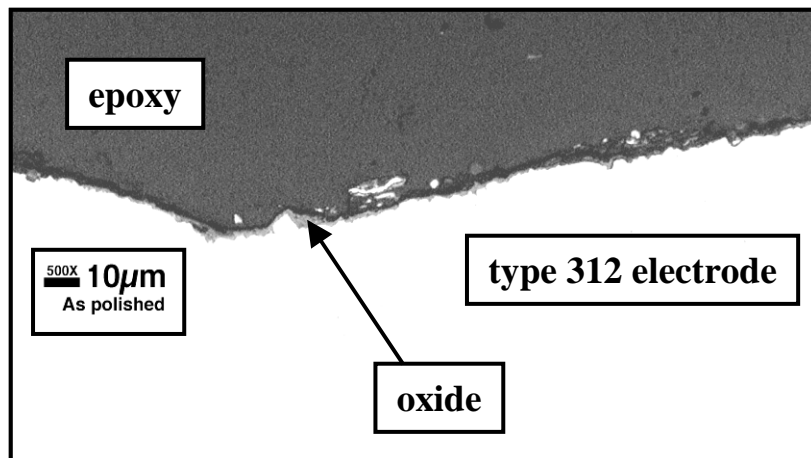
Fig. 14. Unexposed cross-section of type 312 stainless steel electrode. This specimen was prepared from material remaining following fabrication of the test probes.

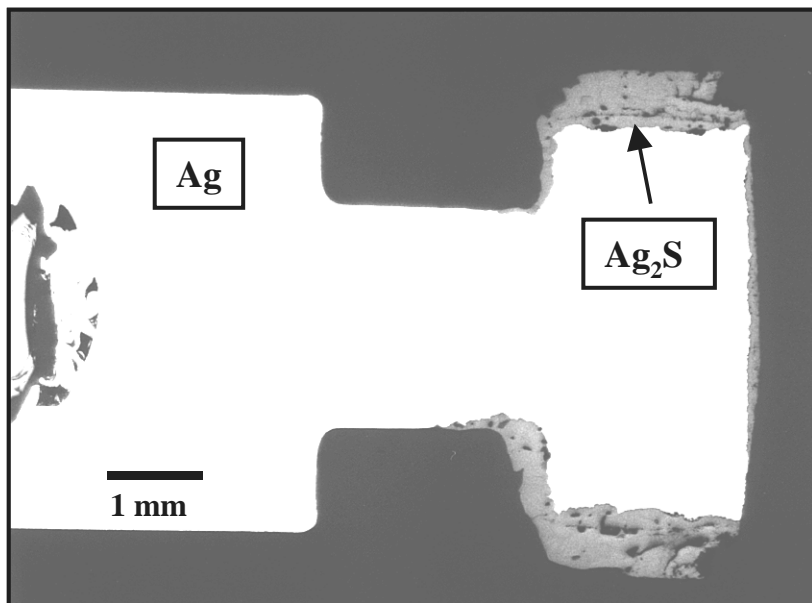
Metallographic examination of the silver electrodes was also performed, and the extent of dissolution/attack of the silver varied substantially with position in the digester. Figures 15-18 are representative of the range of post-test conditions observed for the silver electrodes. In Figure 15, the cross-section of silver electrode shown was exposed in the probe at ring 12, and the working end (exposed to the process) is at the right. A relatively adherent layer of dark gray Ag_2S can be seen on the sides (relatively thick) and on the working face. At the time the silver electrode was removed from the probe header after the exposure, the amount of Ag_2S on the working face was very similar to that observed on the sides of the electrode in Fig. 15; however, in an attempt to gage its relative adherence, some amount of grinding – while recording progressive thickness measurements – was attempted on this surface. The “notch” in the silver, roughly in the middle of the photograph, is the location of the elastomeric o-ring that was squeezed between the silver and the teflon probe header to help prevent in-leakage at the interface. The discontinuity in the center of the Ag rod (far left center of Fig. 15) is the end of the threaded connection to the electrometer. The silver electrode from the probe at ring 12, as well as that from the flash tank probe, exhibit only very minor dimension changes (loss of 25-30 mils of Ag on the radius and length) compared to the original dimensions prior to installation.

Fig. 15. As-polished cross-section of the approximate mid-plane of the Ag electrode from the ring 12 probe.

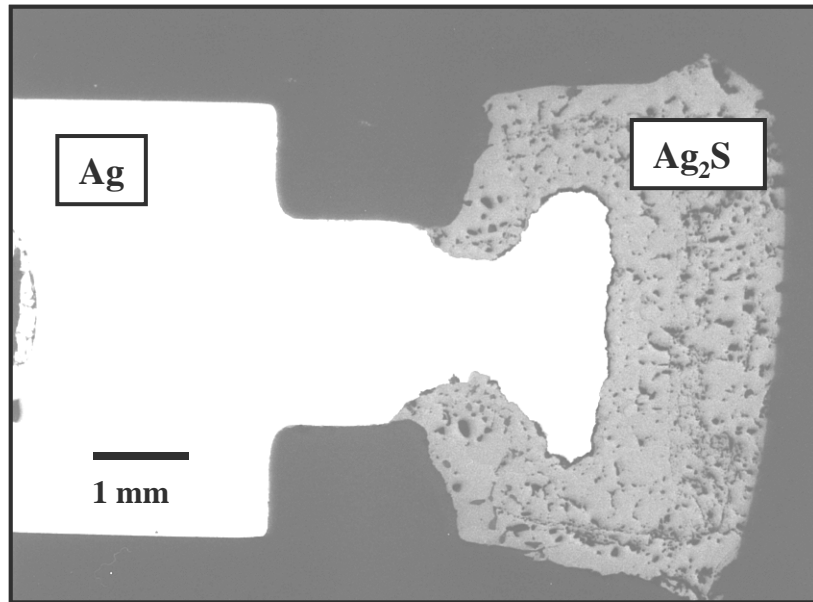
Figure 16 shows the post-test silver electrode from the ring 3 probe in cross-section. The extent of interaction with the process is more severe than indicated in Fig. 15, and approximately one third of the original working length and radius have been converted to Ag_2S . Yet more extreme is the silver from the ring 6N probe (Fig. 17), which was almost completely consumed during the exposure period. Finally, Fig. 18 shows the ring 6S probe silver, which was essentially completely consumed. [There was actually a sliver of metallic silver remaining after the exposure, but polishing to the center of the cross-section went slightly too deep and the remaining metallic silver was lost.]

Fig. 16. As-polished cross-section of the approximate mid-plane of the Ag electrode from the ring 3 probe.

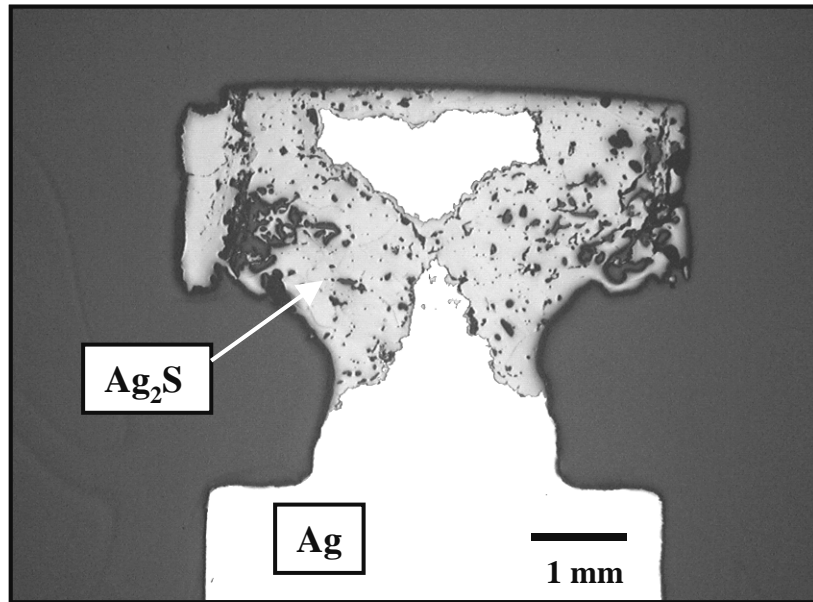
Fig. 17. As-polished cross-section of the approximate mid-plane of the Ag electrode from the ring 6N probe.

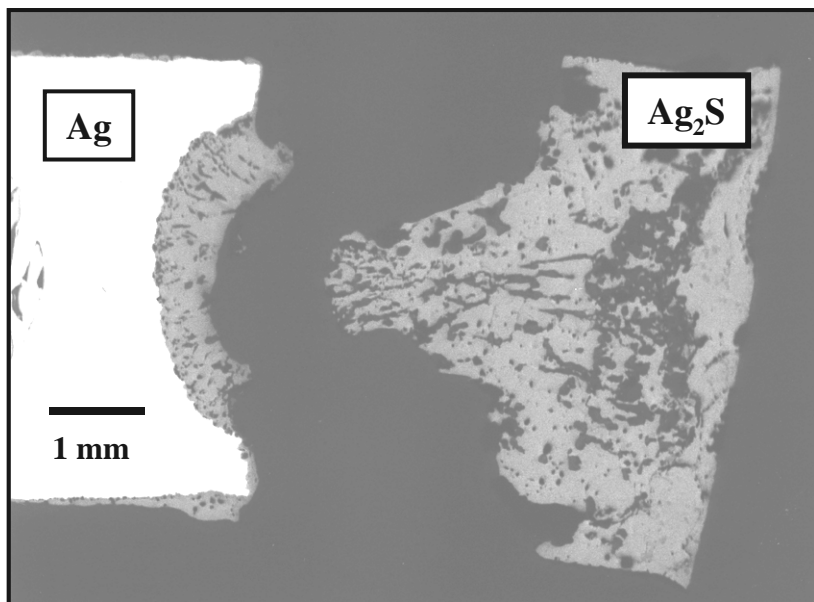
Fig. 18. As-polished cross-section of the approximate mid-plane of the Ag electrode from the ring 6S probe.

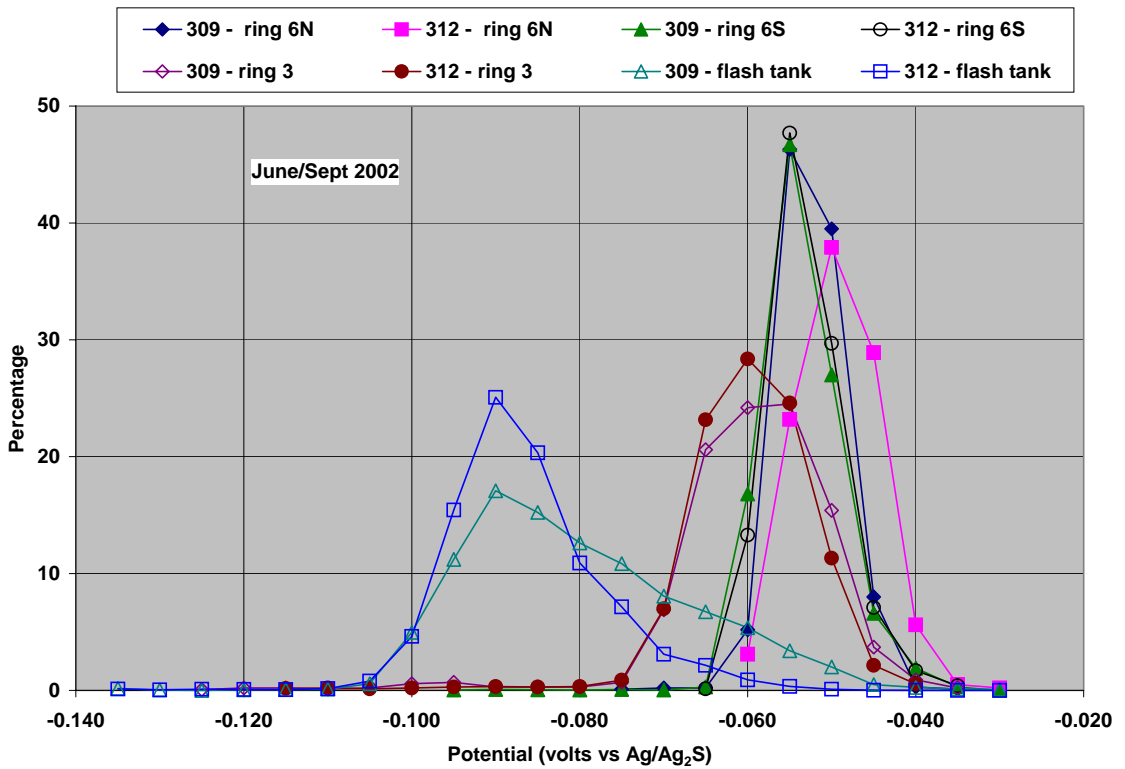
Figure 19 shows a histogram for the EN potentials for each probe during the first three months of the year #2 exposure. The data indicate the similarity in potentials between type 309LSi and type 312 at each probe position, with a nominal range of potentials only 15-20 mV wide for each probe/material except the flash tank. The median potential values (the “peak” in each histogram) for the stainless alloys in the ring 6N, ring 6S, and ring 3 probes shifted only slightly over the year #2 exposure, tending to drift upward by 5-10 mV each over the 12-month experiment. No systematic change in current activity was associated with the slight drift of potential with time for these three probe positions.

Fig. 19. Histogram representing the EN potential data for each probe position and electrode material for the period June-September 2002.

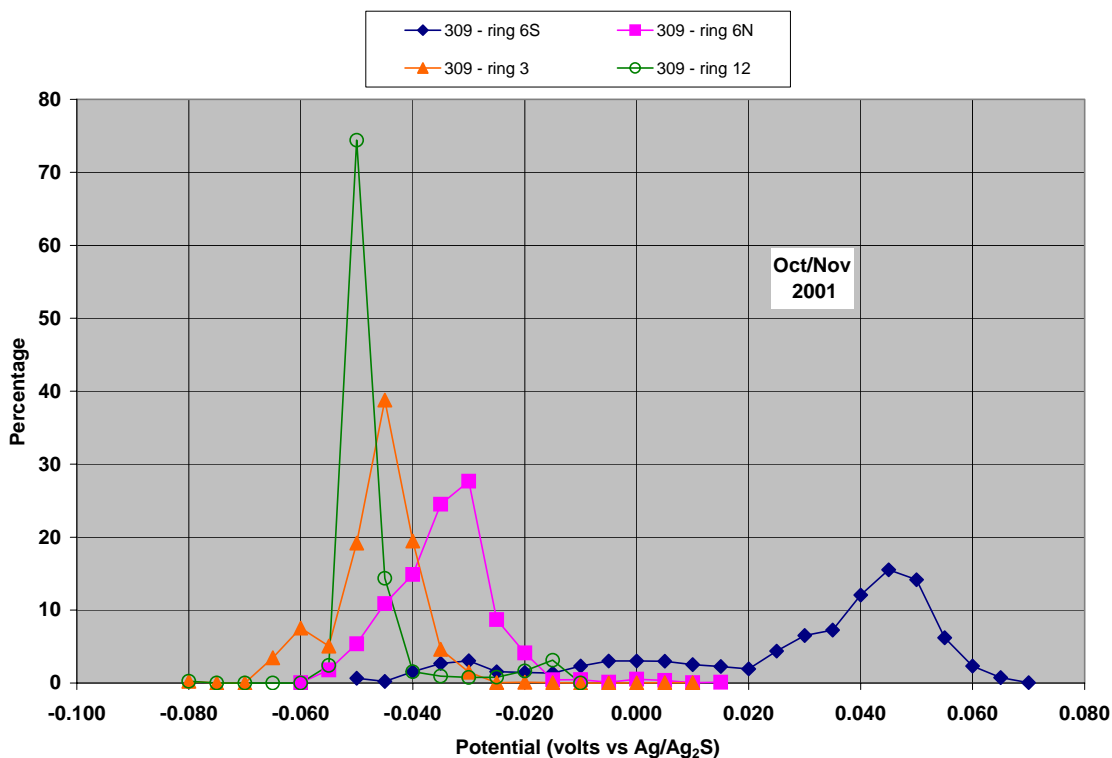
Figure 20 shows an EN potential histogram for the 309LSi probe materials during an early portion of the year #1 exposure. Comparison with potentials of the type 309LSi electrodes from the year #2 exposure indicates a significant difference for the nominal value for the ring 6N probe (value of -30 mV early in year #1) and particularly the ring 6S probe (value of +45 mV early in year #1) compared to early in year #2. The potential of the 309LSi at the ring 6S probe in year #1 drifted slowly toward the value exhibited by the 309LSi at this position in year #2, and this data suggests that the digester chemistry at the ring 6 position may have changed substantially from early in year #1 to year #2. However, no significant change in the chemistry data routinely collected by the mill was recorded.

Fig. 20. Histogram representing the EN potential data for 309LSi electrodes early in the year #1 experiment.

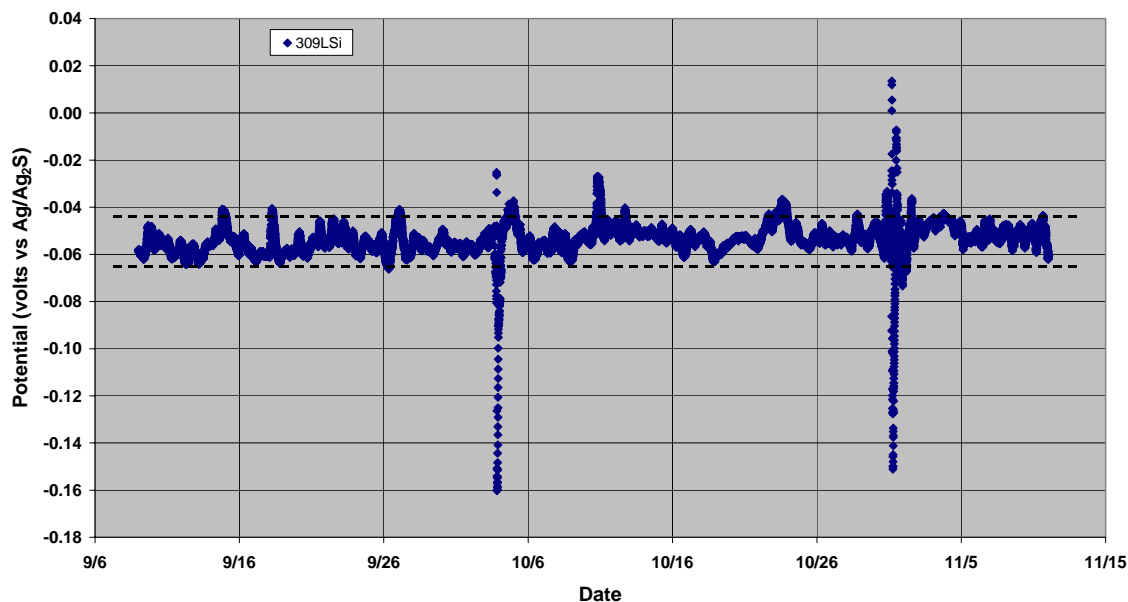
Representative potential data as a function of time specific to the 309LSi stainless steel electrode in the ring 6S probe for year #2 is shown in Fig. 21. Consistent with the histogram in Fig. 19, the potential of the 309LSi electrode varies only about ± 10 mV or so around the median value of -55 mV for weeks at a time, and the potential of the 312 electrode is essentially indistinguishable from that of the 309LSi. During the entire year of exposure, there were eight relatively large potential excursions (> 25 mV out of the nominal range of -45 to -65 mV), two of which are represented in Fig. 21. All eight of the large potential excursions can generally be described as very brief (six hours or less is typical) and associated with a sudden temperature decrease of more than about 20°C at the probe 6S location.

Fig. 21. Representative EN potential data for the 309LSi electrodes in the ring 6S probe. The dashed lines represent the ± 10 mV boundary around the median potential of -55 mV.

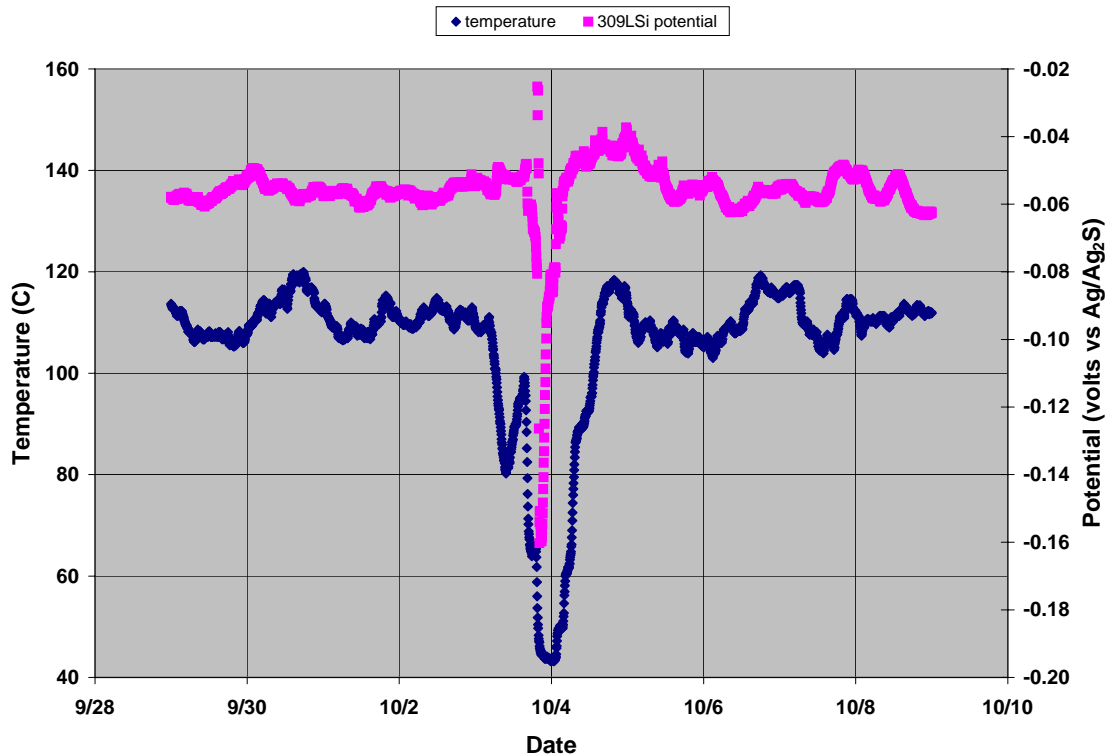
Figure 22 provides more detail of the potential excursion on/about October 4. Note that there is a modest temperature decrease of about 30°C (no associated potential variation outside normal scatter) just prior to a larger temperature drop that coincides with the potential excursion. Further, note that the potential recovery is essentially complete prior to the return of the temperature to the normal range.

Fig. 22. EN potential data along with probe temperature for the ring 6S 309LSi electrode surrounding the October 4 event in the digester.

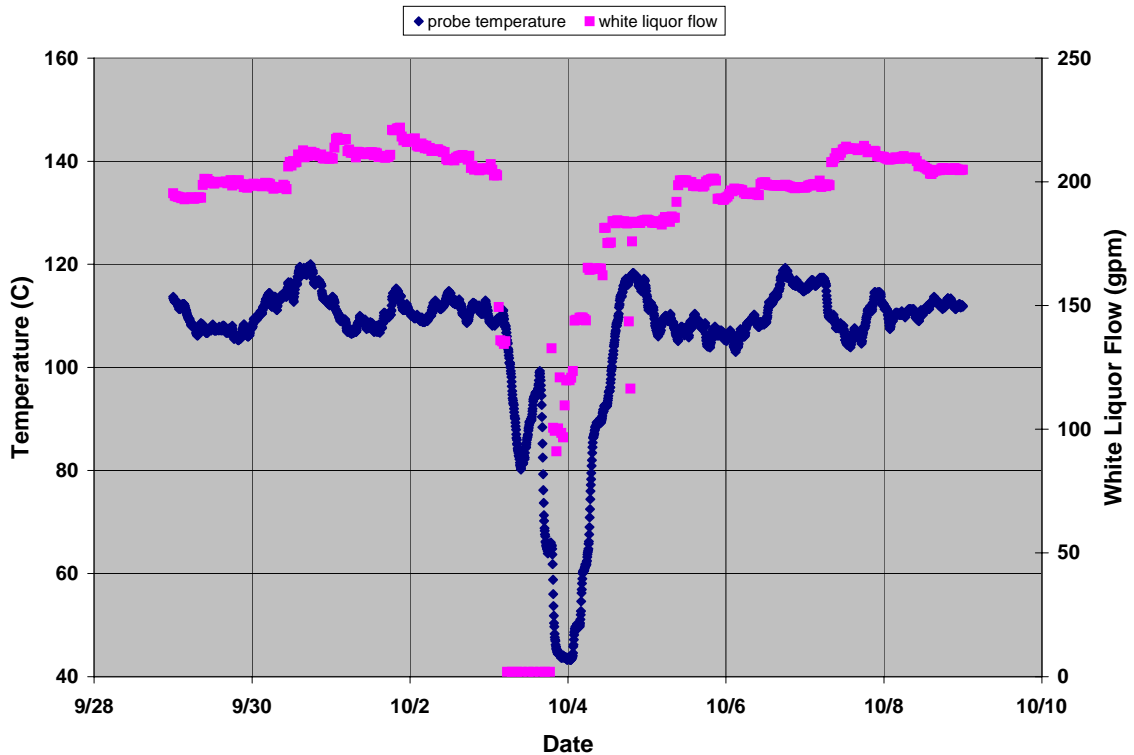
The temperature decrease shown in Fig. 22 is related to a process interruption which is reflected in most of the major process parameters that are routinely tracked at the mill. For example, Fig. 23 plots the white liquor flow (as representative of the continuity of the process) along with the ring 6S probe temperature as a function of time. [The actual process data for white liquor flow indicated a few small negative numbers on October 3; these were assumed to be an artifact of a very low flow rate measured by a device calibrated to much higher values of flow.

Here, all rates less than 1 gpm were arbitrarily set to 1 gpm for ease of graphing.] It is clear that the disruption in the process (white liquor flow decrease) and the temperature are closely related, but note in particular that the temperature decrease that begins coincident with the halt in white liquor flow is not continuous – there appears to be a brief recovery in the temperature before a plunge toward room temperature. It is not clear why the digester temperature would behave in this fashion (no apparent clues in the other process data), but it is possible that the slightly occluded position of the probe thermocouple (recessed slightly in the probe port rather than positioned on the probe face) is involved. In any case, the resumption of white liquor flow is followed by a return to the nominal process temperature at this location. Again, a time lag between the resumption of white liquor flow and the probe temperature may be related to the thermocouple position in the probe port, but this document will also cite examples where the probe temperature tracks a process upset simultaneously with the event.

Fig. 23. Relationship of ring 6S probe temperature and the white liquor flow to the digester surrounding the October 4 event in the operation.

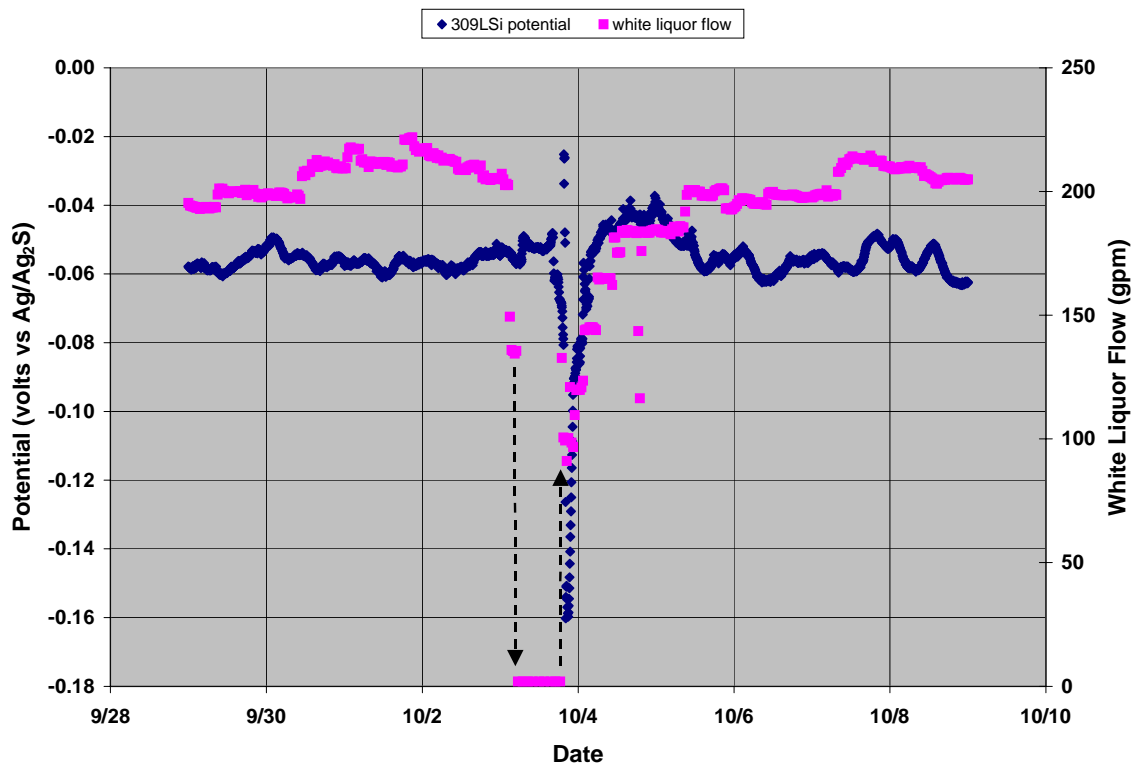
Further detail is shown in Fig. 24, which includes the process white liquor flow plotted along with the corresponding potential for the October 4 event. This plot reveals that the potential change (and presumably the associated liquor chemistry change) occurs after the white liquor flow has been stopped for a few hours, and in fact the potential drop and subsequent recovery each seem to happen during the resumption of white liquor flow. That the potential change occurs after the decrease in white liquor flow may indicate a time-dependent chemistry change (e.g., consumption of a species; leaching a species) resulting from overcooking chips in black liquor.

Fig. 24. White liquor flow plotted with 309LSi potential data for the ring 6S probe surrounding the October 4 event in the digester. The dashed vertical lines represent the boundaries of the ~zero white liquor flow period.

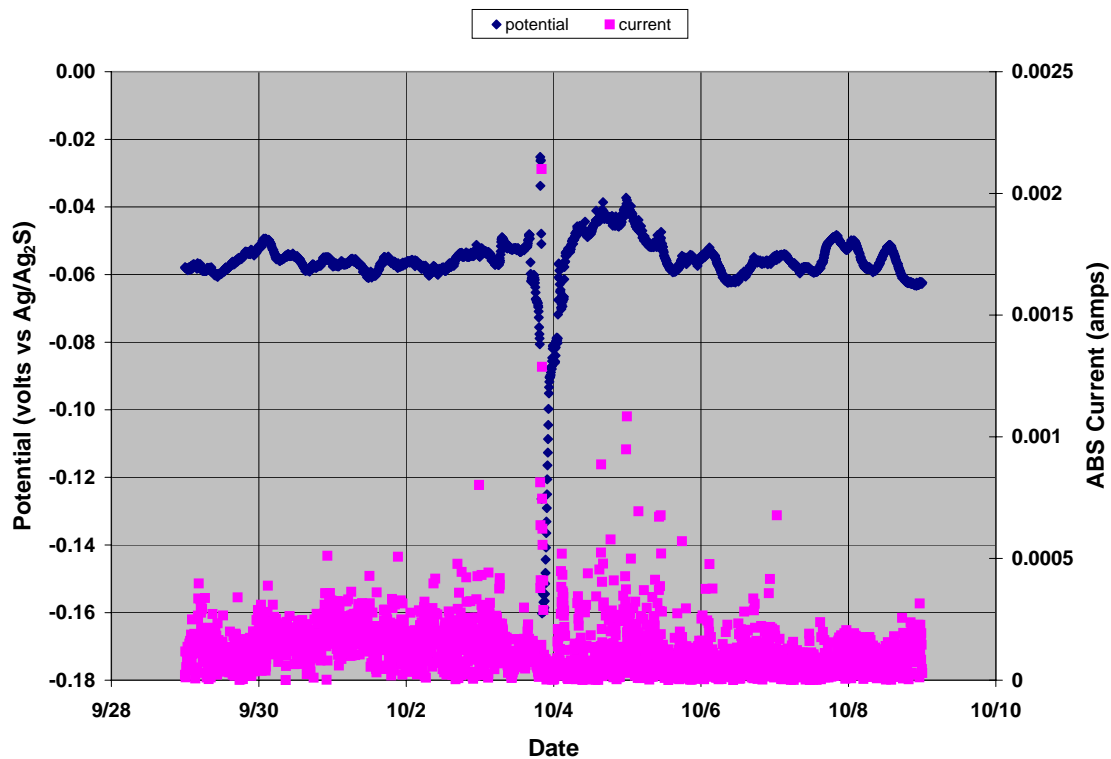
Figure 25 shows the October 4 potential excursion along with the corresponding electrochemical noise current for the 309LSi probe. In this instance, as in five of the eight overall large potential excursions at Ring 6S during the year, there is only a very minor/brief current change (inconsequential to current sums) associated with the potential excursion.

This general behavior observed at Ring 6S is consistent with previous results at Spring Grove in that process disruptions were closely associated with large/sudden changes in the temperature and electrochemical noise patterns. However, the stainless steel electrode materials appear resistant to corrosion, independent of the upsets and fluctuations where the carbon steel electrodes suffered at least periodically high corrosion rates [2]. No significant liquor chemistry changes

Fig. 25. Relationship of current and potential noise for the 309LSi electrodes on the ring 6S probe for the October 4 event in the digester.

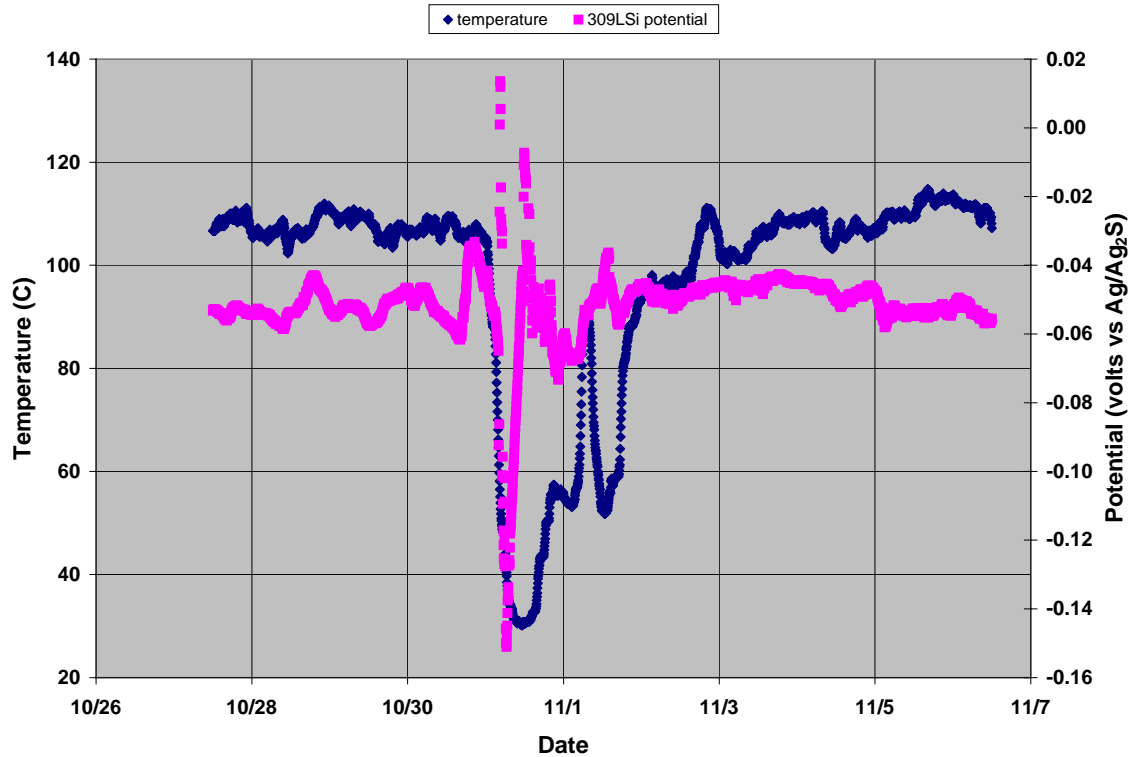
While also caused by an interruption in the digester process, the other potential excursion in Fig. 21 (Oct. 31) has somewhat different characteristics than the Oct. 4 excursion. Figure 26 plots probe temperature and potential as a function of time for the October 31 event. In this case, the potential excursion and the temperature drop are coincident, but the potential seems to recover to the nominal range many hours prior to a return to normal operation temperature at this location. [The potential excursion for 312 at this time was even larger, with bounds of about +40 and -220 mV vs. Ag/Ag₂S.] Unlike the previous example, the probe temperature tends to track white liquor flow in the present case (see Fig. 27). Also unlike the previous example, there is a

Fig. 26. Probe temperature and 309LSi potential at the ring 6S probe associated with the October 31 event in the digester.

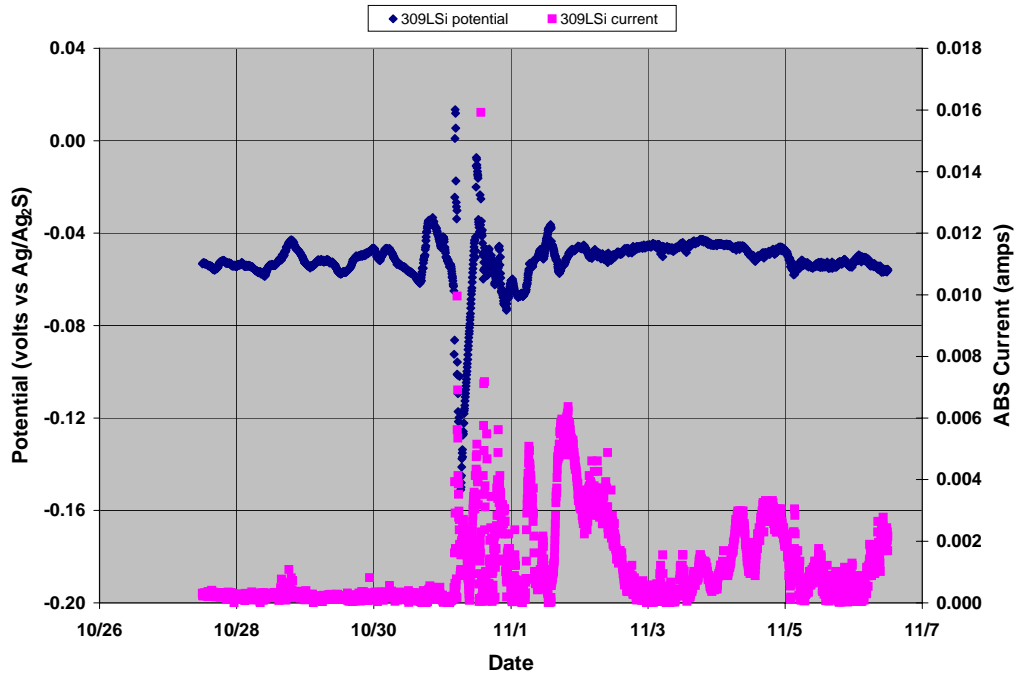
Fig. 27. Relationship of current and potential noise data for the ring 6S 309LSi electrodes associated with the October 31 event in the digester.

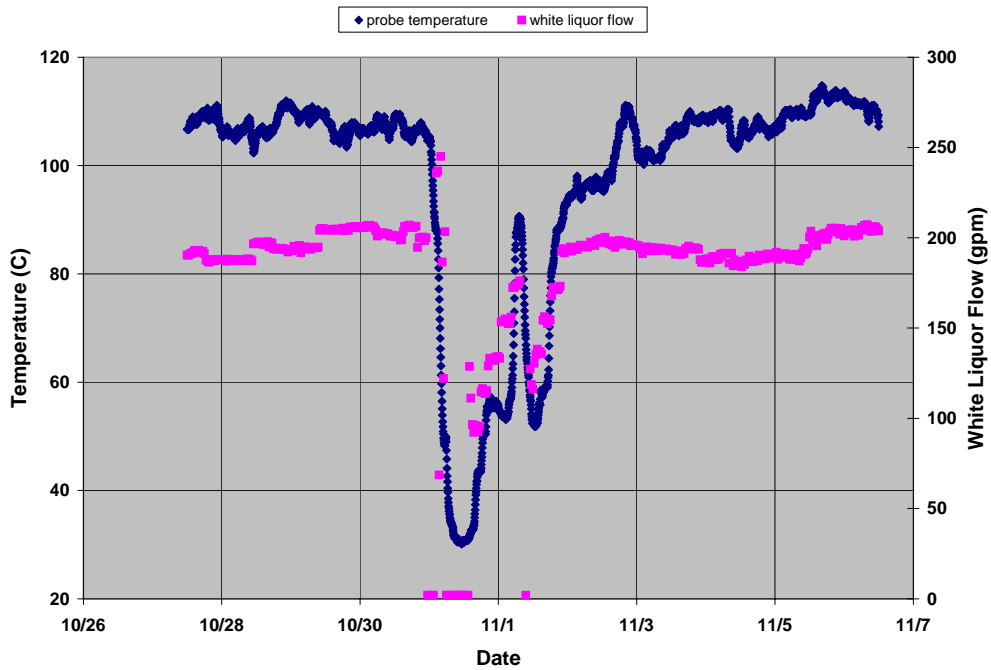
substantial change in current noise associated with the Oct. 31 process upset, which lingers for almost three days following the initial potential drop (Fig. 28). The increase in current noise roughly coincides with the temperature decrease, and unlike many other similar excursions, seems to be related also to the total filtrate flow (Fig. 29).

Fig. 28. Ring 6S temperature and white liquor flow plotted together for the October 31 event in the digester.

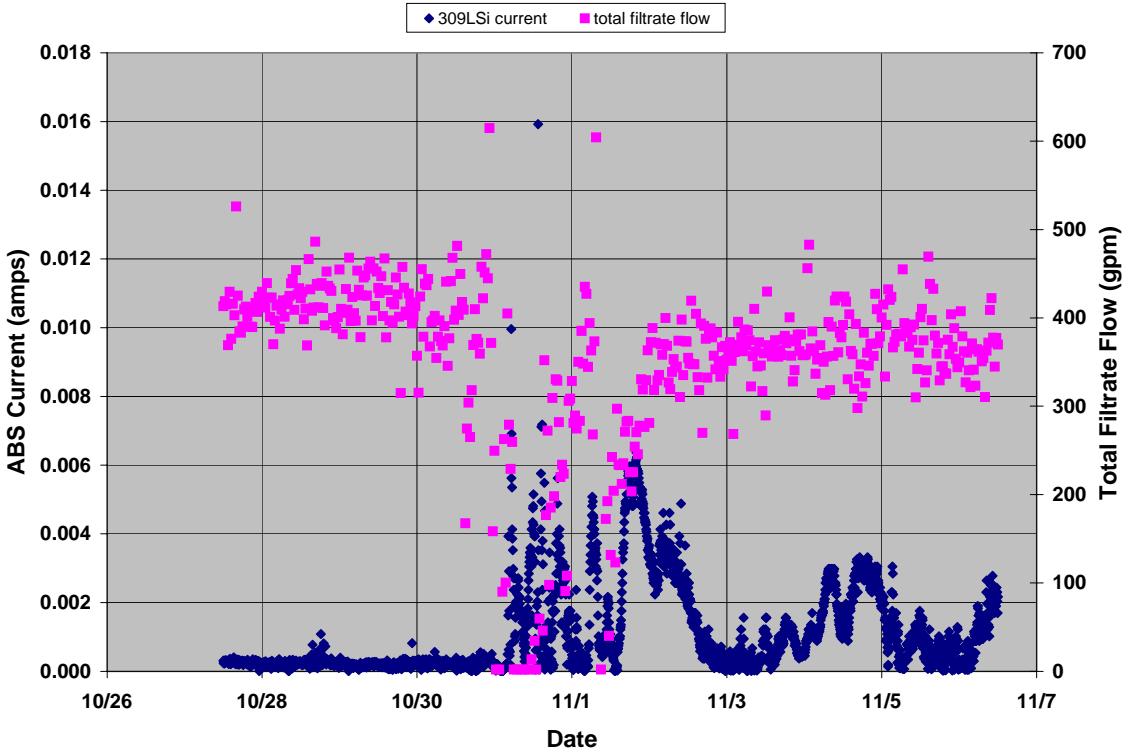
Fig. 29. Current noise for the ring 6S 309LSi electrodes plotted with the total filtrate flow associated with the October 31 event in the digester.

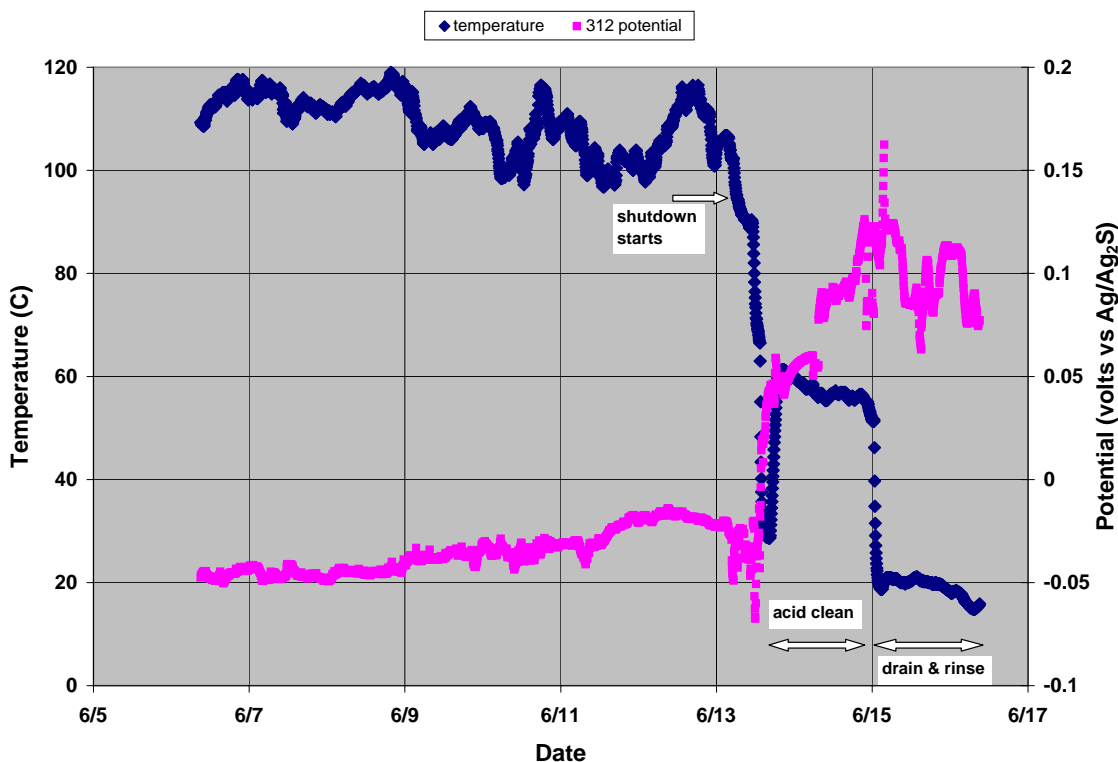
Yet a different example of electrochemical noise changes associated with a temperature drop is shown in Fig. 30. The data here show the potential noise and temperature leading up to and including the vessel shutdown in June 2003. In this case, the potential noise is from the 312 electrode pair in the ring 6S probe (but the data from the 309LSi electrode pair was similar). On June 13, when the operation was halted and the temperature at Ring 6 drops precipitously, the potential of the 312 increases approximately 100 mV above the median value for the previous 12

Fig. 30. Potential noise of the 312 electrodes along with the shutdown temperature excursion at ring 6S.

months. Shortly after the initial shutdown, the temperature again rises from near ambient up to about 60°C reflecting the beginning of the approximately 24-h acid cleaning step. [Vessel cleaned with 3% formic acid inhibited with rhodine.] During the acid cleaning step, the 312 potential remained near + 50 mV for a period, then increased further to +125 mV (and, briefly, even higher potential). Subsequently, the vessel was drained and rinsed, causing the temperature to drop but the potential remained quite elevated. As has been observed in previous digester investigations [1,2], there is an irregular but substantial increase in the current noise corresponding to the shutdown and cleaning of the vessel (see Fig 31). In the case of the stainless steel overlay materials at Spring Grove, this is not a corrosive condition but perhaps is quite aggressive toward mild steel construction materials.

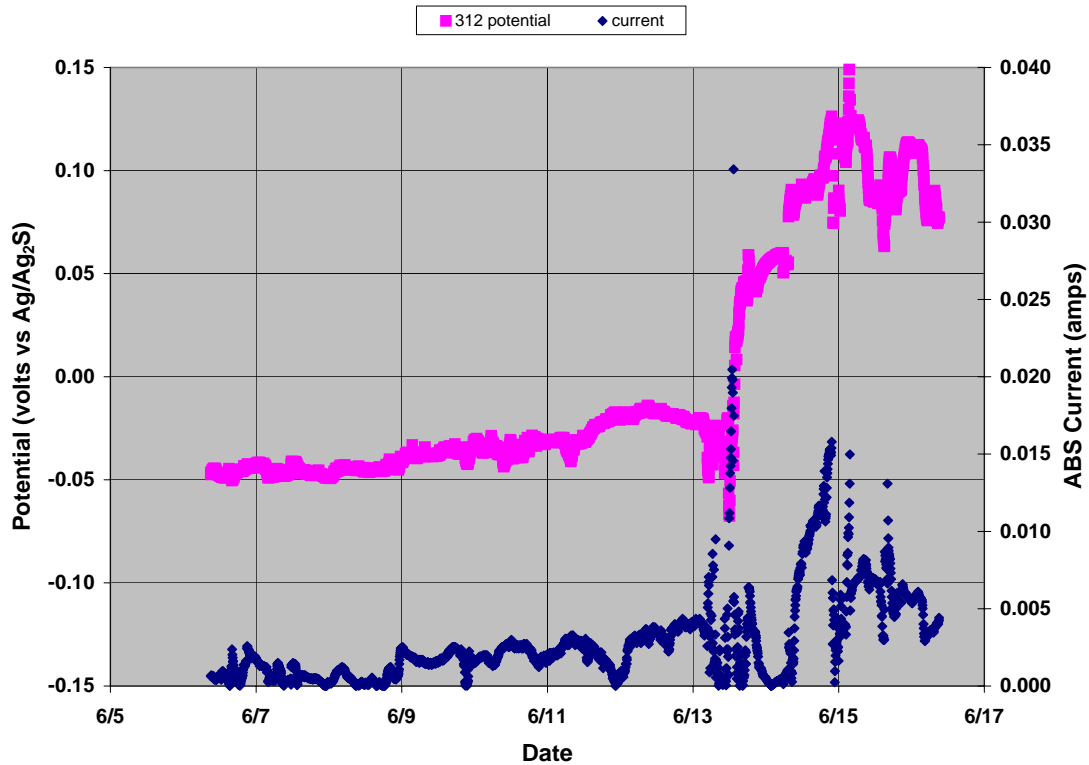
Fig. 31. Potential and current noise for the 312 electrodes of the ring 6S probe during the shutdown transient.

It is also interesting to note that, even after draining the vessel, measurements of the current and potential noise continued until the data-gathering system was deactivated, indicating that the probe surface retains a sufficient film of residual black liquor that continuity between the electrodes is maintained. Note that this same film, while not necessarily aggressive toward the stainless steel overlay materials, is likely very aggressive toward carbon steel (contains thiosulfates), even when the vessel appears to be empty.

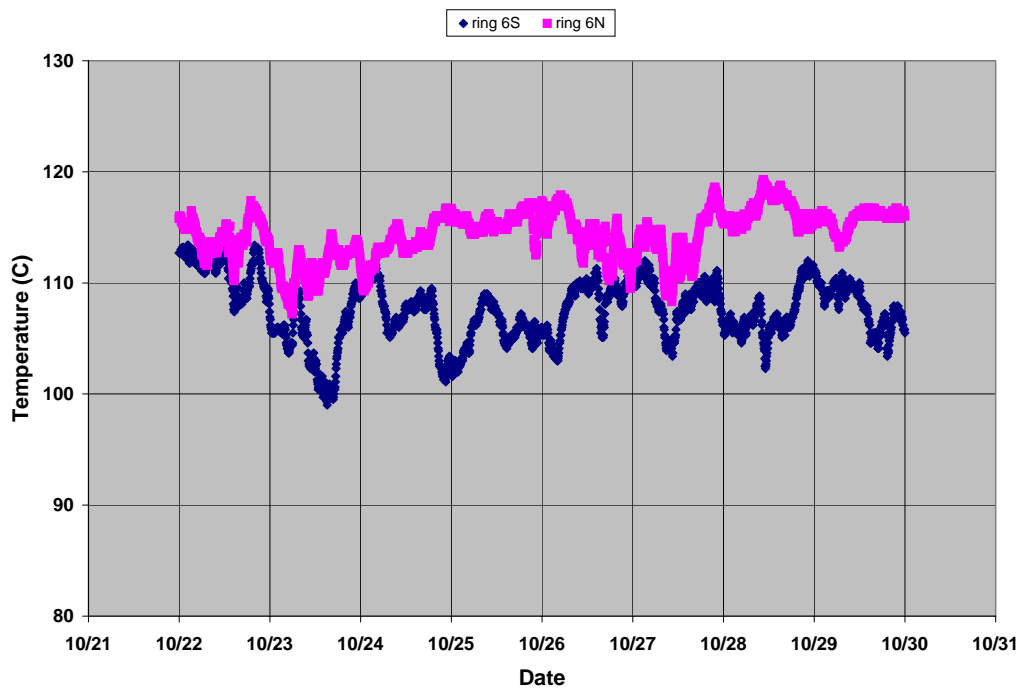
For example, in the year #1 exposure at Spring Grove, the temperature of the ring 6S probe was routinely about 15°C higher than that of the ring 6N probe. [See Fig. 53 in Reference 2.] However, as shown in Fig. 32, in the year #2 exposure the temperature profile was largely reversed at the ring 6 elevation, with the temperature of the ring 6N probe frequently 7-8°C higher than that of the ring 6S probe. [Thermocouple location was precisely the same for each probe and exposure year.] Certainly, 7-8°C is a modest difference, but it represents a potentially significant (uncontrolled) change in the pattern of liquor flow from the prior year of operation. Also, although both probe locations respond similarly during major process disruptions, the temperature of probes 6S and 6N do not particularly track each other on a day-to-day basis – frequently, one temperature is increasing while the other is decreasing – which is also different than the previous year at the ring 6 elevation.

Fig. 32. Representative temperature data as a function of time at the ring 6 elevation.

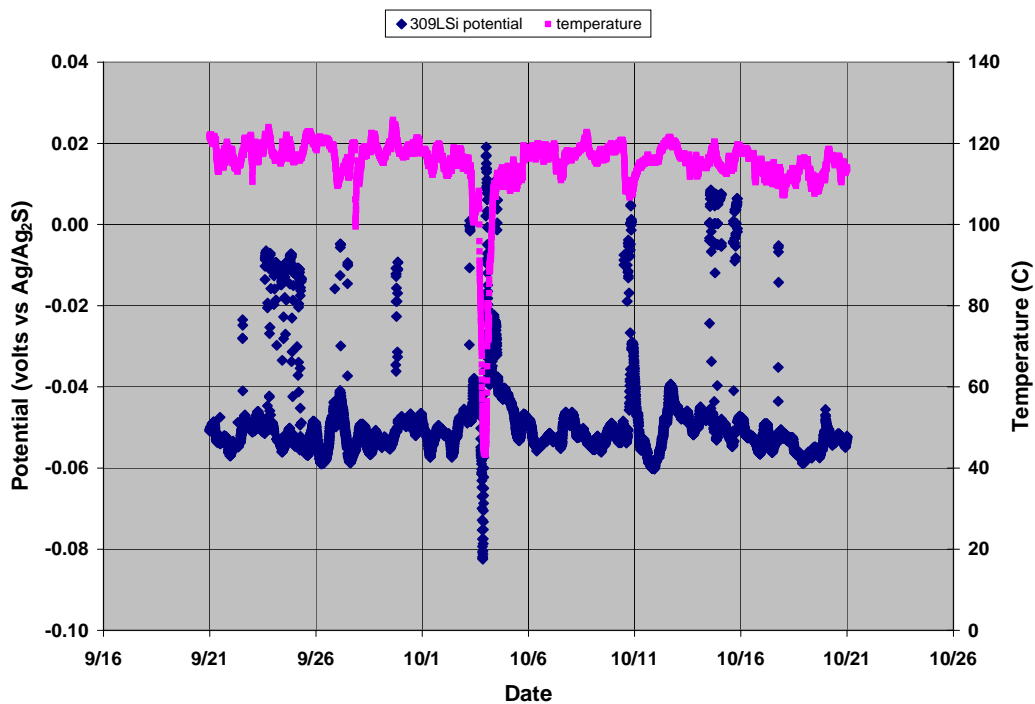
Fig. 33. Representative potential noise for 309LSi electrodes along with temperature data for the ring 6N probe.

It could perhaps be argued that the relative degradation of the silver electrodes at the ring 6 position calls the potential measurements into question. On an absolute basis, that is no doubt true; however, the silver in both probes was similarly degraded at the end of year #2, and the data shown in Fig. 33 represent a period relatively early in the exposure. Further, the similarly degraded silver at ring 6S did not detect a large number of relatively brief potential transients during the period shown in Fig. 33 (or any other period), suggesting that the different behavior at probe 6N is a result of short-lived but significant chemistry gradients at the ring 6 level.
