**Correlation of Process Data and Electrochemical Noise to Assess Kraft Digester
Corrosion: Second Year at Spring Grove**

S. J. Pawel*
D. W. Townley†
D. E. Roy‡
D. F. Wilson*

Date Published: April 2004

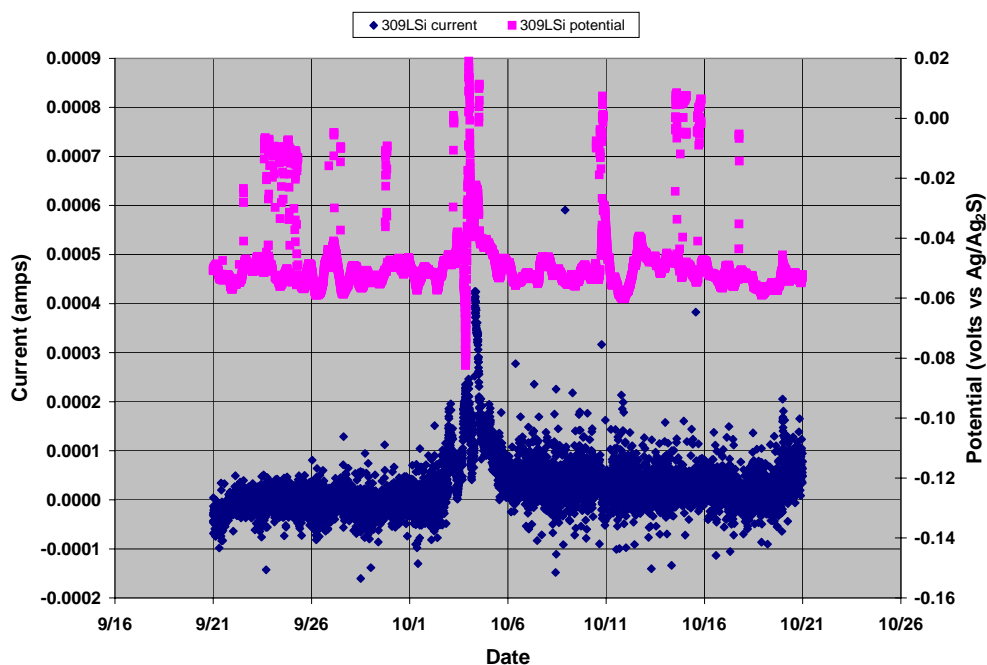
For both electrode alloys, there was only one substantial current noise transient from probe 6N in the period shown, which was coincident with the largest potential transient (see Fig 34). Also note in Fig. 34 that the current noise is relatively unbiased (“centered” on, or very near, zero – neither electrode dominant in direction of current flow), which is generally representative of all the current noise data for the year #2 experiment. The main exceptions were observed mostly for the 312 electrodes, which periodically – for days or even a few weeks at a time – exhibited a slight drift toward positive current, meaning the same electrode was favored for the oxidation portion of the redox reaction each time bias was observed. During the period shown in Fig. 34, the average current noise for the 312 electrodes is perhaps a factor of six higher than that for 309LSi, with some significant bias.

Fig. 34. Current and potential noise for the 309LSi electrodes in the ring 6N probe surrounding the early October event in the digester.

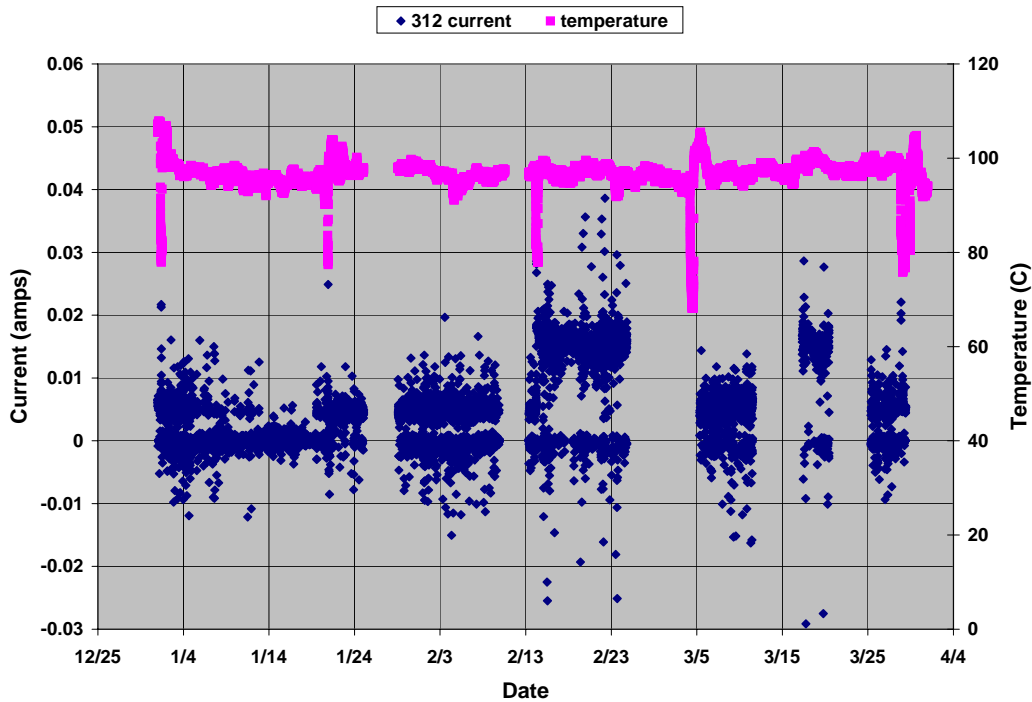
Figure 35 shows a representative period of current noise for the flash tank probe plotted along with the probe temperature. While the data given are for type 312 stainless steel, the current noise in Fig. 35 is largely indistinguishable from the behavior of type 309LSi in this or any other time period. In particular, note that the current noise frequently seems to fluctuate between two value ranges – a modest positive number and a smaller negative number (or near zero) with a distinct gap frequently apparent between the two current ranges. In this particular period, 72% of the current values in Fig. 35 are greater than zero, suggesting slight but consistent bias. The potential noise data for this period (and others) also reveals a small gap between distinct values/ranges.

Fig. 35. Representative current noise for the 312 electrodes plotted with temperature of the flash tank probe.

There are five substantial temperature perturbations ($> 20^{\circ}\text{C}$, related to upsets in digester operation) in the period shown in Fig. 35, and it is clear that none of these alter the basic character of the current noise pattern. It might be argued that the gap in the current noise becomes more distinct immediately following some of the temperature transients, and there are several examples where this is true, but there are also a few counterexamples in which the size of the gap changes without a corresponding temperature change.

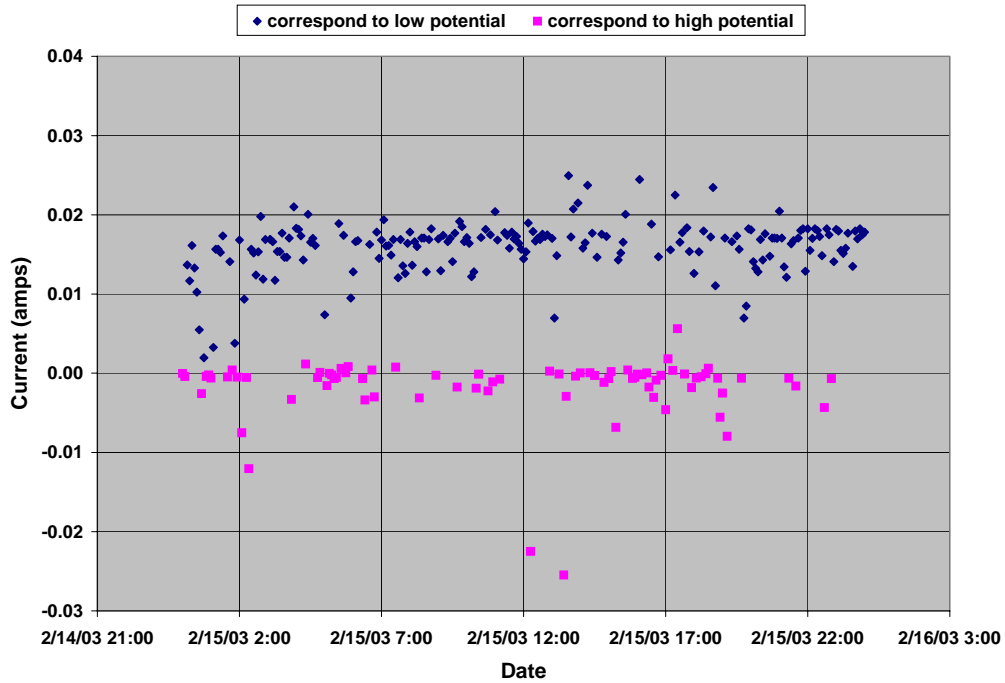
Figure 36 plots the current noise for the February 15 segment of the data shown in Fig. 35. During this period, the maximum temperature variation is less than 2°C , so temperature swings are not likely to be responsible for the distinct current fluctuations shown here. Further, note that Fig. 36 plots the current noise distinguished by relative potential. The average value of the “high current” noise in the period shown in Fig. 36 is 1.60×10^{-2} amps, while the average (absolute value) of the “low current” range is about an order of magnitude less at 2.08×10^{-3} amps. As shown in Fig. 37, the nominal potential difference generating the current noise range is only about 10 mV. (A similar, but perhaps even larger, fluctuation in current was noted for the 309LSi electrodes in the flash tank in year #1 of the Spring Grove experiment [2] although the year #1 data was not plotted in the fashion shown here.) In consideration of a standard active-passive polarization curve for stainless steels, the only location where a 10 mV increase in nominal potential corresponds to a decrease in current activity by approximately an order of magnitude is near the passivation (Flade) potential, but the current activity indicated is likely to be entirely related to redox reactions. Among aqueous sulfur chemistry reactions, for example, it is not apparent what reaction may participate in the potential range -30 to -60 mV vs. $\text{Ag}/\text{Ag}_2\text{S}$ (approximately -905 to -935 mV vs. saturated calomel electrode) of interest in Fig 37.

Fig. 36. Current noise for the February 15 portion of the general current noise recorded in Fig. 35. Data points are coded corresponding to the relative potential associated with each.

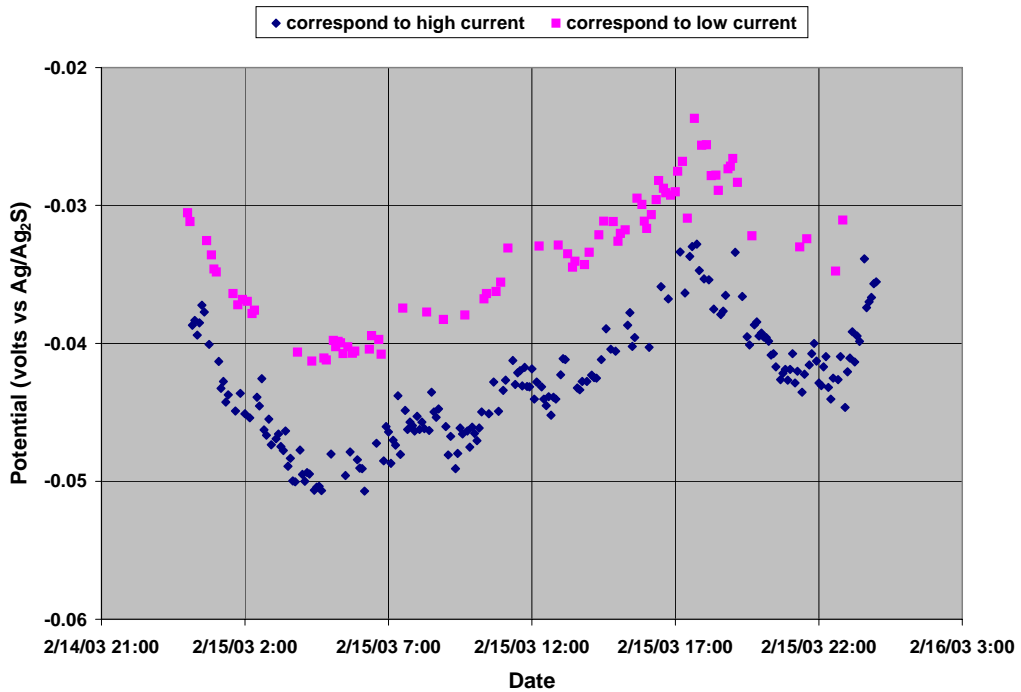
Fig. 37. Potential noise corresponding to the current noise data plotted in Fig. 36.

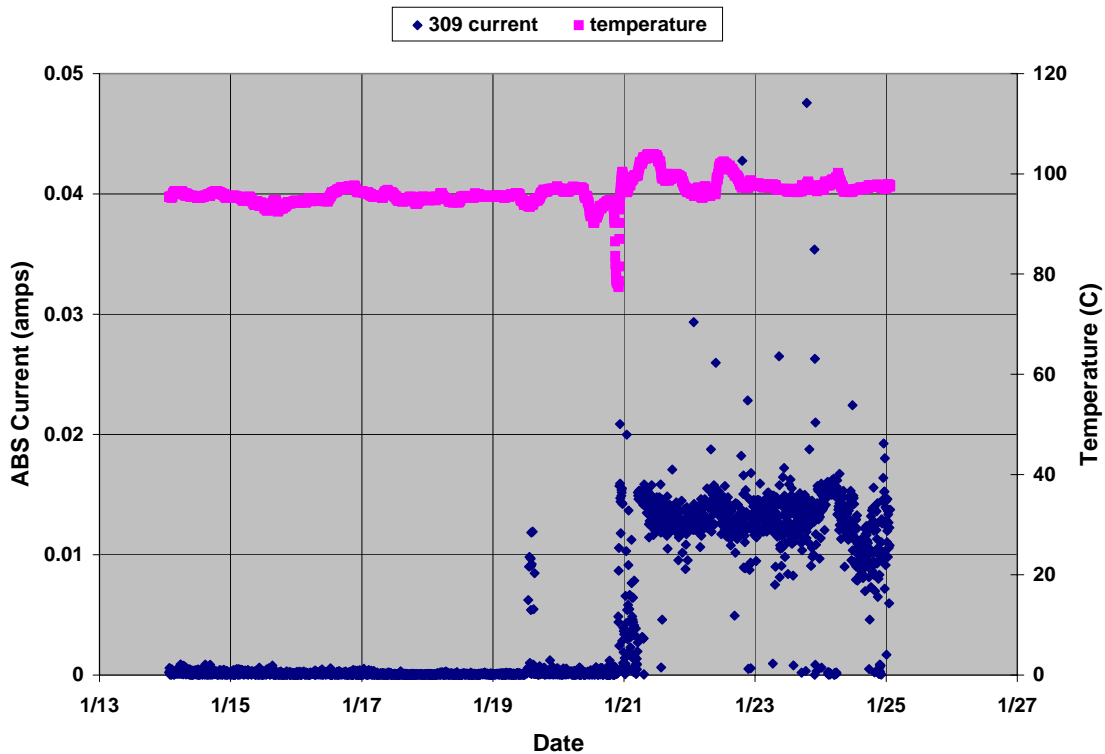
Although not always observed, it was relatively common that a digester operation upset tended to change the current noise behavior in the flash tank. Generally, the digester upsets were associated with a halt of continuous operation (or at least a significant production rate decrease) and the temperature in the flash tank (and other locations) drops for a few hours or even a day. These changes in temperature/operation tend to increase the gap between the flash tank current ranges that tend to decay slowly with extended time. Examples from Fig. 35 where this is so can be seen on approximately January 2 and 21 and February 14. EN current data along with probe temperature is shown for the type 309 electrodes in Fig. 38 for the event associated with approximately January 21. While the data for 312 (Fig. 35) imply the change in current activity may very slightly precede the temperature drop, it is clear that, at least for type 309LSi in Fig. 38, the temperature drop and change in redox activity coincide.

Fig. 38. Current noise transient associated with a digester upset (temperature excursion) near January 21.

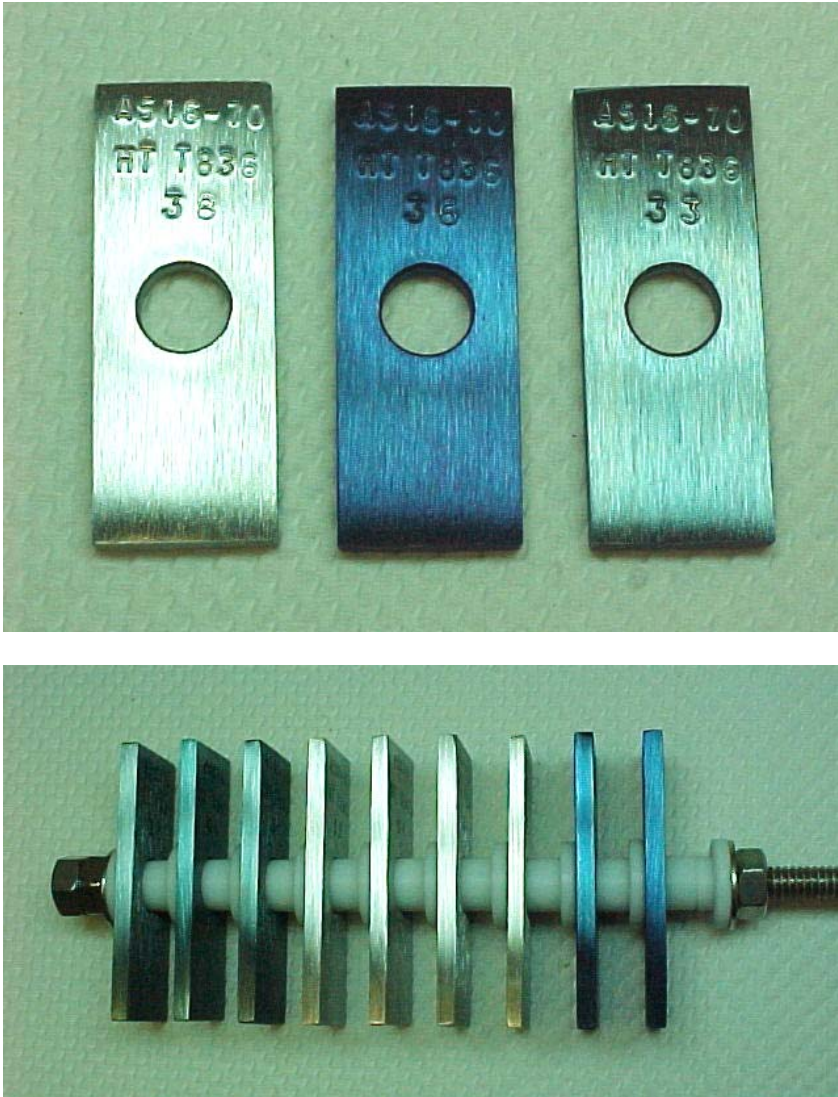
Fig. 39. Coupons used in autoclave testing. Top: A series of A516-70 panels with a 120 grit finish, 45 min/305°C scale, and 135 min/305°C scale, from left-to-right, respectively. Bottom: A series of coupons (one of each material and heat treatment) arranged on a piece of all-thread for exposure in the autoclave.

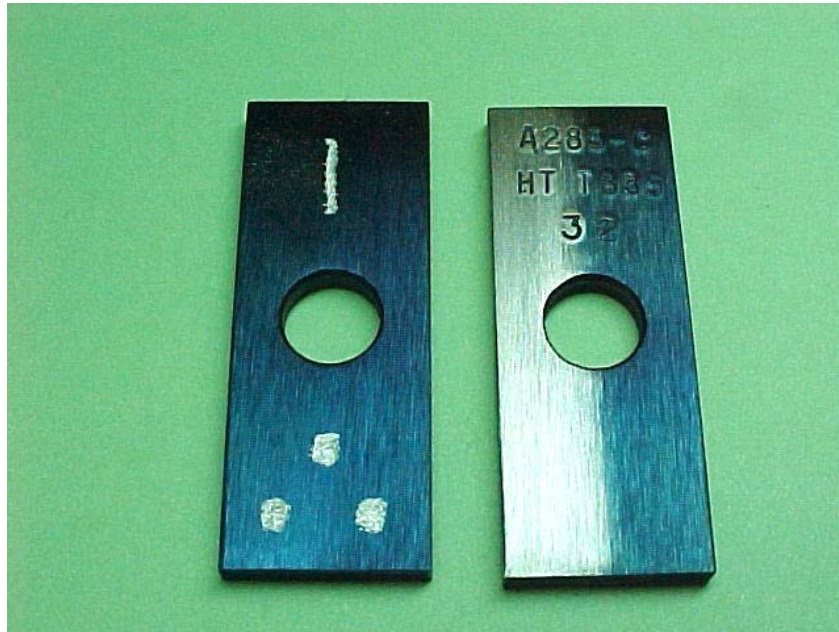
Fig. 41. Examples of oxide removal patterns to examine potential galvanic effects of the scale during autoclave testing. The dark/blue areas have scale formed in 45 min/305°C, and the shiny areas have been ground to 120 grit finish.

On coupons with oxide removed in both of the patterns shown in Fig. 41, there was no accelerated corrosion of bare material in any test environment. Further, general corrosion rates calculated from weight loss for coupons with no oxide (120 grit surface) and for full oxide (45 min/305°C) were not particularly reproducible compared to earlier results, indicating more effort is required for testing and interpretation of a possible effect of oxide on corrosion rate.
