ORNL/TM-2005/34

Field Testing of Energy-Efficient Flood-Damage- Resistant Residential Envelope Systems Summary Report

June 2004

Oak Ridge National Laboratory, Oak Ridge, Tennessee

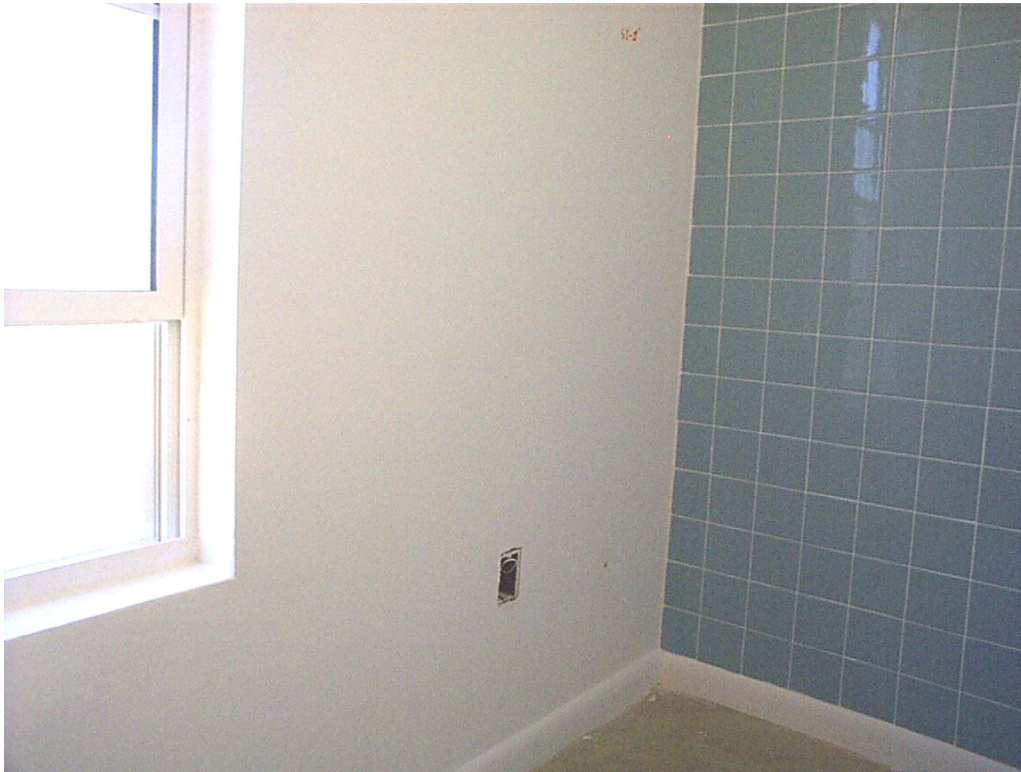
Figure 4-4 Module S-1 (Walls 1 & 2) Pre-flood. Walls, window, floor are in new condition.

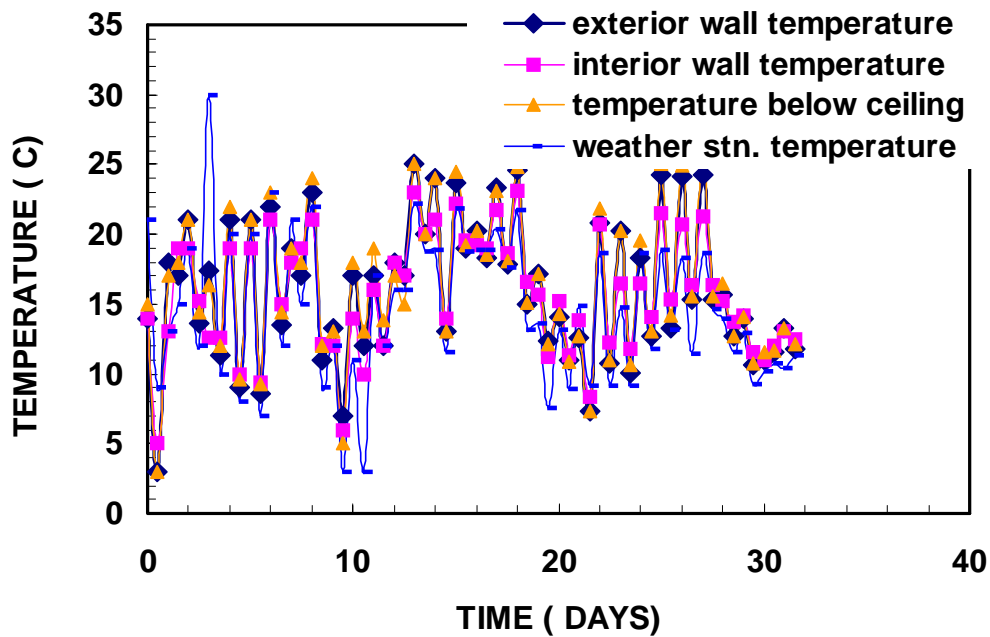
The temperature in the cavity of the exterior Wall 3, the cavity of the internal wall and Room 101 were monitored continuously. The relationship between temperatures and time for these locations as well as the outdoor temperature profile are shown in Figure 4-18. Temperature readings were the same for both modules. The exterior temperature profiles are based on two readings per day; one at 12:00 noon and the other at 12:00 midnight. As shown in Figure 4-18, the three readings follow that of the outside temperature. The difference in the temperature between the three readings in the module varies by at the most 6°C. These profiles are influenced by other factors such as fluctuation in the daily average outdoor temperature, wall orientation, wind-speed, rain etc.

Figure 4-18 Temperature profiles for three different locations in Module S-1 and the outdoor air temperature. Day 1 is the time at which the basins were completely filled. The basins were drained at Day 4 and the door and window were opened on Day 9.

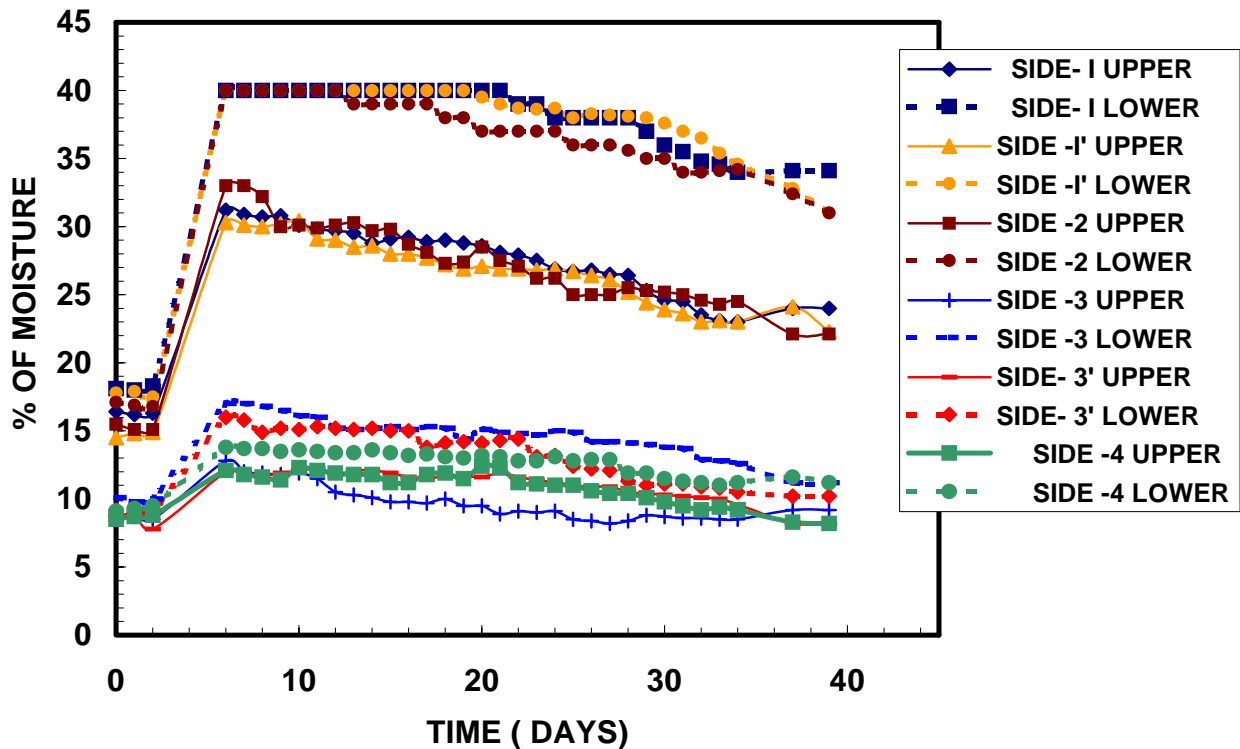
The relationship between the moisture content and time for Module S-1 is shown on Figure 4-21. (The readings were similar for Module C-1.) The data are clustered in three groups. The drying rate for each group appears to be similar. Group 1, which has the highest moisture content consists of: Wall 1 lower, Wall 1' lower, and Wall 2 lower. The moisture content in this group started at about 40% after draining the basin. Group two consists of: Wall 1 upper, Wall 1' upper and Wall 2 upper. The moisture content in this group started at about 30%. Group 3 consists of: Wall 3 and 3' upper and lower, and Wall 4 upper and lower. Although the moisture content in Wall 3 upper and lower at the two locations are in this group there is a difference of about 8% between the above and below water level readings. In the case of Wall 4 the difference between the readings at the upper and lower locations is only a few percent. The moisture content for Walls 3 and 4 probably remained lower after flood exposure and dried closer to their original value due to the material they were covered with. Walls 3 and 4 were covered with hard board lap siding, while Walls 1 and 2 were covered with a plywood siding.

Plywood is more porous and contains a grainy structure that will hold and transport moisture. Hardboard siding is more dense and homogeneous, which tends to slow the penetration of moisture. The hardboard siding used in the test modules was new and had well-sealed edges. Older siding with less well-sealed edges may absorb significantly more moisture than the present tests reflect. The orientation of the walls did not appear to play a significant factor in the rate of drying in either Module S-1 or C-1. Wall 3 faces south, while Wall 4 faces west; however since these walls did not absorb as much water during flooding, during which time orientation would not have a significant effect.

Figure 4-21 Moisture content versus time for the siding on Module S-1. Day 2 through Day 5 is the period of flooding. The drying period begins with Day 5.

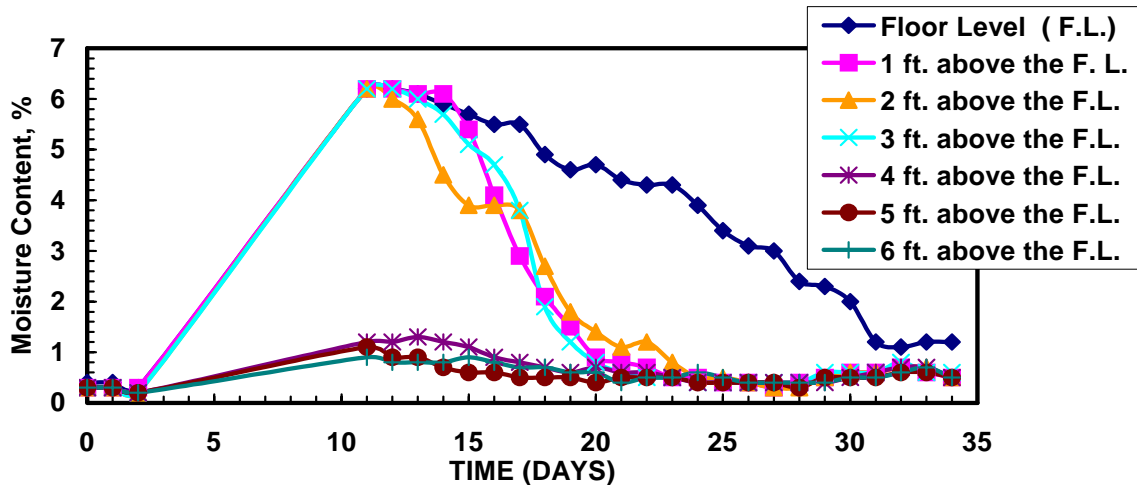
The relationship between the moisture content and time for the gypsum board on Wall 3 of Module S-1, an exterior wall facing south, is shown in Figure 4-24 below. Moisture content versus time for the gypsum board on Wall 3 was similar for Module C-1, as seen in Figure 4-26 below. Similar to the interior wall, the highest moisture content was about 6 % for the floor level, 1, 2 and 3 feet above the floor level. The moisture content at heights 4 feet and above was just under 1 percent after opening the door and window and it reached the pre-flood condition at the end of the drying period. Also the floor level moisture resembled that of the interior wall; however, it had a slower drying rate. This was the case for the floor level measurements and at 1 foot above the floor. For 2 and 3 feet above the floor the drying rate was faster in Wall 3.

Figure 4-26 Moisture content versus time in the gypsum board on the interior of **Wall 3** (south wall) in **Module C-1**. Day 2 is the beginning of flooding, Day 5 is the draining of the basin, Day 10 is the reentry into the module and the beginning of observation and measurement, Day 33 is the end of the drying period. *All moisture contents should be considered relative to their original readings and not absolute values.*

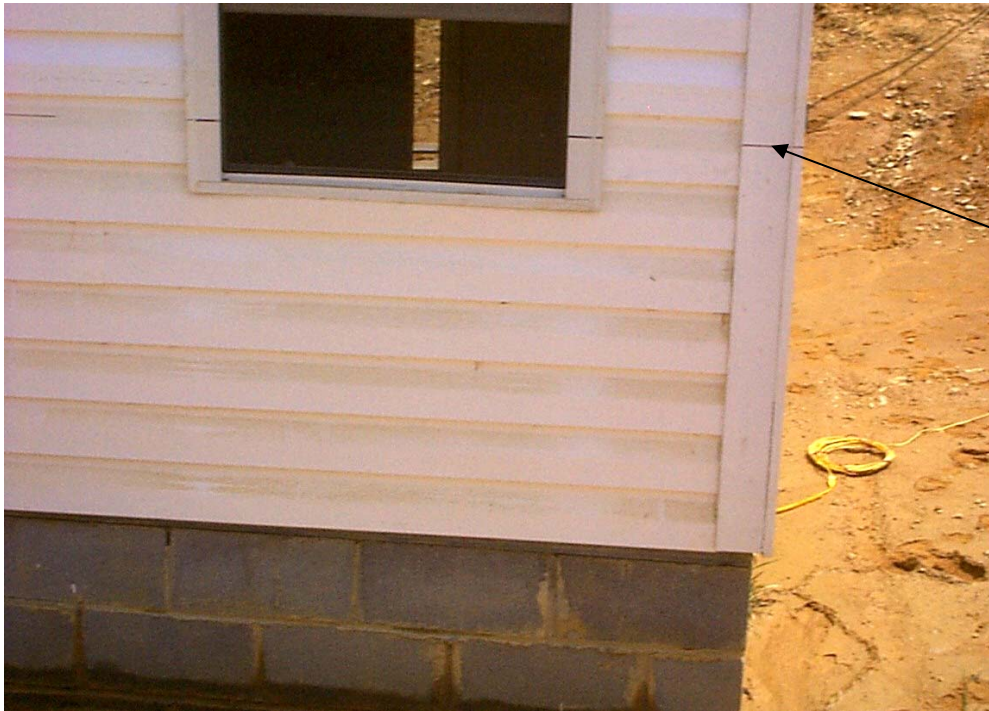
Depth to
which unit
was flooded

Figure 5-16 Module C-2 (Wall 1) Day 8 before washing. Wall is discolored

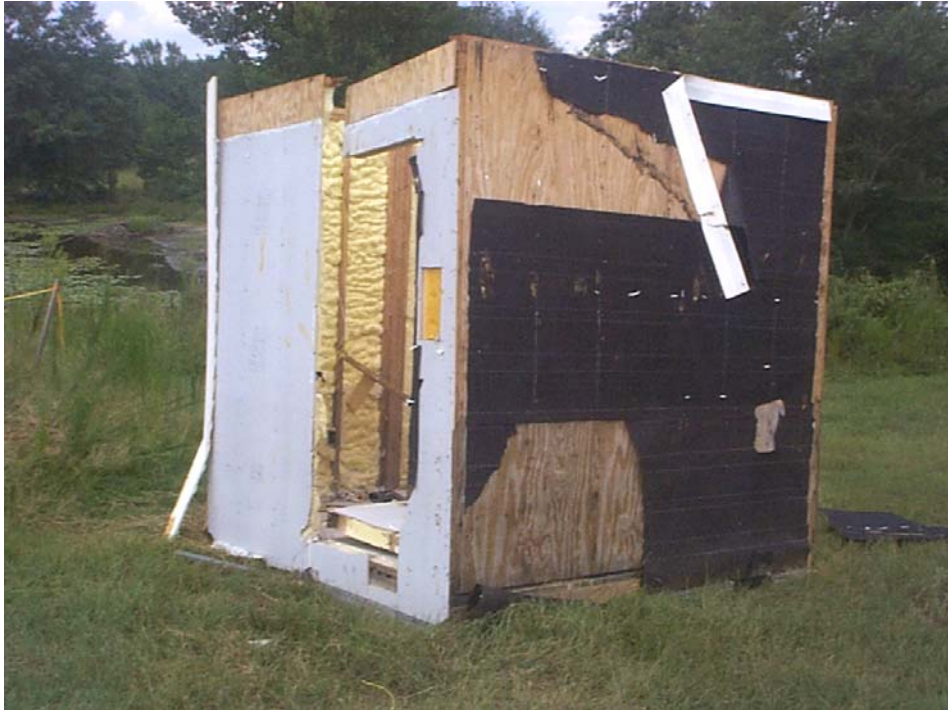
At the end of the drying period and following the completion of the restoration, an autopsy was performed on selected walls. In both Modules S-2 and C-2, Wall 1 exterior and Wall 2 exterior, as well as the interior wall were autopsied. The autopsy revealed no mold on the inside surfaces. The polyurethane foam appears to be intact with no discoloration or staining. On the exterior side, the cement and vinyl siding as well as the gypsum sheathing material were intact with no apparent mold or permanent damage.

Figure 5-18 Module C-2 - Body of module at final autopsy and demolition

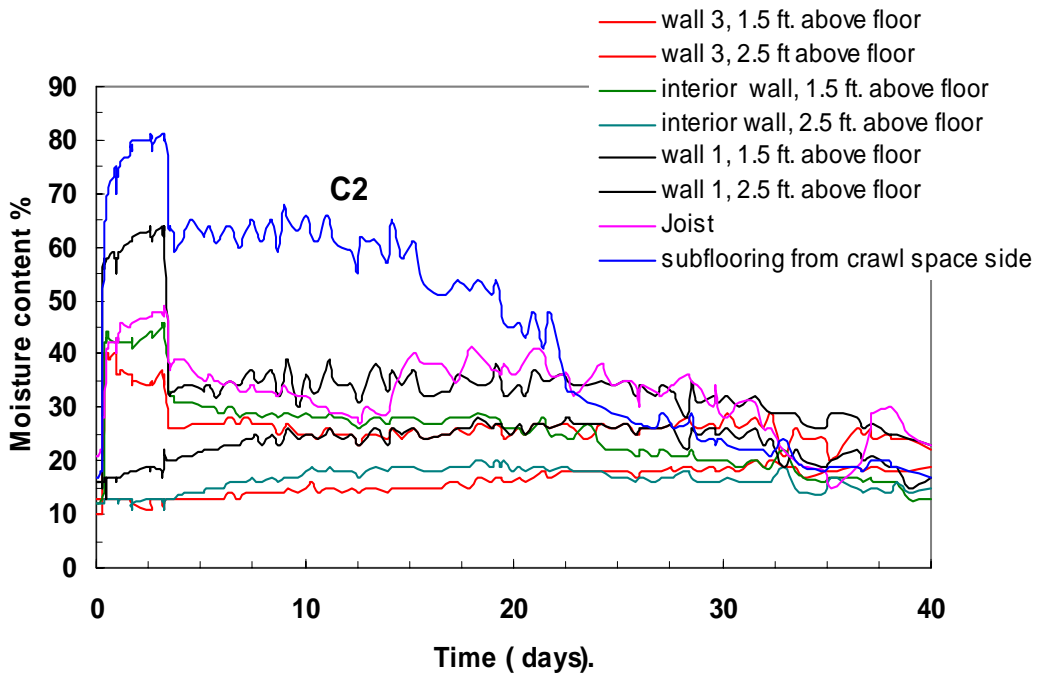
The relationship between moisture content and time for the entire 40 days is given in Figure 5-24. The rate of moisture absorption during flooding is higher for the subfloor and it took a longer time to dry. It reached about 80% during the flooding period and it took more than 22 days to drop to 30%. After draining, which occurred on Day 3, the readings of all other sensors dropped suddenly reaching a range of 25-35% on Day 5. All sensors above the water level appear to have a very similar pattern throughout the flooding and drying period.

Figure 5-24 Relationship between the moisture content and time for exterior and interior wall studs, subflooring and joist in Module C-2. Days 1- 4 is the period of flooding. The drying period begins with Day 4.

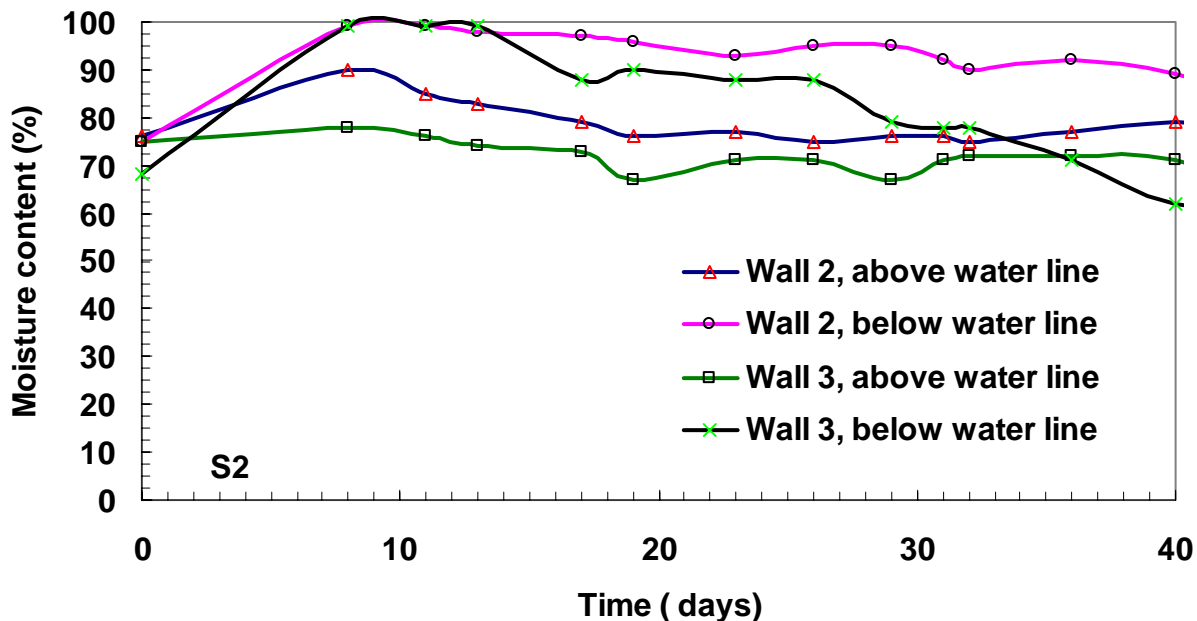
The moisture content was measured for the cement board siding on Walls 2 and 3 in Module S-2 using the hand held moisture meter. The results in Figure 5-25 are for Walls 2 (east wall) and 3 (south wall), since these walls have the cement board siding. (Results for Module C-2 are similar.) The moisture content below the flood level was at maximum wetness from Day 8 to Day 14. Then, Wall 3 experienced a faster drying rate than Wall 2 due to its orientation to the south. In the time period from Day 0, which is pre-flood, to Day 8, no measurements were taken. Measurements started on Day 8, once the module had been drained and was open for inspection. Above flood level there was no significant change in the moisture content.

Figure 5-25 Moisture content of the cement siding, Walls 2 and 3 versus time for Module S-2. All moisture contents should be considered relative to their original readings and not absolute values.

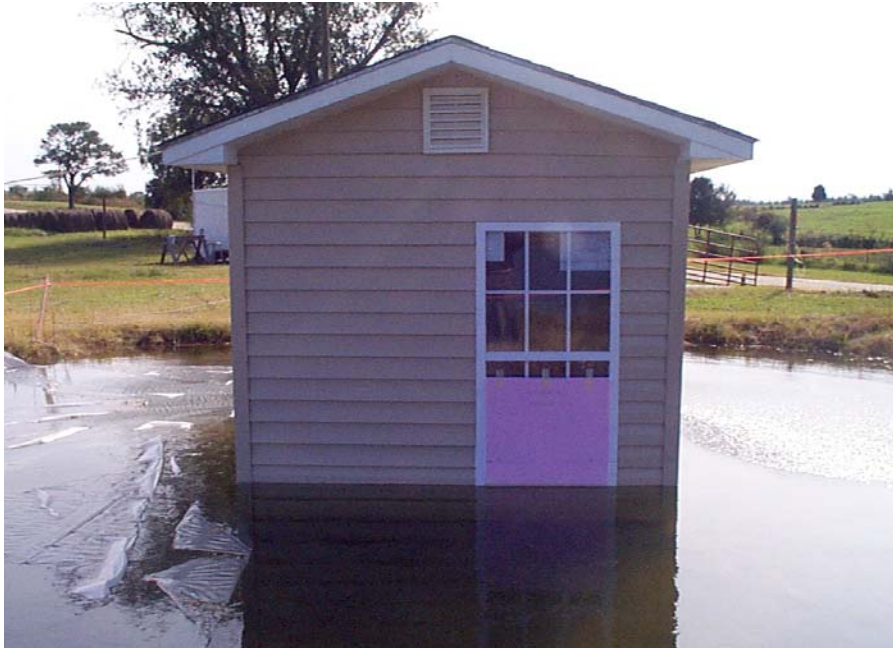
Figure 6-2 Module S-3 Wall 1. Dam on window during flooding is staying in place.

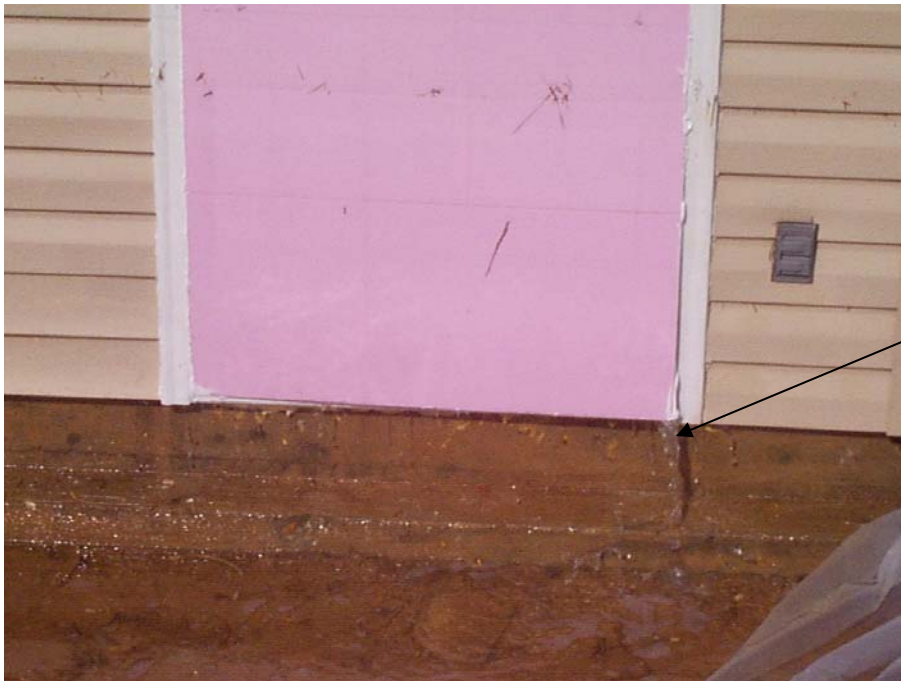
Water from the inside of the module

Figure 6-3 Module S-3 Exterior door dam. Dam on door is leaking at right lower corner where it has been pushed out from the force of the retained water. Leakage was also observed at the corners of the test module as well as at the intersection of the interior partition and exterior walls along the slab foundation.

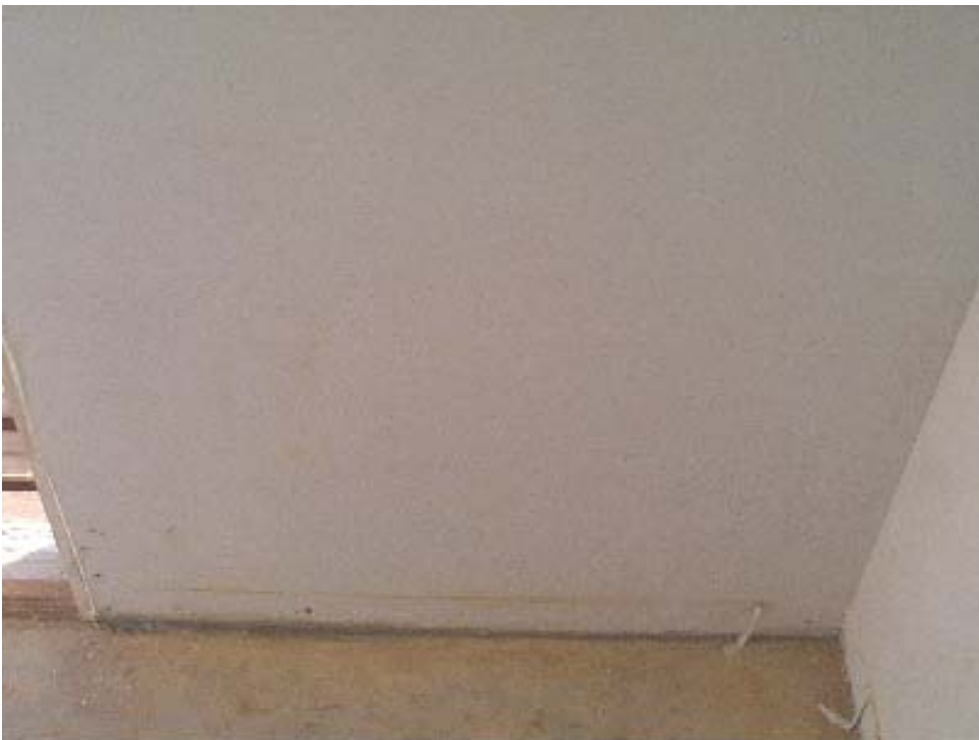
Figure 6-10 Module S-3 (Wall 3) Day 15 - After sanitizing. No mold visible

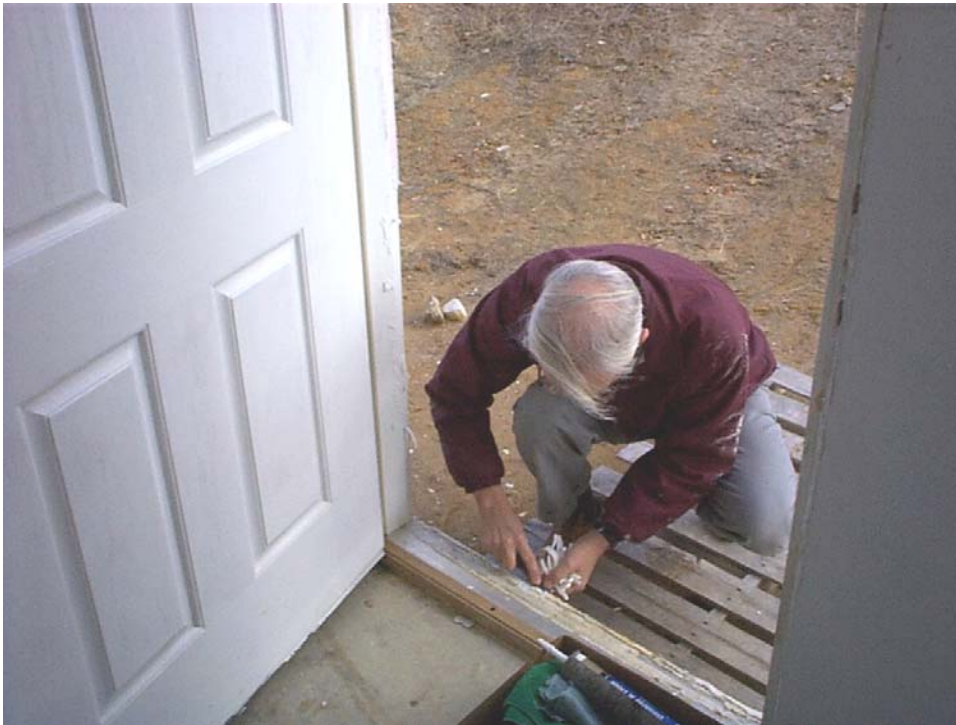
Figure 6-28 Silicon II caulking was installed on the threshold. Prior to reinstalling the polystyrene foam flood dams

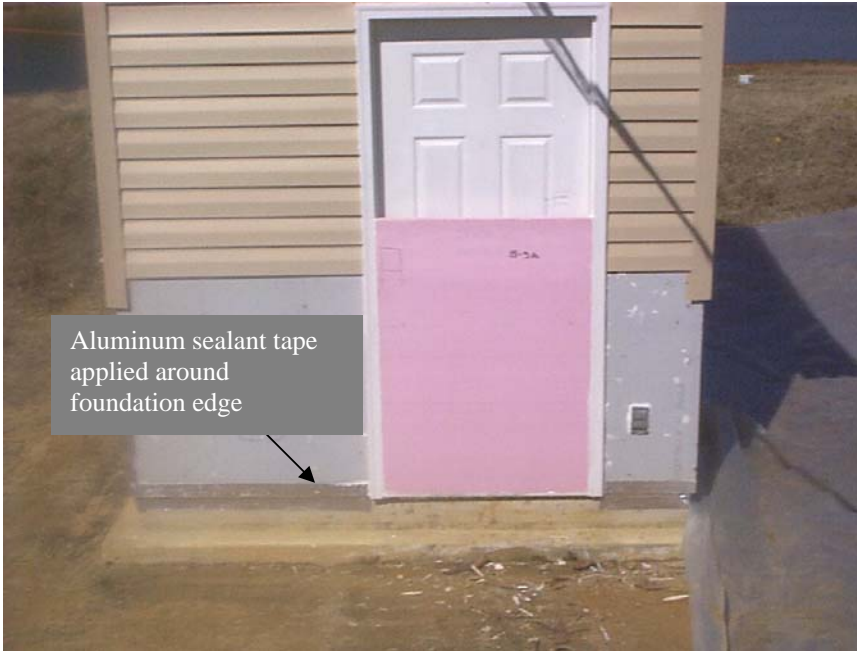
Figure 6-29 Module S-3a, south wall with door dam and aluminum/butyl rubber adhesive sealant tape installed. Prior to flooding

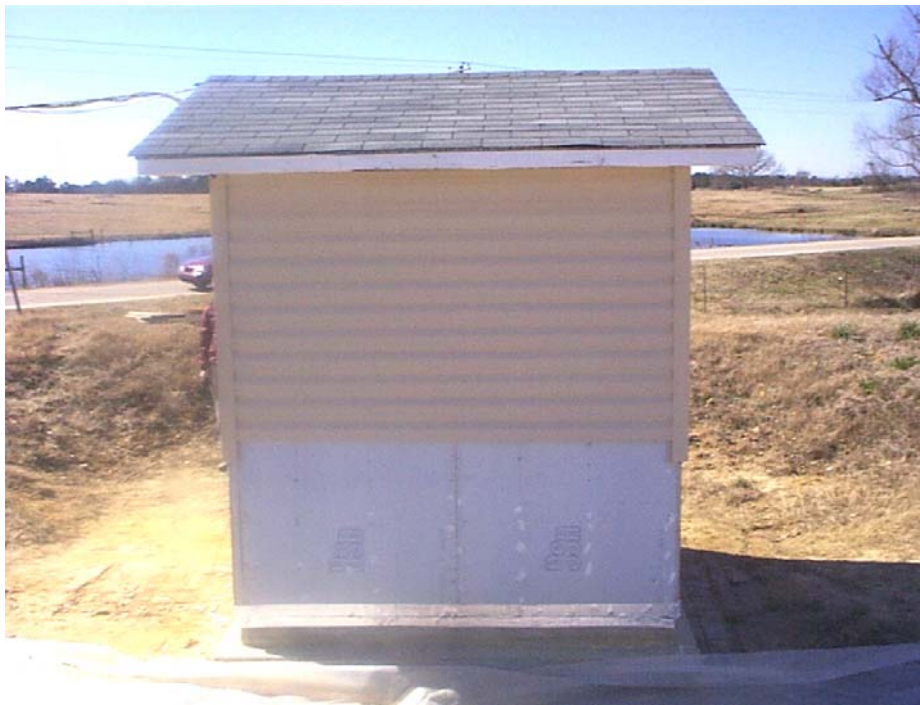
Figure 6-32 Module S-3a, east wall with adhesive sealant tape installed. Prior to flooding

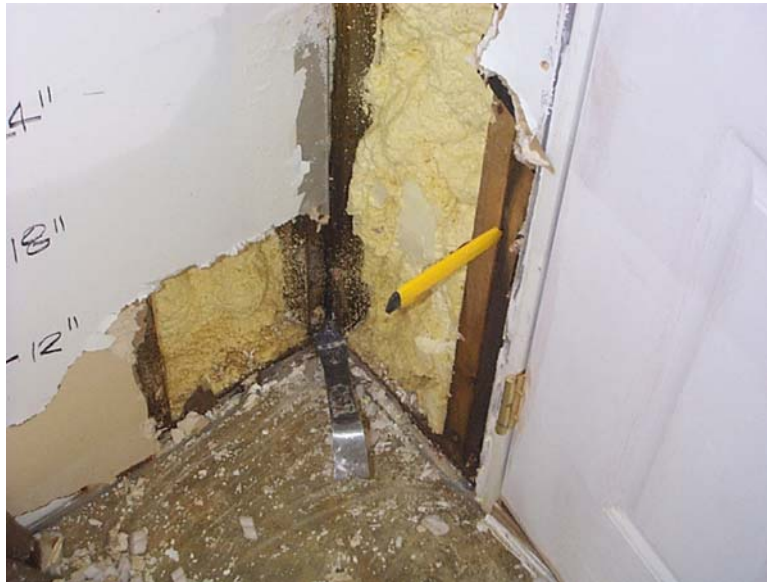
Figure 6-35 Module S-3a Interior southeast corner of Room S-301 after second dry flood proof test. Water entered the module during flooding through the crack between the doubled studs (yellow knife) that form the door rough framing. It also entered through the crack between the corner studs and the sill plate (grey pry bar).

2. Water entered the unit from the corners and underneath the door frame in spite of the efforts to seal these areas. Places where the concrete foundation was chipped appeared to be the problem areas based on observations at draining of water exiting from these locations.

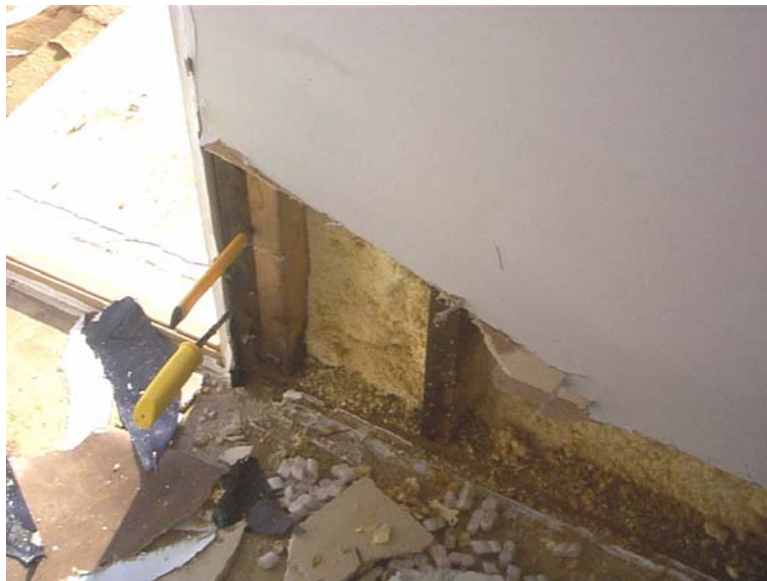
Figure 6-36 Module S-3a Interior south wall after second dry flood proof test. Water entered the module during flooding through the crack between the doubled studs (yellow knife and saw) that form the door rough framing.
