**SUPPORT SERVICES FOR CERAMIC FIBER- CERAMIC MATRIX COMPOSITES**

Final Annual Technical Progress Report

September 28, 2001

Report Prepared by  
John P. Hurley and Charlene R. Crocker  
Energy & Environmental Research Center  
University of North Dakota  
PO Box 9018  
Grand Forks, North Dakota 58202-9018  
under  
Subcontract No. 19X-SS 112V

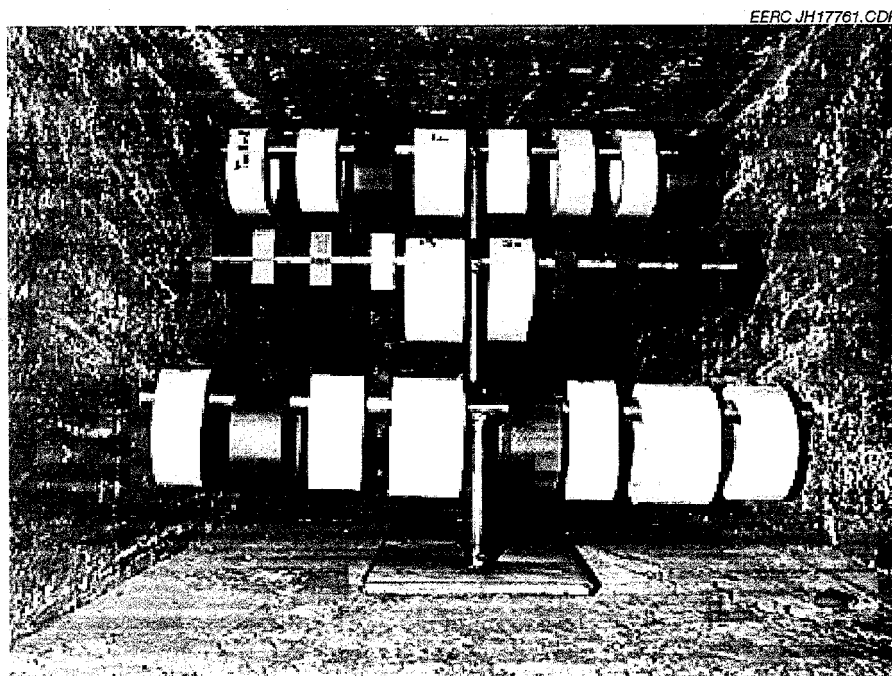
Figure 3. Upstream view of samples installed in the SFS convective pass.

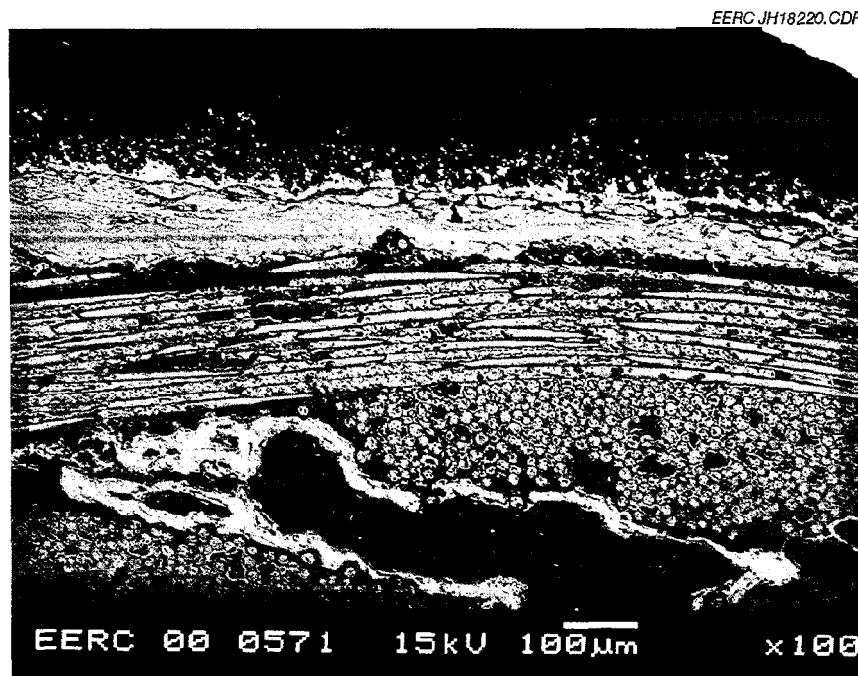
The sample was described by the submitter as SiC fibers in a SiC matrix. It was prepared for SEM analysis according to the submitter's instructions. Figure 8 is a backscattered electron image of the sample material and ash deposit at 100× magnification. It shows a cross section of weave of lengthwise and crosswise fibers, amorphous bundles and voids, amorphous binder at the surface, and a light layer of ash. The darkest areas are mounting epoxy.

No subsurface corrosion was observed in the cross section. The material-ash interface appears limited to the surface of the ring. The depth of the ash deposit ranged from less than 1  $\mu\text{m}$  to greater than 70  $\mu\text{m}$ . Figure 9 includes a natural divot in the surface (left of center in the photo) that filled with ash. It did not penetrate or otherwise degrade the material. Composition of the deposited ash layer was consistent with that of the convective pass ash deposit described in Table 1. No signs of corrosion or erosion were indicated throughout the sample cross section, although a thin surface layer less than 5  $\mu\text{m}$  thick was rich in calcium and silicon which may indicate very limited attack.

Figure 8. Honeywell SiC-SiC material and ash deposit at 100× magnification (HACI #0257-01-001-2-5).

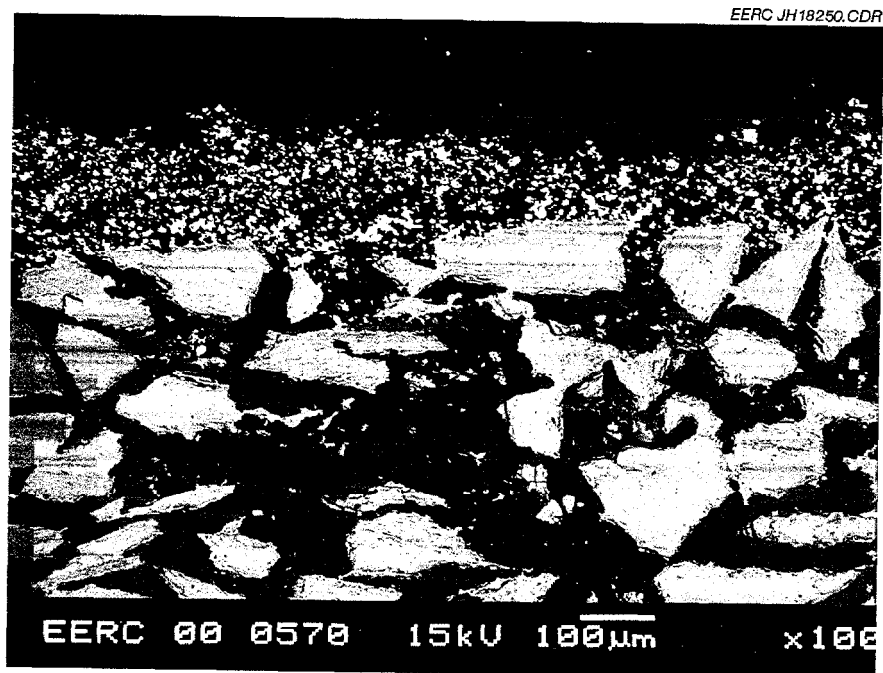
The sample was described as being composed of mullite. Figure 11 shows a representative example of the material and deposited ash at 100× magnification. SEM analysis of the bulk material indicated a composition of 49 wt% Al, 37 wt% O, and 13 wt% Si.

Ash penetration was minimal, but there was no gas flow through the material. No subsurface corrosion was observed in the cross section. Ash filled the voids between the mullite grains at the surface to a depth of 180  $\mu\text{m}$  as shown in the figure. It otherwise did not penetrate or degrade the sample.

Composition of the deposited ash layer was consistent with that of the convective pass ash deposit described in Table 1. Evidence of surface corrosion may be indicated by a thin, discontinuous layer (<5  $\mu\text{m}$  thick) of apparent corrosion product at the sample-ash interface. This layer is rich in calcium, aluminum, and silicon.

Figure 11. ORNL mullite composite and deposited ash at 100x magnification (ORNL #Jan 1 I-I).

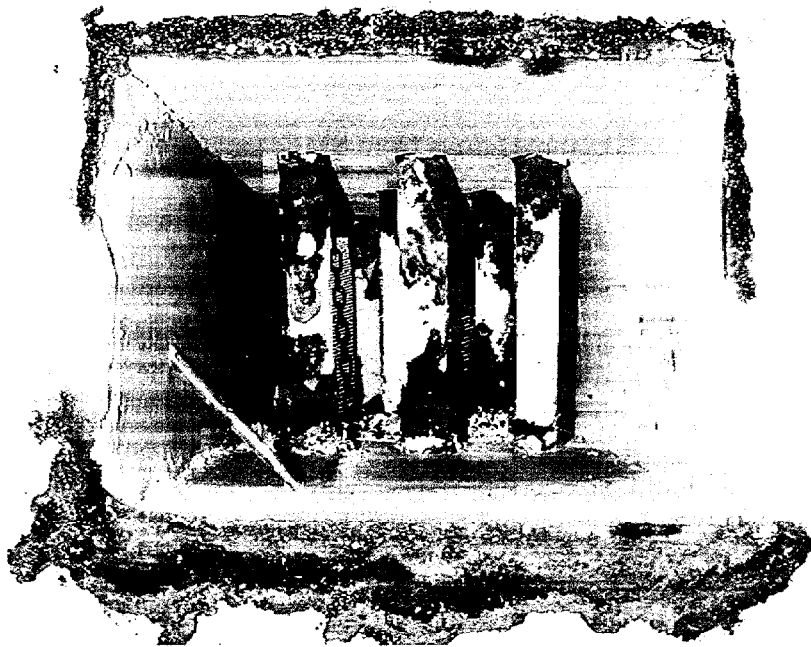
Figure 36. The installed ORNL Cr/Ta rod.

**Sample description:** Shiny, gray alloy rod 156 mm long, 9 mm diameter, weighing 92.745 g. Figure 36 shows the sample embedded in the refractory material downstream of the slag screen in the SFS.

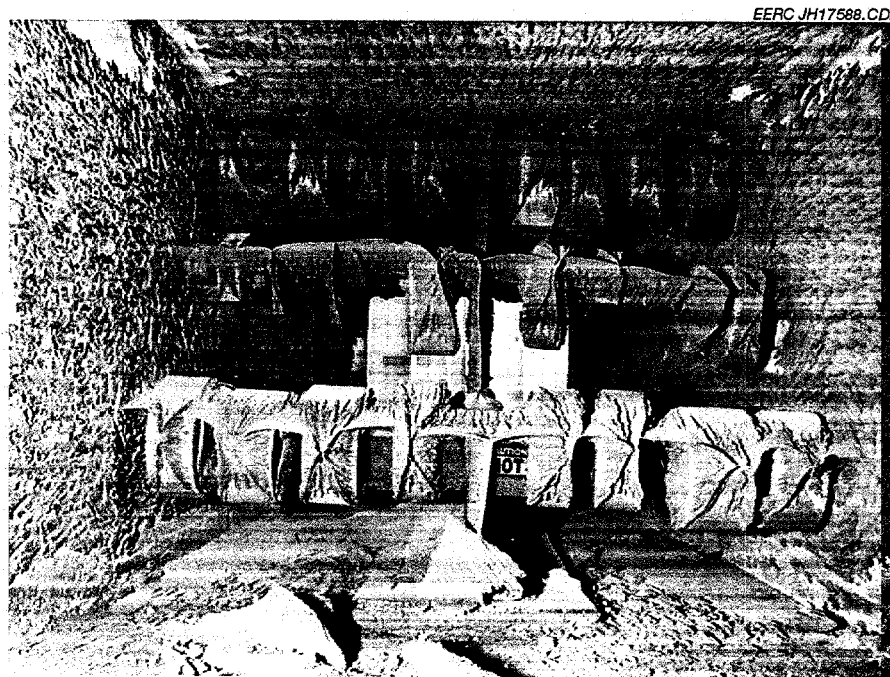
The CAH pass samples were examined and photographed in place after the test run was completed. Figure 40 shows the extent of the sintered ash deposit on the upstream surfaces of samples at the end of the test. In addition, ash filled the open areas in the center of each ceramic ring. Downstream deposition on the samples is shown in Figure 41. Ash deposit weights were lower than those deposited during the March test with the Powder River Basin coal.

Figure 40. Upstream surfaces after the June test.

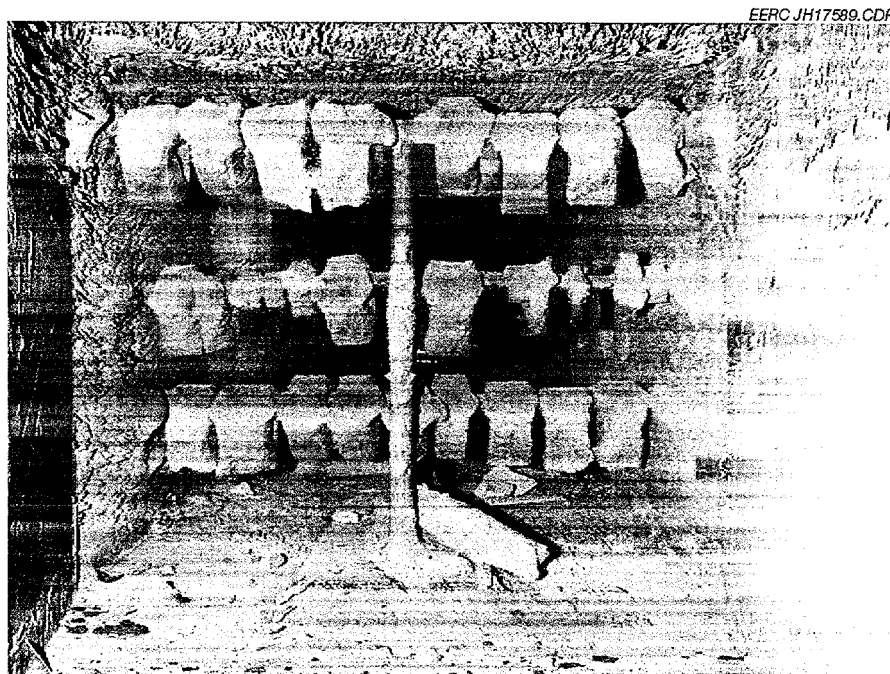
Figure 41. Downstream deposition.

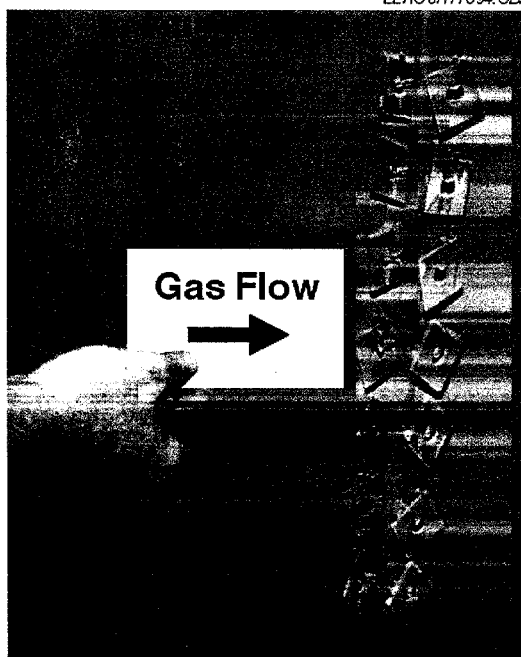
The alloy coupons installed in the elbow between process air heaters and the first set of shell-and-tube heat exchangers were coated with a very light layer of ash on both the upstream and downstream sides. Figure 42 shows the samples after they were removed from the SFS. Visual inspection indicates that all samples probably underwent surface corrosion. Half of the samples were analyzed by SEM.

Figure 42. Samples after removal from the SFS.

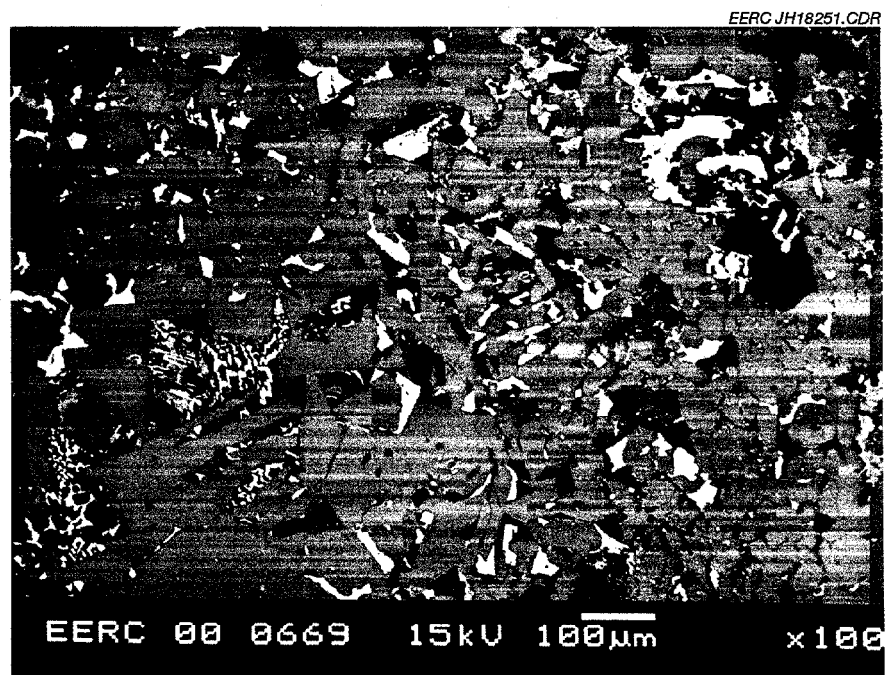
The sample was reported to contain 83 wt% Cr, 16 wt% Ta, 5 wt% Mo, 0.8 wt% Si, 0.2 wt% La, and 0.05 wt% Ti. Figure 44 shows a representative example of the sample remains after exposure at 100 $\times$  magnification. It reveals a heterogeneous mass—a field of medium gray with light and dark portions in sample cross-section surface. SEM analysis of the sample revealed no evidence of virgin alloy material remaining after exposure. Analysis of the medium gray material indicated a high level of Cr with some O and Al and small amounts of Ta, Fe, and Si. This was common to all areas examined regardless of proximity to the sample surface. The lightest regions were high in Ta (54-57 wt%), with Si, Cr, and O and trace amounts (<2 wt %) of Ti, Fe, and P. Dark regions contained either high levels of ash constituents with small amounts of Cr and Ta or nearly pure SiO<sub>2</sub>. Black areas in the figure indicate voids filled with epoxy during sample preparation. The shading in SEM photographs is limited by the sensitivity of the backscatter detector. Therefore, regions of the same shade may contain different constituents or different concentrations of the same constituents. Table 4 summarizes the concentration ranges of multiple analyses by region shade.

Figure 44. Representative example of sample remains after exposure at 100× magnification (ORNL Ca-Ta alloy rod).

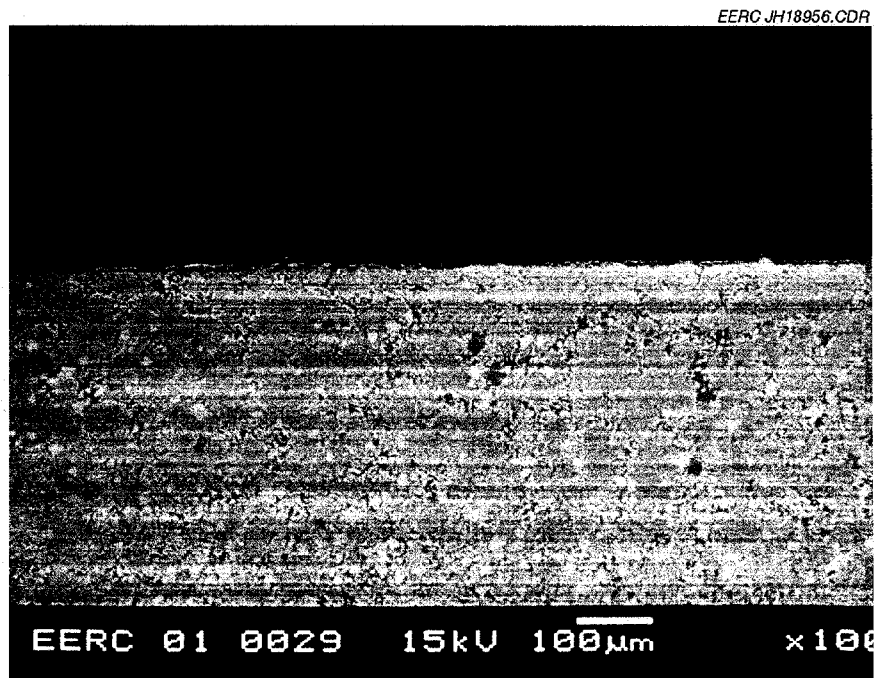
The sample was reported to contain 83 wt% Cr, 16 wt% Ta, 5 wt% Mo, 0.8 wt% Si, 0.2 wt% La, and 0.05 wt% Ti. Figure 46 shows a representative example of the sample and ash deposit at 100× magnification. It reveals a heterogeneous sample mass of irregular shapes in shades ranging from light to dark gray covered with a thin discontinuous oxide layer and a light coating of ash particles. SEM analysis of the bulk alloy material sample indicated an overall composition of 52 wt% Cr, 28 wt% Ta, 11 wt% Si, 6 wt% Mo, and 4 wt% O. Figure 47 shows the alloy in greater contrast and detail at 500× magnification. Analysis of the larger white portions of the alloy indicate high Ta content (48 wt%), with some Cr (30 wt%), Si (16 wt%), Mo (4 wt%), and O (1 wt%). The medium gray material contained high Cr (72 wt%), with Mo (14 wt%), Ta (5 wt%), O (4 wt%), and Si (2 wt%). The shading in SEM photographs is limited

Figure 46. Example of material and deposited ash at 100× magnification (ORNL Sample A).

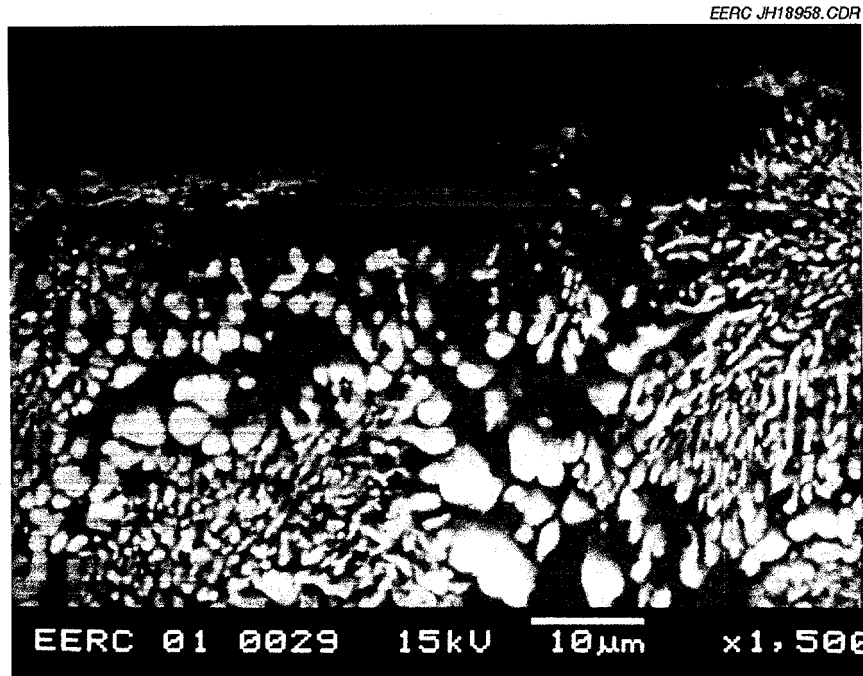
No subsurface corrosion was observed in the sample cross section. No obvious pitting occurred at the sample surface. There is, however, a very distinctive discontinuous oxide layer across the sample surface that can be seen in the upper left corner of Figure 48. The oxide layer is composed of two sections: the inner layer which is nearly white and the outer layer which is dark gray and barely visible in the figure. The bright inner layer contains more Ta than Cr, with some Si, O, and traces of Fe. The outer layer is Cr (64 wt%) and O (22 wt%), with some Si (8 wt%) and traces of flue gas constituents, Fe, Ca, Al, Cl, P, and Mg. At the corrosion layer-ash interface, Si (13-21 wt%) replaced some of the Cr (38-42 wt%) in the Cr-O layer. There is also high Ca (12-20 wt%) and trace Al, Fe, and Mg. The oxide layer is about 14 μm at its thickest. No obvious erosion was observed.

Figure 48. Sample at 1500x magnification (ORNL Sample A).

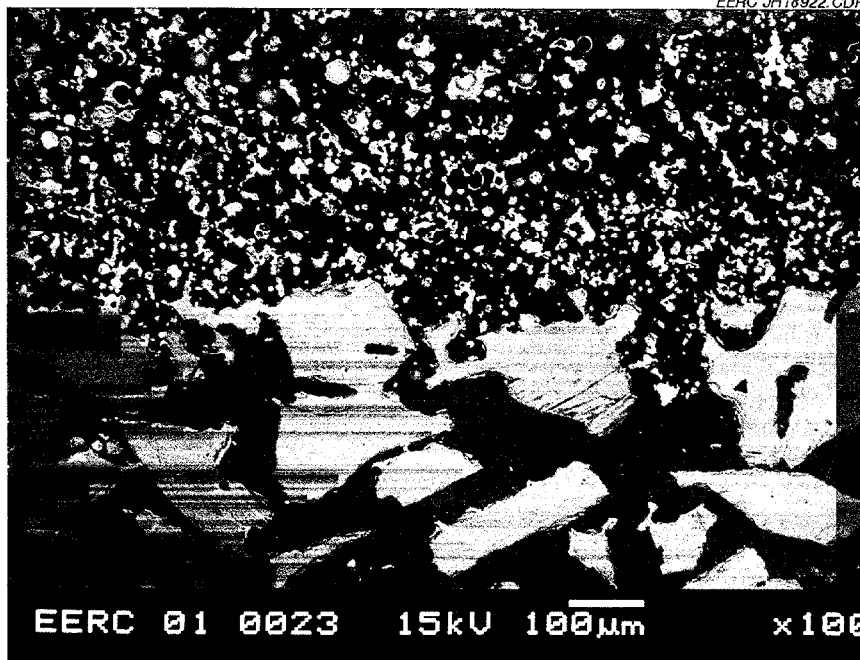
The sample was described as being composed of mullite. Figure 50 shows a representative example of the material and deposited ash at 100x magnification. SEM analysis of the bulk material indicated a composition of 48 wt% Al, 36 wt% O, and 15 wt% Si. Inclusions in the bulk material seen as light gray streaks in the figure were present throughout the sample. Their average composition was 9.7 wt% Al, 37 wt% O, and 43 wt% Si, with 7 wt% K, 2 wt% Ca, and trace amounts of P and Na. Because of their morphology and location, these inclusions are most likely an artifact of manufacturing rather than evidence of corrosive exposure from flue gas.

Ash penetration into the ring structure was minimal, but there was no gas flow through the material. No subsurface corrosion was observed in the sample cross section. Ash filled the voids between the mullite grains at the surface to a depth of less than 200 μm as observed in the figure. Some mullite-ash interaction was apparent at the surface of the ring. Figure 51 illustrates the typical appearance of surface corrosion, a discontinuous layer of material ranging from less than 1 μm to 7 μm thick at 1500x magnification. Constituents in the corrosion product include O

Figure 50. Example of material and deposited ash at 100× magnification (ORNL #3-1).

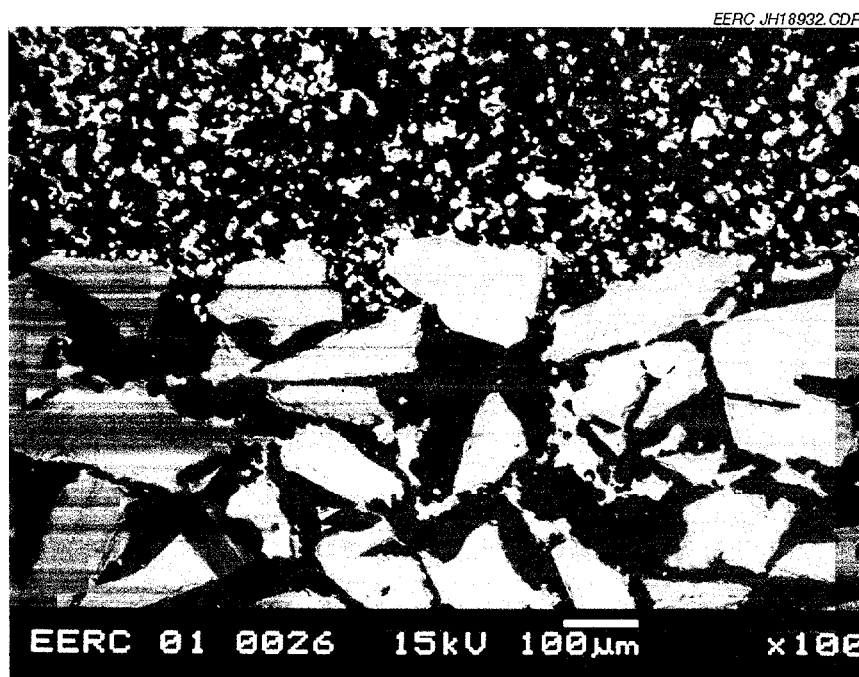
The sample was described as being composed of mullite. The sample surface directly facing oncoming flue gas (upstream surface) was examined. Figure 60 shows a representative example of the material and deposited ash at 100 $\times$  magnification, a porous field of ceramic grains largely separated from a band of ash across the top of the figure. SEM analysis of the bulk material indicated a composition of 48 wt% Al, 36 wt% O, and 16 wt% Si. Inclusions in the grains seen as light gray streaks in the figure were present throughout the sample. Their average composition was 11 wt% Al, 36 wt% O, and 40 wt% Si, with 9 wt% IS, 2 wt% Ca, and trace amounts of P and Na. As was true for the other mullite rings, because of their morphology, composition, and location, these inclusions are most likely artifacts of manufacturing rather than evidence of corrosive exposure from flue gas or ash.

Figure 60. Example of material and deposited ash at 100 $\times$  magnification (ORNL #3-4).

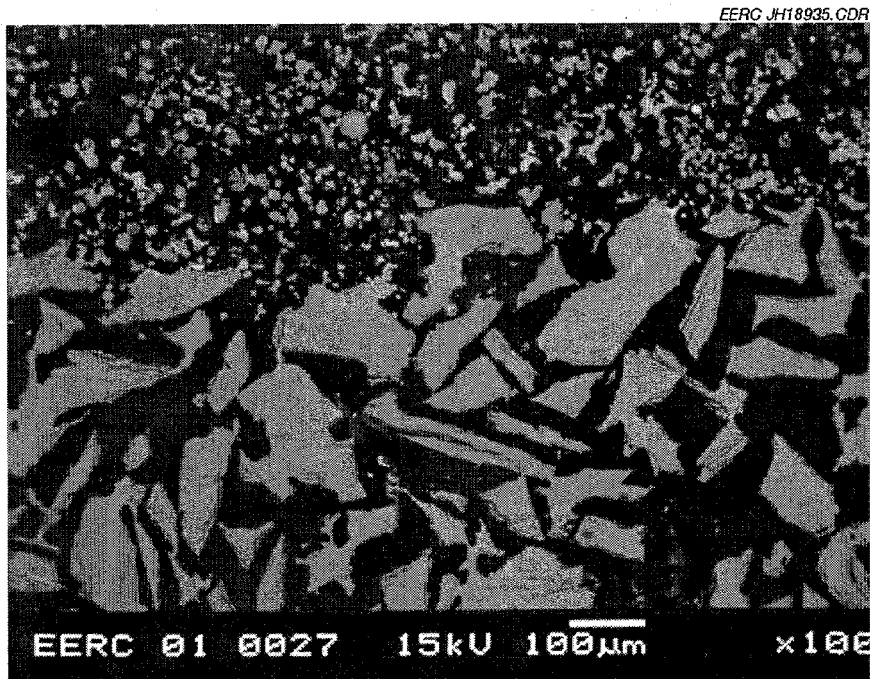
The sample was described as being composed of mullite. The sample surface directly facing oncoming flue gas (upstream surface) was examined. Figure 63 shows a representative example of the material and deposited ash at 100 $\times$  magnification, a porous field of ceramic grains largely separated from a band of ash across the top of the figure. SEM analysis of the bulk material indicated a composition of 47 wt% Al, 37 wt% O, and 15 wt% Si. Inclusions in the bulk material seen as light gray streaks in the figure were present throughout the sample. Their average composition was 12 wt% Al, 37 wt% O, and 39 wt% Si, with 7 wt% K, 2 wt% Ca, and trace amounts of Na and Fe. Because of their composition, morphology, and location, these inclusions are most likely artifacts of manufacturing rather than evidence of corrosive exposure from flue gas or ash. The surface of this sample exhibited large irregular depressions as large as 370–530  $\mu\text{m}$  deep and 1220  $\mu\text{m}$  wide. Although filled with ash, there appeared to be no corrosive or erosive effects causing the depressions.

Figure 63. Example of material and deposited ash at 100× magnification (ORNL #5-1).

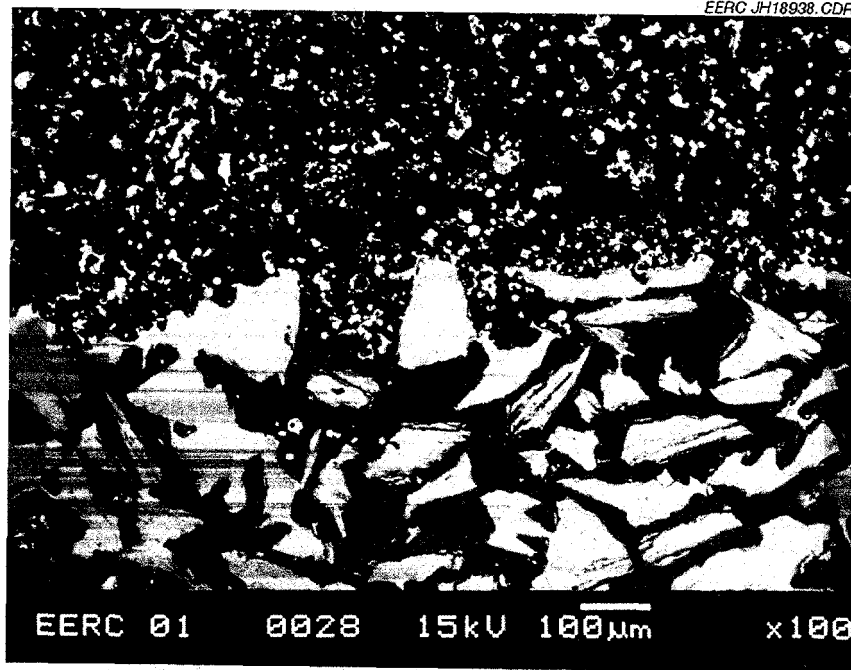
The sample was described as being composed of mullite. The sample surface directly facing oncoming flue gas (upstream surface) was examined. Figure 66 shows a representative example of the material and deposited ash at 100 $\times$  magnification, a porous field of ceramic grains largely separated from a band of ash across the top of the figure. SEM analysis of the bulk material indicated a composition of 58 wt% Al, 22 wt% O, and 18 wt% Si. Inclusions in the grains seen as light gray streaks in the figure were present throughout the sample. Their average composition was 13 wt% Al, 26 wt% O, and 48 wt% Si, with 8 wt% K, 2 wt% Ca, and 1 wt% Na. Because of their morphology, composition, and location, these inclusions are most likely artifacts of manufacturing rather than evidence of corrosive exposure from flue gas or ash.

Figure 66. Example of material and deposited ash at 100× magnification (ORNL #5-2).

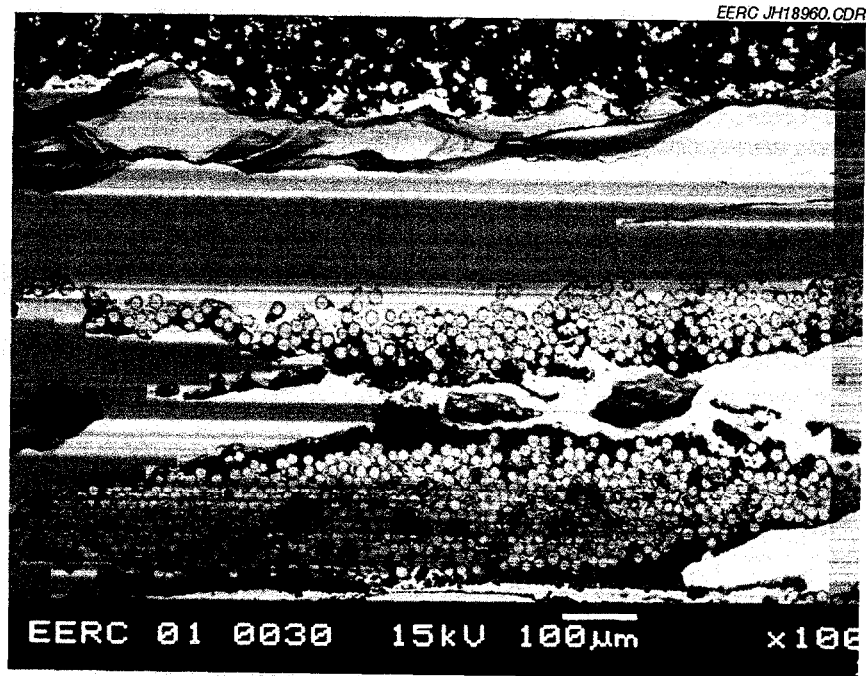
The sample was described by Honeywell as SiC fibers in a SiC matrix. The sample was prepared for SEM analysis according to Honeywell instructions. Figure 70 is a backscattered electron image of the sample material and ash deposit at 100× magnification. It shows a cross section of weave of lengthwise and crosswise fibers, amorphous bundles and voids, amorphous binder at the surface, and a light layer of ash. The darkest areas are mounting epoxy. SEM analysis of the sample matrix indicated a composition of 49 wt% C, 46 wt% Si, and 5 wt% O in the fiber bundles and 32 wt% C, 66 wt% Si, and 2 wt% O in the matrix. It must be noted that the C in the mounting epoxy may interfere with accurate analysis of C in samples.

Figure 70. Sample material and ash deposit at 100× magnification (HACI #0257-01-001-1-6).

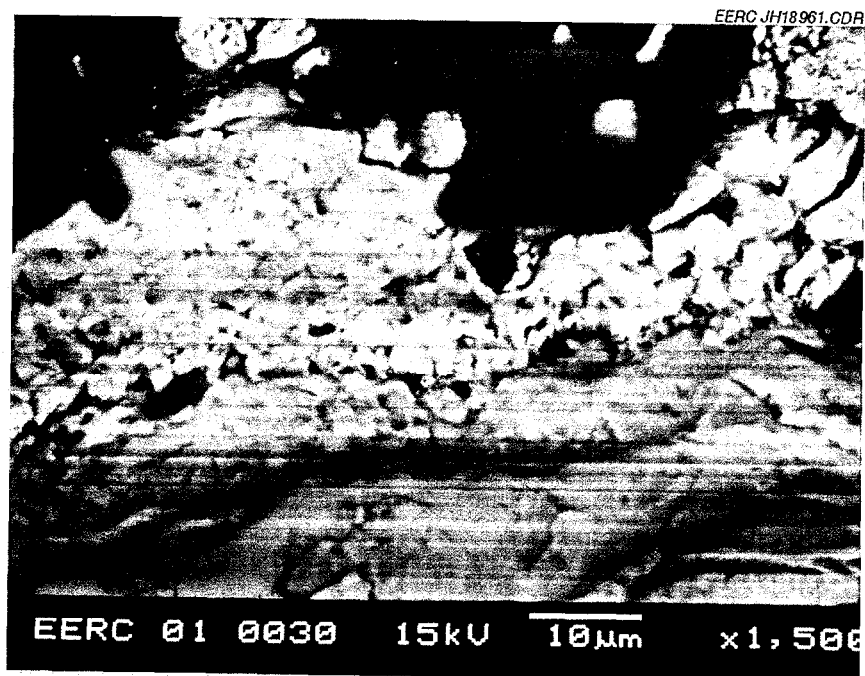
No subsurface corrosion was observed in the sample cross section. The material-ash interface appears limited to the surface of the sample. The depth of the ash deposit on the sample ranged from less than 1 mm to greater than 30 mm. Figure 71 is a backscattered electron image of the sample material-ash deposit at 1500× magnification. The sample matrix, medium gray mass at the bottom of the figure, appears unimpaired by the light gray ash layer at its surface. Composition of the deposited ash layer was consistent with that of the ash deposits on other samples installed in the convective pass. No signs of corrosion or erosion were indicated throughout the sample cross section, although a thin surface layer less than 30 microns thick was rich in calcium and silicon, which indicates some interaction with the ash constituents.

Figure 7 1. Sample material and ash deposit at 1500× magnification (HACI #0257-01-001-1-6).

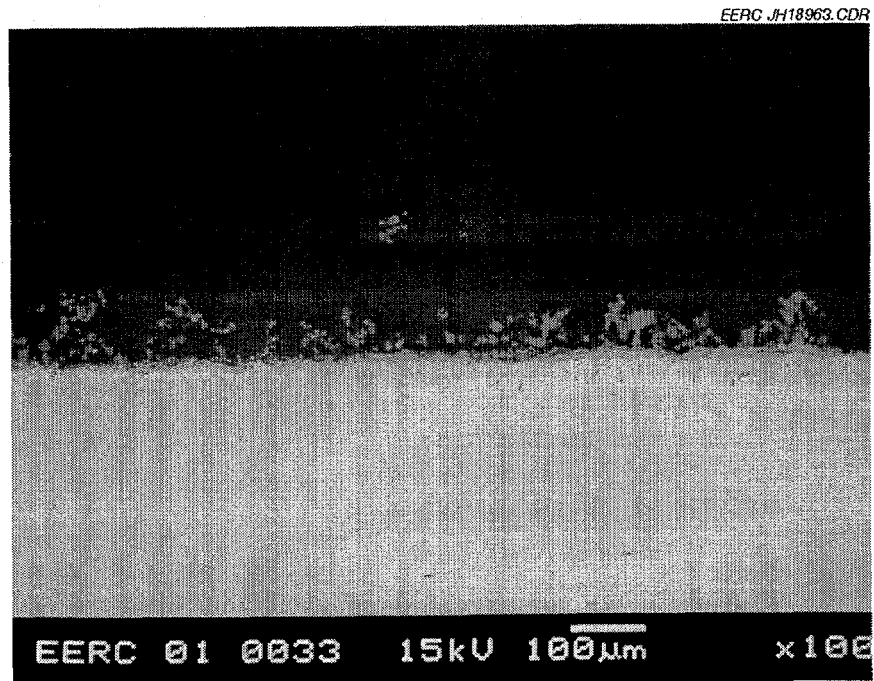
Thermie Alloy 020 is reported to contain 52 wt% Ni, 25 wt% Cr, 20 wt% Co, 1.7 wt% Ti, and <1 wt% Si and Al. Figure 73 shows a representative example of the cross-sectioned alloy material, products of corrosive activity, and ash deposit at 100× magnification. The alloy material appears as a homogeneous field. SEM analysis of the bulk material indicated 47 wt% Ni; 25 wt% Cr; 20 wt% Co; 2 wt% Nb, 0, Ti, and Fe; and trace (<1 wt%) Si and Al. Alloy in the corrosion zone is of similar composition.

Figure 73. Cross-sectioned alloy material, products of corrosive activity, and ash deposit at 100× magnification (#Thermie-020-1).

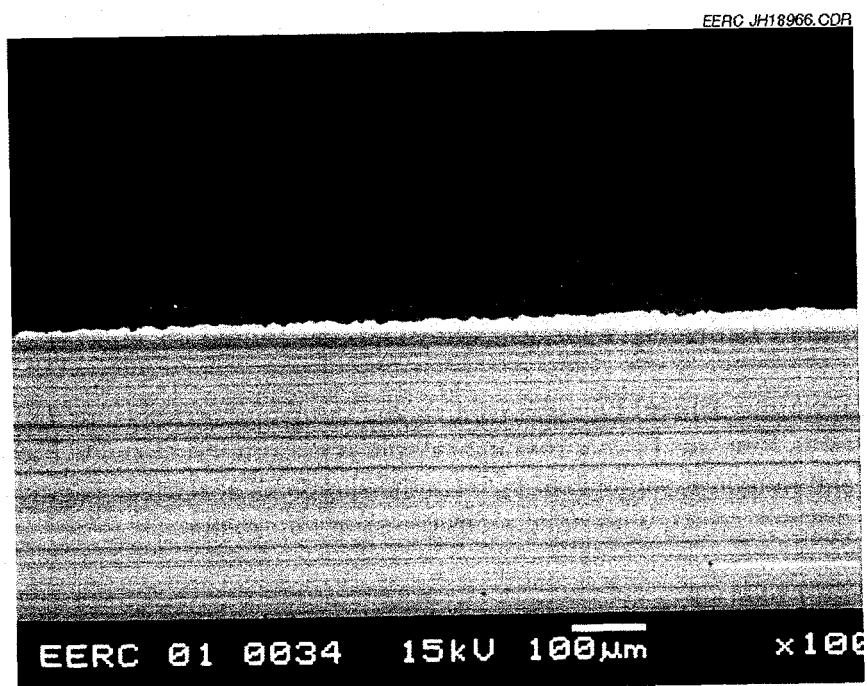
Metal Alloy 956 is reported to contain 73-75 wt% Fe, 19-21 wt% Cr, 4.5 wt% Al, 0.1-0.5 wt% Ti, and 0.5 wt%  $Y_2O_3$ . Figure 76 shows a representative example of the cross-sectioned alloy material, corrosion layer, and ash deposit at 100× magnification. The alloy material appears as a homogeneous field. SEM analysis of the bulk material indicated 74 wt% Fe, 20 wt% Cr, and 4 wt% Al.

Figure 76. Example of cross-sectioned alloy material, corrosion layer, and ash deposit at 100 $\times$  magnification (#956-1).

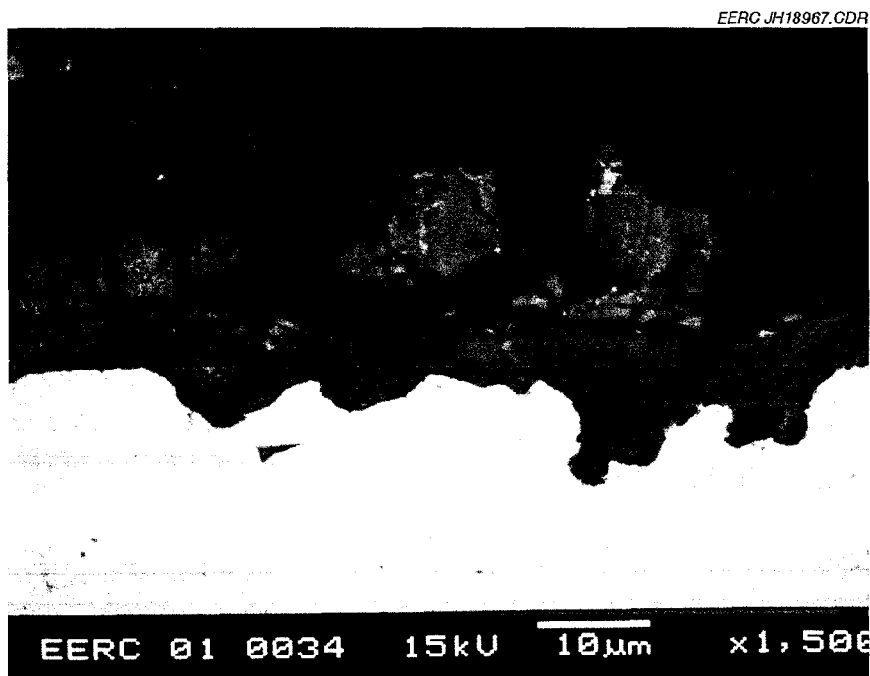
The surface of the sample contains a continuous layer of corrosion product as shown in Figure 77 at 1500× magnification. The dark gray corrosion material adjacent to the alloy comprises 57 wt% Al, 34 wt% O, 3 wt% Fe, and 2 wt% Ti and Cr. Light gray spots in this area contain more Ti (up to 9 wt%). Near the corrosion product-ash interface, Ca, Si, and traces of Mg, P, S, K, Ba, and V appear. The overall effect is formation of a protective aluminum oxide

Figure 77. Example of cross-sectioned alloy material, corrosion layer, and ash deposit at 1500× magnification (#956-l).

layer 4 to 15 μm thick, limiting penetration of ash constituents beyond the outer corrosion layer and into the alloy. No sulfidation or halide attack was indicated. No signs of erosive attack were indicated.

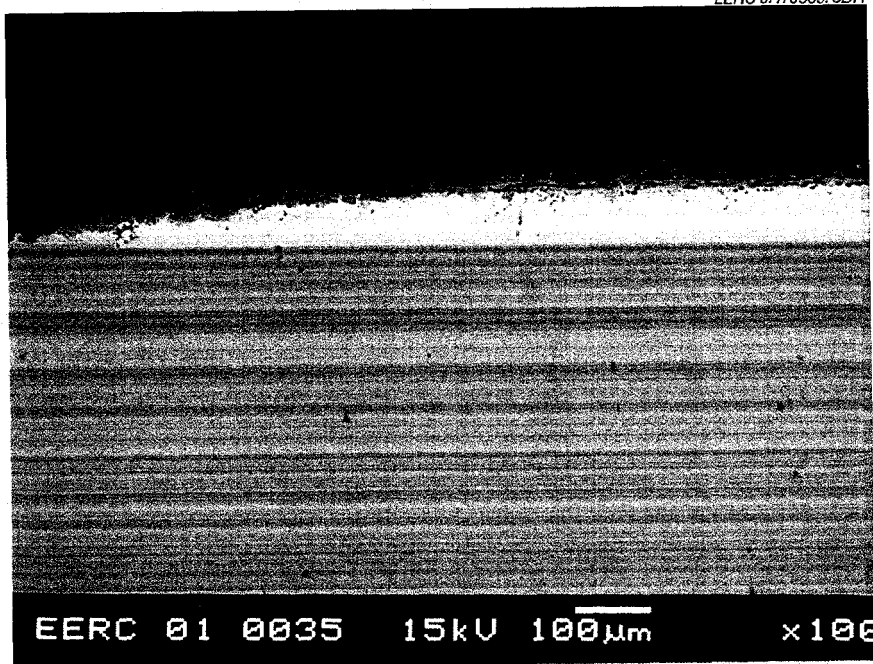
Metal Alloy 803 is reported to contain 35-36 wt% Ni, 35 wt% Fe, 25 wt% Cr, <1.5 wt% Mn, <1 wt% Si and C, <0.75 wt% Cu, 0.15-0.60 wt% Al and Ti, and <0.015 wt% S. Figure 79 shows a representative example of the cross-sectioned alloy material, corrosion layer, and ash

Figure 79. Sample surface at 100x magnification (#803-1).

deposit at 100× magnification. The alloy material appears as a homogeneous white field. SEM analysis of the bulk material indicated 38 wt% Ni, 36 wt% Fe, 23 wt% Cr, and 1 wt% O. Occasional light gray spots appearing in the alloy are depressions in the sample cross section representing holes in the alloy material.

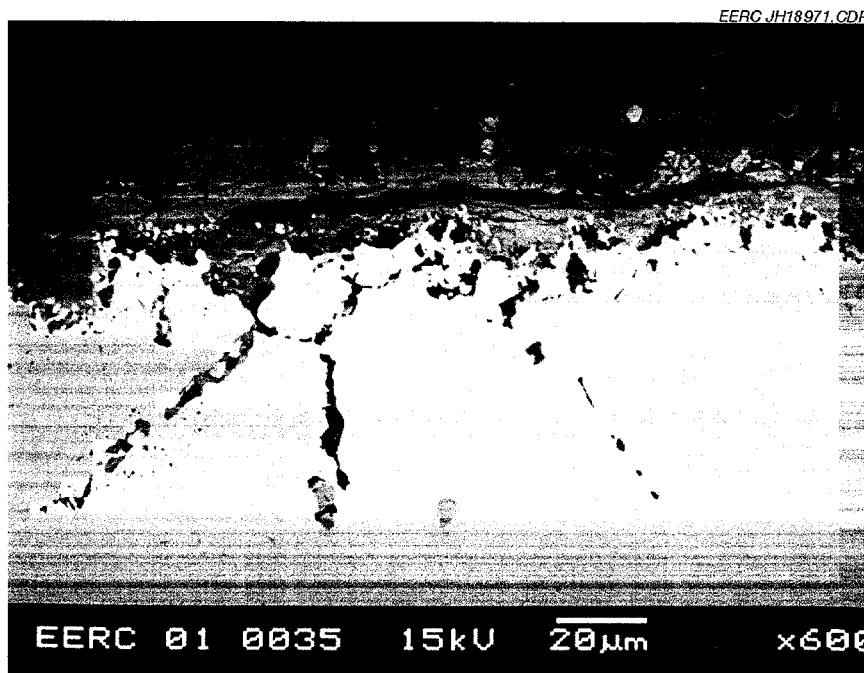
Subsurface corrosion occurs sporadically in the upper 70 μm of the sample. Figure 80 shows the sample surface just right of center in Figure 79 at 600× magnification. Most of the intrusions in Figure 80 are hollow pores in the alloy. The medium gray patches associated with these intrusions are composed of 50 wt% Cr, 20 wt% Ti, 20 wt% O, 4 wt% Al, and 2 wt% Ni and Fe, indicating oxidative penetration into the subsurface.

Figure 80. Sample at 600× magnification (#803-1).

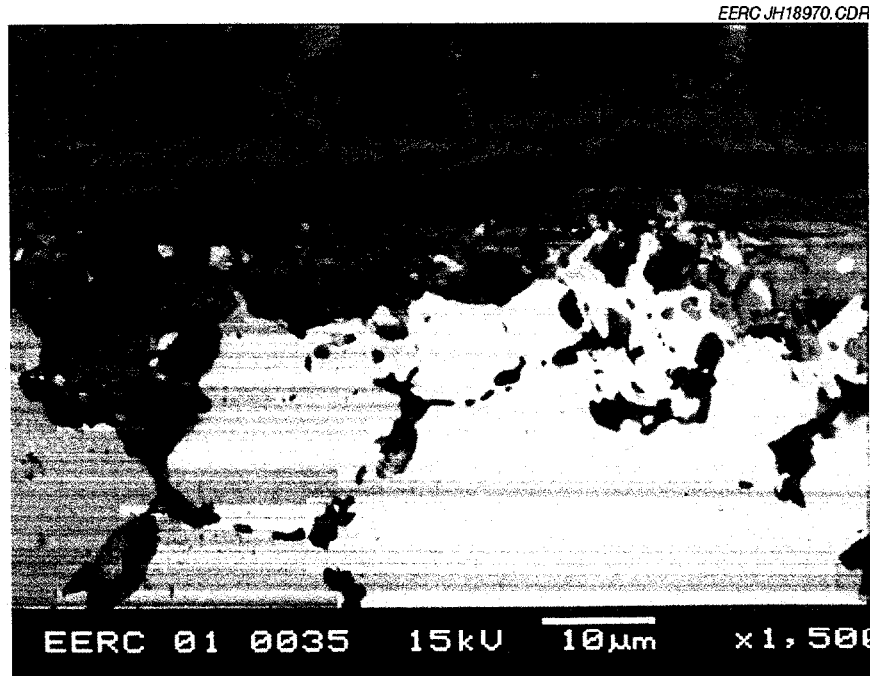
The surface of the sample contains a continuous, irregular layer of corrosion product. Figure 81 shows the area left of center in Figure 80 at 1500× magnification. The dark gray corrosion material adjacent to the alloy comprising 52 wt% Ti, 26 wt% Cr, 10 wt% Fe, 8 wt% Ni, and 2 wt% O indicates a shift in alloy concentration. Closer to the gas interface, oxidation has led to the formation of a chromium titanium oxide layer. The corrosion layer in this area also includes a large separation. The lighter gray layer above the crack is chromium (72 wt%) oxide (21 wt%), with pockets of TiO and TiOMn. In addition, ash particles sticking to the corrosion layer surface appear as entrained spheres. These spheres incorporate Cr, with ash constituents Al, Si, O, and Mn. The corrosion layer was approximately 40 μm thick. No sulfidation or halide attack was indicated. No signs of erosive attack were indicated.

Figure 81. Sample surface at 1500× magnification (#803-1).

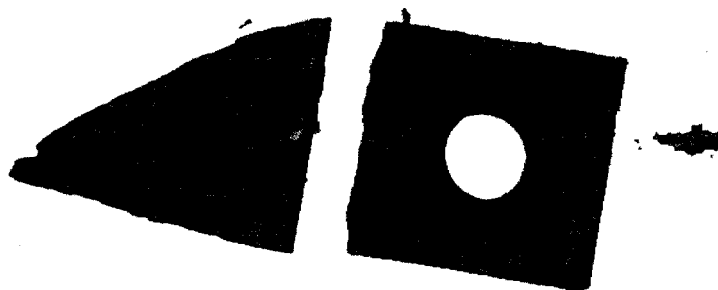
17681 (4)

**Postexposure appearance:** Figure 82 shows the sample removed from the sample holder after the June test run. The large mass of ash deposited on the sample separated easily from the sample. The surface is brown and dull through a thin layer of ash particle. The sample appears intact, with indications of surface corrosion.

Figure 82. Metal Alloy ORNL #17681 (4) removed from the sample holder after the June test run.

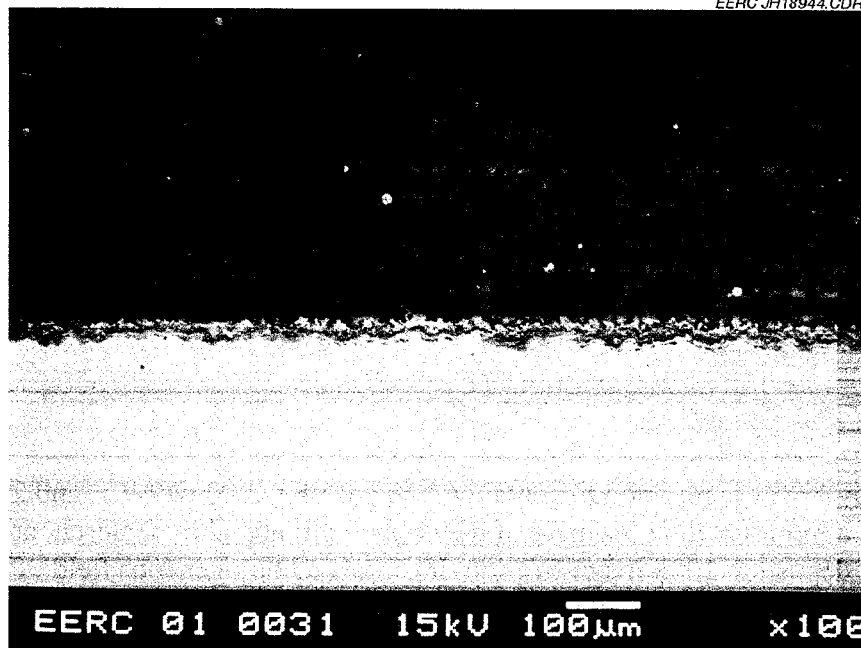
Metal Alloy 17681 is reported to contain 62.50 wt% Fe, 35.0 wt% Cr, and 2.5 wt% Si. Figure 83 shows a representative example of the cross-sectioned alloy material, corrosion product, and ash deposit at 100× magnification. It reveals a homogeneous field of alloy material. SEM analysis of the bulk material indicated 61 wt% Fe, 36 wt% Cr, 1.75 wt% Si, and 1 wt% O. Although not present in the photo, the alloy material also contained occasional darker streaks with higher proportions of Cr (93 wt%), less Fe (4 wt%), some O (2 wt%), and no Si.

Figure 83. Example of cross-sectioned alloy material, corrosion product, and ash deposit at 100x magnification (ORNL #17681 [4]).

Subsurface corrosion in the sample cross section examined includes a few long pits extending 85 to 129  $\mu\text{m}$  deep and 35  $\mu\text{m}$  wide into the sample. Oxidation appears to be the major mode of corrosion in these areas, since the constituents of the corrosion product in these pits are Cr, Si, O, and occasionally Fe. Trace S was present in the pits as well.

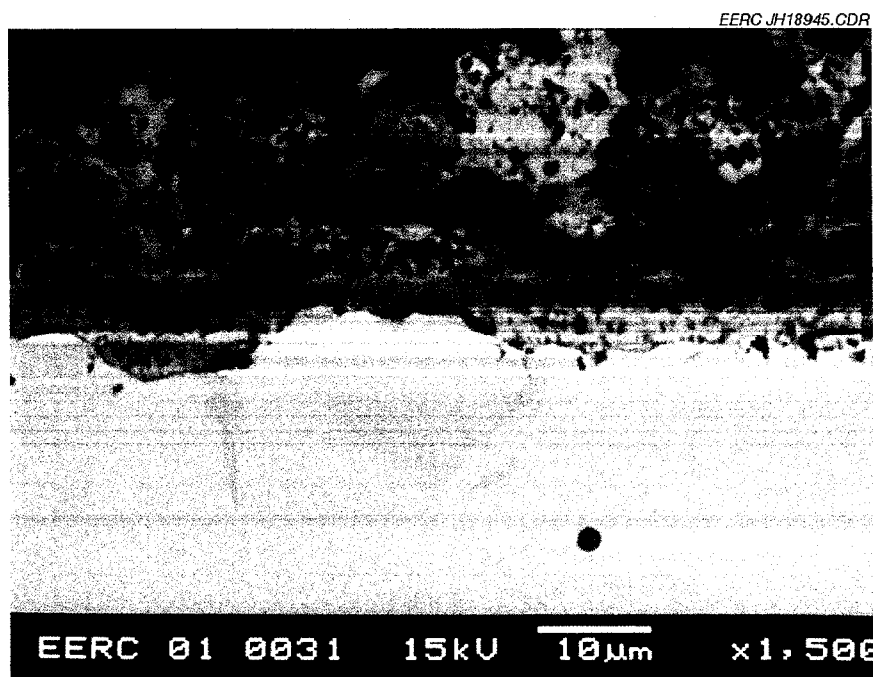
The surface of the sample exhibited almost no deep pitting, but it did show shallow pitting grading into a smoother surface recession as shown in Figure 84 at 1500 $\times$  magnification. This figure shows the alloy in white covered by a layer of corrosion product in light and medium gray and topped by heterogeneous corrosion product-ash layer. The corrosion layers detached from the alloy and from each other during epoxy polymerization, indicating weak bonding to the alloy. The alloy-corrosion product interface contains mainly Cr (39-75 wt%), Si (5-28 wt%), and O (14-30 wt%). The outer surface of this corrosion layer contained less Cr (12-28 wt%) and more Si (45 wt%), possibly infusing from the ash. Fe concentration in the corrosion layer is generally less than 5 wt%. The layer ranges in thickness from 6, to 20  $\mu\text{m}$ . The outer layer of corrosion contains several flue gas constituents, Ca, Si, Fe Al, Mg, and Ti (in order of decreasing proportion), and Cr at 11-57 wt%, suggesting that ash components in the flue gas assisted O in the corrosive degradation of the outer corrosion layer. No sulfidation or halide attack was indicated.

The ash deposit on the upstream face of the sample was originally up to 40 mm thick. A layer up to 1 mm thick remained on the sample after preparation, indicating more interaction with the alloy corrosion layer than most of the other samples, but was still relatively weak at the interface as indicated by separation during epoxy polymerization. SEM analysis indicated that the

Figure 84. Example of cross-sectioned alloy material, corrosion product, and ash deposit at 1500 $\times$  magnification (ORNL #17681 [4]).

ash 160  $\mu\text{m}$  from the outer corrosion layer had higher Fe (12 wt%) and Cr (9 wt%) content and lower Ca (4 wt%) content than the CAH bulk ash analysis. The Cr in the layer indicates some dissolution of the corrosion product into the ash layer.

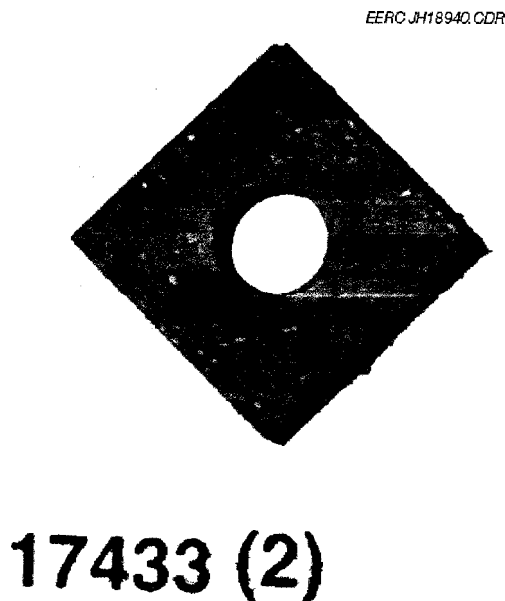
**Postexposure appearance:** Figure 85 shows the sample removed from the sample holder after the June test run. The large mass of ash deposited on the sample separated easily from the sample. The surface is dullish gray and covered with patches of ash particles. Visual inspection suggests that the sample has been corroded.

Figure 85. Metal Alloy ORNL #17433 (2) removed from the sample holder after the June test run.

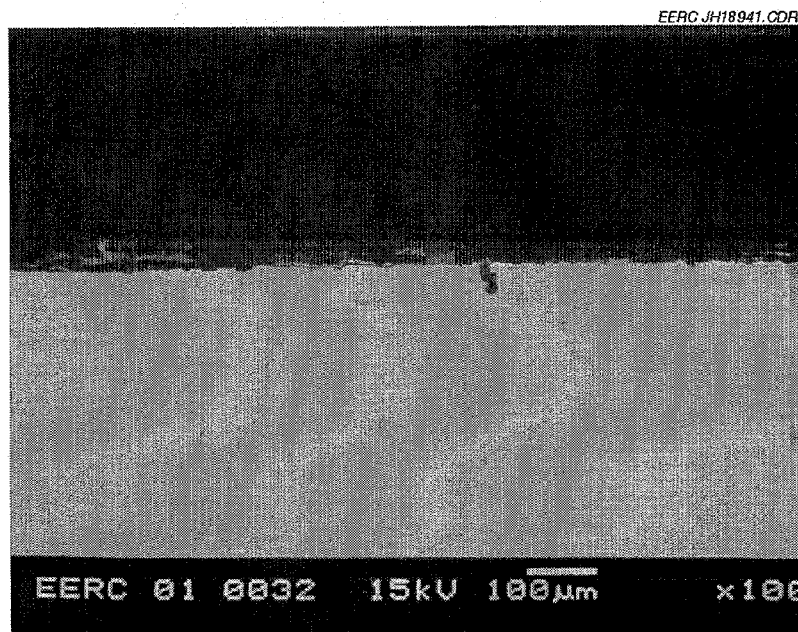
Figure 86. Example of cross-sectioned alloy material, corrosion product, and ash deposit at 100× magnification (ORNL #17433 [2]).

The sample underwent corrosion exhibited by both sporadic deep pitting of the surface and much shallower pitting grading into a relatively smooth oxidation. Figure 86 includes one of several deep pits in the sample, extending 52  $\mu\text{m}$  into the metal alloy and 21  $\mu\text{m}$  wide, as well as the shallow pitting which is more of a general, smoother, oxidation. Depth of shallow pitting was <10  $\mu\text{m}$ . Figure 87 shows that same deep pit at 1500× magnification. Composition at the alloy-corrosion product interface of pits and recession areas was constant. Constituents of the dark gray areas of corrosion product included 62 wt% Al, 33 wt% O, 4 wt% Fe, and 1-6 wt% S, with traces of Cr and, occasionally, Ti, P, Si, K, or Ca, suggesting the loss of Fe from the sample and formation of an Al-O skin resulting from oxidation by the flue gas constituents. Also visible in the alloy-corrosion product interface of the pit are a few light gray patches. These illustrate initiation of corrosive attack in progress, with decreasing Fe levels (63 wt%), increasing Al levels (30 wt%), and the presence of some O (3 wt%). At the surface, the transition areas include higher concentrations of O (18 wt%). These are present in Figure 87 as the white patches at the surface on either side of the pit. The deepest pit observed in the sample cross section extended 280  $\mu\text{m}$  into the sample.

The corrosion product at the surface contains mostly areas with element proportions similar to those at the alloy interface (dark gray in the figures), but occasional spots of nearly pure Fe (83 wt%) O (14 wt%) are also present. At 67-83 wt%, Al remains the dominant element in the thin corrosion layer at the sample surface, likely having formed a partially oxidized layer with the 1-20 wt% O present. Minor constituents at the sample surface include 2-7 wt% Fe, 1-2 wt% Cl, and 2 wt% S and Si.

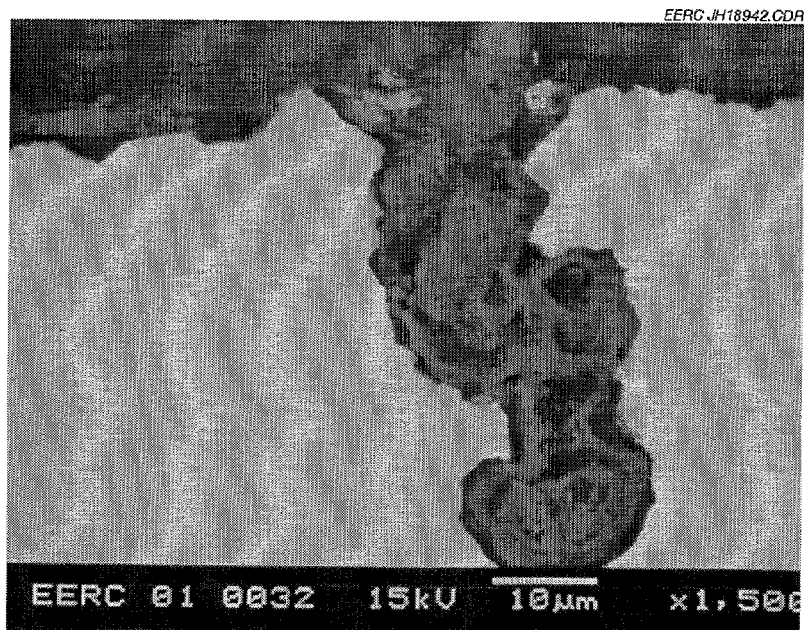
Figure 87. Example of cross-sectioned alloy material, corrosion product, and ash deposit at 1500× magnification (ORNL #17433 [2]).

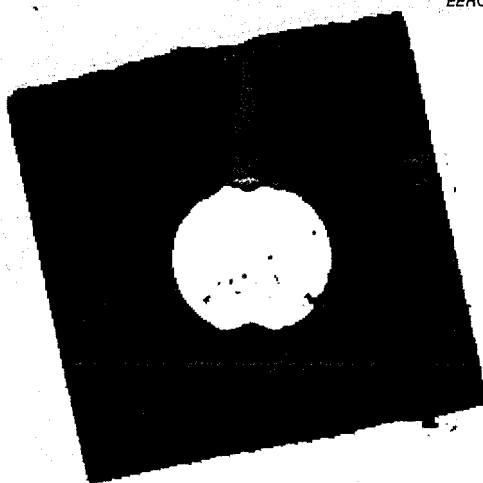
**310 HCBN**

**Postexposure appearance:** The Swindeman samples were all exposed in an elbow following the process air-tube and-shell heat exchanger, which immediately follows the convective pass in which the previous samples were exposed. Average gas temperature for the Swindeman samples was 708°C. Figure 88 shows the sample removed from the sample holder after the June test run. The surface is coated with a thin brown layer of ash particle. The sample appears intact.

Figure 88. Alloy ORNL #310HCbN SS (HR3C Weld)-1 removed from the sample holder after the June test run.
